**U.S. EPA, Region 5 Enforcement and  
Compliance Assurance Division  
77 West Jackson Street, Chicago, IL 60604**

**UNPERMITTED INDUSTRIAL FACILITY STORMWATER INSPECTION REPORT**

<b>Inspection Date(s):</b>			5/3/2022		
<b>Time:</b>			<b>Entry: 9:40 AM</b>		<b>Exit: 10:35 AM</b>
<b>Weather Conditions:</b>			Light rain, Temperature 45°F		
<b>Media/Program:</b>			Water – CWA §§ 301, 402 – Industrial Stormwater		
<b>Operator Name:</b>			Welch Bros., INC.		
<b>Owner Name:</b>			Brad Welch		
<b>Facility or Site Name:</b>			Welch Bros., INC.		
<b>Permit ID or Tracking # (leave blank if no permit):</b>					
<b>SIC Code(s) (Primary &amp; Relevant Others):</b>			3441		
<b>Facility Address:</b>			333 Hammond Ave.		
<b>(City, State, Zip Code)</b>			Elgin, IL		
<b>County:</b>			Cook and Kane Counties		
<b>Geographic Coordinates:</b>			Lat/Long: 42.015294, -88.271280		
<b>Operator Mailing address:</b>			1050 St. Charles Street, P.O. Box 749, Elgin, IL 60121-0749		
<b>Owner Mailing address:</b>			1050 St. Charles Street, P.O. Box 749, Elgin, IL 60121-0749		
<b>Regular Days/Hours of Operation:</b>			6:00 am – 4:00 pm, Monday - Saturday

**Welch Brothers, Inc.**  
**EPA Inspection 5/3/2022**  
*

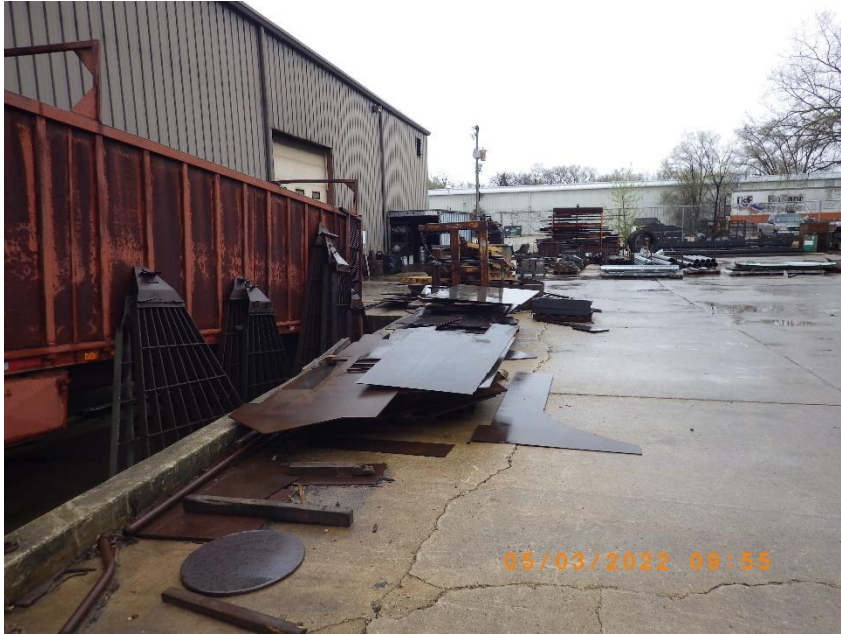
1: RIMG2606

Description: Steel products stored on the concrete yard of Welch Brothers Inc.

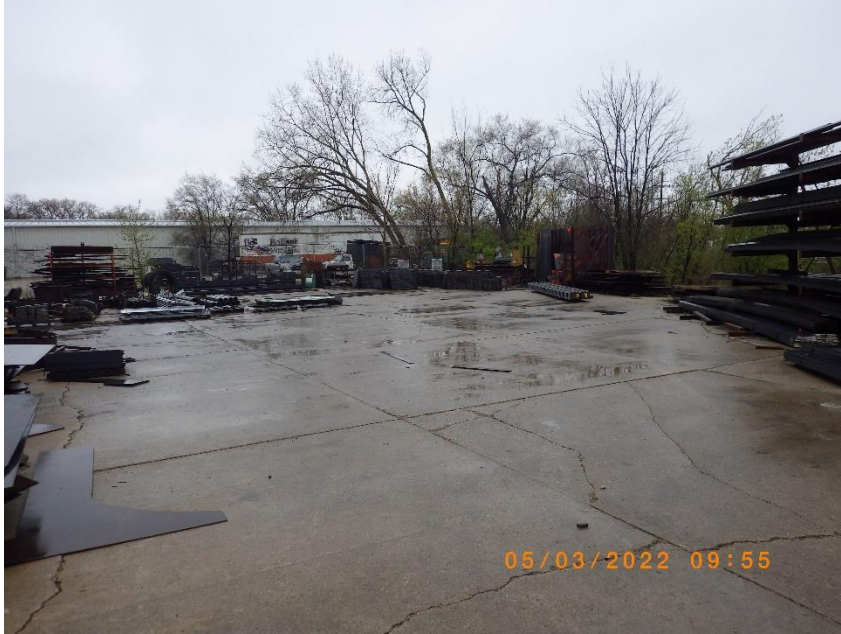
2: RIMG2607

Description: Steel products stored on the concrete yard of Welch Brothers Inc.

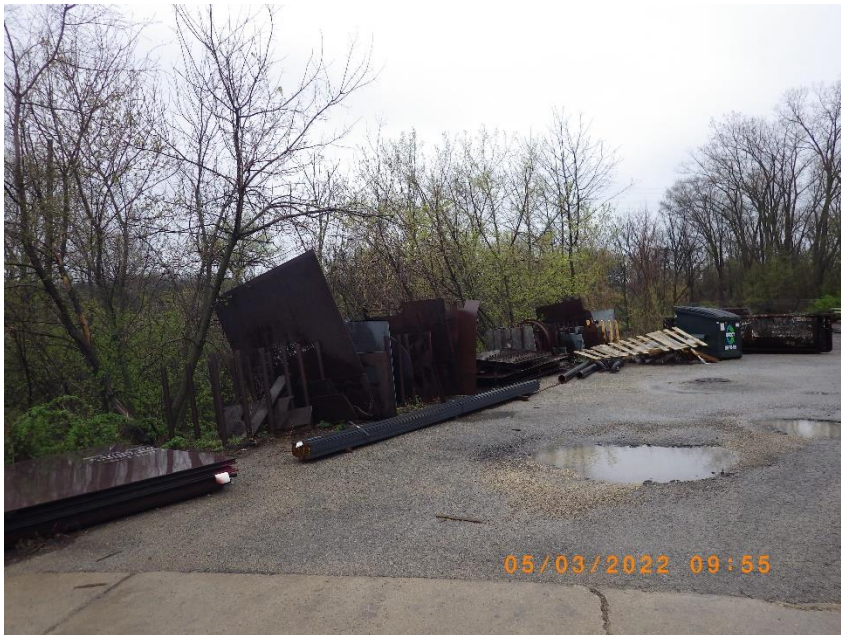
3: RIMG2608

Description: Steel products stored close to the banks of Poplar Creek.

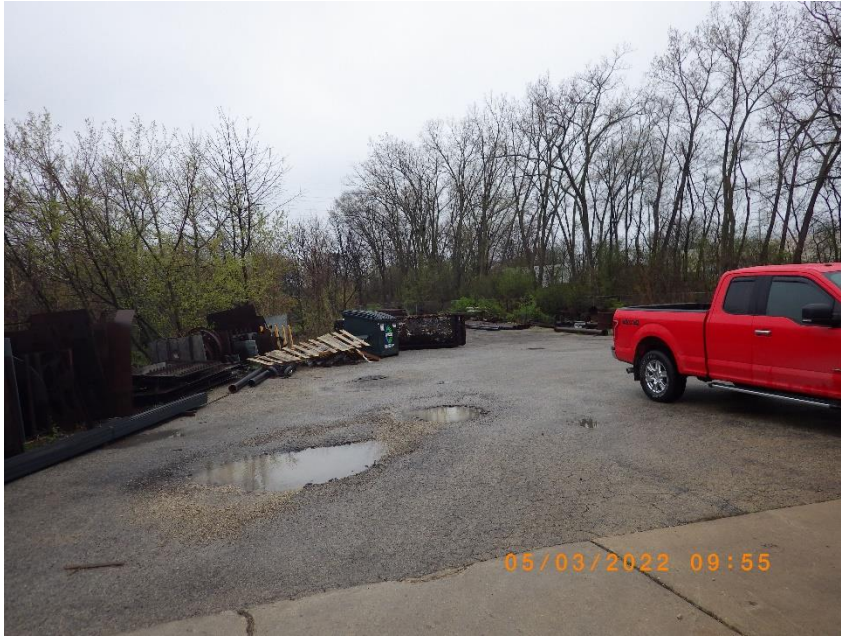
4: RIMG2609

Description: Steel products and wooden pallets stored on the yard of Welch Brothers Inc.

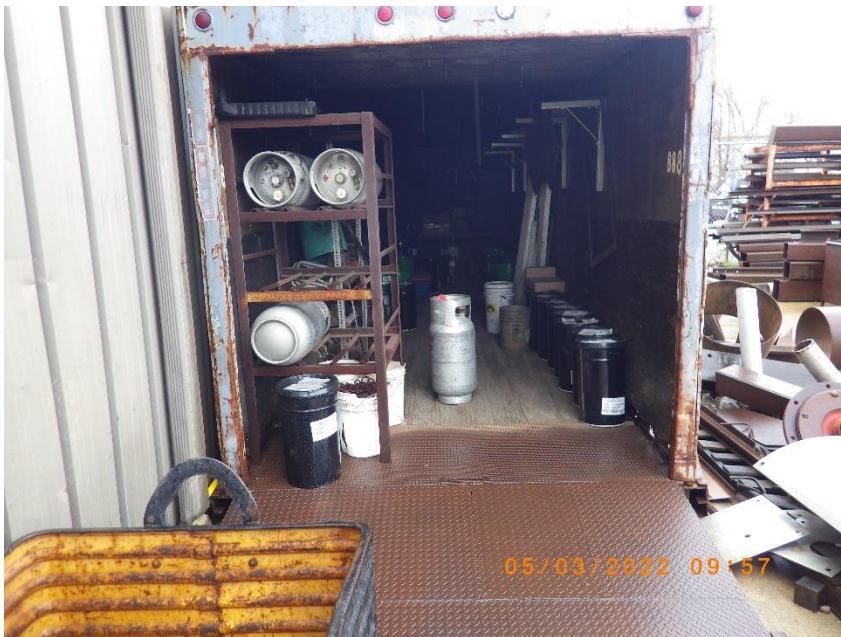
5: RIMG2610

Description: Indoor storage area with buckets filled steel material.

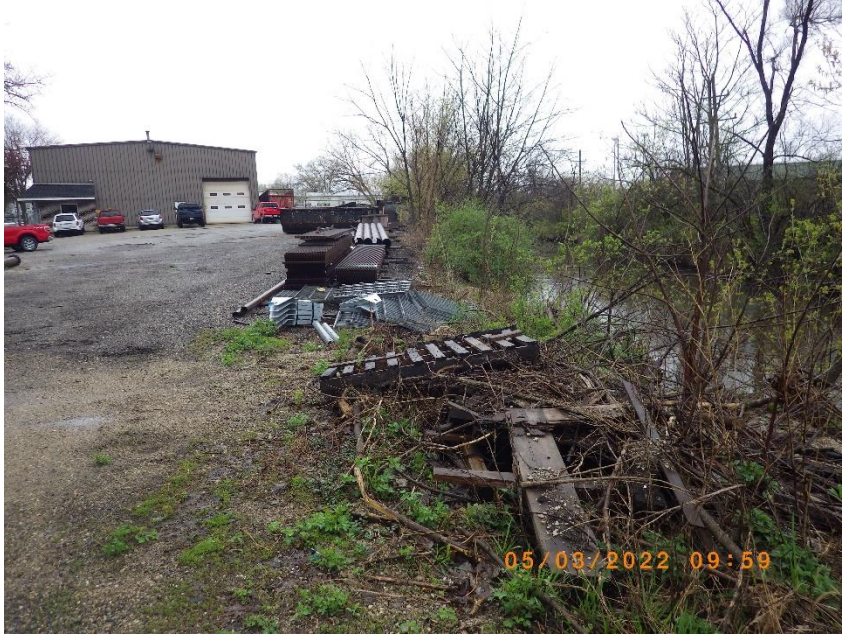
6: RIMG2611

Description: Steel products and wooden pallets stored on the yard on the banks of Poplar Creek.

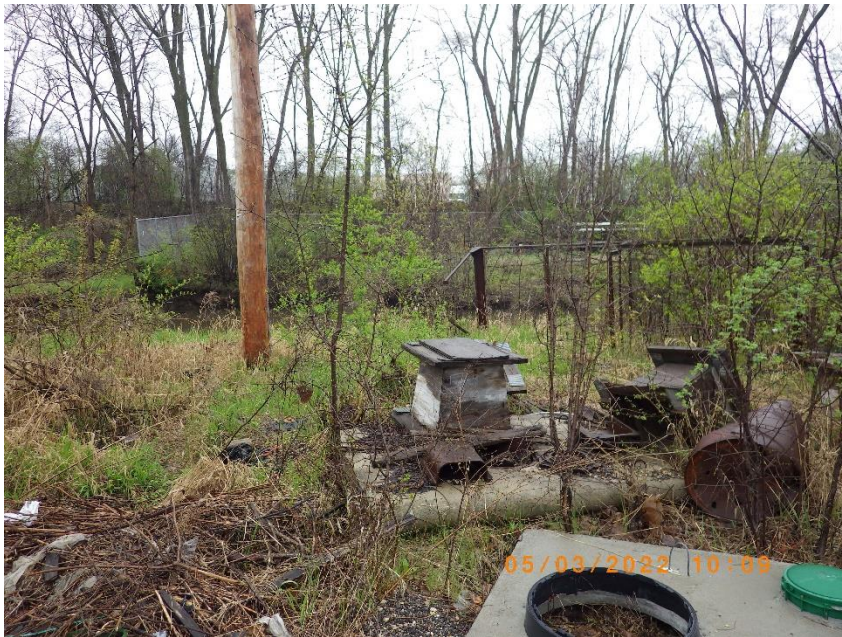
7: RIMG2612

Description: Concrete and wooden material on the retail facility's yard.

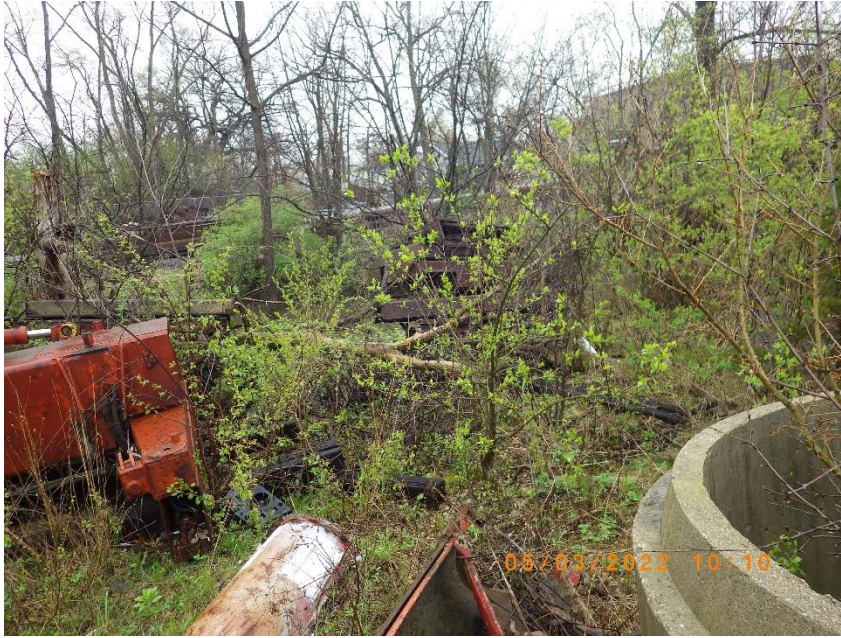
8: RIMG2613

Description: Concrete and wooden material on the retail facility's yard.

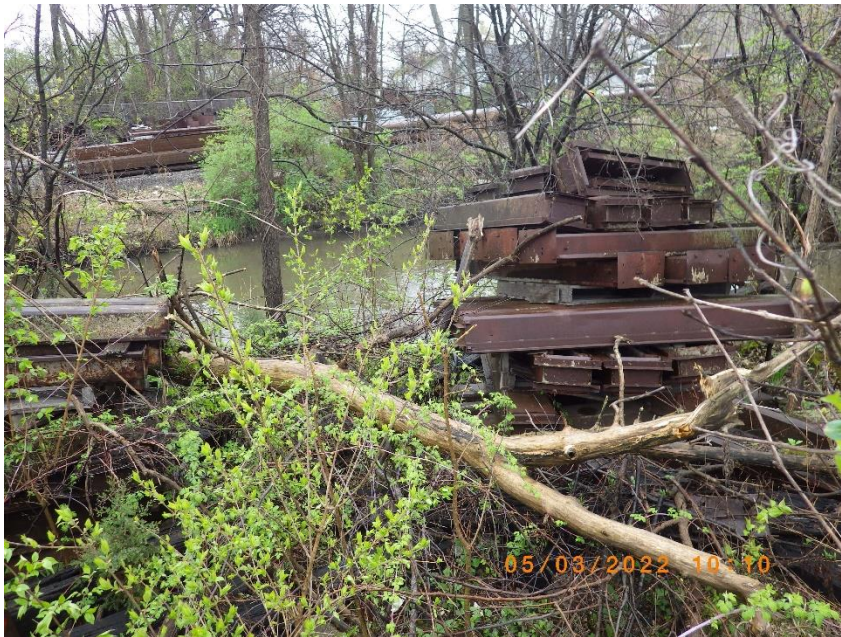
9: RIMG2614

EPA observed some steel products on the banks of the Poplar Creek that could potentially fall into the Poplar Creek if the tree holding them broke or was uprooted during a highwater situation.

Description: Pile of steel product leaning against a tree on the south bank of Poplar Creek.

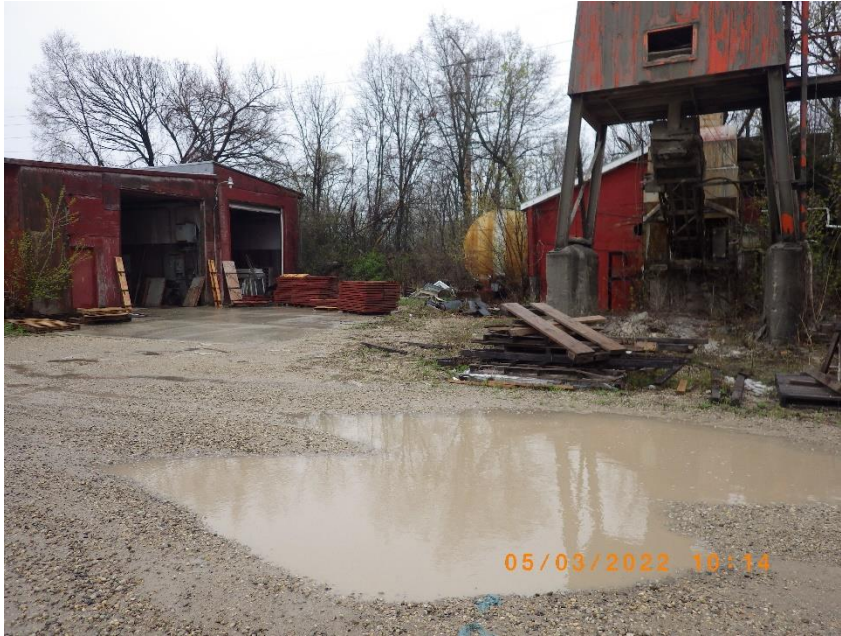
10: RIMG2615

Description: Gravel yard at the retail store and covered storage structure.

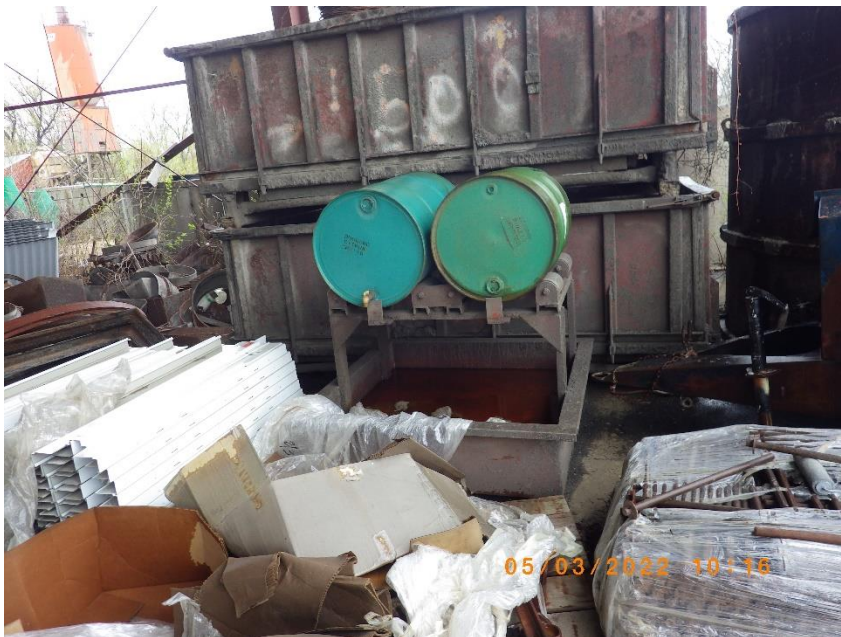
11: RIMG2616

Description: Tanks contains Duoguard Citrus oil used on concrete products.

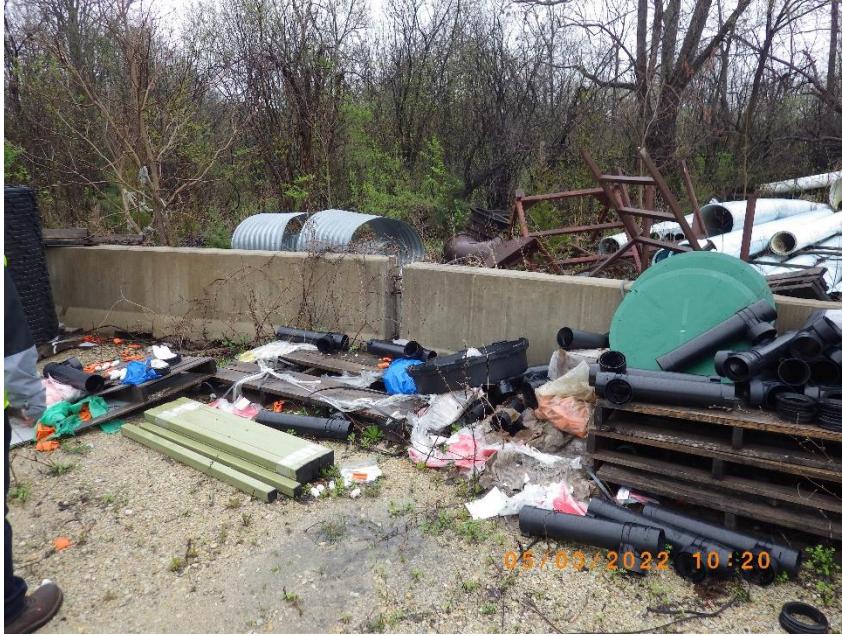
12: RIMG2617

EPA observed some trash (plastic bags and bottles) along the property line and on the banks of the Poplar Creek, on the retail side of the facility.

Description: PVC pipes and plastic bags at the retail store in an area surrounded by concrete blocks next to Poplar Creek.

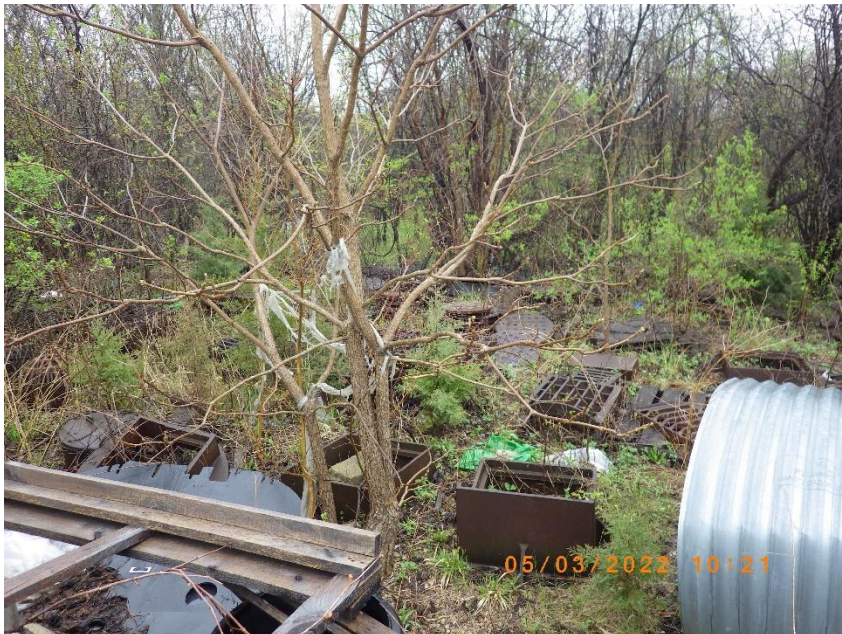
13: RIMG2618

Description: Steel products close to the banks of Poplar Creek at the retail store.
