INSPECTION REPORT

| <b>Facility or Site Name:</b> | ALASKA DOT & PF 6860 GLACIER HWY | | |

Type of inspection: CEI - Compliance Evaluation Inspection

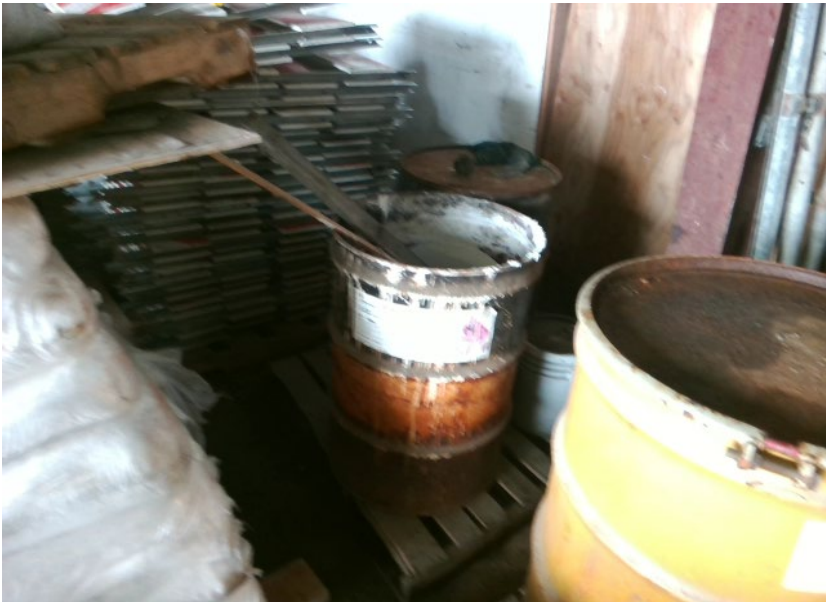
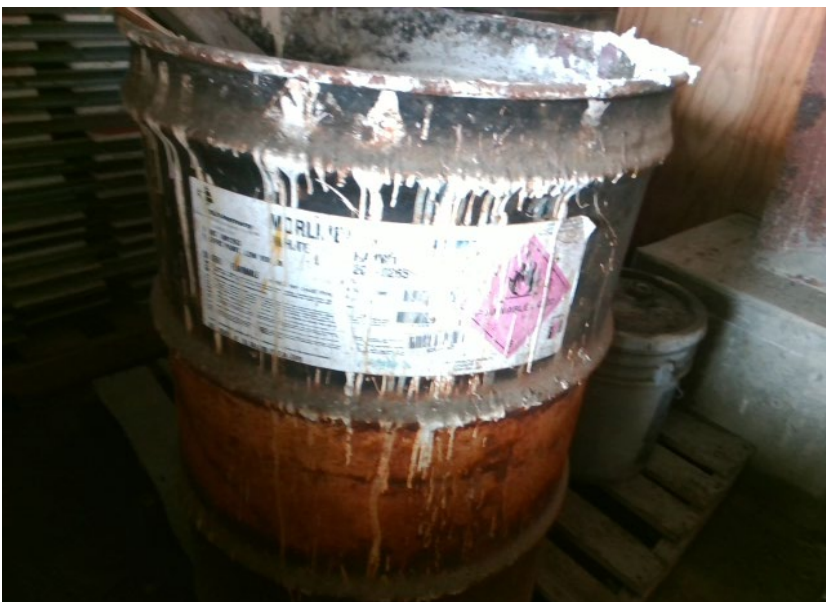
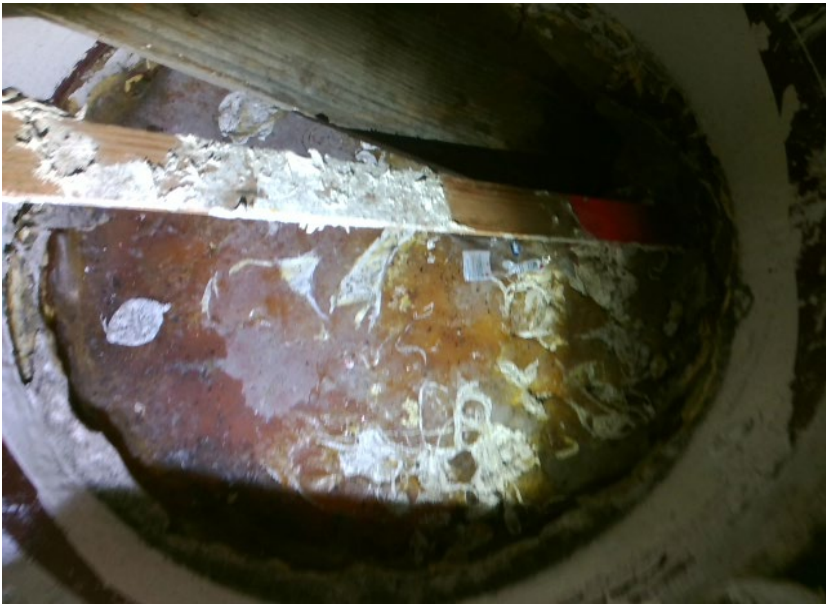
| <p>While inspecting the Cold Shed, I saw two 55-gallon containers on a pallet. One container was open and more than half full of solid, hardened, white traffic paint. The label on the container indicated that the ingredients of the paint included Methyl Ethyl Ketone (2-Butanone). The label also contained an ignitable hazard indicator. The container that held hardened white traffic paint was open and I saw two small wooden boards that were sticking out of the container. The other container felt as though it was full when I pushed on it, looked old and rusty and according to the label, contained Toluene. While inspecting these containers, we were joined onsite by Mr. Tunley, Safety officer.</p> <p>Mr. Spencer Gates, M&amp;O Equipment Operator Foreman, told me they got rid of approximately 12 containers of paint last spring and said I should talk to Marcus Zimmerman, M&amp;O Specialist, for more information. I asked Mr. Gates for a safety data sheet for the white traffic paint and toluene. SDS's for both were provided by the facility either during or shortly following the inspection.</p> <p>Mr. Gates said the vendor (Clean Harbors) they used to pick up the 12 containers of waste paint last spring would not take two additional containers in the shipment of waste because the contents of those containers was unknown to Clean Harbors. At the time of the inspection, there seemed to be some confusion as to which two containers Mr. Gates was referring to that were not picked up by Clean Harbors. At the time of the inspection, no one had any information regarding how long either of the 55-gallon containers had been onsite. Just prior to leaving the area where these containers were located, Mr. Gates told me that the container of Toluene was good product and not a waste.</p> | |

| <b>Building: Cold Shed</b> | | |
|---|---|---|
| While in the Cold Shed, I saw two 55-gallon containers on a pallet. One container was half-full of hardened, white traffic paint. The other container felt as though it were full, looked old and rusty and according to the label, contained Toluene. | <b>Citation:</b> | <b>Section:</b> |

| <div data-bbox="67 622 687 674">[Title]</div> <div data-bbox="67 674 687 768">Observation_Image-202104121259565956271225.jpg</div> <div data-bbox="67 768 687 819">04/12/2021 12:59 PM (AKT)</div> <div data-bbox="67 819 687 871">Jon Jones</div> <div data-bbox="67 871 687 922">Cold Shed</div> <div data-bbox="67 922 687 974">No CBI</div> <div data-bbox="67 974 687 1025">No PII</div> <div data-bbox="67 1025 687 1339">View of open container that was half full of hardened, white traffic paint.</div> | |
| <div data-bbox="67 1339 687 1391">[Title]</div> <div data-bbox="67 1391 687 1485">Observation_Image-20210412130041041289380.jpg</div> <div data-bbox="67 1485 687 1536">04/12/2021 01:00 PM (AKT)</div> <div data-bbox="67 1536 687 1588">Jon Jones</div> <div data-bbox="67 1588 687 1639">Cold Shed</div> <div data-bbox="67 1639 687 1691">No CBI</div> <div data-bbox="67 1691 687 1742">No PII</div> <div data-bbox="67 1742 687 2056">Close-up view of the label on the open container that was half full of hardened, white traffic paint.</div> | |

| <p>[Title]</p> <p>Observation_Image-2021041213010616296971.jpg</p> <p>04/12/2021 01:01 PM (AKT)</p> <p>Jon Jones</p> <p>Cold Shed</p> <p>No CBI</p> <p>No PII</p> <p>Close-up view looking down into the open container that was half full of hardened, white traffic paint.</p> | |

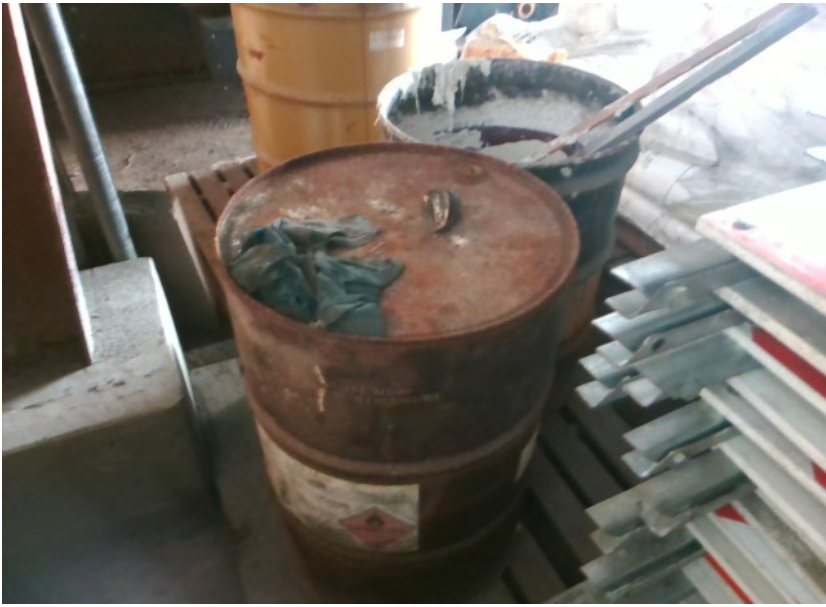
| <p>[Title]</p> <p>Observation_Image-20210412130226226259617.jpg</p> <p>04/12/2021 01:02 PM (AKT)</p> <p>Jon Jones</p> <p>Cold Shed</p> <p>No CBI</p> <p>No PII</p> <p>Another view of the open container that was half full of hardened, white traffic paint, and next to a 55-gallon container labeled as Toluene.</p> | |

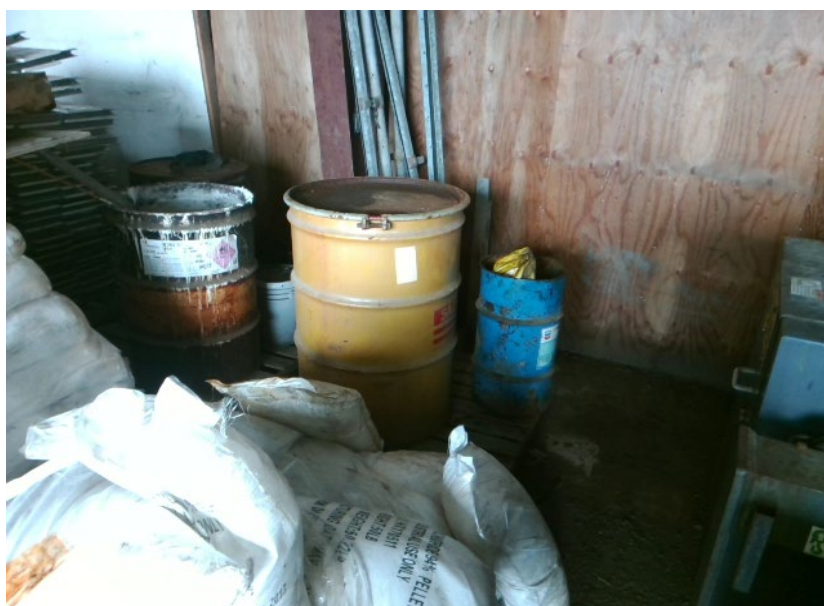
| <p>While in the same area where the containers of hardened white traffic paint and toluene were observed, I also saw an 85-gallon overpack salvage drum that contained something. I asked Mr. Gates what the salvage drum contained and he said he wasn't sure. I explained that a waste determination would need to be made regarding the contents of the overpack salvage drum. Mr. Gates indicated that this was one of the two containers that was not picked up by Clean Harbors originally referenced in JJ1-OB-009.</p> | |

| View of an 85-gallon salvage drum that held unknown contents. I asked Mr. Gates what the salvage drum held and he said he wasn't sure. |

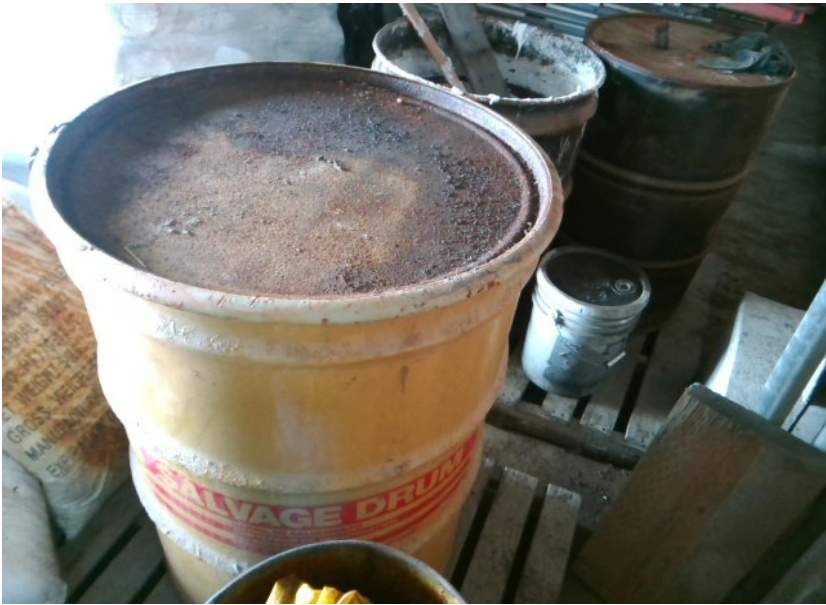
| Another view of the 85-gallon salvage container with unknown contents. | |

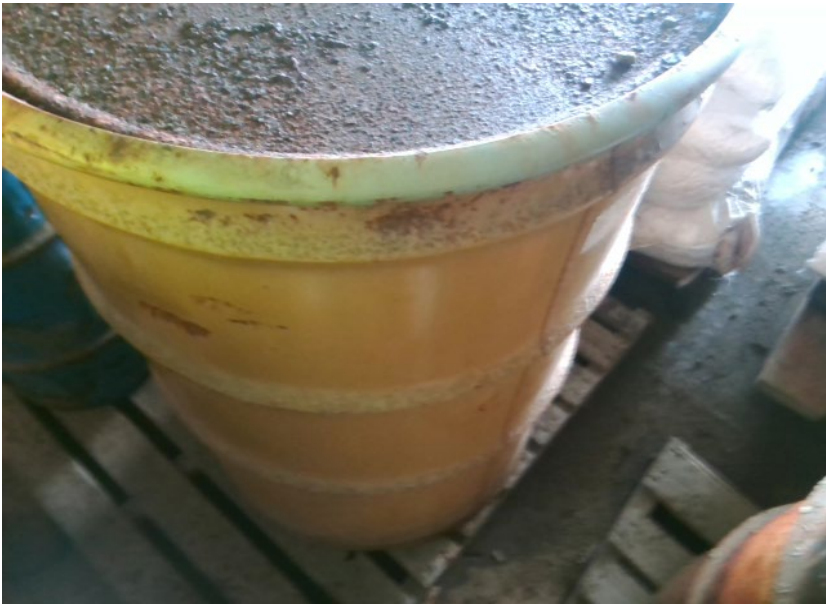
| Another view of the 85-gallon salvage container with unknown contents. | |

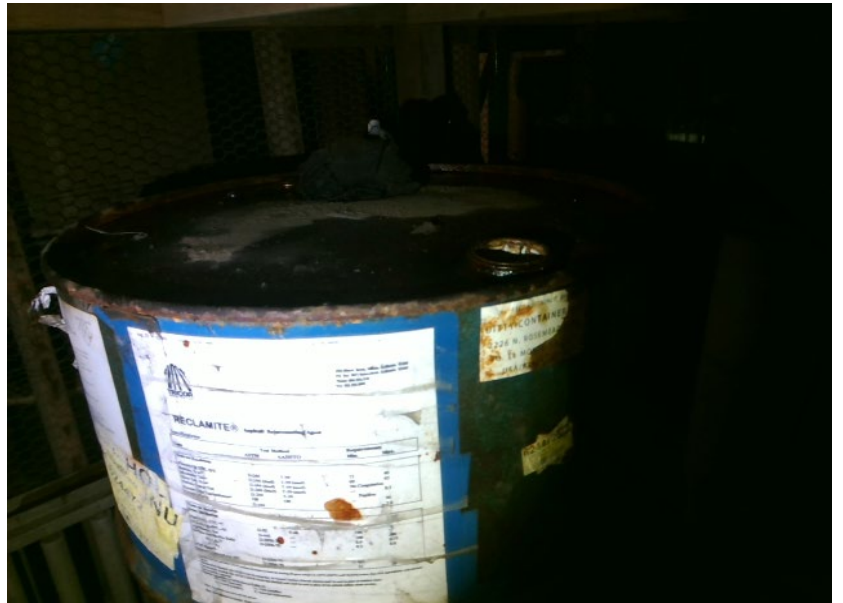
Another view of 55-gallon container label  
marked as being Reclamite.

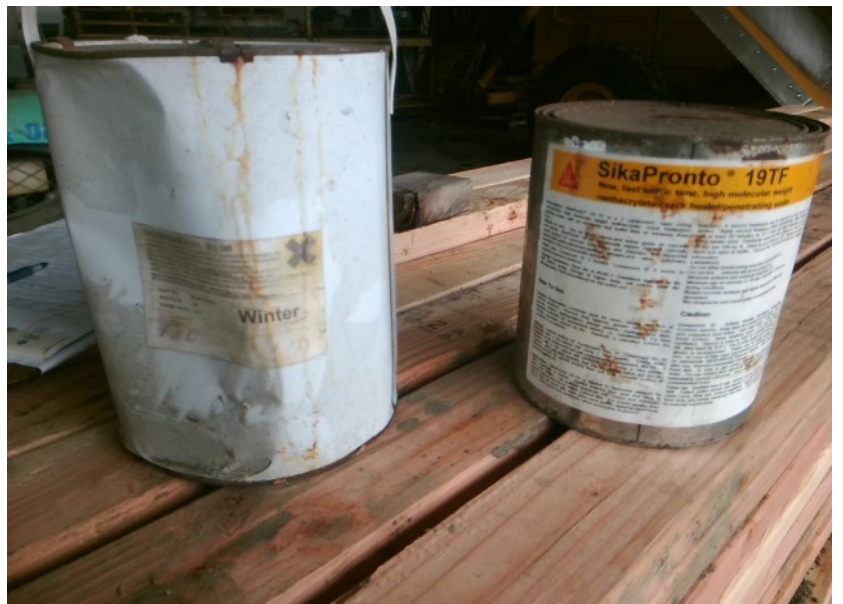
| <p>While inspecting another area of the cold shed, I saw a pallet containing various one-gallon cans of a resin and a road penetrating sealer, as well as other miscellaneous containers. Writing on the resin container read, "Do not allow to freeze." In addition to the containers that were sitting loose on the pallet, there were also approximately 22 boxes of one-gallon cans on the pallet. During the inspection I asked for an inventory and SDS's for the items on the pallet. Mr. Tunley provided the information to me following the inspection. A cursory review of the inventory indicated that there were fifty, one-gallon containers containing Sitka Pronto 19TF Modified Methacrylate Crack Sealer Part A with a DOT Category of 3 (Flammable). According to the SDS, the Crack Sealer has a flashpoint of 135°F. At the time of the inspection, this pallet and its contents were located in</p> | |

Various one-gallon cans of a resin and a road  
penetrating sealer observed on a pallet.  
Writing on the resin container says do not  
allow to freeze. Approximately 22 boxes on  
pallet.

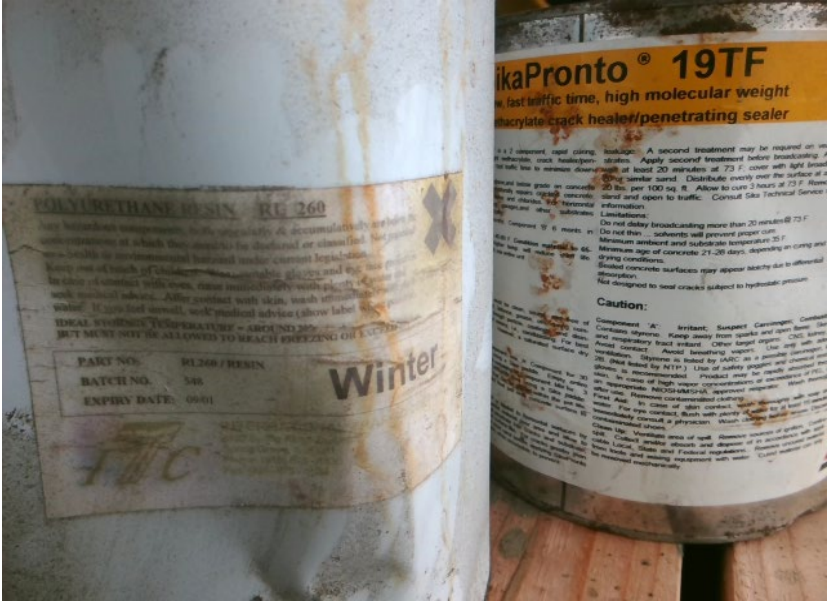
| Close-up view of the labels on various one-gallon cans of a resin and a road penetrating sealer. Writing on the resin container does not allow to freeze. Approximately 22 boxes on pallet. | |

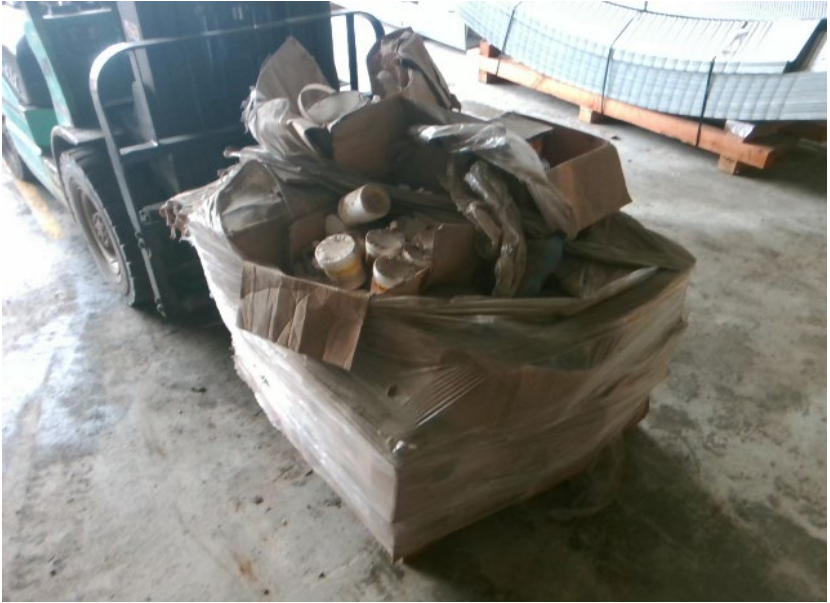
| View of the pallet containing various one-gallon cans of a resin and a road penetrating sealer. Approximately 22 boxes on pallet along with other miscellaneous containers. | |

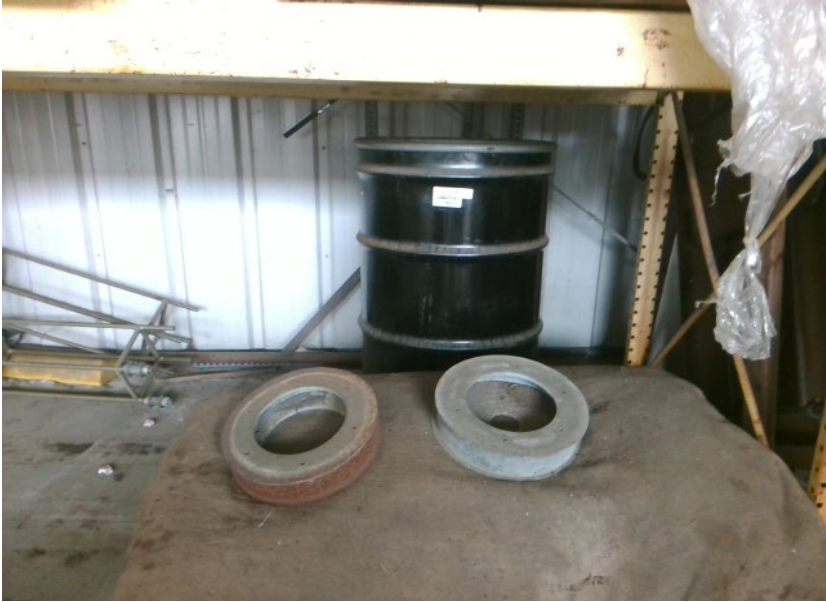
| <p>[Title]</p> <p>Observation_Image-202104121337553755265440.jpg</p> <p>04/12/2021 01:37 PM (AKT)</p> <p>Jon Jones</p> <p>Cold Shed</p> <p>No CBI</p> <p>No PII</p> <p>View of unlabeled 55-gallon container, that was next to pallet of resin beneath the steel shelving.</p> | |

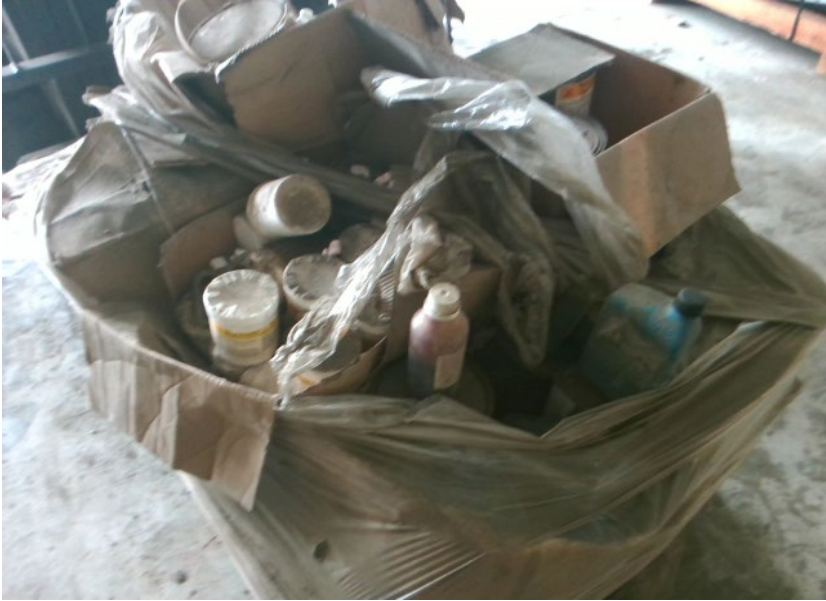
| <p>[Title]</p> <p>Observation_Image-20210412133807387275125.jpg</p> <p>04/12/2021 01:38 PM (AKT)</p> <p>Jon Jones</p> <p>Cold Shed</p> <p>No CBI</p> <p>No PII</p> <p>Close-up view of the contents of the pallet.</p> | |

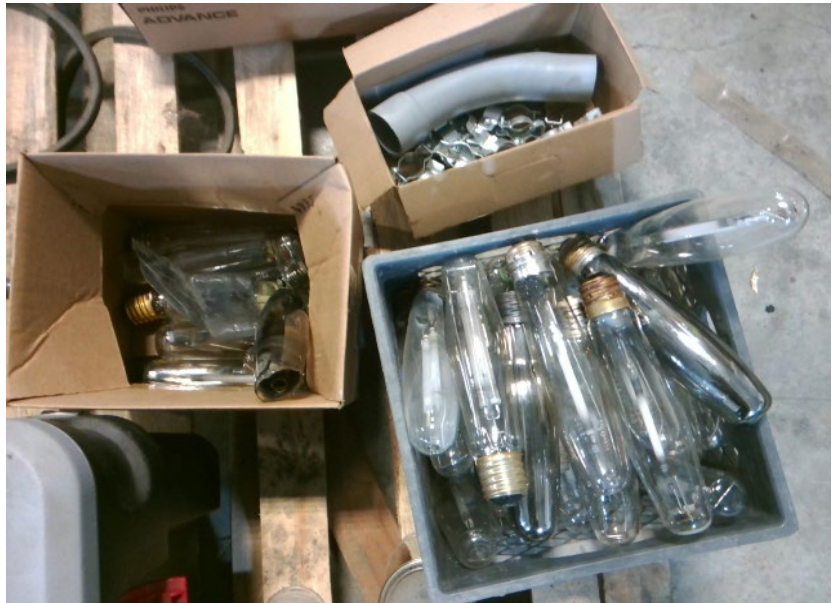
During the inspection I saw two small cardboard boxes that contained waste high-pressure sodium light bulbs. I saw approximately 36+ waste bulbs and one of the bulbs was broken. Mr. Gates asked me how the lamps should be managed and I told him that his facility would need to make a hazardous waste determination and at that point they could determine how to manage the bulbs. At that point, I was told that the lamps and bulbs that were generated at State of Alaska facilities were being managed by the Division of Facility Services. I was told that when lamps and bulbs burn out, Facility Services sends someone out to replace the waste lamps/bulbs with new lamps/bulbs. Facility Services then takes all the waste lamps and bulbs to their shop and puts them through their bulb crusher. Following the inspection, I received an email from Mr. Tunley with an updated inventory, dated 4/15/2021. In that email, Mr. Tunley told me, "I've updated the inventory we provided to you. I've revised the counts: - 47 High-pressure sodium bulbs - 10 fluorescent light tubes Also note that these bulbs were crushed by the Division of Facility Services in their bulb crusher."

During the inspection I saw two small cardboard boxes that contained waste high-pressure sodium light bulbs. I saw 36+ waste lamps and one was broken. Mr. Gates asked how the lamps should be managed and I told him that his facility would need to make a hazardous waste determination. Following the inspection, the facility updated the inventory, indicating that there were 47 High-pressure sodium bulbs and 10 fluorescent light tubes. The bulbs and lamps were not labeled and there was no indication of when the bulbs/lamps first became a waste.

Close-up view of the waste high-pressure sodium bulbs. A broken bulb can be seen in the bottom right-hand corner of the box on the left.

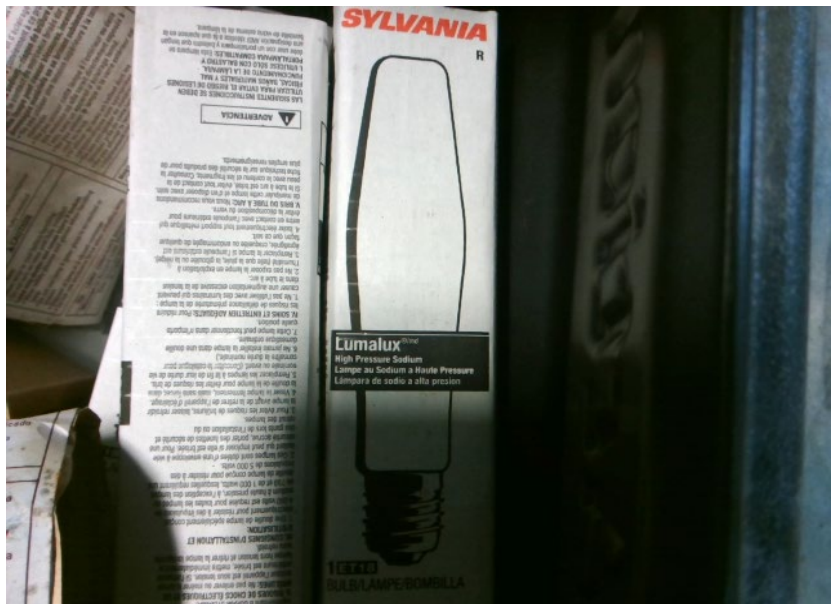
Close-up view of a high-pressure sodium bulb sleeve, showing the manufacturer information.

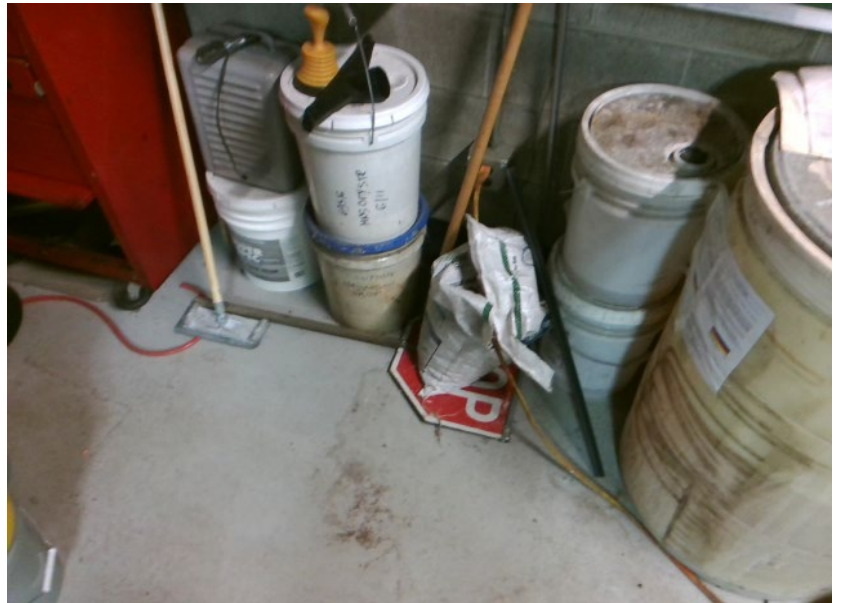
While in the boiler room, I saw a five-gallon container that was marked with the words "Caution Hazardous Waste" and the date 9-17-02. I picked up the container and estimated it was one third full of an unknown waste. Mr. Wolfe told me that the ADOT&PF Facilities group was maintaining the equipment in the boiler room. Mr. Wolfe said he would check with Mr. Bill Campbell, Building Maintenance Foreman, to see if he knew what was in the container. At the time this inspection report was written, the contents of the container were still unknown.

| While in the boiler room, I saw a five-gallon container that was marked with the words "Caution Hazardous Waste" and the date 9-17-02. At the time of the inspection there was no other information available regarding the container or its contents. The container was not marked with a hazard indicator. | <b>Citation:</b> | <b>Section:</b> |

View of a five-gallon container that was marked with the words "Caution Hazardous Waste" and the date 9-17-02. The container is seen here with the blue lid.

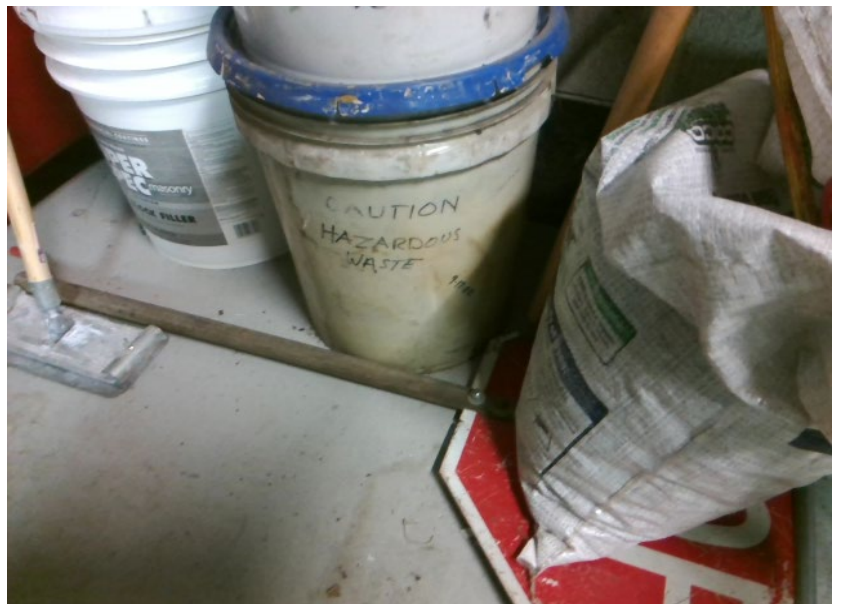
Close-up view of the five-gallon container that was marked with the words "Caution Hazardous Waste" and the date 9-17-02.

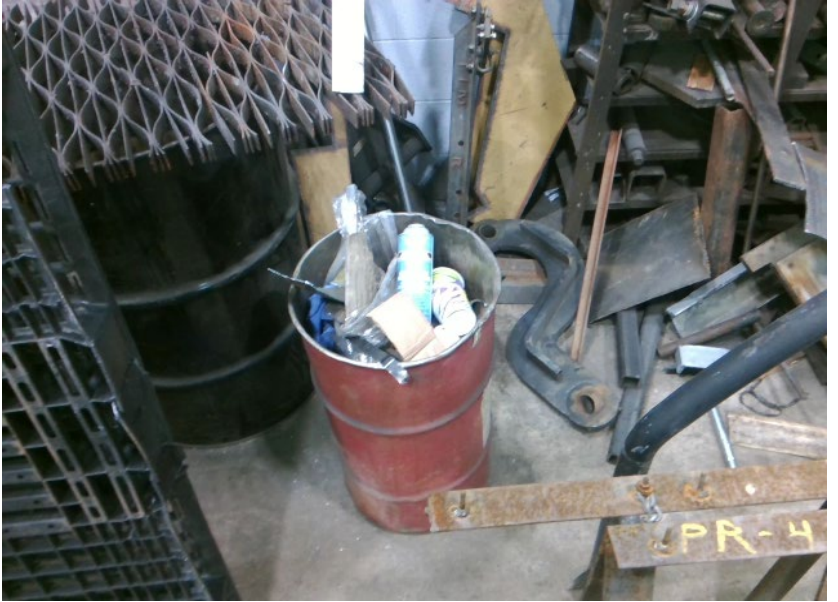
| View of waste aerosol can inside a trash receptacle, in the welding room. | |

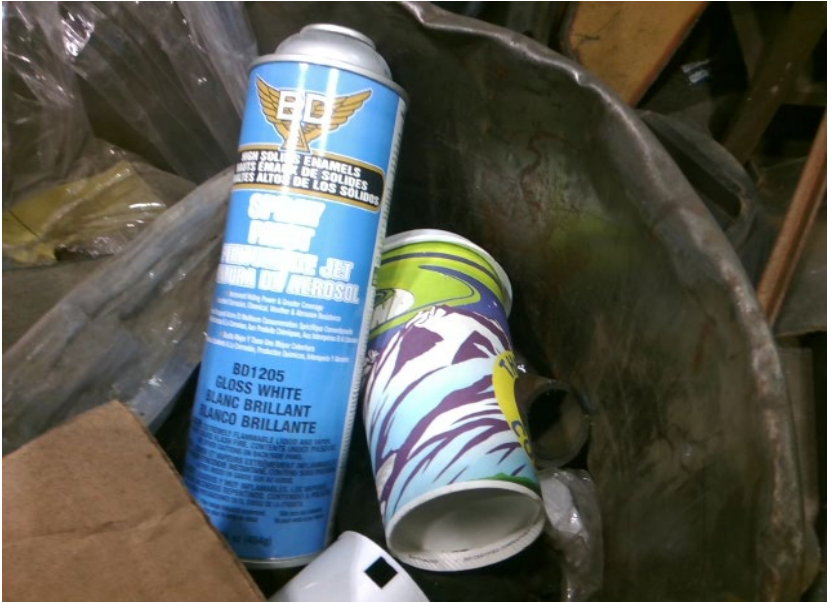
| Close-up view of same waste aerosol can inside a trash receptacle, in the welding room. | |

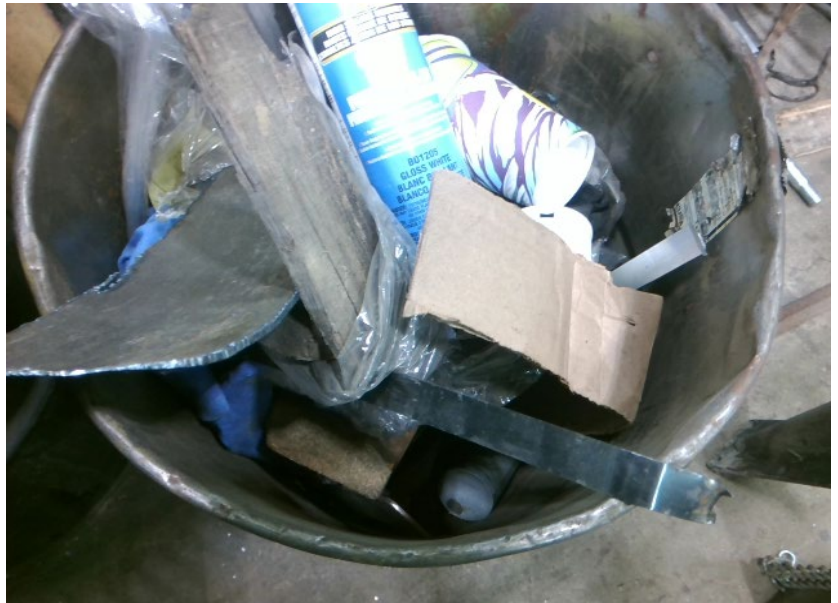
View of second waste aerosol can in the bottom of the trash receptacle, in the welding room.

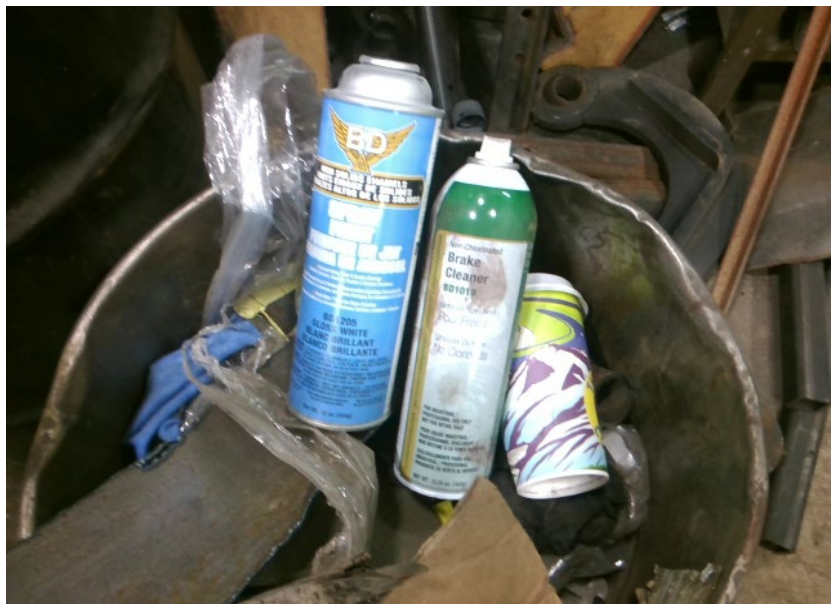
Close-up view of both waste aerosol cans inside a trash receptacle, in the welding room.

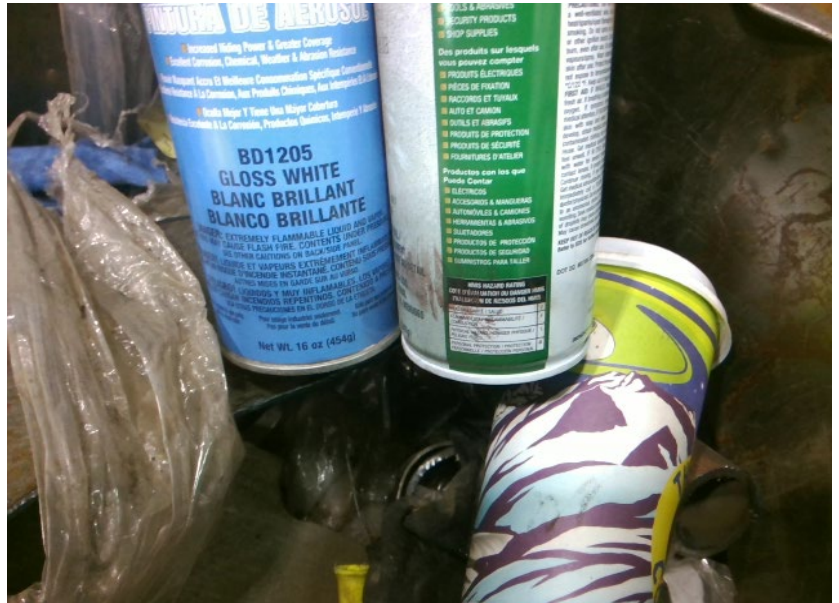
Close-up view of the labeling on the waste aerosol cans inside a trash receptacle, in the welding room.

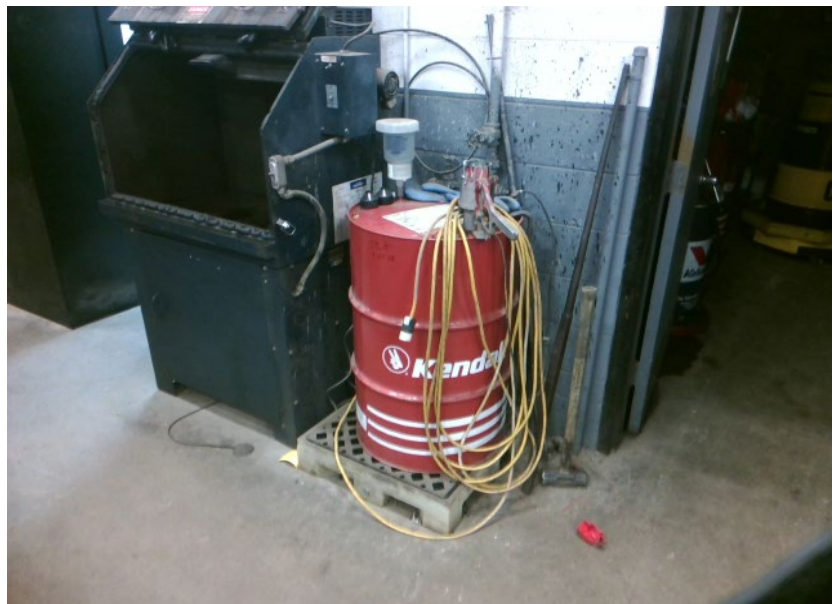
View of the SAA container with attached aerosol can popper.

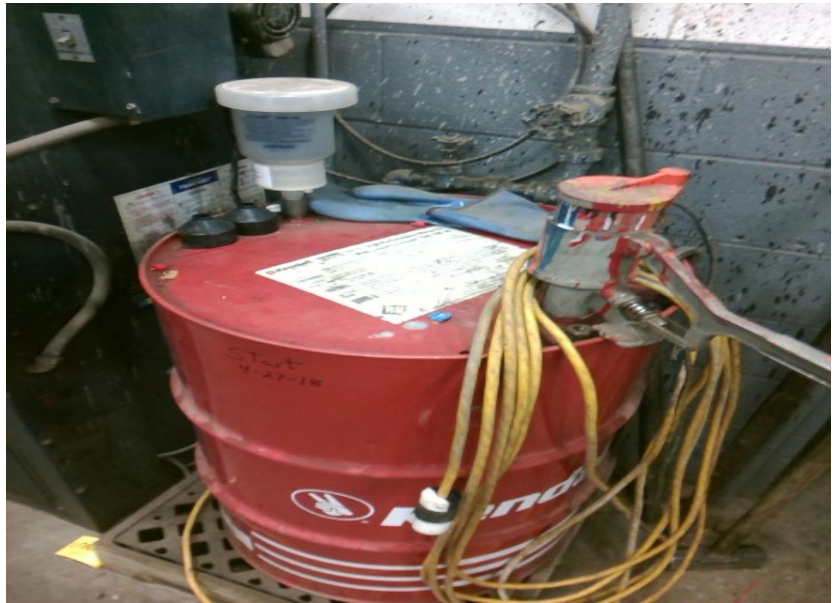
Mr. Wolfe closed the container during the inspection by placing the lid back on the aerosol can popper.

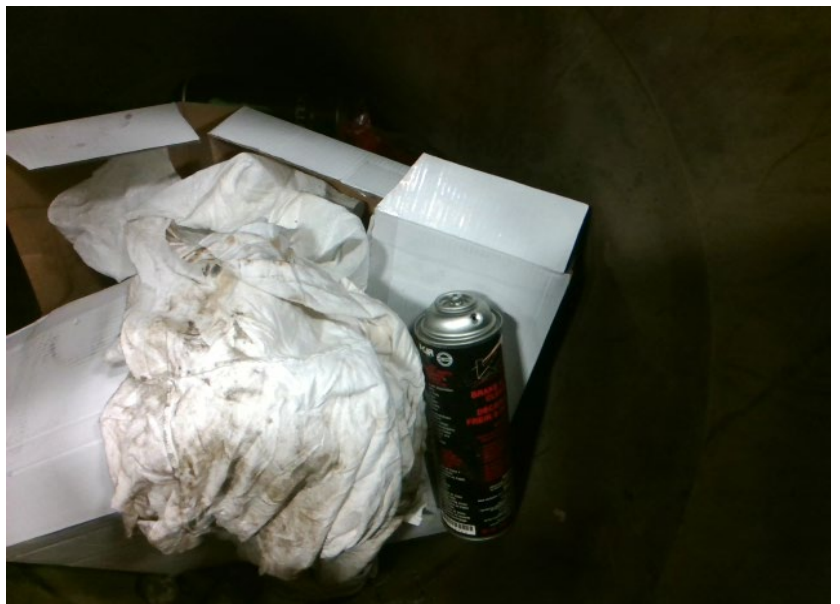
View of a punctured aerosol can in the trash.

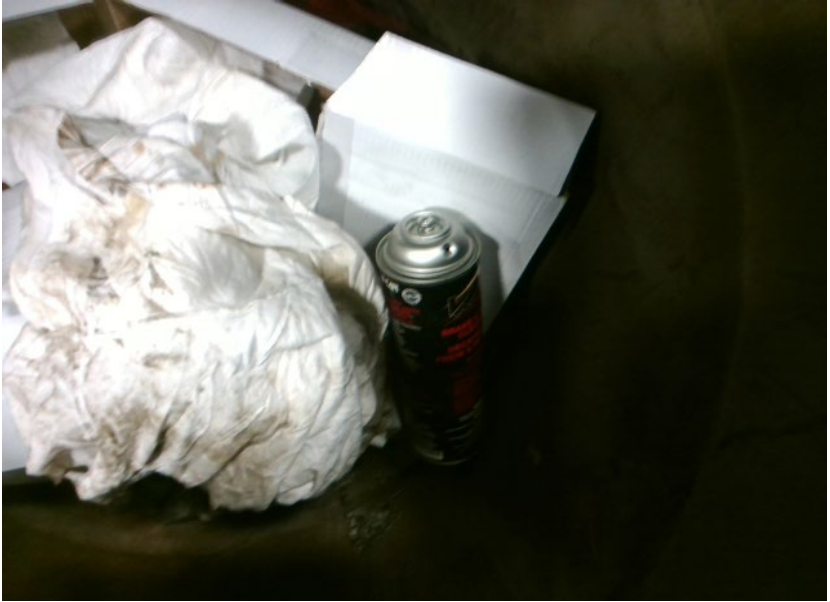
| <p>[Title]</p> <p>Observation_Image-202104121126302630229247.jpg</p> <p>04/12/2021 11:26 AM (AKT)</p> <p>Jon Jones</p> <p>Equipment Shop/Vehicle Maintenance</p> <p>No CBI</p> <p>No PII</p> <p>Close-up view of a punctured aerosol can in the trash.</p> | |

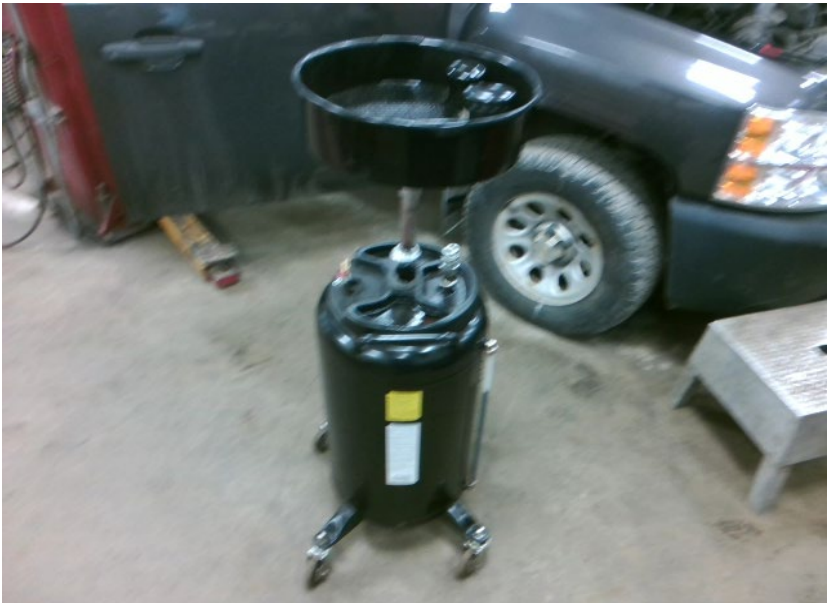
| <p>[Title]</p> <p>Observation_Image-20210412113203323257203.jpg</p> <p>04/12/2021 11:32 AM (AKT)</p> <p>Jon Jones</p> <p>Equipment Shop/Vehicle Maintenance</p> <p>No CBI</p> <p>No PII</p> <p>View of 15-gallon used oil receiver, containing approximately 10 gallons of used oil, that is not labeled with the words "Used Oil."</p> | |

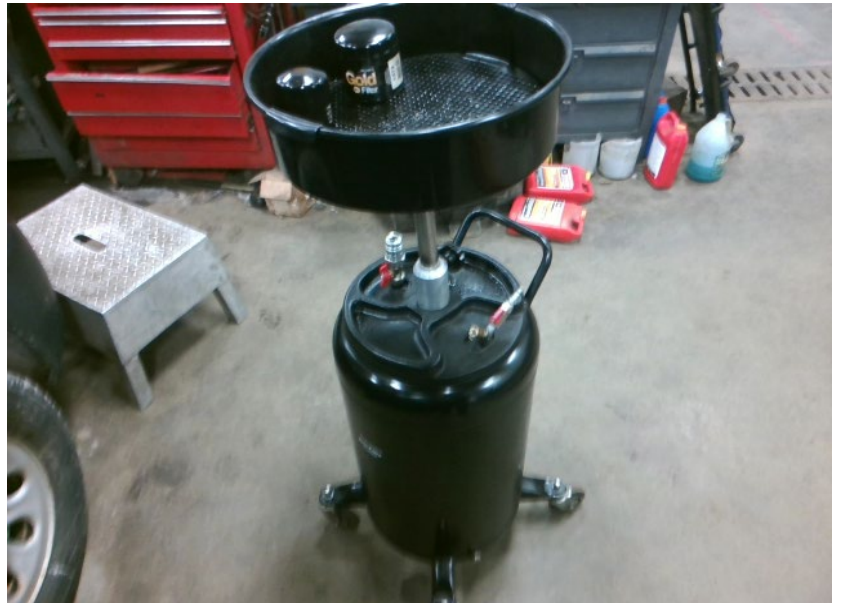
Another view of 15-gallon used oil receiver, containing approximately 10 gallons of used oil, that is not labeled with the words "Used Oil."

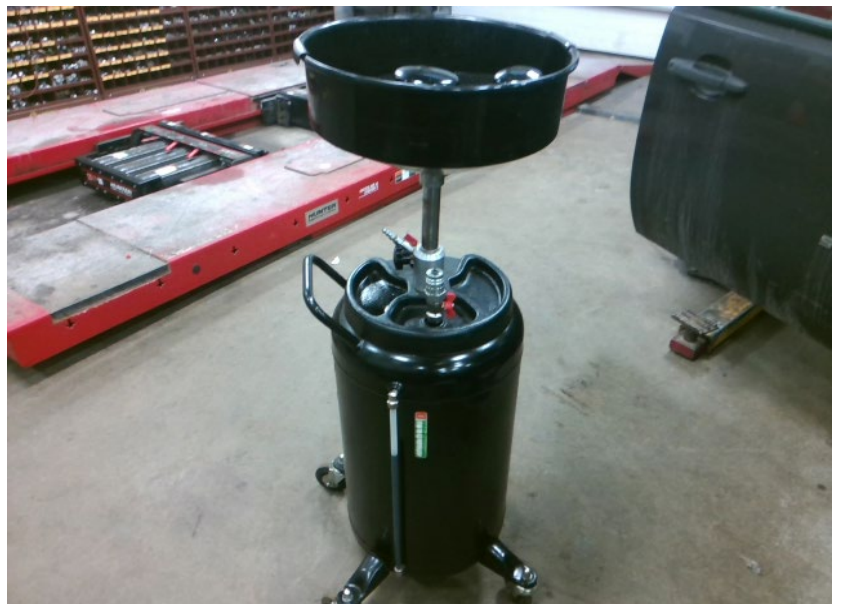
Another view of 15-gallon used oil receiver, containing approximately 10 gallons of used oil, that is not labeled with the words "Used Oil."

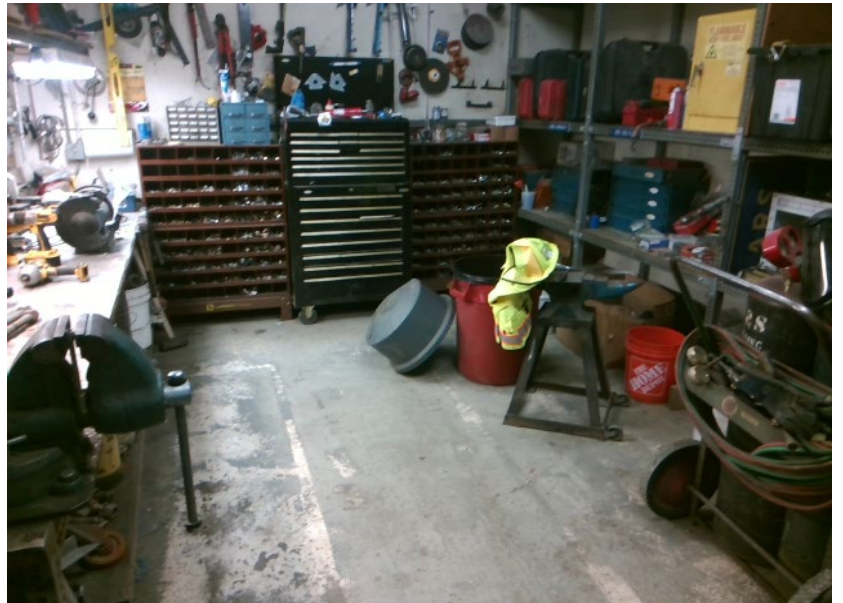
View of the tool room, where I inspected the contents of a trash receptacle and saw a punctured aerosol can in the trash. Upon further inspection, I noticed that the puncture hole was different from the other punctured cans I had seen at the facility. I asked Mr. Gates if there was an aerosol can puncturing device on this end of the building. He said there was not. I then asked if someone was puncturing the aerosols with something else and he said, "That's what it looks like."

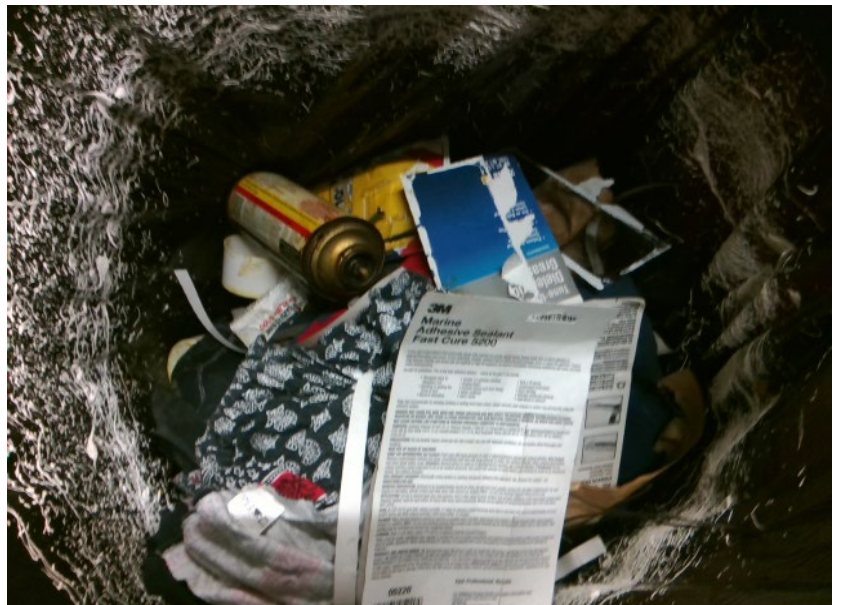
View of the punctured aerosol can in the trash receptacle.

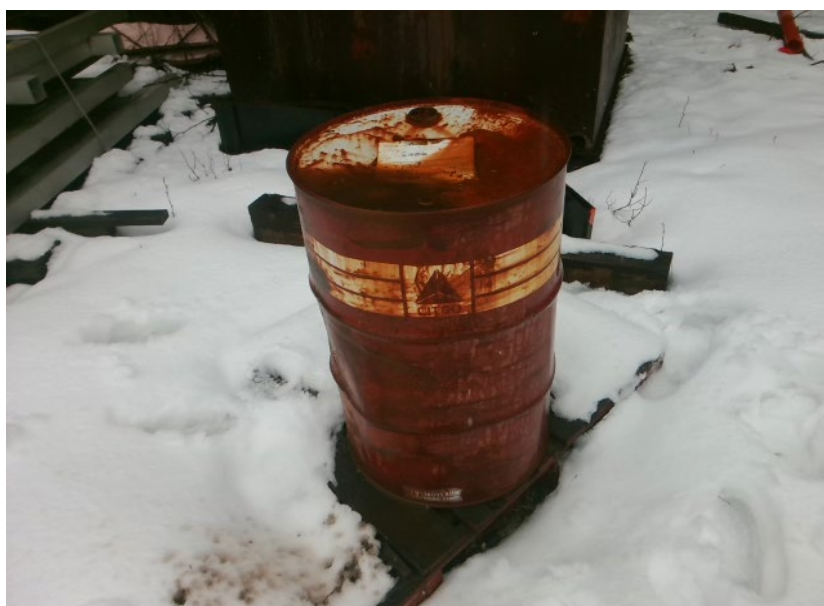
| <p>While inspecting the area west of the Cold Shed, referred to as "The Hill," I saw a lone rusty and dented 55-gallon container on a pallet that was located northwest of the Cold Shed.</p> <p>Mr. Gates told me the facility disposed of approximately 12 containers of hazardous waste through Clean Harbors during the spring 2020 (March/April). Mr. Gates stated that they intended to ship this container too, but Clean Harbors would not take it because it was an unknown waste.</p> <p>According to Mr. Gates, no weekly inspections were being conducted for this container. The container was not labeled and had no hazard indicator.</p> | |

| Rusty and dented 55-gallon container holding unknown contents. |

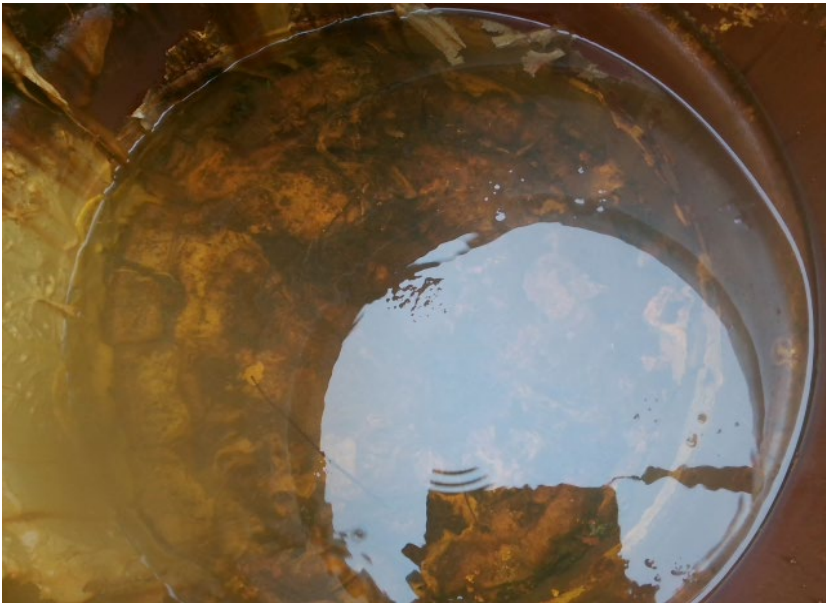
| <p>Prior to leaving "The Hill", I saw an old rusty container by the edge of the roadway. I noticed that the container was not closed, and I asked what the container held. Mr. Gates spoke up and said that it was full of chains. I went over to get a closer look and it appeared to be half full of something with water, possibly snowmelt filling the rest of the container. At first glance I was unable to determine what the container held beneath the water. I poked at the material with a stick and found it to be hard and thought it might be full of chains.</p> <p>I returned to the office to conduct the closing conference and after the closing conference I decided to go back out with Messrs. Wolfe, Gates, and Tunley to remove some of the water in the container in order to get a better look at the contents of the container. After Mr. Wolfe removed some of the standing water in the container, I could see that it contained dried yellow traffic paint. I asked for a copy of the Material Safety Data Sheet (MSDS) for the paint and I was provided with a copy during the inspection. According to the MSDS, the waste paint contained the following constituents: Lead (3% by weight) and Chromium (Hexavalent Chromium 0.69 % by weight)</p> | |

| Container of dried waste traffic paint was identified. The container was not closed, not labeled with the words Hazardous Waste, a hazard indicator, or accumulation start date. According to the MSDS, the waste paint contains lead and chromium. | <b>Citation:</b> | <b>Section:</b> |

| View of the bottom of the container, showing that at one point in time, the waste paint was leaking from the bottom of the container. | |

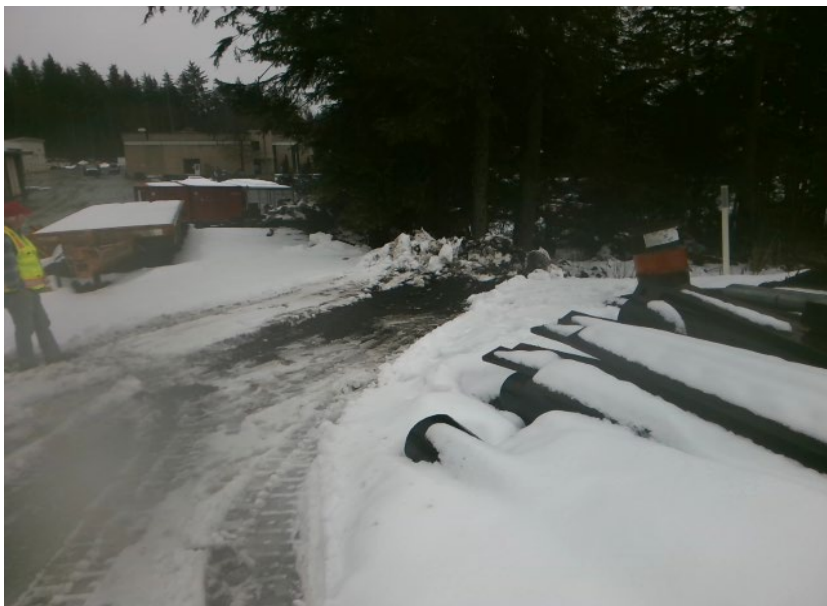
| View of the container, half full of waste traffic paint, as seen from the roadway leading into the area known as “The Hill.” | |
