Clean Water Act (CWA) Inspection Report

| <b>Inspection Entry Date/Time</b> | 01/22/2024 10:30 AM (PT) | Announced: No | | |
| <b>Type of Inspection</b> | CEI - Compliance Evaluation Inspection | | | |
| <b>Project or Site Name</b> | HD Fowler SR-3 Industrial Stock Yard | | | |

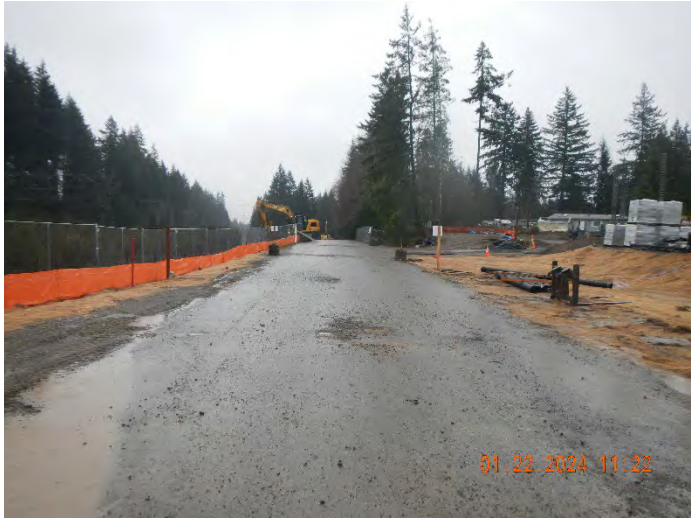
We first observed areas north of the job-site trailer, including north and south of SW Birt Drive. Perimeter chain-link fencing was installed around the property, as well as silt fencing along the construction boundary. As a best management practice (BMP), unstabilized areas were generally covered with straw (**Photo 3**).

Photo #:03 (DSCN3512)  
Description: Facing northeast, photo of SW Bird Drive from just north of the jobsite trailer.

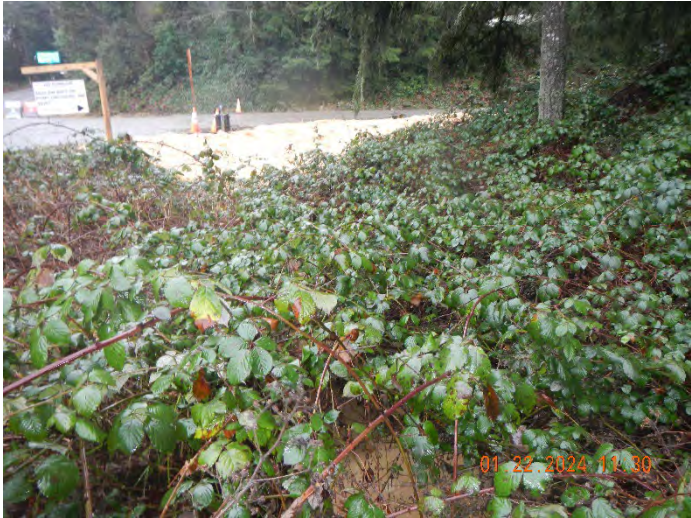
Along SW Birt Drive, we observed active trenching and water pipe installation occurring on the north end of SW Birt Drive. The new trench was being dewatered just north of the trench, between SW Birt Drive and SR-3. The trench dewatering water appeared turbid, discharging to a vegetated area off-site near the intersection of SW Birt

Drive and Sunnyslope Road SW, south of SR-3 (**Photo 4 & Photo 5**). The discharge was not observed downslope of the vegetative area, east of Sunnyslope Road SW (**Photo 6 & Photo 7**). We returned to SW Birt Drive and continued to observe the flow path of the dewatering discharge and trenching activity (**Photo 8 – Photo 12**).

| <p>AOC:</p> <p>Along SW Birt Drive, we observed active trenching and water pipe installation occurring on the north end of SW Birt Drive. The new trench was being dewatered just north of the trench, between SW Birt Drive and SR-3. The trench dewatering water appeared highly turbid, discharging to a vegetated area off-site near the intersection of SW Birt Drive and Sunnyslope Road SW, south of SR-3 (<b>Photo 4 &amp; Photo 5</b>). The discharge was not observed downslope of the vegetative area, east of Sunnyslope Road SW (<b>Photo 6 &amp; Photo 7</b>). We returned to SW Birt Drive and continued to observe the flow path of the dewatering discharge and trenching activity (<b>Photo 8 – Photo 12</b>).</p> <p>According to Section F.3. “Utilities” of the Project’s SWPPP: “Dewatering devices shall discharge to an appropriate sediment trap or pond, preceded by adequate energy dissipation, prior to runoff leaving the site. If a sediment trip is not used on the site, discharge shall be upstream of a properly installed silt fence.”</p> <p>The concern was the highly turbid dewatering water observed to be discharging off-site without controls.</p> | |

Photo #:04 (DSCN3513)  
Description: Facing south/southeast, photo of the observed trench dewatering discharge location. A vegetative area on the north side of SW Birt Drive, south of SR-3 along Sunnyslope Road SW.

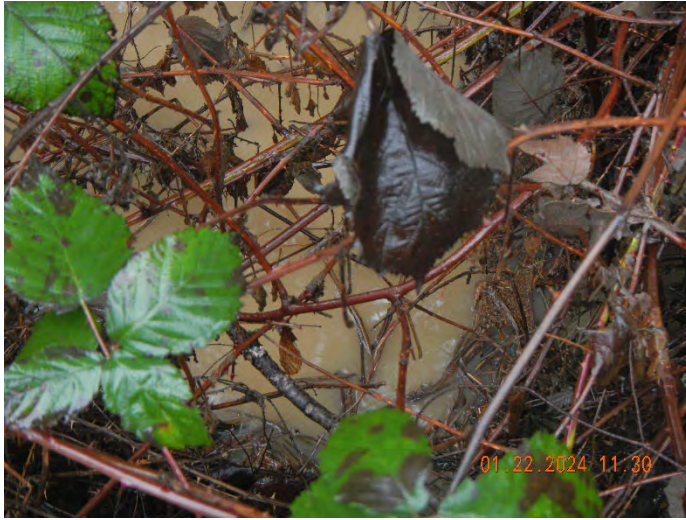
Photo #:05 (DSCN3514)

Description: Facing south, photo of the observed trench dewatering discharge location. Area is north of SW Birt Drive, south of SR-3 along Sunnyslope Road SW.

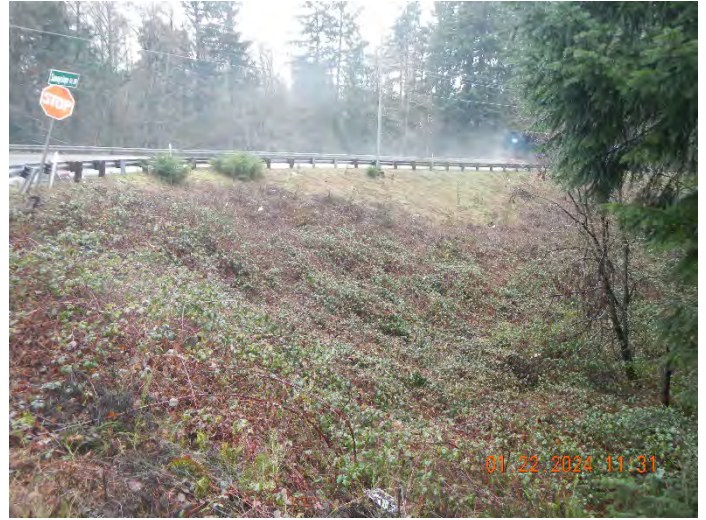
Photo #:06 (DSCN3515)

Description: Facing northeast, photo of drainage area south of SR-3, north of Sunnyslope Road SW. Downslope of dewatering discharge location.

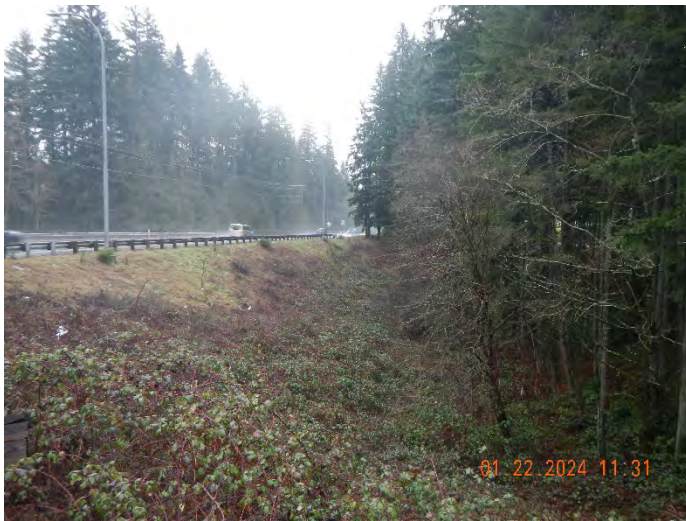
Photo #:07 (DSCN3516)

Description: Facing northeast, photo of drainage area south of SR-3, north of Sunnyslope Road SW. North of dewatering discharge location.

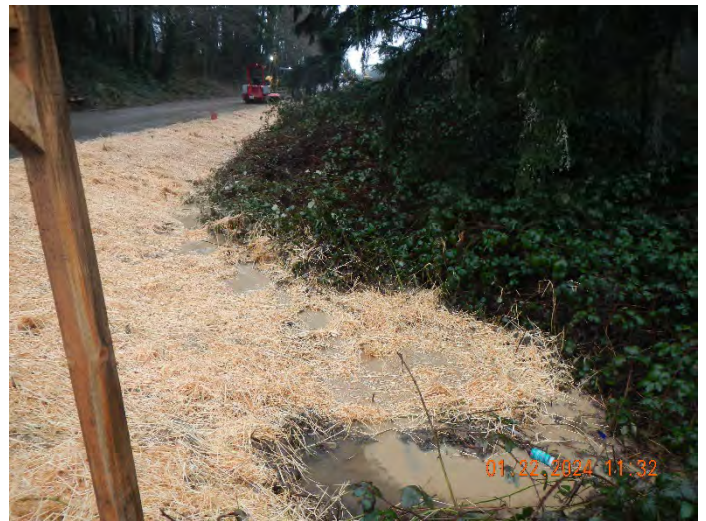
Photo #:08 (DSCN3517)

Description: Facing southwest, photo of trench dewatering water flowing northeast along SW Birt Drive and entering vegetative area.

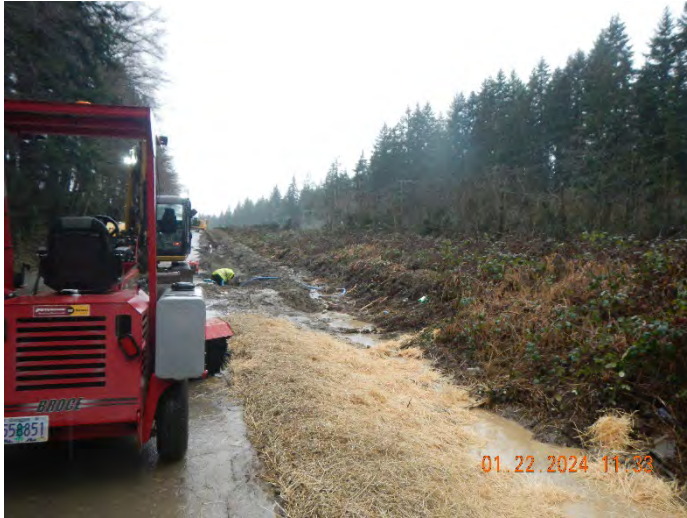
Photo #:09 (DSCN3518)

Description: Facing southwest, photo of dewatering water from trench operations along SW Birt Drive.

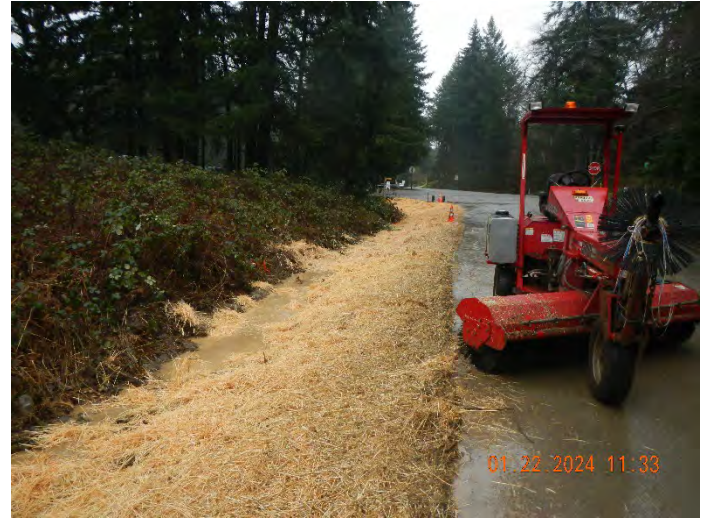
Photo #:10 (DSCN3519)

Description: Facing northeast, photo of dewatering water from trench operations along SW Birt Drive.

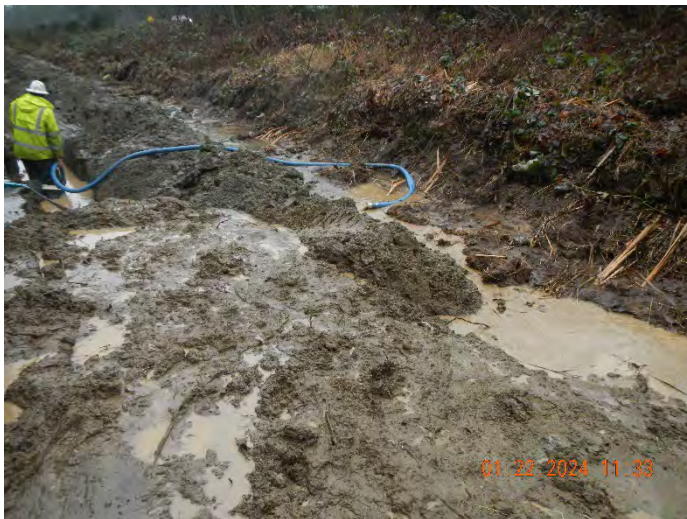
Photo #:11 (DSCN3520)

Description: Facing northwest, photo of trench dewatering along SW Birt Drive.

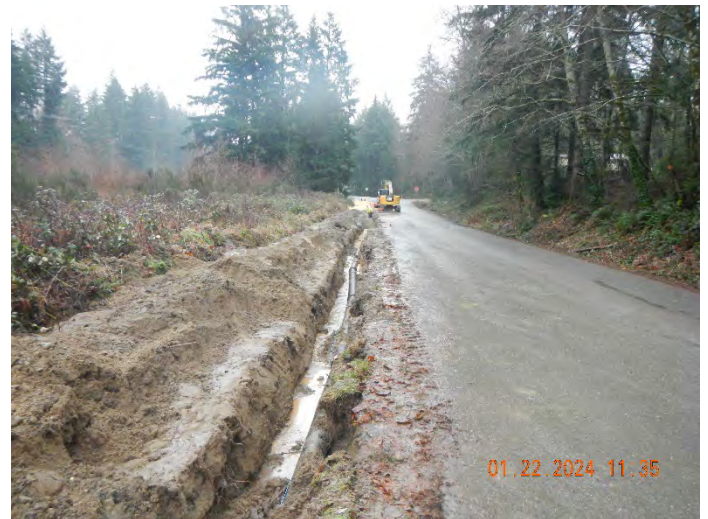
Photo #:12 (DSCN3521)

Description: Facing northeast, photo of trenching operations along SW Birt Drive.

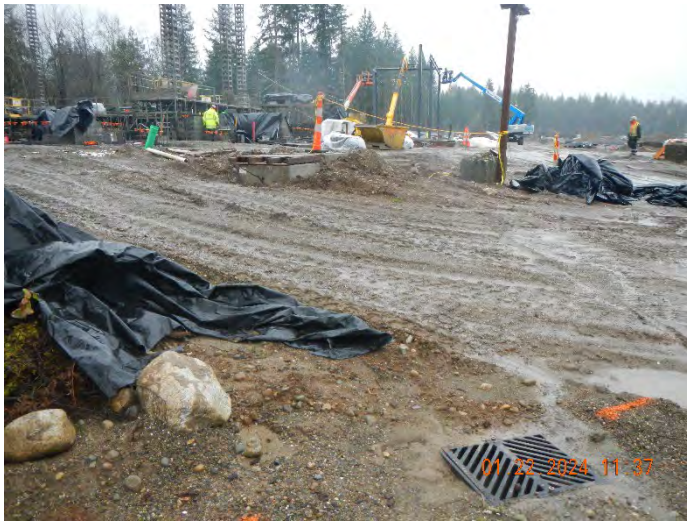
| <p>AOC:</p> <p>We observed a single catch basin located north of the planned warehouse structure (<b>Photo 13 &amp; Photo 14</b>). Mr. Halme discussed that the single catch basin is the sole catch basin not currently routed/connected to the Project’s stormwater vaults/ponds. The single catch basin discharges separately to the SR-3 roadside ditch, northwest of</p> | |

the catch basin. The areas around the catch basin were unstabilized, no inlet protection or stormwater BMPs were observed. Stormwater was observed entering the catch basin as sheet flow from the area(s) west/southwest of the catch basin.

The concerns are that no inlet protection was observed to be installed for the identified catch basin and the discharge from the catch basin to the SR-3 roadside ditch was not being sampled/monitored. Accumulated sediment was observed at the discharge location within the SR-3 roadside ditch.

Photo #:13 (DSCN3522)

Description: Facing south, photo of stormwater catch basin. No inlet protection observed at the time of inspection. Catch basin discharges directly to SR-3 roadside ditch.

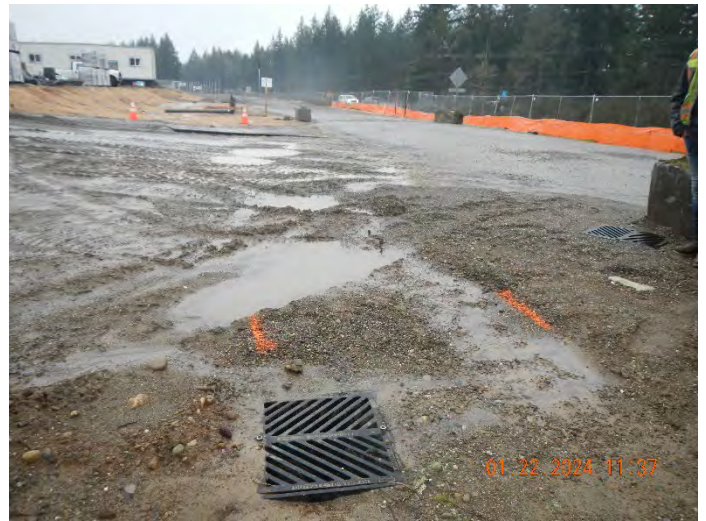
Photo #:14 (DSCN3523)

Description: Facing west, photo of stormwater catch basin. No inlet protection observed at the time of inspection. Catch basin discharges directly to SR-3 roadside ditch.

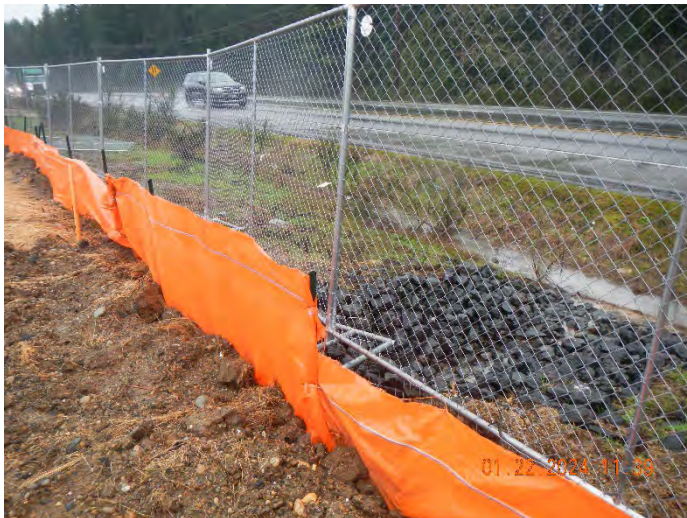
We then walked southwest and observed discharge location for the single catch basin we had just visited. The discharge location was on the north side of the perimeter fencing (**Photo 15**). A below ground PVC pipe was discharging stormwater to a rip-rapped area into the SR-3 roadside ditch. Accumulated sediment was observed within the rip-rapped area (**Photo 16**). It was discussed that the outfall/discharge was not being monitored/sampled.

Photo #:15 (DSCN3524)

Description: Facing west, photo of stormwater outfall from the single catch basin to the SR-3 roadside ditch. Outfall discharging at the time of inspection.

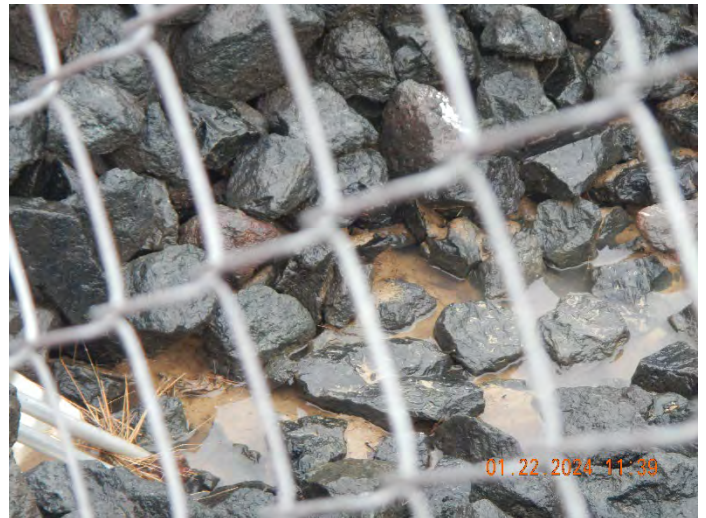
Photo #:16 (DSCN3525)

Description: Facing west, photo of stormwater outfall from the single catch basin to the SR-3 roadside ditch. Outfall discharging at the time of inspection.

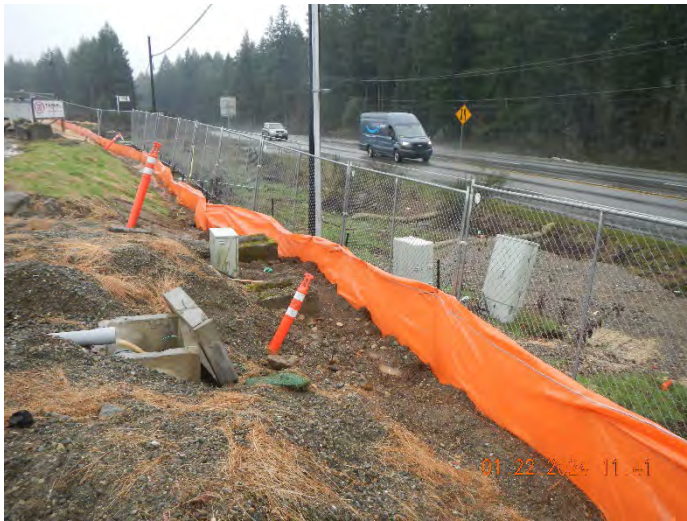
Near the northwest perimeter, we came to an area of silt-fencing that had previously failed according to Mr. Halme (**Photo 19**). Mr. Halme discussed that the area appeared to be a low spot of the northern perimeter, after the silt-fencing failed and was repaired, a temporary drainage pipe was installed to divert stormwater under the newly constructed access road and into a stormwater catch basin that discharges to the primary/permanent stormwater pond (**Photo 20 & Photo 21**).

Photo #:19 (DSCN3528)

Description: Facing southwest, photo of stormwater being piped to stormwater catch basin connected to stormwater vault and stormwater pond. According to Mr. Halme, temporary pipe was installed after the area experienced significant stormwater and the silt-fence failed.

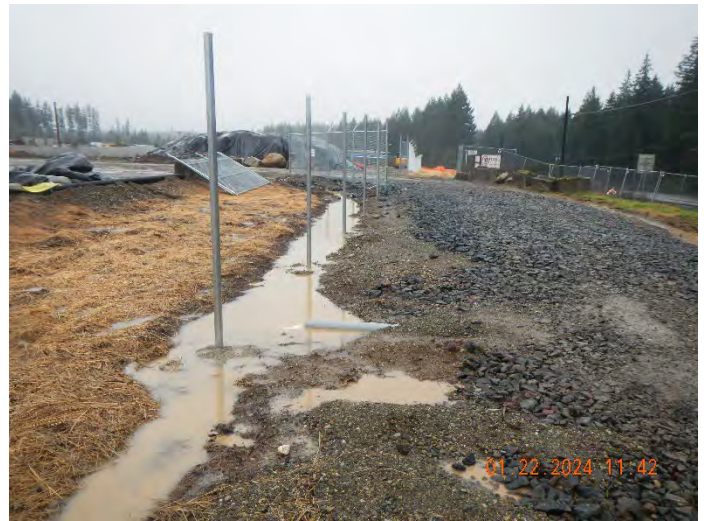
Photo #:20 (DSCN3529)

Description: Facing southwest, photo of inlet to stormwater pipe, area being drained to stormwater catch basin connected to stormwater vault and stormwater pond. According to Mr. Halme, temporary pipe was installed after the area experienced significant stormwater and the silt-fence failed.

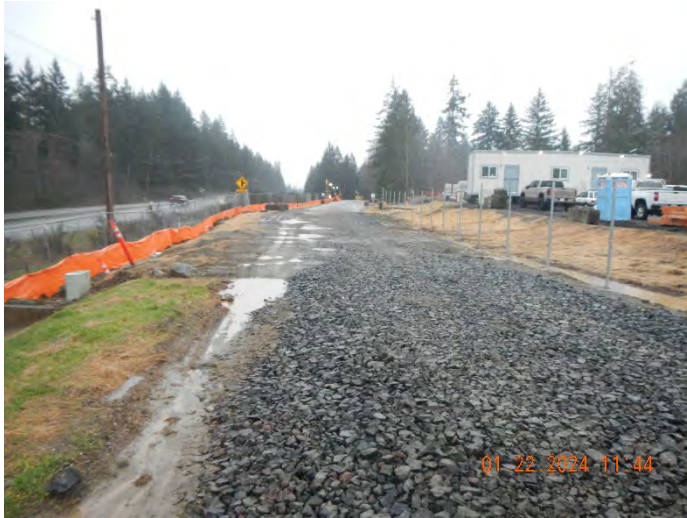
Photo #:21 (DSCN3530)

Description: Facing northeast, photo of area being drained to stormwater catch basin connected to stormwater vault and stormwater pond. According to Mr. Halme, temporary pipe was installed after the area experienced significant stormwater and the silt-fence failed.

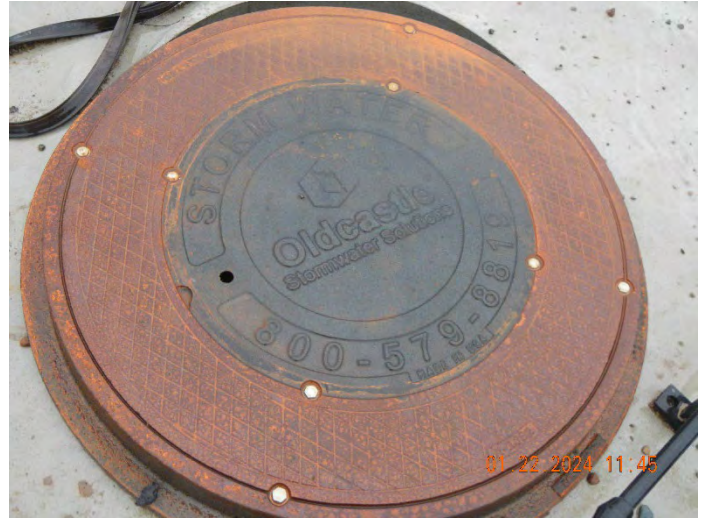
We continued southwest and observed the northernmost stormwater vault that receives stormwater from the northern catch basins (**Photo 22 & Photo 23**). The stormwater vault(s) discharge to the primary/permanent stormwater pond via piping. Mr. Halme discussed that the media for the stormwater vaults had been received and currently staged on-site.

Photo #:22 (DSCN3531)

Description: Photo of northernmost stormwater vault connected to stormwater pond. Media for the stormwater vault currently not installed and stockpiled in staging area.

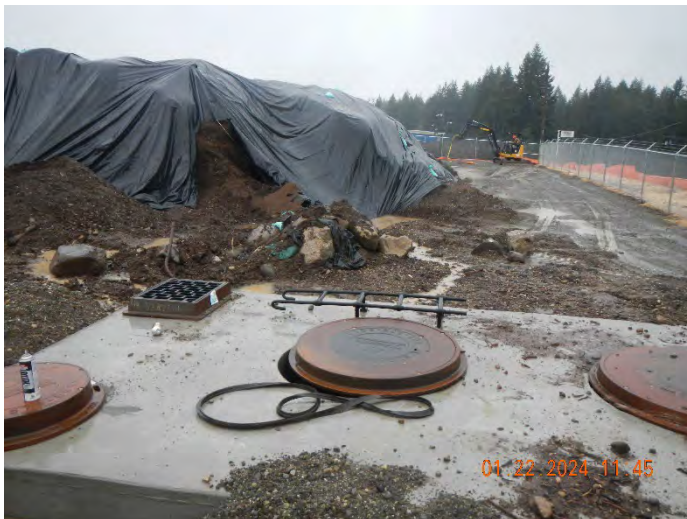
Photo #:23 (DSCN3532)

Description: Facing southwest, photo of northernmost stormwater vault connected to stormwater pond. Media for the stormwater vault currently not installed and stockpiled in staging area.

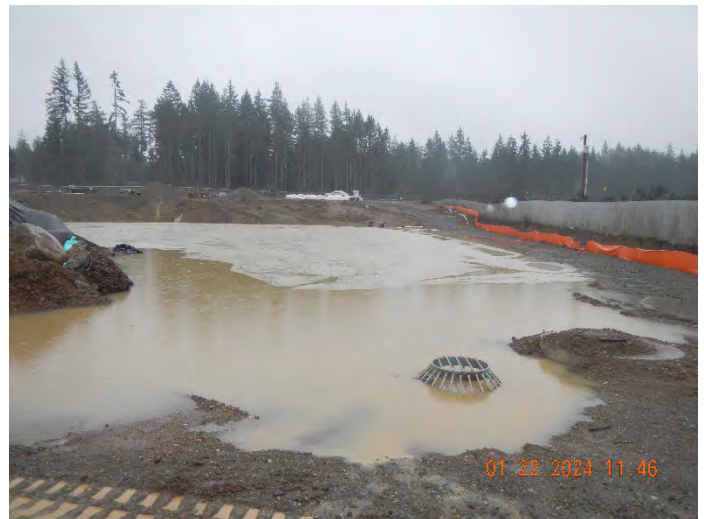
We then observed the primary/permanent stormwater pond located in the northwest corner of the site; the pond was observed to be at or near full capacity (**Photo 24**). Mr. Halme discussed that the Project was currently unable to pump/dewater the pond to their upper temporary pond and designated dewatering area. This was due to several sections of PVC pipe currently damaged after a recent cold/freeze event.

Photo #:24 (DSCN3533)

Description: Facing south, photo of stormwater pond. Stormwater pond routinely pumped to upper (secondary) pond and pumped to vegetative area for infiltration. Above ground PCV pipes used for pumping froze and burst the week prior from below freezing temperatures.

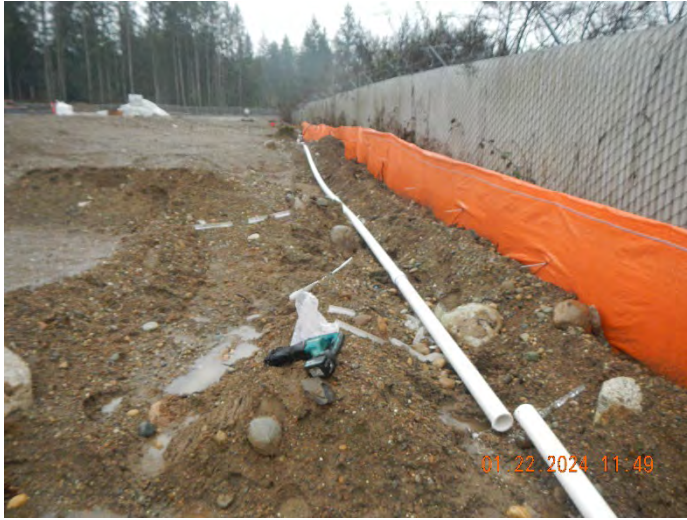
From the northwest boundary we then traveled south along the western perimeter. We observed the southern areas of the stormwater pond and several sections of broken PVC piping currently in repair **(Photo 25)**. We also observed the southern stormwater vault **(Photo 26)** and staged media for future use within vault(s) **(Photo 27)**. Along the western perimeter, we observed a section of silt fence in need of maintenance **(Photo 28)**. The adjacent property to the west was an auto wrecking business that was temporarily closed. Construction areas had generally been covered with base rock. As we continued south, we observed the secondary/temporary stormwater pond and dewatering area located within the vegetated/wooded area **(Photo 29 - Photo 32)**.

Photo #:25 (DSCN3534)

Description: Facing south, photo of above ground PVC pipes being repaired for the pumping of stormwater from primary pond to secondary pond.

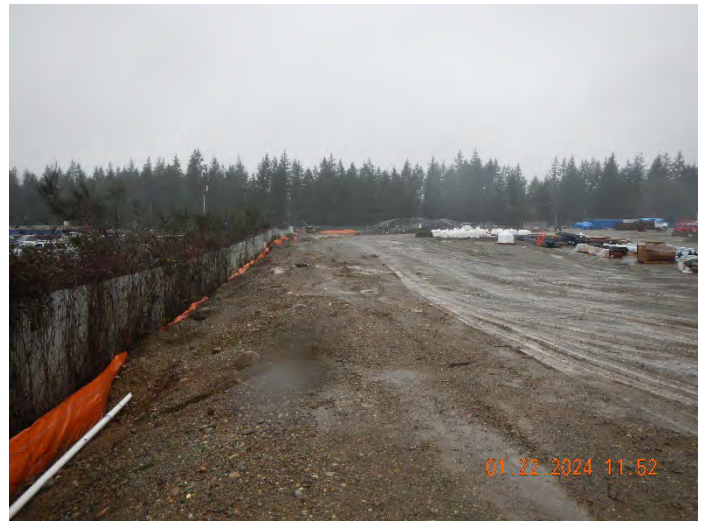
Along the western perimeter, we observed a section of silt fence in need of maintenance (**Photo 28**). The adjacent property to the west was an auto wrecking business that was temporarily closed.

Photo #:28 (DSCN337)

Description: Facing northwest, photo of western perimeter silt fencing in need of maintenance per standard (*BMP C233 Stormwater Management Manual for Western Washington*).

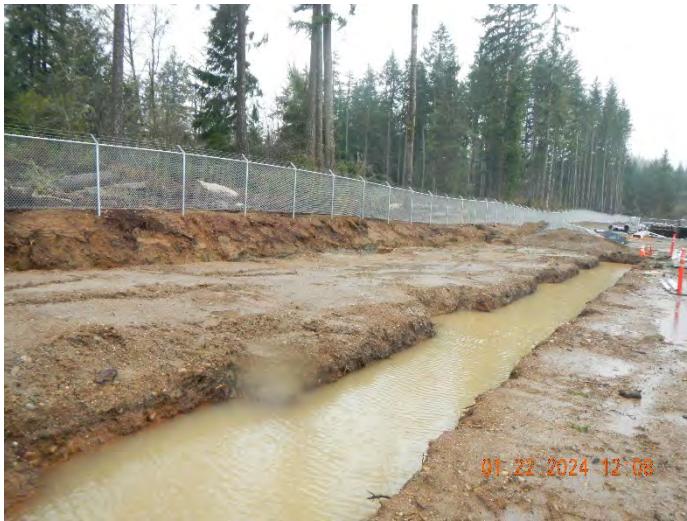
Photo #:35 (DSCN3544)

Description: Facing southeast, photo of foundation trench full of water along the northeast perimeter.

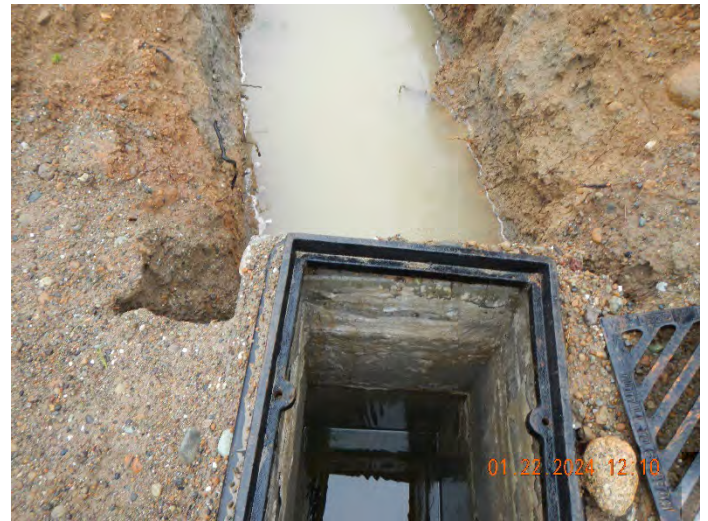
Photo #:36 (DSCN3545)

Description: Facing northwest, photo of catch basin at foundation trench full of water along the northeast perimeter.

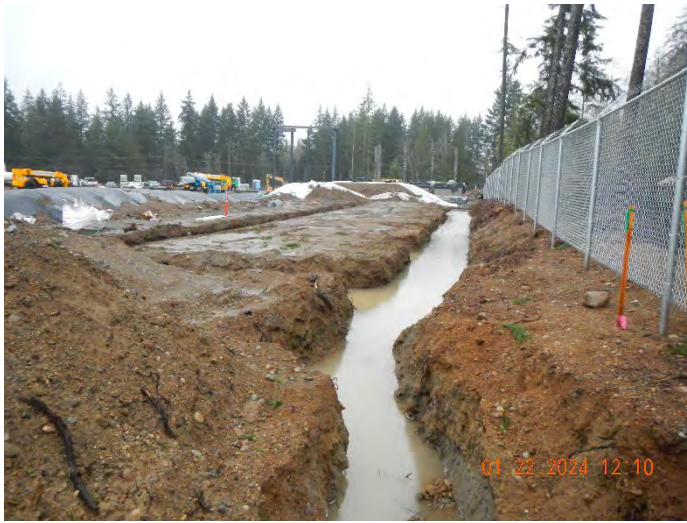
Photo #:37 (DSCN3546)

Description: Facing northwest, photo of foundation trench full of water along the northeast perimeter.

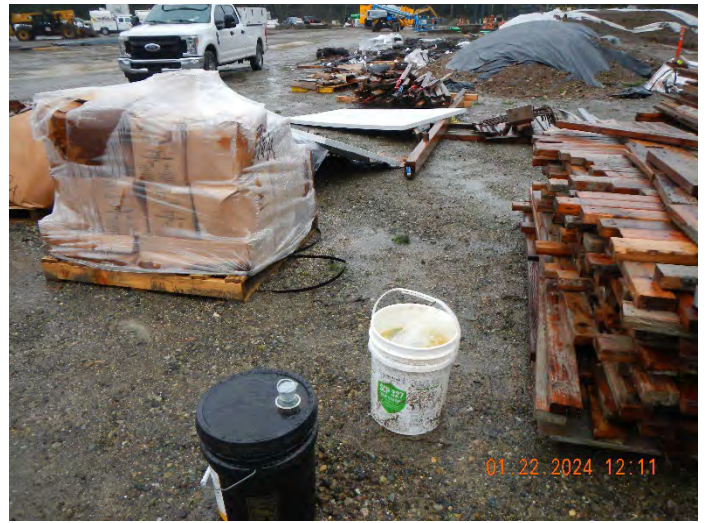
Within the construction area we observed numerous materials staging areas. Within one staging area, we observed an open 5-gallon bucket labeled "Spraylock SCP 327," as well as a 5-gallon bucket of lubrication oil (**Photo 38 – Photo 39**).

Photo #:38 (DSCN3547)

Description: Facing north, photo of opened bucket of "spraylock SCP 327" and lubrication oil near temporary stockpile area.

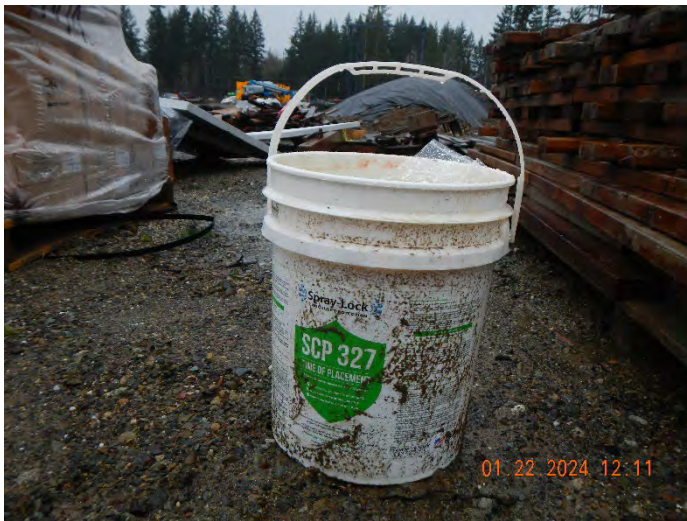
Photo #:39 (DSCN3548)

Description: Facing north, photo of labeling of open bucket "Spraylock SCP 327."

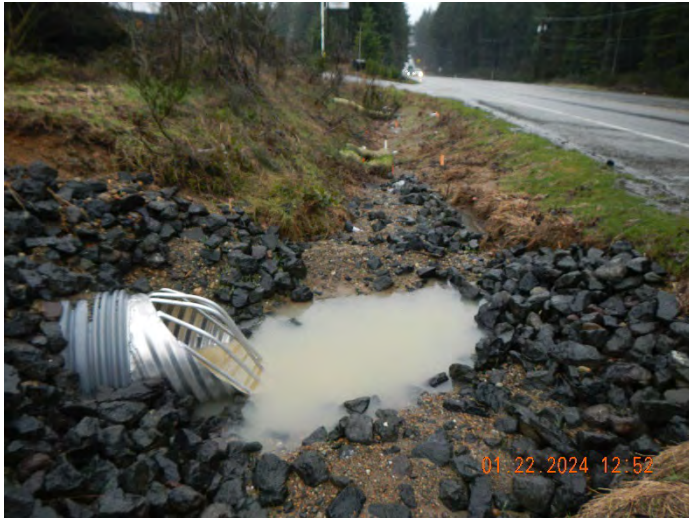
Photo #:45 (DSCN3569)

Upon arriving at the SR-3 roadside ditch and pond outfall along SR-3, we observed ponded water within the stormwater pond's discharge pipe and within the SR-3 roadside ditch. Stormwater within the SR-3 ditch was observed to be either infiltrating or ponding (**Photo 45 & Photo 46**).

Although water was not observed to be flowing at the discharge location, the concern is the presence of the ponded water observed within the stormwater pond's discharge pipe and within the SR-3 roadside ditch with the gate valve not having been opened.

Description: Facing southwest, photo of primary stormwater pond discharge location to the SR-3 roadside ditch. No flow observed at the time of inspection.

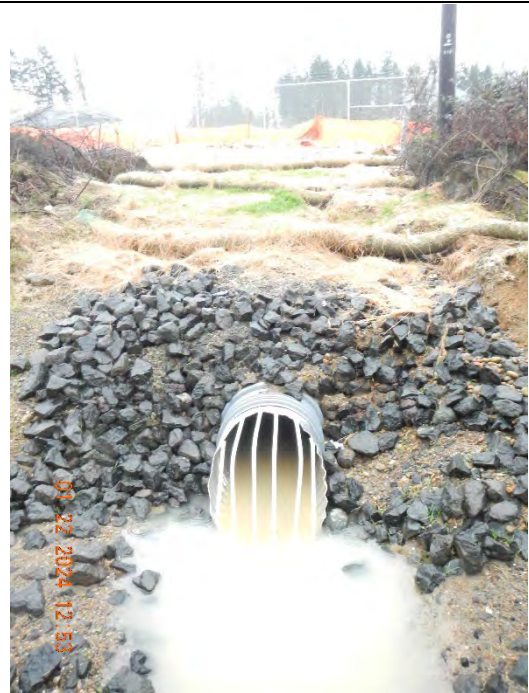
Photo #:46 (DSCN3570)

Description: Facing south/southeast, photo of primary stormwater pond outfall location to the SR-3 roadside ditch. No flow observed at the time of inspection.
