**Region 6 Compliance Assurance and Enforcement Division**  
**INSPECTION REPORT**

| Inspection Date(s): | 4/17/19 | | |
| Facility Name: | Dutch Harvest Dairy | | |
| Identification/Permit Number: | TXG921539 | | |

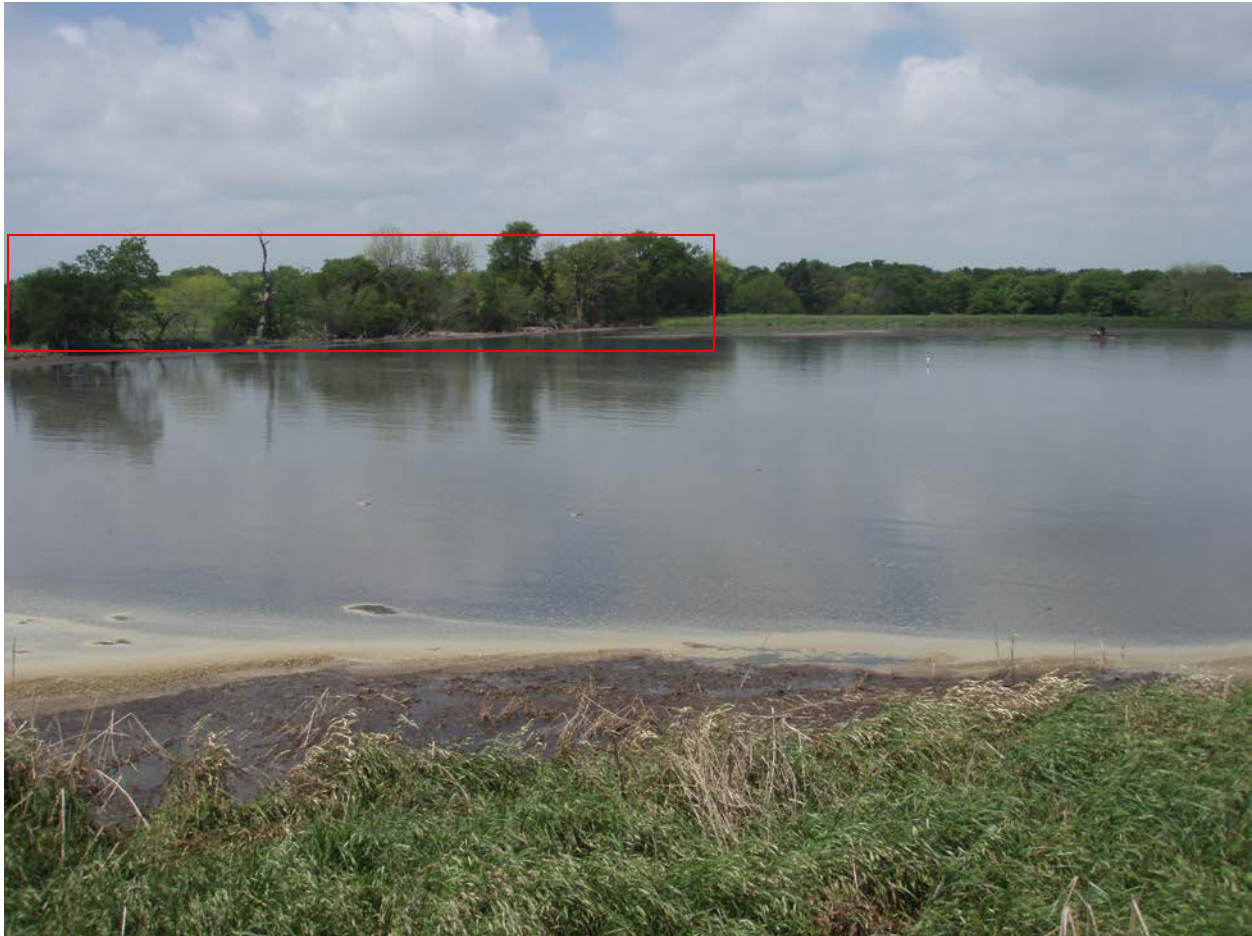
Photo No. 4

On the day of the inspection I observed trees located within the berm of RCS #2. In addition to these trees, there was a fence line within the boundaries of RCS #2. The tree-line and fence-line ran east-west approximately fifteen feet north of the designed southern berm of RCS #2 (Photo #4).

Description: This photo was taken facing southwest from the northeast corner of RCS #2. Note the trees are rooted within the interior of the RCS.

1. Piles of manure were being stored uncovered adjacent to the waste bailage area. Per TXG921539 Part III.A.9(b) manure or sludge stored for more than 30 days must be stored within the drainage area of an RCS or stored in a manner (i.e. storage shed, bermed area, tarp covered area, etc.) that otherwise prevents contaminated storm water runoff from the storage area.
2. Trees and woody vegetation had taken root within the interior of RCS #2. This vegetation will need to be removed to prevent the root zone from intruding upon the RCS liner per TXG921539 Part III.A.10(f)(3).

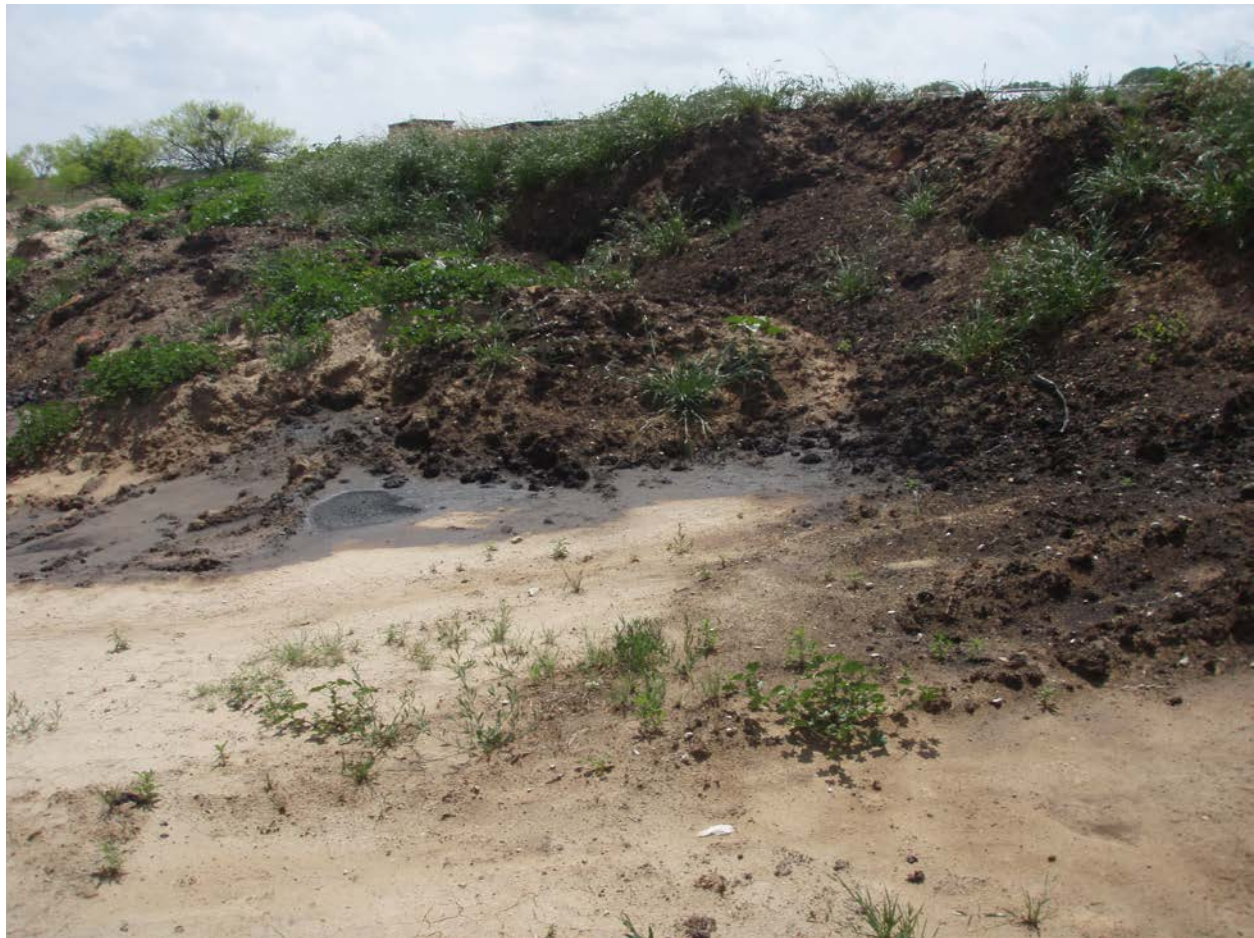
Photo No. 5

Description: This photo was taken facing the facility's compost pile. The facility's mortalities are composted in this pile.

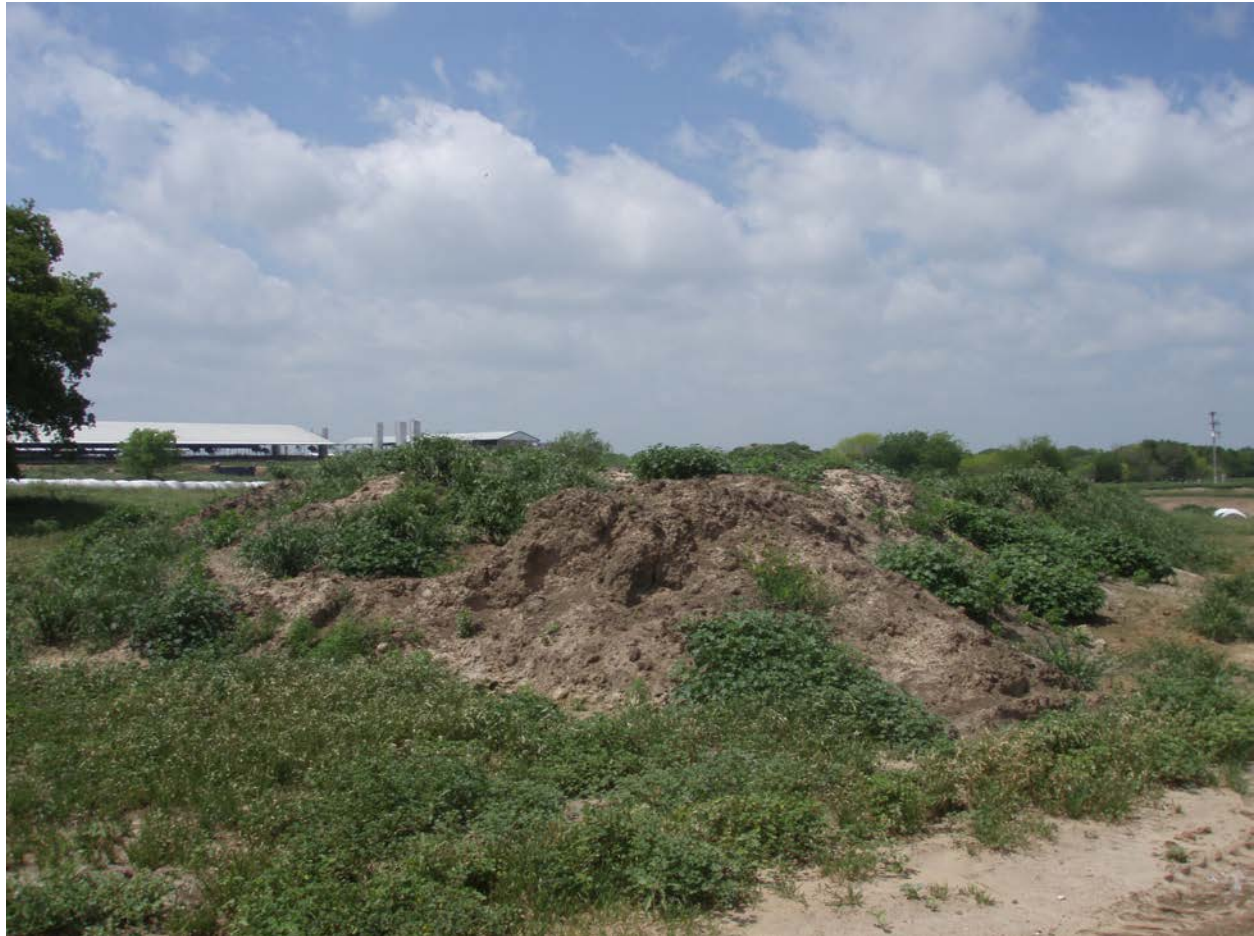
Photo No. 6

On the day of the inspection, I observed a large manure pile adjacent to the waste bailing storage area. This manure was being stored outside the watershed of an RCS. (Photo #5). Mr. Hicks informed us that this manure was scraped out of the RCS and had been stored there for more than thirty days.

Description: This photo was taken facing southwest toward the manure pile which was located outside of the watershed of an RCS. Note the vegetation which has grown on the surface of the pile which indicates it has been stored for longer than thirty days.

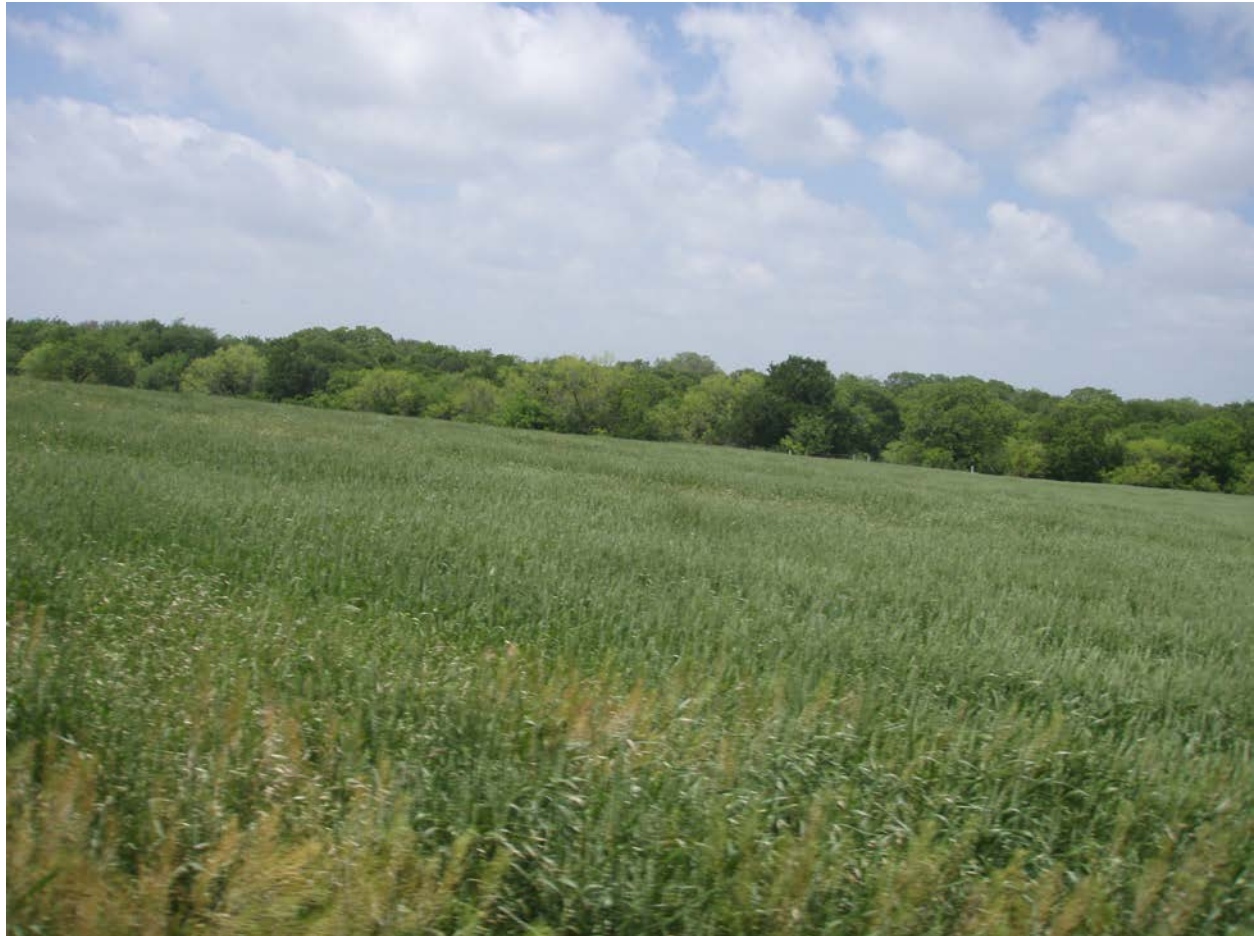
Photo No. 7

On the day of the inspection, I observed the Land Management Units to be in good condition and free from any evidence of overapplication such as ponding or puddling. I spoke with Mr. Hicks to confirm that he was adhering to the conditions set by his Nutrient Management Plan (NMP).

Description: This photo was taken facing northwest across one of the facility's Land Management Units.
