## TROPICAL SHIPPING-CROWN BAY, NPDES Stormwater Reconnaissance Inspection (RI) Photo Album; 9-8-2022 Walkthrough

### A. Observations that revealed potential non-compliance with regulations implementing the CWA and TPDES Stormwater Rules during the RI

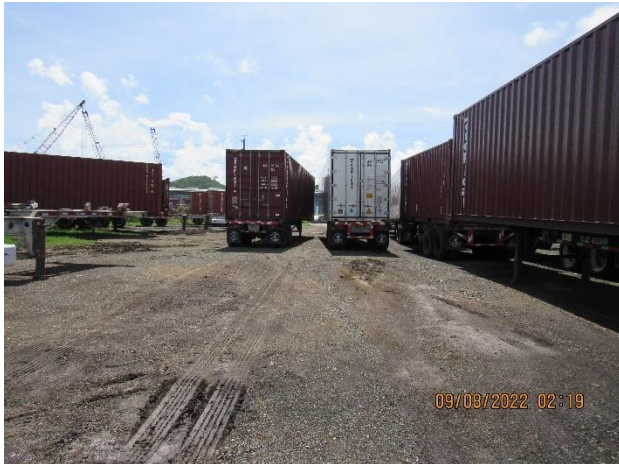
**IMG 471**-Section of former Cancryn Field occupied by Tropical for staging containers to be dispatch and at section of Cancryn Field occupied by Tropical. that are being received.

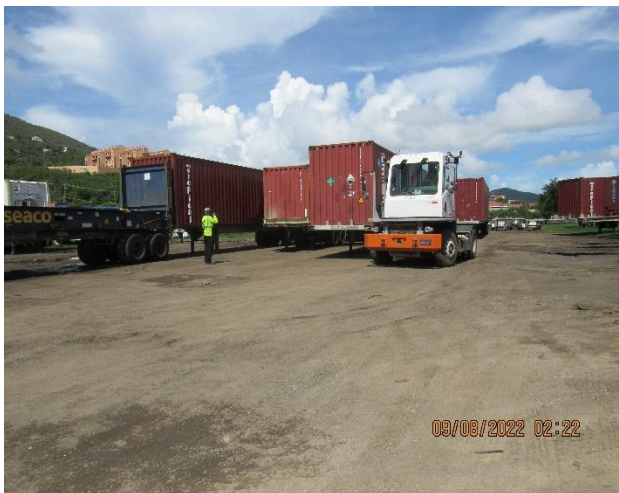
**IMG 475**-Front area of the Cancryn Field section occupied by Tropical. On-going activity observed, with no erosion control and soil retention installed.

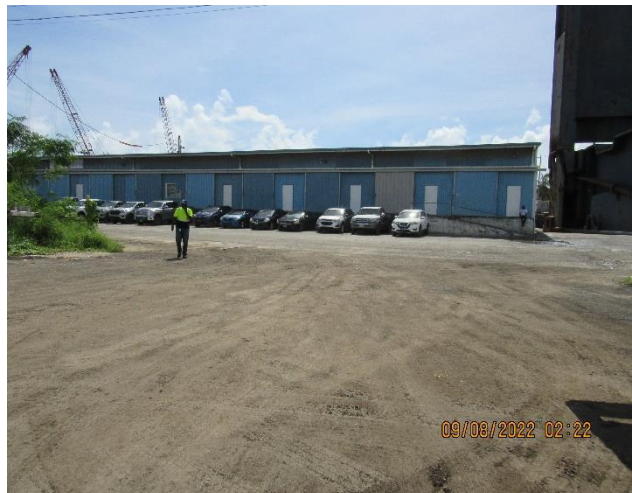
**IMG 476**-Entrance/exit of Cancryn Field occupied by Tropical. Evidence of transport of sediment from the Field section that reaches the road.

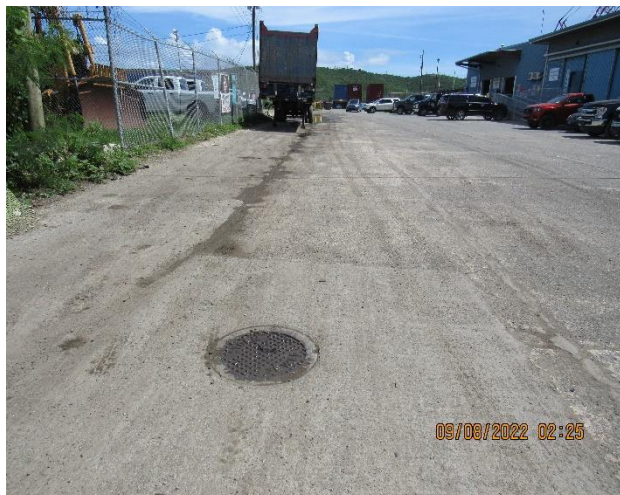
**IMG 477**-Road going into the dock area. Sediment transported by storm water runoff from Field seen in the stormwater flow path along the road.

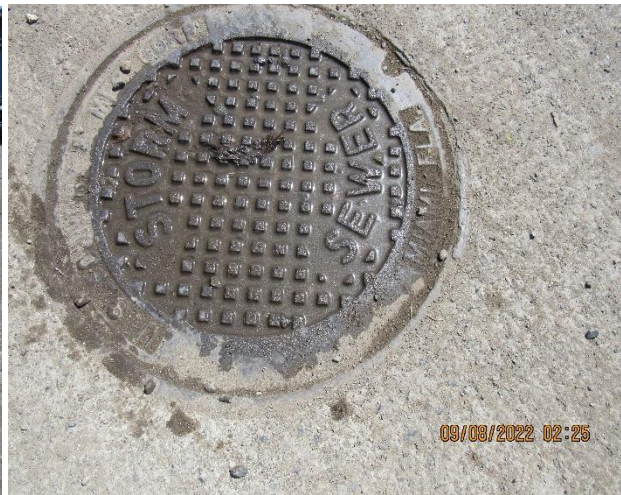
**IMG 478**-Picture of cover to storm sewer that conveys stormwater from upstream area.

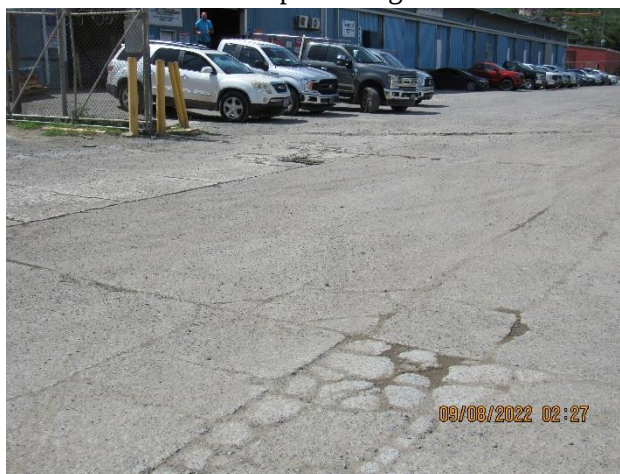
**IMG 479**-A stormwater catch basin of stormwater drainage system in the Crown Bay port area.

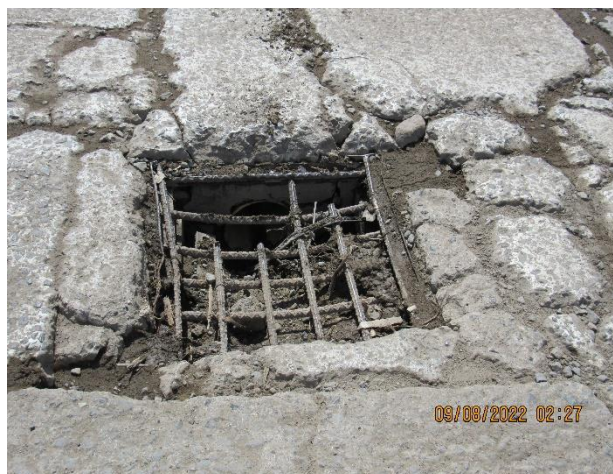
**IMG 480**-Close-up of the stormwater catch basin partially clogged with sediment from upstream. The inlet of the catch basin is not protected.

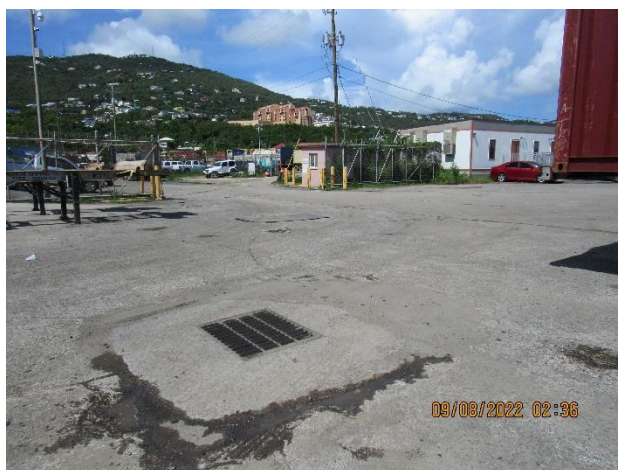
**IMG 485**-Stormwater catch basin with raised inlet just in front of Tropical's fenced dock area. The inlet of the catch basin is not protected.

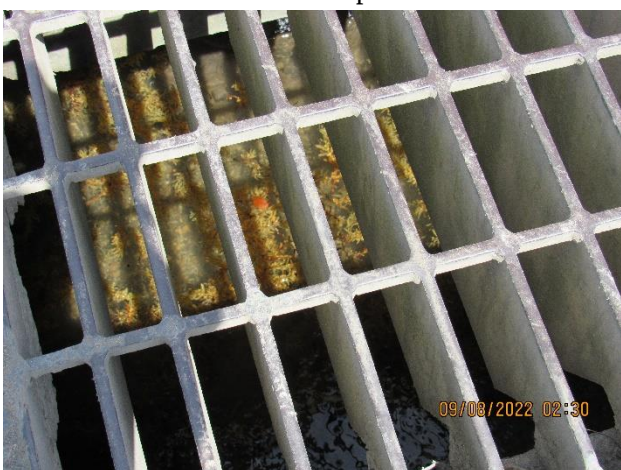
**IMG 484**-Close-up view of stormwater catch basin with raised inlet. Observed sea water intrusion with large amount of marine vegetation inside catch basin.

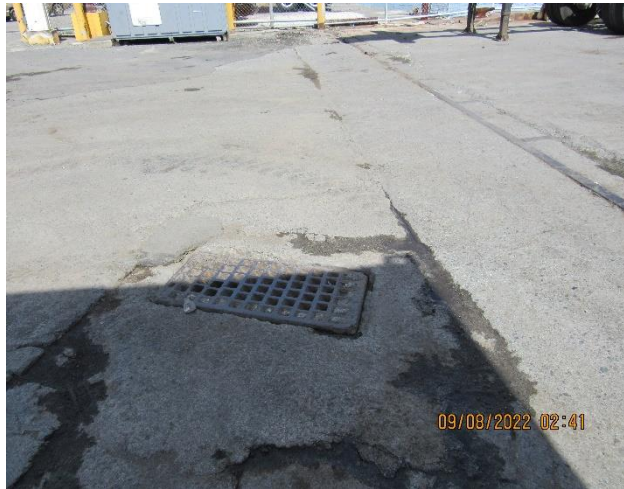
**IMG 486**-A storm water catch basin within the fence line. The inlet of the catch basin is not protected.

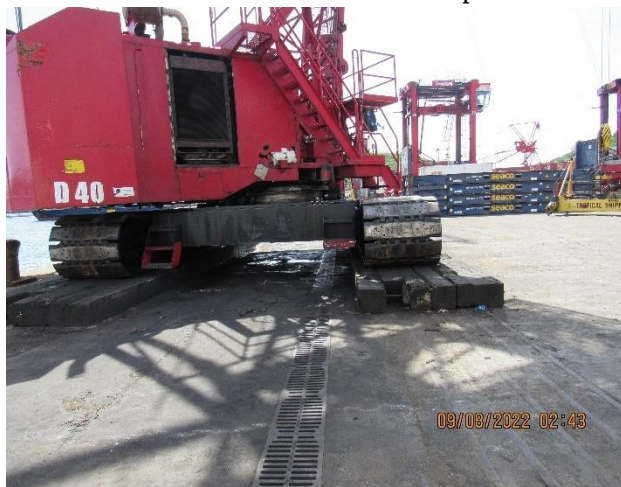
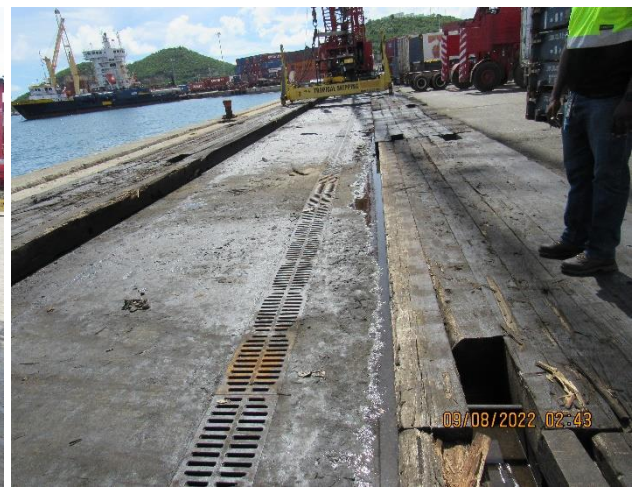
**IMG 489**-Crain staged on dock platform for loading and unloading cargo. **IMG 490**-View of the crain track system along the active dock where loading and unloading occurs. Drain collects stormwater runoff, oil and grease leaks and spills installed in place. View of drain along the entire dock bulkhead.

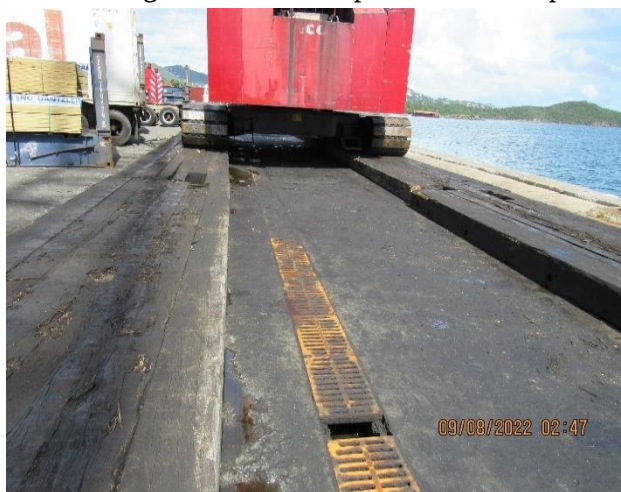
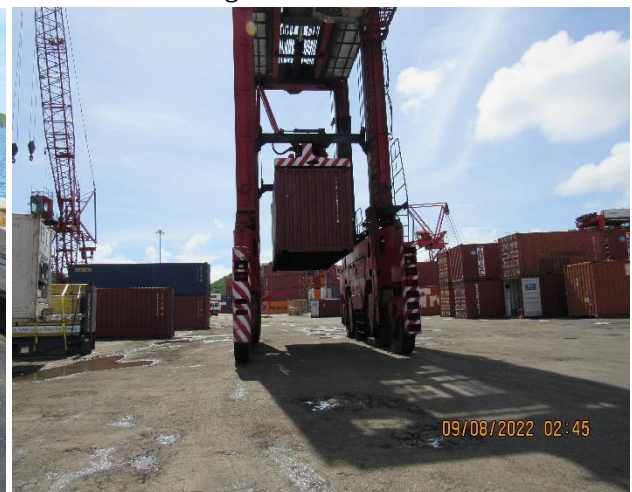
**IMG 495**-Evidence of oil and grease residue open to all environmental conditions. Dock graded to allow stormwater to drain towards inner yard and the catch of spills and leaks of oil and grease in yard area. basins. **IMG 492**-Container transport vehicle in operation in dock area and inner yard. Increased possibilities

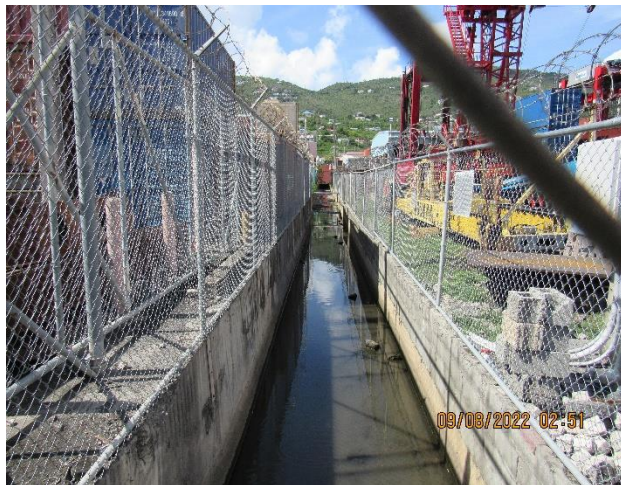
**IMG 498**-Large stormwater drainage canal that runs through Tropical, north to south, and drains into the Bay.

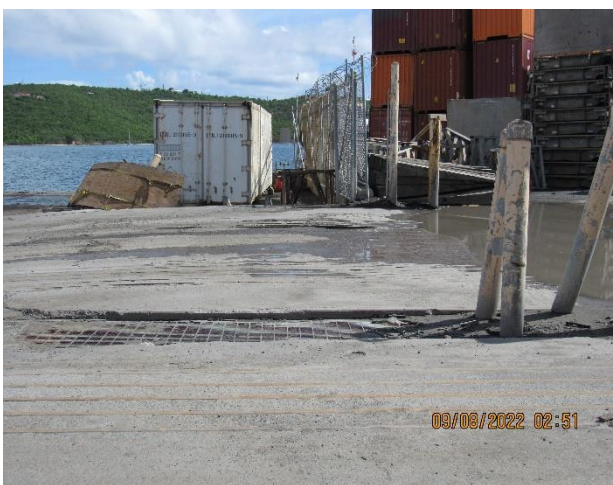
**IMG 500**-Large catch basin in which mid-section of the Facility through which stormwater enters the large drainage canal, and into the Bay.

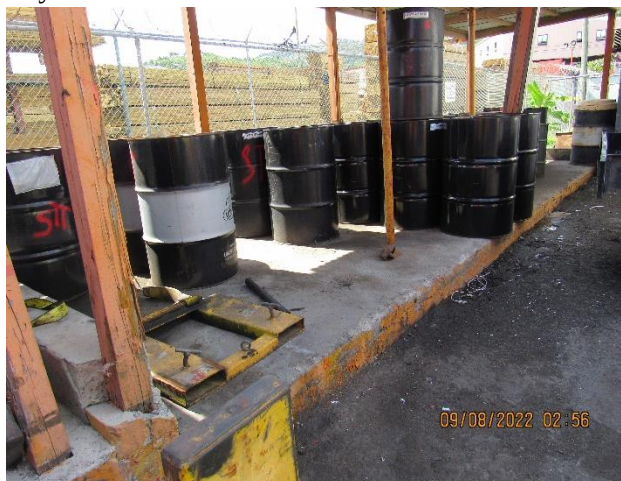
**IMG 503**-Lubricant and chemical storage area. No containment to capture spills and leaks onto concrete base. Will be washed-off by stormwater runoff flow.

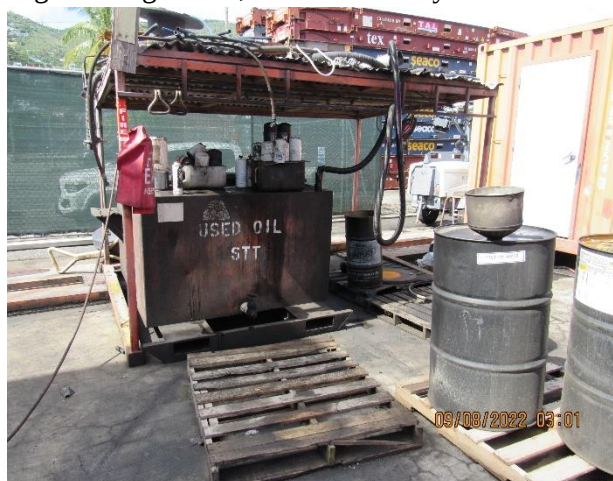
**IMG 510**-Use Oil management tank not within containment to capture used oil spills and prevent releases that are exposed to stormwater runoff flow.

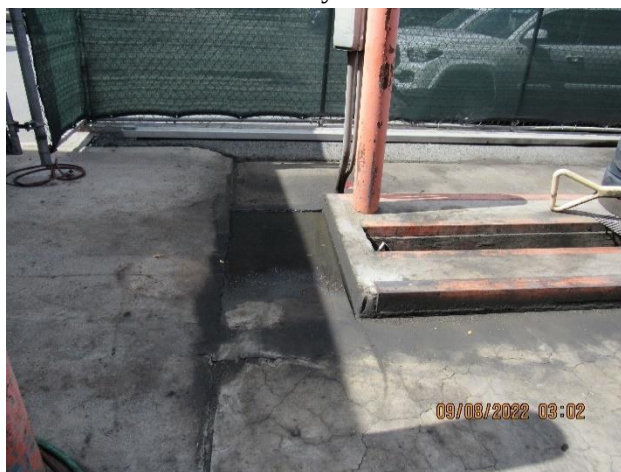
**IMG 511**-Evidence of spilled used oil on platform washed-off by stormwater runoff flow away from the used oil storage system.

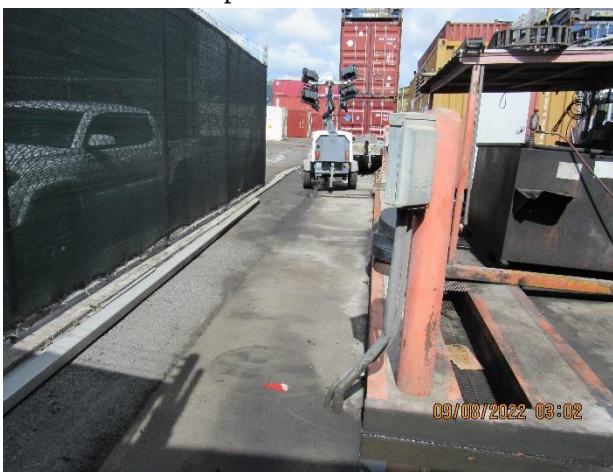
**IMG 512**-Evidence that used oil residue washed-off by stormwater runoff flow towards stormwater catch basins in the central area of the Facility.

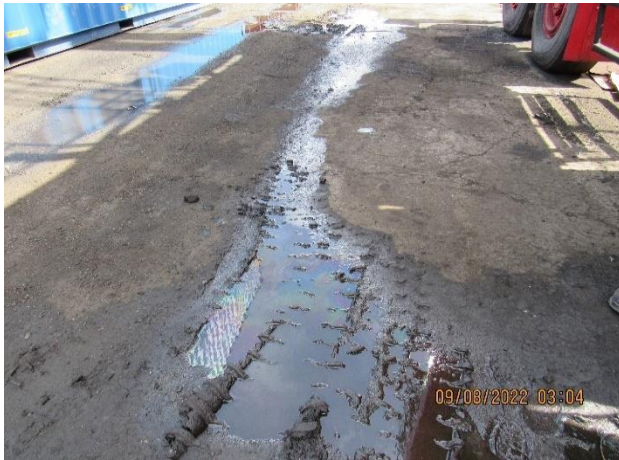
**IMG 513**-Evidence of oil and grease residues draining into inlet of a submerged Oil/Water Separator in operation at the Facility.

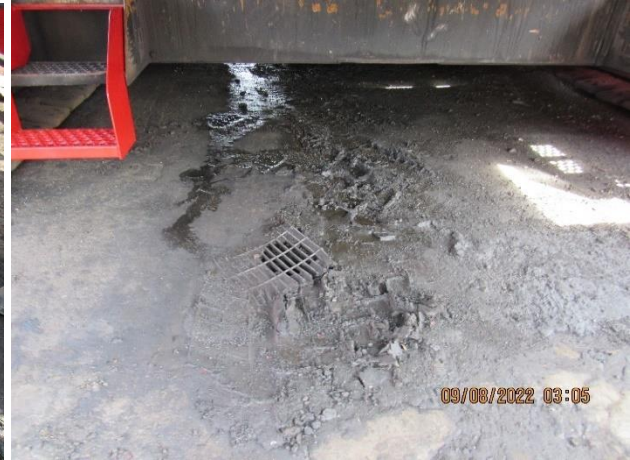
**IMG 514**-View of the inlet submerged in oily-mud. Oily-water runoff and sediment entering the Oil/Separator unit. Did not identify discharge port.

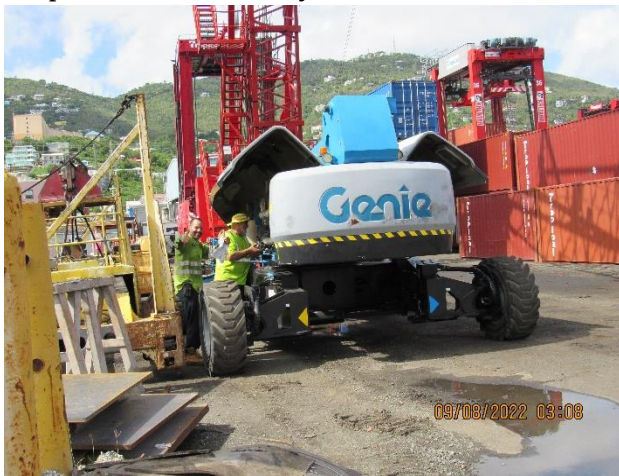
**IMG 517**-Observed personnel actively engaged in maintenance of heavy-load equipment outside of the maintenance shed.

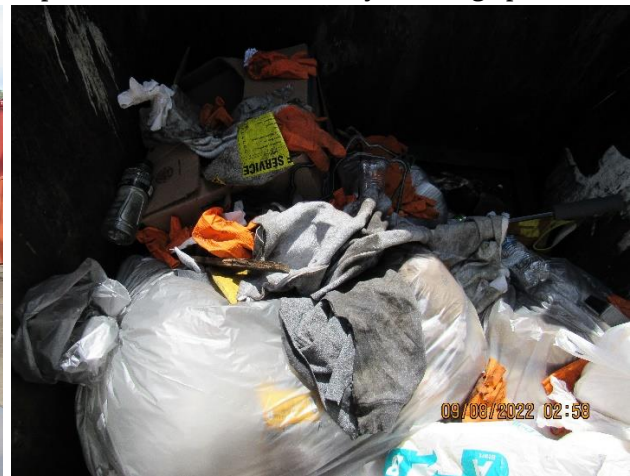
**IMG 506**-Identified oil-soaked rags and absorption pads thrown among regular garbage in dumpster Staged outside of the maintenance shed.

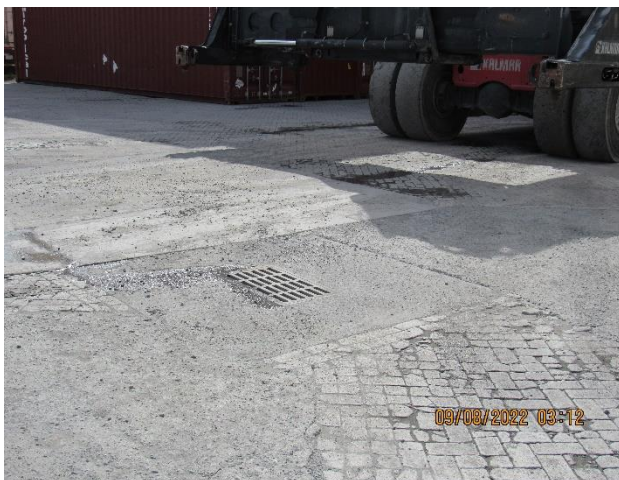
**IMG 518**-Stormwater catch basin that drains entire area of Tropical's MT Yard. Inlet of catch basin not protected.

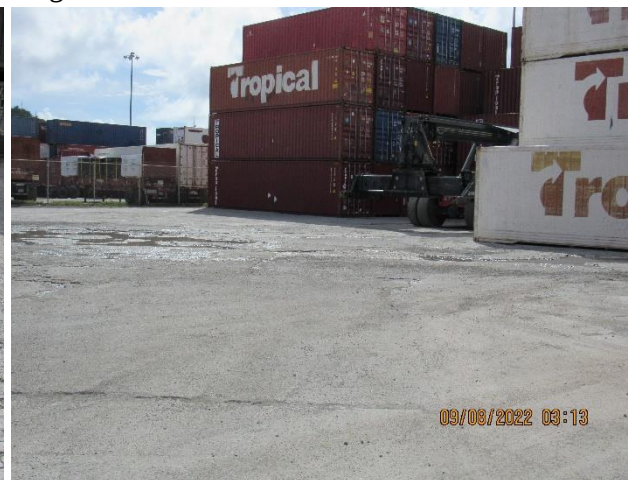
**IMG 519**-View of Tropical's MT Yard area that drains into the single stormwater catch basin.

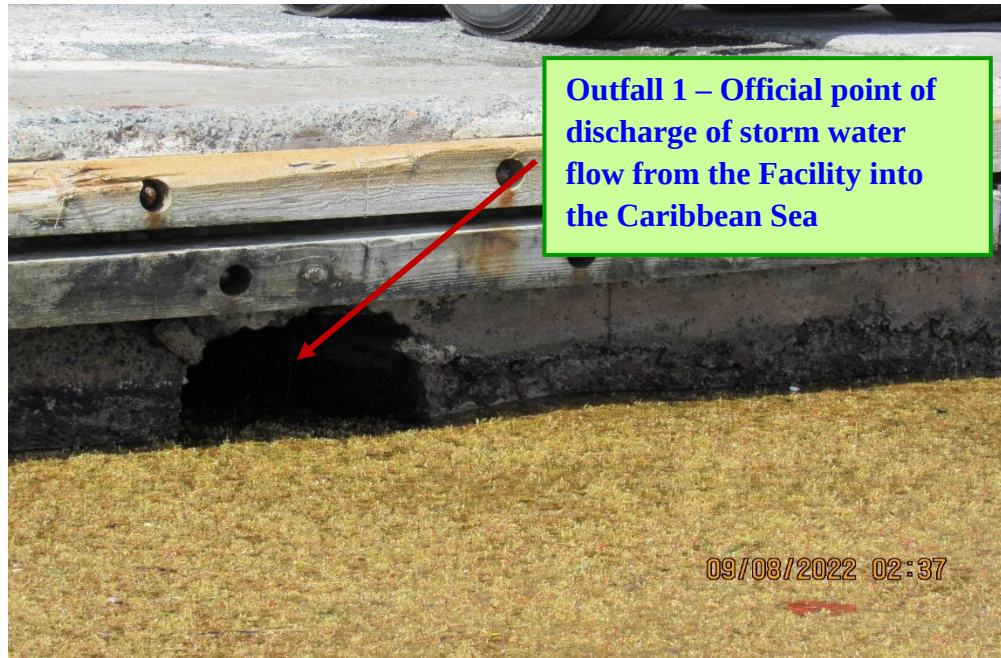
#### Outfall 1

Outfall 1 – Official point of discharge of storm water flow from the Facility into the Caribbean Sea

**IMG 486**-Discharge point where storm water from the Field and Warehouse areas north of the Facility and stormwater runoff drainage from within the Tropical's Main Container Yard combined into Charlotte Amalie Harbor.

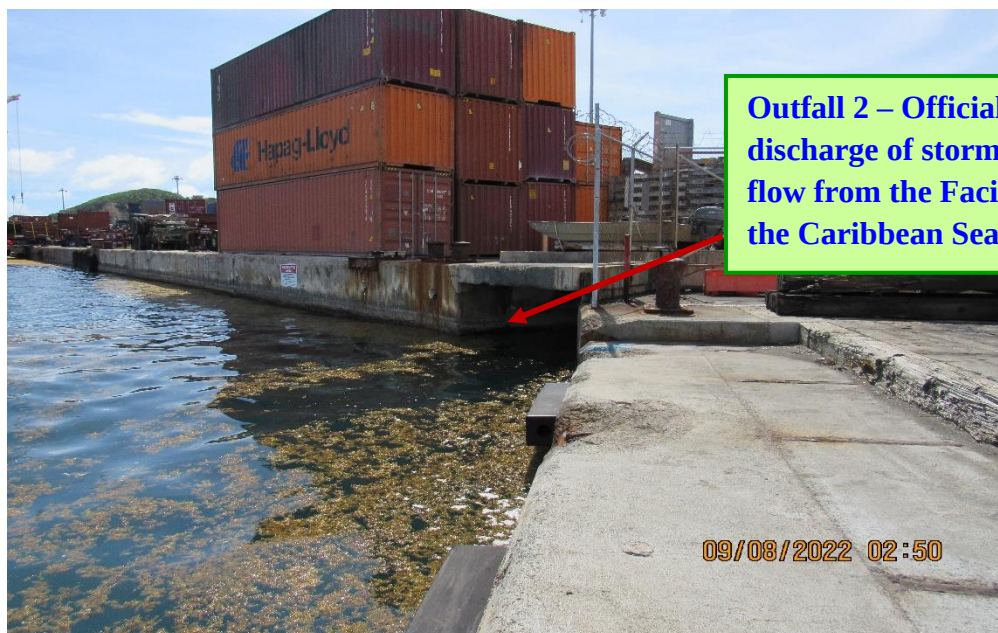
#### Outfall 2

Outfall 2 – Official point of discharge of storm water flow from the Facility into the Caribbean Sea

**IMG 496**-Discharge point of a stormwater channel that traverses the Facility. Stormwater runoff from Tropical's MT Yard drains into the channel before final discharge into the Charlotte Amalie Harbor.
