Clean Water Act Section 404: Site Visit/Case Development

Site Name: John Tringali Property

Site Address*: 6 Paula Drive (103.3-4-76)

EPA CWA 404 Inspection Photolog
John Tringali Property
Milton, Ulster County, NY

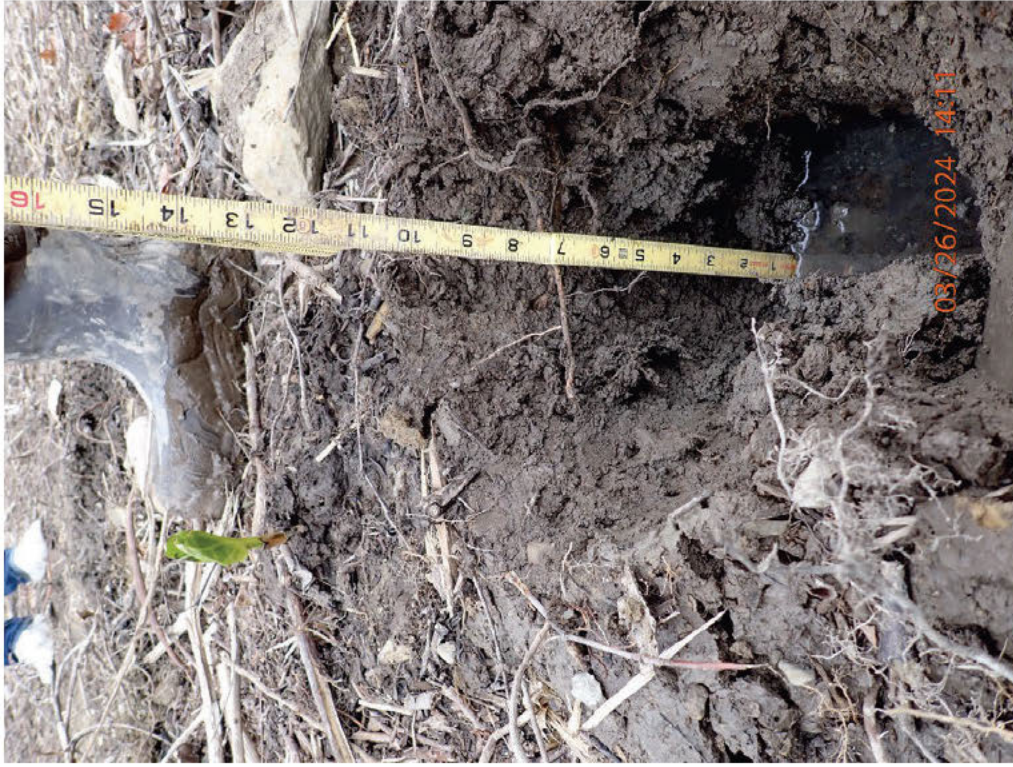
Date: 3/26/2024
Time: 2:11 PM
Photographer: S. Andreescu
Photo ID: 1 – P3260348

Soil Sampling Location within grubbed area
Water table at 9" below soil surface

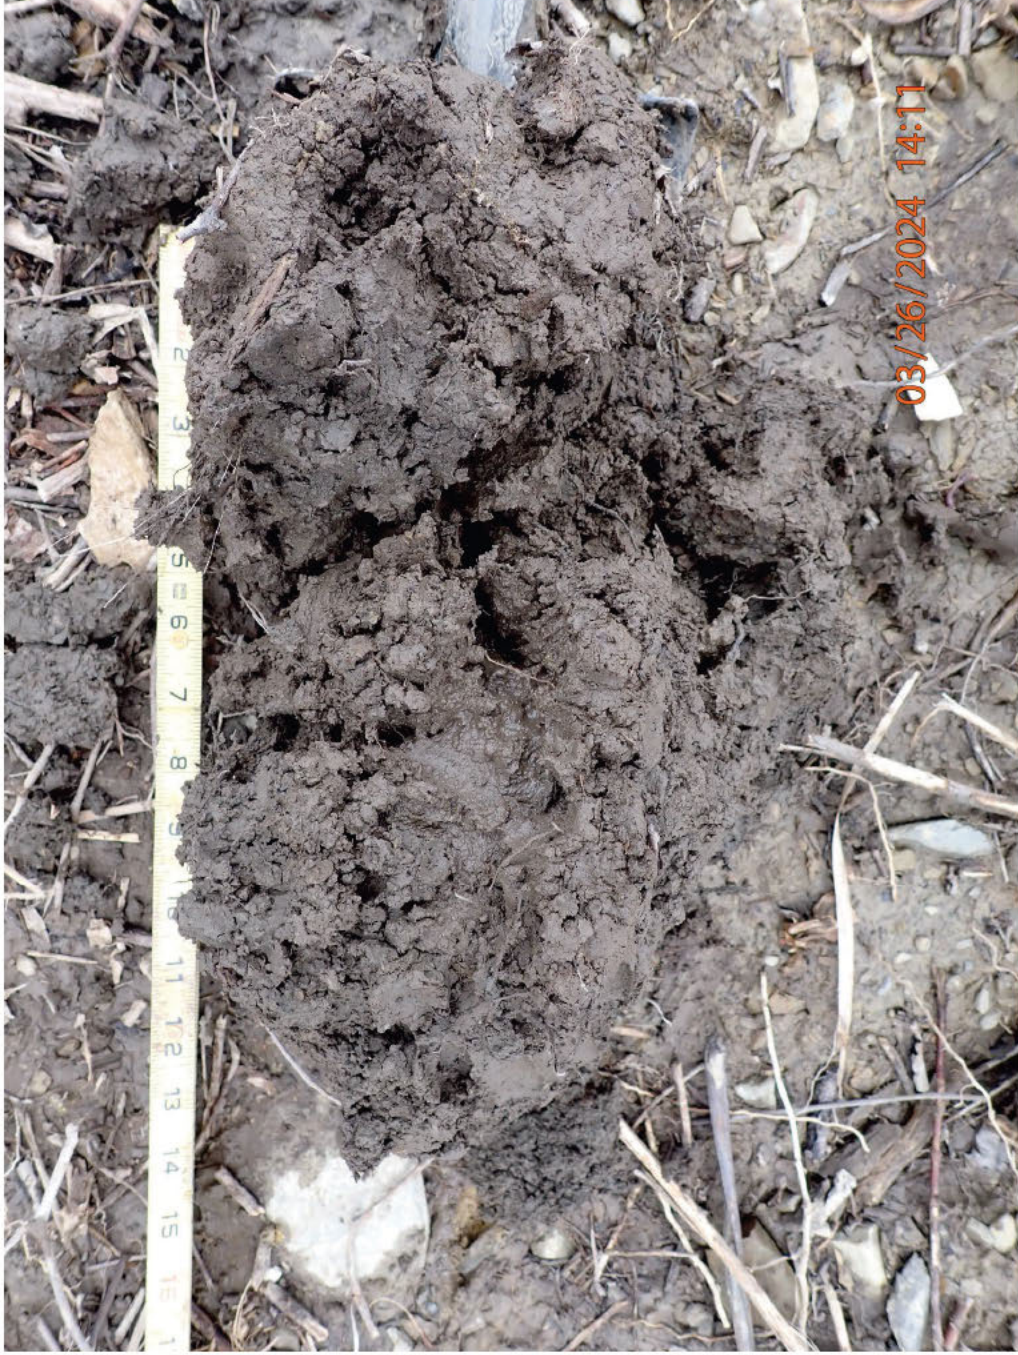
Date: 3/26/2024
Time: 2:11 PM
Photographer: S. Andreescu
Photo ID: 2 – P3260349

Soil Sampling Location within grubbed area
Soil profile

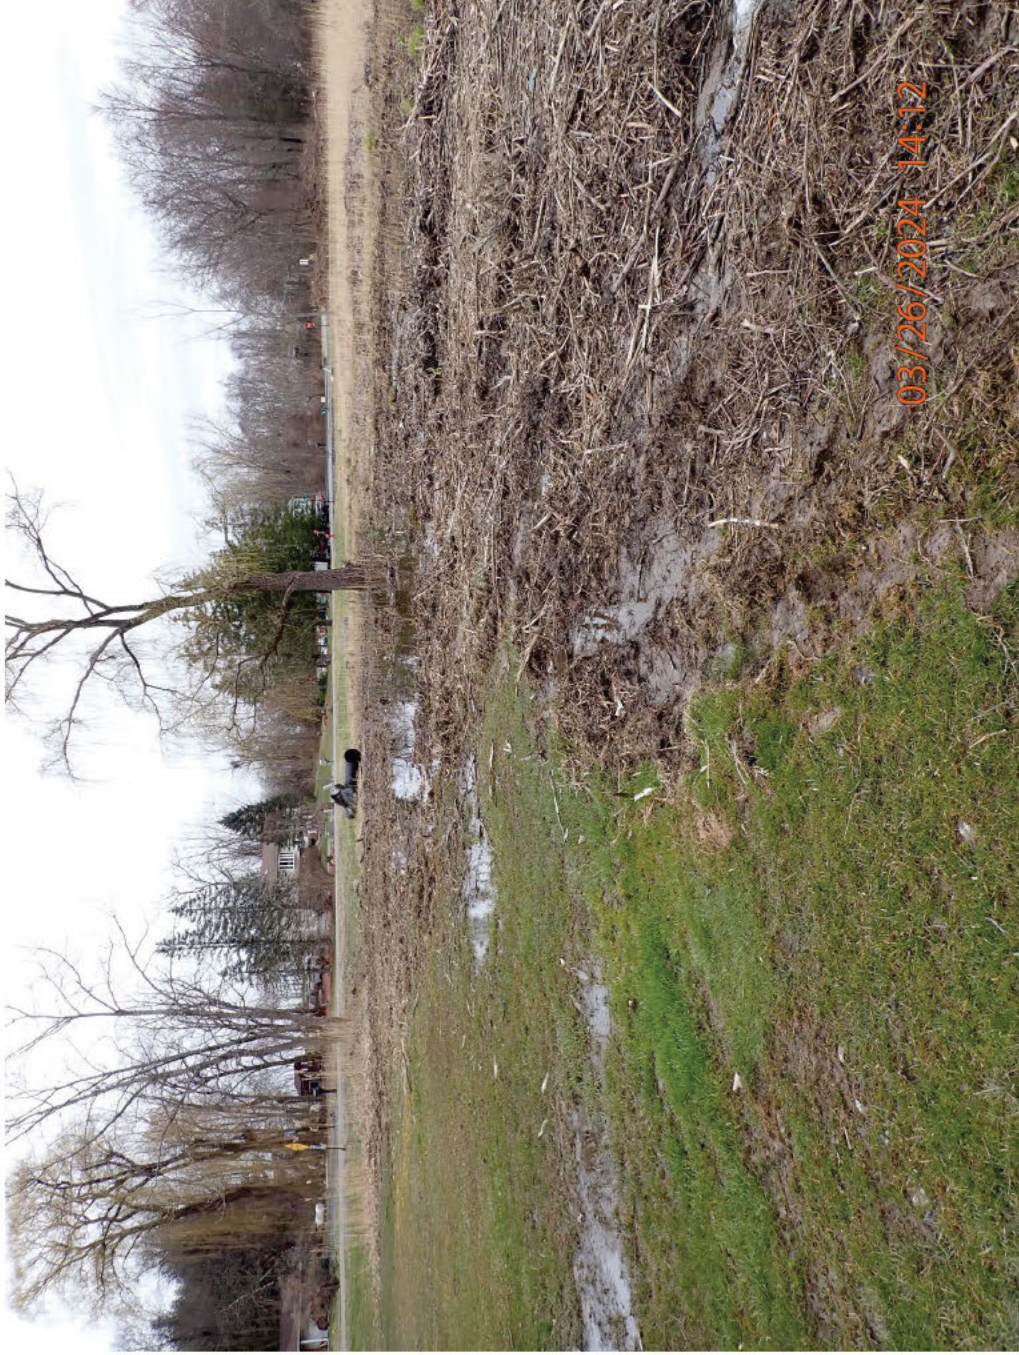
Date: 3/26/2024
Time: 2:12 PM
Photographer: S. Andreescu
Photo ID: 3 – P3260350

Description:
(1/4) Panorama of vegetation clearing and grubbing

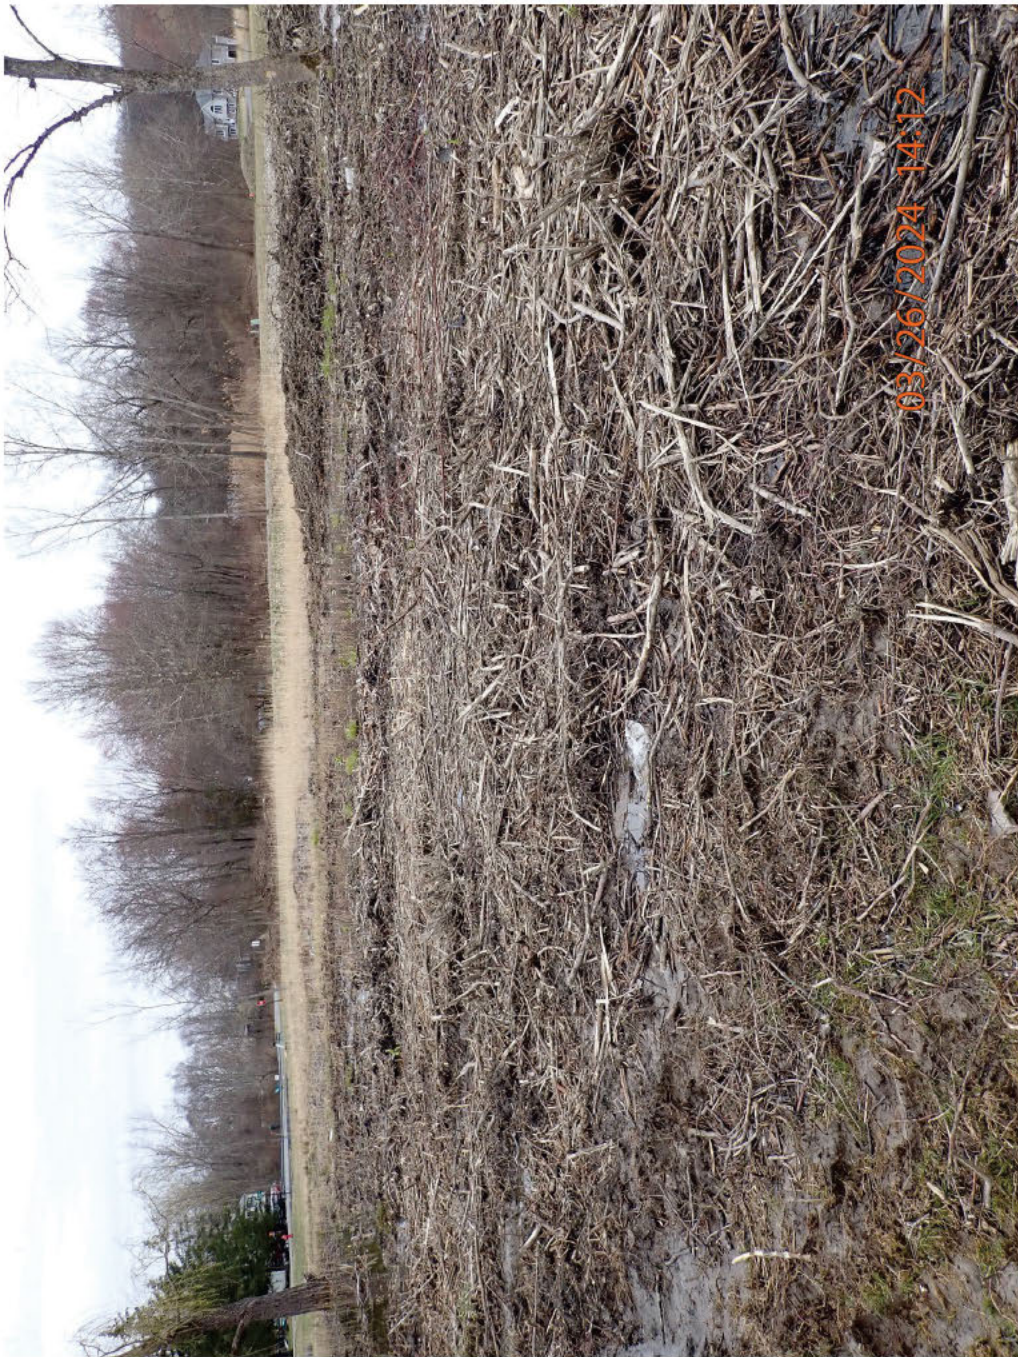
Date: 3/26/2024
Time: 2:12 PM
Photographer: S. Andreescu
Photo ID: 4 – P3260351

Description:
(2/4) Panorama of vegetation clearing and grubbing

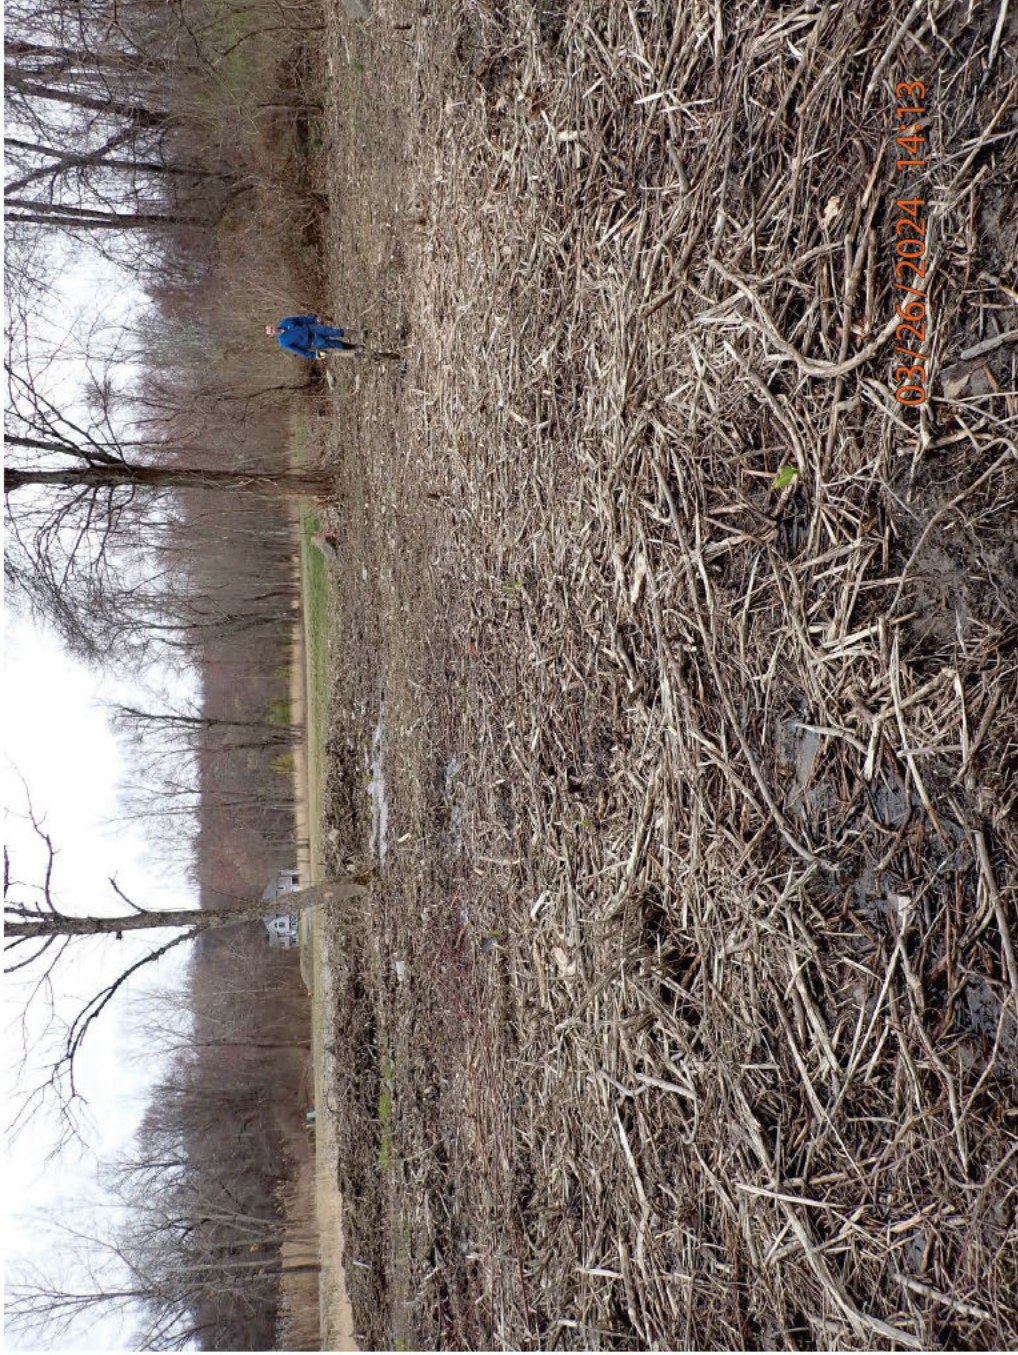
Date: 3/26/2024
Time: 2:13 PM
Photographer: S. Andreescu
Photo ID: 5 – P3260352

Description:
(3/4) Panorama of vegetation clearing and grubbing

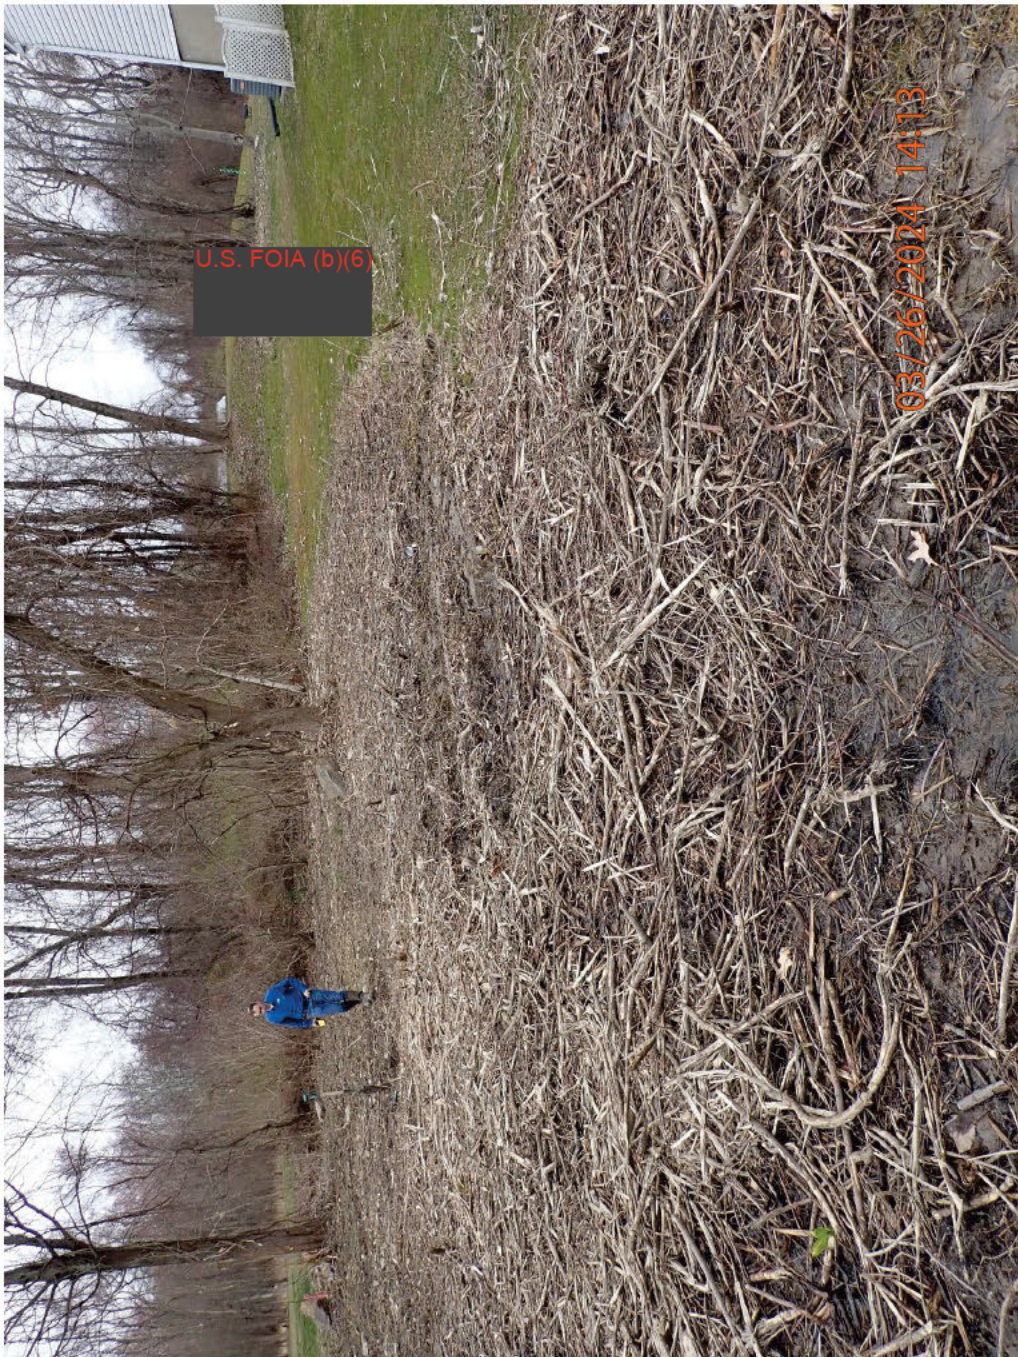
Date: 3/26/2024
Time: 2:13 PM
Photographer: S. Andreescu
Photo ID: 6 – P3260353

Description:
(4/4) Panorama of vegetation clearing and grubbing

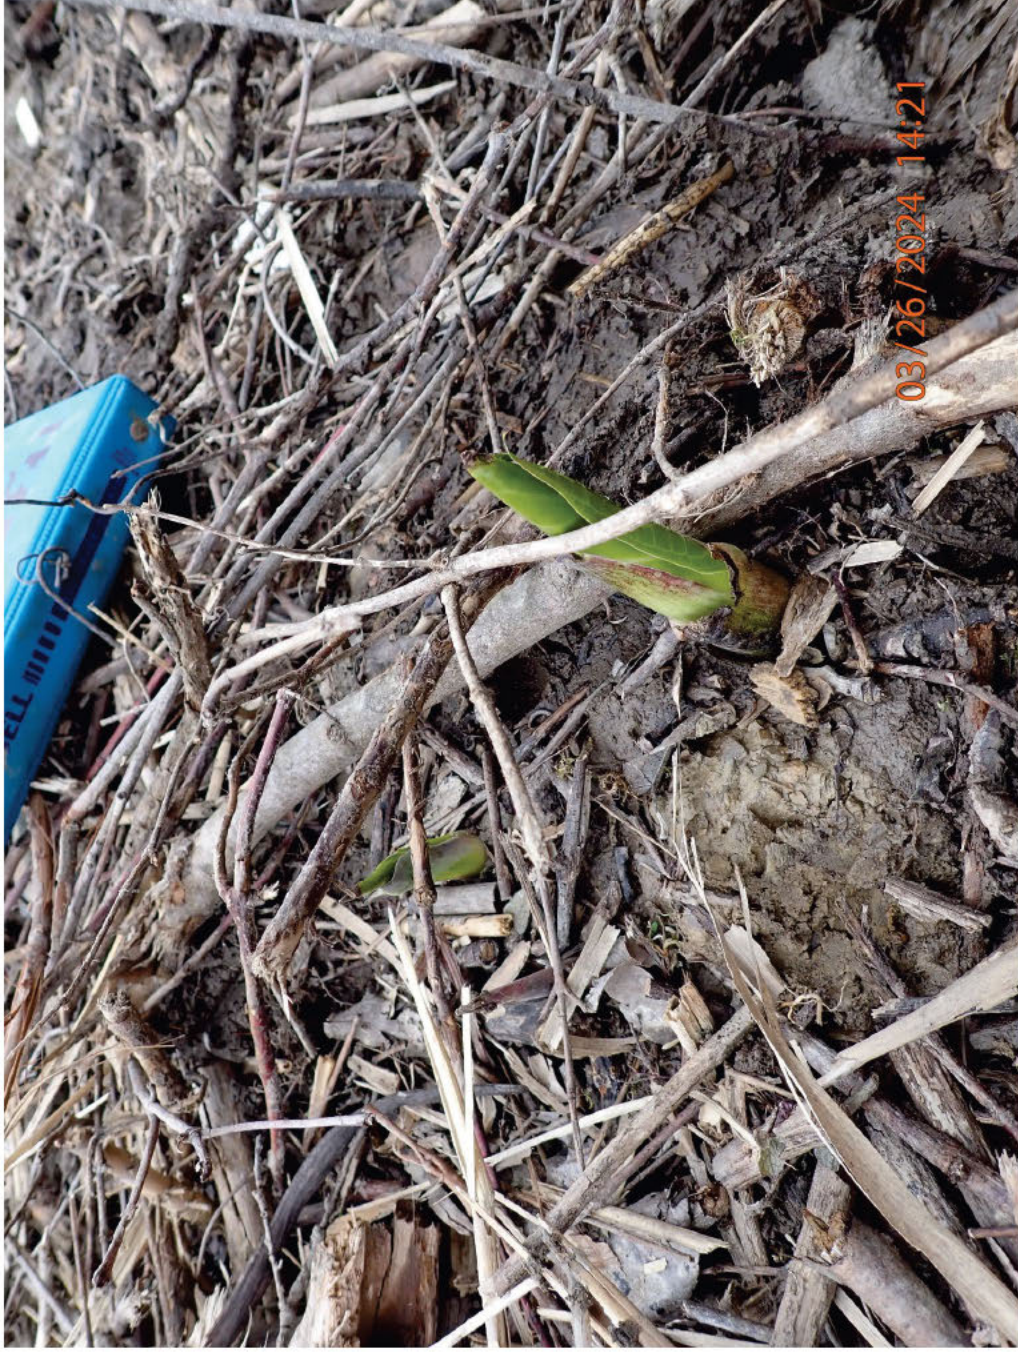
Date: 3/26/2024
Time: 2:21 PM
Photographer: S. Andreescu
Photo ID: 7 – P3260354

Skunk cabbage growing near
sampling location

Remarks: (Include photo numbers here or on a separate sheet.)
 Recent clearing and grubbing has removed all vegetation. Some skunk cabbage (Symplocarpus foetidus) was observed growing back.

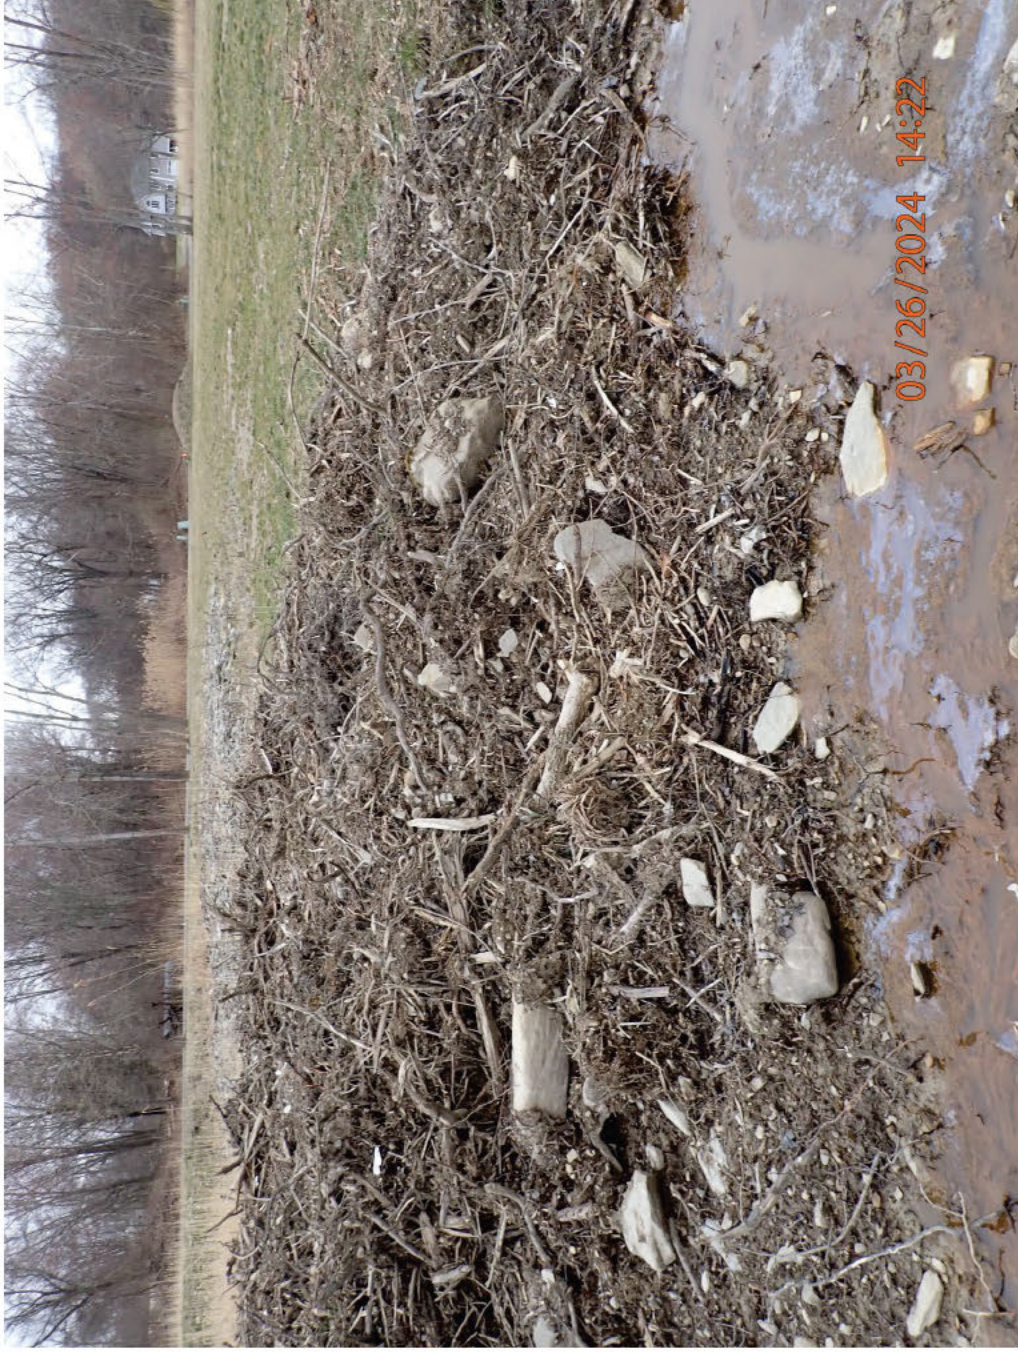
Date: 3/26/2024
Time: 2:22 PM
Photographer: S. Andreescu
Photo ID: 8 – P3260355

(1/3) Woody debris, roots, and branches from the cleared and grubbed areas piled onto neighboring property (26 Evy Lane)

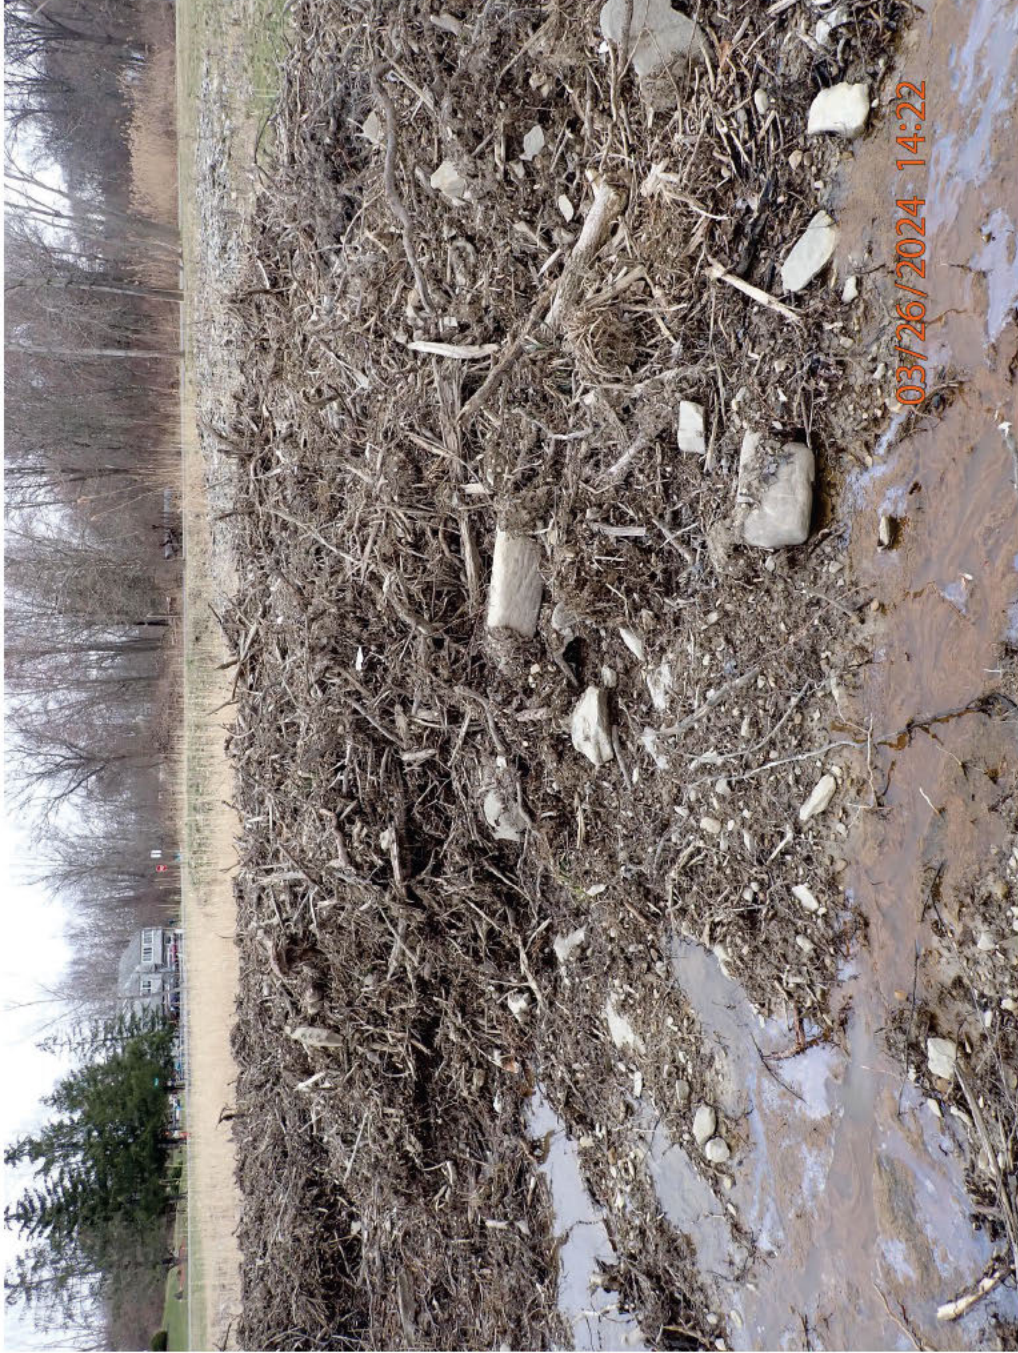
Date: 3/26/2024
Time: 2:22 PM
Photographer: S. Andreescu
Photo ID: 9 – P3260356

(2/3) Woody debris, roots, and branches from the cleared and grubbed areas piled onto neighboring property (26 Evy Lane)

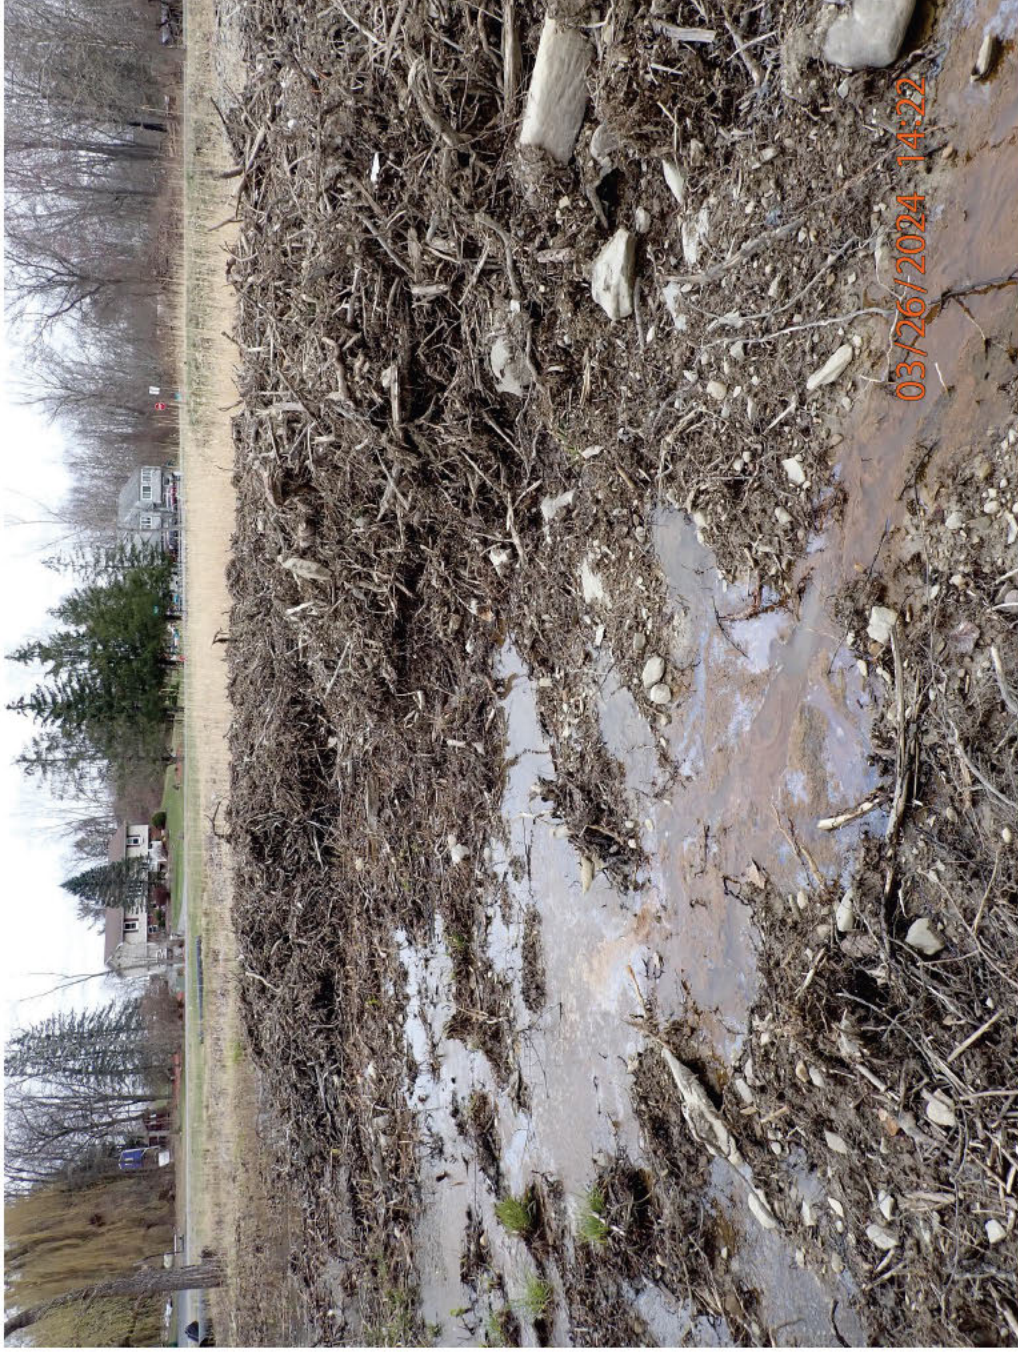
Date: 3/26/2024
Time: 2:22 PM
Photographer: S. Andreescu
Photo ID: 10 – P3260357

(3/3) Woody debris, roots, and branches from the cleared and grubbed areas piled onto neighboring property (26 Evy Lane)

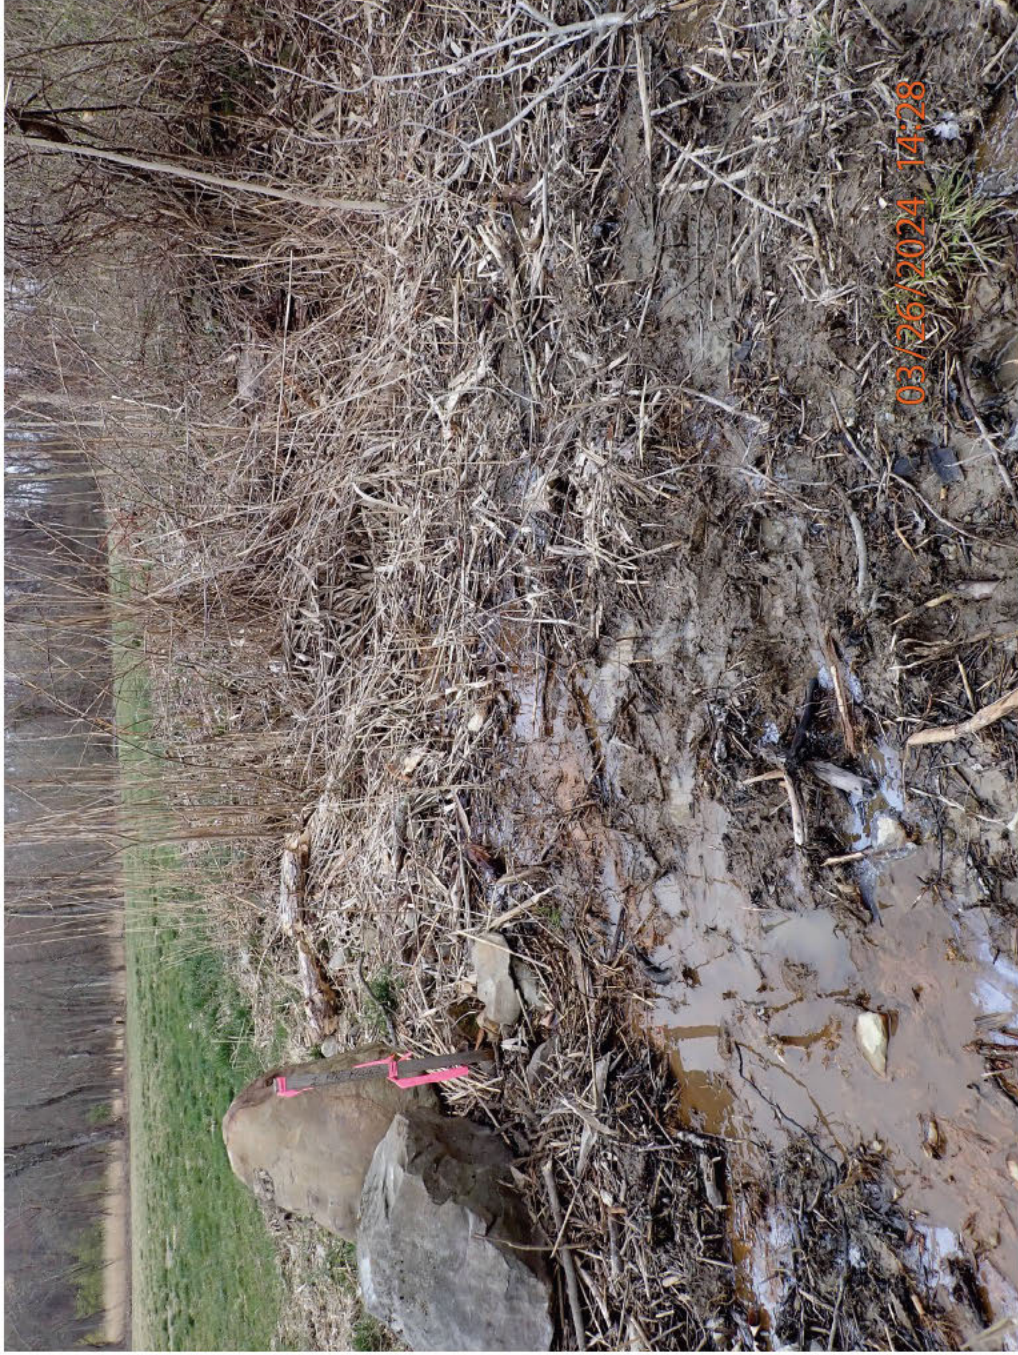
Date: 3/26/2024
Time: 2:28 PM
Photographer: S. Andreescu
Photo ID: 11 – P3260358

(1/2) Water seeping from
hillside and collecting on
property

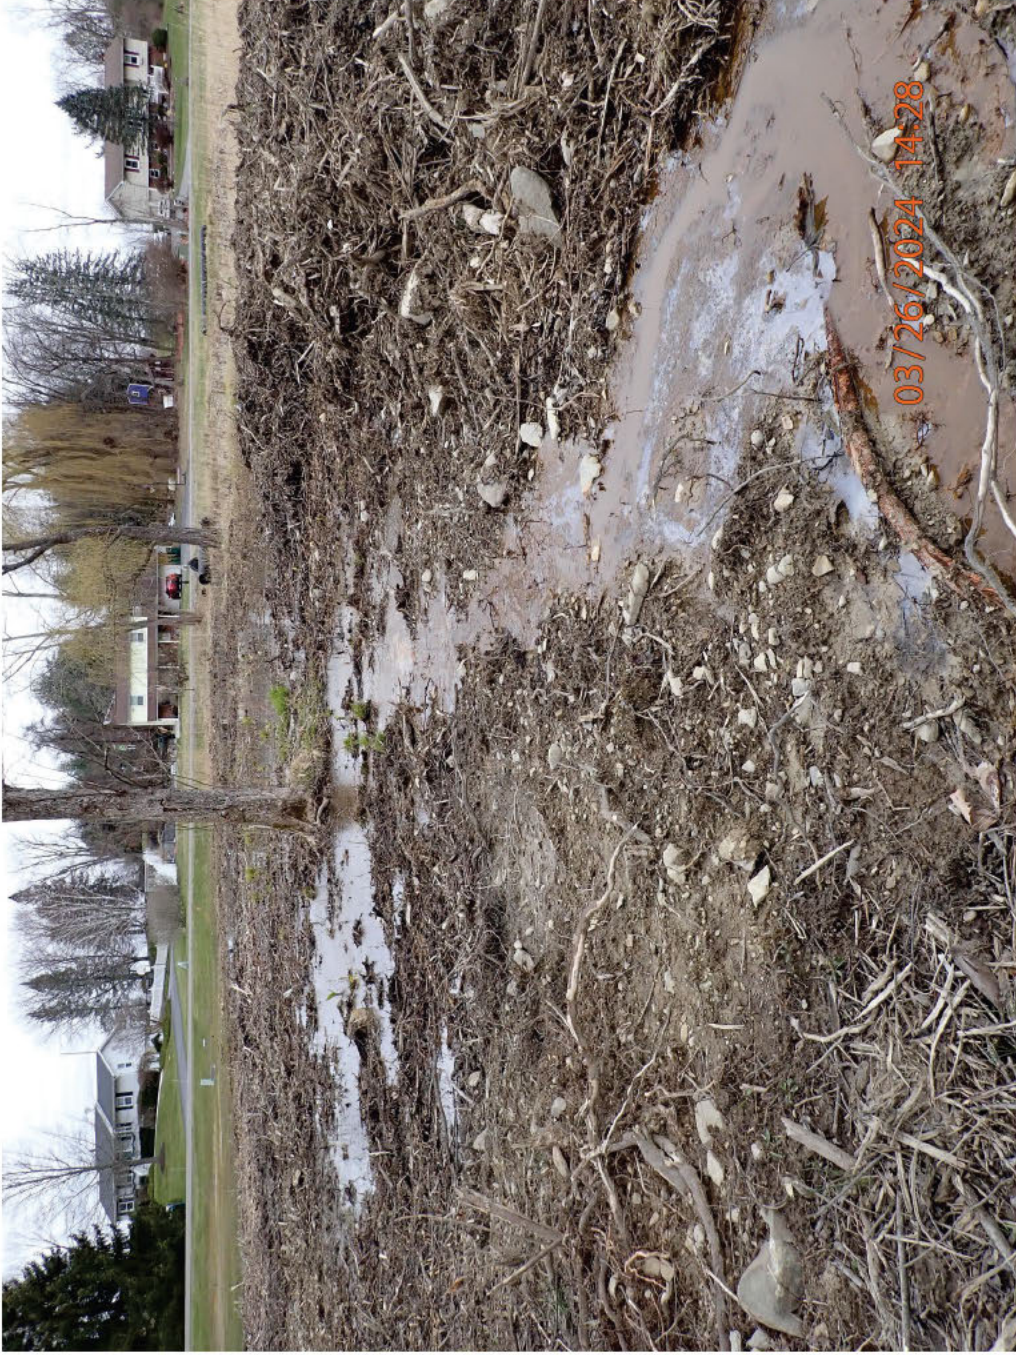
Date: 3/26/2024
Time: 2:28 PM
Photographer: S. Andreescu
Photo ID: 12 – P3260359

(2/2) Water seeping from
hillside and collecting on
property

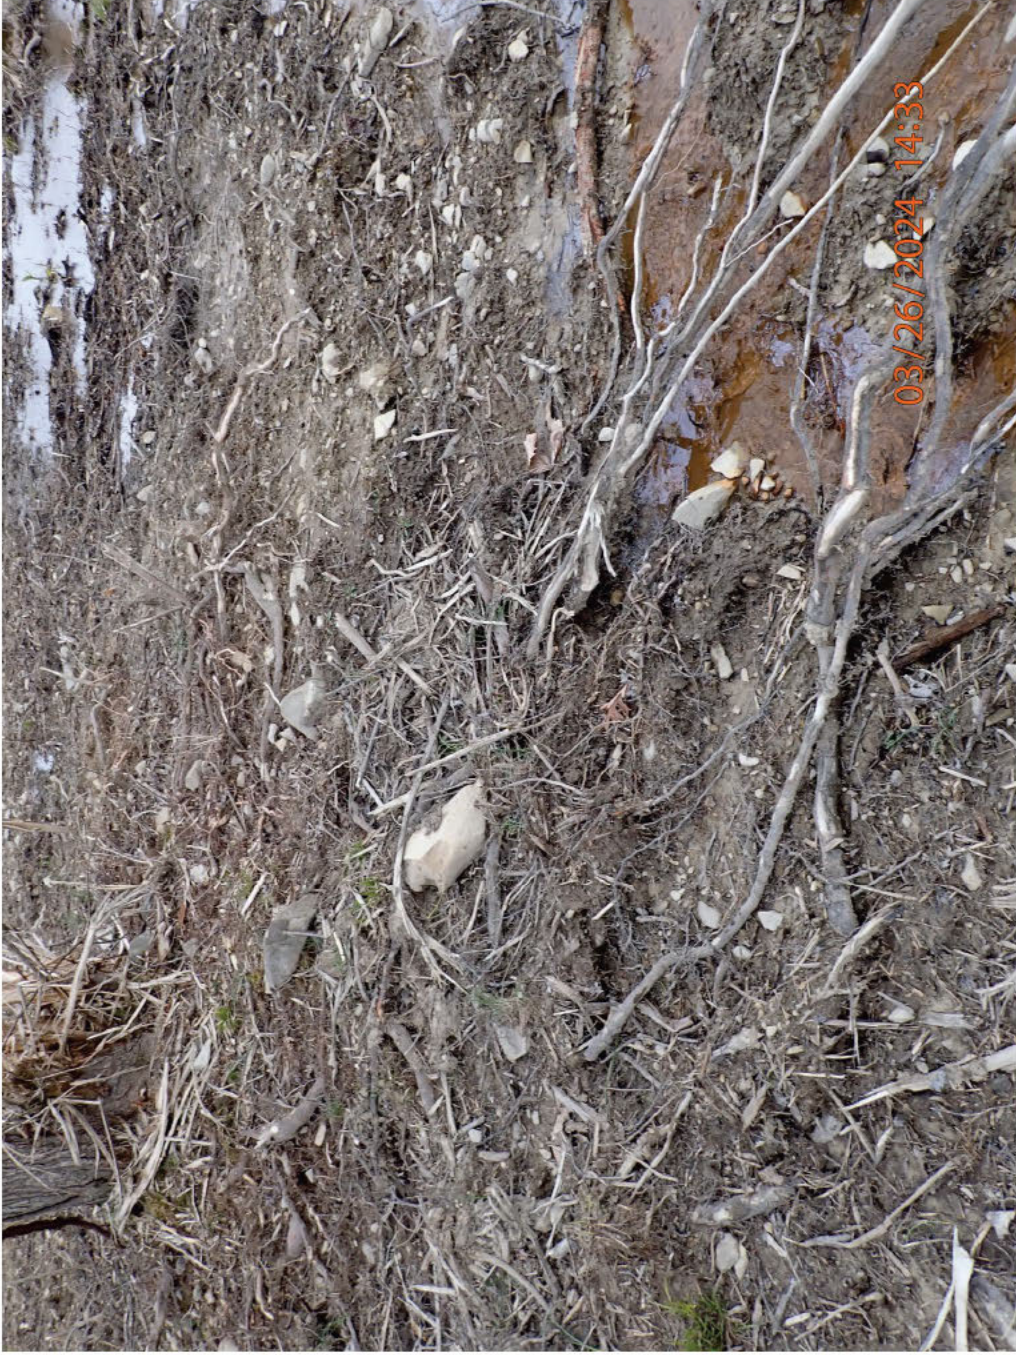
Date: 3/26/2024
Time: 2:33 PM
Photographer: S. Andreescu
Photo ID: 13 – P3260360

Exposed tree roots on Tringali property

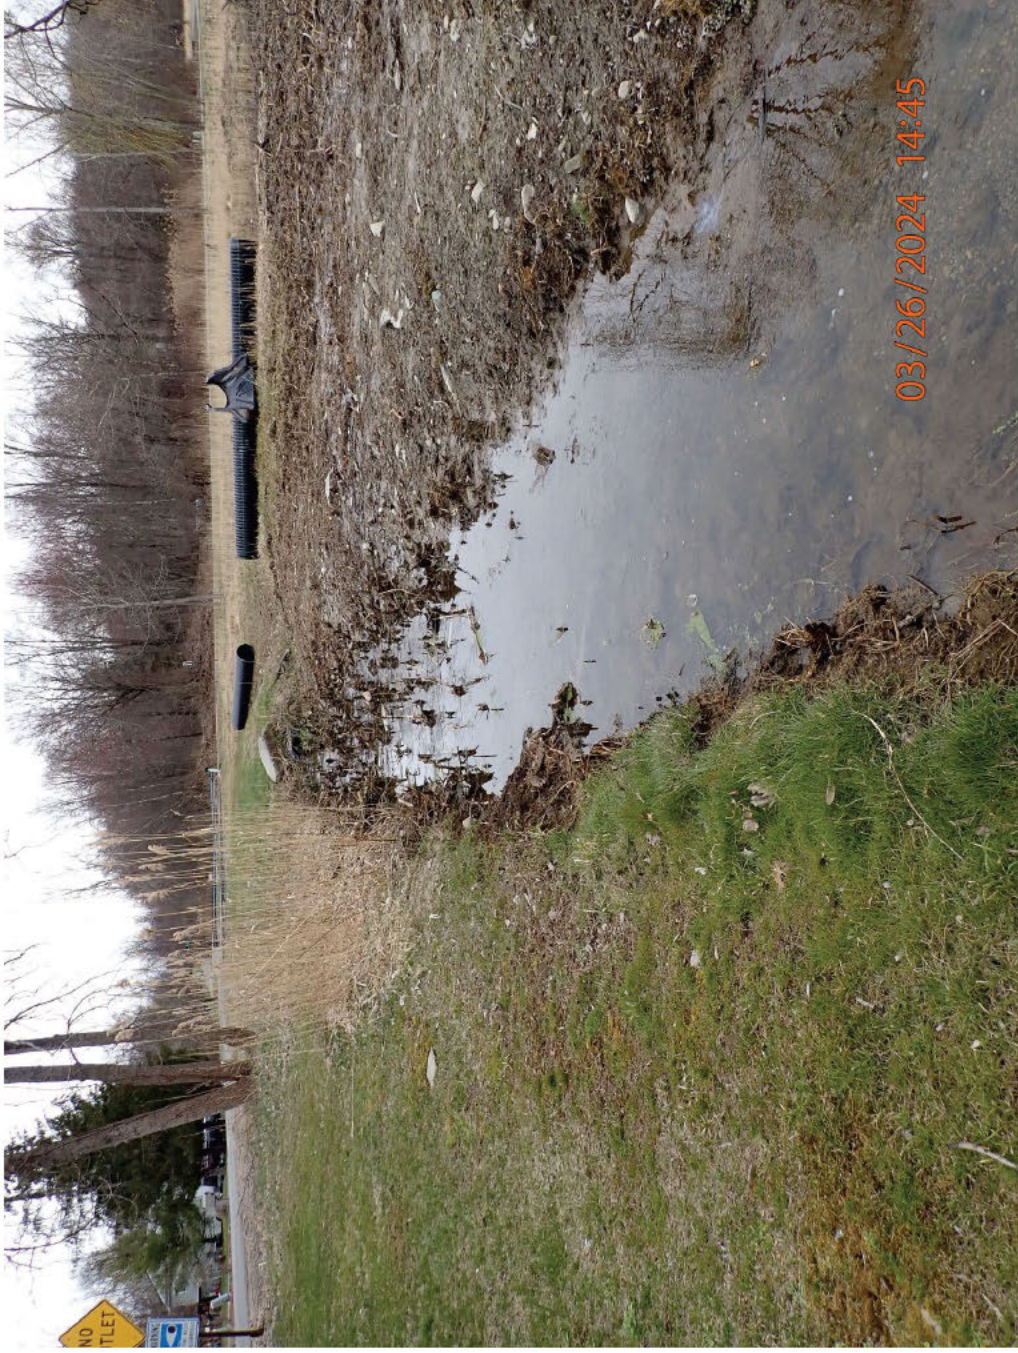
Date: 3/26/2024
Time: 2:45 PM
Photographer: S. Andreescu
Photo ID: 18 – P3260365

Description:
(1/4) Stream piped under
Tringali property front lawn

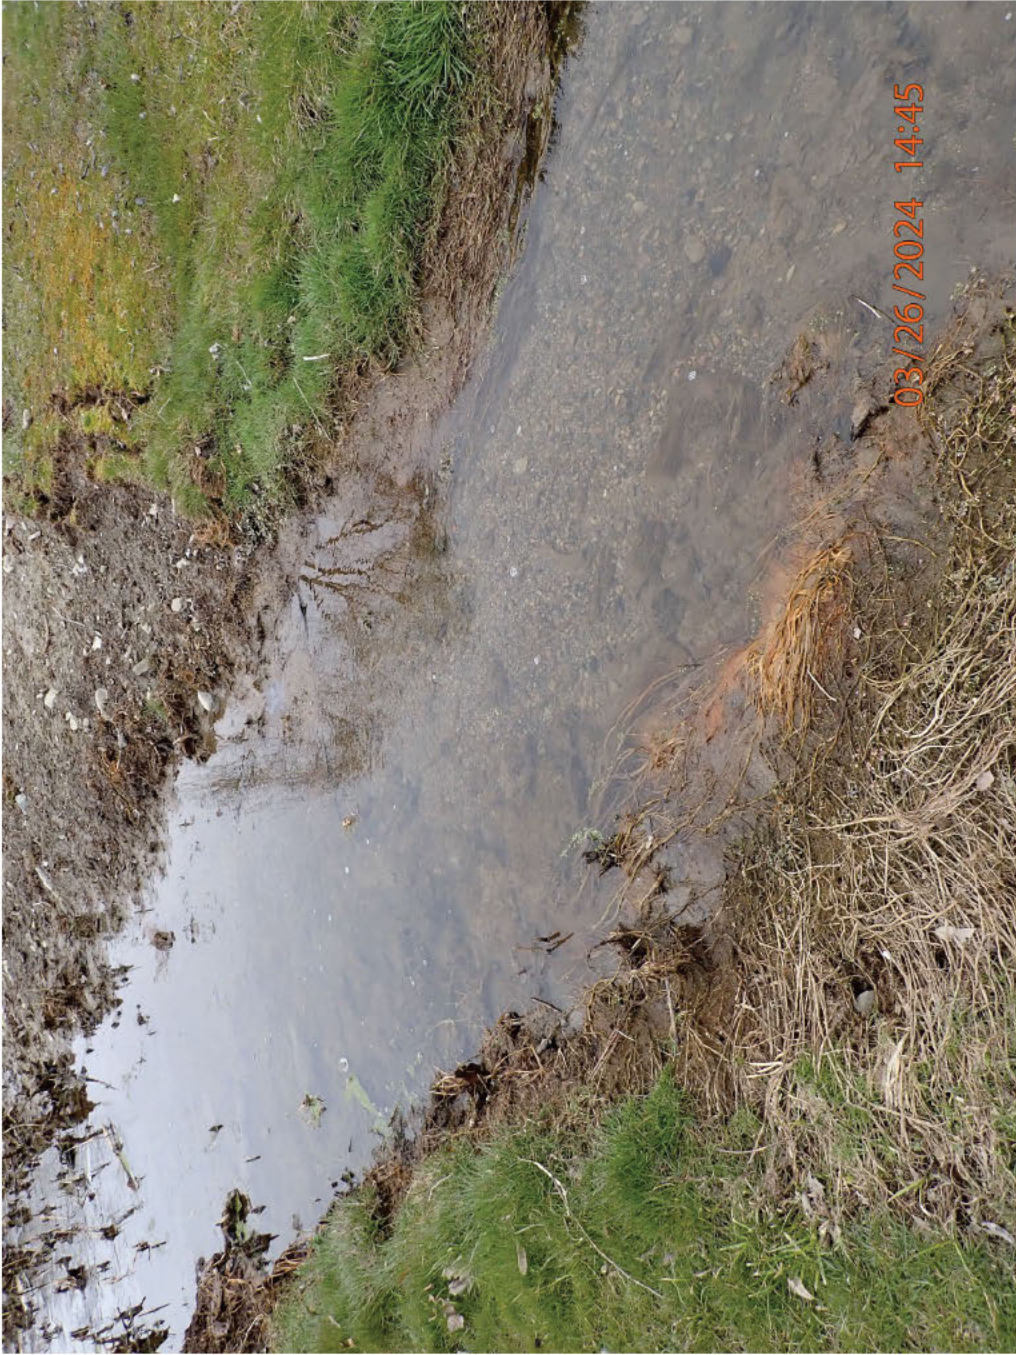
Date: 3/26/2024
Time: 2:45 PM
Photographer: S. Andreescu
Photo ID: 19 – P3260366

Description:
(2/4) Stream piped under
Tringali property front lawn

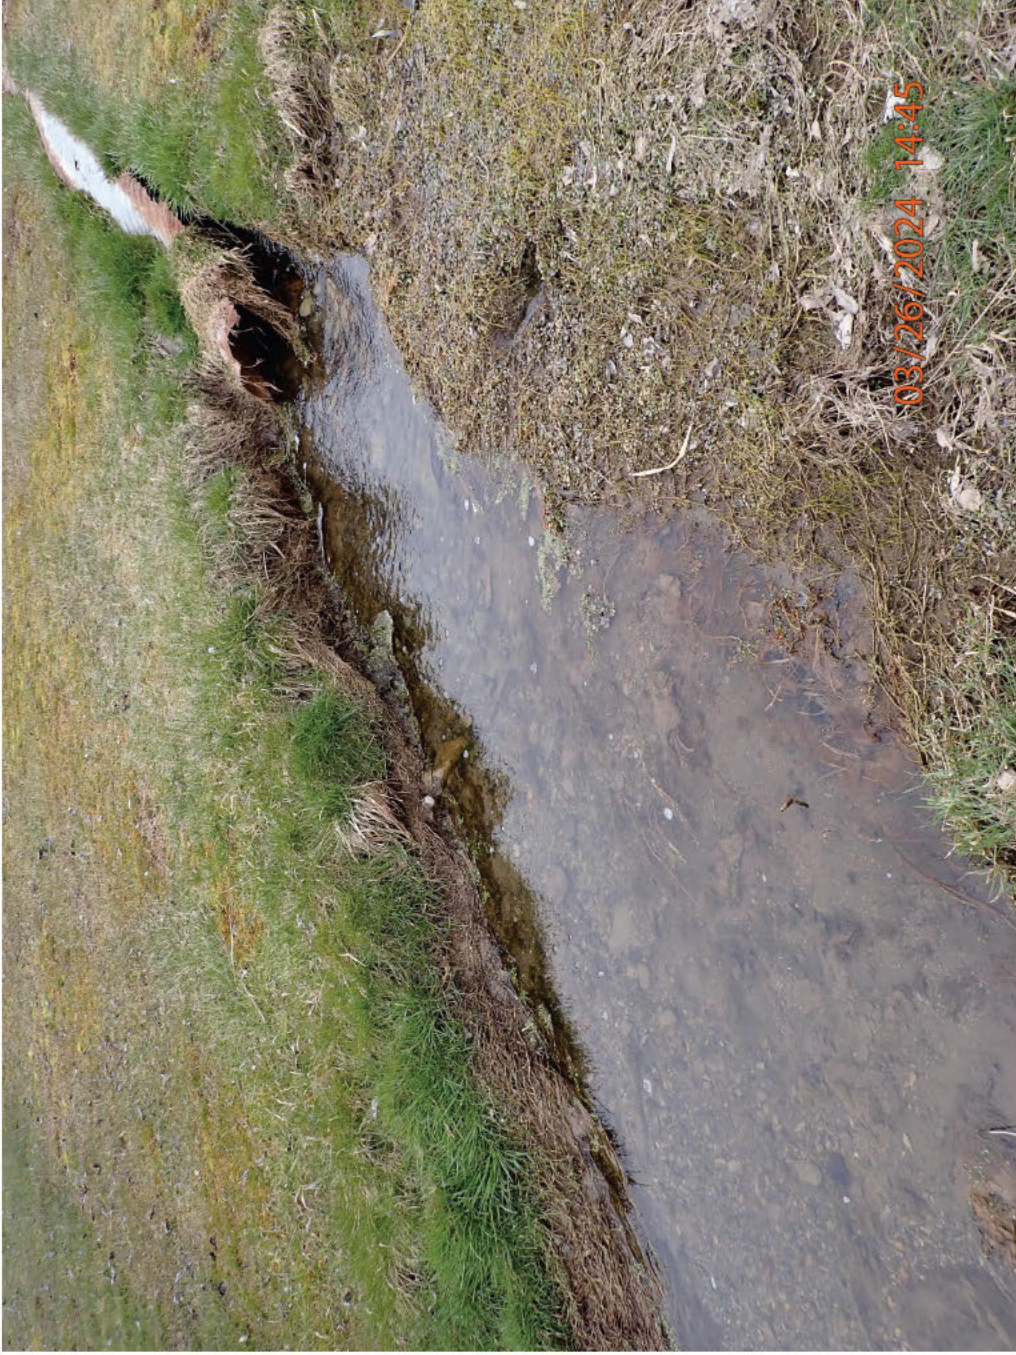
Date: 3/26/2024
Time: 2:45 PM
Photographer: S. Andreescu
Photo ID: 20 – P3260367

Description:
(3/4) Stream piped under
Tringali property front lawn
