Clean Water Act Section 404: Site Visit/Case Development

Site Name: John Tringali Property

Site Address*: 6 Paula Drive (103.3-4-76)

EPA CWA 404 Inspection Photolog
John Tringali Property
Milton, Ulster County, NY

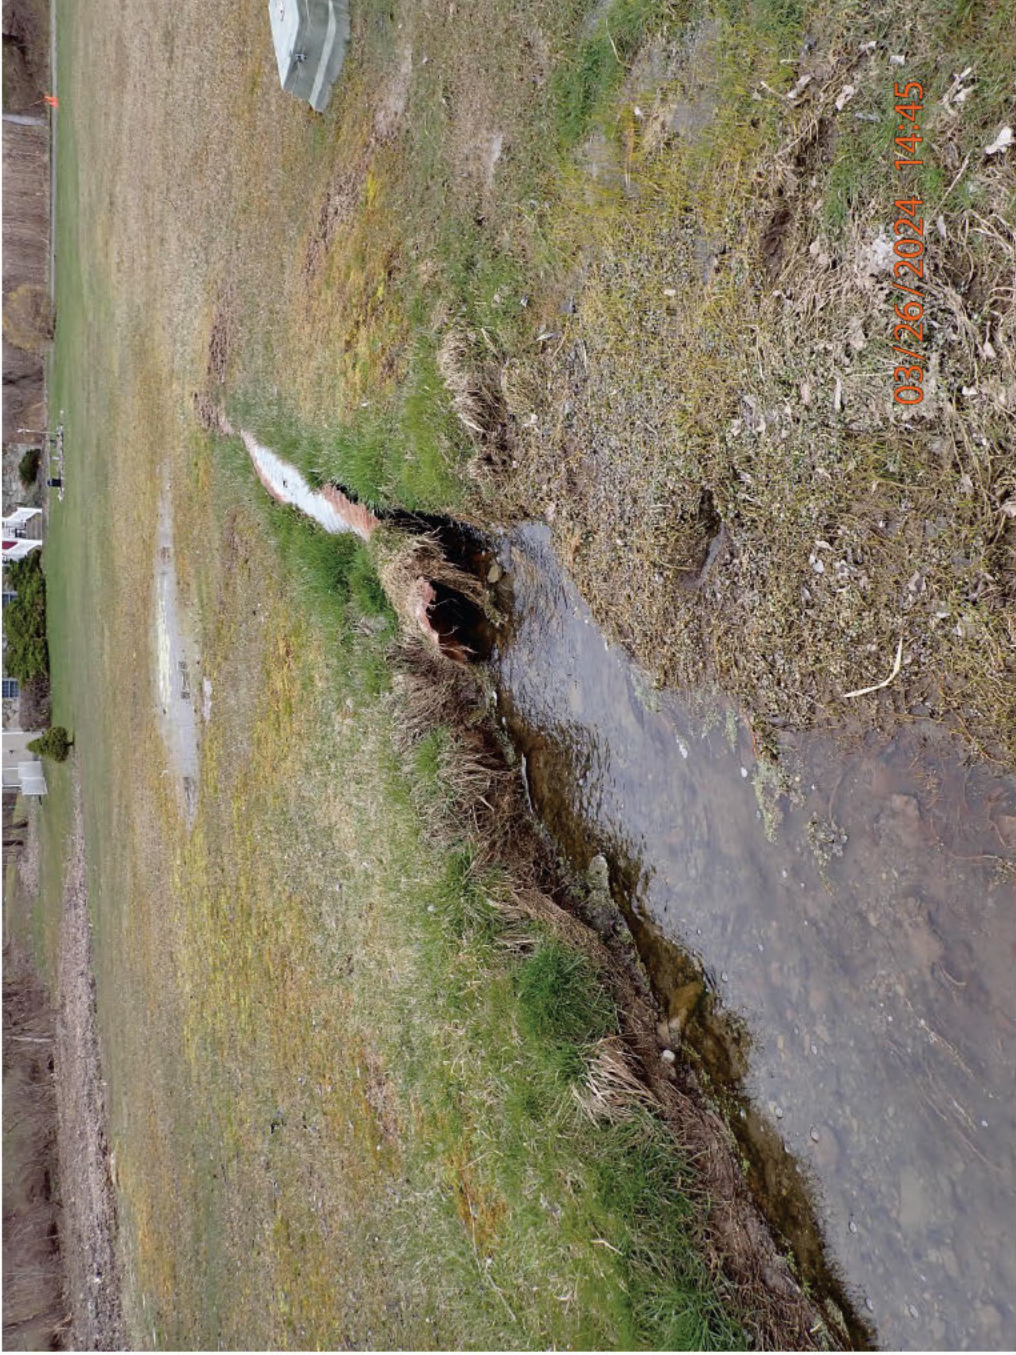
Date: 3/26/2024
Time: 2:45 PM
Photographer: S. Andreescu
Photo ID: 21- P3260368

Description:
(4/4) Stream piped under
Tringali property front lawn
