**NPDES STORMWATER RECONNAISSANCE INSPECTION**  
**Industrial Activities**

**ANGUILLA MUNICIPAL SOLID WASTE LANDFILL FACILITY**  
3C Estate Bethlehem Middle Works, St. Croix, USVI 00820  
Latitude: 17°41'55.46" N; Longitude: 64°46'51.78" W  
Telephone Number: 340-712-4962

**NPDES ID: VIU056746**

Inspection Date: March 14, 2024

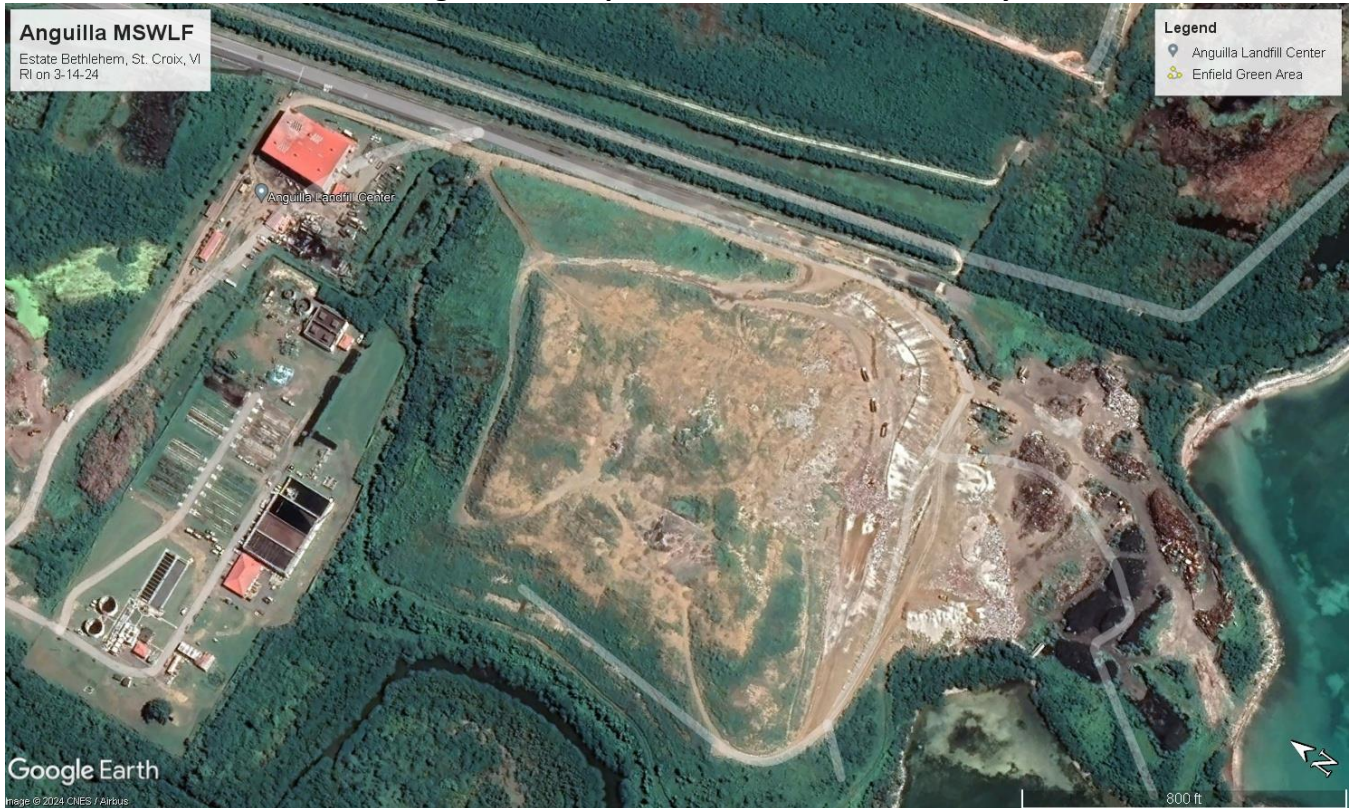
**Figure 1**

**VIWMA's Anguilla Municipal Solid Waste Landfill Facility, St. Croix, VI**

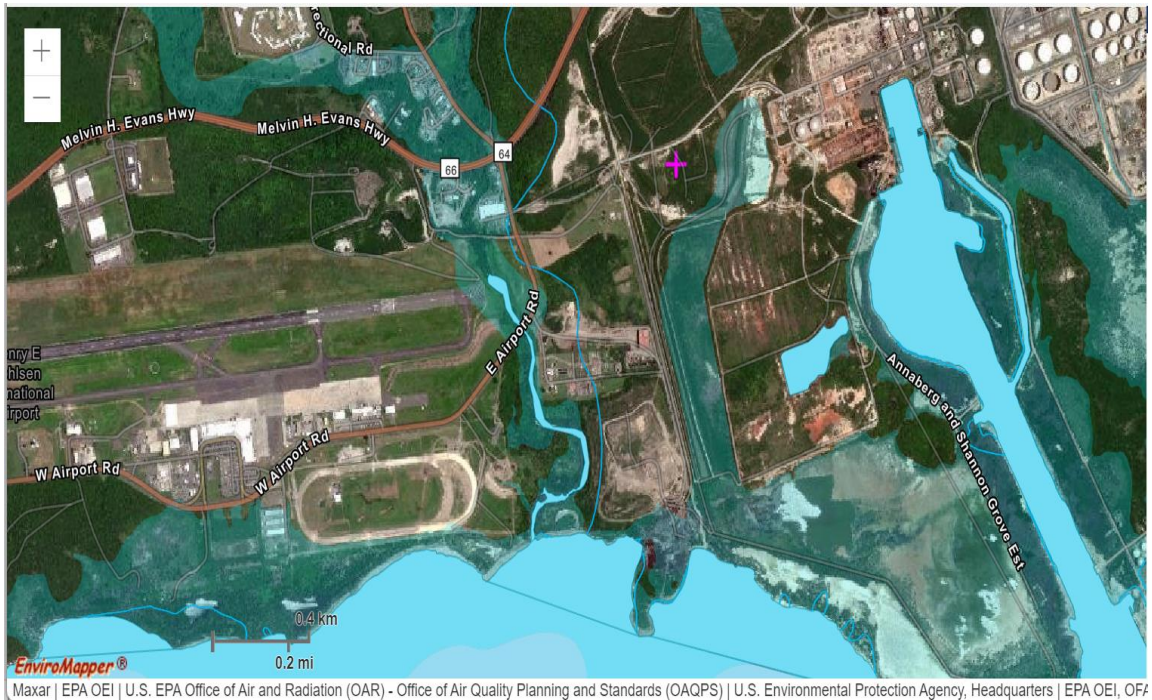
**Figure 2**

**VIWMA's Anguilla MSWLF situated within the southeastern section the watershed**
