DOCUMENT DESCRIPTION: NIOSH Inspection Report - Air Sampling & Industrial Hygiene Survey

**GENUINE PARTS COMPANY  
RAYLOC DIVISION  
ATLANTA, GEORGIA**

**Survey Conducted By:  
JOHN M. DEMENT  
PATRICK J. SHULER**

**August, 1972**

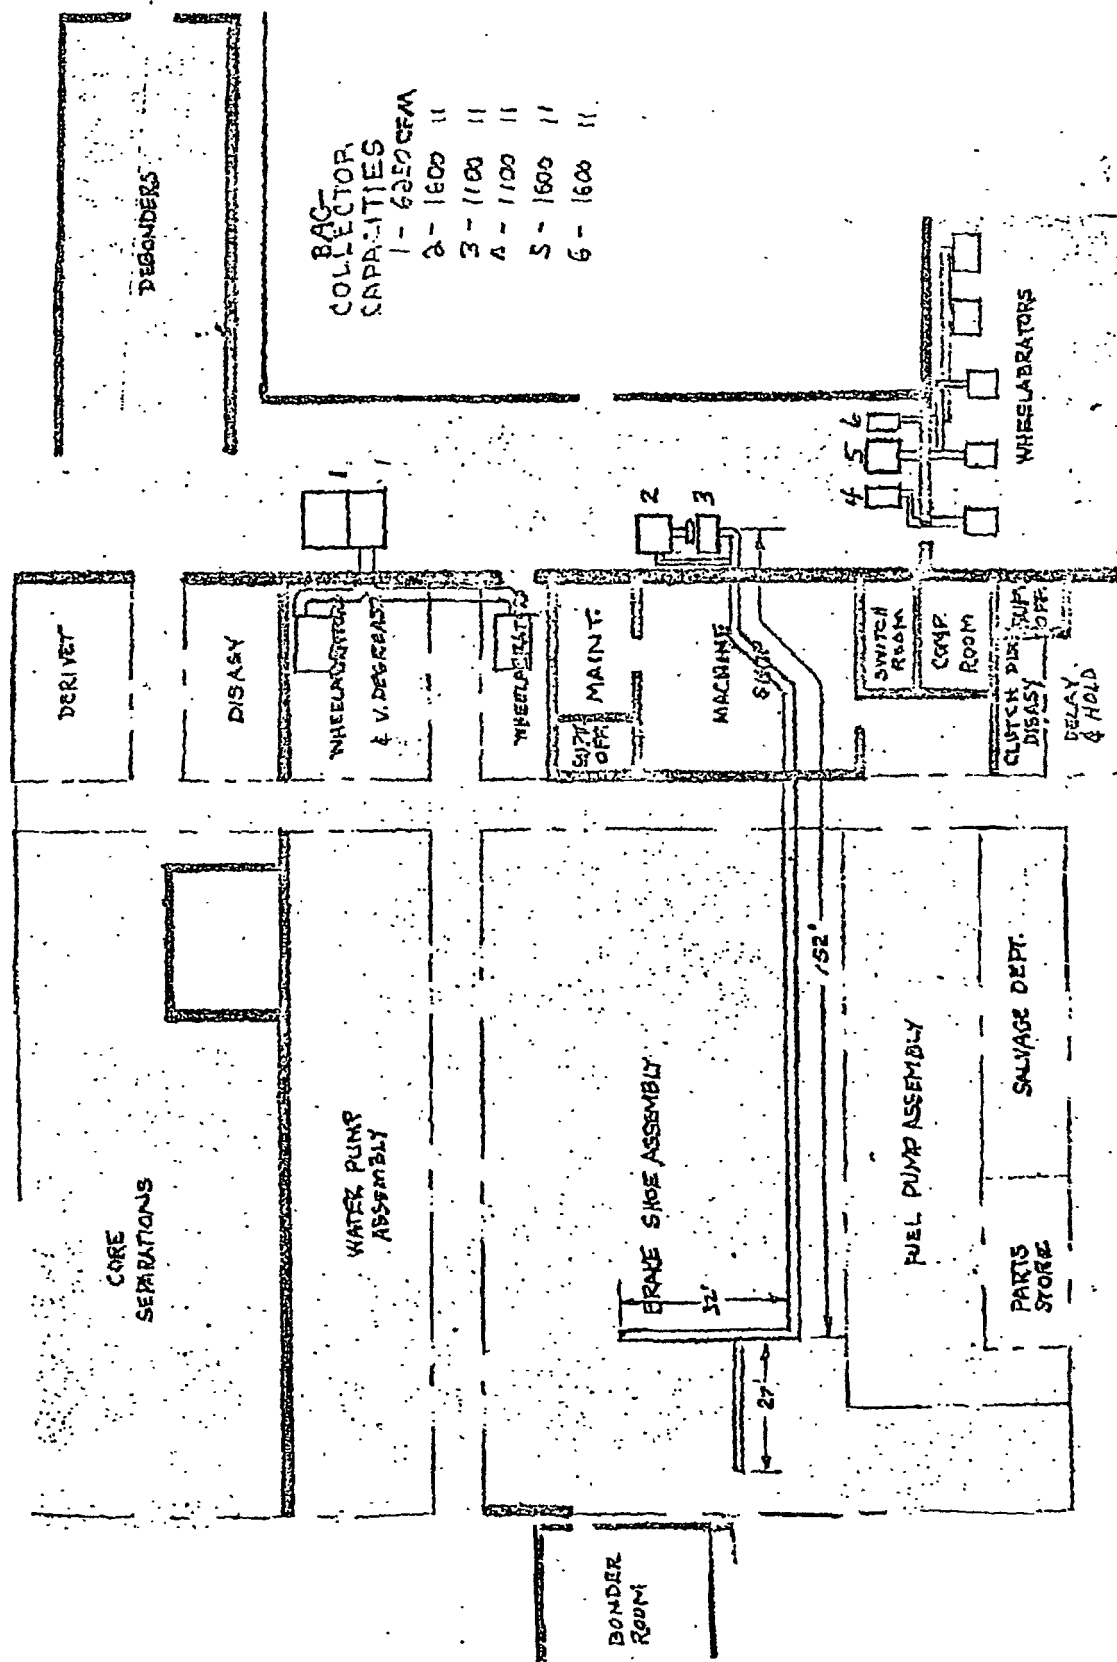
FIGURE 1: FRICTION PRODUCT LAYOUT WITH COLLECTORS

Local exhaust ventilation is provided on all 3 brake lining grinders and on all 5 "Wheelabrator" cleaning machines. These machines are vented to 6 "Wheelabrator" bag dust collectors.

Figure 1 shows a layout of the friction products area of the plant along with locations of the dust collectors and their respective capacities.

Velocity measurements at the entrance to the grinder hoods showed velocities ranging from 600 fpm to 1100 fpm. No ventilation is provided at the clutch deriveting operation.
