**CWA COMPLIANCE EVALUATION INSPECTION REPORT  
U.S. ENVIRONMENTAL PROTECTION AGENCY, REGION 5**

**Facility:** LYCON Ready Mix Plant #31  
2100 Larsen Road  
Green Bay, Wisconsin 54303

**NPDES Permit Number:** WIR05IA0F

**Date of Inspection:** April 30, 2025

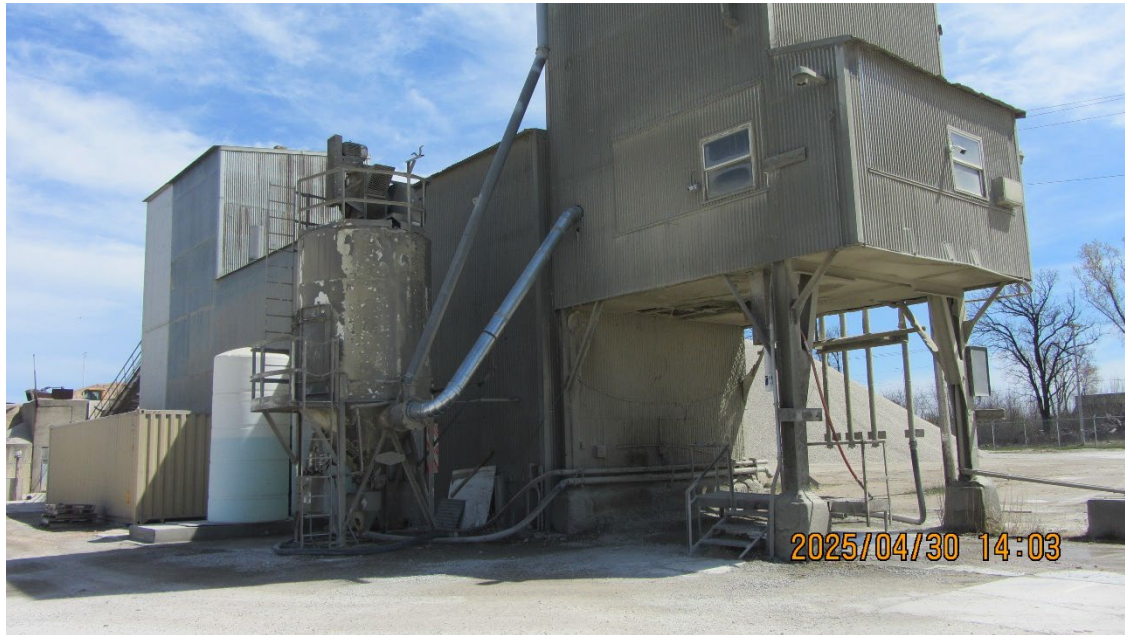
1: IMG\_1225

At approximately 2:00 P.M., the EPA Inspection Team was accompanied by Ms. Greco and Mr. Yaklin to conduct a walkthrough of the Facility, beginning at the loading station for the ready-mix plant (see Photo 1 in Attachment A). Mr. Yaklin indicated that the tank observed on the north side of the ready-mix plant contains calcium chloride, which is used as an additive in the process (see Photo 2 in Attachment A). Proceeding to the north, the EPA Inspection Team next observed the initial basin, where trucks are washed (see Photo 3 in Attachment A).

Description: Ready-Mix Plant

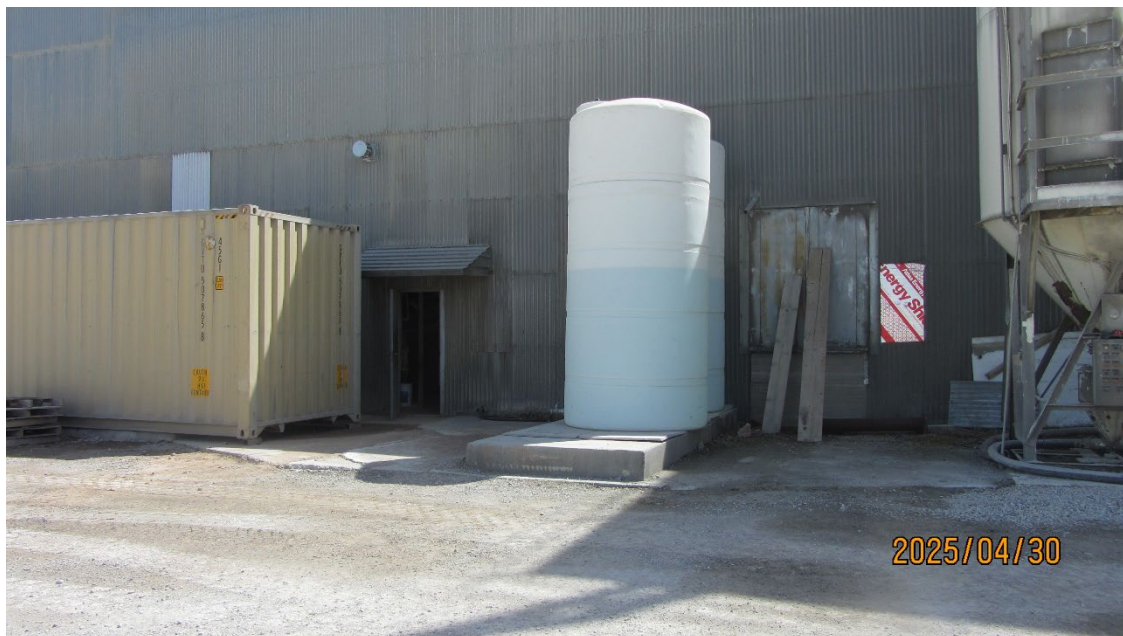
2: IMG\_1226

Description: Calcium chloride tank

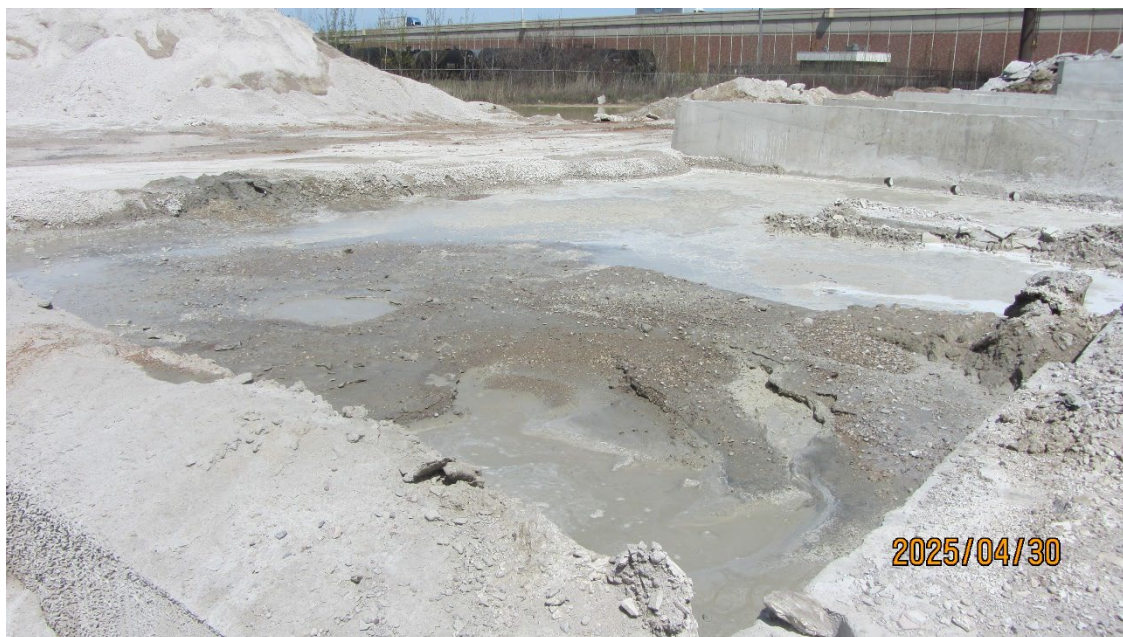
3: IMG\_1227

Description: Initial basin for water treatment

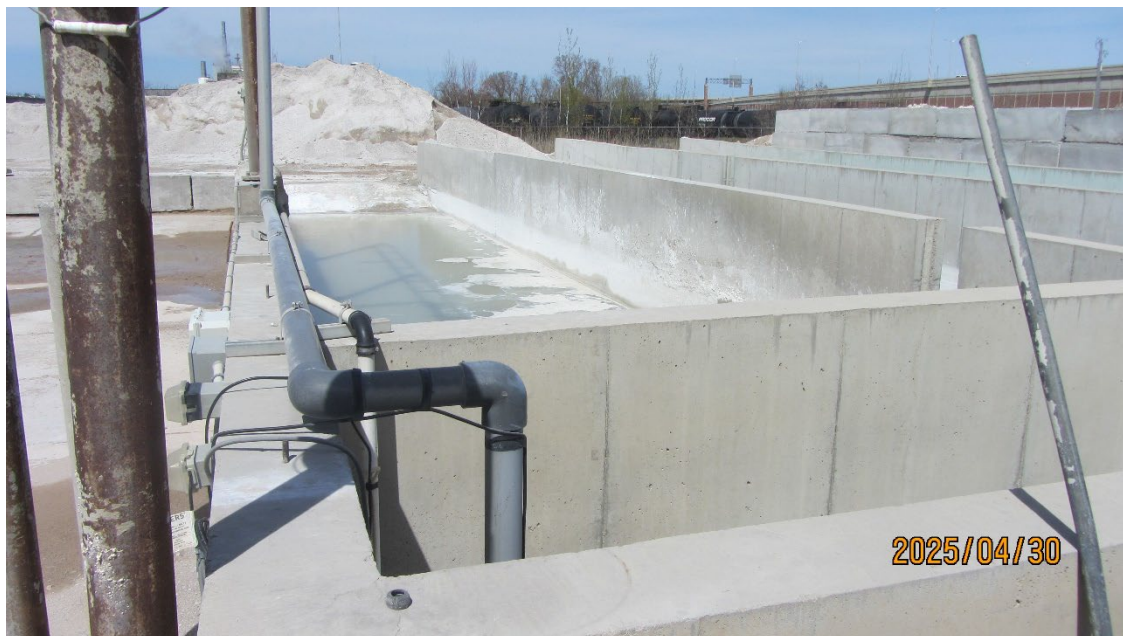
4: IMG\_1228

Wastewater generated from this process is gravity-fed into the Facility's wastewater treatment system, which is composed of three settling ponds and is subsequently funnelled to a final bay/treatment area (see Photos 4-5 in Attachment A). Mr. Yaklin indicated that the first three bays are dredged to a sludge pit located to the west of the wastewater treatment area. The EPA Inspection Team next entered the colorizer building, which is attached to the ready-mix plant. The Facility representatives pointed out two plugged drains in this building as well as their new coloring system tanks installed in November (see Photos 6-7 in Attachment A). Mr. Yaklin elaborated that these tanks help infuse color into the ready-mix concrete, depending on customer request. While walking out of the colorizer building, the EPA Inspection Team observed three totes of bulk colorizer stored outside of the building (see Photo 8 in Attachment A).

Description: One of three treatment bays (back) that gravity feeds to final bay (front)

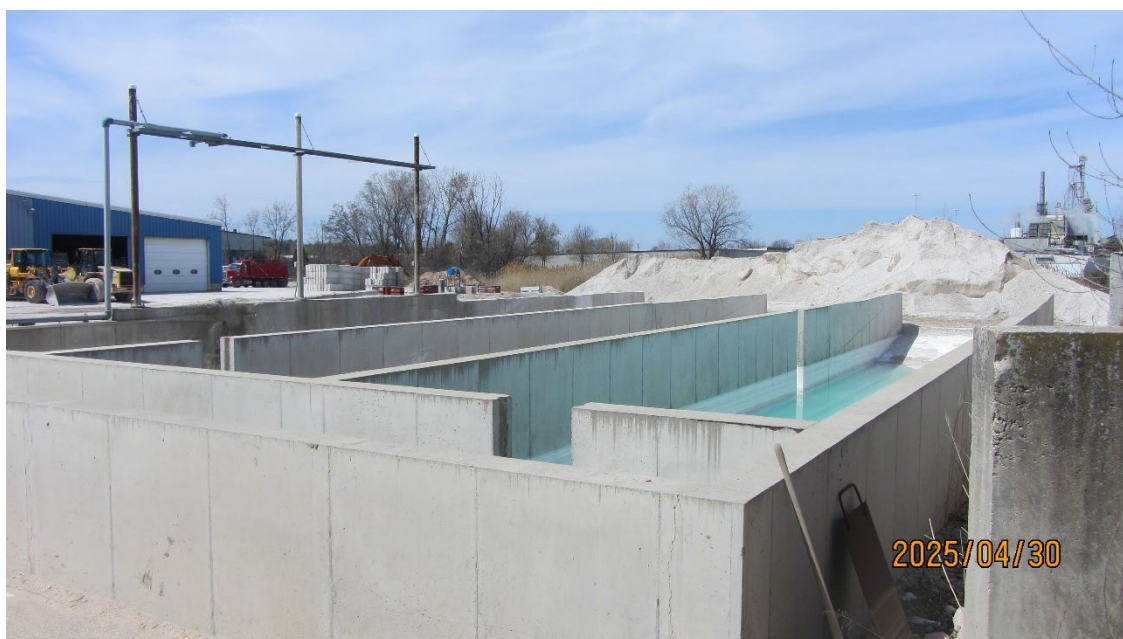
5: IMG\_1229

Description: Three gravity-fed treatment bays (back left to right) that funnel wastewater to final treatment bay (front)

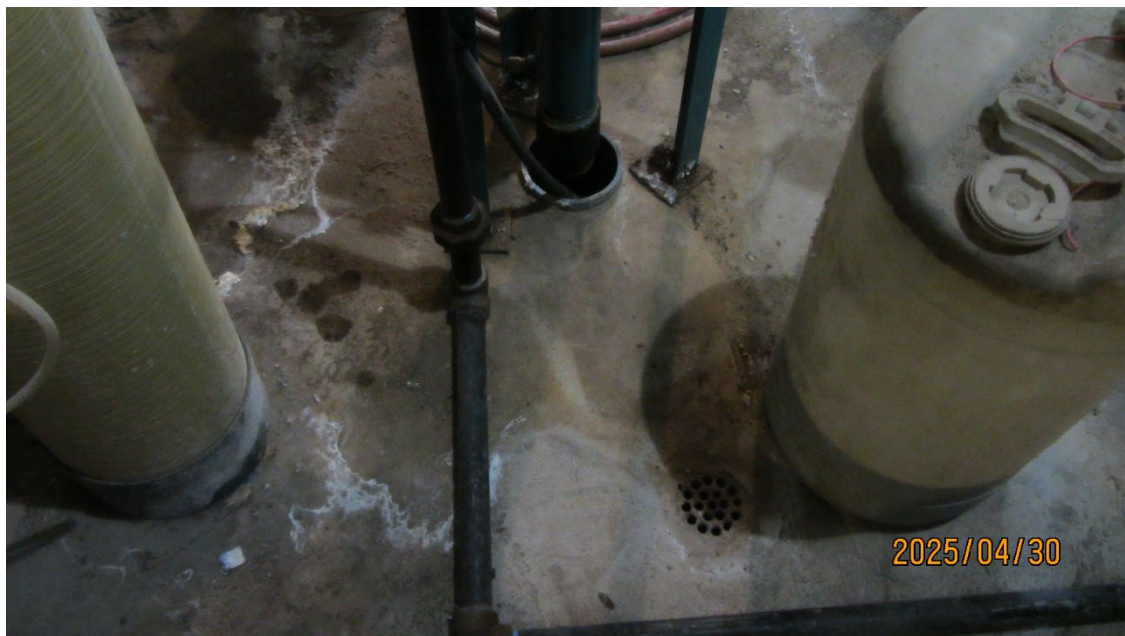
6: IMG\_1230

Description: Plugged drain

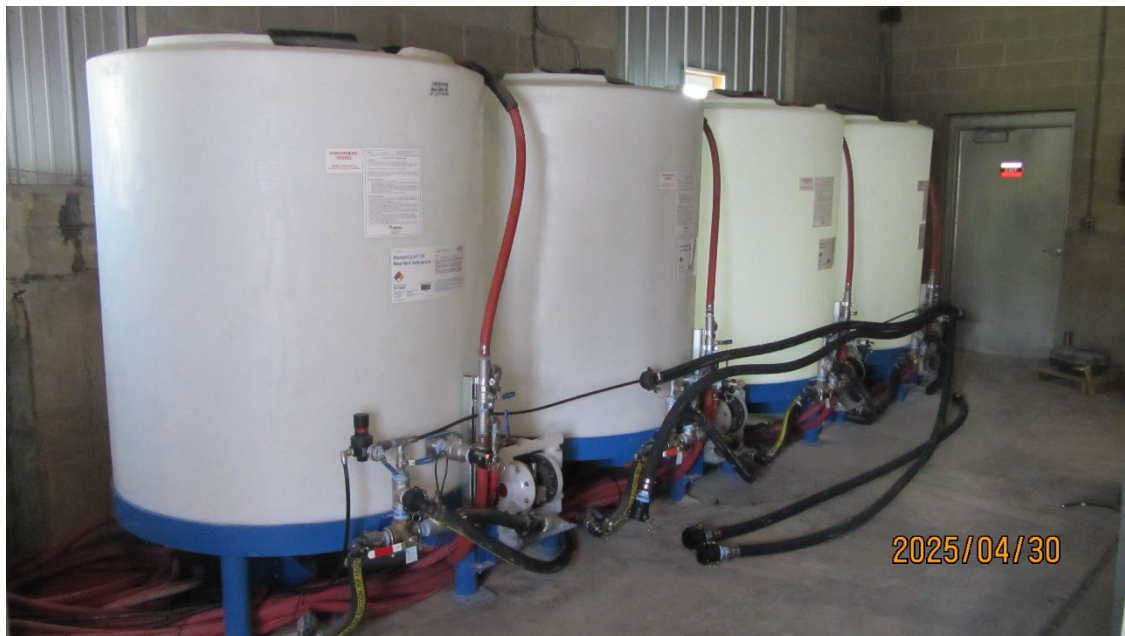
7: IMG\_1231

Description: New coloring system tanks

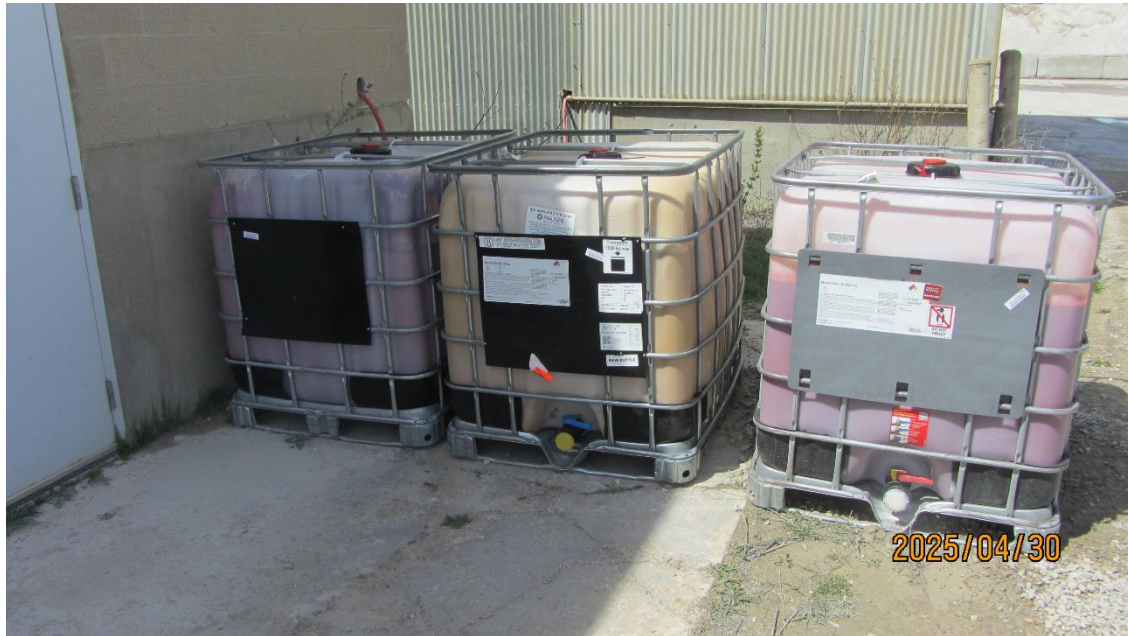
8: IMG\_1232

During the inspection, the EPA Inspection Team noted three totes of colorizer and two totes of Hammer Clean susceptible to stormwater without secondary containment. In a May 9, 2025 email to the inspector, Ms. Greco indicated in a subsequent email that these totes had been moved indoors.

Description: Colorizer totes stored outside of building

On May 9, 2025, Ms. Greco emailed Mr. Small with information indicating that the color totes noted near the ready-mix plant and truck wash in the northwestern portion of the site have all been moved indoors. Ms. Greco also added that a sign entailing requirements of Section 1.3.5 of the Permit has been ordered and will be installed as soon as possible, with pictures of its installation to follow.

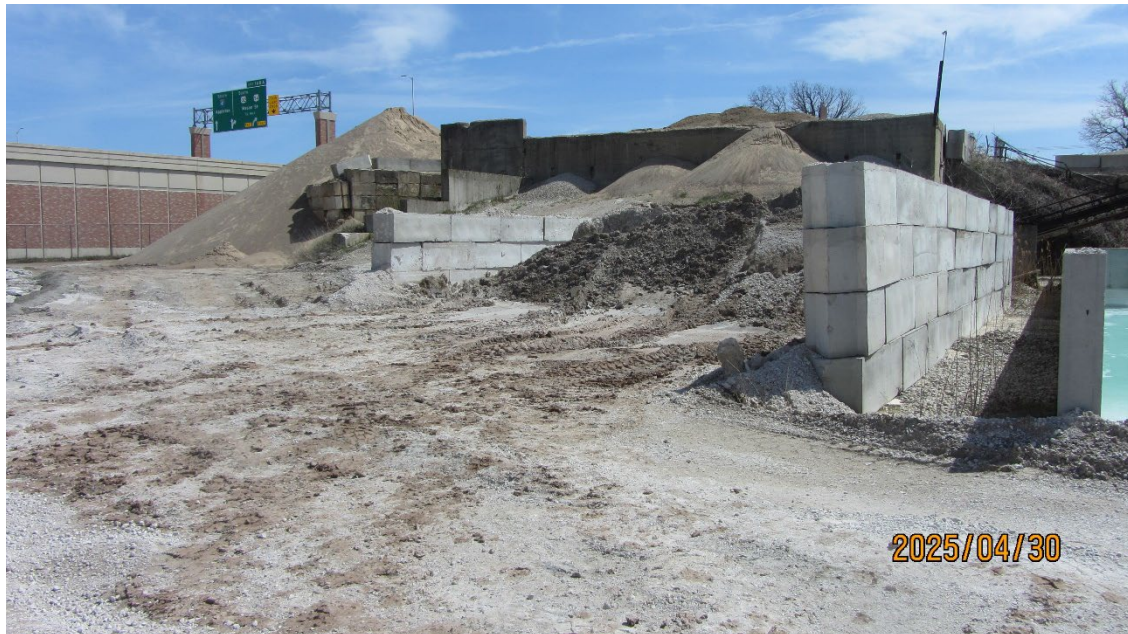
9: IMG\_1233

Moving to the northeast, Facility representatives guided the EPA Inspection Team to the wet cleanout bunker, where dredged media is dried. Piles of virgin sand and aggregate material were stored to the and northeast and southeast of this bunker (see Photos 9-10 in Attachment A). Mr. Yaklin emphasized that the bunker is designed to contain the dredged media, ensuring it does not migrate out of the bay. The EPA Inspection Team next traversed further to the north to observe the stormwater infiltration basin, located in the northeast corner of the Facility (see Photos 11-12 in Attachment A). Facility personnel indicated that there have been no issues with the adjoining property to the north, as the infiltration basin straddles the northeastern property boundary. Walking westward, Ms. Greco and Mr. Yaklin pointed out the concrete block casting and storage area located along the northern Facility perimeter, where 3 and 6' blocks are cast for a variety of industrial and residential customers (see Photos 13-15 in Attachment A).

Description: Wet cleanout bunker

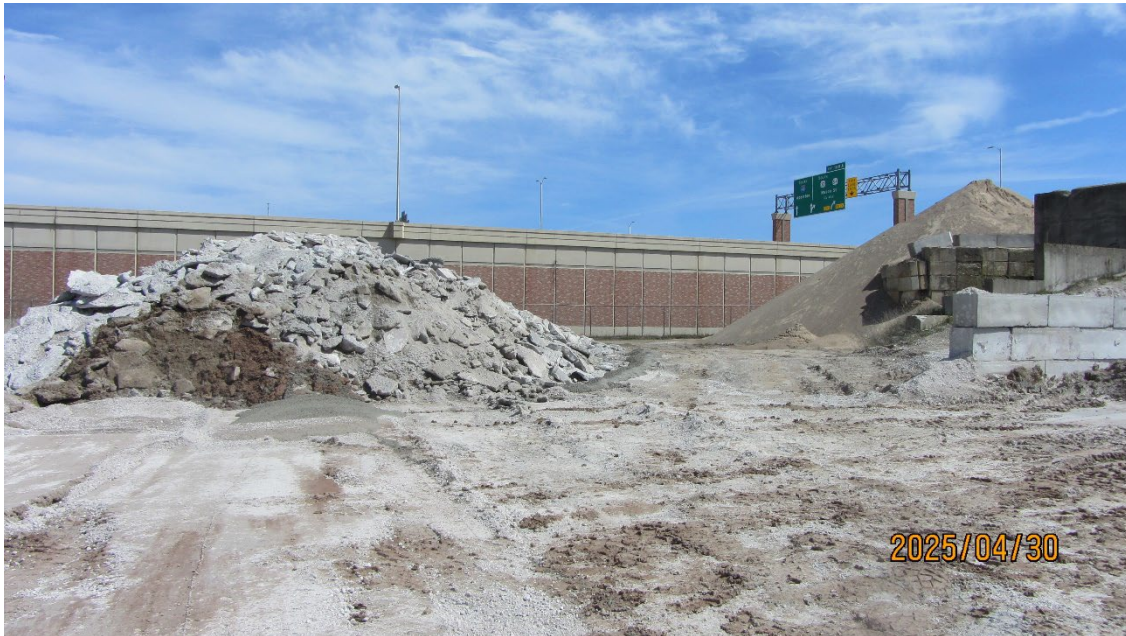
10: IMG\_1234

Description: Piles of sand and aggregate near cleanout bunker

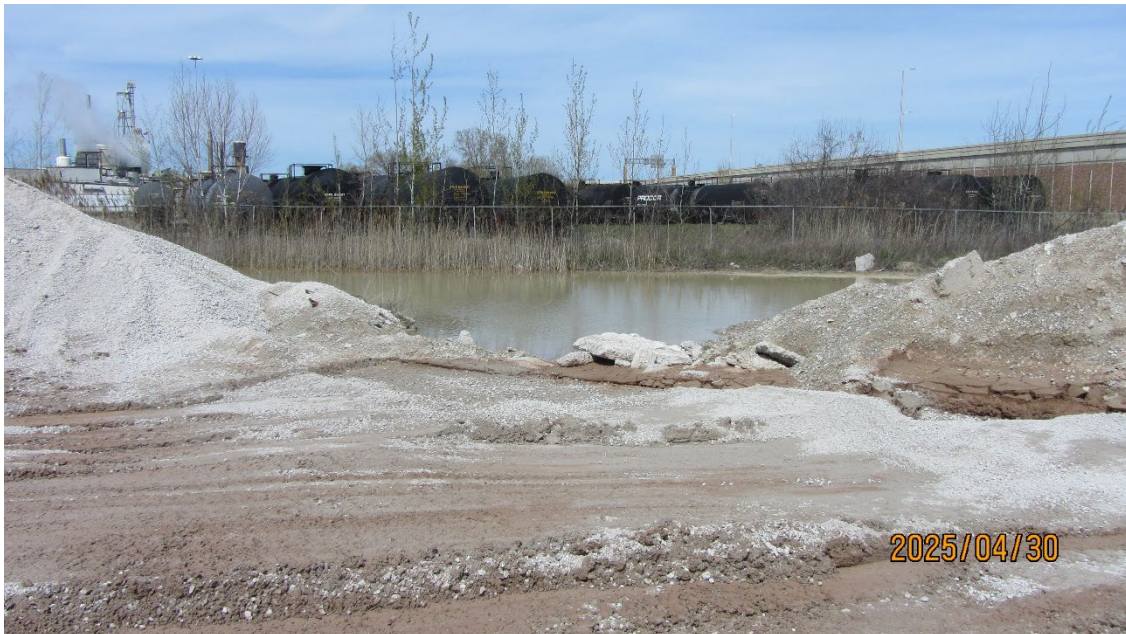
11: IMG\_1235

Description: Stormwater infiltration basin

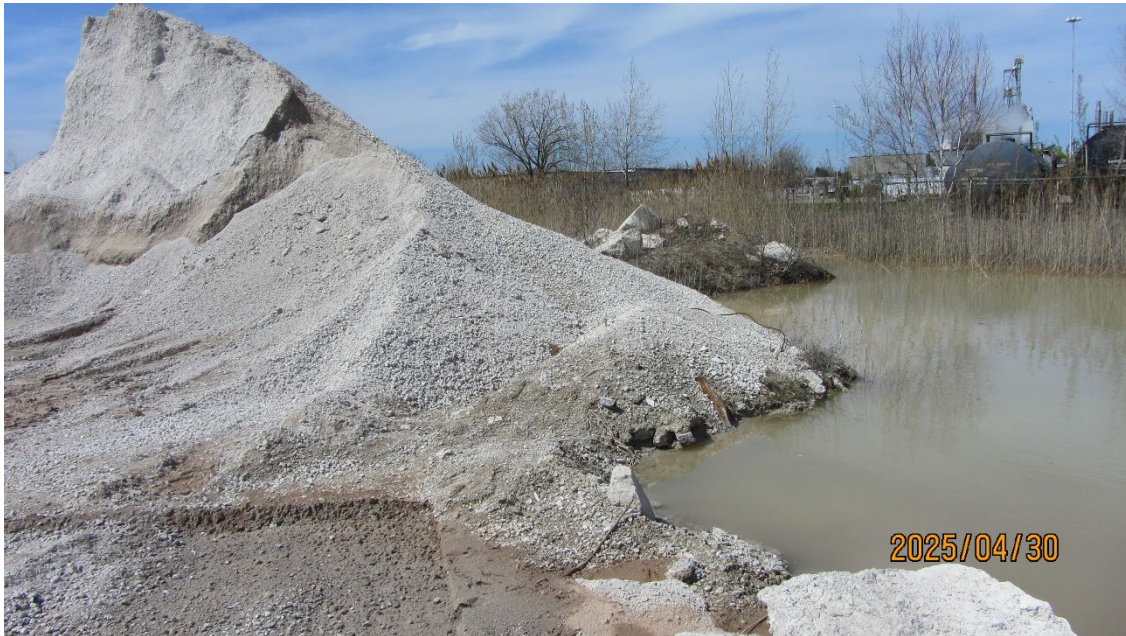
12: IMG\_1236

Description: Crushed aggregate adjacent to stormwater infiltration basin

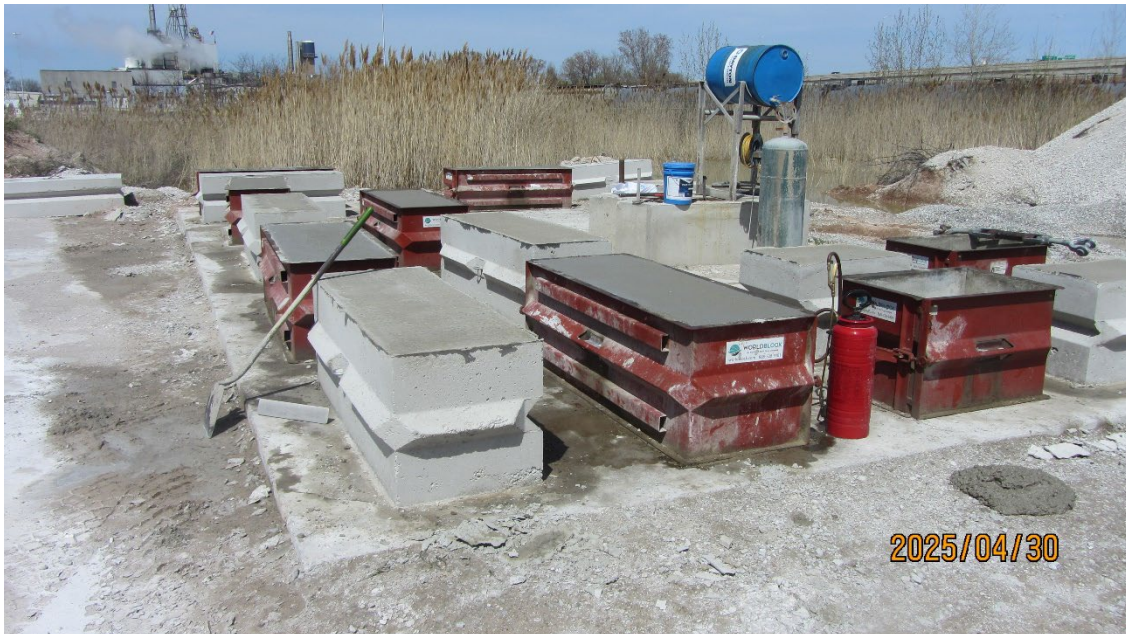
13: IMG\_1237

Description: Concrete block casting area

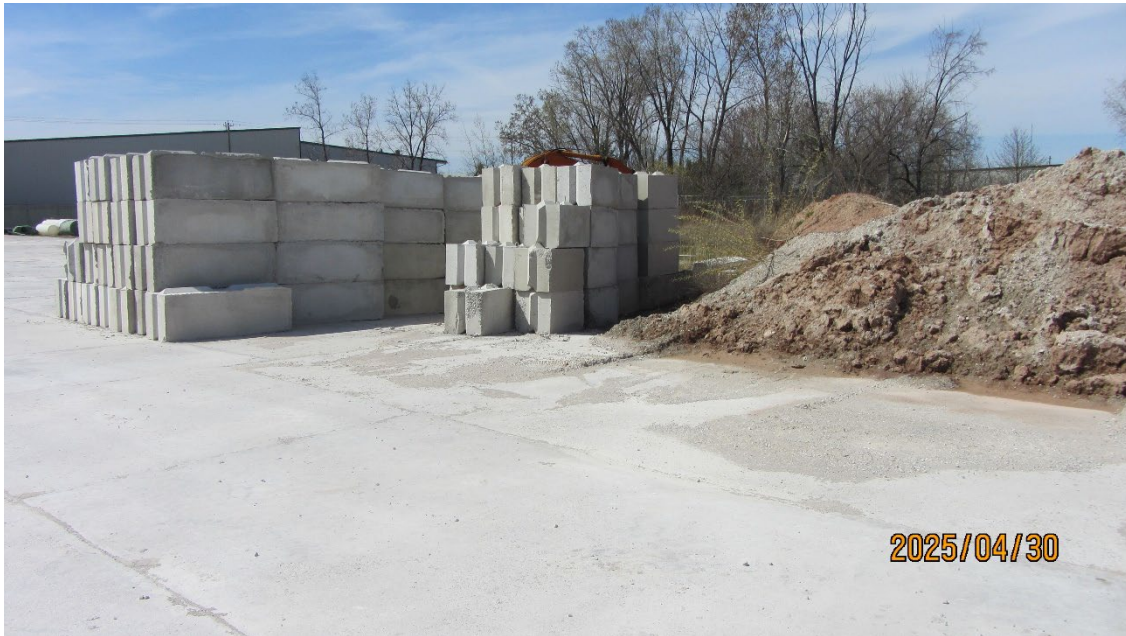
14: IMG\_1238

Description: Aggregate and block storage

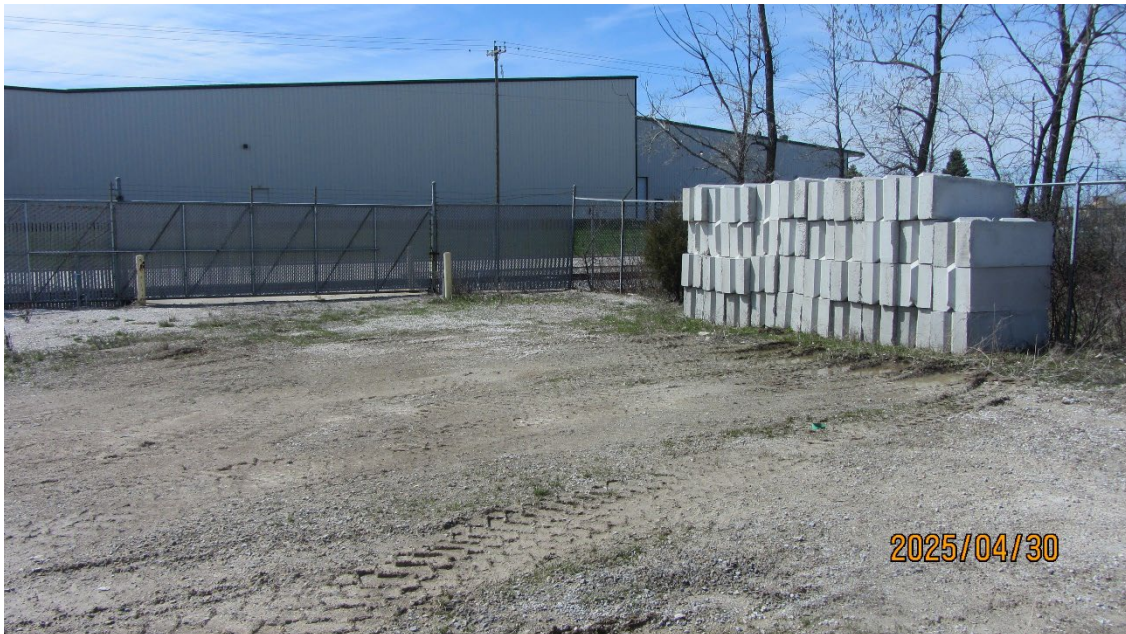
15: IMG\_1239

Description: Concrete blocks in storage

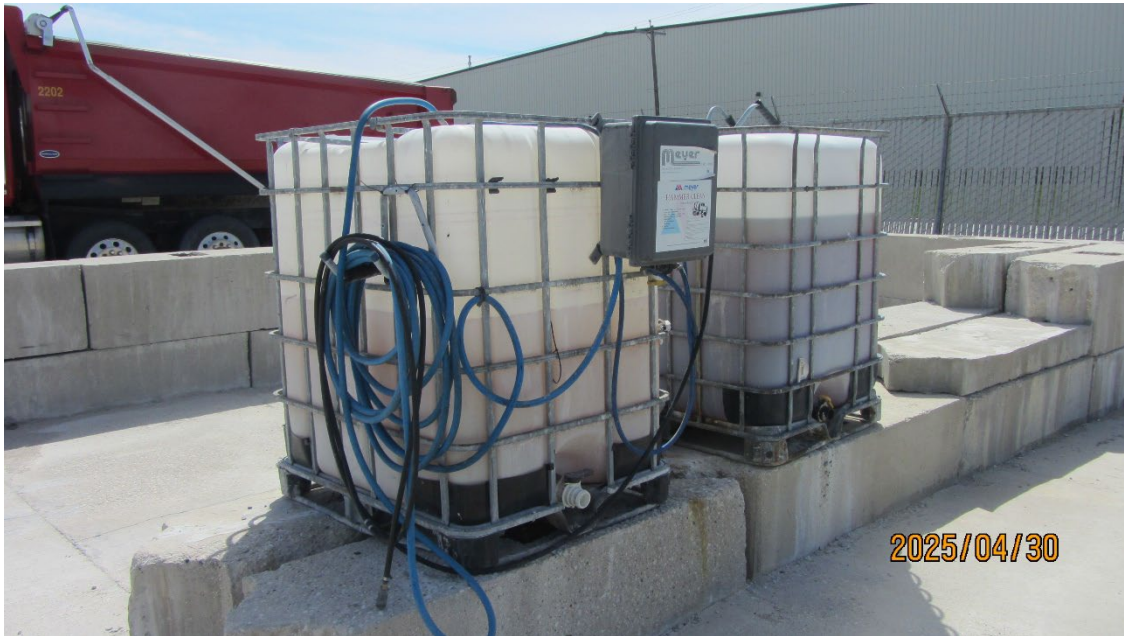
16: IMG\_1240

Beginning to walk along the western extent of the Facility, the EPA Inspection Team observed two totes of Hammer Clean product, which Ms. Greco indicated is used to help remove concrete before it solidifies on or in vehicles (see Photo 16 in Attachment A). Municipal solid waste and recycling dumpsters were also observed by the EPA Inspection Team along the western fence line (see Photo 17 in Attachment A). Both dumpsters were covered at the time of the inspection. The EPA Inspection Team then walked into the Facility maintenance shop (see Photos 18-19 in Attachment A). The trench drain leads to a sump, which is vacuumed out by either a Safety-Kleen or Crystal Clean contractor as needed. Harlon Lubricants Inc. and Crystal Clean service the Facility's used oil, per Ms. Greco. While exiting the Facility maintenance shop, the EPA Inspection Team noted a diesel exhaust fluid tote, which is used by Facility vehicles (see Photo 20 in Attachment A).

Description: Two totes of Hammer Clean product used to aid concrete removal

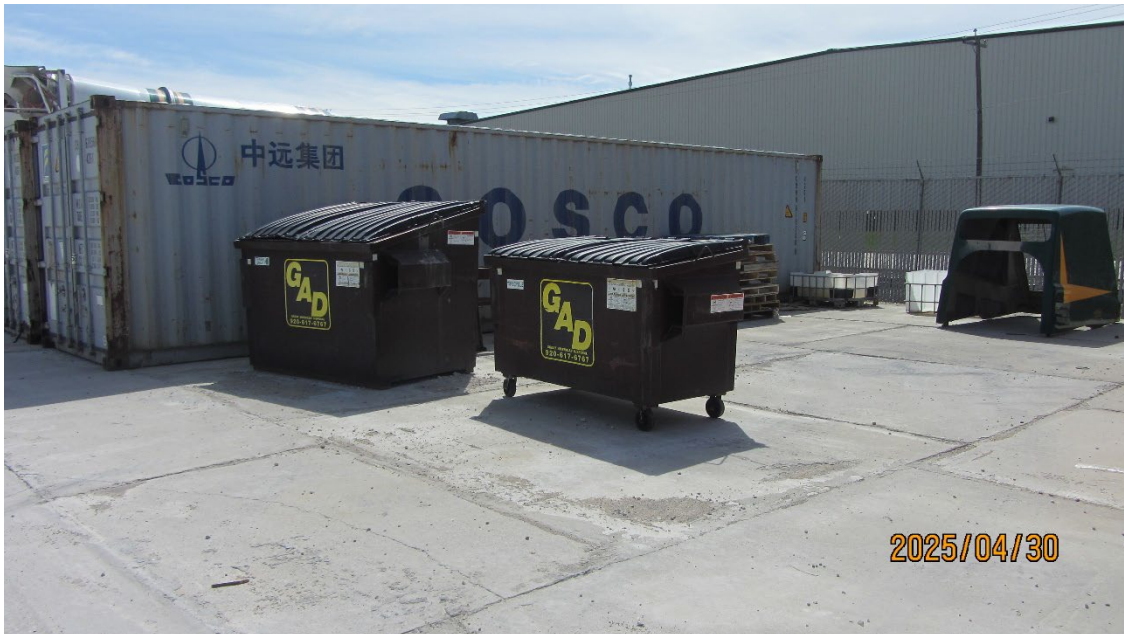
17: IMG\_1241

Description: Municipal solid waste and recycling dumpsters

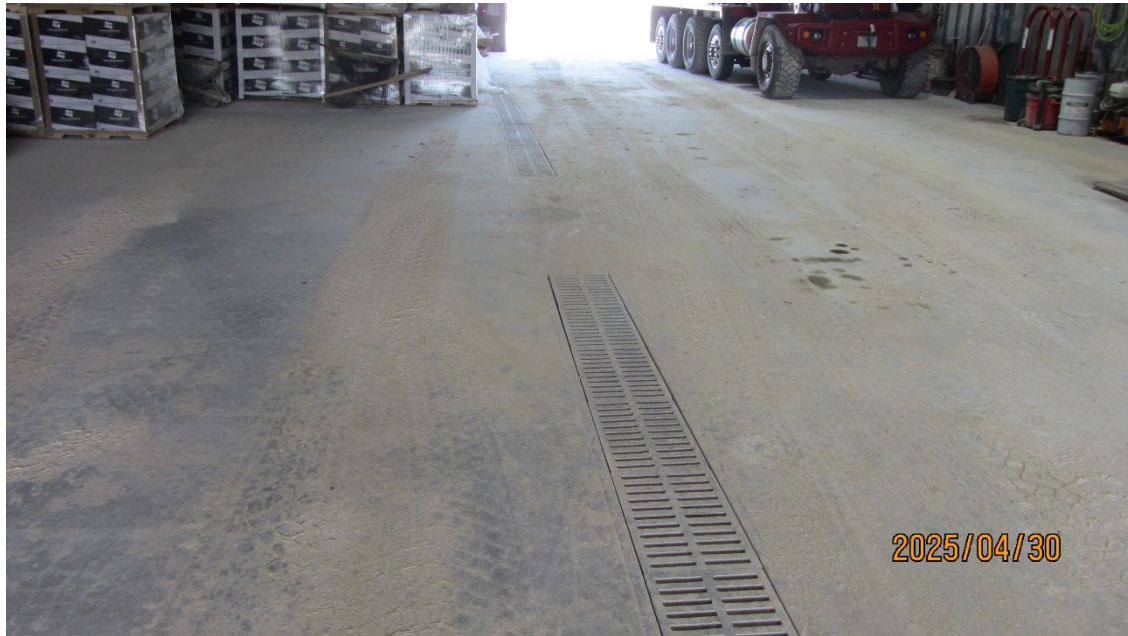
18: IMG\_1242

Description: Trench drain

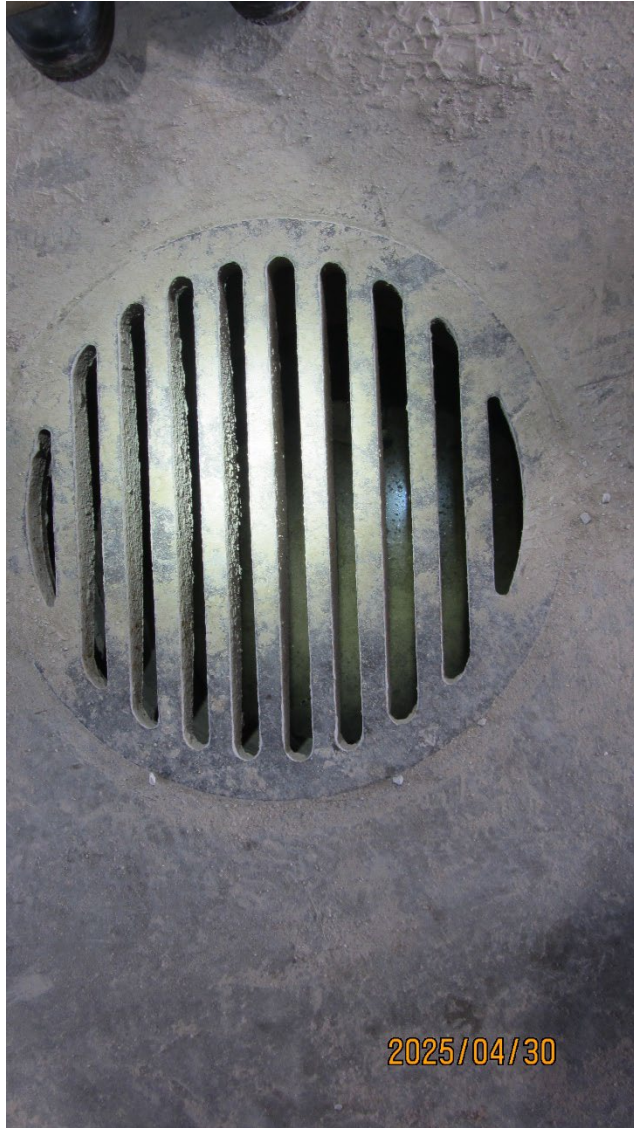
19: IMG\_1243

Description: Facility sump

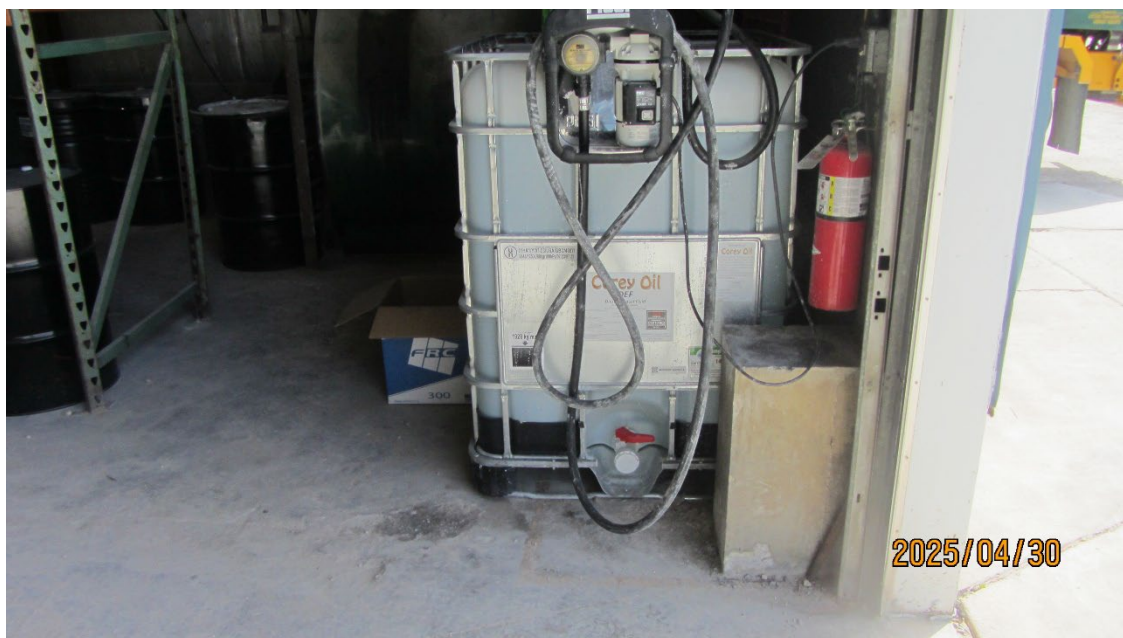
20: IMG\_1244

Description: Diesel exhaust fluid tote

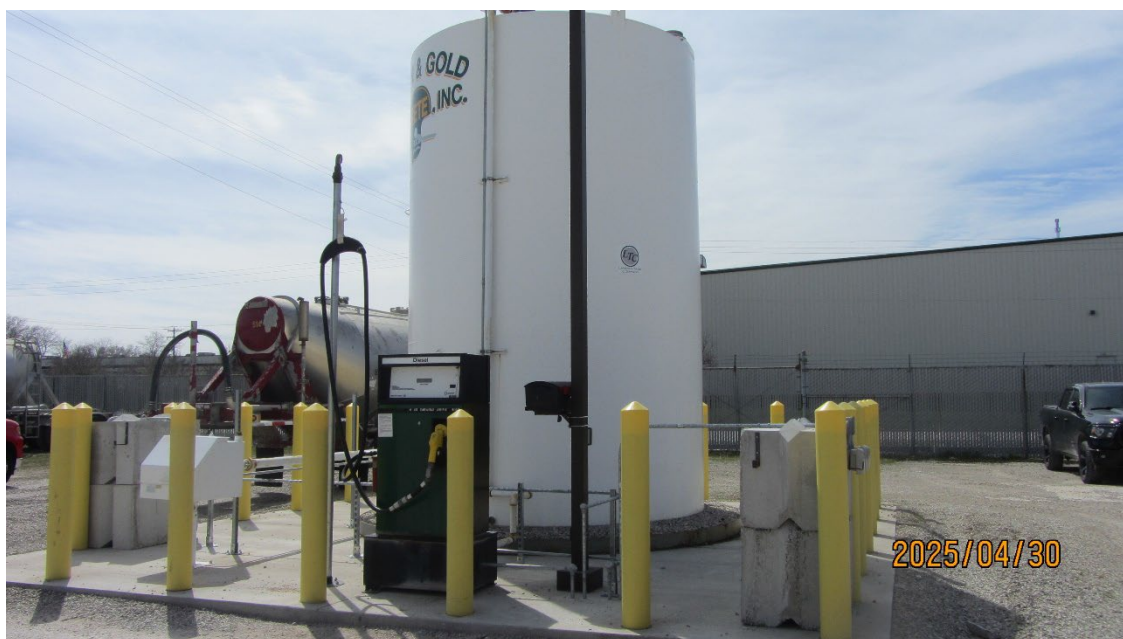
21: IMG\_1245

Walking back outside, the EPA Inspection Team observed a 10,000-gallon diesel tank, which Ms. Greco stated has one nozzle and is grounded (see Photo 21 in Attachment A). Additionally, the EPA Inspection Team walked around the southeastern quadrant of the Facility to observe stormwater runoff pathways from the Facility's bulk storage piles and overflow material storage piles containing peat gravel and 1.5" limestone (see Photos 22-23 in Attachment A). Near the center of the Facility, the EPA Inspection Team next observed Outfall 001, with discharging process water entering the outfall from the ready-mix area (see Photos 24-27 and 30 in Attachment A). Before finishing the walkthrough, the EPA Inspection Team evaluated the southern property boundary and did not observe any discharge paths flowing southward offsite (see Photos 28-29 in Attachment A).

Description: 10,000-gallon above ground diesel storage tank and pump station

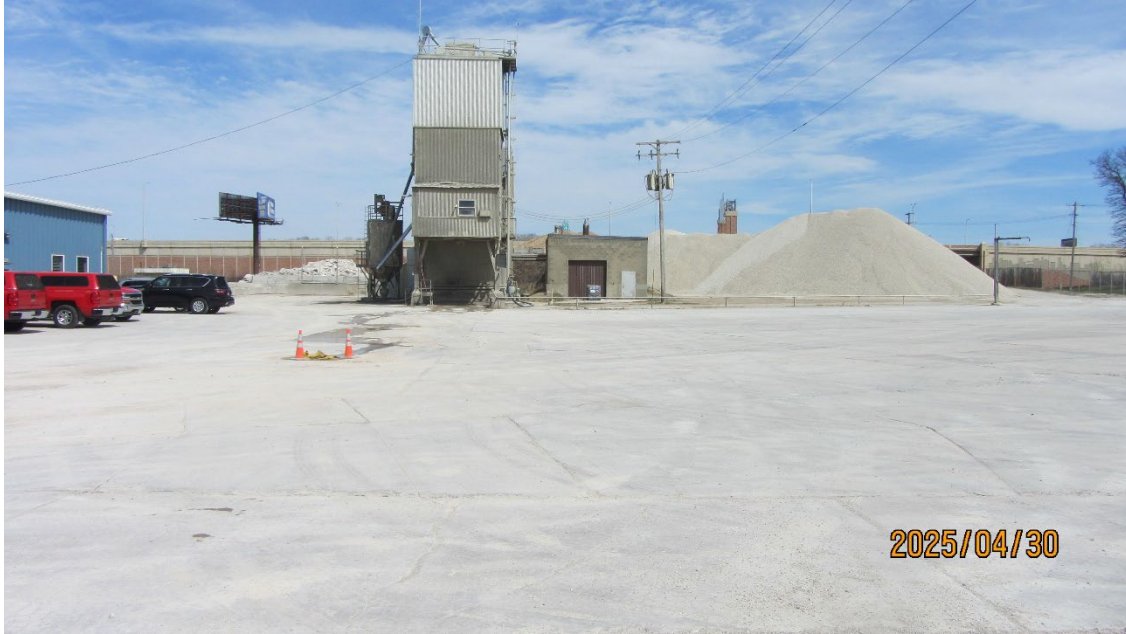
22: IMG\_1246

Description: Ready-mix concrete plant and bulk storage piles

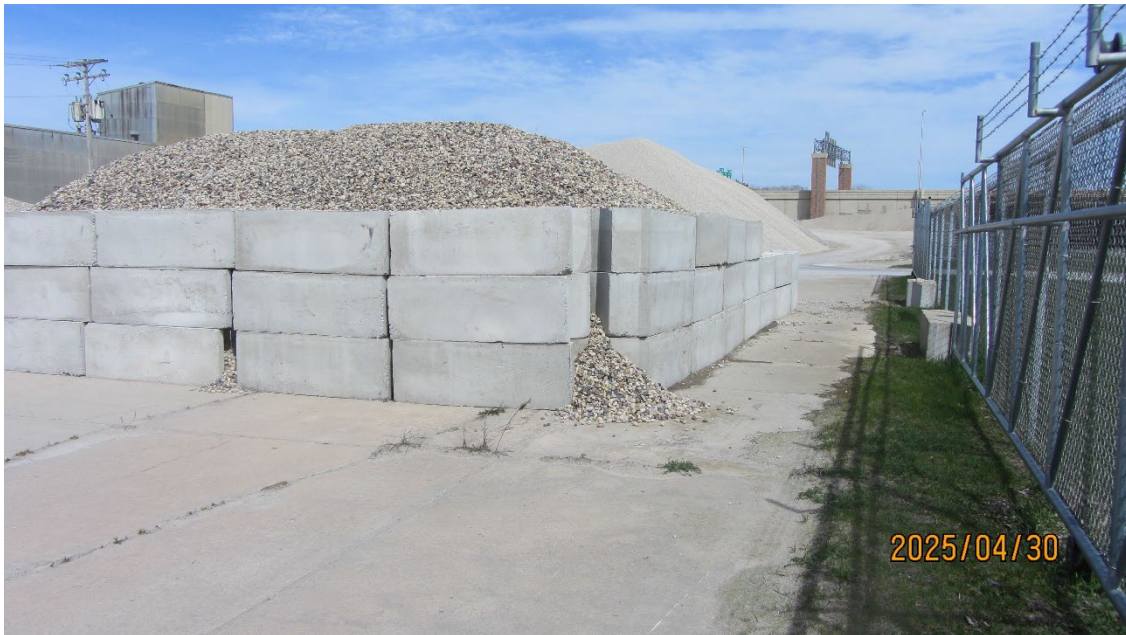
23: IMG\_1247

Description: Overflow material storage near gate entering the facility

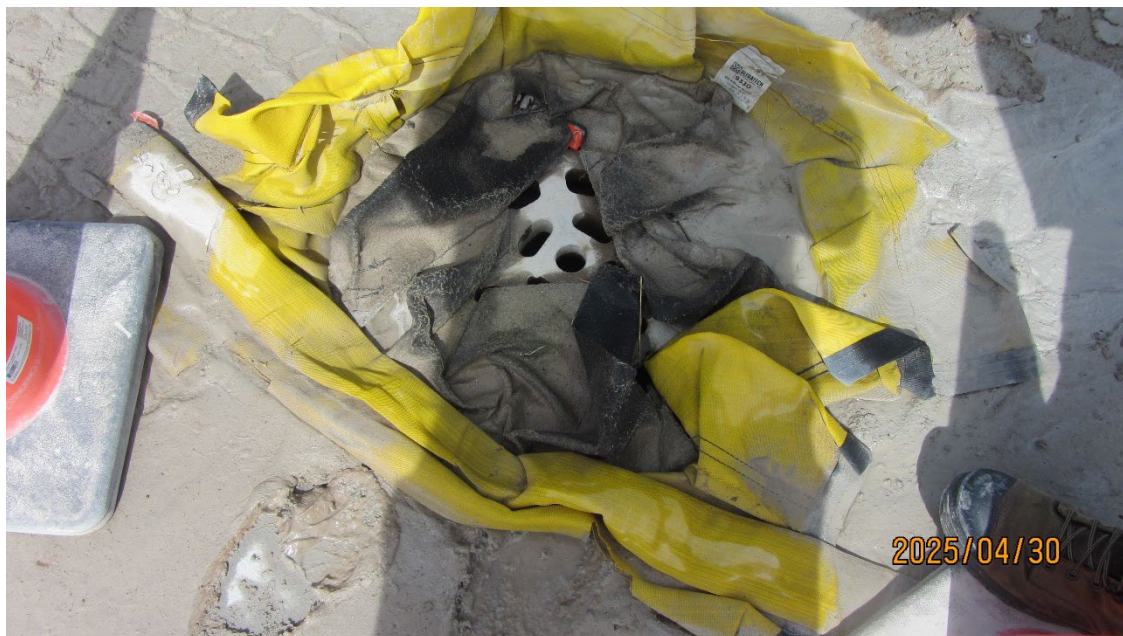
24: IMG\_1248

Description: Filter sock on Outfall 001

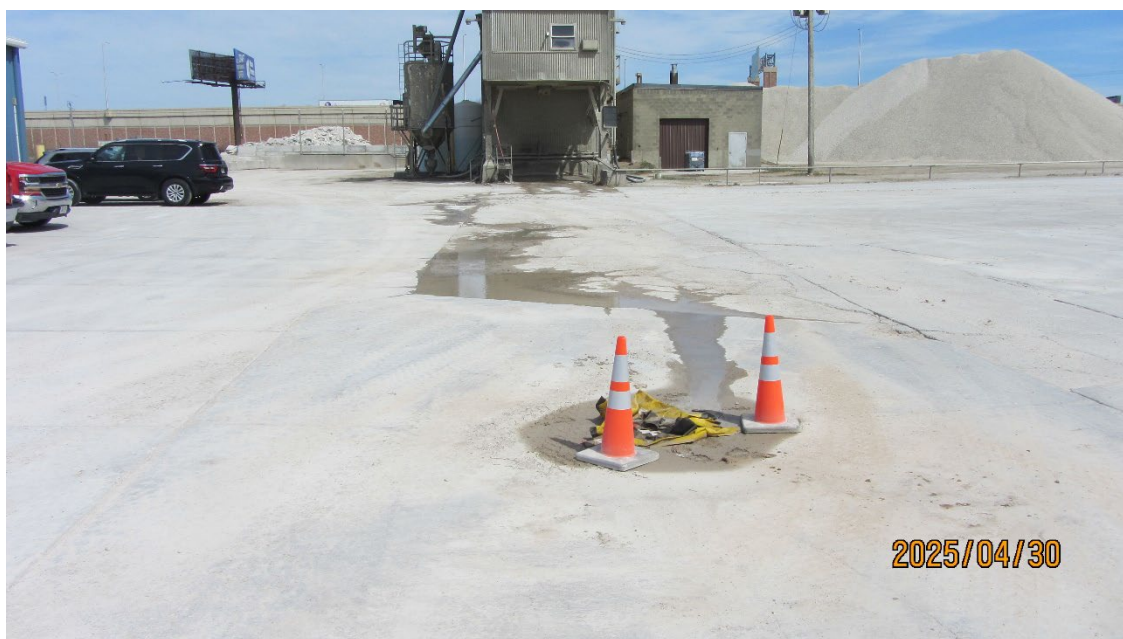
25: IMG\_1249

1. Non-Stormwater Discharge: Section 2.1.2.9 of the Permit requires the Facility to “evaluate for the presence of non-stormwater discharges. You must eliminate any non-stormwater discharges not explicitly authorized in Part 1.2.2 or covered by another NPDES permit, including vehicle and equipment/tank wash water...If not covered under a separate NPDES permit, wastewater, wash water and any other unauthorized non-stormwater must be discharged to a sanitary sewer in accordance with applicable industrial pretreatment requirements, or otherwise disposed of appropriately.” During the inspection, the EPA Inspection Team observed process water from the ready-mix plant discharging into the storm drain, Outfall 001. During the inspection, Ms. Greco and Mr. Yaklin described that this water is likely attributable to the final rinsing stage for vehicles when under the loading bay, and it is discharged out of a pipe. Review of the Facility’s SWPPP and the non-stormwater discharge certification does not currently account for this discharge.

Description: Process water discharging to Outfall 001

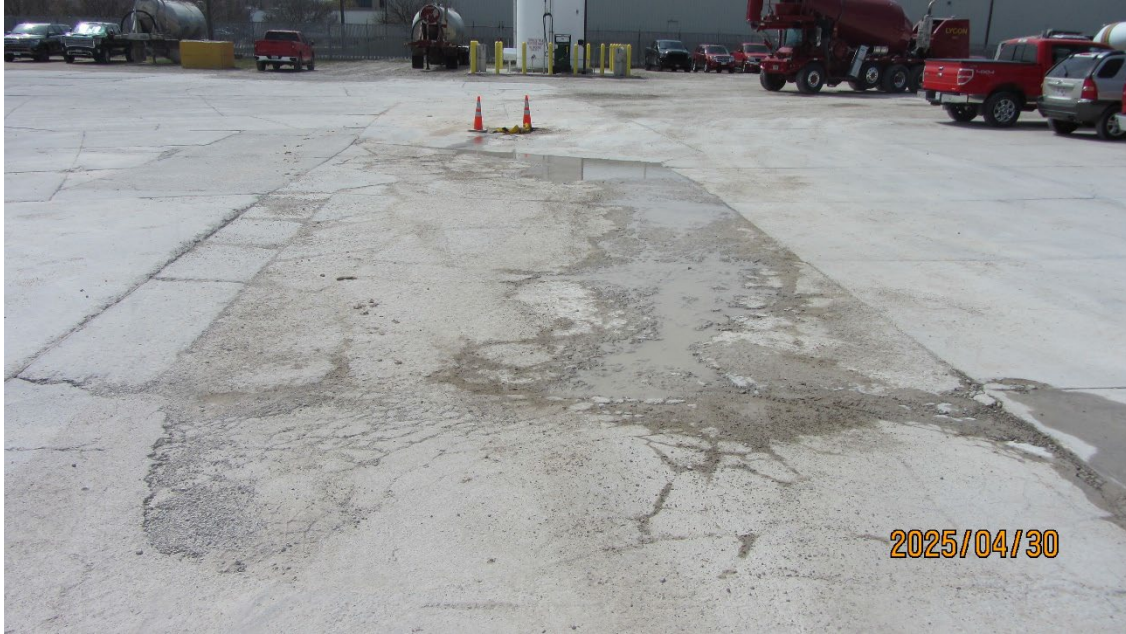
26: IMG\_1250

Description: Process water discharging to Outfall 001

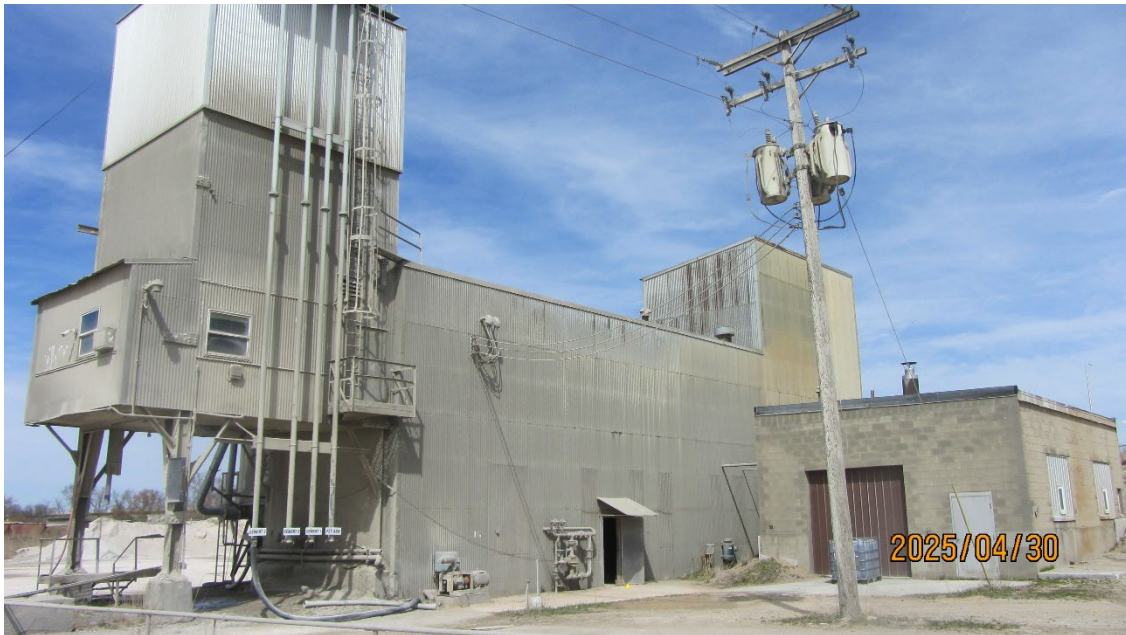
27: IMG\_1251

Description: Ready-mix concrete building

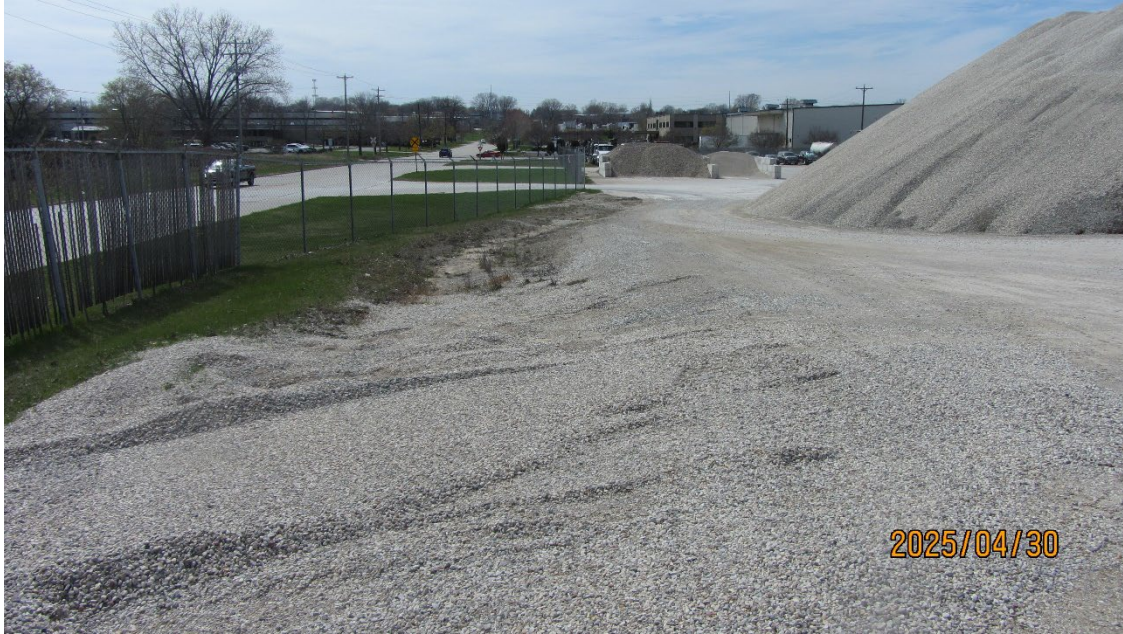
28: IMG\_1252

Description: South property boundary
