**CWA COMPLIANCE EVALUATION INSPECTION REPORT  
U.S. ENVIRONMENTAL PROTECTION AGENCY, REGION 5**

**Facility:** LYCON Ready Mix Plant #31  
2100 Larsen Road  
Green Bay, Wisconsin 54303

**NPDES Permit Number:** WIR05IA0F

**Date of Inspection:** April 30, 2025

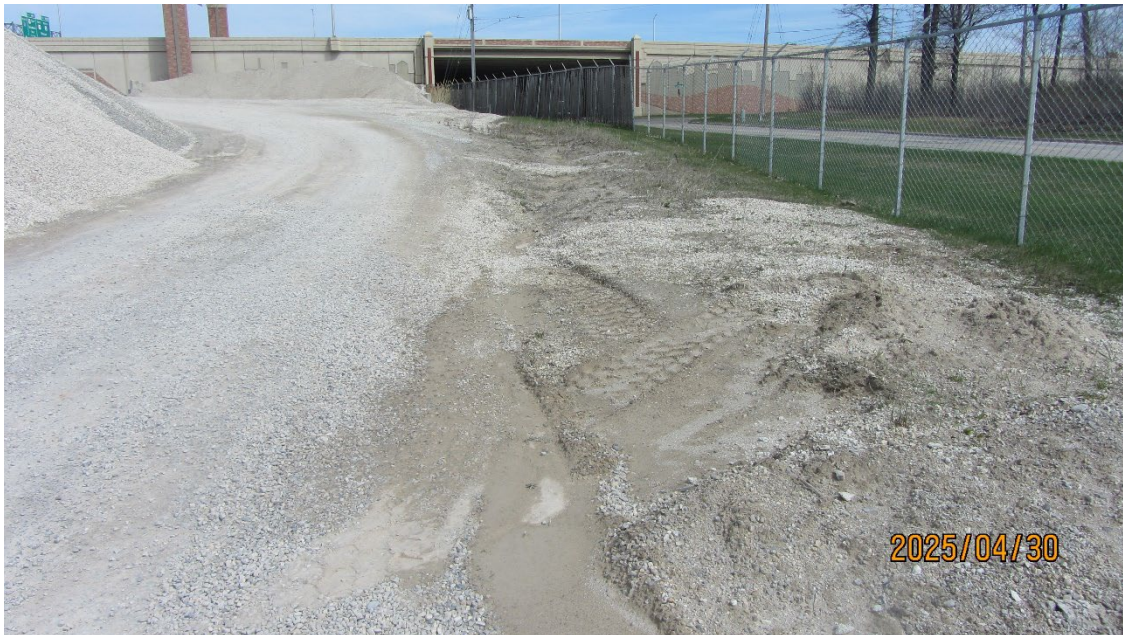
29: IMG\_1253

Walking back outside, the EPA Inspection Team observed a 10,000-gallon diesel tank, which Ms. Greco stated has one nozzle and is grounded (see Photo 21 in Attachment A). Additionally, the EPA Inspection Team walked around the southeastern quadrant of the Facility to observe stormwater runoff pathways from the Facility's bulk storage piles and overflow material storage piles containing peat gravel and 1.5" limestone (see Photos 22-23 in Attachment A). Near the center of the Facility, the EPA Inspection Team next observed Outfall 001, with discharging process water entering the outfall from the ready-mix area (see Photos 24-27 and 30 in Attachment A). Before finishing the walkthrough, the EPA Inspection Team evaluated the southern property boundary and did not observe any discharge paths flowing southward offsite (see Photos 28-29 in Attachment A).

Description: South property boundary

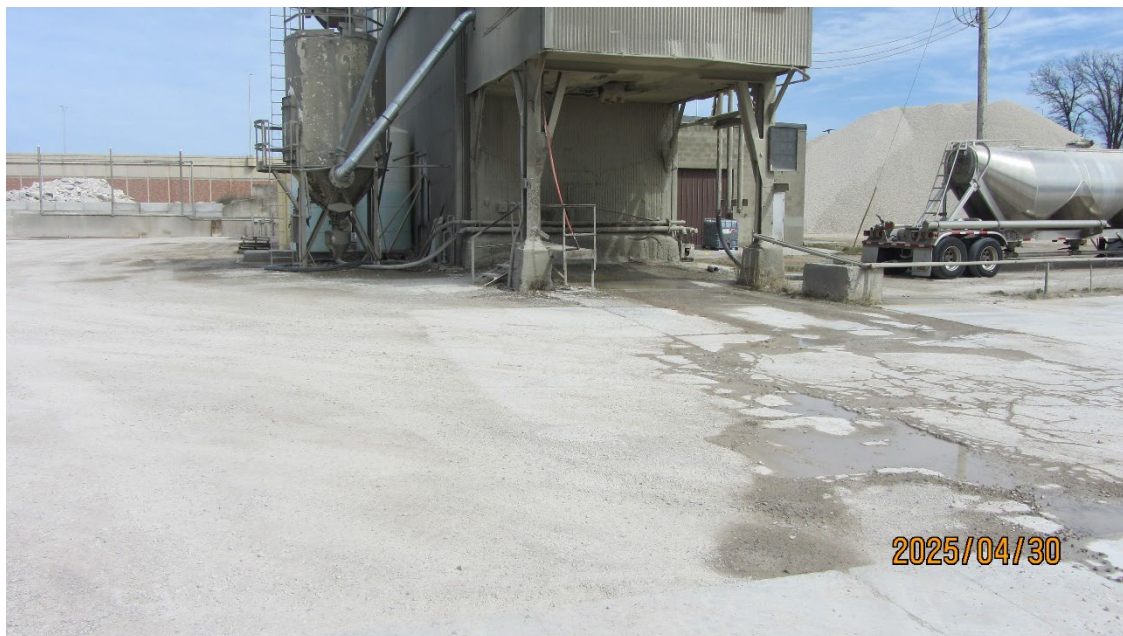
30: IMG\_1254

1. Non-Stormwater Discharge: Section 2.1.2.9 of the Permit requires the Facility to “evaluate for the presence of non-stormwater discharges. You must eliminate any non-stormwater discharges not explicitly authorized in Part 1.2.2 or covered by another NPDES permit, including vehicle and equipment/tank wash water...If not covered under a separate NPDES permit, wastewater, wash water and any other unauthorized non-stormwater must be discharged to a sanitary sewer in accordance with applicable industrial pretreatment requirements, or otherwise disposed of appropriately.” During the inspection, the EPA Inspection Team observed process water from the ready-mix plant discharging into the storm drain, Outfall 001. During the inspection, Ms. Greco and Mr. Yaklin described that this water is likely attributable to the final rinsing stage for vehicles when under the loading bay, and it is discharged out of a pipe. Review of the Facility’s SWPPP and the non-stormwater discharge certification does not currently account for this discharge.

Description: Ready-mix concrete process wastewater draining toward Outfall 001
