INSPECTION REPORT

| Type of Inspection | Compliance Evaluation Inspection (CEI) | | |
| Permittee Name | Hirzel Canning Co (0387000242) | | |
| Permit Number(s) (If Applicable) | OH0135666 | | |

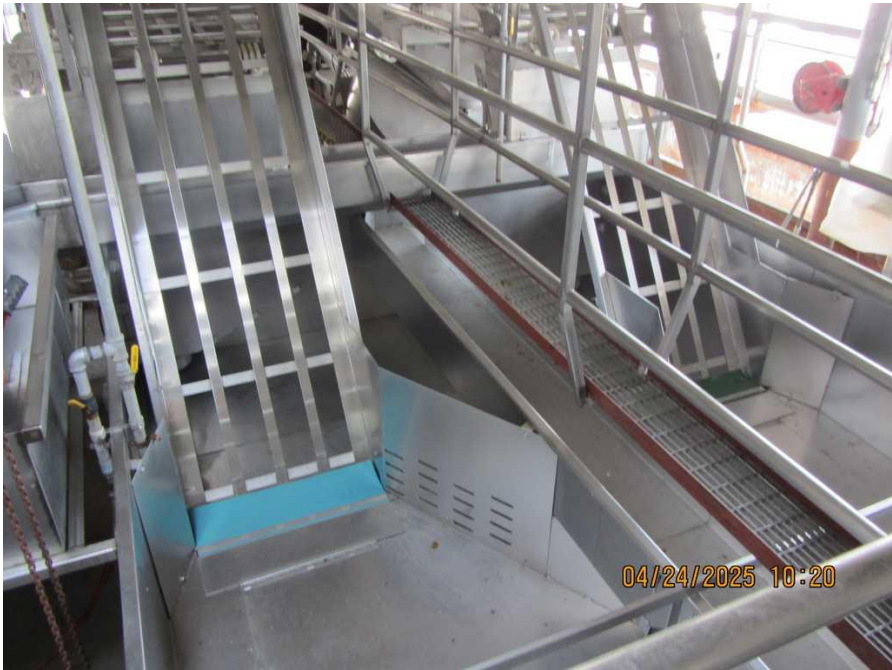
| Photo #1 | | | IMG_0465.JPG |

| Photo of tomato washing area and peeler feed. | | | |

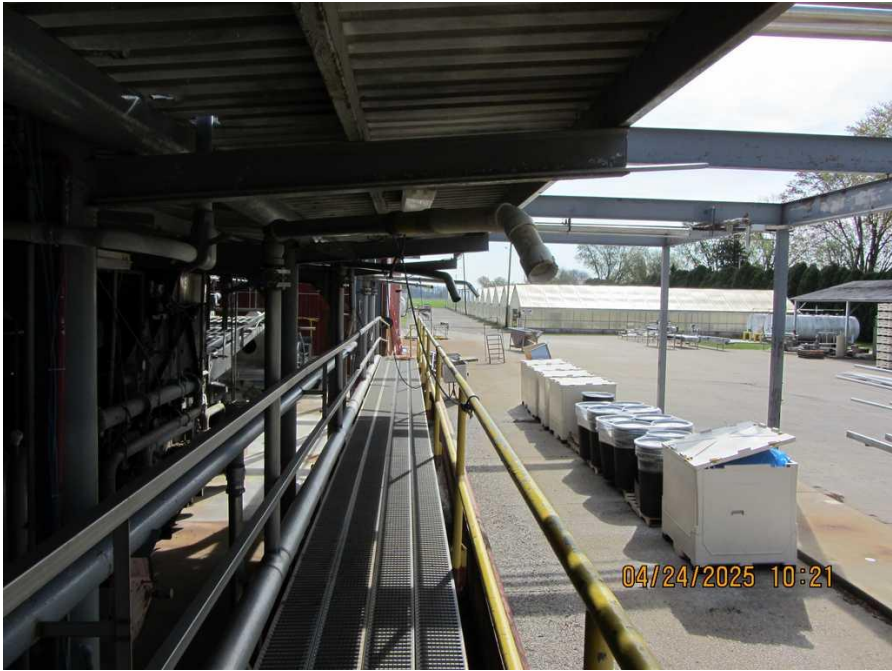
| Photo 2 | | | IMG_0466.JPG |

| Photo of water spouts to fill tomato trucks | | | |

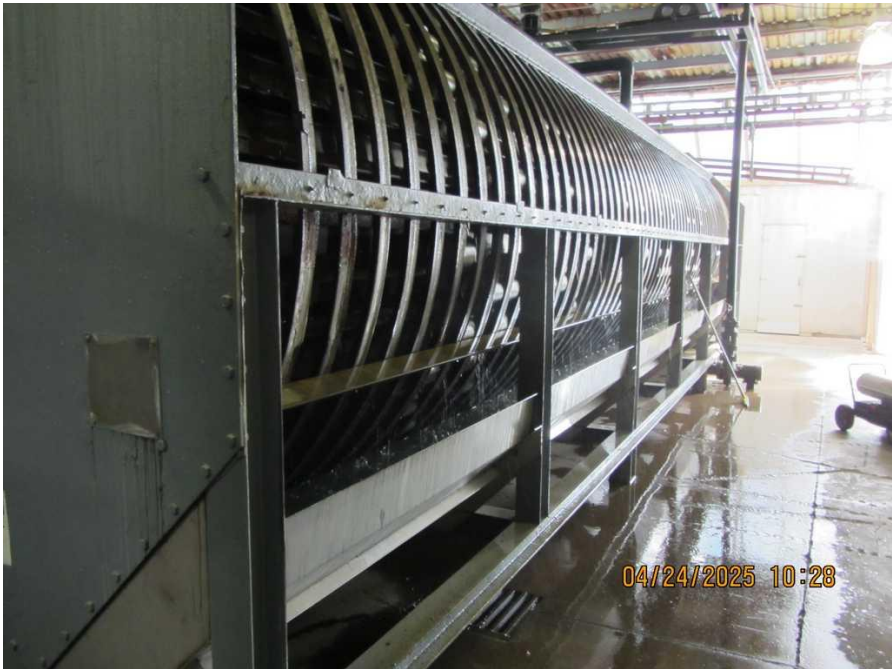
| Photo 3 | | | IMG_0467.JPG |

| Facility utilizes a caustic bath to separate skins from the tomatoes. According to the Facility, all floor drains in the production area connect to the wastewater system. The can cooler system recycles water throughout the day, then purges to wastewater at the end of the day. Storm drains in the produce unloading area are connected to the wastewater system. | |

| Photo of can cooling system. | | | |

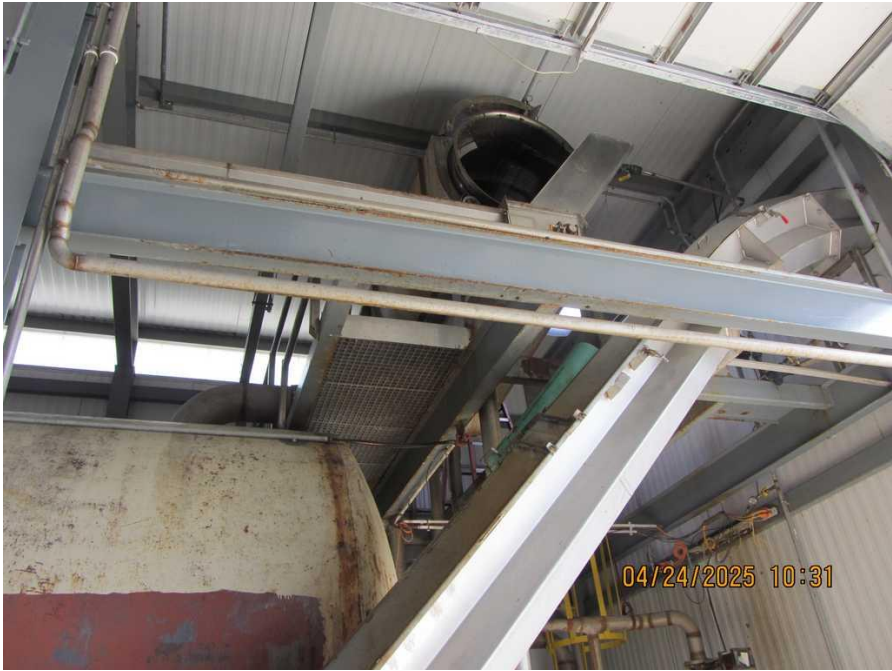
| Photo 4 | | | IMG_0468.JPG |

| Photo of rotary screen. | | | |

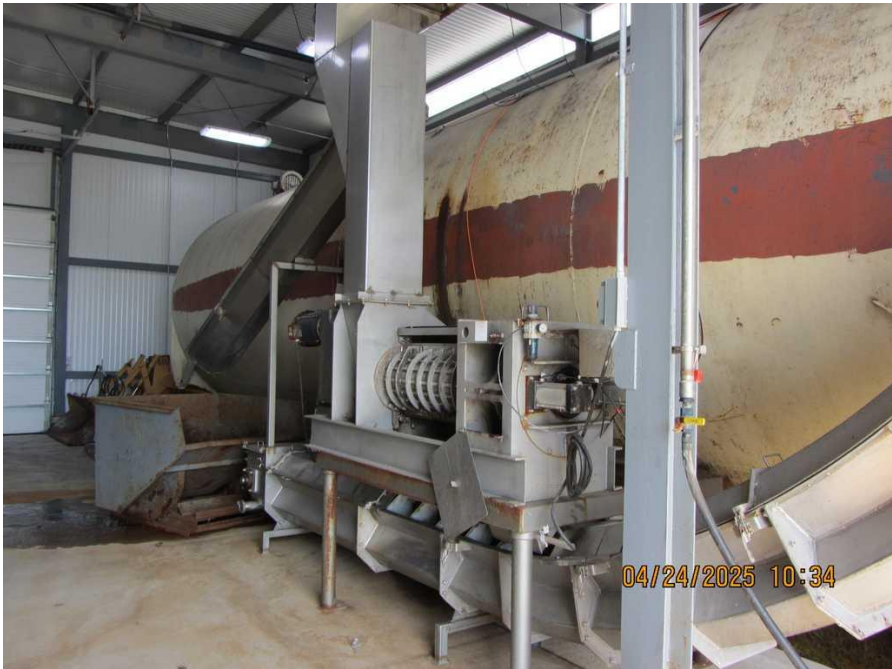
| Photo 5 | | | IMG_0469.JPG |

| Photo of aeration tank and solids dumpster. | | | |

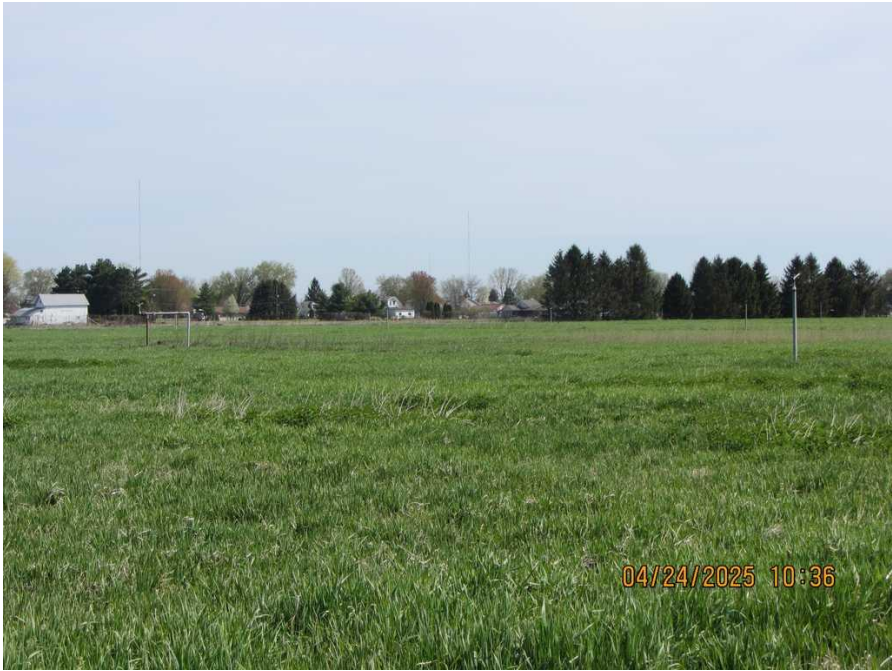
| Photo 6 | | | IMG_0470.JPG |

Screened wastewater is kept in aeration tanks until full, then discharges to be sprayed in the application fields.

| Photo of spraying field. | | | |

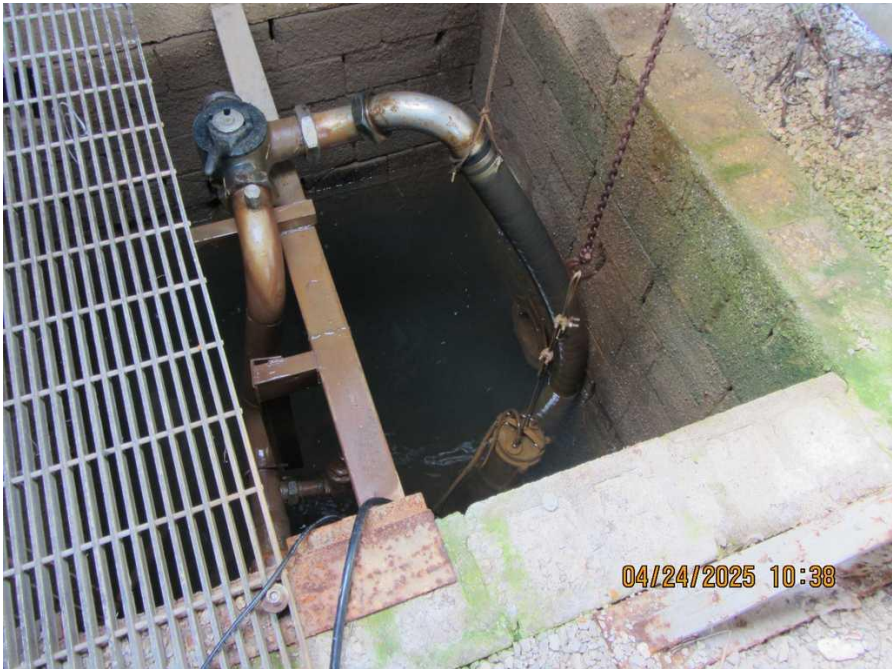
| Photo 7 | | | IMG_0471.JPG |

| Photo of wastewater collection pit from spraying field that will be pumped to the lagoons. | | | |

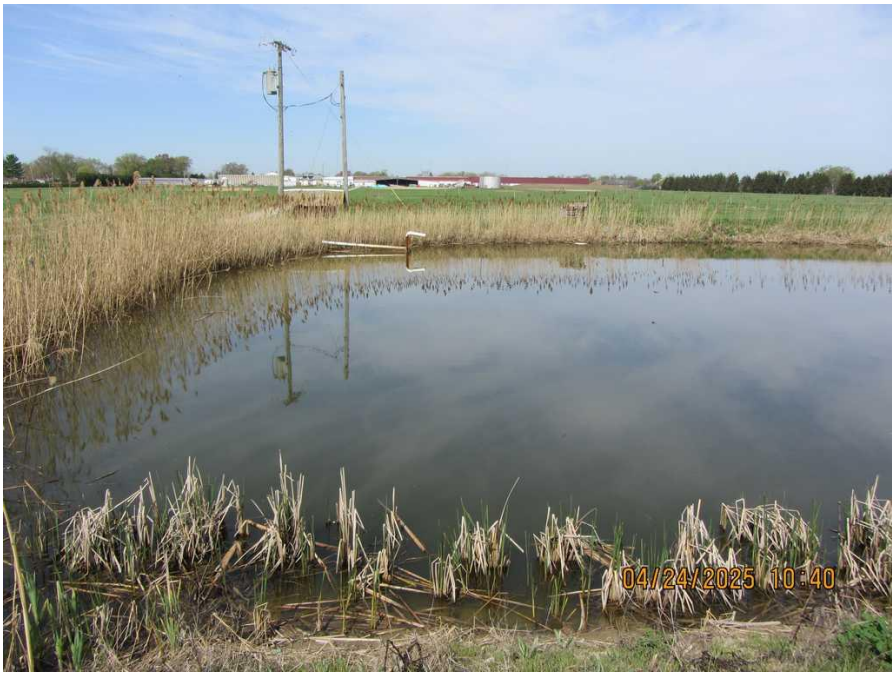
| Photo 8 | | | IMG_0472.JPG |

| Photo of pond 1 and inlet pipe. | | | |

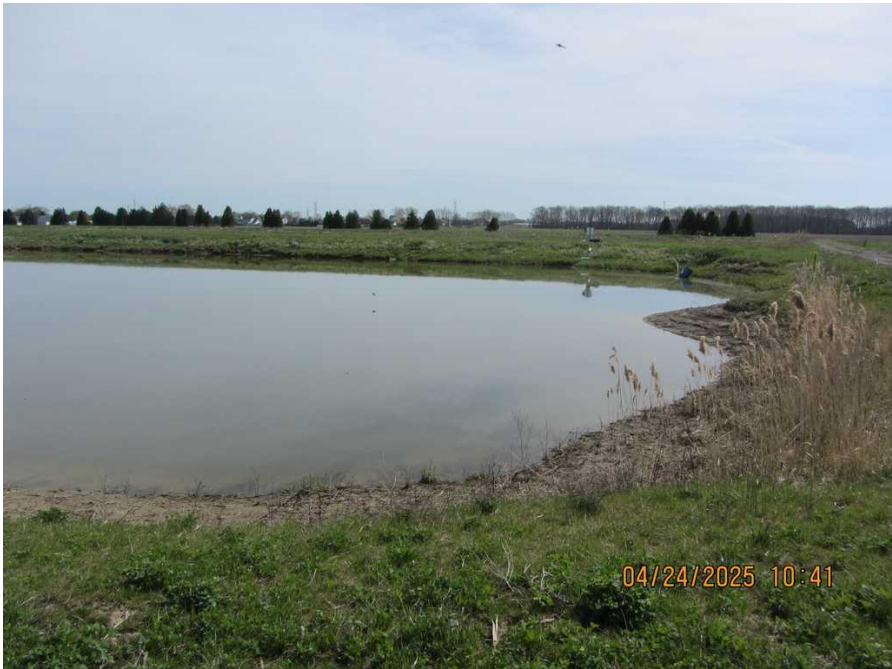
| Photo 9 | | | IMG_0473.JPG |

| Photo of pond 2. | | | |

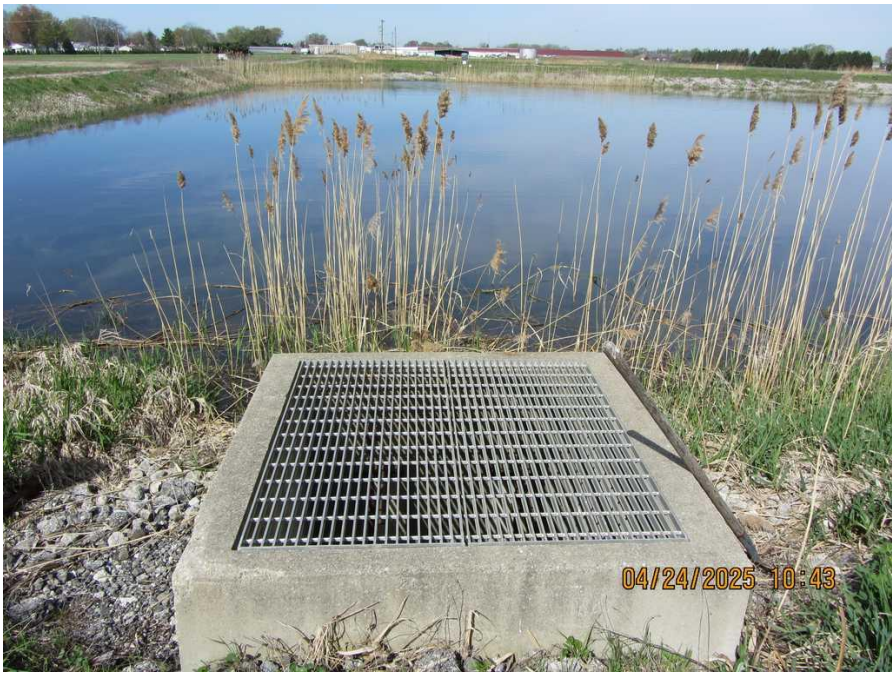
| Photo 10 | | | IMG_0474.JPG |

At the time of inspection, Outfall 001 was discharging. Dan Jackson stated that the valve which controls the discharge had begun malfunctioning in early April 2025, allowing some discharge to continuously exit the outfall. At the time of the inspection the outfall was discharging. On May 15, 2025, after the inspection, the Facility provided a photo of the newly installed valve.

| AOC Reference #: JF1-OB-002 | Location: Application Fields, Treatment Lagoons, and Outfalls |
|---|---|
| <b>AOC:</b><br><br>At the time of inspection, Outfall 001 was discharging. Dan Jackson stated that the valve which controls the discharge had begun malfunctioning in early April 2025, allowing a portion of the discharge to continuously exit Outfall 001, including constantly during the inspection. | |

| Photo of pond 4 and discharge valve. | | | |

| Facility provided a photo of the replaced valve for Outfall 001. | | |

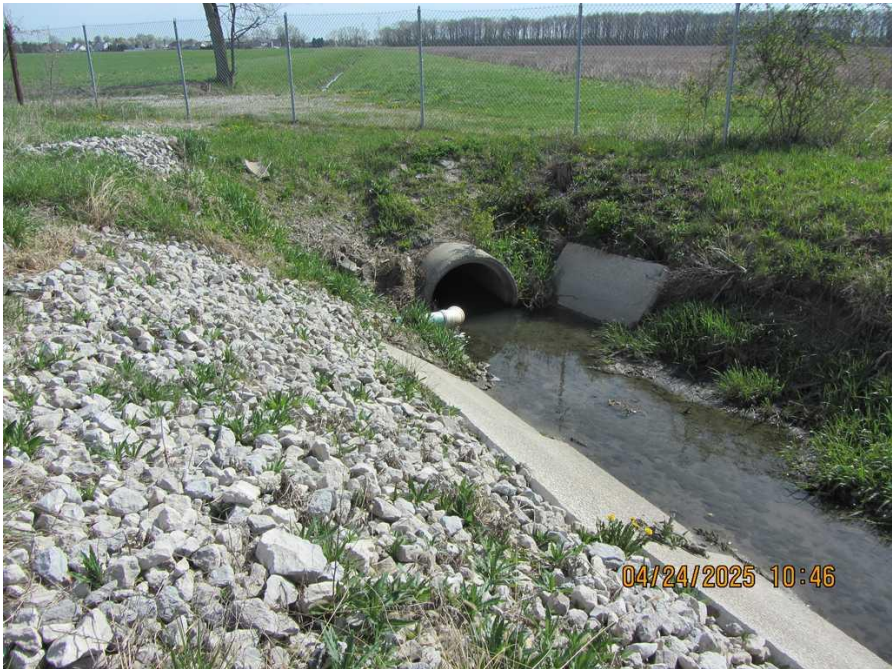
| Photo 11 | | | IMG_0475.JPG |

| Photo of Outfall 001. | | | |

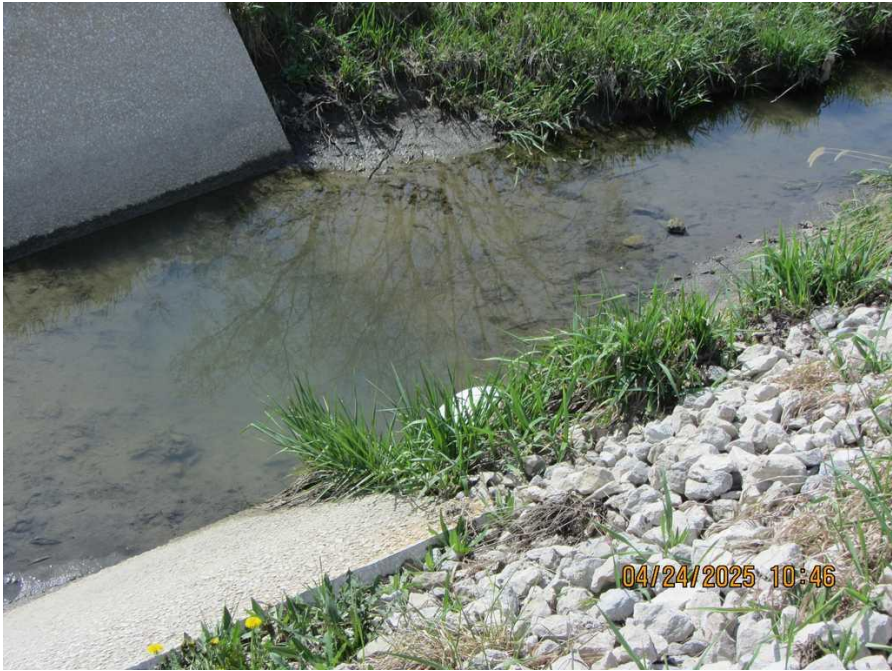
| Photo 12 | | | IMG_0476.JPG |

| Photo of Outfall 002. | | | |

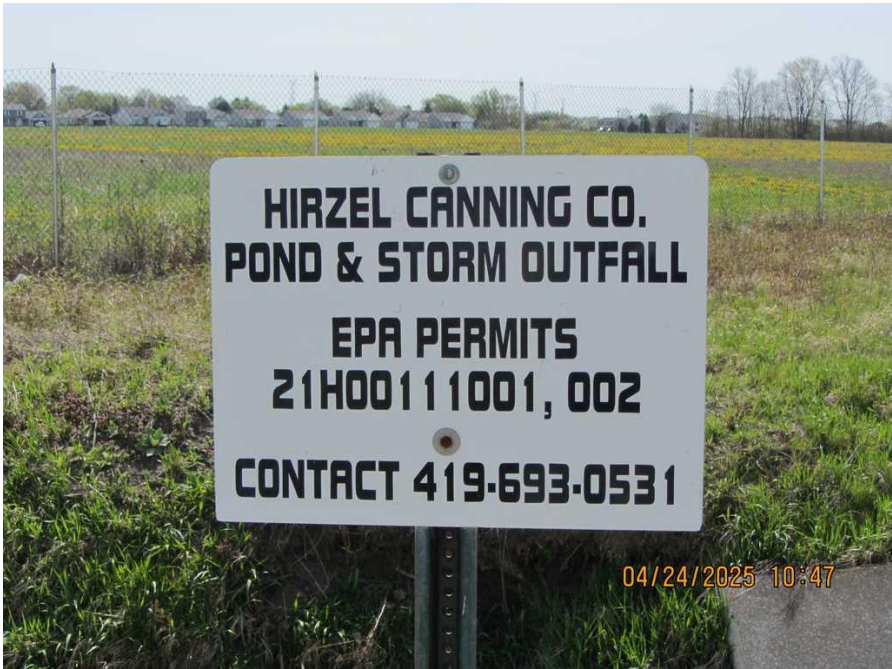
| Photo 13 | | | IMG_0477.JPG |

| Photo of outfall signage for Outfalls 001 and 002. | | | |

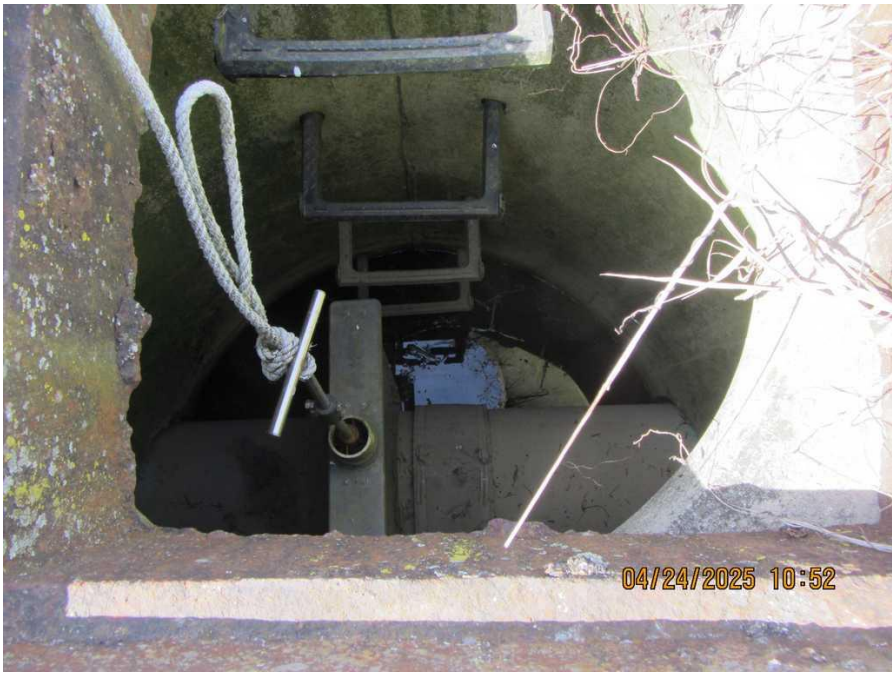
| Photo 14 | | | IMG_0478.JPG |

| Photo of stormwater outfall valve. | | | |

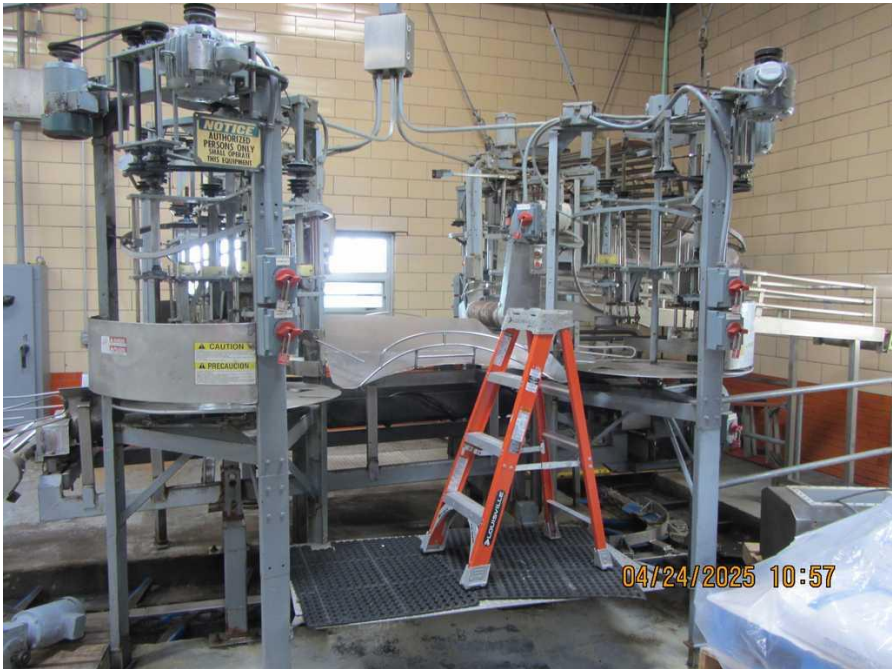
| Photo 15 | | | IMG_0479.JPG |

| Photo of cabbage tumbler. | | | |

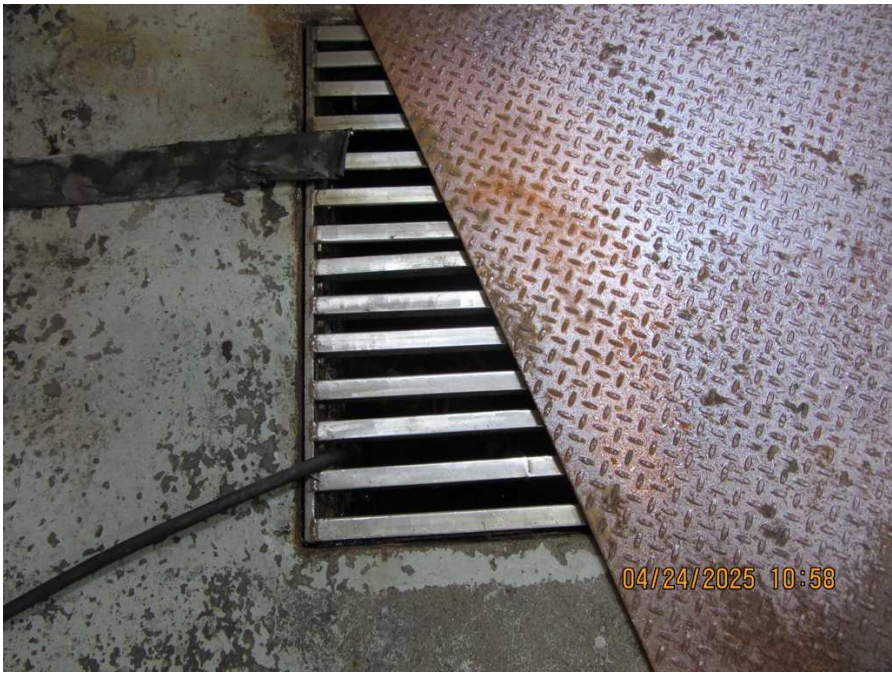
| Photo 16 | | | IMG_0480.JPG |

| Photo of cabbage wastewater holding tank. | | | |

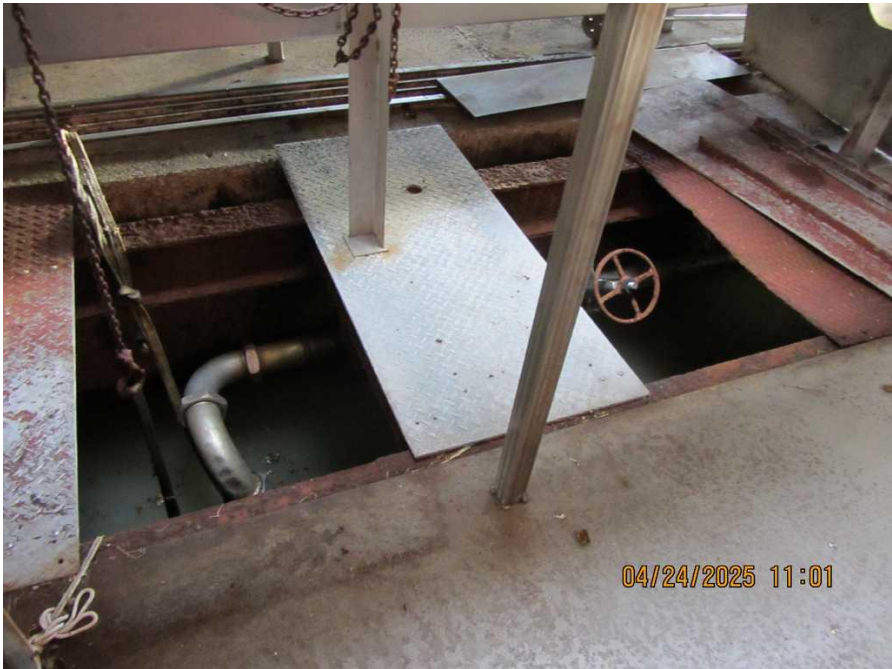
| Photo 17 | | | IMG_0481.JPG |

| Photo of tomato pit waste water. | | | |
