**Region 6 Compliance Assurance and Enforcement Division  
INSPECTION REPORT**

| Media: | Water | | | |
| Regulatory Program(s) | NPDES | | | |
| Identification/Permit Number: | TXU011232 | | | |

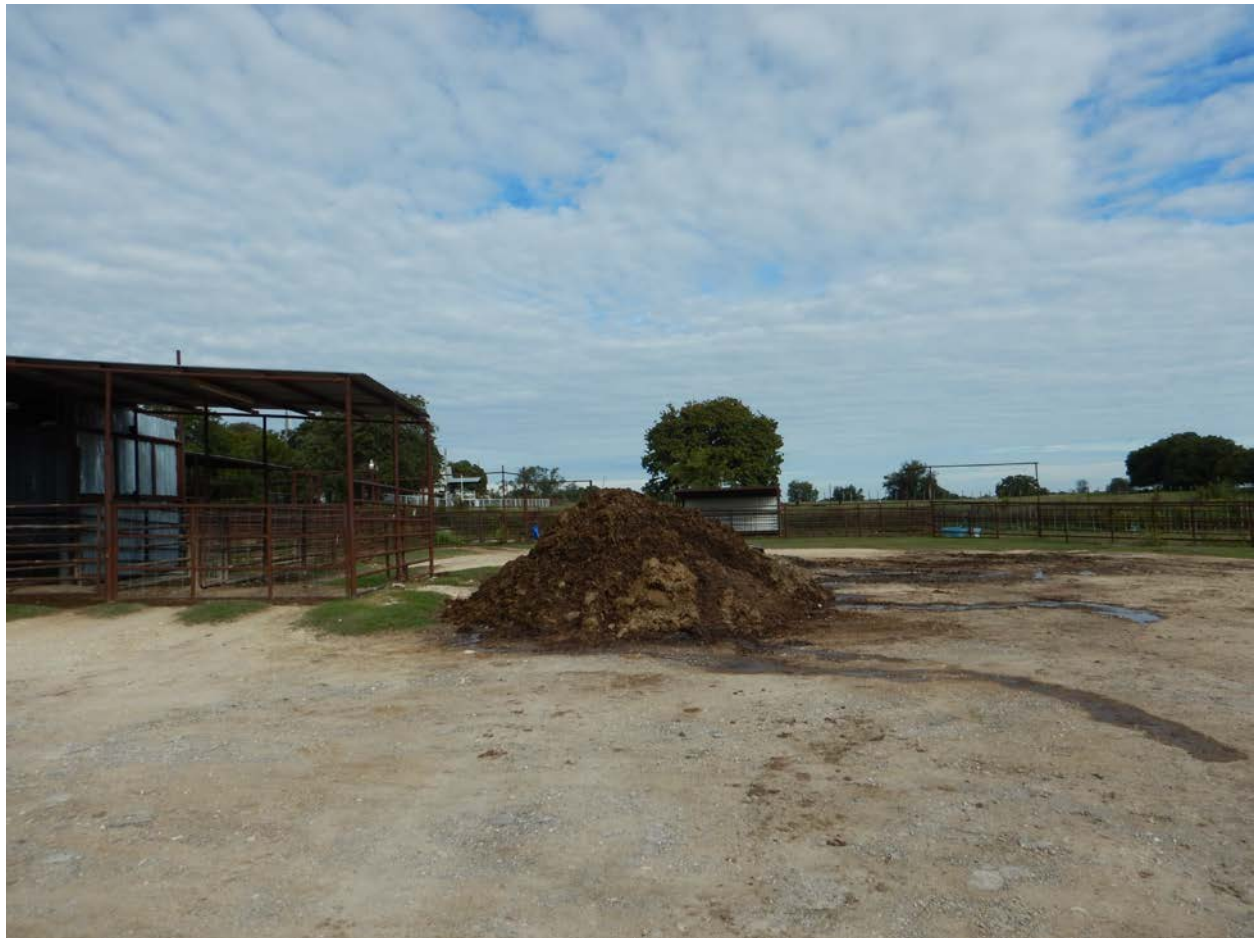
Photo No. 1

Description: This photo was taken facing north towards the facility's pile of lot scrapings/manure. It had rained recently, so I observed wastewater runoff emanating from this pile.

- As a best management practice, manure and lot scrapings should be stored under cover. This practice would prevent the production of process wastewater as rainwater comes in contact with the storage pile.
