INSPECTION REPORT

Inspection Date(s):	08/30/2022 - 08/31/2022	Announced: Yes
Time:	Entry: 01:05 PM (ET)	Exit: 01:20 PM (ET)
Media:	Water	
Statute(s)/Program(s):	Clean Water Act, NPDES, WWTP	
Type of inspection:	CEI - Compliance Evaluation Inspection	
Access:	Granted	
Permittee Name: CITY OF KENDALLVILLE		
Facility or Site Name: CITY OF KENDALLVILLE WASTEWATER TREATMENT PLANT		
Facility/Site Physical Address: 501 WEST WAYNE STREET		
(City, state, zip code) KENDALLVILLE, IN 46755		
County/Parish: NOBLE		
Facility GPS Coordinates: 41.446444, -85.273806		
Facility/Site Identifier: 110005973900		
Permit Number: IN0020656

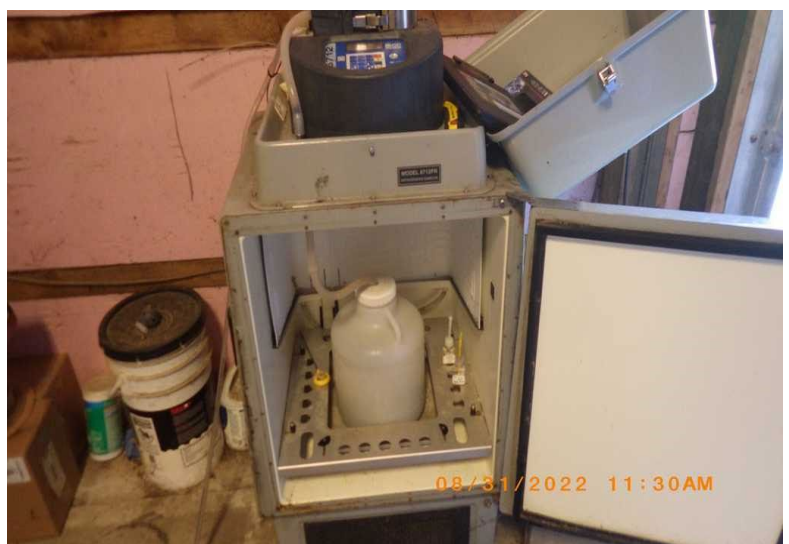
We then walked into the Grit Building and observed the bar screen which was behind plastic curtains to minimize odor (see Photo Log image KEND0120). Patrick Howell said that aside from a recently repaired bearing issue, the bar screen is working well. I also observed a caustic chemical tank which is no longer in use (see Photo Log image KEND0121). Before leaving the Grit Building, I observed the influent composite sampler (ISCO). I noticed the sampler was refrigerated and included a thermometer (see Photo Log image KEND0122).

Influent composite sampler
KEND0122.JPG
08/31/2022 11:30 AM (ET)
Dean Maraldo
Physical Inspection/Headworks
No CBI
No PII
ISCO composite sampler was refrigerated and included a thermometer.

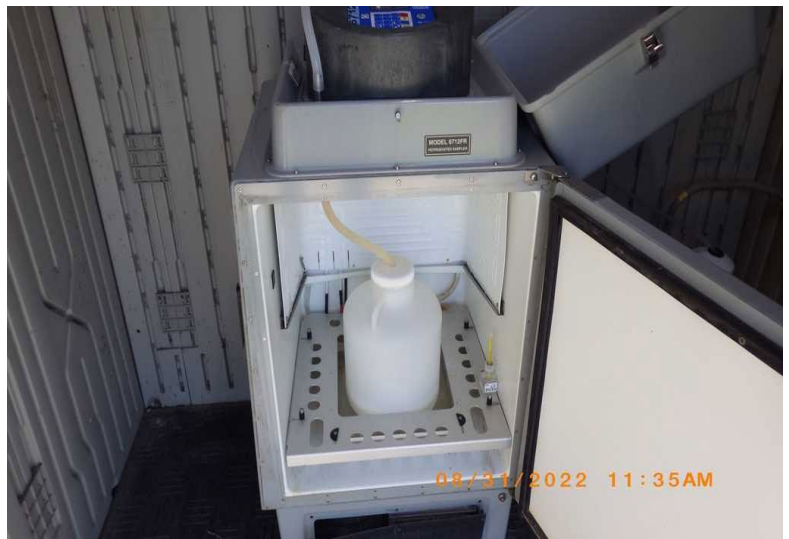
Earlier in the physical plant inspection we walked from the headworks to primary clarification and stopped at the effluent sampling building to observe the effluent composite sampler (see Photo Log image KEND0123). The small building also housed a flowmeter that measured flow between headworks and primary clarification (see Photo Log image KEND0124). At the time of observation, the flowmeter read 1,575 gallons per minute. From here, we walked to the Operations Building and primary clarification area (see Primary Clarification observation section).

Effluent composite sampler
KEND0123.JPG
08/31/2022 11:35 AM (ET)
Dean Maraldo
Physical Inspection/Final Outfall
No CBI
No PII
Located in the small effluent building.

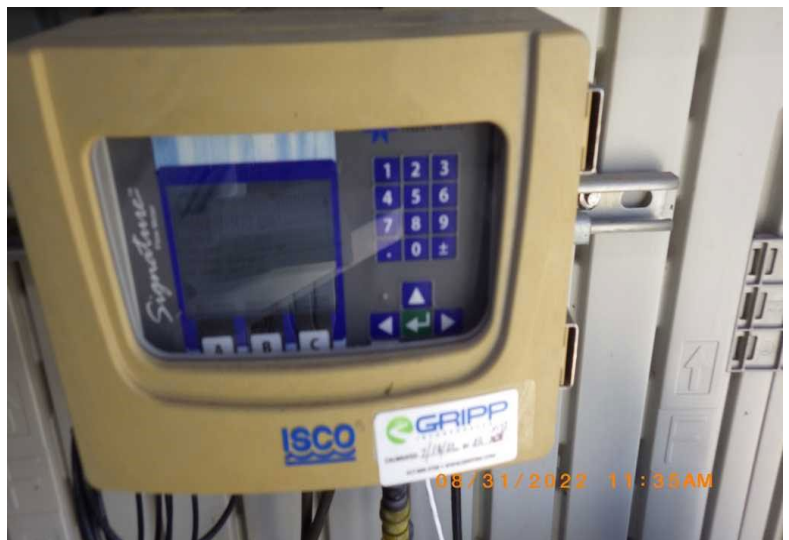
Flowmeter measuring flow between headworks and primary clarification
KEND0124.JPG
08/31/2022 11:35 AM (ET)
Dean Maraldo
Physical Inspection/Final Outfall
No CBI
No PII
Located in the small effluent building.

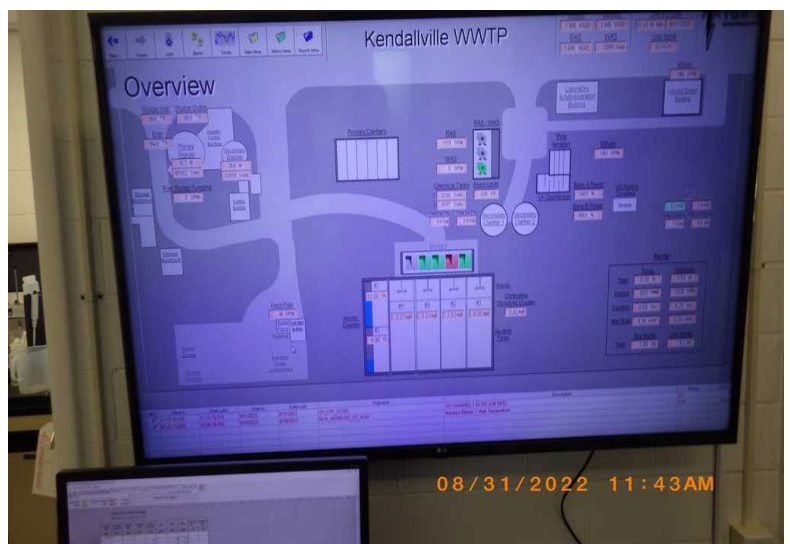
Prior to reaching the primary clarification area, we stopped at the Operations Building. We observed the raw sewage pumps (4) and SCADA system display (see Photo Log image KEND0125). Patrick Howell used the SCADA display to explain the procedure for managing wet weather flows. To avoid Return Activated Sludge (“RAS”) washout, they begin to shut down RAS and blowers at 5 MGD (blowers) and 6 MGD (RAS). After wet weather events the RAS starts to come back online at 5.5 MGD.

SCADA Display
KEND0125.JPG
08/31/2022 11:43 AM (ET)
Dean Maraldo
Physical Inspection/Primary Clarification
No CBI
No PII
SCADA system display in the Operations Building.

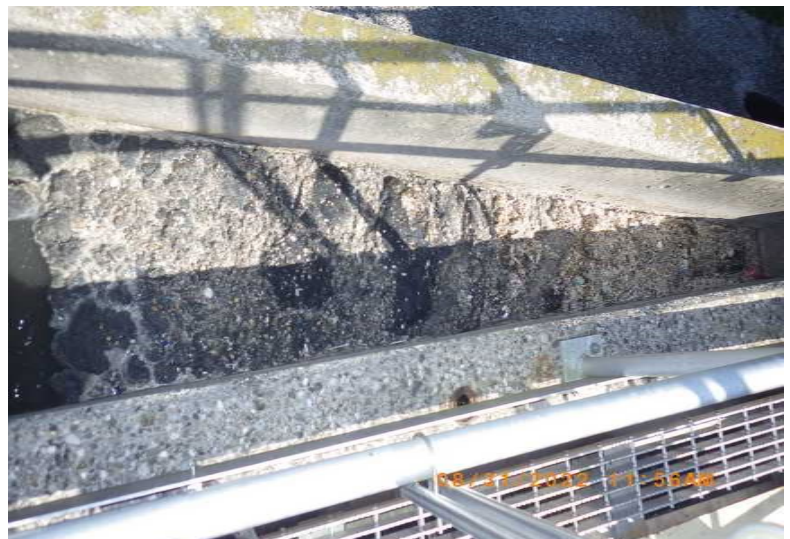
Influent raw water
KEND0126.JPG
08/31/2022 11:56 AM (ET)
Dean Maraldo
Physical Inspection/Primary Clarification
No CBI
No PII
Note the small palm oil blobs floating on top of raw influent to the primary clarifiers.

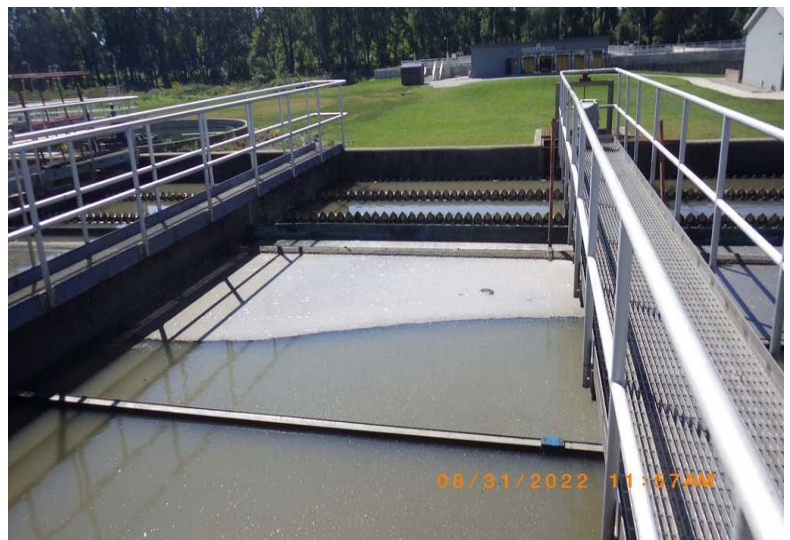
After the wet-weather discussion we walked to the primary clarifiers (6). Three were in operation. The Superintendent said the system runs best with three primary clarifiers in service, and they remove about 50% of the total suspended solids (“TSS”) and about 25-30% of the CBOD. He pointed out the small palm oil blobs floating on top of the influent raw water (see Photo Log image KEND0126). I also observed the floating palm oil blobs collected along the back of primary clarifier #2 (see Photo Log image KEND0127). The palm oil is

Primary Clarifier #2
KEND0127.JPG
08/31/2022 11:57 AM (ET)
Dean Maraldo
Physical Inspection/Primary Clarification
No CBI
No PII
I observed the floating palm oil blobs collected along the back of primary clarifier #2

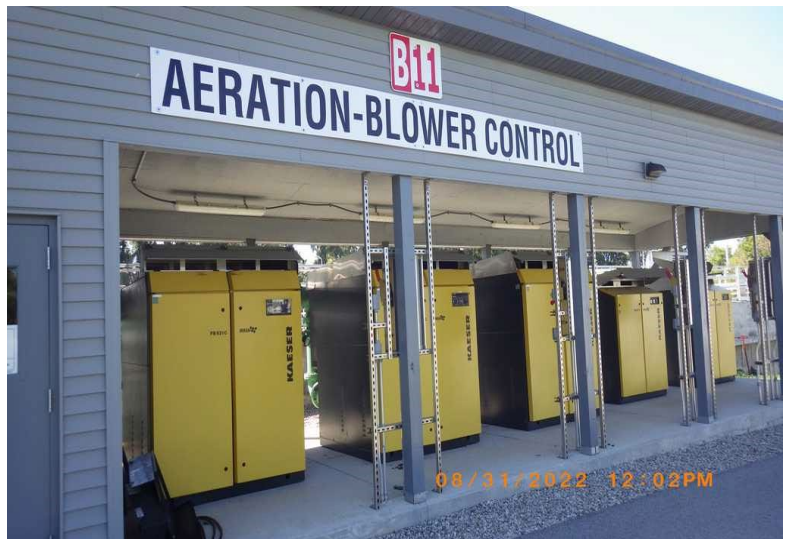
DM1-OB-004	
According to Facility representatives, Kraft variable CBOD loading is the cause of recent plant upsets.	Citations: Permit Part II.B.1.a-b; Permit Part III.A.4
Unit: Physical Inspection	Area: Aeration
DM1-OB-010	
The Superintendent said they may be having nitrogen-ammonia issues due to the out-of- service aeration blower and aeration tank.	Citations: Permit Part II.B.1.a-b
Unit: Physical Inspection	Area: Secondary Clarification
DM1-OB-011	
I observed significant vegetation growth and debris in the effluent trough and weir notches in secondary clarifier #1.	Citations: Permit Part II.B.1.a
Unit: Physical Inspection	Area: Disinfection
DM1-OB-012	
The City hires a contractor to service the UV system in the spring prior to recreation season startup. Jordan Undeen stated that when the clarifiers are cleaned, the algae and wastewater is bypassed around the UV treatment system to prevent the algae from getting physically stuck on the UV light banks. The cleaning wastewater is also routed around the effluent sampler and reconnects with the effluent piping prior to discharge at the receiving stream.	Citations: Permit Part II.B.2

Aeration Blowers (4)
KEND0129.JPG
08/31/2022 12:02 PM (ET)
Dean Maraldo
Physical Inspection/Aeration
No CBI
No PII
One of the blowers (second from the left) was out of service due to motor repairs.

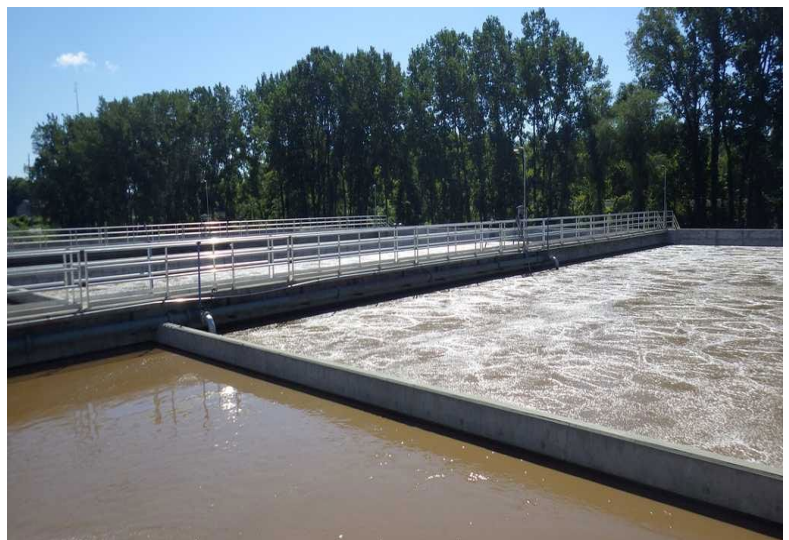
View of aeration tanks
KEND0130.JPG
08/31/2022 12:07 PM (ET)
Dean Maraldo
Physical Inspection/Aeration
No CBI
No PII
One of the four aeration tanks was off line due to the out-of-service blower.

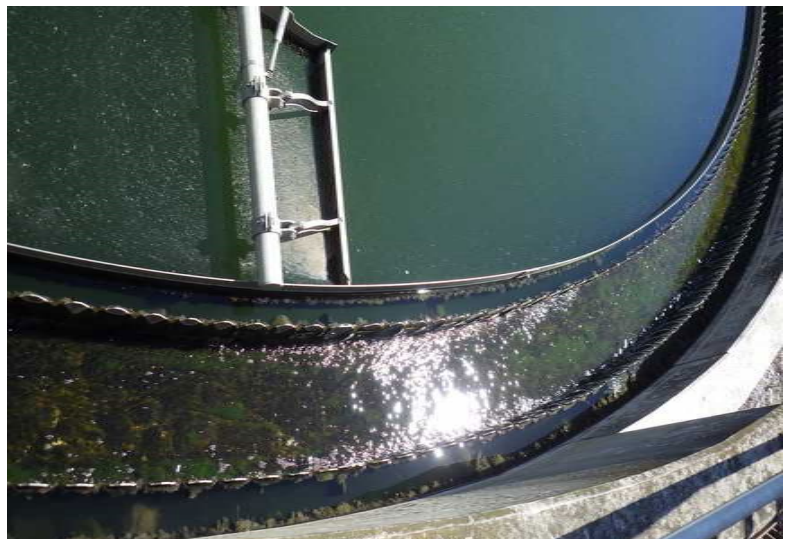
Secondary Clarifier #1
KEND0132.JPG
08/31/2022 12:23 PM (ET)
Dean Maraldo
Physical Inspection/Secondary Clarification
No CBI
No PII
Note the significant vegetation growth and debris in the effluent trough and weir notches. Also note skimmer capturing palm oil blobs on the surface of the secondary clarifier.

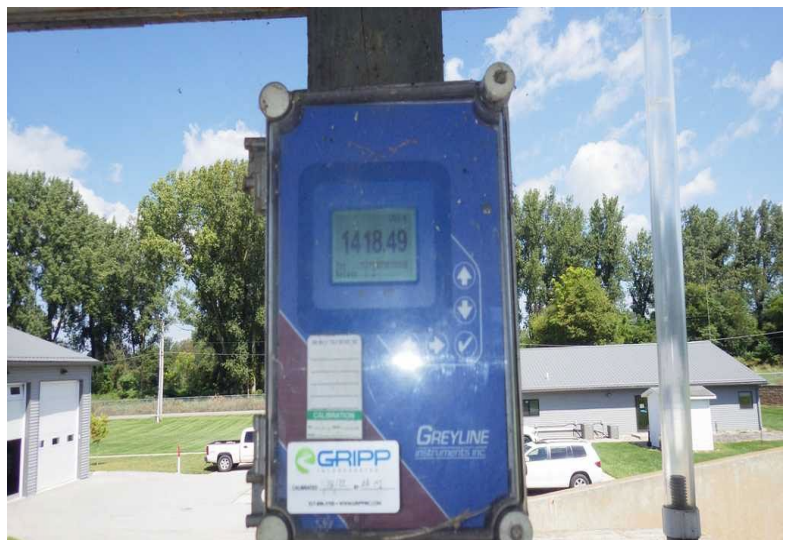
Effluent flow meter
KEND0133.JPG
08/31/2022 12:32 PM (ET)
Dean Maraldo
Physical Inspection/Disinfection
No CBI
No PII

Observation #: DM1-OB-012	Date: 08/31/2022
<p>We walked to the disinfection area and observed the effluent flow meter (see Photo Log image KEND0133) and Wedeco ultraviolet ("UV") disinfection system (covered by a grate, see Photo Log image KEND0134). The effluent flow meter read 1,418 gallons per minute. The UV system consists of two units housing 16 bulbs each. The City hires a contractor to service the UV system in the spring prior to recreation season startup. Jordan Undeen stated that when the clarifiers are cleaned, the algae and wastewater is bypassed around the UV treatment system to prevent the algae from getting physically stuck on the UV light banks. The cleaning wastewater is also routed around the effluent sampler and reconnects with the effluent piping prior to discharge at the receiving stream.</p>	
<p>Photo(s)</p> <ol style="list-style-type: none"> 1. KEND0133.JPG 2. KEND0134.JPG

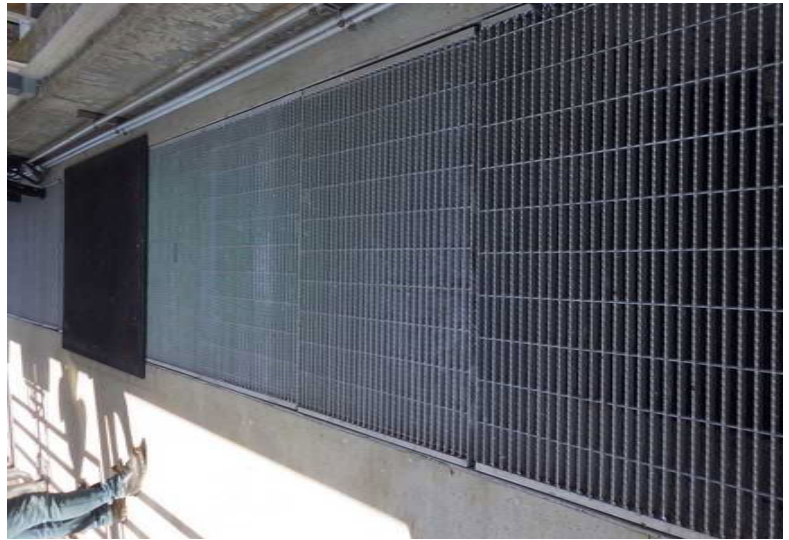
Wedeco Ultraviolet ("UV") disinfection system
KEND0134.JPG
08/31/2022 12:32 PM (ET)
Dean Maraldo
Physical Inspection/Disinfection
No CBI
No PII
The UV bulb system is under the grates.

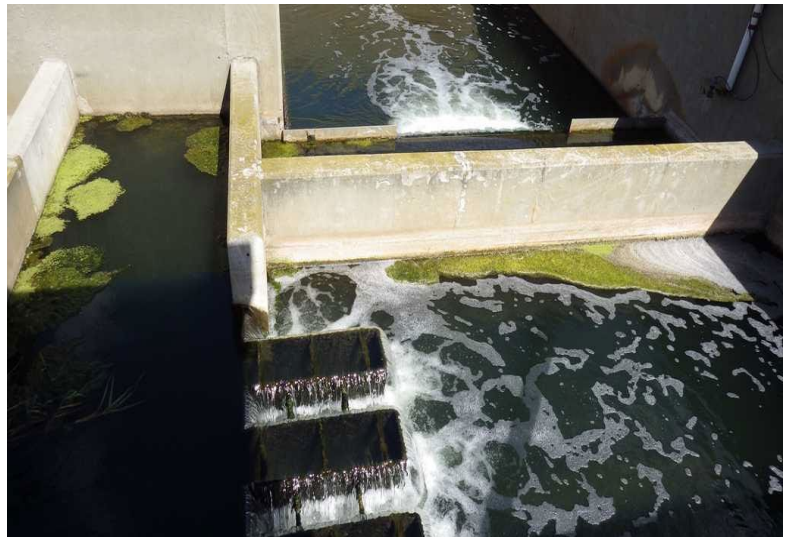
Unit: Physical Inspection	Area: Post-aeration
DM1-OB-013	
I observed significant duckweed and vegetation growth in the post-aeration tank and cascades.	Citations: Permit Part II.B.1.a

Post-aeration basin
KEND0135.JPG
08/31/2022 12:34 PM (ET)
Dean Maraldo
Physical Inspection/Post-aeration
No CBI
No PII
Note the significant duckweed and vegetation growth in the post-aeration basin.

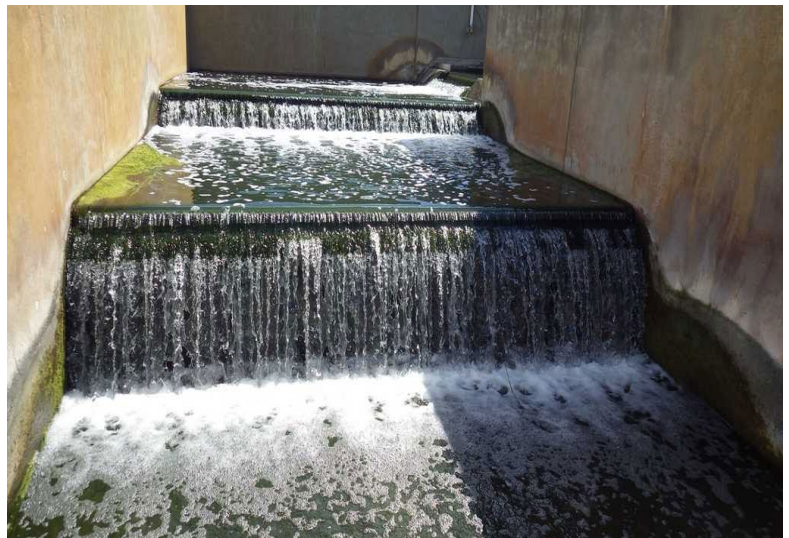
Post-aeration cascades
KEND0136.JPG
08/31/2022 12:35 PM (ET)
Dean Maraldo
Physical Inspection/Post-aeration
No CBI
No PII
Note the significant duckweed in the post-aeration cascades.

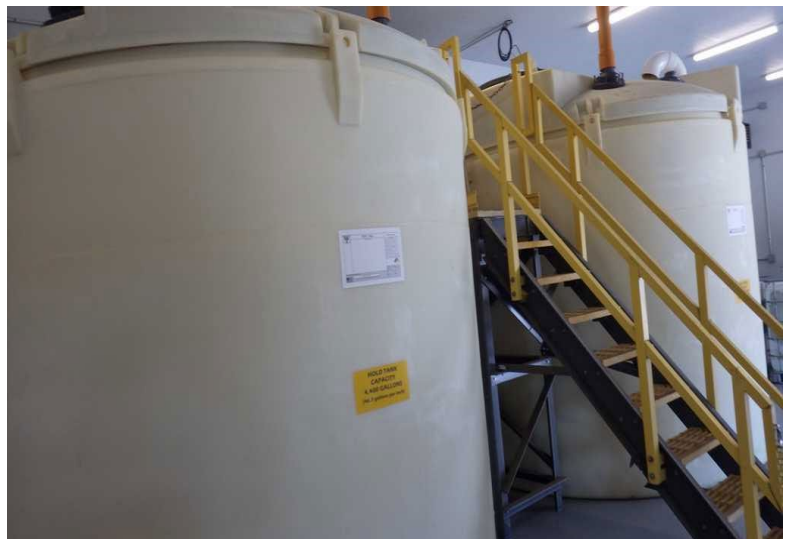
BOD feed tanks (2)
KEND0138.JPG
08/31/2022 12:43 PM (ET)
Dean Maraldo
Physical Inspection/Phosphorus Removal
No CBI
No PII
Tanks contain molasses-based BOD feed.

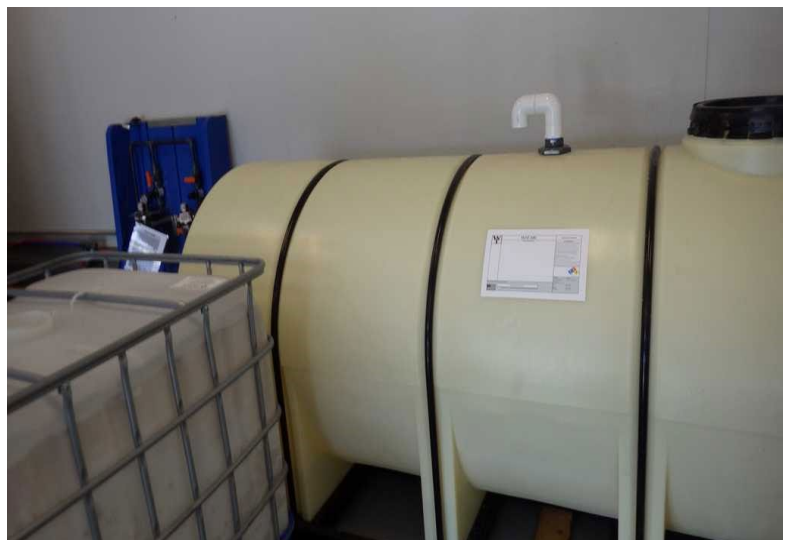
Phosphorus removal chemical tank
KEND0139.JPG
08/31/2022 12:44 PM (ET)
Dean Maraldo
Physical Inspection/Phosphorus Removal
No CBI
No PII
The aluminum-bearing chemical product is also used to help with copper.

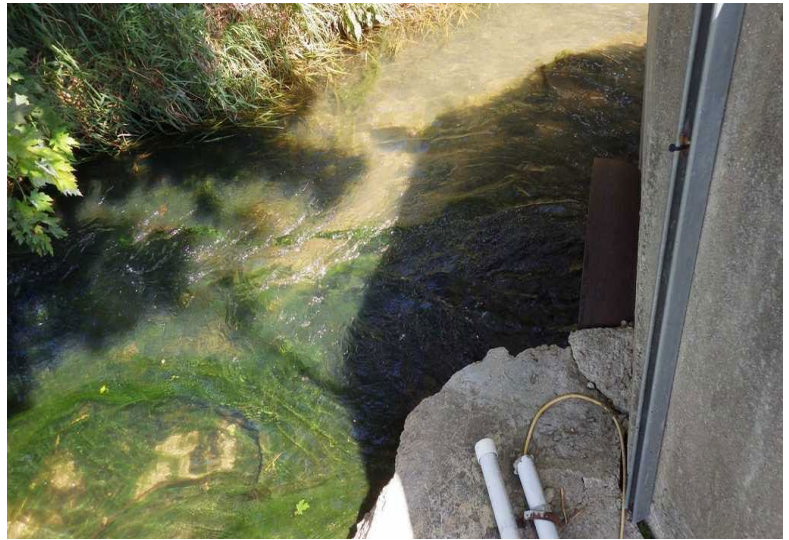
We returned to the final outfall area at the end of the physical facility tour. I observed a clear discharge from Final Outfall #003 and noted some vegetation growth along the bed of the receiving water (see Photo Log image KEND0140). Outfall #003 discharges to an unnamed tributary just upstream of Henderson Lake.

Final Outfall #003
KEND0140.JPG
08/31/2022 12:48 PM (ET)
Dean Maraldo
Physical Inspection/Final Outfall
No CBI
No PII
Outfall #003 discharges to an unnamed tributary just upstream of Henderson Lake. Discharge appeared clear.

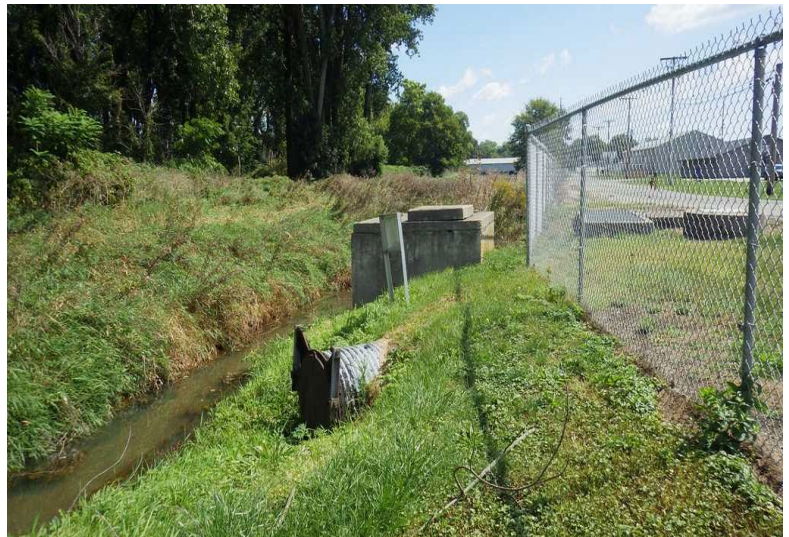
CSO Outfall #002
KEND0141.JPG
08/31/2022 12:49 PM (ET)
Dean Maraldo
Physical Inspection/CSO Outfall
No CBI
No PII
CSO Outfall #002 is located just upstream from Outfall 003, on the unnamed tributary that flows to Henderson Lake.
