**Region 6 Compliance Assurance and Enforcement Division  
INSPECTION REPORT**

| Inspection Date(s): | 06/08/2022 | | |
| Regulatory Program(s) | NPDES | | |
| Company Name: | Farm and Ranch Heritage Museum | | |

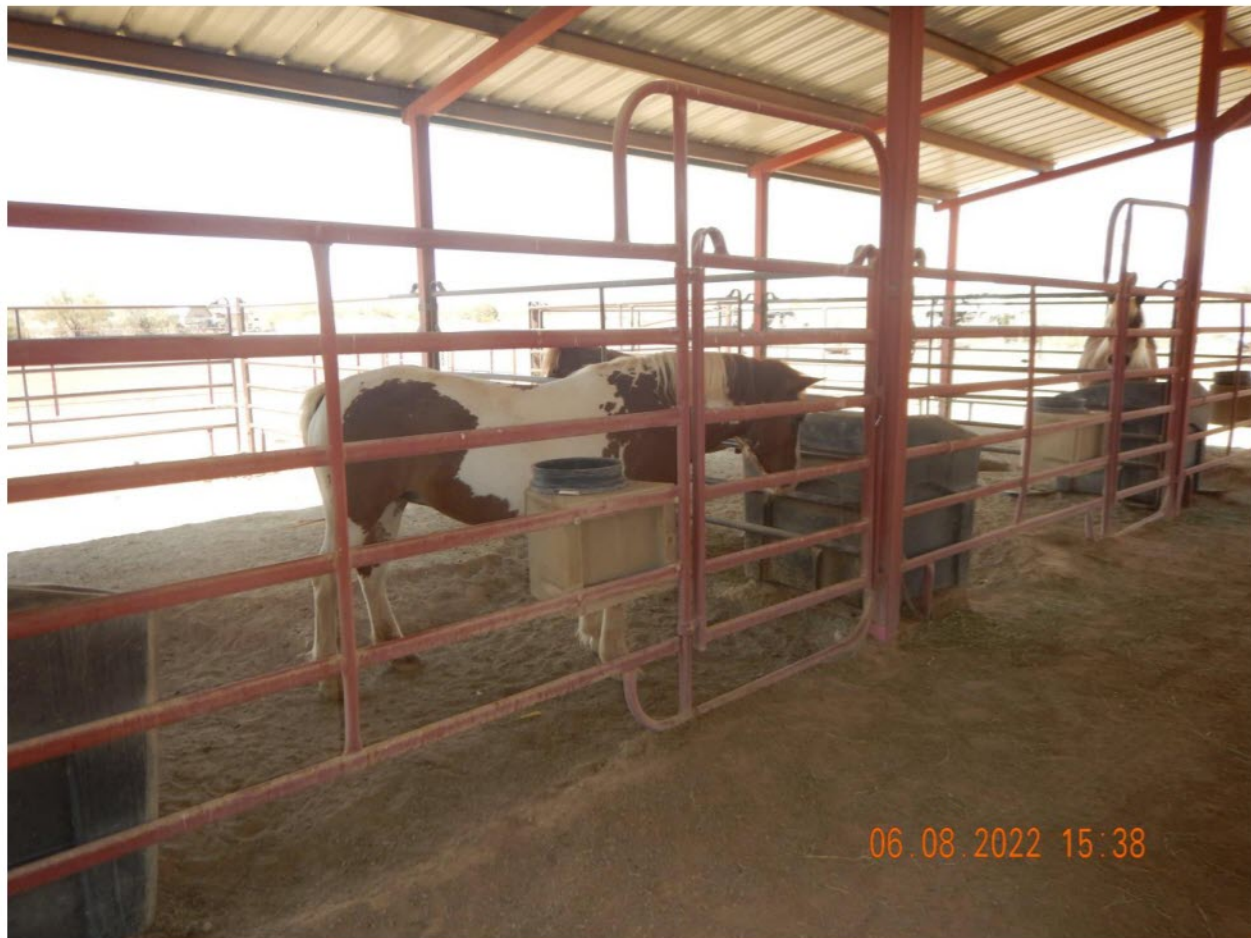
Photo No. 2

Photograph File Name: DSCN0957.JPG  
Date of Photograph: 06/08/2022  
Latitude and Longitude: 32.29732126673403, -106.71832702718748  
Orientation: N  
Map Datum: WGS-84  
Time of Photo: 15:38 PM  
Photographer: Jack Arias  
Description: This image shows confined/covered pens surrounded by a metal fence.

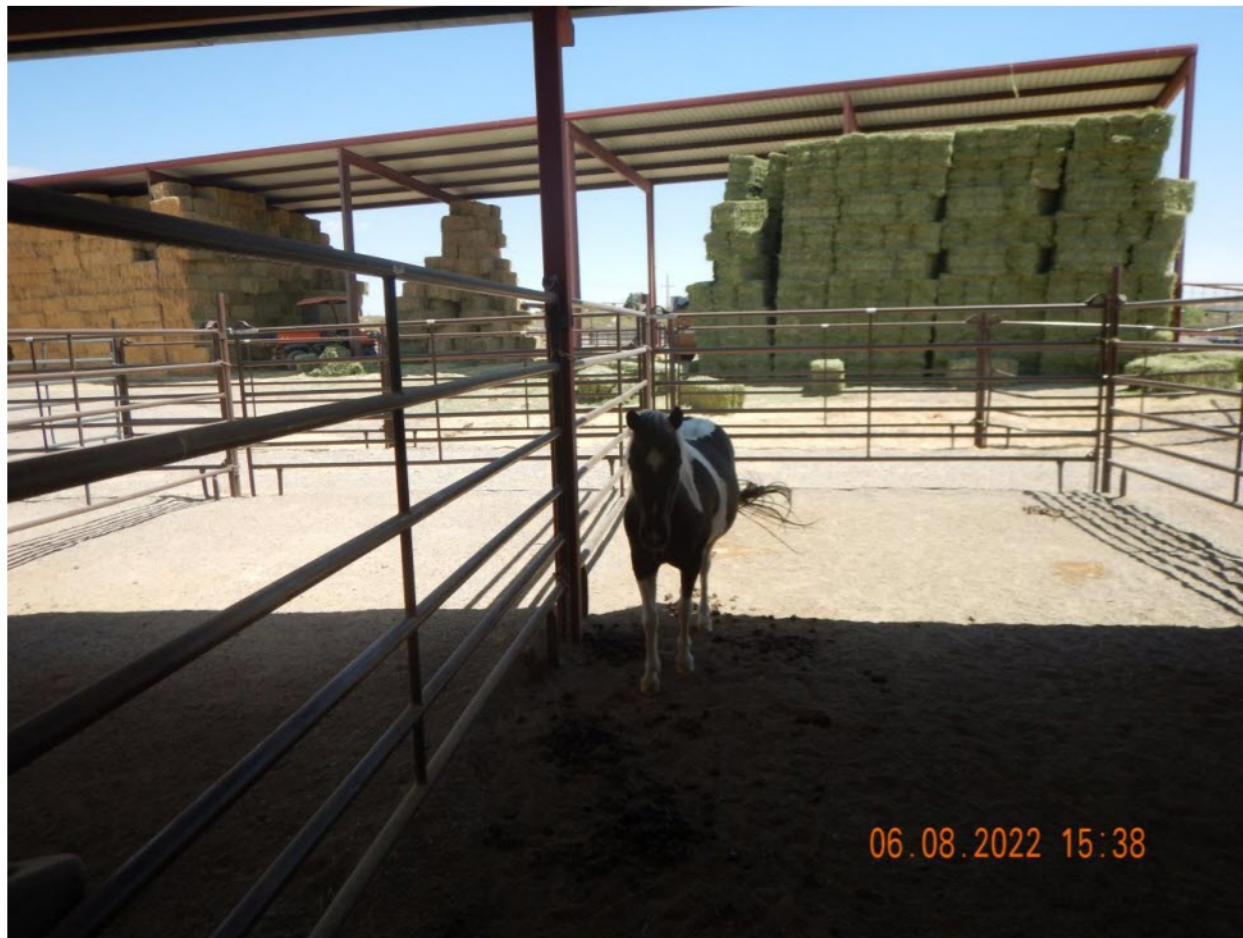
Photo No. 3

Photograph File Name: DSCN0969.JPG  
Date of Photograph: 06/08/2022  
Latitude and Longitud: 32.29732126673403, -106.71832702718748  
Orientation: N  
Map Datum: WGS-84  
Time of Photo: 15:38 PM  
Photographer: Jack Arias  
Description: This image shows confined/covered pens surrounded by a metal fence.

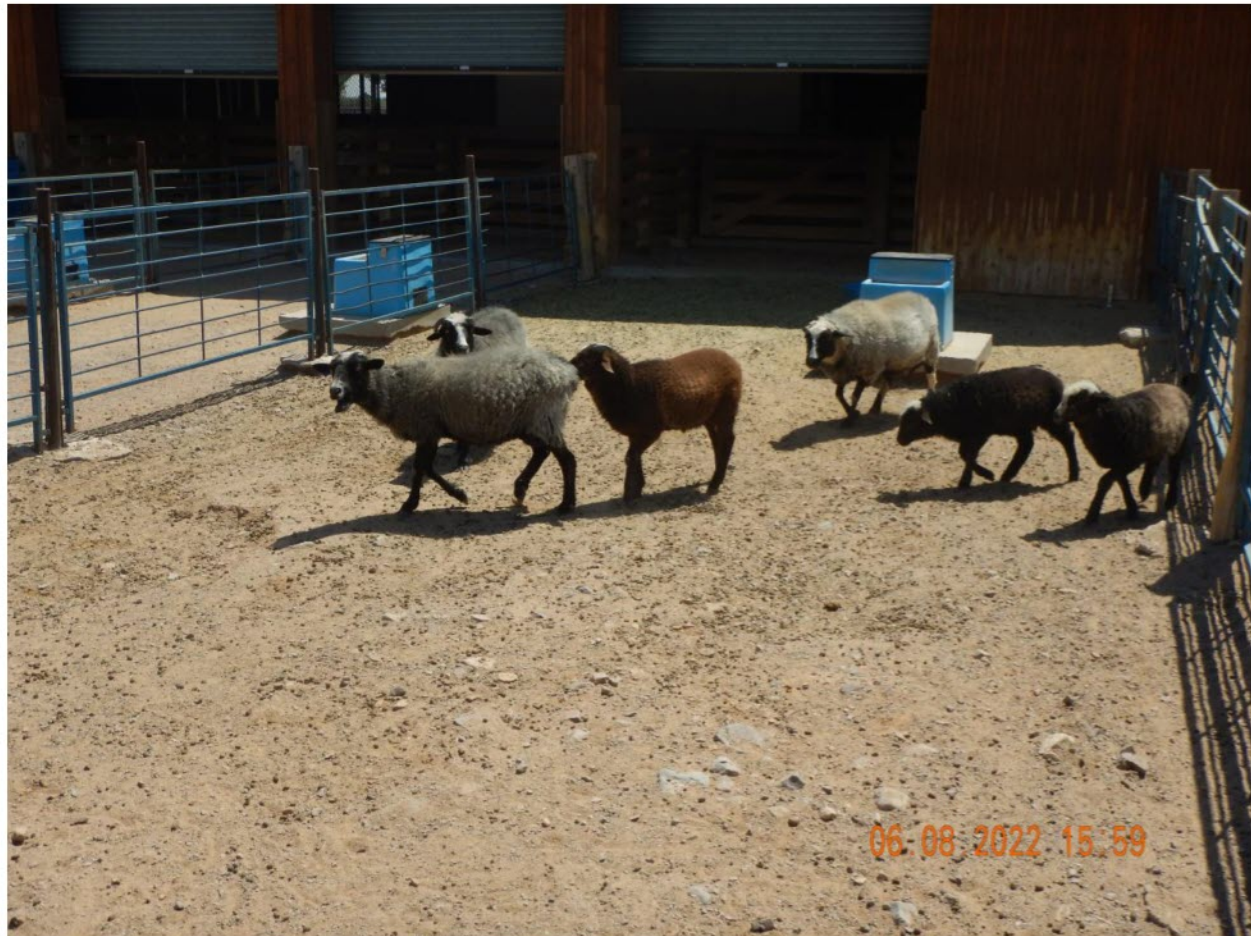
Photo No. 4

Photograph File Name: DSCN0992.JPG  
Date of Photograph: 06/08/2022  
Latitude and Longitud: 32.29716042516051, -106.71906796718407  
Orientation: S  
Map Datum: WGS-84  
Time of Photo: 15:59 PM  
Photographer: Jack Arias  
Description: This image shows confined/open pens surrounded by a metal fence.

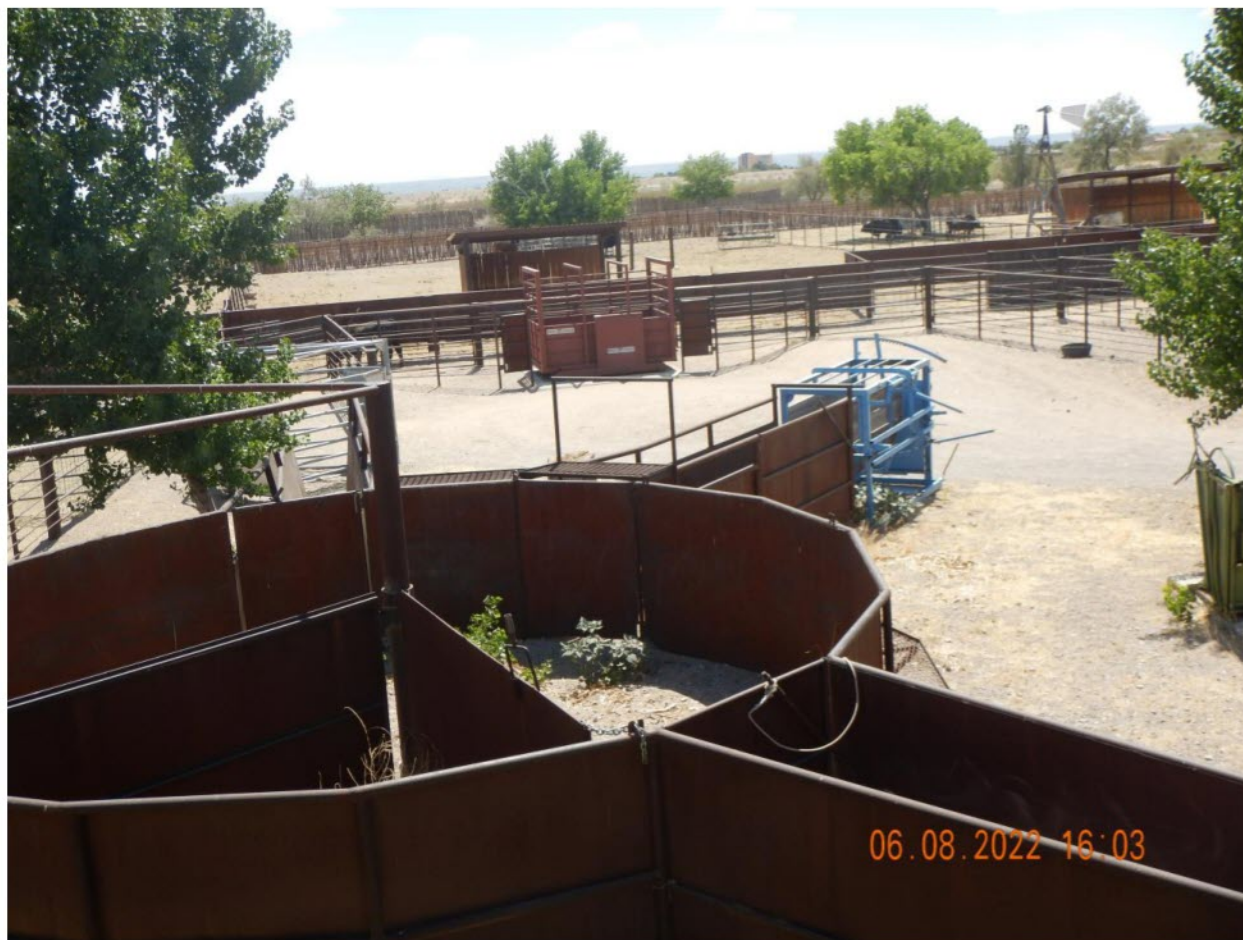
Photo No. 5

Photograph File Name: DSCN1003.JPG  
Date of Photograph: 06/08/2022  
Latitude and Longitud: 32.29691916226511, -106.71877678064844  
Orientation: S  
Map Datum: WGS-84  
Time of Photo: 16:03 PM  
Photographer: Jack Arias  
Description: This image shows the outside of the confined and covered pens.

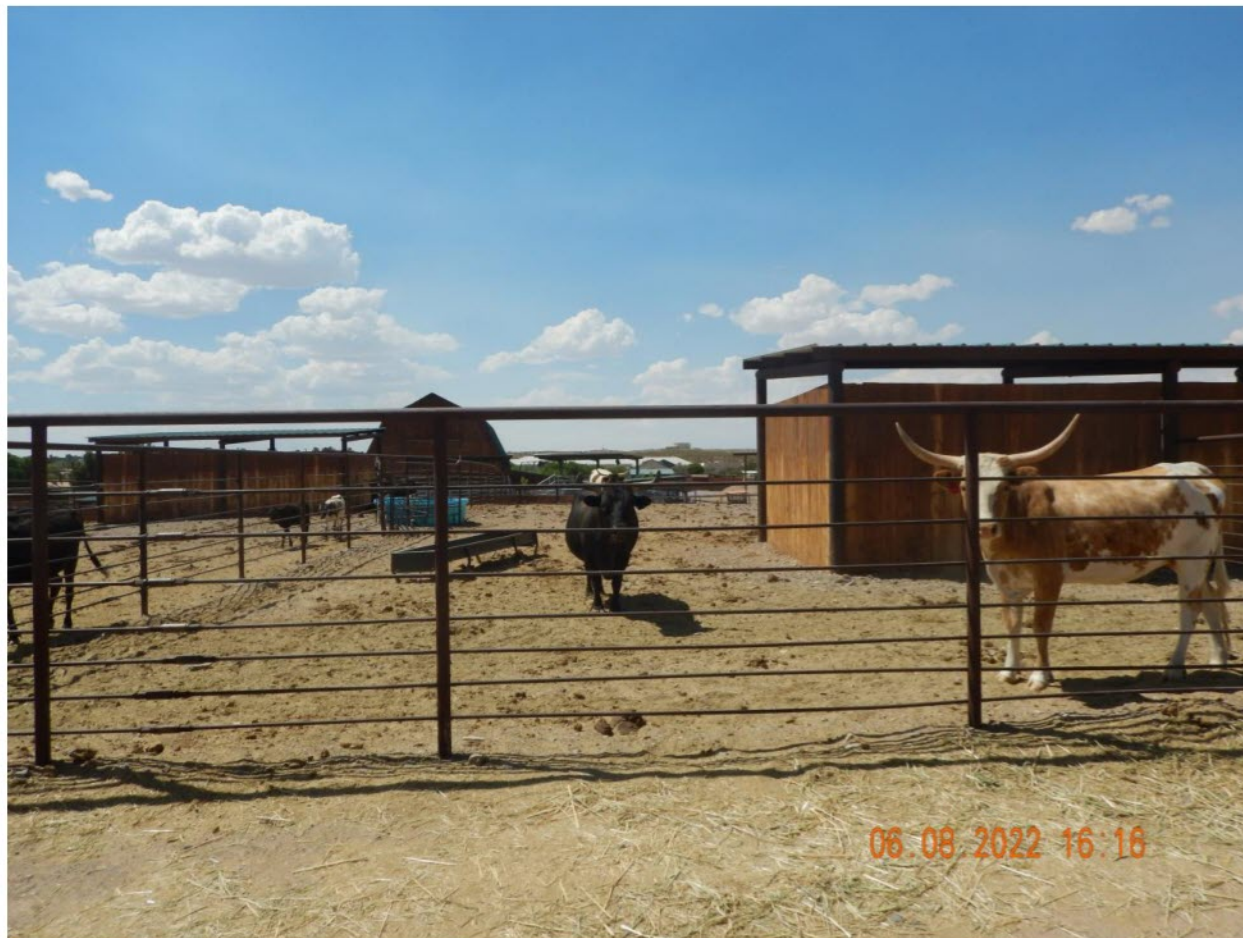
Photo No. 6

There is a small buildup of manure solids outside of the pens. Manure solids should be removed. The area of concern should be regraded and leveled to allow proper runoff and reduce risk of wastewater intrusion into arroyos (See Photo Nos. 6 - 10 in Appendix 1).

Photograph File Name: DSCN1010.JPG  
Date of Photograph: 06/08/2022  
Latitude and Longitud: 32.29760883126021, -106.71948600725997  
Orientation: S  
Map Datum: WGS-84  
Time of Photo: 16:18 AM  
Photographer: Jack Arias  
Description: This image shows some buildup of manure solids in the pens.

1. Small buildup of manure solids outside of the pens.
2. Undefined runoff control ditch system that formed part of the RCS.
3. Areas of concern next to pens should be regraded and leveled to allow proper runoff and reduce risk of wastewater intrusion into arroyo.

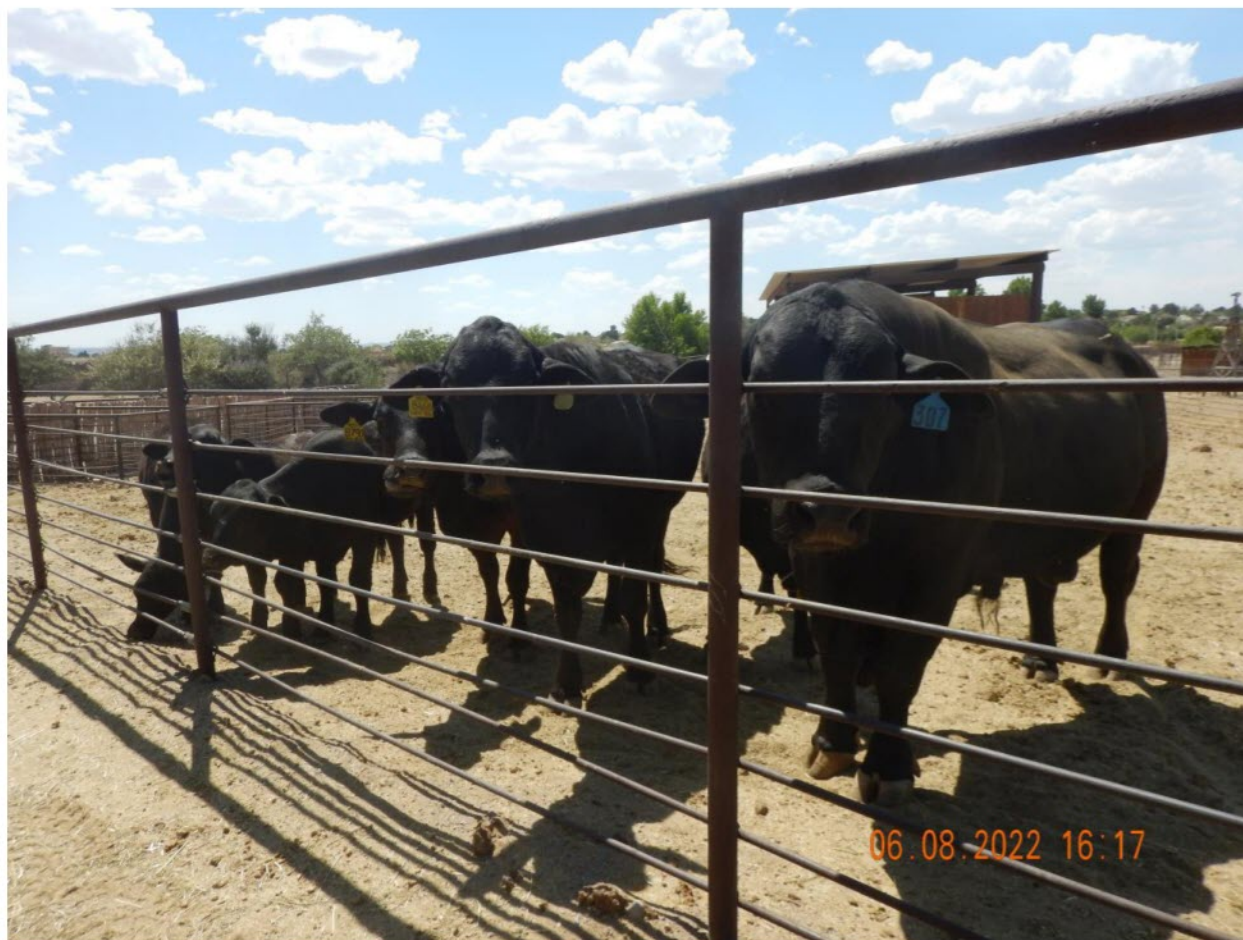
Photo No. 7

Photograph File Name: DSCN1012.JPG  
Date of Photograph: 06/08/2022  
Latitude and Longitude: 32.29648537482737, -106.71928131177586  
Orientation: SE  
Map Datum: WGS-84  
Time of Photo: 16:17 PM  
Photographer: Jack Arias  
Description: This image shows more buildup of manure solids outside of the pens.

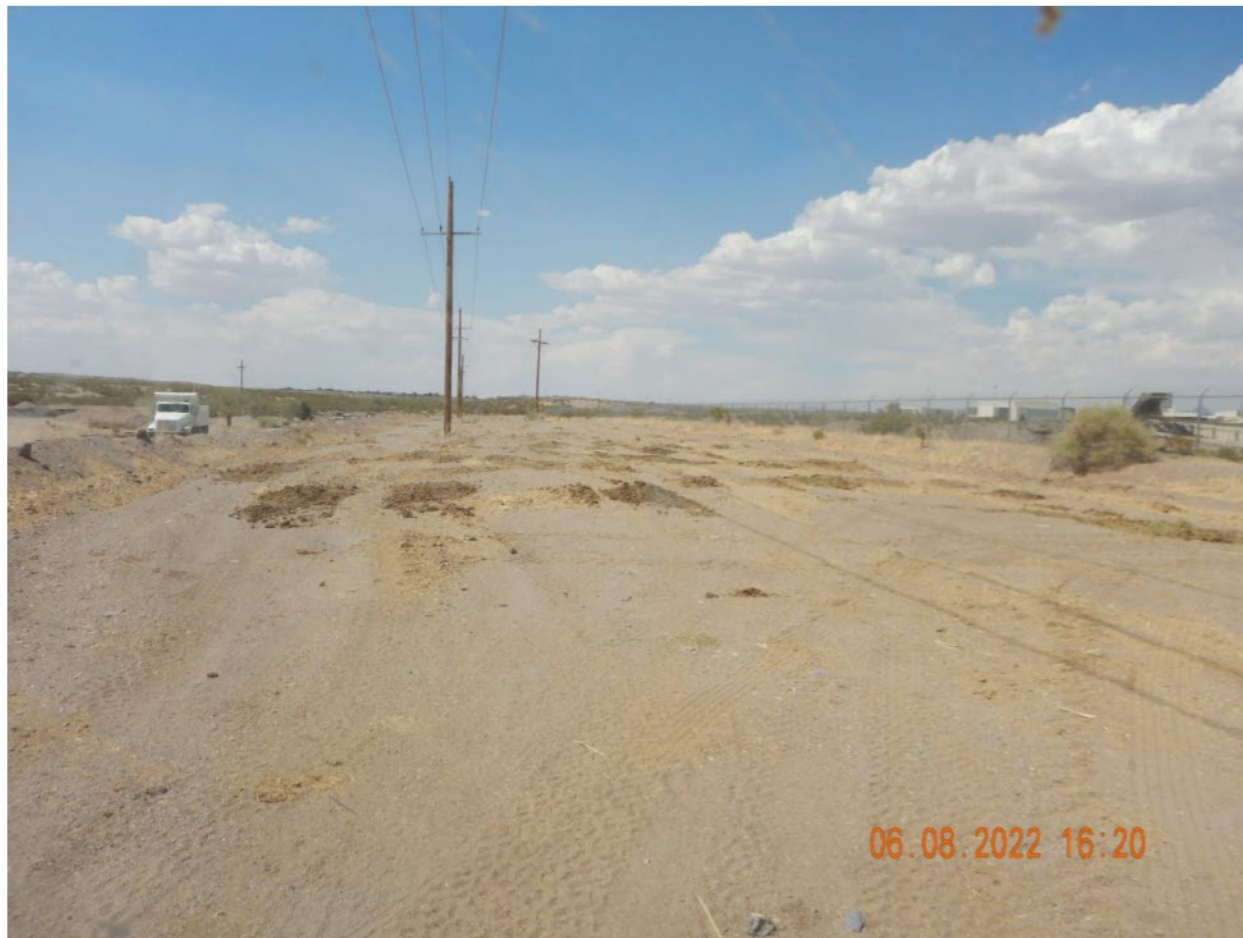
Photo No. 8

Farm and Ranch Heritage Museum is 20 feet from Tortugas's arroyo and consists of an undefined runoff control ditch system that forms part of the RCS (See Photo Nos. 8 - 9 in Appendix 1).

Photograph File Name: DSCN1013.JPG  
Date of Photograph: 06/08/2022  
Latitude and Longitud: 32.29985082852095, -106.71775906928823  
Orientation: N  
Map Datum: WGS-84  
Time of Photo: 16:20 PM  
Photographer: Jack Arias  
Description: This image shows a buildup of manure solids outside of the north pens.

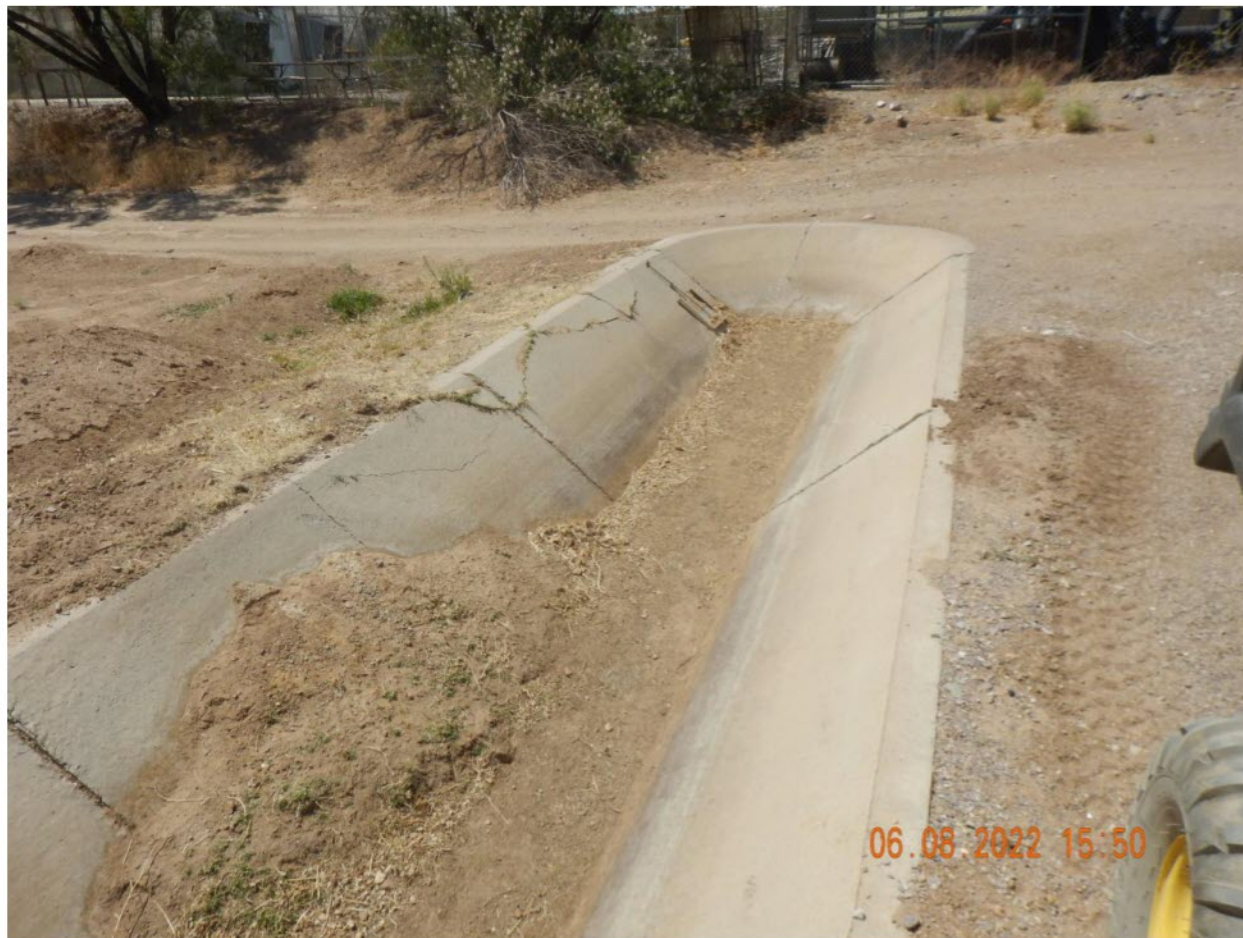
Photo No. 9

Photograph File Name: DSCN0981.JPG  
Date of Photograph: 06/08/2022  
Latitude and Longitude: 32.299468230744445, -106.7185317226741  
Orientation: NW  
Map Datum: WGS-84  
Time of Photo: 15:50 PM  
Photographer: Jack Arias  
Description: This image shows a buildup of manure solids inside the ditch system.

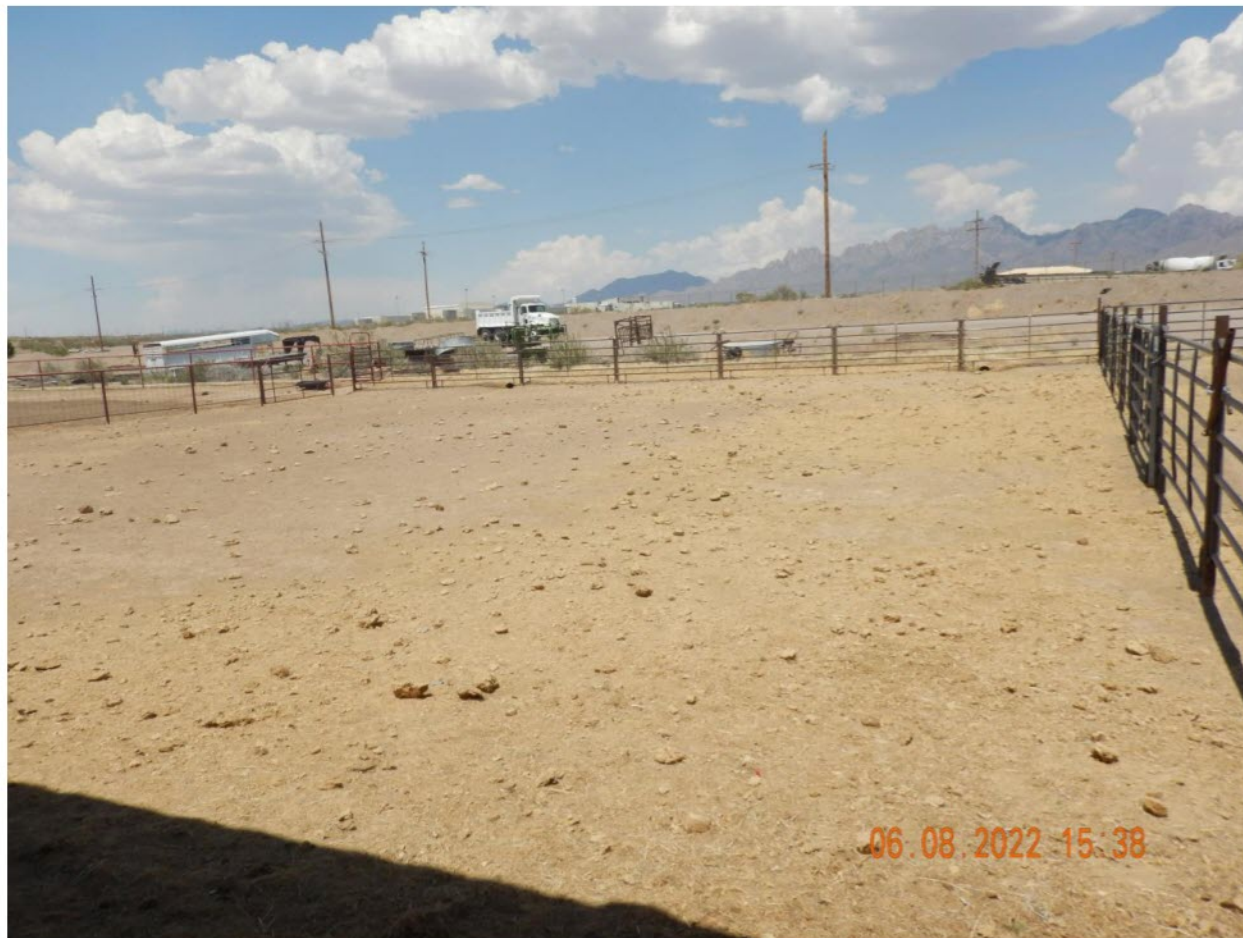
Photo No. 10

Photograph File Name: DSCN0971.JPG  
Date of Photograph: 06/08/2022  
Latitude and Longitude: 32.29869571947307, -106.71833855933231  
Orientation: N  
Map Datum: WGS-84  
Time of Photo: 15:38 PM  
Photographer: Jack Arias  
Description: This image shows a buildup of manure solids inside of the pens.
