**Region 6 - Enforcement & Compliance Assurance Division**  
**INSPECTION REPORT**

| Media Program: | Water (CWA) | |
| Company Name: | <b>Perdure Petroleum, LLC</b> | |
| Facility Name: | <b>NBU 16 South Satellite</b> | |

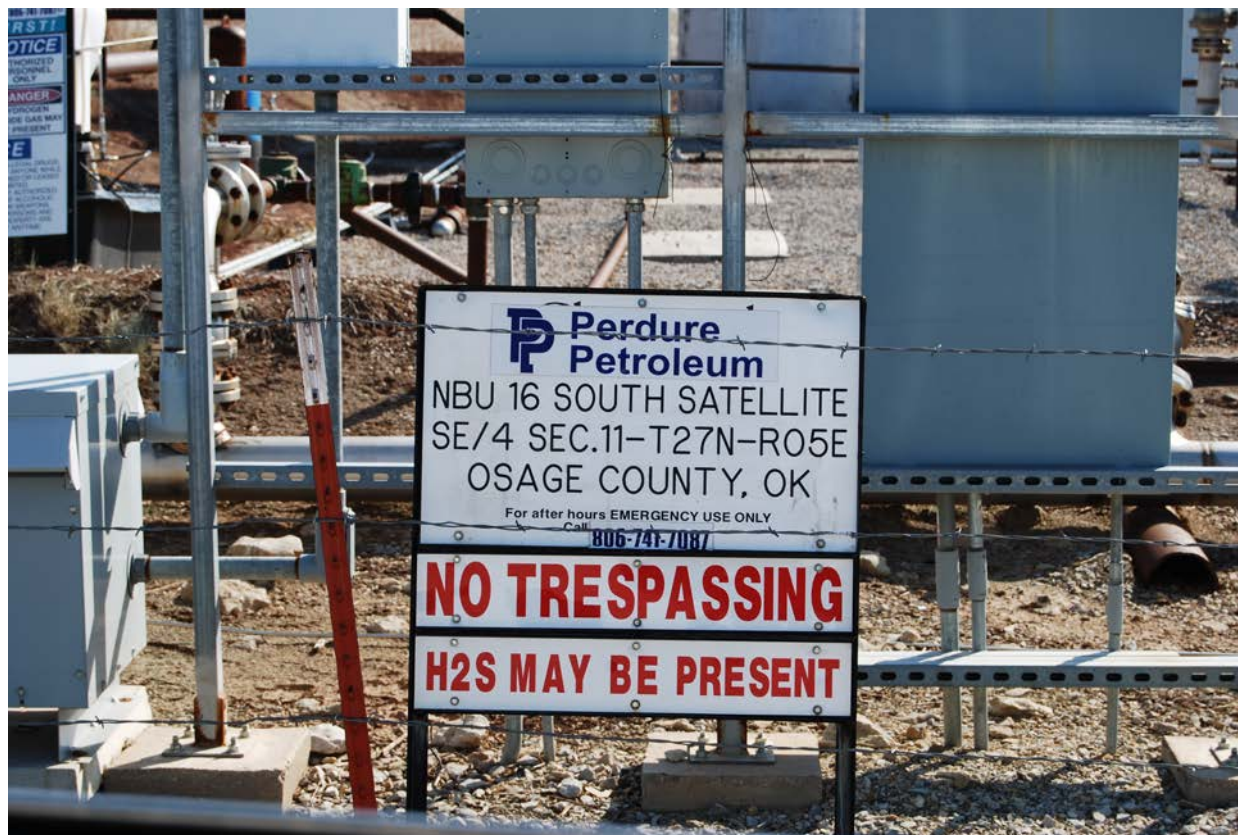
Photo No. 1

Description: The discharge occurred on the southwest side of this facility.

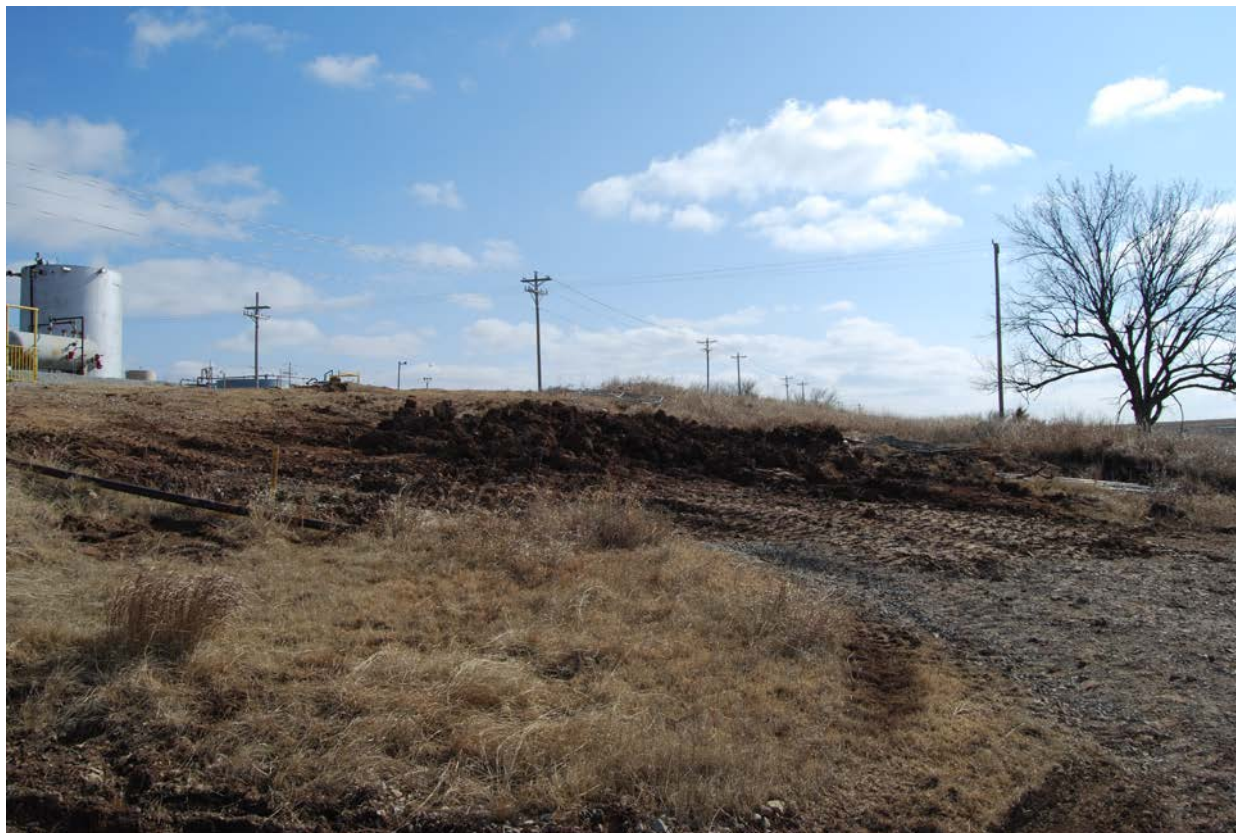
Photo No. 2

Description: The discharge occurred from a now repaired injection line. The line has been reburied.

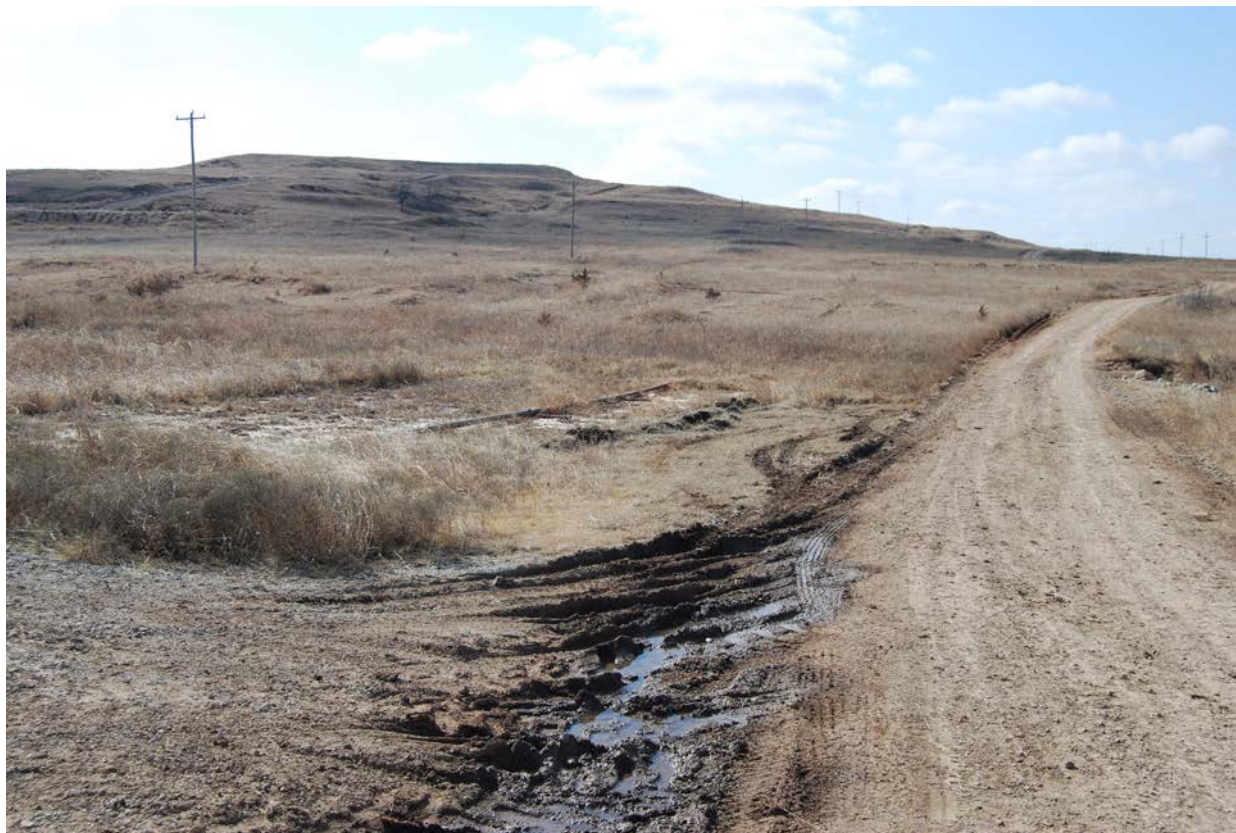
Photo No. 3

Description: The brine ran west down the hill to the tributary of Beaver Creek. The tributary flowed northwest.

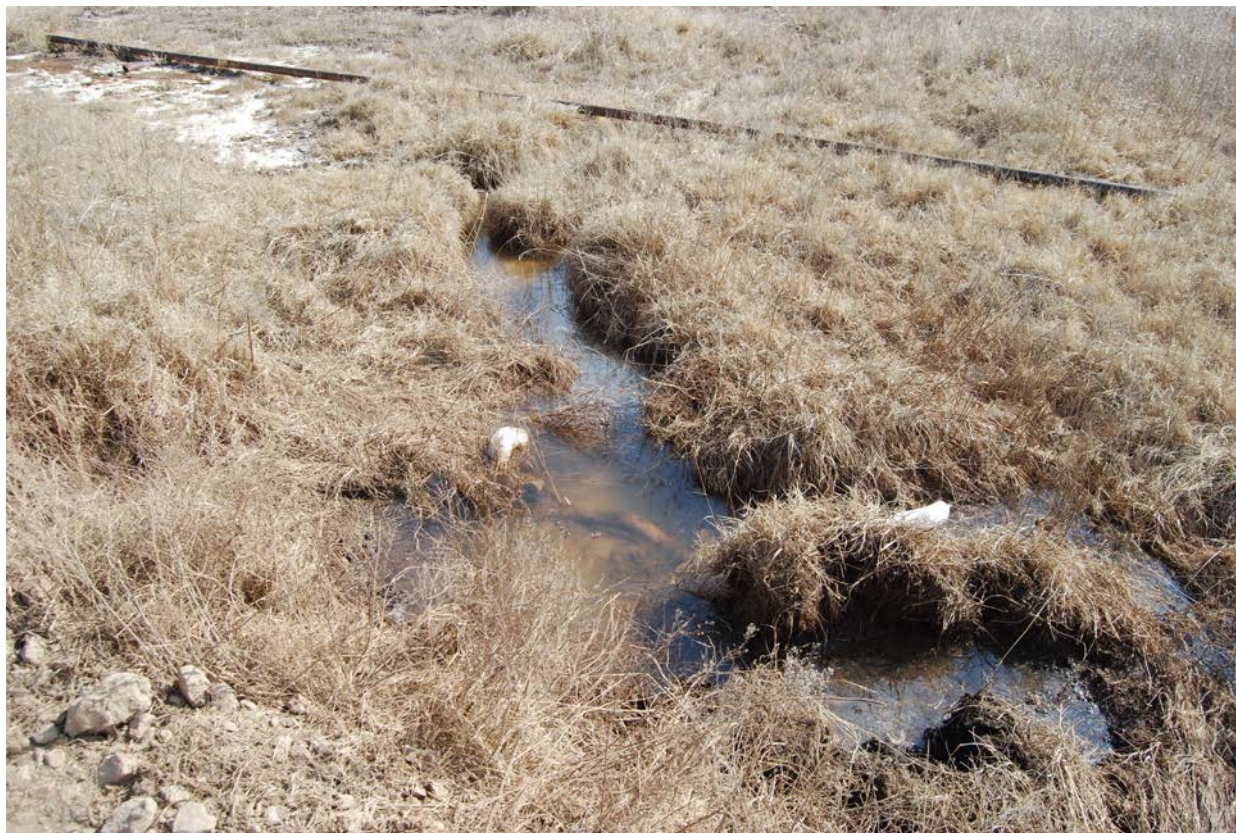
Photo No. 4

Description: The brine entered the tributary of Beaver Creek here. A small boom was present to catch a small amount of oil.

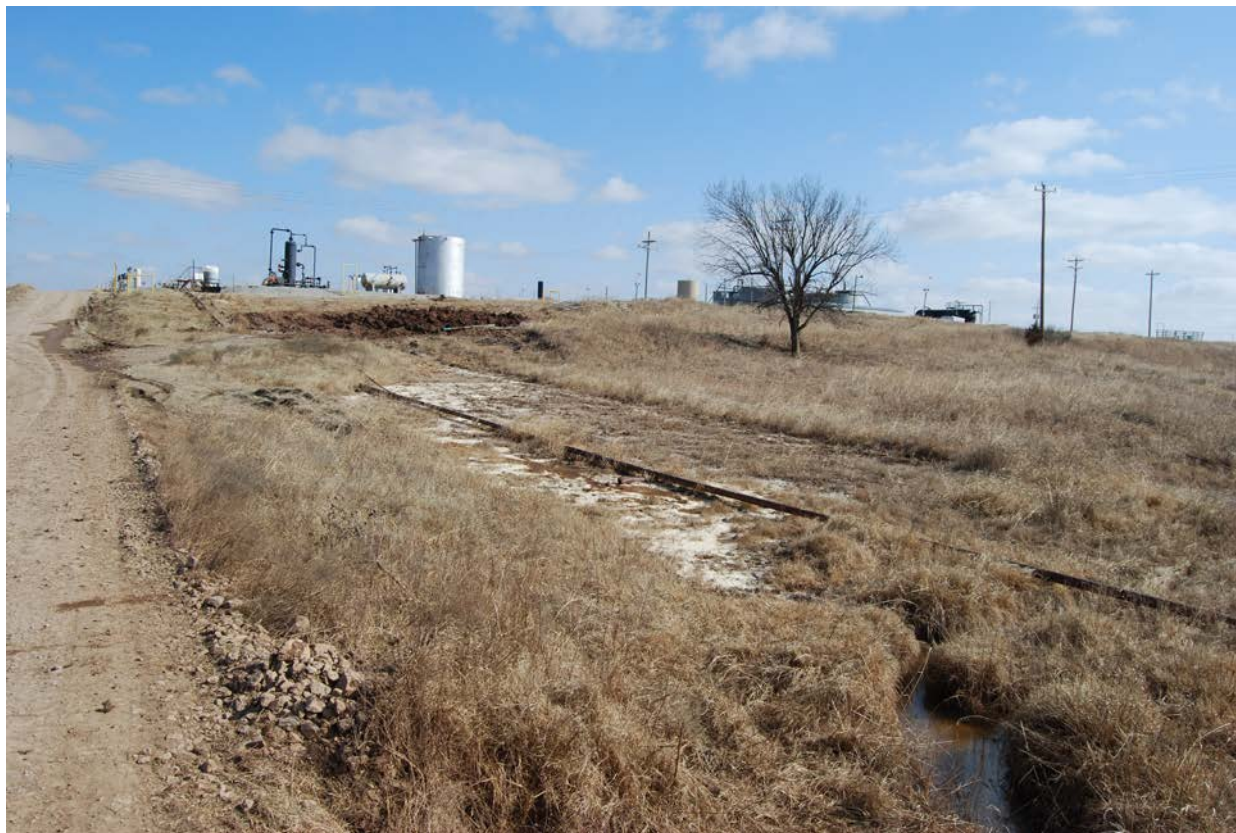
Photo No. 5

Description: Reverse angle photo from the tributary entry point to the discharge point at the facility.

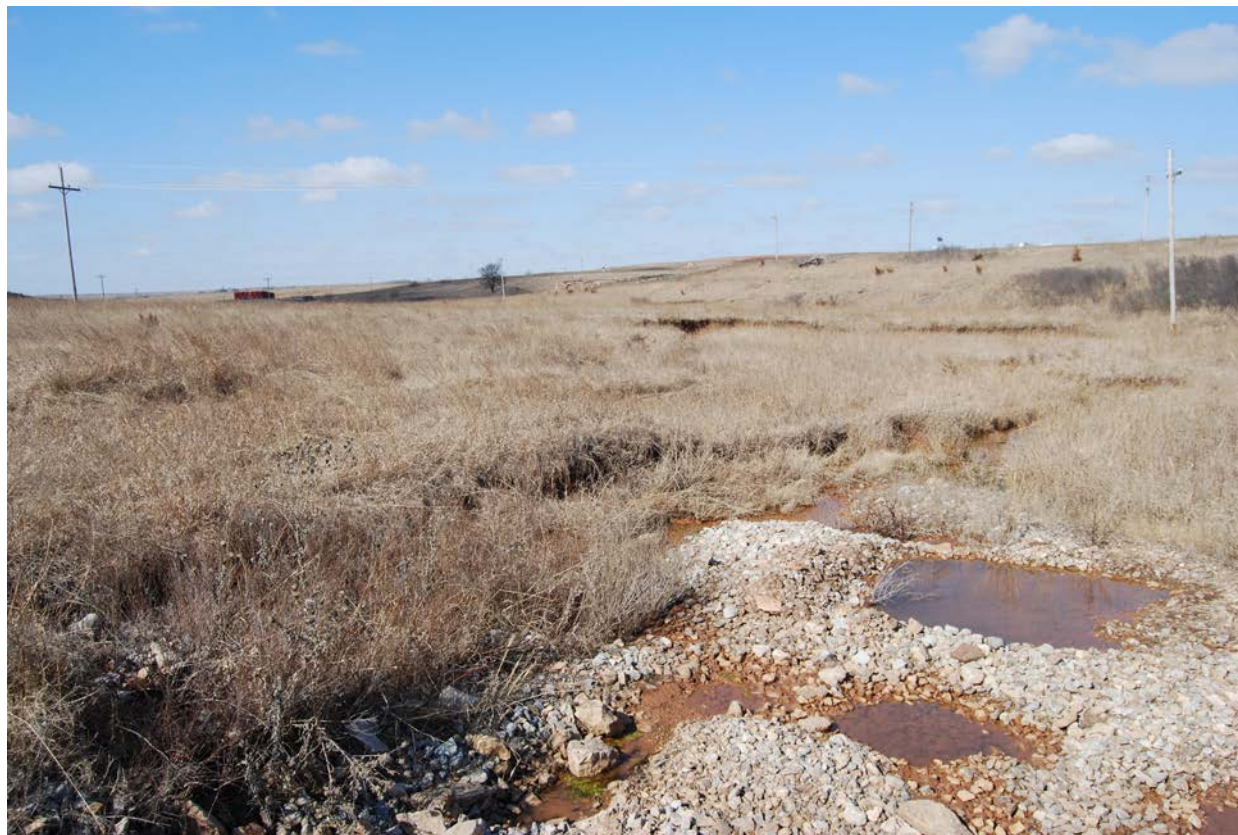
Photo No. 6

Description: This was the view of the tributary of Beaver Creek flowing northwest from the discharge entry point. I observed a defined channel.

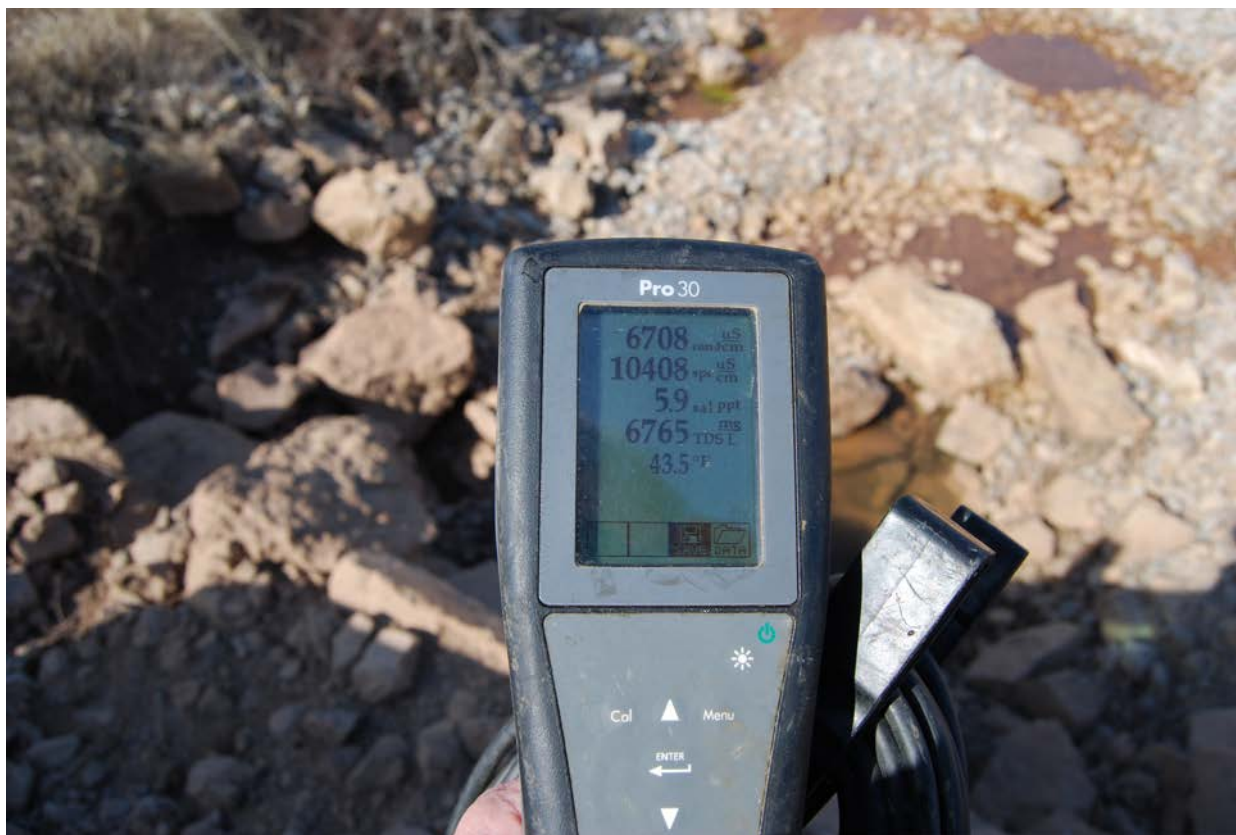
Photo No. 7

Description: With a calibrated YSI Pro 30 conductivity meter, total dissolved solids (TDS) of the tributary of Beaver Creek at the point of entry was 6,765 milligrams per liter (mg/l).

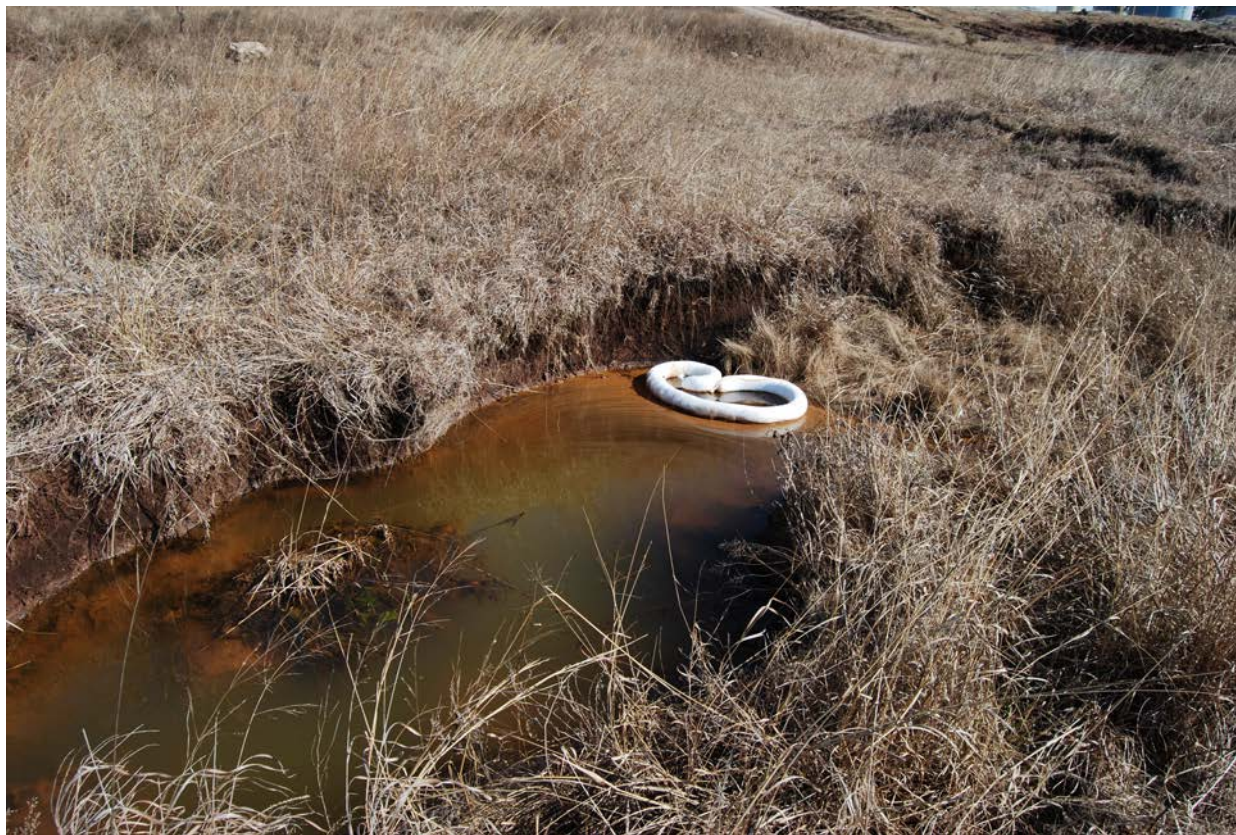
Photo No. 8

Description: This showed a location just northwest of the brine entry point. A boom was present to catch some residual oil. I observed only a sheen was seen along with the brine.

Description: The TDS at the tributary of Beaver Creek shown in Photo 8 was 17,175 mg/L. The tributary flowed northwest during the inspection.

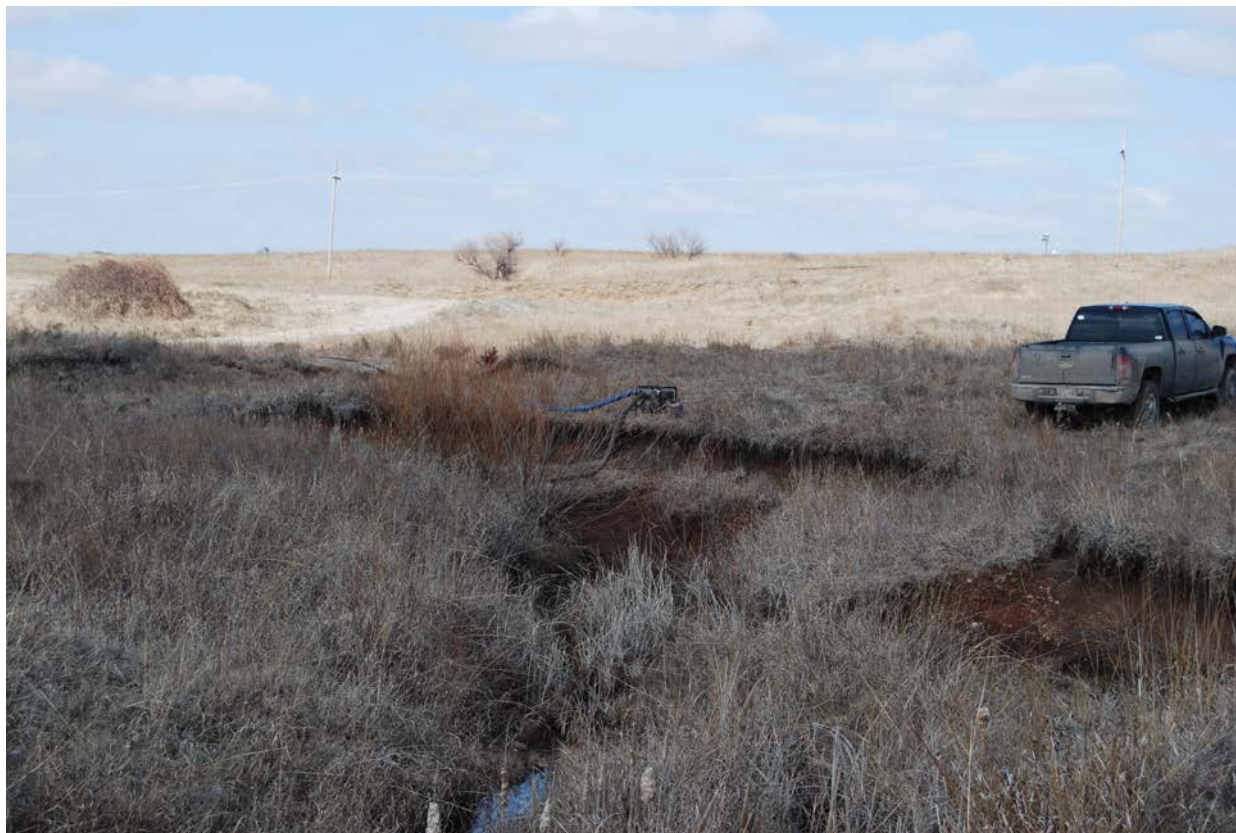
Photo No. 10

Description: The operator was pumping out a section of the tributary downstream of the discharge point.

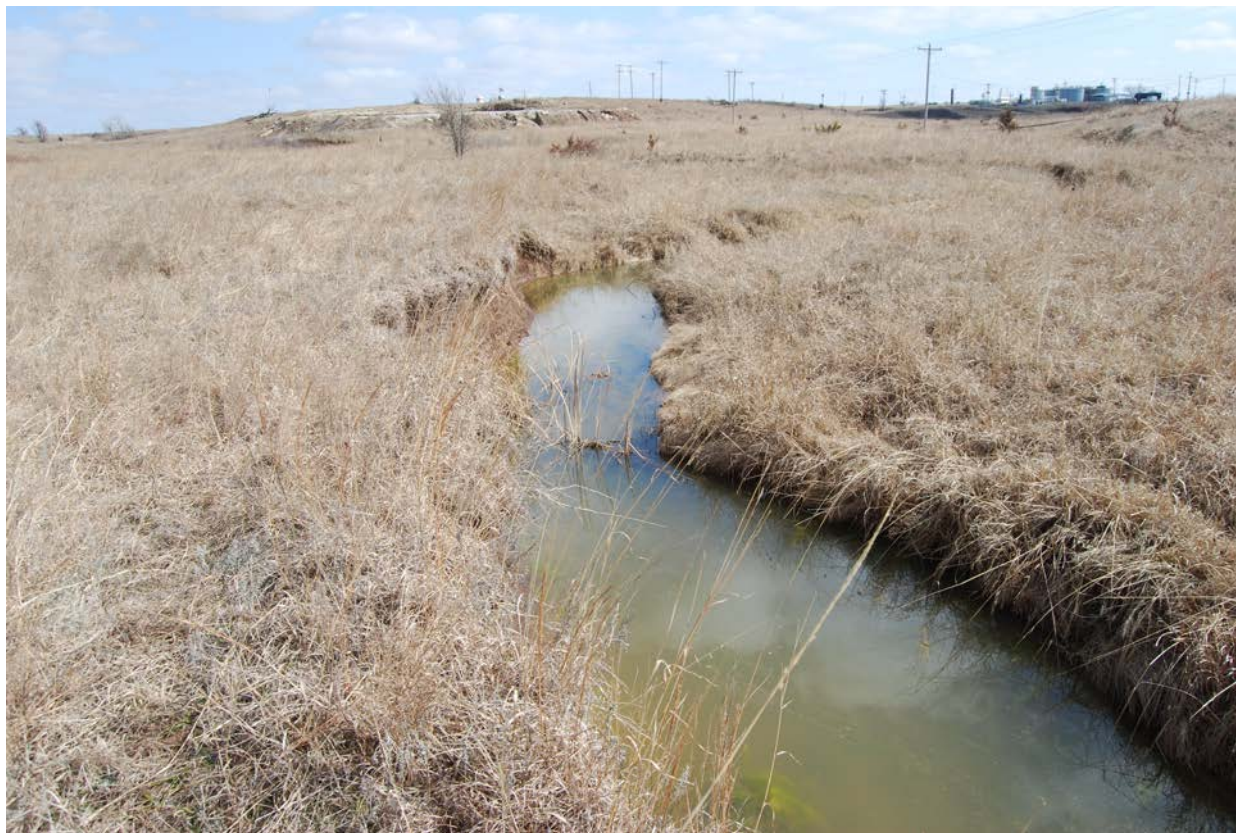
Photo No. 11

Description: The tributary of Beaver Creek shown here was near the pumping site shown in Photo 10. The point of discharge at the facility was shown in the far background.

Description: TDS at the tributary shown in Photo 11 was 6,373 mg/L.

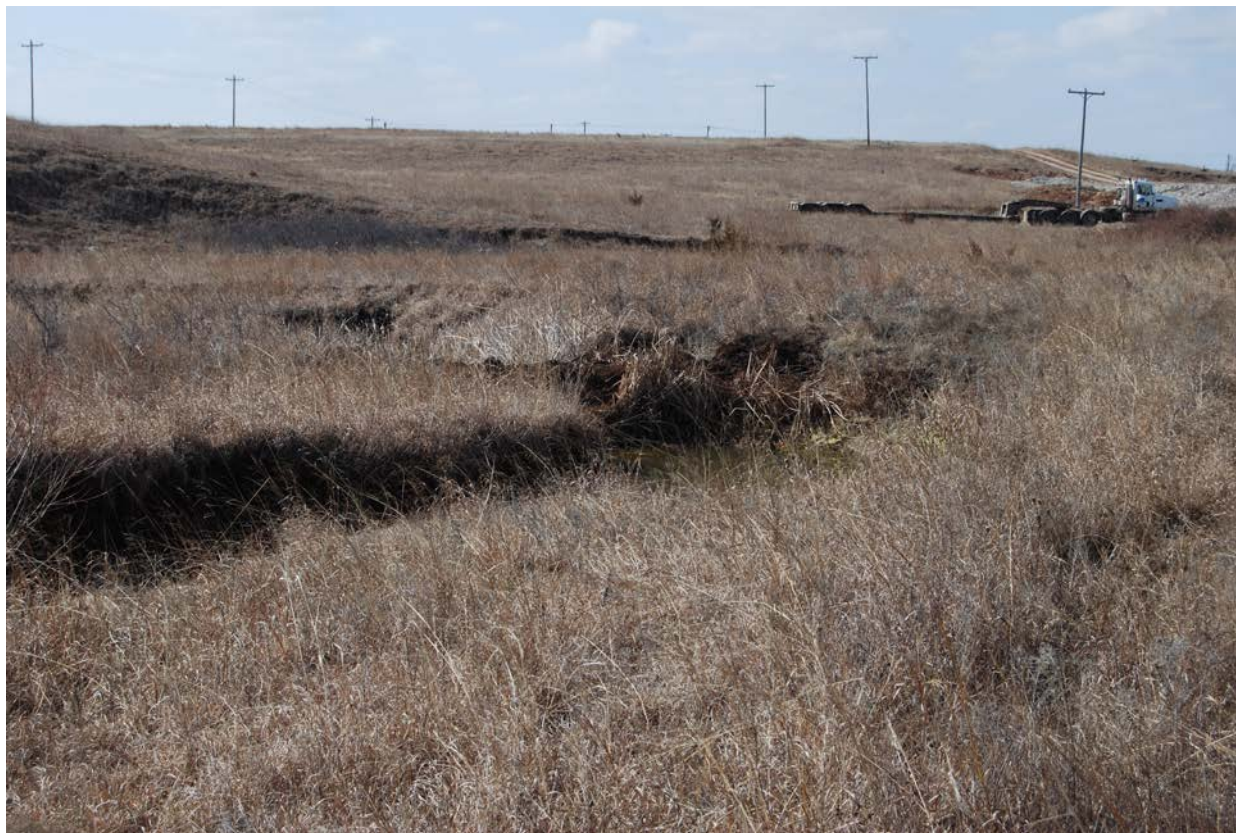
Photo No. 13

Description: This was the last dam downstream of the discharge constructed by the operator.

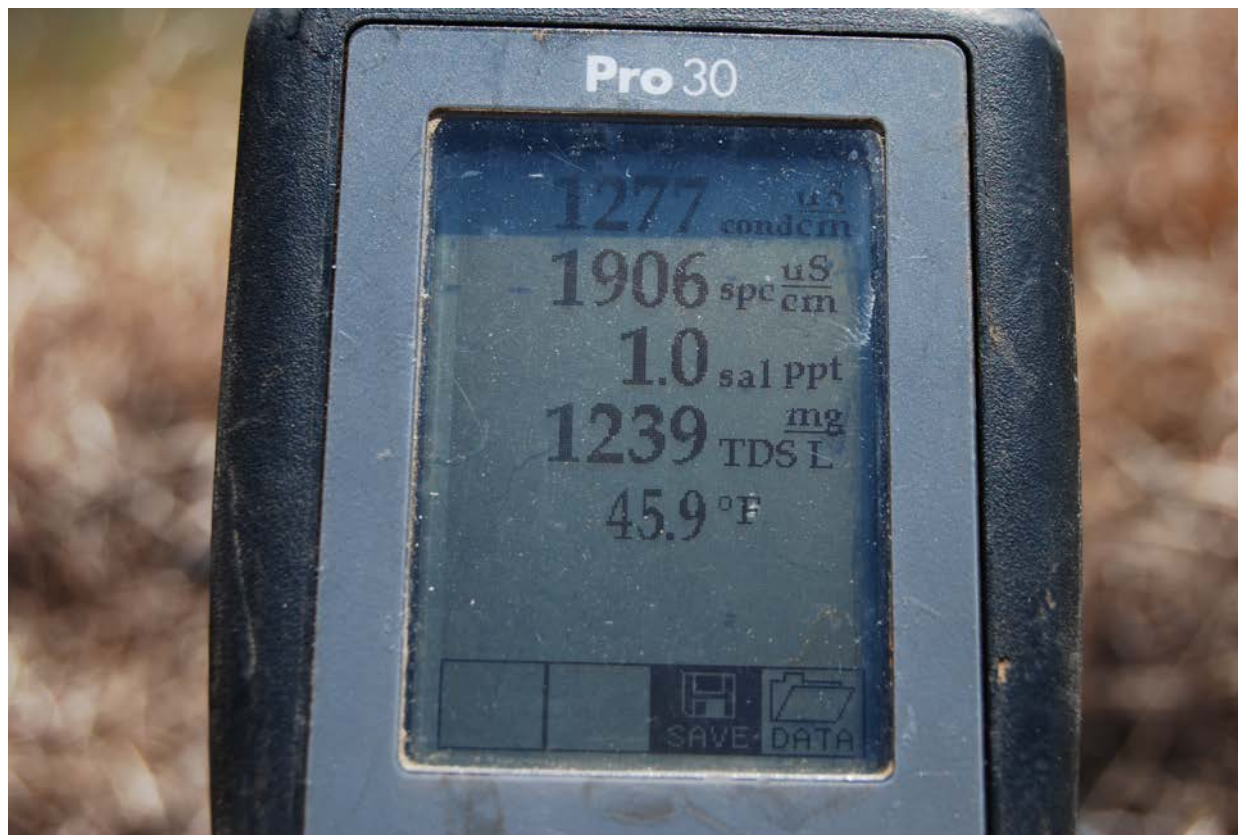
Photo No. 14

Description: TDS near the last dam was 1,239 mg/L. A slight flow seeping past the dam was observed.

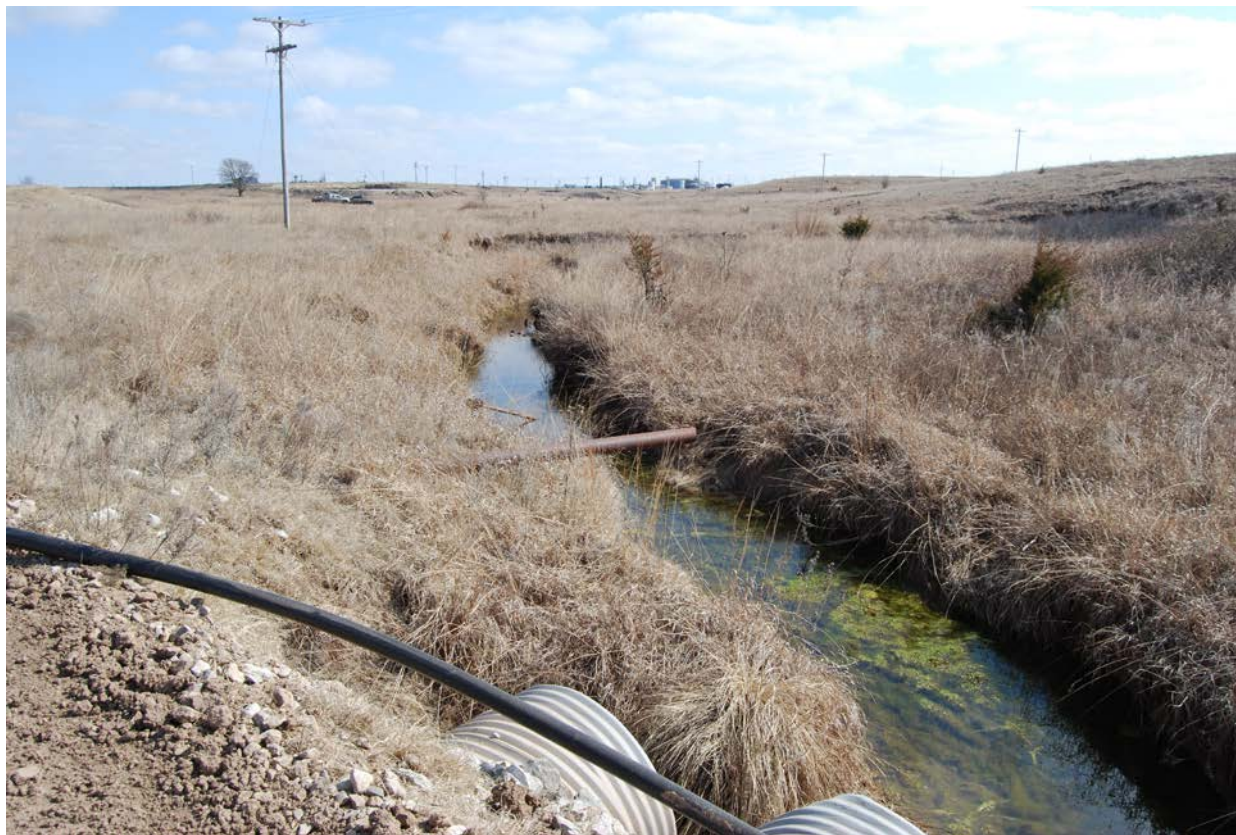
Photo No. 15

Description: This was a view of the tributary of Beaver Creek downstream of the dam, which flows towards Beaver Creek and then Kaw Lake.

Description: TDS of the tributary at the point shown in Photo 15 was 1,050 mg/L.

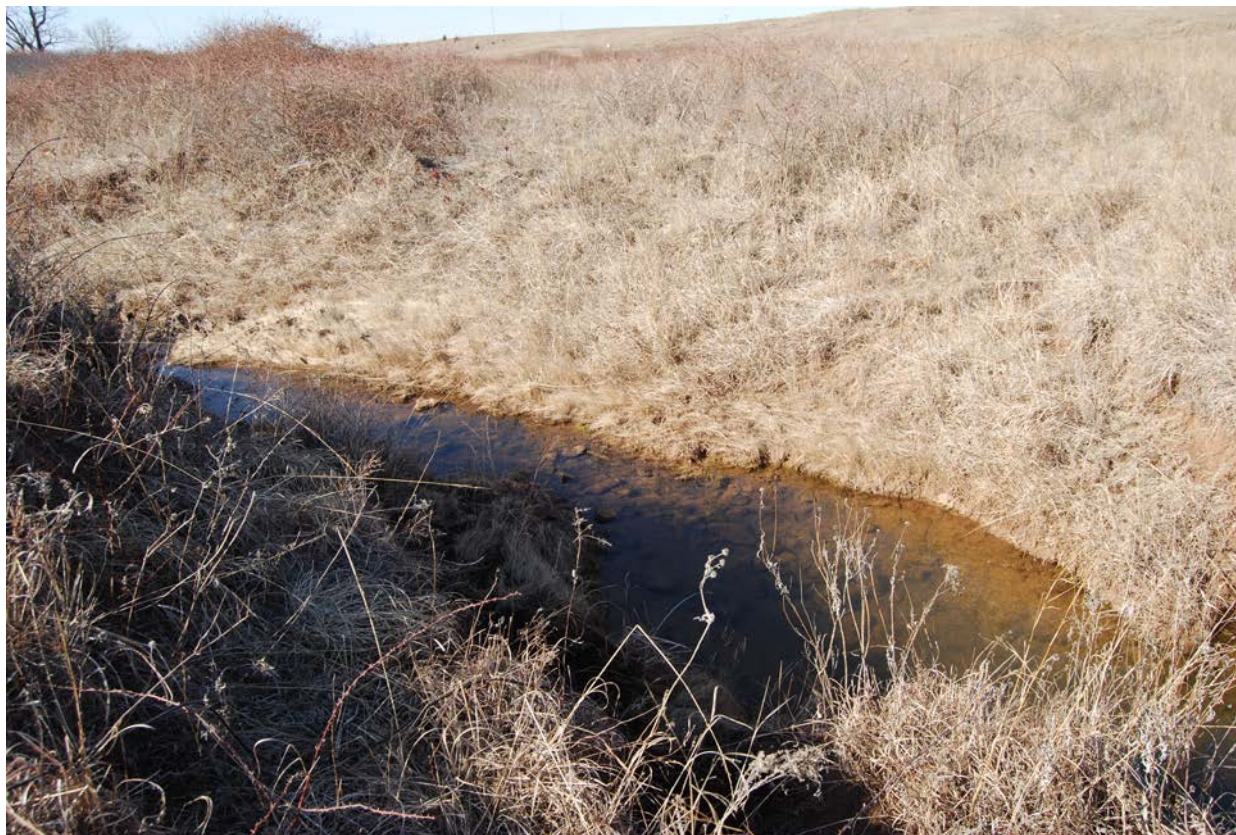
Photo No. 17

Description: The tributary shown here was northwest and downstream of the location shown in Photo 15.

Description: TDS of the tributary shown in Photo 17 was 854 mg/L.

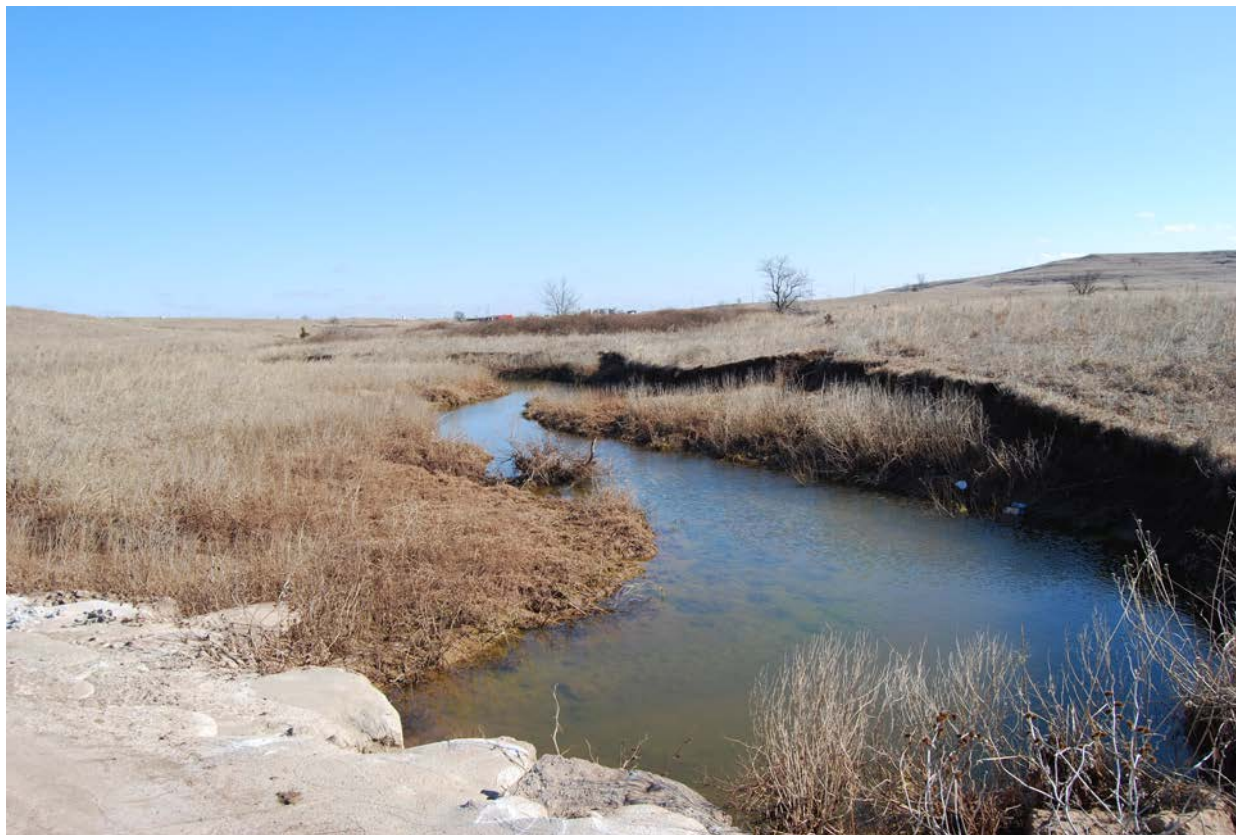
Photo No. 19

Description: This was the farthest point measured downstream (northwest) of the discharge entry point.

Description: TDS of the tributary of Beaver Creek shown in Photo 19 was 754 mg/L.

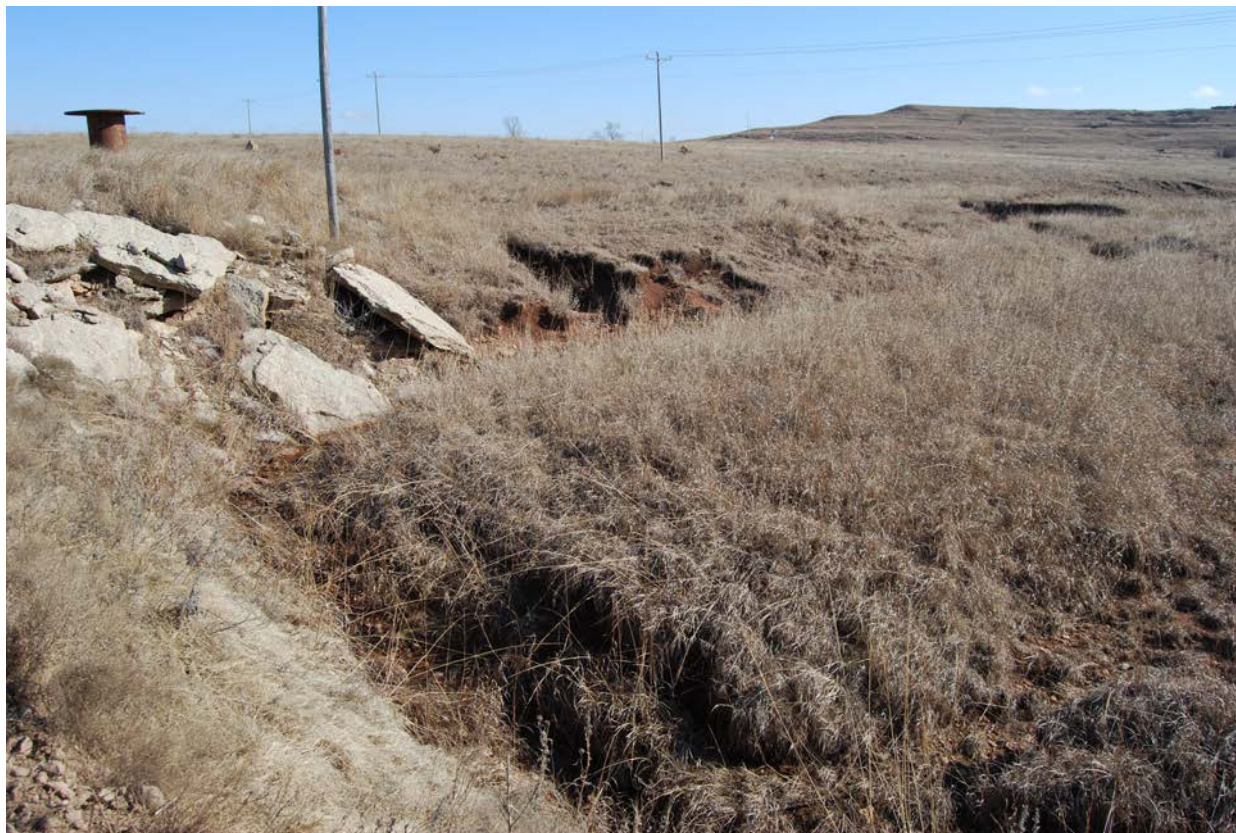
Photo No. 21

Description: This was another tributary in the nearby area measured for background TDS readings.

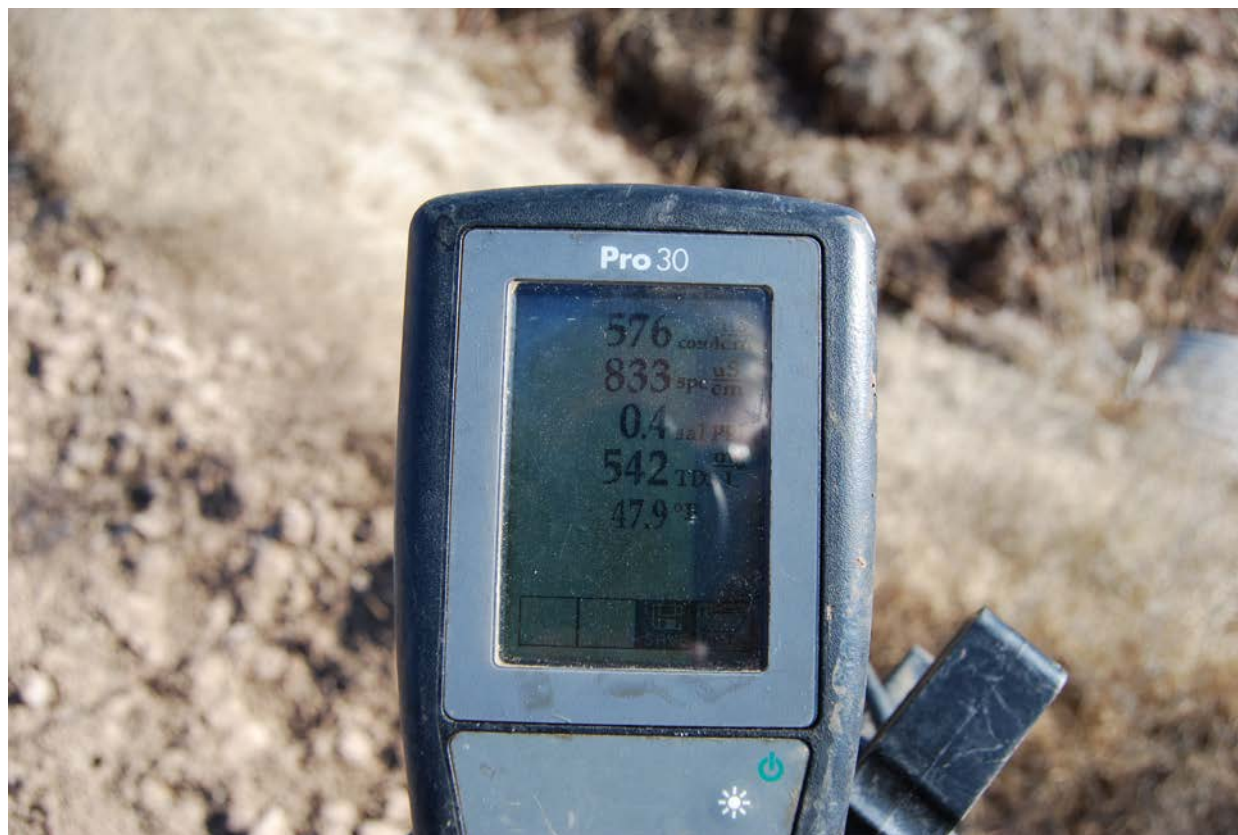
Photo No. 22

Description: TDS of the tributary water considered background for the area was 542 mg/L.

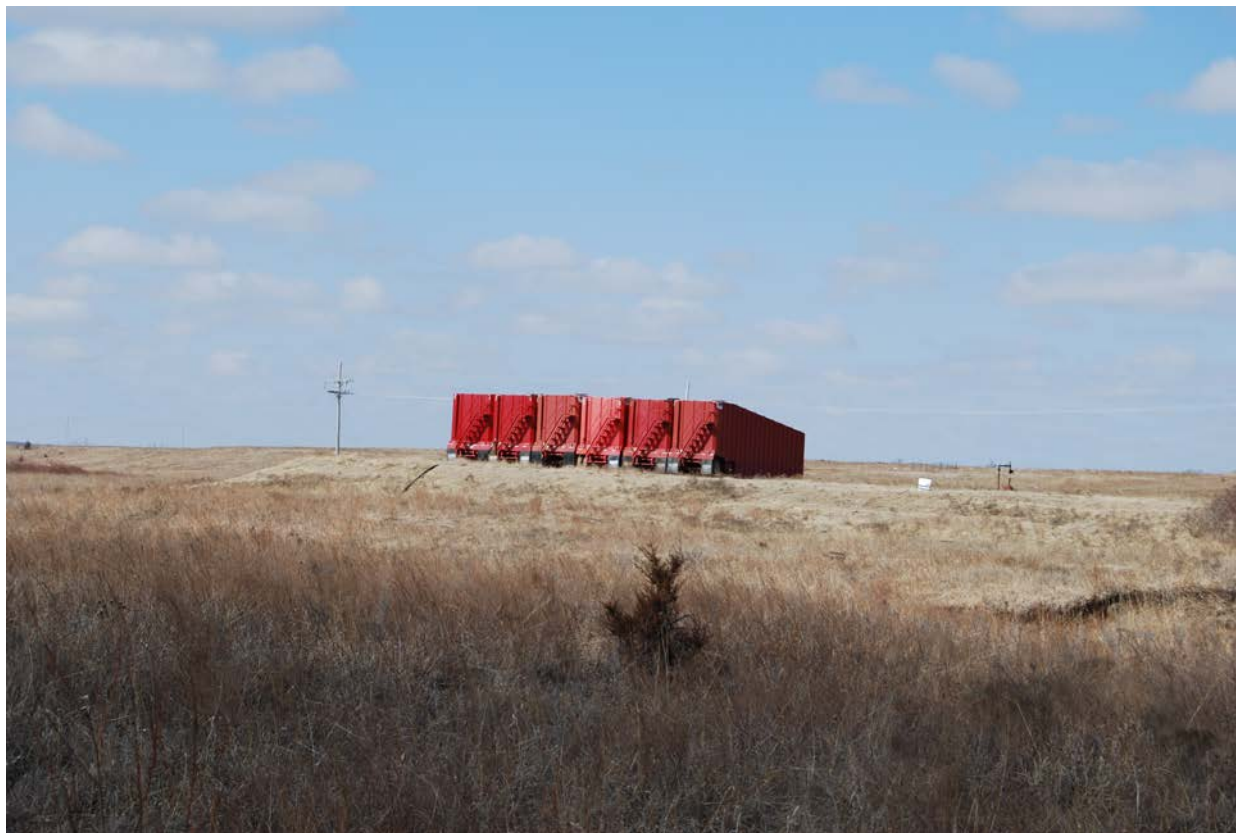
Photo No. 23

Description: Frac tanks were being used to store brine contaminated fluids until trucks could remove them from the location.
