# Loss Case Histories in Pressurized Ethylene Systems

Laurence G. Britton

Engineering Department, Process Safety Technology Group,  
Union Carbide Corp., South Charleston, WV 25303

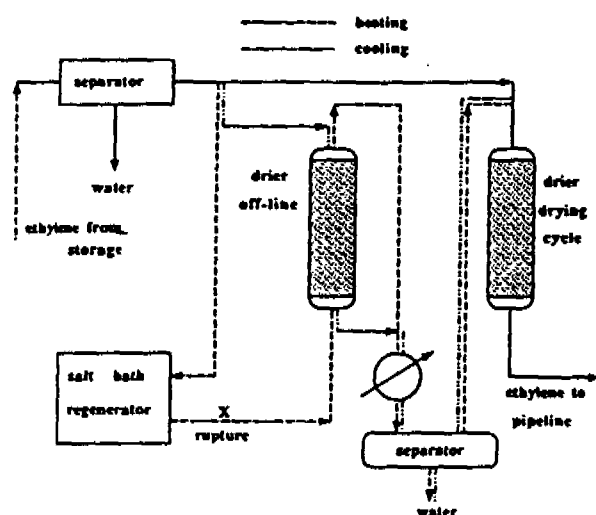
On Christmas Day 1971 at approximately 6:30 a.m. the 2-inch diameter regeneration gas inlet and outlet lines on the South drier ruptured releasing high pressure ethylene with an attendant explosion and fire. The ruptures were caused by high temperature metal failure due to an ethylene decomposition flame in the piping. Damage also occurred in the South drier in the area of flame impingement from the outlet line fire. Operational records were destroyed by the fire, but analysis of previous cycle profiles suggested that the incident occurred 4.5 hours into the heating cycle of the South drier. The system was operated as designed except that the regeneration feed rate was low (3830 lb/hr) and this would have increased the regeneration gas temperature. The facility was unattended at the time of the explosion. Loss was estimated at \$150,000 in 1972 dollars.

FIGURE 1. Heater outlet pipe rupture.

As shown in [1] the decomposition was instead more likely to have been initiated in the molecular sieve bed than in the heater. There was no evidence that salt levels in the heater had been low and no evidence cited of soot being found in either the heater or the regeneration line upstream of where the inlet pipe ruptured. For stagnant conditions in the drier bed at 1340 psia, runaway oligomerization/polymerization of ethylene can occur at about 275°C and the runaway timescale is about 3 hours if adiabatic conditions are assumed [1]. While records indicate that flow was not lost prior to the event it is possible for channeling of flow to occur in large sieve beds (sieves can clump together), and parts of the bed could have been effectively stagnant.

Once runaway in the bed had proceeded to decomposition, flames were established in the free gas spaces at the top and bottom of the drier. At the inlet pipe, the decomposition flame stabilized against the regeneration gas flow and heated the pipe, causing it to rupture. The downgoing outlet pipe also ruptured, which is consistent with the fact that ethylene decomposition flames tend to burn upwards and stabilization of

the flame front in a downgoing section of the pipe is likely [1]. The metal at the pipe failures showed severe distortion and thinning down to knife-edge sharpness, indicating the good ductility associated with high temperature failure. Microscopic examination of the pipe failures showed a partially recrystallized grain structure without grain elongation, indicating a temperature of 815-870°C (this was attained after rupture as the hot gases escaped through the failure—the temperature prior to failure could not be determined). Measured ethylene decomposition flame temperatures are in the range 1000-1100°C [1]. The metal microstructures were normal nine and eighteen inches away from the ruptures, indicating a thin zone of heating. Thus, the facts are consistent with runaway in the bed and the formation of simultaneous decomposition flame fronts that stabilized, heated and ruptured the inlet and outlet regeneration gas lines.

- (ii) Replace salt bath with gas convection heater equipped with comprehensive temperature and flow rate monitoring. ESD at prescribed temperature. Loss of flow to switch off heat (note that a salt bath has too much thermal inertia to do this rapidly).

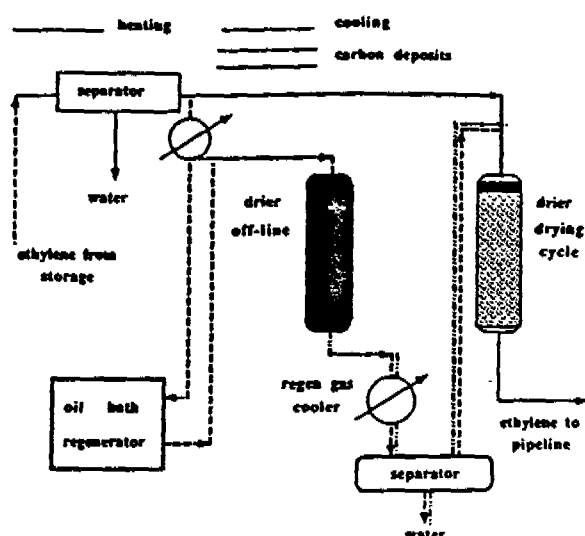
FIGURE 2. Drier inlet pipe rupture.

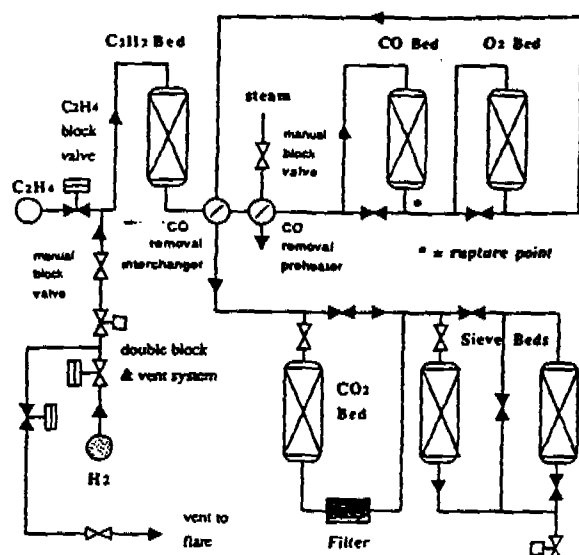
The principal cause of this incident was the failure to measure temperatures in the bed during regeneration and preloading

FIGURE 3. Purification system basic schematic.

with ethylene, since 13X sieve is a polymerization catalyst. Owing to its large pore size, 13X also adsorbs ethylene and releases heat. The temperature measured above the bed gave no measure of the temperature anywhere within the bed where these exothermic processes would occur. Even though the pressure of ethylene involved in this incident was unusually low (280 psig), there was evidently enough potential (via adsorption and polymerization) to generate the temperature required to cause thermal failure of the vessel. Had the bed temperature been comprehensively measured, any shortcomings in the purging and preloading procedures should have become apparent in time to take action. Such temperature measurement should be via fast acting thermocouples distributed throughout the bed and not via thermocouples mounted in heavy thermowells located near the walls, since the sieves are effective thermal insulators.

- (1) Heat sensing devices to be relocated to inside the bed and additional sensors installed.
- (2) Shut off valve to be installed in the ethylene feed line at the inlet to the area.
- (3) Regenerating and preloading procedures to be reviewed.
- (4) Inspect second sieve bed for flaws before restarting.
- (5) Obtain further information on 13X sieves before reusing them in this service.
- (6) Metallurgist to examine damaged bed for flaws.

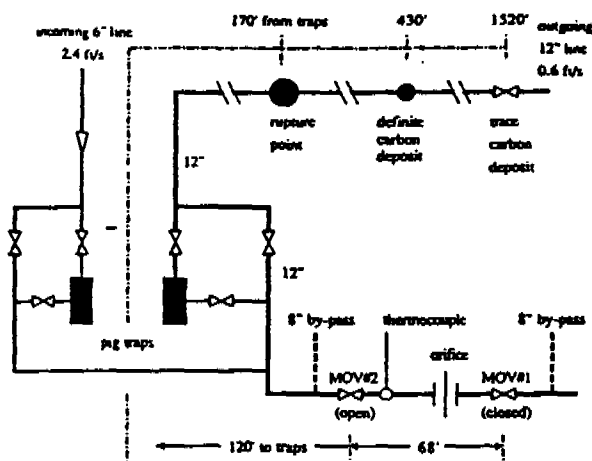
FIGURE 4. Piping system.

The piping system is shown in Figure 4. The orifice box was removed from a 12 inch diameter, 68 foot long meter run for maintenance, leaving a two foot gap in the line which was open to the air for  $45 \pm 15$  minutes. After reinstallation of the box, the power was returned to the motor operated valves. In order to check the MOV limit switches, one valve (#2) was opened completely. This caused sudden compression of an ethylene-air mixture from zero to 1320 psig. The valve took 20 seconds to open completely, although later calculations indicated that the 91:1 pressurization only took about 3-4 seconds, occurring when the valve was about 15% open.

After flame initiation at MOV #1, it traveled into the outgoing 12" line. It did not propagate into the 8" by-pass connection, which went vertically down into the ground, showing that ethylene decomposition flames tend to burn at the pipe roof and will not usually burn into down-going pipe unless carried by gas flow. This is also supported by the fact that paint only peeled from the top third of the meter run piping and pig trap lines. At the rupture point, metal thinning and a longitudinal split were observed, typical for decomposition failures. The estimated failure temperature was  $620 \pm 30^\circ\text{C}$  at 1320 psig. Carbon was found in the 6" incoming line and at least 260 feet beyond the rupture point in the 12" line.

The event was evidently caused by too-rapid compression of diatomic gas in a line closed at one end. Later modeling of

the incident [1] estimated a pressurization time of 4.2 seconds and a maximum temperature of  $740 \pm 5^\circ\text{C}$  in the end-gas with a temperature of  $560 \pm 5^\circ\text{C}$  at the interface with the ethylene. A temperature of  $450\text{--}560^\circ\text{C}$  would have been sustained for about 3 seconds. To correctly pressurize a line, nitrogen purging should have been carried out and the line then pressurized slowly. Ideally, flow purging with ethylene using a bypass should be used to sweep out the diatomic gas. Normally, slow pressurization of long lines is done by "cracking" the valve and keeping the flow rate slow enough to prevent icing and possible embrittlement. This is not practical for short lines and a restrictive by-pass is preferred. So long as all air or nitrogen is removed, there is little practical risk of ethylene decomposition at compression ratios of up to 100:1.
