Re: U.S. EPA-Region 1 Inspection Report of Silvex, Inc., January 22, 2025

### RCRA Compliance Inspection of:

**Silvex, Incorporation  
45 Thomas Drive  
Westbrook, ME 04092**

## RCRA HAZARDOUS WASTE INSPECTION REPORT

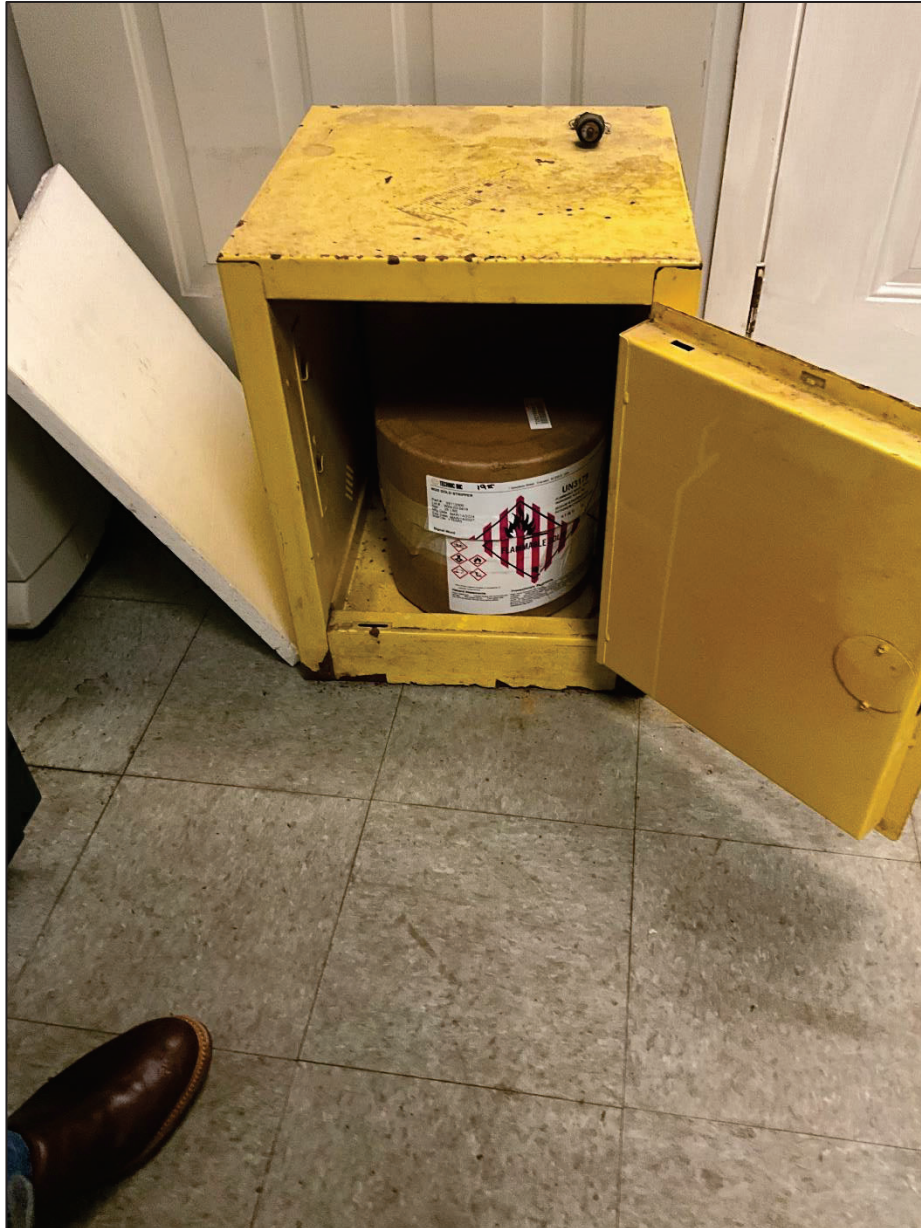
| Photo # | Description | Date |
|---|---|---|
| 1 | Quality Control Laboratory - Flammables Locker | 1/22/2025 |

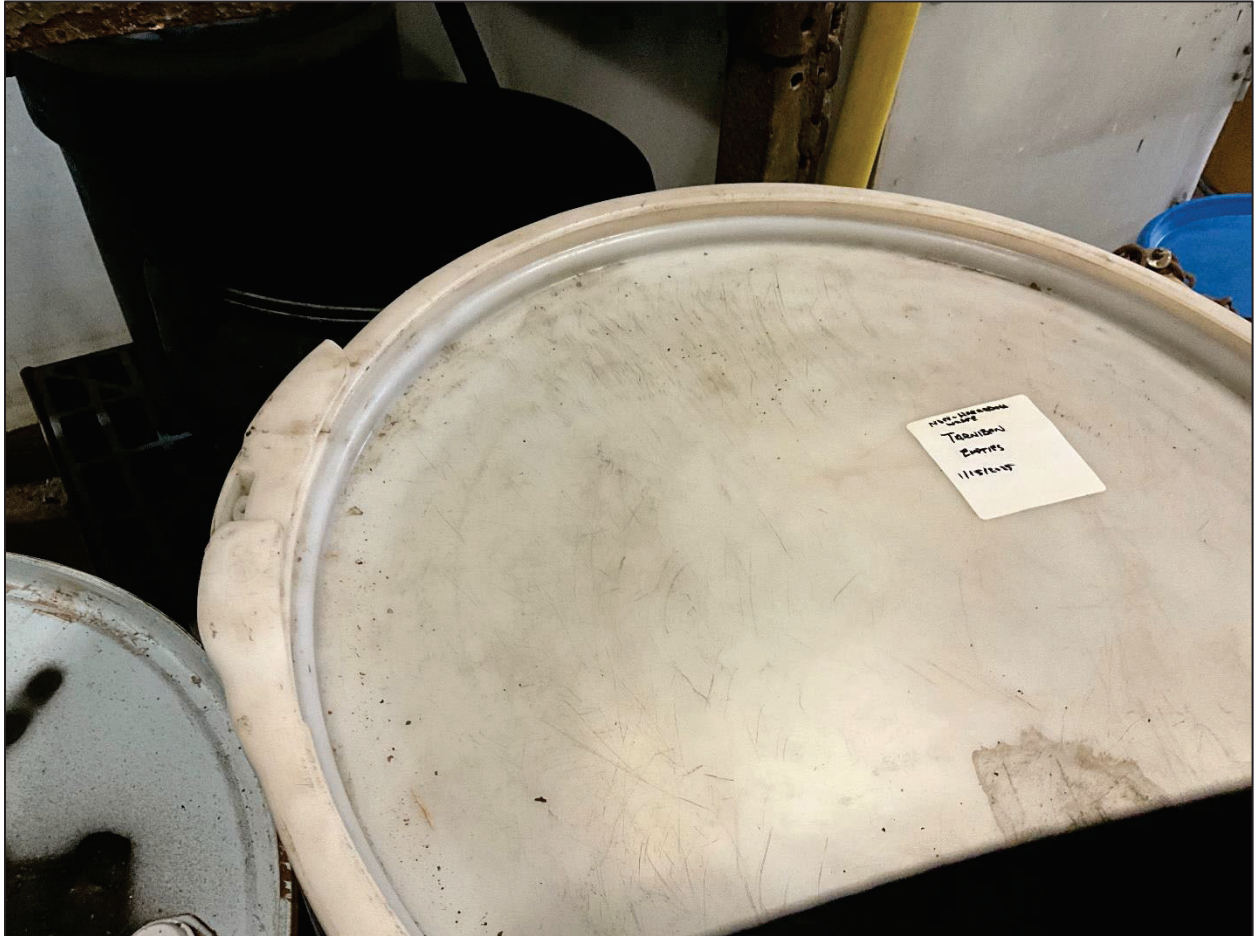
| Photo # | Description | Date |
|---|---|---|
| 2 | 90-Day CAA Non-Hazardous Waste Container #1 Label | 1/22/2025 |

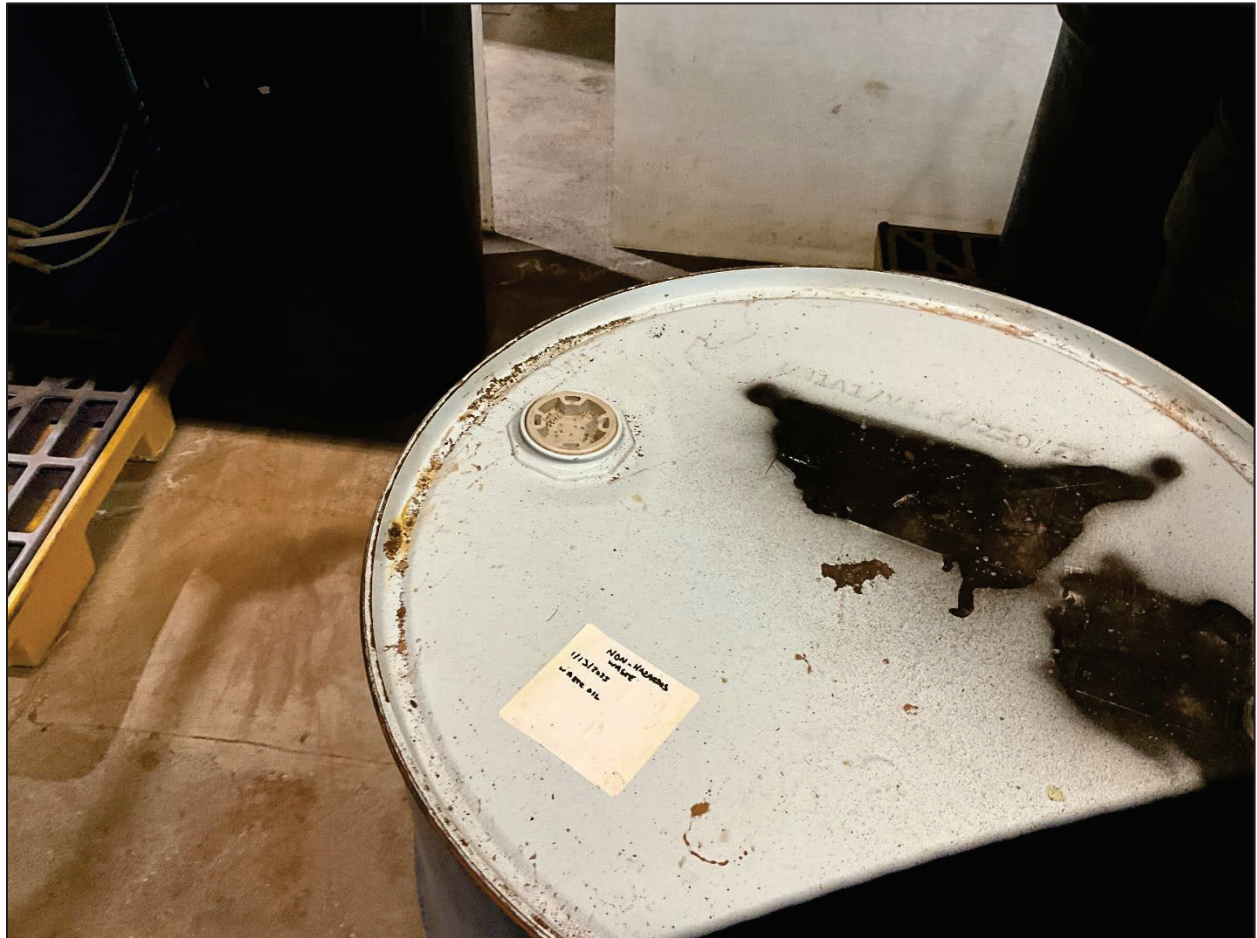
| Photo # | Description | Date |
|---|---|---|
| 3 | 90-Day CAA Non-Hazardous Waste Container #2 Label | 1/22/2025 |

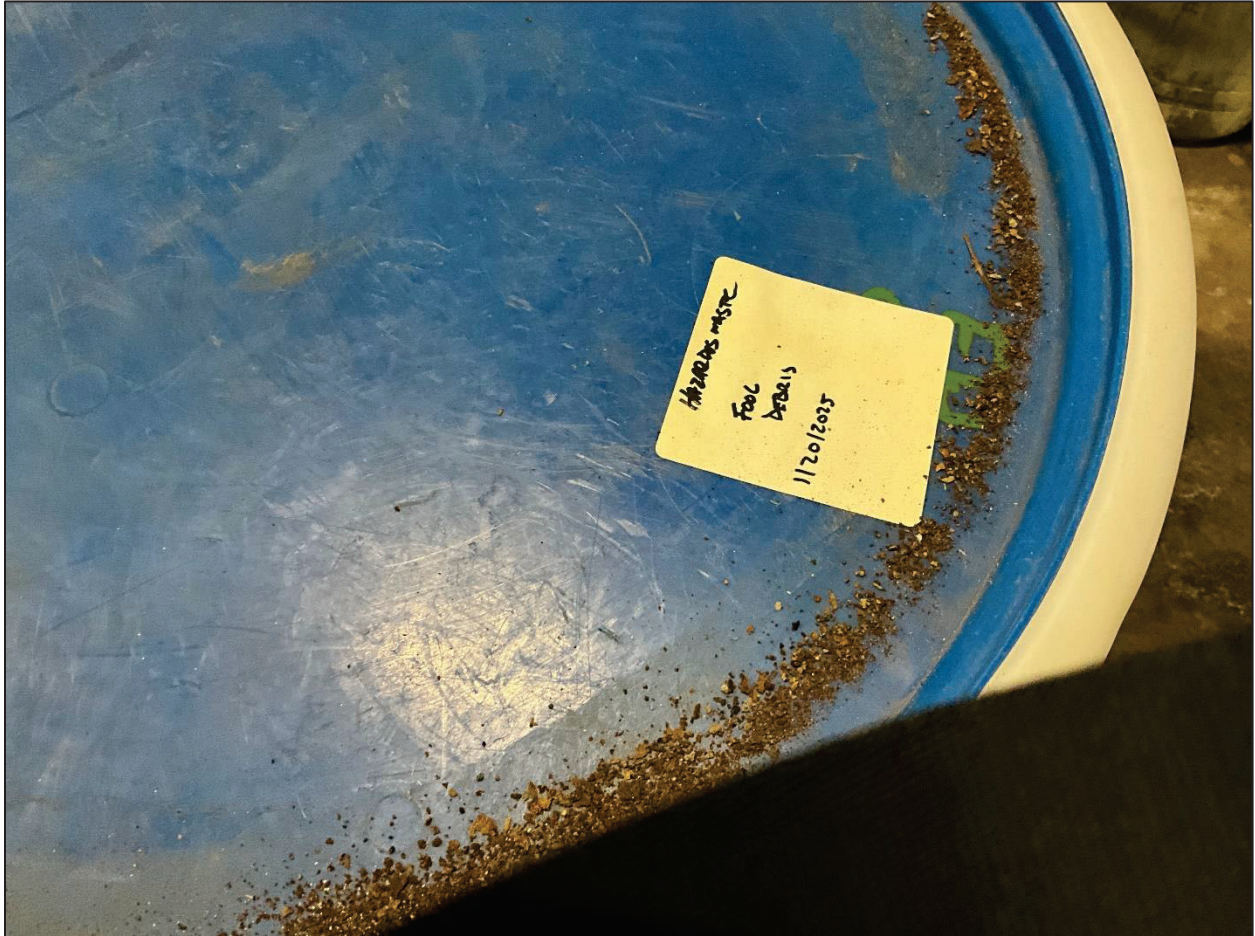
| Photo # | Description | Date |
|---|---|---|
| 4 | 90-Day CAA Hazardous Waste Container #1 Label | 1/22/2025 |

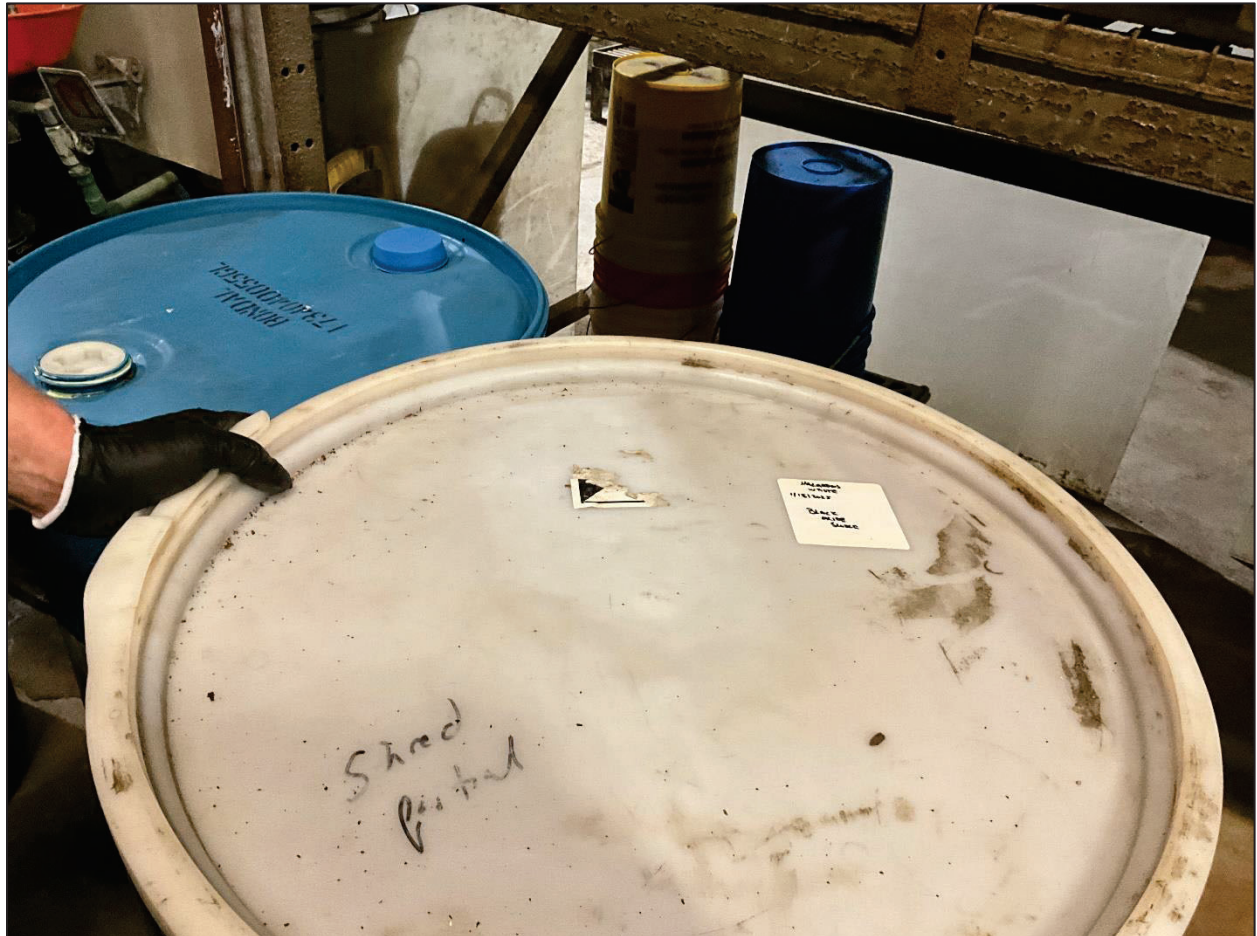
| Photo # | Description | Date |
|---|---|---|
| 5 | 90-Day CAA Hazardous Waste Container #2 Label | 1/22/2025 |

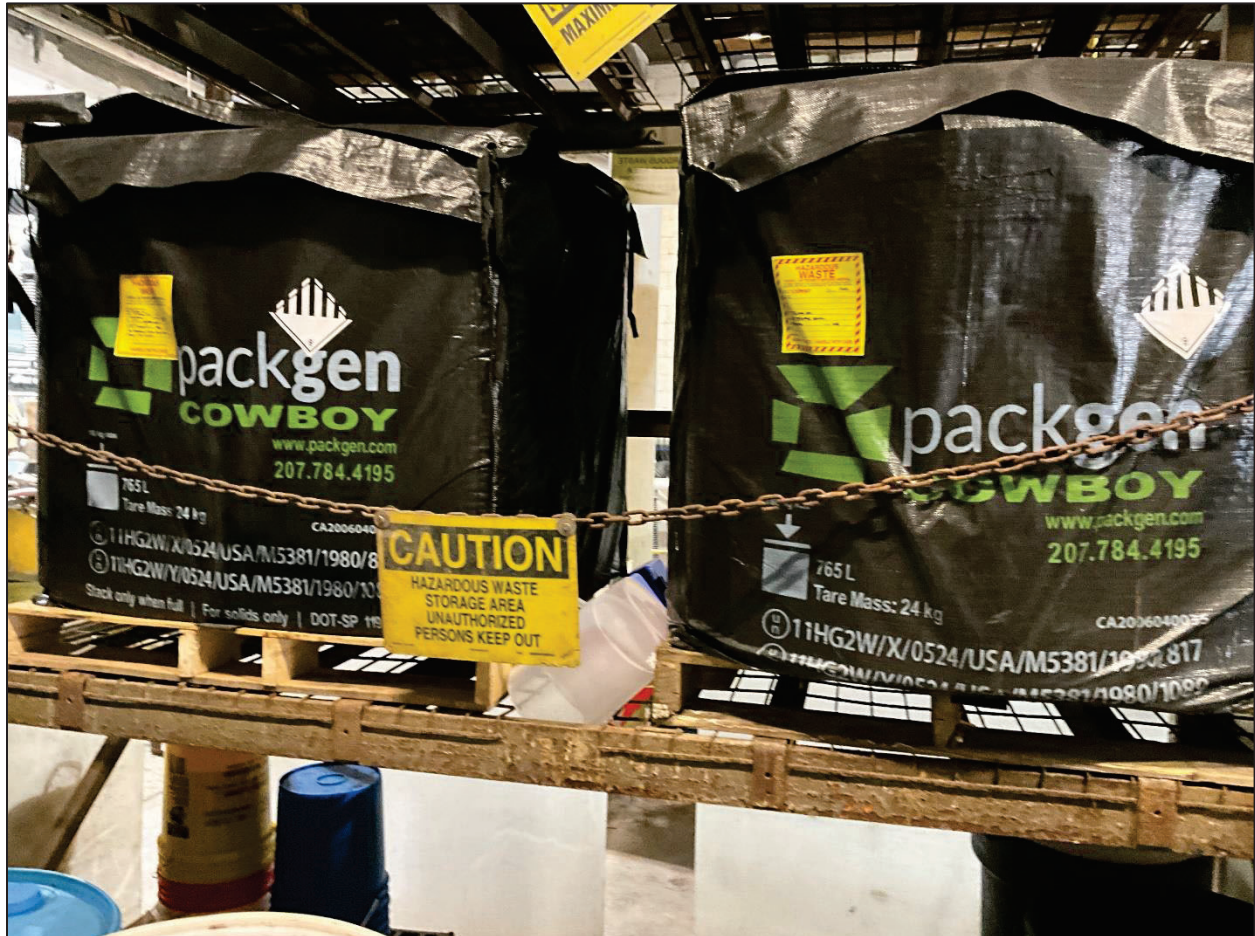
At the CAA, the inspection team observed a hazardous waste storage area sign as well as unauthorized personnel keep away, and caution signs. There was also an eyewash station next to the shelf where the hazardous waste containers were placed. In addition, the inspection team observed an overhead sprinkler system which was inspected monthly and tested yearly as per Mr. Peters. Moreover, the inspection team observed a fire extinguisher located across the CAA. As per Mr. Peters, Maintenance department were performing monthly inspection of the fire extinguisher. The inspection team noticed that the last inspection was performed on 10/26/2024. The inspection team did not observe a physical phone in the area. The nearest phone available to anyone working in the CAA was in the analytical laboratory on the 1<sup>st</sup> floor next to the wastewater treatment area which was adjacent to the CAA as per Mr. Peters. The inspection team did not observe a No Smoking sign at the CAA. In addition, the inspection team also did not observe an emergency contact list, and an evacuation route posted in the CAA. As per Mr. Peters, the emergency contact list was posted in the analytical laboratory on the 1<sup>st</sup> floor. The inspection team then asked Mr. Peters to show the location of the spill kit which was nearest to the CAA. Mr. Peters then pointed out to the absorbent packs placed behind the acidic product raw material that was located across the CAA on the 2<sup>nd</sup> shelf from the floor. Inspector Patel then asked Mr. Peters to describe the process/steps involved in case of a hazardous waste related emergency. Mr. Peters explained that the operator working in the area would first contact the primary coordinator to discuss the situation but would call 911 directly for a bigger spill. Lastly, the inspection team did not observe any label or demarcation tape on the floor separating hazardous waste containers from non-hazardous waste containers.

| Photo # | Description | Date |
|---|---|---|
| 6 | 90-Day CAA Hazardous Waste Area Signage | 1/22/2025 |

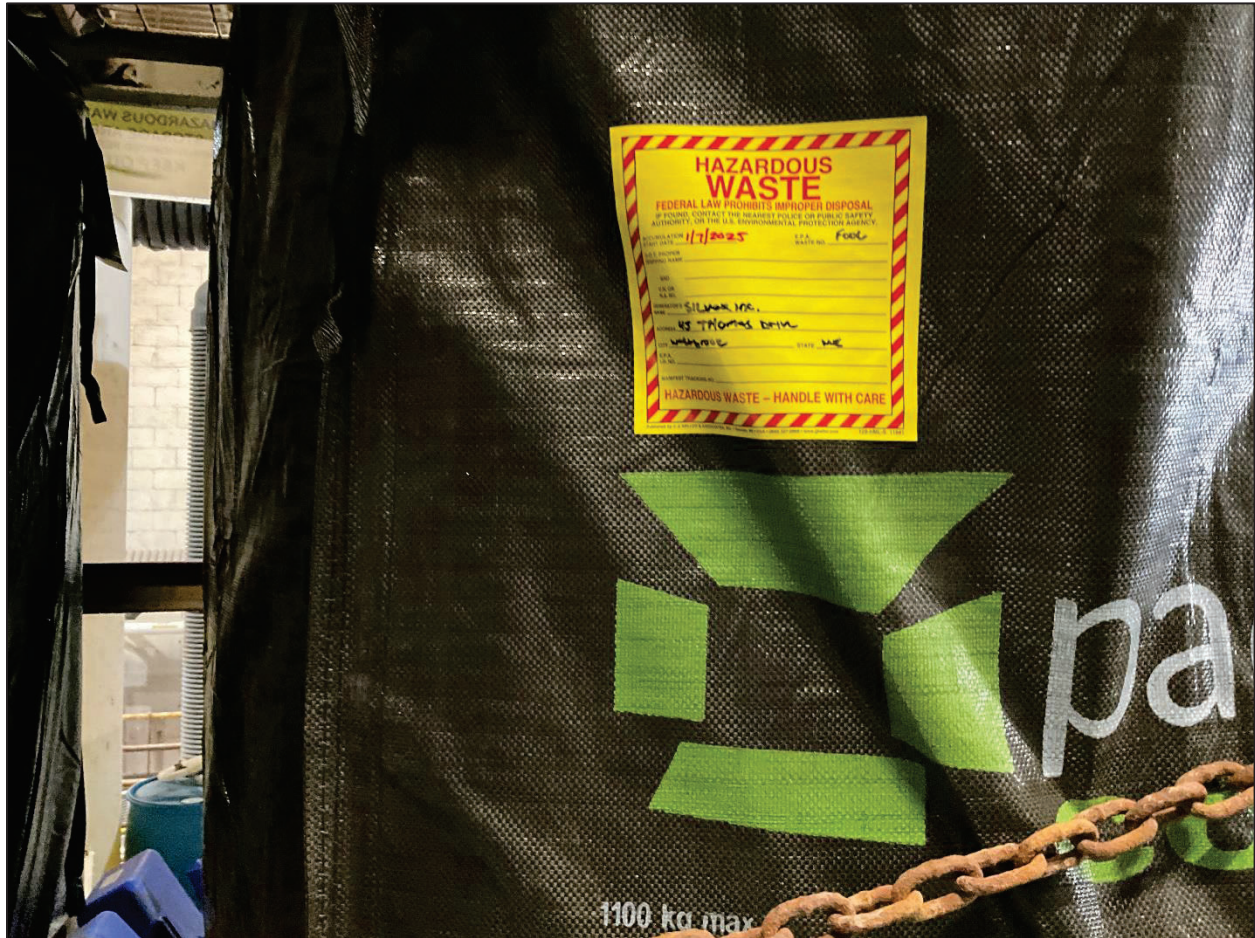
| Photo # | Description | Date |
|---|---|---|
| 7 | 90-Day CAA Hazardous Waste Container #3 Label | 1/22/2025 |

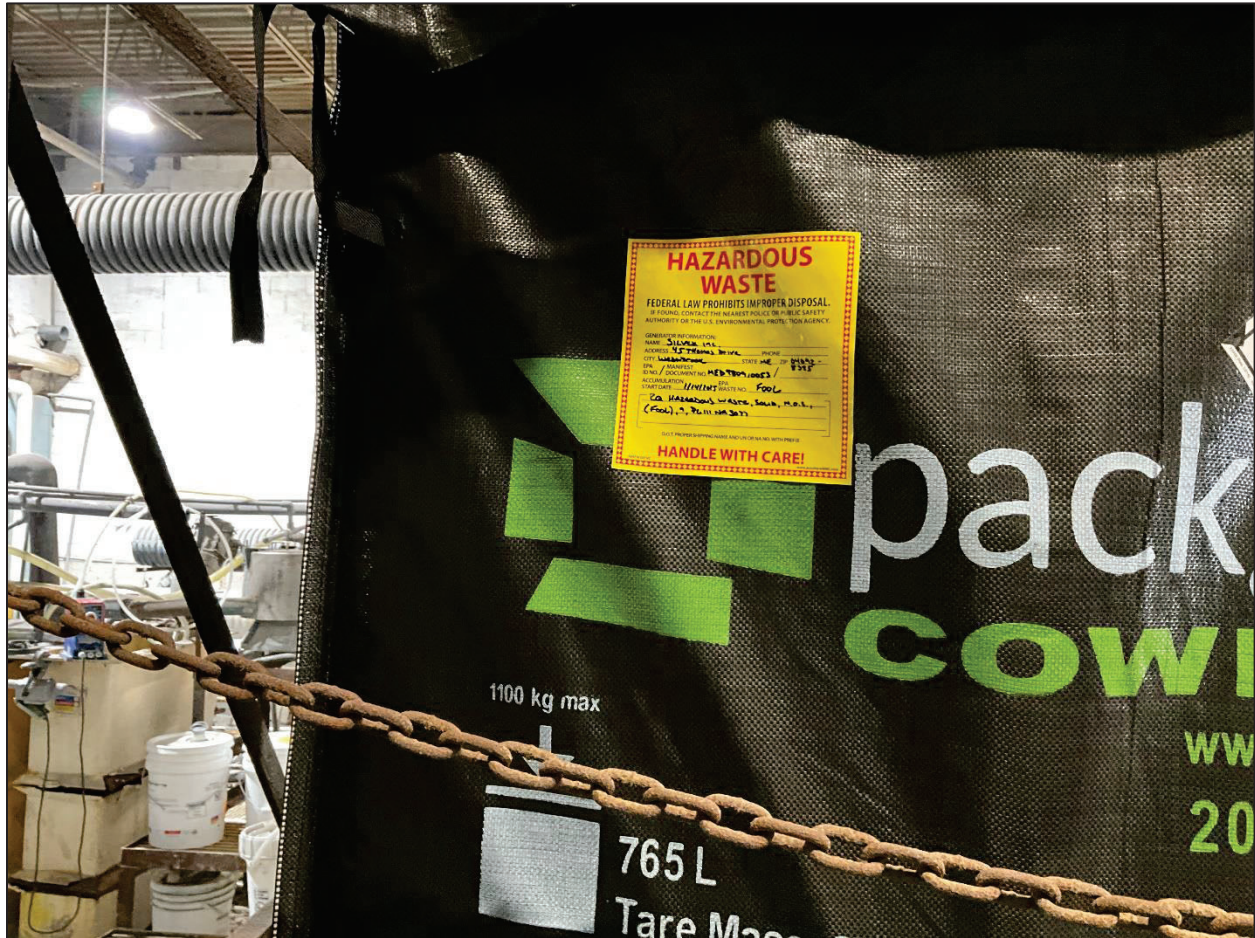
| Photo # | Description | Date |
|---|---|---|
| 8 | 90-Day CAA Hazardous Waste Container #4 Label | 1/22/2025 |

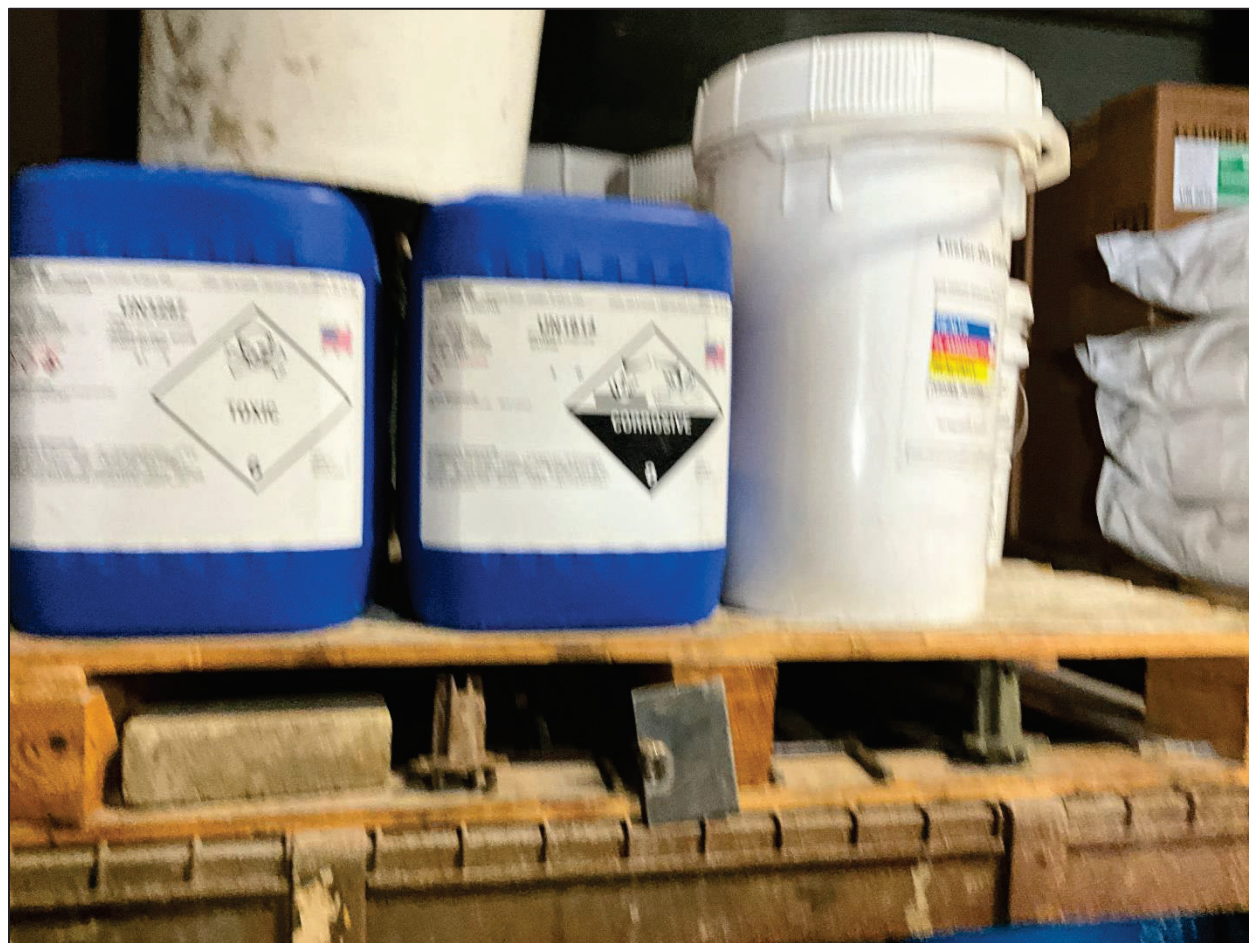
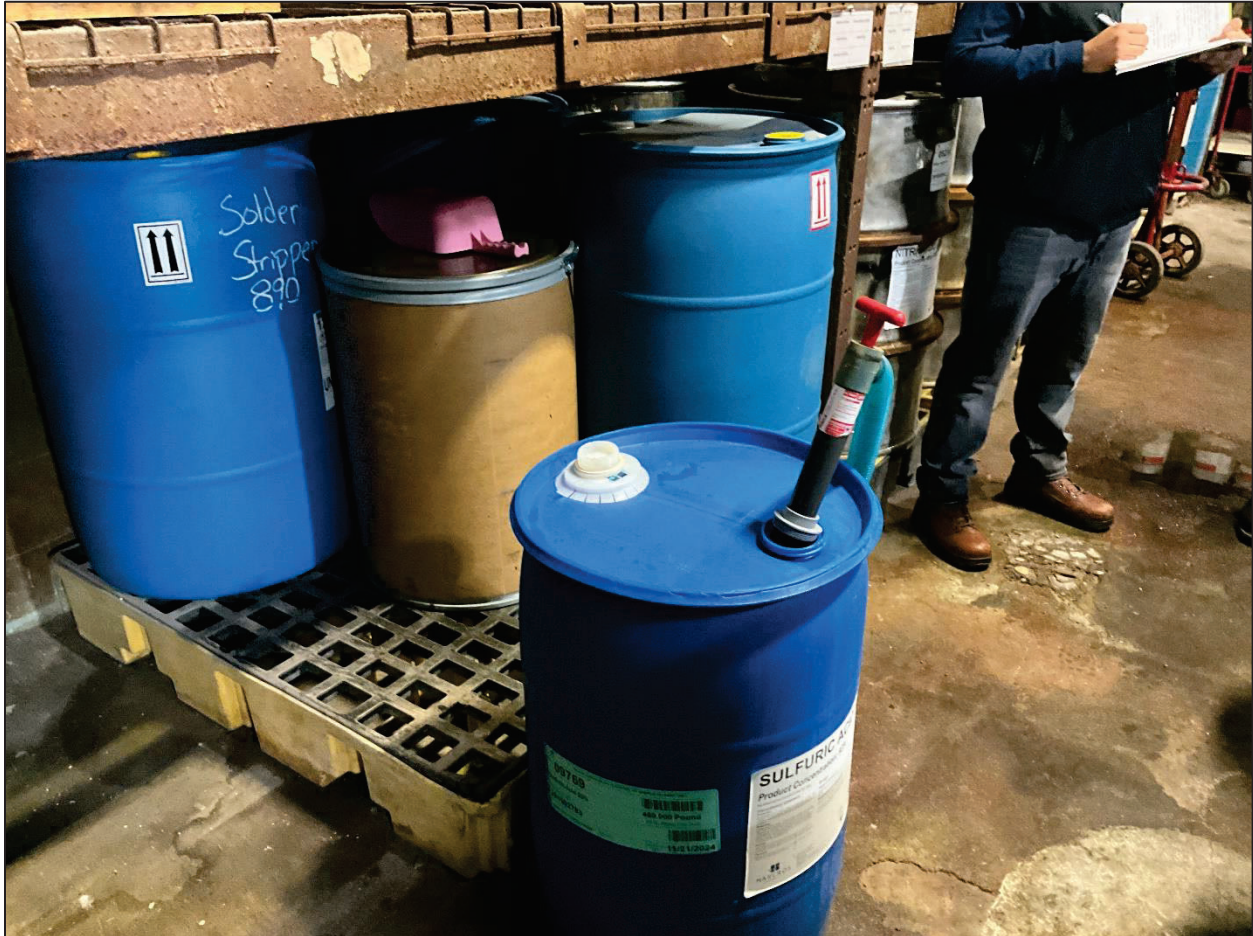
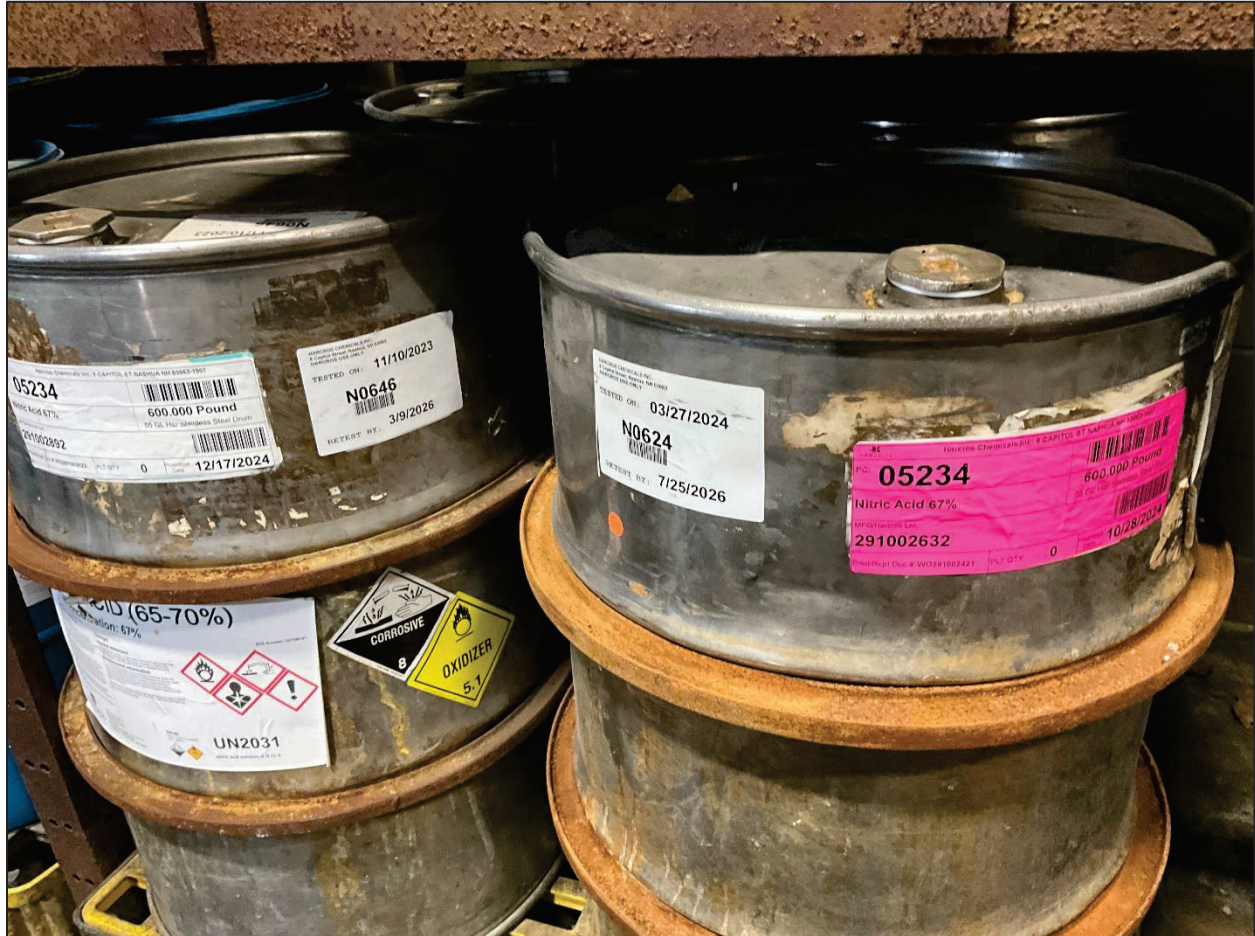
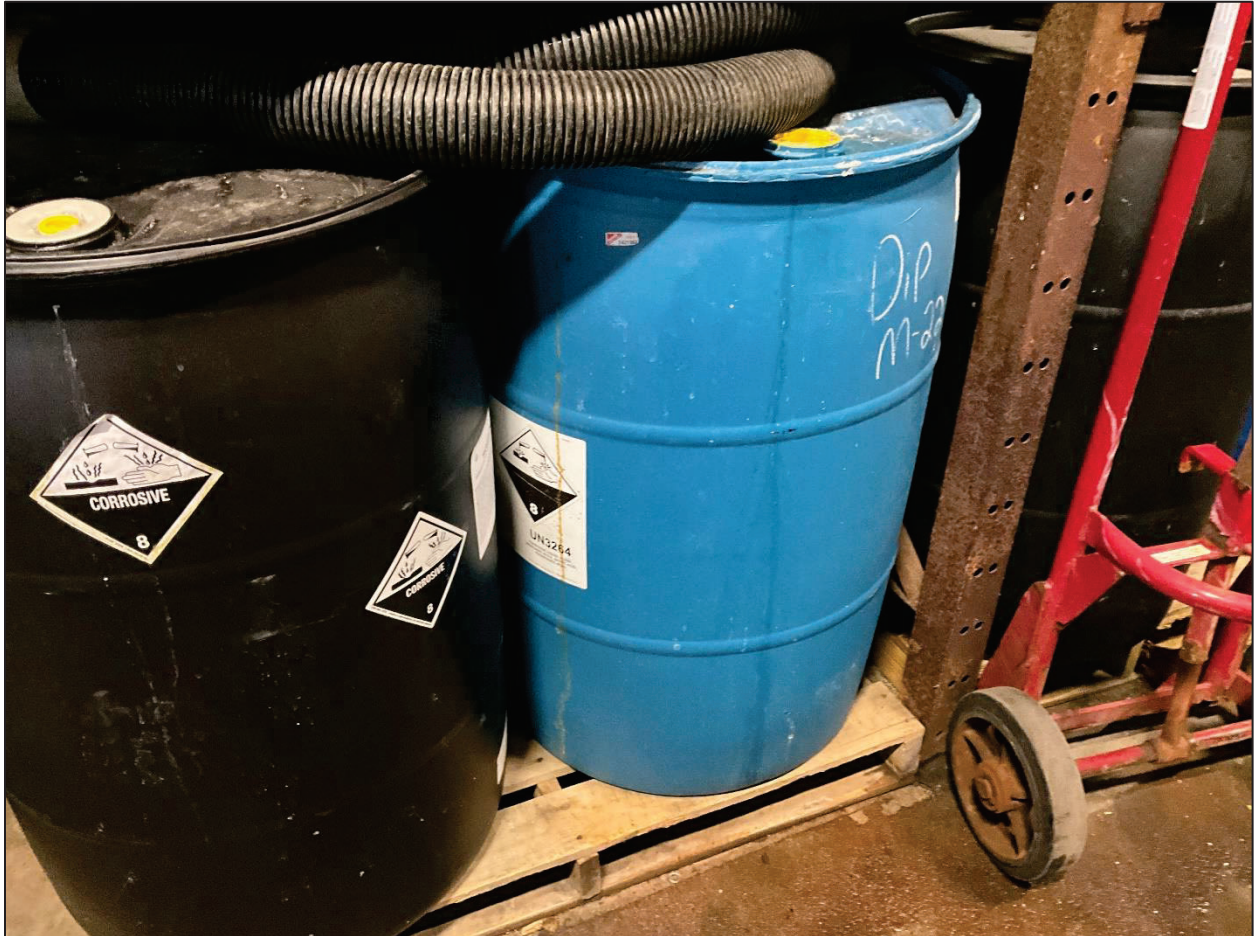
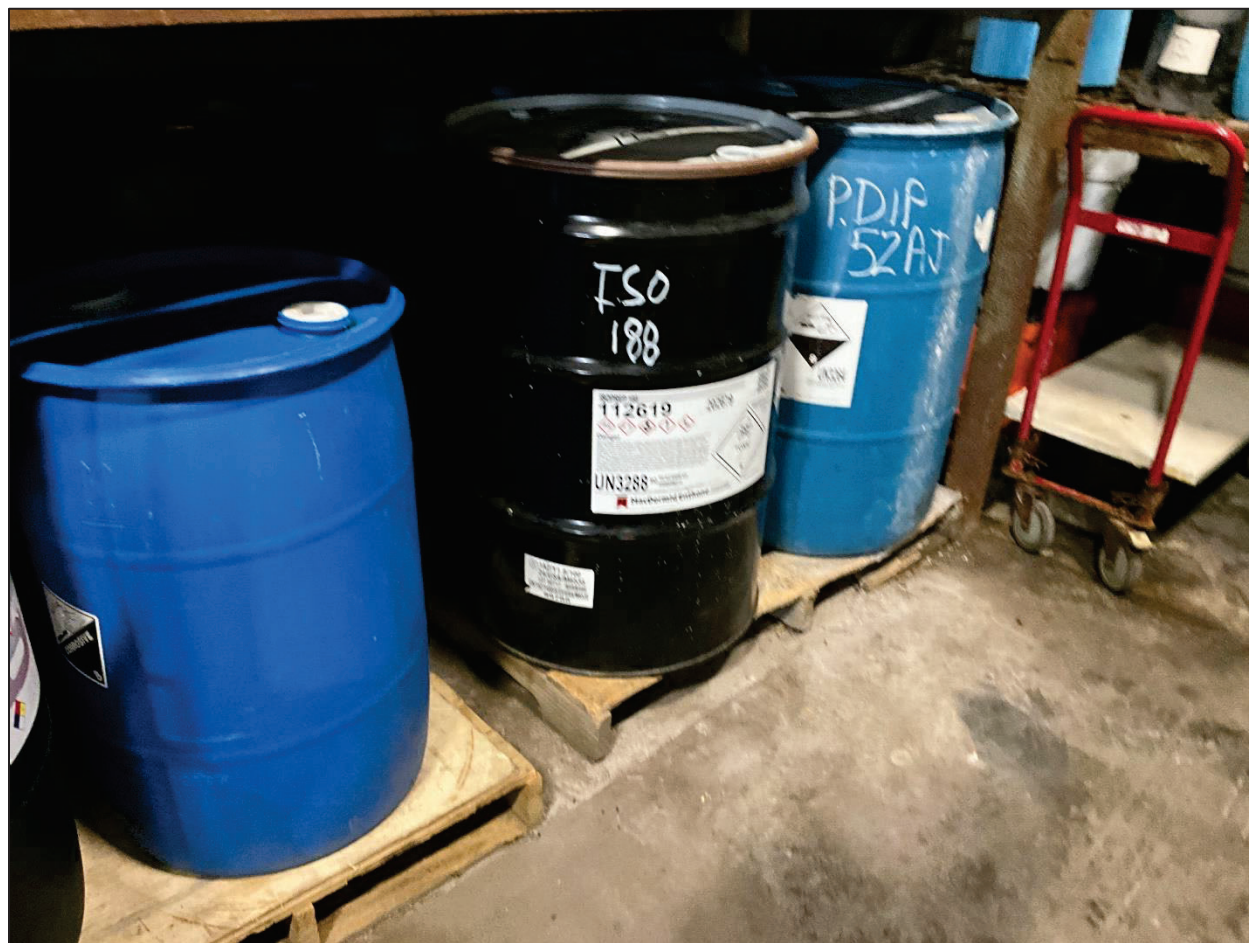
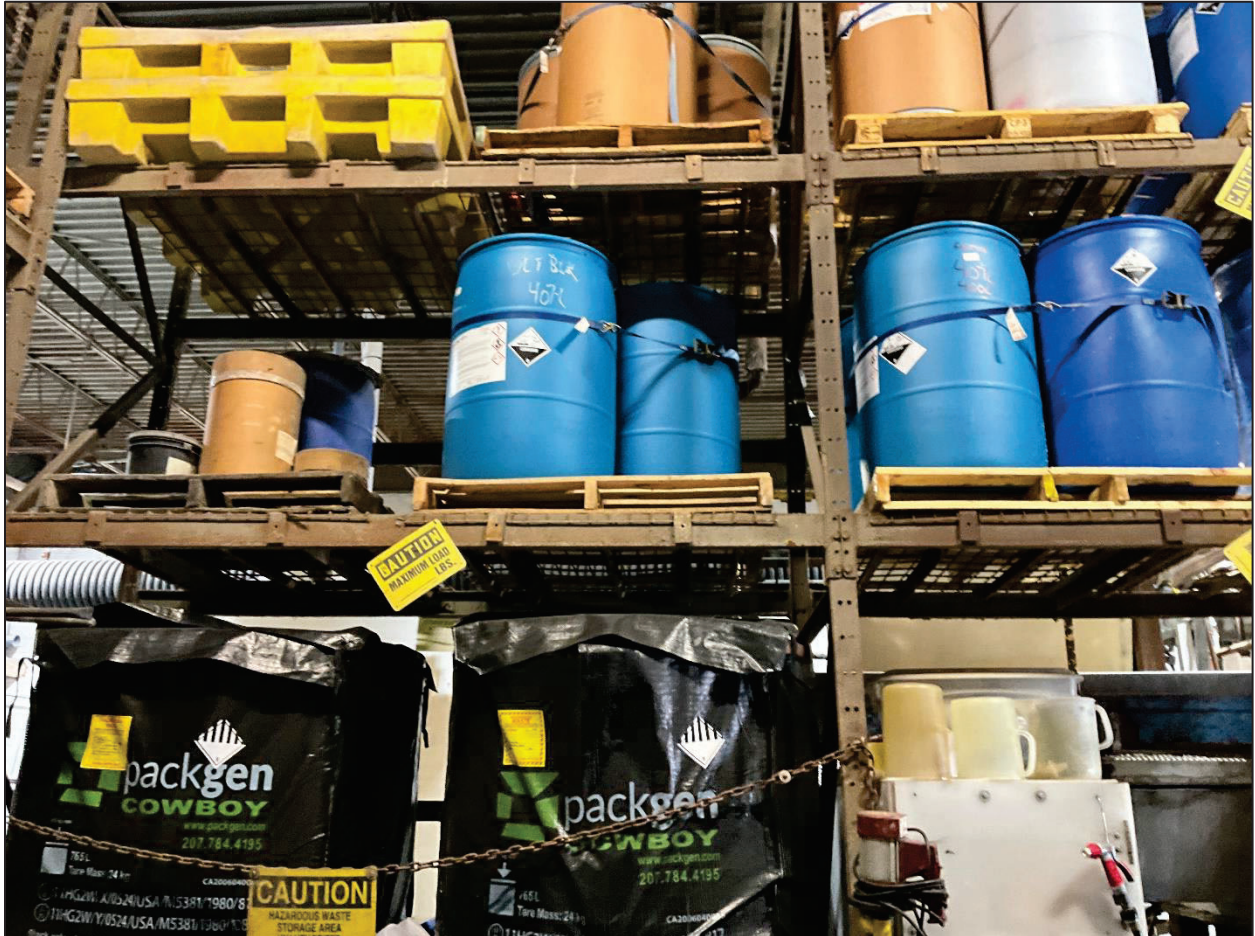
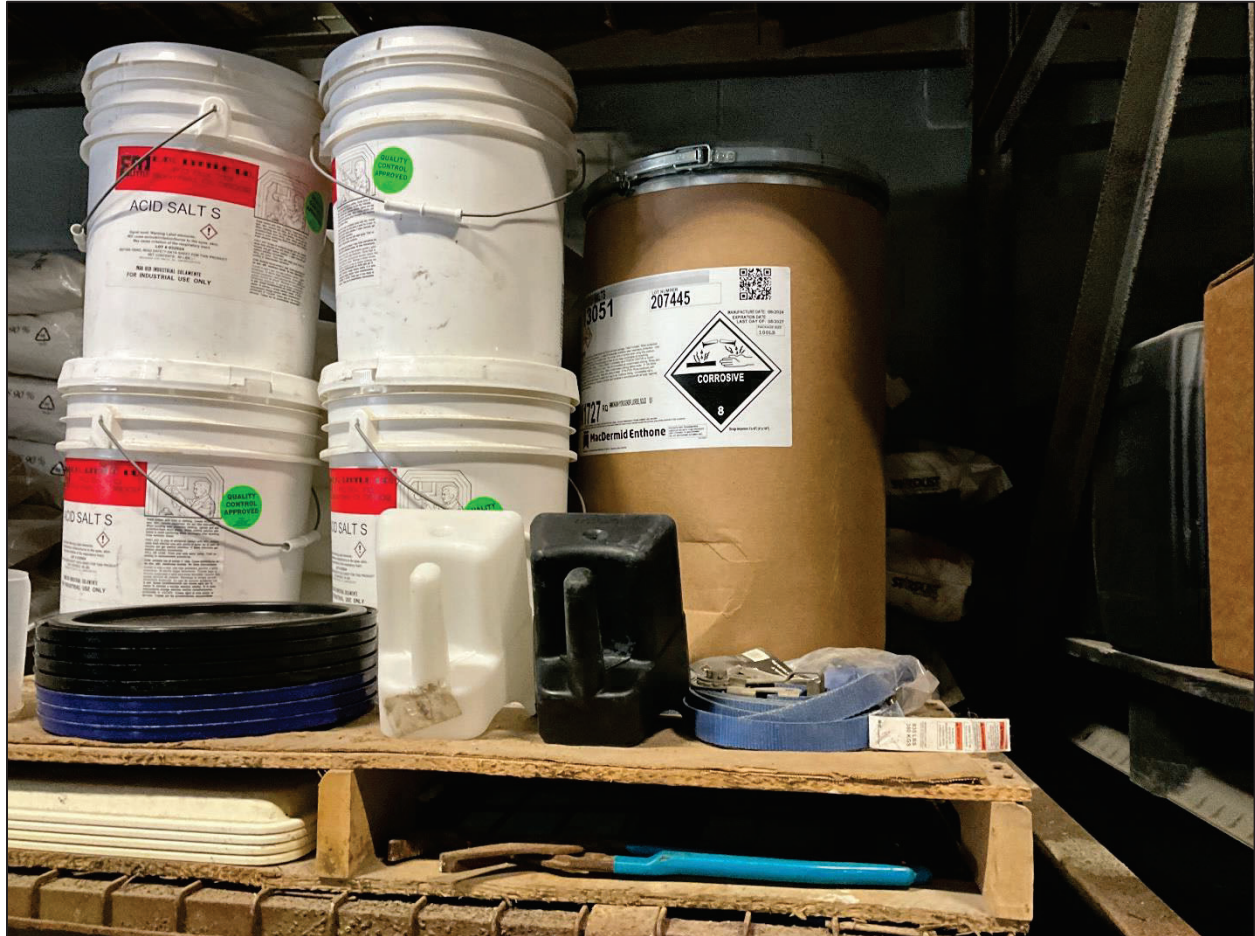
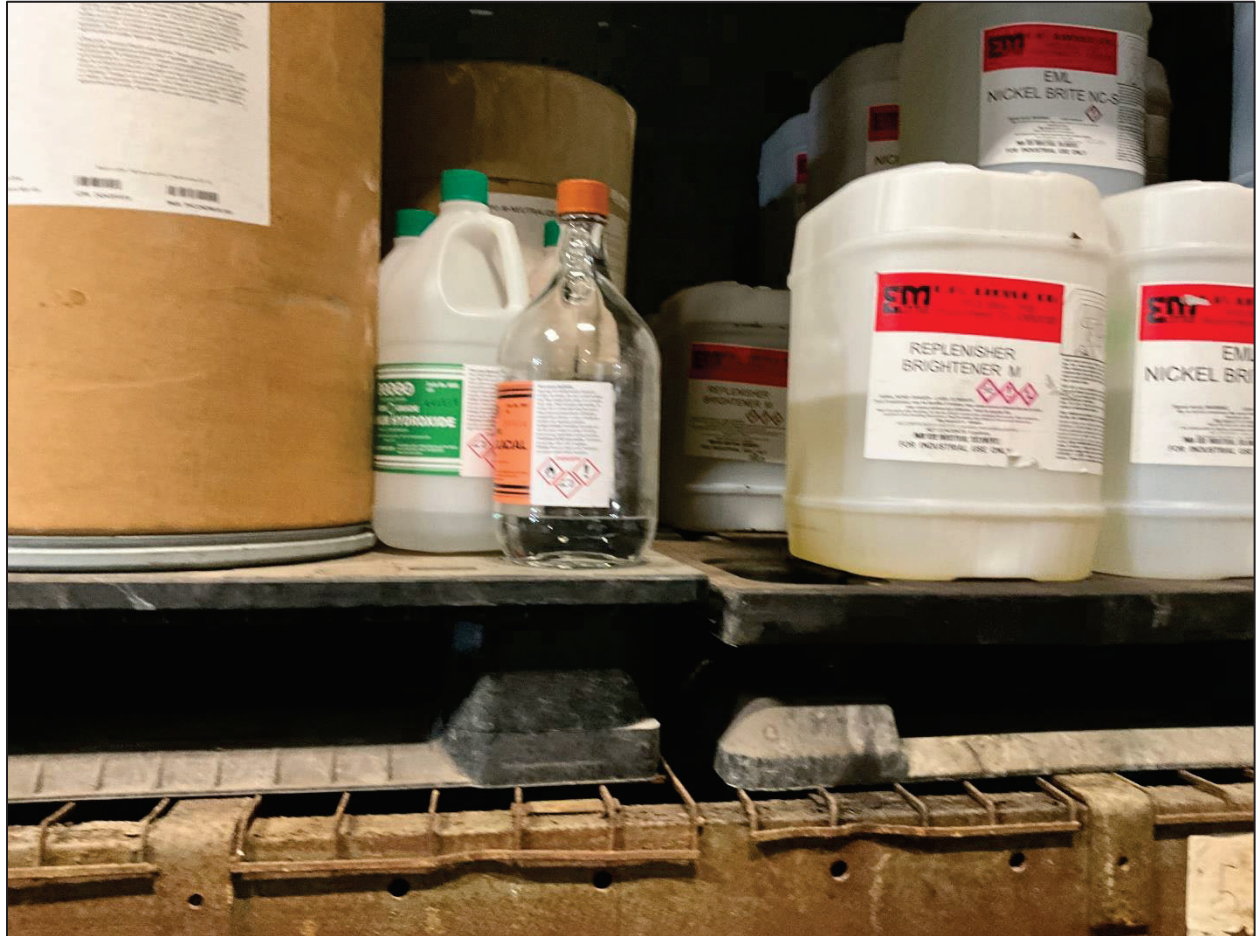
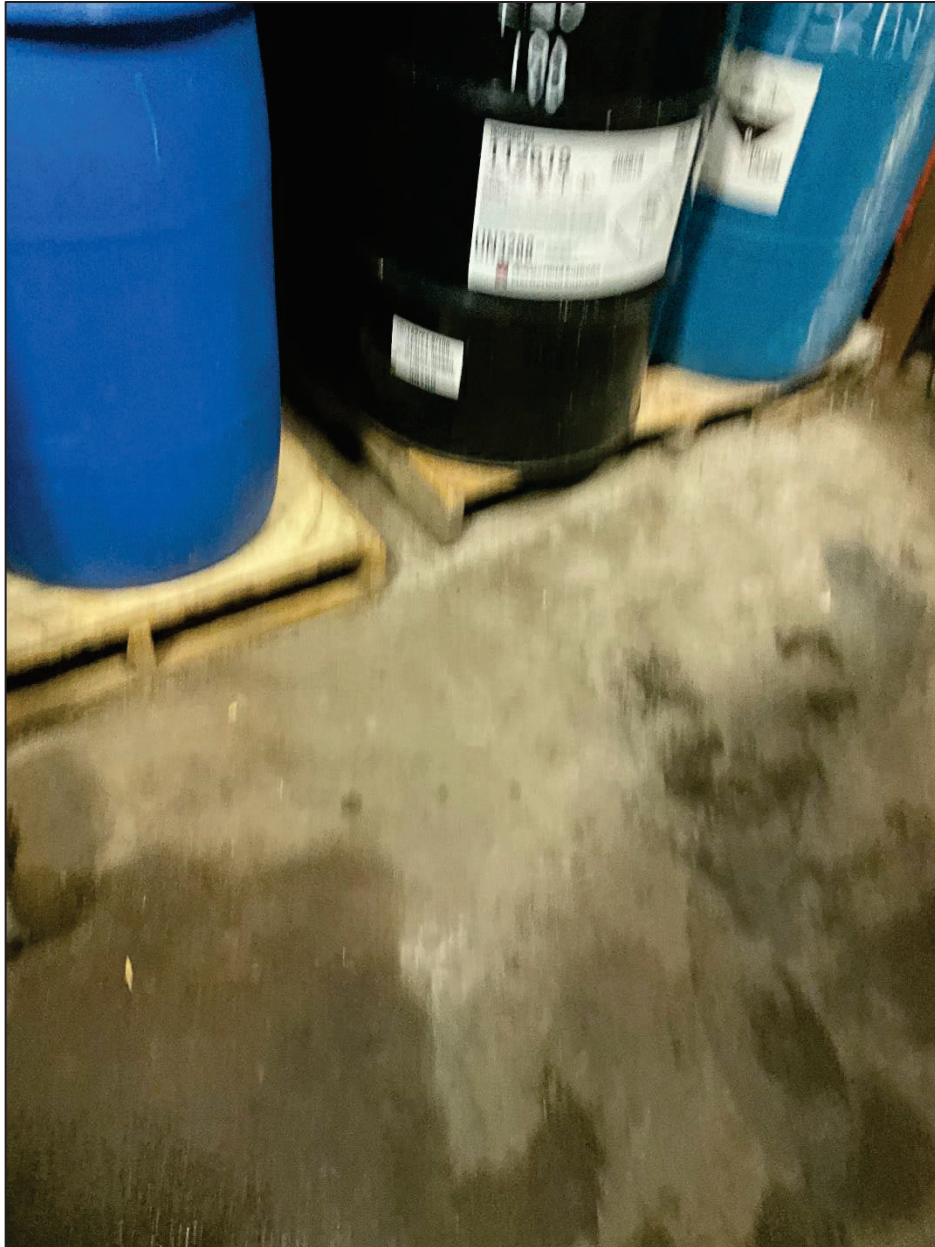
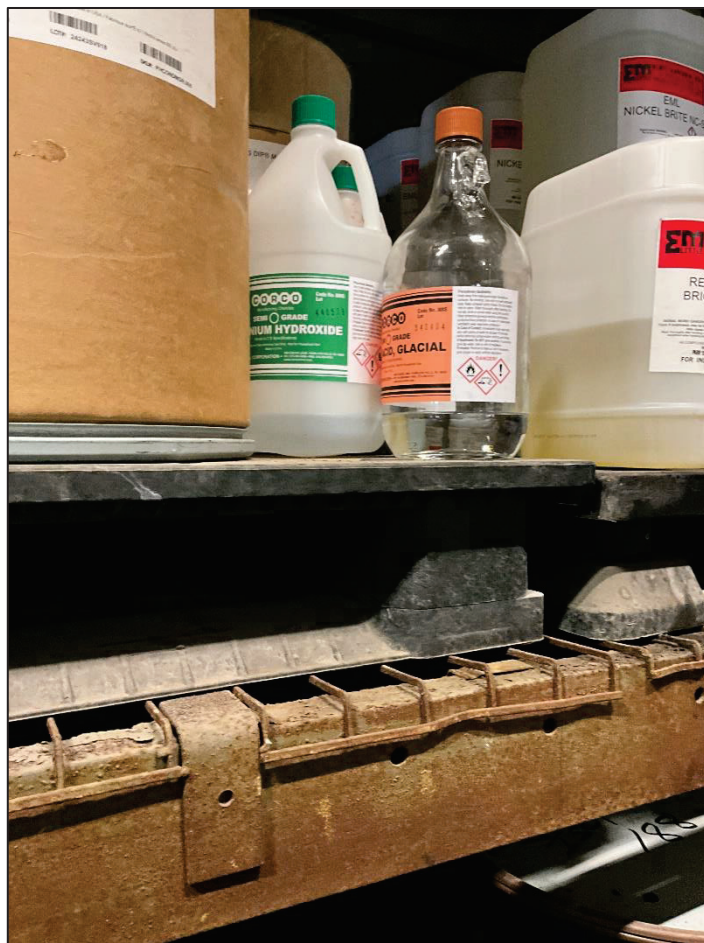
This area is primarily used for storage of the chemical products used in the plating operation. The stored products include oxidizers, acids, alcohols, and salts. The inspection team observed that some of the virgin products which were stored next to each other were incompatible. The inspection team did not observe physical separation of those incompatible products. As per Mr. Peters, all virgin products stored in this area have at least one (1) year of shelf life but can be reused with certification from the manufacturer/supplier. Regardless, the products are used within a month or so as per Mr. Peters. Besides the central waste accumulation area, there was no other waste accumulation point at the chemical warehouse.

| Photo # | Description | Date |
|---|---|---|
| 9 | Chemical Warehouse - Virgin Products | 1/22/2025 |

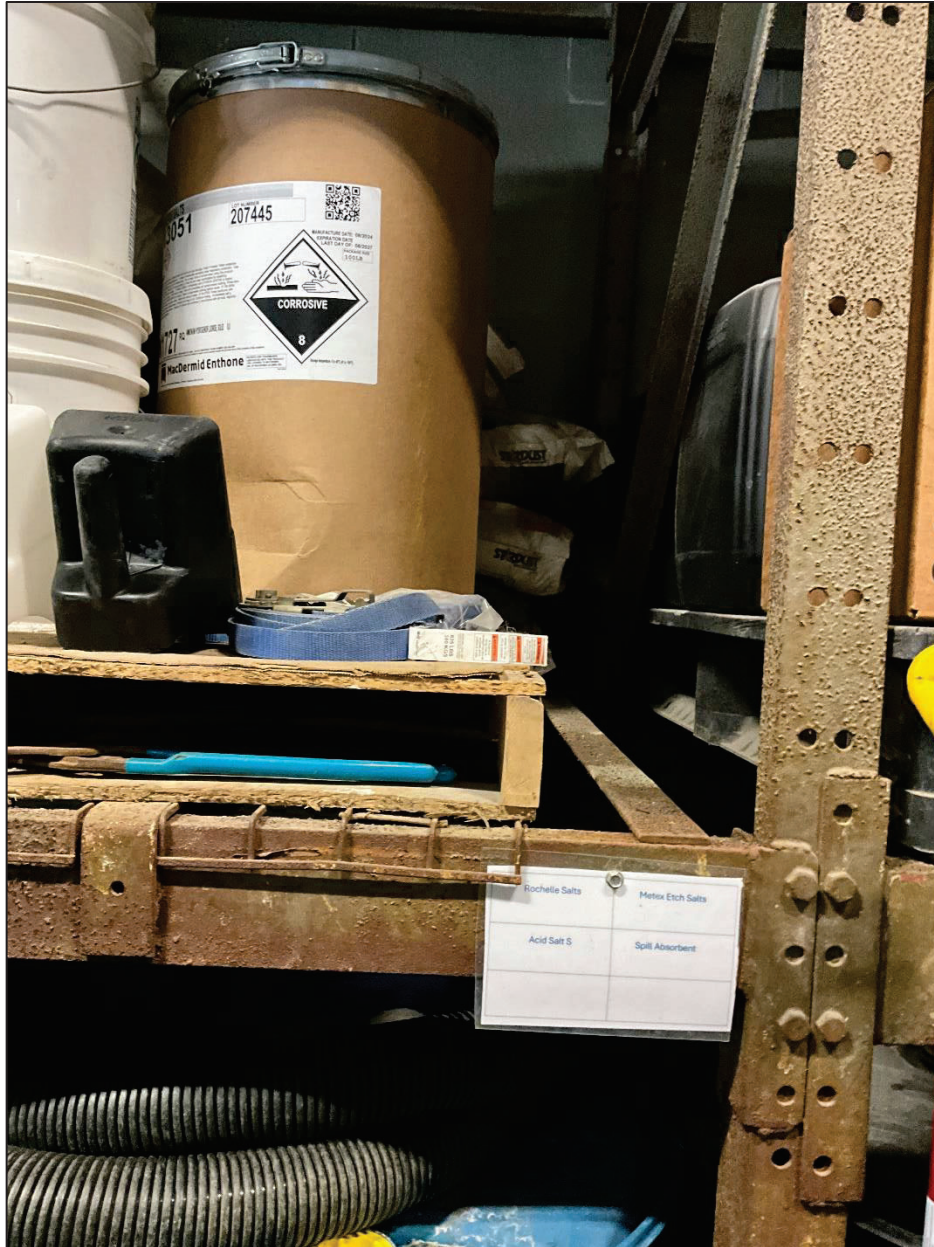
| Photo # | Description | Date |
|---|---|---|
| 19 | Spill Kit Location across from the CAA | 1/22/2025 |
