Re: U.S. EPA-Region 1 Inspection Report of Silvex, Inc., January 22, 2025

### RCRA Compliance Inspection of:

**Silvex, Incorporation  
45 Thomas Drive  
Westbrook, ME 04092**

## RCRA HAZARDOUS WASTE INSPECTION REPORT

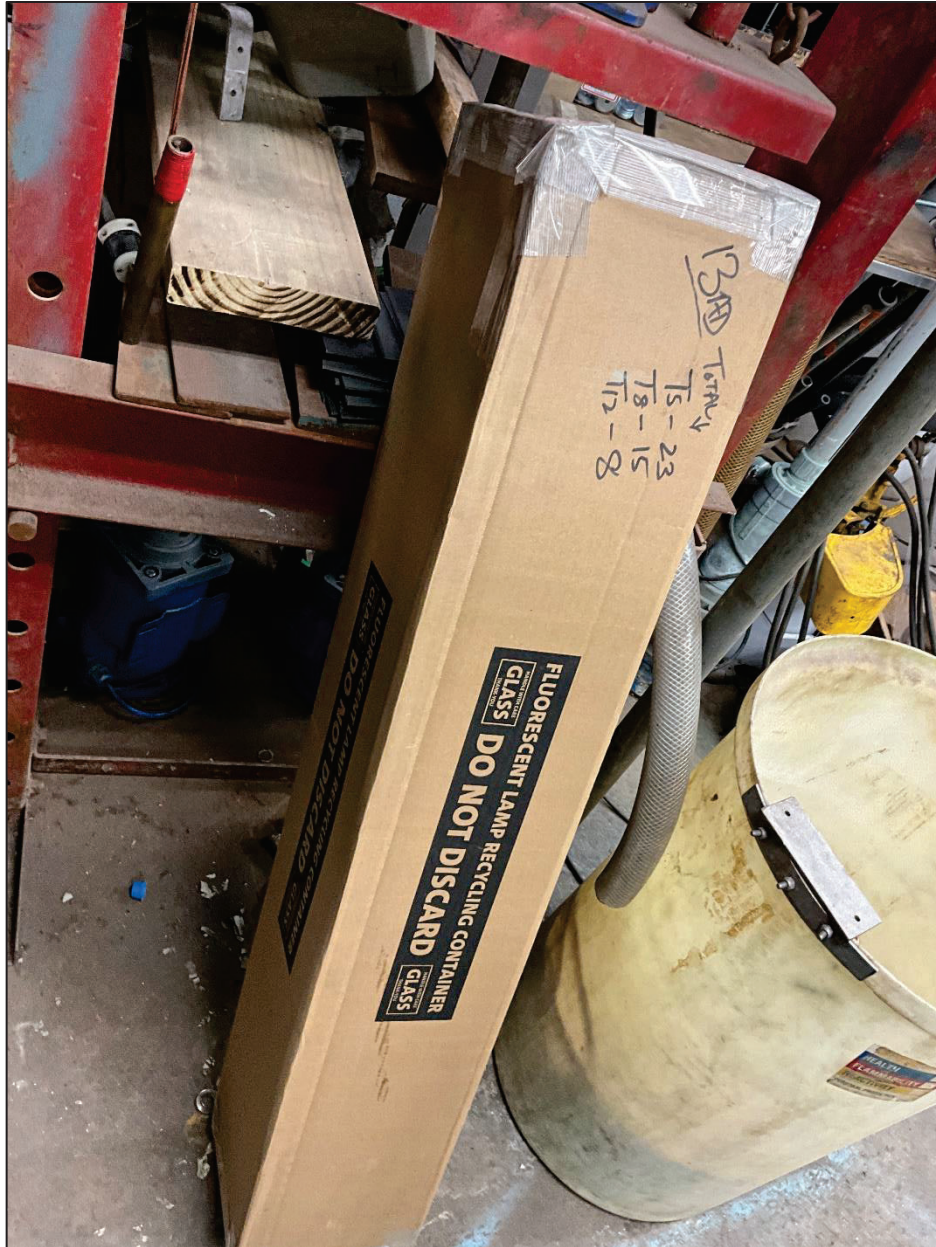
| Photo # | Description | Date |
|---|---|---|
| 20 | Maintenance Room - Closed box of fluorescent bulbs | 1/22/2025 |

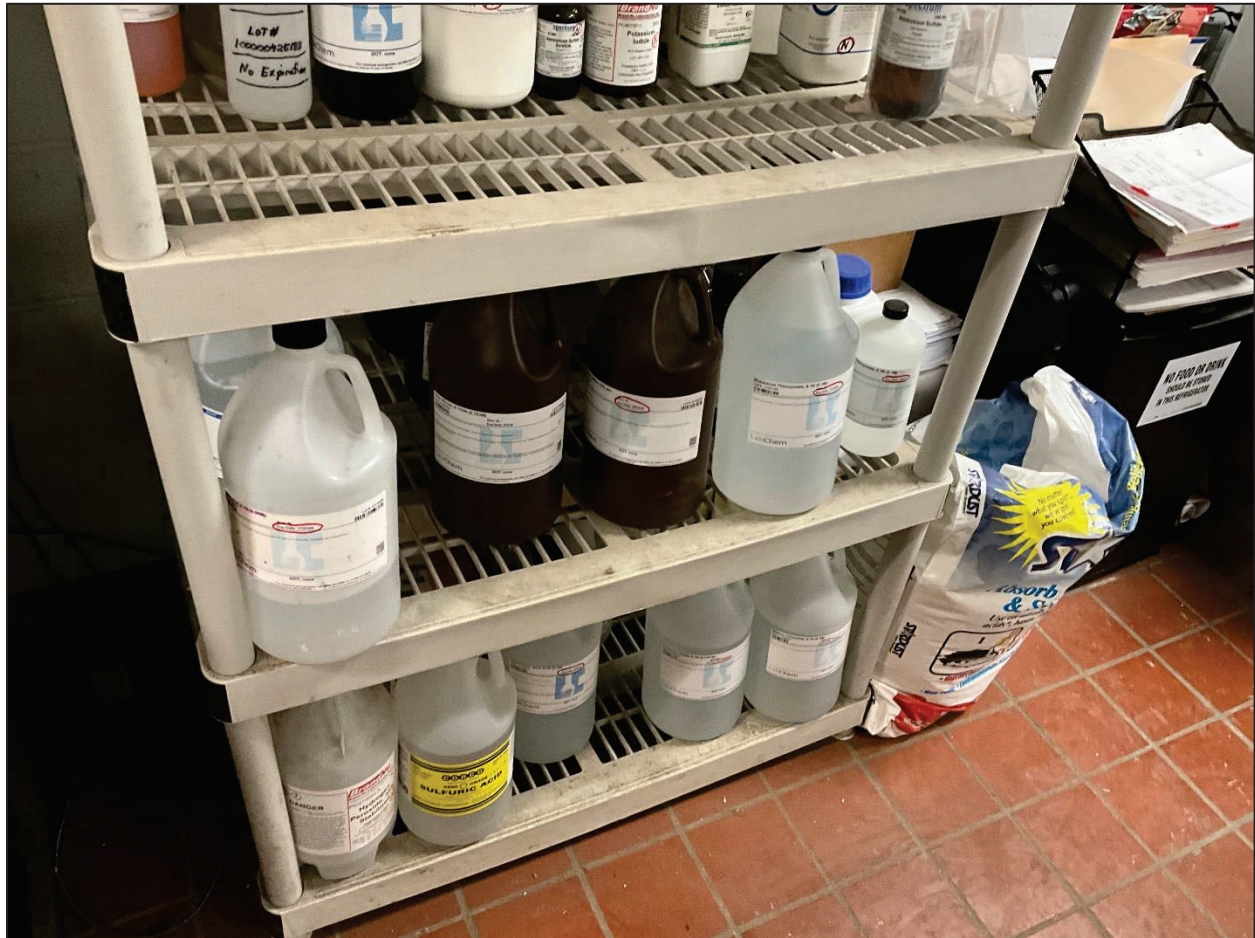
| Photo # | Description | Date |
|---|---|---|
| 21 | Analytical Laboratory - Virgin Products & Absorbent Pack | 1/22/2025 |

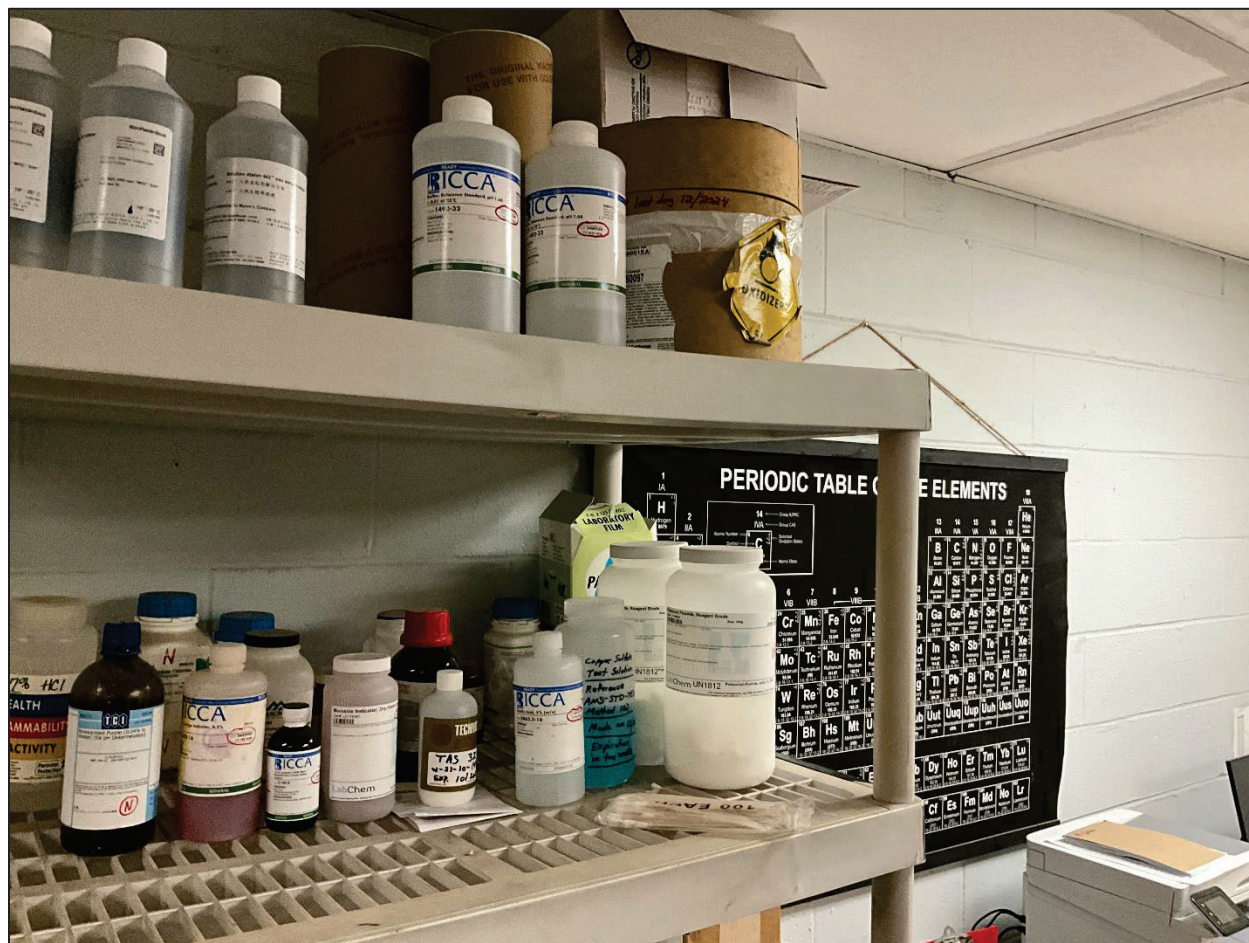
Inspector Patel received the recertification documentation for the Iridite 14-2 Bush kit found in the analytical laboratory (expired oxidizer) during the walkthrough portion of the inspection on 2/6/2025. The product was being used for touch-ups of anodizing contact marks on aerospace processes as well as for dilute chromate solution which is used to impart corrosion resistance. As per the certificate, the product is not authorized by the manufacturer (MacDermid) for reuse on aerospace process, but the facility was planning to use it for its “brite dip” process on commercial copper components. The product can be exclusively used past its expiry date for “brite dip” process without a need for recertification as indicated on the recertification document.

| Photo # | Description | Date |
|---|---|---|
| 22 | Analytical Laboratory - Expired Solvent (with Oxidizer Hazard) | 1/22/2025 |

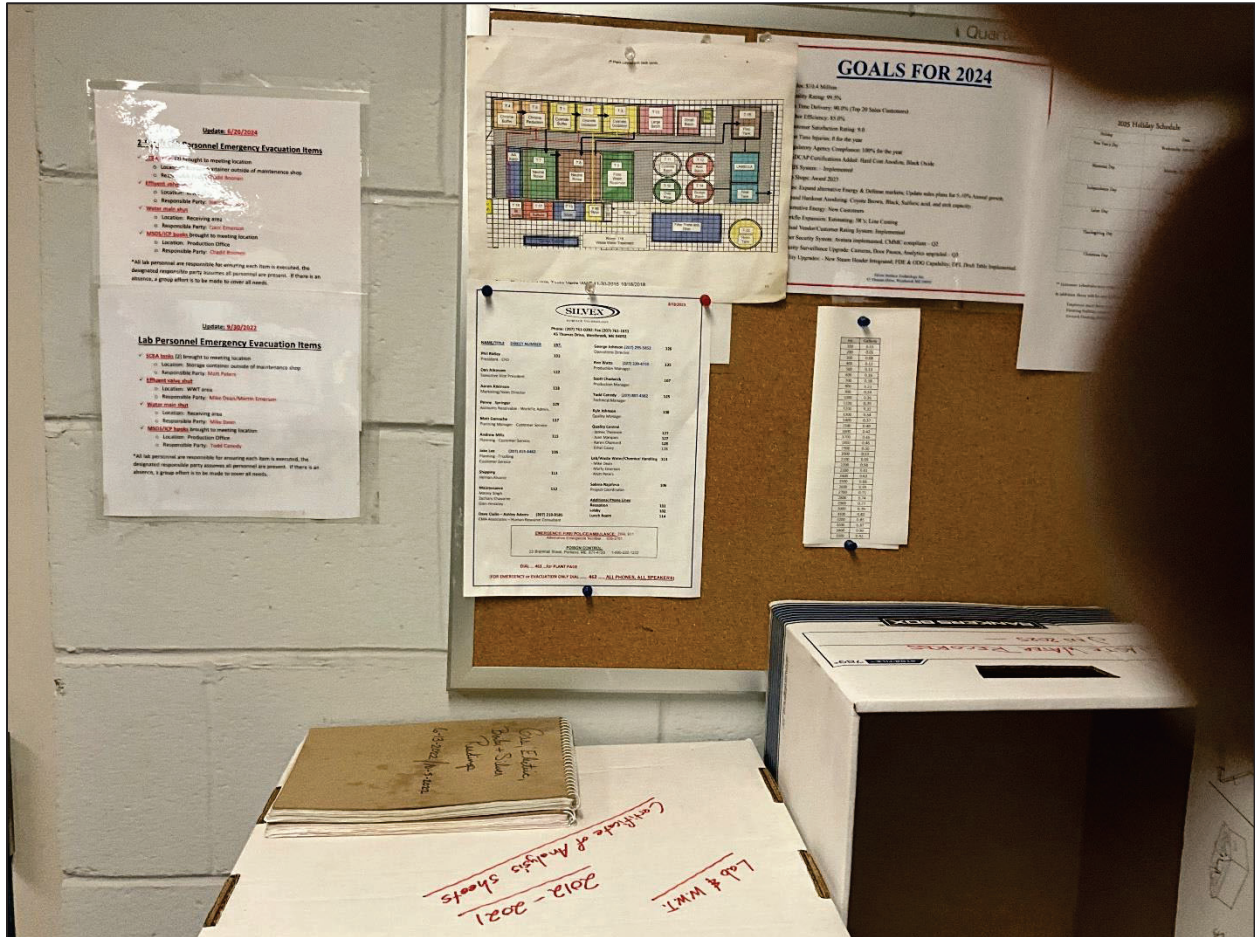
| Photo # | Description | Date |
|---|---|---|
| 23 | Analytical Laboratory - Contact List of different employees at the work desk | 1/22/2025 |

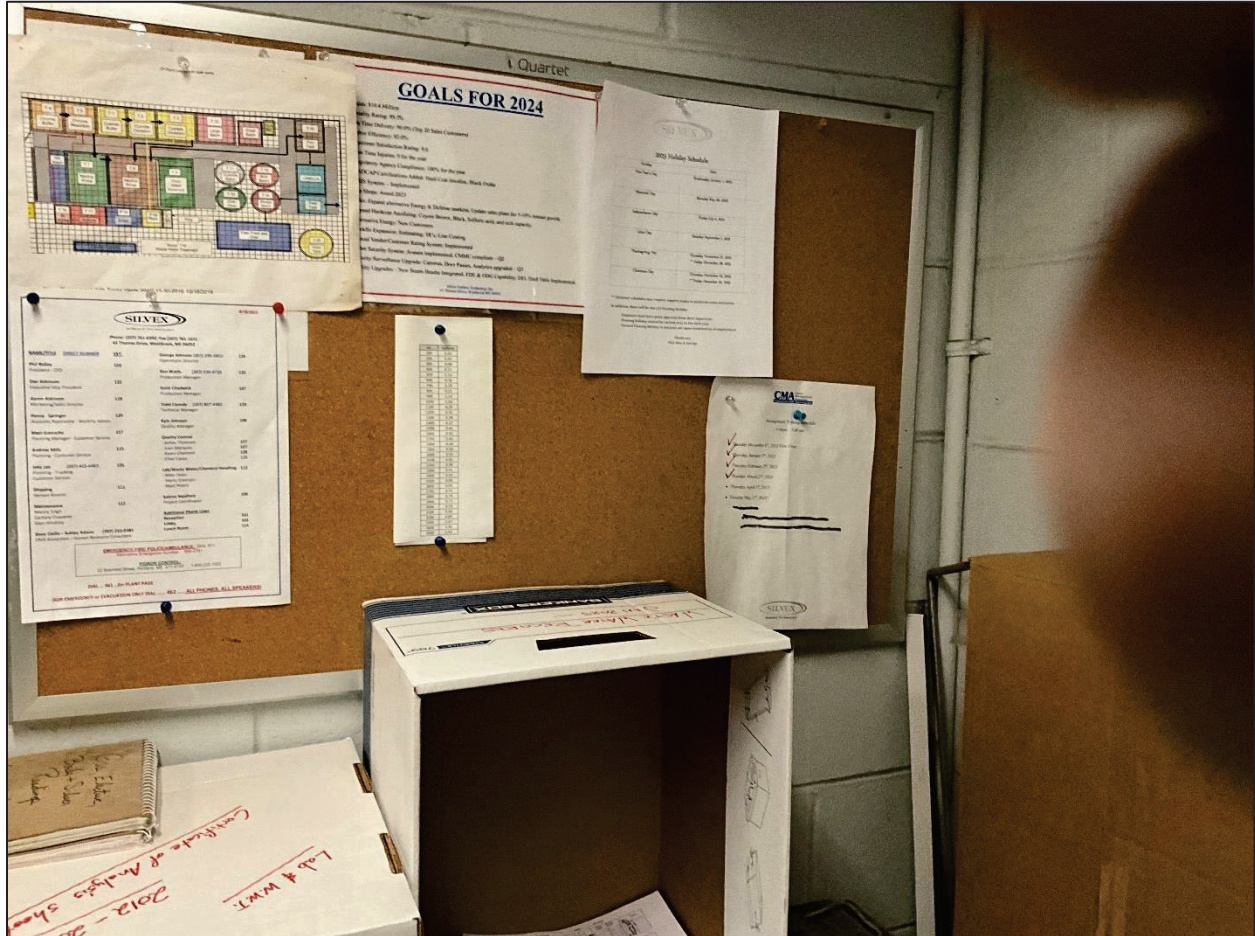
| Photo # | Description | Date |
|---|---|---|
| 24 | Analytical Laboratory - Additional posts near the work desk. | 1/22/2025 |

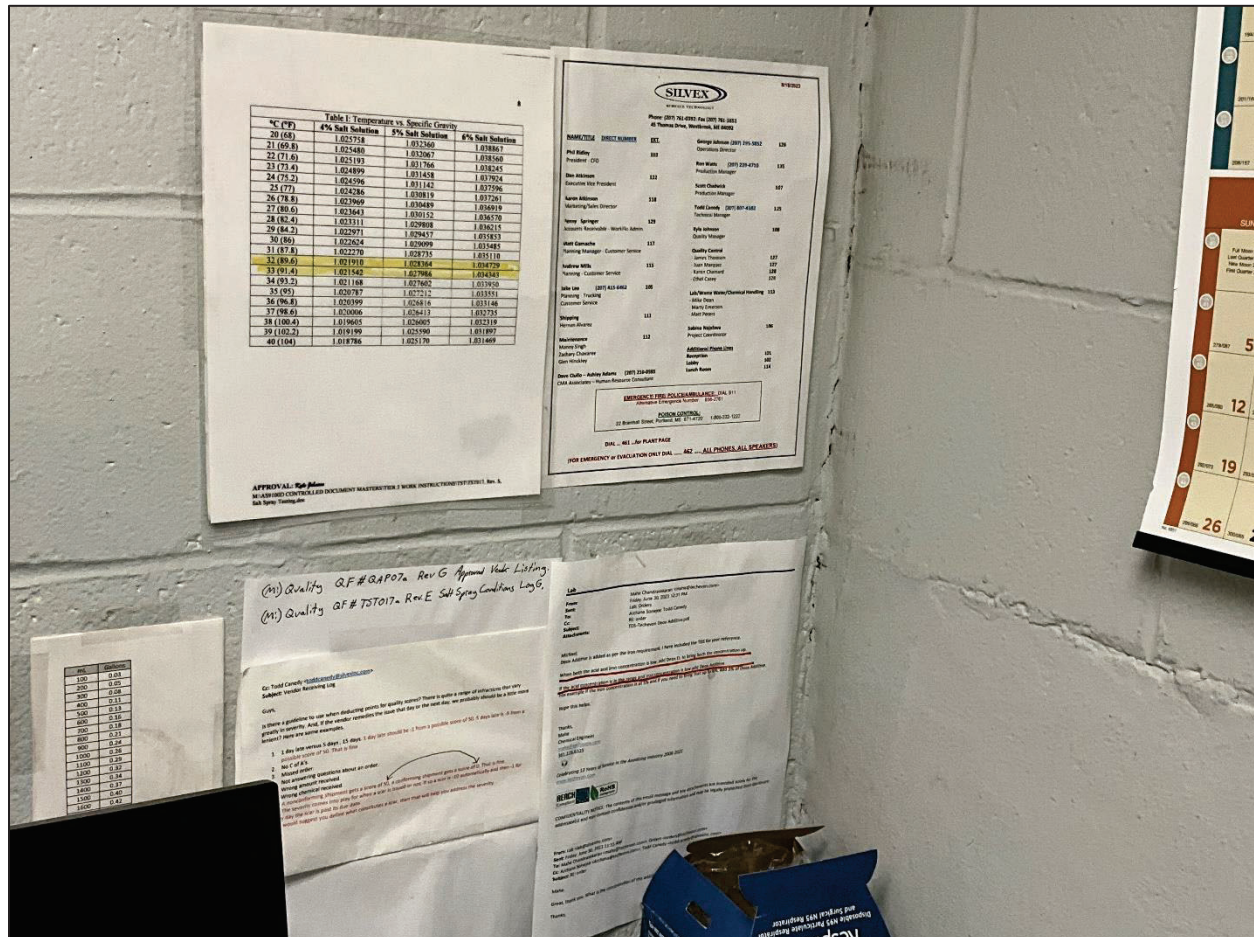
| Photo # | Description | Date |
|---|---|---|
| 25 | Analytical Laboratory - Contact List of different employees near the Phone. | 1/22/2025 |

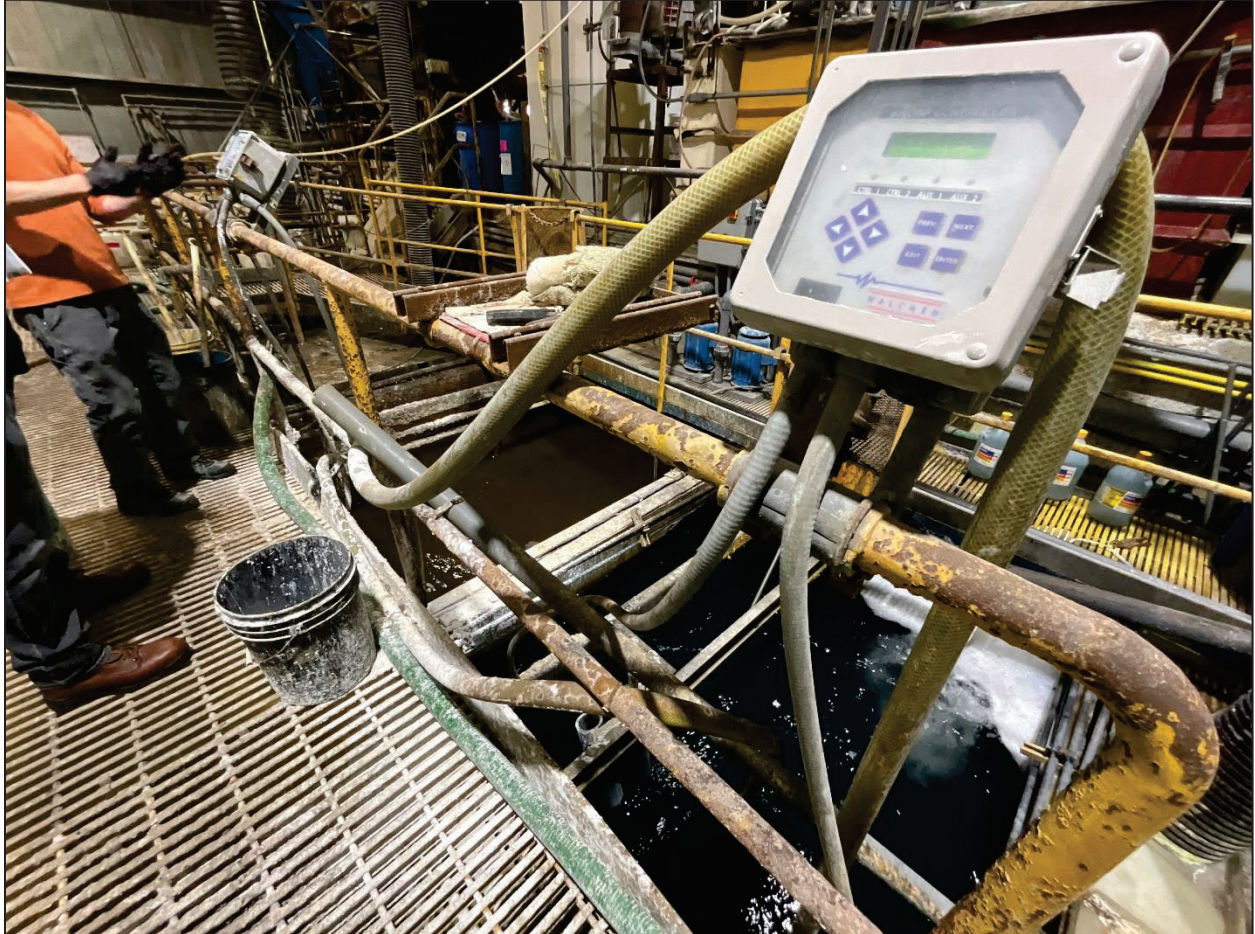
| Photo # | Description | Date |
|---|---|---|
| 26 | Wastewater Treatment Area - Neutralizing Tanks | 1/22/2025 |

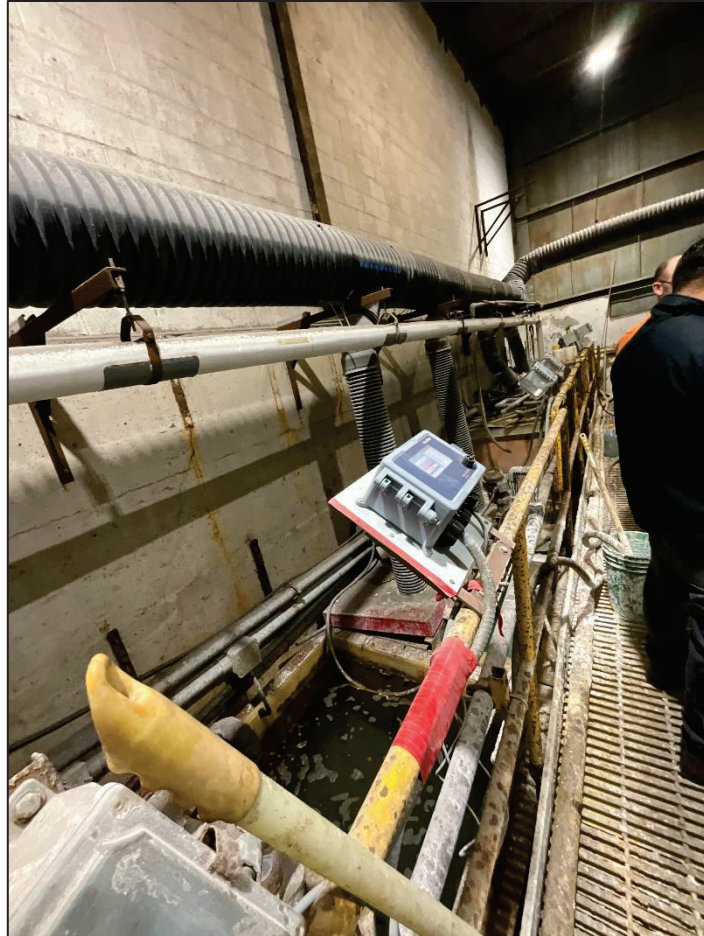
| Photo # | Description | Date |
|---|---|---|
| 27 | Wastewater Treatment Area - Tanks with incoming wastewater | 1/22/2025 |

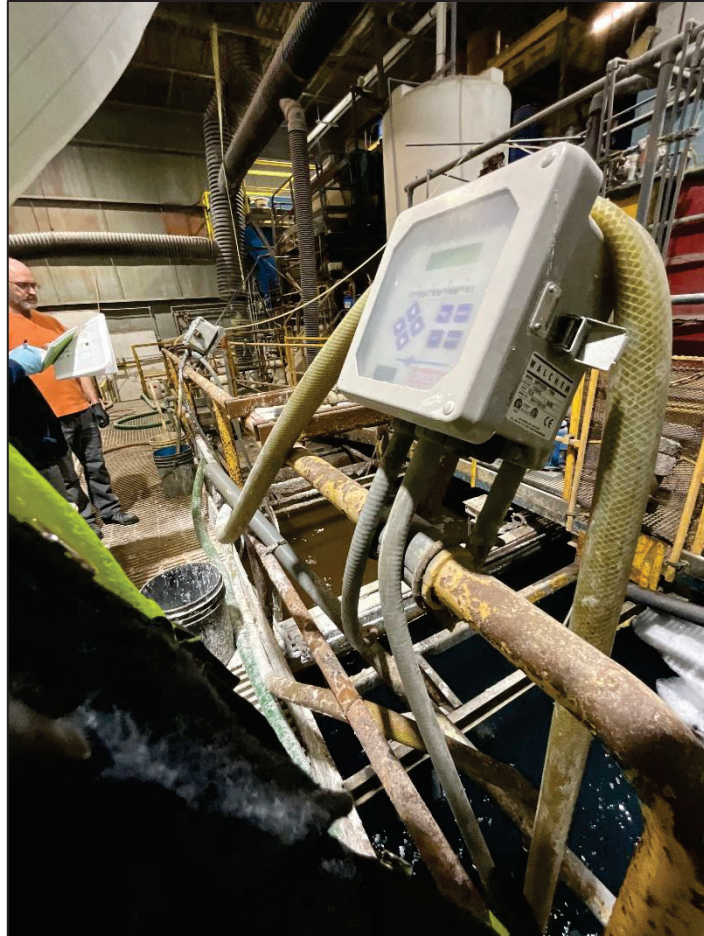
| Photo # | Description | Date |
|---|---|---|
| 28 | Wastewater Treatment Area - Control Unit | 1/22/2025 |

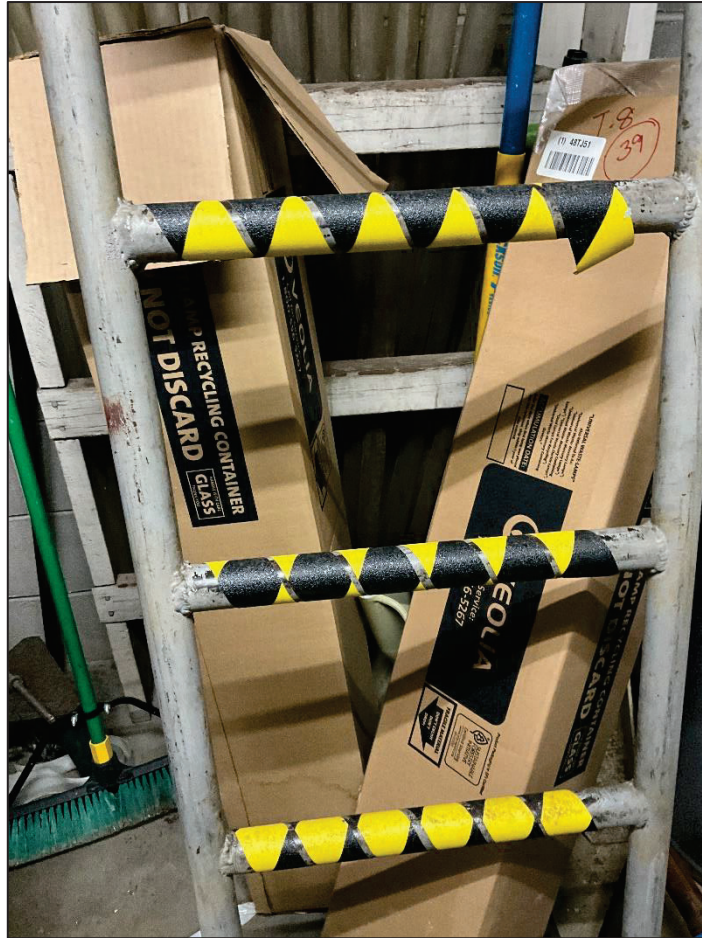
| Photo # | Description | Date |
|---|---|---|
| 29 | Pre-boiler Room - Closed box of universal waste and open box with no universal waste inside. | 1/22/2025 |

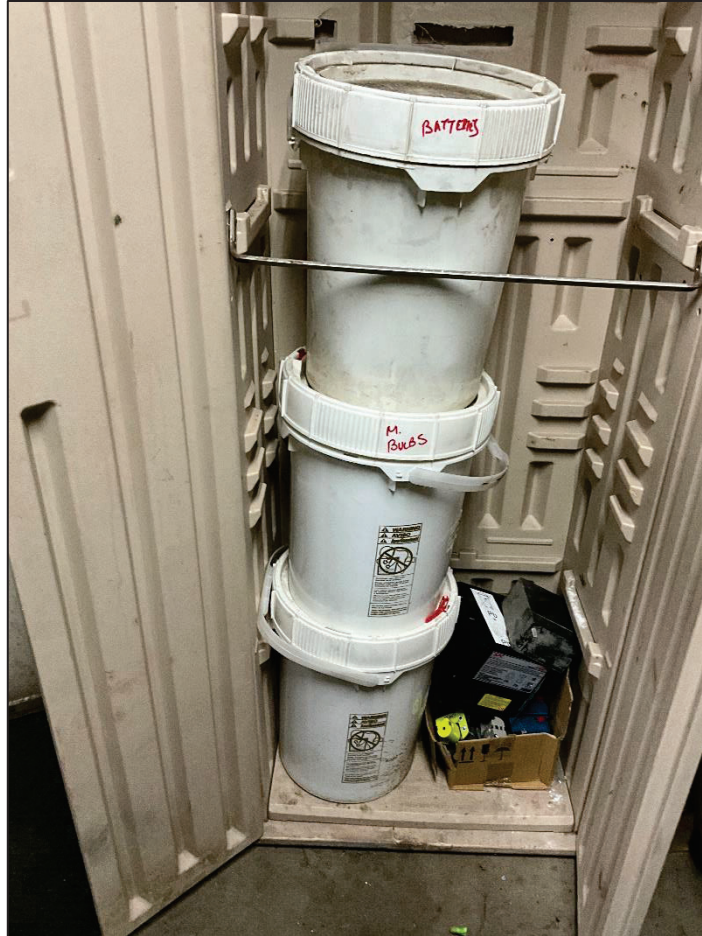
The inspection team also observed a closet with three (3) 5-gallon containers with universal waste as well as an open box with a loose battery pack on it. This closet was located in the pre-boiler room next to the entrance door. In addition, the wall behind the closet had a "UNIVERSAL HAZARDOUS WASTE" sign posted.

| Photo # | Description | Date |
|---|---|---|
| 30 | Pre-boiler Room - Universal waste storage closet | 1/22/2025 |

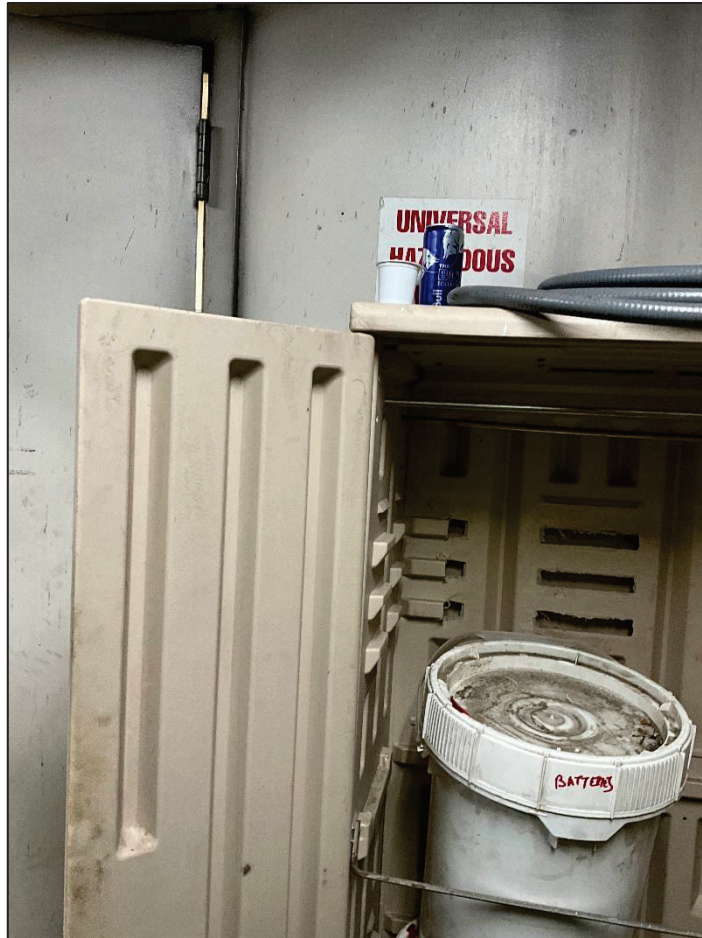
| Photo # | Description | Date |
|---|---|---|
| 31 | Pre-boiler Room - Universal Hazardous Waste signage | 1/22/2025 |
