# **REPORT OF PUBLIC WATER SYSTEM COMPLIANCE INSPECTION**

**AT**  
**Republic County Rural Water District Number 2**  
**1903 North Street, Post Office Box 501**  
**Belleville, Kansas 66935**

**Public Water Supply ID#: KS2015711**

**November 4-5, 2025**

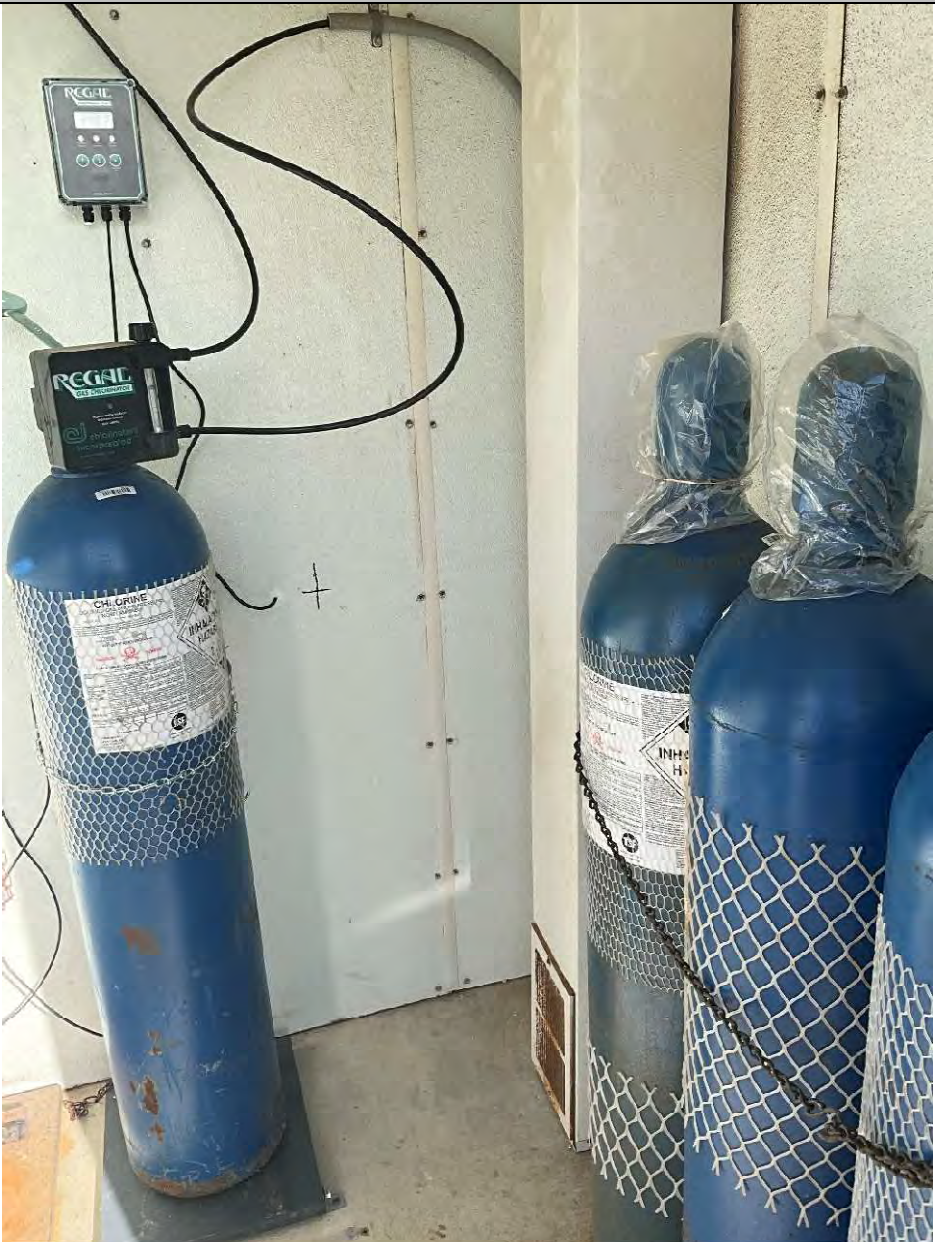
As noted in the system description, the system’s only treatment includes disinfection using gas chlorine. I inspected the District’s chlorine storage room and chlorine injection equipment at the South Well House (Photograph #1). The chlorine storage room, and injection components appeared well maintained and in proper operating condition.

| Number | Photo |
|---|---|
| | <p data-bbox="537 1382 1696 1417">Storage room for gas chlorine cylinders and chlorine feed system with scale and ventilation system</p> <p data-bbox="1020 1455 1209 1484">IMG_0931.JPG</p> |

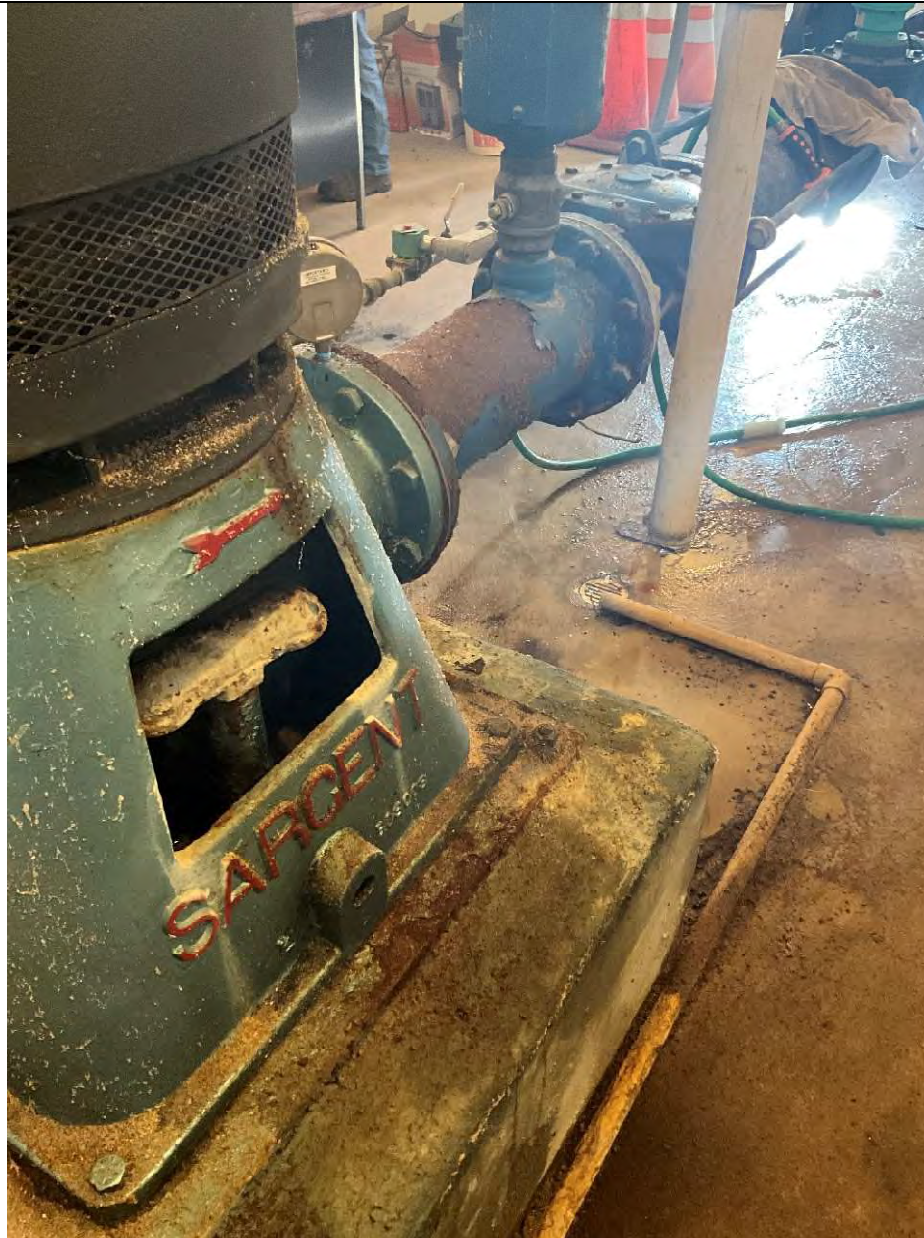
2

During the inspection, I observed each of the active wells. Mr. Vieselmeyer explained that the wells are visually inspected each day and readings and measurements (Photograph #4) are recorded on the daily log. The South Well (Well #3) was observed first, and it was located inside a physically secure, structurally sound, and temperature controlled well house. Water was observed on the floor of the well house and corrosion was noted on the well plumbing and piping (Photograph #3). This issue was listed as Finding #1 of the NOPF provided to the system and discussed during the exit conference. Leaking water in the building and on the plumbing surfaces can lead to an environment that allows or encourages corrosion. Leaks should be repaired to prevent water loss and to ensure a dry environment in the well house. In addition, the raw water sample tap was observed to have a threaded opening and was not a smoothed nosed sample tap. This issue was noted as Finding #2 in the NOPF. According to Kansas Minimum Design Standards, "*Smooth-nosed sampling taps shall be provided, for control purposes, for each raw water source*", in addition the Design Standards also reference the following American Water Works Association information, "AWWA Standard C651-05 recommends the use of a specially installed sampling tap consisting of a smooth, unthreaded, 0.5-inch hose bib". Therefore, the threaded sample tap should be replaced with a smooth nosed sample tap as required by the State's design guide.

South Well with pump motor, casing vent, concrete well base, and pressure relief valve screened discharge line. Note corrosion on piping

- 1) Corrosion of piping of the South Well (Well #3). Ensure painting of pipe surfaces is conducted and consider dehumidification in the well house to prevent corrosion of piping.

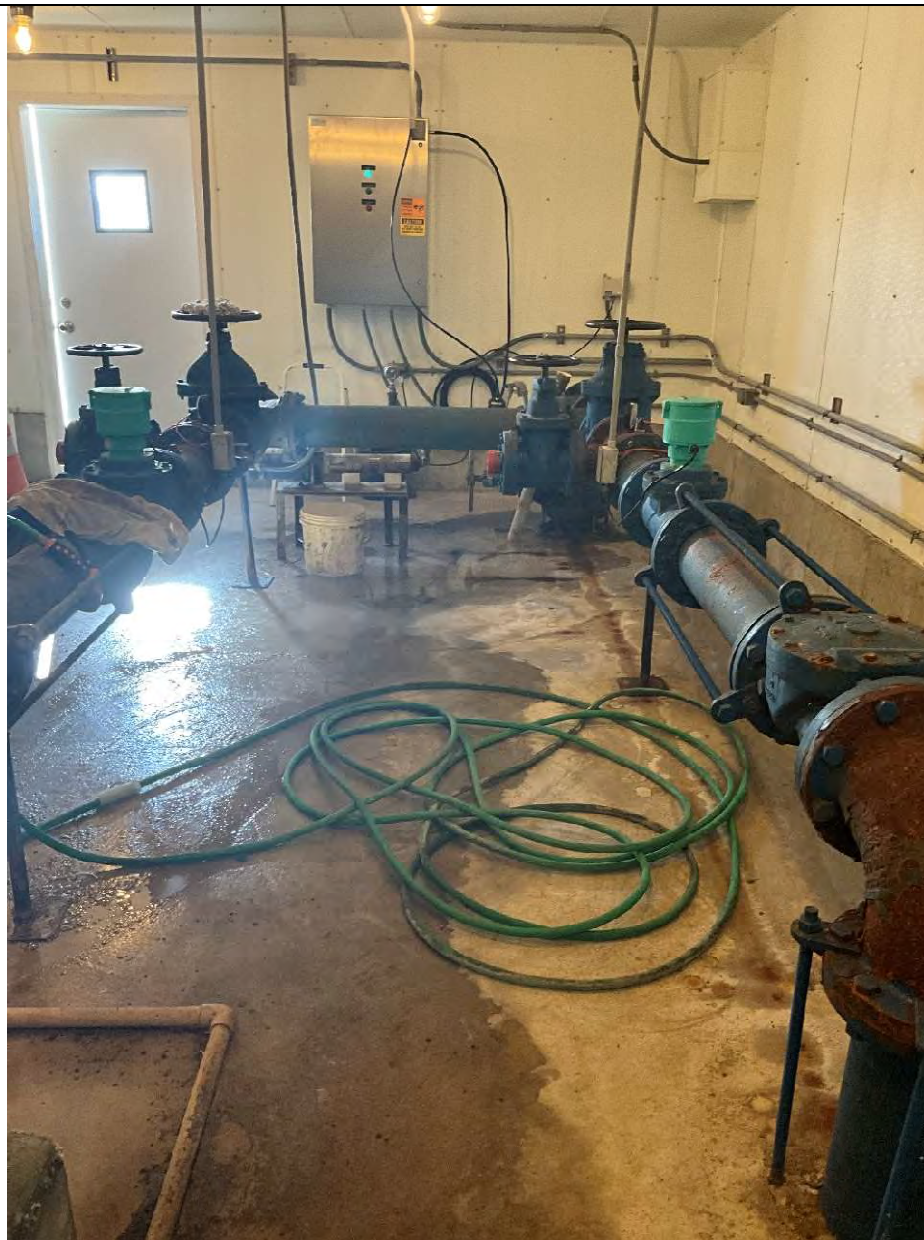
3

View of South Well piping

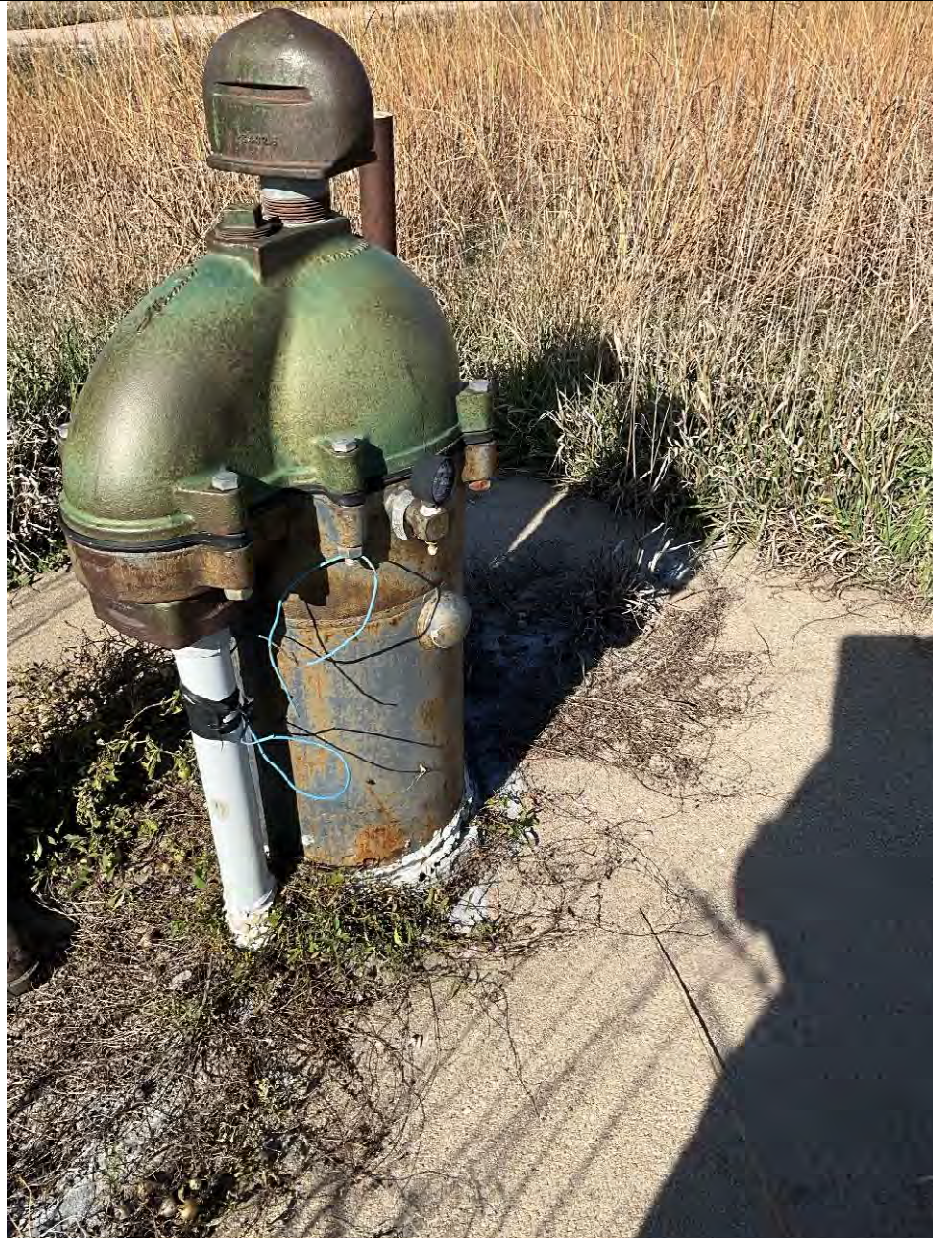
5

The North Well (Well #4), a submersible pump, was located outside of the treatment building. I noted that the well had adequate physical protection with concrete posts, the well vent cap was securely bolted (Photograph #5) and the well screen intact. The concrete pad for the well had a large crack through the center of the pad and tall vegetation had grown up around the well pad. These issues were listed as Findings #3 and #4 on the NOPF. The well pad should be stable to prevent settling or expansion of the pad that could affect the well's operations. Vegetation should be controlled around the well to prevent rodents or other small animals from nesting near the well structure. In addition, I also observed that the pressure gauge for the well was inoperable. This Finding was listed as Finding #5 in the NOPF. Pressure gauges are important for ensuring proper pumping and operating pressures are maintained in order to supply water to the distribution system.

- 2) Threaded sample points on South Well.
- 3) Tall vegetation surrounding the North Well (Well #4).
- 4) Large crack in the concrete well pad of North Well.

North Well – submersible pump with cracked concrete pad and tall vegetation surrounding

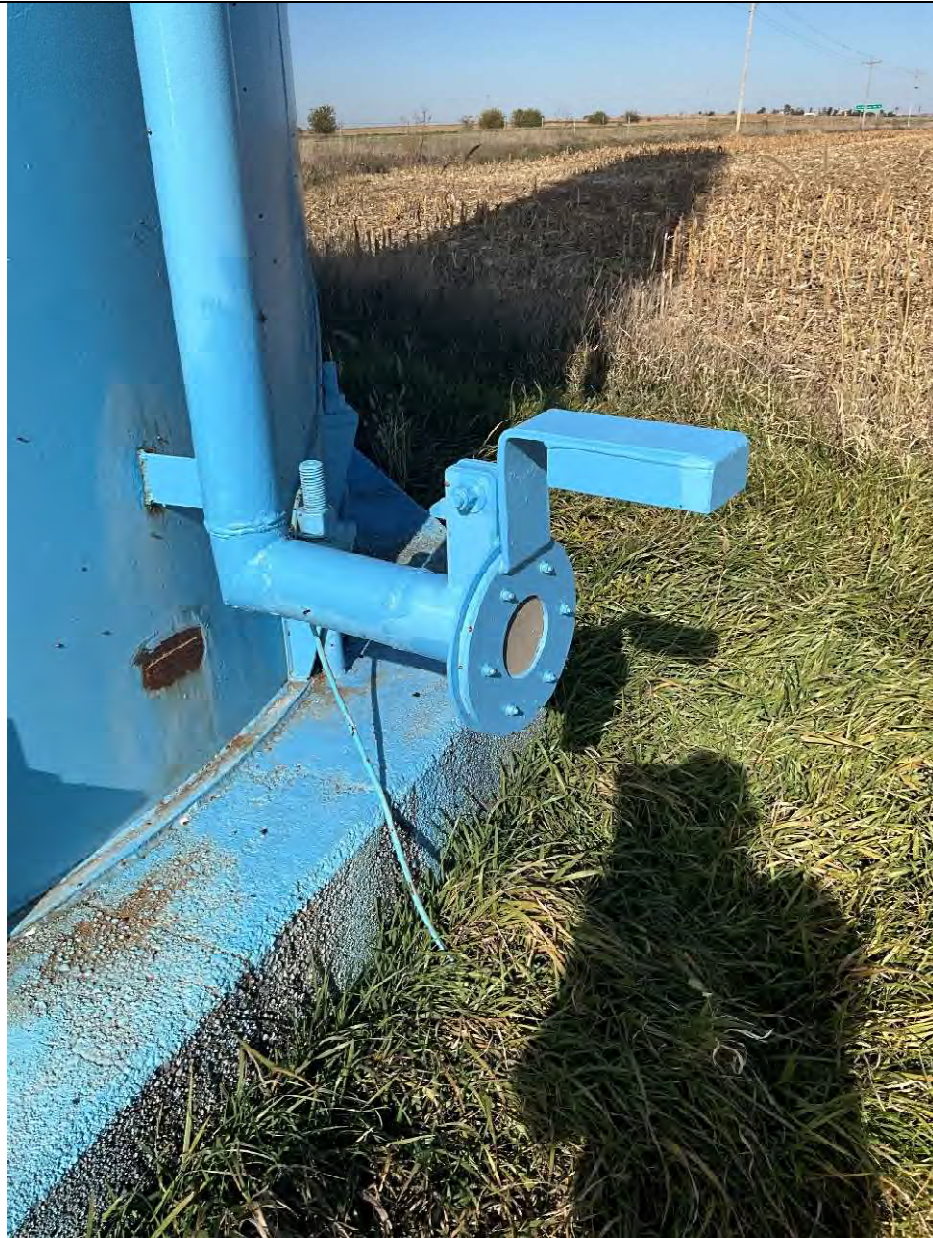
7

Finding #7 – There was no splash pad located under the overflow of the 81 Tower (Photograph #7). Splashpads are important to prevent erosion near the base of the standpipe and to ensure stability of the base.

81 Tower -overflow discharge outlet with screen and without splash pad

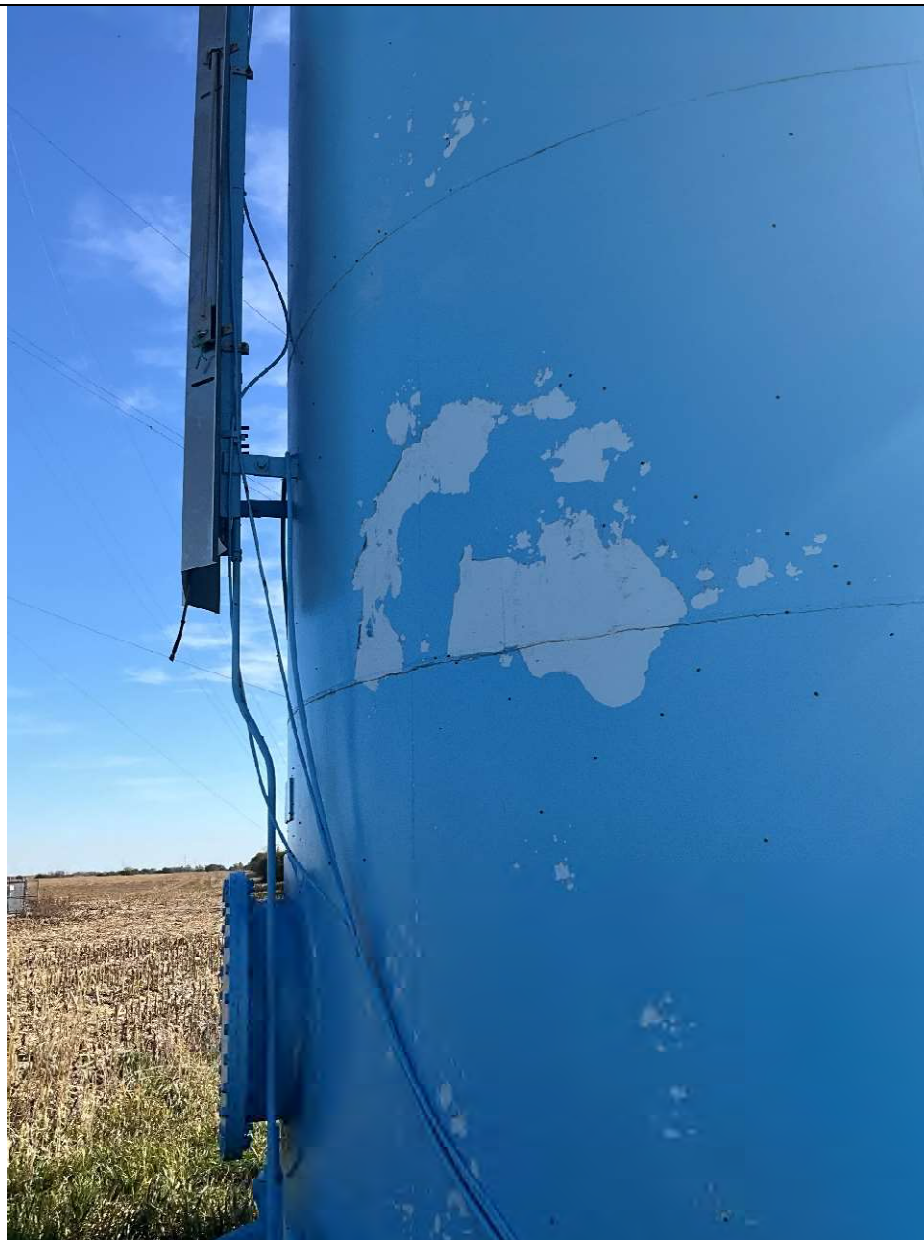
8

Finding #6 – The exterior paint of the 81 Tower was flaking and peeling (Photograph #8). District staff explained that this standpipe was painted less than 1 year prior and is working with the contractor to explore warranty coverage to correct the issue.

81 Tower exterior paint peeling after being recently painted

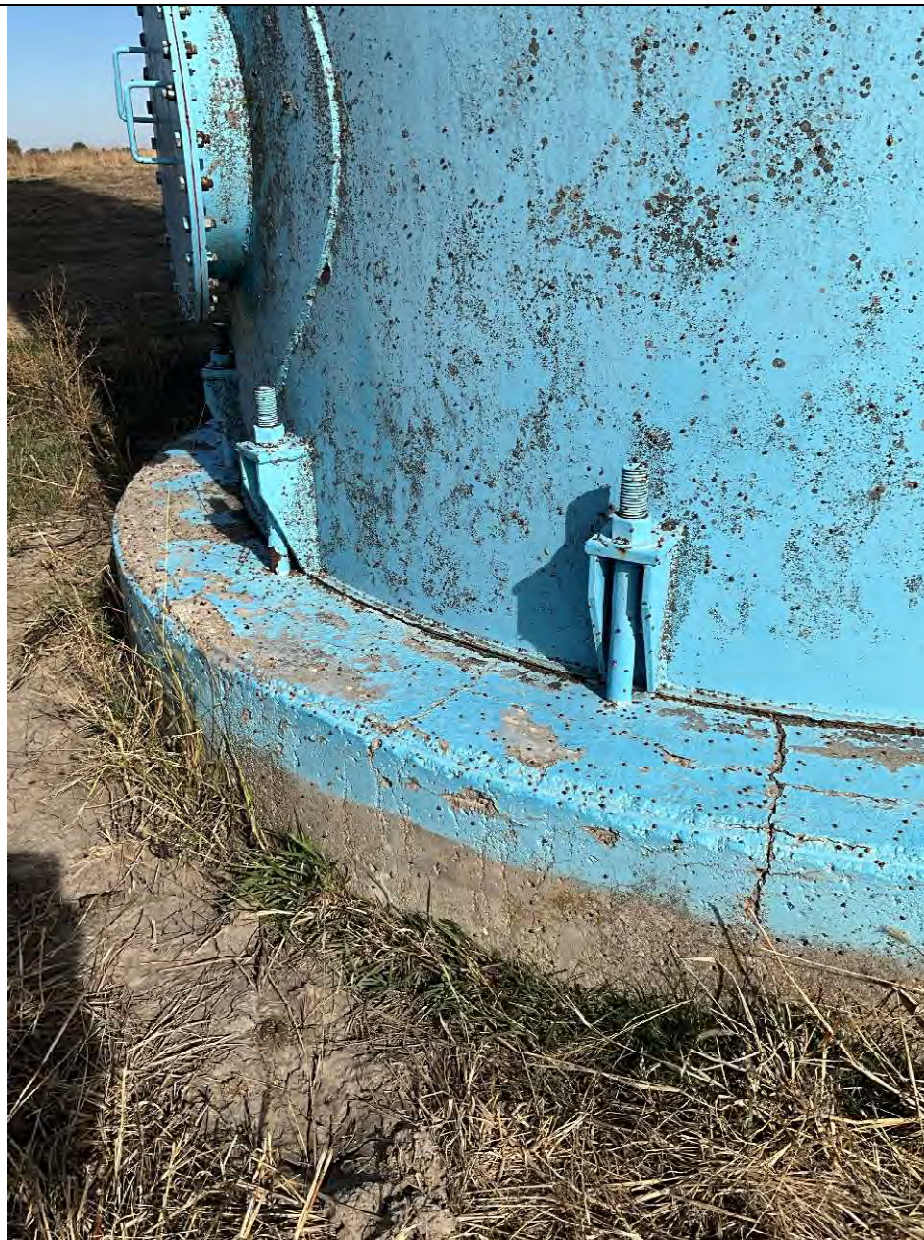
10

Finding #9 – While observing the standpipes’ concrete bases, there were various levels of cracking or pitting noted of concrete bases of the Francis Tower (Photograph #10), Norway Tower (Photograph #13), and Narka Tower (Photograph #16).

Mildew accumulation on exterior paint and cracks in the concrete base of the Francis Tower

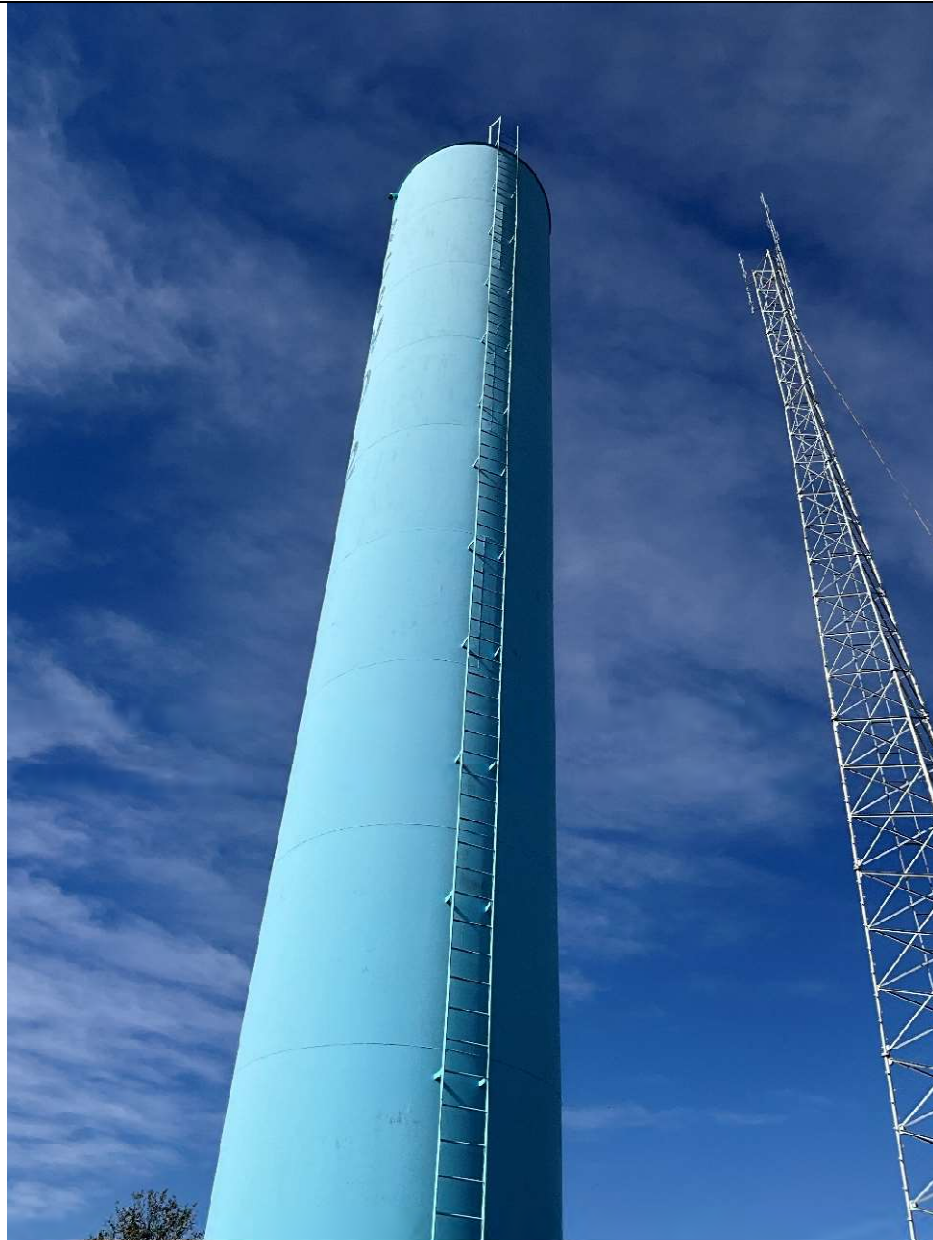
11

Finding #8 – The overflow of the Francis Tower (Photograph #11) and Norway Towers were not extended down to 12 to 24 inches above ground level as required by the KS Minimum Design Standards. Overflows shall be located 12 to 24” above ground level to allow for inspection to ensure insects or animals are not allowed to enter overflow or the standpipe.

Francis Tower exterior – note the overflow is screeded but not extended to ground level

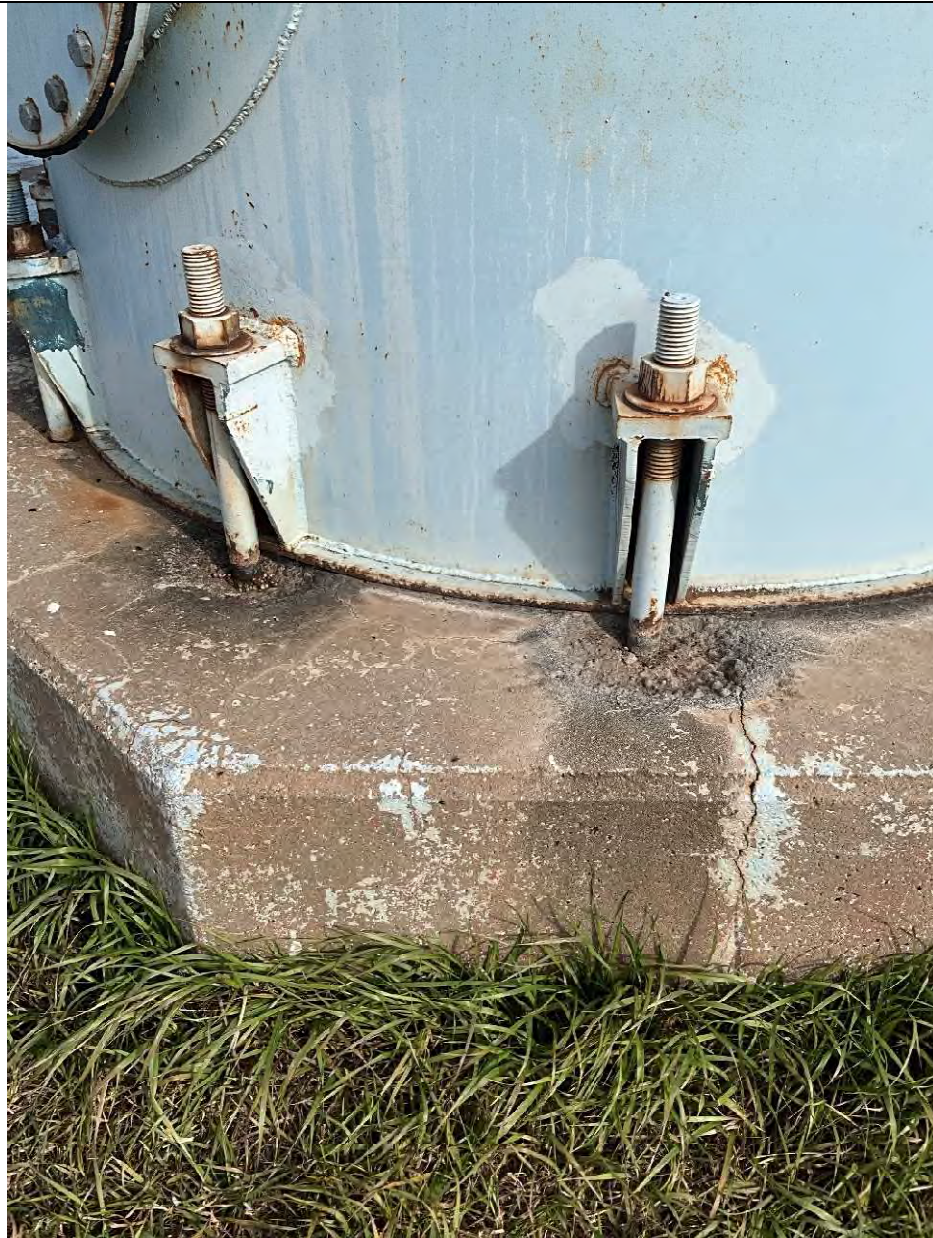
13

Norway Tower concrete base with cracks and pitting around the foundation bolts

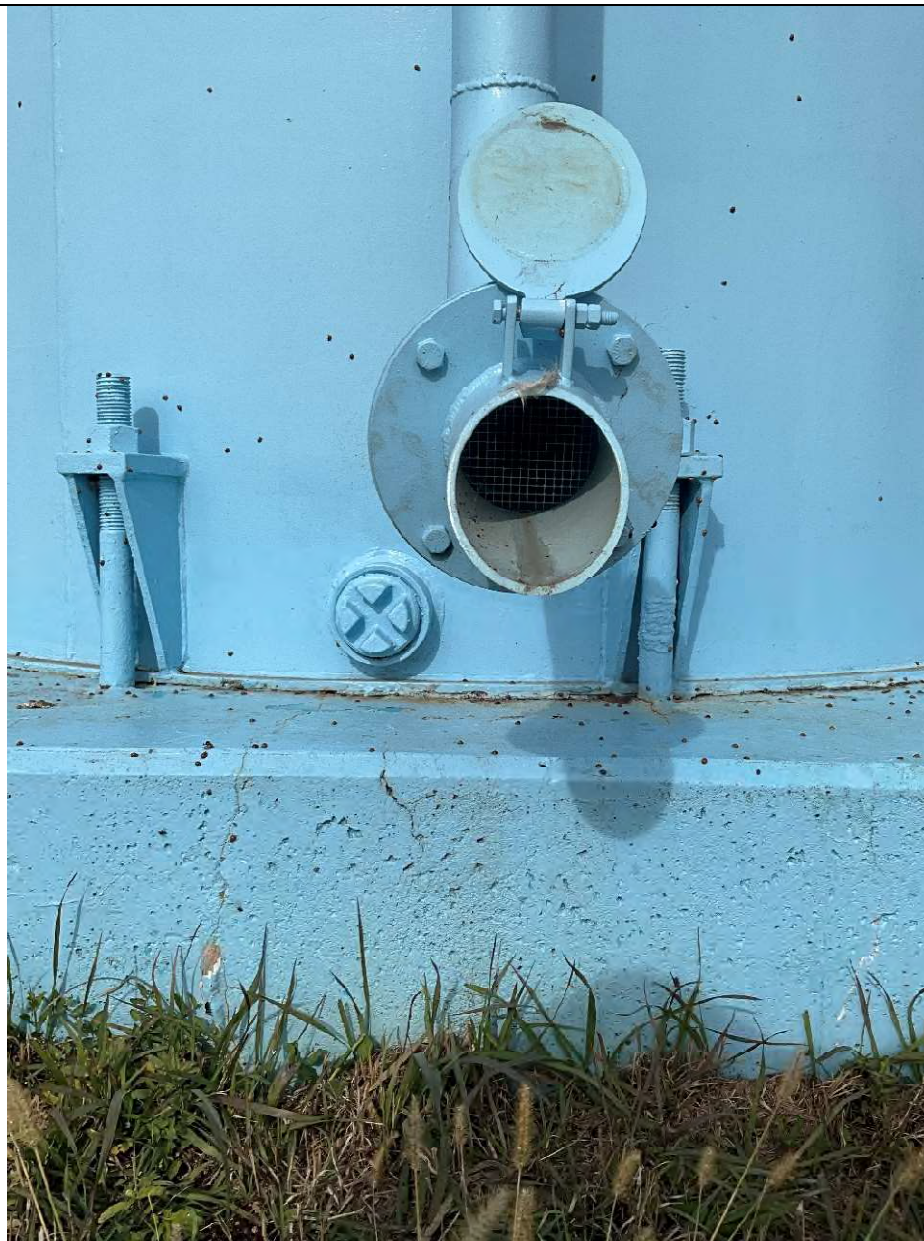
15

Cuba Tower overflow extended to 12-24" above the ground with screen

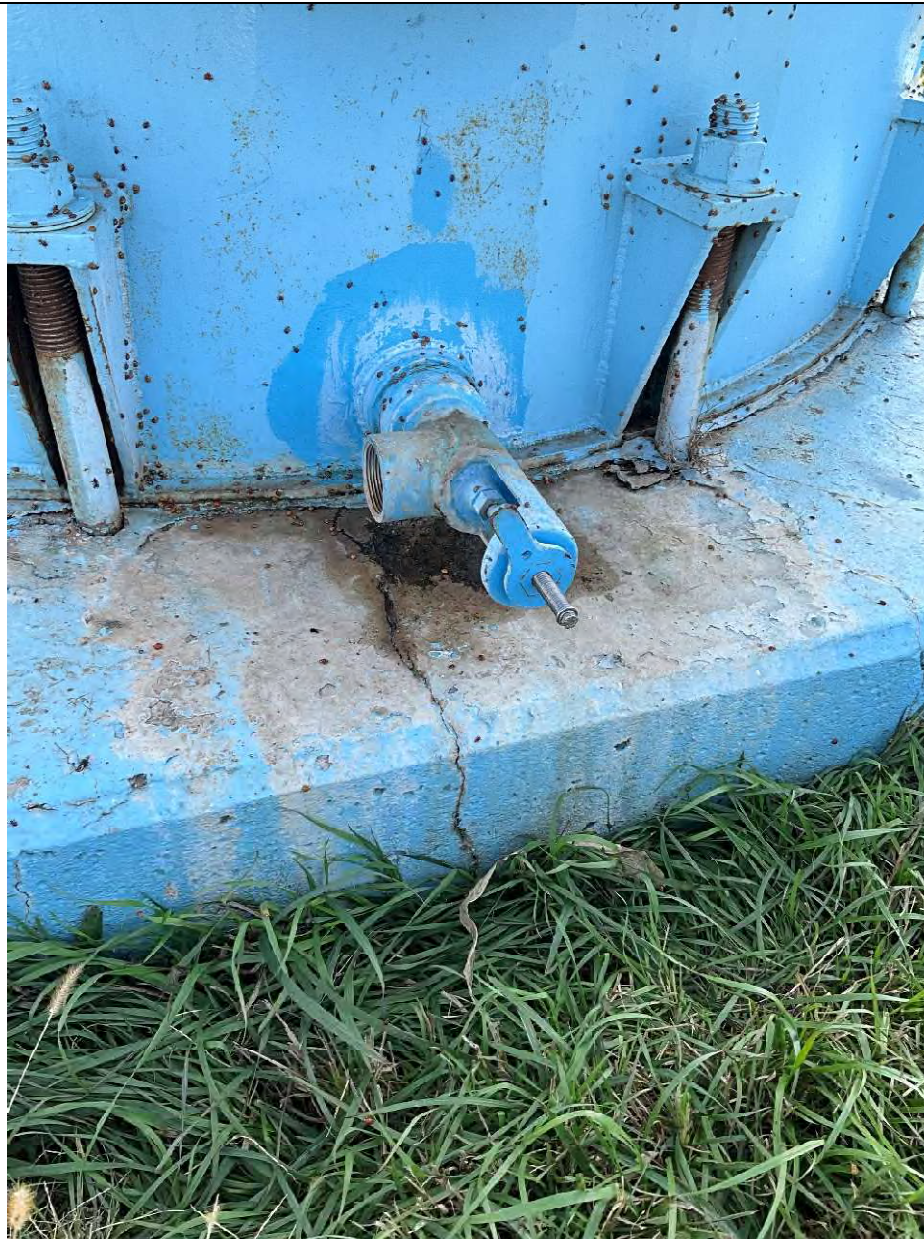
Narka Tower drain valve and concrete base with cracking

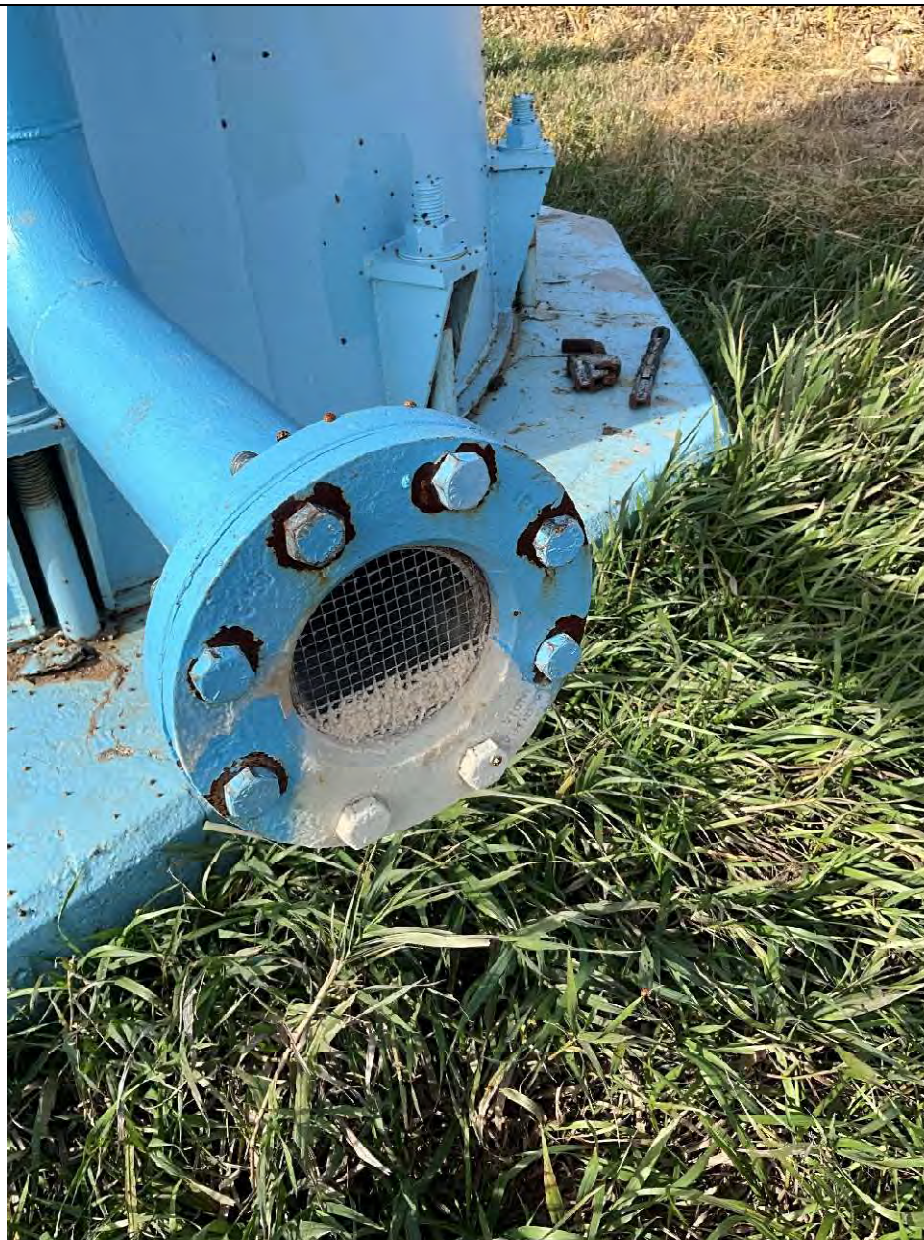
17

Narka Tower overflow with screen note calcium accumulation on the overflow screen

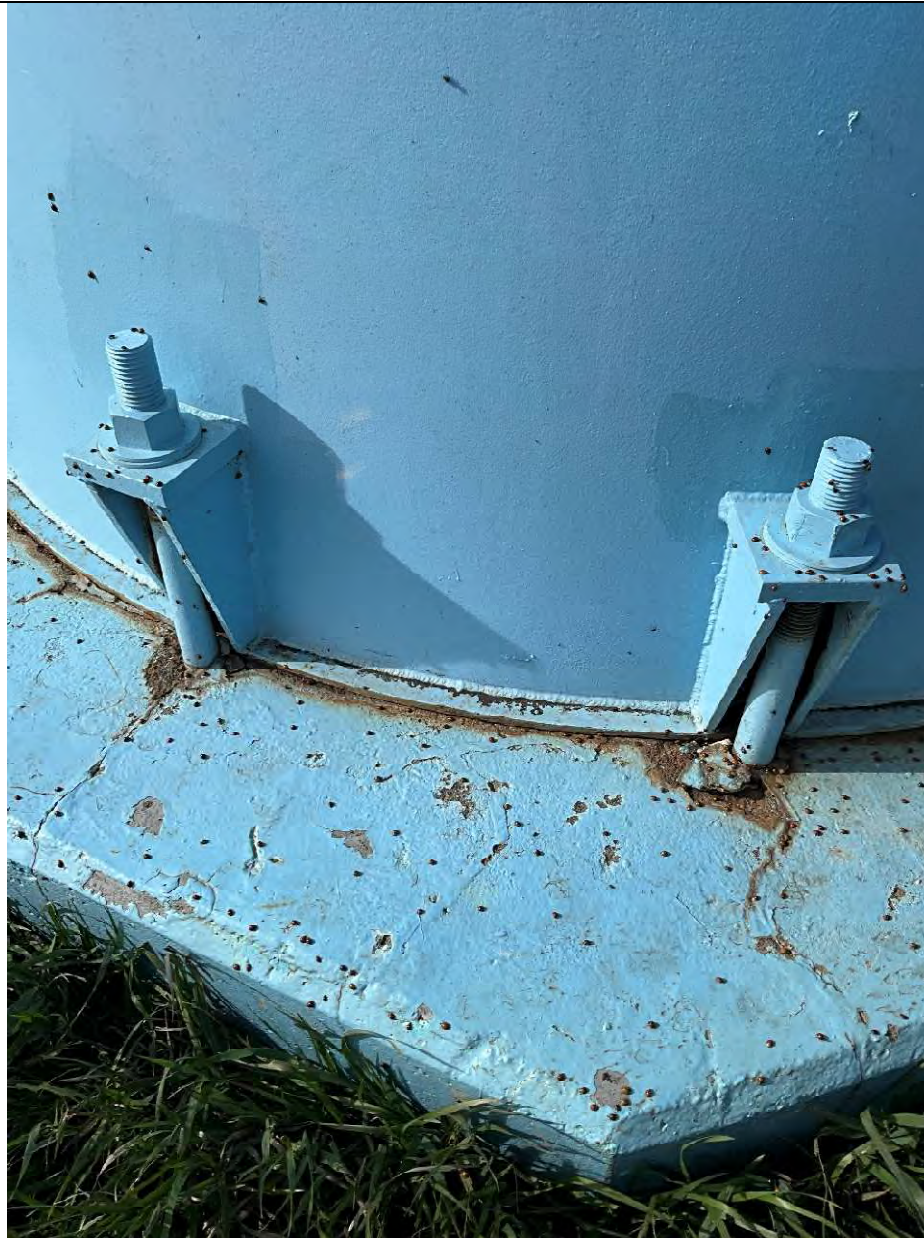
18

Narka Tower concrete base with minor cracking

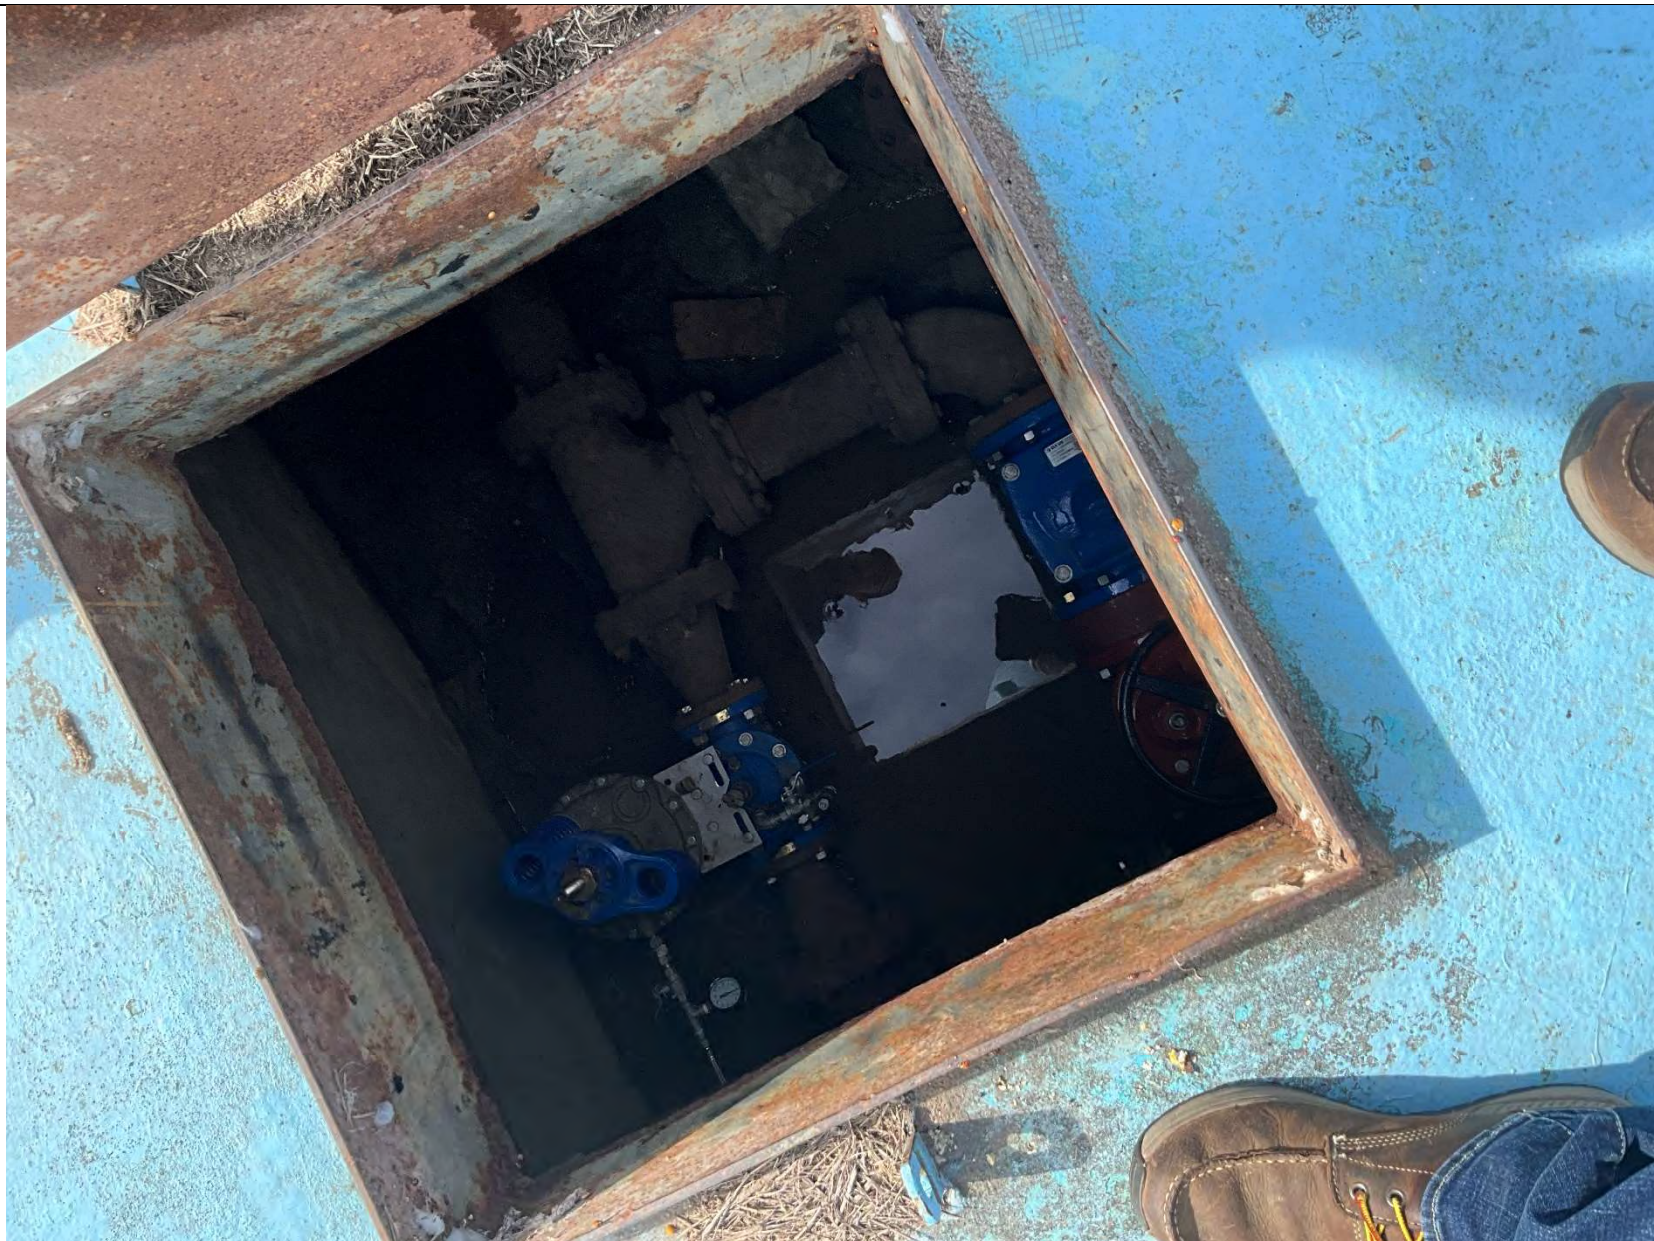
19

Narka Tower altitude valve vault with leak observed

These findings were discussed with District staff during the exit meeting at the close of the inspection. Mr. Vieselmeyer explained that the leaking valve would be repaired immediately, and the other issues would be discussed with the Board and the inspection company to determine which repairs would be the priority.
