Region 2 Enforcement & Compliance Assurance Division
Air Compliance Branch
CAA Inspection Report

Inspection Date: 2/14/2024

Facility Name: Quality Electroplating Corporation

Appendix A: Digital Image Log for Quality Electroplating Corporation, Caguas, PR

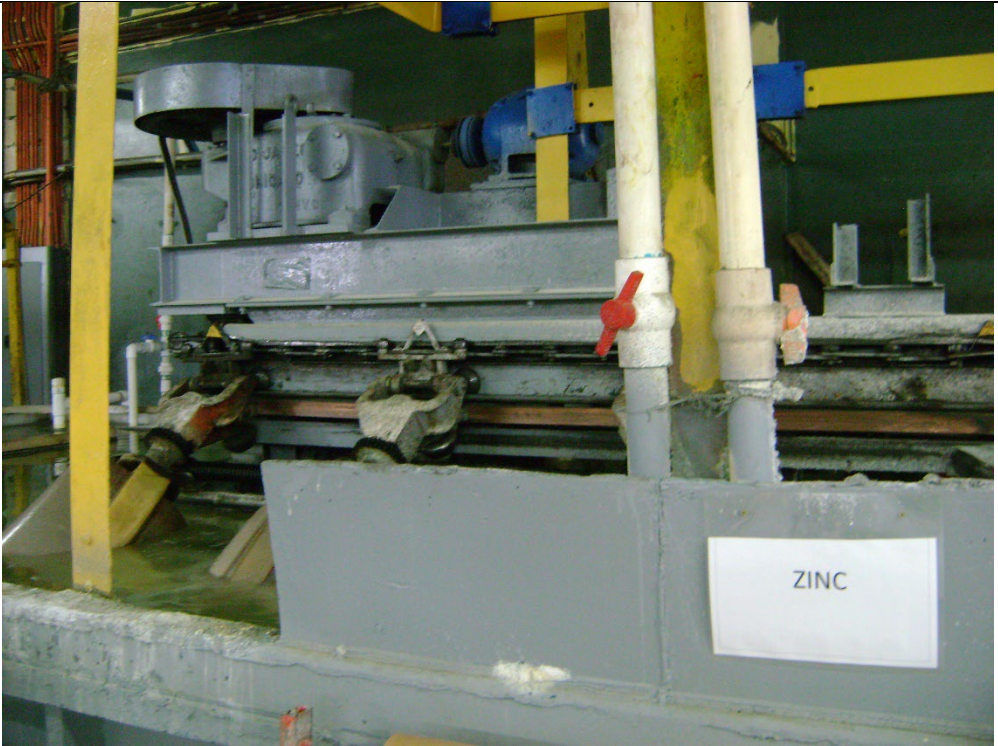
7	DSC01255.JPG

Zinc electroplating line.

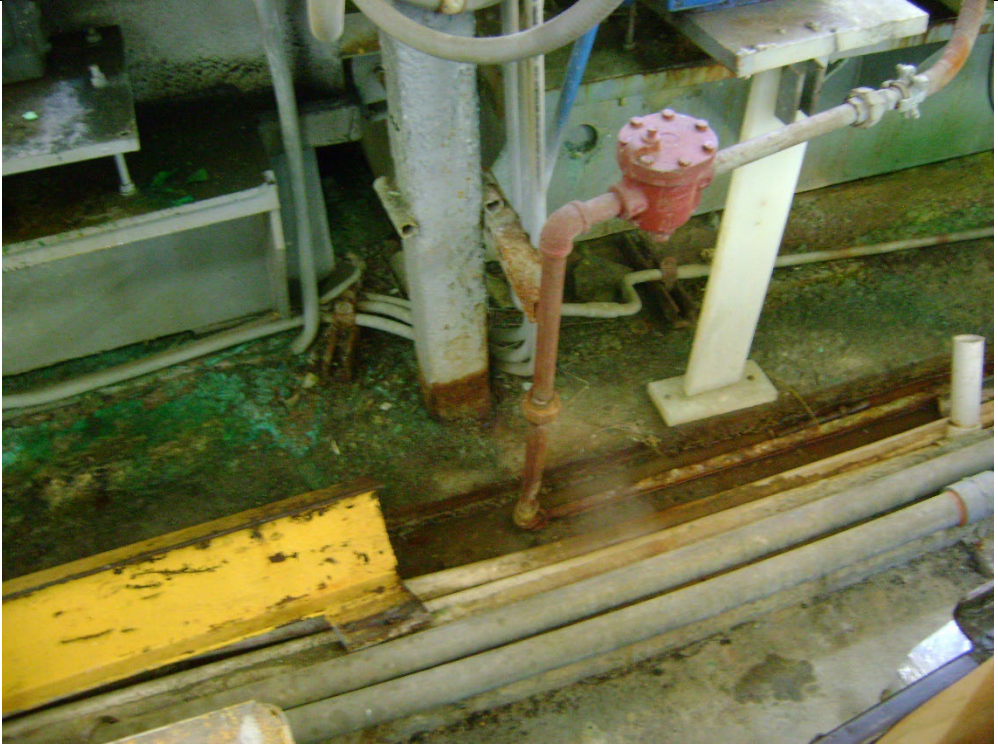
8	DSC01256.JPG

electroplating area that had visible vapor emissions leaking from a coupling (see image 8). Ms. Miranda told the inspectors the emissions were water vapor.

Leaking pipe with visible vapor emissions.

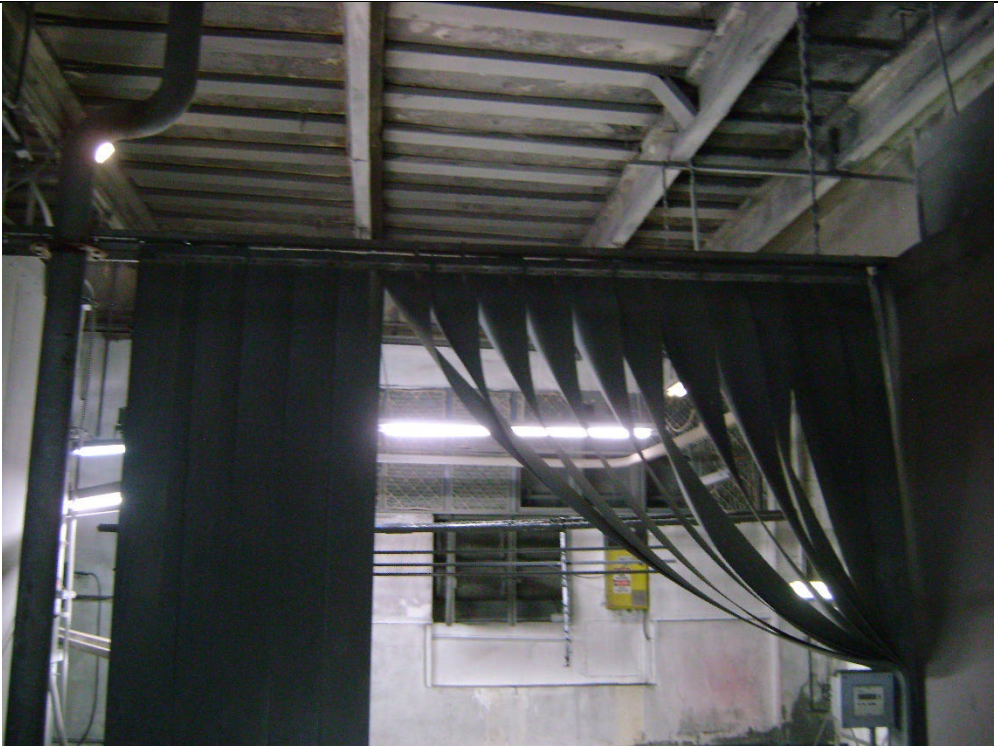
13	DSC01261.JPG

At the large part powder coating area, the inspectors noted there are plastic strip curtains hanging to separate the coating area from other areas of the building, but the curtains do not extend all the way to the ceiling (see image 13). The inspectors also observed air filters on the back wall of the coating area which appeared very dirty (see image 14). Ms. Miranda indicated these filters are the only form of emission control in this area. She showed the inspectors two coating drying ovens for large parts which have open ended exhaust pipes that vent back into the room (see images 15, 18, and 19).

2/14/2024	12:06 pm
<p>Large part powder spray coating area. Strip curtain open and does not extend all the way to the ceiling.</p>

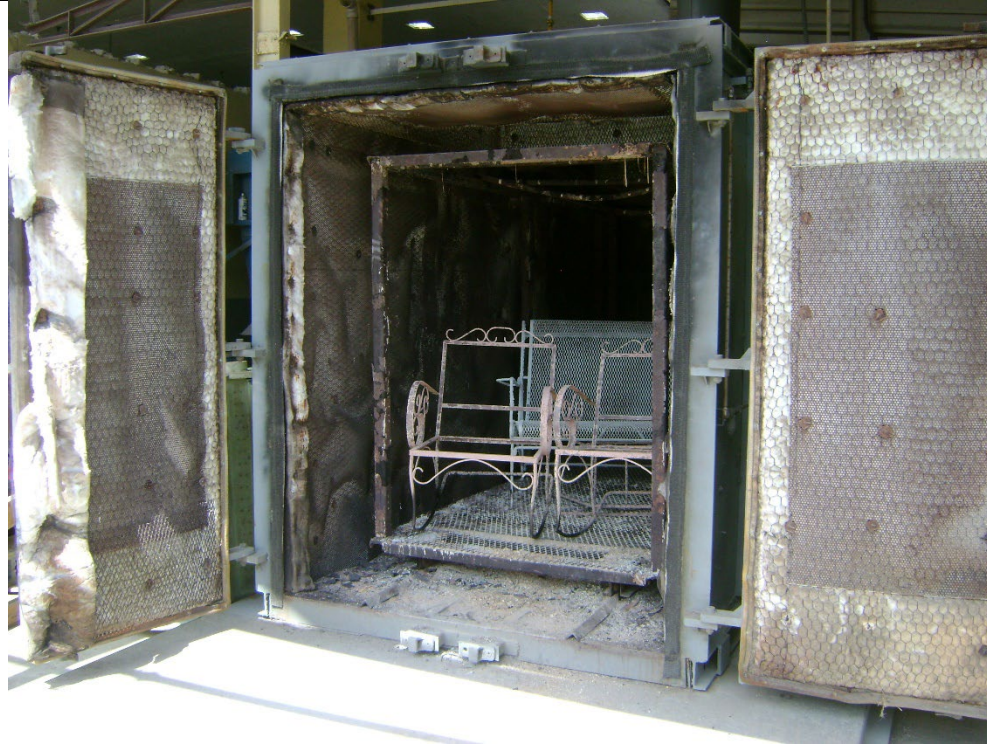
22

Outside the building, the inspectors noticed an enclosure with several metal chairs sitting inside of it that appeared to have been stripped of their original coating (see image 22). Ms. Miranda informed the inspectors that the enclosure is an incinerator which the facility uses to remove coatings from metal items. The incinerator did not appear to have any emission controls and is vented through the roof of the building where it is located (see image 25). The inspectors observed a large machine running which appeared to be a control device. Ms. Miranda informed the inspectors that the device is the filter for the facility's sand blasting operation and that it contains 8 filters (see image 24). She told the inspectors she was not sure why it was running because there was no sand blasting being done at that time. The inspectors observed the inside of the sand blasting building and noted that the air intake on the ceiling of the building appeared to have a pre-filter that was in poor condition (see image 26).

Incinerator with metal chairs inside. Used for removing coatings from parts.

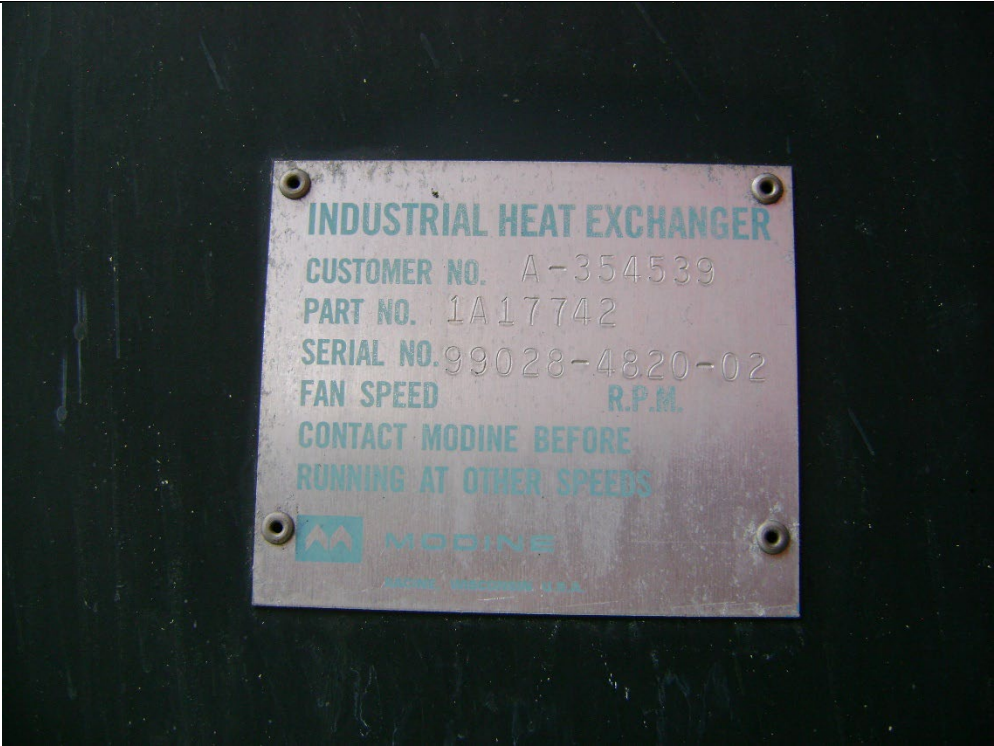
39	DSC01290.JPG

Plate on backup electricity generator.

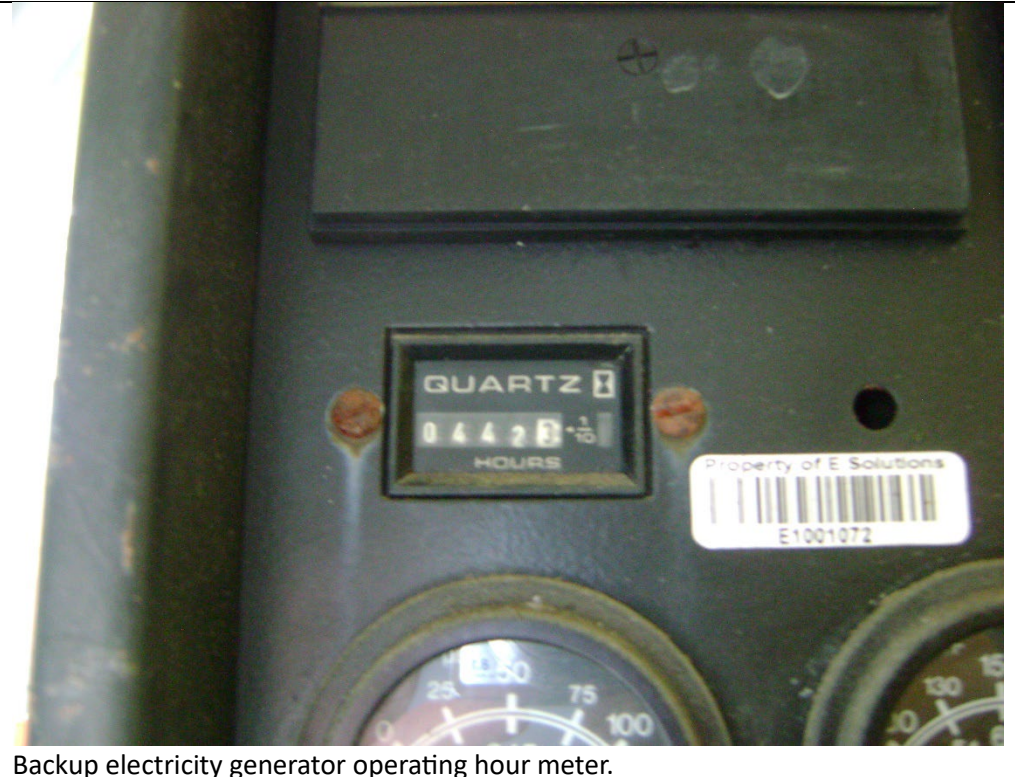
41	DSC01293.JPG

Backup electricity generator operating hour meter.

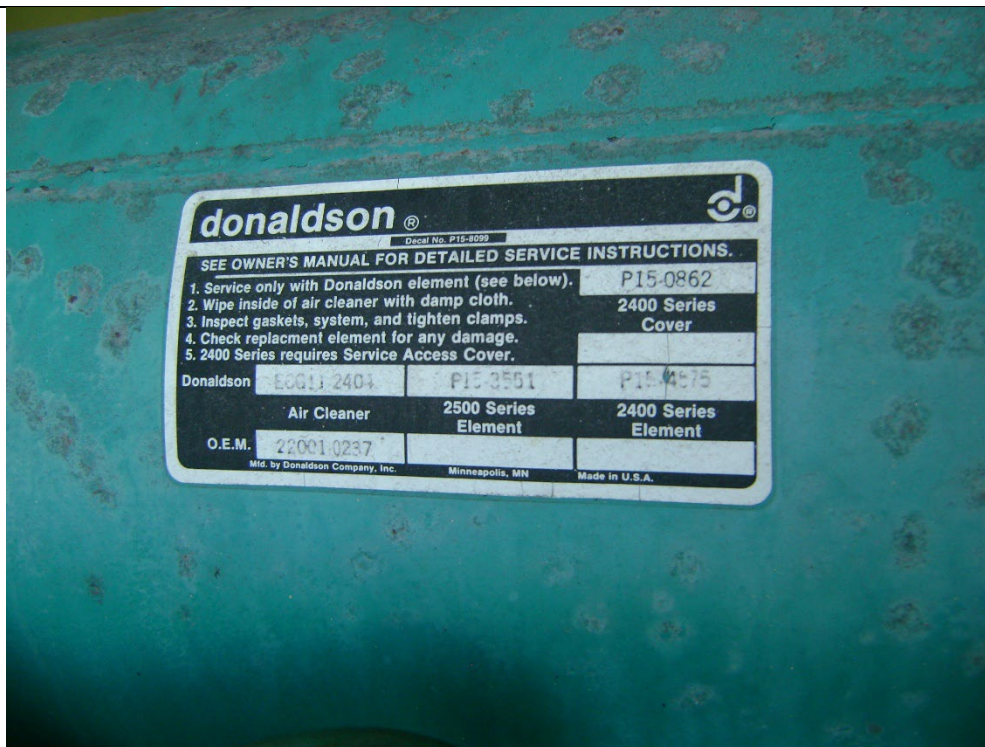
44

Plate on emergency generator.

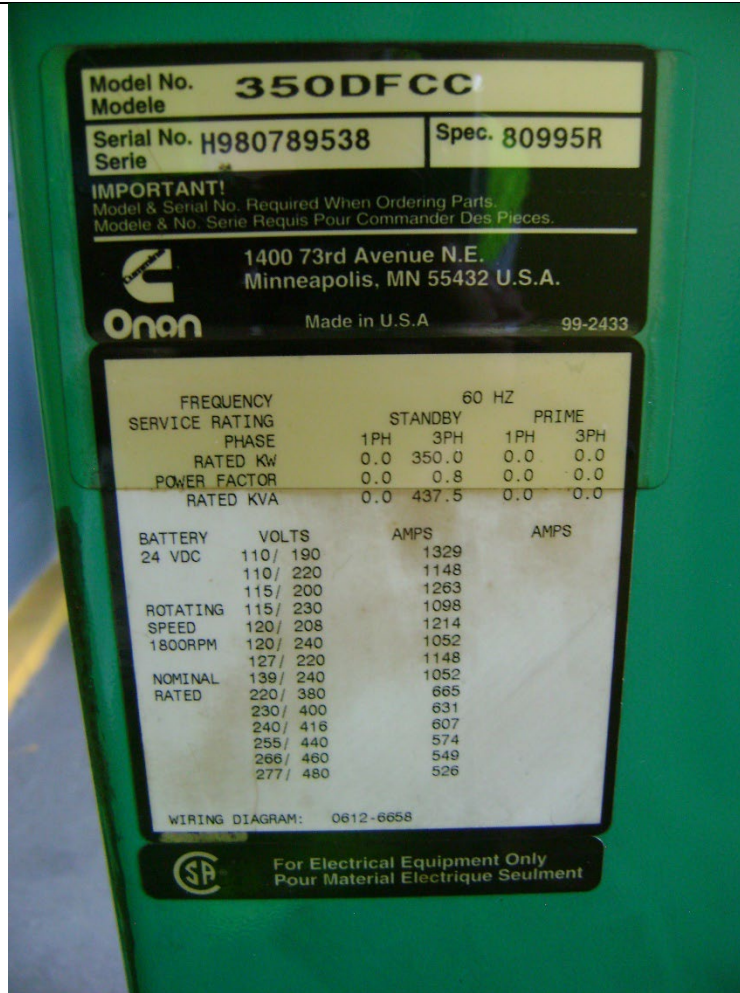
45

Plate on emergency generator.
