INSPECTION REPORT

| Type of Inspection | Compliance Evaluation Inspection (CEI) | |
| Facility or Site Name | City of Raton Water Filtration Facility | |
| Permit Number(s) (If Applicable) | NM0029891 | |

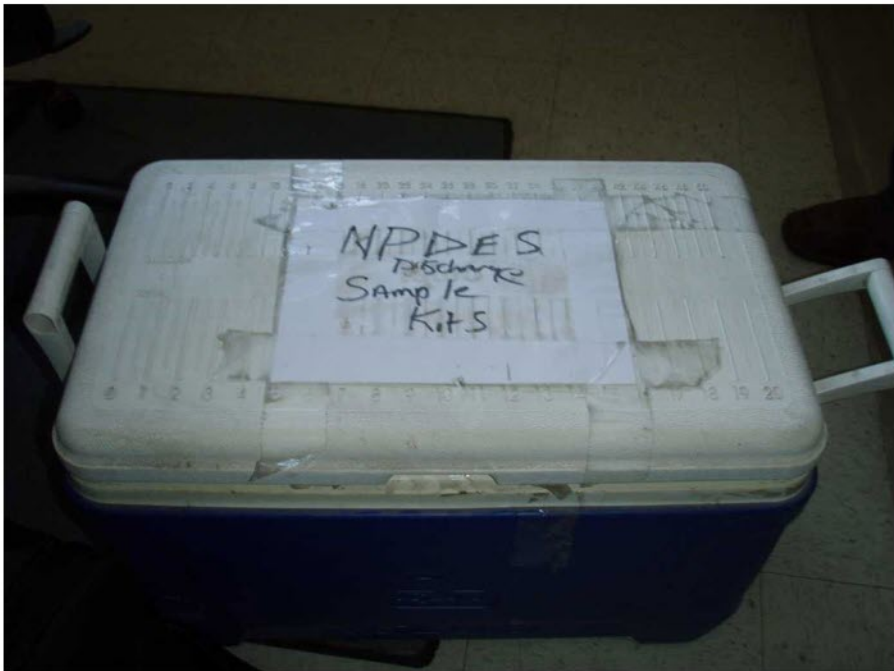
| Sampling Cooler | | | P1011067.JPG |

Facility had a prepared sampling cooler that contained all sample bottles necessary if a discharge would occur.

| Cooler containing necessary sampling bottles if a discharge would occur. | | | |

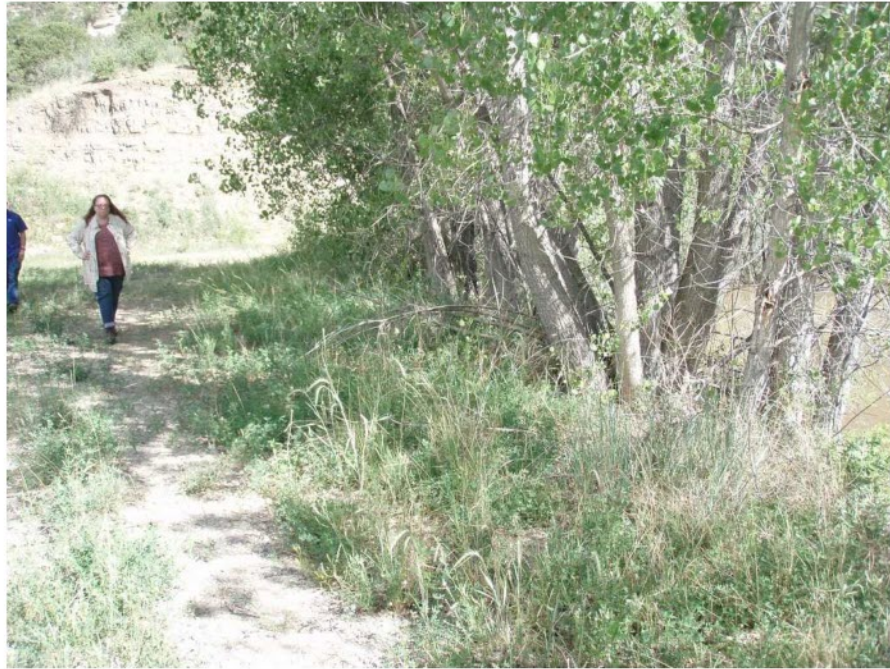
| Basin Levies | | | P1011072.JPG |

At the time of the inspection, large trees were growing and embedded in the overflow / down gradient of the settling basin. The tree roots weaken the berm and may lead to bypass paths of the outfall.

| AOC Reference #: KA1-OB-005 | Location: 2. Treatment System/Settling Basin |
|---|---|
| 122.41(e) - (e) Proper operation and maintenance. The permittee shall at all times properly operate and maintain all facilities and systems of treatment and control... | |
| <b>AOC:</b><br><br>At the time of the inspection, large trees were growing and embedded in the overflow / down gradient of the settling basin. The tree roots weaken the berm and may lead to bypass paths of the outfall. | |

| Heavy tree growth on the downside of the settling basins. | | | |

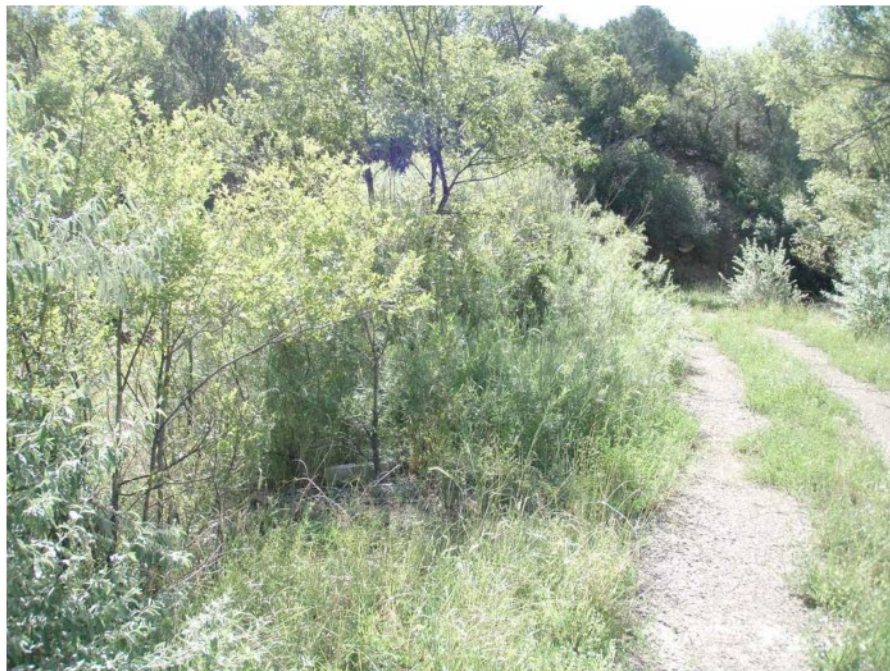
| Basin Levees | | | P1011073.JPG |

| Heavy tree growth on the downside of the settling basins levee. | | | |

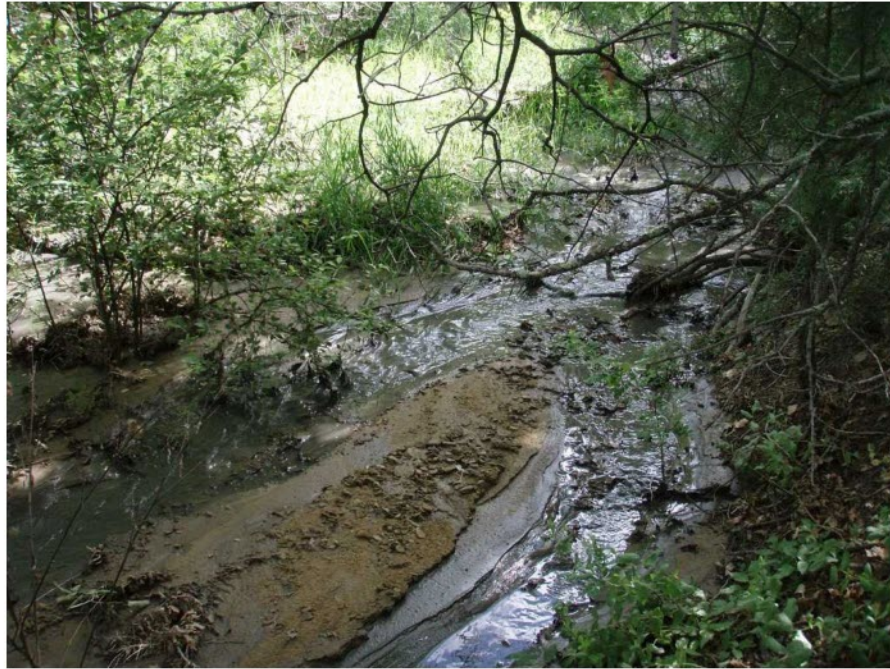
| Raw Water Bypass | | | P1011075.JPG |

| <b>Location:</b> 2. Treatment System/Raw Water Tank | | |
|---|---|---|
| At the time of the inspection, the 2.5million gallon Raw Water Tank was being cleaned and repaired. The sediment that was being removed from the tank was being discharged directly to an ephemeral arroyo, thence to Raton Creek, thence to Chicorica Creek, thence to the Canadian River in segment 20.6.4.305 of the Canadian River Basin according to the State of New Mexico Standards for Interstate and Intrastate Surface Waters, 20.6.4 NMAC bypassing the permitted outfall. The discharge consisted of heavy solids that were vacuumed out of the Raw Water Tank. | | |

| AOC Reference #: KA1-OB-004 | Location: 2. Treatment System/Raw Water Tank |
|---|---|
| <b>Regulation and/or Permit Requirement</b><br><br>NPDES Permit NM0029891 Part I. D. Overflow Reporting | |
| <b>AOC:</b><br><br>At the time of the inspection, the 2.5million-gallon Raw Water Tank was being cleaned and repaired. The sediment that was being removed from the tank was being discharged directly to an ephemeral arroyo, thence to Raton Creek, thence to Chicorica Creek, thence to the Canadian River in segment 20.6.4.305 of the Canadian River Basin according to the State of New Mexico Standards for Interstate and Intrastate Surface Waters, 20.6.4 NMAC bypassing the permitted outfall. The discharge consisted of heavy solids that were vacuumed out of the Raw Water Tank. | |

| Discharge from the raw water cleaning that was bypassing the settling basins permitted discharge location. | | | |

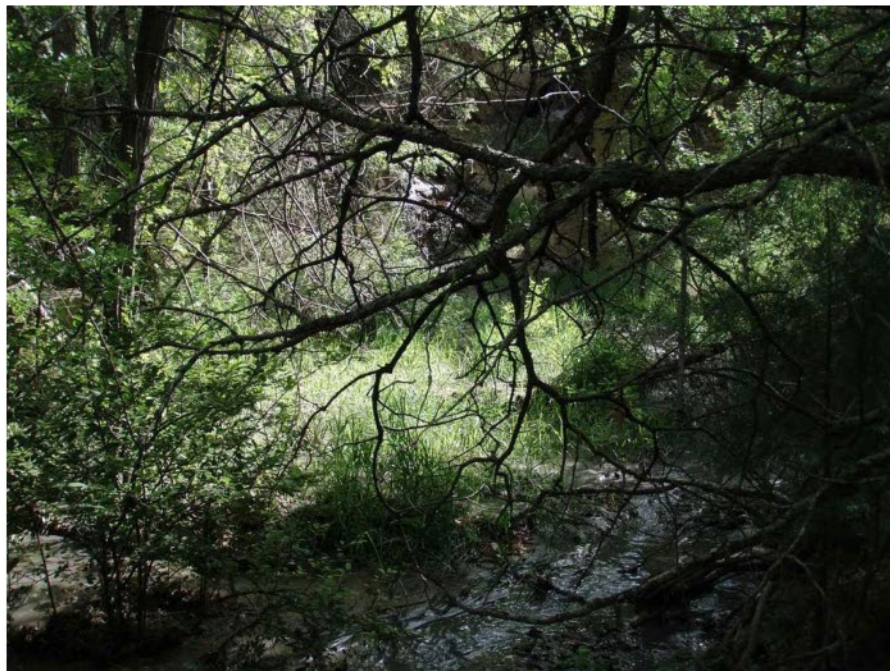
| Discharge from Raw Water tank cleaning | | | P1011076.JPG |

| Discharge from the raw water tank cleaning that was bypassing the settling basins permitted discharge location. | | | |

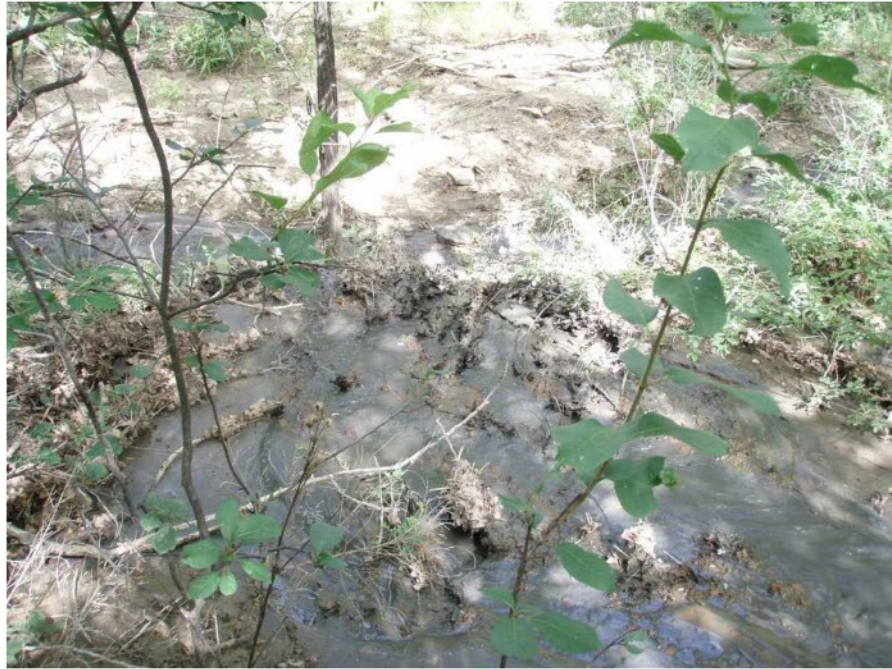
| Raw Water Tank Cleaning Discharge | | | P1011077.JPG |

| Discharge from the raw water tank cleaning that was bypassing the settling basins permitted discharge location. | | | |

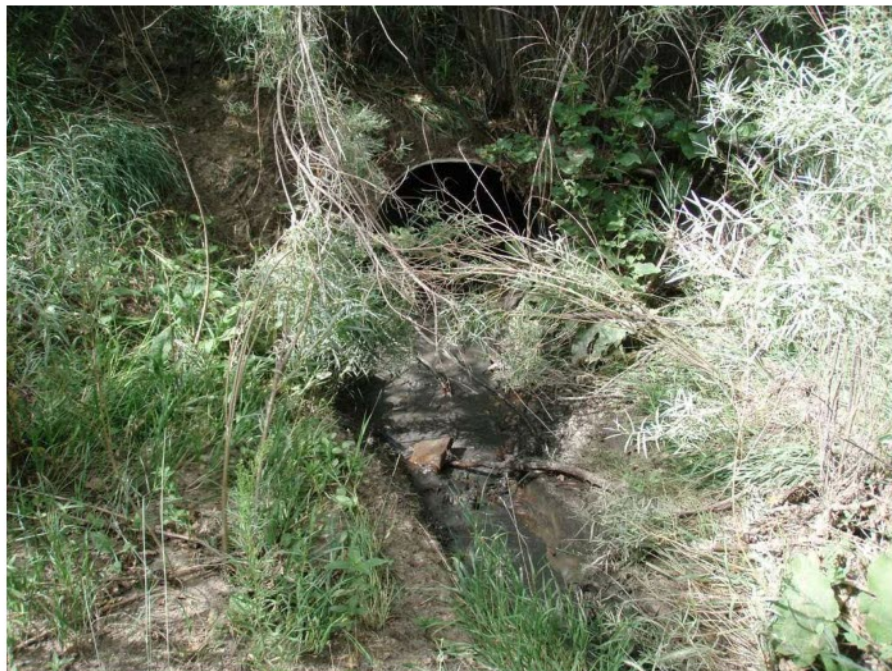
| Raw Water Tank Cleaning Discharge/Bypass | | | P1011078.JPG |

| Discharge from the raw water tank cleaning that was bypassing the settling basins permitted discharge location. | | | |

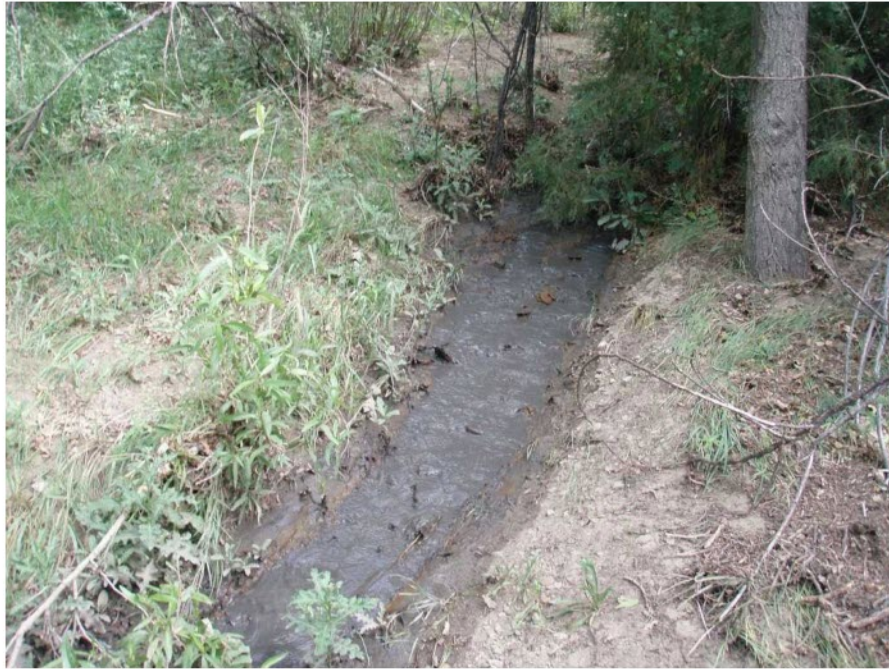
| Raw Water Cleaning Discharge / Bypass | | | P1011079.JPG |

| Discharge from the raw water tank cleaning that was bypassing the settling basins permitted discharge location. | | | |

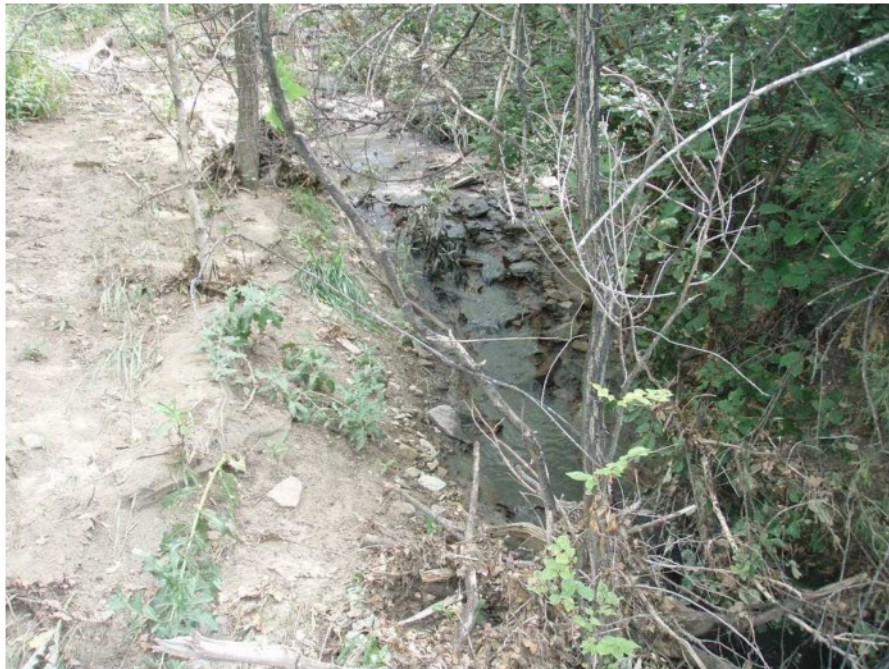
| Raw Water Tank Cleaning Discharge/Bypass | | | P1011080.JPG |

| Discharge from the raw water tank cleaning that was bypassing the settling basins permitted discharge location. | | | |

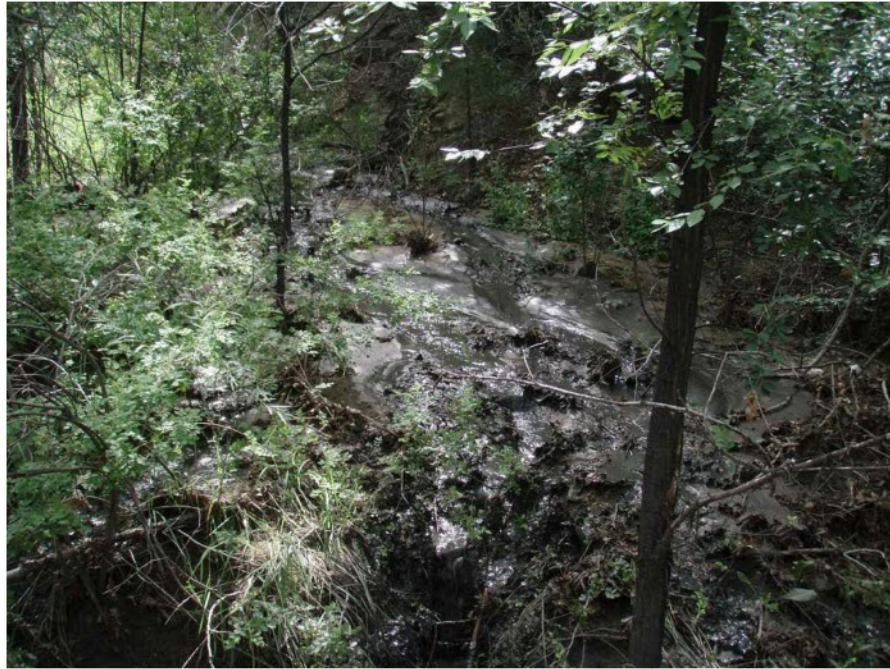
| Raw Water Cleaning Discharge / Bypass | | | P1011081.JPG |

| Discharge from the raw water tank cleaning that was bypassing the settling basins permitted discharge location. | | | |

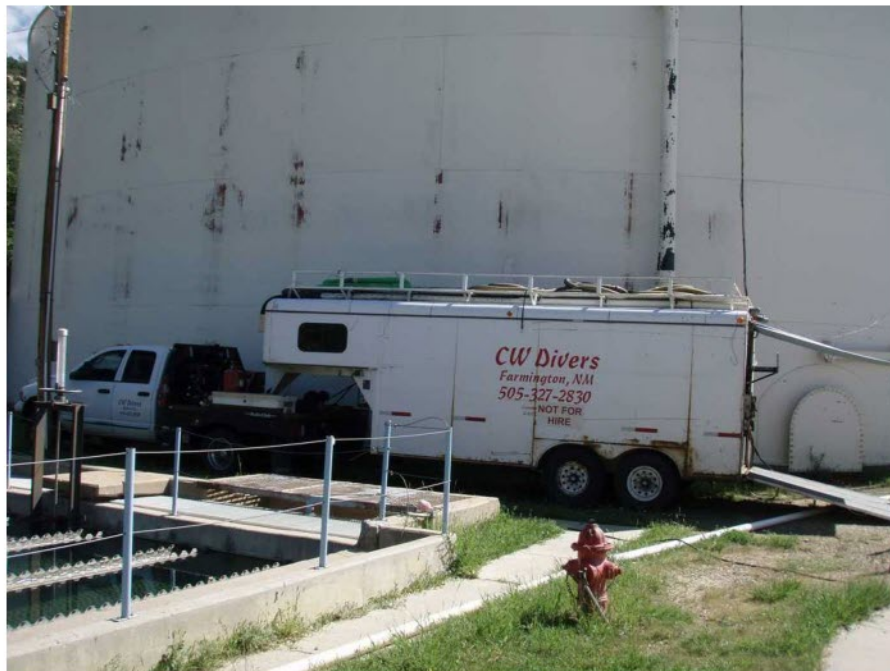
| Tank Cleaning Company | | | P1011082.JPG |

| Cleaning company that was discharging from the raw water tank cleaning. | | | |

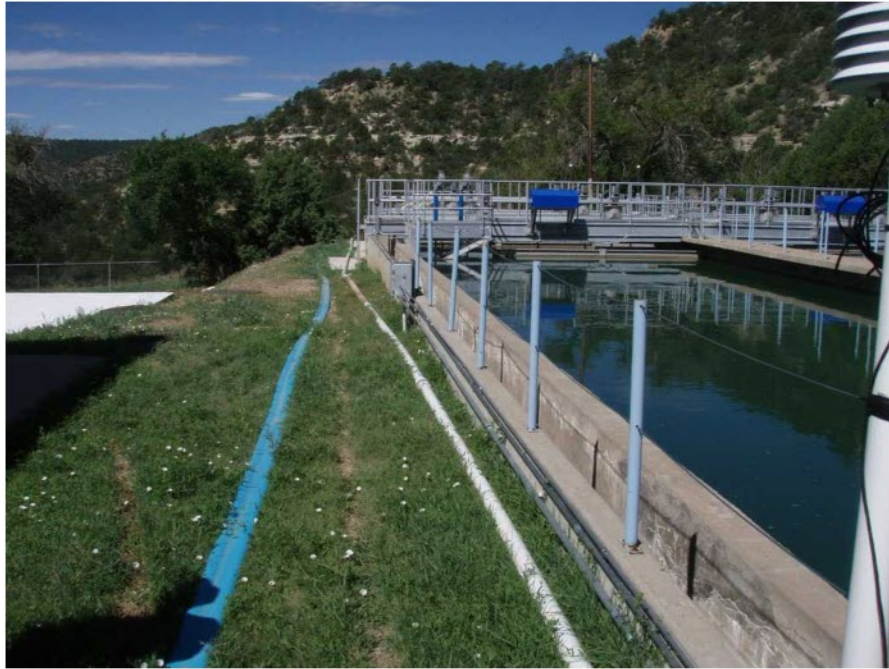
| Discharge / Bypass Lines | | | P1011083.JPG |

| Discharge from the raw water tank cleaning that was bypassing the settling basins permitted discharge location. | | | |

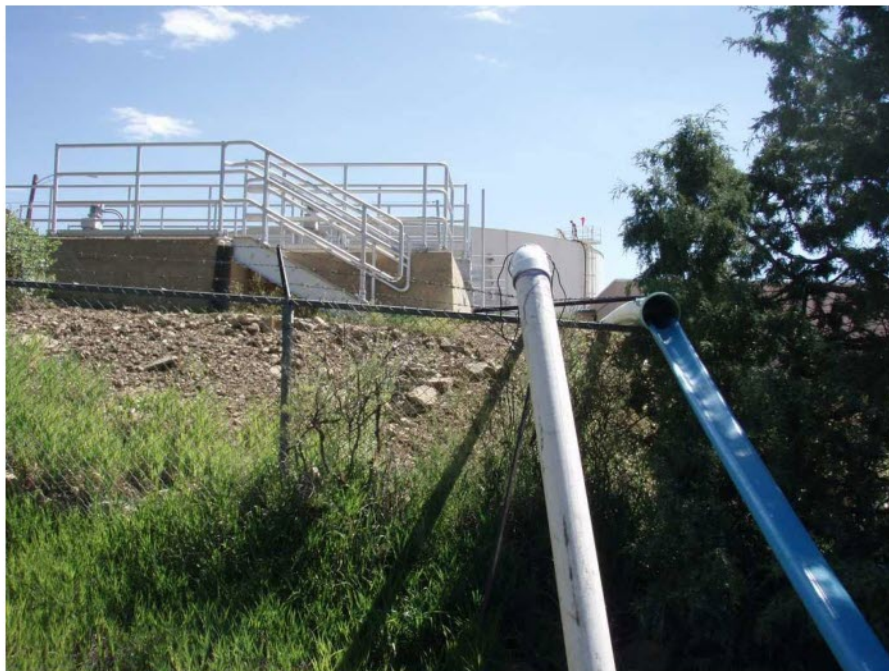
| Discharge / Bypass Lines | | | P1011084.JPG |

| Discharge from the raw water tank cleaning that was bypassing the settling basins permitted discharge location. | | | |

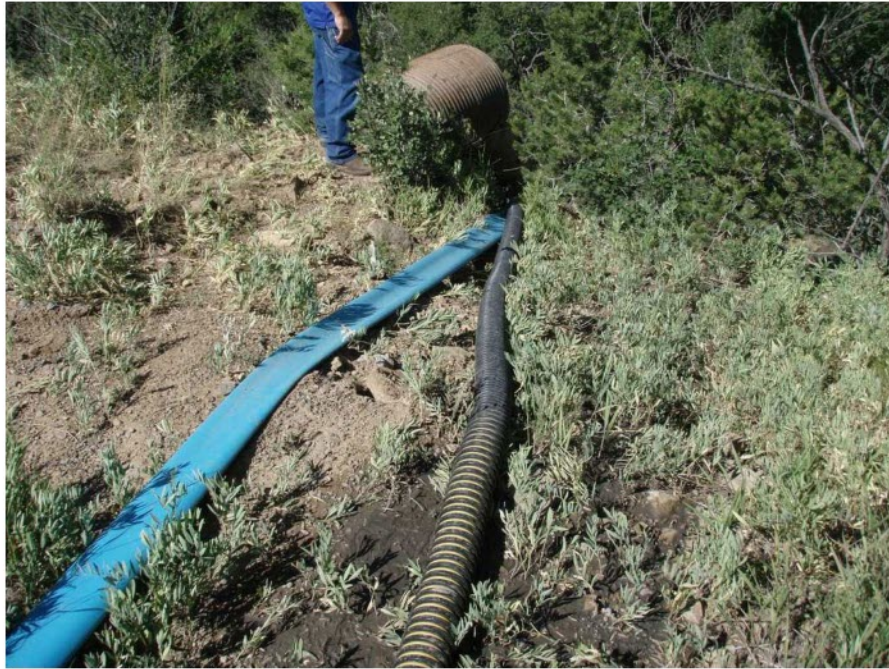
| Discharge / Bypass Lines | | | P1011085.JPG |

| Discharge from the raw water tank cleaning that was bypassing the settling basins permitted discharge location. | | | |

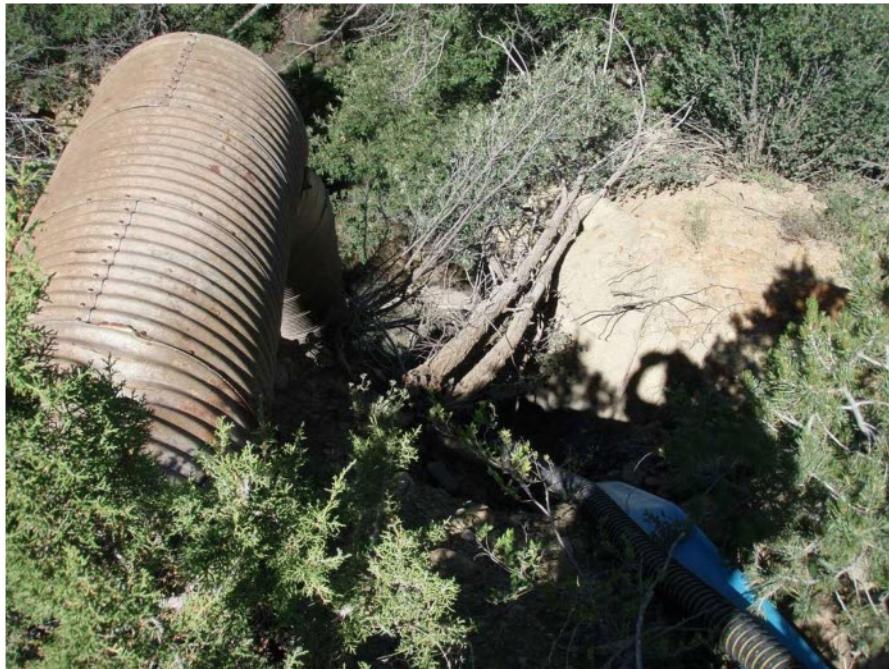
| Sediment from Discharge | | | P1011086.JPG |

| Discharge from the raw water cleaning that was bypassing the settling basins permitted discharge location. | | | |
