## Clean Water Act Section 404: Site Visit/Case Development

| Site Name | Super Café Randy Inc. (hereinafter as "The Site") | | | | |
| Site Address* | Tax Parcel No. 003-077-067-63-001(segreated parcel), Francisco Camacho St., close to Punta Sardinas | | | | |

# CWA 404 Follow-up Inspection

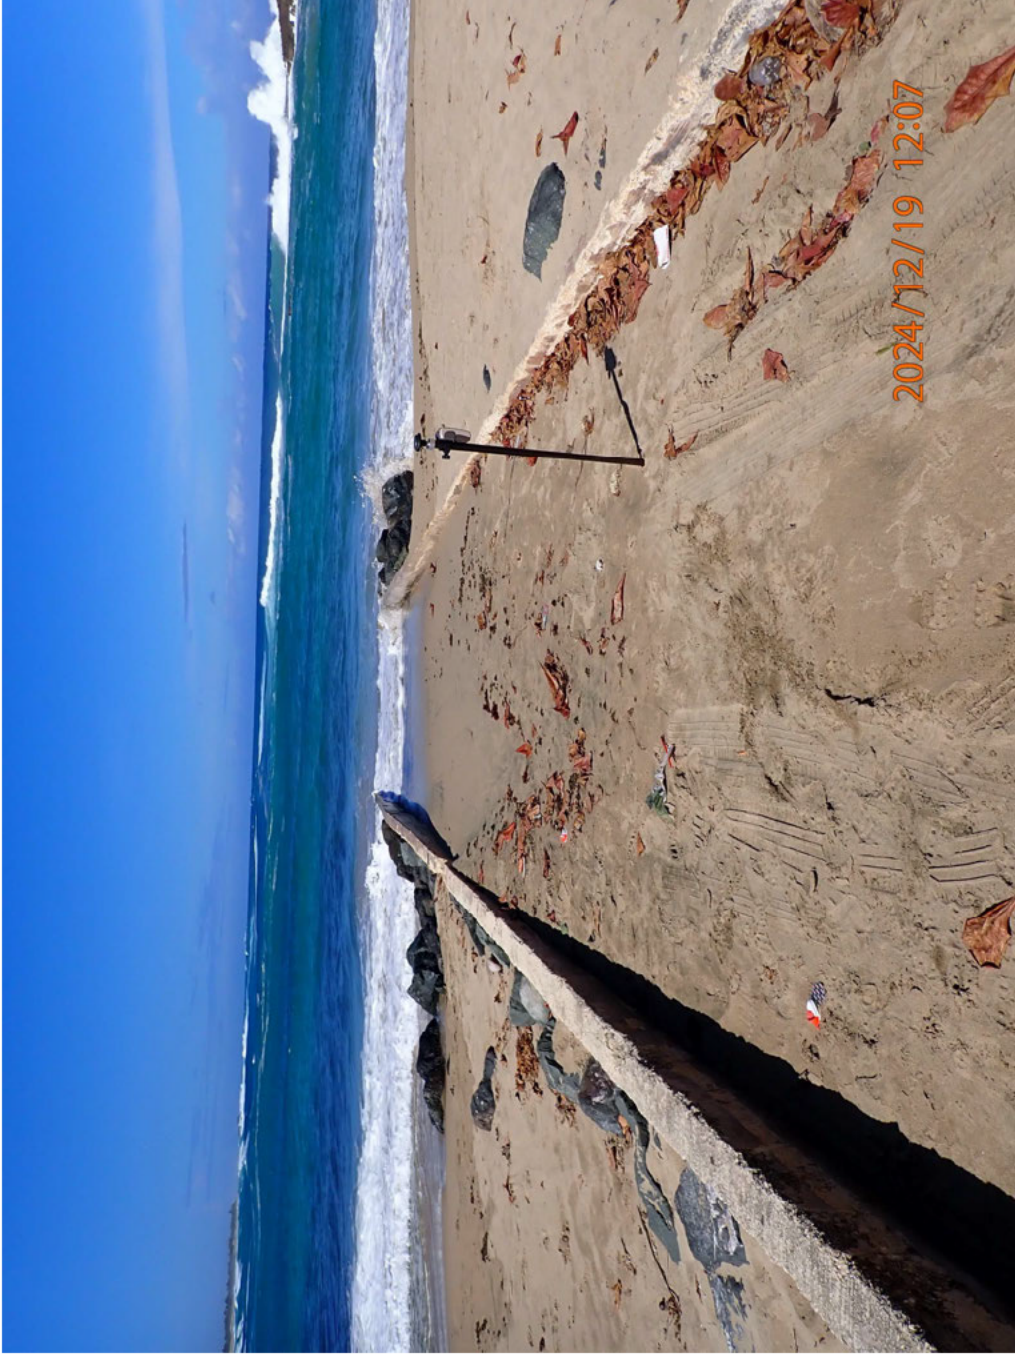
**Date:** 12/19/2024  
**Time:** 12:07 PM  
**Photographer:** SOL  
**Photo ID:** PC-191170

Boat ramp looking to the west to the Atlantic Ocean. GPS receiver pole marking visible high tide line at the time of inspection.

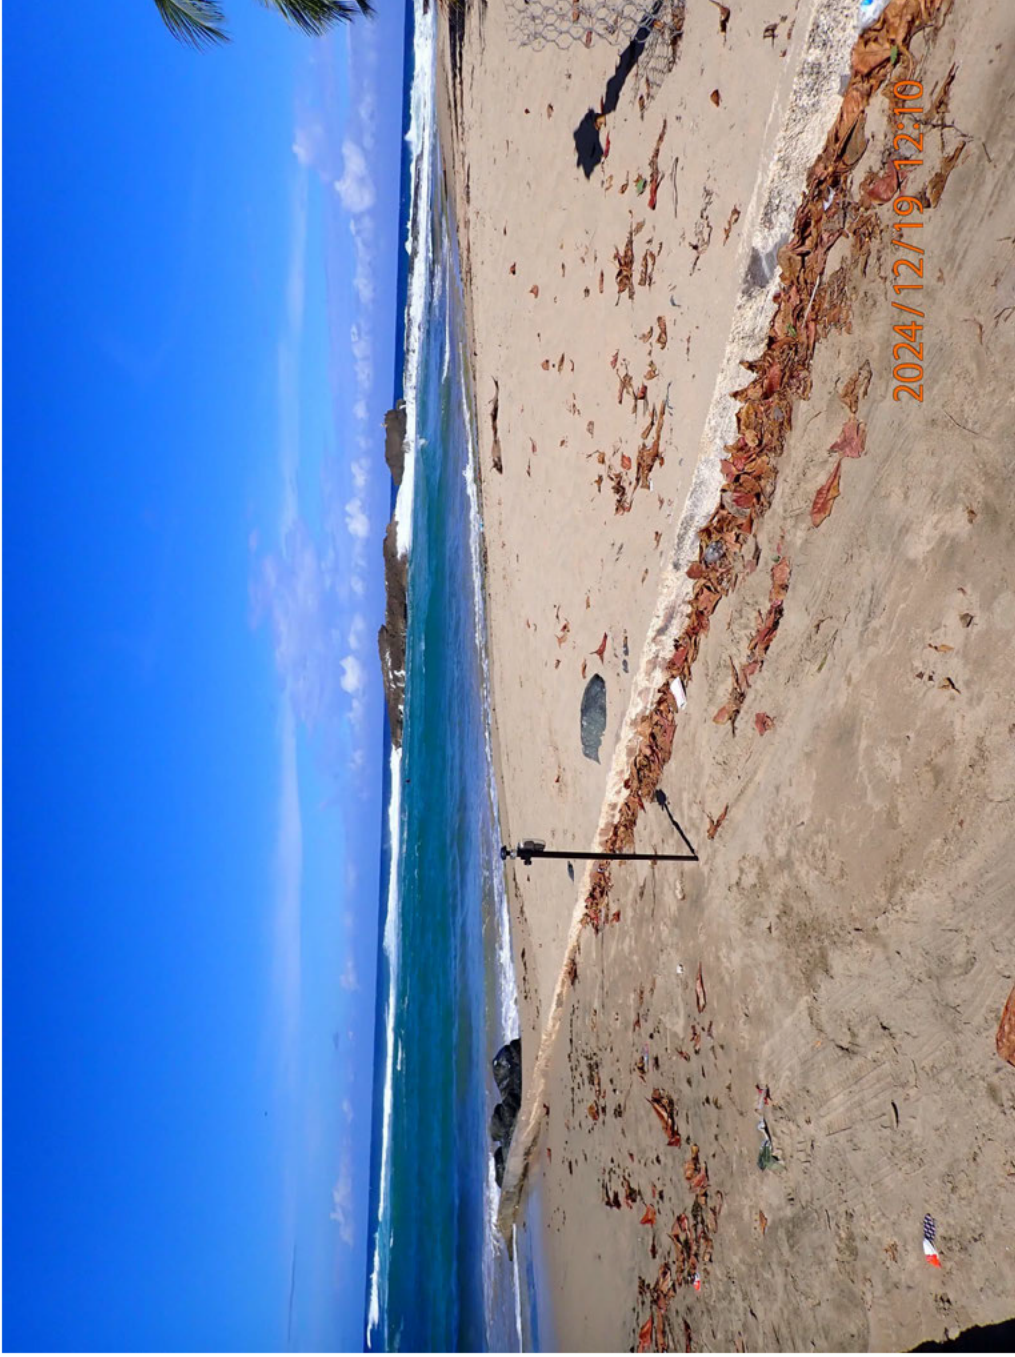
**Date:** 12/19/2024  
**Time:** 12:10 PM  
**Photographer:** SOL  
**Photo ID:** PC-191173

Boat ramp looking north,  
depicting ocean swell angle.

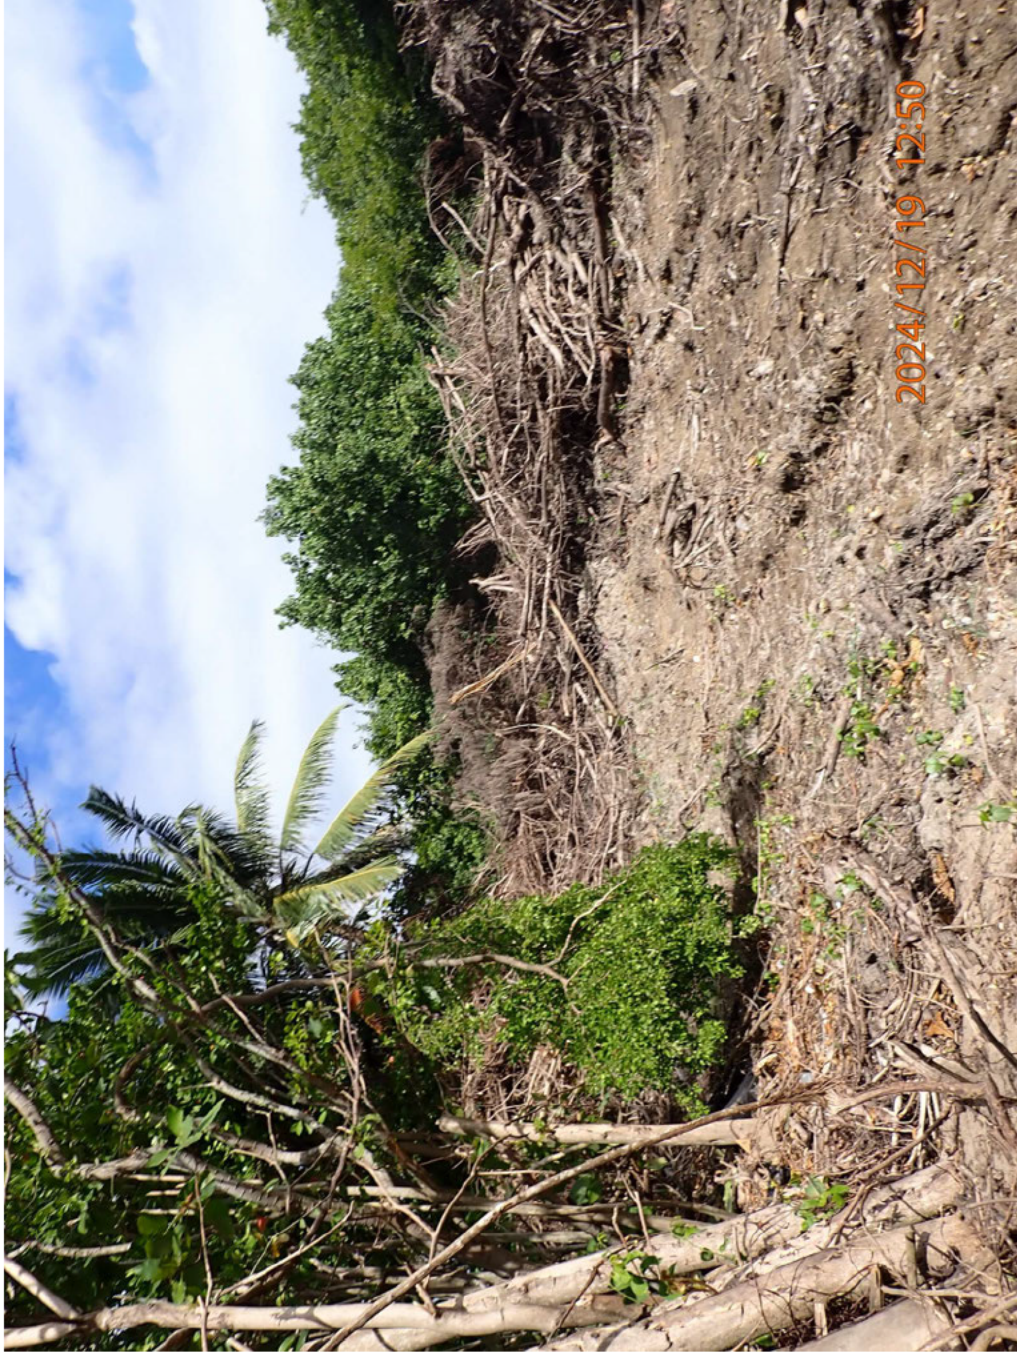
**Date:** 12/19/2024  
**Time:** 12:50 PM  
**Photographer:** SOL  
**Photo ID:** PC-191175

Fill pile photo looking north.

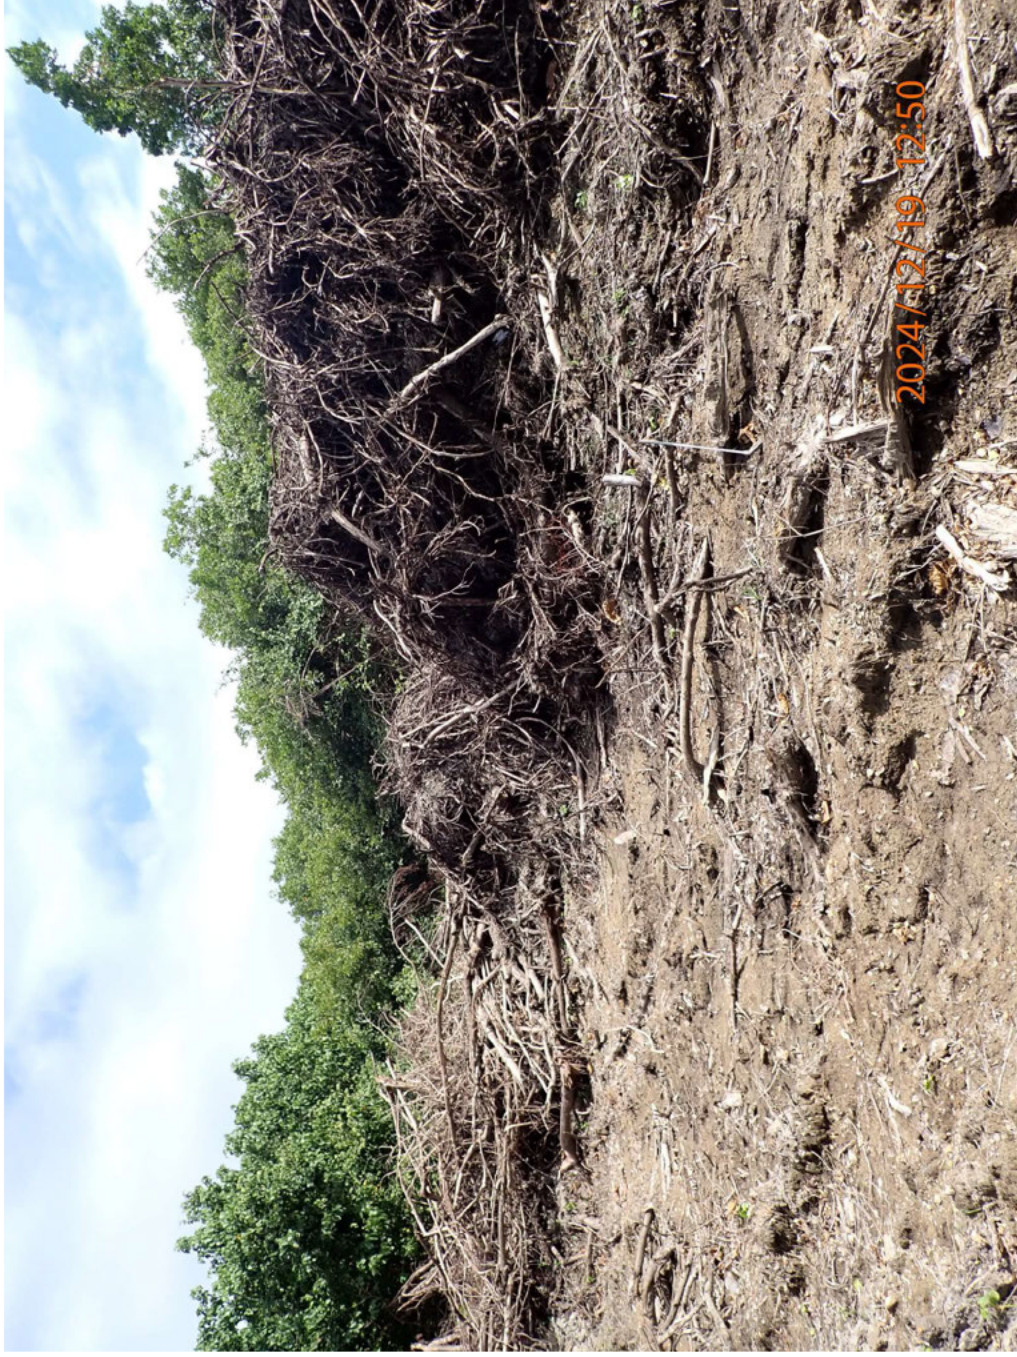
**Date:** 12/19/2024  
**Time:** 12:50 PM  
**Photographer:** SOL  
**Photo ID:** PC-191176

Fill pile photo looking northeast.

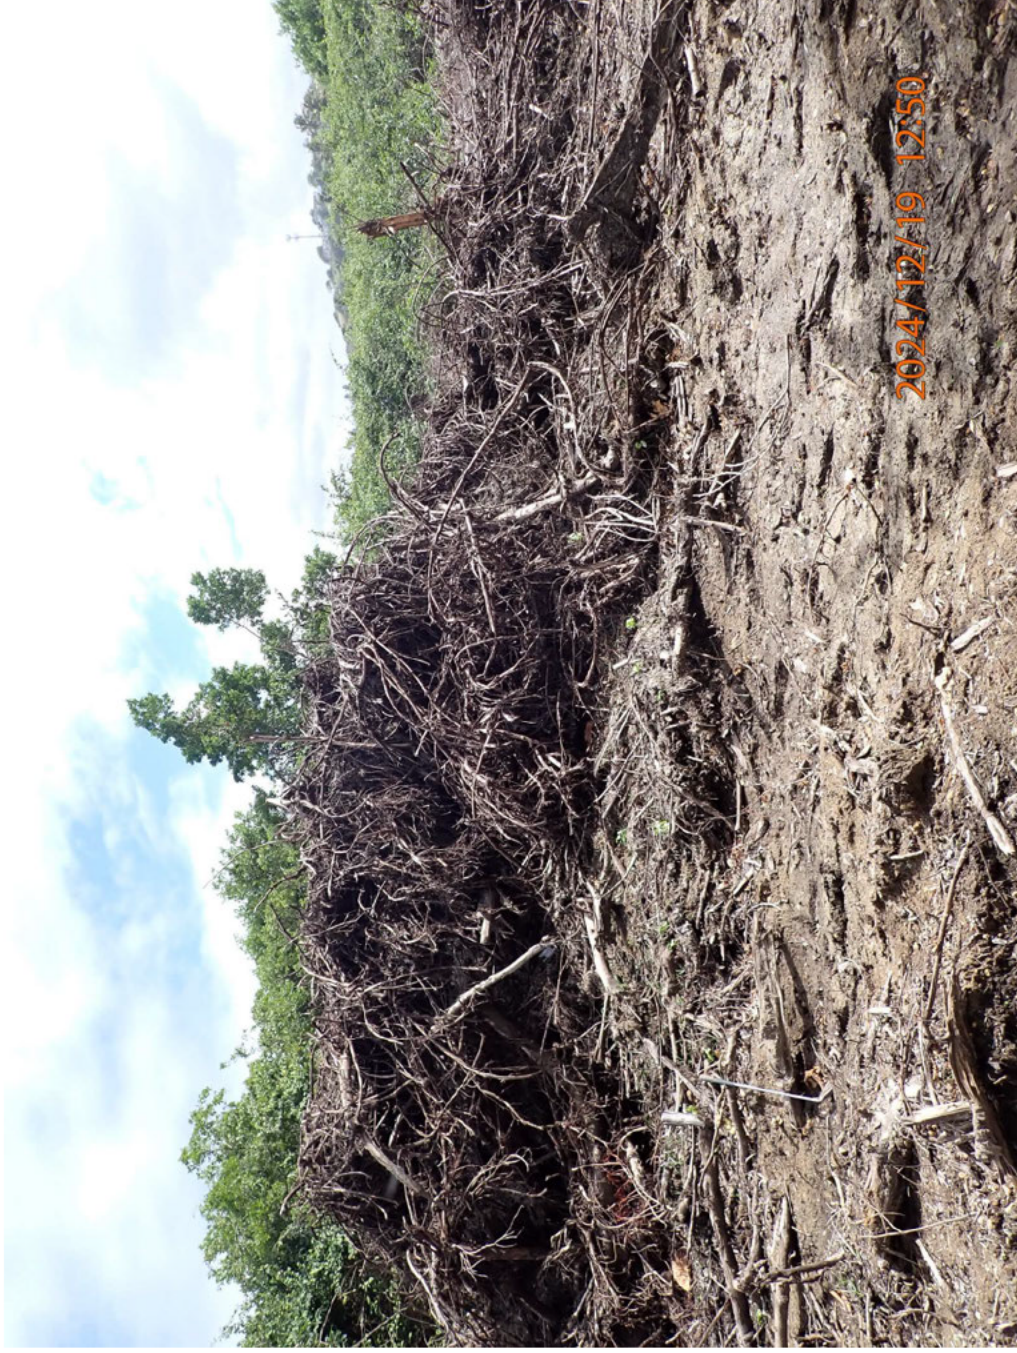
**Date:** 12/19/2024  
**Time:** 12:50 PM  
**Photographer:** SOL  
**Photo ID:** PC-191177

Fill pile photo looking east.

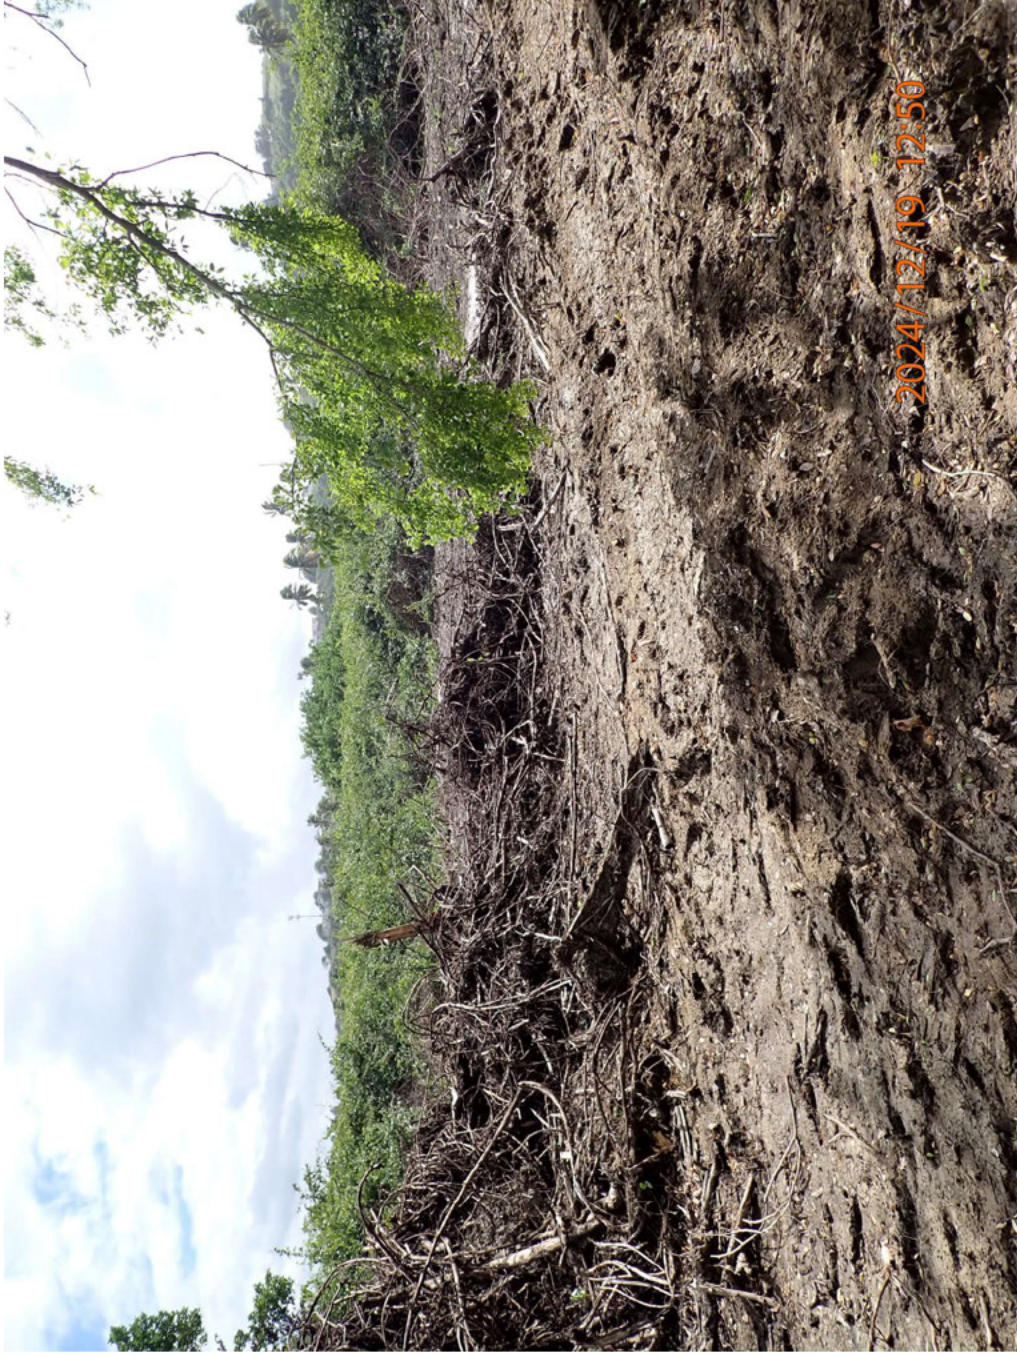
**Date:** 12/19/2024  
**Time:** 12:50 PM  
**Photographer:** SOL  
**Photo ID:** PC-191178

Fill pile photo looking east and slightly south.

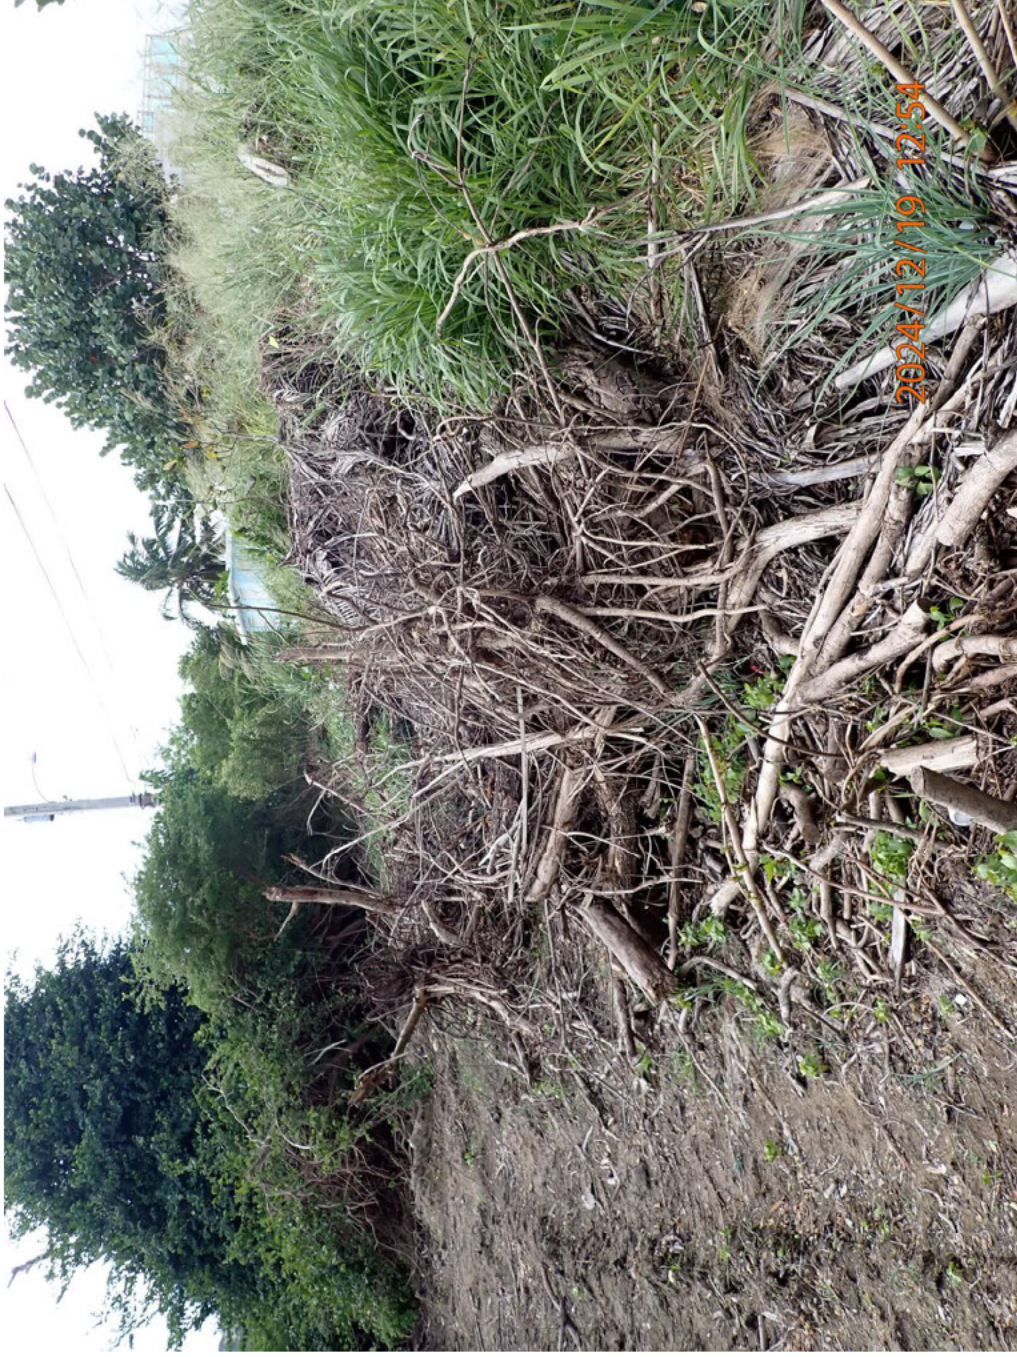
**Date:** 12/19/2024  
**Time:** 12:54 PM  
**Photographer:** SOL  
**Photo ID:** PC-191179

Small additional pile located at the start of the berm elevation.

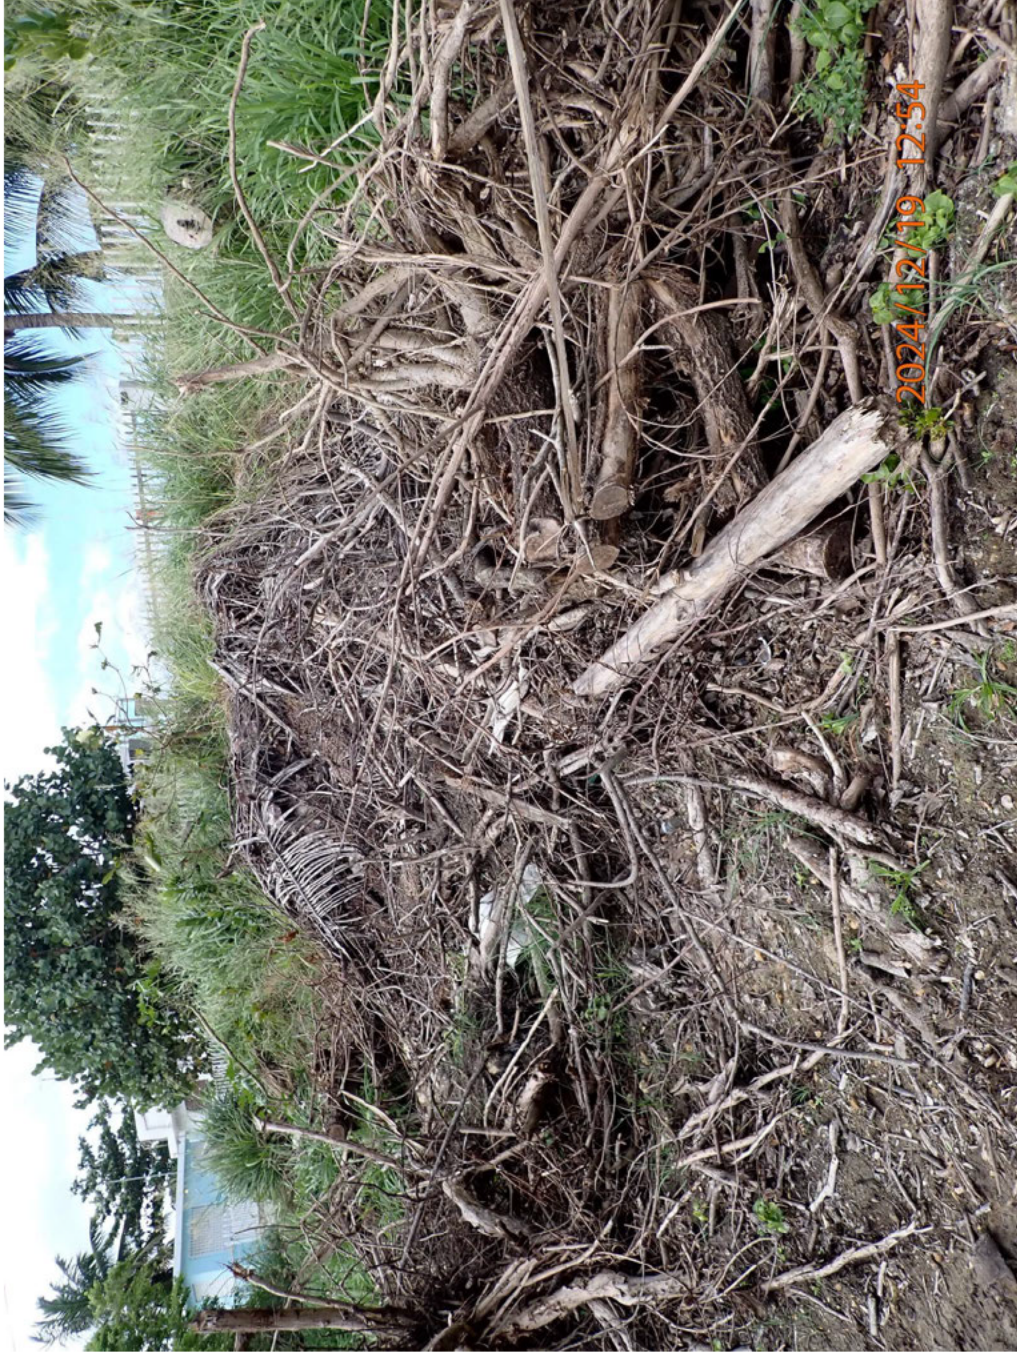
**Date:** 12/19/2024  
**Time:** 12:54 PM  
**Photographer:** SOL  
**Photo ID:** PC-191180

Small additional pile from different angle.
