**Region 6 - Enforcement & Compliance Assurance Division**  
**INSPECTION REPORT**

| Inspection Date(s): | 3/2/2023 – 3/3/2023 | |
| Company Name: | Texas Molecular Svcs, LLC | |
| Facility Name: | Texas Molecular – Deer Park Facility | |

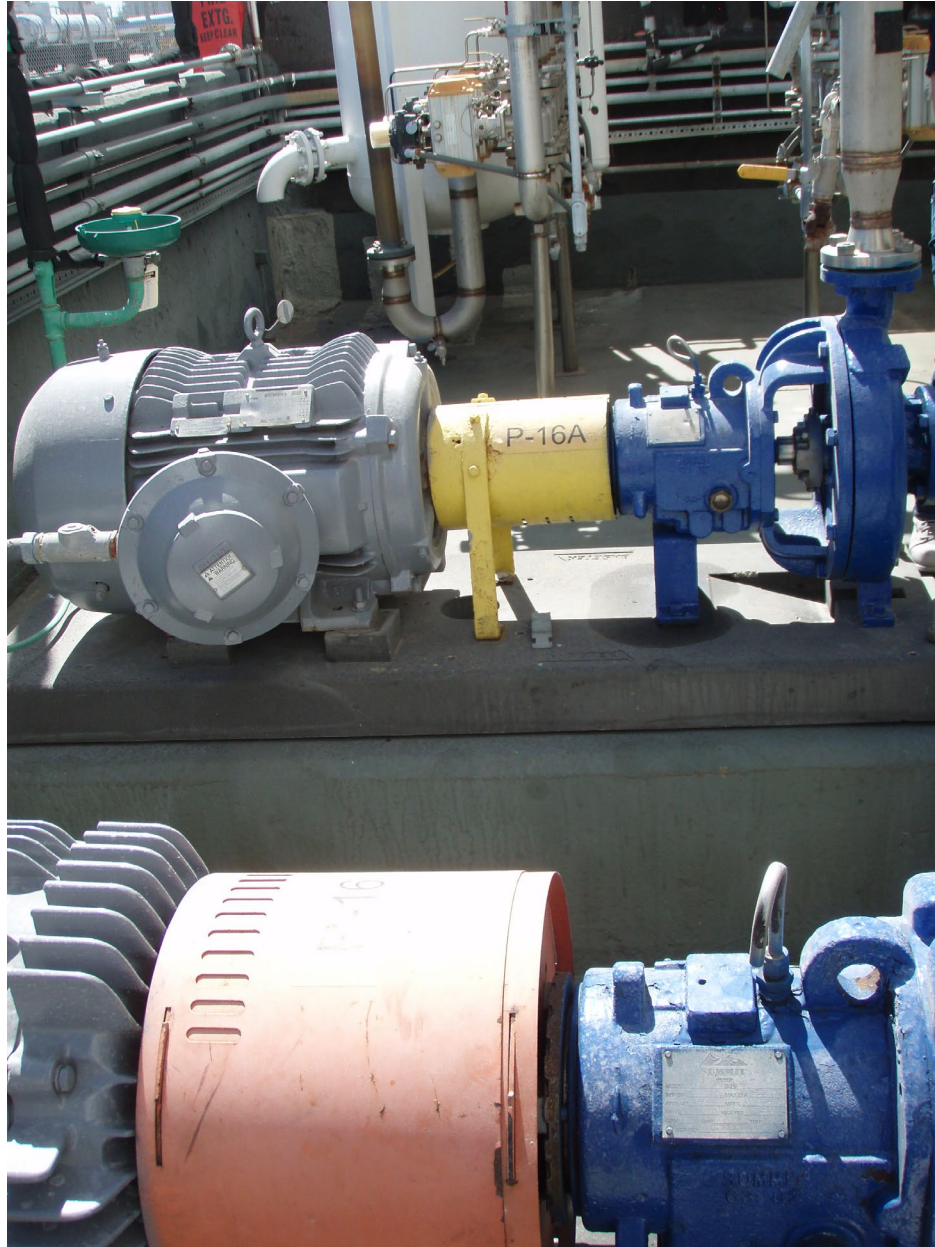
Once the wastewater is filtered at DE-7, the filtrate is piped to T-8. When injection begins, the contents of T-8 are piped to down-hole pump P-16A, which pumps the waste into the appropriate injection well. Mr. Edwards mentioned that P-16A can also be used as a filtration pump, but its purpose is down-hole pumping. An old oil stain underneath the pump was explained to be an old drip from the pump engine or a maintenance activity.

| <b>Description:</b><br>Facing S. Pumps P-16 and P-16A on pipeline for tanks T-56 and T-8 and injection wells within secondary containment. The small (approximately 1 ft diameter) dark stain under P-16A was stated to be a possible oil leak but not a waste leak. Close-up of Photo 32. | | |

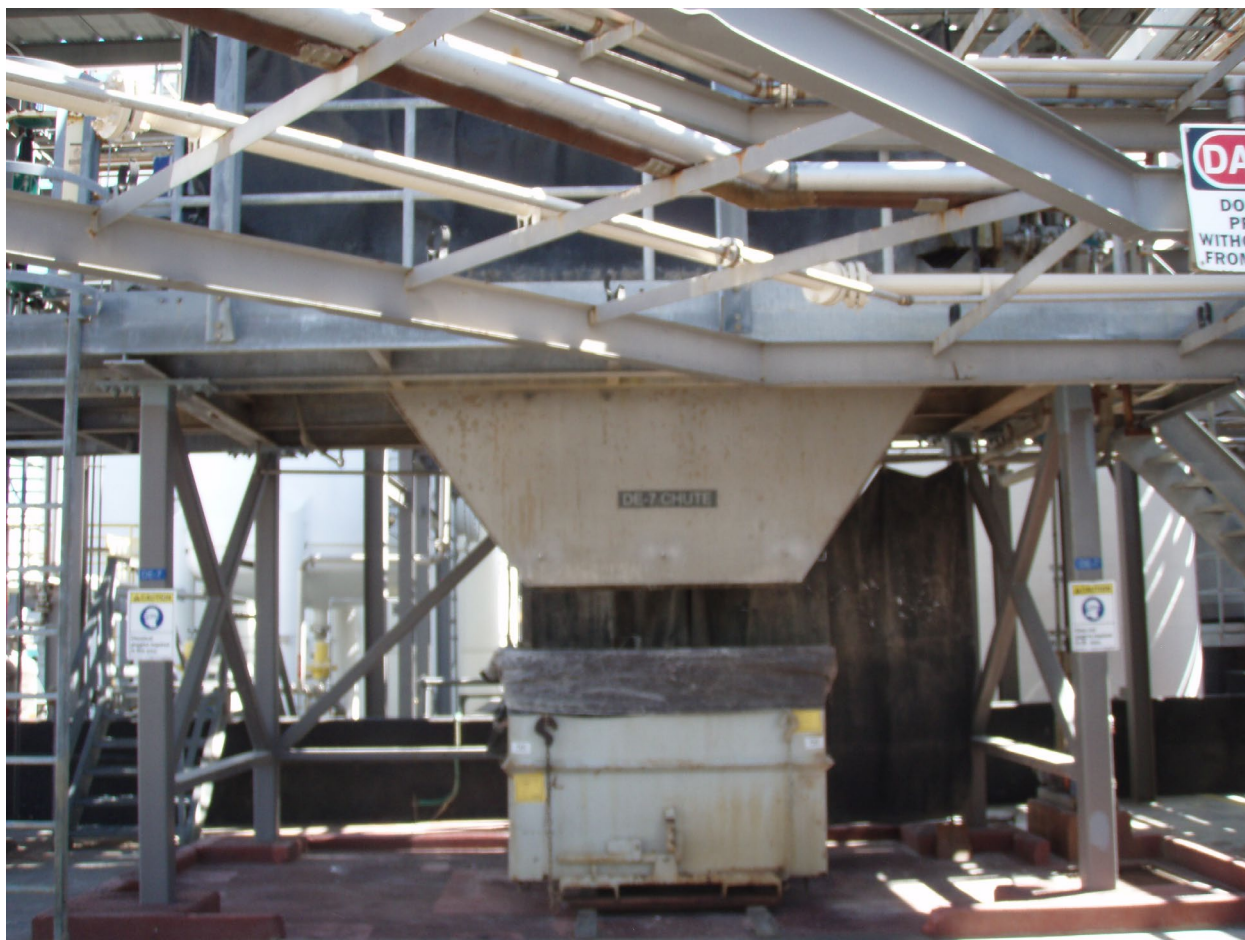
The inspection team noticed an extra hazardous waste ID label on the hopper beneath the press (Appendix 1, Photo 34). Facility representatives immediately removed the excess label.

| <b>Description:</b><br>Facing E. Filter press used to filter waste from receiving tank T-56 to down hold tank T-8. Accumulation hopper located underneath. The hopper contained two hazardous waste labels (close-ups shown in Photos 34 and Photo 35). The incorrect label shown in Photo 34 was removed at the time of the inspection and was believed to have just been forgotten to be removed. | | |

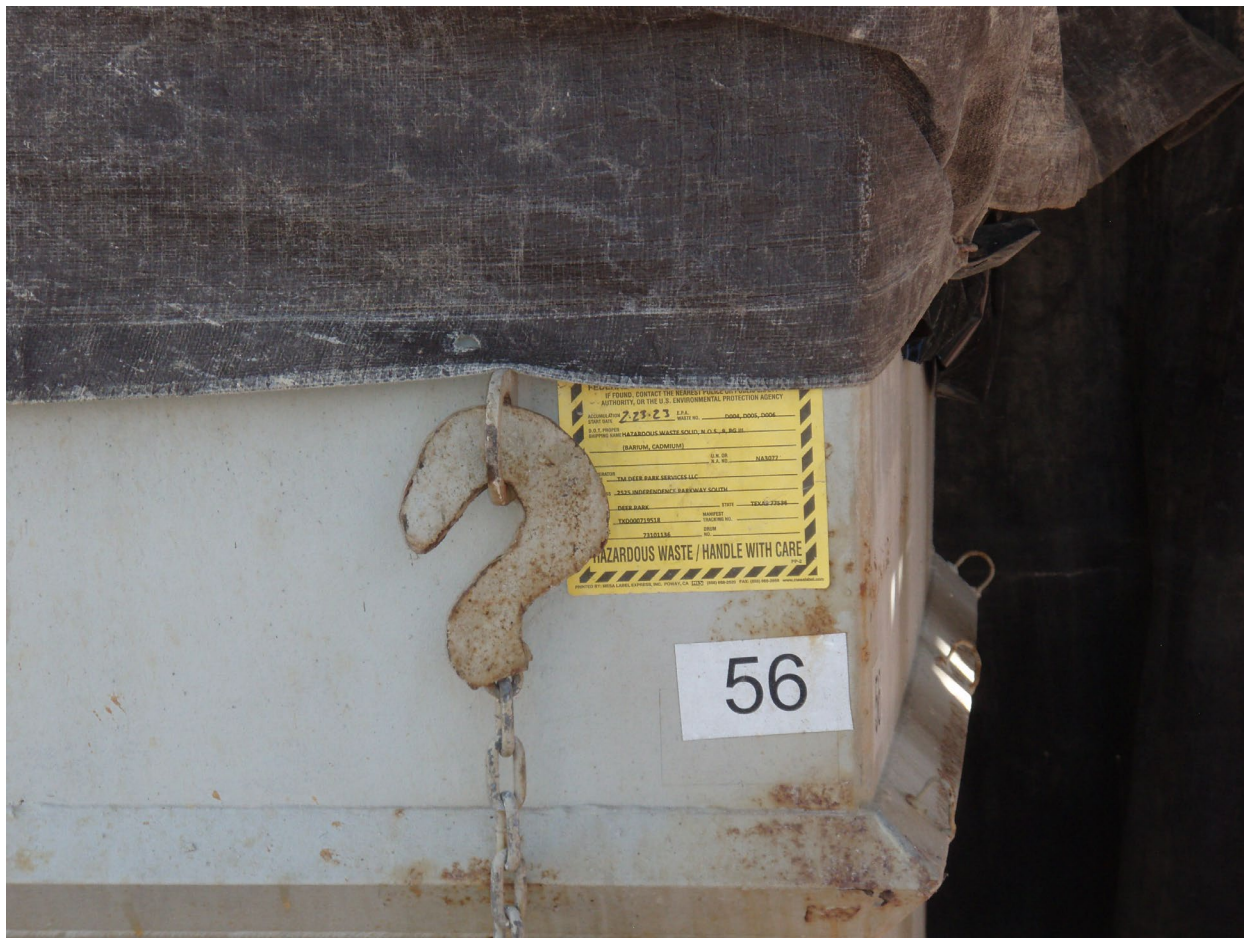
| Photo File Name: P2030036.jpg | Date of Photo: 3/3/2023 | Time: 1151 hrs |

| Description:<br>Facing E. Close-up of hazardous waste label dated 2/23/23 on right of hopper in Photo 33. | | |

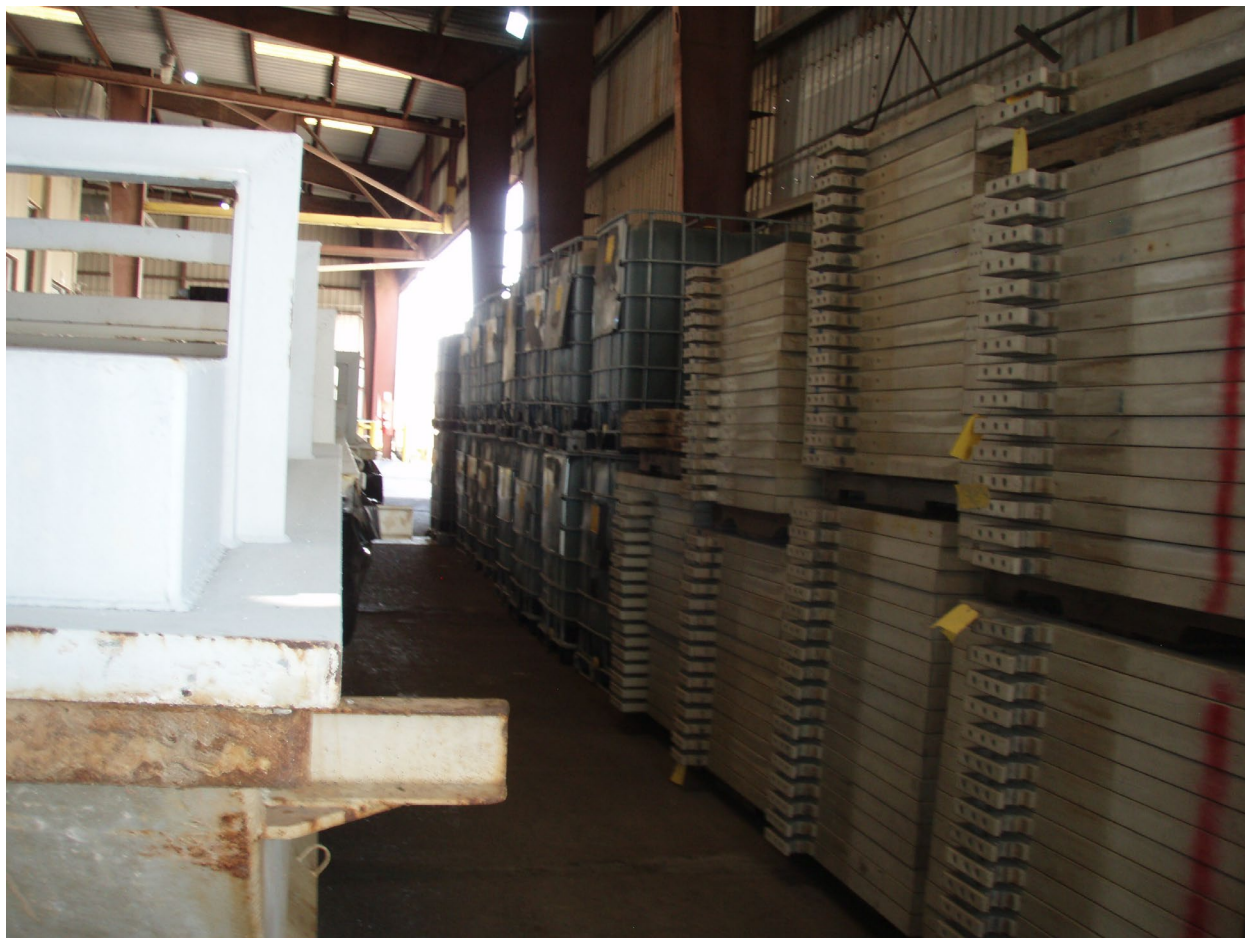
| Photo File Name: P2030037.jpg | Date of Photo: 3/3/2023 | Time: 1200 hrs |

In the permitted storage area, we observed three full, covered hoppers containing filter cake from onsite filter presses, though not necessarily including cake from DE-7 (Appendix 1, Photos 36 - 37). Hoppers were labeled and dated. Many full totes were also being stored in the area at the time of the inspection.

| <b>Description:</b><br>Facing S. ST-7 permitted storage area. Totes on right and hoppers on left of hazardous waste being stored. | | |

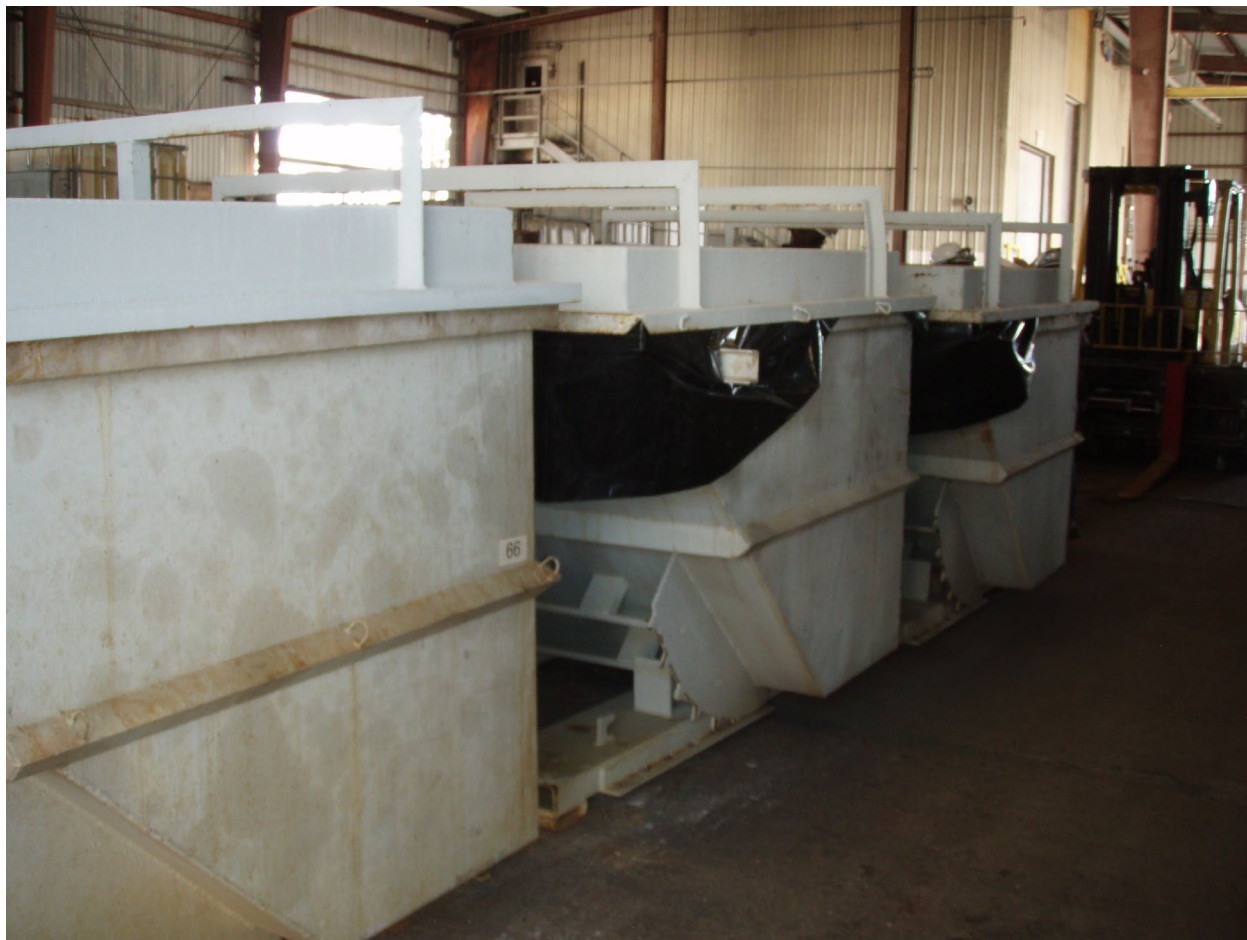
| <b>Photo File Name:</b> P2030038.jpg | <b>Date of Photo:</b> 3/3/2023 | <b>Time:</b> 1201 hrs |

| <b>Description:</b><br>Facing SE. ST-7 permitted storage area. Hoppers shown in Photo 36 of hazardous waste being stored. | | |

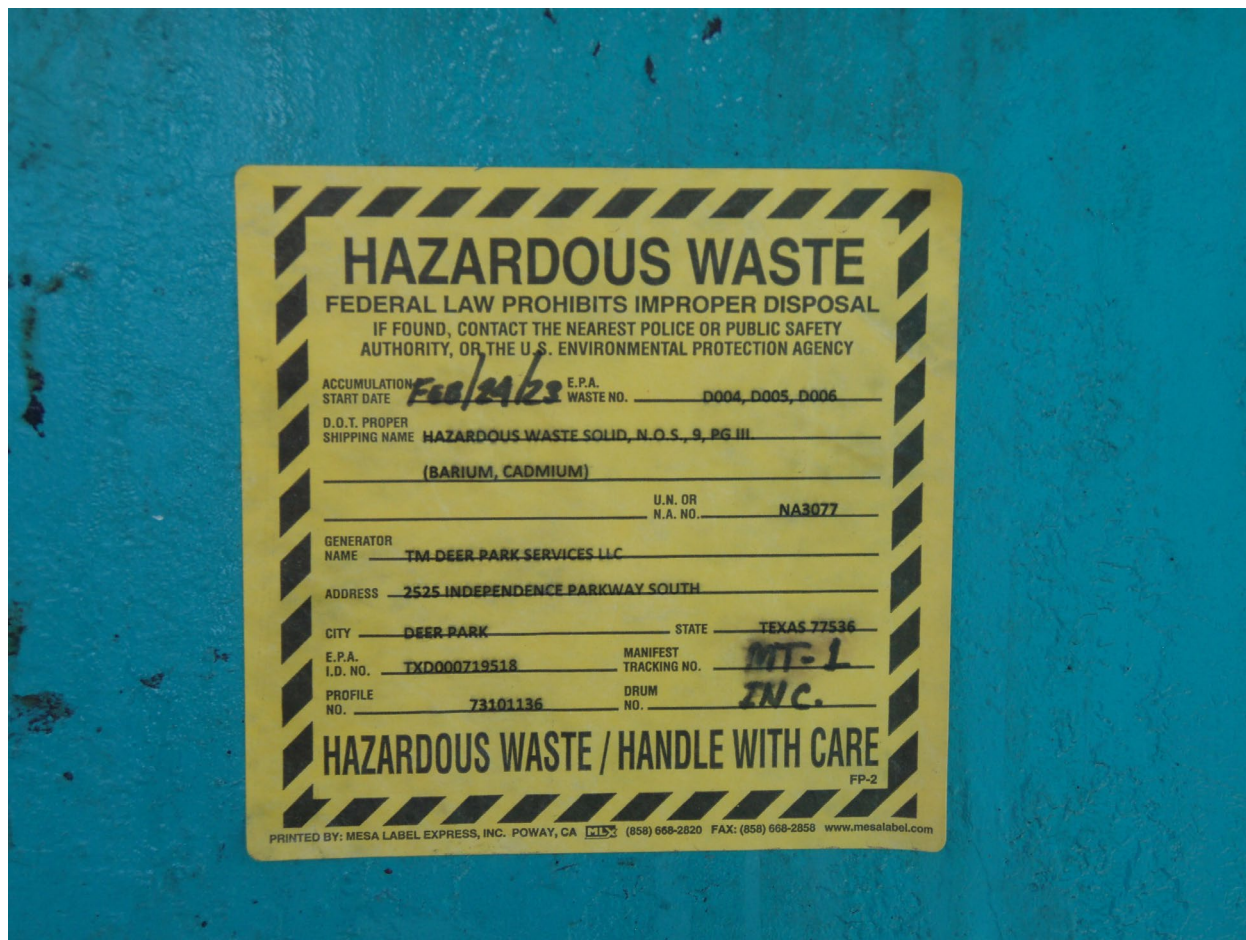
| <b>Description:</b><br>Facing S. Roll-Off <90 Day Storage Area - Close-up of the hazardous waste label dated "Feb/24/23" on roll-off #WT-805 that contained hazardous waste generated from solids removed from some of the East Palestine waste that was mixed with lime dust and other hazardous waste received from off-site. | | |

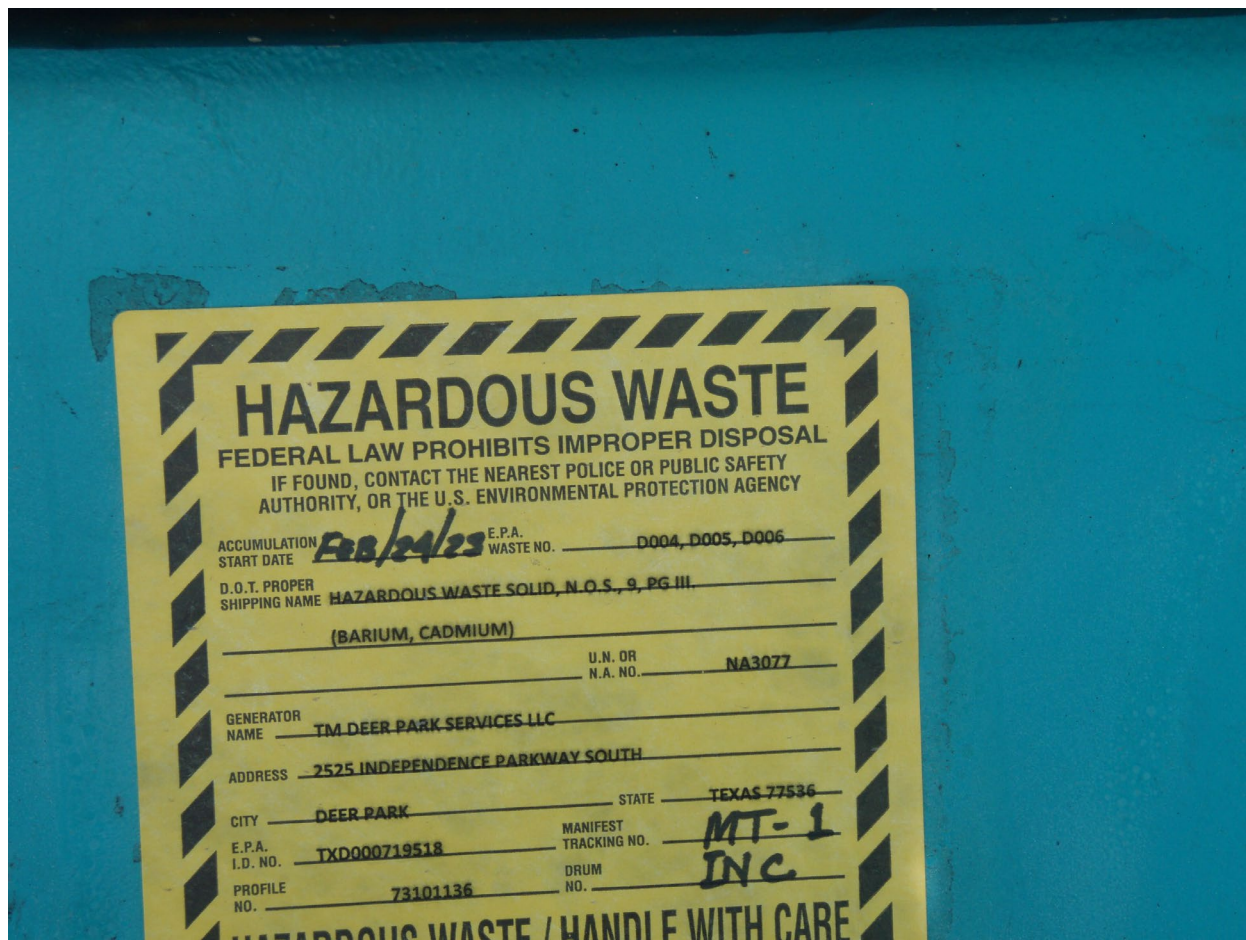
| <b>Description:</b><br>Facing S. Roll-Off <90 Day Storage Area - Close-up of the hazardous waste label dated "Feb/24/23" on roll-off #WT-857 that contained hazardous waste generated from solids removed from some of the East Palestine waste that was mixed with lime dust and other hazardous waste received from off-site. | | |

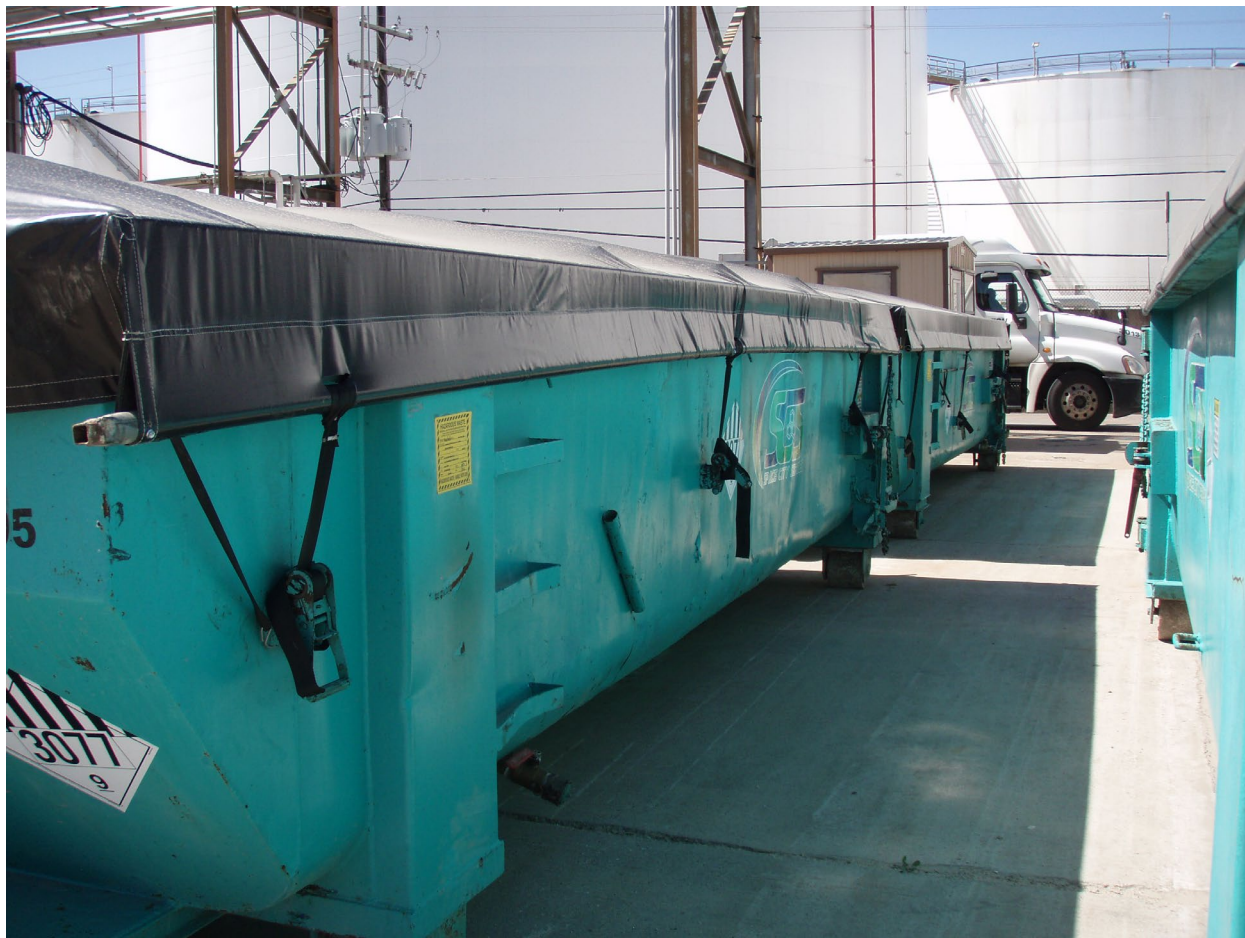
| <b>Description:</b><br>Facing SW. Roll-Off <90 Day Storage Area - Two roll-offs (numbers WT-805 and WT-857) containing hazardous waste generated from solids removed from some of the East Palestine waste that was mixed with lime dust and other hazardous waste received from off-site. Close-ups of the labels on each of the roll-offs are shown in Photo 38 and Photo 39. WT-805 is closest to the camera. | | |
