**Region 6 Compliance Assurance and Enforcement Division  
INSPECTION REPORT**

| Inspection Date(s): | 06/29/2017 | | |
| Company Name: | Cedar Hill, City of – Trinity River Authority (TRA) Member City | | |
| Facility Name: | Cedar Hill Wastewater Collection System | | |

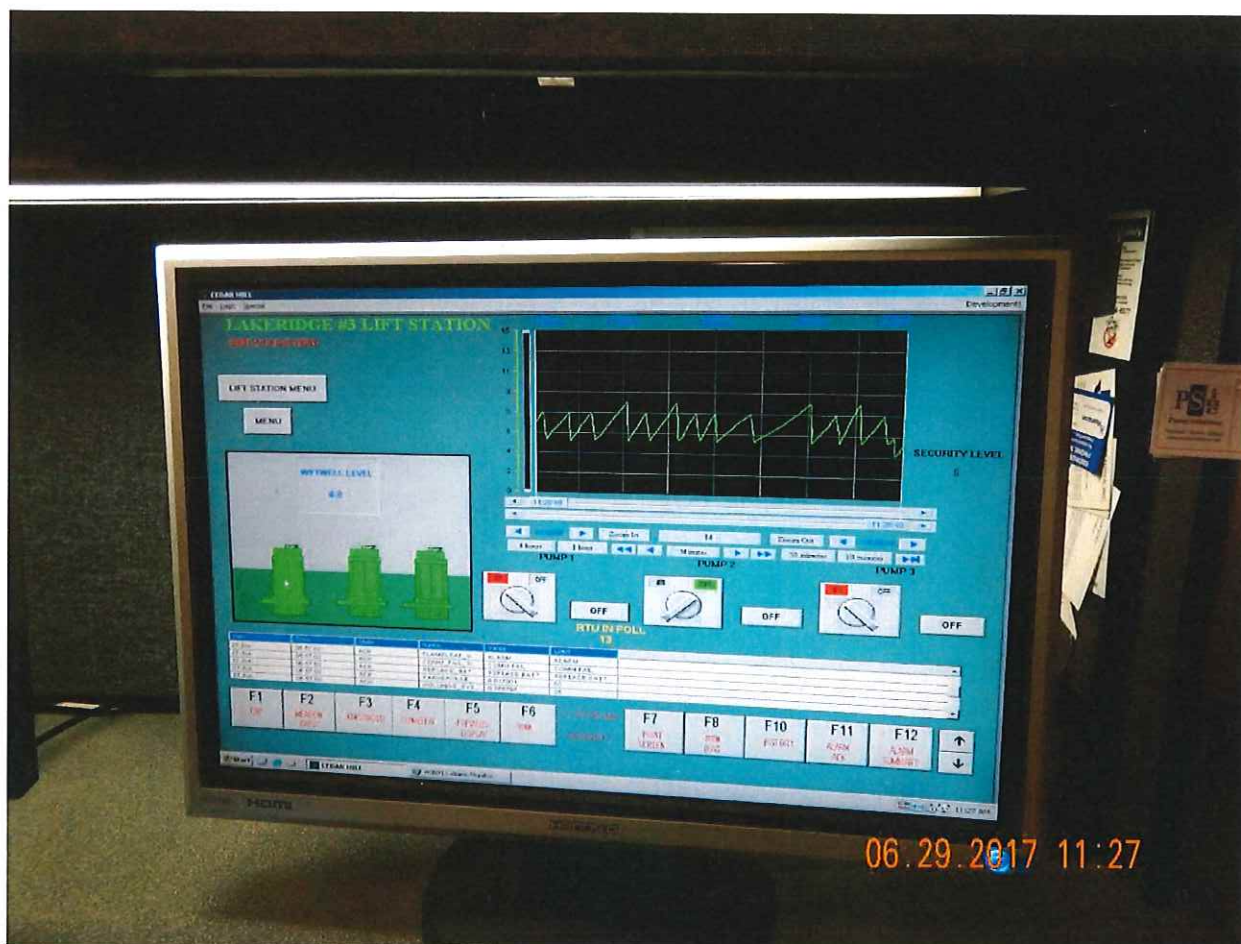
| Comments: Wastewater SCADA System. | | |

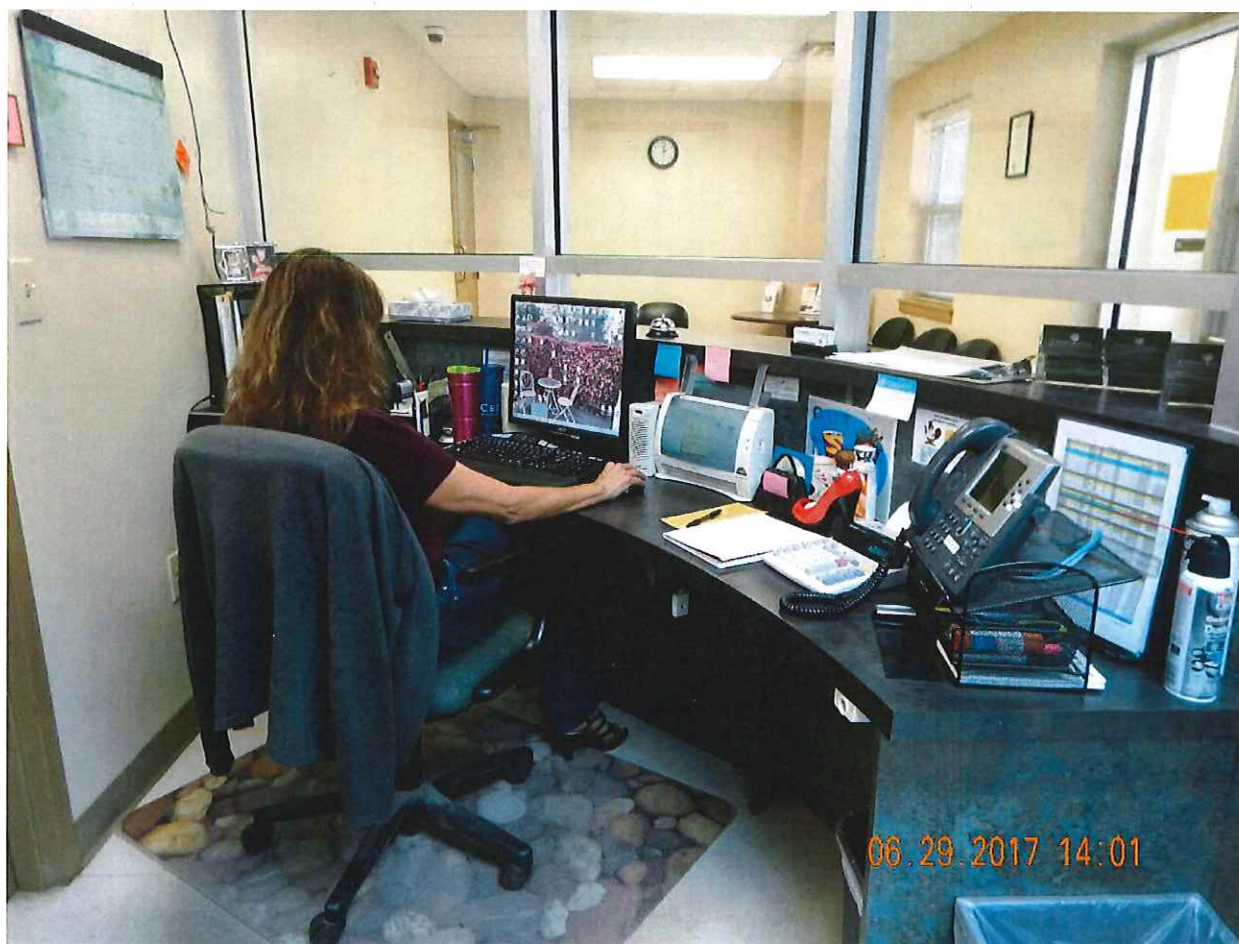
| Comments: Customer Call Center at the Public Works Department. | | |

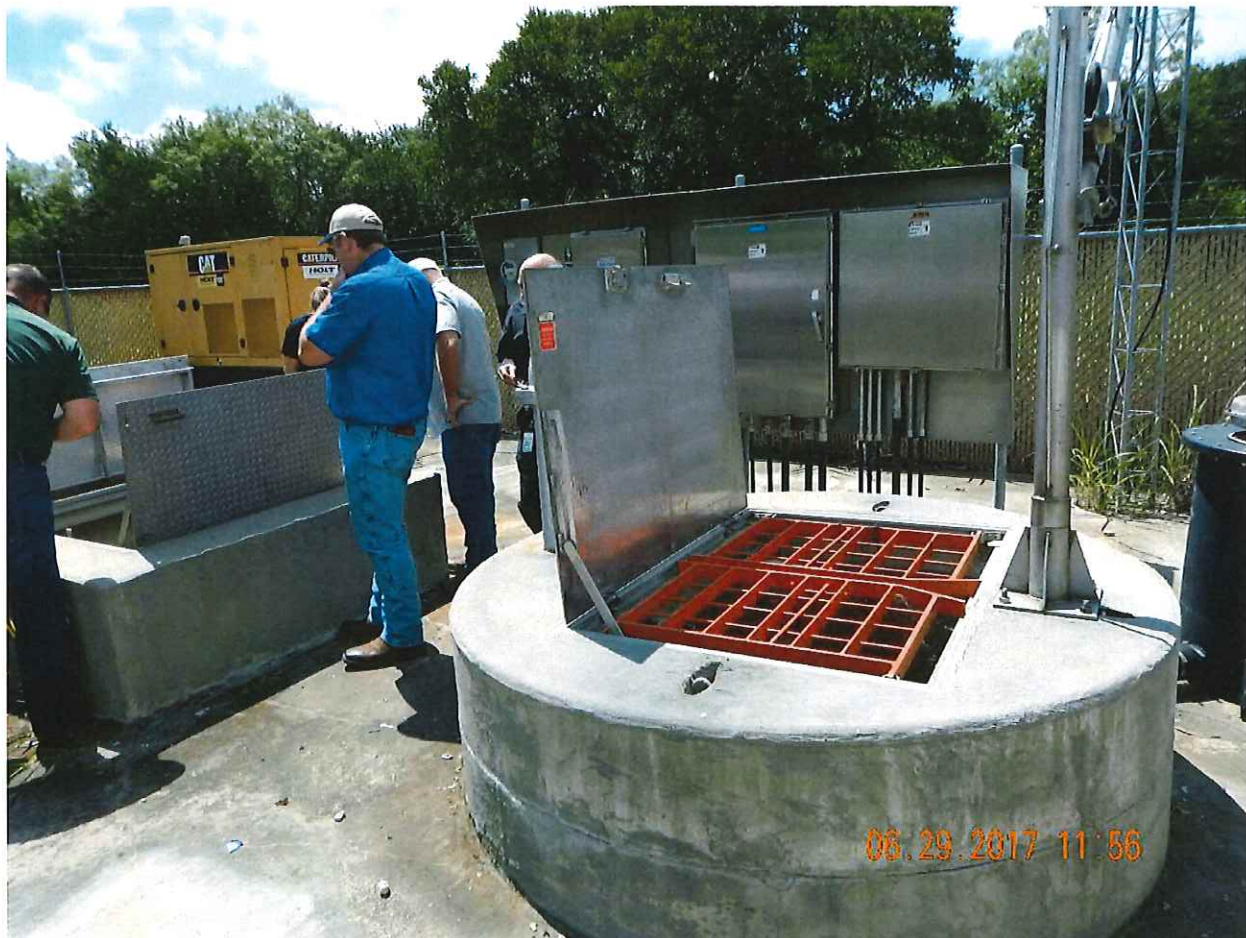
| Comments: Lift station with electrical panel and back-up generator in the back ground. | | |

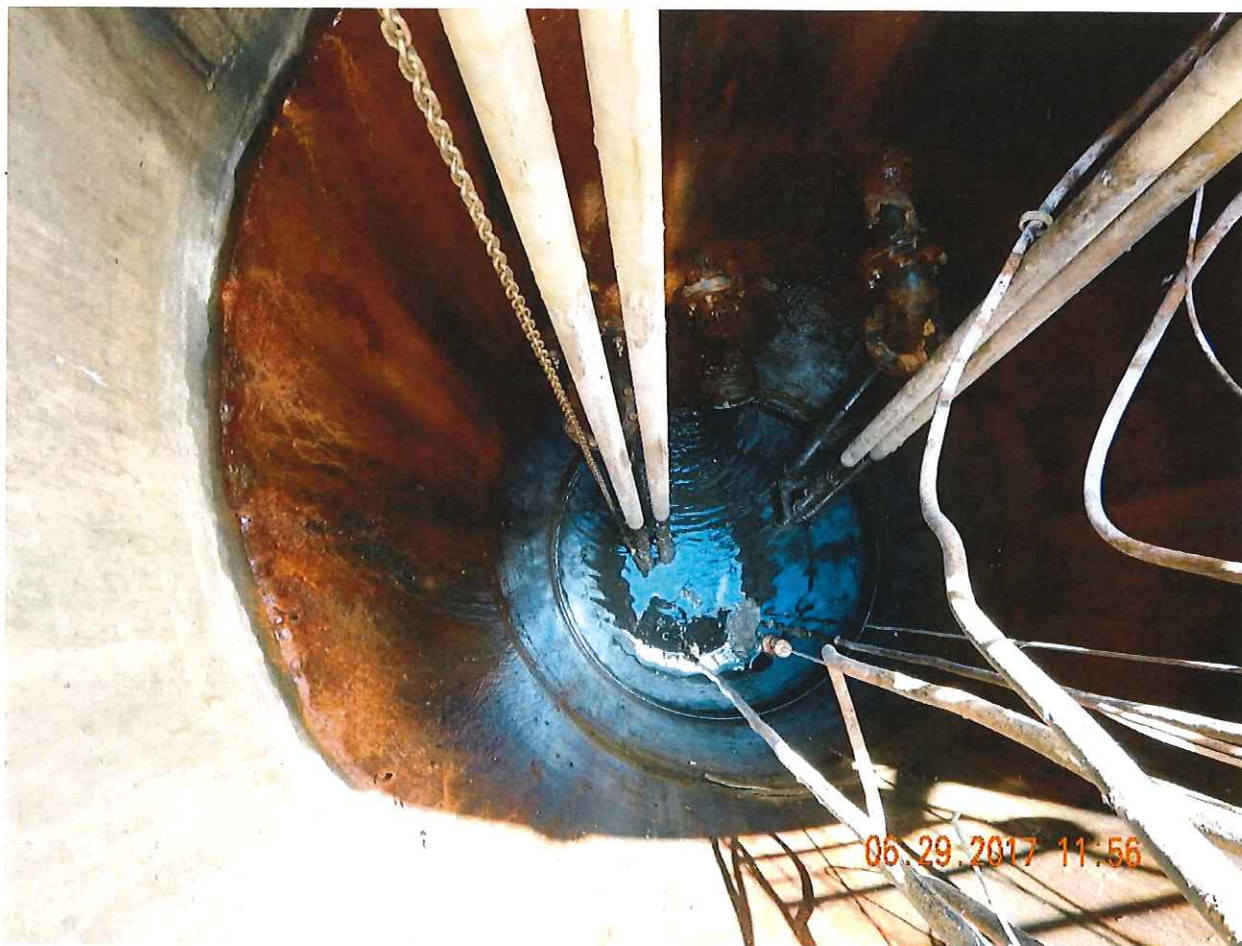
| Comments: Bedford Branch wet well. | | |

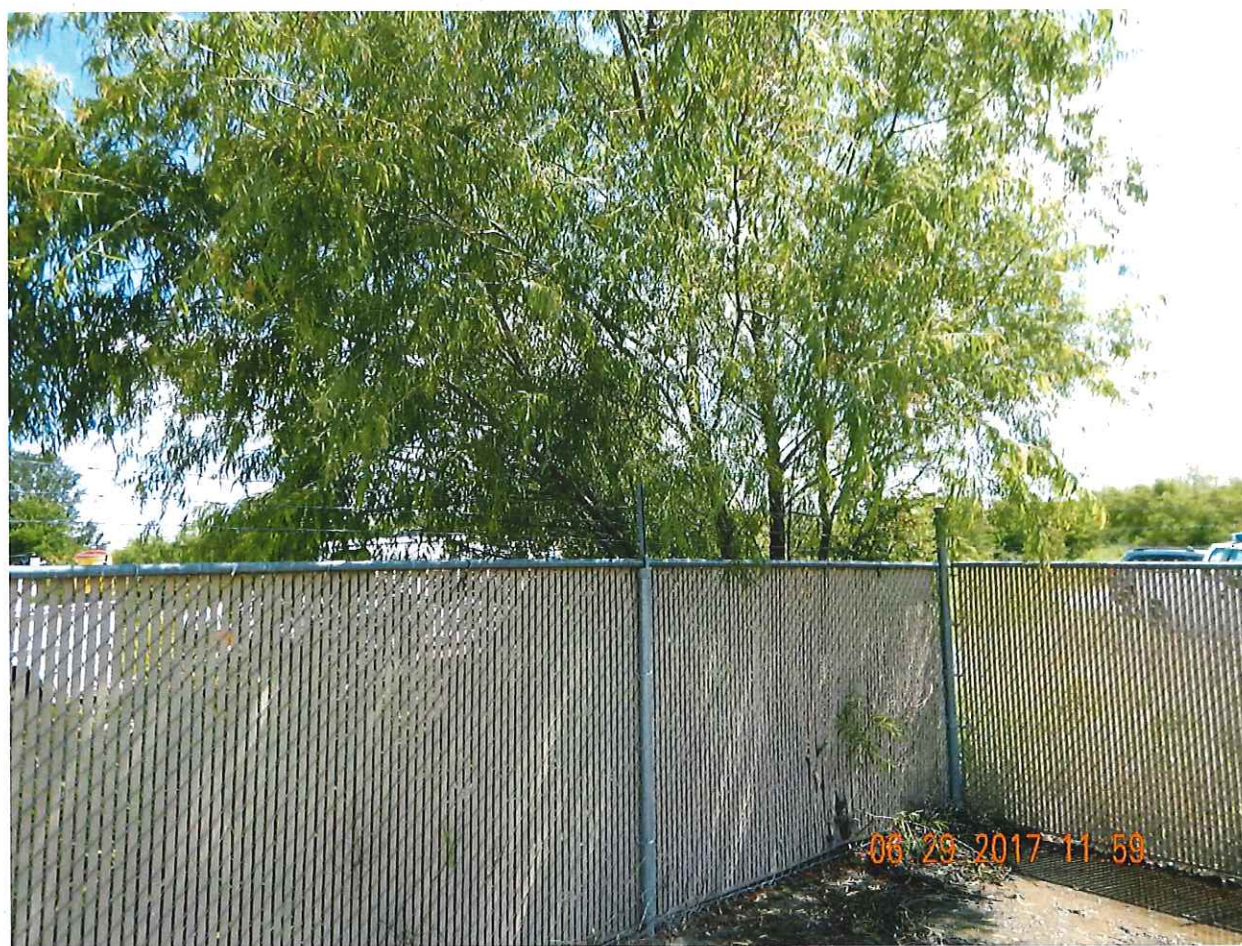
| Comments: Note trees encroaching on security fencing need to be trimmed away. | | |

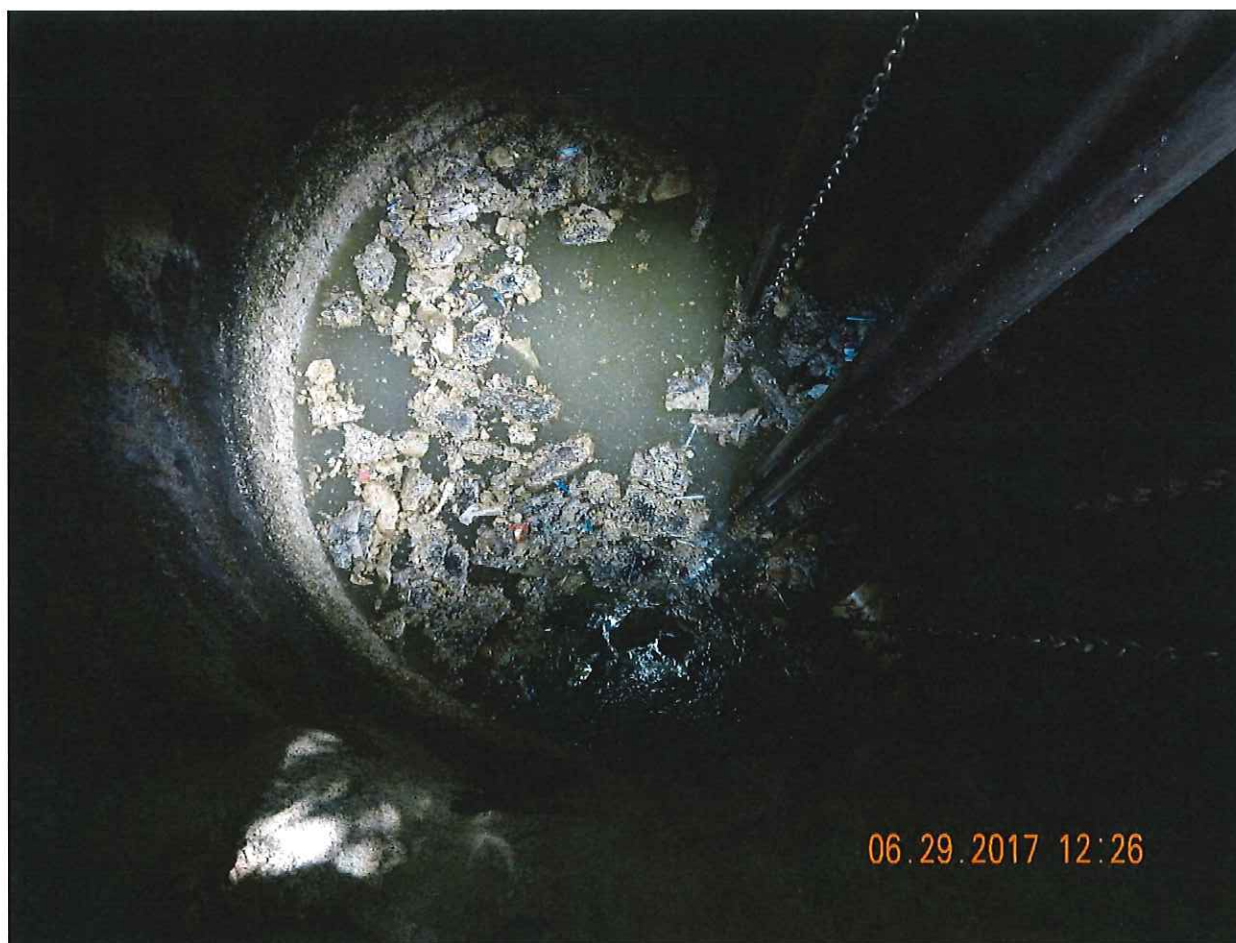
| Comments: Lake Ridge 3 wet well. Note heavy amounts of grease / floating debris and apparent need of cleaning. | | |

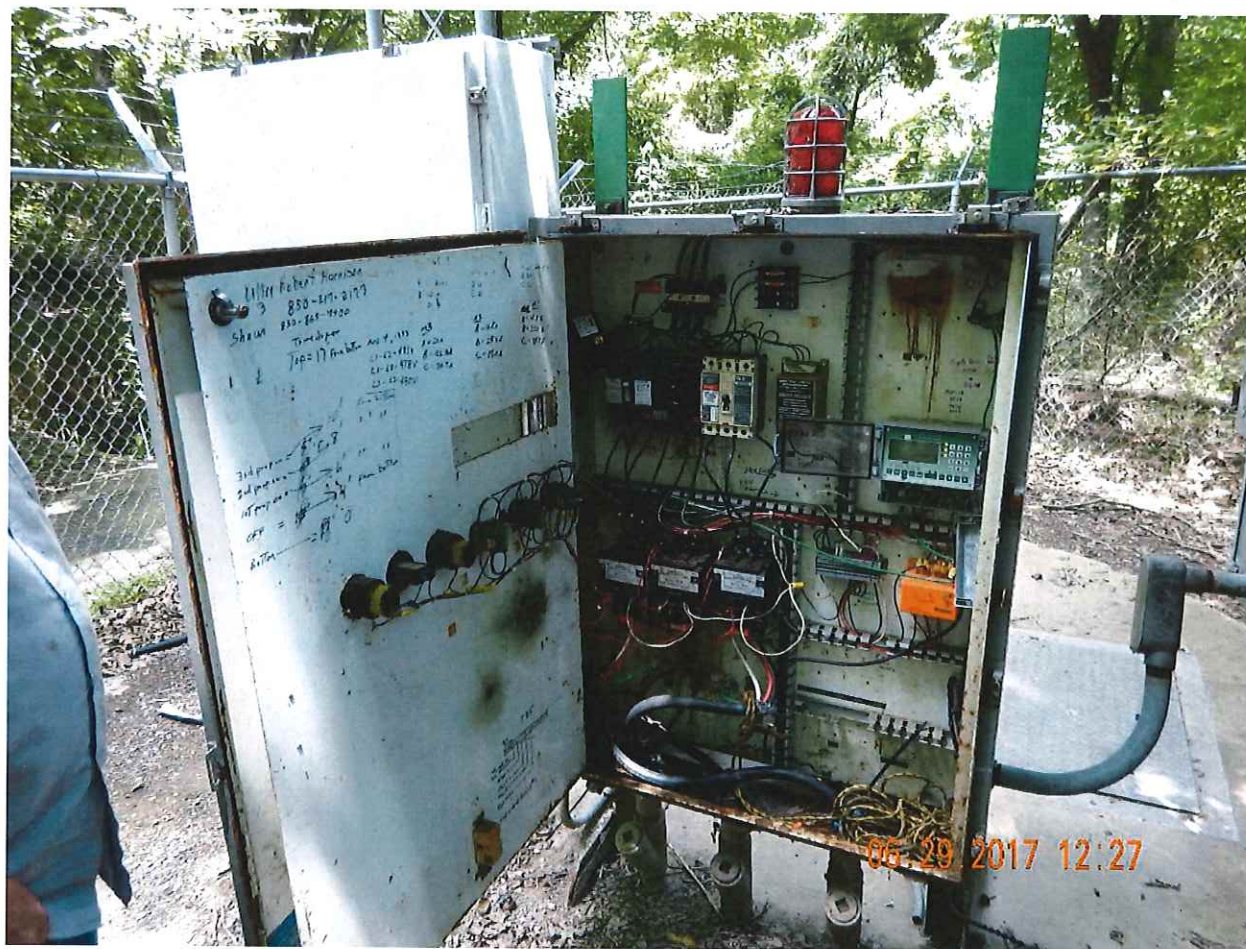
Photo No. 8

| Comments: Lake Ridge 3 electrical panel with visual alarm. Note audio / visual alarm inoperative at the time of inspection. | | |

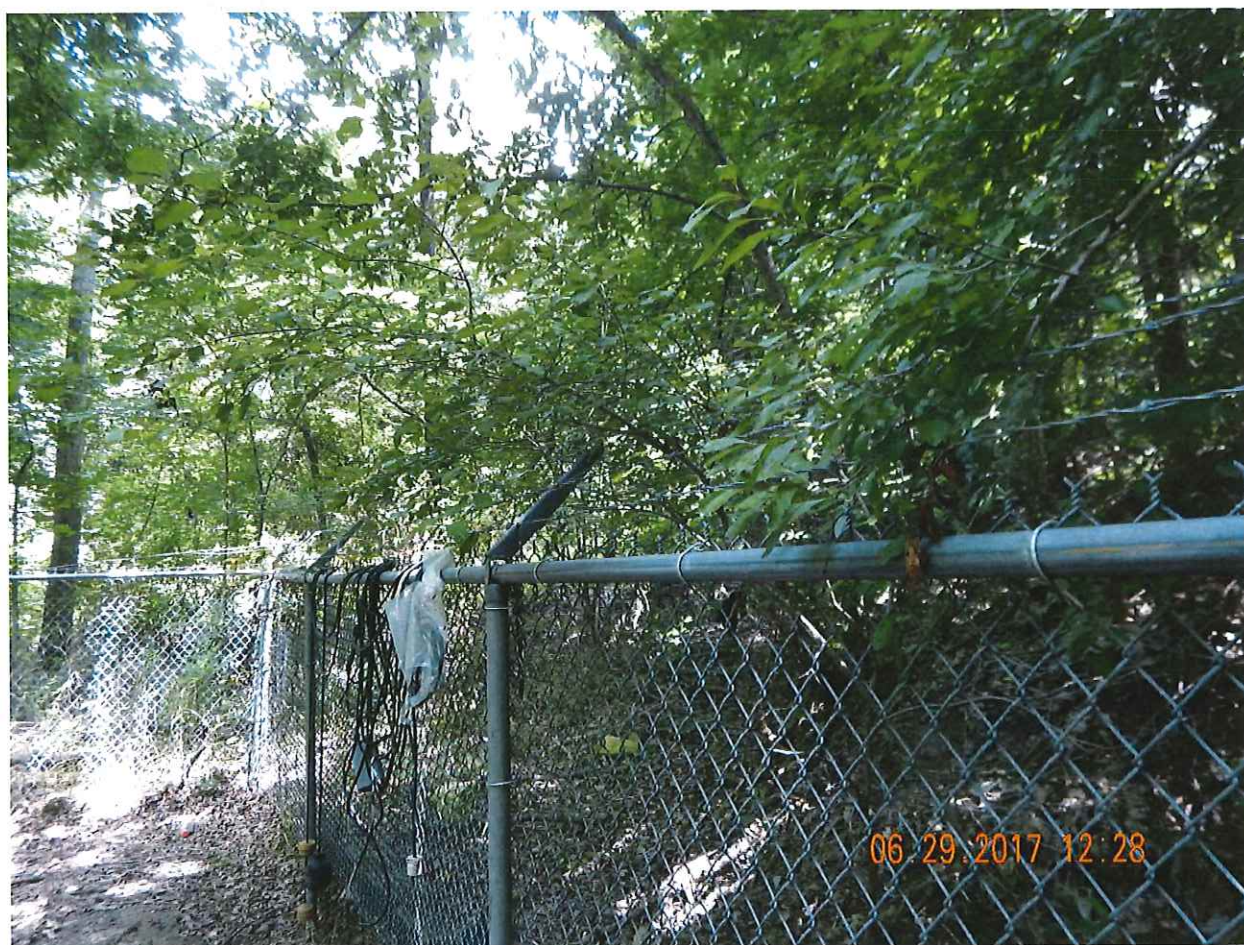
| Comments: Note trees and vegetation encroaching on security fencing, need to be trimmed away. | | |

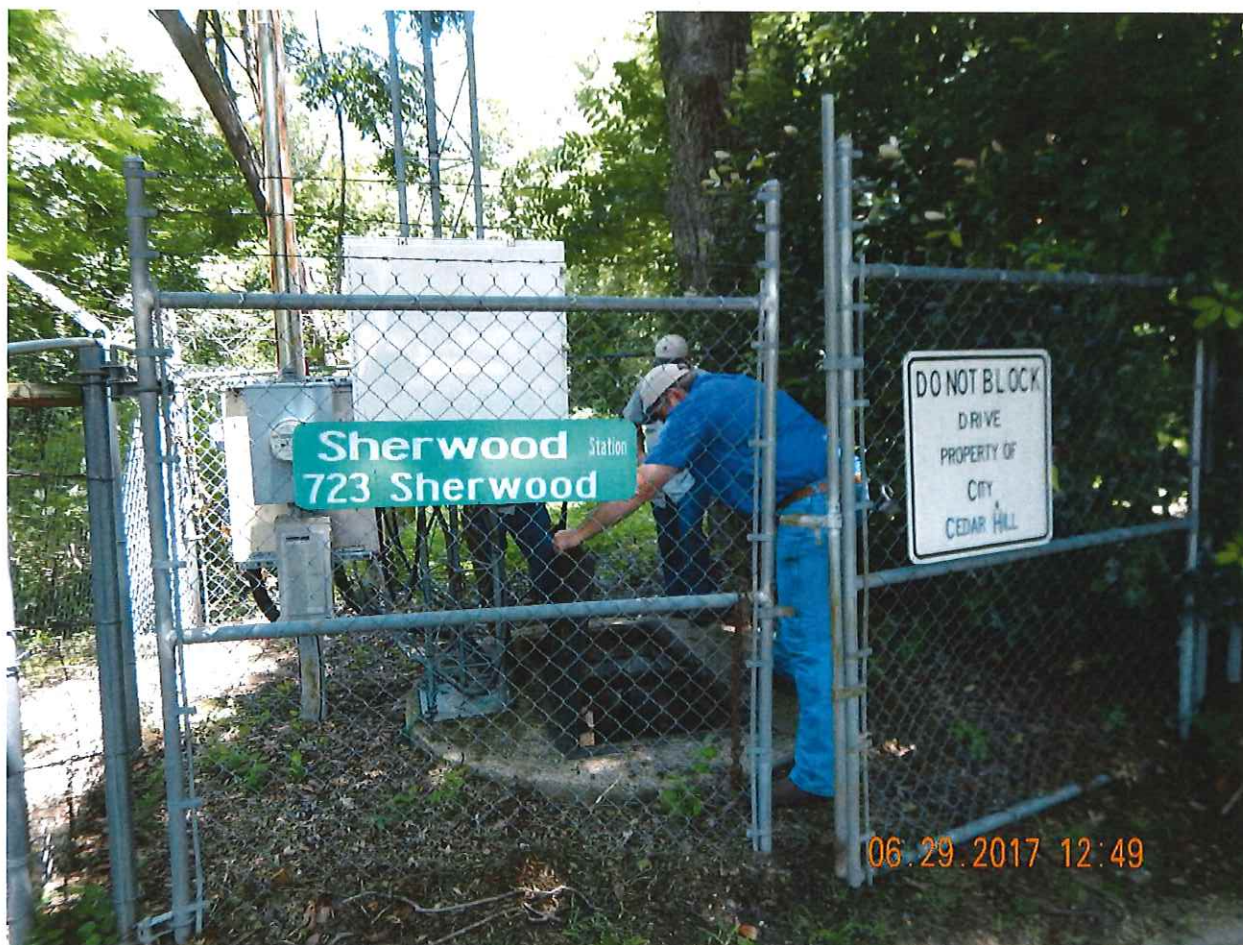
- A review of TCEQ's SSO data base determined that Cedar Hill is missing reporting data for 2013 and 2014. Although sampling data for these years is available, neither TCEQ or the City can locate any of the SSO reports. (Example SSO Report – Appendix 9).
- Visits to the Bedford Branch, Lake Ridge 3, and Sherwood lift stations provided evidence of tree and/or vegetation encroachment into the security fencing. Additionally, fence maintenance was in need of attention at the Sherwood site (Appendix 1; photo #'s 5, 9, 10, and 13.)
- The audio/visual alarm at the Lake Ridge 3 lift station was inoperative at the time of inspection (Appendix 1; photo # 8.)
- Physical signage at the Sherwood lift station is lacking emergency contact information (Appendix 1; photo # 10.)

| Comments: Note physical signage with emergency contact information is missing from the gate. | | |

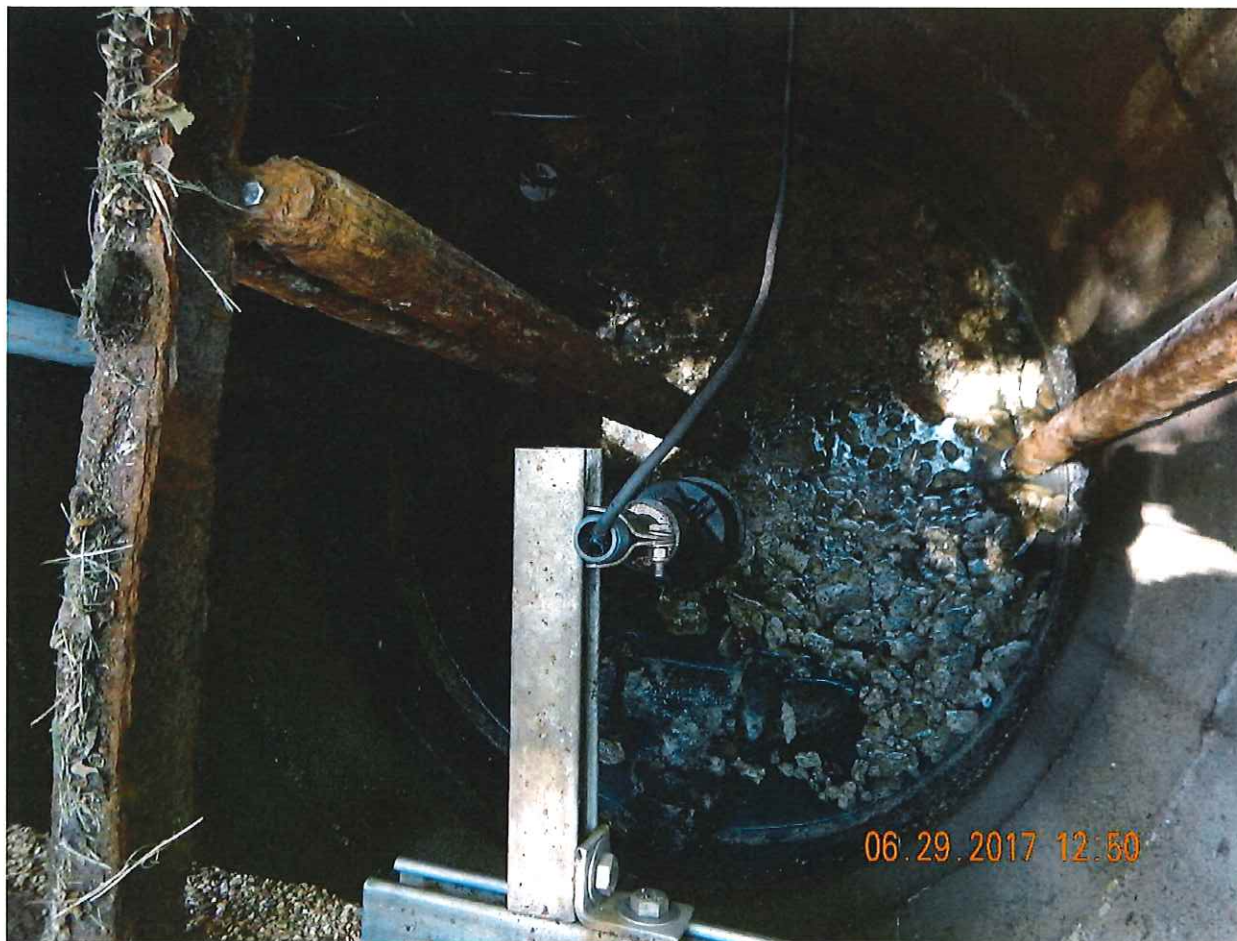
| Comments: Sherwood wet well. Note heavy amounts of grease / floating debris and apparent need of cleaning. | | |

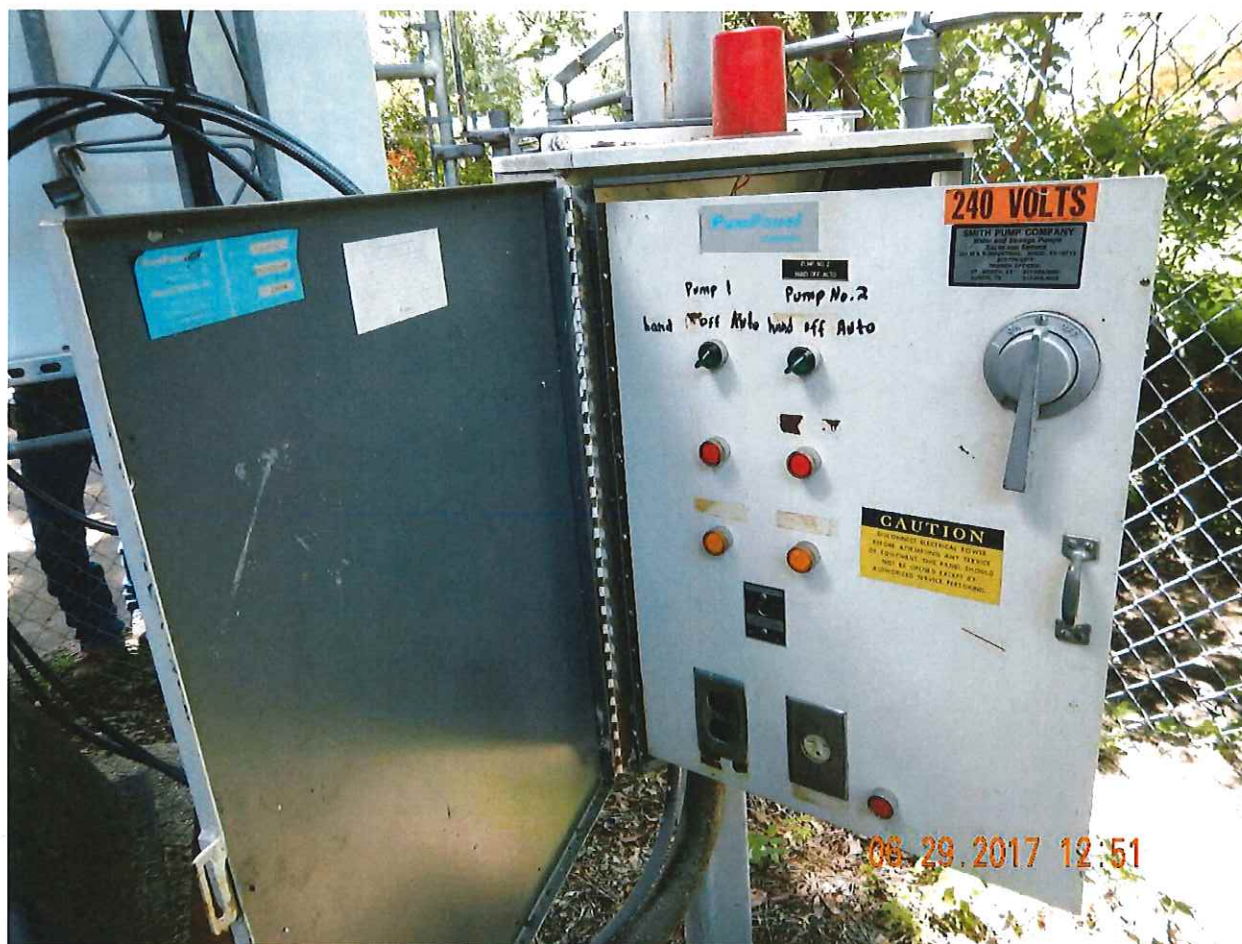
| Comments: Sherwood electrical panel with visual alarm. | | |

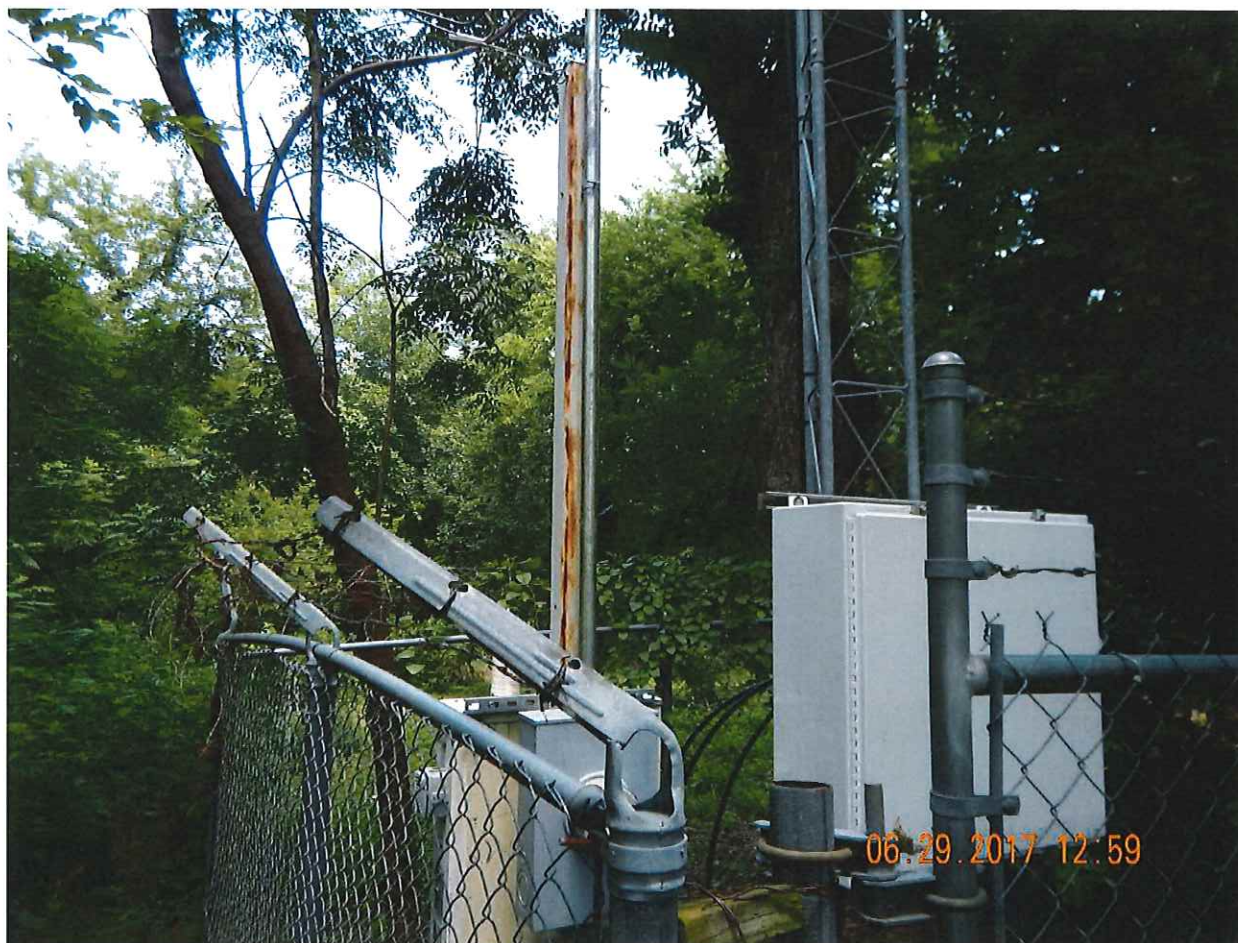
| Comments: Note trees and vegetation encroaching on security fencing, need to be trimmed away. Fencing in state of disrepair with gaps in barbed wire at front gate. | | |
