**U.S. ENVIRONMENTAL PROTECTION AGENCY  
REGION III WATER BRANCH, ENFORCEMENT  
AND COMPLIANCE ASSURANCE DIVISION  
CLEAN WATER ACT  
COMPLIANCE INSPECTION REPORT**

**Name of Municipality:** Scott Township, Pennsylvania MS4  
**Municipality Address:** 1038 Montdale Road #101, Scott, PA 18447  
**Mailing Address:** 1038 Montdale Road #101, Scott, PA 18447

Report Prepared on: 9/7/2021 By: Cassidy Owen,  
Date Cassidy Owen, Eastern Research Group

| <b>Type of Inspection:</b> | MS4 Compliance Inspection |

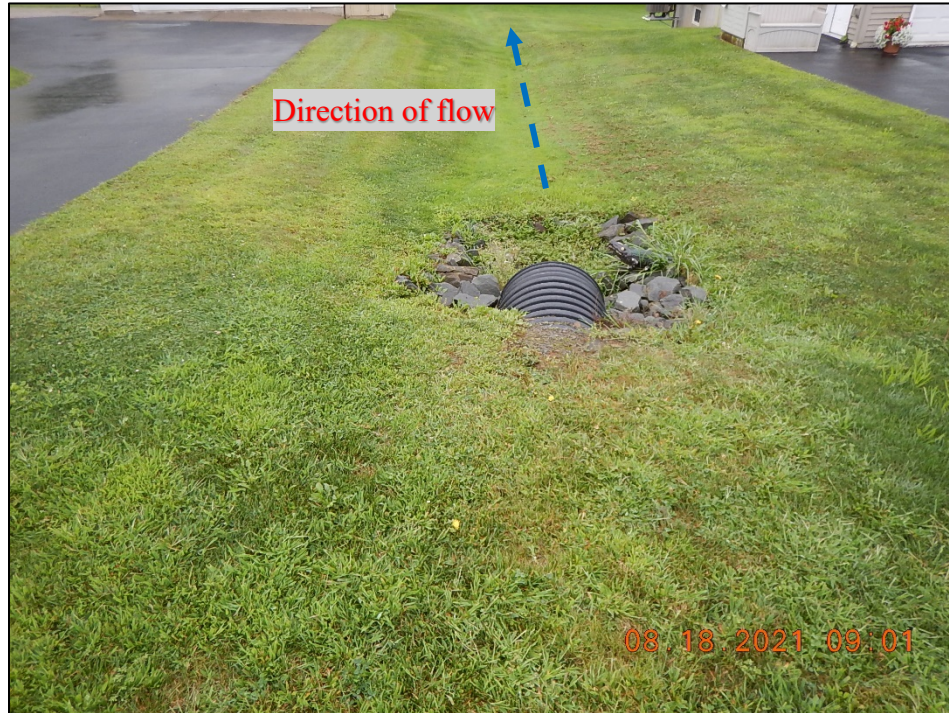
- 2) The EPA Inspection Team observed the end of a corrugated plastic pipe designated as Outfall #2 (refer to Photograph 1). Outfall #2 discharges to a grassy ditch that runs between two houses into a nearby wooded area. The EPA Inspection Team observed rip rap around the end of the pipe opening with no ditch erosion beyond the area containing rip rap (refer to Photograph 2). The EPA Inspection Team also observed a concrete block inside the end of the outfall pipe with some sediment buildup behind the block. The Township Administrator stated that this block was placed in the pipe to slow the flow of water discharging from the outfall. The EPA Inspection Team observed a small amount of flow discharging from the outfall pipe.

**Photograph 1. Outfall #2:** (DSCN0701) View, facing south, of the end-of-pipe labelled Outfall #2. The outfall discharges to a grassy ditch between two houses, which connects to a tributary to Leggetts Creek, approximately 300 feet to the southeast.

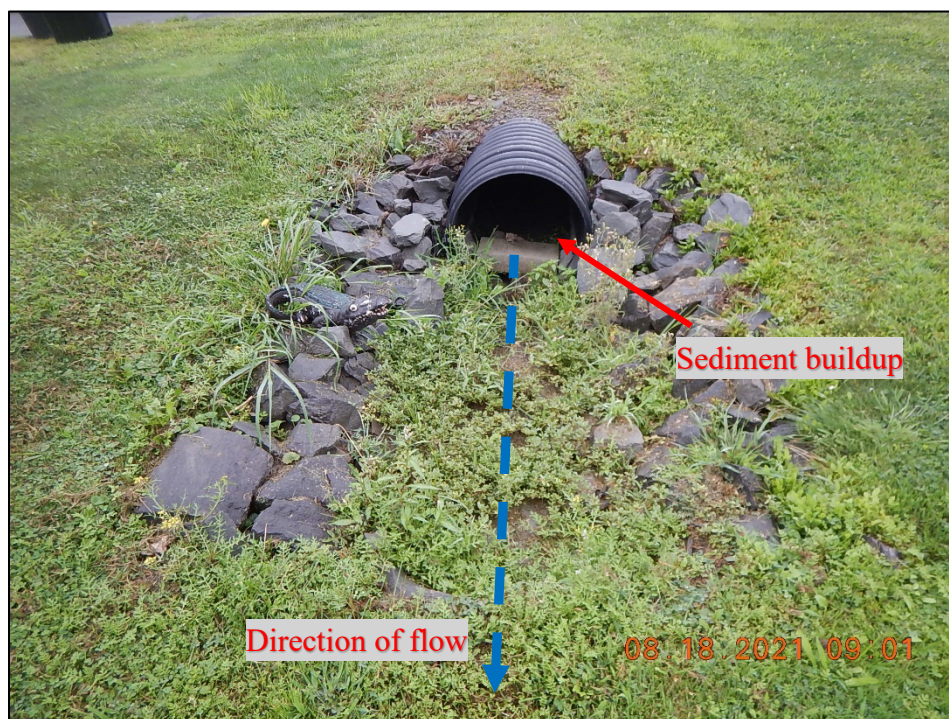
**Photograph 2. Outfall #2:** (DSCN0702) View, facing north, of the end-of-pipe labelled Outfall #2. Note the rip rap around the outfall, concrete block inside the pipe, and sediment buildup behind the concrete block.

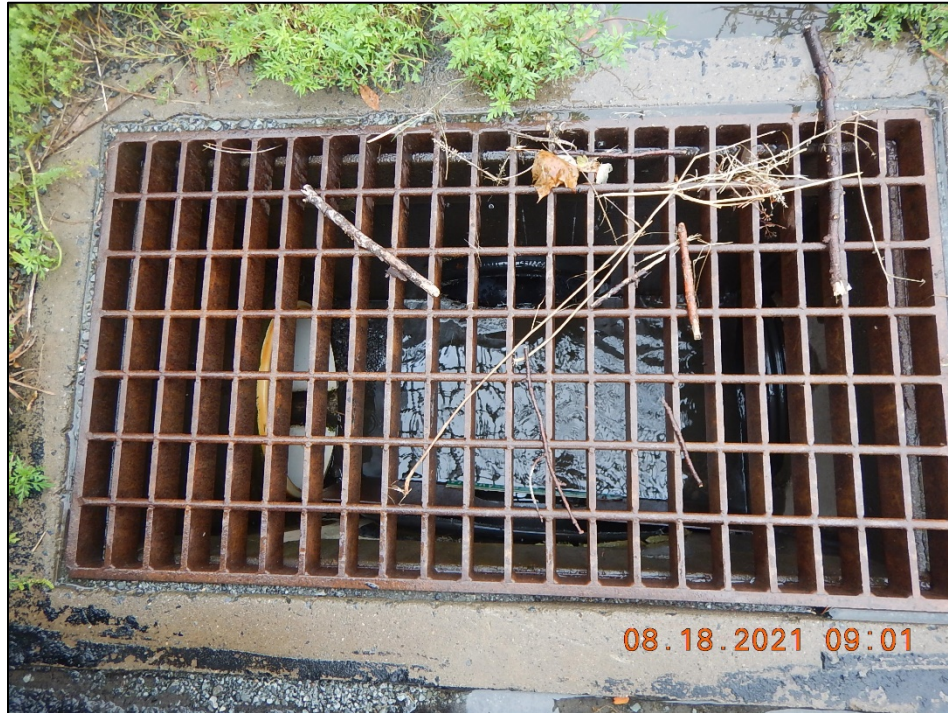
- 3) The EPA Inspection Team observed the closest upgradient inlet from the Outfall #2, located approximately 20 feet north of Outfall #2 on the opposite side of Laurel Drive (refer to Photograph 3). The inlet appeared to be in good condition and free of debris. The EPA Inspection Team observed stormwater flow through the inlet. The EPA Inspection Team also observed surface sheen on Laurel Drive running towards the inlet (refer to Photographs 4 and 5).

**Photograph 3. Outfall #2: (DSCN0700)** View of the closest upgradient inlet from Outfall #2.

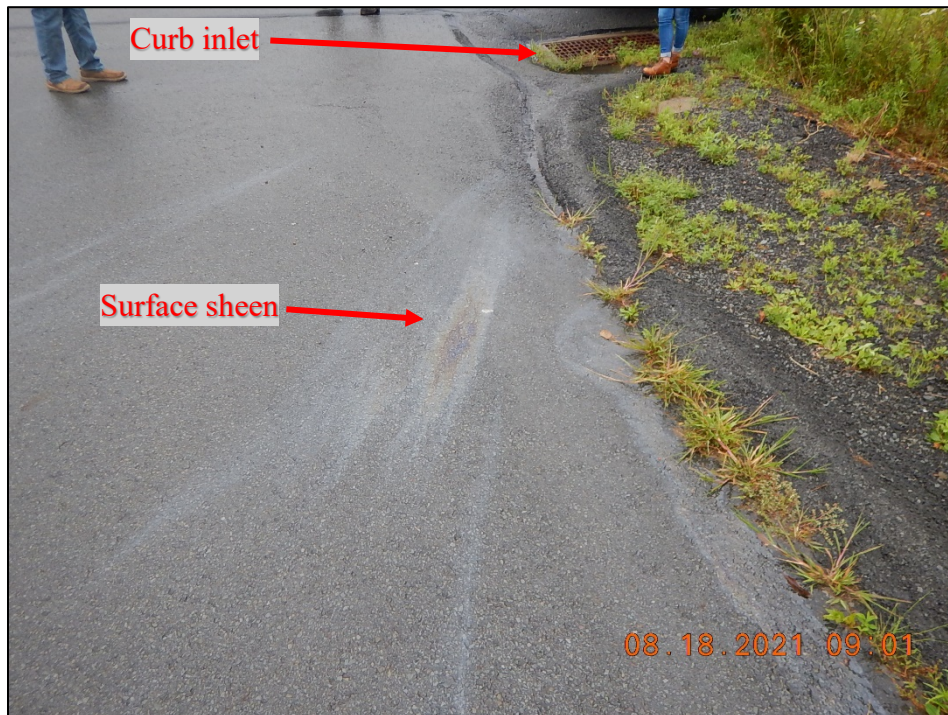
**Photograph 4. Outfall #2: (DSCN0698)** View, facing south, of surface sheen running down Meadow Drive towards the curb inlet shown in Photograph 6.

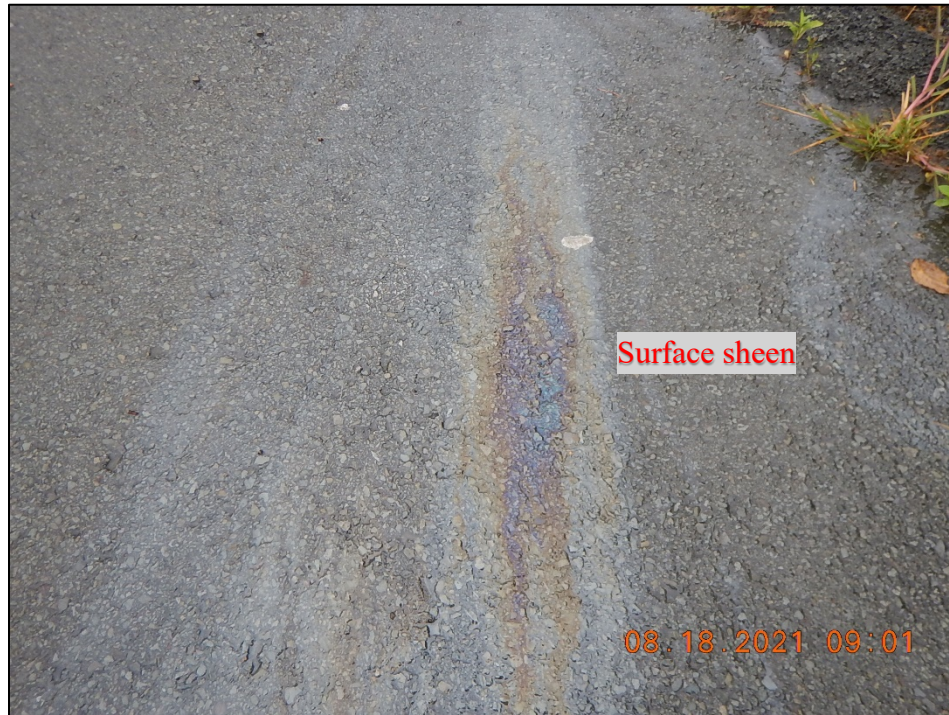
**Photograph 5. Outfall #2:** (DSCN0699) Close-up view, facing south, of the surface sheen shown in Photograph 7.

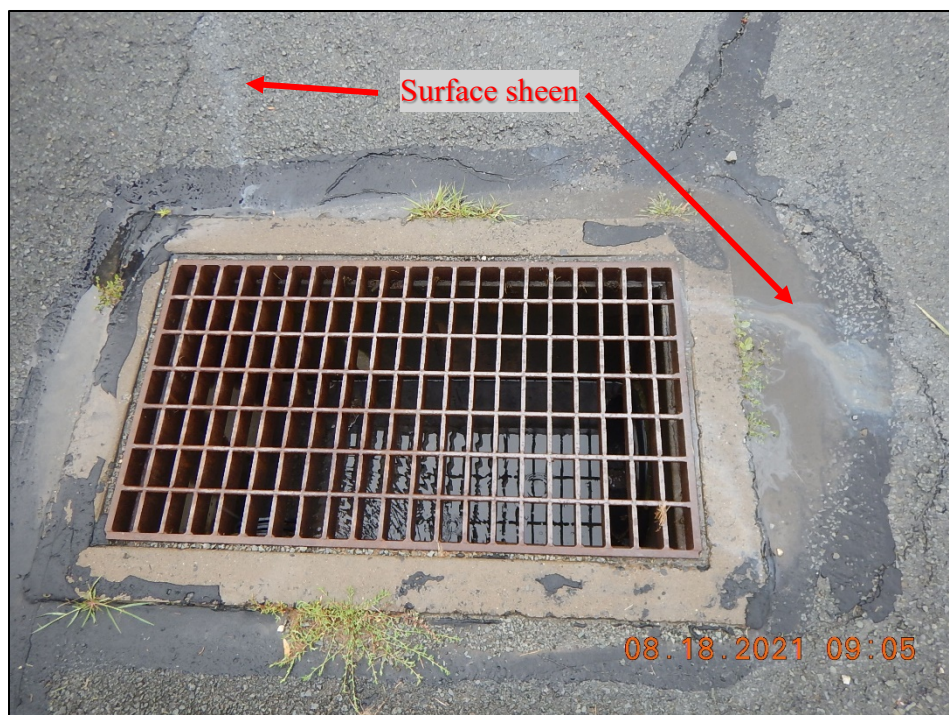
- 4) The EPA Inspection Team observed the next upgradient inlet from Outfall #2, located on the opposite side of Laurel Drive and Meadow Drive (refer to Photographs 6 and 7). The EPA Inspection Team observed surface sheen flowing into this inlet. The EPA Inspection Team asked the Township Administrator if the Township would do anything about the surface sheen. The Township Administrator stated that they have the ability to collect samples, but that he was not concerned with this amount of surface sheen. Additionally, the Township Administrator stated that the surface sheen may have emanated from a patch of asphalt used to repair a crack in the pavement (refer to Photograph 8). The Township Administrator stated that the pavement cracks had been repaired last year. The EPA Inspection Team observed that some surface sheen appeared to be emanating from a crack in the pavement, but other

**Photograph 6. Outfall #2:** (DSCN0703) View, facing south, of the next most upgradient inlet from Outfall #2. Note the surface sheen flowing into the inlet.

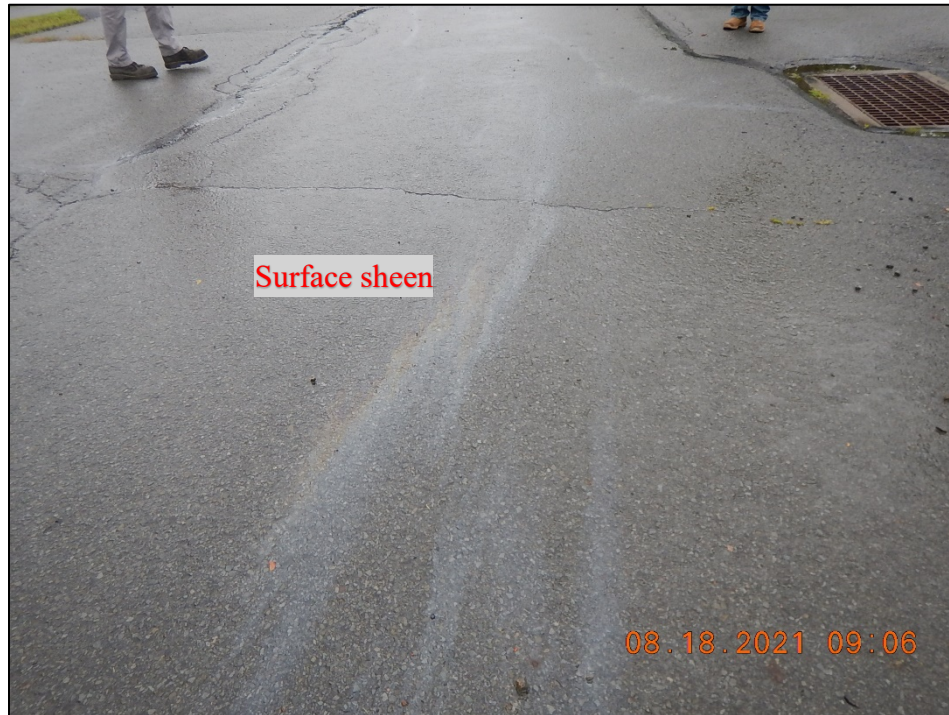
**Photograph 7. Outfall #2: (DSCN0704)** View, facing west, of surface sheen flowing along Laurel Drive to the inlet shown in Photograph 9.

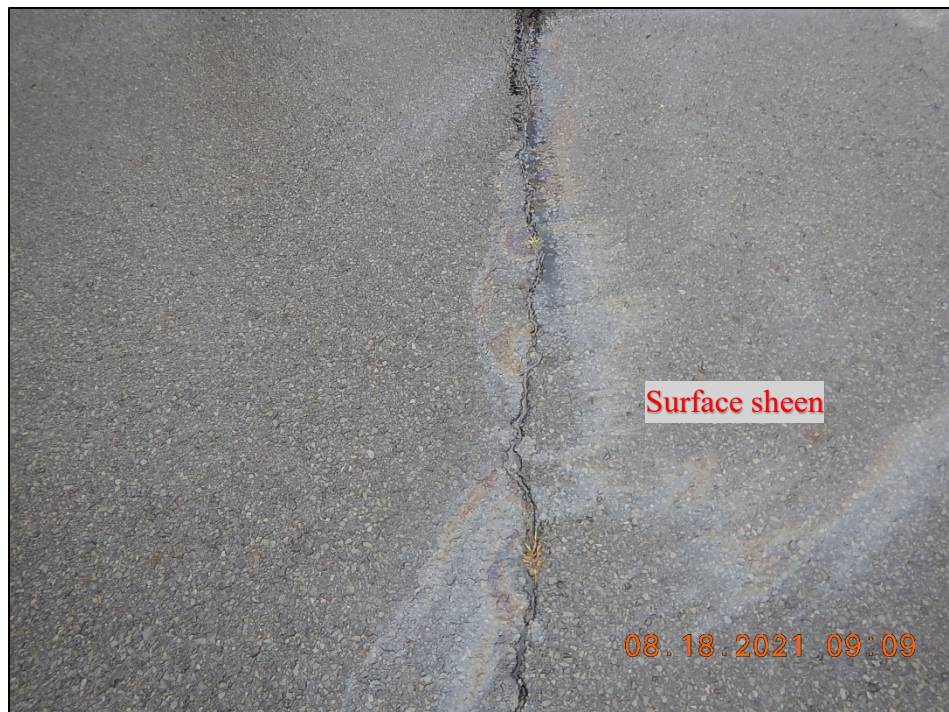
areas of surface sheen were not near cracks in the pavement. The Township Administrator stated that no additional investigation would be performed by the Township.

**Photograph 8. Outfall #2: (DSCN0705)** View of surface sheen that appears to be emanating from a crack in the pavement.

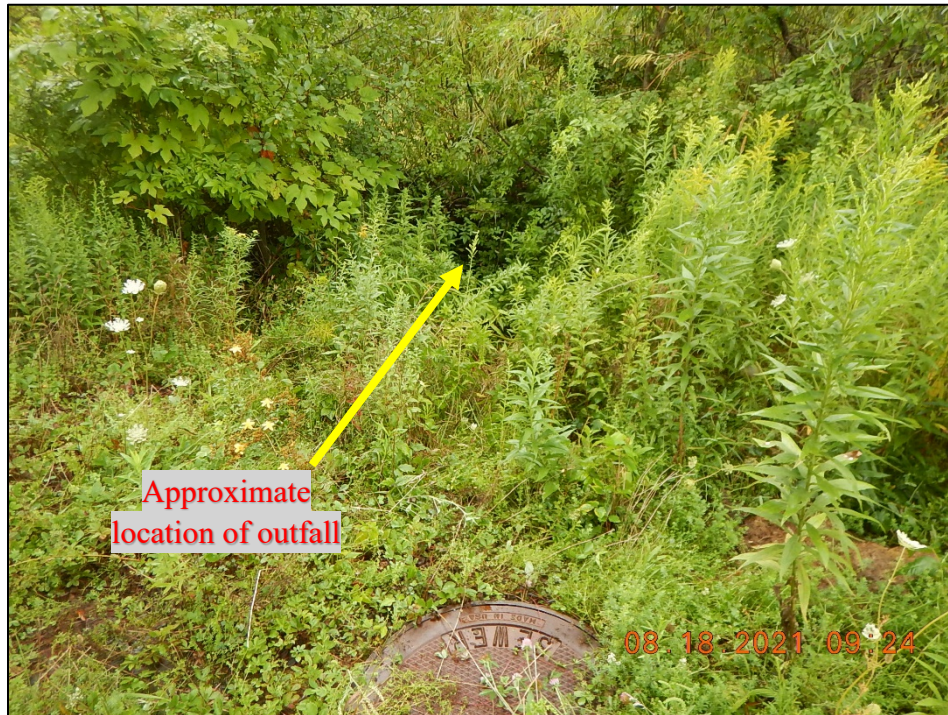
- 2) The EPA Inspection Team observed a heavily overgrown area in which the Township Administrator stated the outfall was present. After approximately 10 minutes of searching for the outfall in the overgrowth, the Township Administrator stated that he had found it near a fallen tree in the overgrowth (refer to Photograph 9). The EPA Inspection Team was unable to fully observe the outfall due to the lack of access and vegetative overgrowth.

**Photograph 9. Hill Street Outfall: (DSCN0707)** View, facing west, of a manhole leading to the Hill Street Outfall. The EPA Inspection Team was unable to observe the outfall due to the lack of access and vegetative overgrowth.

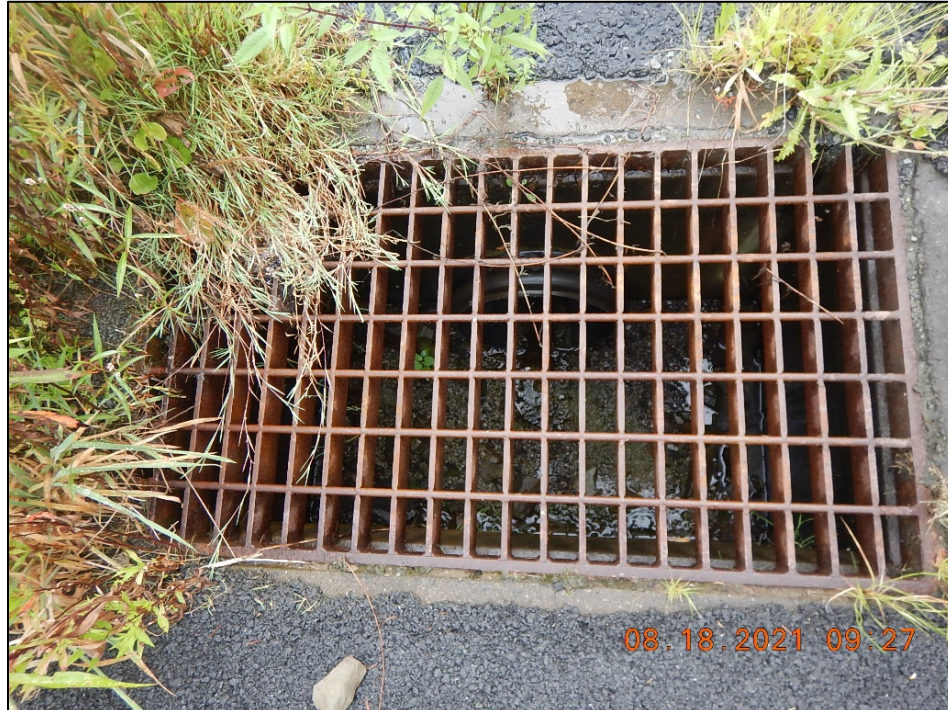
- 3) The EPA Inspection Team observed the only upgradient inlet piped to the Hill Street Outfall, located approximately 20 feet west of the outfall (refer to Photograph 10). The inlet appeared to be in good condition and free of debris. The EPA Inspection Team observed stormwater flow through the inlet.

**Photograph 10. Hill Street Outfall: (DSCN0709)** View of the only upgradient inlet piped to the Hill Street Outfall, located approximately 20 feet west of the outfall. Stormwater runoff was observed going into the inlet at the time of the inspection.

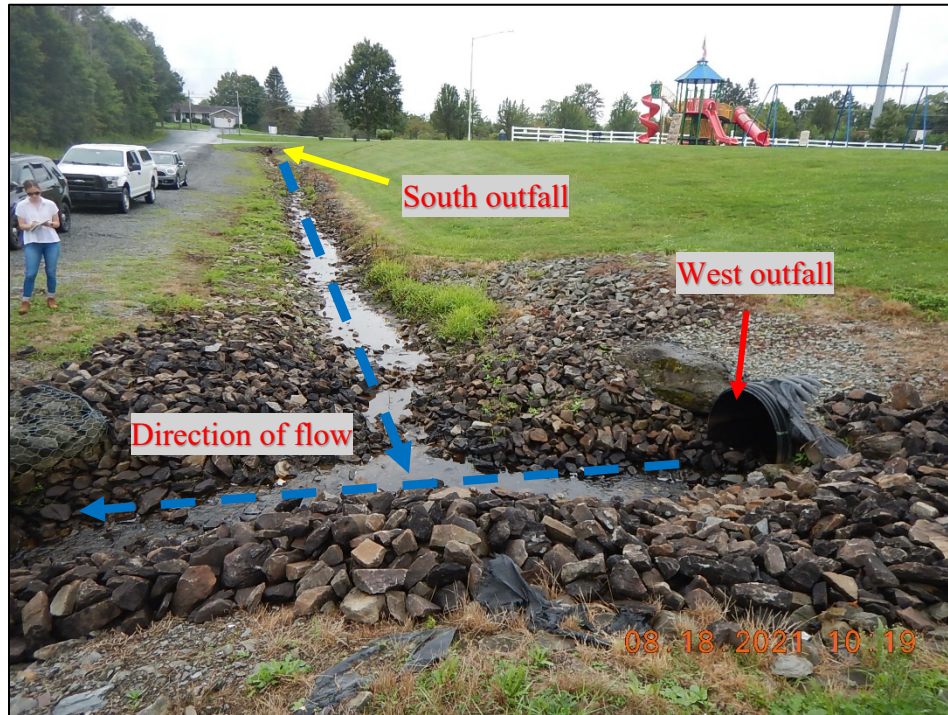
- 2) The EPA Inspection Team observed the outfalls from the point at which the south and west outfall ditches meet (refer to [Photograph 11](#)). The Township Administrator stated that both outfalls have consistent flow, even during dry-weather conditions. The EPA Inspection Team observed stormwater flow through both outfalls. Both outfall ditches contained rip rap stabilization.

**Photograph 11. Municipal Park Outfalls: (DSCN0723)** View, facing south, of the south outfall discharging to a ditch and merging with the outfall ditch from the west outfall.

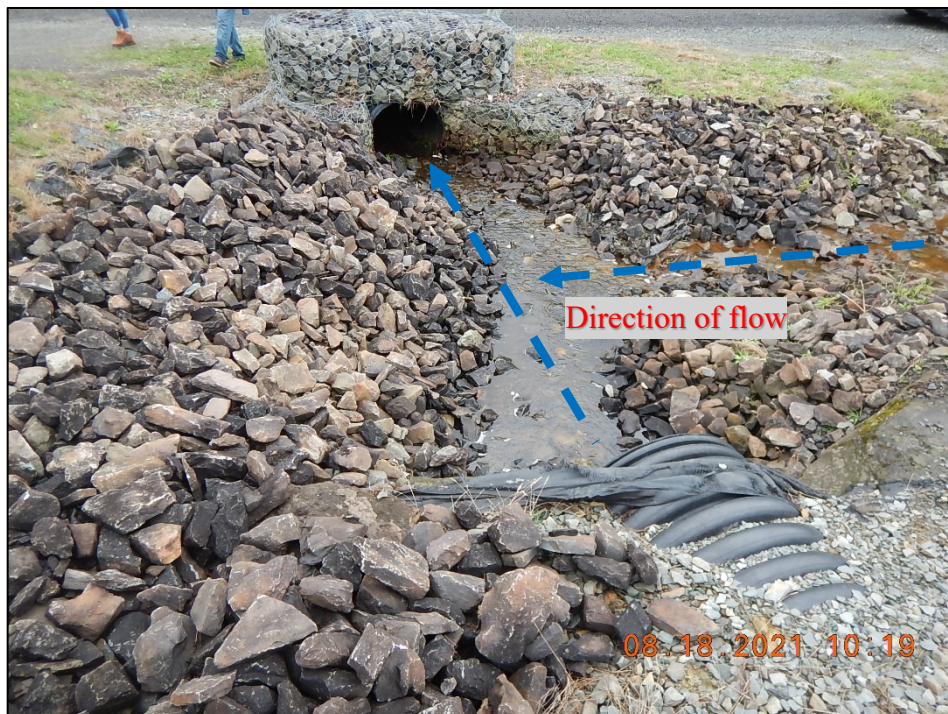
- 3) The EPA Inspection Team observed the combined outfall ditches flowing under Mostowski Road (refer to [Photograph 12](#)) and then discharging into an unnamed tributary to the South Branch Tunkhannock Creek (refer to [Photograph 13](#)). The EPA Inspection Team observed stormwater flow in the unnamed tributary to the South Branch Tunkhannock Creek.

**Photograph 12. Municipal Park Outfalls: (DSCN0724)** View, facing east, of the south and west outfall ditches merging and flowing under Mostowski Road.

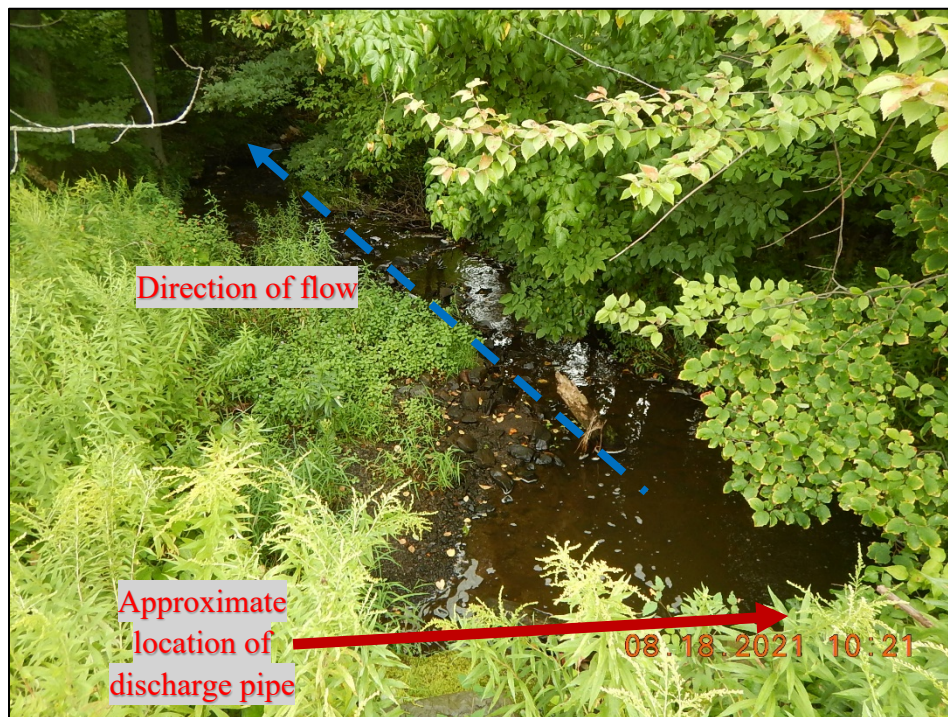
**Photograph 13. Municipal Park Outfalls:** (DSCN0725) View, facing east, of the combined outfall ditches discharging to an unnamed tributary to the South Branch Tunkhannock Creek.

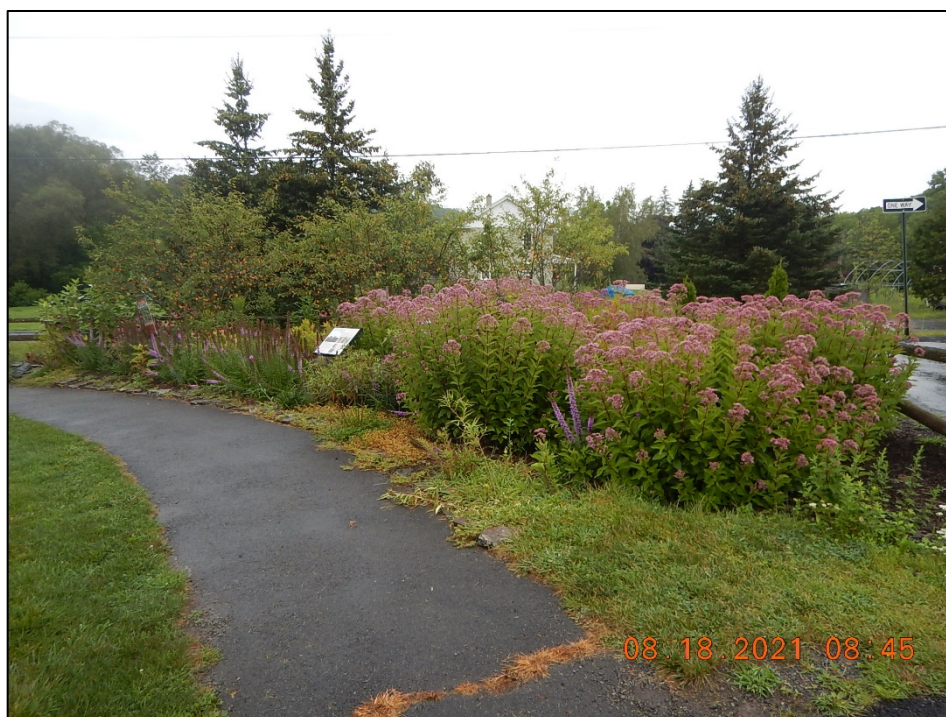
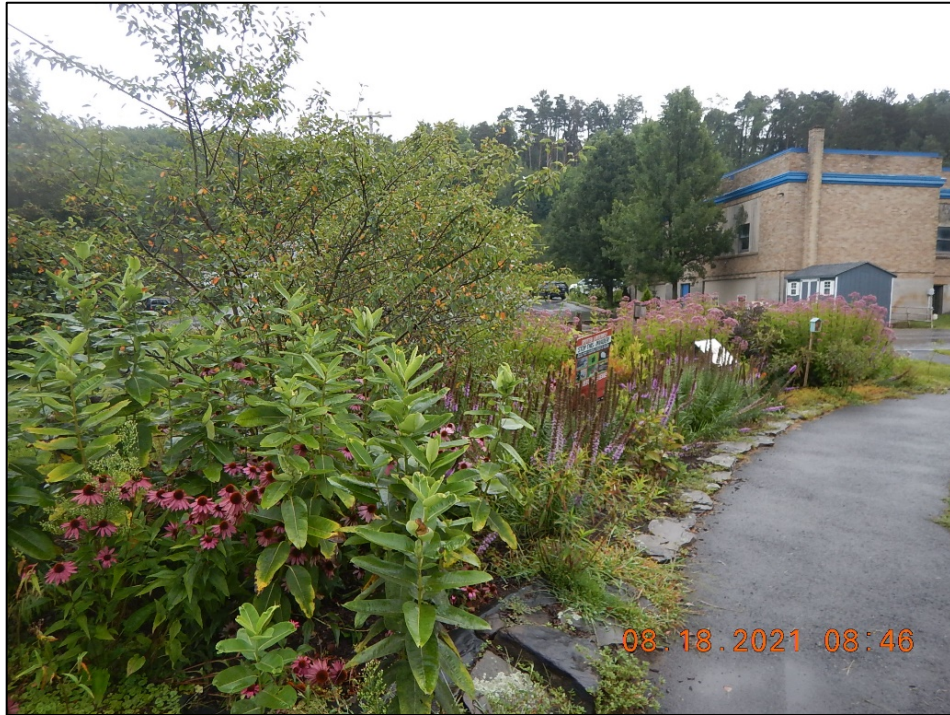
- 4) The EPA Inspection Team observed that plants within the rain garden appeared to be in good condition (refer to Photographs 14 and 15). The EPA Inspection Team also observed a synthetic liner beneath the rain garden that appeared to be in good condition (refer to Photograph 16).

**Photograph 14. Municipal Building Rain Garden:** (DSCN0694) View, facing northwest, of the municipal building rain garden.

**Photograph 15. Municipal Building Rain Garden: (DSCN0696)** View, facing northeast, of the municipal building rain garden. Note the Scott Township Municipal Building and parking lot in the background.

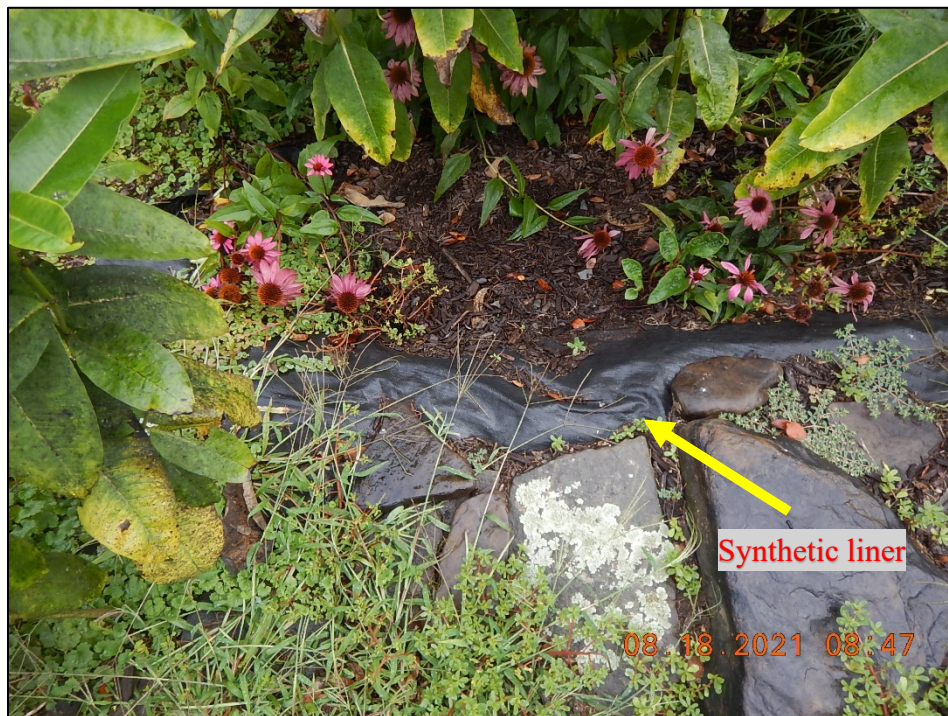
**Photograph 16. Municipal Building Rain Garden: (DSCN0697)** View of a synthetic liner beneath the municipal building rain garden.

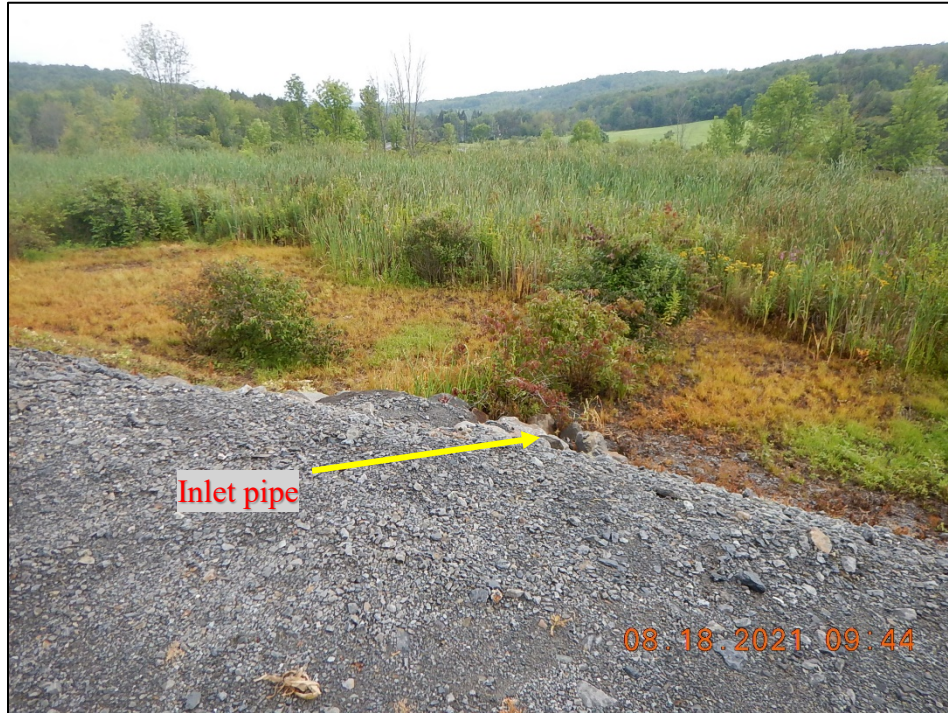
- 3) The EPA Inspection Team observed the east detention basin located approximately 20 feet downhill from the Francis Smith & Sons parking lot (refer to Photograph 17). The basin was almost entirely full of cattails with the exception of a mowed patch of grass closest to the inlet pipe. The inlet pipe consisted of a small plastic corrugated pipe surrounded by rip rap (refer to Photograph 18). The EPA Inspection Team observed stormwater flow from the end of the inlet pipe. The Township Administrator stated that there were no outlet pipes for stormwater leaving the detention basin.

**Photograph 17. Francis Smith & Sons Detention Pond: (DSCN0713)** View, facing north, of the east detention basin, located approximately 20 feet downhill from the parking lot.

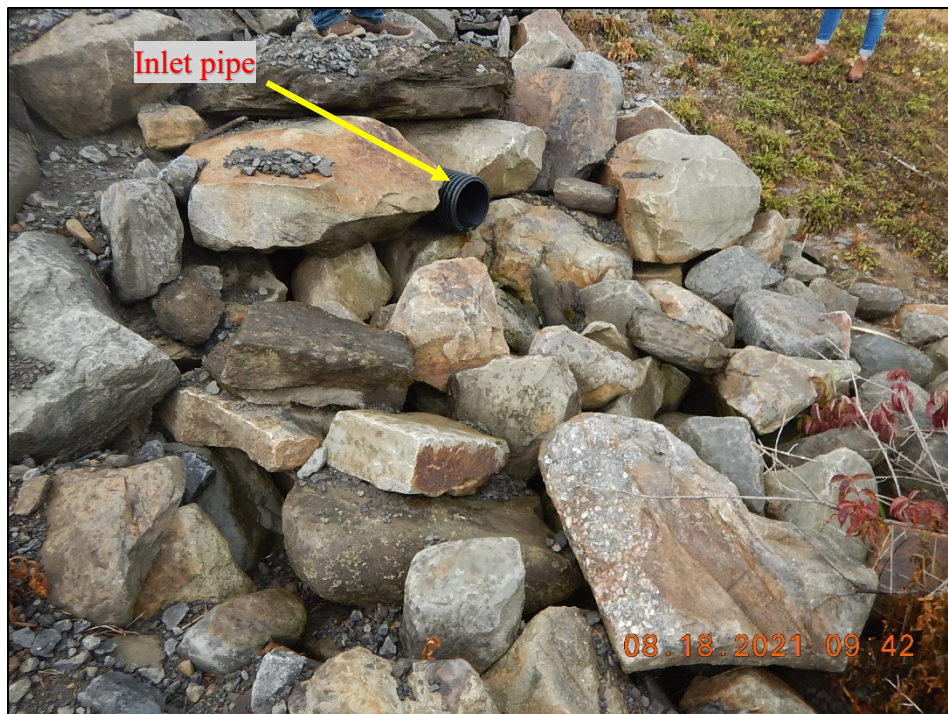
**Photograph 18. Francis Smith & Sons Detention Pond: (DSCN0710)** View, facing west, of the inlet pipe from the parking lot to the east detention basin. Note the rip rap surrounding the pipe opening.

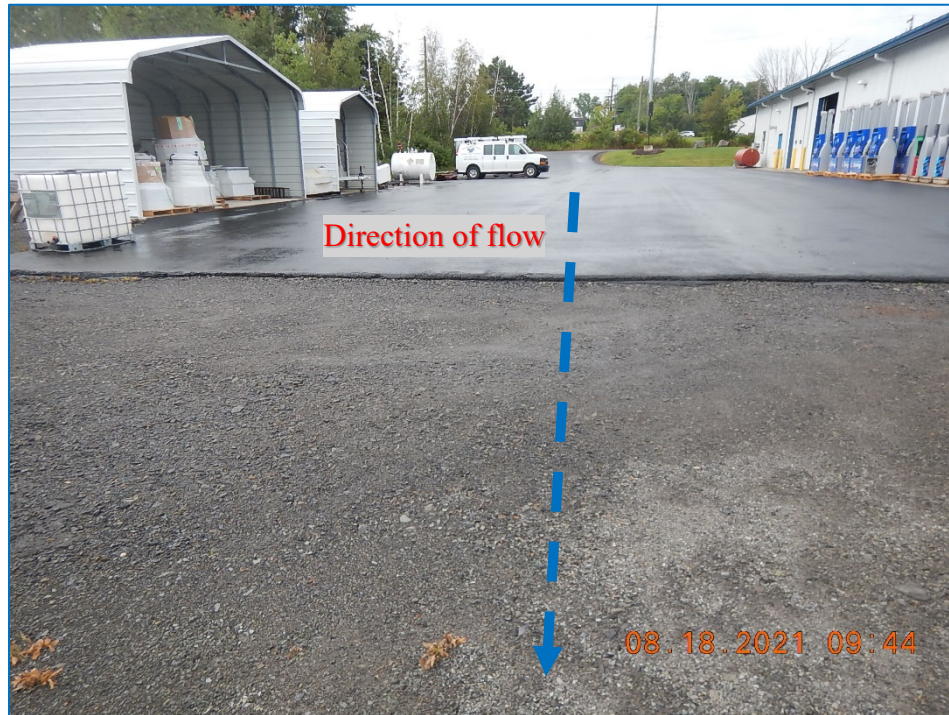
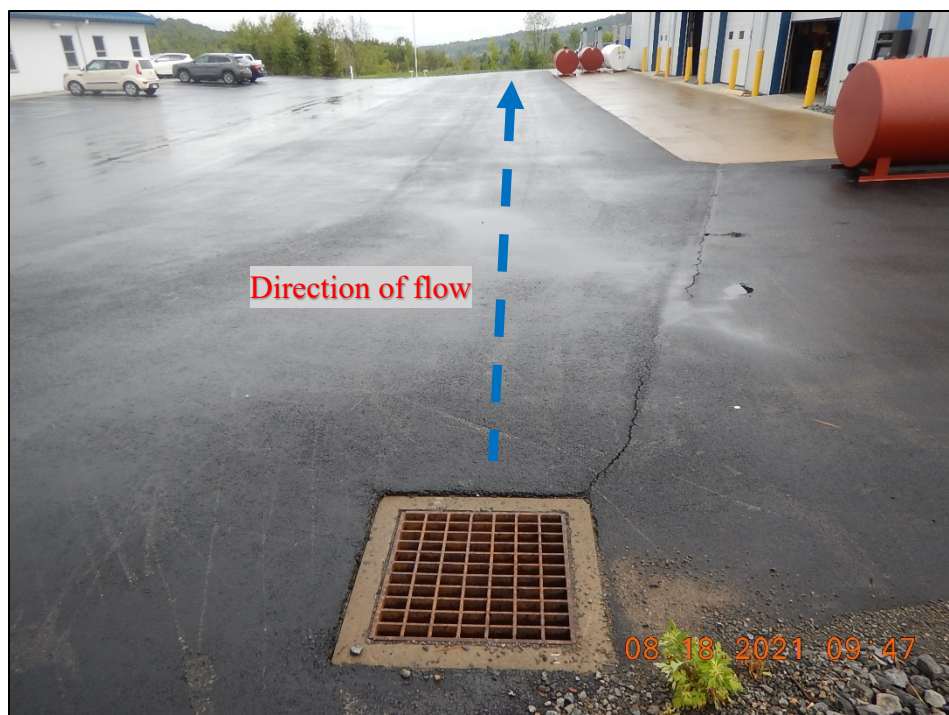
- 4) The EPA Inspection Team observed that the majority of the Francis Smith & Sons parking lot was paved (refer to Photographs 19 and 20). The Township Administrator stated that stormwater from the parking lot mainly moved via sheet flow to the detention basin; however, the parking lot contained a few stormwater inlets that were piped to the east and west detention basins.
- 5) The EPA Inspection Team observed the west detention basin and corresponding inlet pipe (refer to Photograph 21). The EPA Inspection Team observed that the west detention basin and inlet pipe appeared to be identical in design and condition to the east detention basin. As with the east detention basin, the Township Administrator stated that there were no outlet pipes for stormwater leaving the detention basin. All captured runoff infiltrates.

**Photograph 19. Francis Smith & Sons Detention Pond: (DSCN0714)** View, facing south, of the parking lot uphill of the east detention basin.

**Photograph 20. Francis Smith & Sons Detention Pond: (DSCN0716)** View, facing north, of the parking lot uphill of the west detention basin. Note the presence of an inlet flowing to the west detention basin.

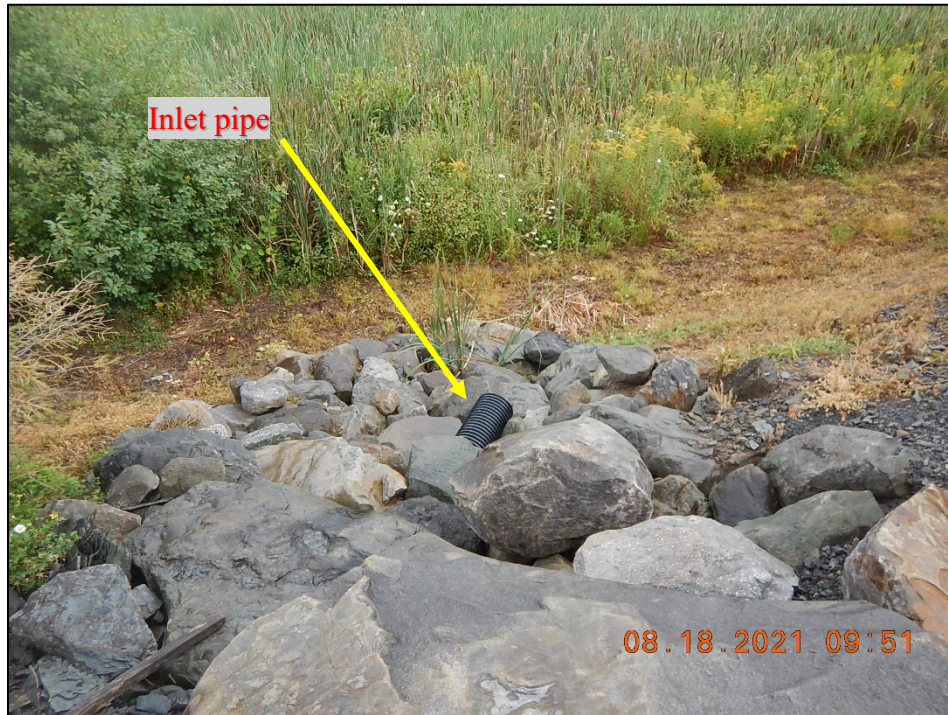
**Photograph 21. Francis Smith & Sons Detention Pond:** (DSCN0717) View, facing north, of the inlet pipe from the parking lot to the west detention basin. Note the rip rap surrounding the pipe opening.

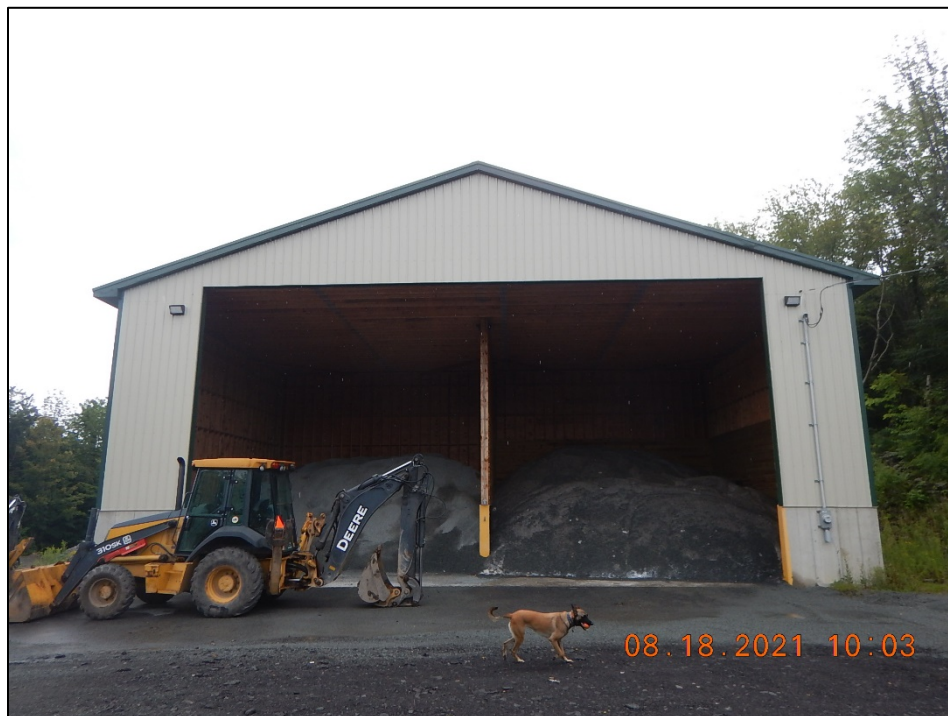
- 3) The EPA Inspection Team observed the salt storage shed (refer to Photograph 22), which appeared to be in good structural condition without visible holes in the roof or walls. The EPA Inspection Team observed no track-out of salt from the entrance of the shed.

**Photograph 22. Municipal Salt Storage Shed:** (DSCN0719) View, facing east, of the municipal salt storage shed.

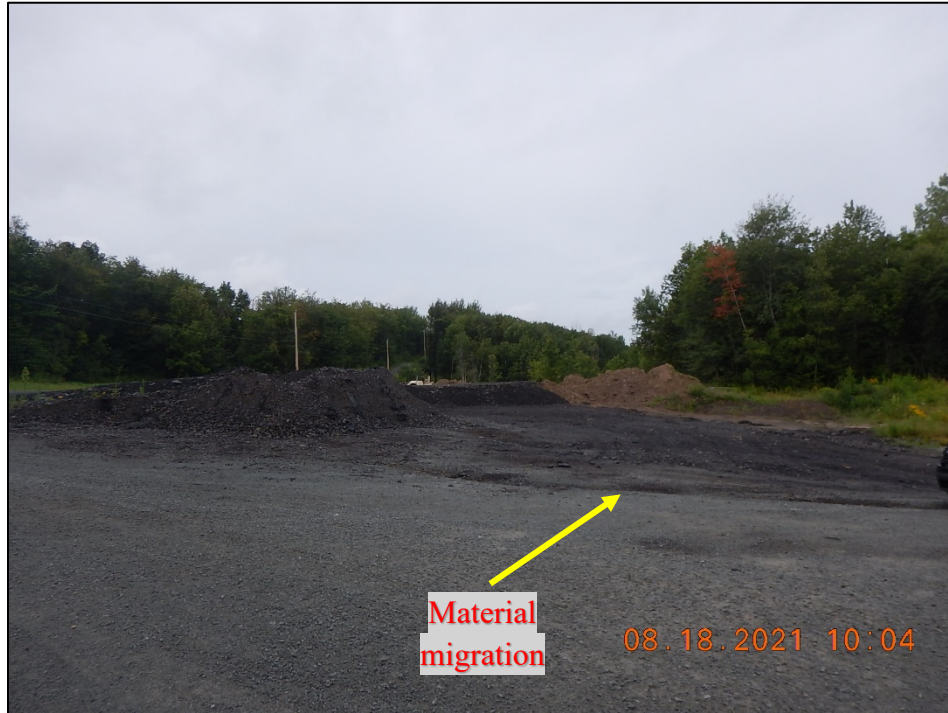
- 5) The EPA Inspection Team observed two piles of asphalt road fill and one pile of soil stored approximately 100 feet west of the salt storage shed (refer to Photograph 23). The piles did not have cover or impermeable containment, and the EPA Inspection Team observed runoff of asphalt road fill to the north.

**Photograph 23. Municipal Salt Storage Shed: (DSCN0720)** View, facing west, of two asphalt road fill piles and one pile of soil stored west of the salt storage shed. Note the lack of cover, impermeable containment, and migration of material from the piles to the north.

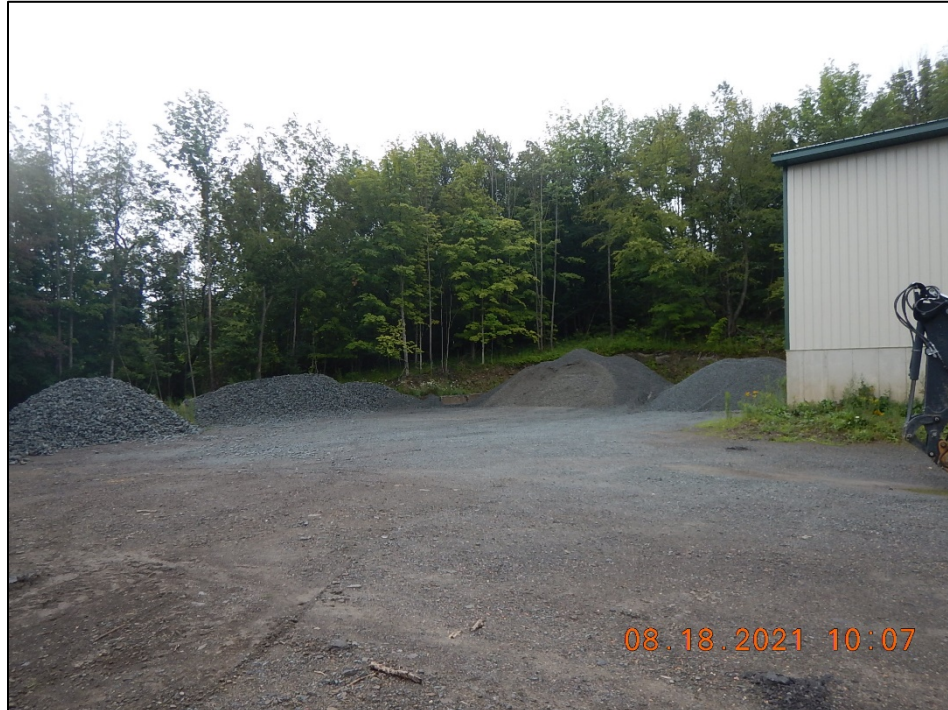
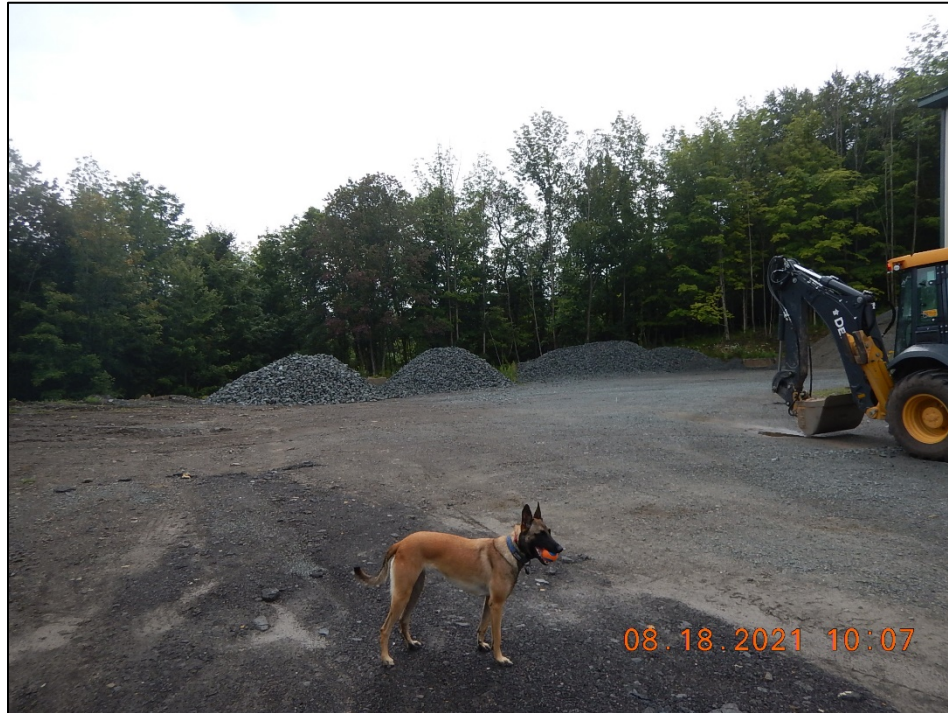
- 6) The EPA Inspection Team observed five piles of crushed stone located behind the salt storage shed (refer to Photographs 24 and 25). The piles did not have cover or impermeable containment, and the piles were located on the perimeter of the property.

**Photograph 24. Municipal Salt Storage Shed: (DSCN0722)** View, facing southeast, of four crushed stone piles behind the salt storage shed. Note the lack of cover and impermeable containment.

**Photograph 25. Municipal Salt Storage Shed:** (DSCN0721) Alternate view, facing east, of crushed stone piles behind the salt storage shed.

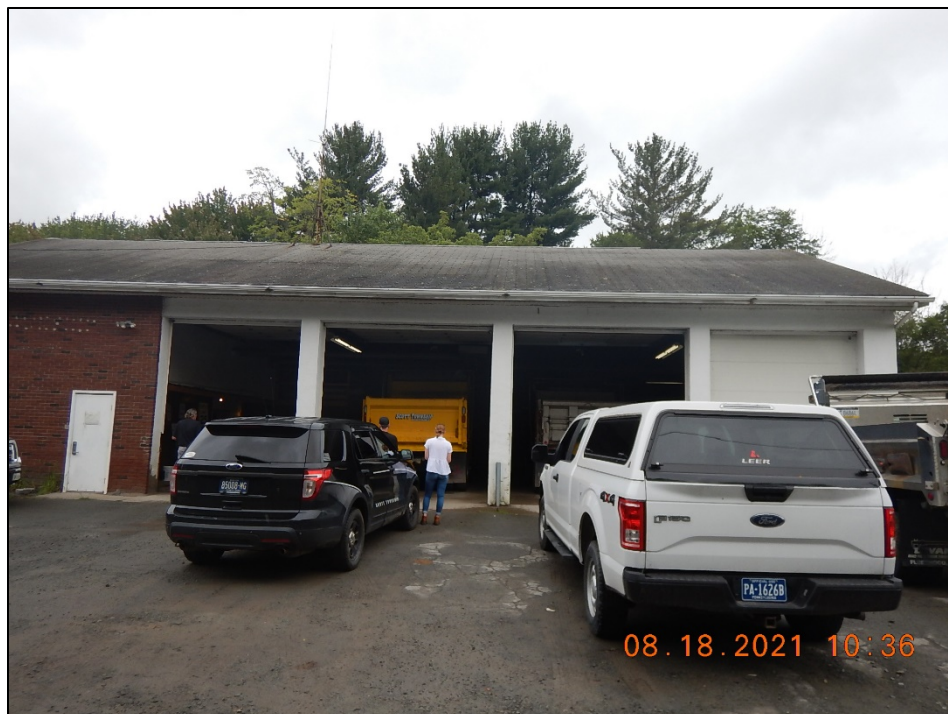
- 2) The EPA Inspection Team observed the municipal garage to consist of a building with four vehicle bays and a small gravel parking lot (refer to Photograph 26). The EPA Inspection Team observed no stormwater inlets or BMPs on the property. The EPA Inspection Team observed that the property was flat, with a grass field to the north and a small commercial building to the south. The nearest waterbody to the municipal garage is the South Branch Tunkhannock Creek, approximately 500 feet west of the facility through a wooded area.

**Photograph 26. Municipal Garage:** (DSCN0728) View, facing west, of the Municipal Garage and gravel parking lot.

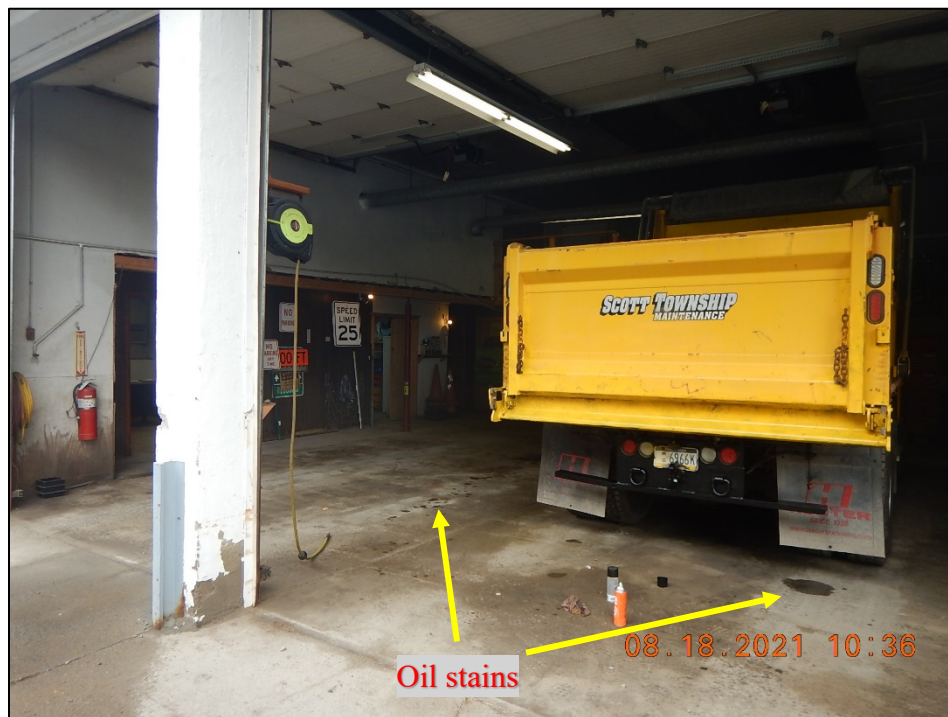
- 3) The EPA Inspection Team observed the floor of the municipal garage to have oil stains (refer to Photograph 27). The EPA Inspection Team also observed that the municipal garage contained floor drains; however, they were plugged (refer to Photograph 28). The EPA Inspection Team observed an oil spill kit inside the municipal garage.
- 4) The EPA Inspection Team observed small tool storage along the west wall of the municipal garage (refer to Photograph 29). The EPA Inspection Team also observed two 55-gallon drums of motor oil stored in the southwest corner of the municipal garage (refer to Photograph 30). The drums were not located on spill pallets or within secondary containment. The EPA Inspection Team also observed other small bottles of chemicals stored near the motor oil drums.

**Photograph 27. Municipal Garage: (DSCN0727)** View, facing southwest, of the interior of the municipal garage. Note the presence of oil stains on the floor.

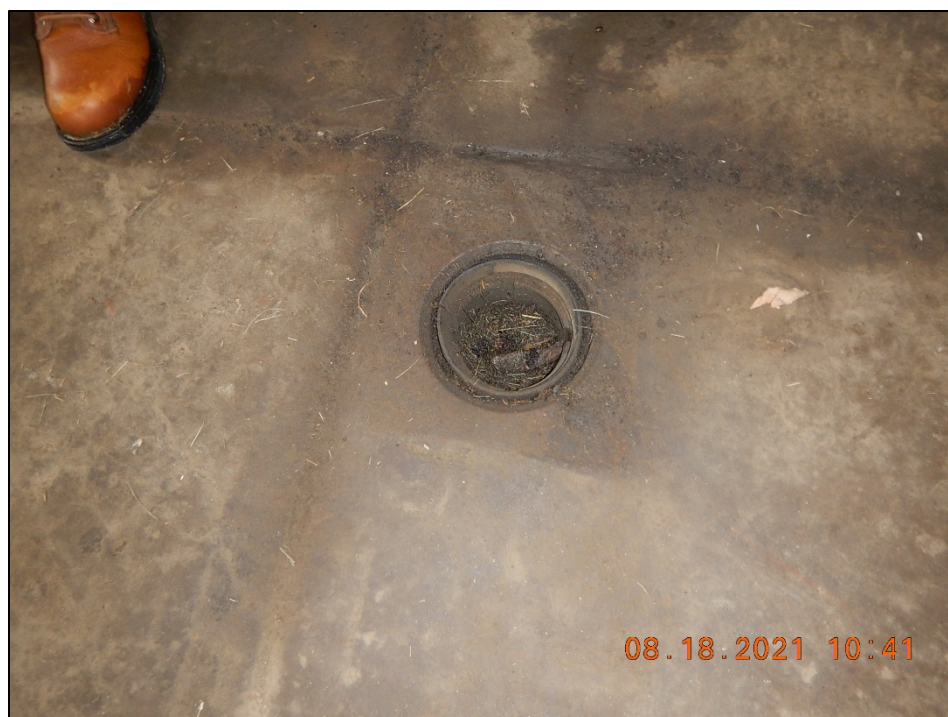
**Photograph 28. Municipal Garage: (DSCN0732)** View of a drain plug inside of the municipal garage.
