**U.S. ENVIRONMENTAL PROTECTION AGENCY  
REGION III WATER BRANCH, ENFORCEMENT  
AND COMPLIANCE ASSURANCE DIVISION  
CLEAN WATER ACT  
COMPLIANCE INSPECTION REPORT**

**Name of Municipality:** Scott Township, Pennsylvania MS4  
**Municipality Address:** 1038 Montdale Road #101, Scott, PA 18447  
**Mailing Address:** 1038 Montdale Road #101, Scott, PA 18447

Report Prepared on: 9/7/2021 By: Cassidy Owen,  
Date Cassidy Owen, Eastern Research Group

| <b>Type of Inspection:</b> | MS4 Compliance Inspection |

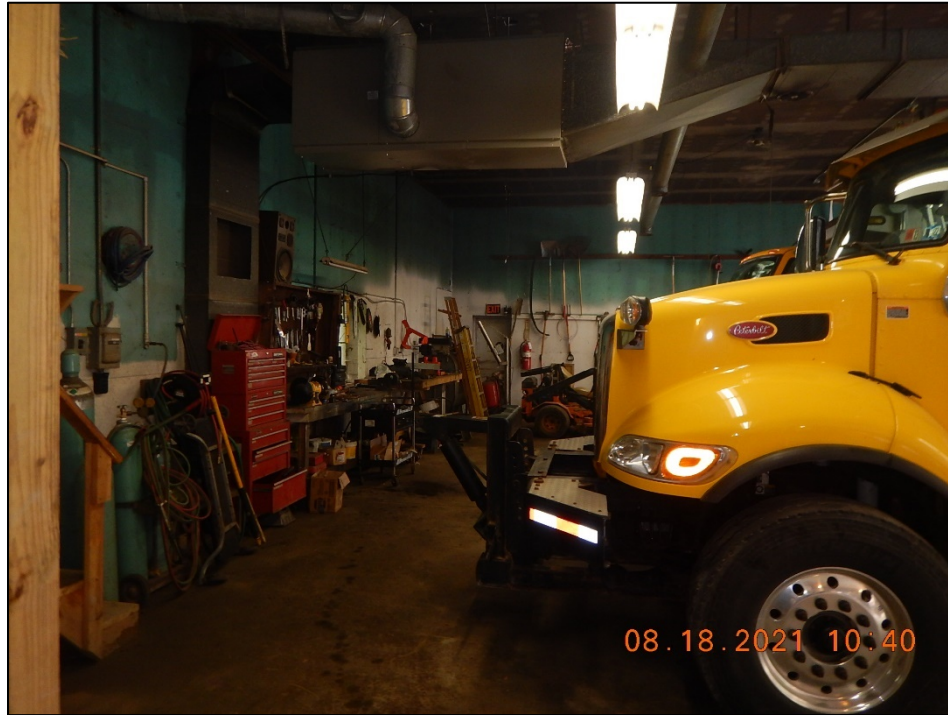
**Photograph 29. Municipal Garage: (DSCN0731)** View of tool storage inside the municipal garage.

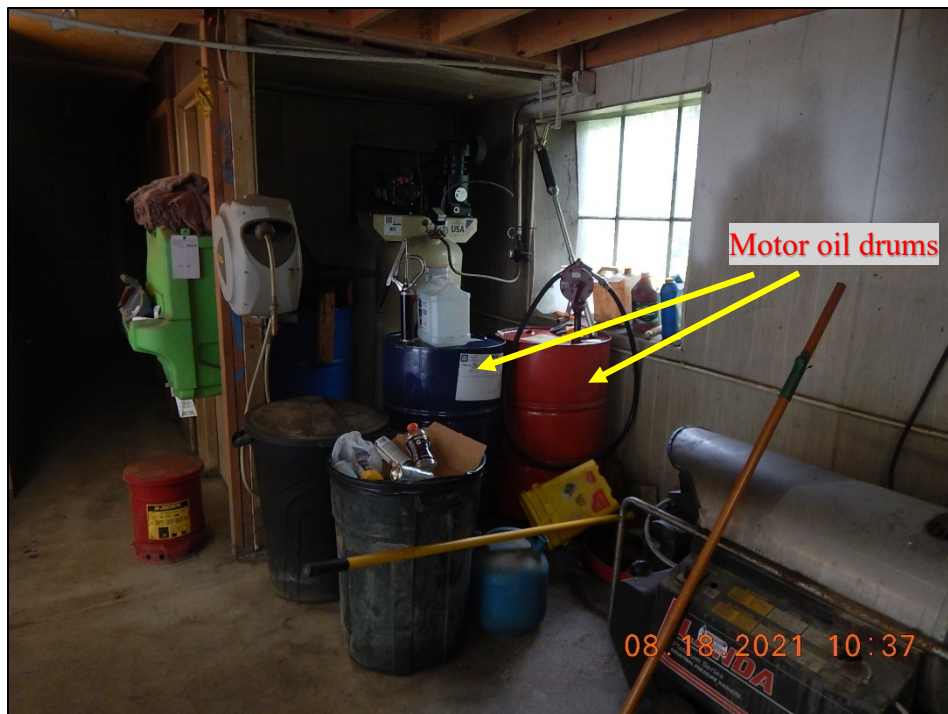
**Photograph 30. Municipal Garage: (DSCN0730)** View of two 55-gallon drums containing motor oil and other small chemical storage. Note that the 55-gallon drums were not located on spill pallets or within secondary containment; however, an oil spill kit was located inside the municipal garage.
