**Region 6 - Enforcement & Compliance Assurance Division**  
**INSPECTION REPORT**

| Inspection Date(s): | 01-13-2025 | |
| Company Name: | Blue Sky Farms | |
| Facility Name: | Southland Dairy (TX0130907) | |

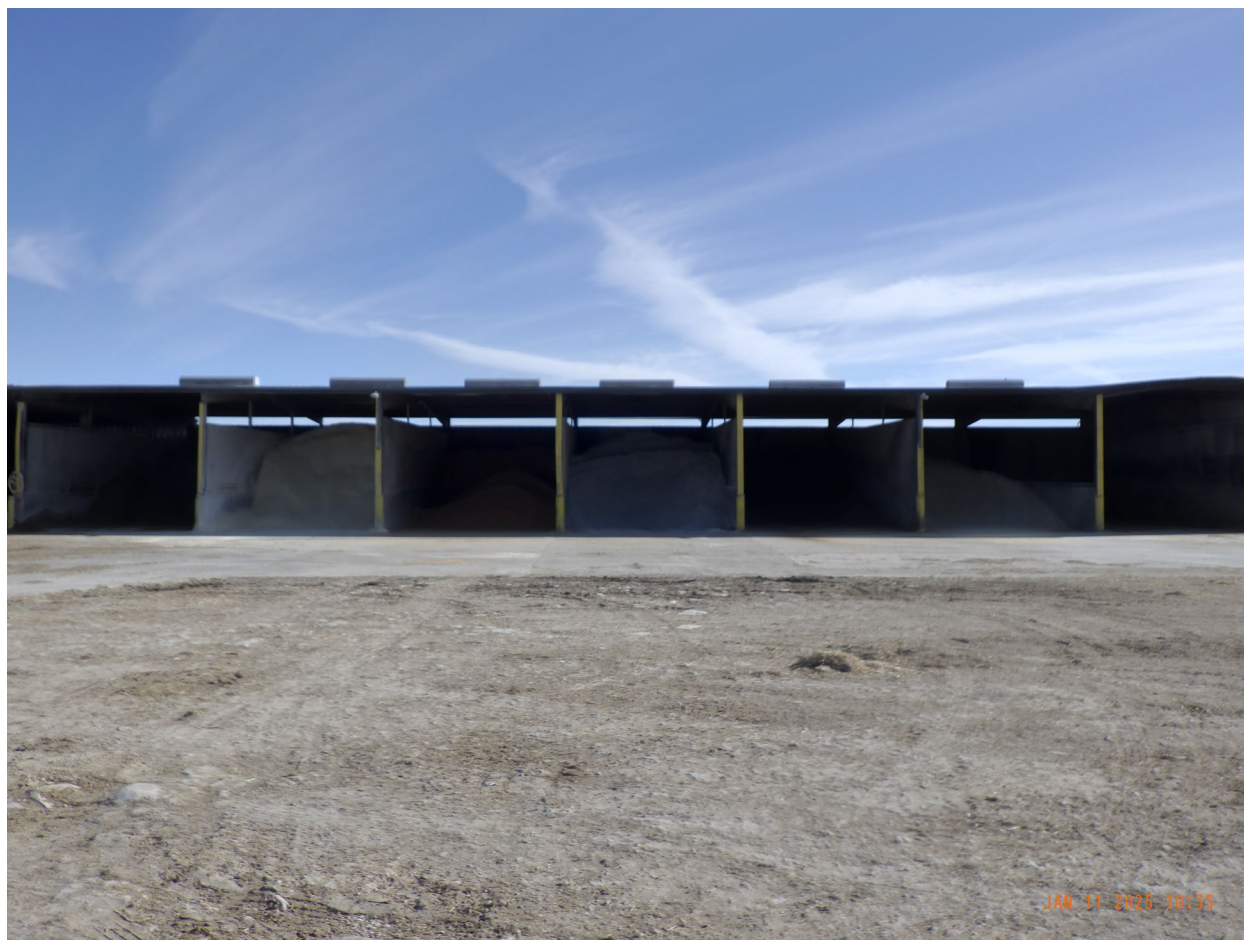
Photo No. 1

Description: Commodities storage bunkers under cover.

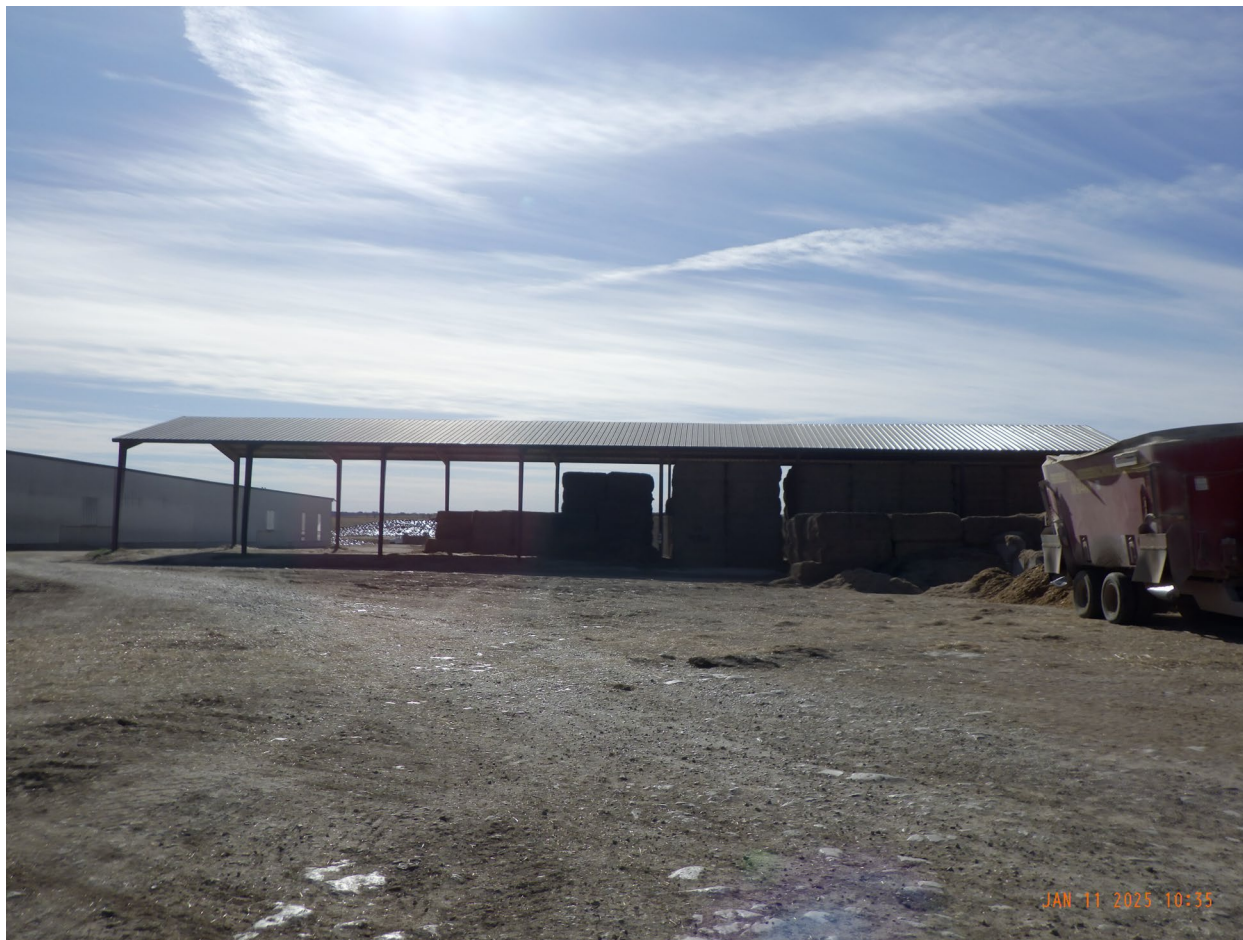
Photo No. 2

Description: Hay bale piles under roof.

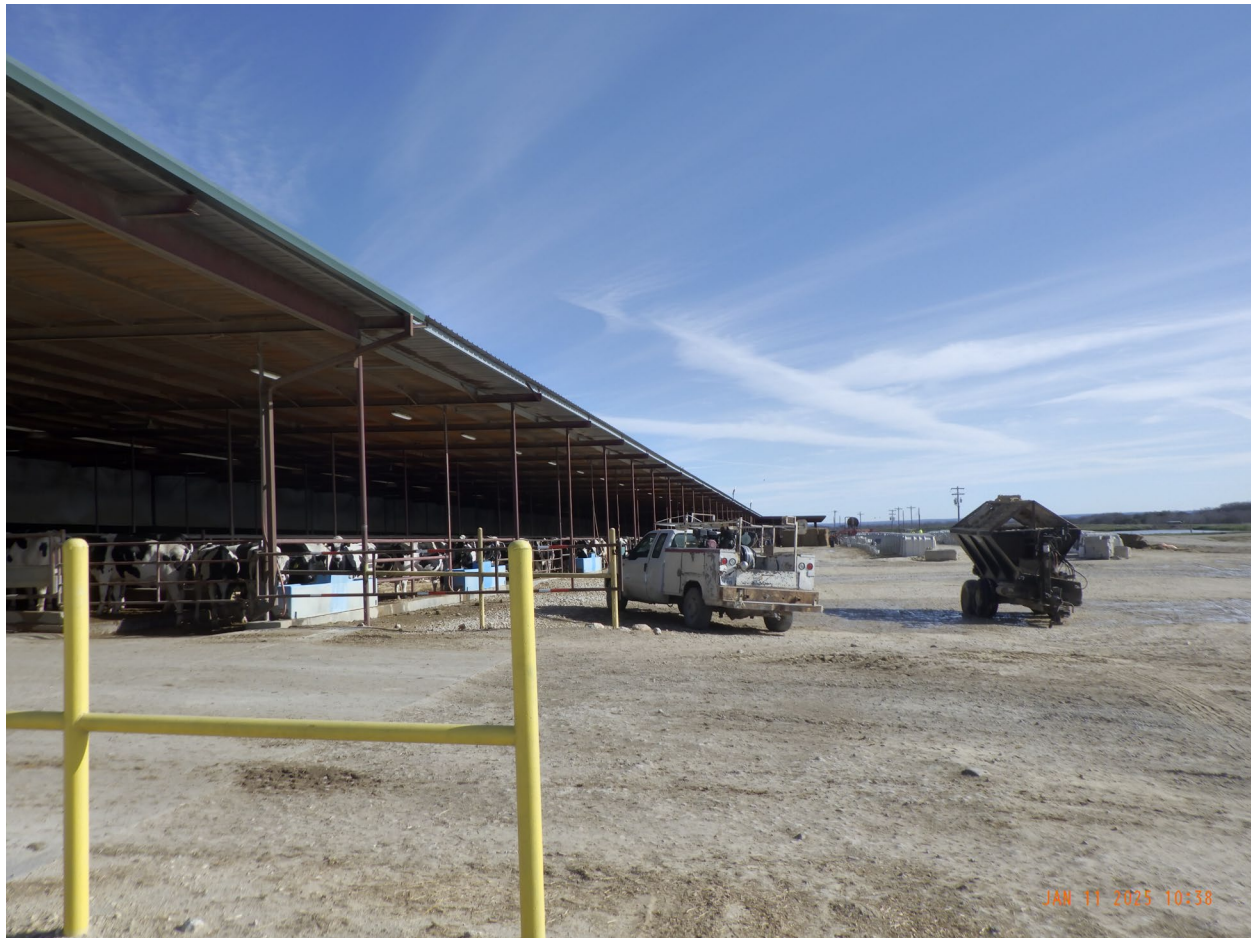
Photo No. 3

Description: Shot of covered free stalls with slope to drainage channel.

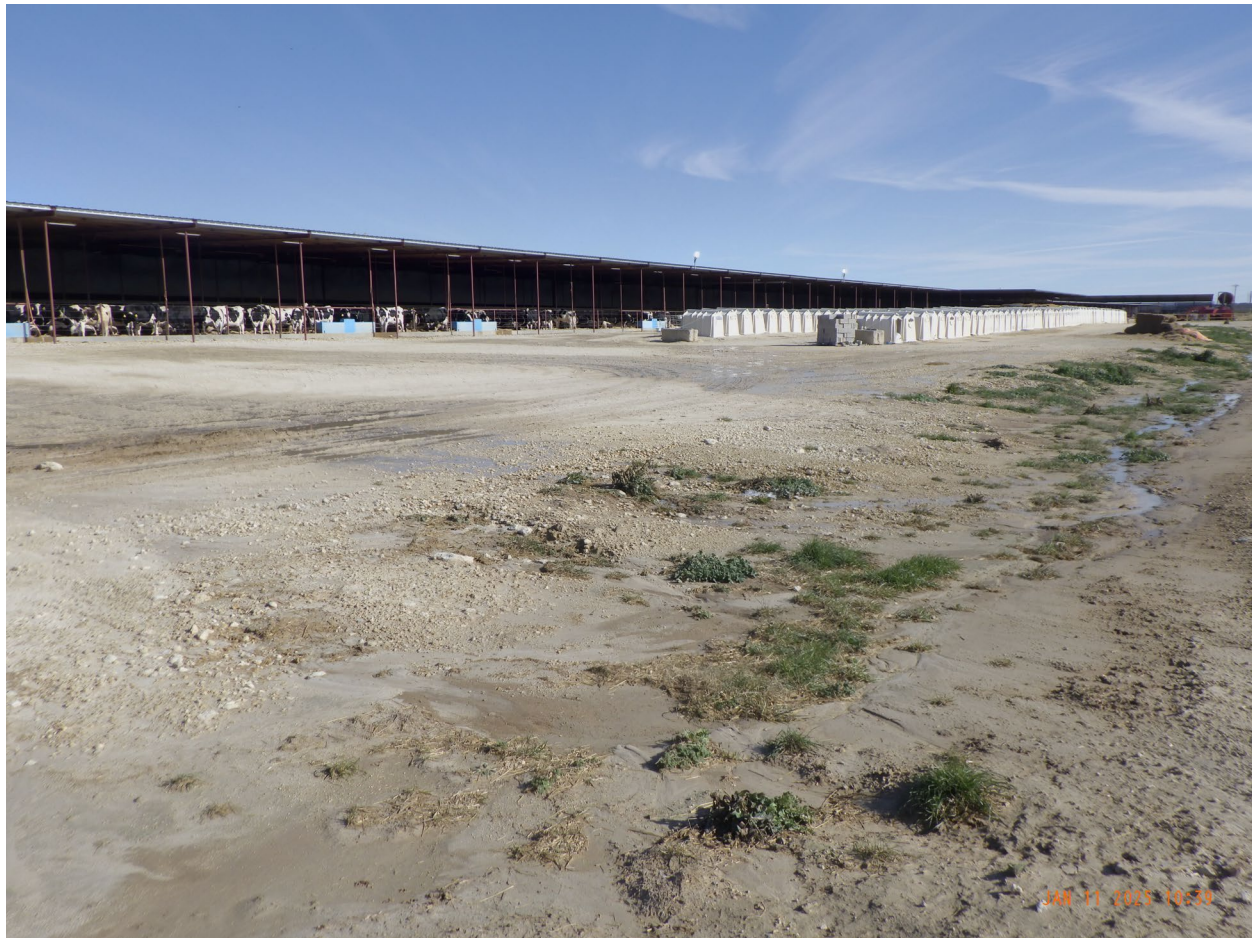
Photo No. 4

Description: Drainage channel next to covered free stalls. Routes to RCS 1.

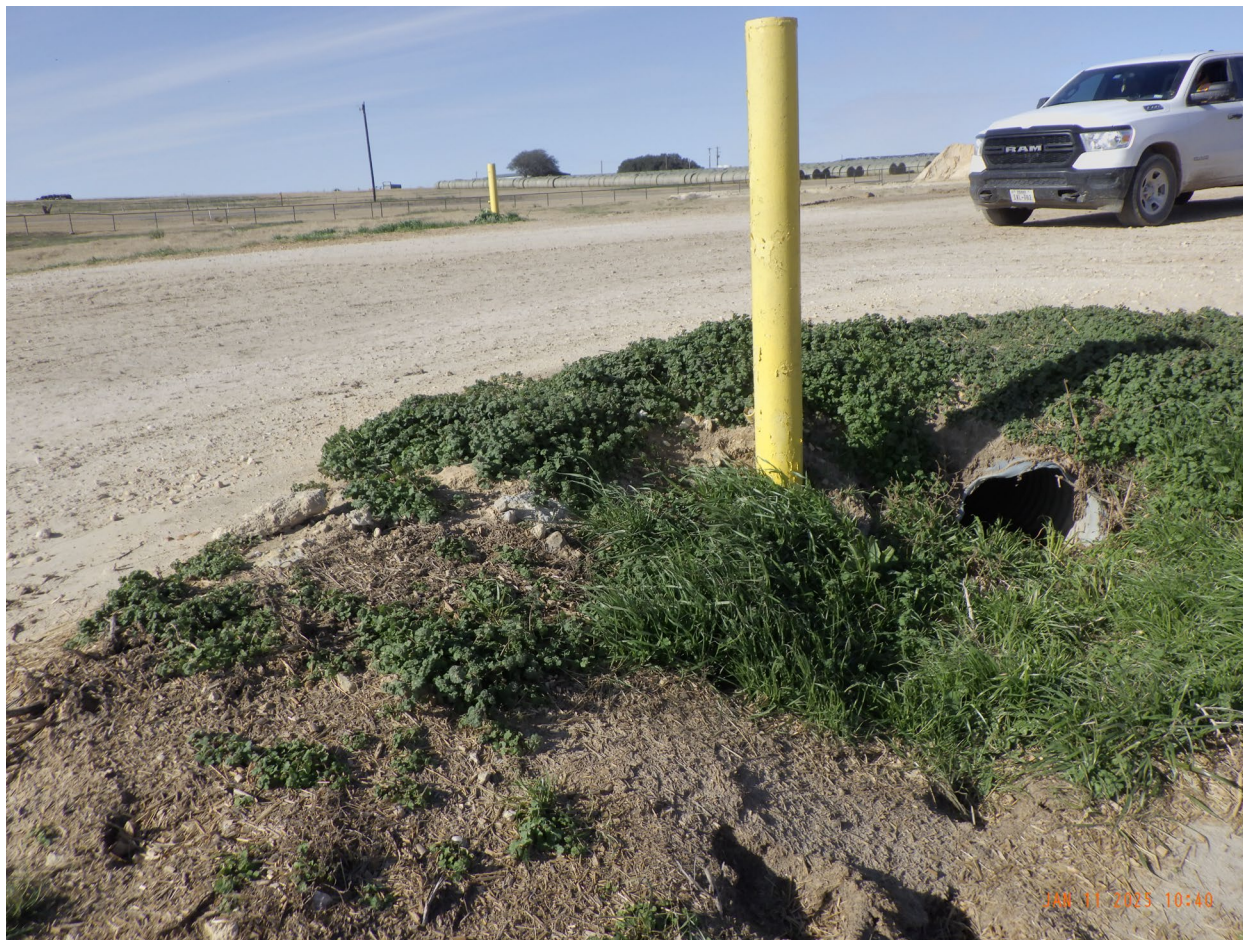
Photo No. 5

Description: Shot of culvert in drainage channel. Diverts water to RCS 1.

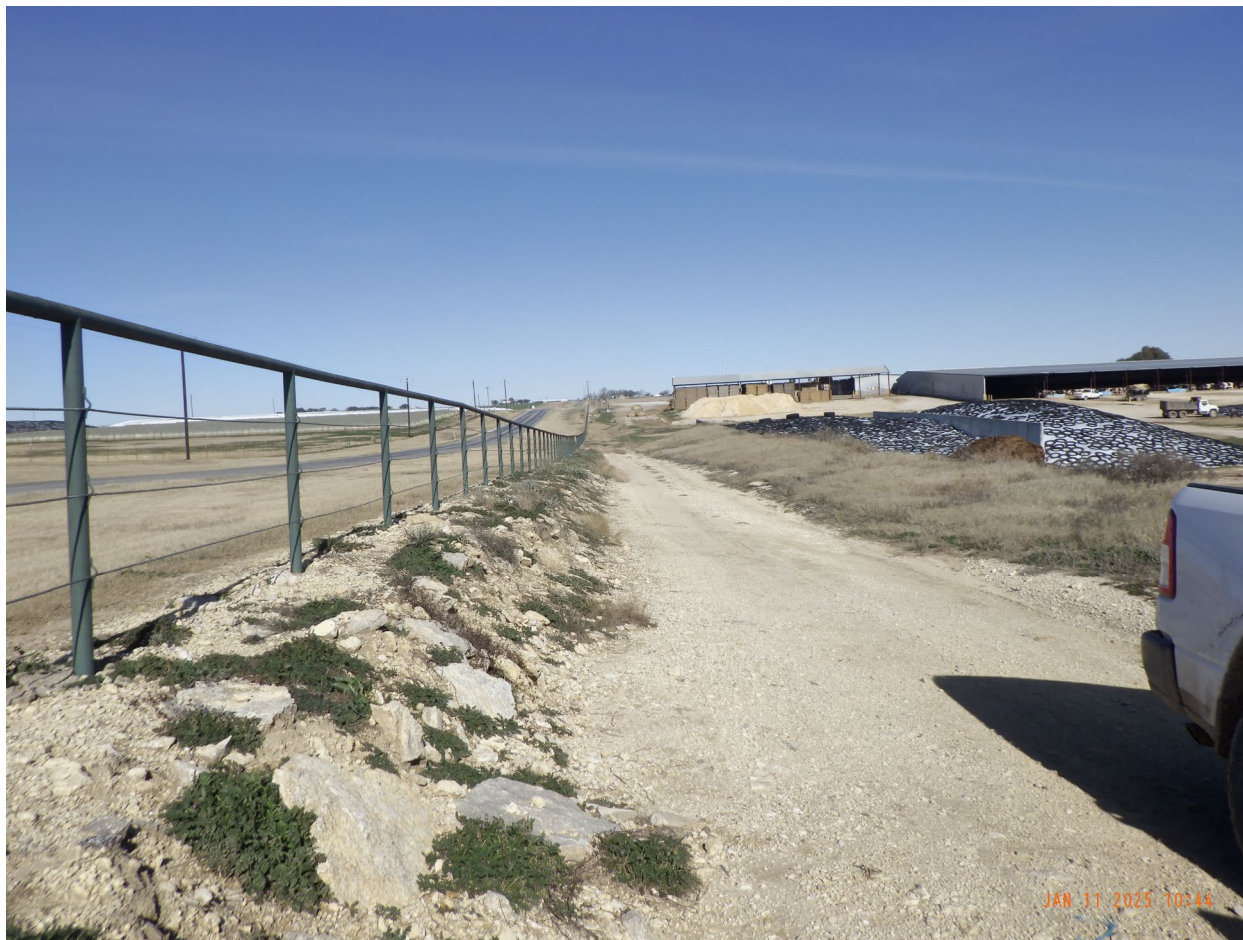
Photo No. 6

Description: Berm on perimeter between road and silage bunkers.

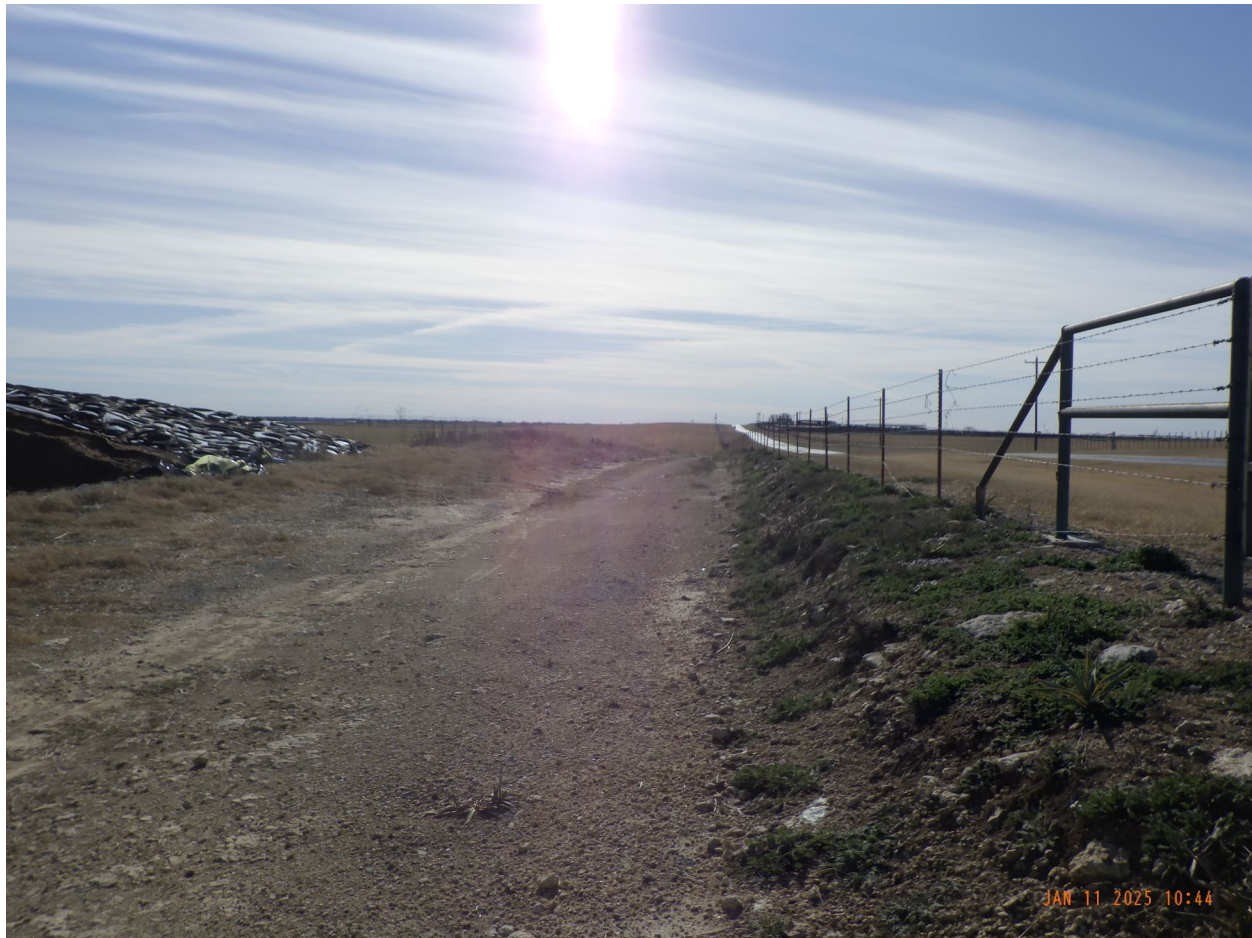
Photo No. 7

Description: Perimeter berm extending south.

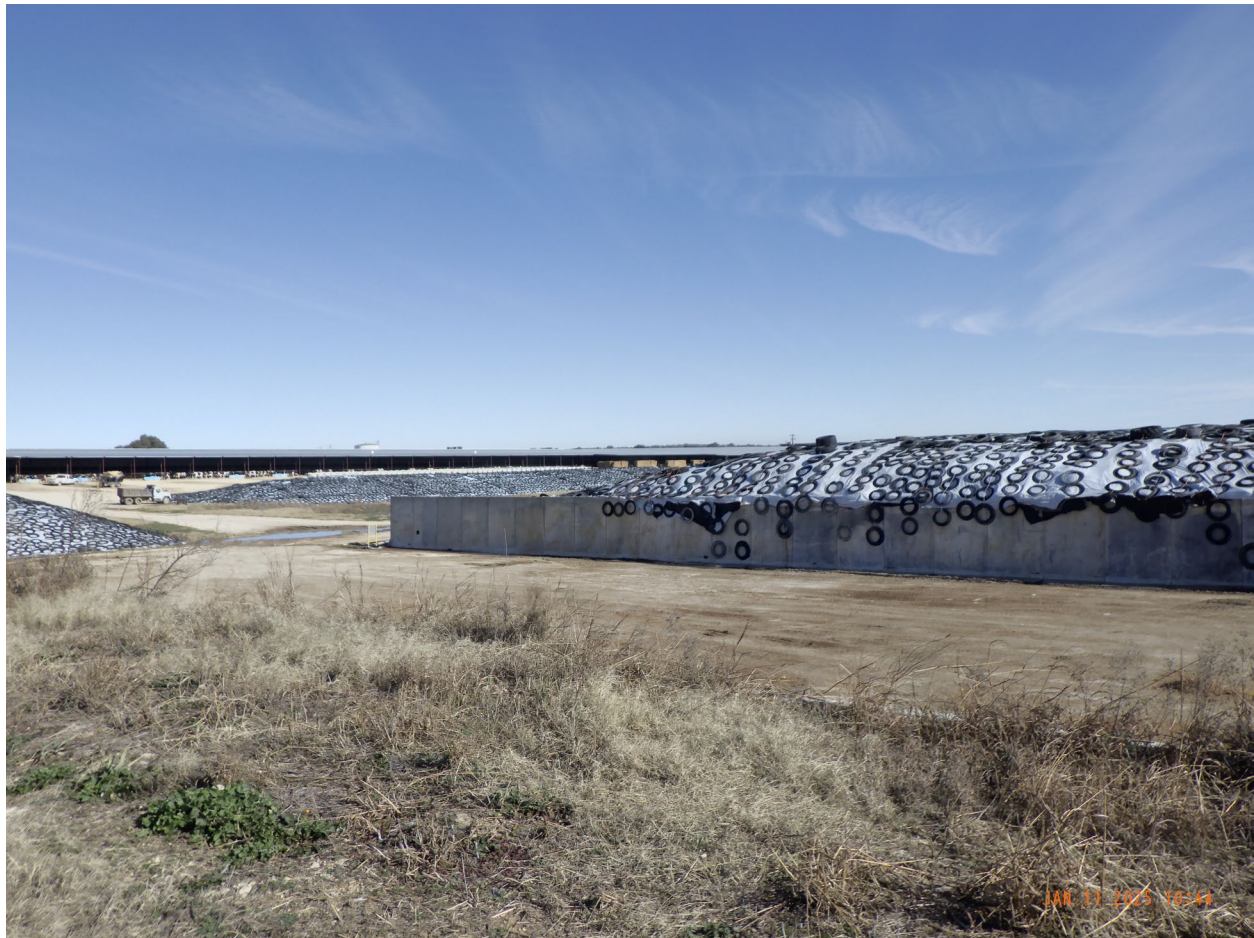
Photo No. 8

Description: Covered silage storage bunkers.

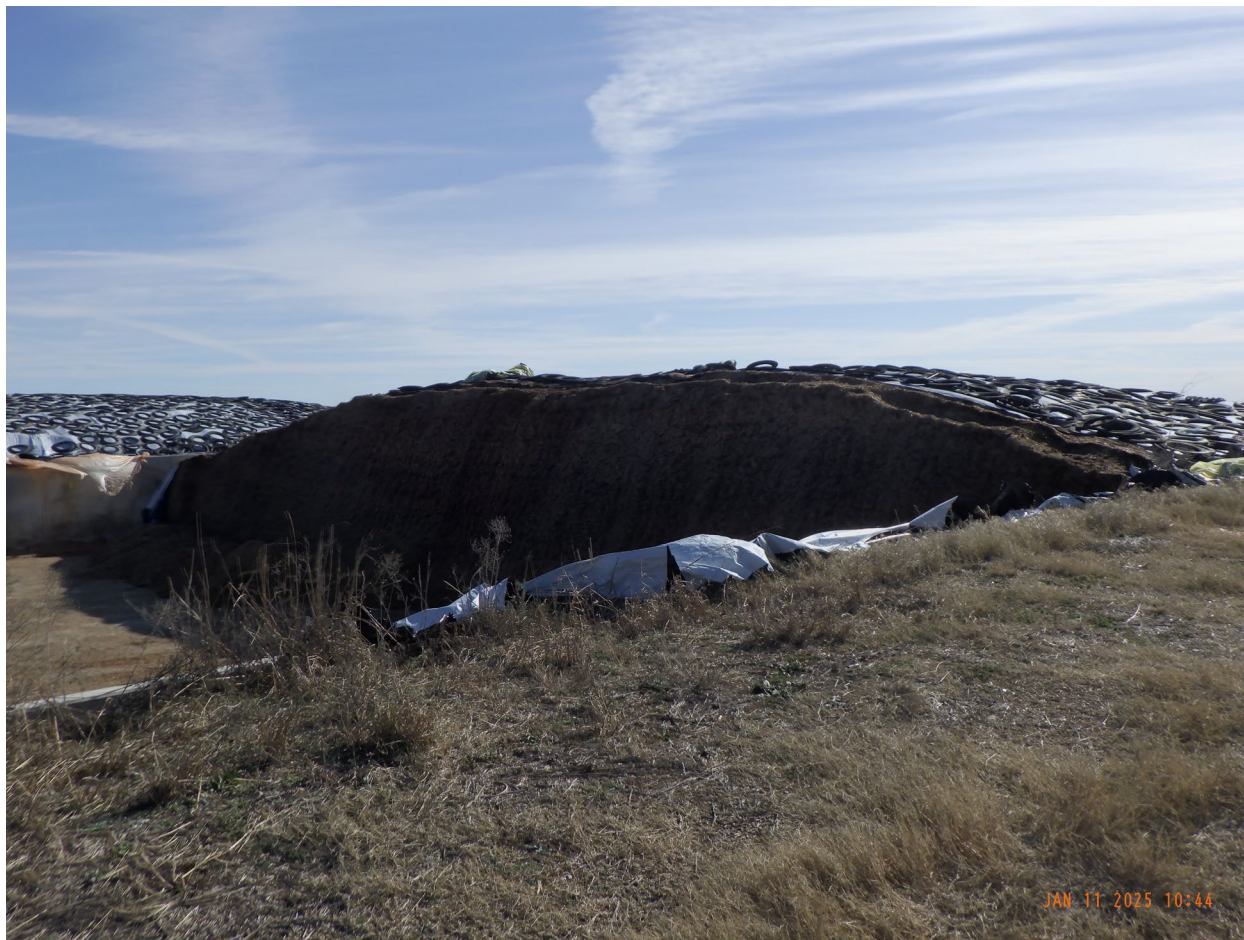
Photo No. 9

Description: Covered silage storage with only working end open.

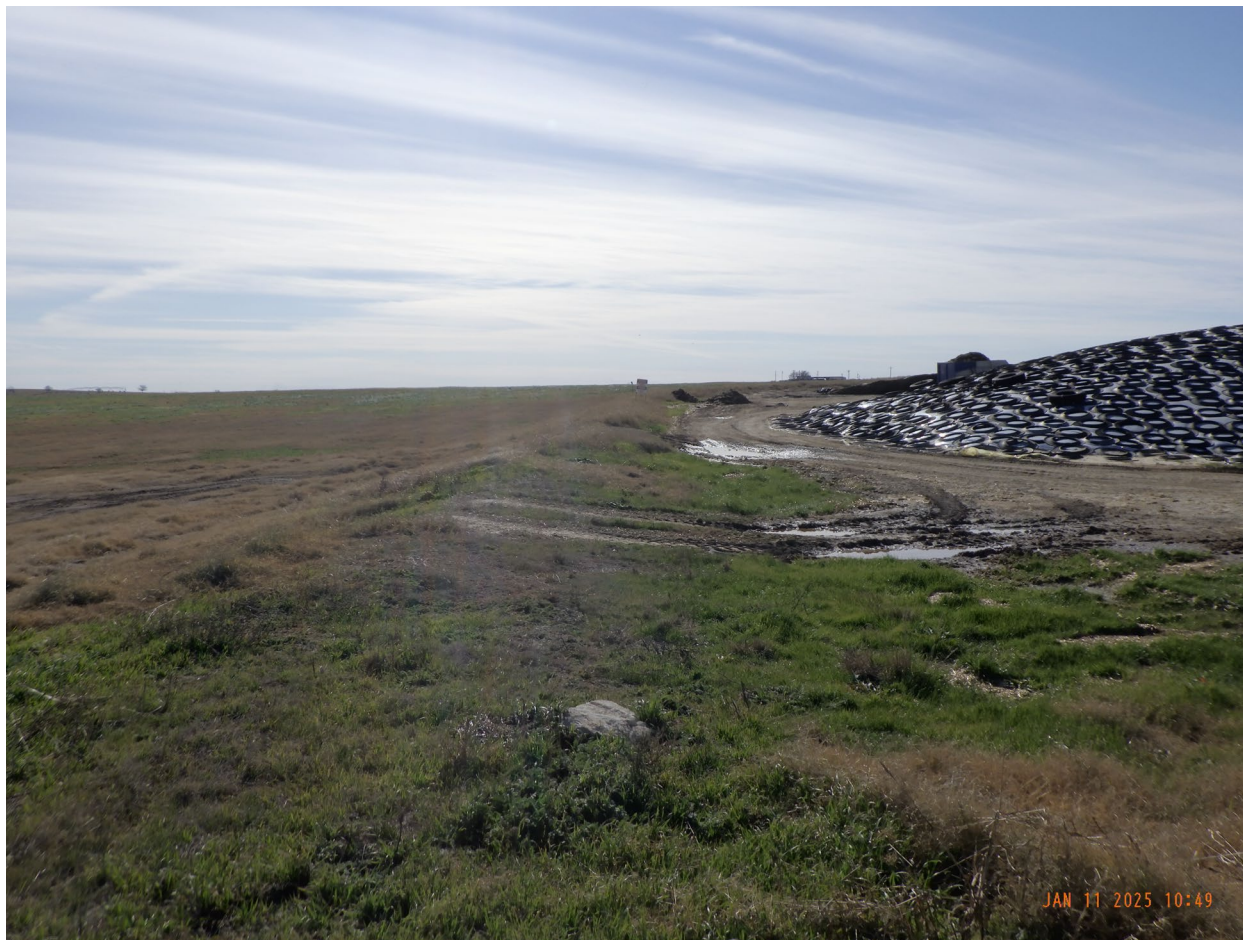
Photo No. 10

Description: Berm around perimeter of silage storage bunkers diverting runoff to silage storage basin.

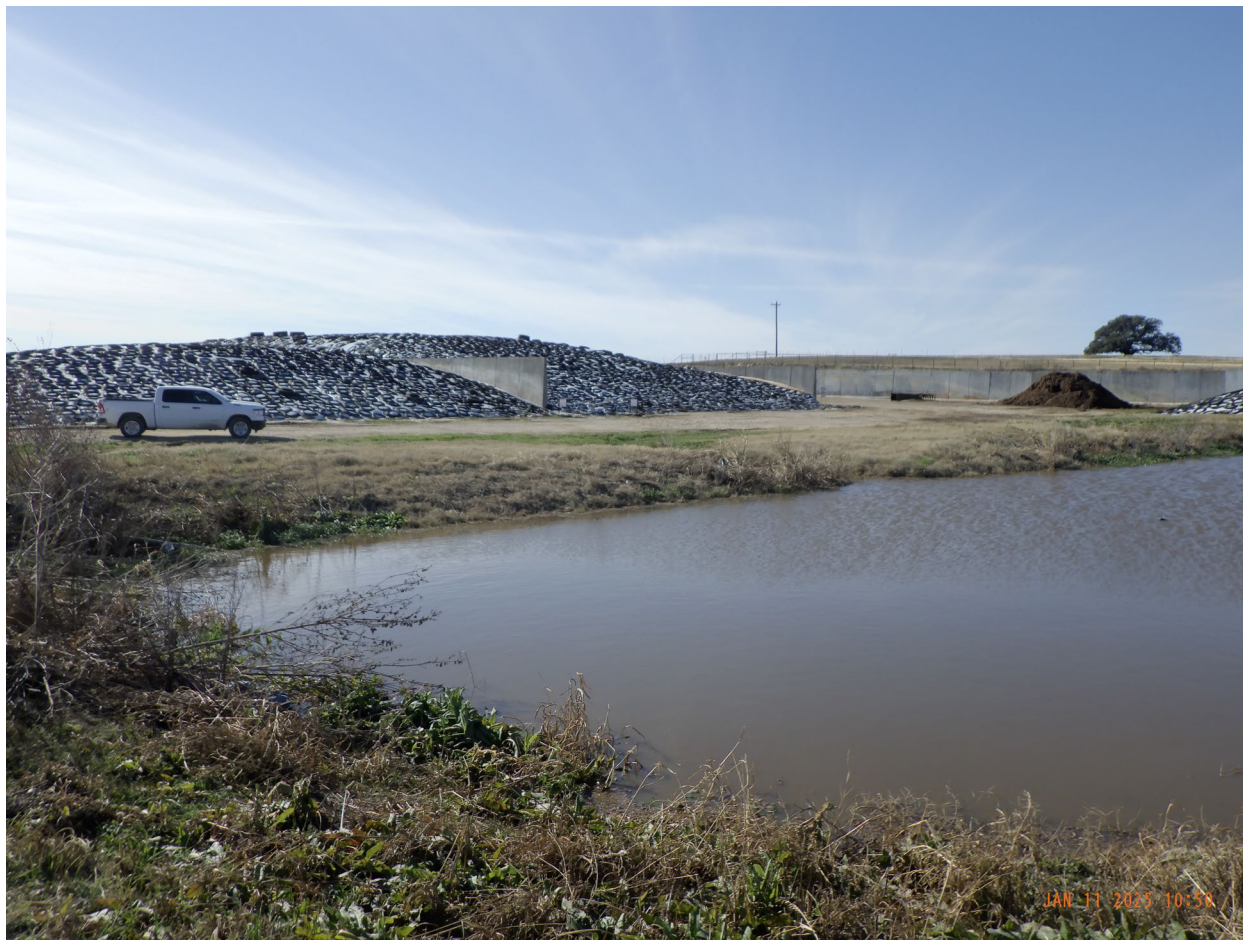
Photo No. 11

Description: Silage storage basin with silage bunkers in background.

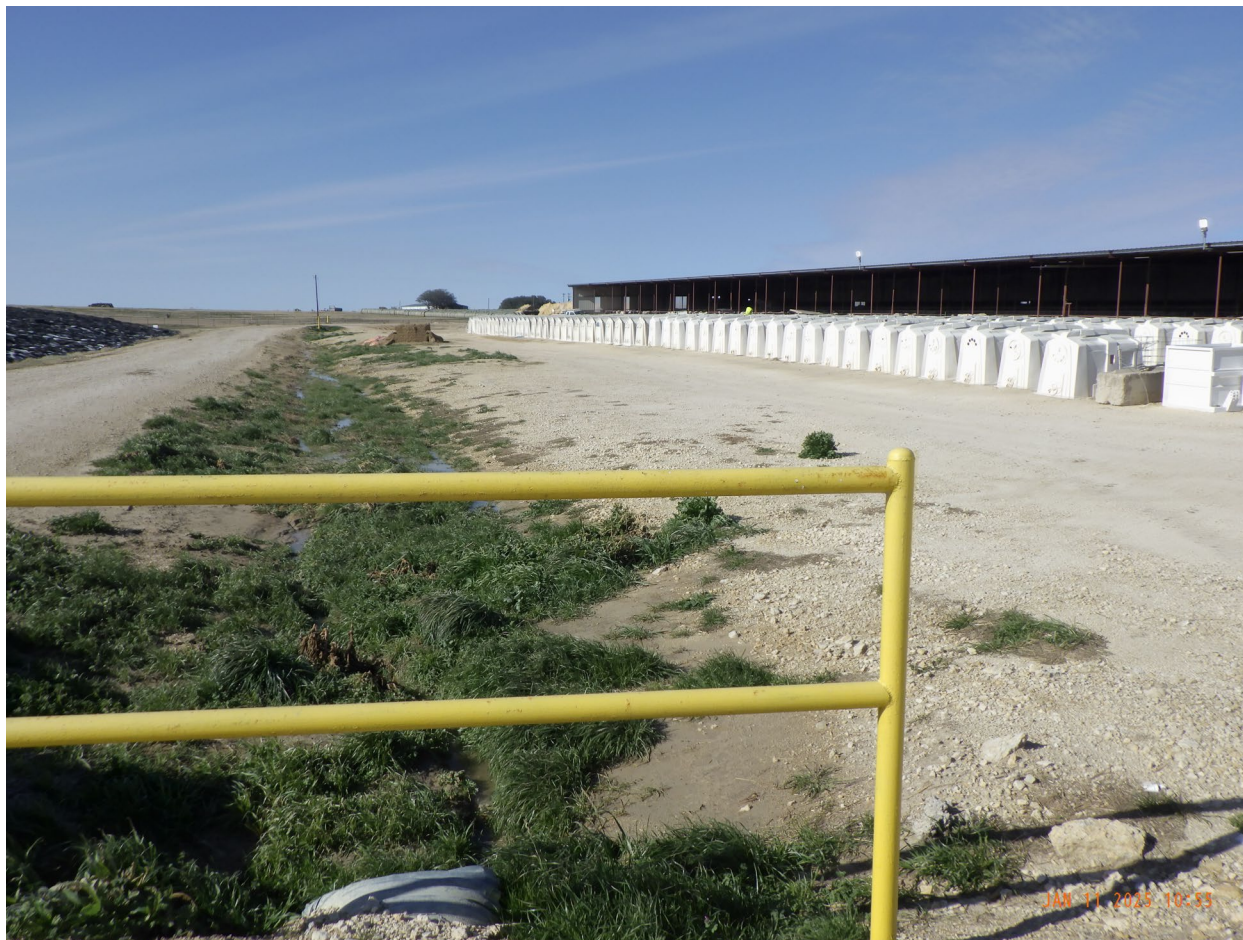
Photo No. 12

Description: Drainage channel next to calf hutches. Routes to RCS 1.

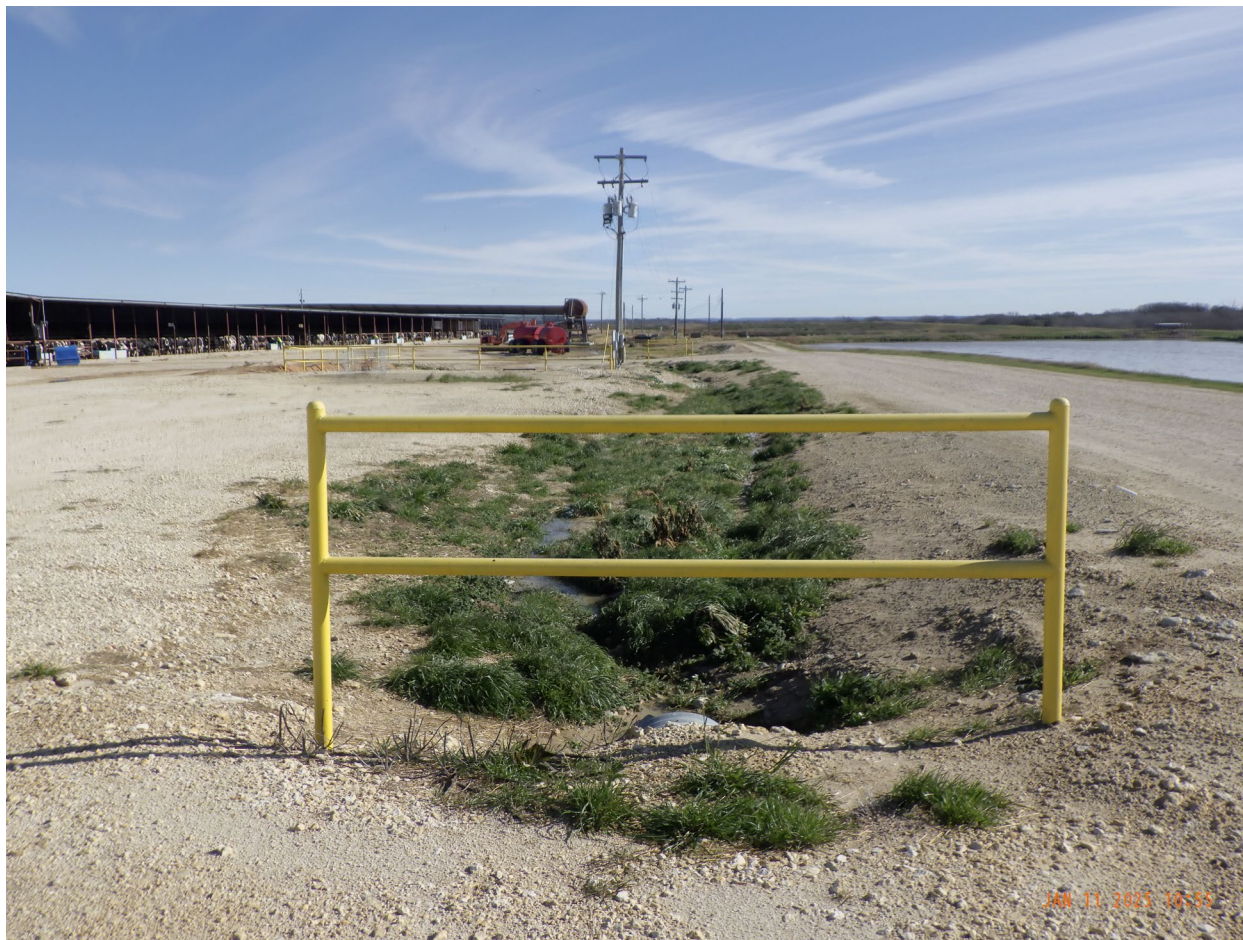
Photo No. 13

Description: Drainage channel extending with RCS 1 in background.

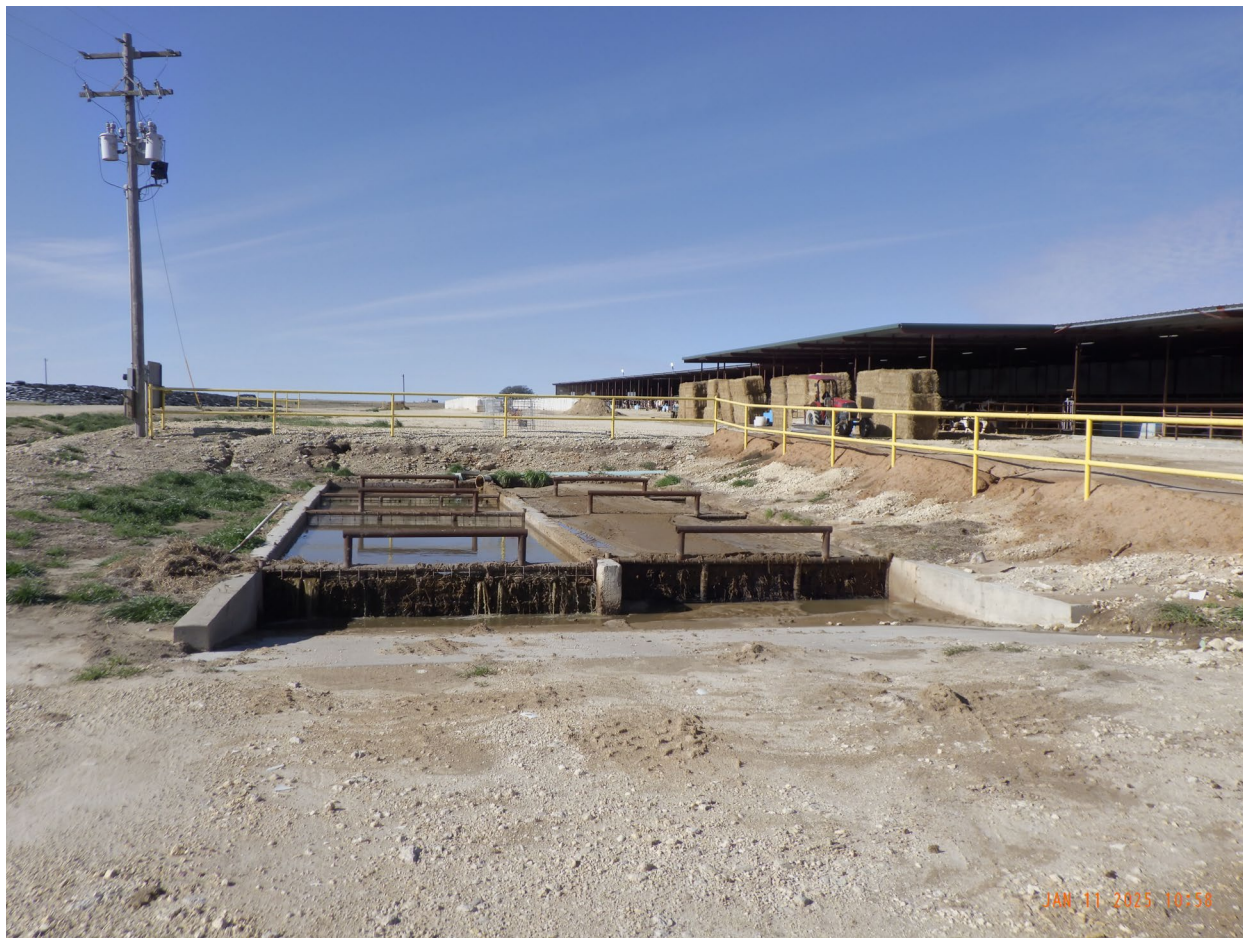
Photo No. 14

Description: Concrete settling structures between drainage channel and maternity stalls.

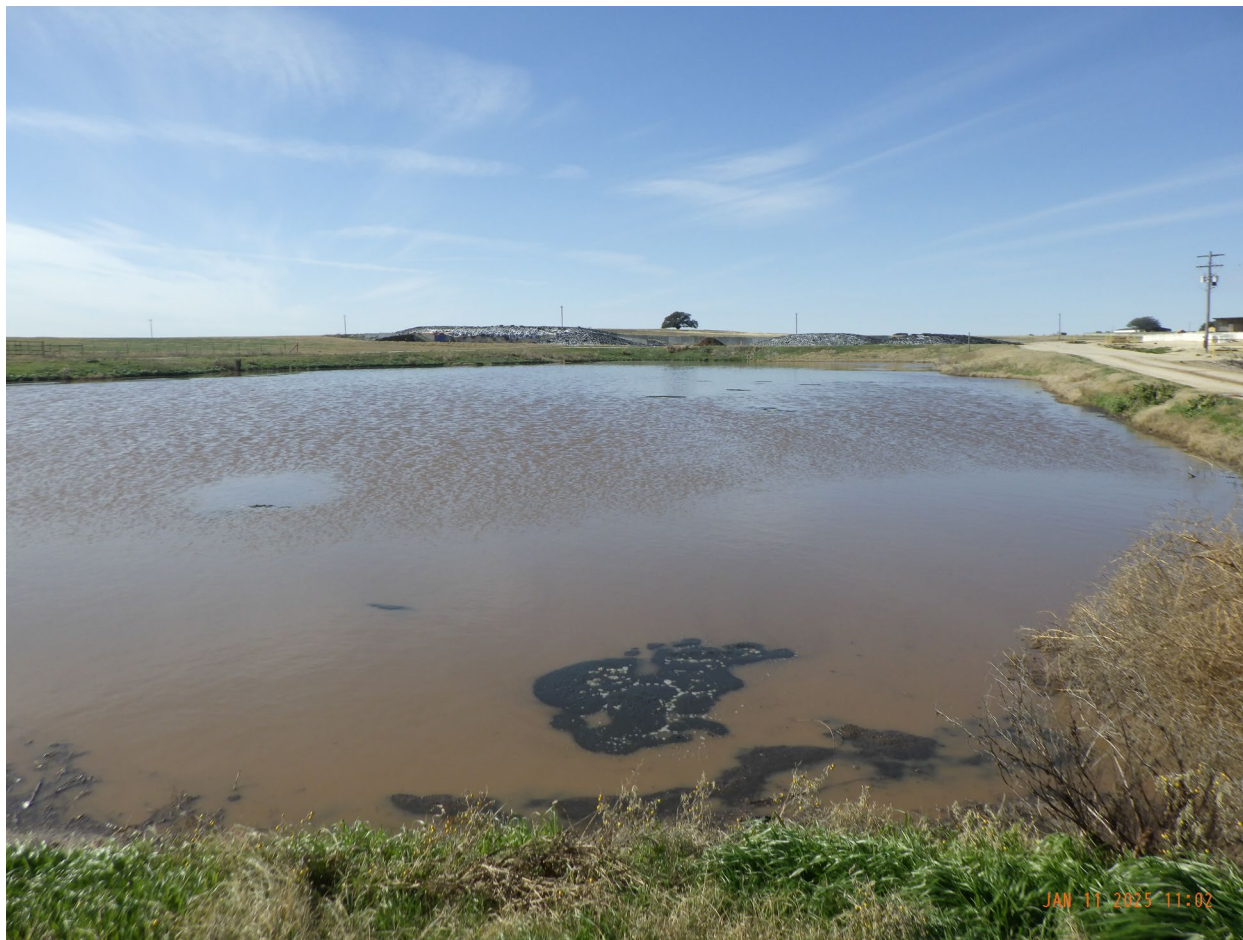
Photo No. 15

1) Small trees are growing around the perimeter of RCS 1 and RCS 2, and all the lagoon embankments need to be mowed to remove tall weeds to prevent liner intrusion. The TCEQ CAFO General Permit Part IIIA.10(f)(3) requires that “No tree shall be allowed to grow such that the root zone would intrude or compromise the structure of the liner or embankment.”

Description: RCS 1.1 Some woody vegetation in embankment in foreground.

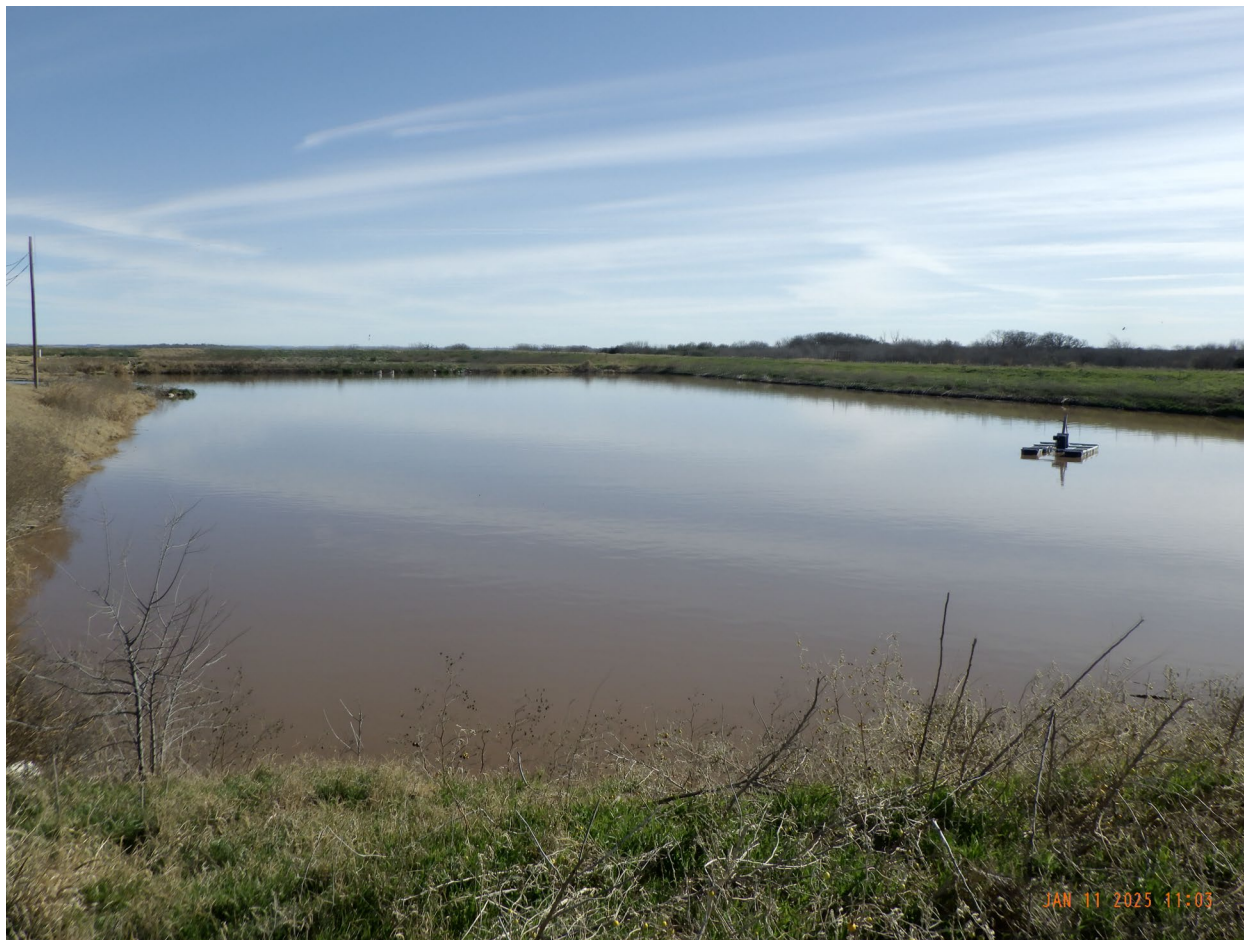
Photo No. 16

Description: RCS 1.2. Some small trees in embankment in foreground.

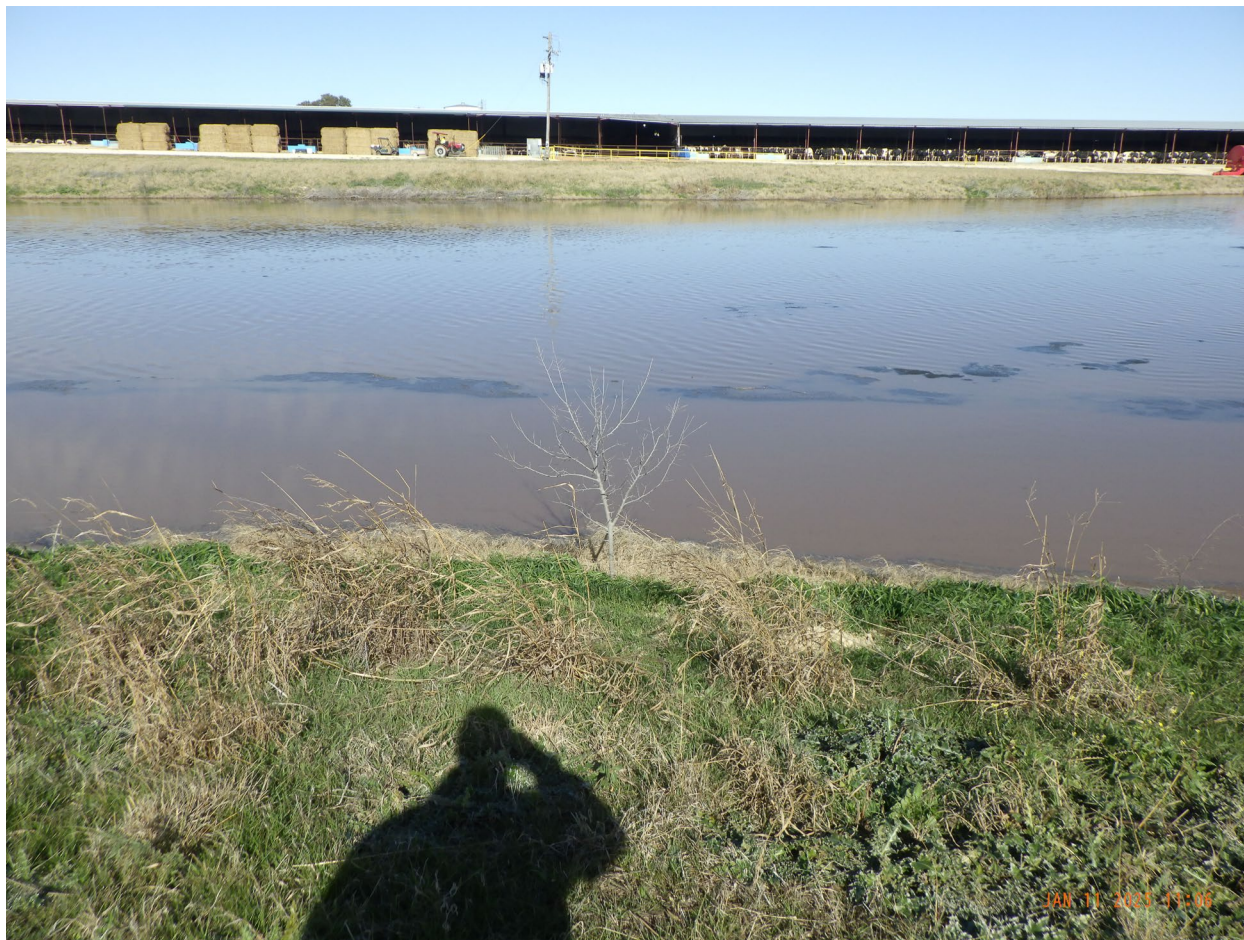
Photo No. 17

Description: RCS 1.2. Small tree in embankment. Free stalls in background.

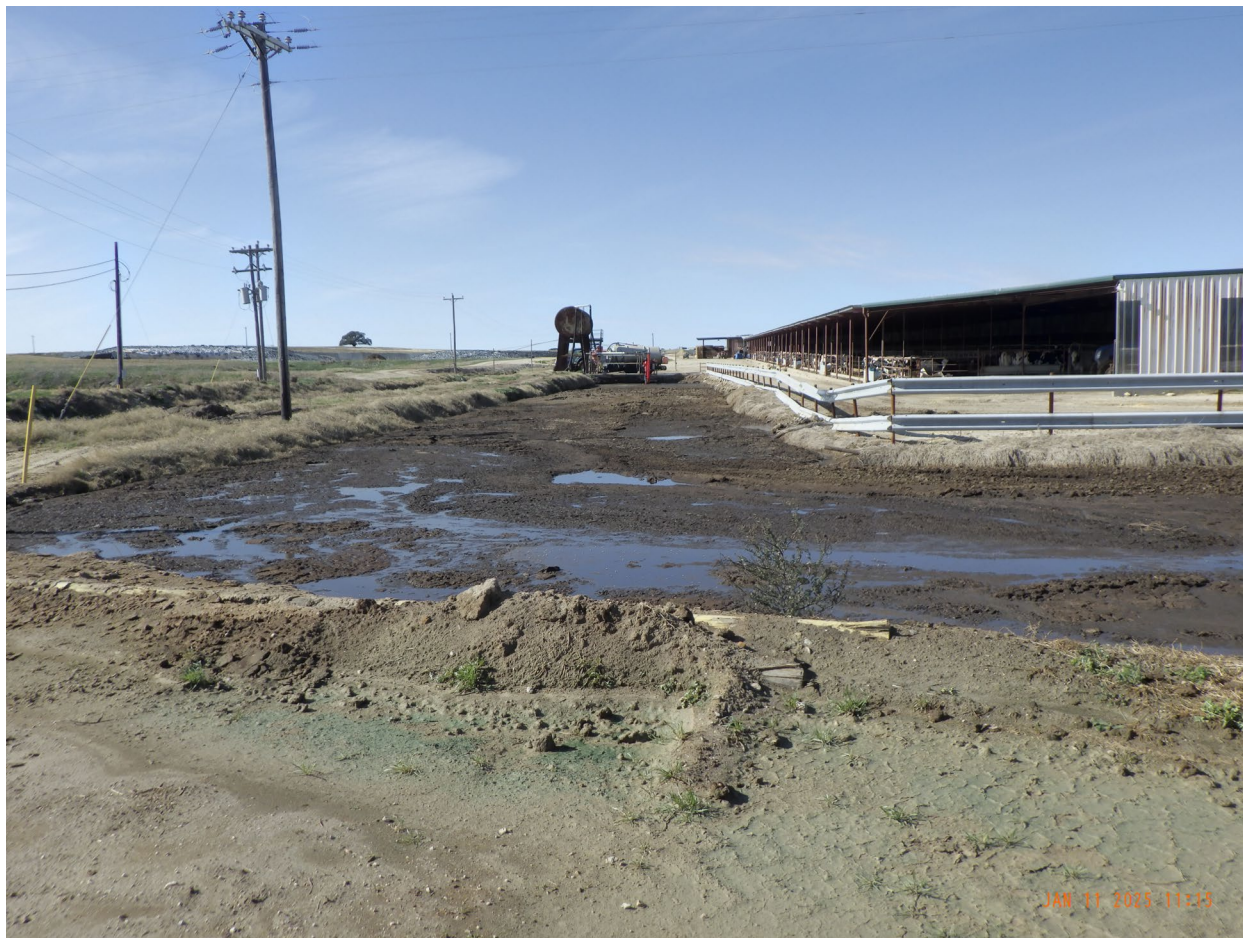
Photo No. 18

Description: Slurry pit with truck wash and free stalls in background.

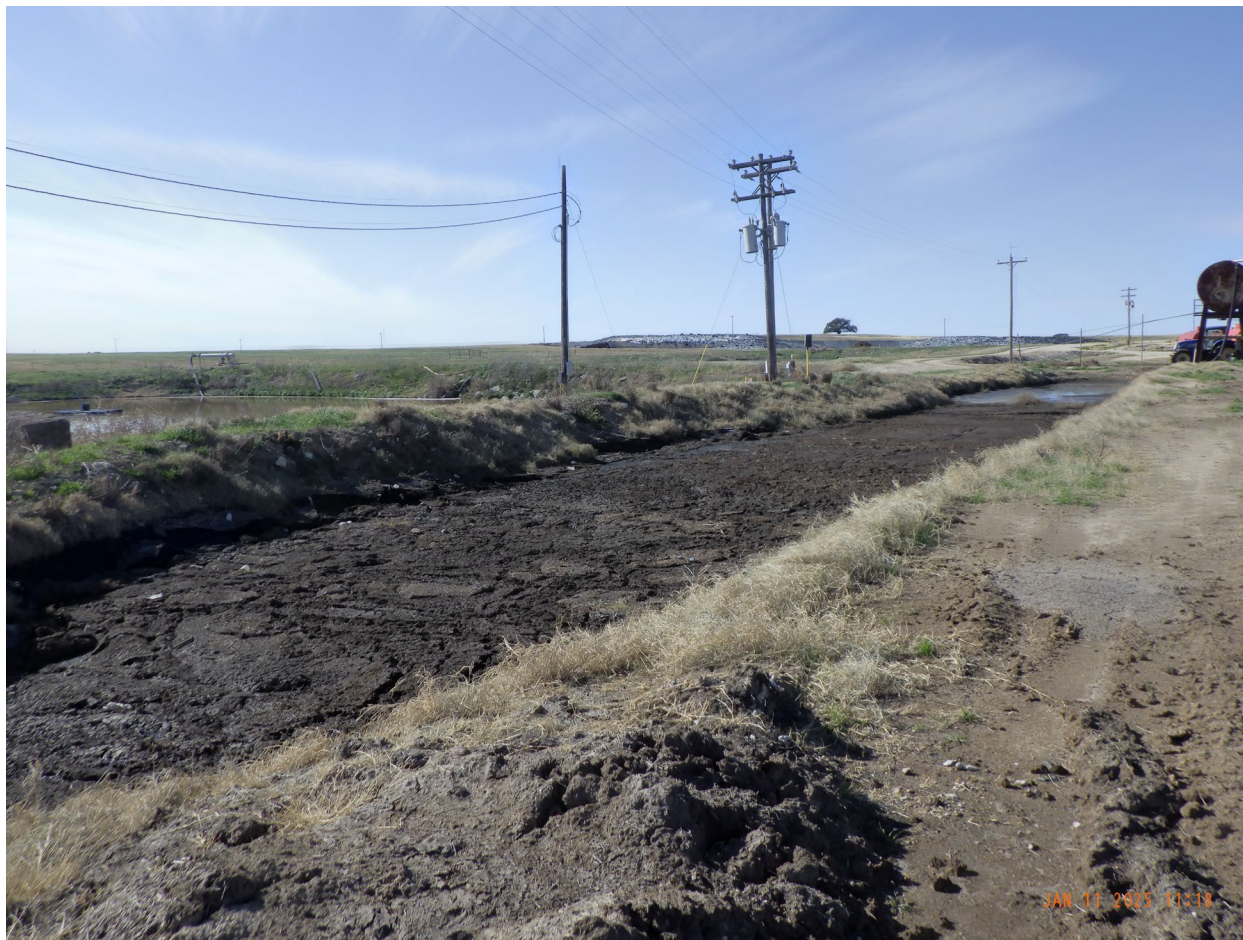
Photo No. 19

Description: Second slurry pit in series. Routes to RCS 1.2.
