**Region 6 - Enforcement & Compliance Assurance Division**  
**INSPECTION REPORT**

| Inspection Date(s): | 01-13-2025 | |
| Company Name: | Blue Sky Farms | |
| Facility Name: | Southland Dairy (TX0130907) | |

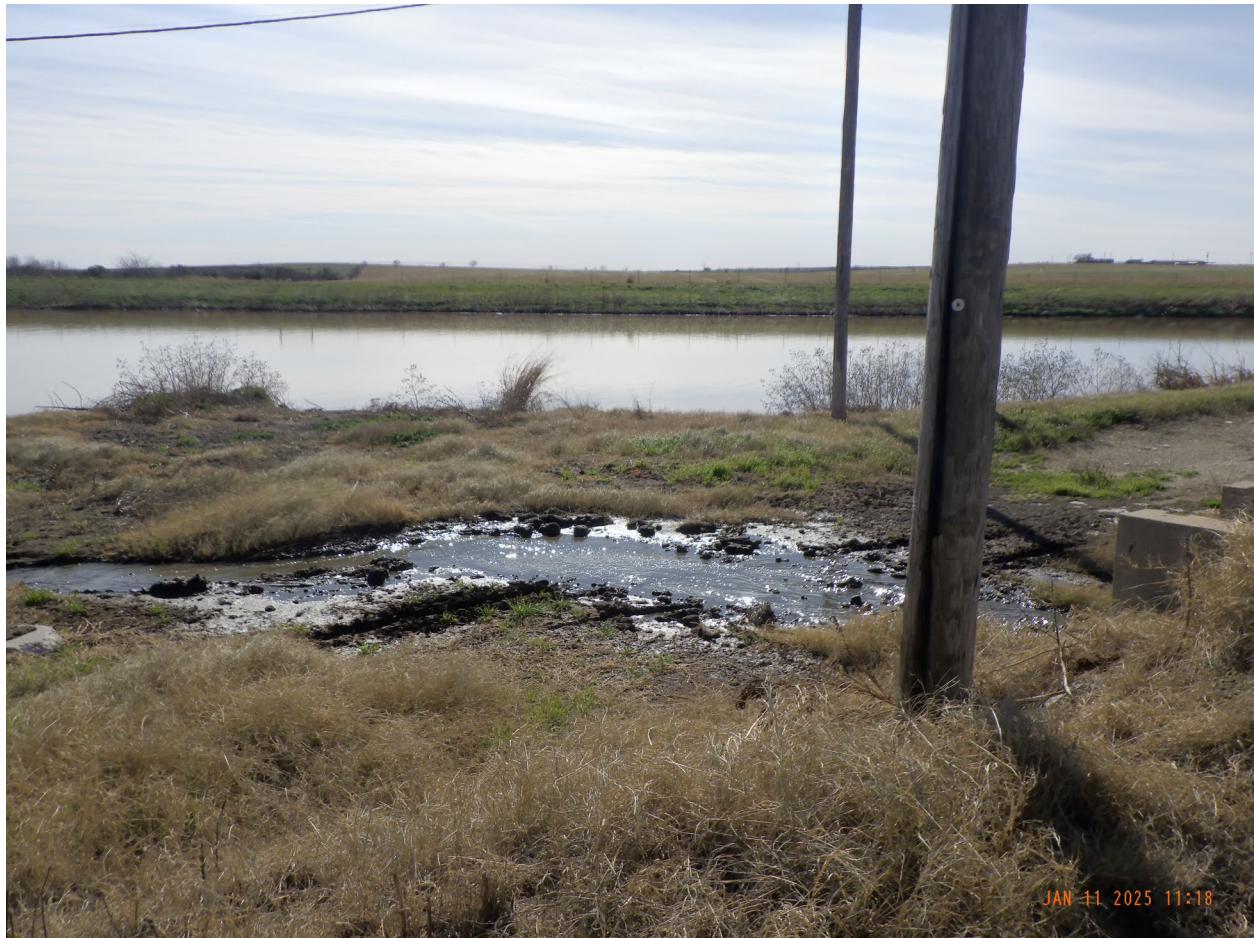
Photo No. 20

Description: Slurry pit channel to RCS 1.2.

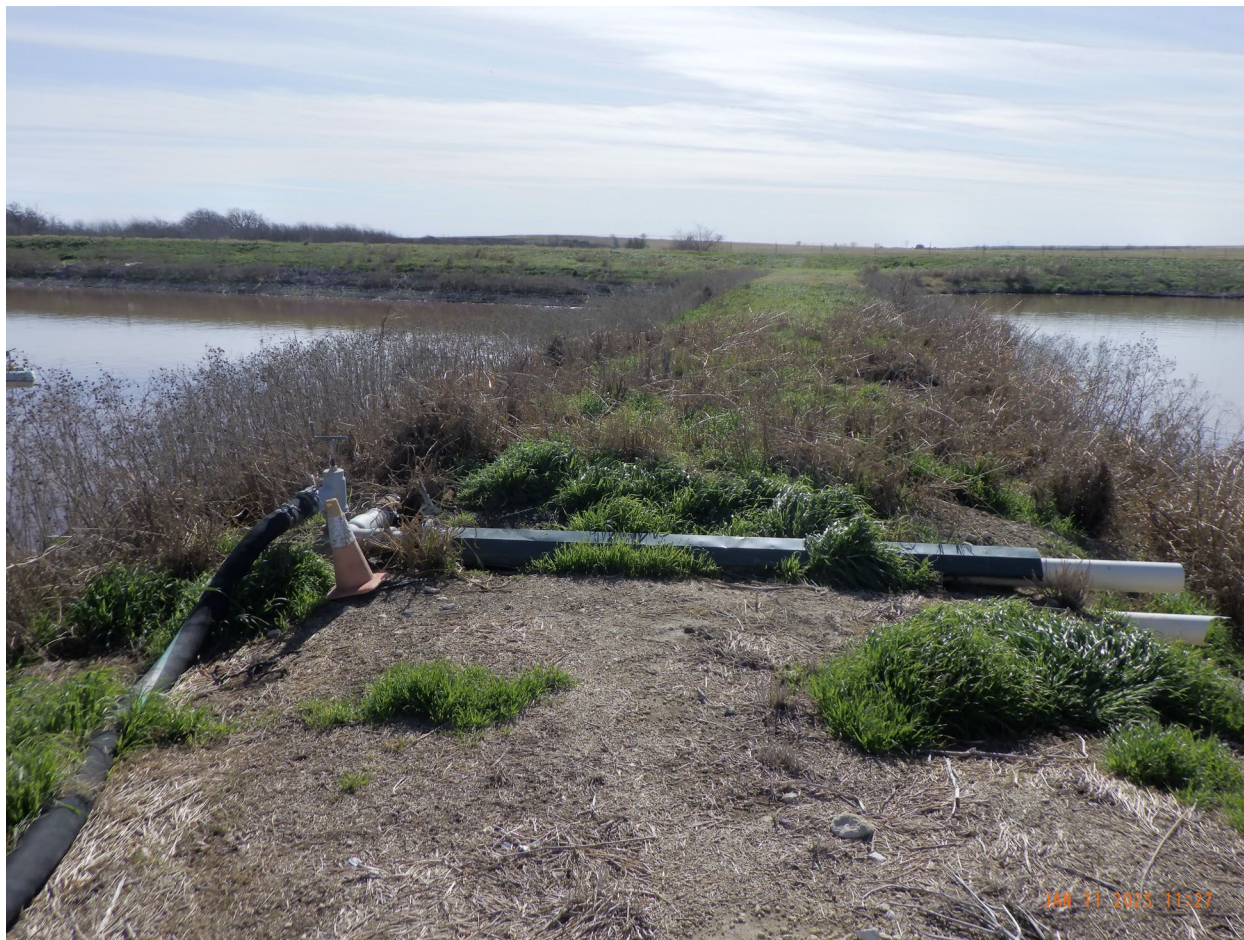
Photo No. 21

1) Small trees are growing around the perimeter of RCS 1 and RCS 2, and all the lagoon embankments need to be mowed to remove tall weeds to prevent liner intrusion. The TCEQ CAFO General Permit Part IIIA.10(f)(3) requires that “No tree shall be allowed to grow such that the root zone would intrude or compromise the structure of the liner or embankment.”

Description: Berm between lagoon 1.2 and 1.3 with pumps. Woody vegetation in embankments.

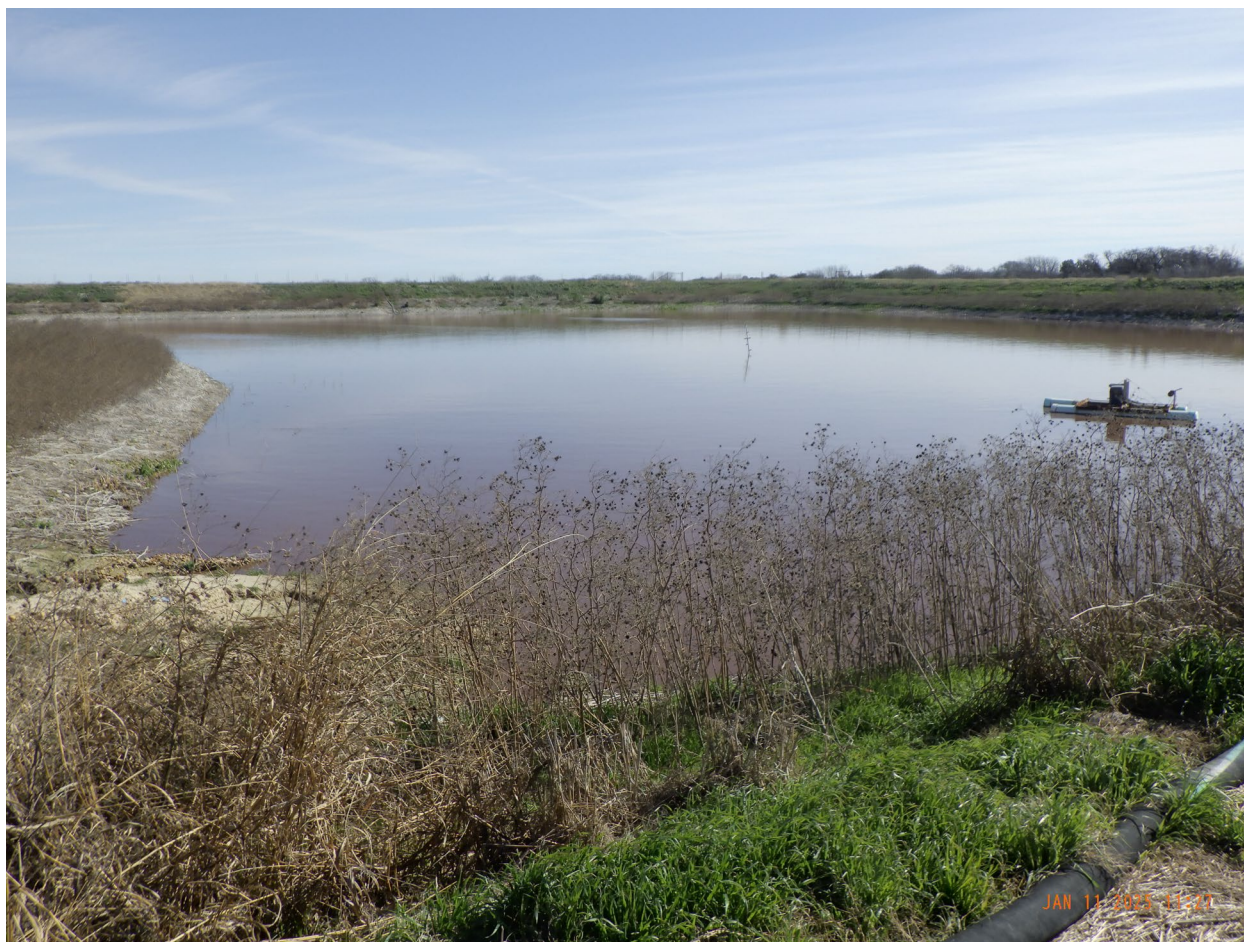
Photo No. 22

Description: RCS 1.3. Woody vegetation in embankment in foreground. Pole marker visible in background.

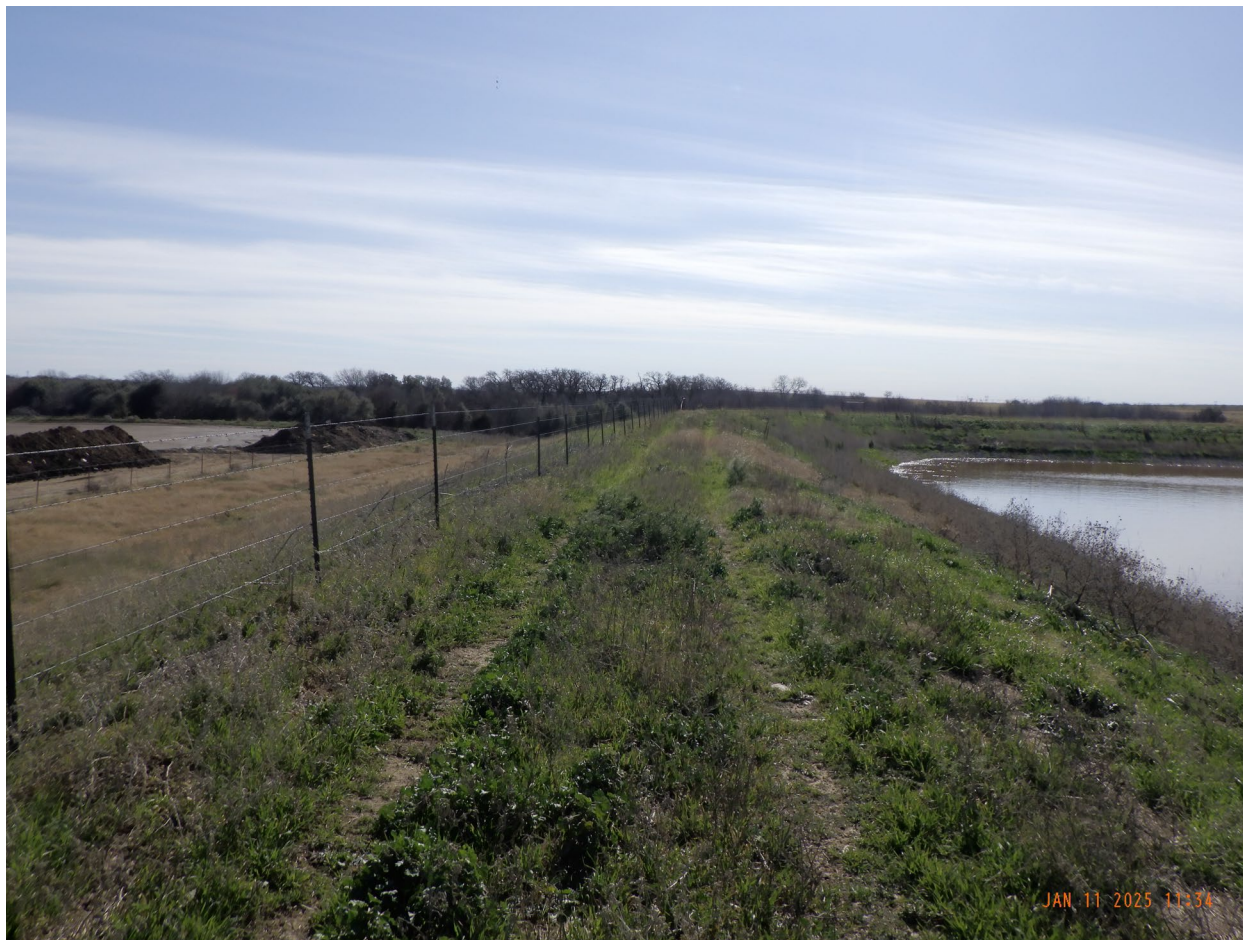
Photo No. 23

Description: Berm between RCS 1.3 and manure dry yard.

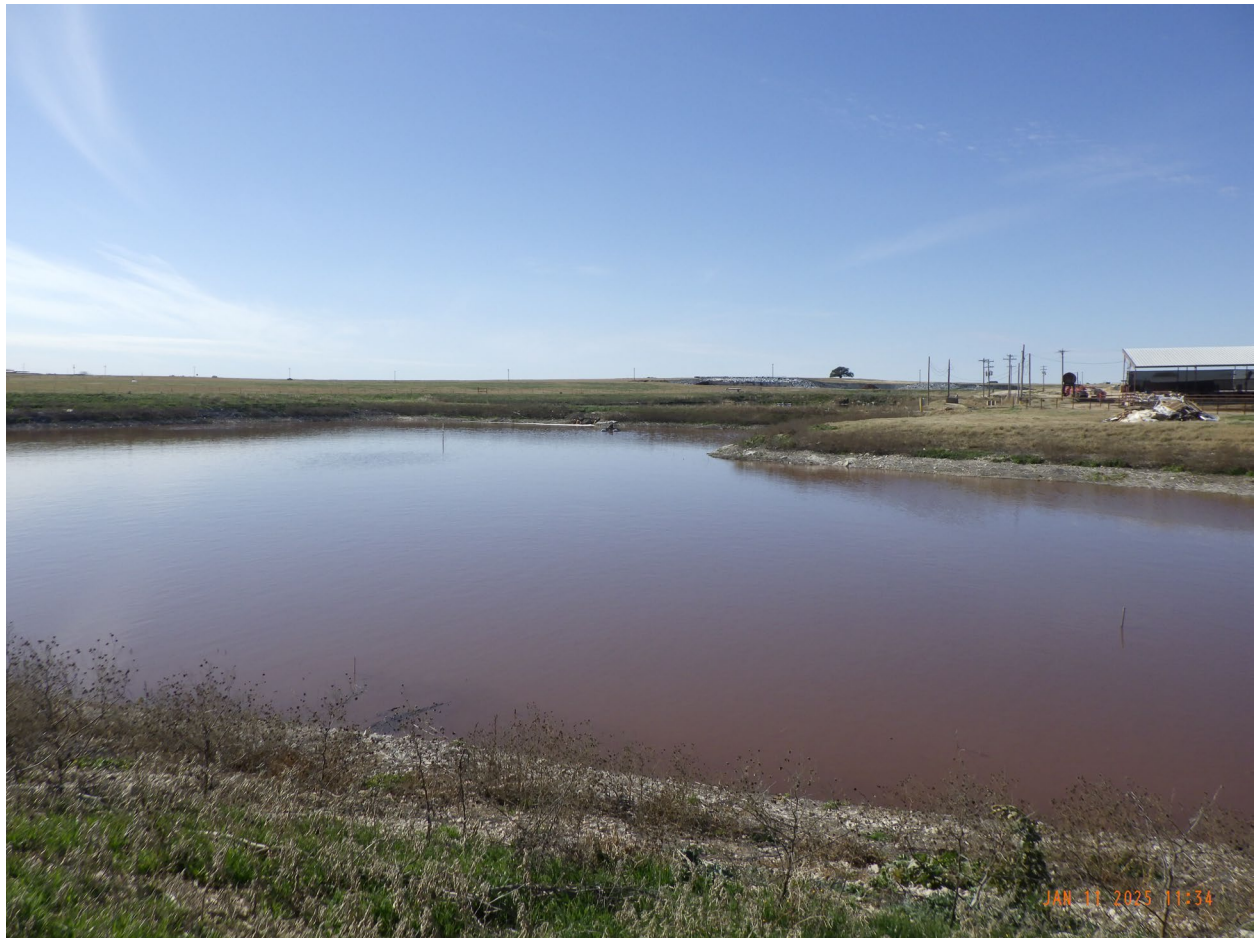
Photo No. 24

Description: RCS 1.3. RCS 1.2 and 1.1 in background with free stalls.

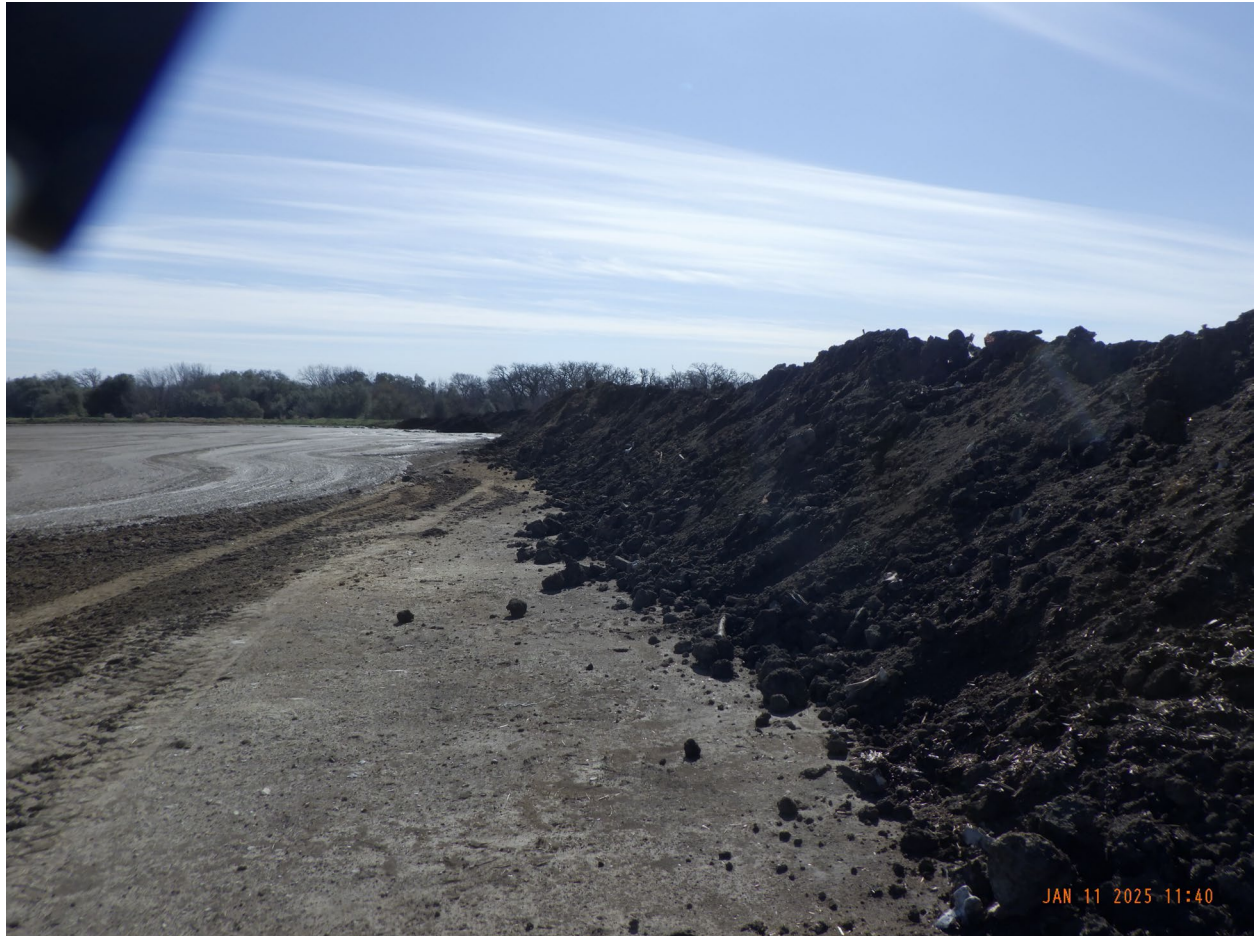
Photo No. 25

Description: Composting on site with dry yard in background.

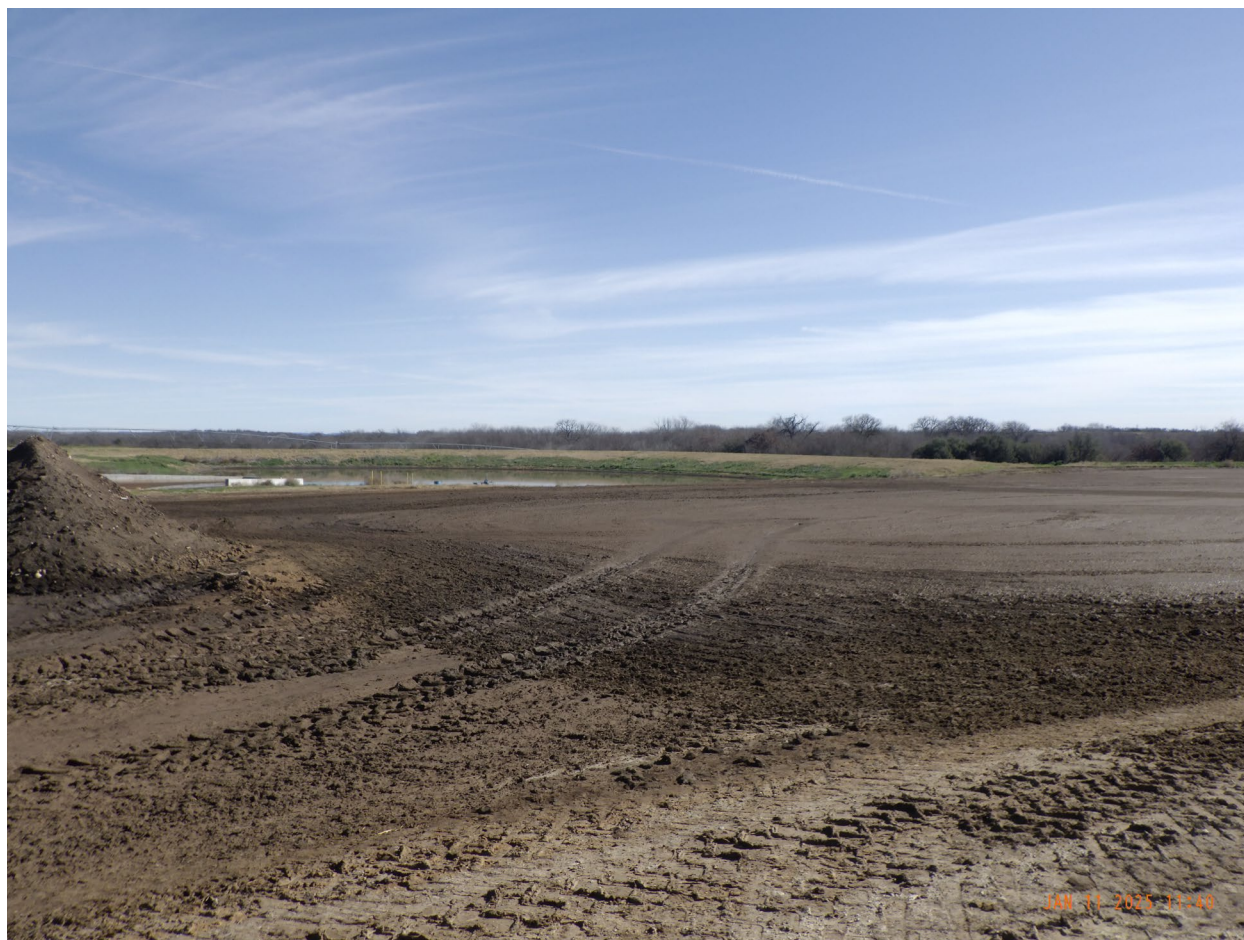
Photo No. 26

Description: Manure dry yard with RCS in background.

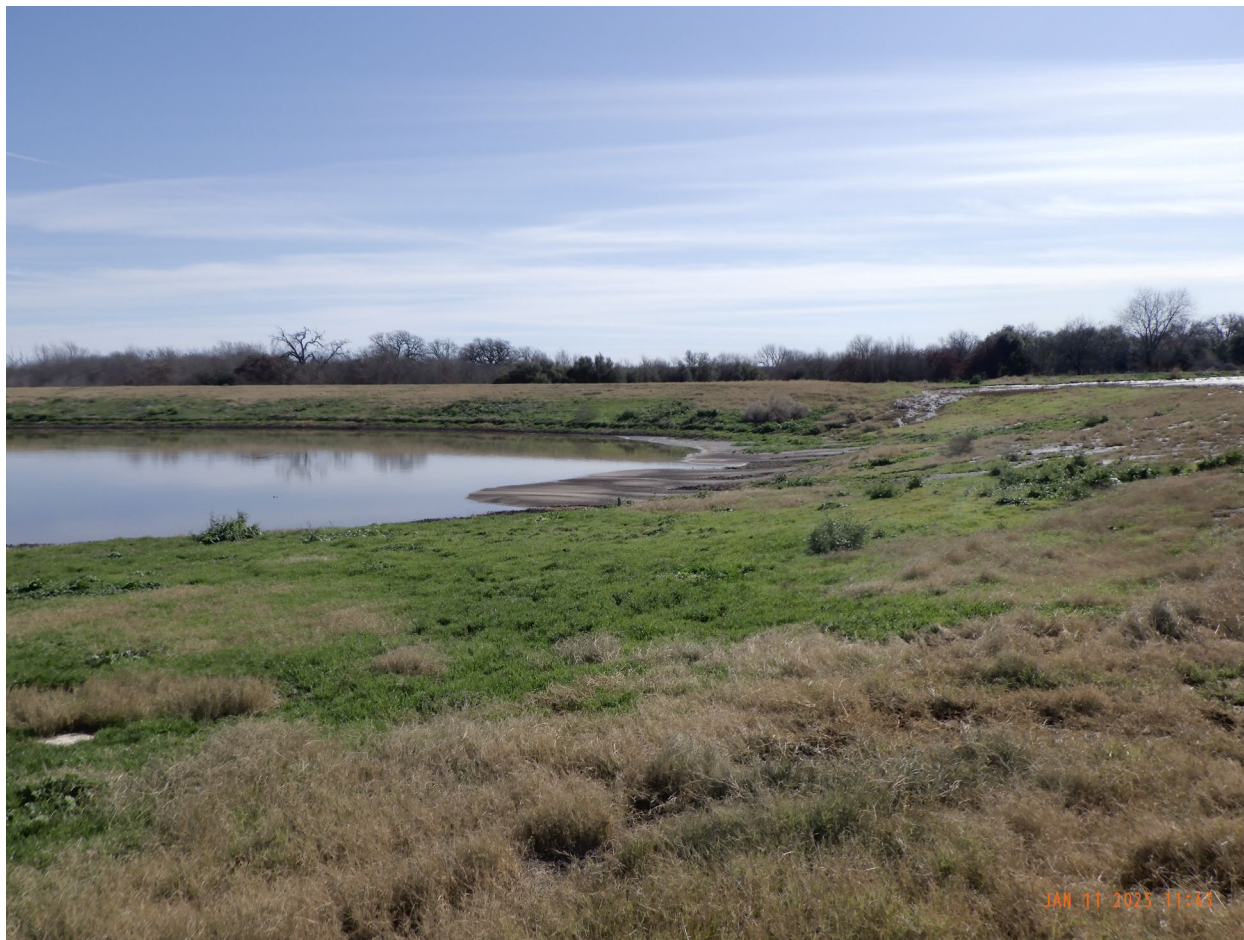
Photo No. 27

Description: Drainage channel from dry yard to RCS.

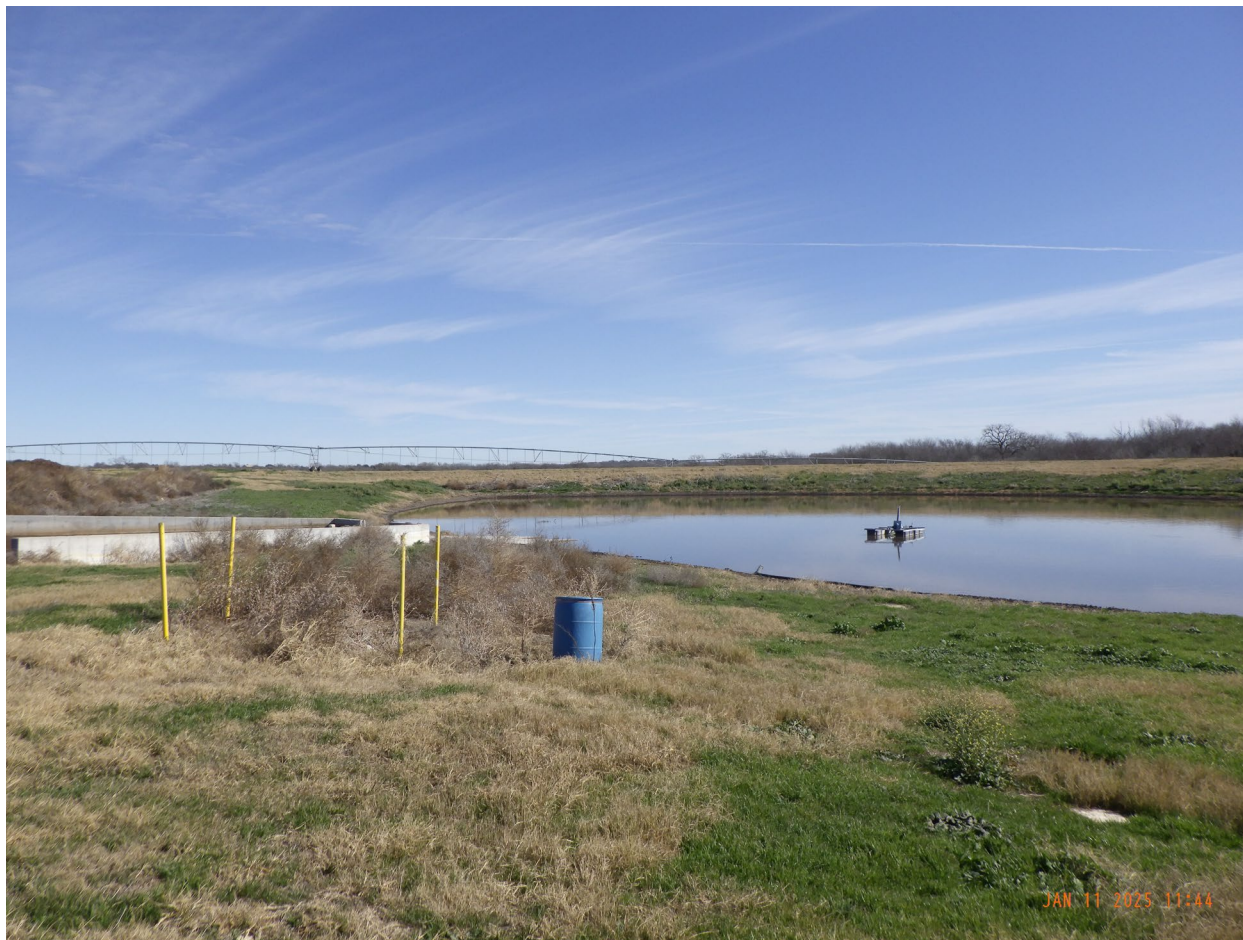
Photo No. 28

Description: RCS below dry yard with pump shown. Has the ability to pump to RCS 1.

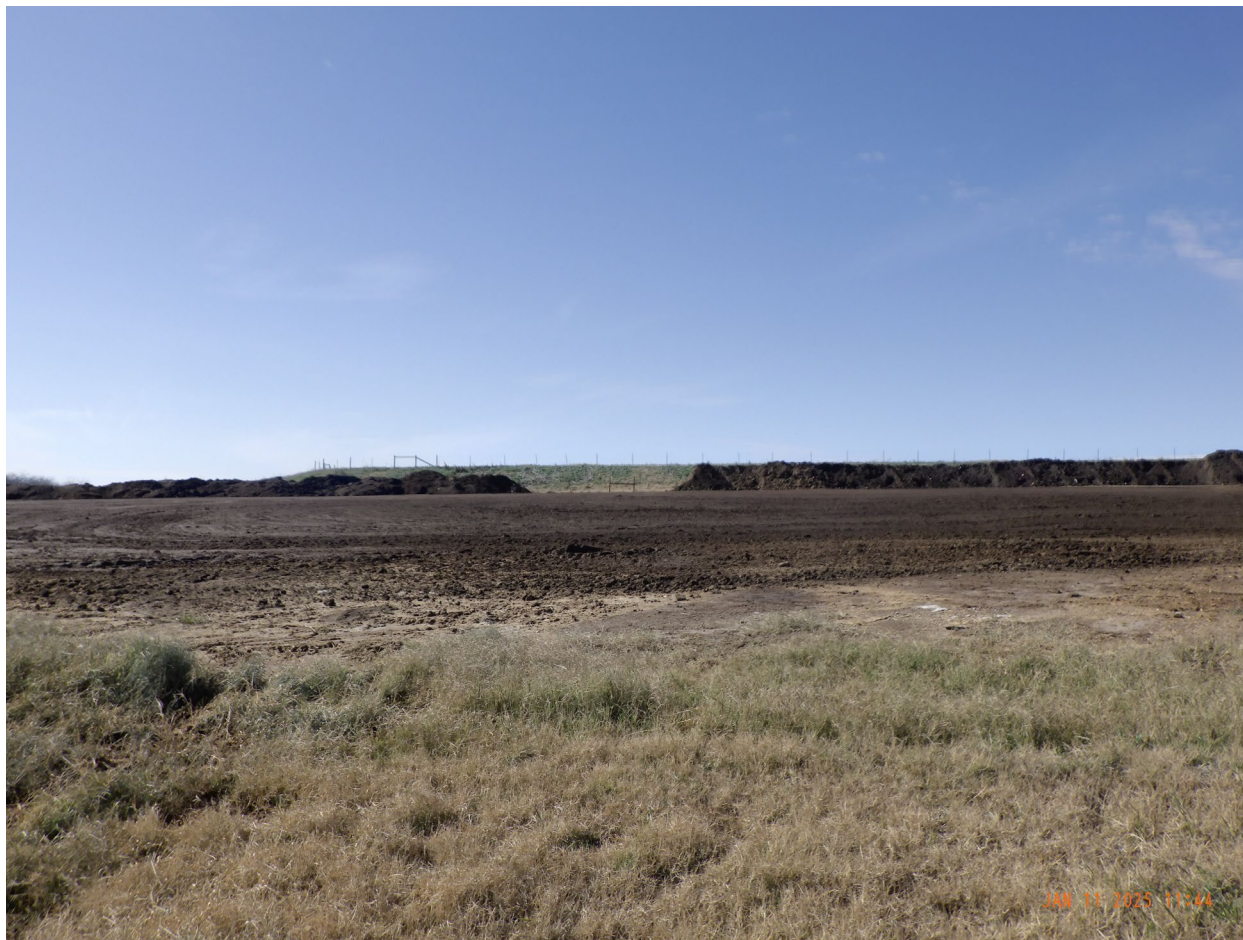
Photo No. 29

Description: Composting and dry yard showing grading to RCS.

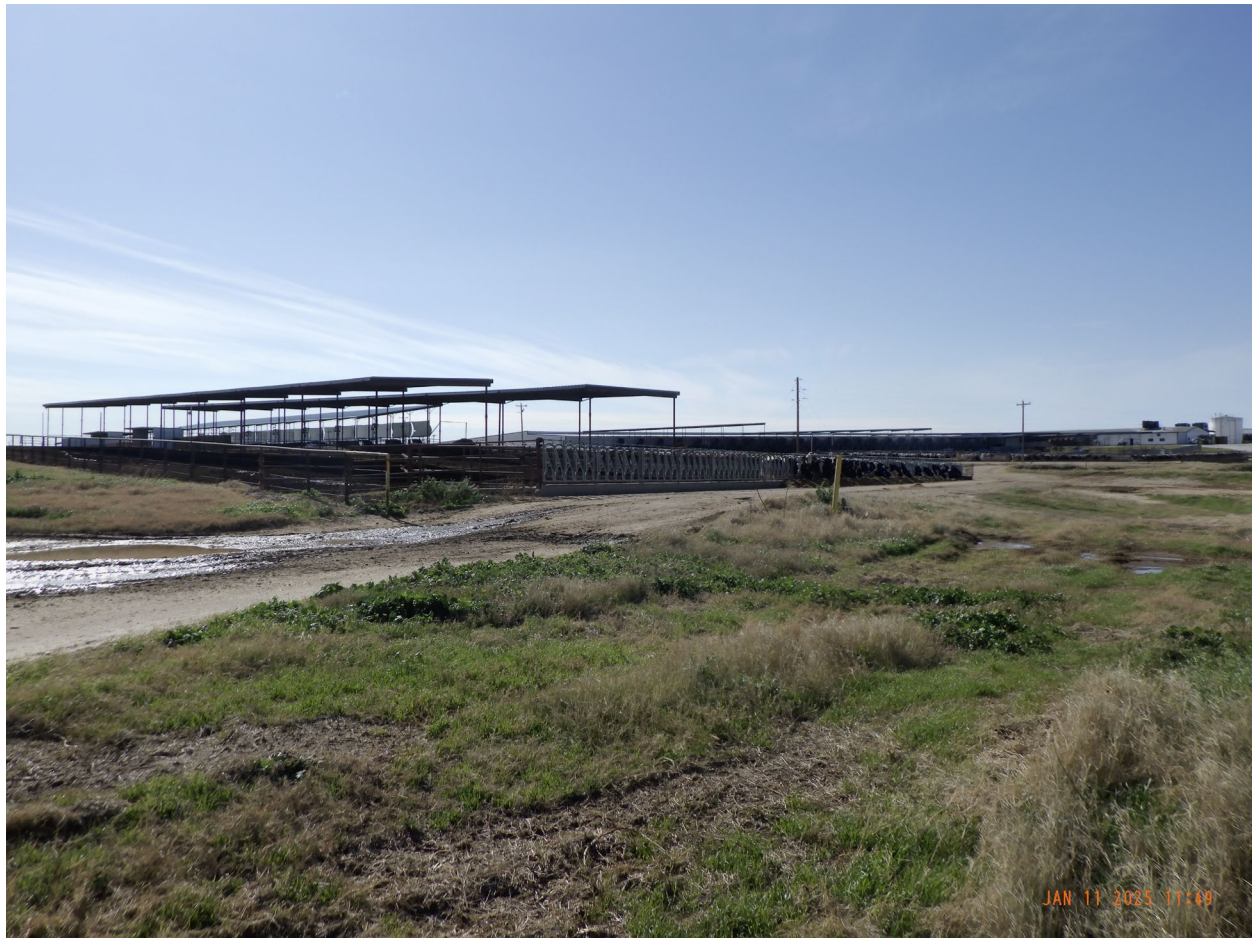
Photo No. 30

Description: Pens graded toward RCS 2.

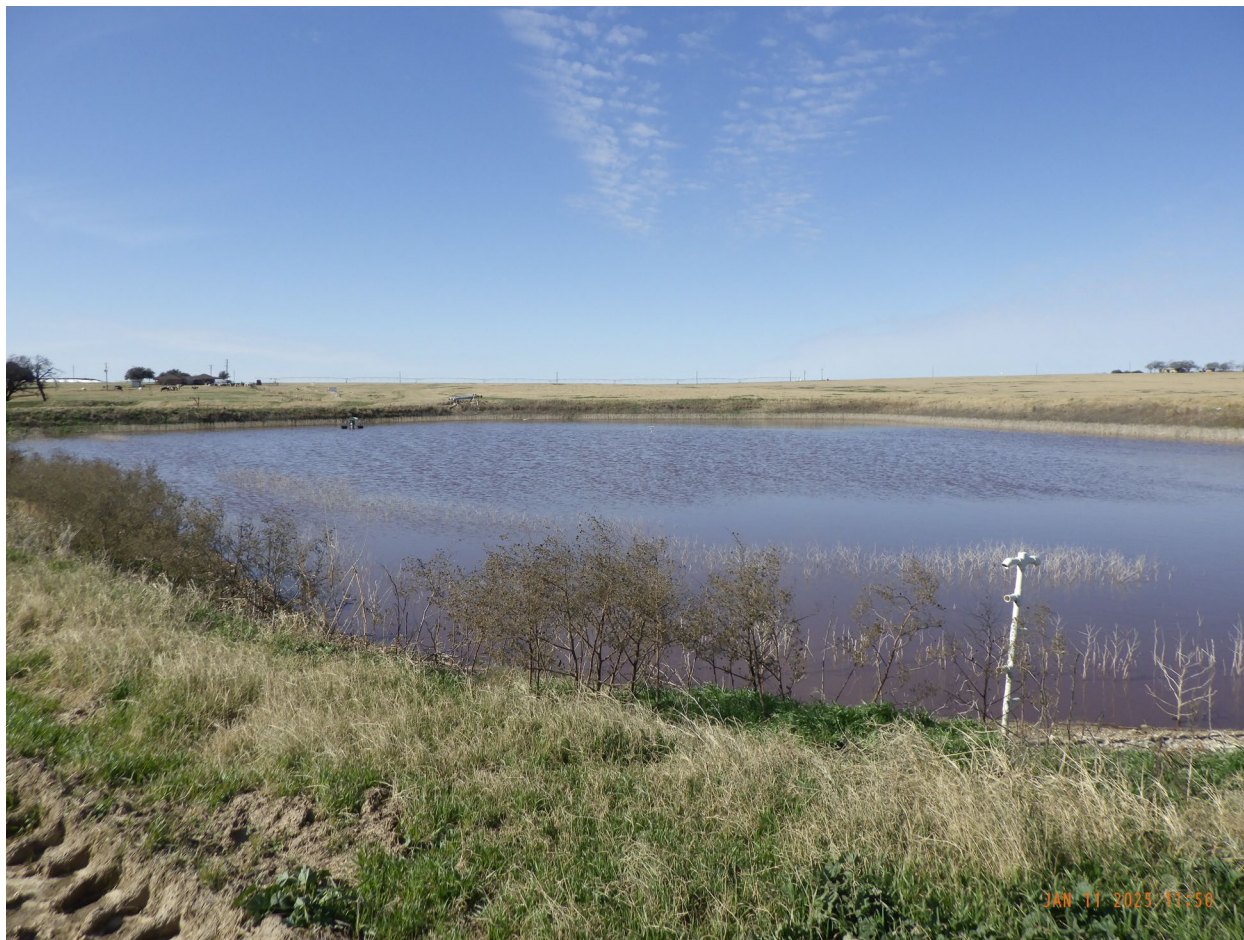
Photo No. 31

Description: RCS 2 with pole marker. Woody vegetation present in embankment in foreground.

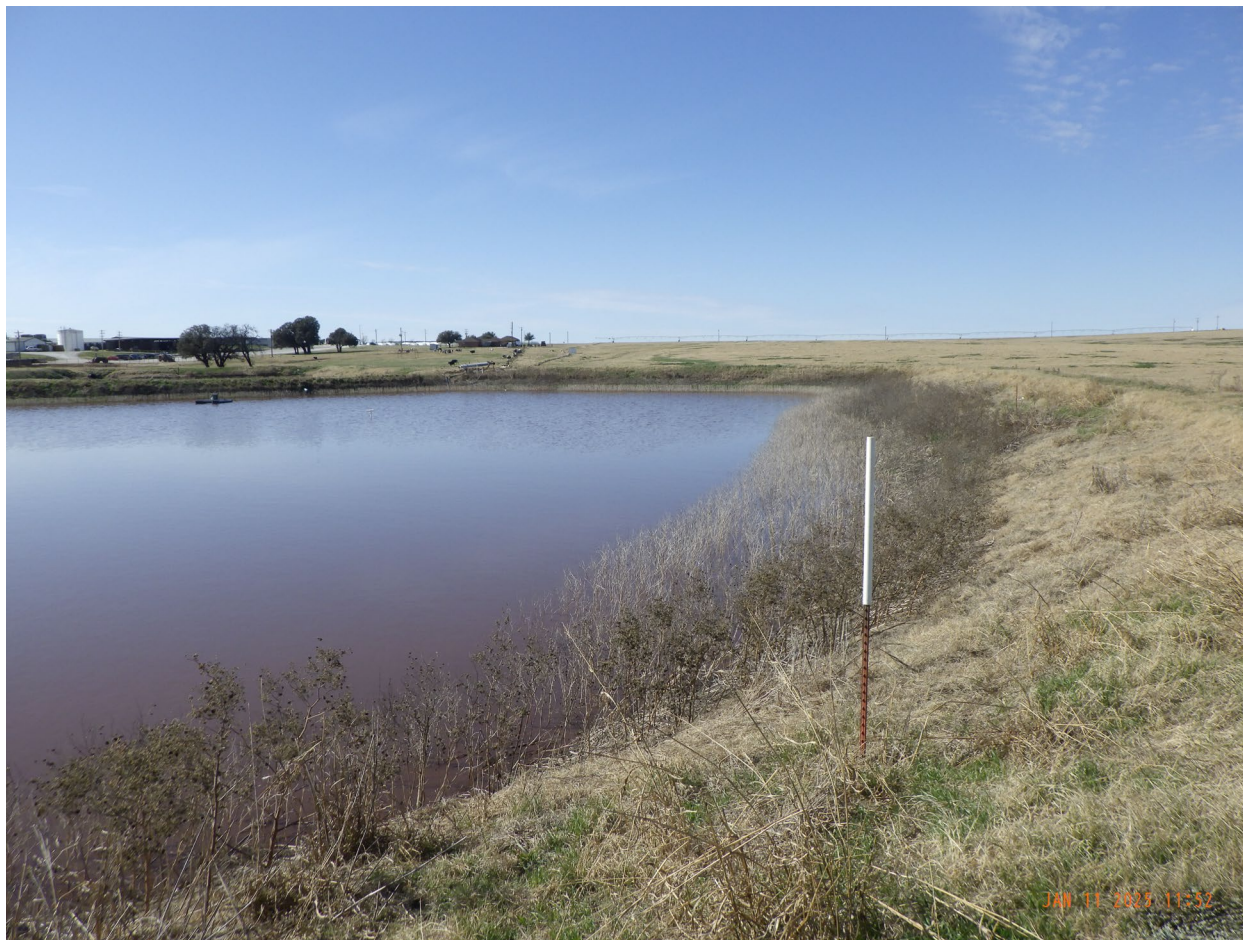
Photo No. 32

Description: RCS 2. Woody vegetation in embankment and growing in lagoon.

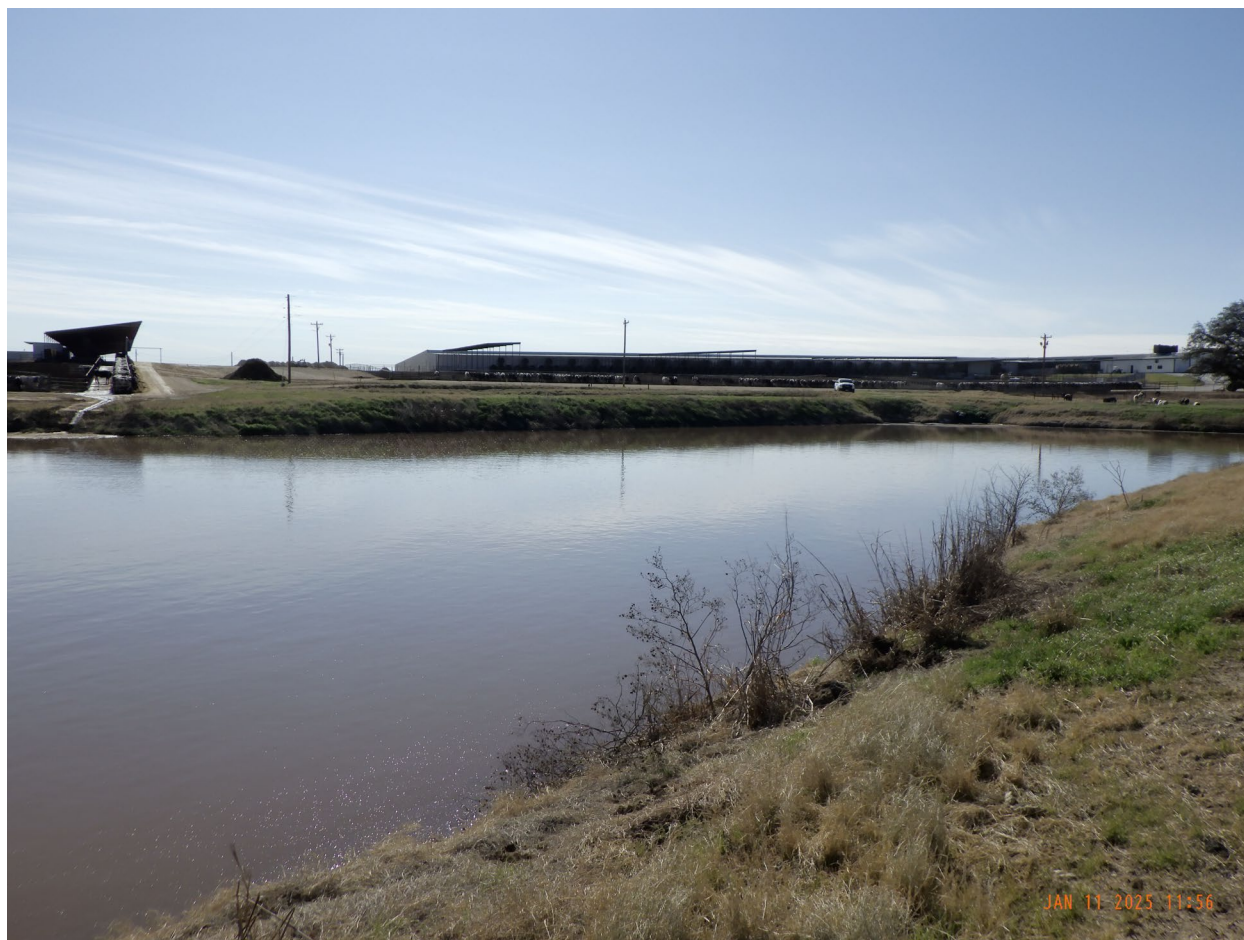
Photo No. 33

Description: RCS 2 with woody vegetation in embankment.

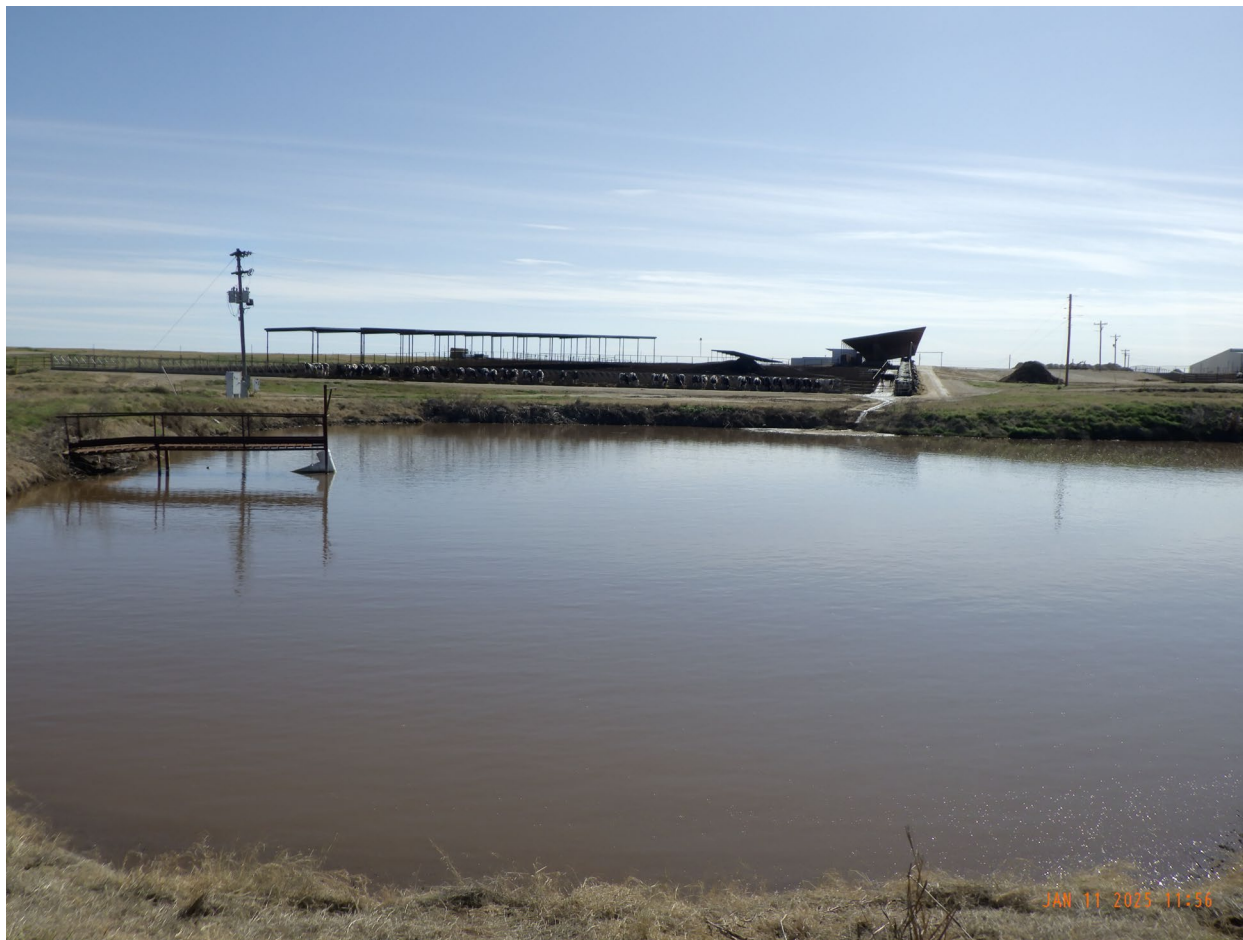
Photo No. 34

Description: RCS 2 with pens in background.
