INSPECTION REPORT

| <b>Type of inspection:</b> | CEI - Compliance Evaluation Inspection | | | | |
| <b>Facility or Site Name:</b> | Wheelersburg WWTP SD NO 2 | | | | |
| <b>Permit Number:</b> | OH0050016 | | | | |

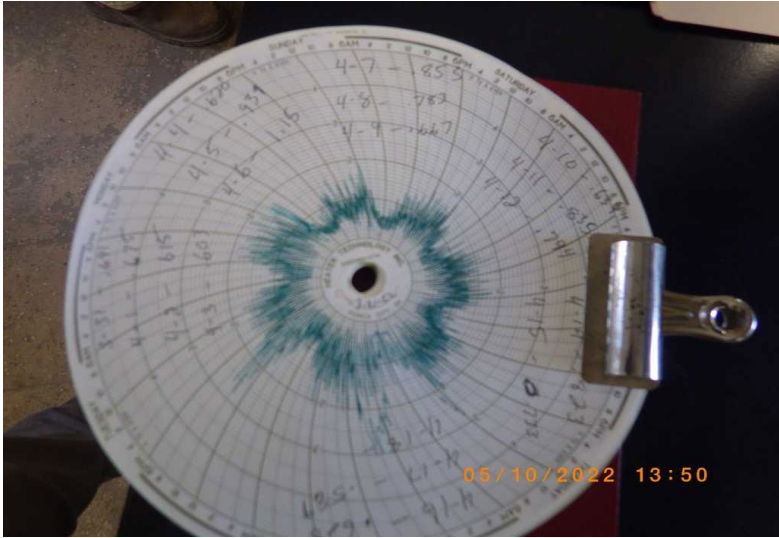
| RIMG2712.JPG | |

| EPA observed the circular chart recorder for flow for the month of April 2022. | |

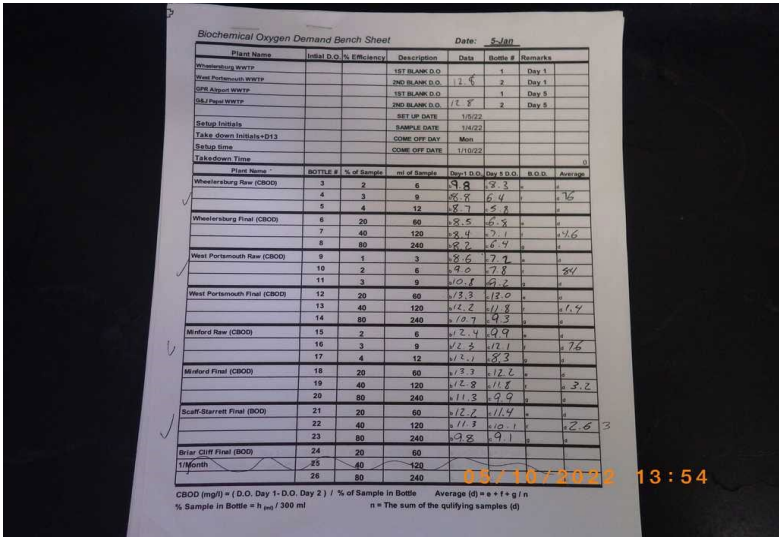
| RIMG2713.JPG | |

| BOD analysis results for the month of January 2022. | |

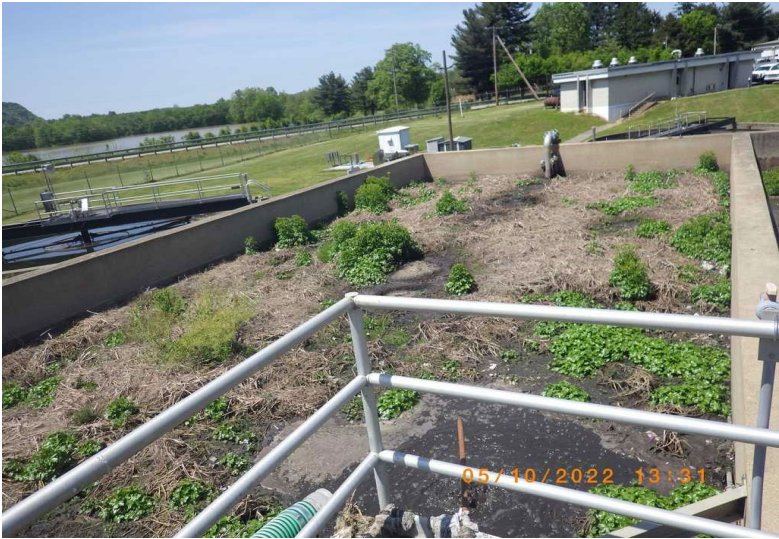
| RIMG2703.JPG | |

| The digesters had plants growing in them and at least one of them was almost fully covered with plants growing on top of it. |

| Half of the east aerobic digester was almost entirely covered with living plants. Camera looking northwest. | |

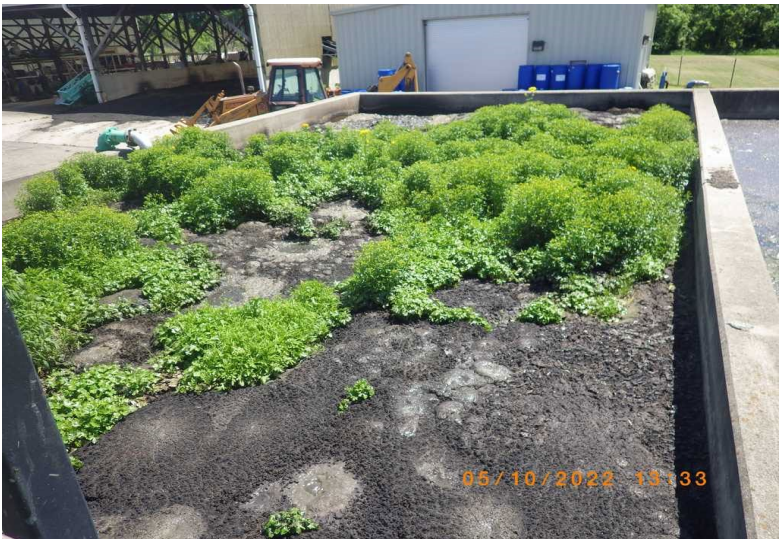
| RIMG2705.JPG | |

| Part of the west aerobic digester was also covered with living plants. Camera looking south. | |

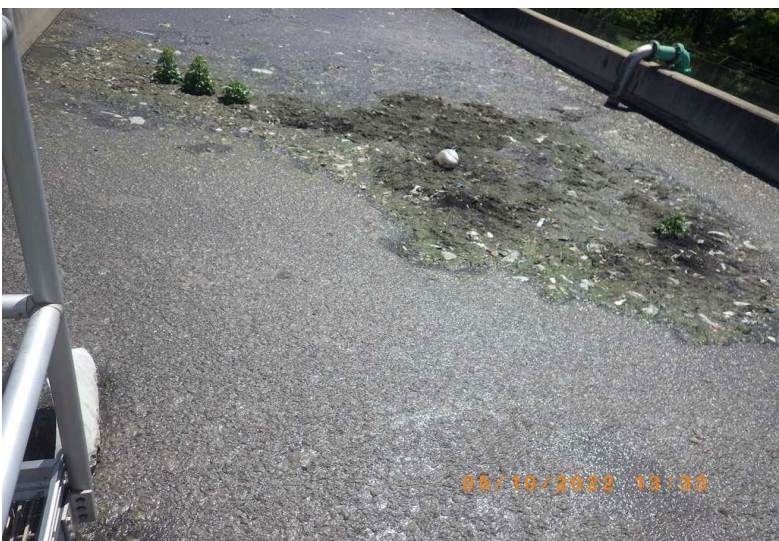
| RIMG2707.JPG | |

| Trash floating at the top of the west digester. Camera looking southwest | |

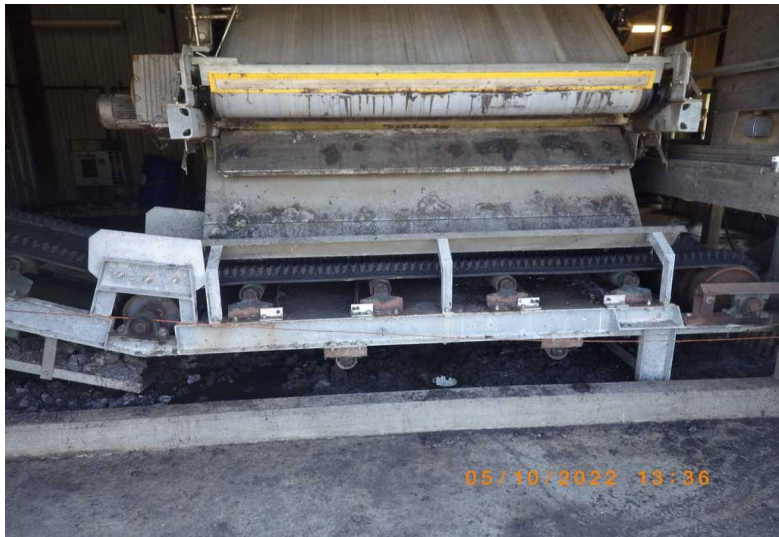
| RIMG2708.JPG | |

| The sludge belt press was not in operation at the time of the inspection. Camera looking south. | |

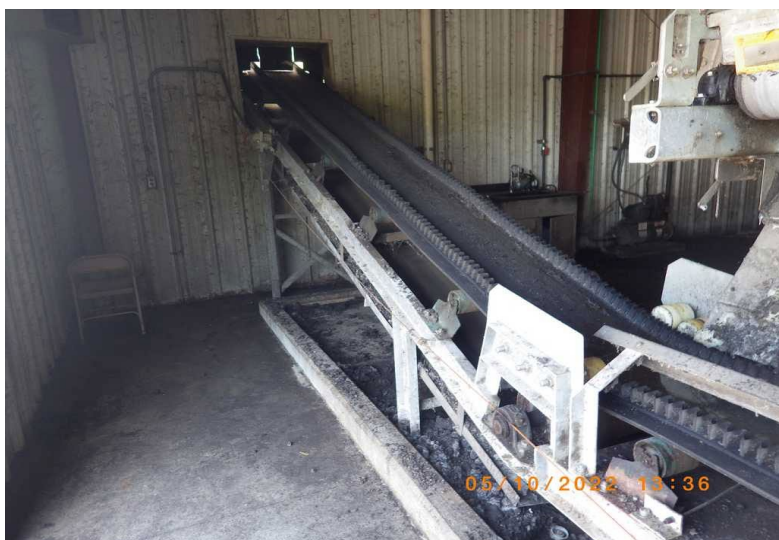
| RIMG2709.JPG | |

| Conveyer belt of the belt press. Camera looking southeast. | |

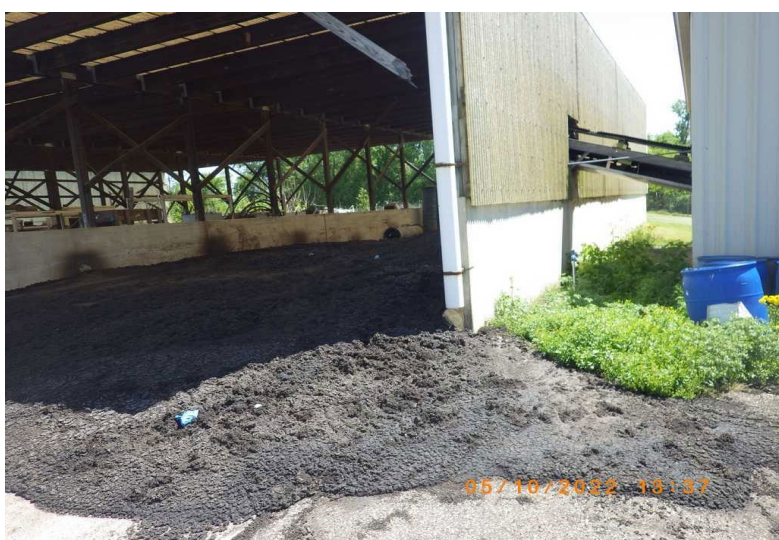
| RIMG2710.JPG | |

| Next to the belt presser there was the dry sludge storage shed. EPA observed sludge overflowing from the covered shed and exposed to stormwater. |

| Dry sludge from the belt press was stored in a covered shed next to the belt press. Sludge was spread outside of the shed area at the time of the inspection. Camera looking south. | |

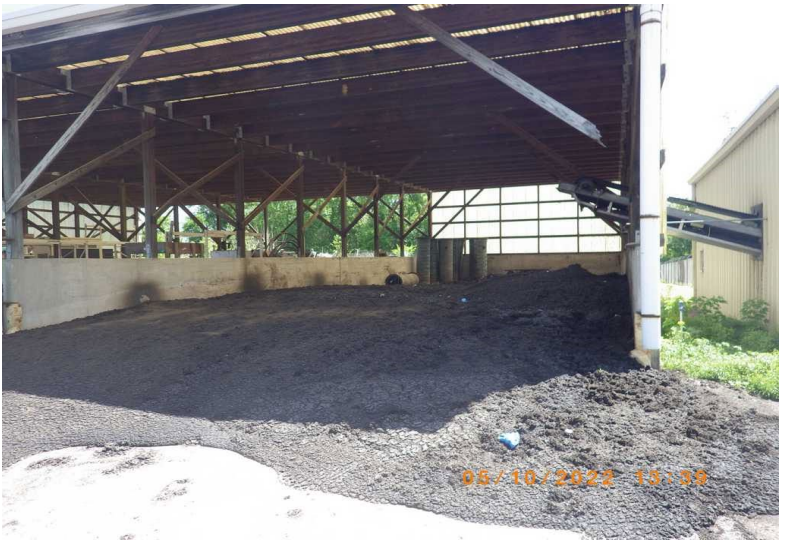
| <p>Dry sludge storage</p> <p>RIMG2711.JPG</p> <p>05/10/2022 14:38 (ET)</p> <p>Andi Hodaj</p> <p>Digesters</p> <p>No CBI</p> <p>No PII</p> <p>Dry sludge from the belt press was stored in a covered shed next to the belt press. Sludge was spread outside of the shed area at the time of the inspection. Camera looking south.</p> | |

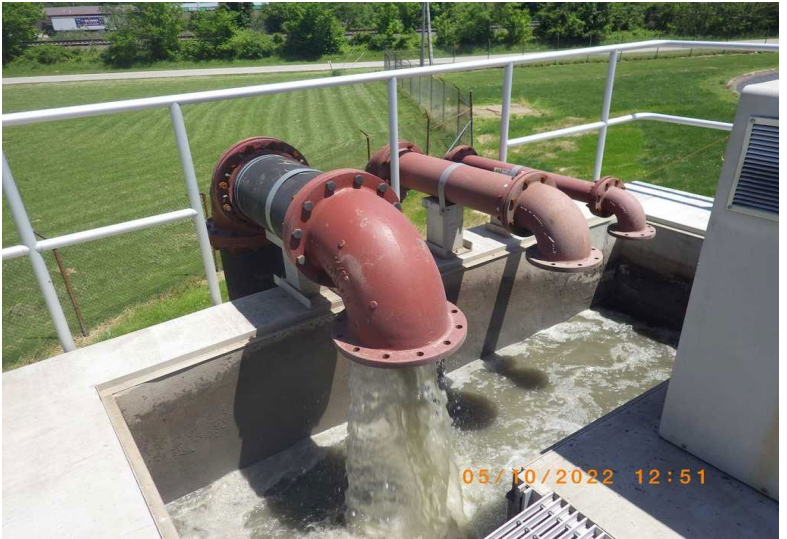
| <p>Influent pipes</p> <p>RIMG2684.JPG</p> <p>05/10/2022 13:51 (ET)</p> <p>Andi Hodaj</p> <p>Primary treatment</p> <p>No CBI</p> <p>No PII</p> <p>The influent pipes at the headworks of the WWTP. Camera looking east.</p> | |

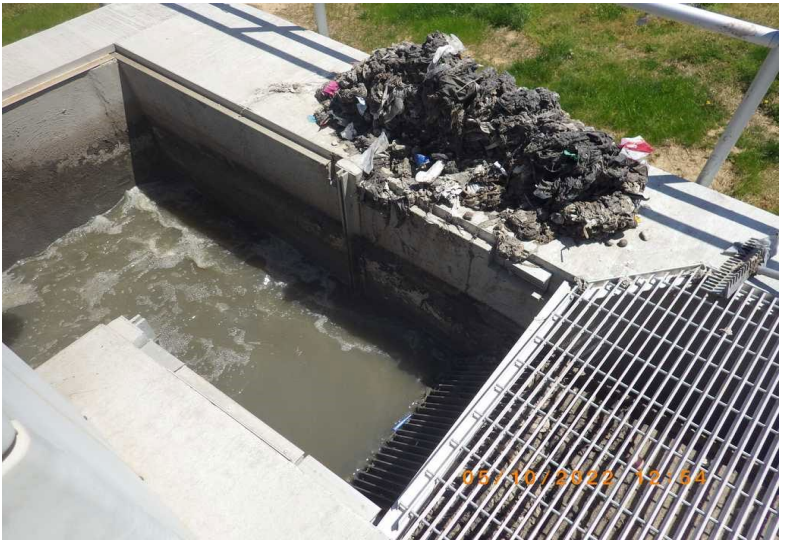
| <p>Influent channel</p> <p>RIMG2685.JPG</p> <p>05/10/2022 13:54 (ET)</p> <p>Andi Hodaj</p> <p>Primary treatment</p> <p>No CBI</p> <p>No PII</p> <p>Influent channel and the bar screen at the headworks of the WWTP. Trash was manually collected and set on side of the channel. Camera looking south</p> | |

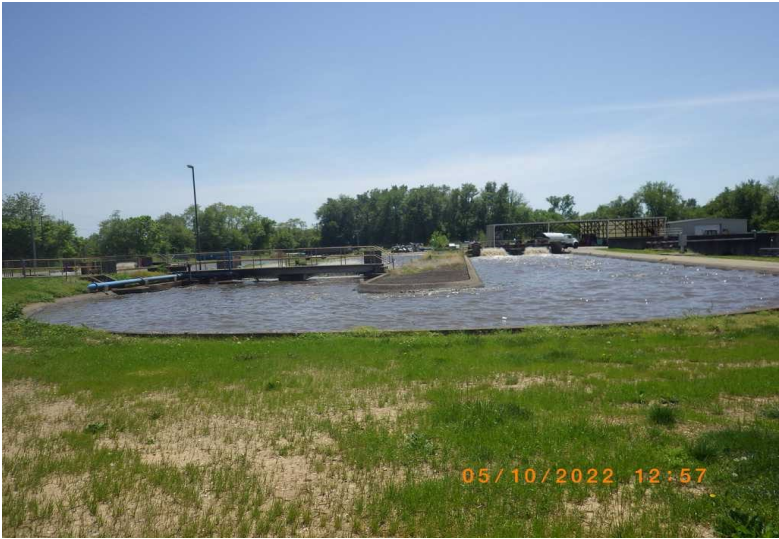
| Oxidation ditches<br>RIMG2686.JPG<br>05/10/2022 13:57 (ET)<br>Andi Hodaj<br>Secondary treatment<br>No CBI<br>No PII<br>Oxidation ditches with four rotors in operation.<br>Camera looking south. | |

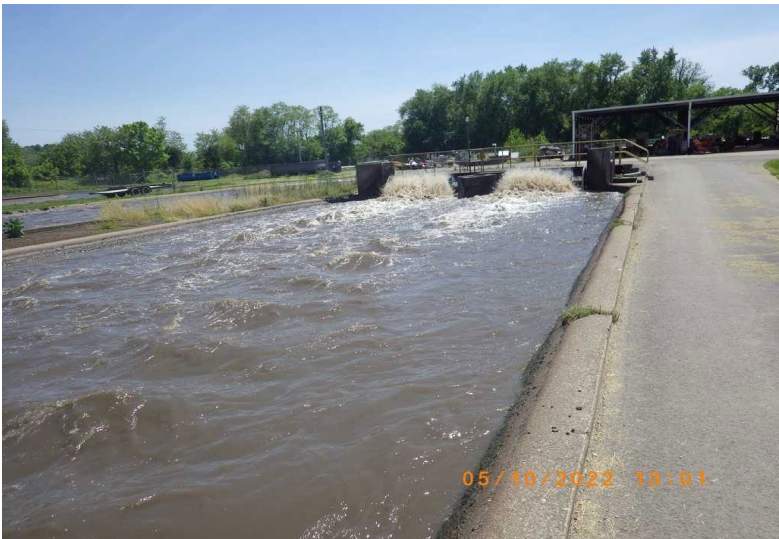
| Oxidation ditch<br>RIMG2687.JPG<br>05/10/2022 14:01 (ET)<br>Andi Hodaj<br>Secondary treatment<br>No CBI<br>No PII<br>Rotors at work in the west oxidation ditch.<br>Camera looking south. | |

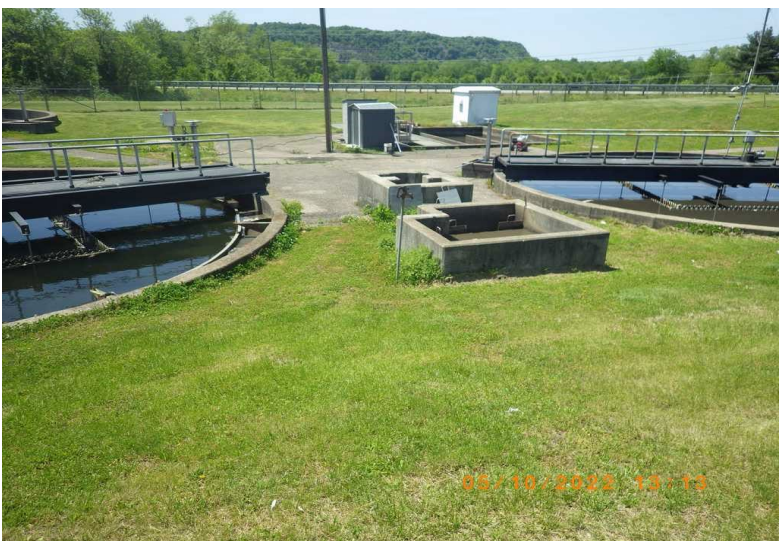
| Clarifier splitter box<br>RIMG2691.JPG<br>05/10/2022 14:13 (ET)<br>Andi Hodaj<br>Secondary treatment<br>No CBI<br>No PII<br>The splitter box that routes wastewater from the oxidation ditches to the three clarifiers. Camera looking northwest. | |

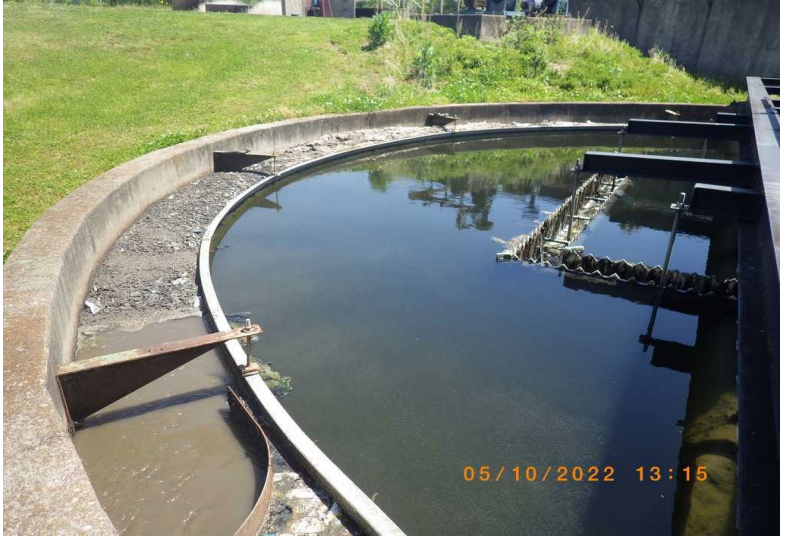
EPA observed a lot of trash and build-up in all three clarifiers.

| Southeast clarifier<br>RIMG2692.JPG<br>05/10/2022 14:15 (ET)<br>Andi Hodaj<br>Secondary treatment<br>No CBI<br>No PII<br>The southeast clarifier had trash and build-up in it. Camera looking south. | |

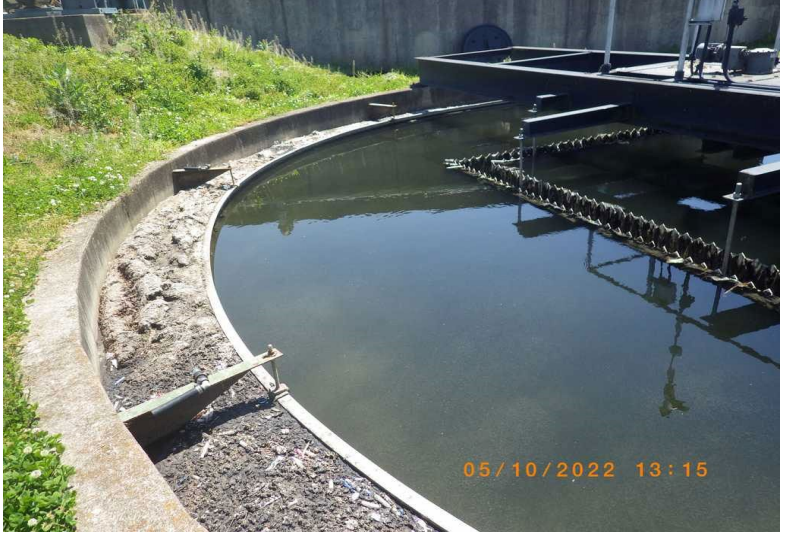
| Southeast clarifier<br>RIMG2693.JPG<br>05/10/2022 14:15 (ET)<br>Andi Hodaj<br>Secondary treatment<br>No CBI<br>No PII<br>The southeast clarifier with a lot of trash in its perimeter. Camera looking southeast. | |

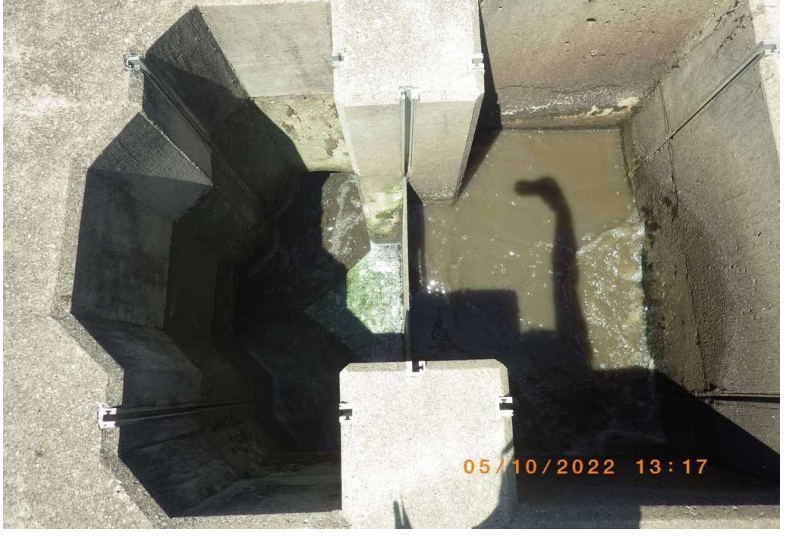
| Clarifier splitter box<br>RIMG2694.JPG<br>05/10/2022 14:17 (ET)<br>Andi Hodaj<br>Secondary treatment<br>No CBI<br>No PII<br>View of the inside of the splitter box for the clarifiers. Camera looking down. | |

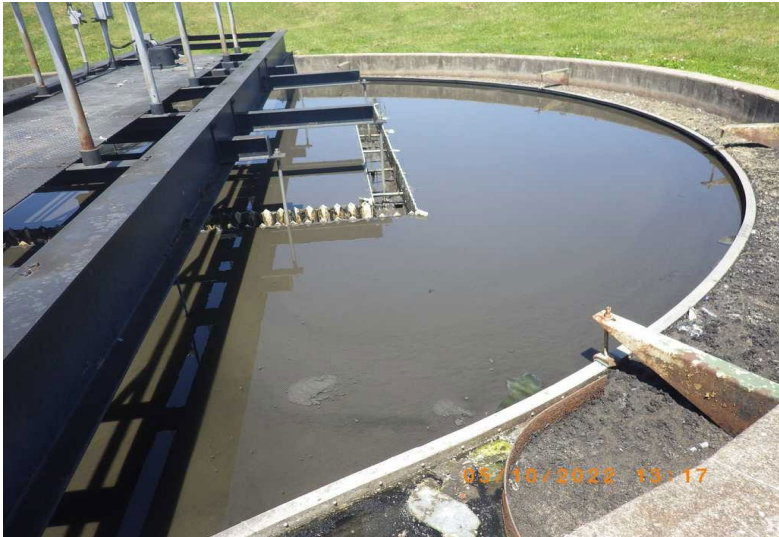
| <p>Northeast clarifier</p> <p>RIMG2695.JPG</p> <p>05/10/2022 14:17 (ET)</p> <p>Andi Hodaj</p> <p>Secondary treatment</p> <p>No CBI</p> <p>No PII</p> <p>Similar to the southeast clarifier, the northeast clarifier had a lot of trash in it. Camera looking northeast.</p> | |

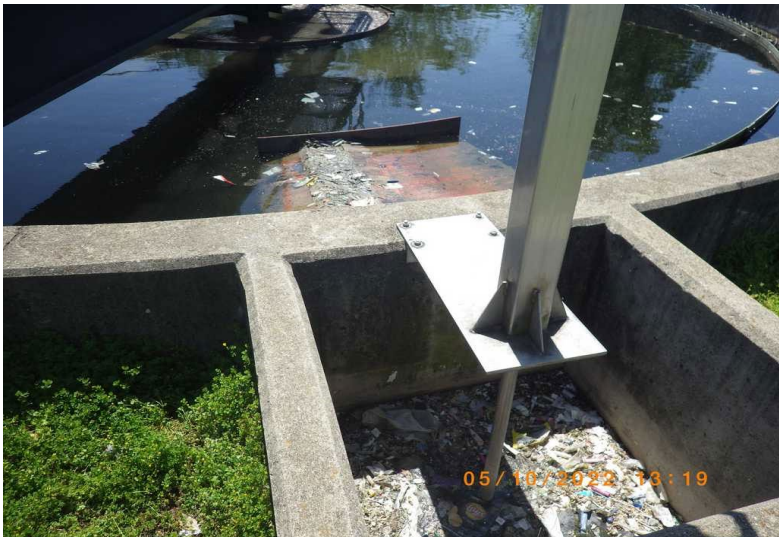
| <p>Southwest clarifier</p> <p>RIMG2697.JPG</p> <p>05/10/2022 14:19 (ET)</p> <p>Andi Hodaj</p> <p>Secondary treatment</p> <p>No CBI</p> <p>No PII</p> <p>Trash chamber at the southwest clarifier. Camera looking southwest.</p> | |

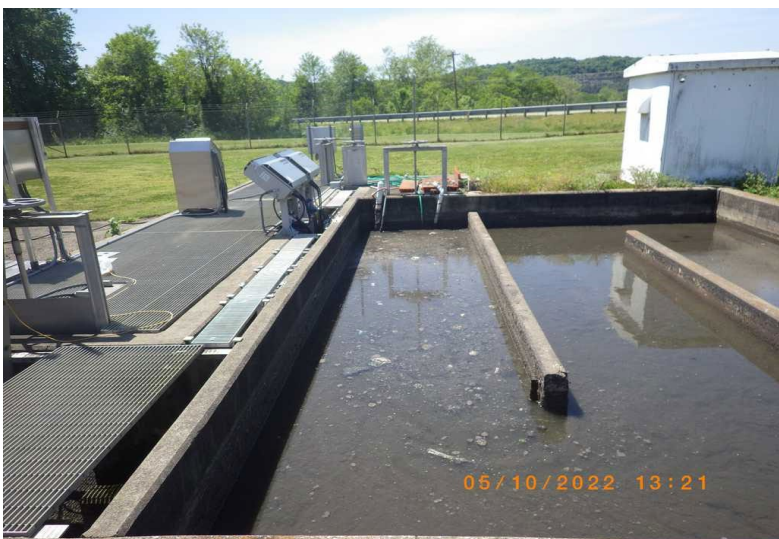
| Wastewater in the UV channel was dark grey with a lot of sediment and trash in it. |

| <p>UV and Discharge channel</p> <p>RIMG2698.JPG</p> <p>05/10/2022 14:21 (ET)</p> <p>Andi Hodaj</p> <p>Secondary treatment</p> <p>No CBI</p> <p>No PII</p> <p>The UV and Discharge channel. Trash was visible in the UV tank. According to Mr. Pickelsimer, the channel is full due to outfall 001 being underwater which is often during spring. Camera looking west.</p> | |

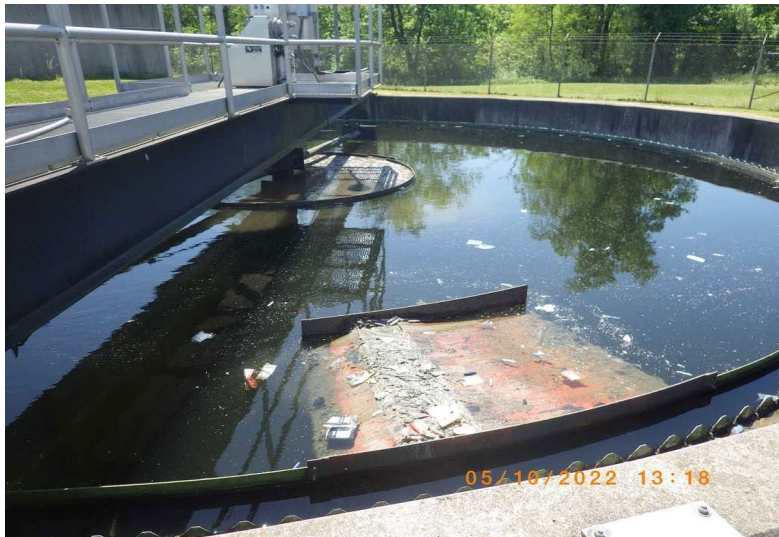
| RIMG2696.JPG | |

| Trash floating at the southwest clarifier. Camera looking southwest. | |

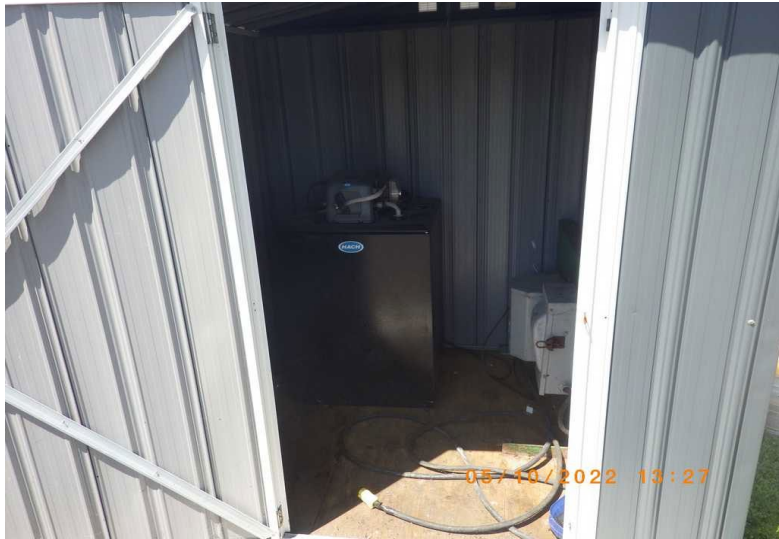
| RIMG2701.JPG | |

| The effluent autosampler was located in a shed next to the discharge channel. Camera looking north. | |

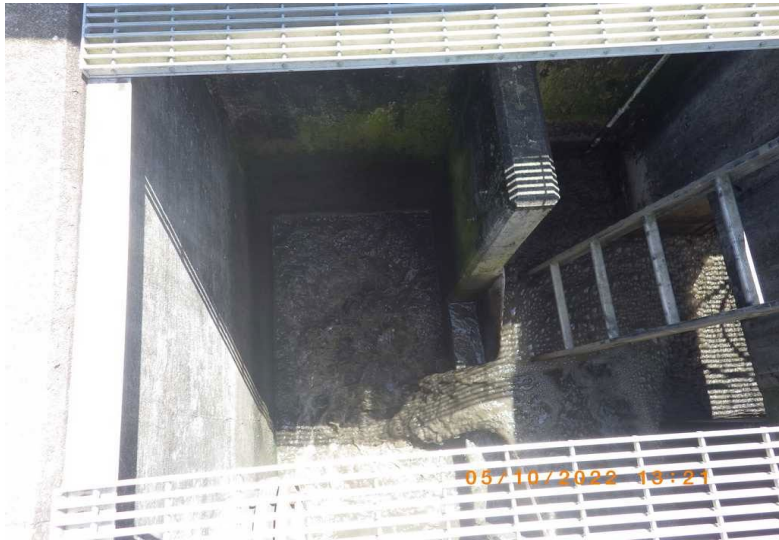
| RIMG2699.JPG | |

| EPA observed a V-notch weir at the outlet of the UV channel, and where effluent flow was measured according to Mr. Schackart, but could not see a depth sensor. |

| View inside of the discharge channel. Photo shows the flow over the V-notch weir inside the discharge channel. EPA could not find a depth sensor in the channel. Camera looking down. | |
