**Region 6 Compliance Assurance and Enforcement Division  
INSPECTION REPORT**

| Inspection Date(s): | 7/31/2018 | | |
| Company Name: | <b>Camino Real Regional Utility Authority (CRRUA)</b> | | |
| Facility Name: | <b>Sunland Park Waste Water Treatment Plant</b> | | |

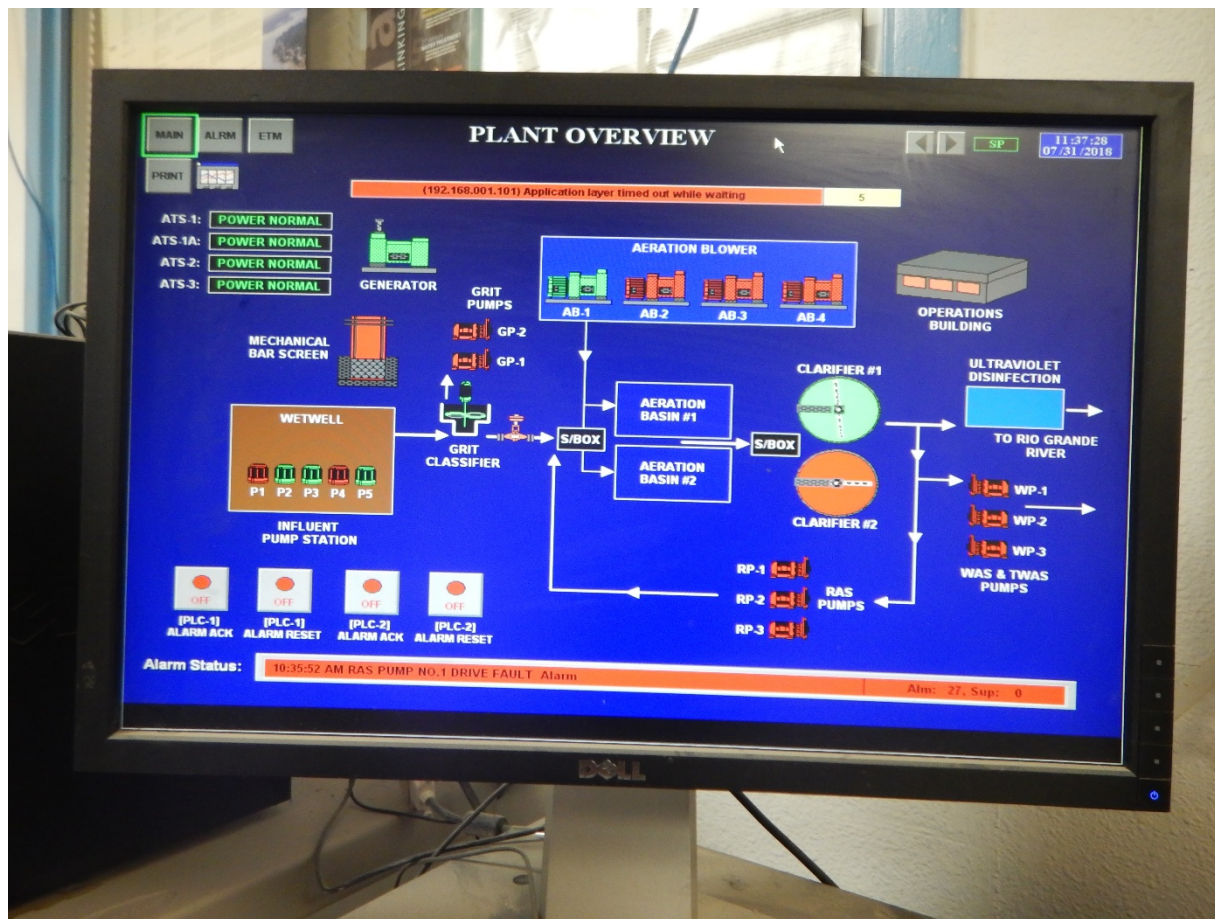
Photo No. 1

Description: Plant overview in the Sunland Park WWTP supervisory control and data acquisition SCADA system.

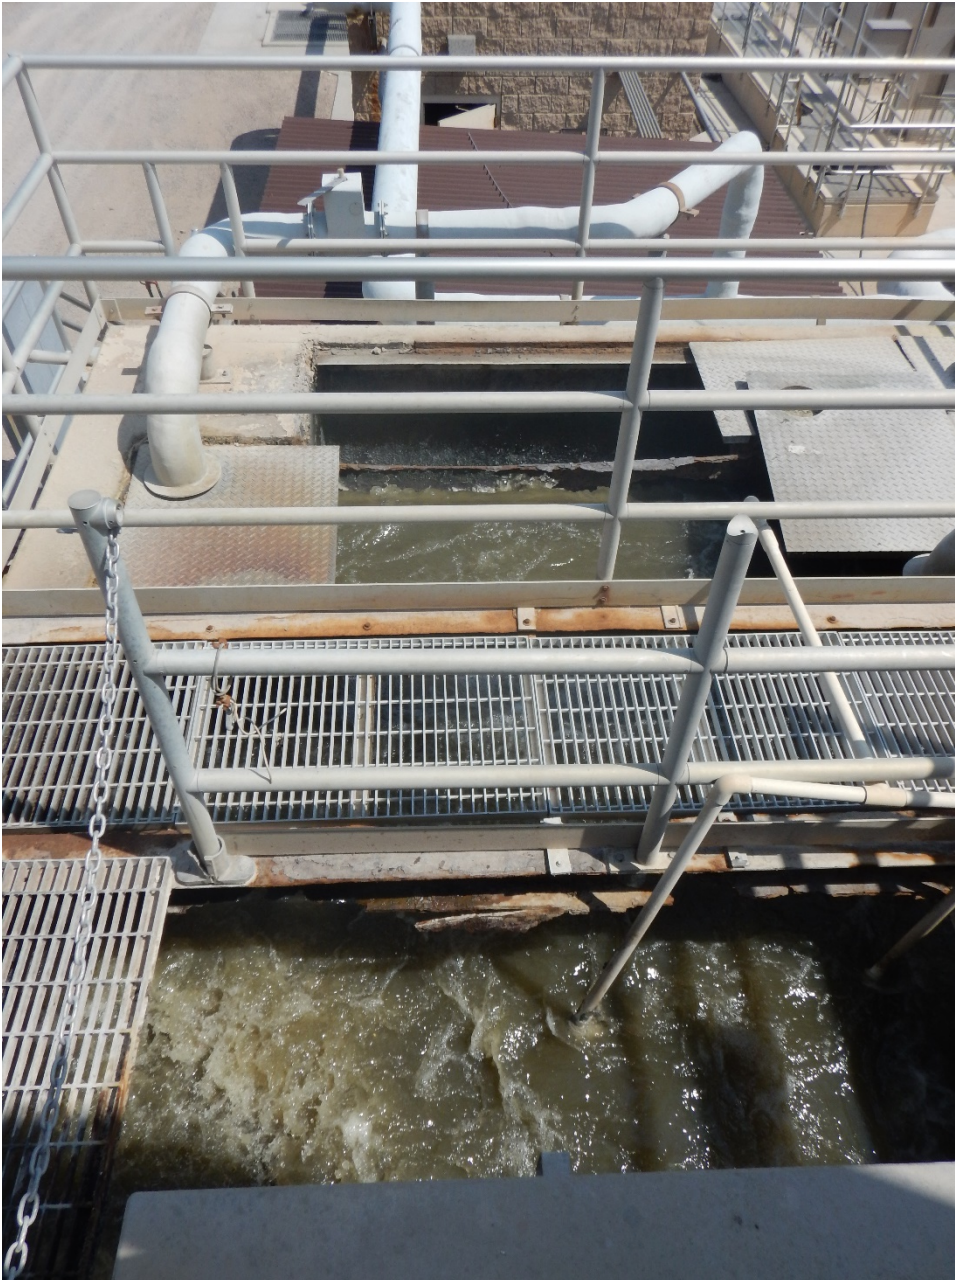
Photo No. 2

The permittee reports that parts are often breaking down, but there is a pumping equipment parts store just down the road who is able to keep many of the needed parts in stock. At the time of this inspection, all trains of the plant were online, however the age of the plant is evident (and can be seen in the Photo Log in Appendix A), in the rusting steel joists holding up the walkways, the rusting (and leaking) vent pipe in the aeration basin, clarifier weirs which need leveling, and the broken hood vent fan in the laboratory. The UV system is difficult to find parts for (not available at the pumping equipment parts store) and is supposed to save energy by not coming on at full power unless the water is at a high turbidity, however due to a malfunction, currently it is either on full power, or completely off. Only four of the eight UV banks are currently operational.

Description: Rusting I-beam under walkway over splitter box prior to aeration basins.

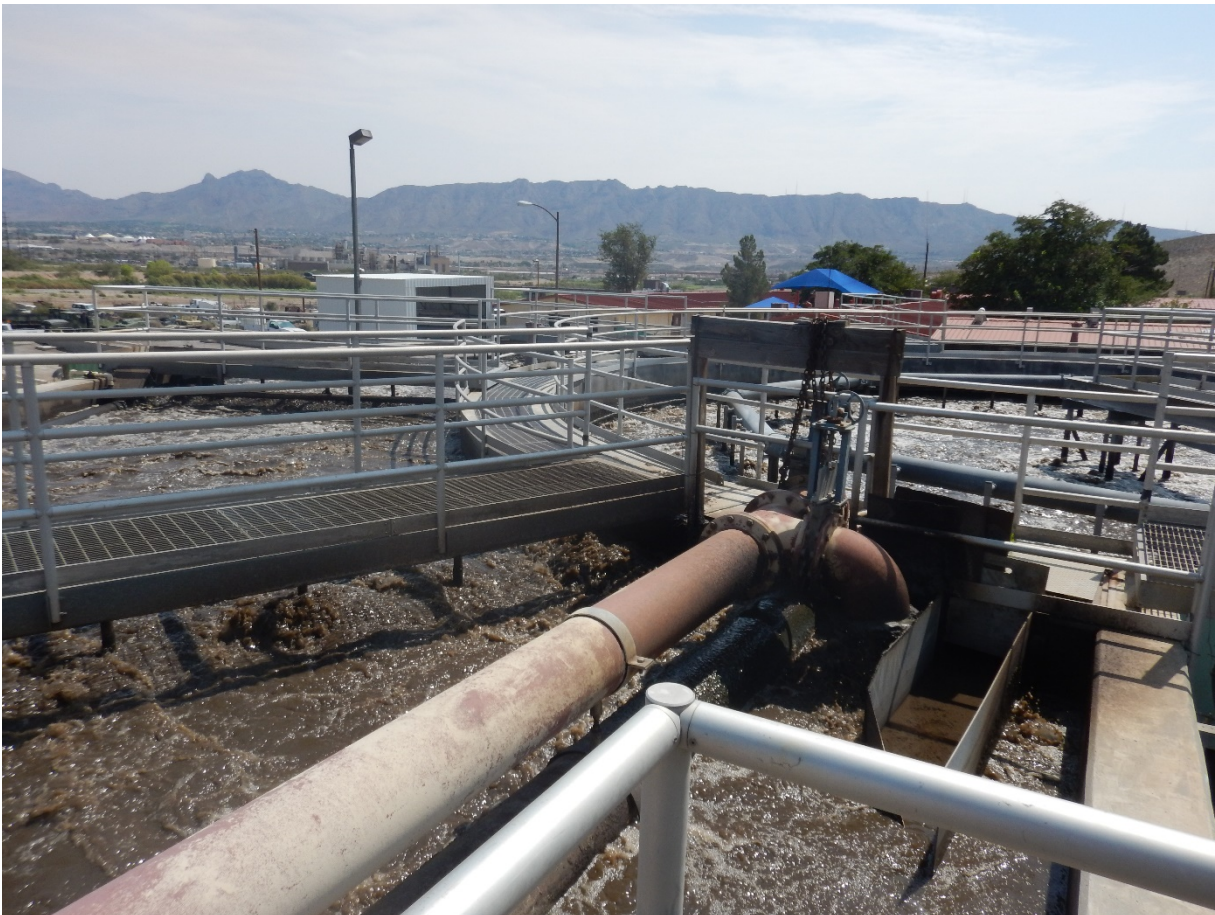
Photo No. 3

Description: Aeration basin with air leaks in rusting air distribution pipes.

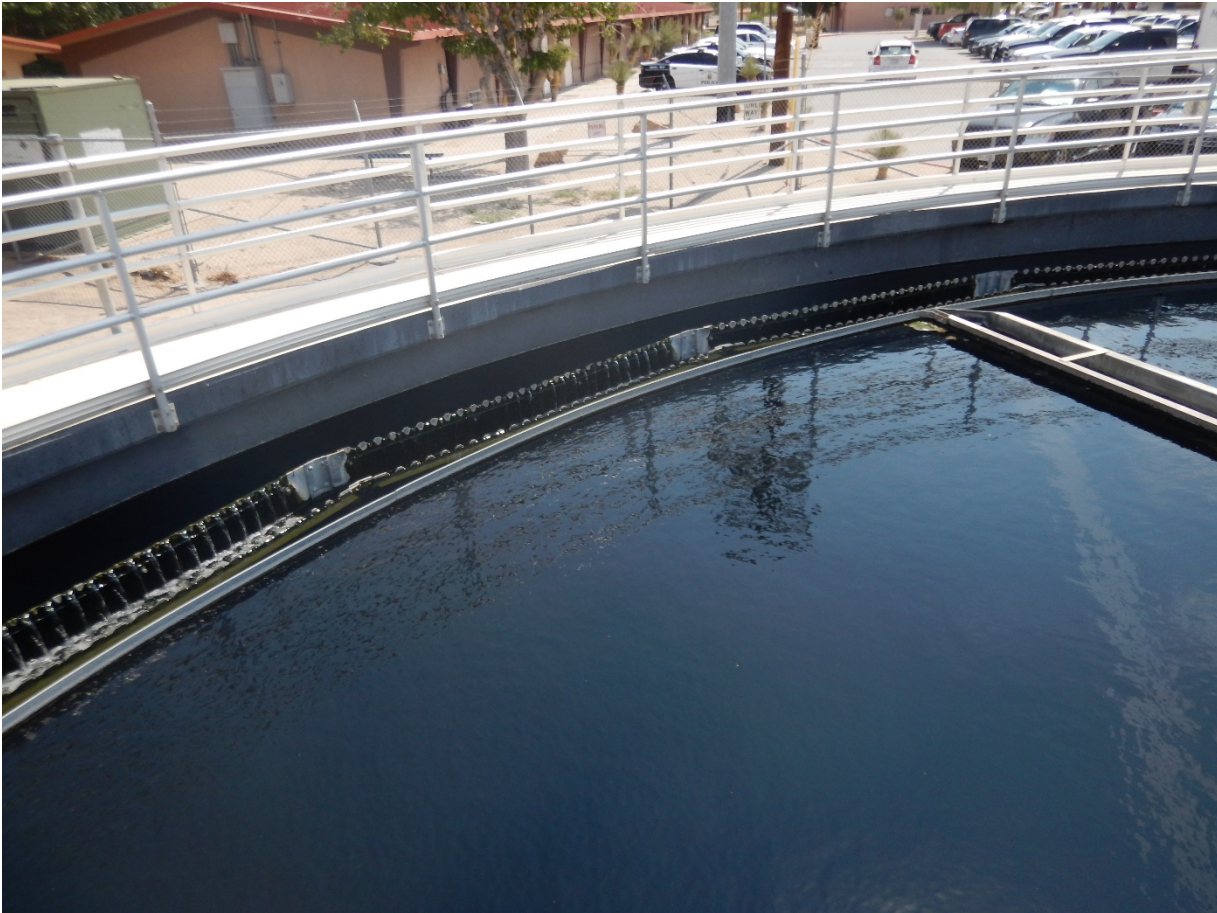
Photo No. 4

Description: Clarifier weirs in need of releveling.

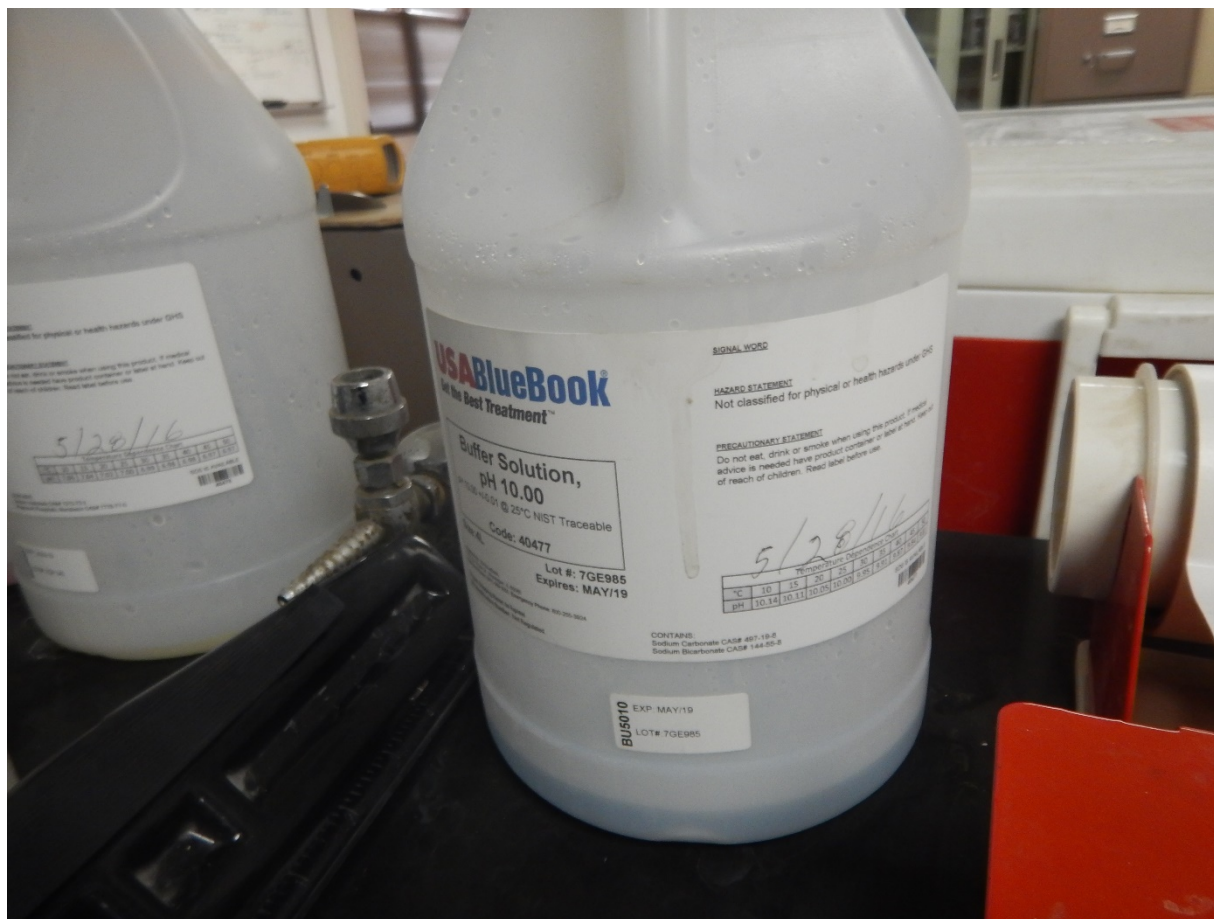
Photo No. 5

pH buffer solutions had a written date of “5/28/16” on them, however there was no other written identification to say whether this date was the received-on date, or the opened-on date. The manufacturer of these solutions, “USABlueBook” states that they must be used within 6 months after opening. Received-on dates, opened-on dates, and expiration date based on the earliest of six months after opening, or manufacturers printed expiration date should be written on every bottle, including smaller, temporary bottles (if used). It was therefore impossible to confirm proper calibration of the pH instrument.

Description: pH buffer bottles with a written date of "5/28/16" on them, however the meaning of the date written is unclear.
