## **Appendix A**

### **Photograph Log**

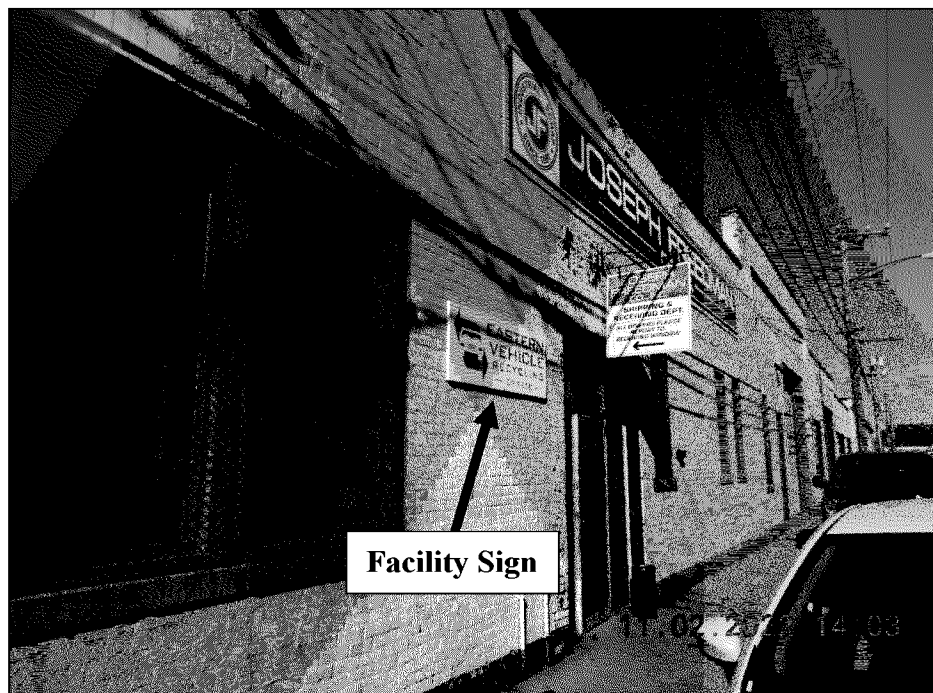
**Photograph 1.** View, facing north, of the sign outside the Facility.

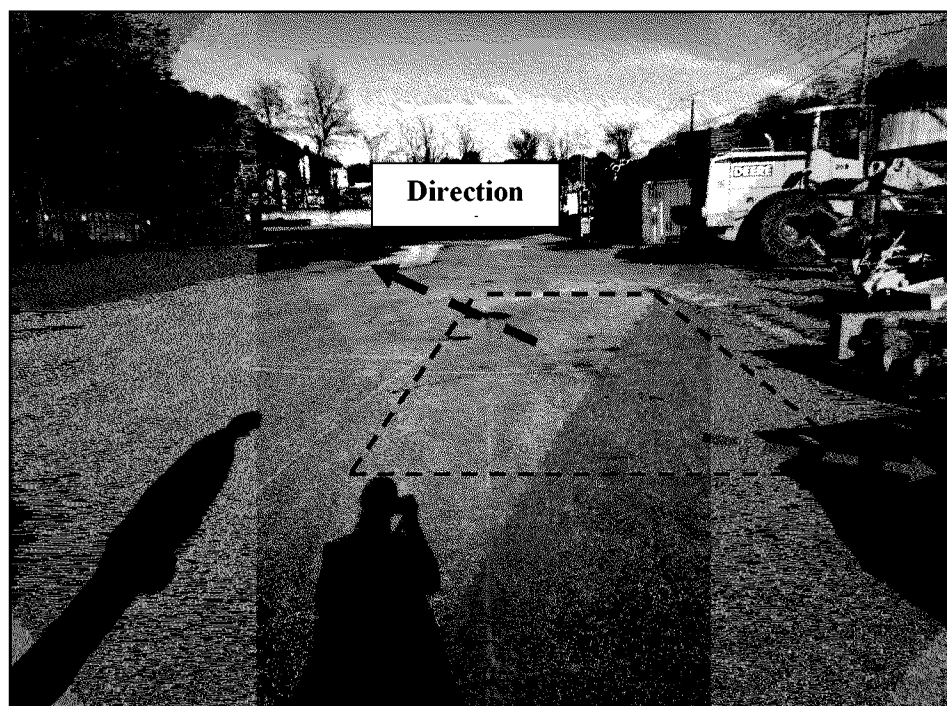
**Photograph 2.** View, facing north, of the Facility (red). It appeared that stormwater would flow towards the separate Joseph Freedman Co., Inc. facility, the facility that surrounded the Facility.

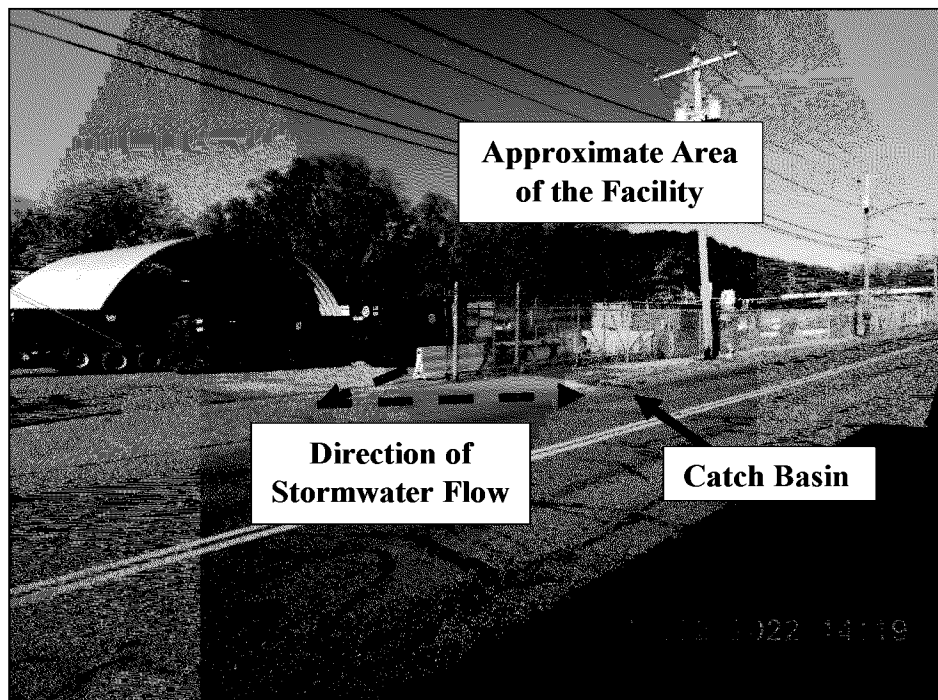
**Photograph 3.** View, facing northwest, of the northwest area of the Joseph Freedman Co., Inc. The EPA Inspection Team observed that stormwater from the Facility had the potential to flow down the Joseph Freedman Co., Inc. facility entrance/exit to a catch basin on Albany Street.

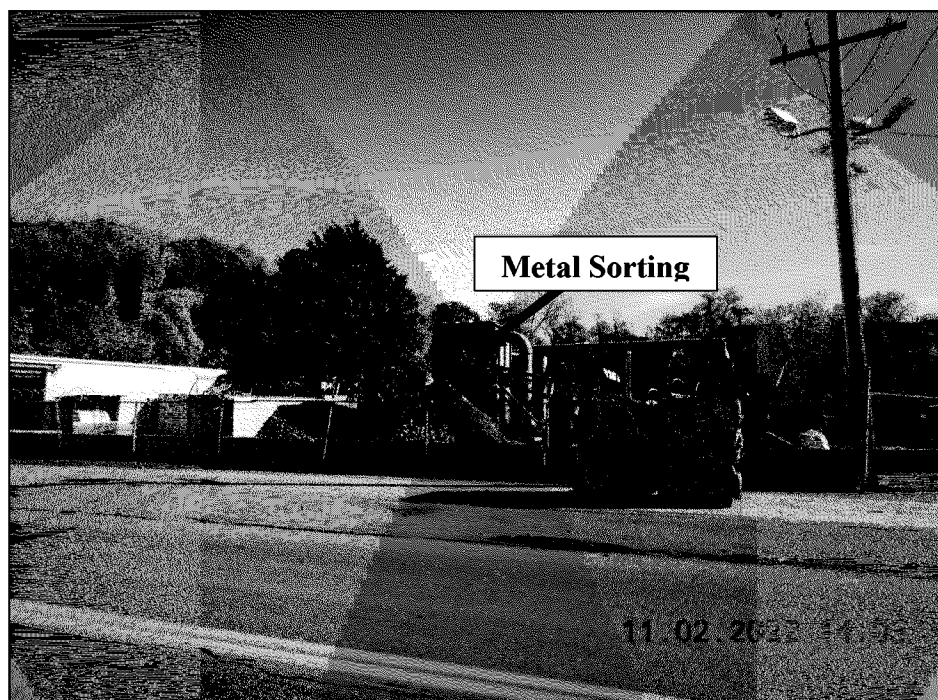
**Photograph 4.** View, facing east, of southeast area of the Joseph Freedman Co., Inc. facility. Joseph Freedman Co., Inc. was sorting scrap metal in this area.

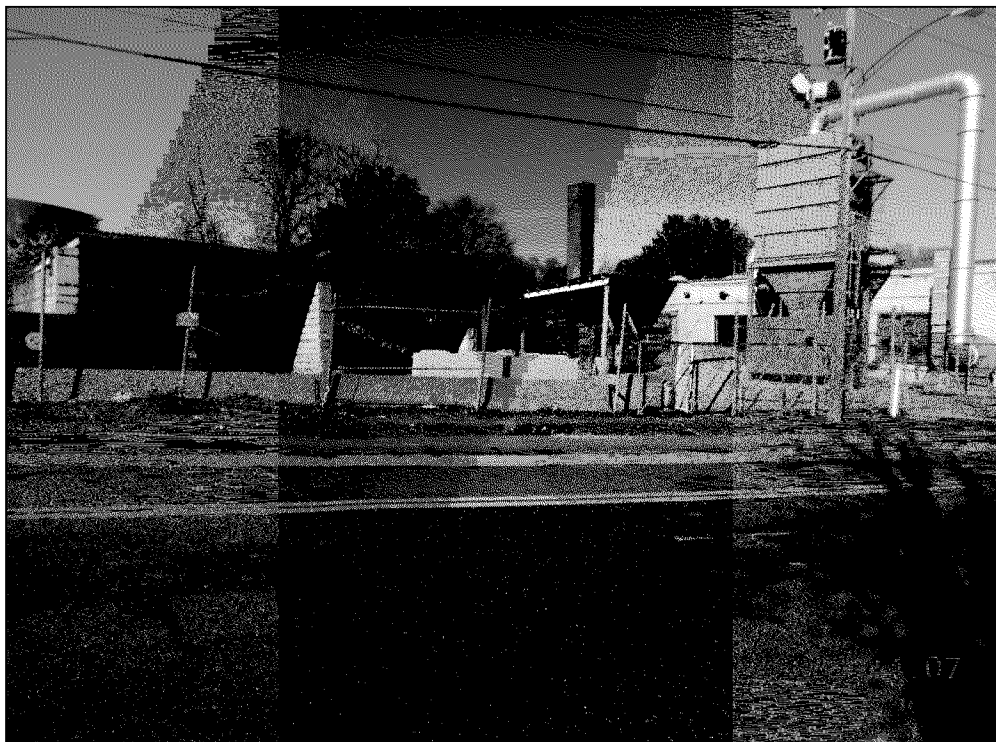
**Photograph 5.** View, facing northwest, of the southwest area of the Joseph Freedman Co., Inc. facility.

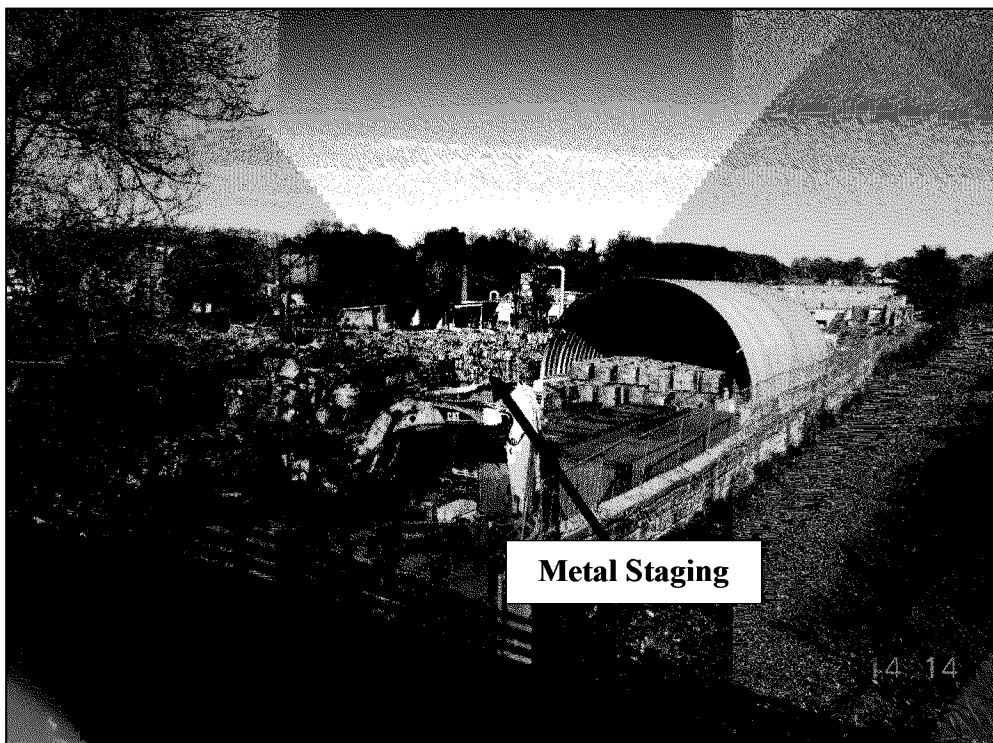
**Photograph 6.** View, facing north, of the southeast area of the Joseph Freedman Co., Inc. facility. Joseph Freedman Co., Inc. was staging scrap metal in this area..

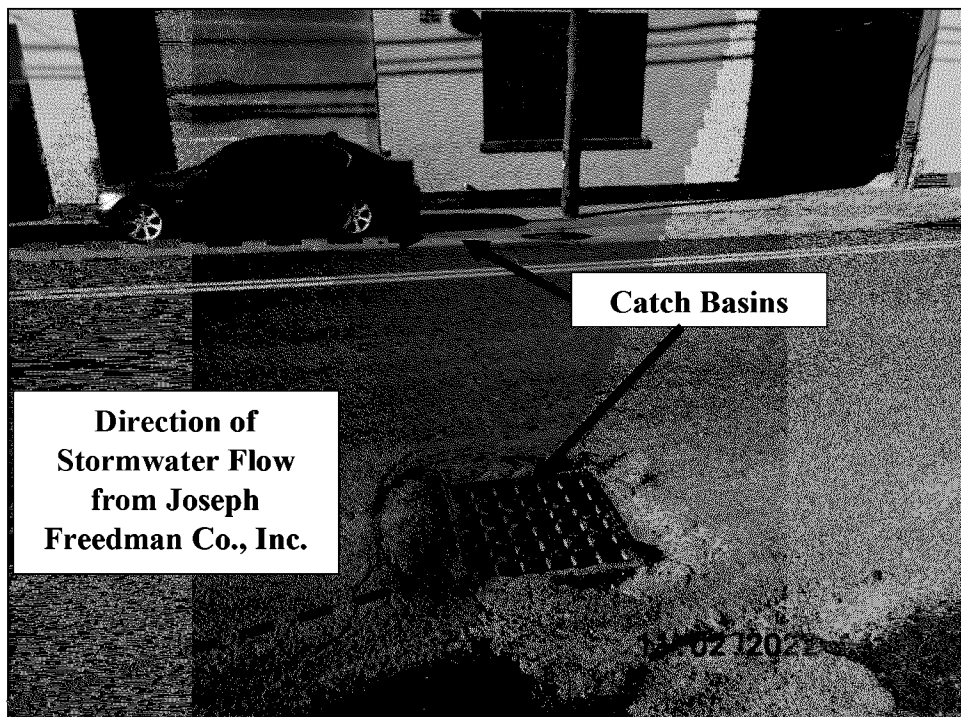
**Photograph 7.** View, facing west, of two catch basins on Albany Street. Stormwater from the south area of the Joseph Freedman Co., Inc. facility may flow to the catch basins.

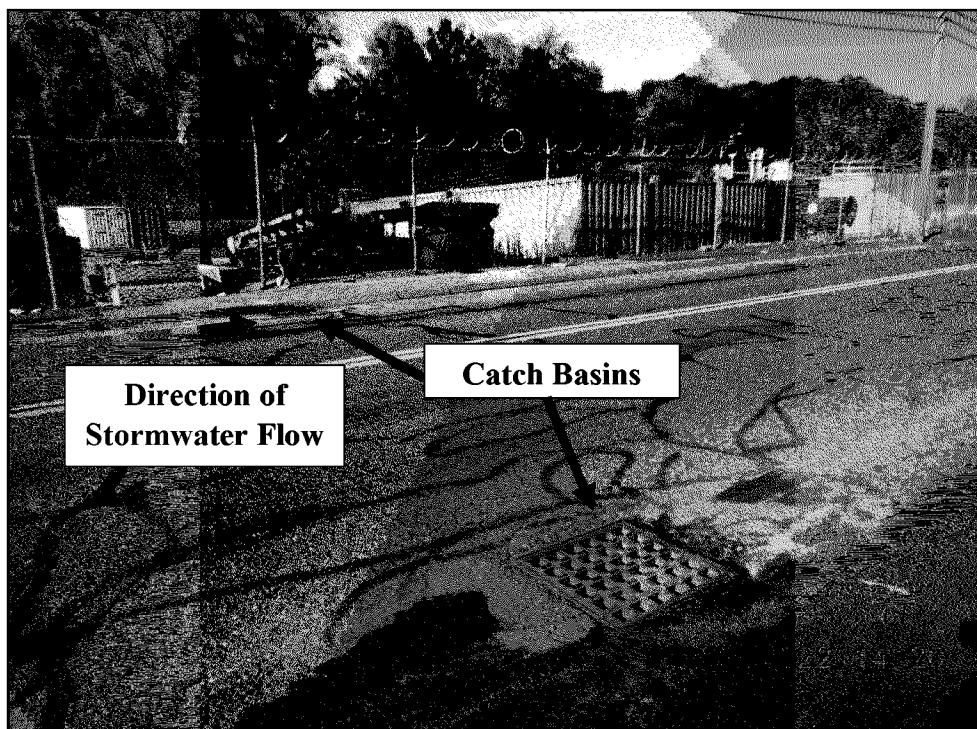
**Photograph 8.** View, facing northwest, of two catch basins located north of the catch basins shown in Photographs 3 and 7. Stormwater from the northwest area of the Joseph Freedman Co., Inc. facility may flow to the farther northwest catch basin.

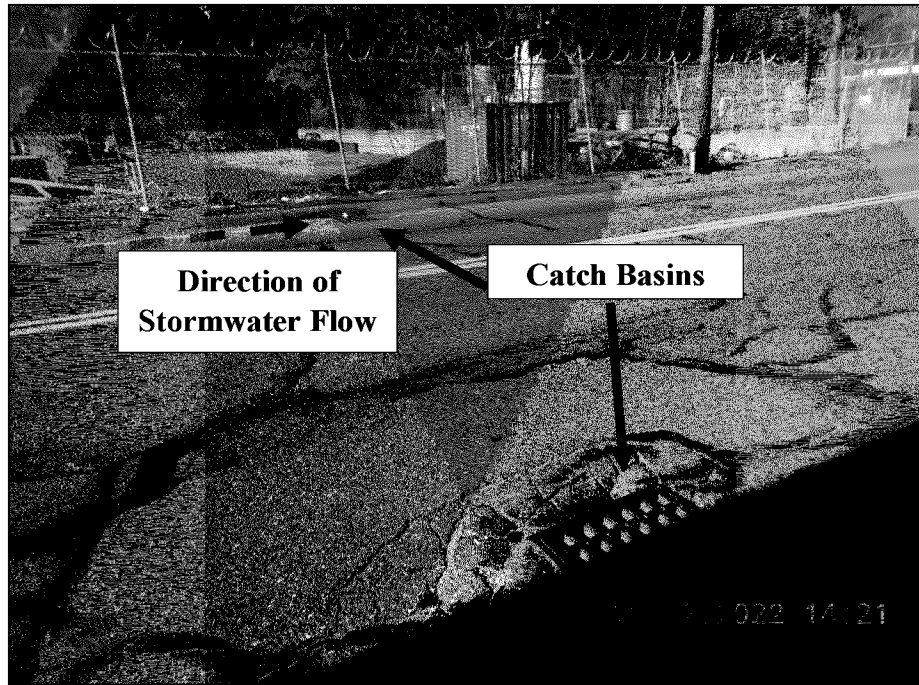
**Photograph 9.** View, facing northwest, of catch basins north of the catch basins shown in Photographs 3, 7, and 8. Stormwater from the northwest area of the Joseph Freedman Co., Inc. facility may flow to the farther northwest catch basin.
