**Region 6 - Enforcement & Compliance Assurance Division**  
**INSPECTION REPORT**

| Inspection Date(s): | 07/10/2024 | |
| Facility Name: | Cutter Treatment Plant Lateral (CTPL) | |
| Identification/Permit Number: | NM0031194 | |

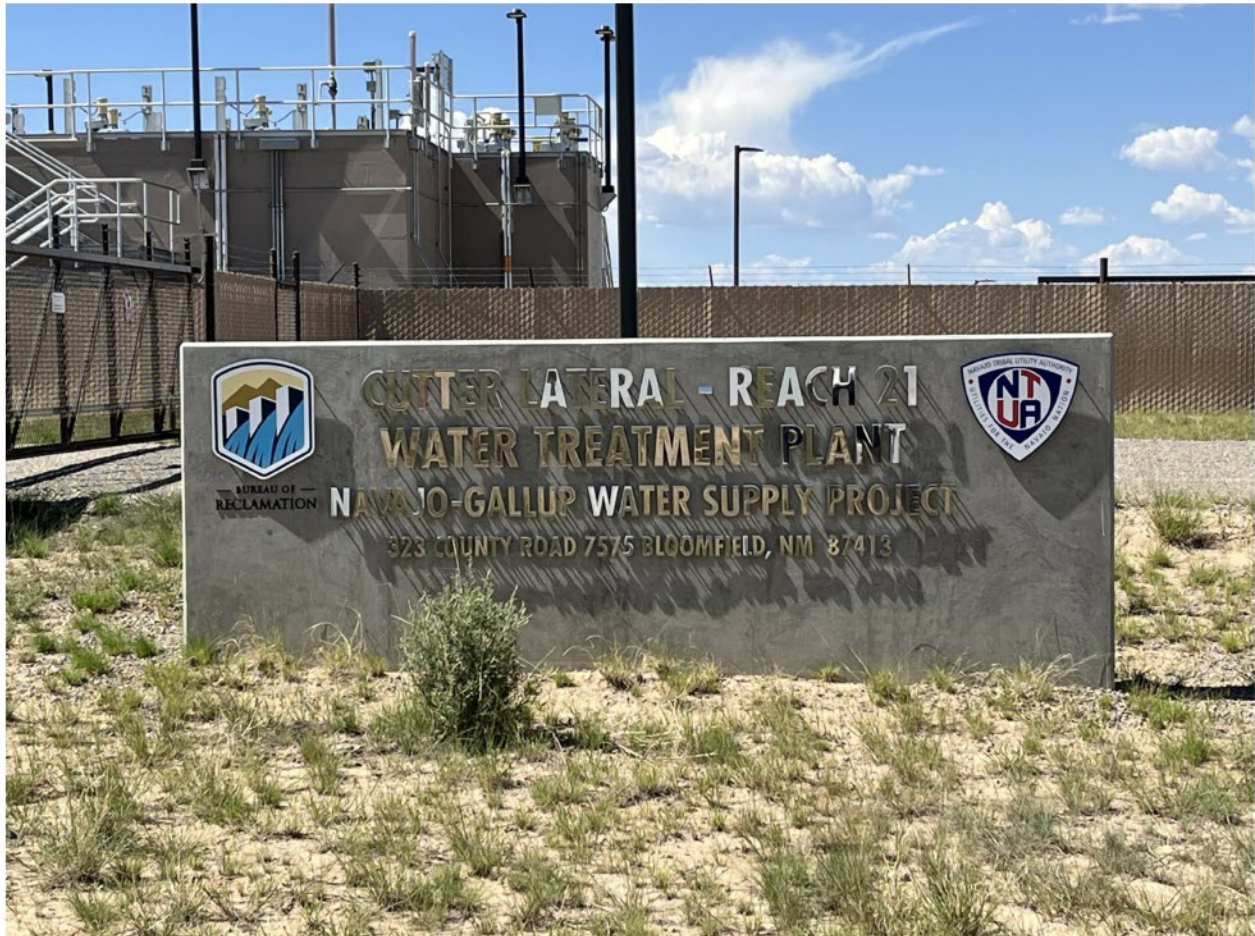
Photo No. 1

Entrance sign to Cutter Lateral Water Treatment Plant. (IMG\_0058) (July 10, 2024: 3:40 PM) Photographed by D. Esparza

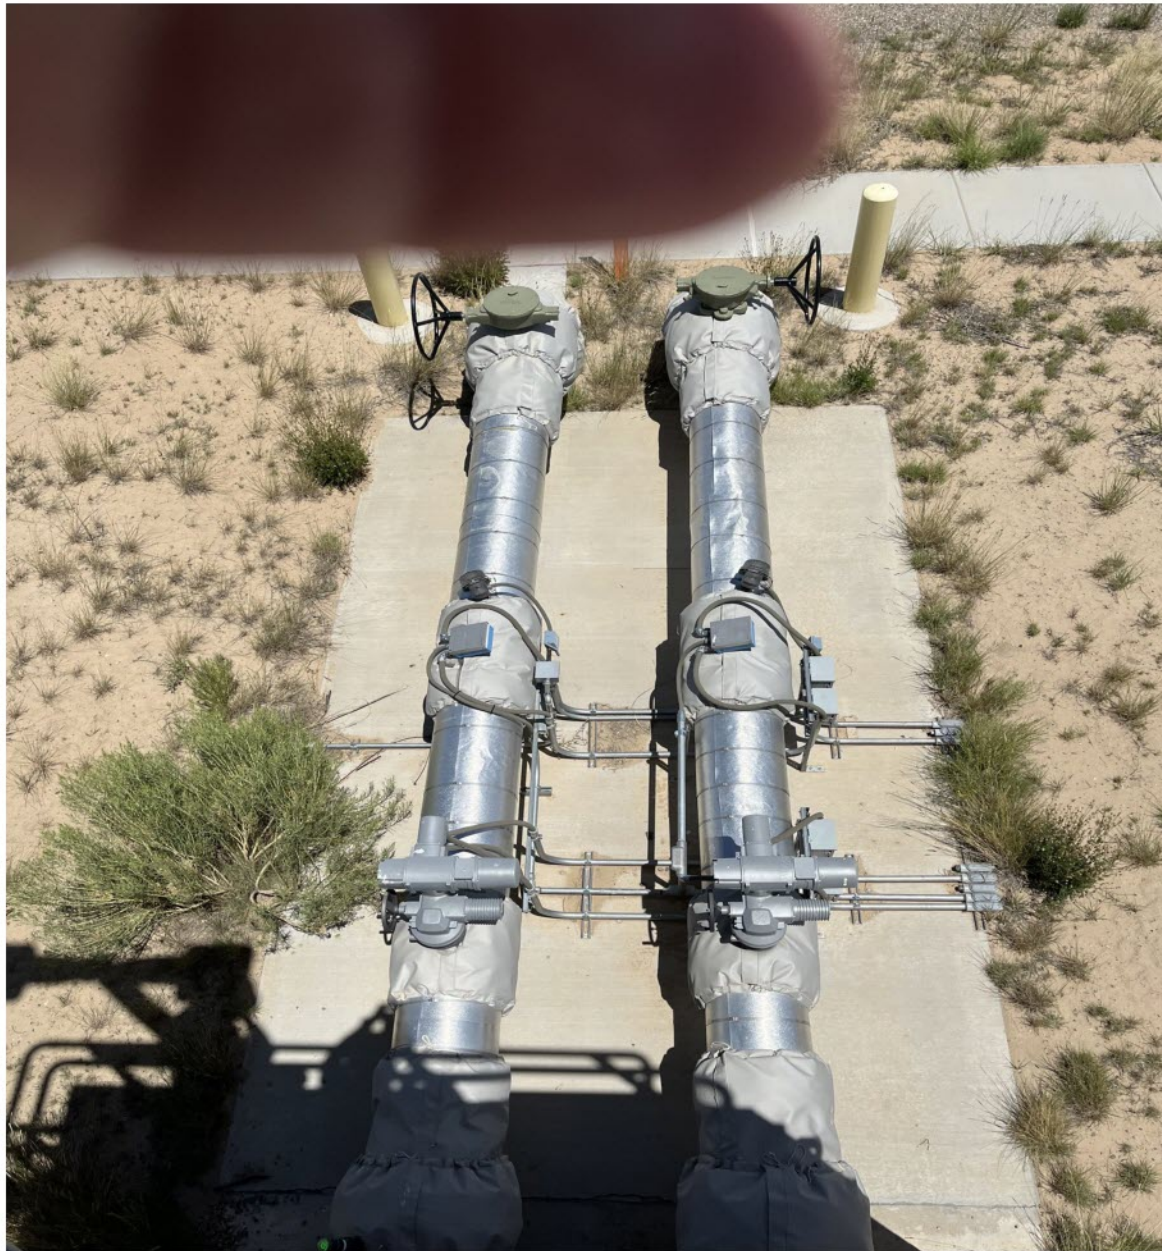
Photo No. 2

View of the raw water influent lines delivered from Pumping Plant #2 prior to the Rapid Mix process. (IMG\_0013) (July 10, 2024: 1:51 PM) Photographed by D. Esparza

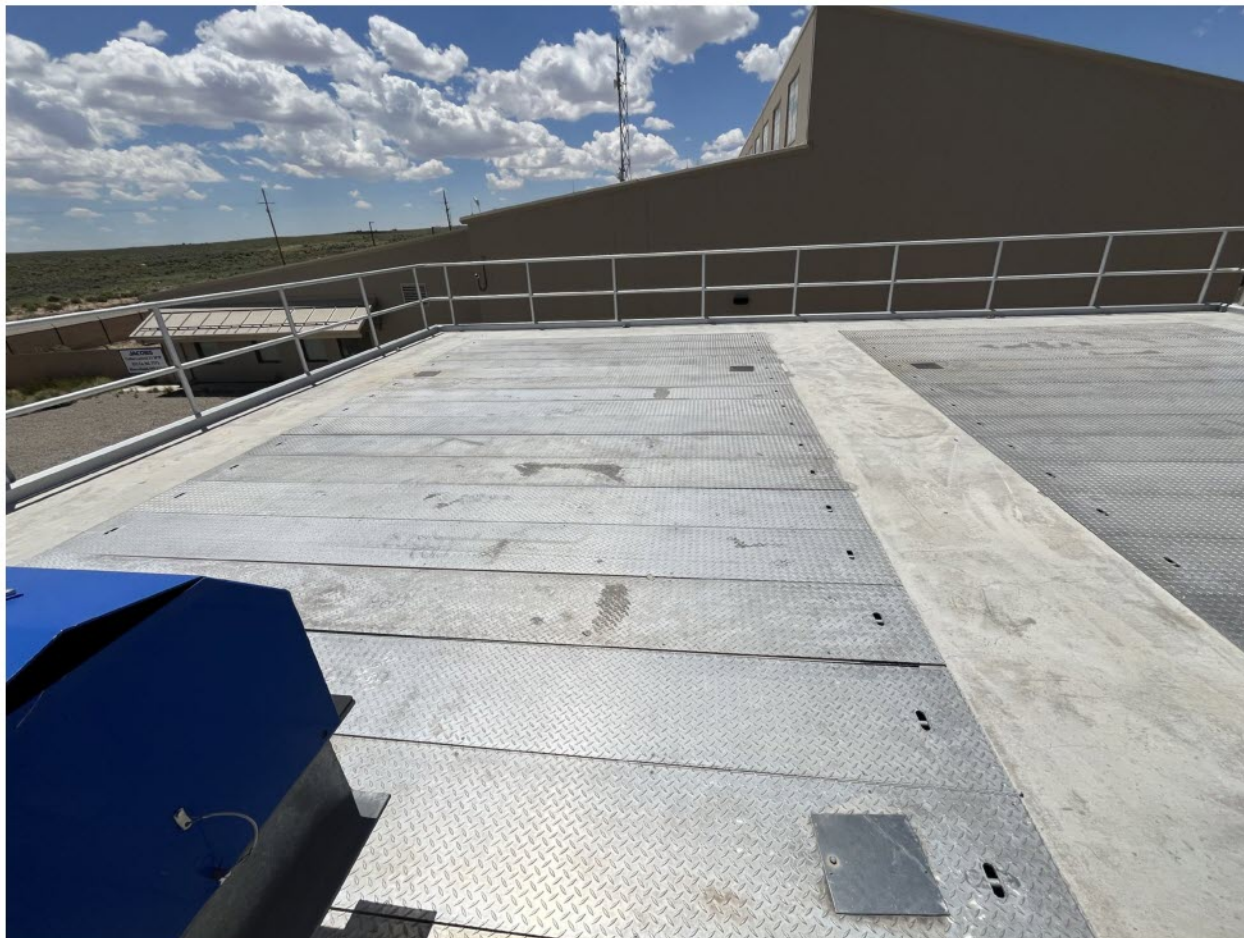
Photo No. 3

View looking approximately Southwest of the Flocculation/Sedimentation basin after the addition of the polymer. (IMG\_0018) (July 10, 2024: 1:55 PM) Photographed by D. Esparza

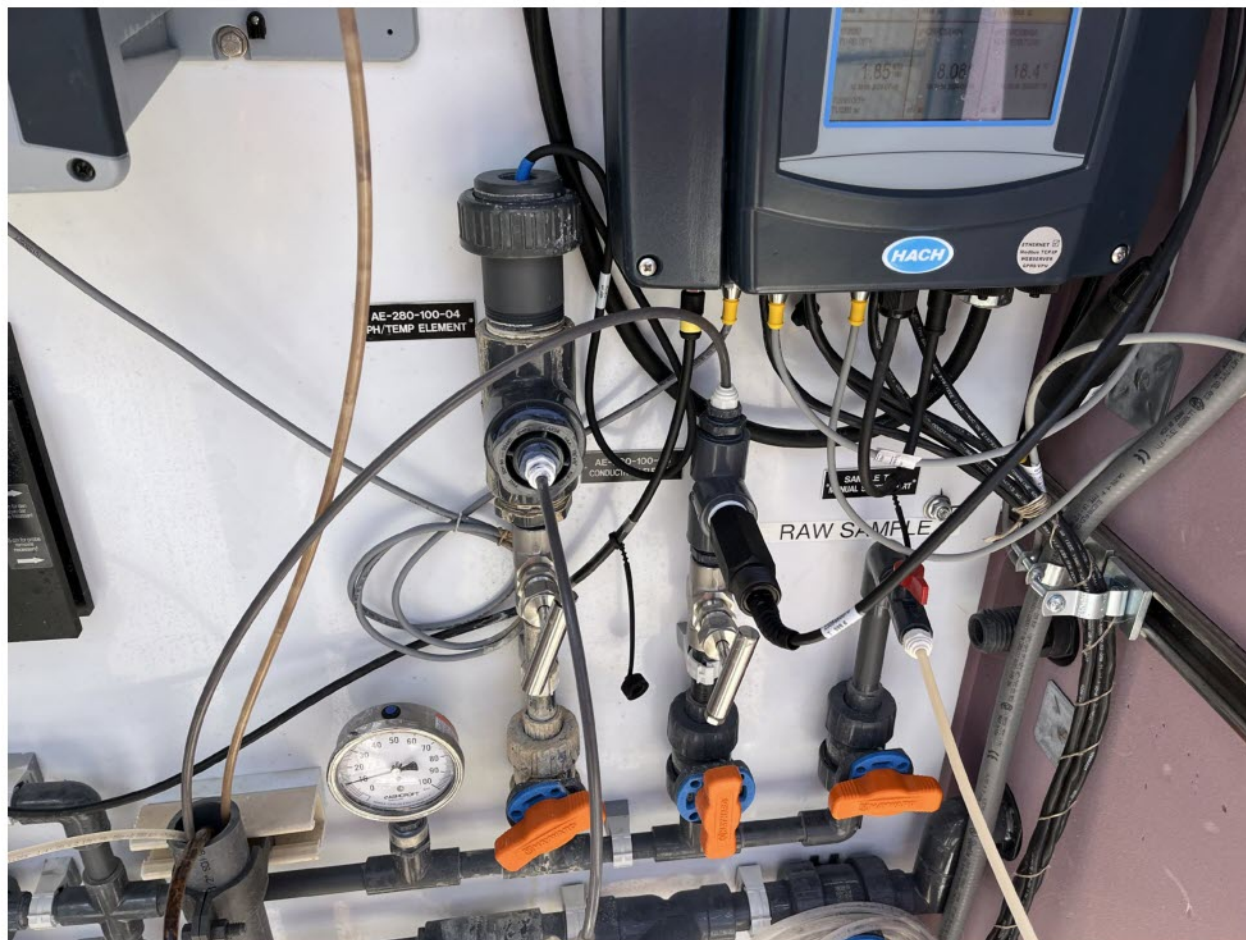
Photo No. 4

View of some of the process sampling equipment. (IMG\_0018) (July 10, 2024: 2:01 PM) Photographed by D. Esparza

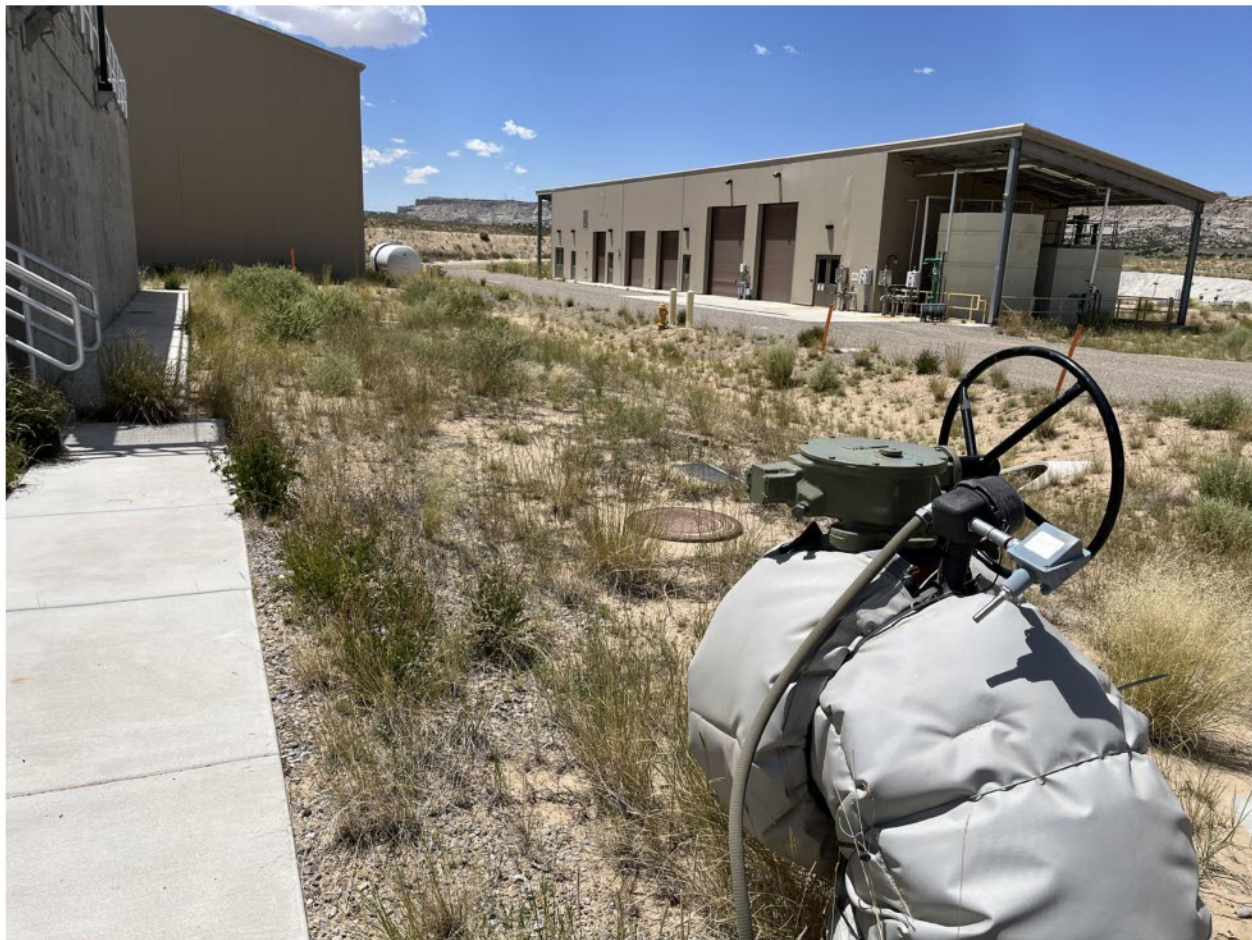
Photo No. 5

View of the location for future expansion adjacent to the existing flocculation/sedimentation basins. Looking approximately West. (IMG\_0023) (July 10, 2024: 2:04 PM) Photographed by D. Esparza

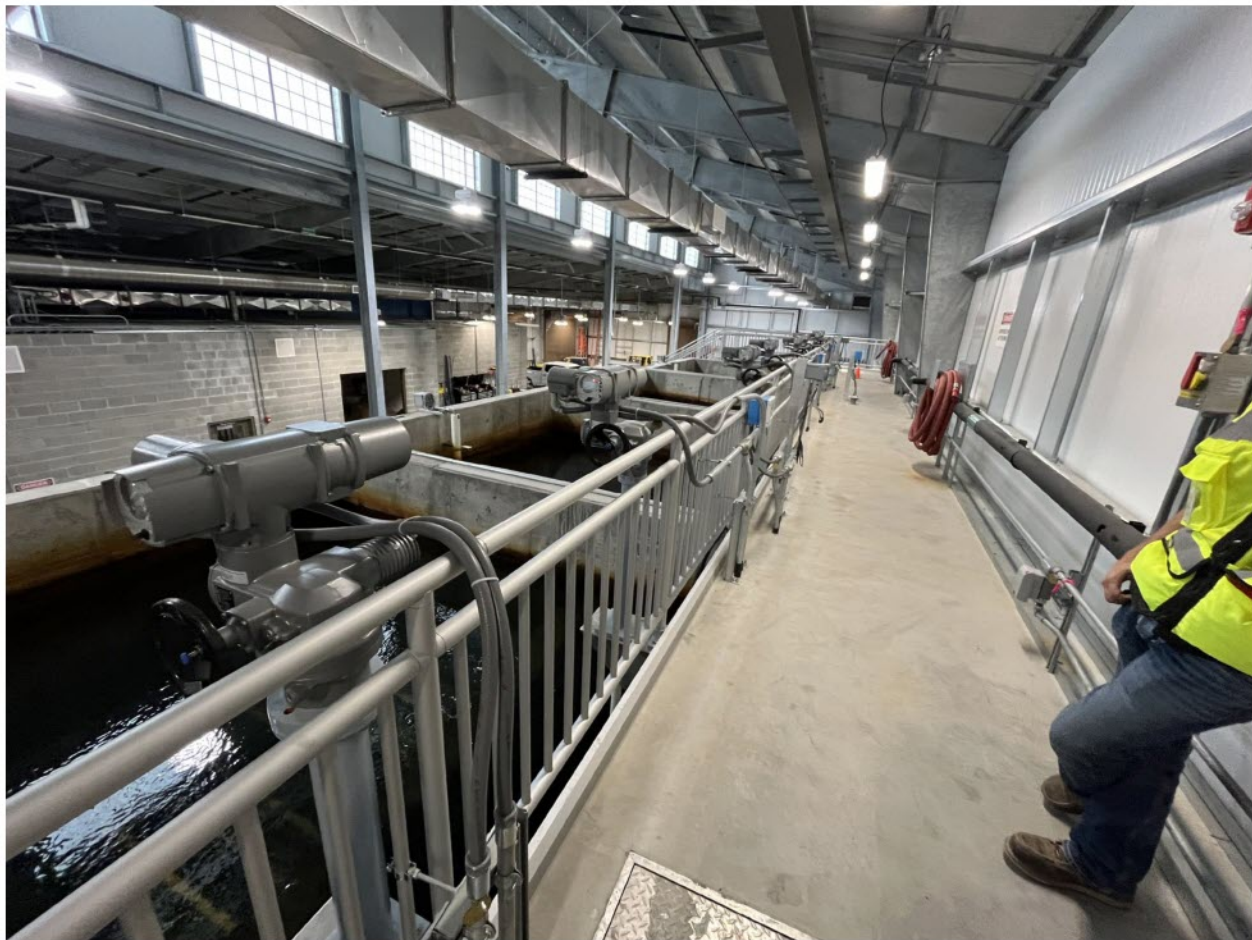
Photo No. 6

View of the filtration basin inside the CTPL facility. (IMG\_0029) (July 10, 2024: 2:09 PM) Photographed by D. Esparza

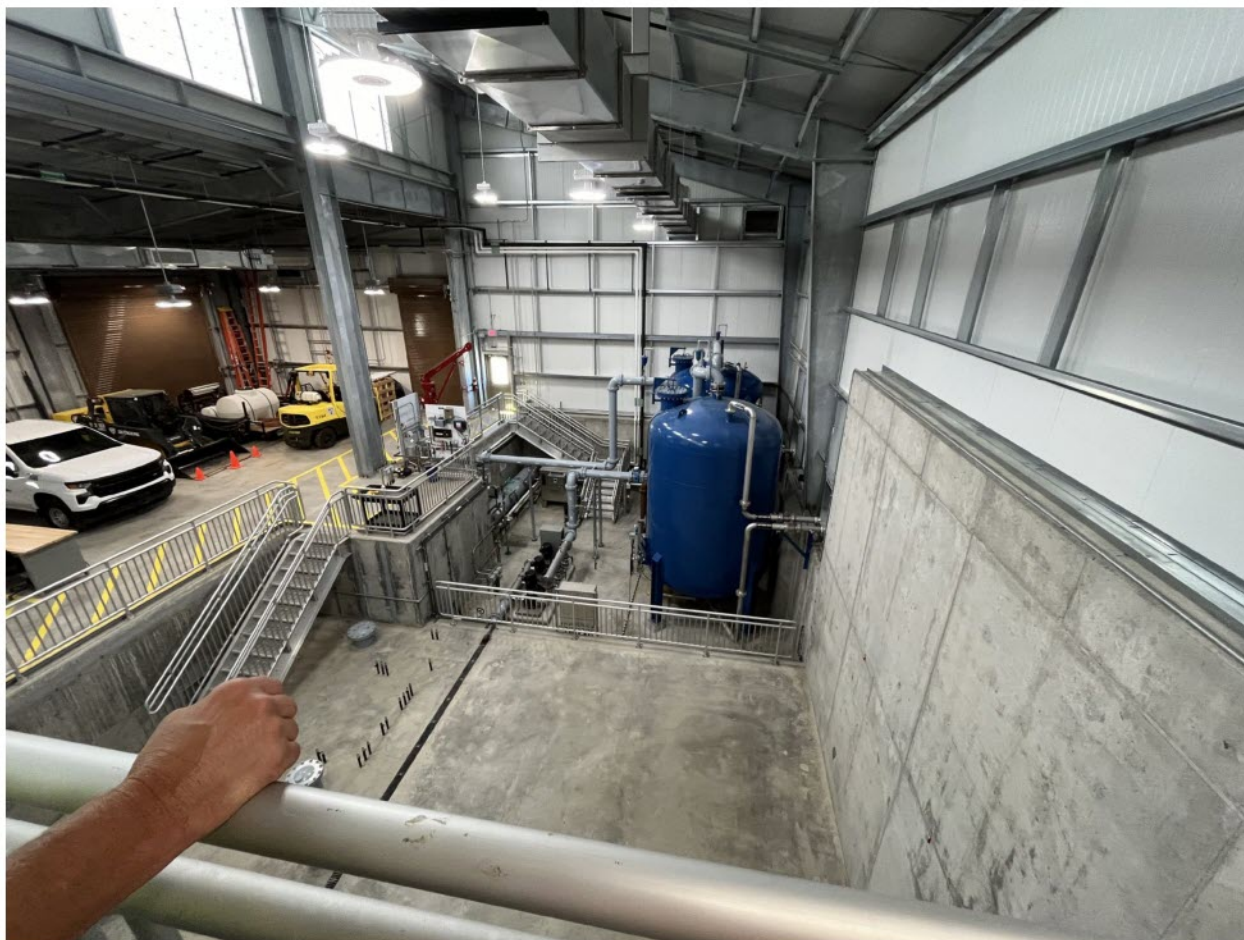
Photo No. 7

View of the granular activated carbon (GAC) filter system inside the CTPL facility. (IMG\_0030) (July 10, 2024: 2:12 PM) Photographed by D. Esparza

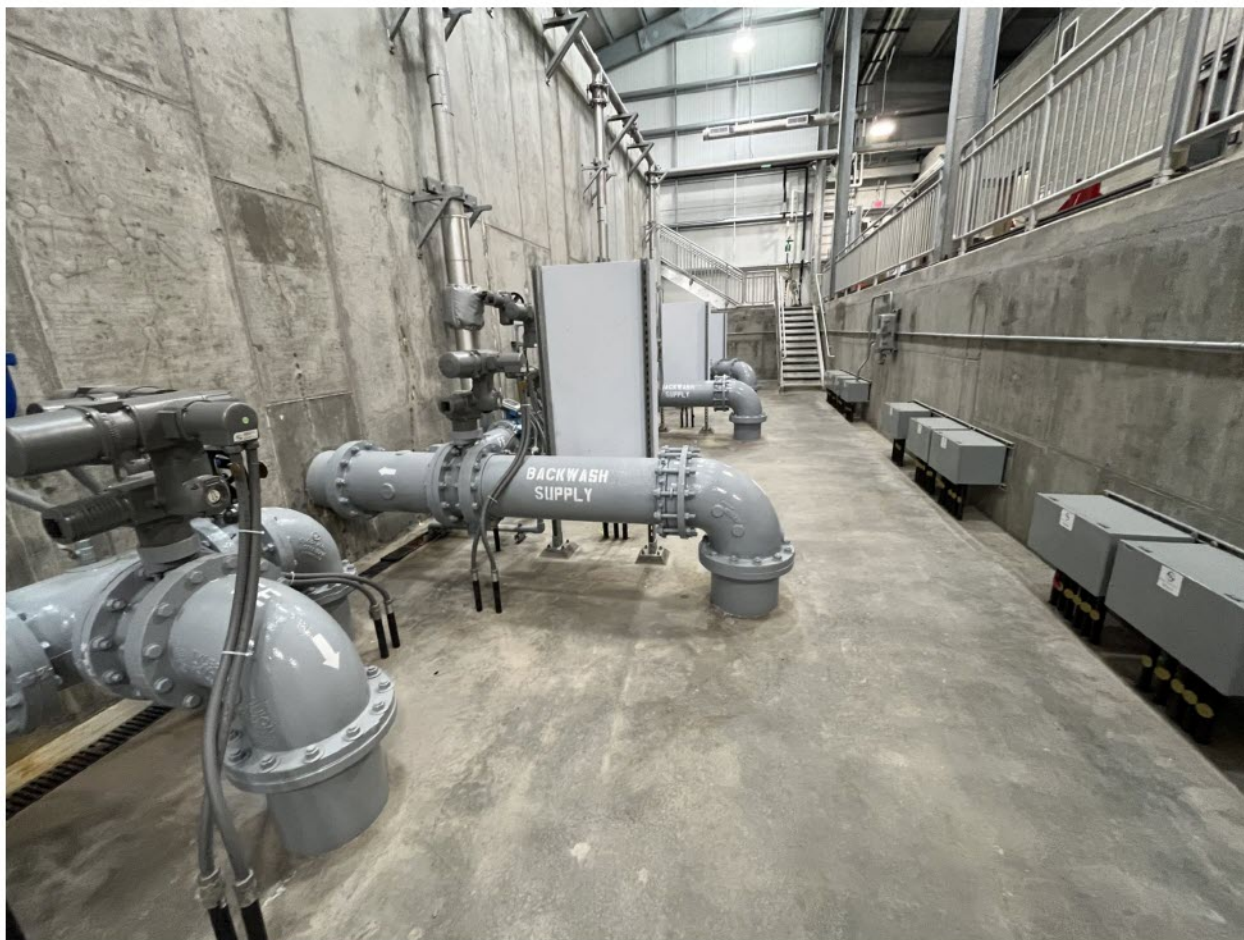
Photo No. 8

View of a portion of the process piping located inside the CTPL facility. (IMG\_0031) (July 10, 2024: 2:17 PM) Photographed by D. Esparza

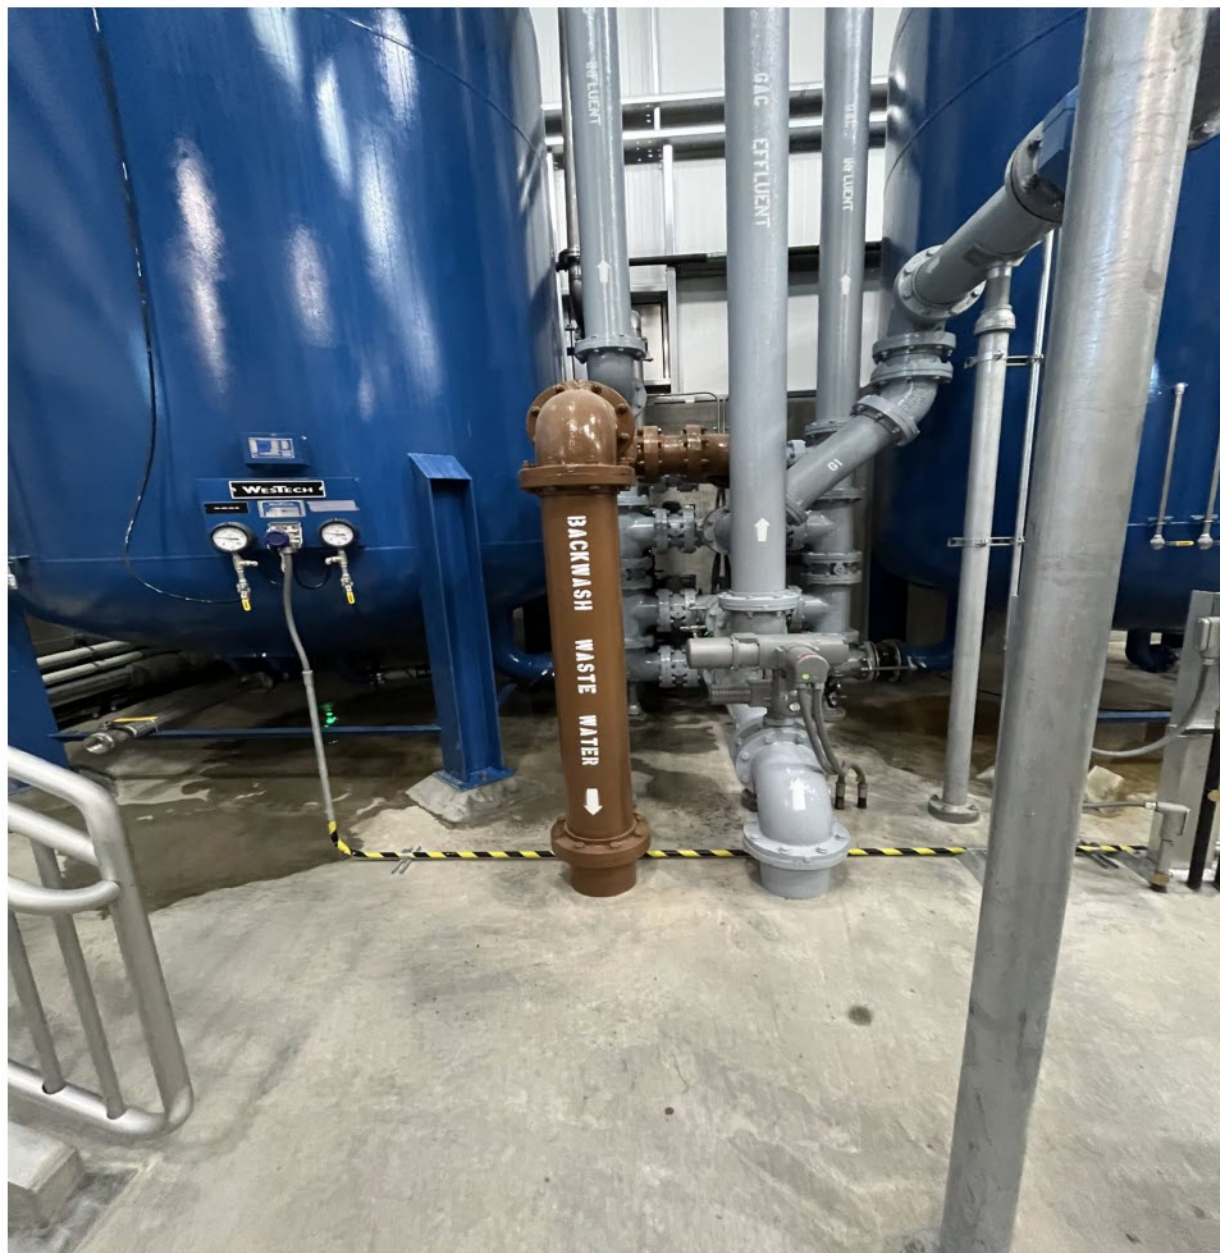
Photo No. 9

View of the backwash waste piping from the GAC tanks. (IMG\_0036) (July 10, 2024: 2:25 PM)

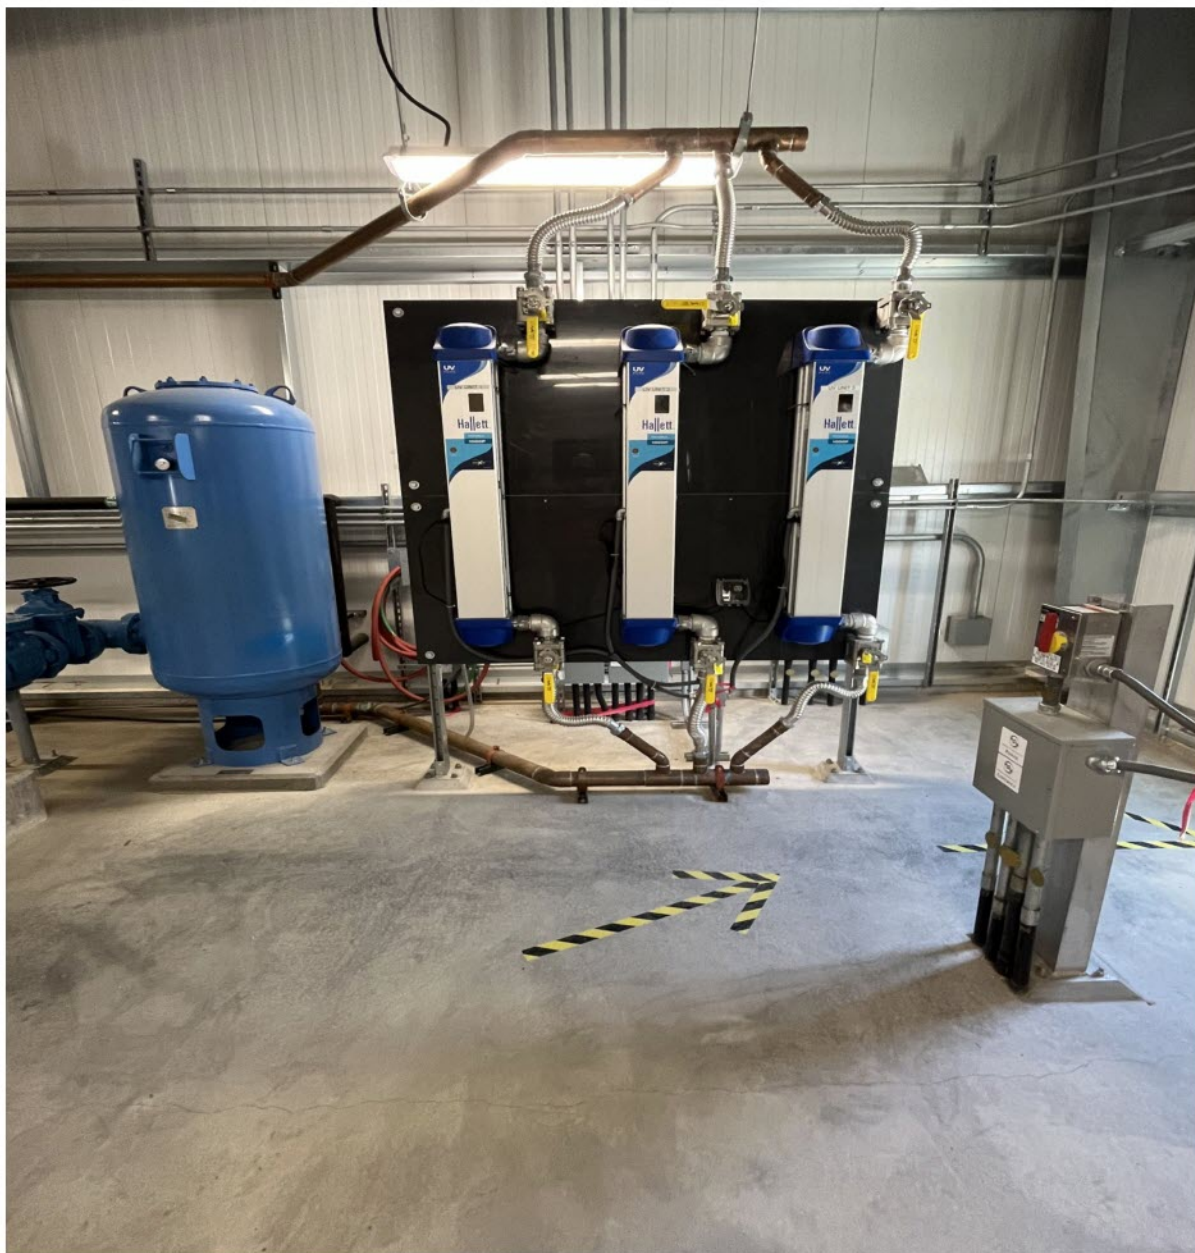
Photo No. 10

View of the Hallet ultraviolet (UV) disinfection system. (IMG\_0039) (July 10, 2024: 2:30 PM)  
Photographed by D. Esparza

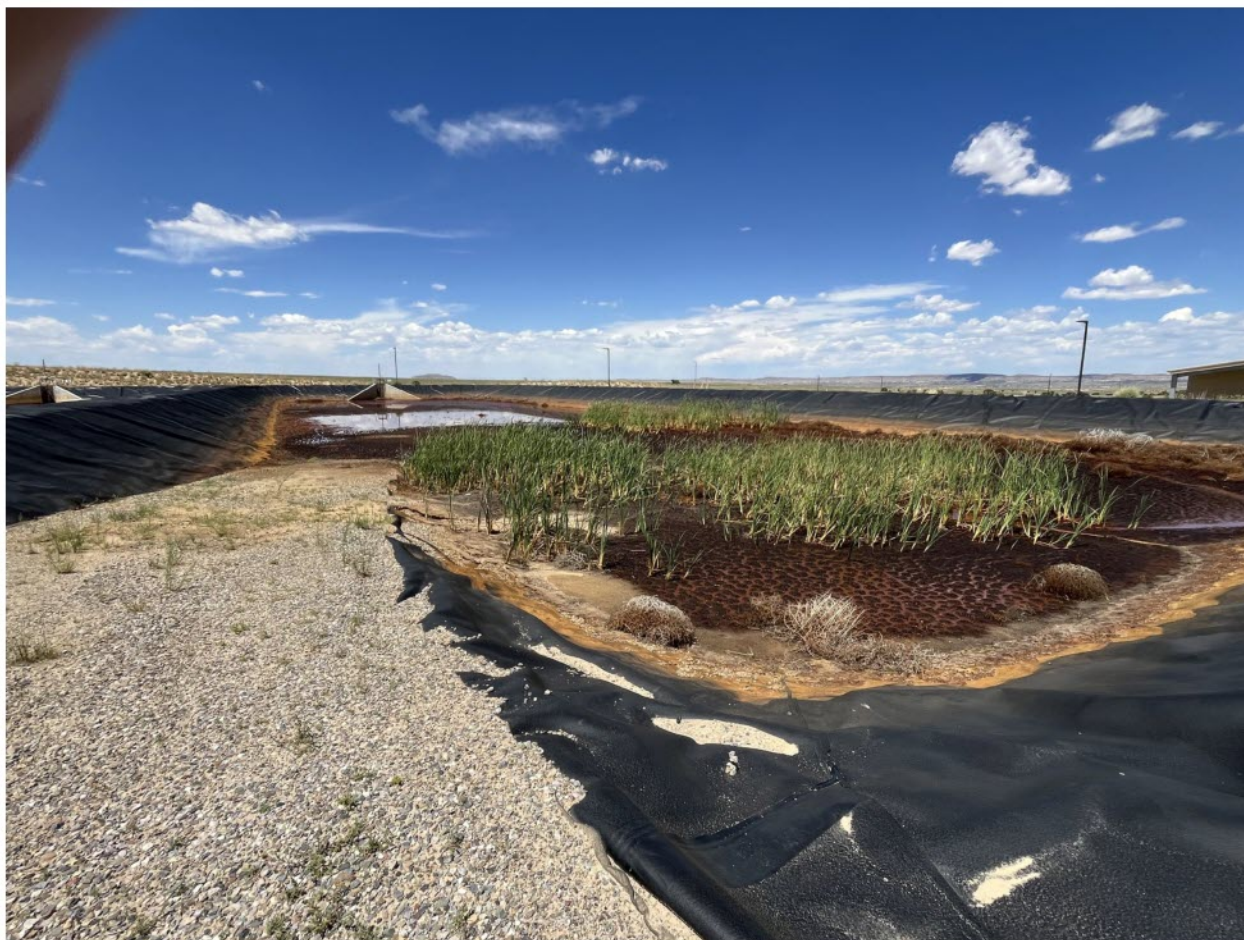
Photo No. 11

View of the solids drying beds. Note: The dried sludge material is transported and disposed at a landfill.  
(IMG\_0046) (July 10, 2024: 2:40 PM) Photographed by D. Esparza

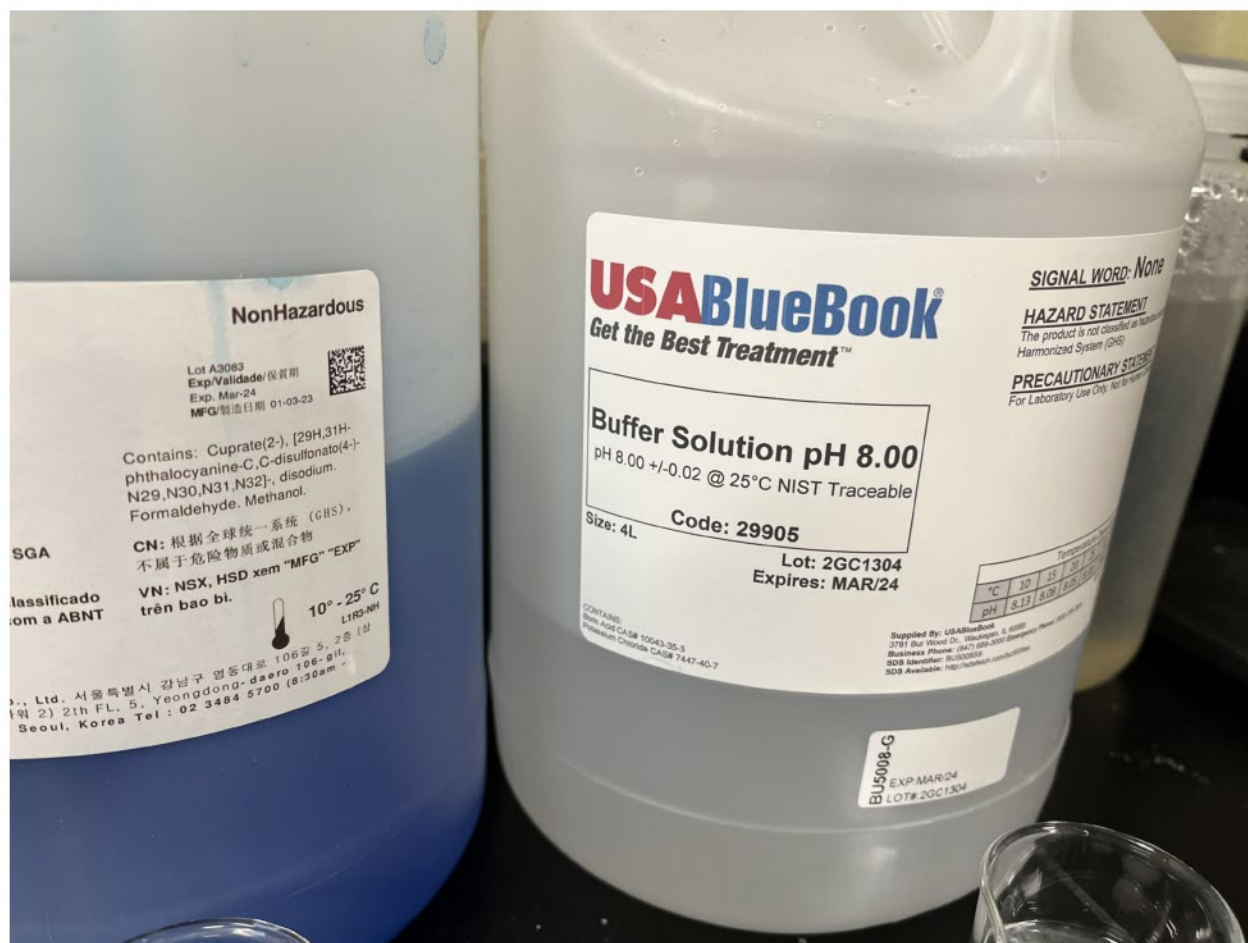
Photo No. 12

1. The on-site laboratory analytical analysis consists of alkalinity and pH. All additional samples are forwarded to Hall Laboratory (Eurofins). Note: the pH-8 and pH-10 were both expired (March 2024). Additionally, a review of the “bench sheet data” appears to indicate the recorded pH values (June 24, 2024) are outside the permitted ranges of 6.43 to 7.21 (S.U.) for the previous NPDES permit (expired in 2023), but within the ranges 6.6 to 9.0 (S.U) in the new permit (issued in January 2024) in some analysis. Note: the recorded values for the sedimentation basins effluent #1 and #2, and the flocculation/sedimentation basins (top) #1 and #2 are outside the ranges for either the old or new NPDES permit.

View of the pH10 and pH8 buffer solutions. Note: Both had expired in March 2024. (IMG\_0007) (July 10, 2024: 1:30 PM) Photographed by D. Esparza

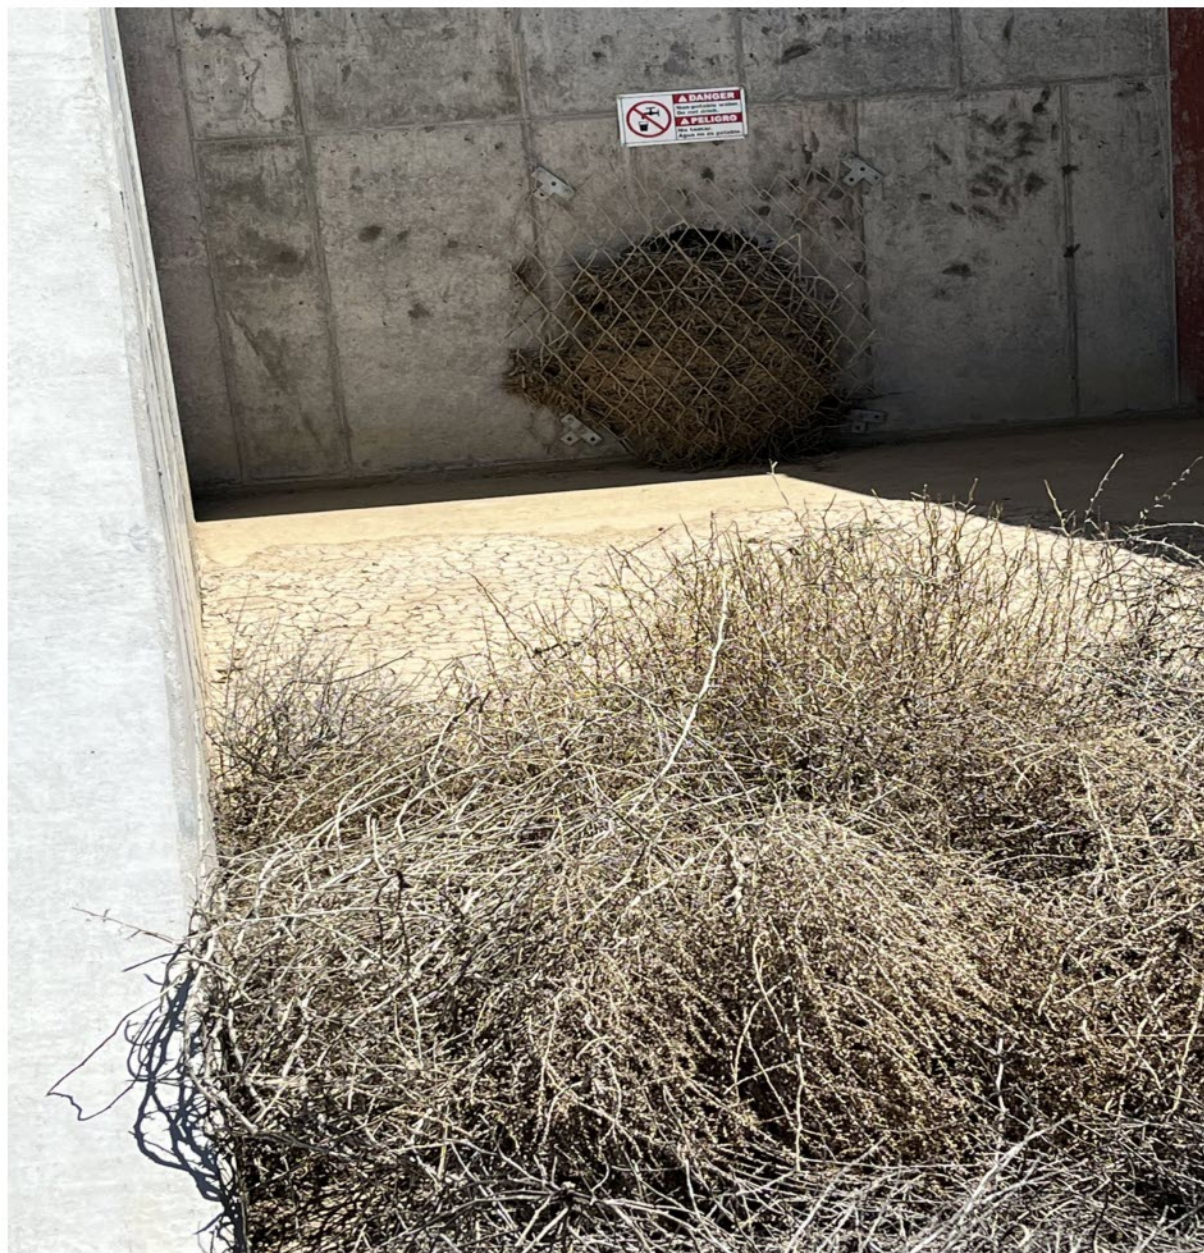
Photo No. 13

View of the CTPL discharge conduit. Note: It was recommended the vagrant debris be removed.  
(IMG\_0056) (July 10, 2024: 2:57 PM) Photographed by D. Esparza
