## Region 6 Compliance Assurance and Enforcement Division

### INSPECTION REPORT

| Inspection Date(s): | 06/08/2022 | | |
| Company Name: | <b>Southern New Mexico State Fair and Rodeo</b> | | |

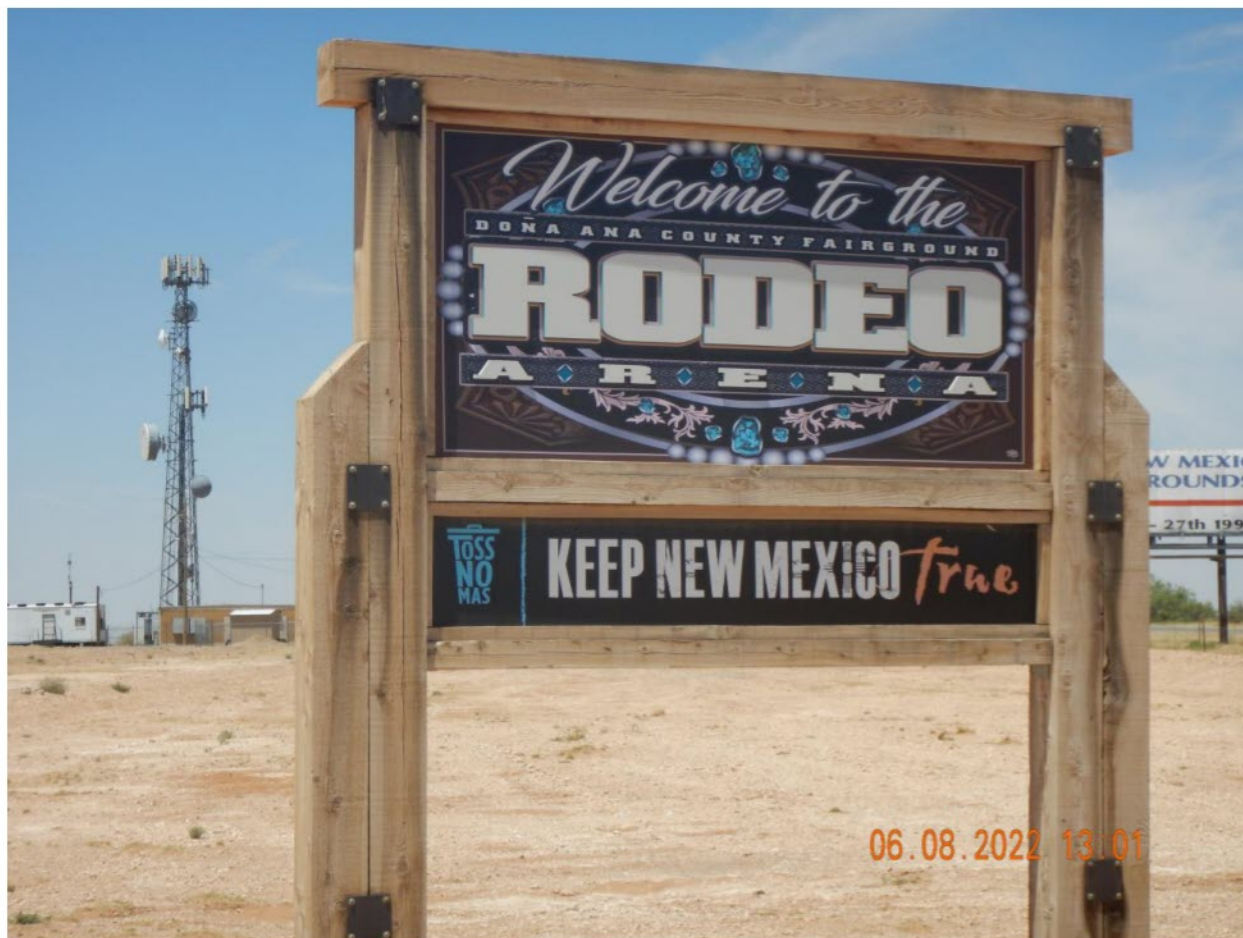
Photo No. 1

Photograph File Name: DSCN0962.JPG  
Date of Photograph: 06/08/2022  
Latitude and Longitude: 32.264582, -106.977653  
Orientation: N  
Map Datum: WGS-84  
Time of Photo: 13:01 PM  
Photographer: Jack Arias  
Description: This image shows the entrance of the facility.

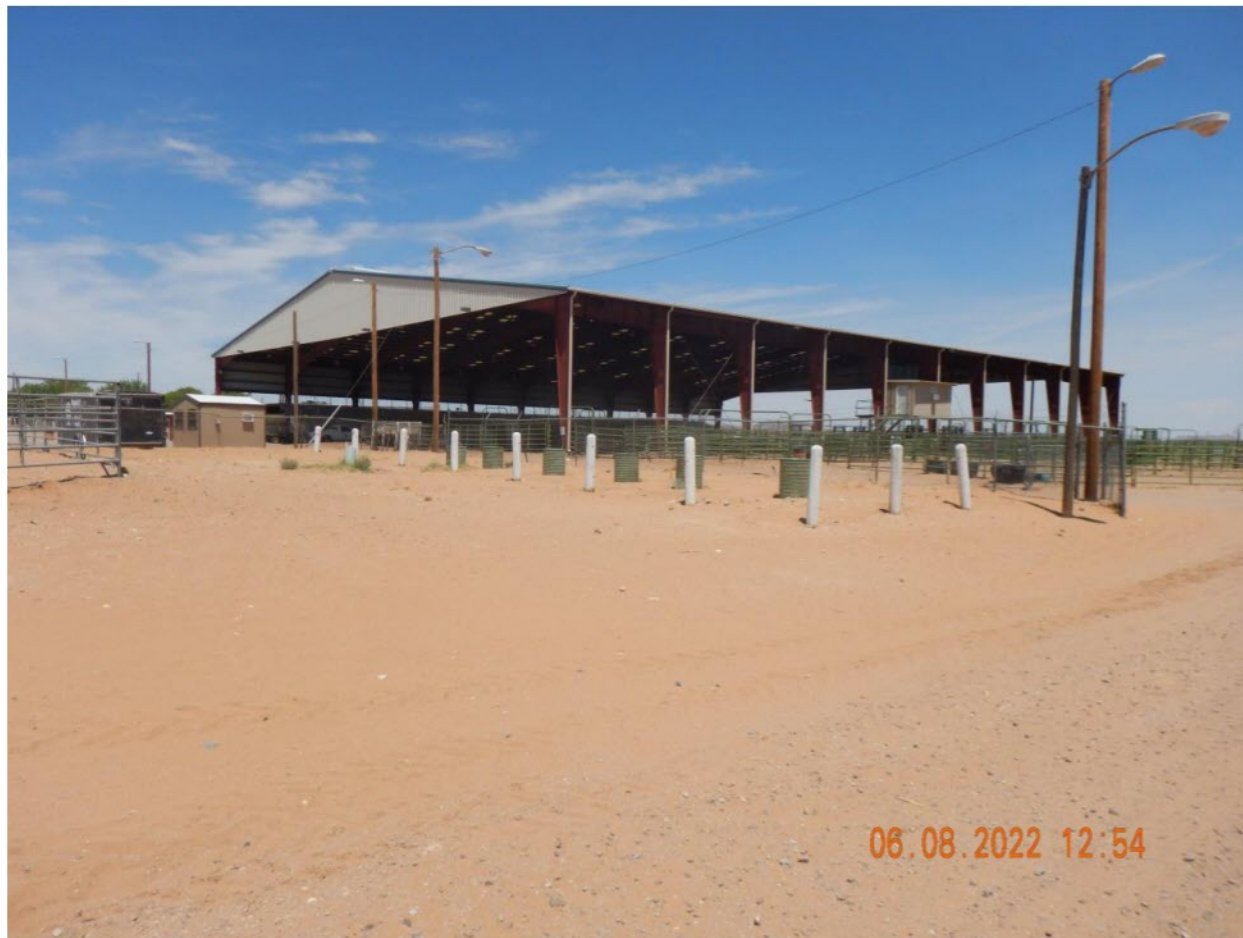
Photo No. 2

New Mexico State Fair and Rodeo consists of undefined runoff control ditch system that formed part of the RCS (See Photo Nos. 2 - 4 in Appendix 1).

Photograph File Name: DSCN0957.JPG  
Date of Photograph: 06/08/2022  
Latitude and Longitud: 32.26160464599611, -106.97527007478672  
Orientation: S  
Map Datum: WGS-84  
Time of Photo: 12:54 PM  
Photographer: Jack Arias  
Description: This image shows confined/open/covered pens surrounded by a metal fence.

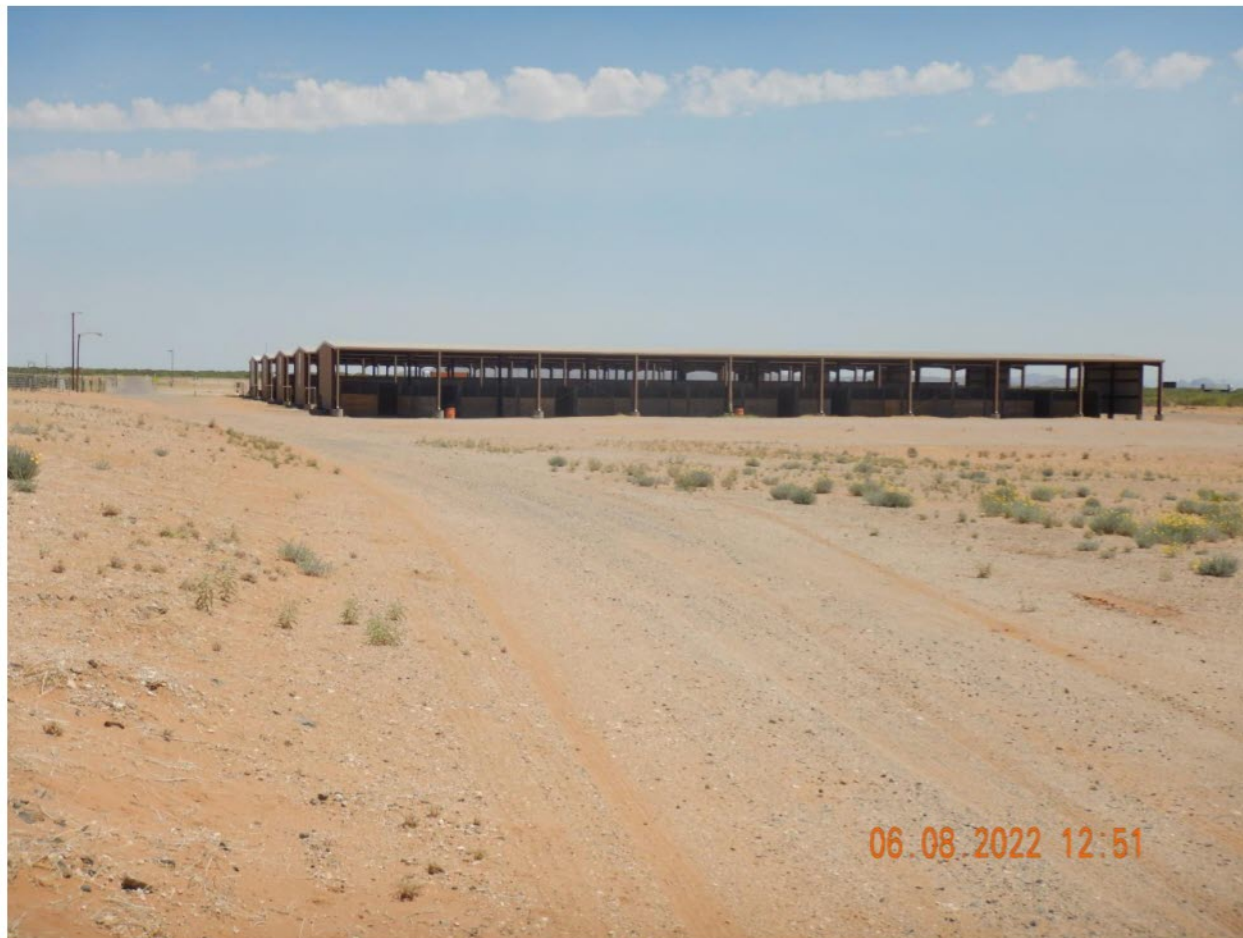
Photo No. 3

Photograph File Name: DSCN0952.JPG  
Date of Photograph: 06/08/2022  
Latitude and Longitude: 32.26011573924785, -106.97423854529792  
Orientation: N  
Map Datum: WGS-84  
Time of Photo: 12:51 PM  
Photographer: Jack Arias  
Description: This image shows the north confined and covered pens.

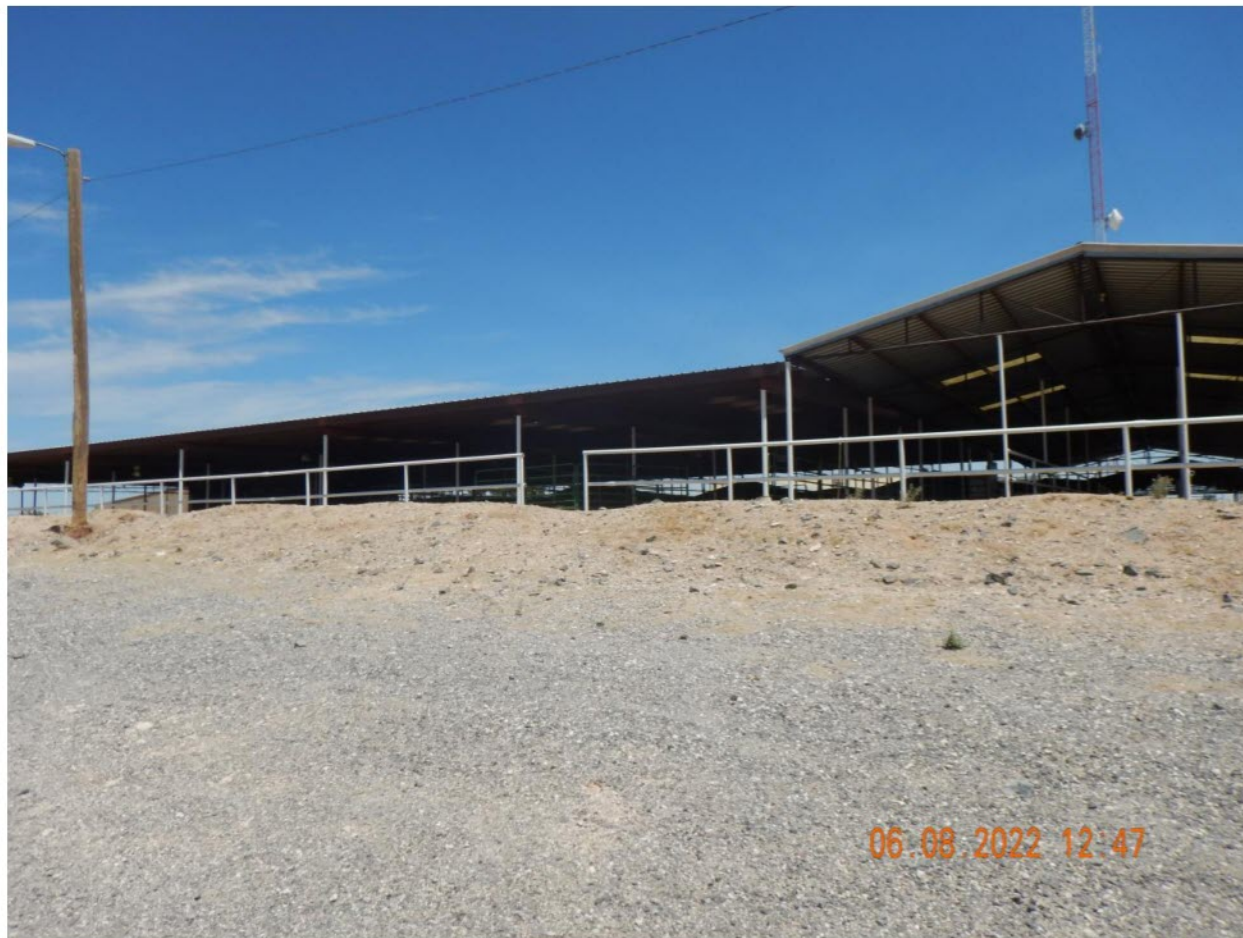
Photo No. 4

Photograph File Name: DSCN0947.JPG  
Date of Photograph: 06/08/2022  
Latitude and Longitud: 32.25877720627409, -106.97607039939011  
Orientation: S  
Map Datum: WGS-84  
Time of Photo: 12:47 AM  
Photographer: Jack Arias  
Description: This image shows the south confined and covered pens.

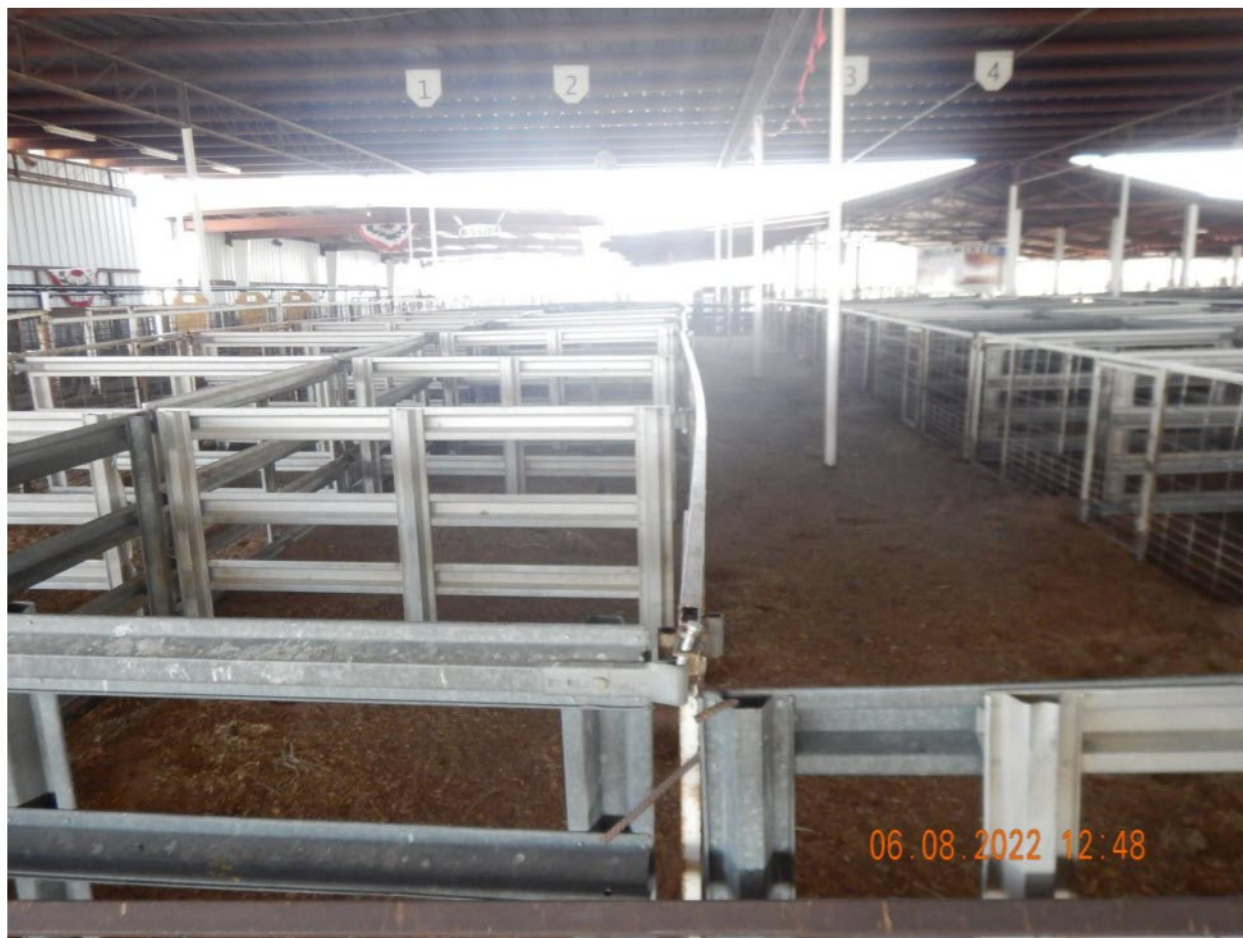
Photo No. 5

Photograph File Name: DSCN0949.JPG  
Date of Photograph: 06/08/2022  
Latitude and Longitud: 32.25877720627409, -106.97607039939011  
Orientation: S  
Map Datum: WGS-84  
Time of Photo: 12:48 PM  
Photographer: Jack Arias  
Description: This image shows the inside of the south confined and covered pens.

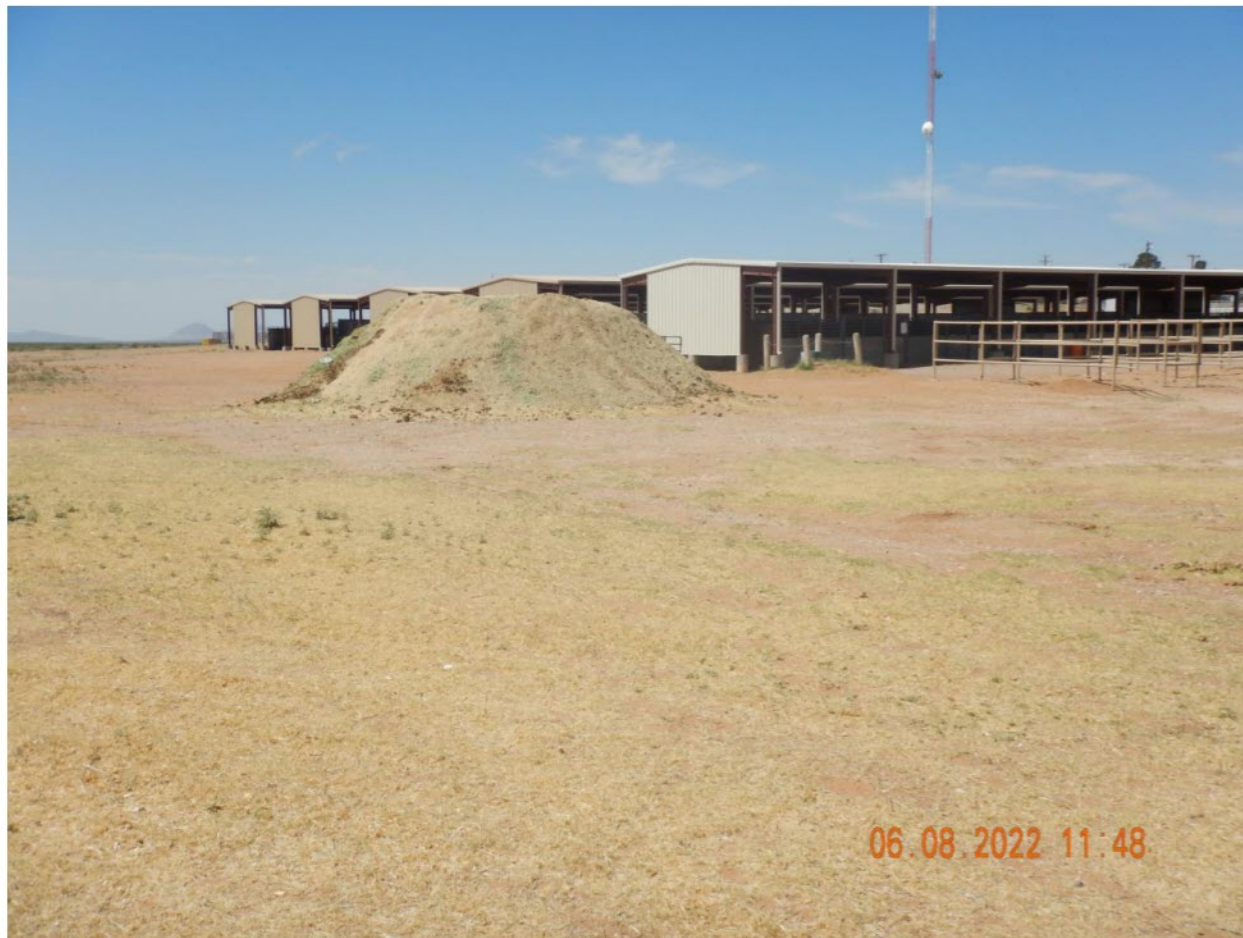
Photo No. 6

We observe small buildup of manure solids outside pens. Areas of concern should be regraded and leveled to allow proper runoff and reduce risk of wastewater and chemicals intrusion into arroyos (See Photo Nos. 6 - 9 in Appendix 1).

Photograph File Name: DSCN0932.JPG  
Date of Photograph: 06/08/2022  
Latitude and Longitud: 32.2612437011483, -106.9740073404125  
Orientation: S  
Map Datum: WGS-84  
Time of Photo: 11:48 AM  
Photographer: Jack Arias  
Description: This image shows a buildup of manure solids outside the south covered pens.

1. Small buildup of manure solids outside pens.
2. Undefined runoff control ditch system that formed part of the RCS.
3. Areas of concern should be regraded and leveled to allow proper runoff and reduce risk of wastewater intrusion into arroyos.

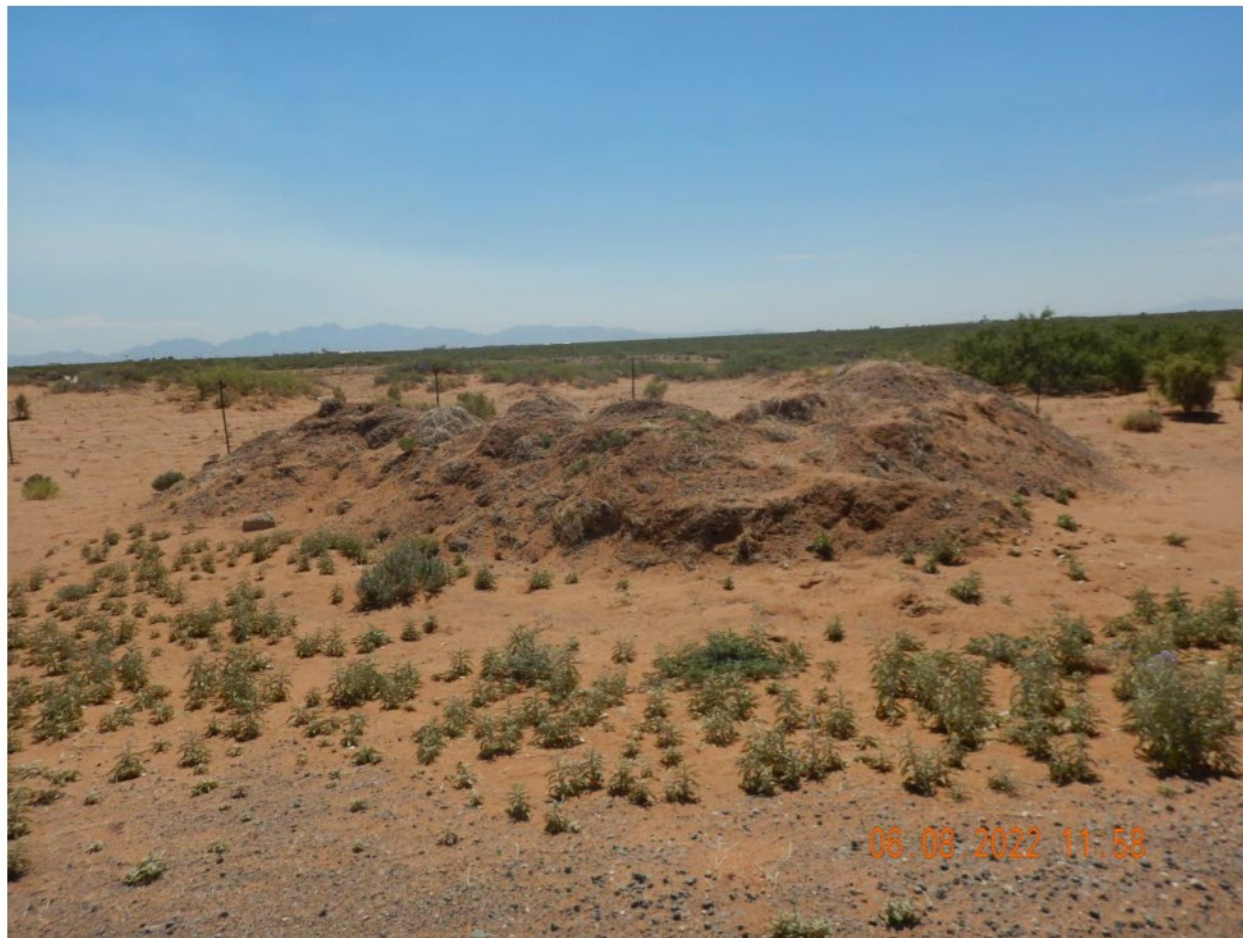
Photo No. 7

Photograph File Name: DSCN0935.JPG  
Date of Photograph: 06/08/2022  
Latitude and Longitud: 32.258717047025286, -106.97382949050062  
Orientation: SE  
Map Datum: WGS-84  
Time of Photo: 11:58 AM  
Photographer: Jack Arias  
Description: This image shows a buildup of manure solids outside the south covered pens.

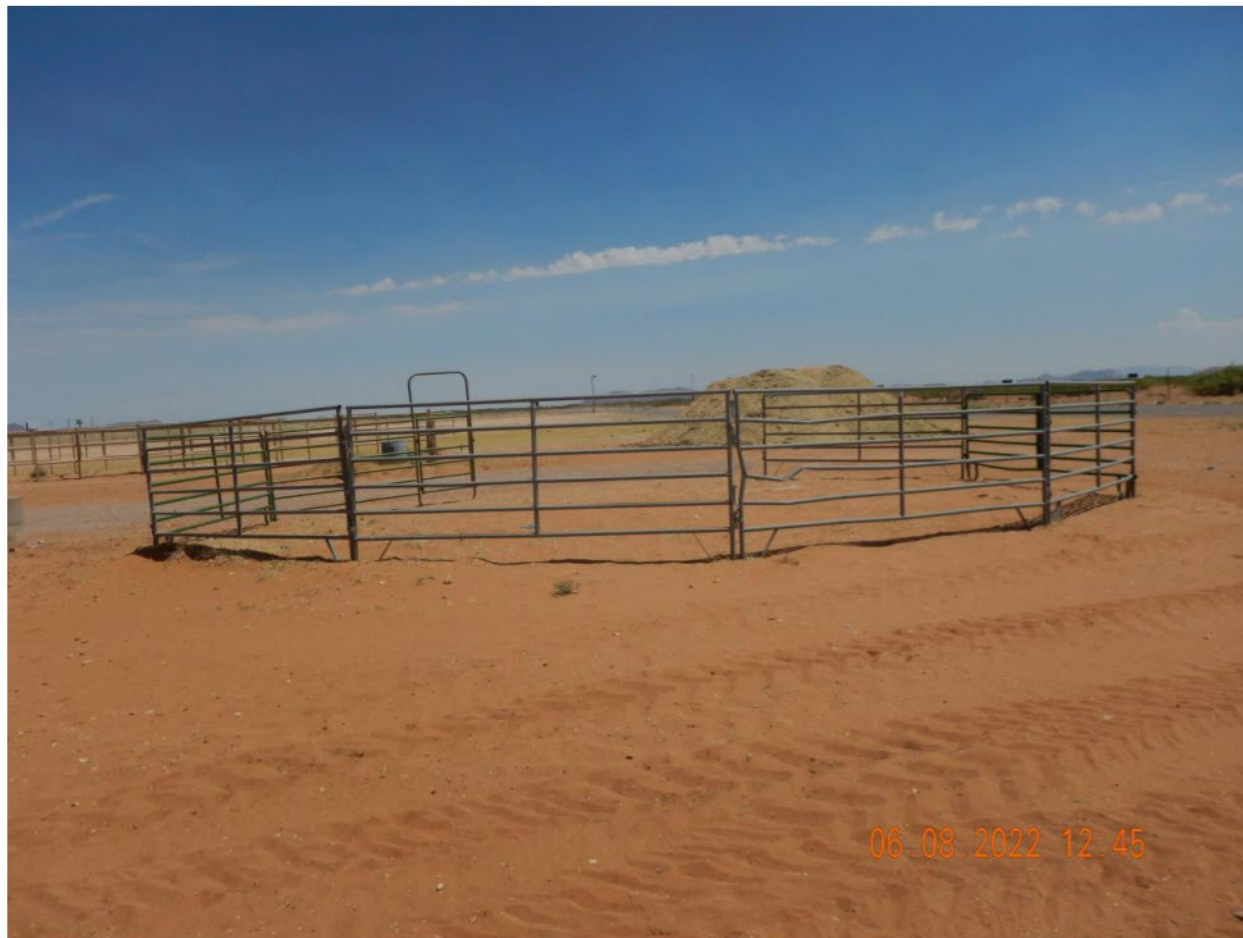
Photo No. 8

Photograph File Name: DSCN0944.JPG  
Date of Photograph: 06/08/2022  
Latitude and Longitud: 32.26192047156055, -106.97519893482198  
Orientation: N  
Map Datum: WGS-84  
Time of Photo: 12:45 PM  
Photographer: Jack Arias  
Description: This image shows a buildup of manure solids outside of the north covered pens.

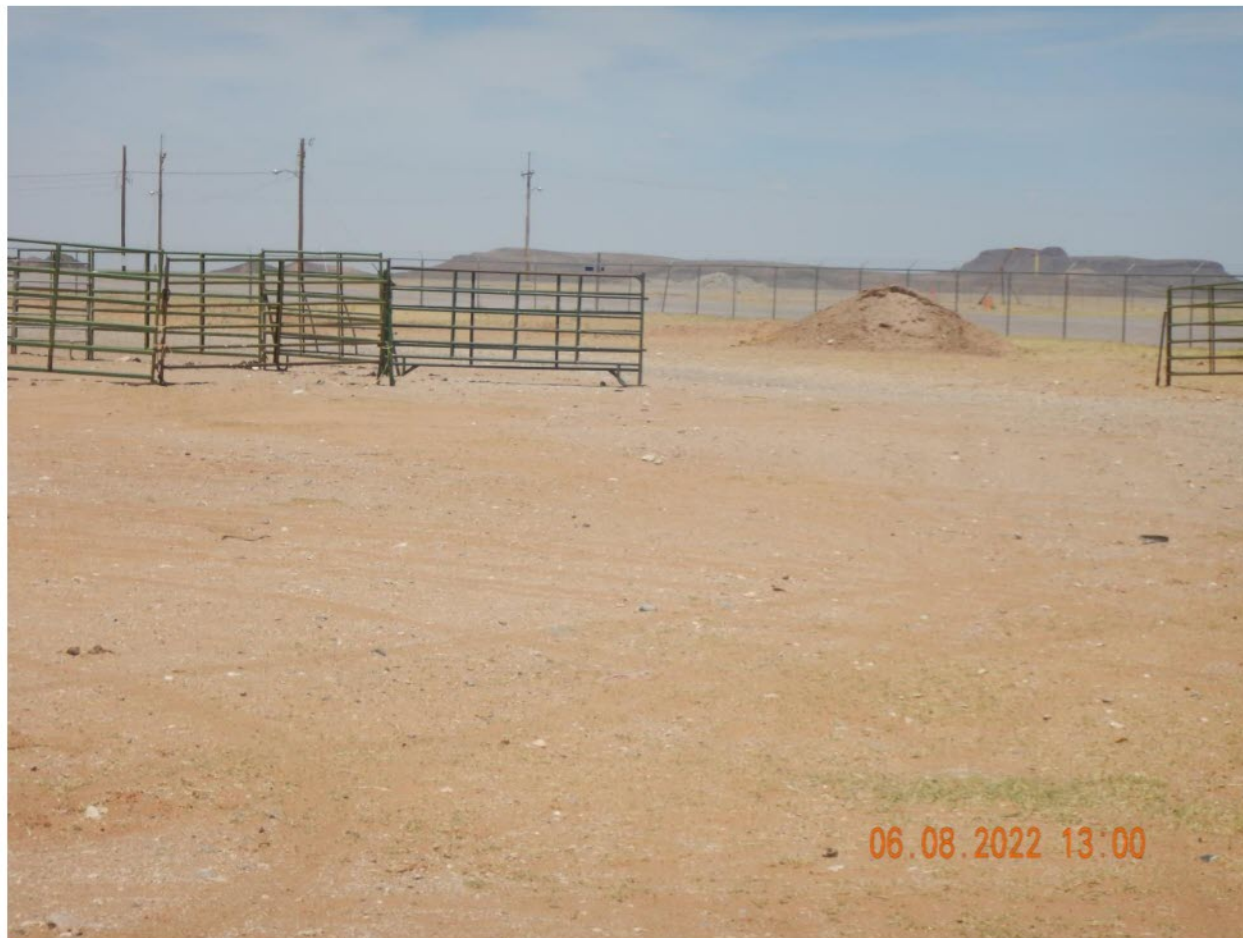
Photo No. 9

Photograph File Name: DSCN0961.JPG  
Date of Photograph: 06/08/2022  
Latitude and Longitude: 32.260521807146745, -106.97498551492775  
Orientation: NW  
Map Datum: WGS-84  
Time of Photo: 13:00 PM  
Photographer: Jack Arias  
Description: This image shows a buildup of manure solids outside of the north open pens.
