**Region 6 - Enforcement & Compliance Assurance Division**  
**INSPECTION REPORT**

| Inspection Date(s): | 01/09/2023 | |
| Company Name: | <b>Calgary Energy, LLC</b> | |
| Facility Name: | <b>Tidal Osage</b> | |

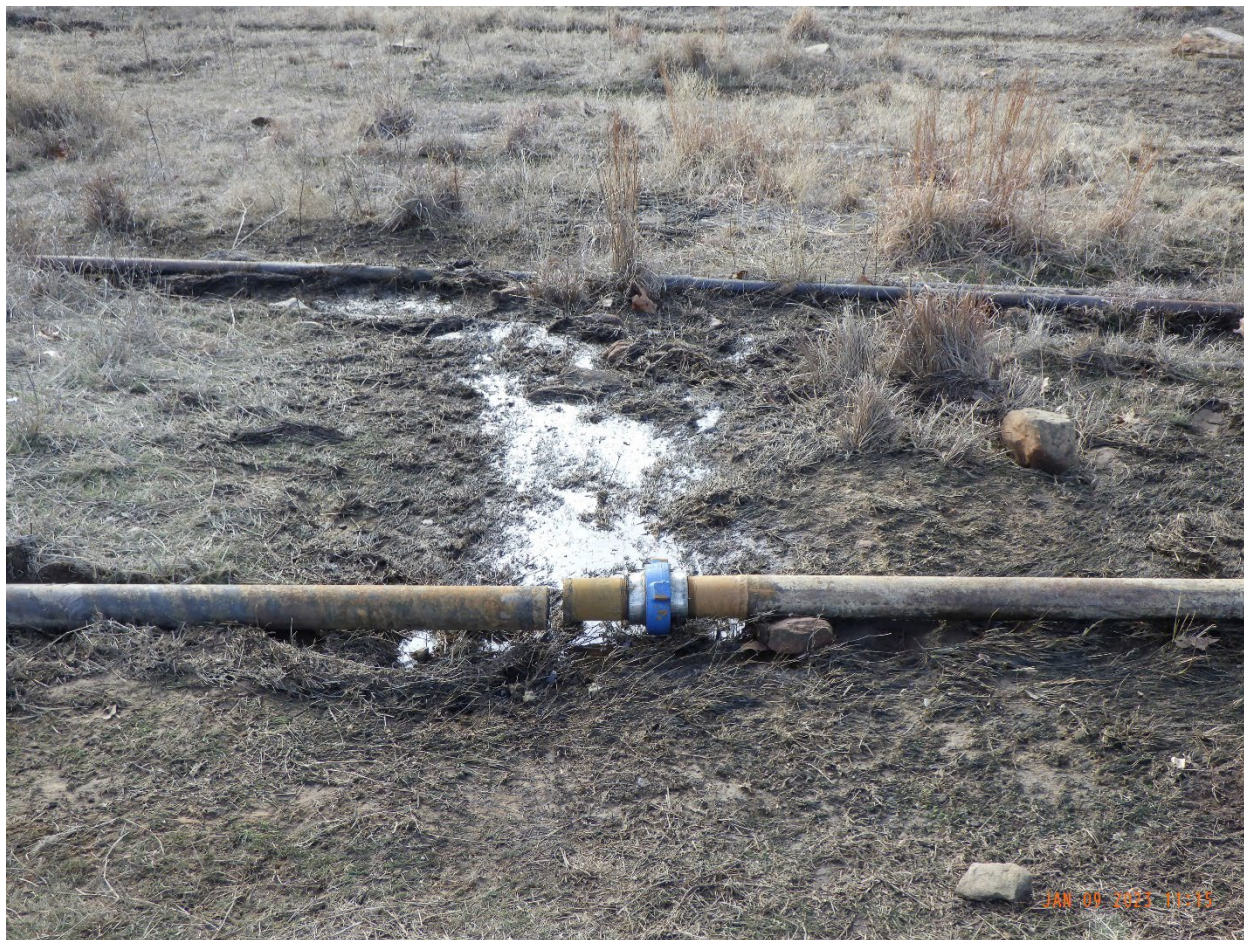
Photo No. 1

I observed the Release Point (GPS 36.541029, -96.418515) of the spill which can be seen in Appendix 1 (photo log) photo No. 1. The release point was a 4" steel/chrome injection line which had recently undergone maintenance, the line experienced a catastrophic failure near the weld allowing the full contents of the line to spill onto the land. At the time of the inspection, the line was not repaired, and a small amount of saltwater was dripping from the line causing an area approximately 2 feet by 6 feet to stay saturated with saltwater.

**Description:** This was the release point of the spill. The operator had recently replaced a section of the 3" steel/chrome saltwater injection line. The flowline failed near the weld. At the time of the inspection, saltwater was dripping from the flowline causing an area approximately 2 feet wide by 6 feet long to stay saturated with saltwater.

EPA Region 6 inspector Matthew Allen conducted a follow-up phone call with Calgary Energy representative, Blaine Haag, at the conclusion of the inspection. The primary areas of concern were to repair the broken flowline to prevent additional fluids being released and to continue removing elevated TDS waters from the impacted tributary. Calgary Energy should ensure no further downstream migration of elevated TDS waters. The impacted tributary should be restored to background TDS levels. Additionally, Calgary Energy should remove the brine impacts from the flowpath between the release point and the point of entry into the unnamed tributary (clean the flowpath).

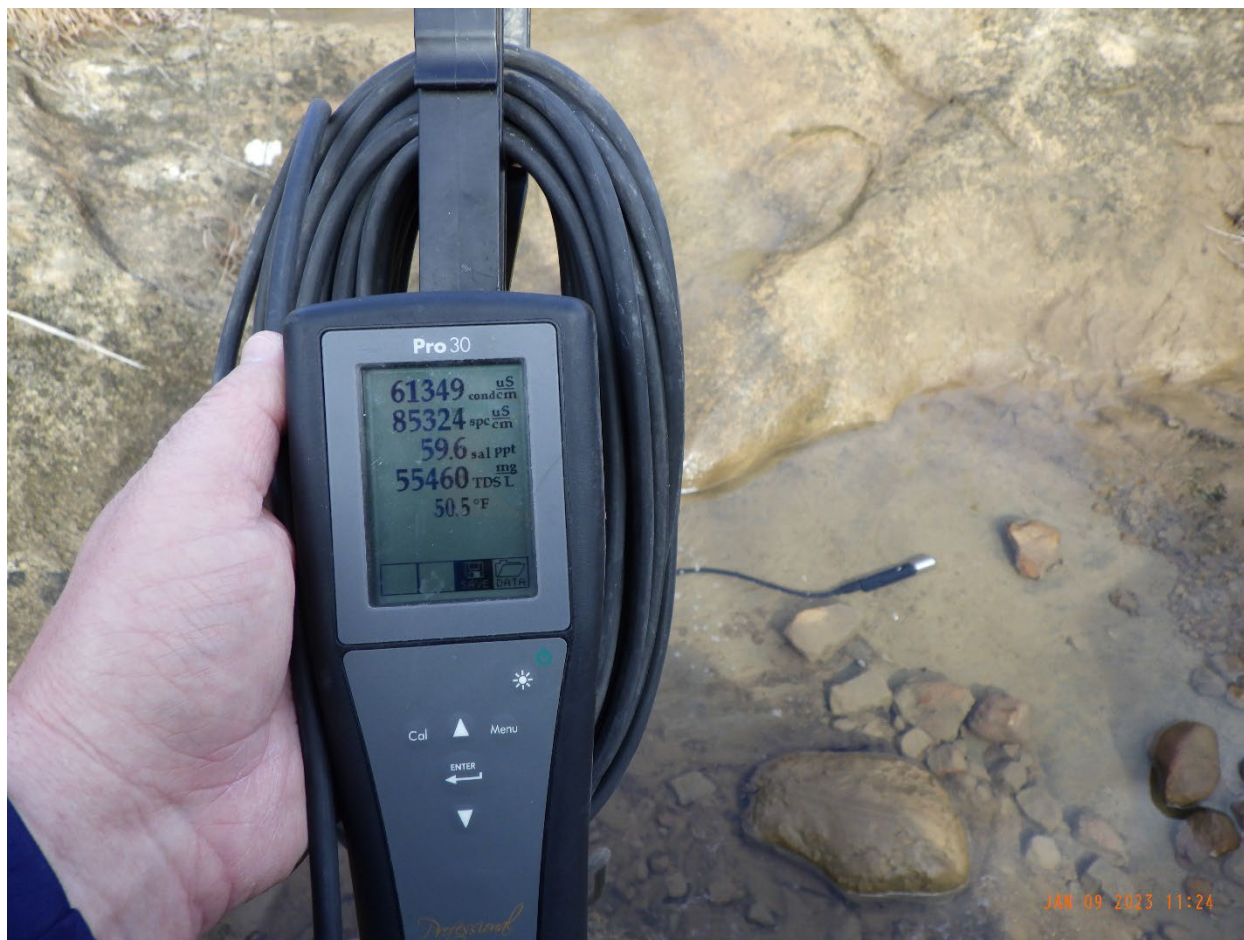
Photo No. 2

I observed the Point of Entry (POE) (GPS 36.540266, -96.418786) into the unnamed tributary as well as an elevated TDS field reading of 55,460 mg/L at the POE, see photo No. 2. I observed the bed and bank features of the tributary near the POE with a view to the east/downgrade, see photo No. 3.

**Description:** This was an elevated TDS field reading of 55,460 mg/L taken at the Point of Entry (POE) into the unnamed tributary of Little Hominy Creek.

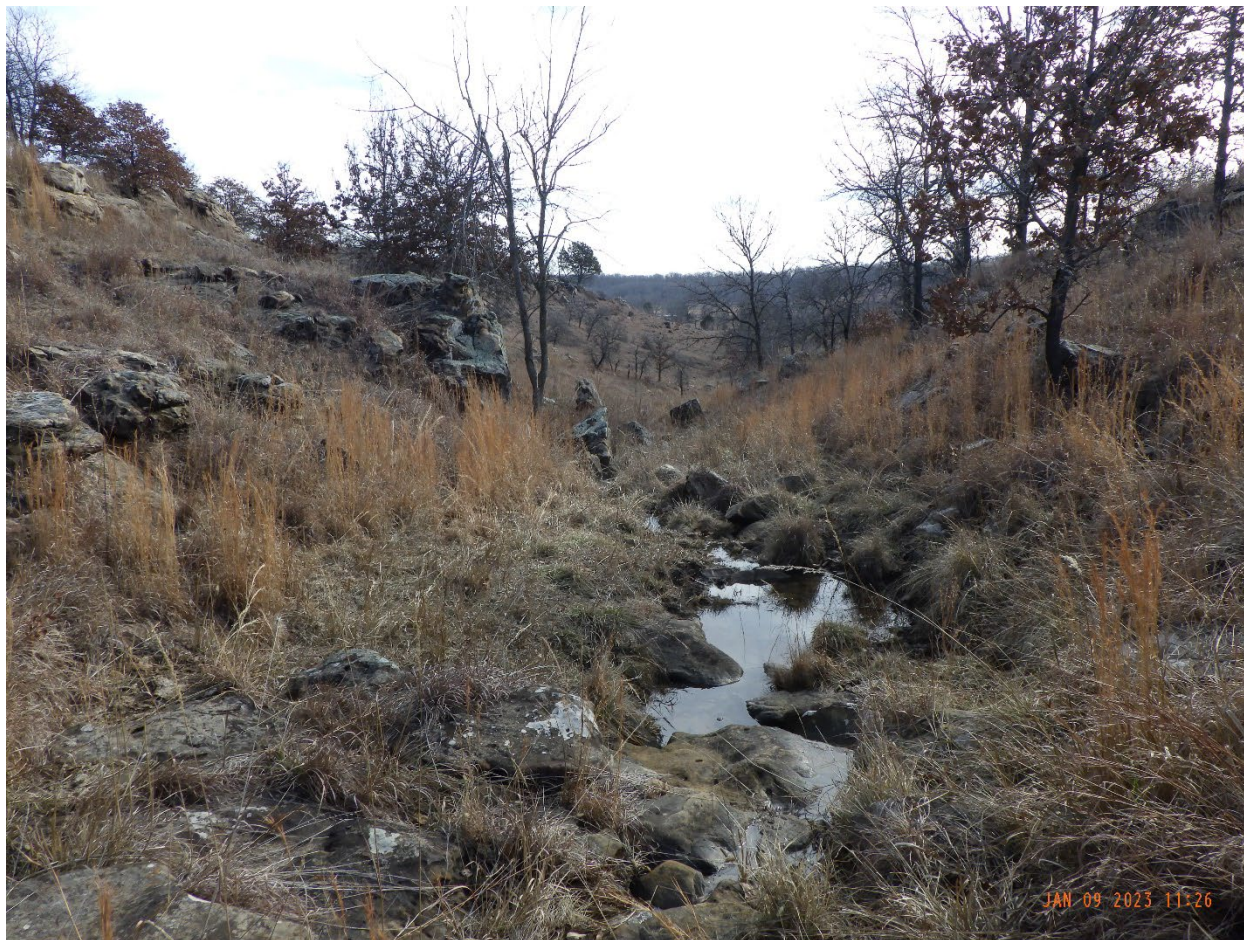
Photo No. 3

**Description:** This was a view of the bed and bank features along the upper section of the impacted tributary, this photo was taken approximately 50 yards downstream from the POE.

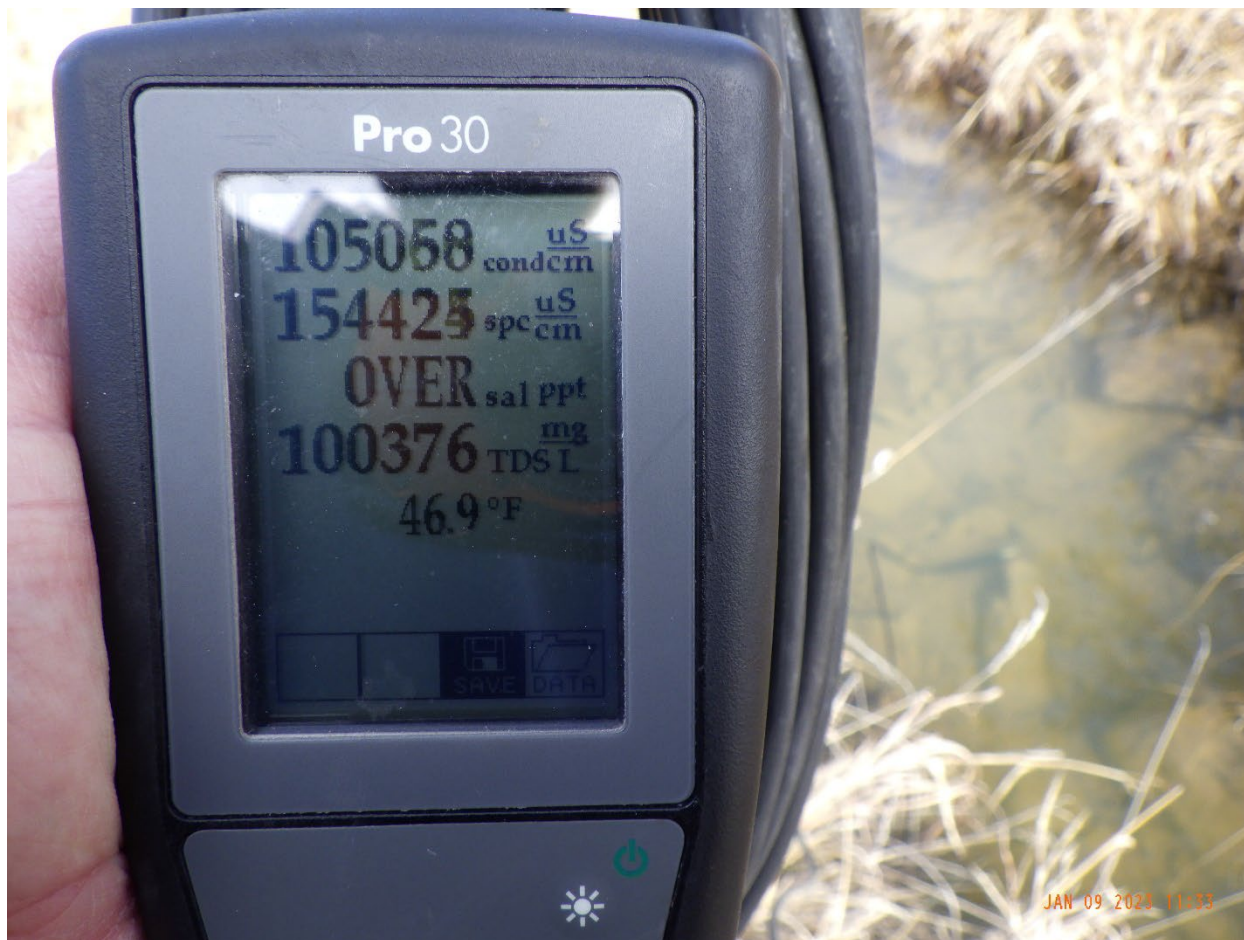
Photo No. 4

As spill impacts continued downstream, I observed an elevated TDS field reading of 100,376 mg/L which was the highest concentration observed during the inspection, see photo No. 4.

**Description:** This was an elevated TDS field reading of 100,376 mg/L taken from a small pool along the main channel of the impacted tributary. This field reading was taken along the upper 1/3 of the impacted area.

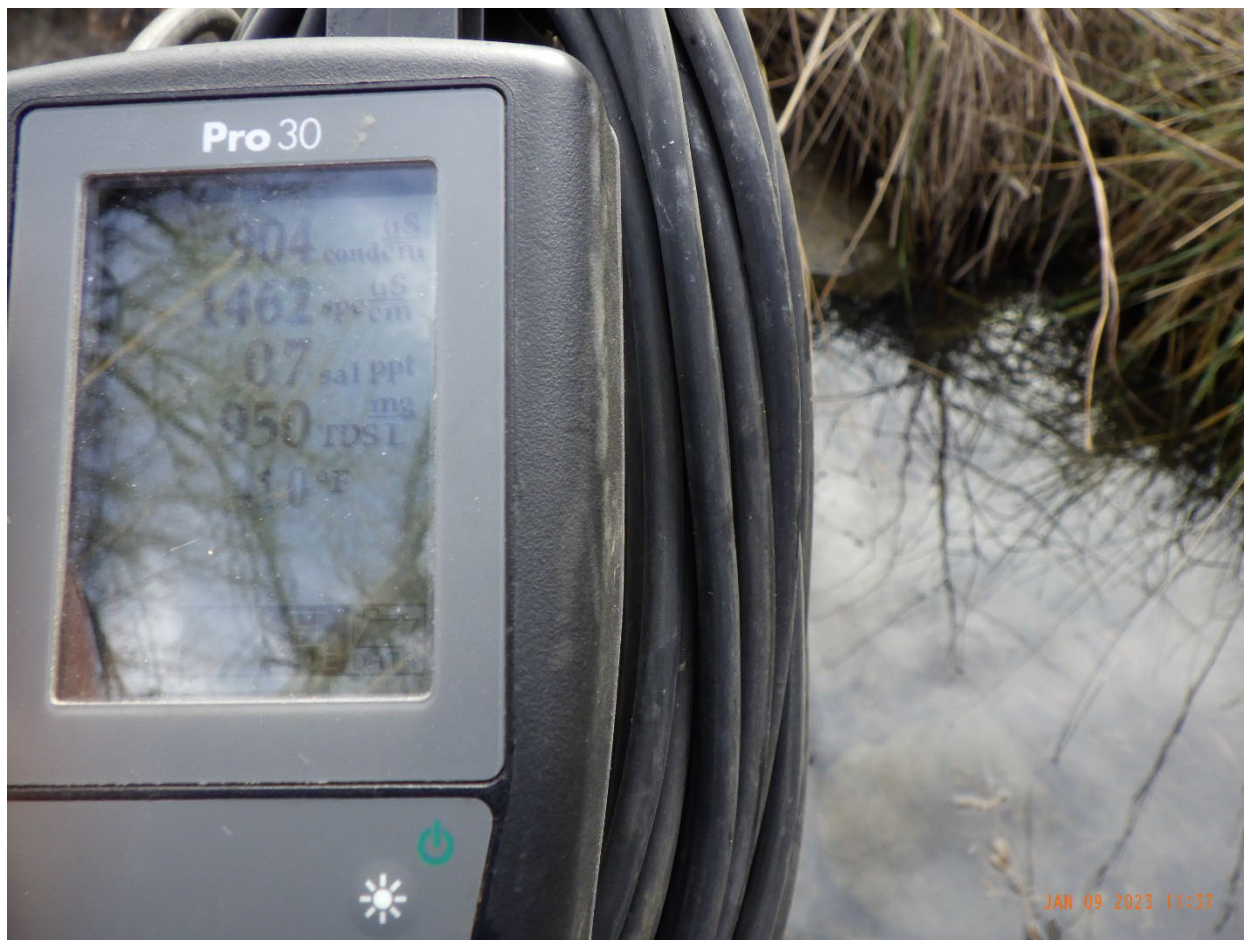
Photo No. 5

I observed a TDS field reading of 950 mg/L in an adjoining, unimpacted tributary (see photo No. 5), this measurement should be used in determining “background” TDS level for the area.

**Description:** This was a TDS field reading of 950 mg/L taken from a small tributary which entered the impacted tributary from the South. This reading was taken in a pool of water which was not and could not be impacted by the spill. This measurement should be used to help establish "background" TDS levels in the area.

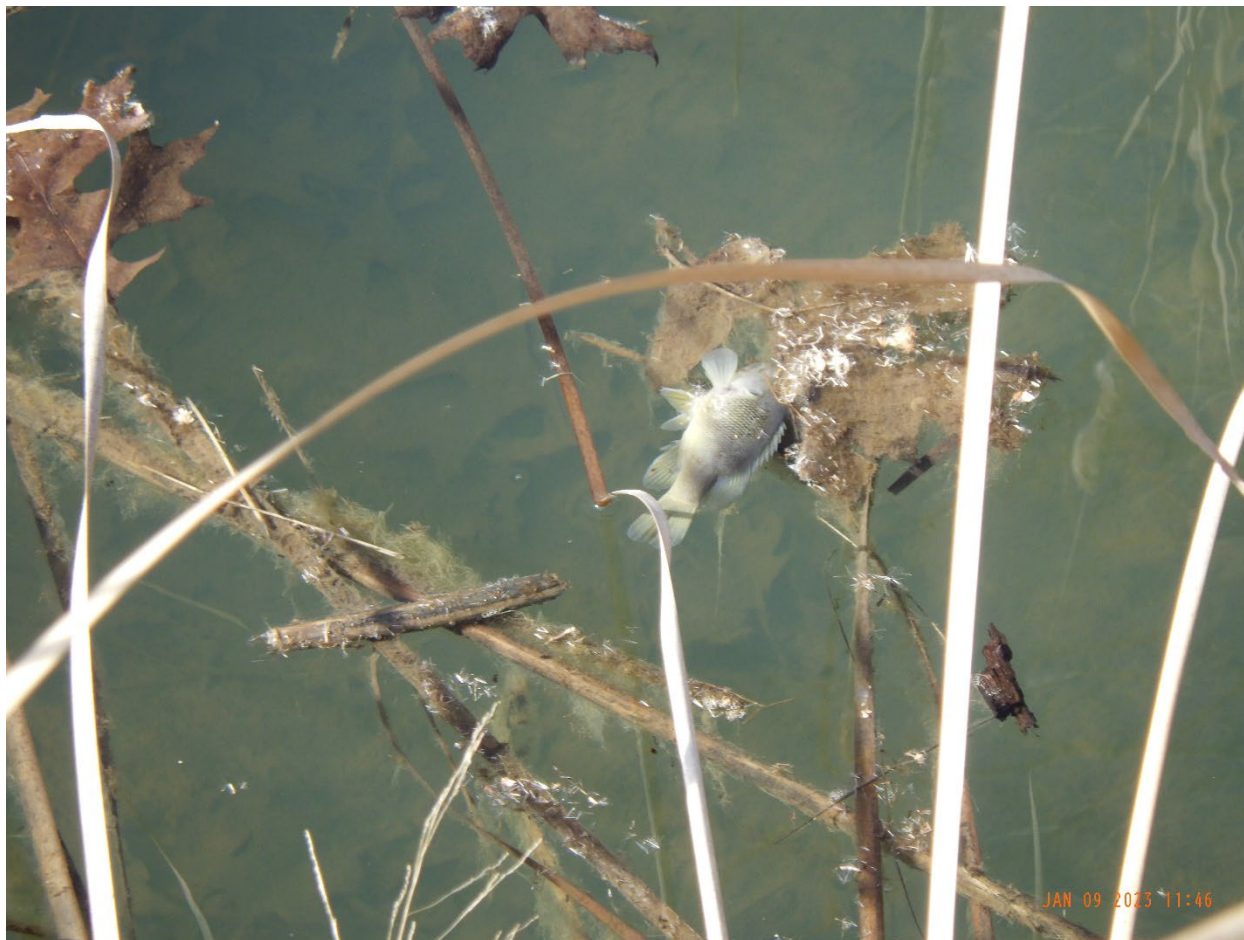
Photo No. 6

I observed 4 dead Green Sunfish, measuring 3”-4” in length. I observed an elevated TDS field reading of 80,375 mg/L at the same location, see photos No. 6, 7, 8.

**Description:** This was a photo of 1 of 4 small Green Sunfish which were observed dead in the impacted tributary. The other 3 Green Sunfish were also in the same pool of water. The fish were approximately 3" - 4" in length.

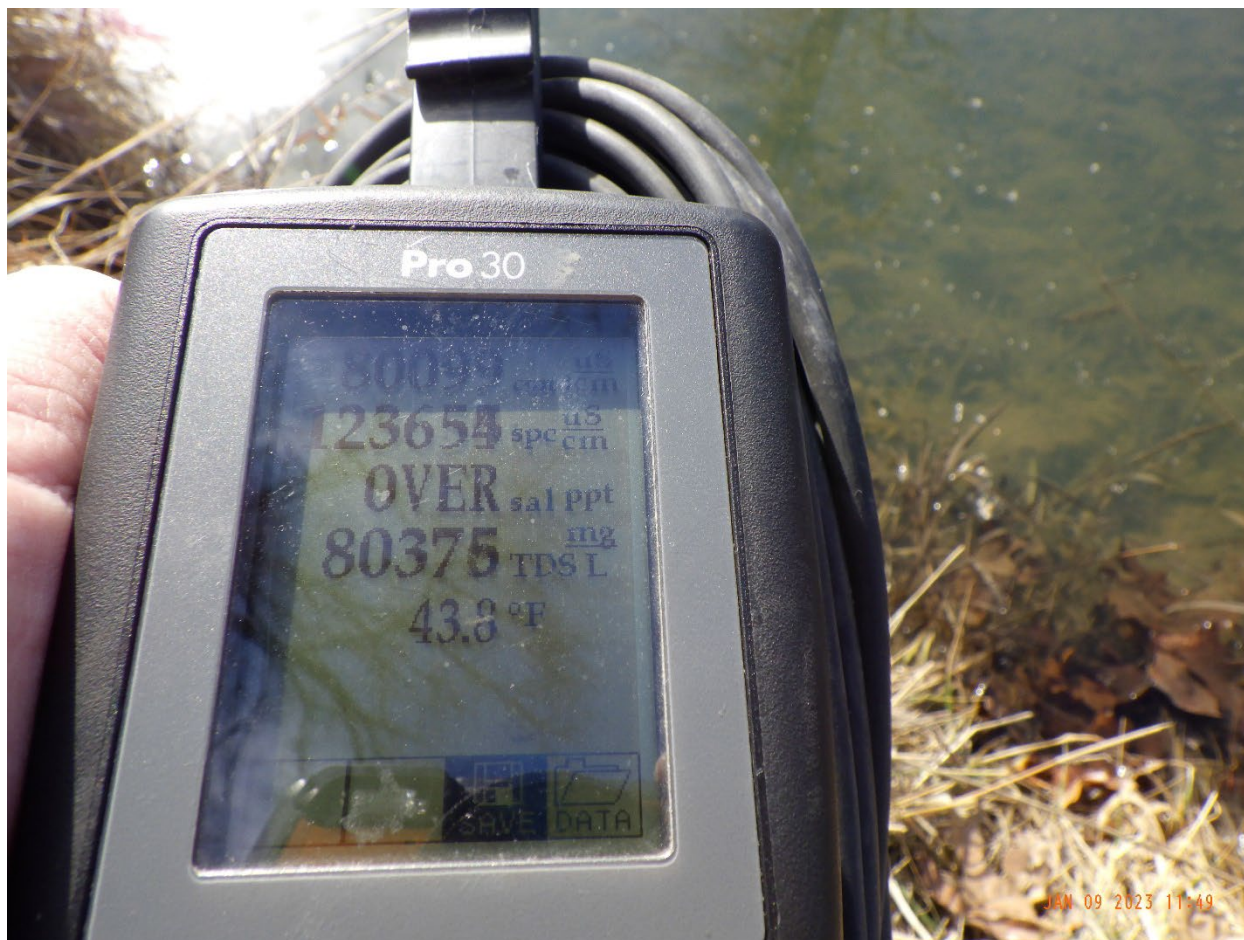
Photo No. 7

**Description:** This was an elevated TDS field reading of 80,375 mg/L taken in the same pool of water where the small dead fish were observed.

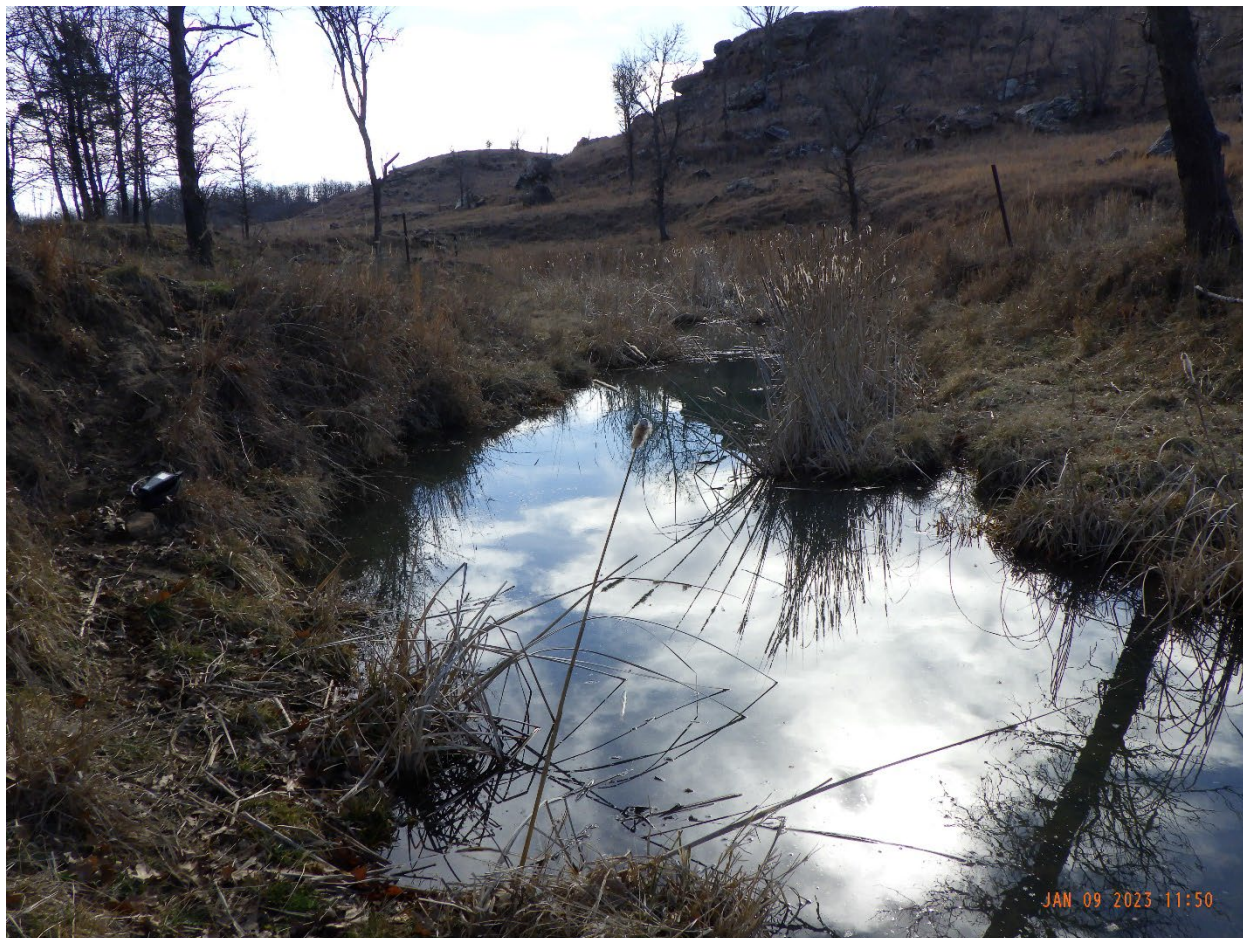
Photo No. 8

**Description:** This was a view of the bed and bank features along the impacted tributary at the pool where the dead fish were located. I did not observe any additional impacted fish/wildlife/livestock during the inspection.

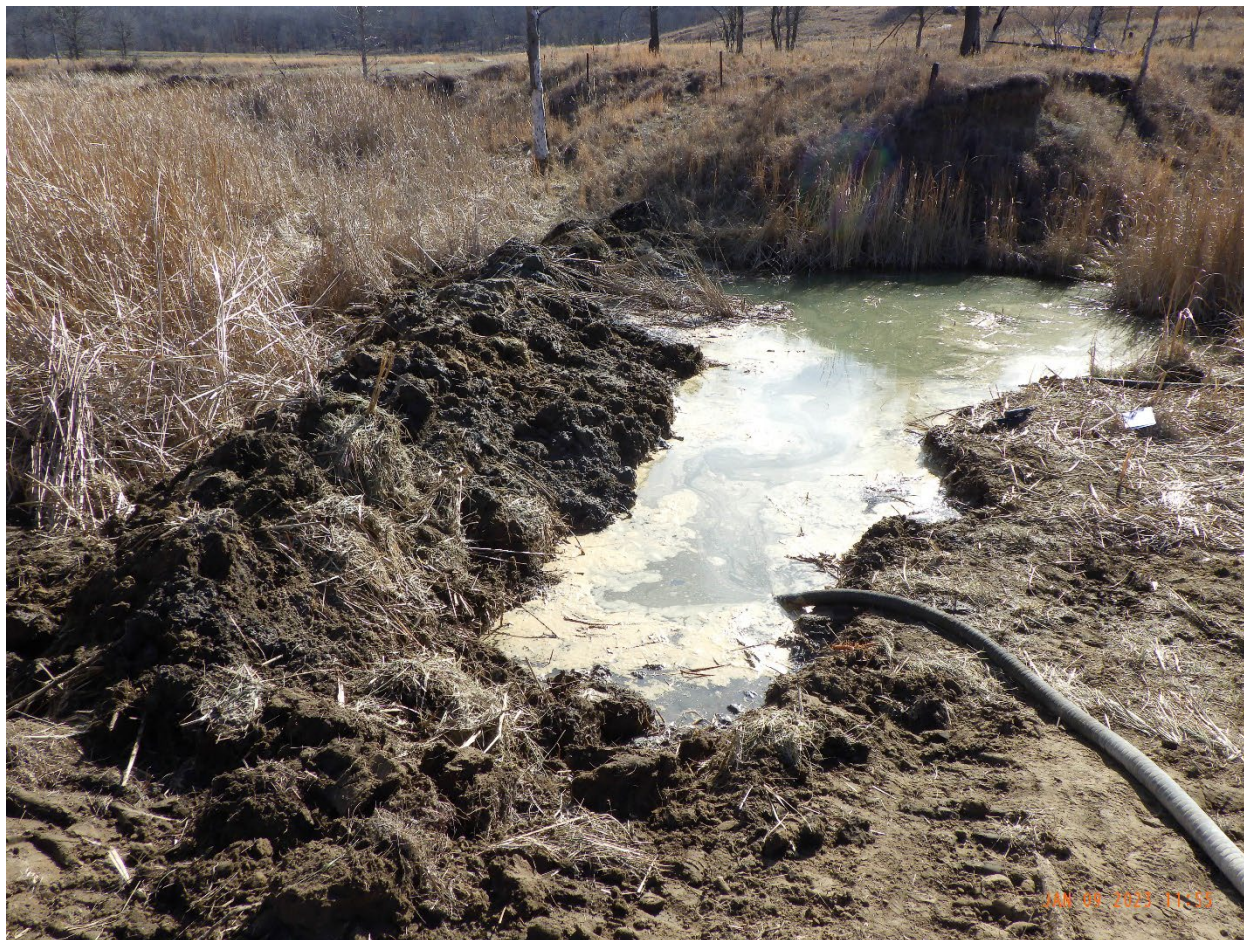
Photo No. 9

I observed a temporary containment dam placed by the operator to prevent further downstream migration of elevated TDS waters. I observed a TDS field reading of 32,840 mg/L on the upstream/impacted side of the dam and a TDS field reading of 2,825 mg/L immediately behind/downstream from the dam. See photos No. 9, 10, 11.

**Description:** This was a temporary containment dam placed by the operator to prevent the downstream migration of impacted waters. This dam was constructed in an acceptable location to prevent migration of waters with significantly elevated TDS. The upstream (impacted) side of the dam measured 32,840 mg/L TDS and the water immediately downstream from the dam (1 foot downstream/behind) the dam measured 2,825 mg/L.

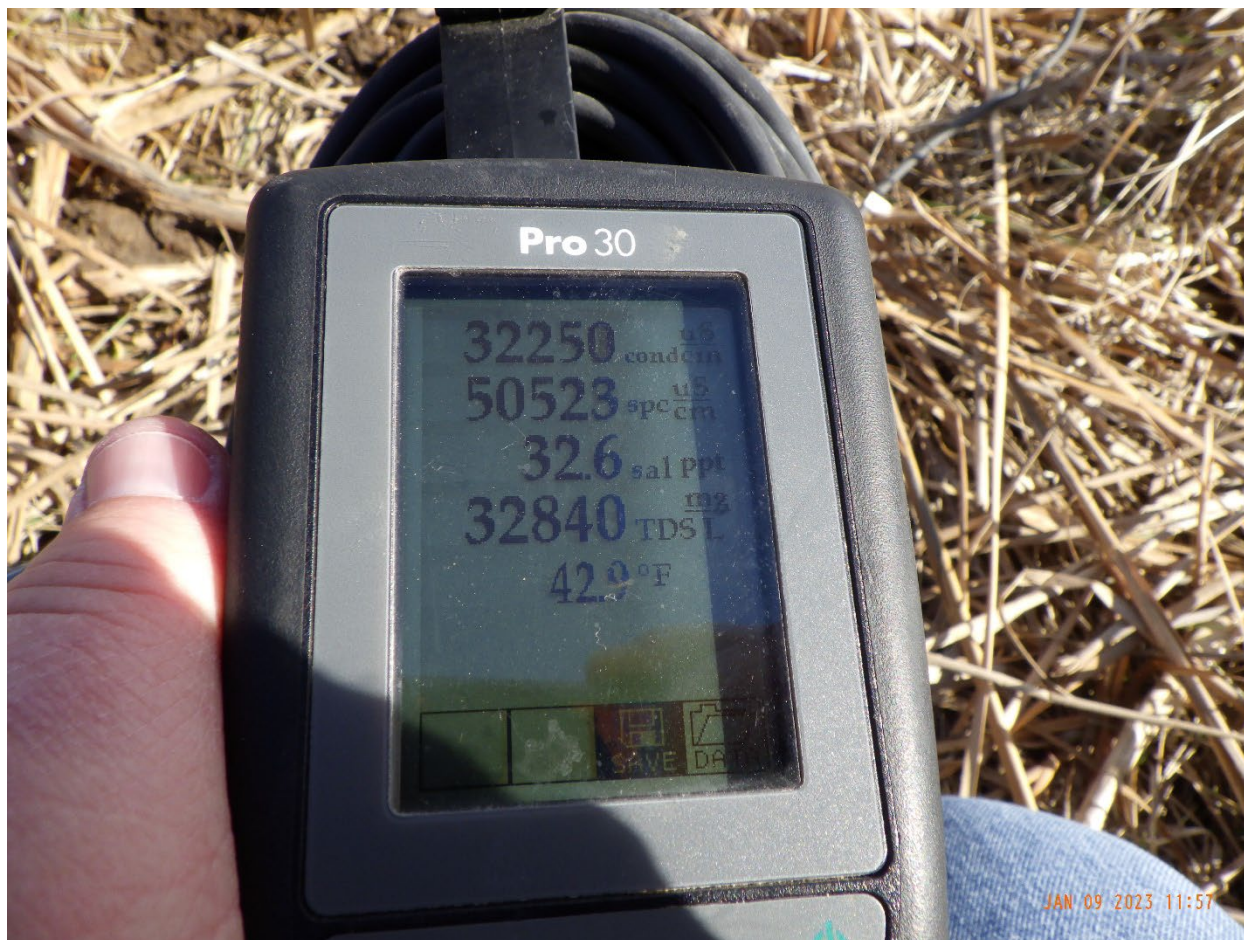
Photo No. 10

**Description:** This was an elevated TDS field reading of 32,840 mg/L taken in the pool located immediately upstream from the temporary containment dam.

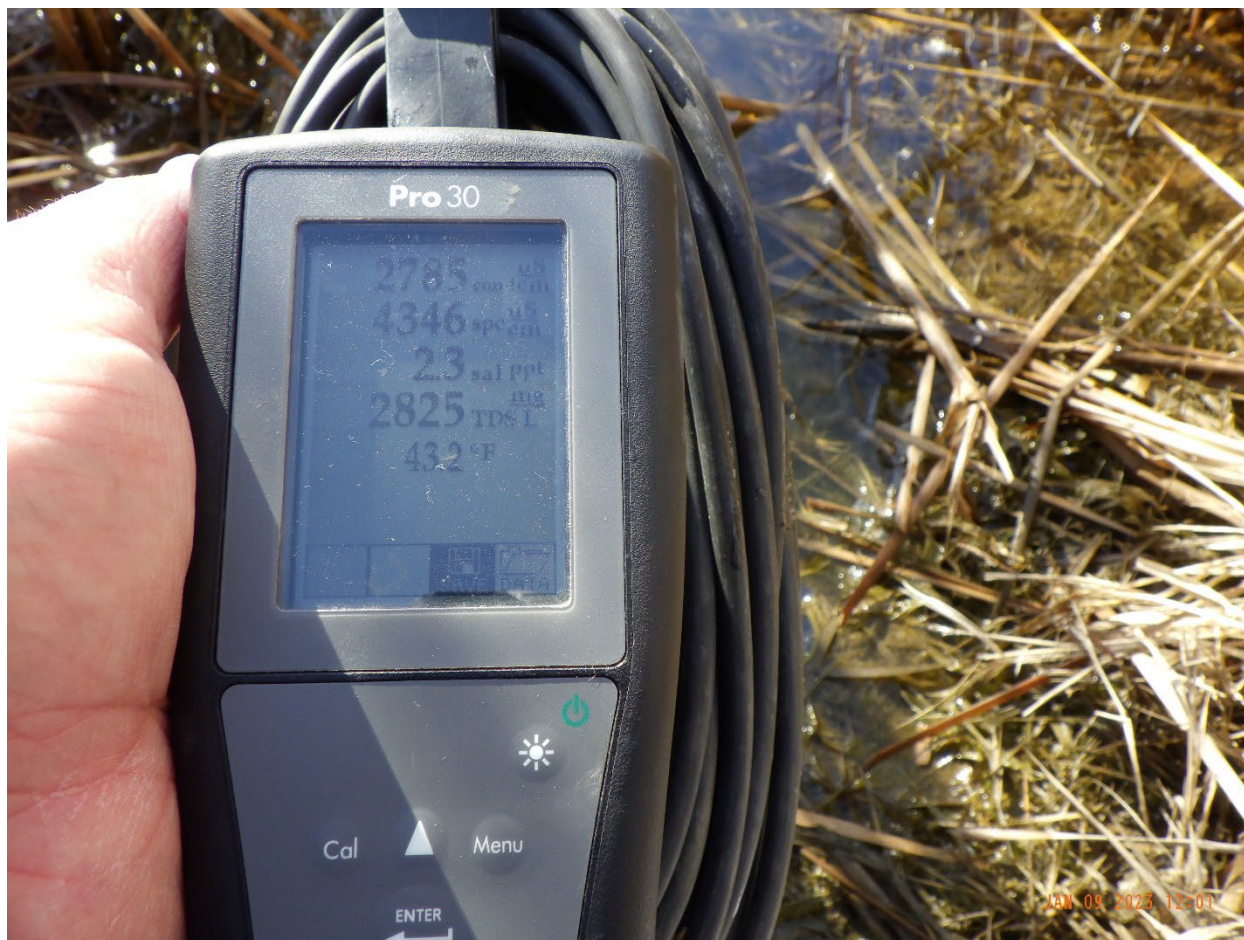
Photo No. 11

**Description:** This TDS field reading of 2,825 mg/L was taken immediately below/downstream the temporary containment dam.

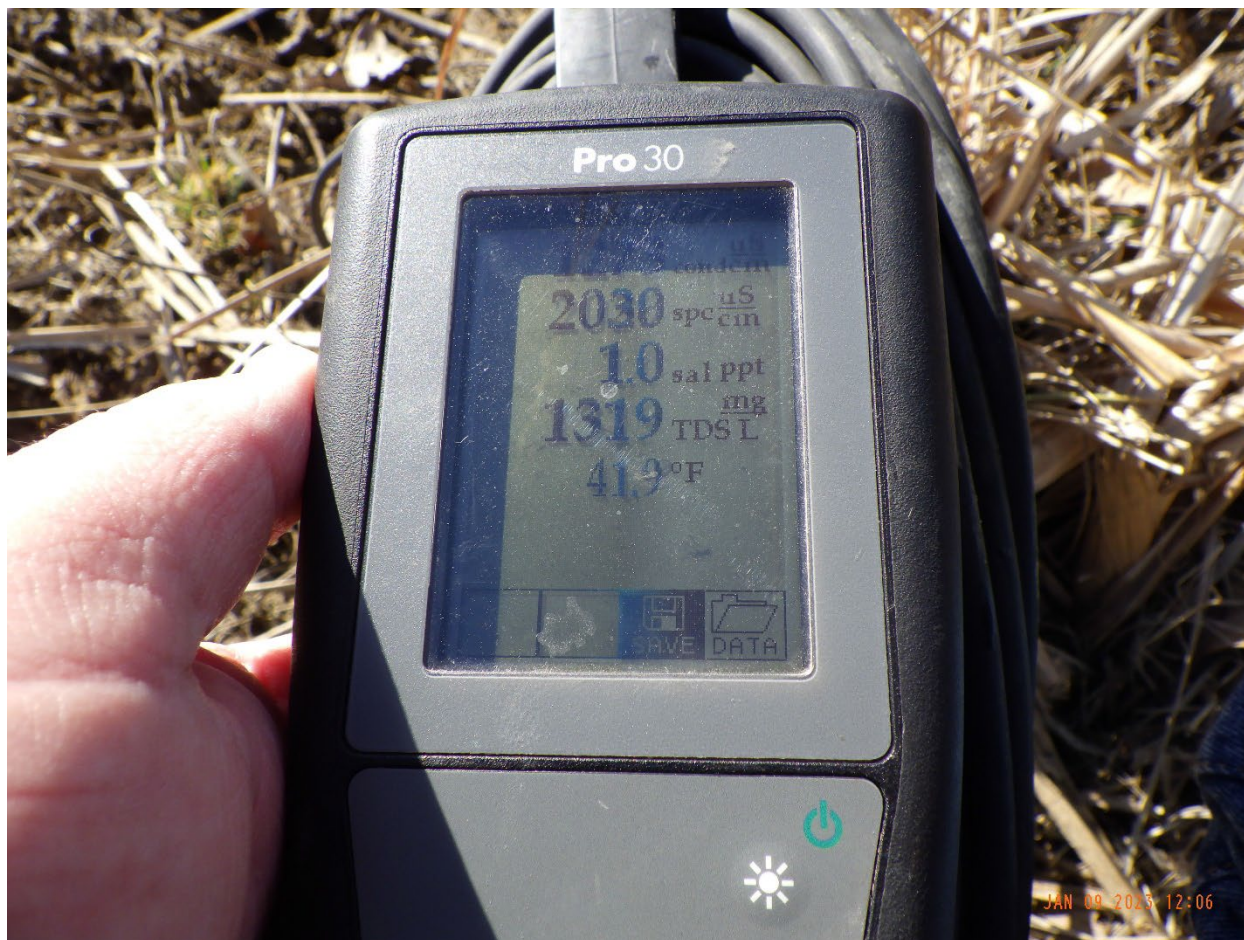
Photo No. 12

I observed a TDS field reading of 1,319 mg/L approximately 50 feet downstream from the temporary containment dam.

**Description:** This was a TDS field reading of 1,319 mg/L taken approximately 50 feet downstream from the temporary containment dam. This represented a TDS level near the background level observed in the area.

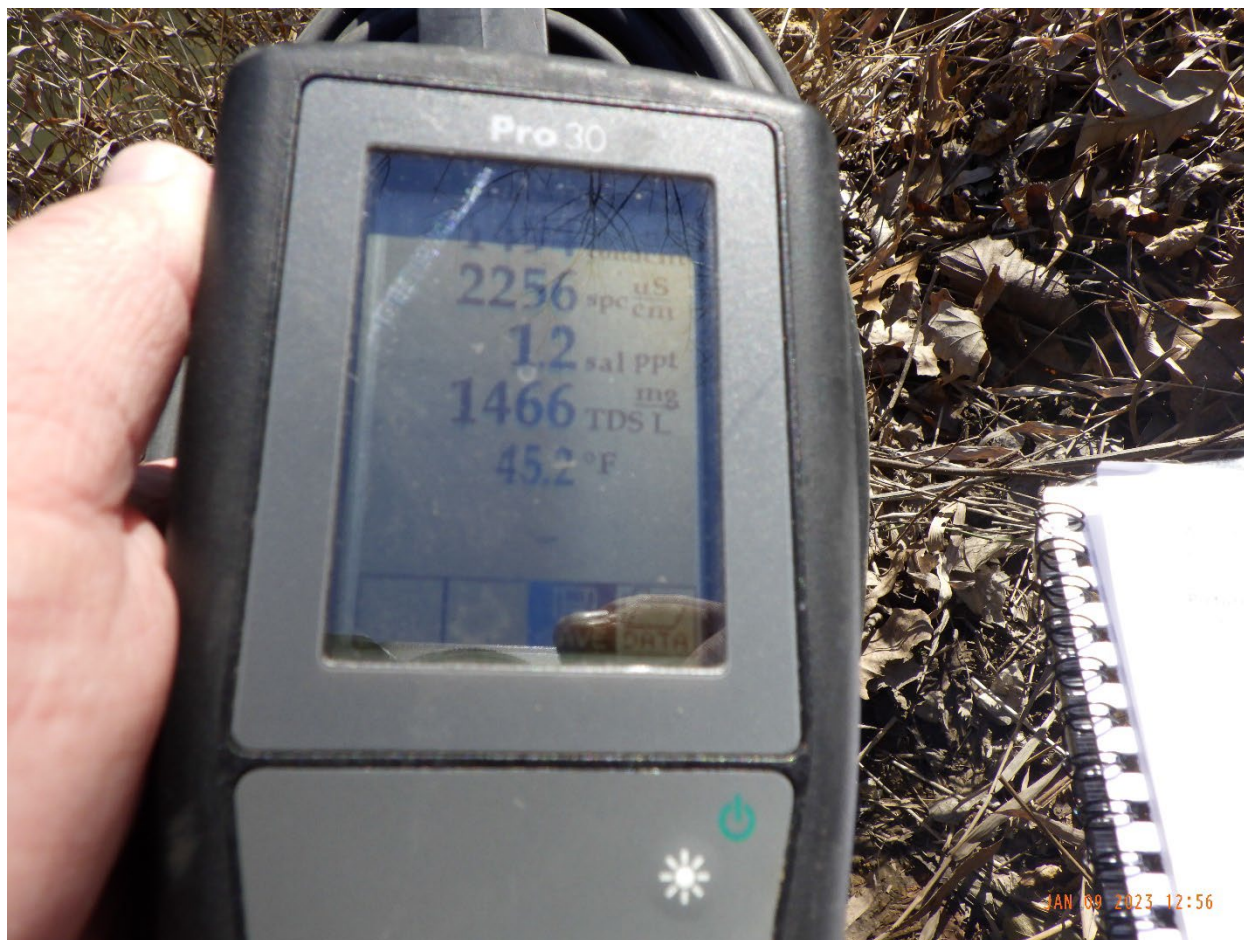
Photo No. 13

I observed a TDS field reading of 1,466 mg/L along the impacted tributary just prior to its confluence with Little Hominy Creek, see photos No. 13 and 14.

**Description:** This was a TDS field reading of 1,466 mg/L taken in the main channel of the impacted tributary just before it flowed into the main channel of Little Hominy Creek.

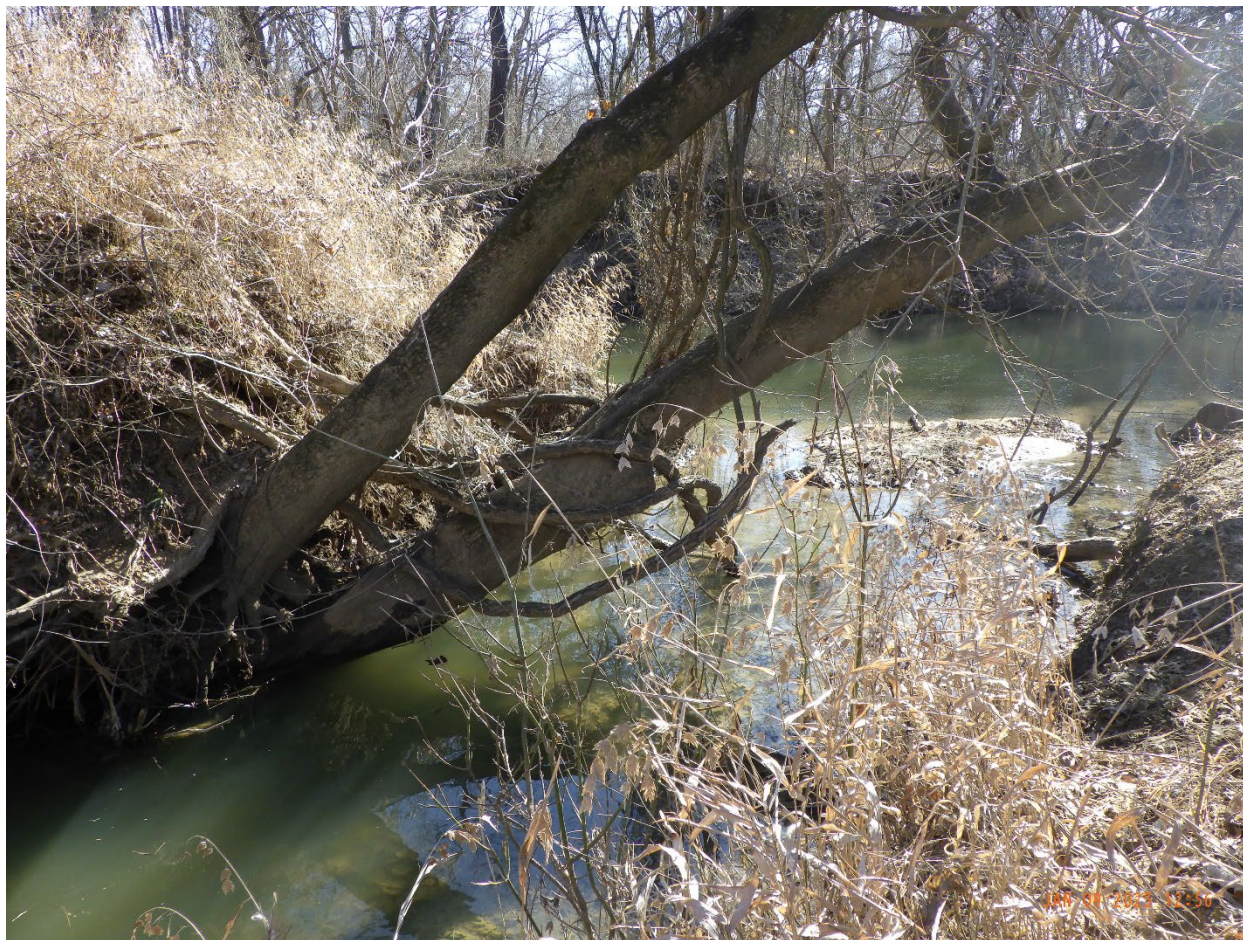
Photo No. 14

**Description:** This was a photo showing the impacted tributary as it flowed into Little Hominy Creek.

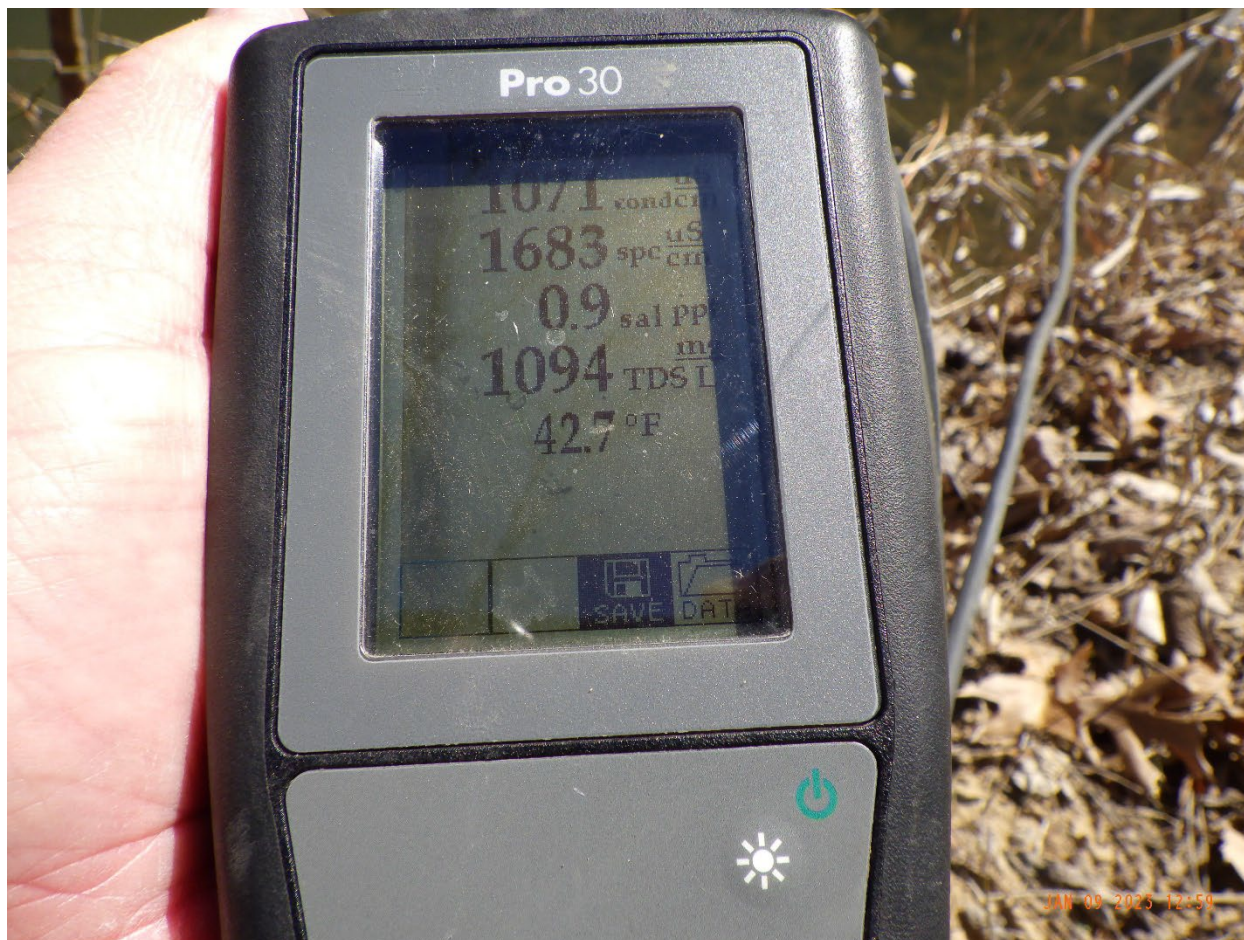
Photo No. 15

I observed a TDS field reading of 1,094 mg/L in the main channel of Little Hominy Creek at its confluence with the impacted tributary, see photos No. 15, 16.

**Description:** This was a TDS field reading of 1,094 mg/L taken in the main channel of Little Hominy Creek.

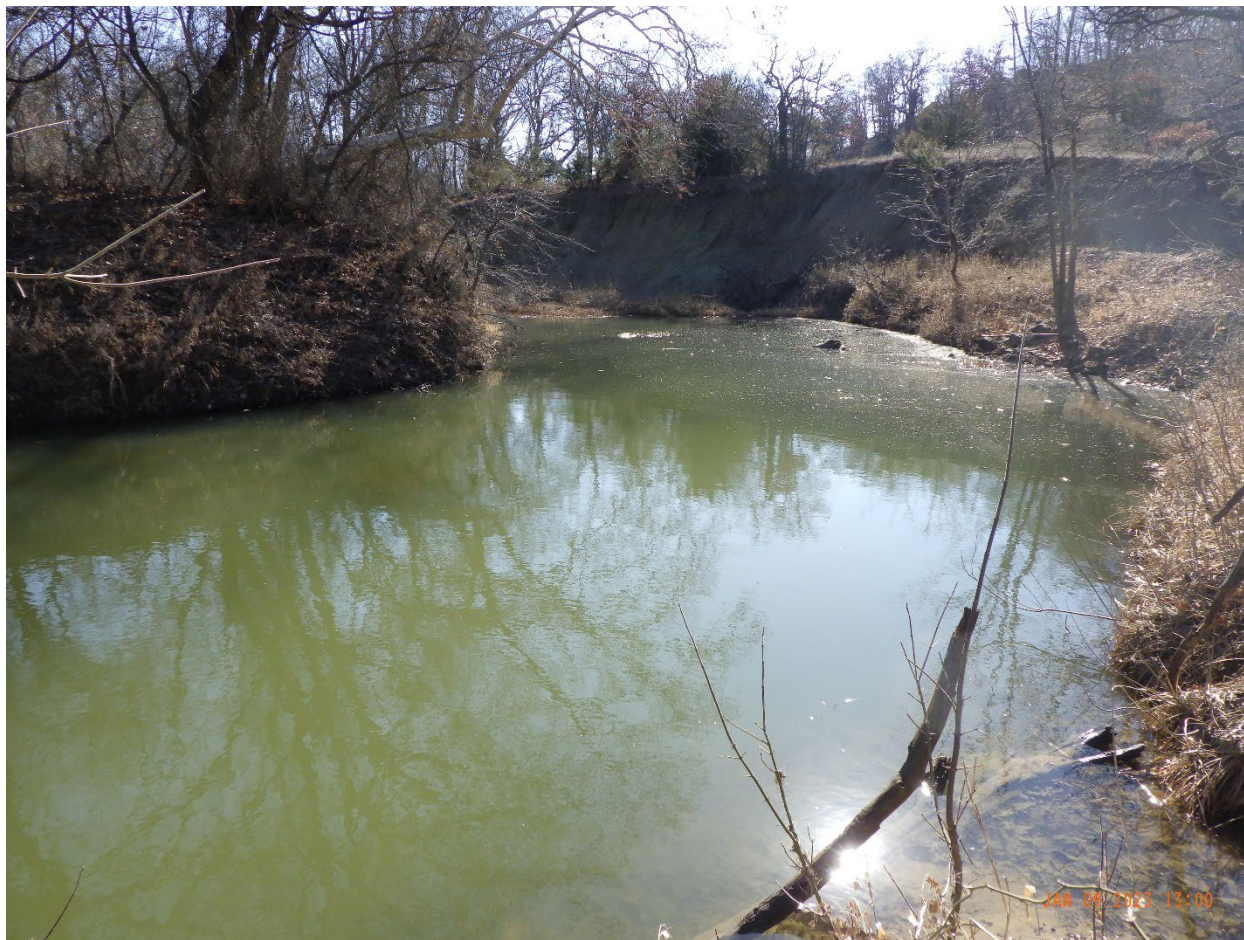
Photo No. 16

**Description:** This was a photo of Little Hominy Creek, with a view to the southwest. The confluence of the impacted tributary and Little Hominy Creek was directly behind the photographer at the time of the photo.
