**Report Title:** Clean Air Act Inspection of Capital Benz Auto Service  
**Inspection Date(s):** 12/06/2023  
**Regulatory Program(s):** NESHAP, SIP

**Company Name:** Capital Benz Auto Service  
**Facility Name:** Same as above  
**Facility Location:** 1801 Adams Street NE  
Washington, D.C. 20018  
**Latitude:** 38.92023 **Longitude:** -76.97847  
**County/Parish:** District of Columbia

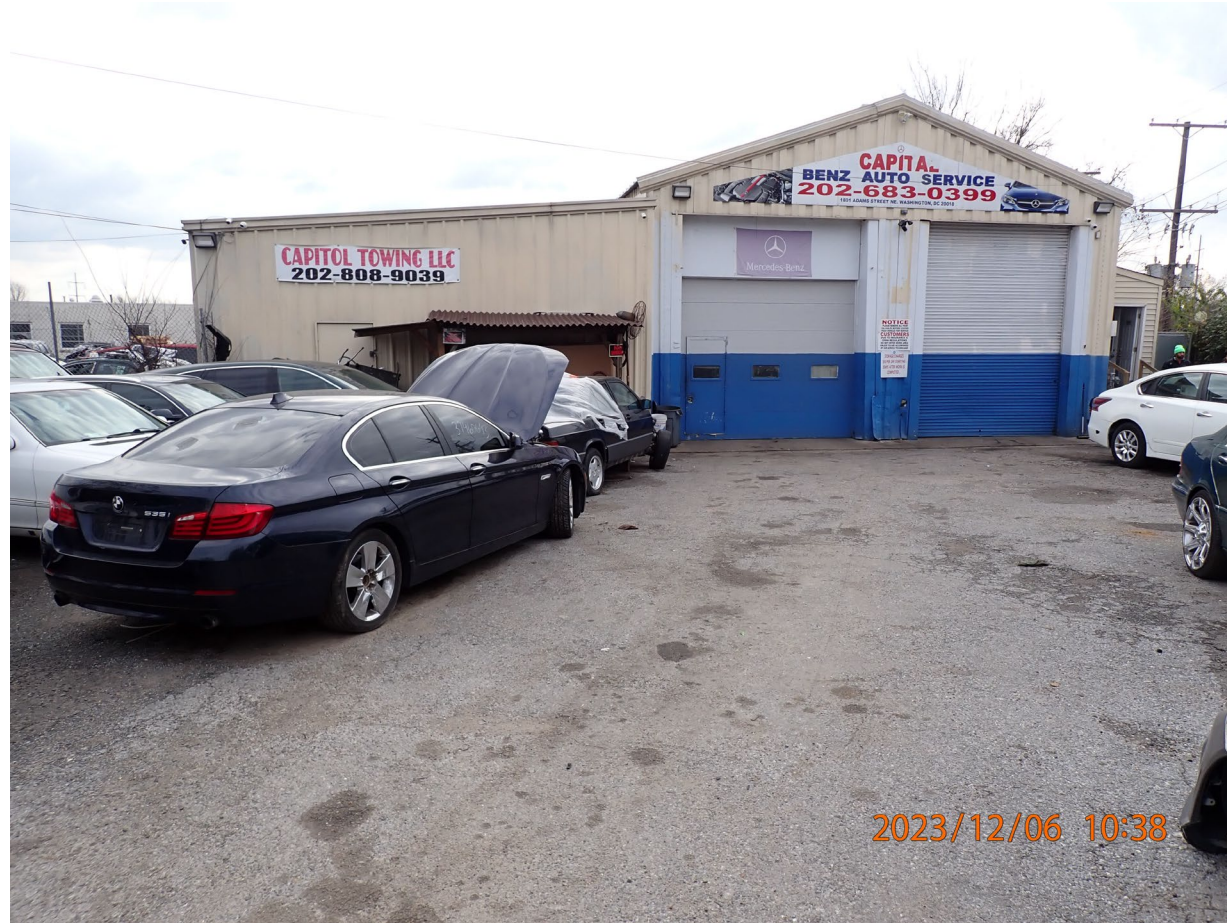
Photo Number: 58

Photo Description: Exterior of Capital Benz Auto Service

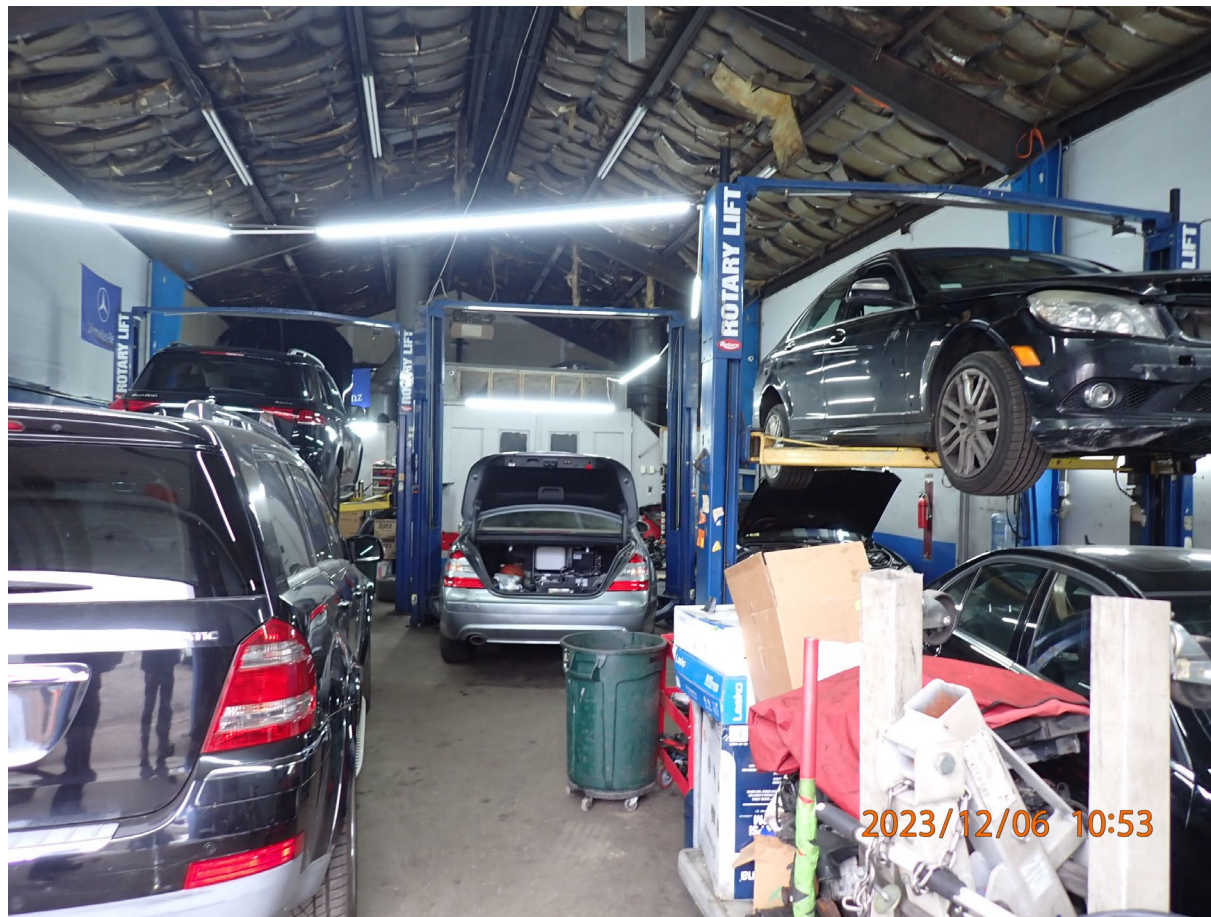
Photo Number: 59

Photo Description: Interior of Garage

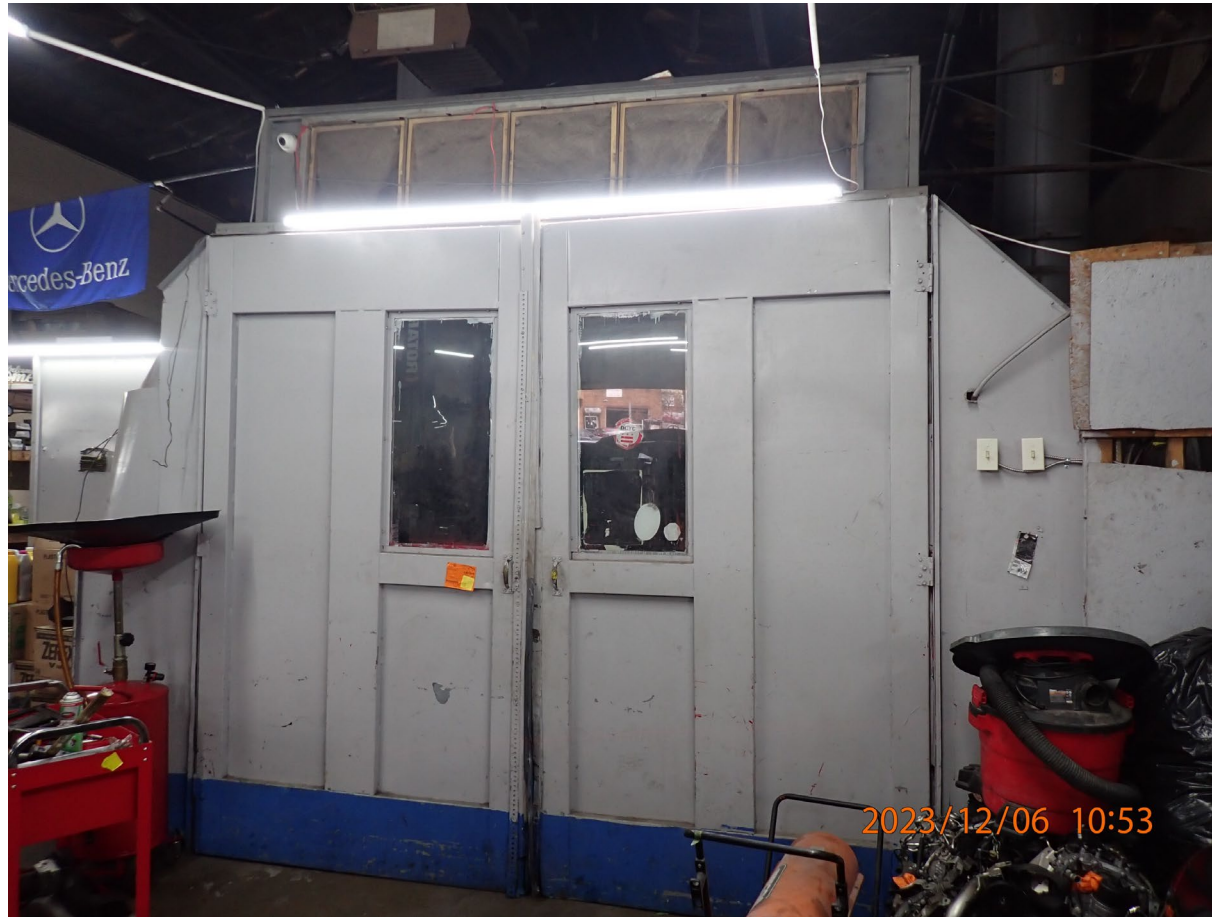
Photo Number: 60

The inspection team exited the paint booth and observed the outside of the booth. The enclosed paint booth had two stacks on top that vent to the atmosphere. Mr. Zeleke stated the Facility paints about one car a month and changes the filters 1-2 times a year. Next, the inspection team observed the Facility's paint storage area. Mr. Zeleke stated Capital Benz purchases paint from Paint Shop Supply and Paisanos Auto Supply. Mr. Zeleke also explained that the Facility's painter is a contractor and he's unsure if the painter has any certifications. The inspections team observed Capital Benz's spray guns which included: six HVLP spray guns, one SATA KLC spray gun, and one Devilbiss Pro Lite spray gun.

Photo Description: Exterior of paint booth

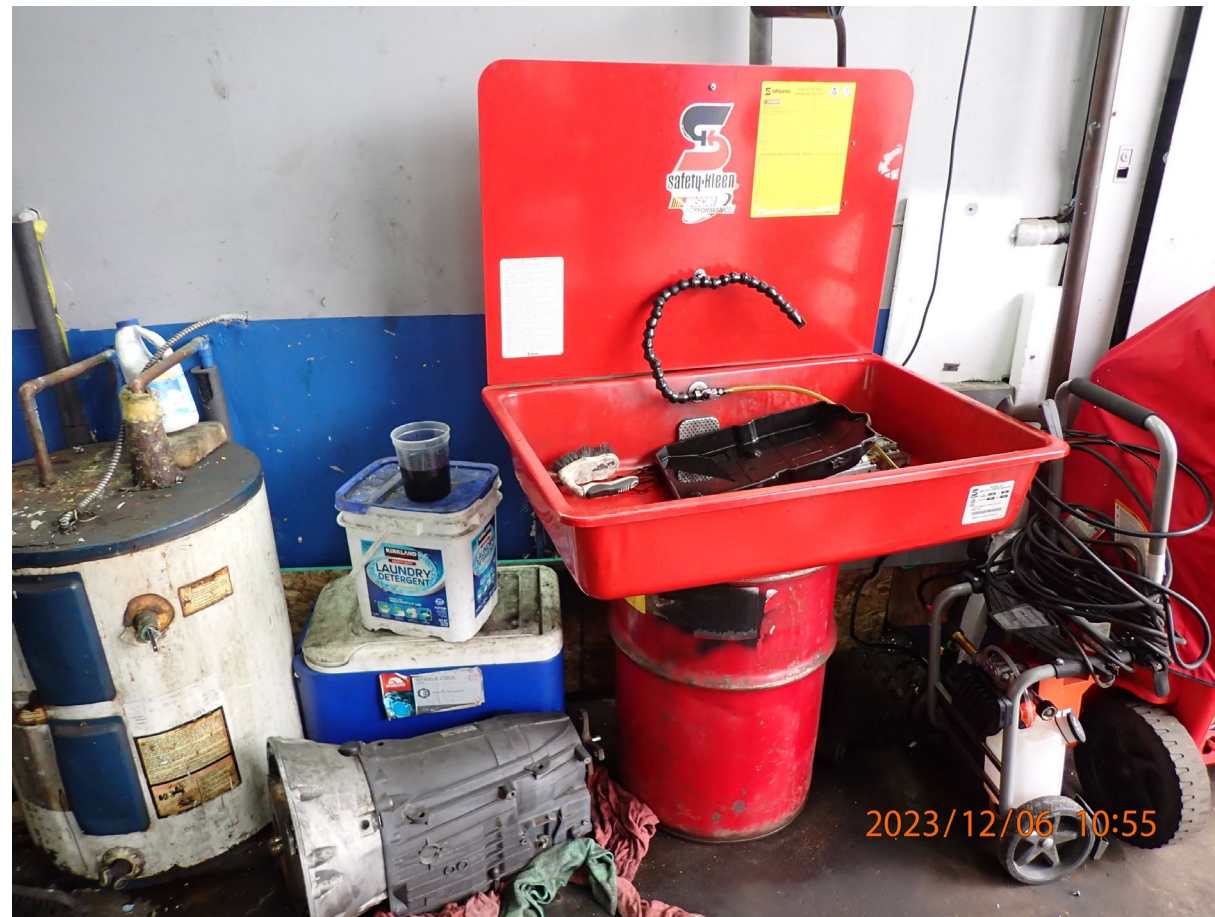
Photo Number: 61

Photo Description: Safety Kleen Parts Cleaner

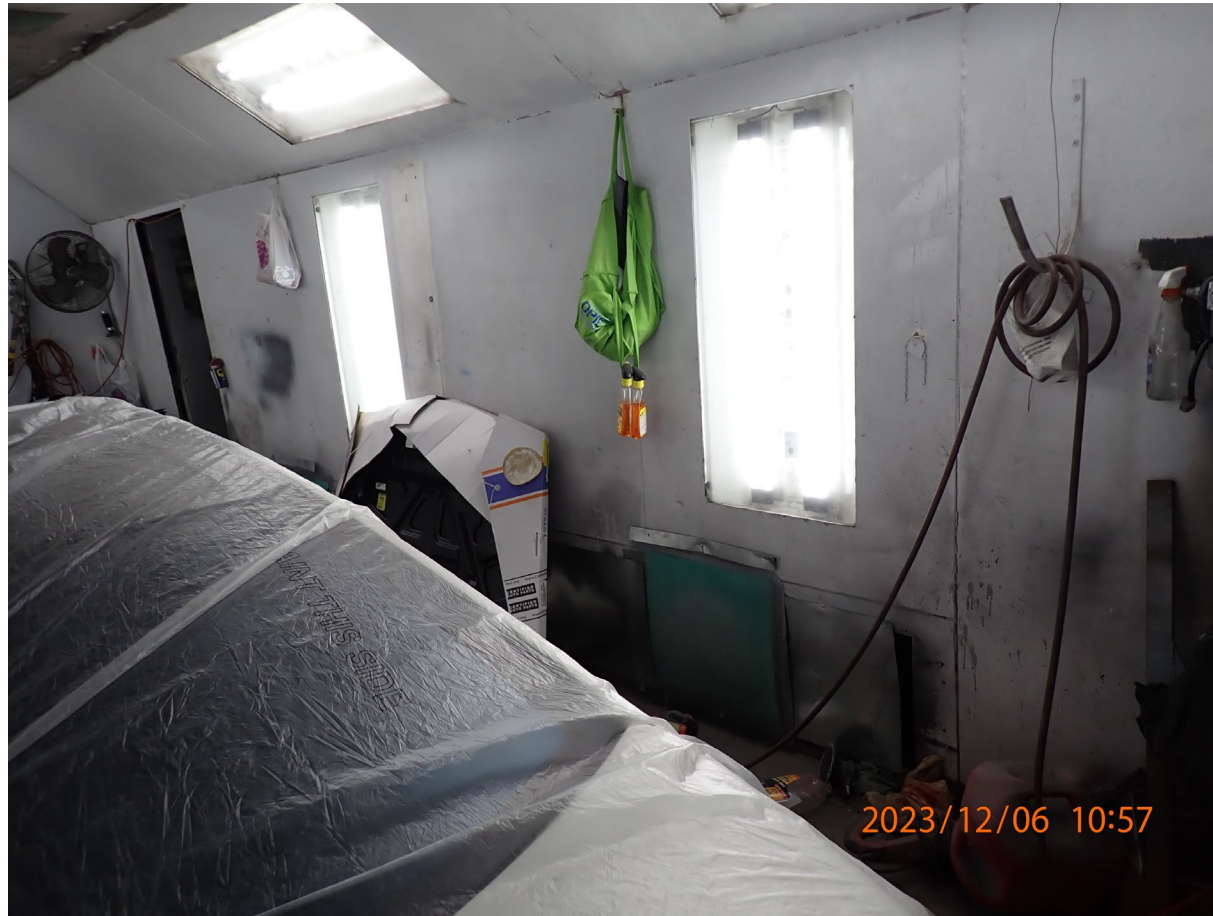
Photo Number: 62

The inspection team entered the paint booth that contained a white vehicle inside. The filters were located on the top of the paint booth and on bottom lower side walls of the paint booth. The observed filters were heavily laden with dirt, dust, or paint overspray. Mr. Deluca requested that Mr. Zeleke turn on the paint so the inspection team could observe how the paint booth operates. Some air could be felt going into the paint booth through the vehicle door. However, the airflow of the booth was unable to demonstrate that the booth was operating under negative pressure.

Photo Description: Interior of paint booth

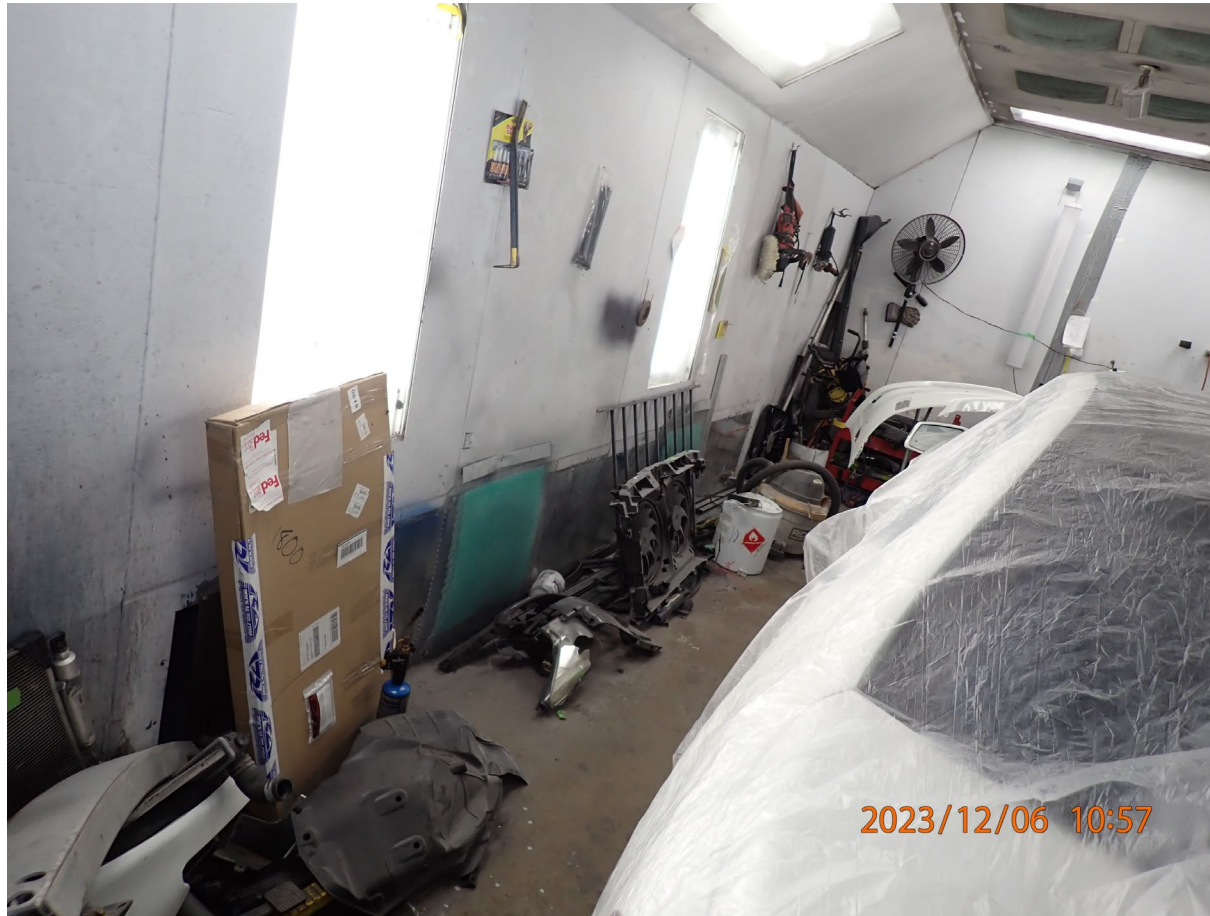
Photo Number: 63

Photo Description: Interior of paint booth

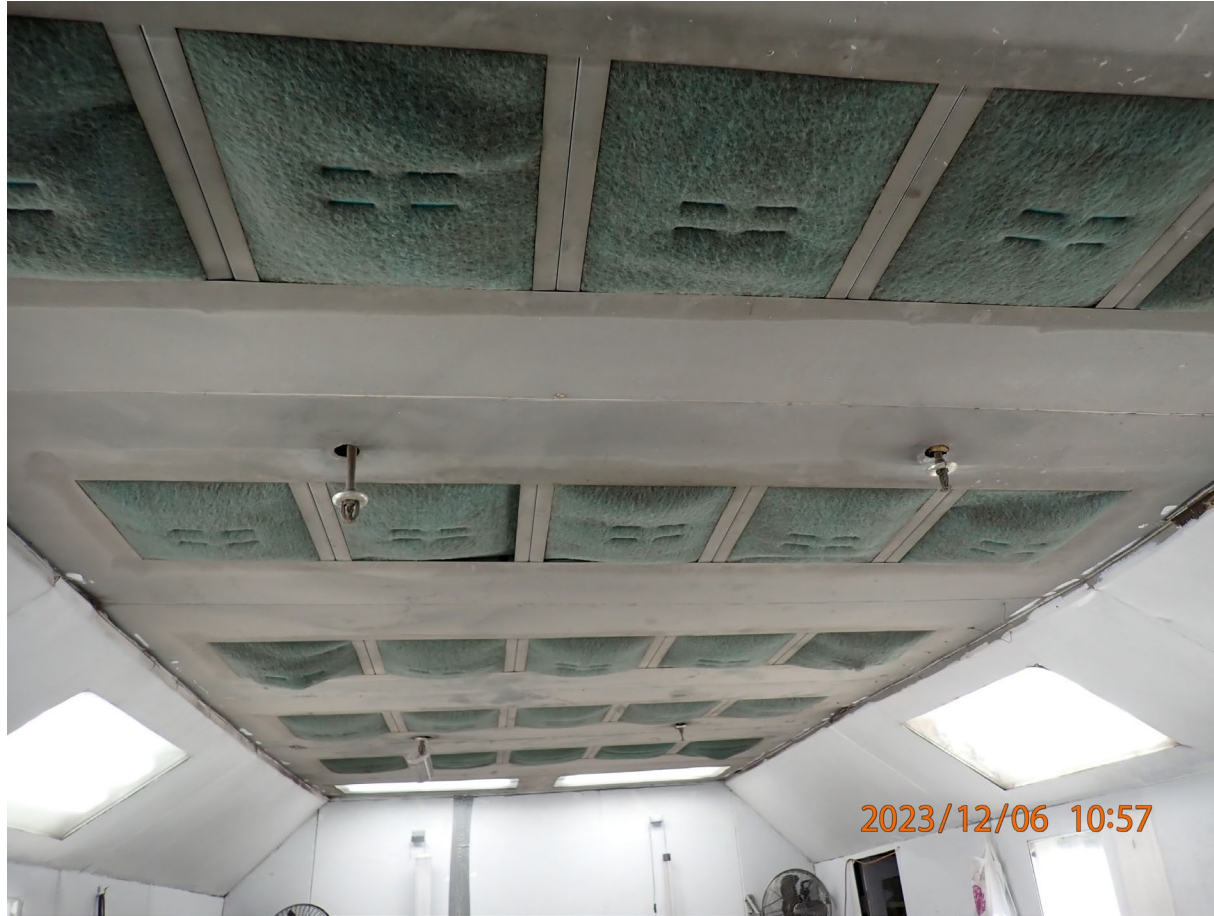
Photo Number: 64

Photo Description: Top of paint booth

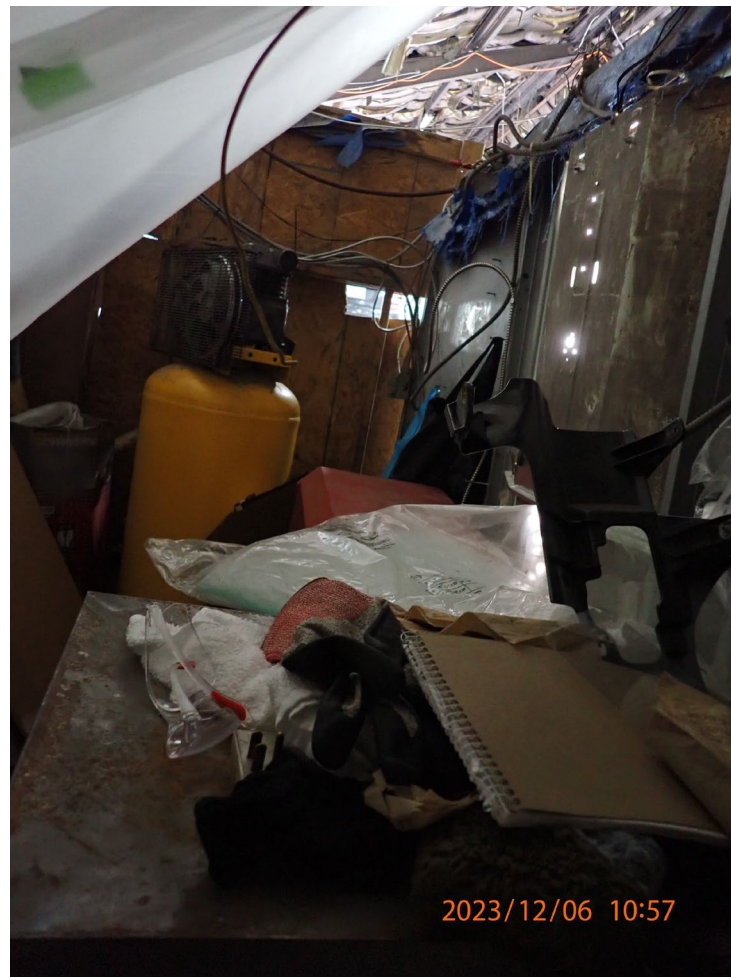
Photo Number: 65

Photo Description: storage area behind the paint booth

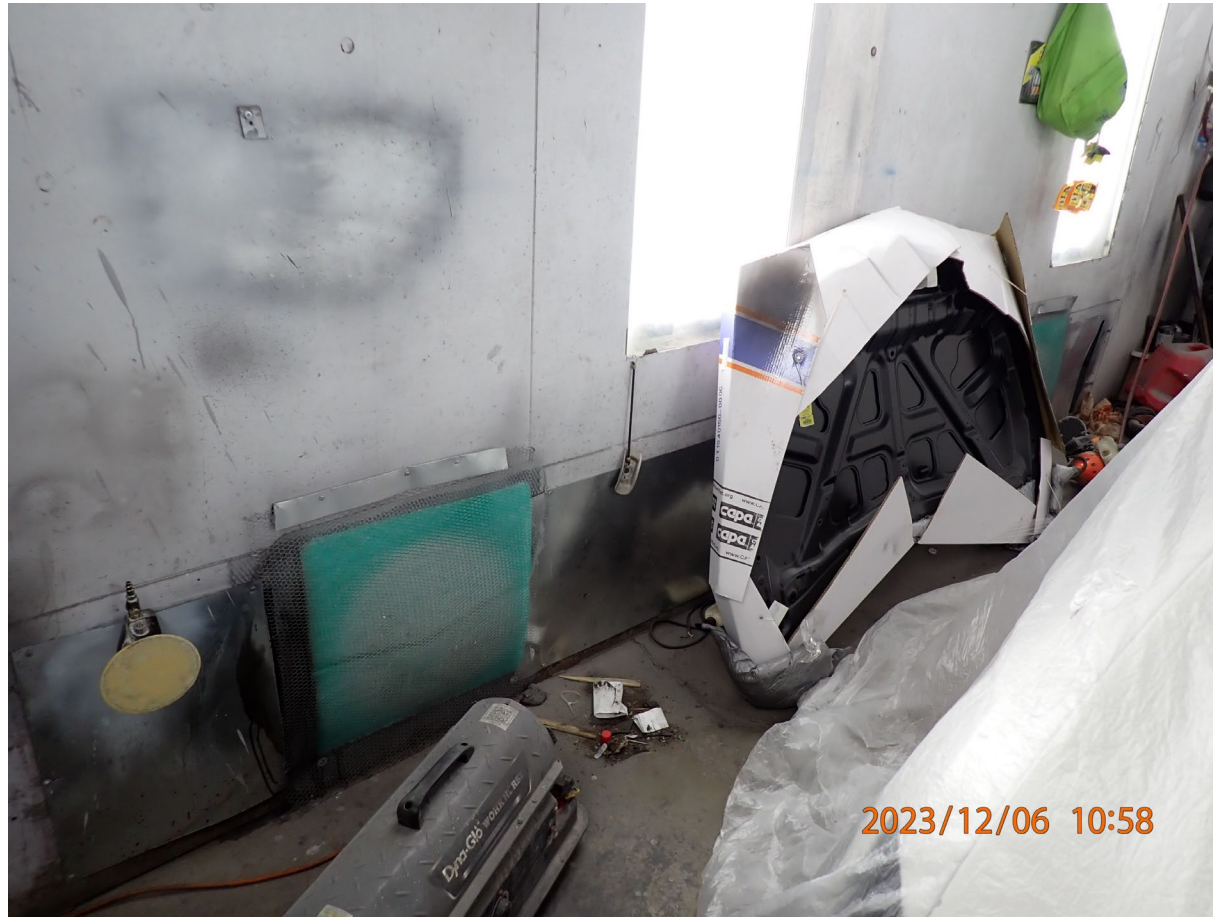
Photo Number: 66

Photo Description: interior of paint booth

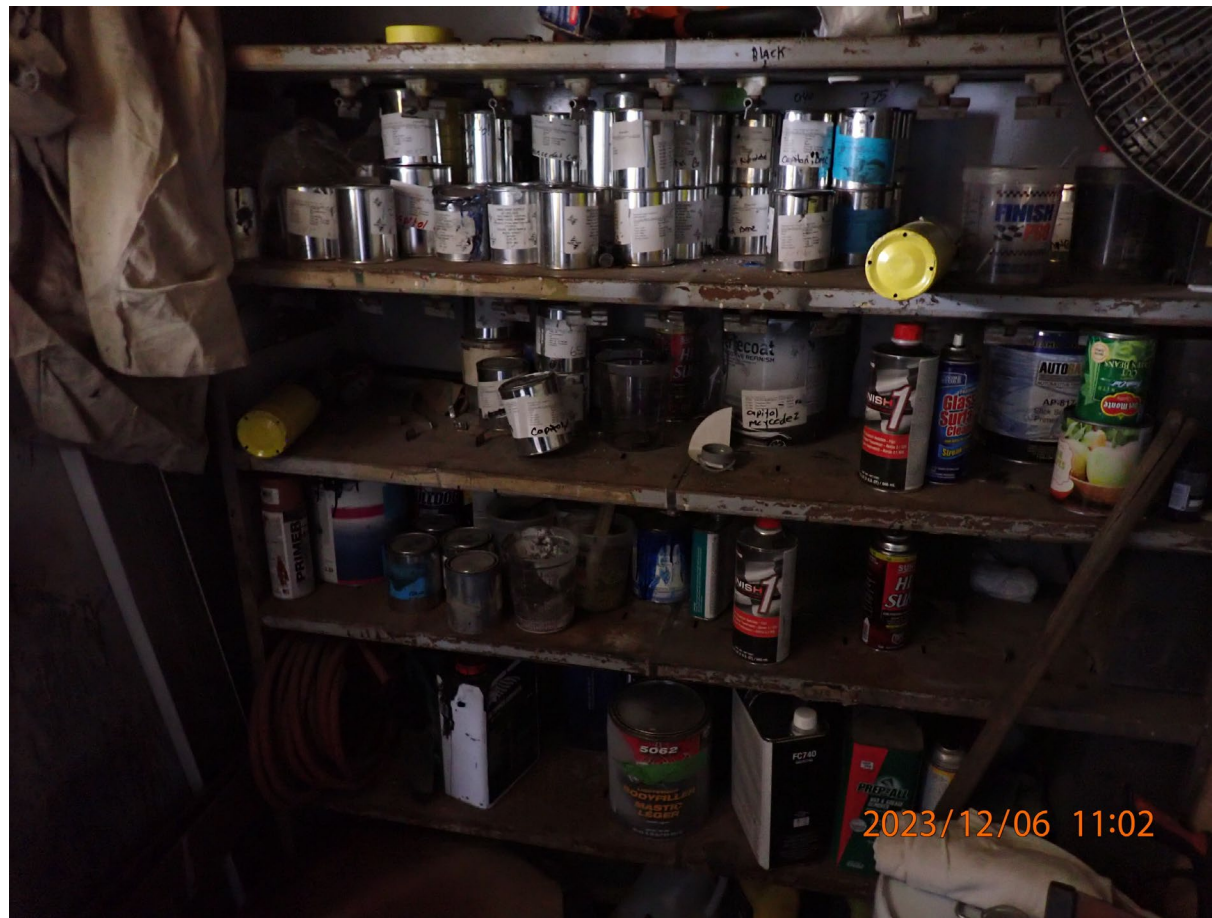
Photo Number: 67

Photo Description: paint storage area

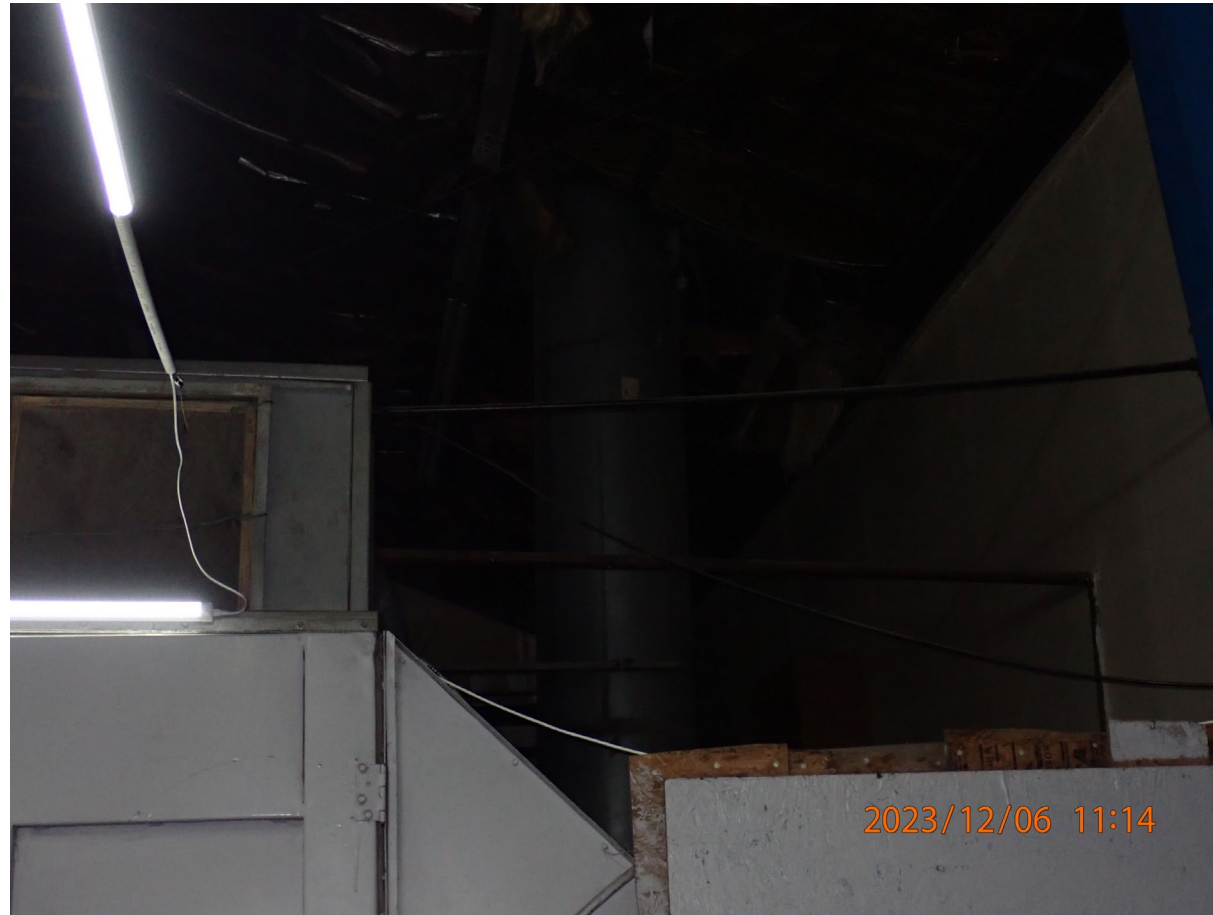
Photo Number: 68

Photo Description: stack on top of paint booth
