SUBJECT SHAC MINUTES - 2/8/84

INCIDENT INVESTIGATION

No. TC 84-1

CONTRACT PIPEFITTER EXPOSED TO STYRENE SPILL IN PIPERACK NEAR  
STYRENE TRUCK LOADING STATION

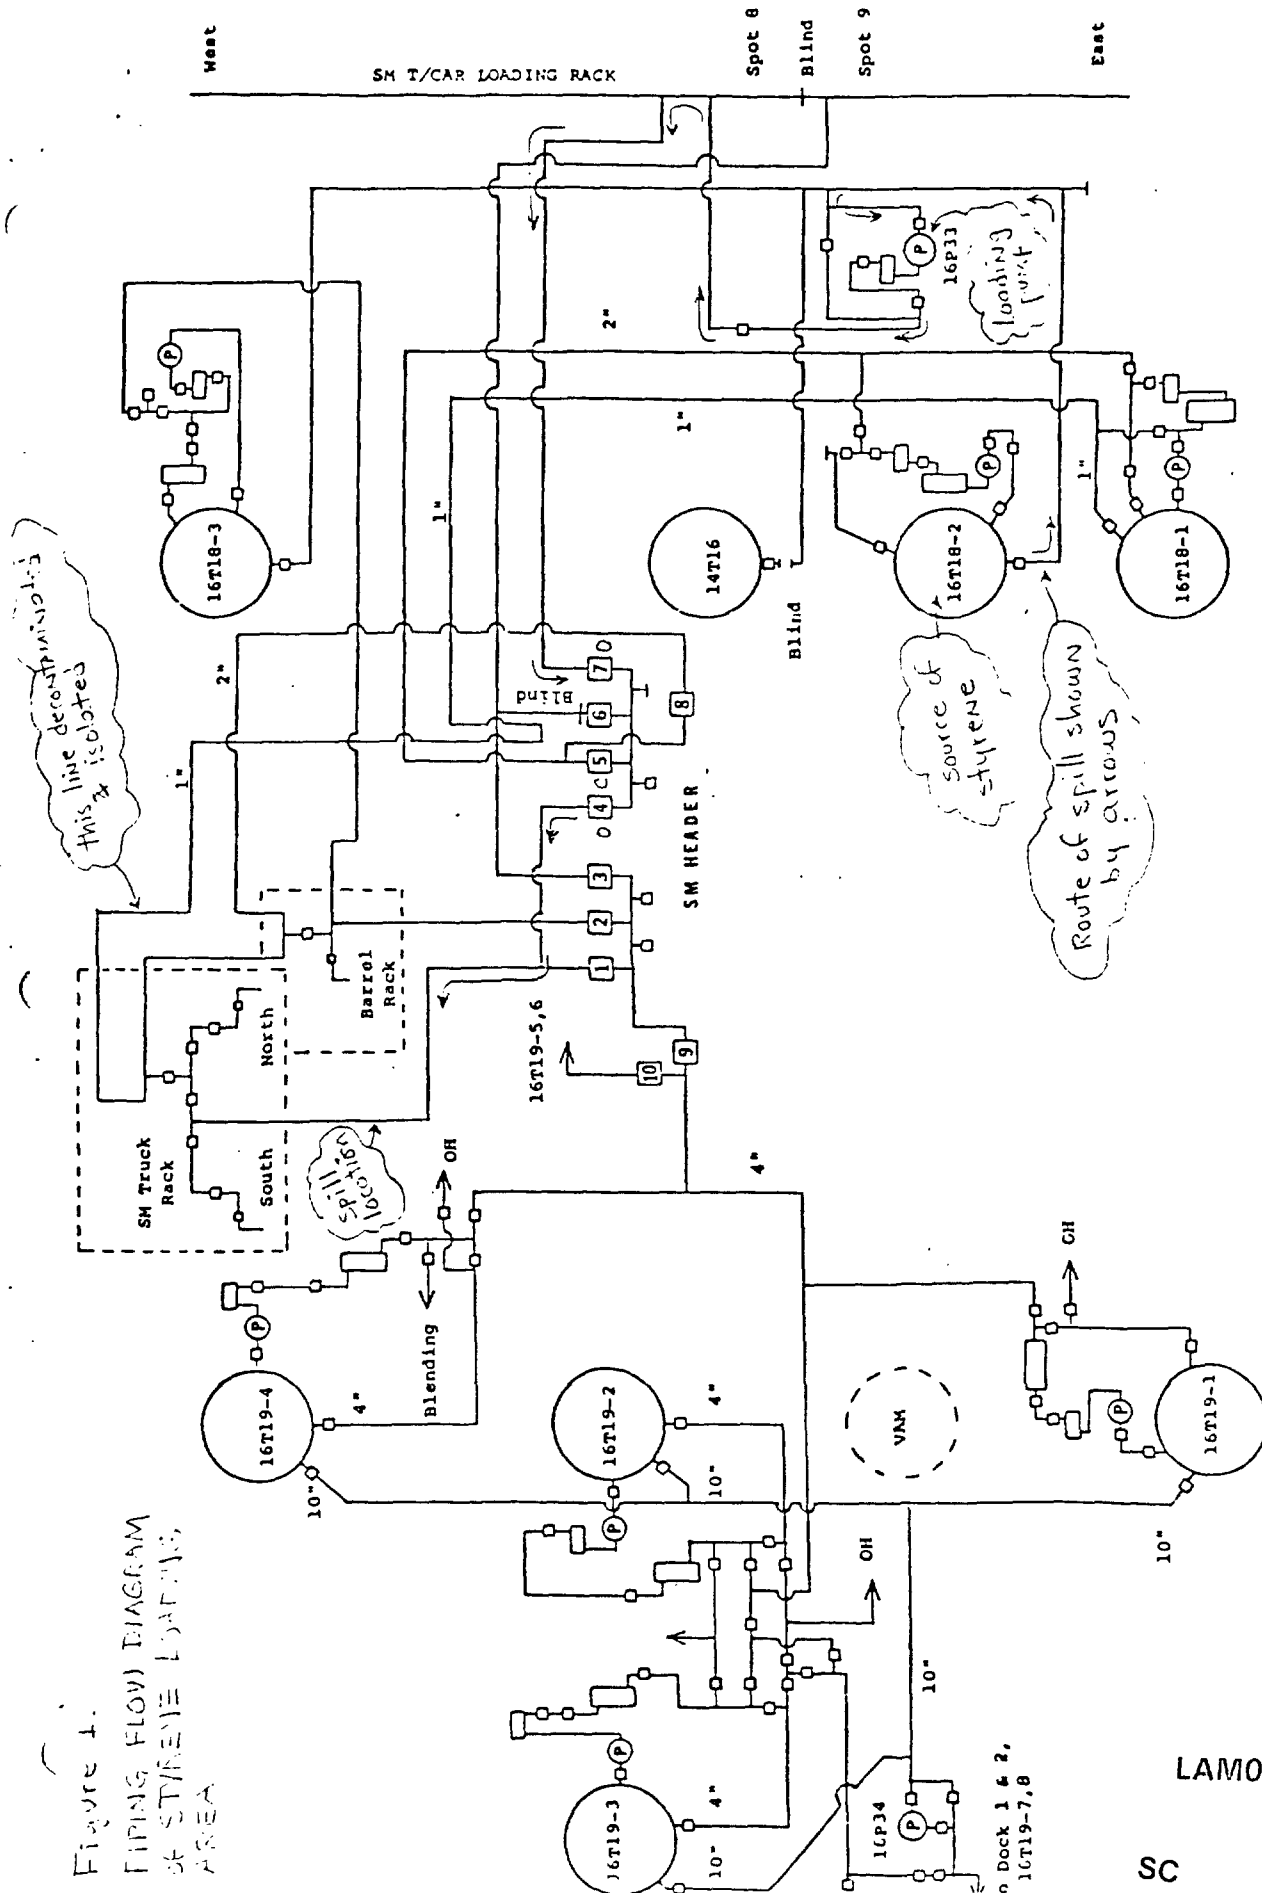
Figure 1.  
PIPING FLOW DIAGRAM  
OF STYRENE LOADING  
AREA

3. The wrong line was decontaminated and isolated. The Styrene Manufacturing foreman was familiar with the styrene loading area. He did not go into the field to inspect the work site, and instructed an operator to prepare the 16T18-1 recirculation line for maintenance, which was done.

7. Styrene manufacturing personnel are generally not familiar with the styrene loading system and do not know how the lines are interconnected and what valving exists.

1. The plant should reexamine the question of ownership of and operational responsibility for ex-battery limits pipelines and systems, with particular attention to material handling systems.  
Responsibility: SHAC  
Complete by: Initial report to PMSB by 3/84.

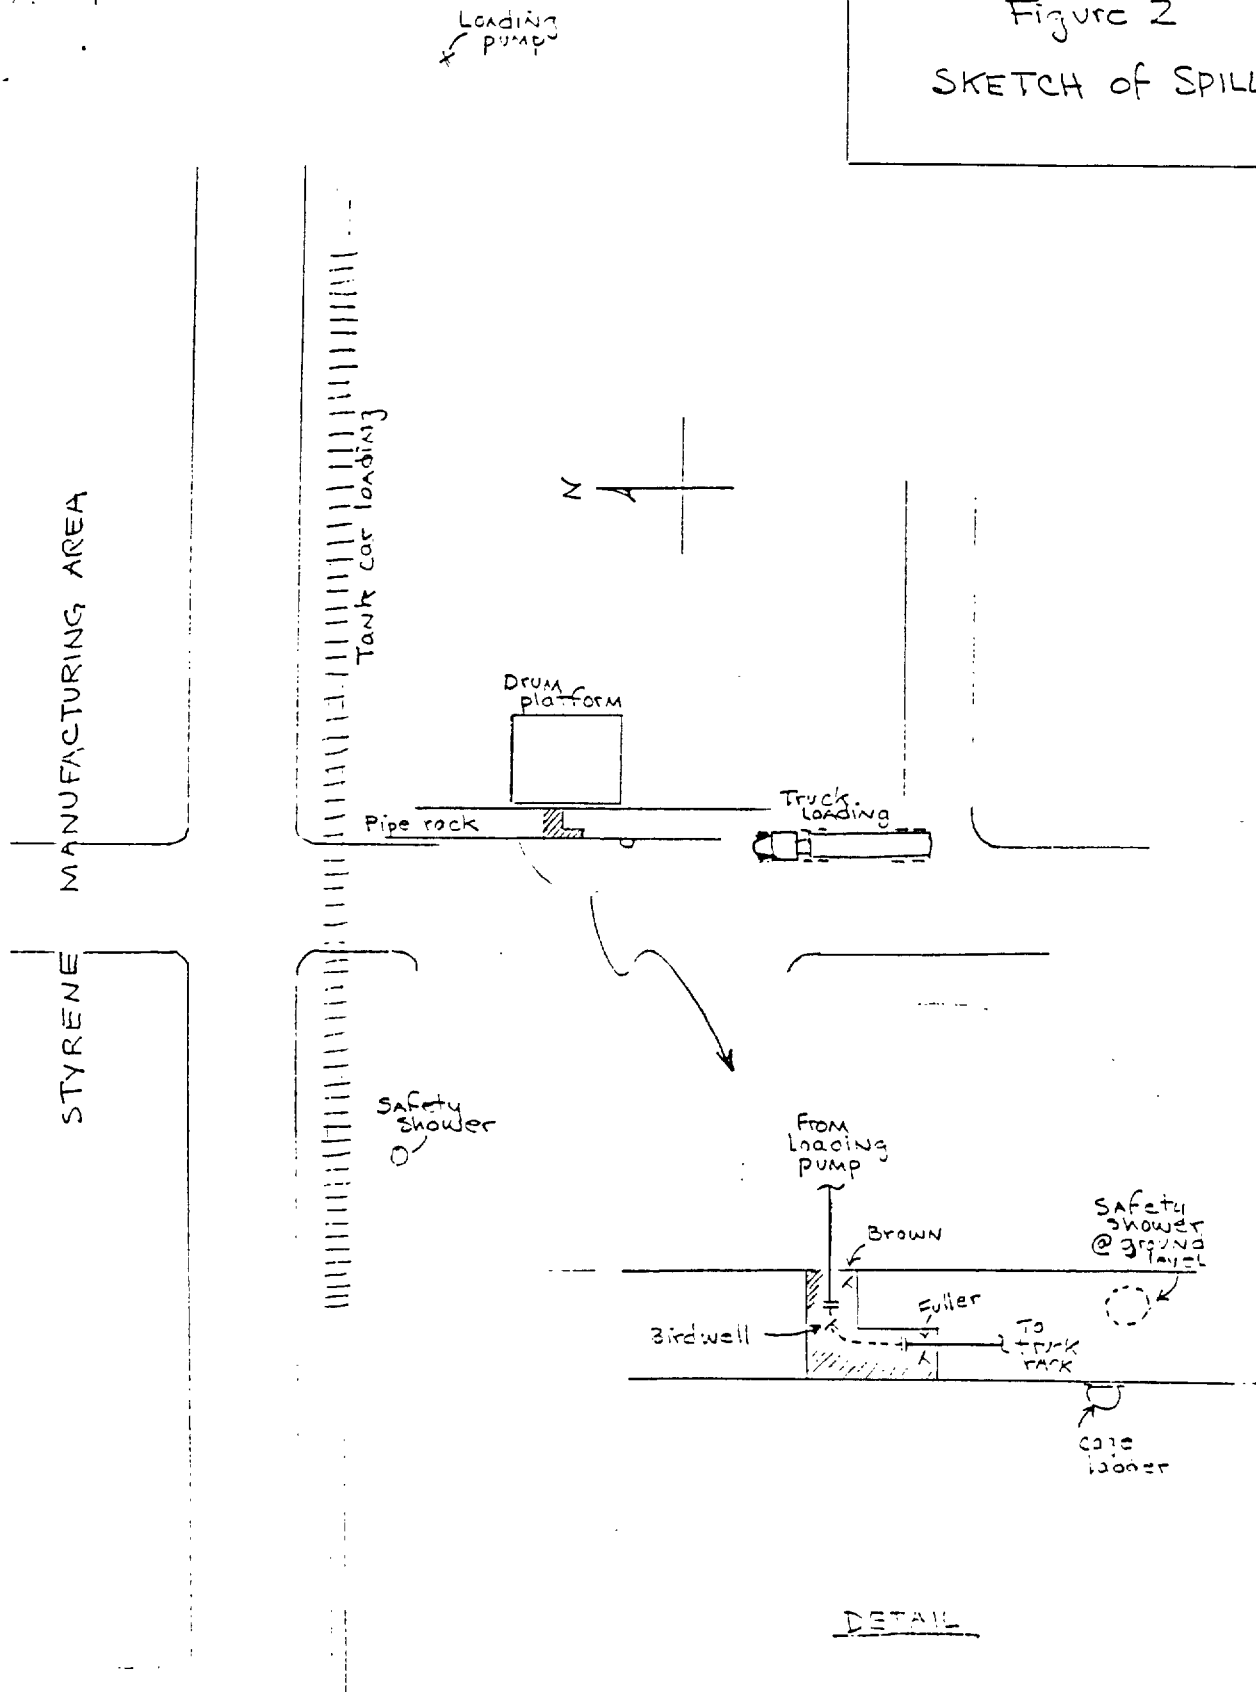
Figure 2  
SKETCH OF SPILL AREA

10. The scaffold constructed for this job, consisting of boards placed across horizontal I beams in the pipe rack, terminated 10 feet from the permanent cage ladder used for access. No means for bridging the gap was provided. The area is very congested and getting across this 10 foot gap would pose a significant hazard.
11. The injured tried to use a safety shower located at the foot of the cage ladder at the job site but it was out of service due to freeze damage. The Opel fitters knew some showers in the area were out of service but did not know which ones.
12. The LP&S review for the Truck Entry project was held about 1 1/2 years ago. Meanwhile, the project engineer for the project had left and been replaced. Styrene operations did not have a clear understanding of what the project was all about.

Three malfunctioning showers were involved in this incident. The safety shower at the spill site was not working (no water) delaying the time required to get under a shower by 30 seconds to a minute. This could have been critical if a severely corrosive or toxic exposure had been involved. The eye bath on the safety shower at the ACY rack did not have sufficient water pressure to function properly, and the shower in the dispensary did not work properly due to low water pressure. These problems were apparently due to potable water system damage that occurred during the heavy freeze between Christmas and New Years -- about 2 weeks before the incident. We are being too complacent about repairs and creating a situation that could lead to a major injury.

3. Safety shower/eyebath repairs should be worked to completion or alternate facilities provided.  
Responsibility: Maintenance & Mfg supt.s  
Timing: immediate

4. Re-emphasise the need to provide proper access to scaffolds and work platforms.  
Responsibility: Maintenance Supt.s  
Capital Projects Supv.  
Complete by: 2/29/84

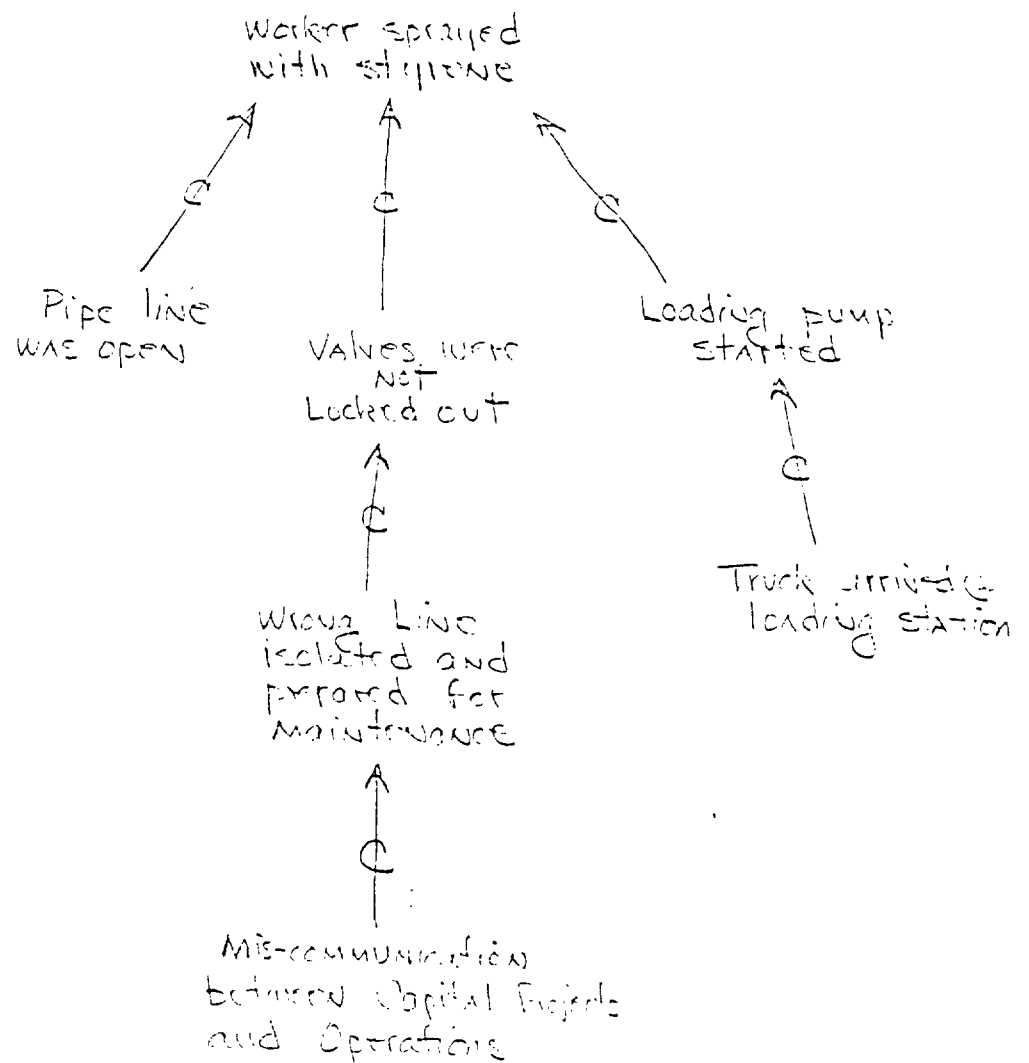
Figure 3  
CAUSE AND EFFECT DIAGRAM

Primary cause of this incident was trying to load styrene through a line which was being worked on. A major contributing factor was failure of the Styrene Manufacturing Foreman to ascertain the nature of the work to be done, which led to decontamination and isolation of the wrong line.
