## Region 6 - Enforcement & Compliance Assurance Division

### INSPECTION REPORT

| Company Name: | CapturePoint, LLC | |
| Facility Name: | North Burbank Unit (NBU) Well #10-13 | |

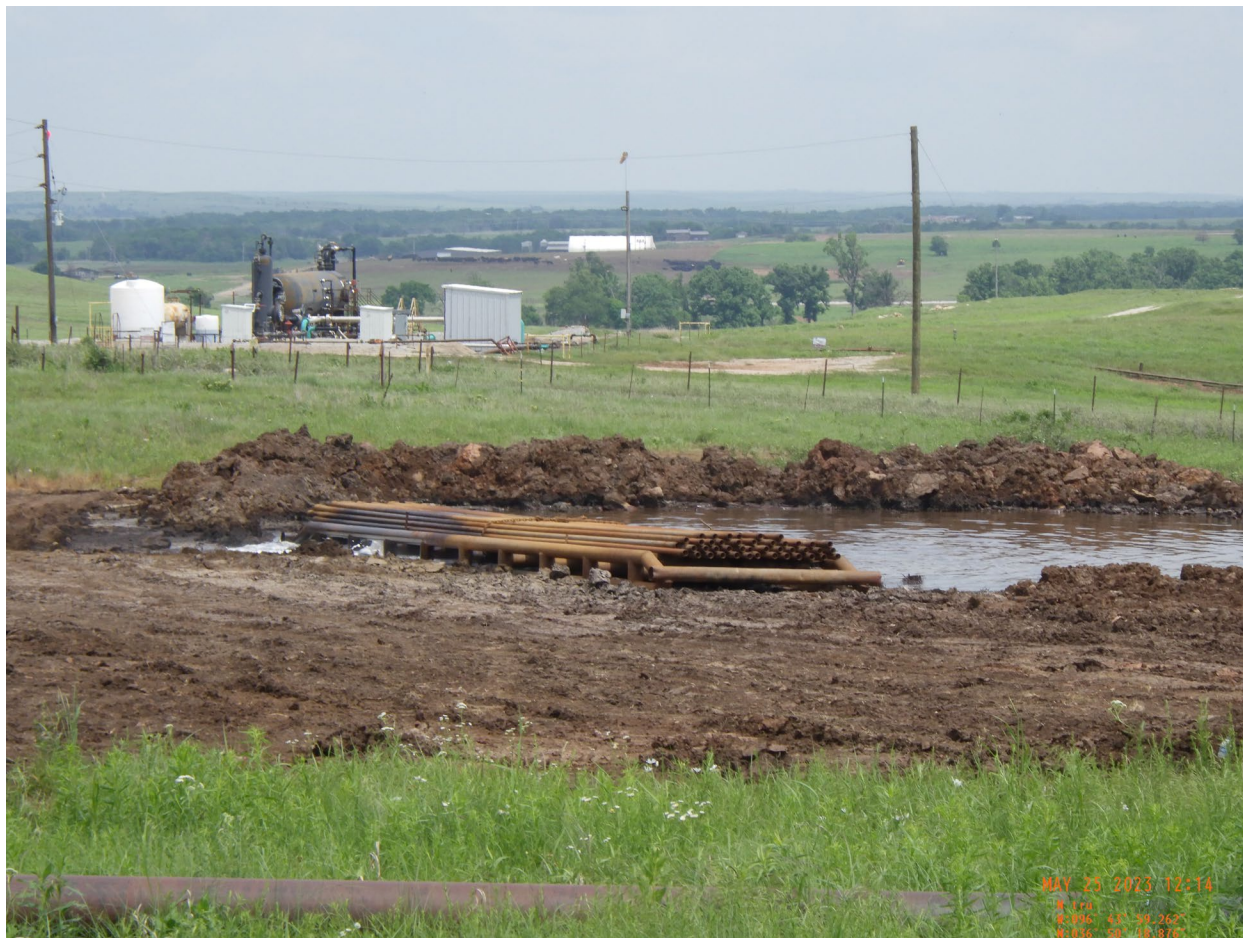
Photo No. 1

I observed the ongoing release, which was well NBU 10-13. Well # 10-13 (release point) can be seen in the Appendix 1 (photo log) photo's 1 and 2 which is attached to this report. From this same location, I observed the first and uppermost, temporary containment pit/dam which can also be seen in the photos. GPS location information is stamped on each photo as well as listed in the metadata section below each photo in the photo log.

**Description:** This was the location of the blowout. This was well NBU 10-13. This was also the first containment pit.

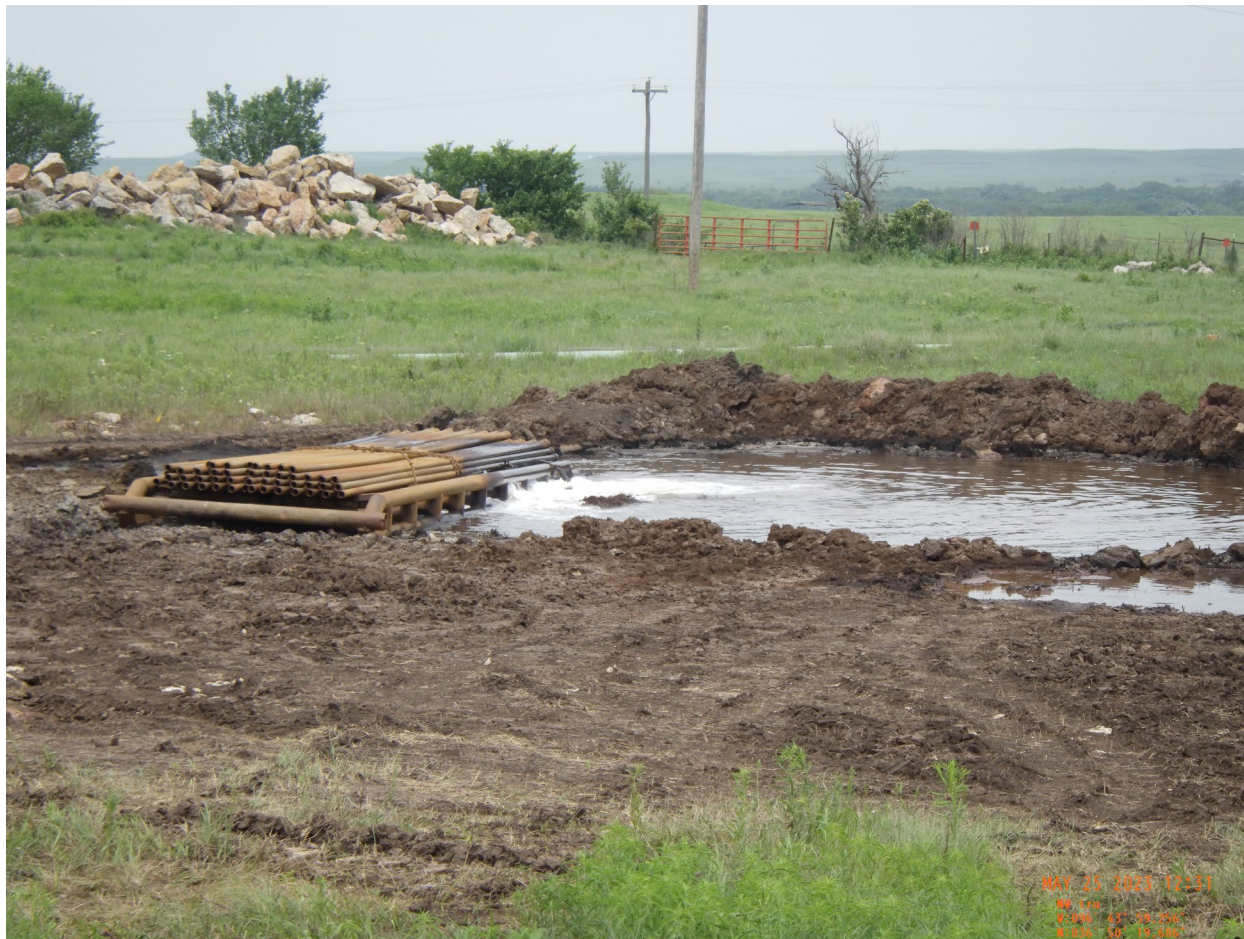
Photo No. 2

**Description:** This was the location of the blowout. This was well NBU 10-13. This was also the first containment pit.

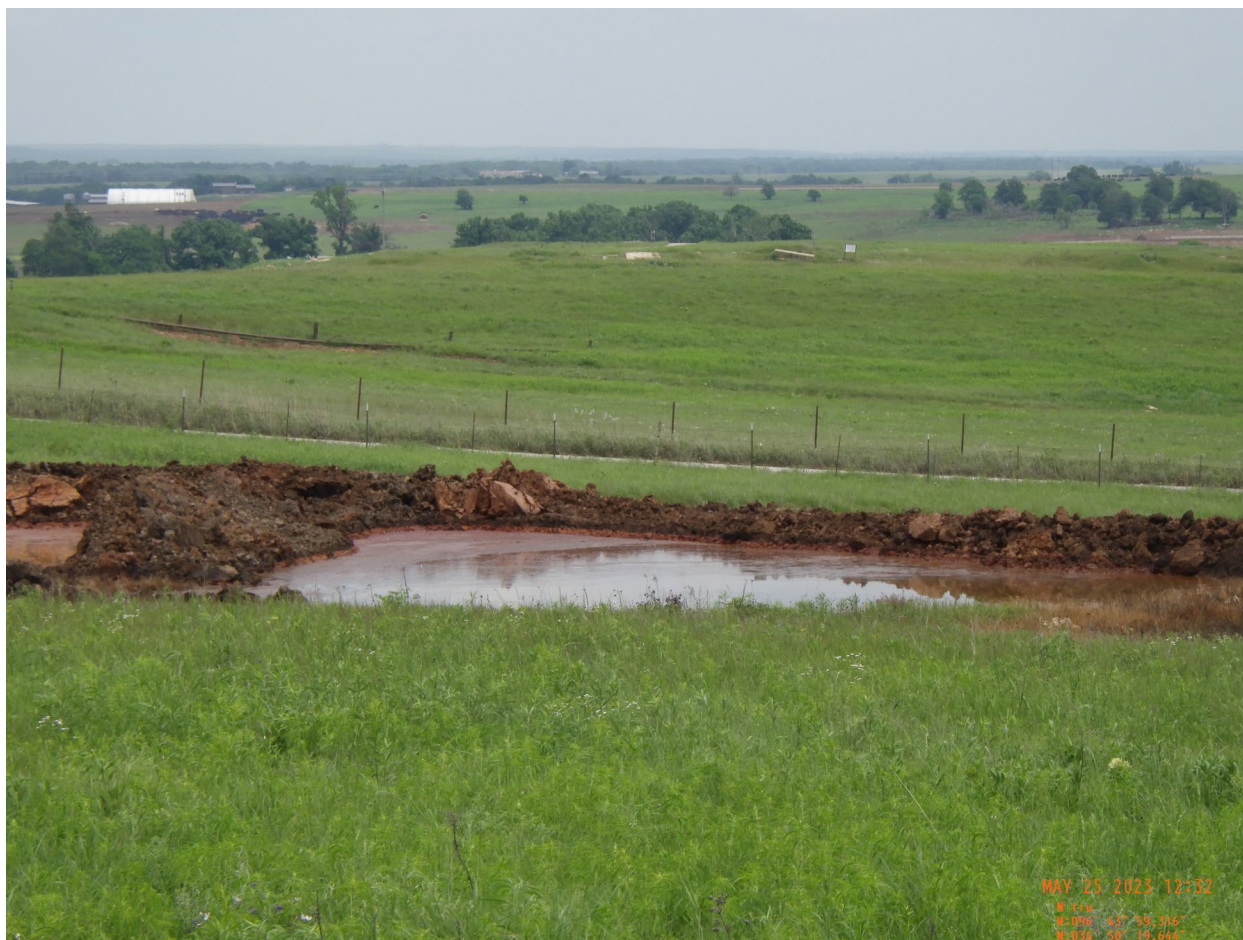
Photo No. 3

I observed the second, temporary containment pit/dam which can be seen in photo No. 3. While the release was being contained at the time of the inspection, we maintained a safe distance from the active release in areas closest to the release point.

**Description:** This was the second containment pit.

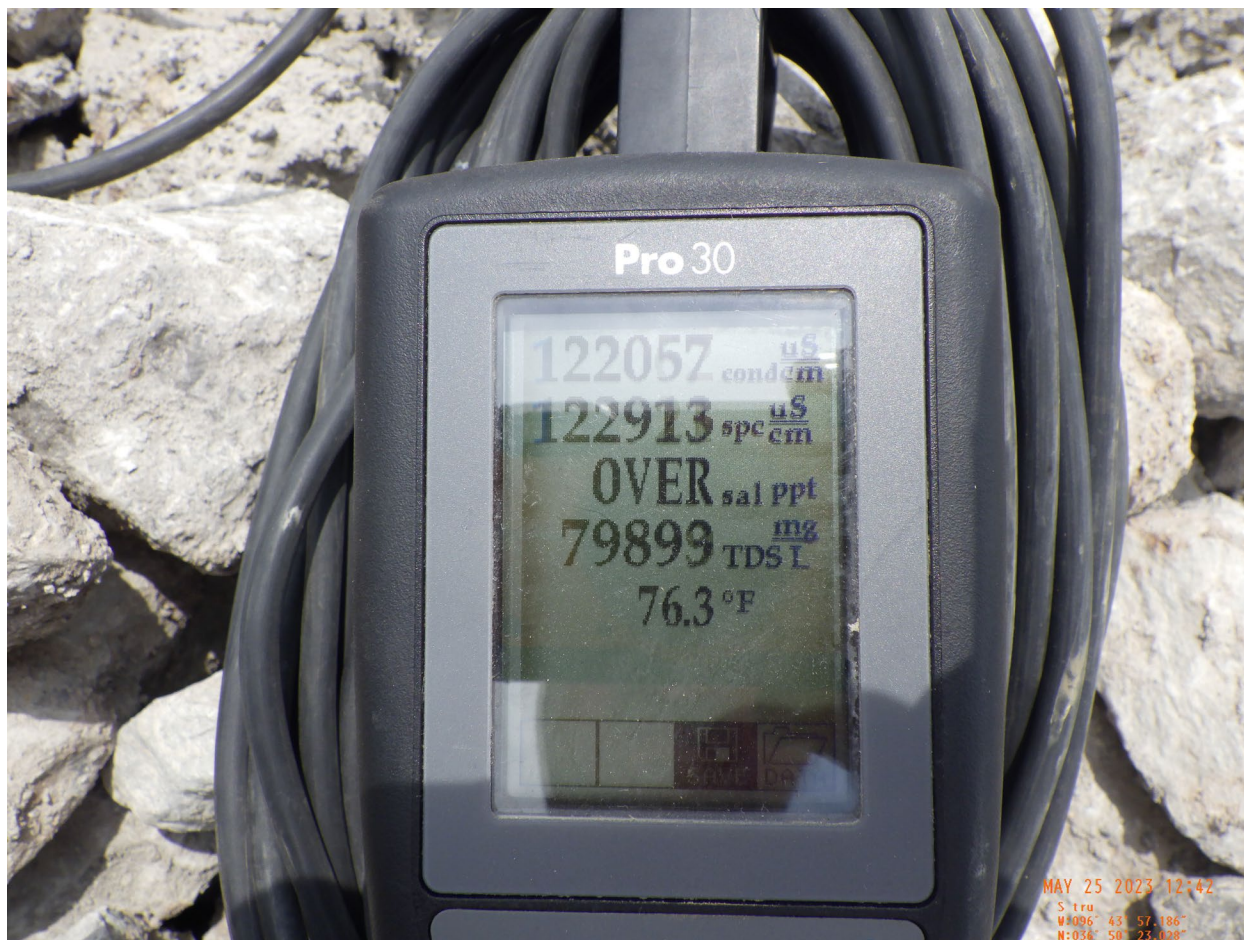
Photo No. 4

I observed the third, temporary containment pit/dam and observed a TDS field reading of 79,899 milligrams per liter (mg/L) from the contained waters. This was the highest level of TDS observed during the inspection. These observations can be seen in photos 4 and 5. All TDS field readings were taken the EPA issued, properly calibrated, YSI Pro 30 conductivity meter. At the same location, I observed water transfer pumps removing water from the catch pit and transferring it to a nearby underground injection facility as stated by Talia Clark.

**Description:** This was a TDS field reading of 79,889 mg/L taken in the third containment pit.

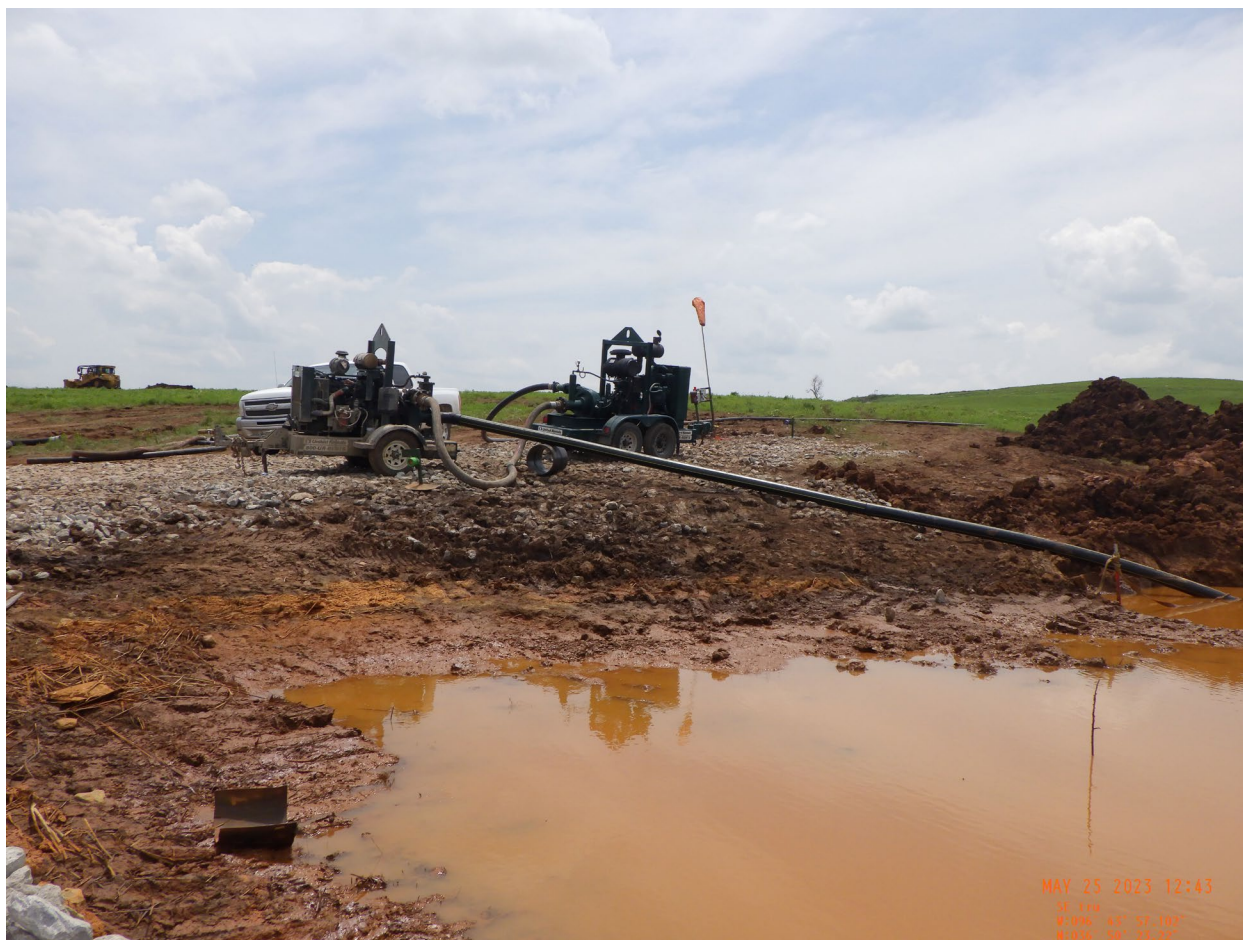
Photo No. 5

**Description:** This was the third containment pit. Large injection pumps were transporting water for underground injection.

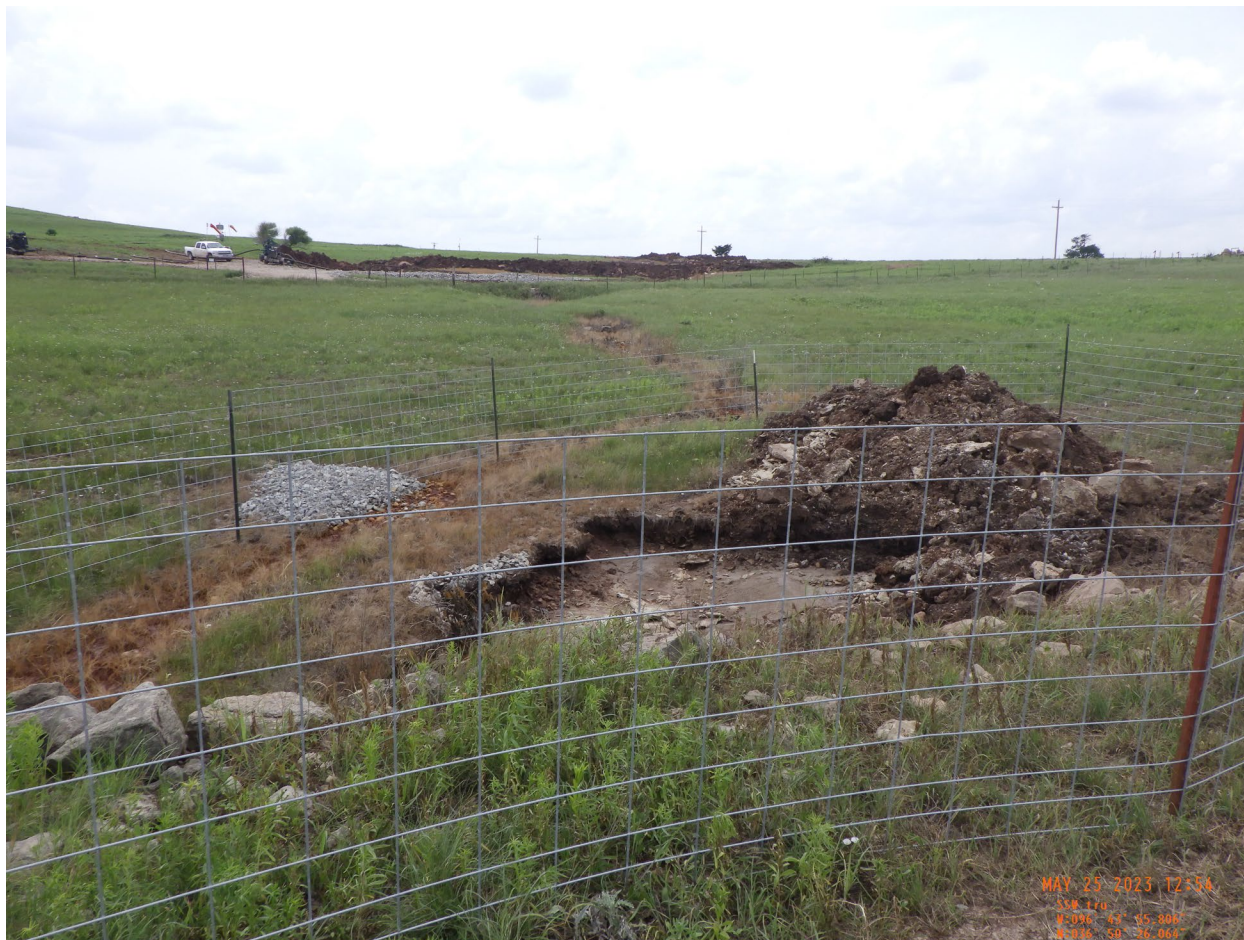
Photo No. 6

I observed the initial pure/release discovery point. Talia Clark stated the release was initially discovered at this location and initial containment measures were implemented, but the ultimate source of the

purge was traced back to well # 10-13. The initial discovery area can be seen in photo No. 6. At the same location I observed an elevated TDS field reading of 42,701 mg/L, which is documented in photo No. 7. I observed the fourth downstream containment pit/dam as well as an elevated TDS field reading of 16,731 mg/L. These observations can be seen in photo's No. 8 and 9.

**Description:** This was the location where the pure was initially discovered.

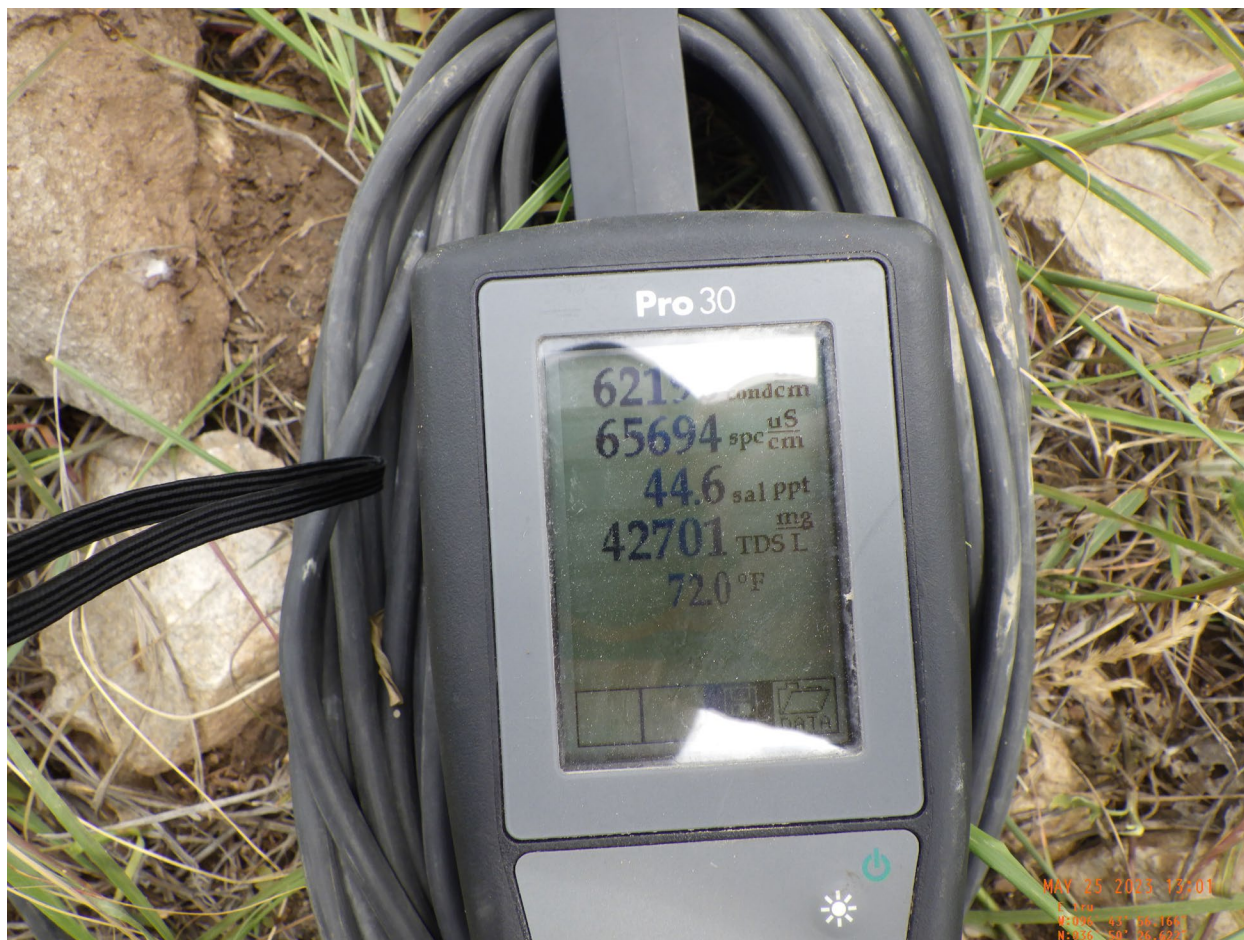
Photo No. 7

**Description:** This was a TDS field reading of 42,701 mg/L at the location where the purge was initially discovered.

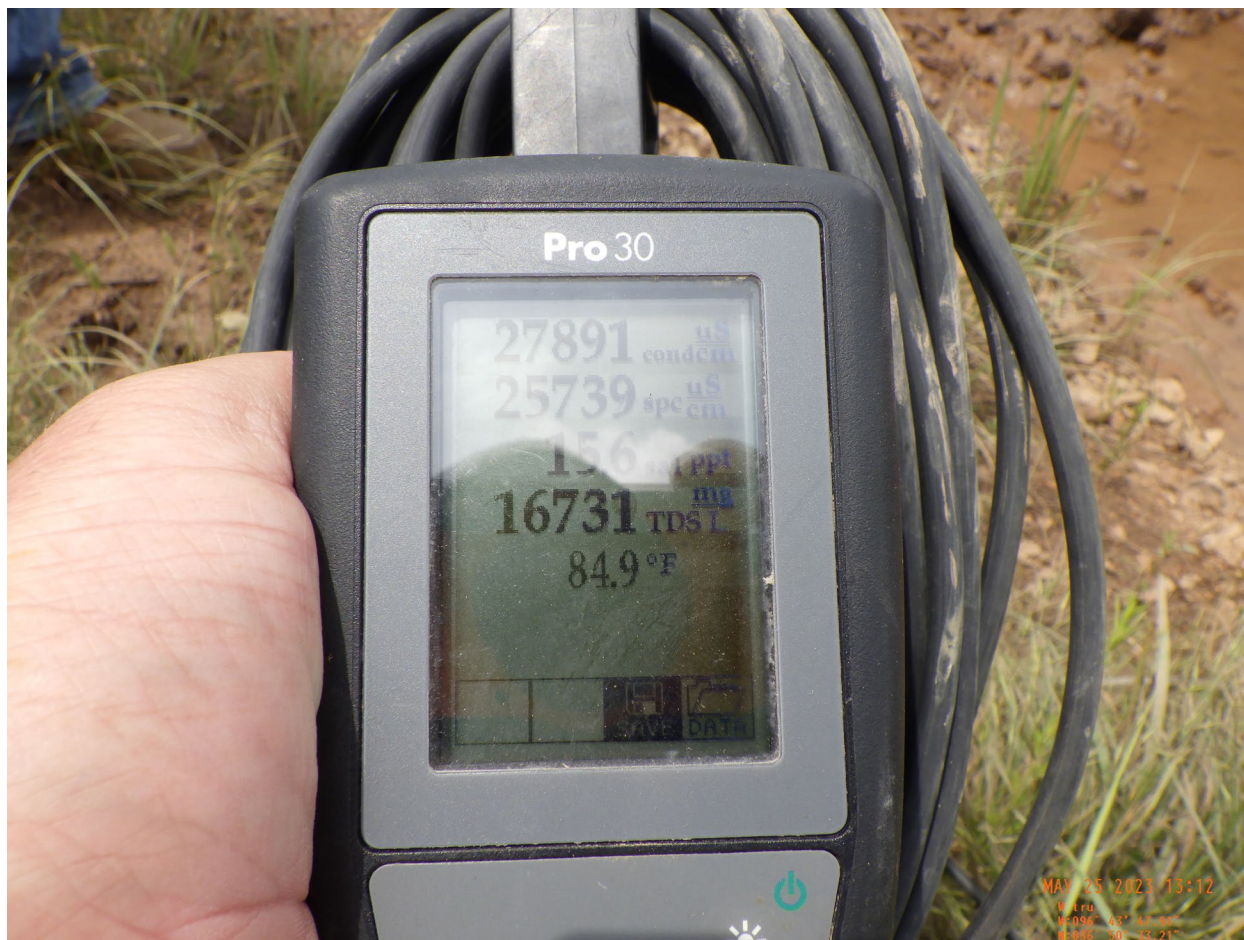
Photo No. 8

**Description:** This was a TDS field reading of 16,731 mg/L taken at the fourth downstream containment dam.

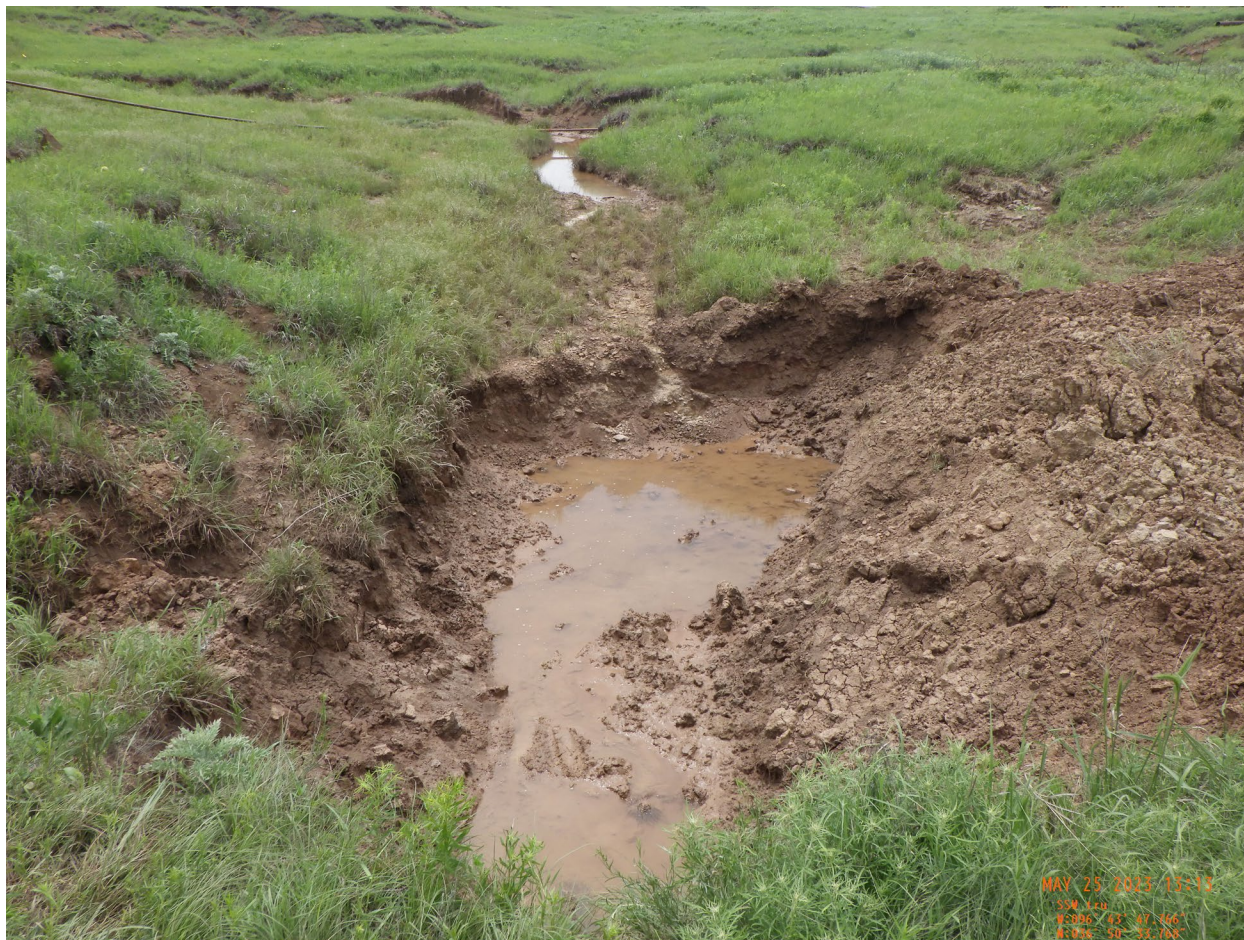
Photo No. 9

**Description:** This was the fourth downstream containment pit/dam which had been placed by the operator.

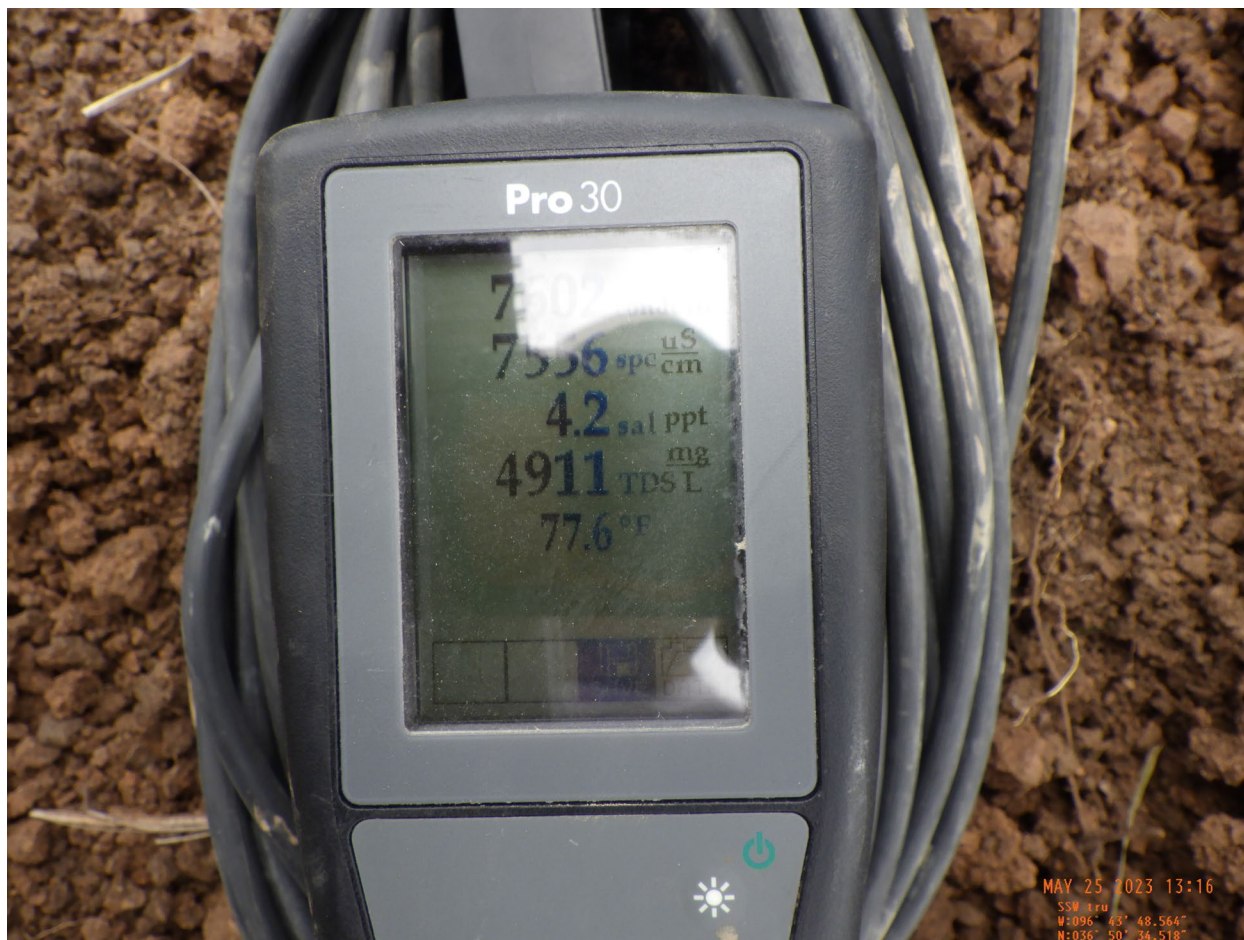
Photo No. 10

Immediately downstream from the 4<sup>th</sup> and lowermost temporary containment dam, I observed an elevated TDS field reading of 4,911 mg/L (see photo No. 10) This observation suggested the contaminated water may be leaching through or under the lowermost containment pit/dam. Talia Clark stated she would have men and equipment place an additional downstream containment dam to prevent further downstream migration of elevated TDS waters.

**Description:** This was an elevated TDS field reading of 4,911 mg/L taken downstream from the fourth/lowermost containment pit/dam.

During the inspection, Talia Clark, representing CapturePoint, LLC stated the company would place an additional downstream containment dam to prevent additional downstream migration.

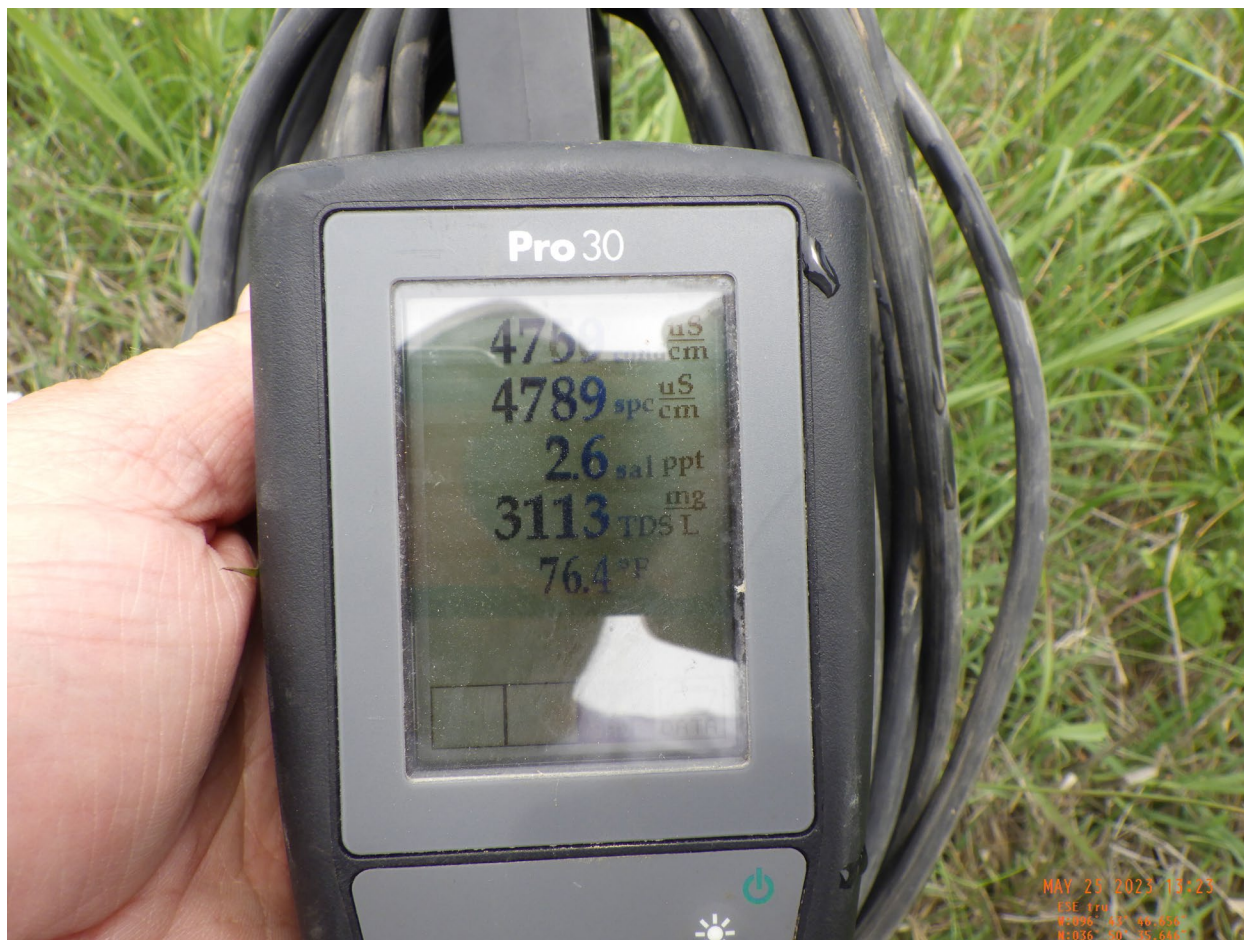
Photo No. 11

Continuing downstream, I observed an elevated TDS field reading of 3,113 mg/L which can be seen in photo No. 11.

**Description:** This was an elevated TDS field reading of 3,113 mg/L taken downstream from the lowermost containment structure.

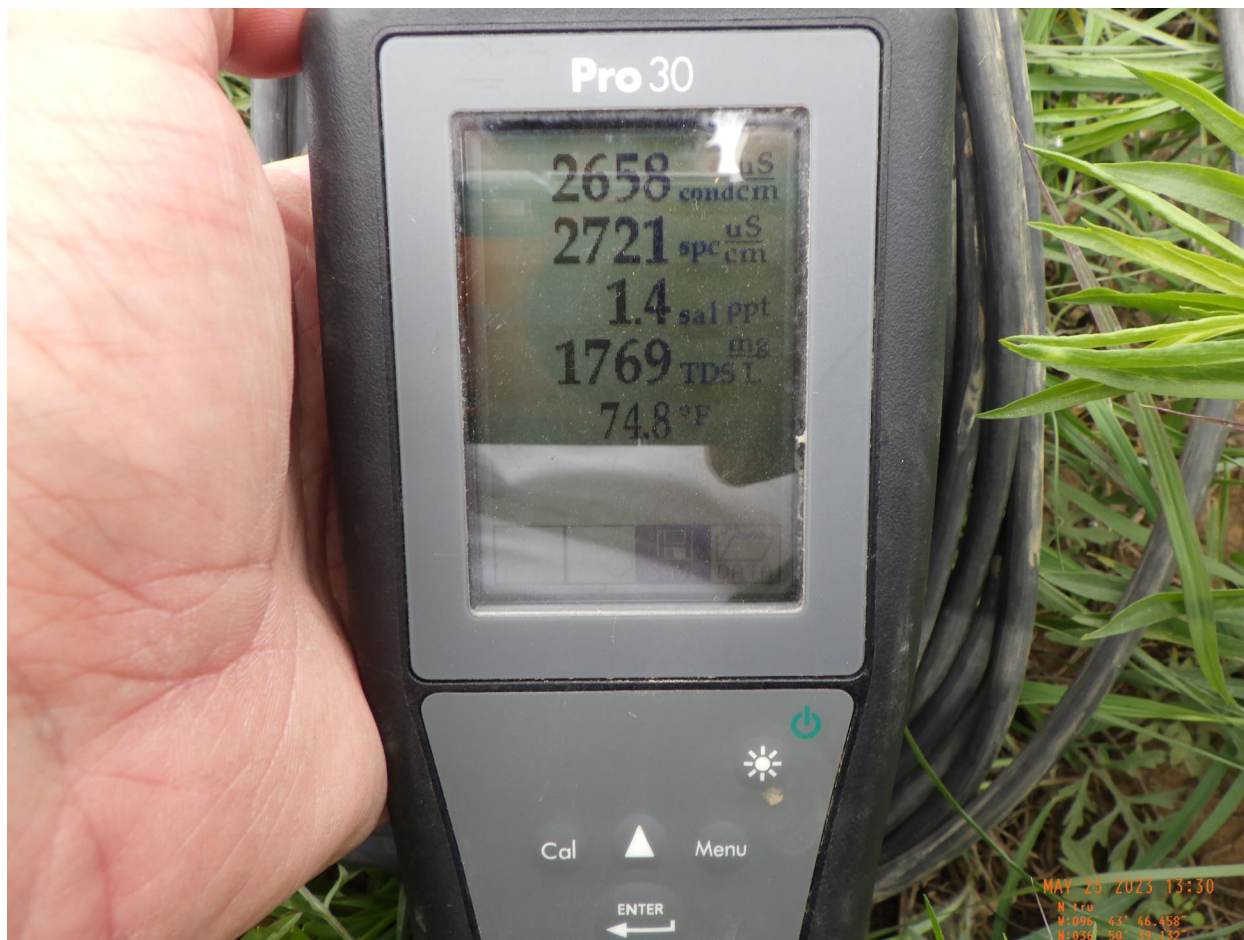
Photo No. 12

Continuing north/downstream, I observed an elevated TDS field reading of 1,769 mg/L which can be seen in photo No. 12. Talia Clark stated from about this point and continuing downstream, we could also observe historic spill impacts, which were under ongoing cleanup operations. I did observe a small gasoline water pump and transfer hose near this location as evidence of recent cleanup activities.

**Description:** This was an elevated TDS field of 1,769 mg/L reading observed downstream from the lowermost containment structure.

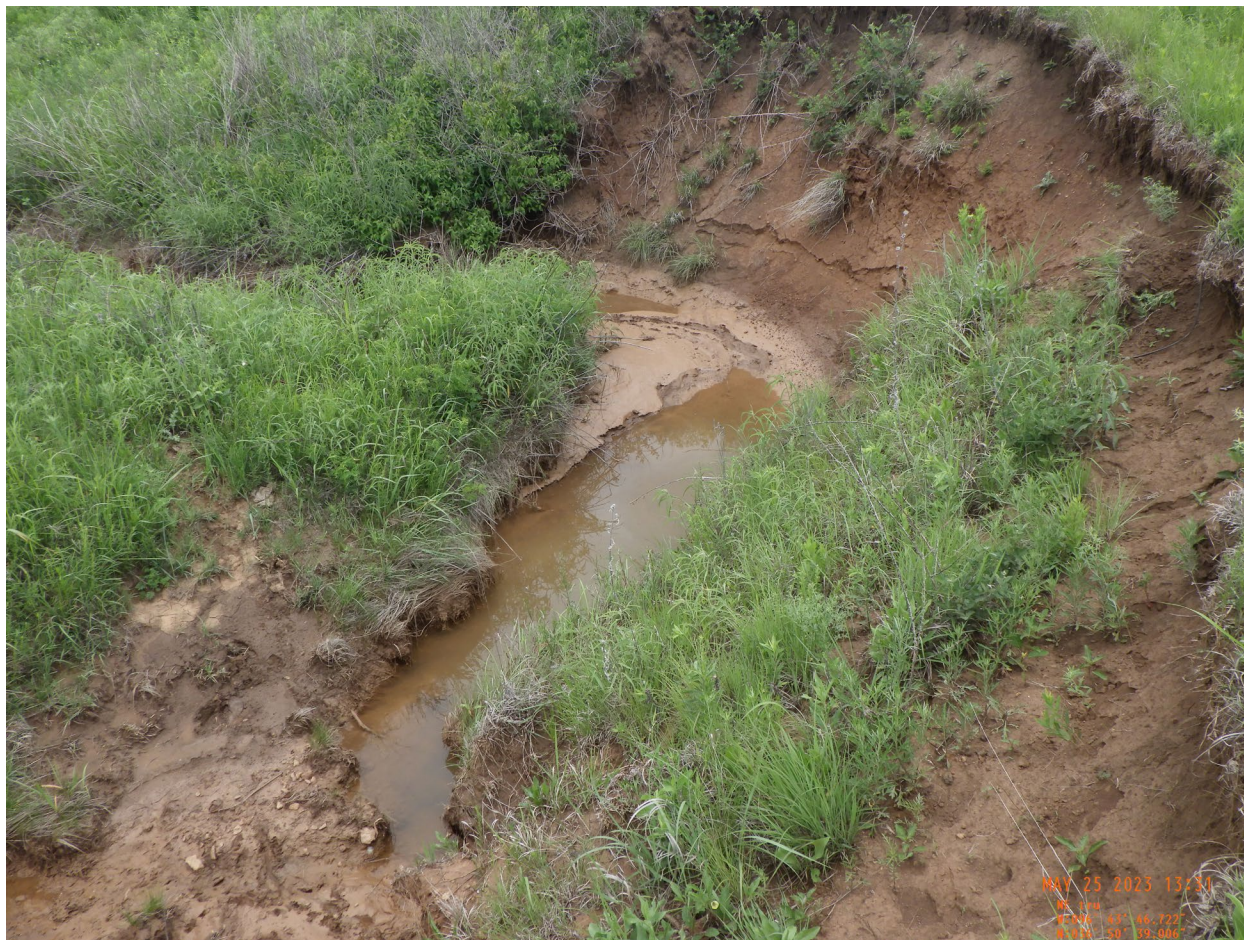
Photo No. 13

**Description:** This was a photo of the streams bed and bank features where the TDS field reading of 1,769 mg/L from photo No. 12 was taken.

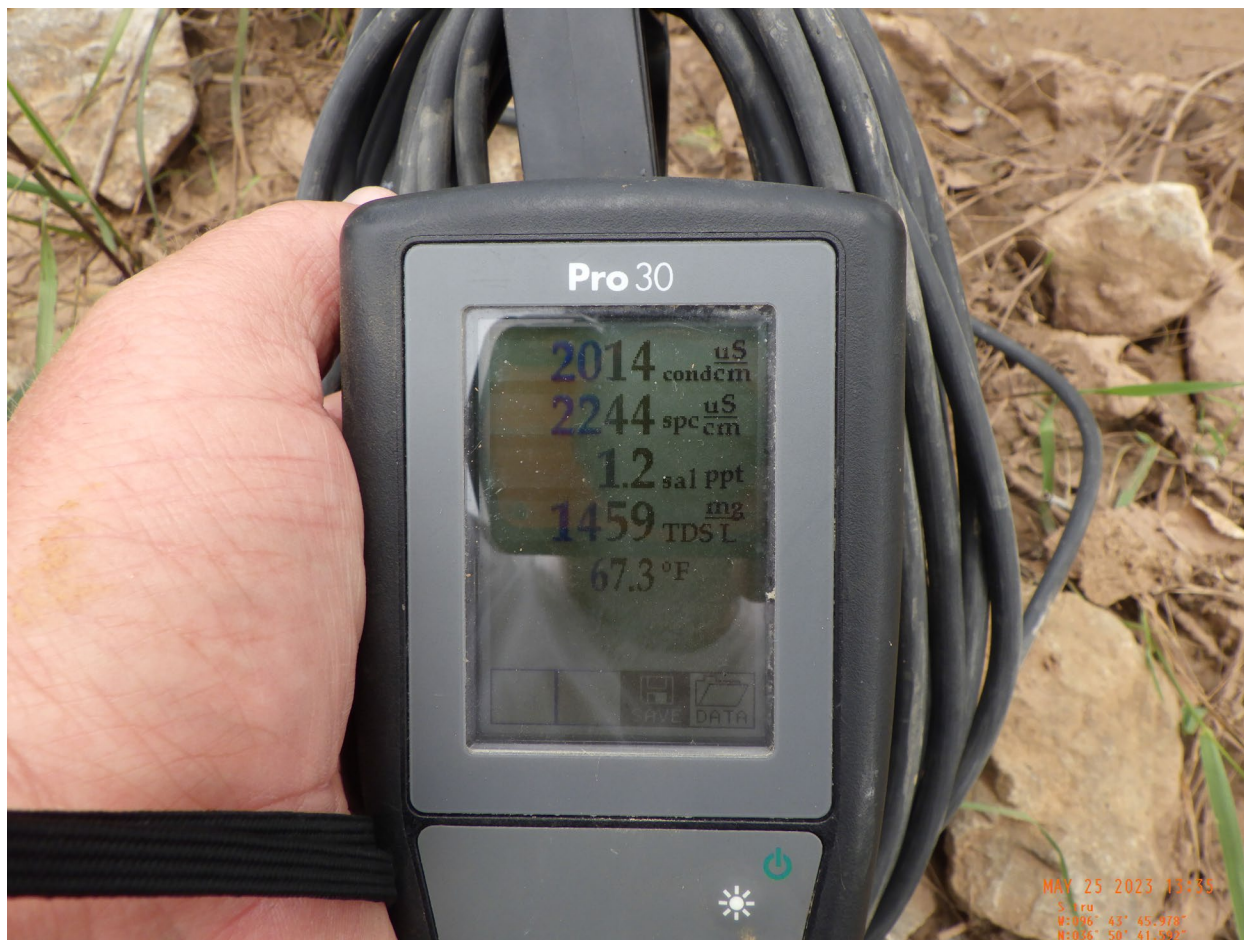
Photo No. 14

I observed an elevated TDS field reading of 1,459 mg/L along the impacted tributary. This represented the lowest observed TDS field reading along the main channel of the tributary. At the same location, I observed the bed and bank features of the impacted tributary, these observations can be seen in photos No. 14 and 14. There were no containment structures below this point to prevent downstream migration of impacted waters.

**Description:** This was an elevated TDS field reading of 1,459 mg/L taken downstream from the lowermost containment structure.

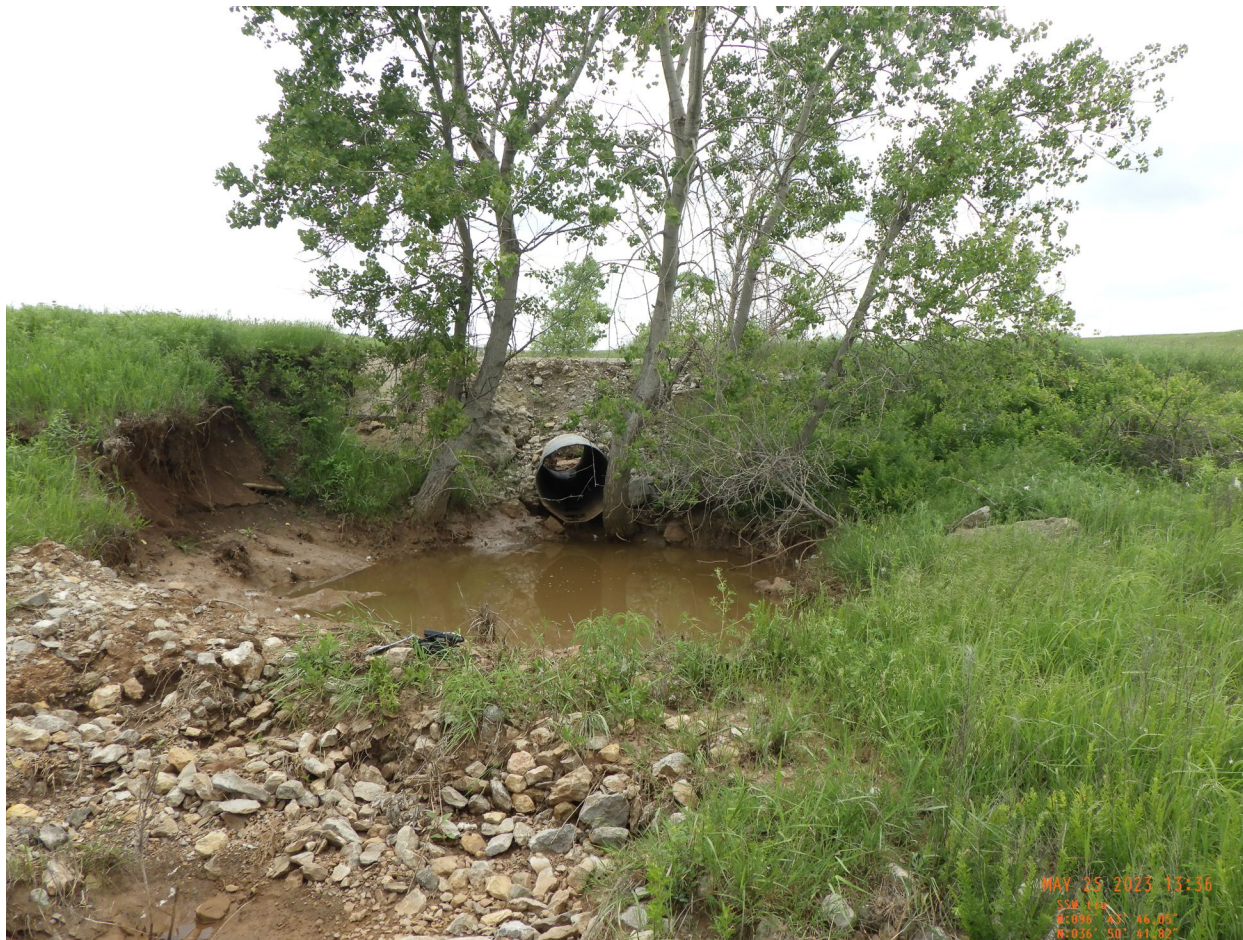
Photo No. 15

**Description:** This was the bed and bank features of the stream where the TDS field reading from photo No. 14 was taken.

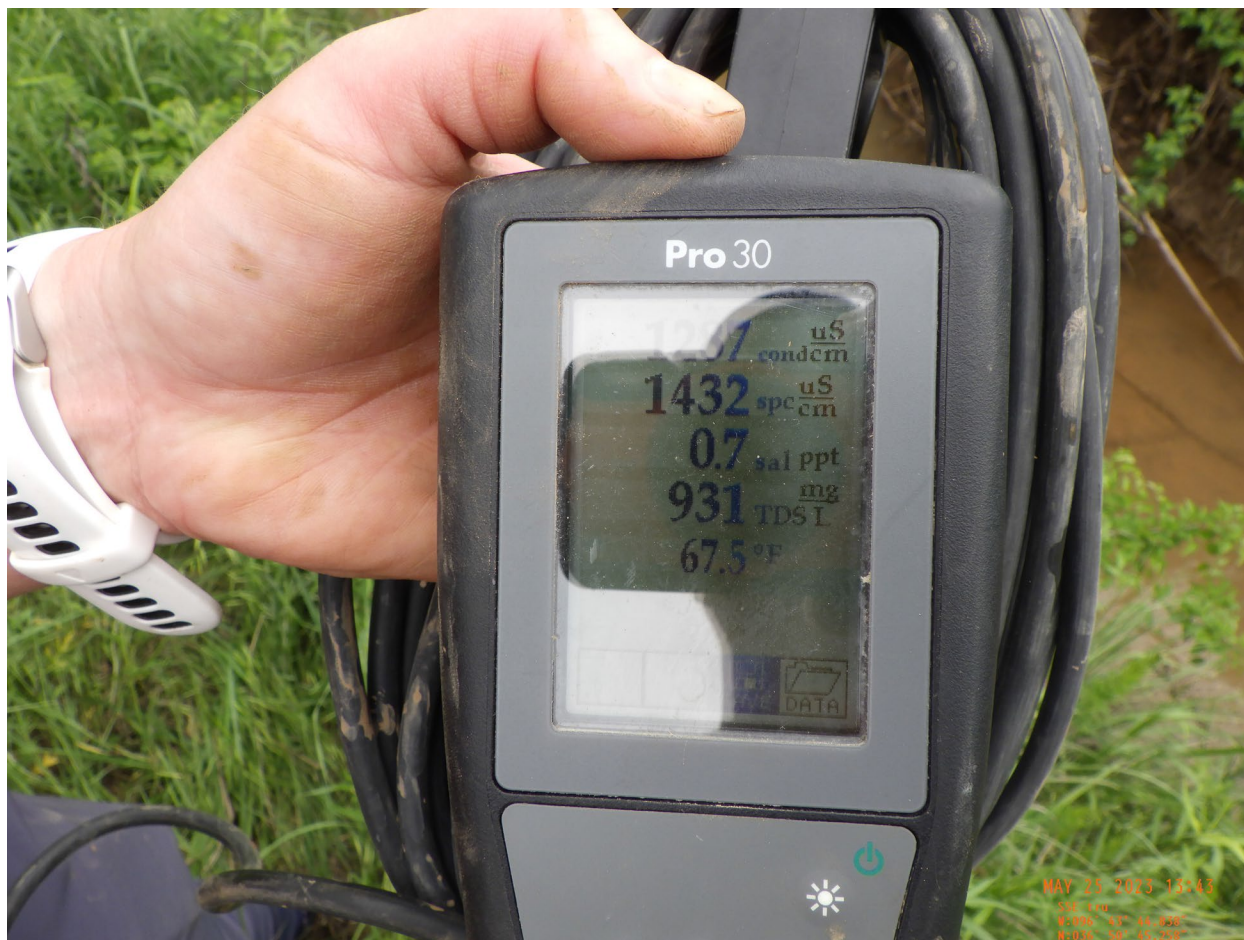
Photo No. 16

I observed a TDS field reading of 931 mg/L taken in an unimpacted stream just upstream, before the confluence with the impacted tributary. I observed the bed and bank features along the unimpacted stream. This TDS field reading was equivalent to background TDS levels in the area. These observations can be seen in photos No. 16 and 17.

**Description:** This was a TDS field reading of 931 mg/L taken from an unimpacted stream just before its confluence with the impacted tributary. This measurement ~~should be used to assess~~ was the background TDS levels in the area.

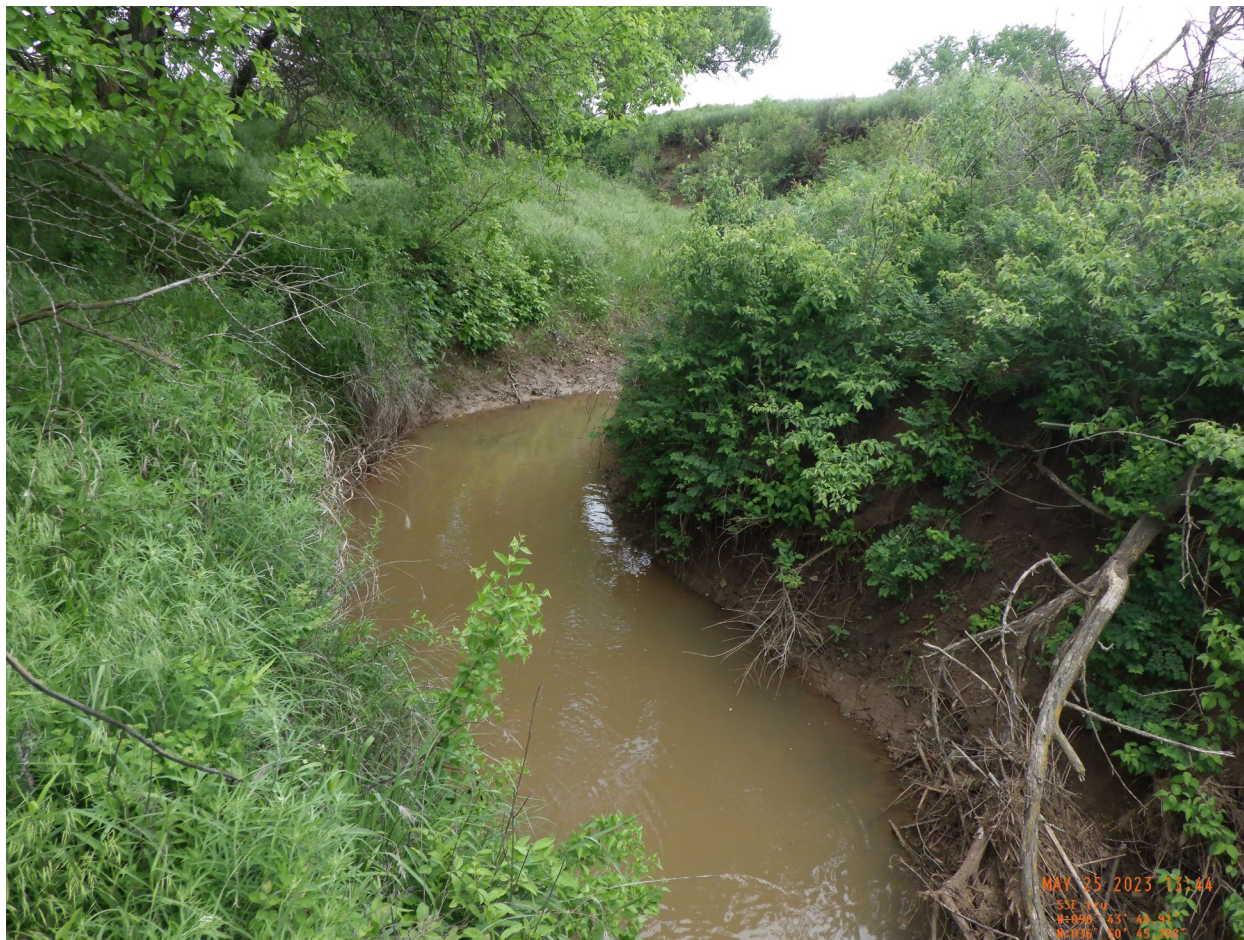
Photo No. 17

**Description:** This was the bed and bank features of the unimpacted stream where the TDS measurement from photo No. 16 was taken.
