Near Miss  
Repetitive Accident  
Type 10A  
Toxic Chemical Release  
Pedricktown, New Jersey

January 11, 1988

SUMMARY:

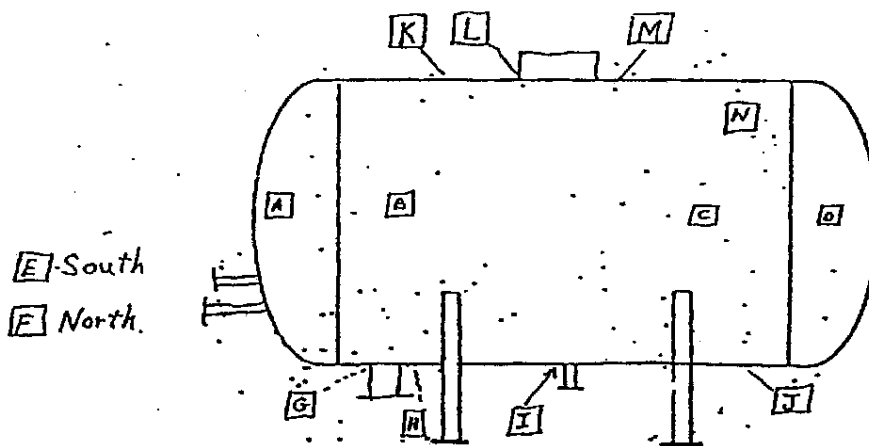
Since it's replacement in 1980, this nozzle and the day tank have not presented any problems, as indicated by periodic inspections. In this past October's inspection, thinning trends were noticed in the vapor space at the top of the tank. No such trends, however, were observed at the measurement point on the tank wall immediately adjacent to the nozzle of interest. The thickness measurement of the tank at the point next to the nozzle was 0.726 inches (0.75 inch is the design thickness; see attached report).

| A. | .707 |
| B. | .747 |
| C. | .740 |
| D. | .715 |
| E. | .406 |
| F. | .331 |
| G. | .743 |
| H. | .769 |
| I. | .726 |
| J. | .861 |
| K. | .518 |
| L. | .654 |
| M. | .699 |
| N. | .610 |
