INSPECTION REPORT

Inspection Entry Date/Time	12/02/2022 08:20 AM (ET)	Announced: Yes
Inspection Exit Date/Time	12/02/2022 10:57 AM (ET)	Access: Granted
Weather	Day 1 – Cloudy and 48°F	
Media	Water	
Statute(s)/Program(s)	Clean Water Act, National Pollutant Discharge Elimination System (NPDES)	
Type of Inspection	CAFO - Concentrated Animal Feeding Operation Inspection	
Permittee Information		
Permittee Name	Trillium Farm Holdings LLC, Layer Site 1	
Facility or Site Name	Trillium Farm Holdings LLC, Layer Site 1	
Facility/Site Physical Address	11995 Croton Road	
City, State, Zip Code	Croton, OH	
County/Borough/Parish	Licking County	
Facility GPS Coordinates	40.214559, -82.685305	
Mailing Address (If different)	10513 Croton Road	
City, State, Zip Code	Croton, Ohio 43013	
Facility Information		
FRS ID	Layer1	
Permit Number(s) (If Applicable)	OH0131121	
SIC and/or NAICS	5144

SECTION I – INTRODUCTION**Site Entry and Inspection Objectives**

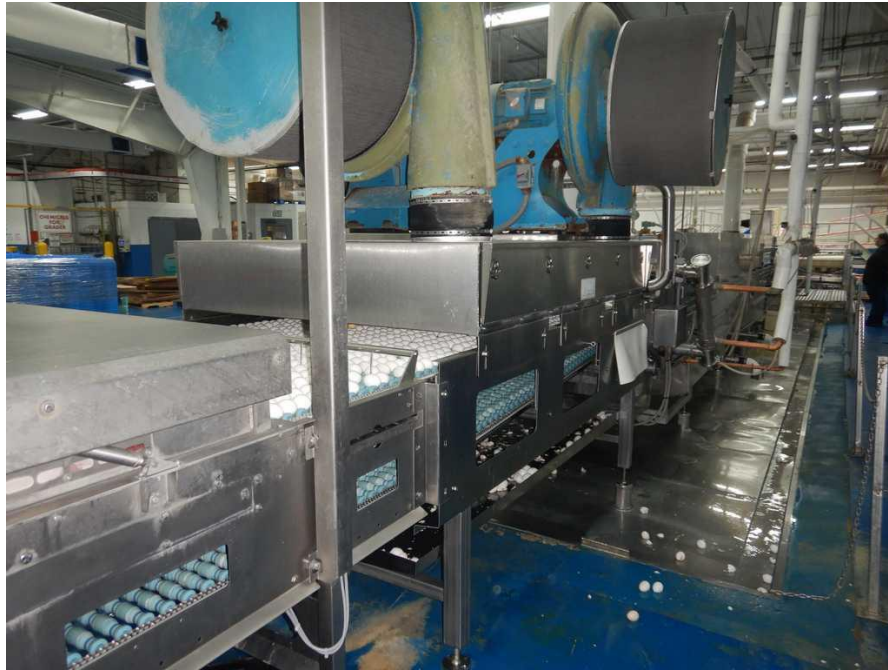
Location: Egg washing and packaging barn		
Observation #: AH2-OB-001	Date: 12/02/2022	Weather: Cloudy and 48°F
EPA observed the egg-washing and packaging process that took place in the same area. Water from the egg washing and egg parts from broken eggs were collected via floor drains and sent to the egg-wash lagoon.		
Photos		
<ol style="list-style-type: none"> 1. DSCN0356.JPG 2. DSCN0385.JPG

Egg Wash	DSCN0356.JPG	
12/02/2022 08:52 AM (ET)	Photographer: Andi Hodaj	
Egg washing and packaging barn	CBI	No PII
Egg wash and packaging operation inside the egg-wash and packaging barn. Camera looking east.

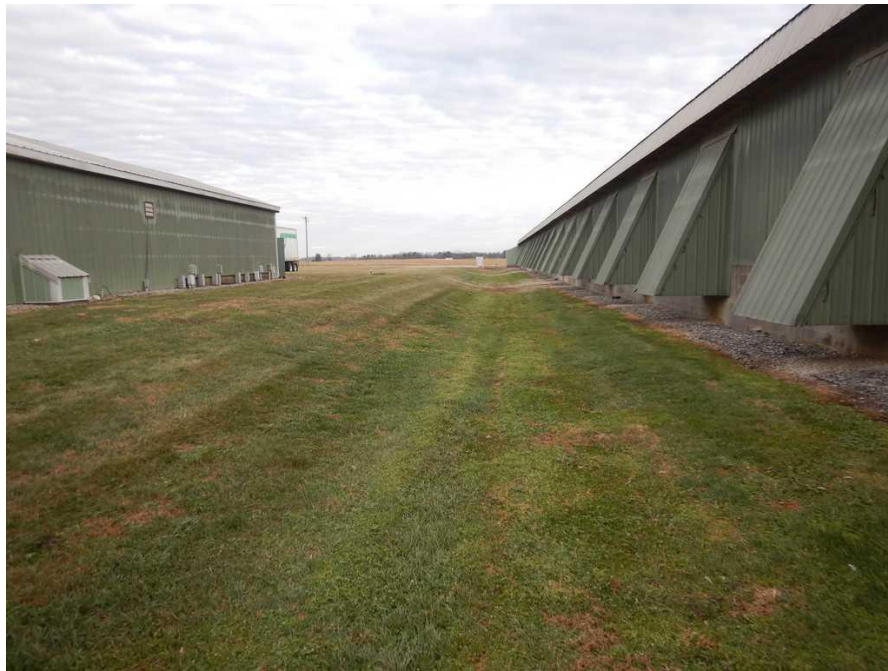
Grassed channel west of Barn 1	DSCN0357.JPG	
12/02/2022 09:00 AM (ET)	Photographer: Andi Hodaj	
Chicken barns	CBI	No PII
Grassed channel west of Barn 1, facing north.

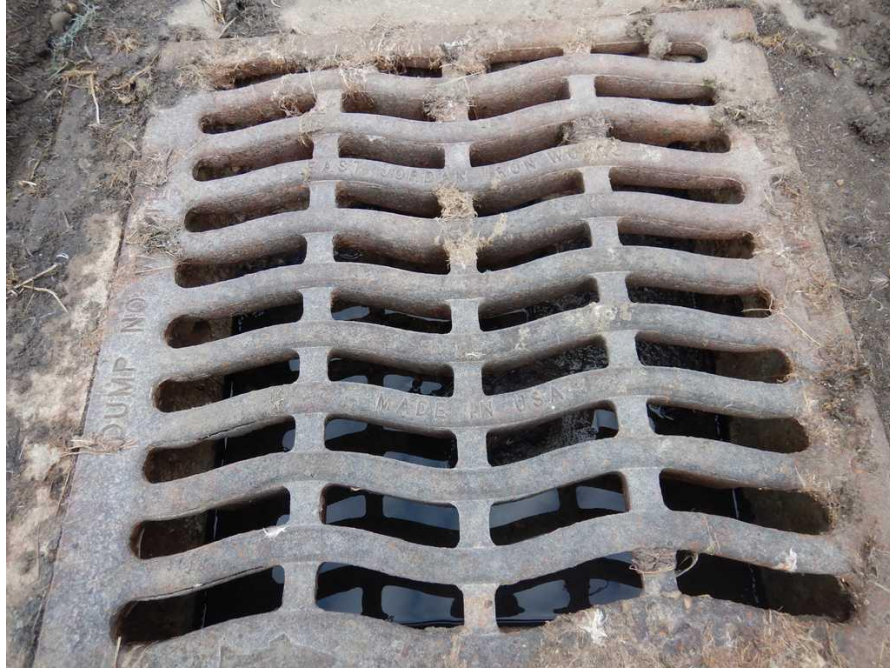
Catch Basin west of Barn 1	DSCN0358.JPG	
12/02/2022 09:03 AM (ET)	Photographer: Andi Hodaj	
Chicken barns	CBI	No PII
Catch basin that drains the grassed area west of Barn 1.

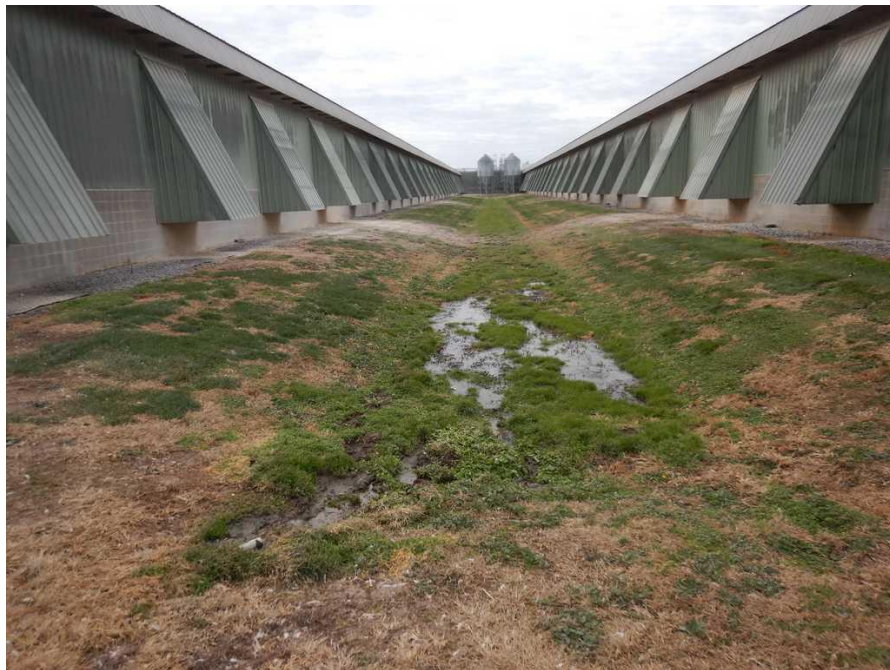
Grassed area between Barns 1 and 3	DSCN0359.JPG	
12/02/2022 09:08 AM (ET)	Photographer: Andi Hodaj	
Chicken barns	CBI	No PII
Grassed area between Barns 1 and 3, facing south.

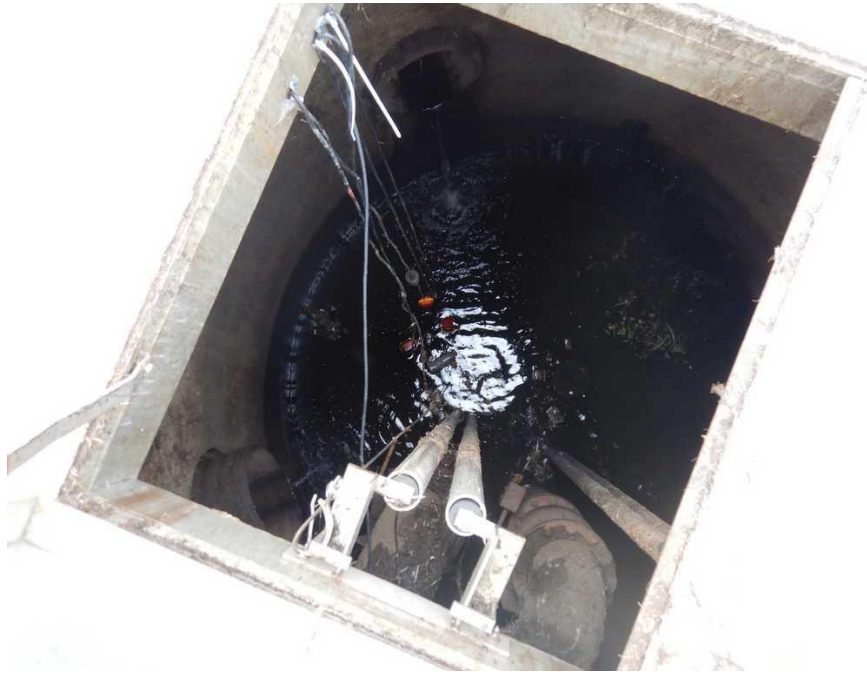
Lift Station	DSCN0362.JPG	
12/02/2022 09:14 AM (ET)	Photographer: Andi Hodaj	
Chicken barns	CBI	No PII
Lift station north of Barn 7.

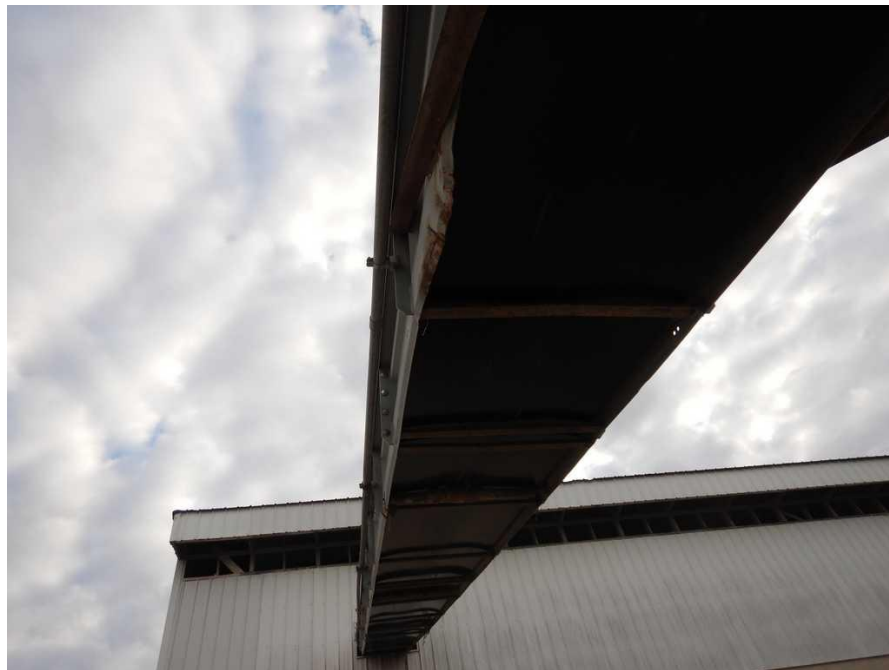
Belt from Incline Room to MSB	DSCN0363.JPG	
12/02/2022 09:21 AM (ET)	Photographer: Andi Hodaj	
Manure Storage Barns	CBI	No PII
Belt going from incline room to Manure Storage Barn. Camera looking east.

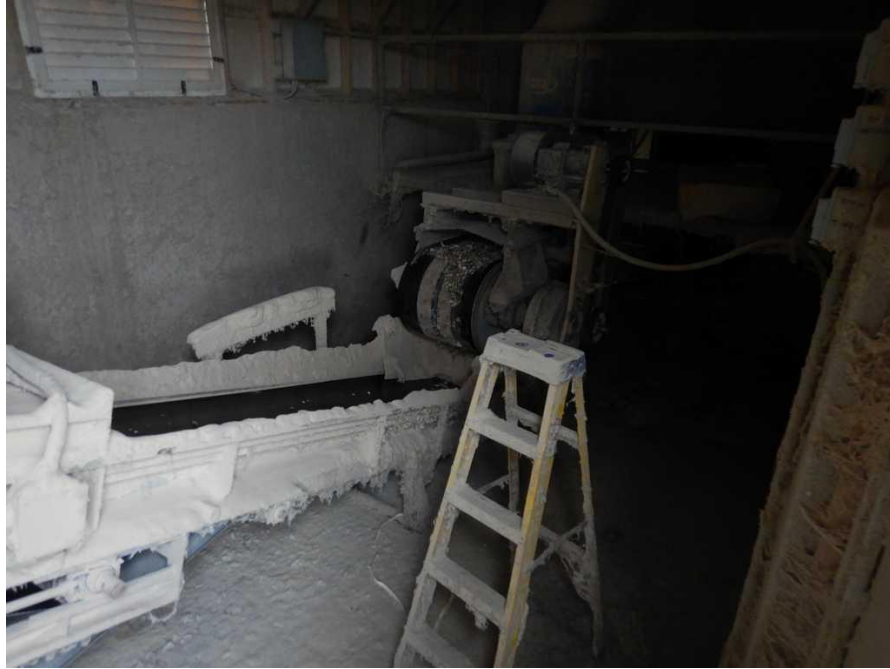
EPA observed the incline room, where the manure conveying belt slopes upwards towards the top of the manure barn and observed accumulated manure dust on the ground below the conveyor belt. Facility representatives stated that when water accumulates in the manure conveying tunnel or the incline room, it gets pumped and hauled off-site. EPA observed the two Manure Storage Barns where the north had one pile of manure in it and south one two smaller piles. Photos [DSCN0380.JPG](#) and [DSCN0381.JPG](#). The concrete driveway in front of the two MSB and driveway between the two rows of chicken barns had several stormwater catch basins that drained to the stormwater pond, according to Facility representatives.

Inside Manure Incline Room	DSCN0365.JPG	
12/02/2022 09:22 AM (ET)	Photographer: Andi Hodaj	
Manure Storage Barns	CBI	No PII
Inside manure incline room. Camera facing southwest.

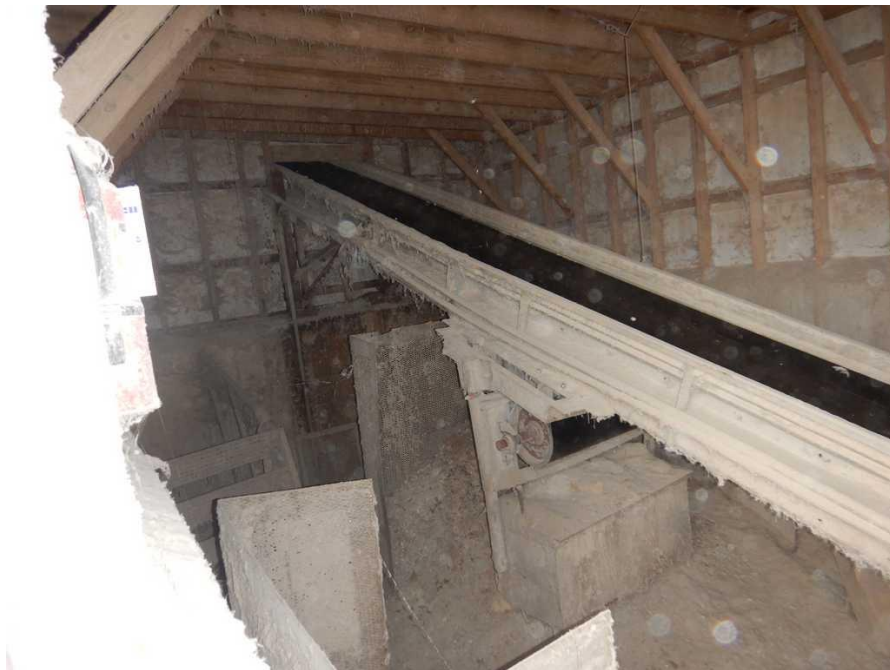
Manure Incline Room	DSCN0364.JPG	
12/02/2022 09:22 AM (ET)	Photographer: Andi Hodaj	
Manure Storage Barns	CBI	No PII
Inside the manure incline room. Camera looking east.

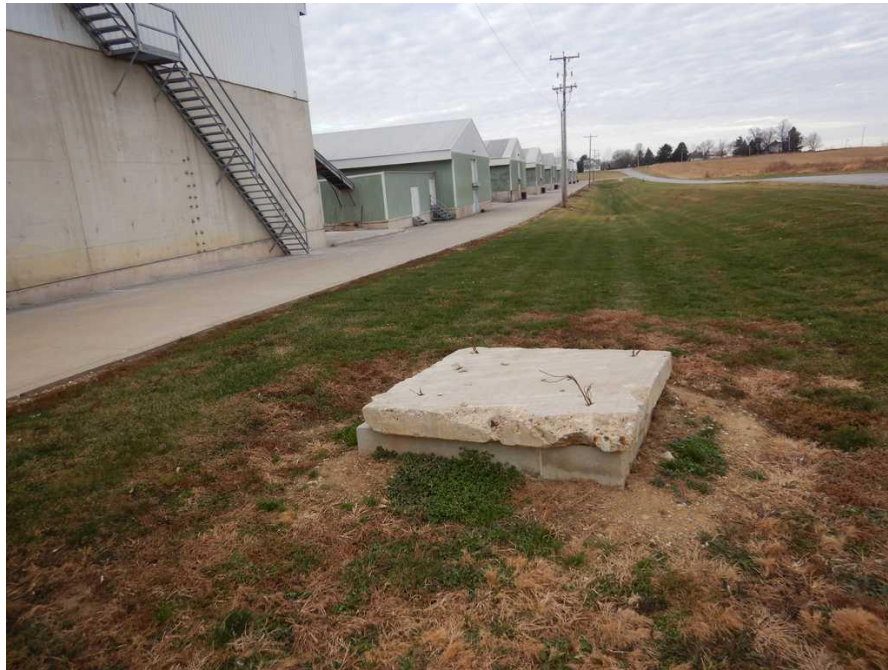
Diversion Structure	DSCN0366.JPG	
12/02/2022 09:24 AM (ET)	Photographer: Andi Hodaj	
Chicken barns	CBI	No PII
Location of the diversion structure (y-shaped pipe) discovered at Layer 1 in June 2021. Camera facing west.

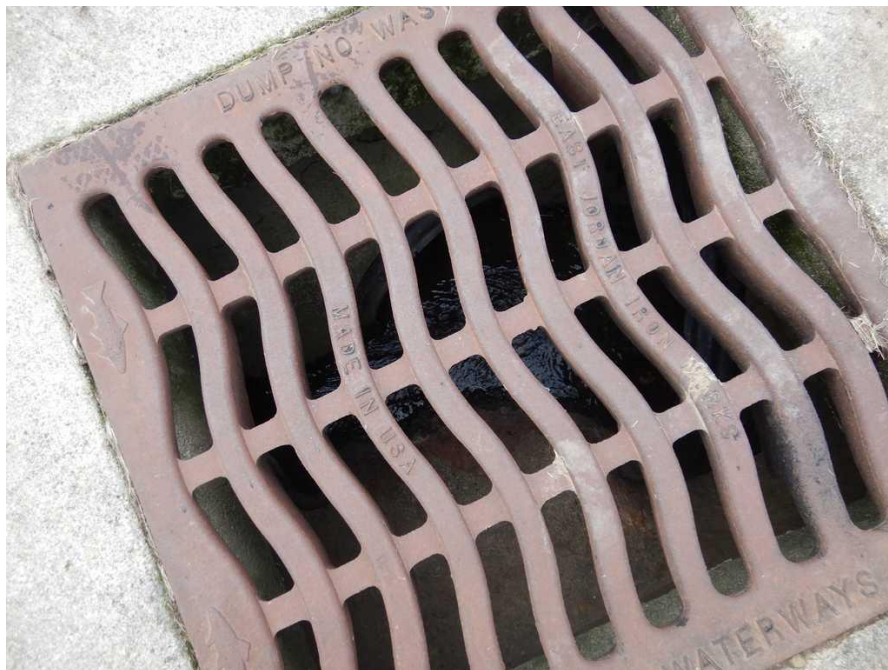
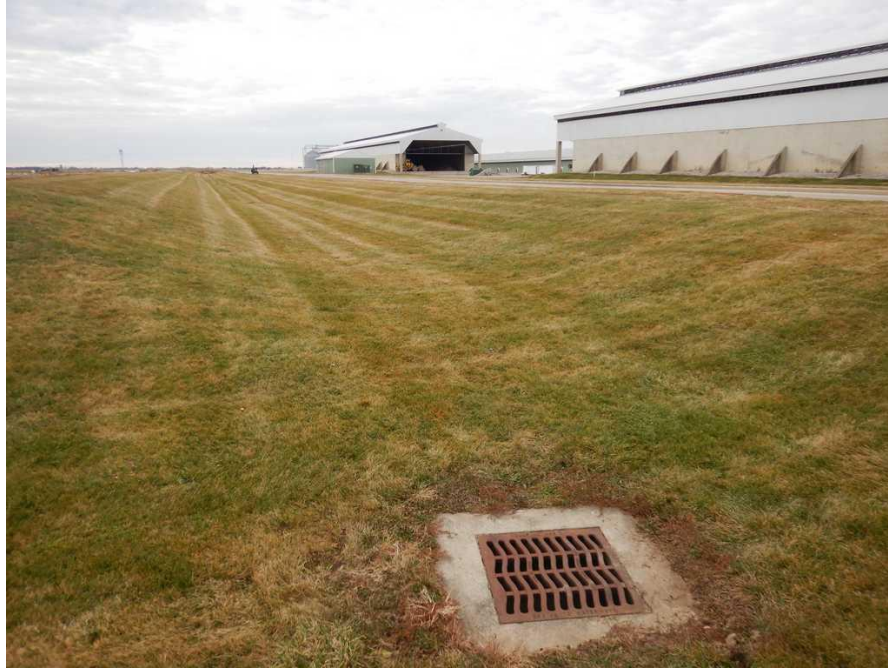
EPA observed a catch basin in the grassed area east of each of the Manure Barns. The catch basins routed water east across the east driveway and into other catch basins located next to the Egg-Wash Lagoon. These catch basins routed water north and into the unnamed tributary of the Otter Fork via a catch basin located at the northeast end of the Facility. Photo [DSCN0368.JPG](#). EPA could not observe the outlet pipe from the catch basin because according to Mr. Beer, the pipe goes underground and outlets into the unnamed tributary on a private cropland north of the Facility.

Catch basin	DSCN0367.JPG	
12/02/2022 09:28 AM (ET)	Photographer: Andi Hodaj	
Manure Storage Barns	CBI	No PII
Catch basin at the northwest corner of the Egg-Wash Lagoon. There are two pipes flowing in it from east and southwest and a pipe that flows out and northwest towards the unnamed tributary of Otter Fork.

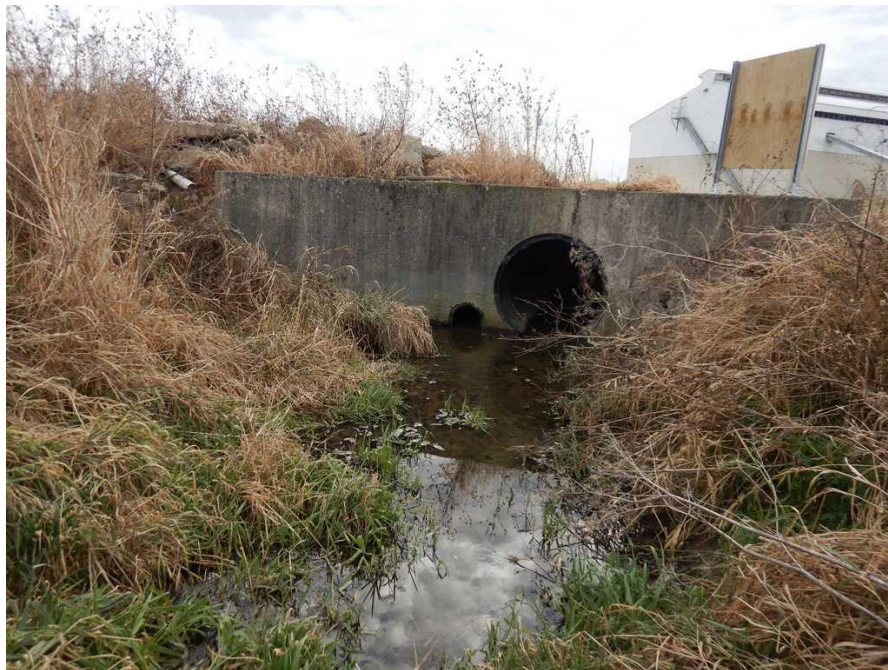
EPA observed two pipes discharging at outfall 001, a big one from which the samples are taken and a smaller one that Facility representatives were unaware of its function. Photo [DSCN0369.JPG](#).

AOC Reference #: AH2-OB-004	Location: Outfall 001
AOC:	
EPA observed two pipes discharging at outfall 001, a big one from which the samples are taken and a smaller one that Facility representatives were unaware of its function or what it was that was discharging.

Outfall 001	DSCN0369.JPG	
12/02/2022 09:33 AM (ET)	Photographer: Andi Hodaj	
Outfall 001	CBI	No PII
Two pipes discharging in the unnamed tributary of Otter Fork. The big pipe in the photo is where Facility takes its samples for outfall 001. Camera looking south.

- Discharges from the Facility that did not go through the wastewater treatment system; and
- The need to identify pipes and sources of discharge that drain into the lift stations and stormwater catch basins throughout the Facility.

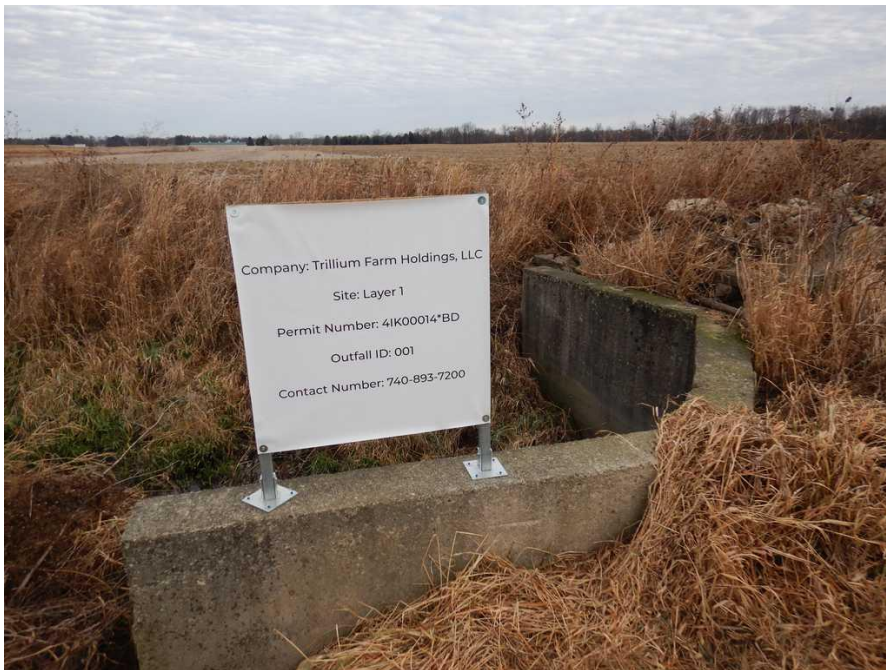
Outfall 001 Sign	DSCN0371.JPG	
12/02/2022 09:35 AM (ET)	Photographer: Andi Hodaj	
Outfall 001	CBI	No PII
Outfall 001 sign, facing north.

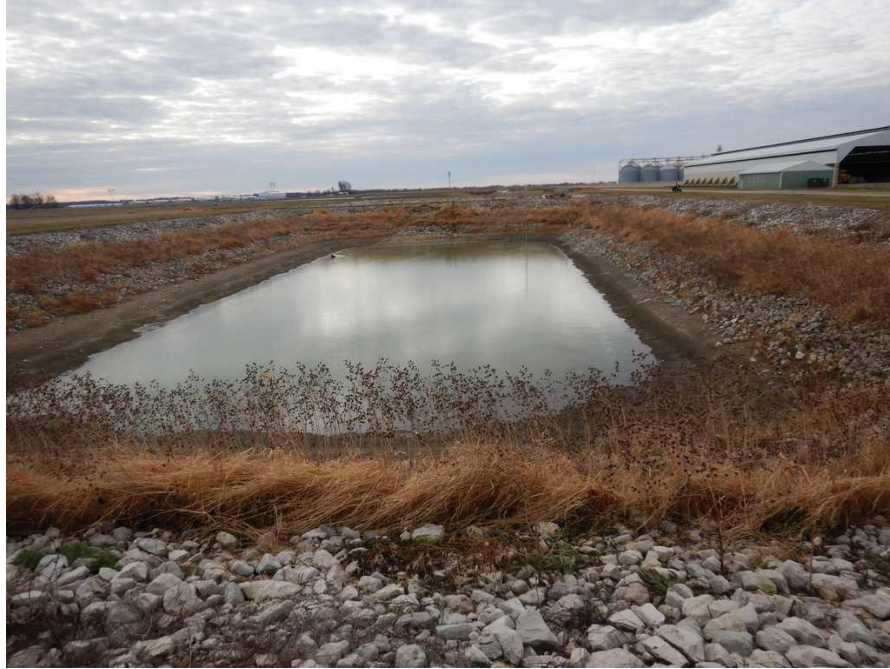
EPA observed the Egg-Wash Lagoon that was split into two cells, north and south cell. The north cell had very little water in it. Photos [DSCN0372.JPG](#) and [DSCN0374.JPG](#). EPA also observed the stormwater pond and the ETS. The stormwater pond had depth markers in it and there was no pooling water in the ETS, even though the stormwater pond was discharging to the ETS at the time. Photos [DSCN0374.JPG](#) - [DSCN0377.JPG](#).

Egg-Wash Lagoon North Cell	DSCN0372.JPG	
12/02/2022 09:43 AM (ET)	Photographer: Andi Hodaj	
Wastewater storage structures	CBI	No PII
The north cell of the Egg-Wash Lagoon, facing south.

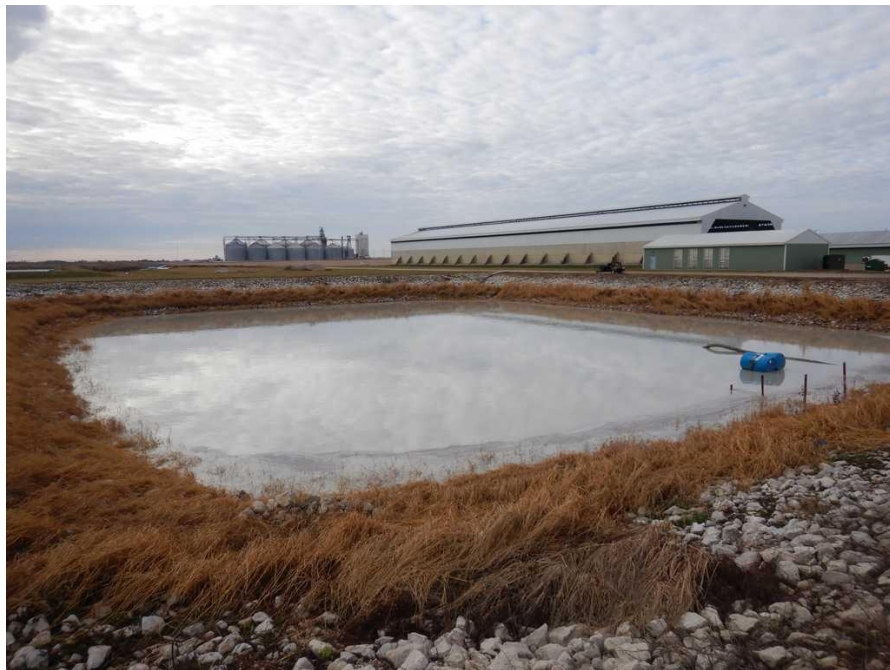
Egg-Wash Lagoon South Cell	DSCN0373.JPG	
12/02/2022 09:47 AM (ET)	Photographer: Andi Hodaj	
Wastewater storage structures	CBI	No PII
South cell of the Egg-Wash Lagoon, facing south.

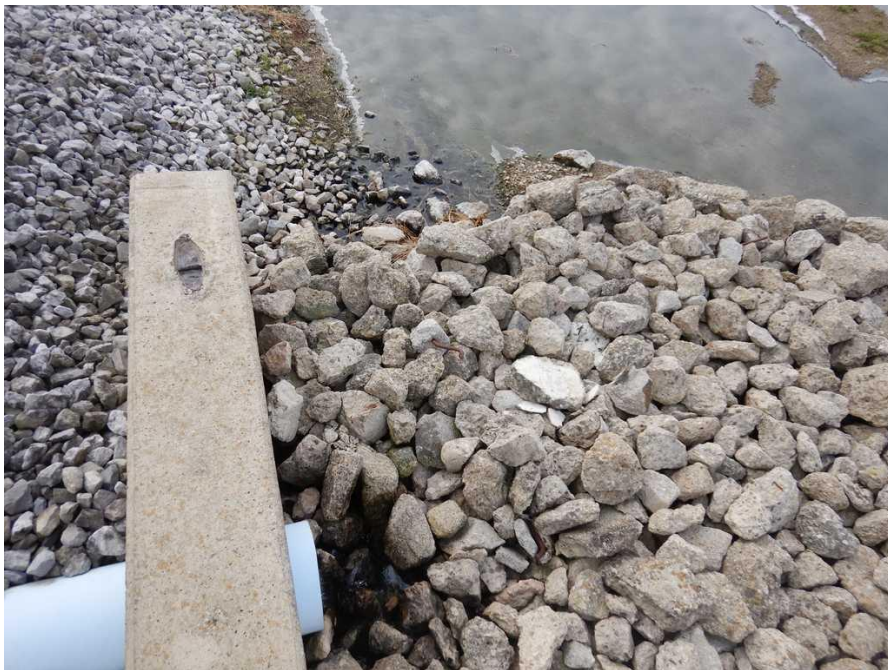
ETS Influent	DSCN0375.JPG	
12/02/2022 09:52 AM (ET)	Photographer: Andi Hodaj	
Wastewater storage structures	CBI	No PII
ETS influent from stormwater pond. Camera looking south.

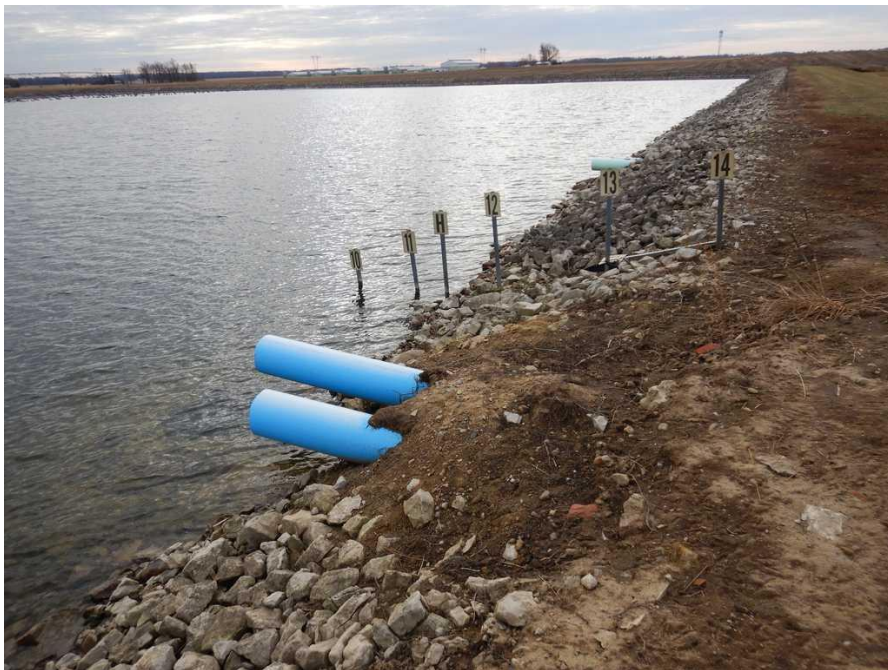
Stormwater Pond Level Indicators	DSCN0377.JPG	
12/02/2022 10:04 AM (ET)	Photographer: Andi Hodaj	
Wastewater storage structures	CBI	No PII
Stormwater pond level indicators, west side of pond, facing south.

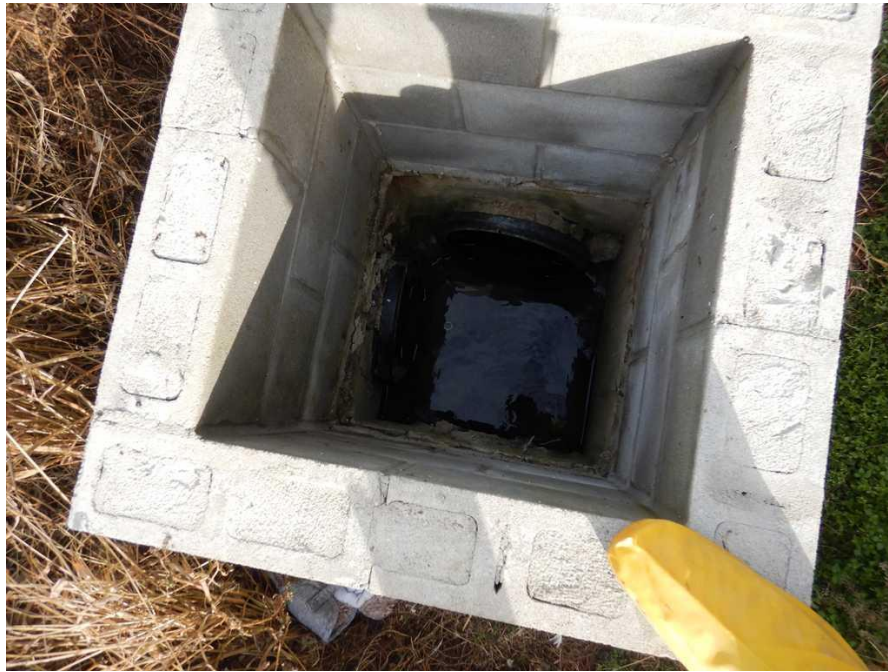
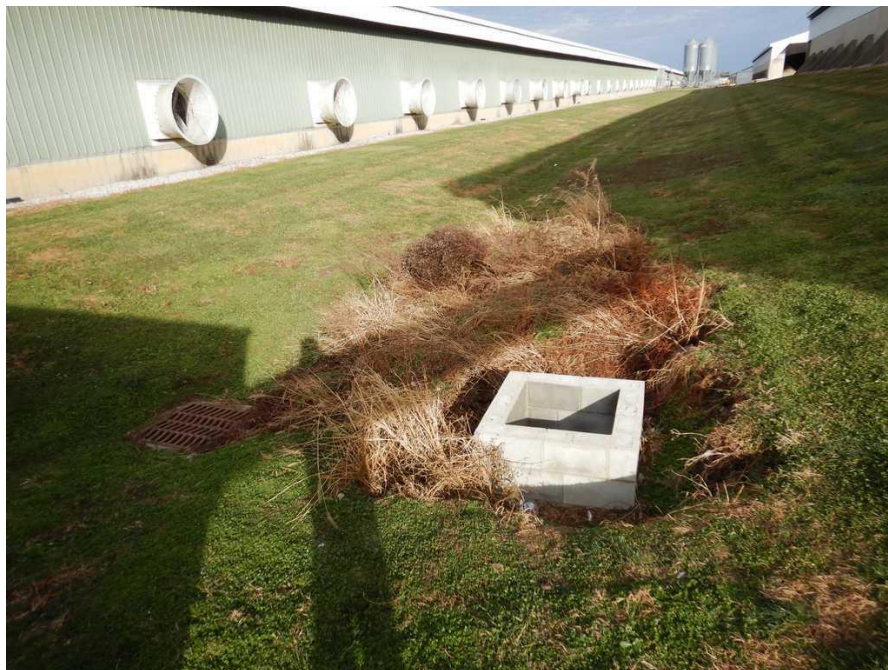
Drainage Structure	DSCN0378.JPG	
12/02/2022 10:09 AM (ET)	Photographer: Andi Hodaj	
Manure Storage Barns	CBI	No PII
Drainage structure (concrete catch basin) between the south MSB and Barn 14A. It has one inflowing pipe from north and an outflowing pipe towards south.

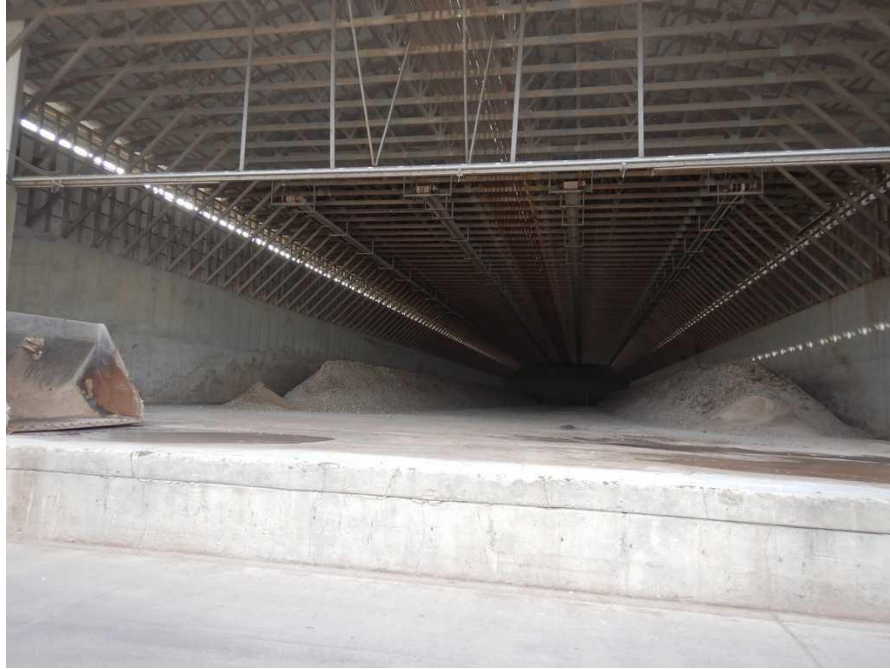
South Manure Storage Barn	DSCN0380.JPG	
12/02/2022 10:13 AM (ET)	Photographer: Andi Hodaj	
Manure Storage Barns	CBI	No PII
South manure storage barn, facing south.

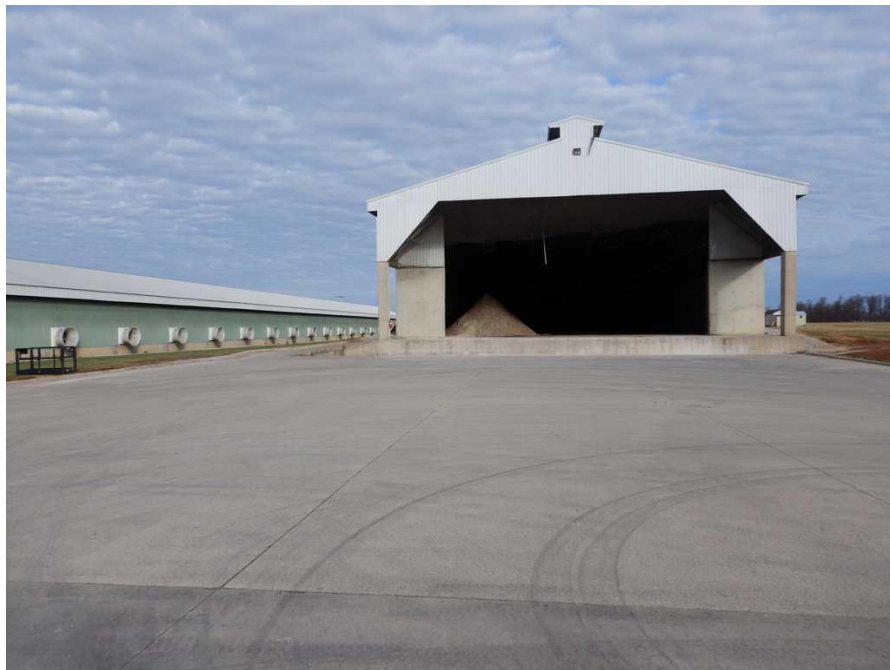
North Manure Storage Barn	DSCN0381.JPG	
12/02/2022 10:14 AM (ET)	Photographer: Andi Hodaj	
Manure Storage Barns	CBI	No PII
North manure storage barn, facing north.

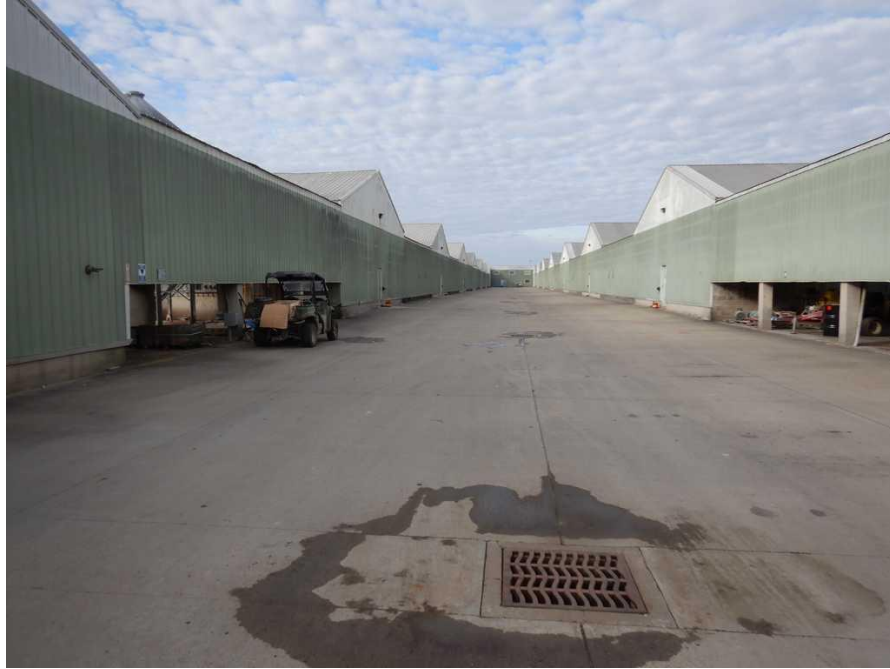
Driveway between the two barn rows	DSCN0382.JPG	
12/02/2022 10:16 AM (ET)	Photographer: Andi Hodaj	
Chicken barns	CBI	No PII
The driveway between the two chicken barn rows has several stormwater catch basins in it. Camera looking west.

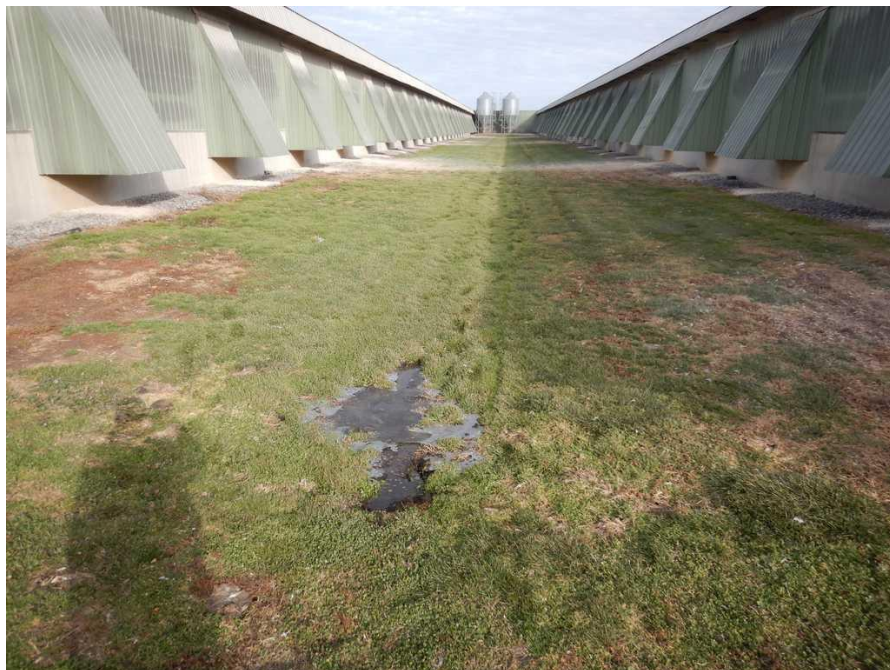
Grassed area between Barns 6 and 8	DSCN0383.JPG	
12/02/2022 10:26 AM (ET)	Photographer: Andi Hodaj	
Chicken barns	CBI	No PII
Grassed area between Barns 6 and 8, facing north.

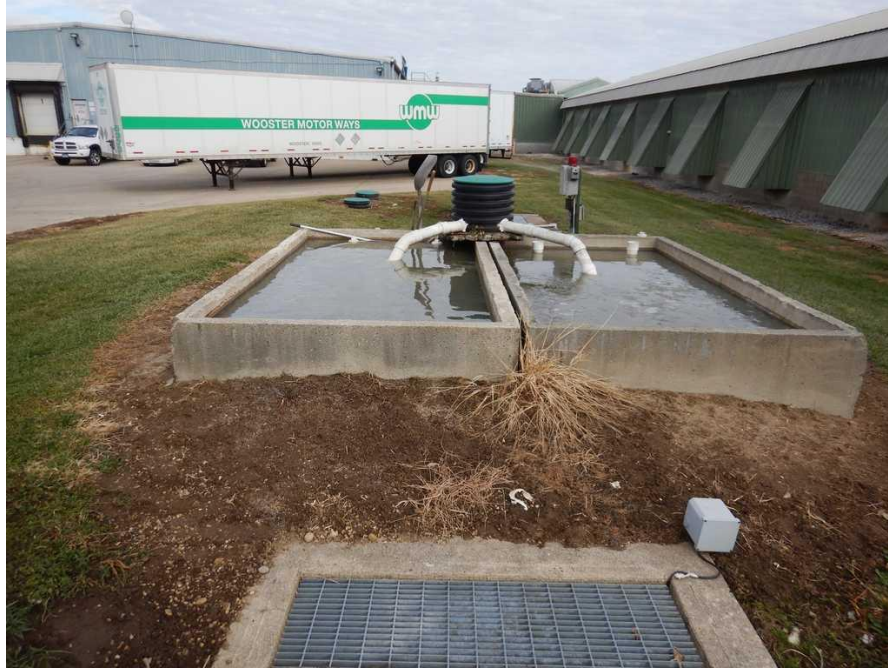
Egg-Wash Lift Station	DSCN0384.JPG	
12/02/2022 10:36 AM (ET)	Photographer: Andi Hodaj	
[Location/Area]	CBI	No PII
Egg-Wash water lift station west of chicken barns, facing north.

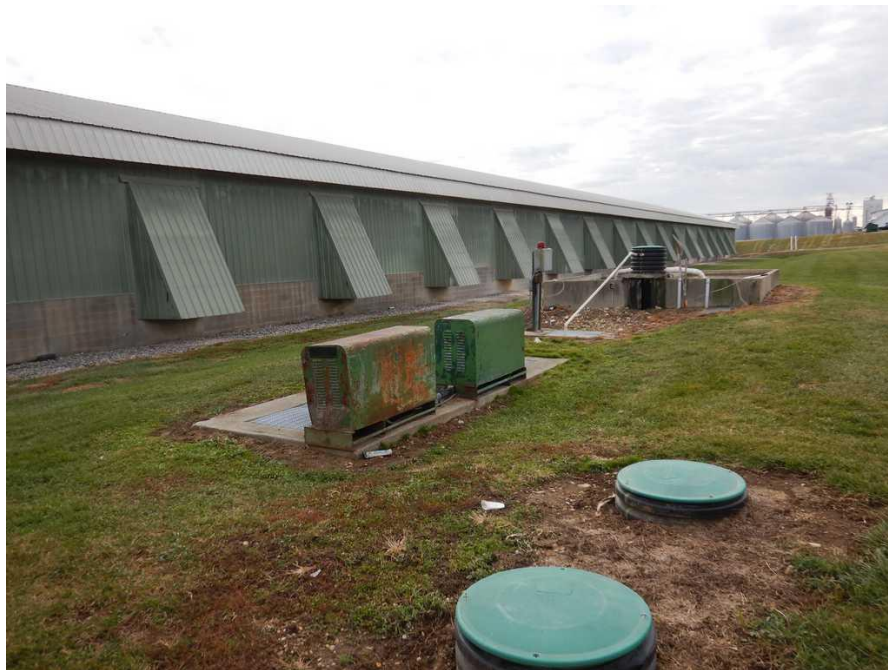
Egg Wash Lift Station	DSCN0385.JPG	
12/02/2022 10:38 AM (ET)	Photographer: Andi Hodaj	
Egg washing and packaging barn	CBI	No PII
Egg wash lift station, facing south/southeast.
