## NPDES Compliance Inspection Report

### AWR Redmond Yard – DTG Recycle

Permit # WAR305821

Inspection Date: February 25, 2021

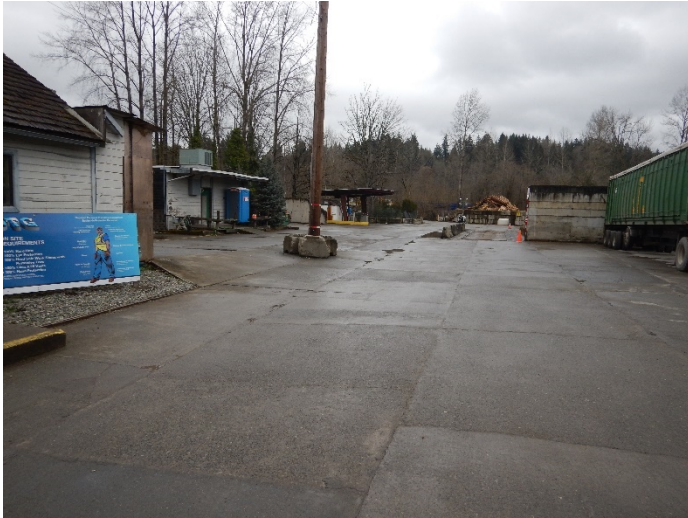
Photo #:01 (DSCN0704)

Description: Facing east, photo of the facility entrance, truck scale, and site office.

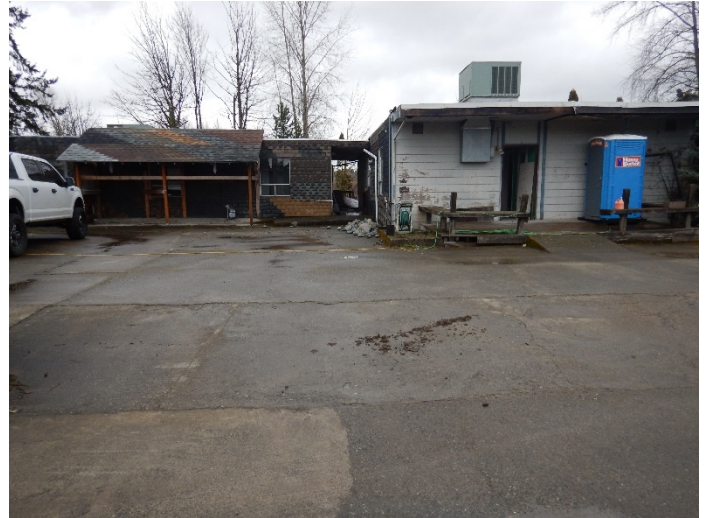
Photo #:02 (DSCN0705)

Description: Facing north, photo of the facility entrance and site office.

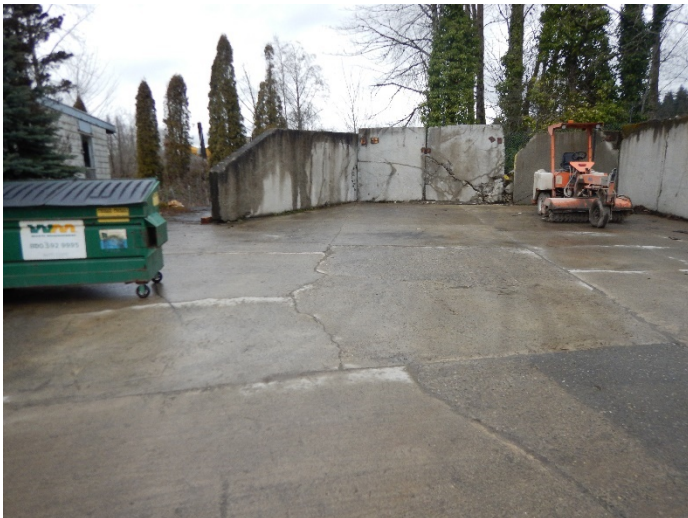
Photo #:03 (DSCN0706)

Description: Facing north, photo of the yard sweeper.

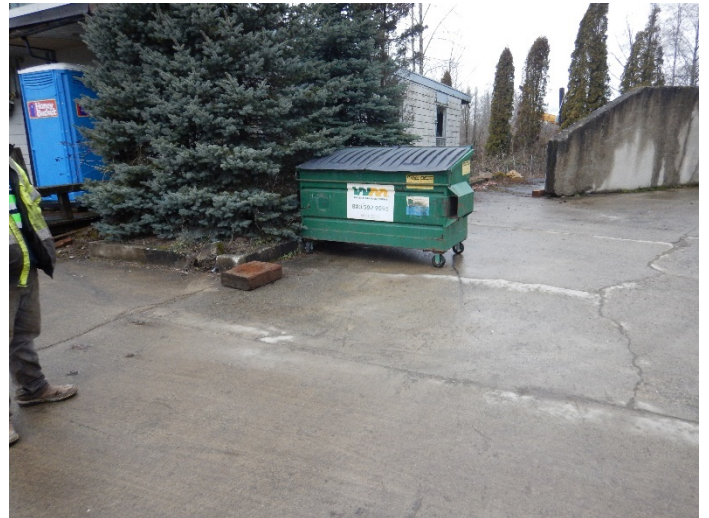
Photo #:04 (DSCN0707)

Description: Facing northwest, photo of a covered dumpster near the site office.

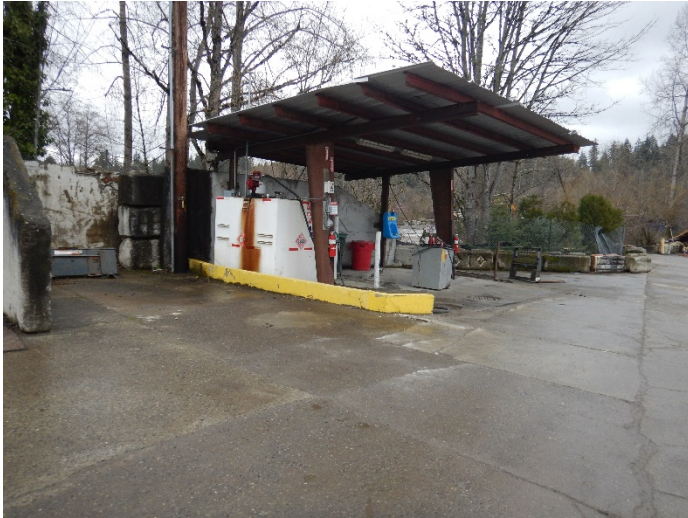
Photo #:05 (DSCN0708)

Description: Facing northeast, photo of the covered diesel refueling station.

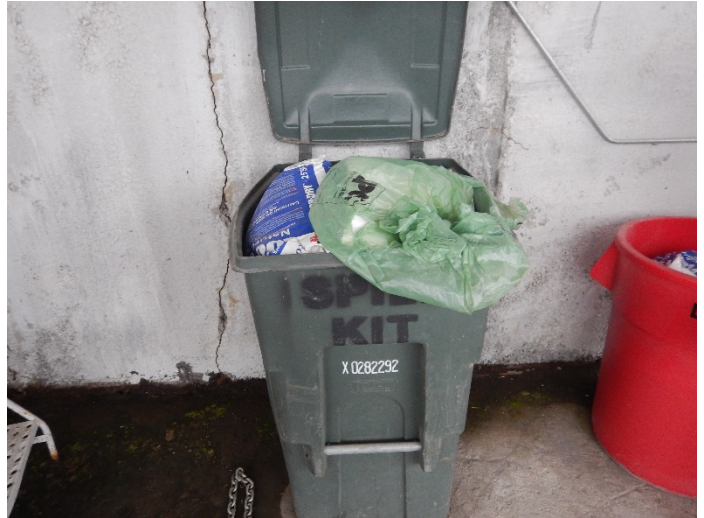
Photo #:06 (DSCN0709)

Description: Facing north, photo of the spill kit at the covered diesel refueling station.

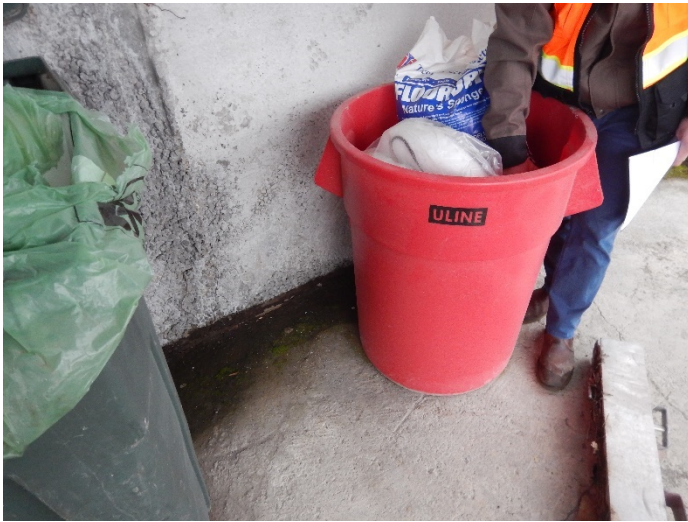
Photo #:07 (DSCN0710)

Description: Facing north, photo of the spill kit at the covered diesel refueling station.

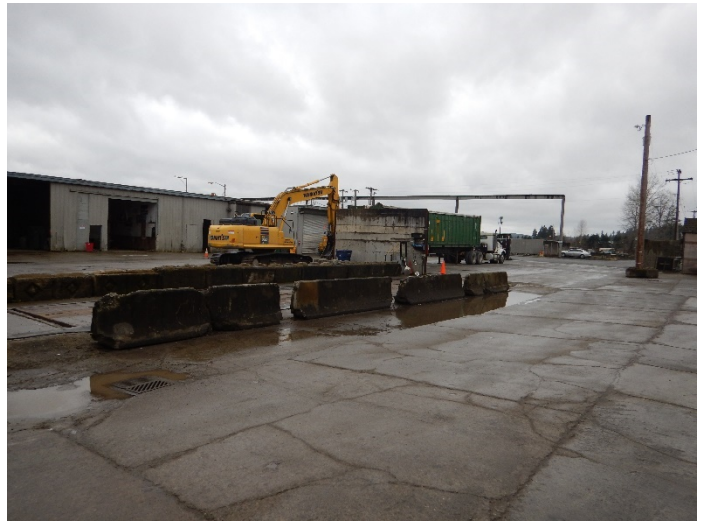
Photo #:08 (DSCN0711)

Description: Facing southwest, photo of the truck scale and product transport equipment.

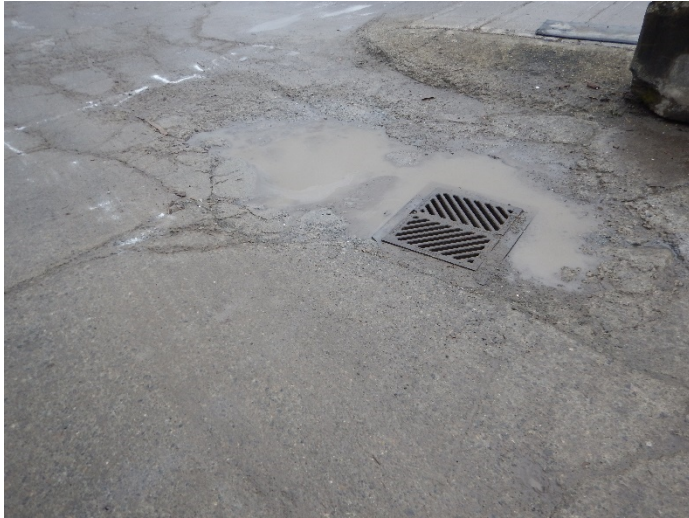
Photo #:09 (DSCN0712)

Description: Facing southeast, photo of one of the catch basins that route stormwater to the oil/water separator.

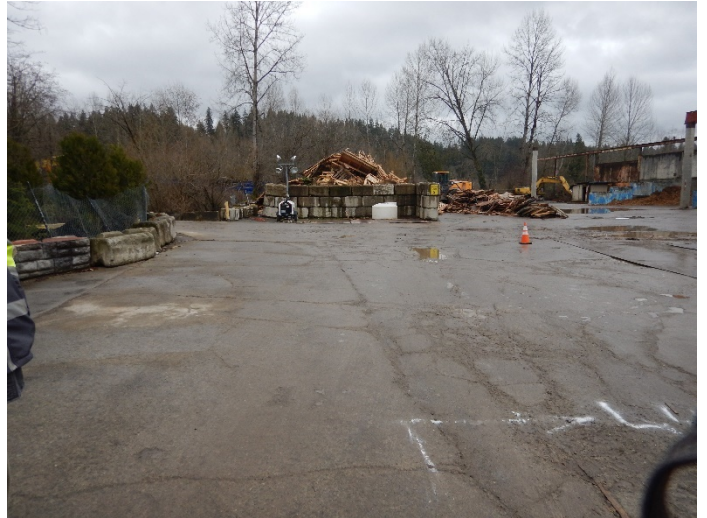
Photo #:10 (DSCN0713)

Description: Facing east, photo of the paved yard area with the wood pile in the back.

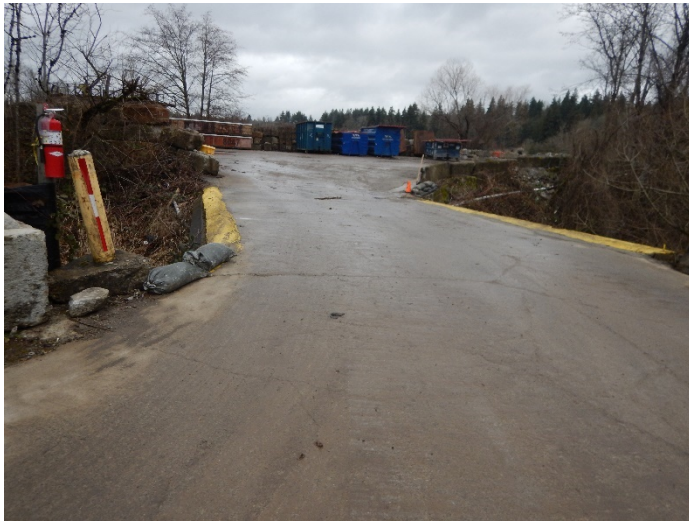
Photo #:11 (DSCN0714)

Description: Facing north, photo of the bridge that crosses over Evans Creek.

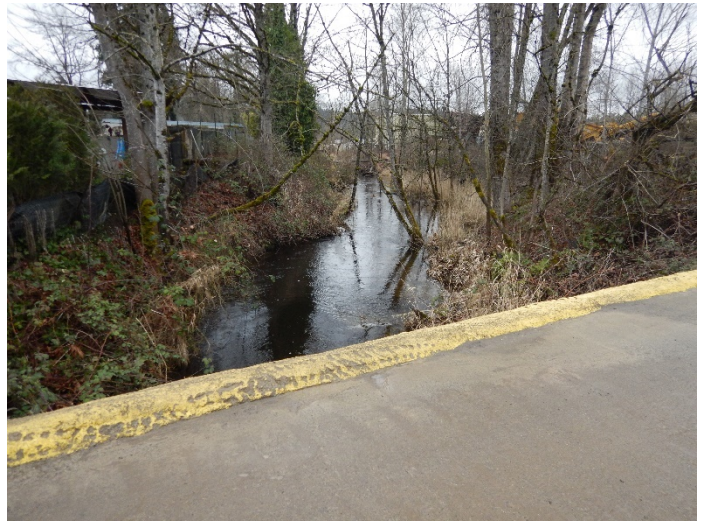
Photo #:12 (DSCN0715)

Description: Facing northwest, photo of Evans Creek.

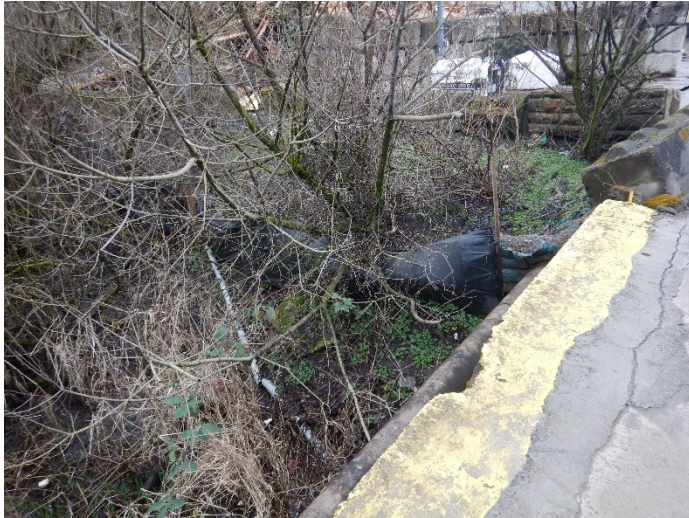
Photo #:13 (DSCN0716)

Description: Facing southeast, photo of the silt fence that lines Evans Creek.

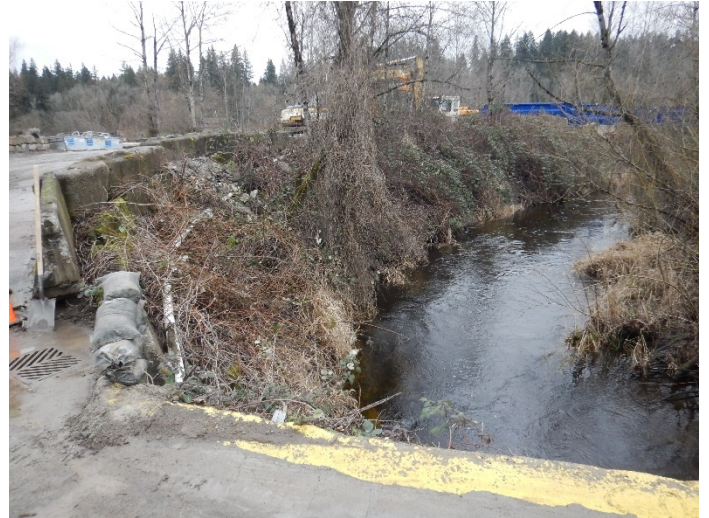
Photo #:14 (DSCN0717)

Description: Facing northeast, photo of the dense vegetation and concrete blocks that line Evans Creek.

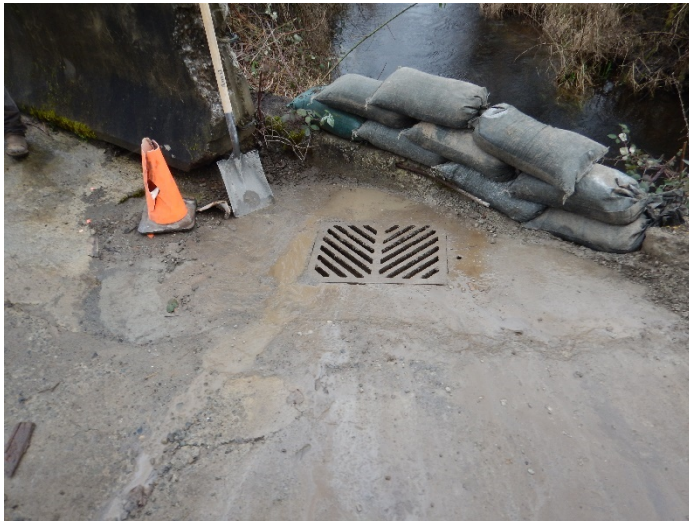
Photo #:15 (DSCN0718)

Description: Facing east, photo of a catch basin that routes stormwater to the oil/water separator.

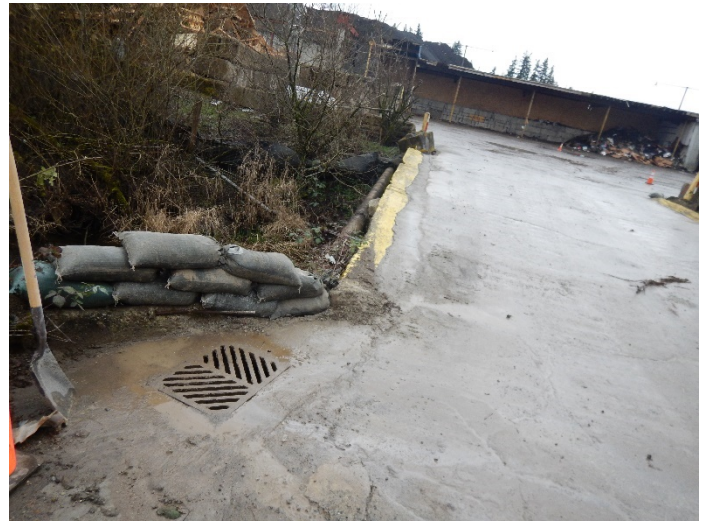
Photo #:16 (DSCN0719)

Description: Facing south, photo of the pipe (lining the bridge) that routes stormwater from the catch basin to the oil/water separator.

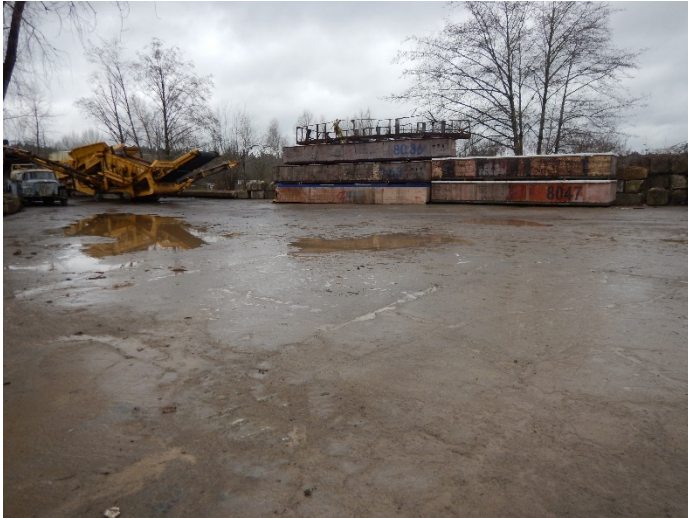
Photo #:17 (DSCN0720)

Description: Facing northwest, photo of stored materials near the mobile rock crusher.

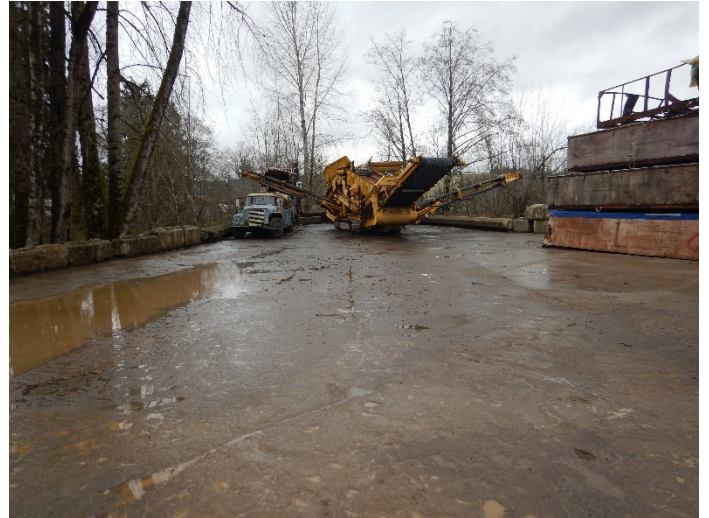
Photo #:18 (DSCN0721)

Description: Facing west, photo of the mobile rock crusher.

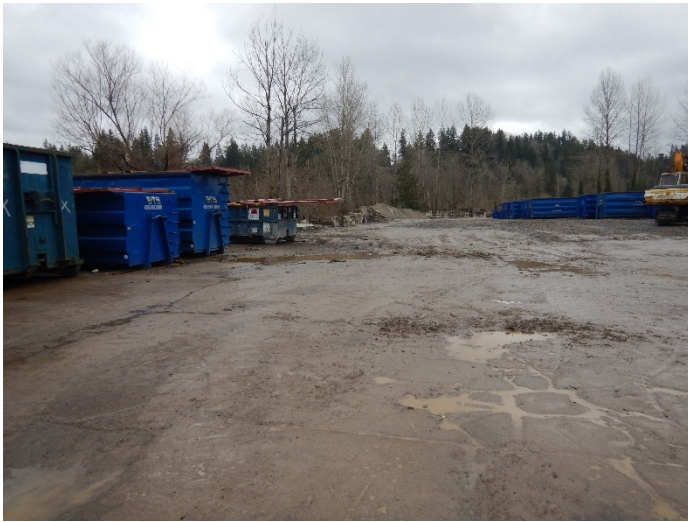
Photo #:19 (DSCN0722)

Description: Facing east, photo of the concrete processing side of the facility. This side of the facility is mostly unpaved. The blue containers are empty storage bins.

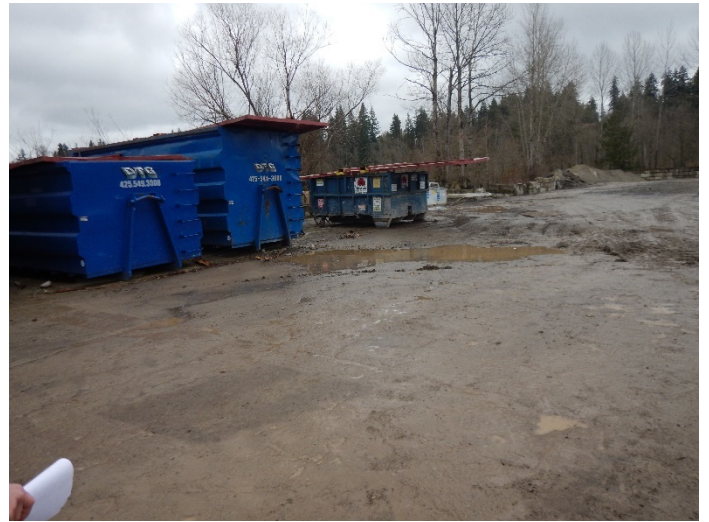
Photo #:20 (DSCN0723)

Description: Facing northeast, photo of the empty storage bins within the concrete processing side of the facility.

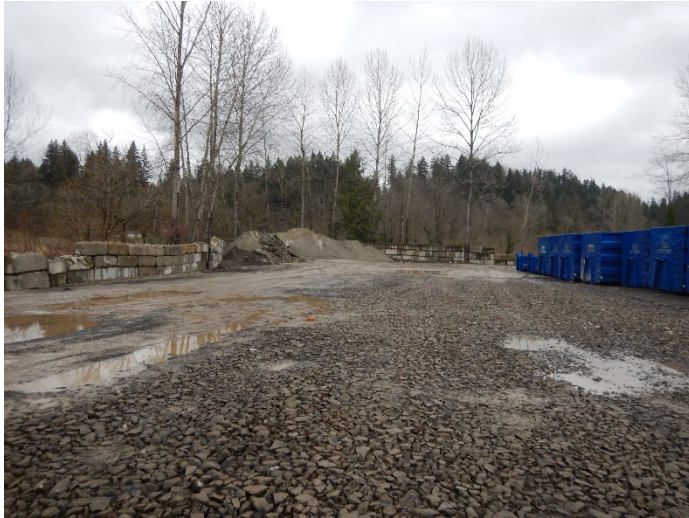
Photo #:21 (DSCN0724)

Description: Facing east, photo of the concrete pile, concrete blocks lining the property, and empty storage containers. Note the stormwater pooling.

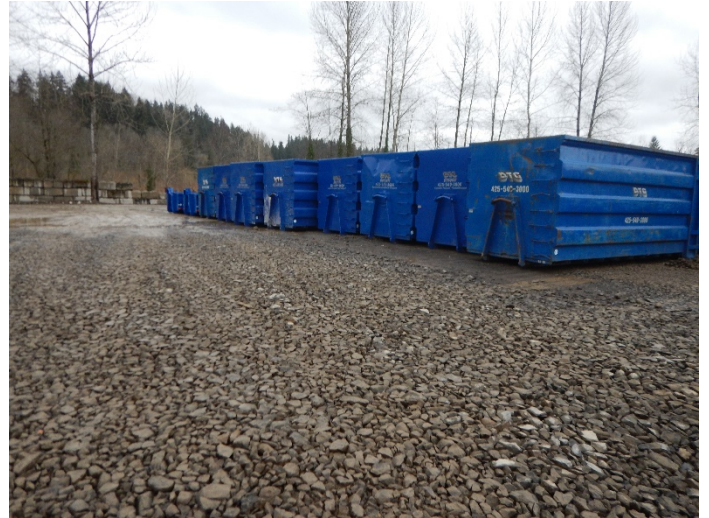
Photo #:22 (DSCN0725)

Description: Facing east, photo of the empty storage containers near the concrete pile.

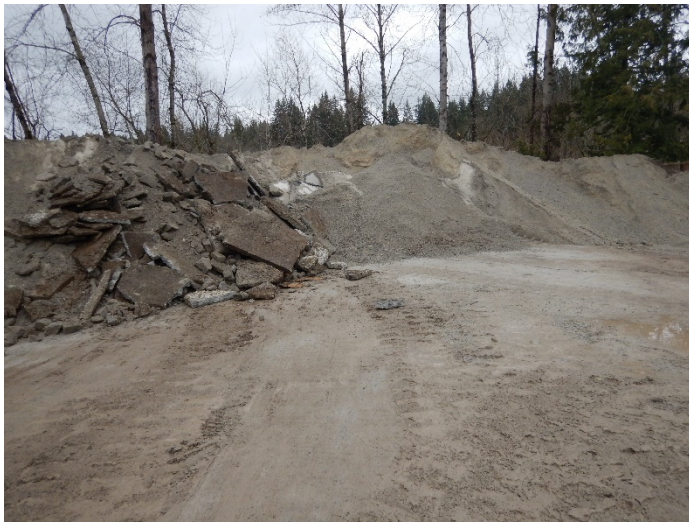
Photo #:23 (DSCN0726)

Description: Facing northeast, photo of the concrete pile.

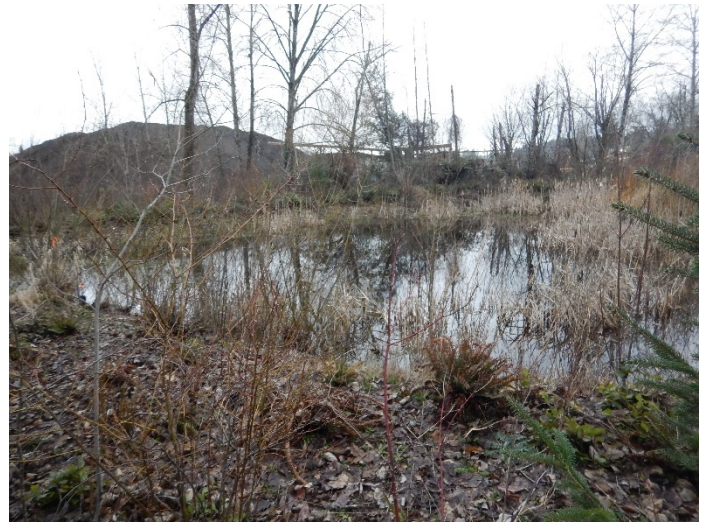
Photo #:24 (DSCN0727)

Description: Facing southwest, photo of the stormwater infiltration pond.

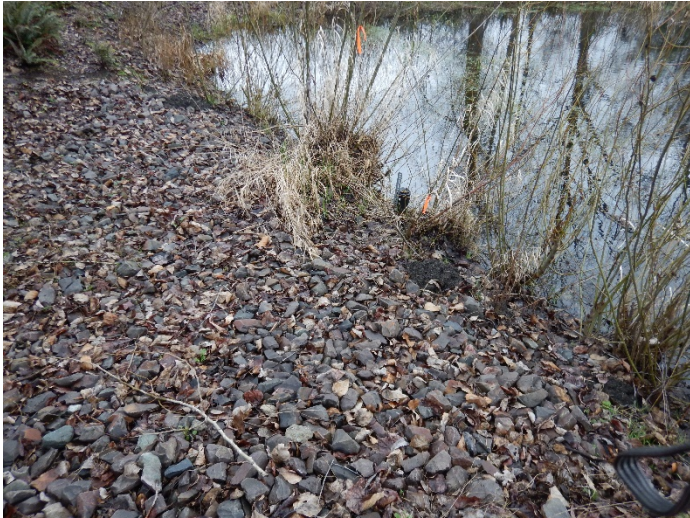
Photo #:25 (DSCN0728)

Description: Facing southwest, photo of the overflow point that discharges stormwater through Outfall 1.

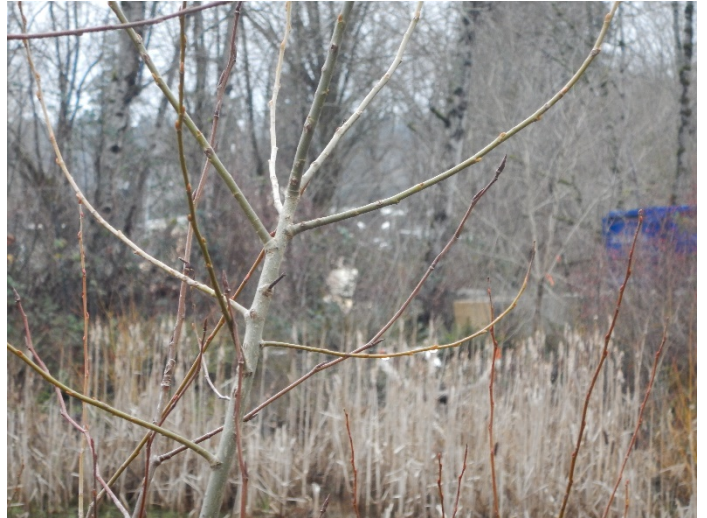
Photo #:26 (DSCN0729)

Description: Facing west, photo of the dense vegetation (cattails) within the infiltration pond.

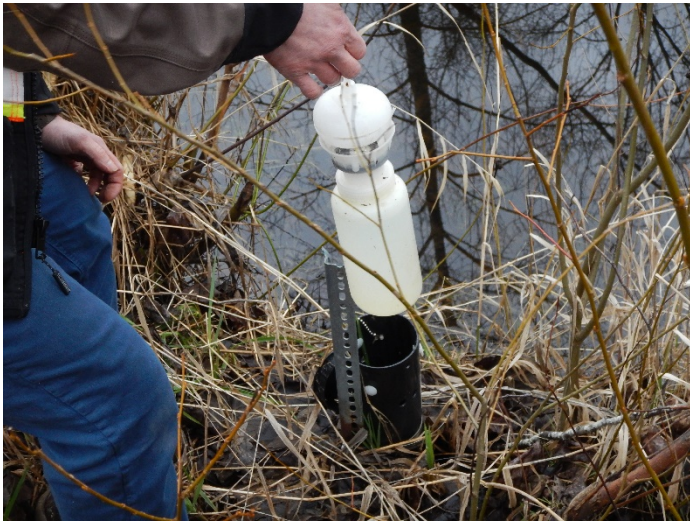
Photo #:27 (DSCN0730)

Description: Facing southwest, photo of the stormwater sampling bottle. The bottle is kept in the black housing for ease of access if discharge is ever observed.

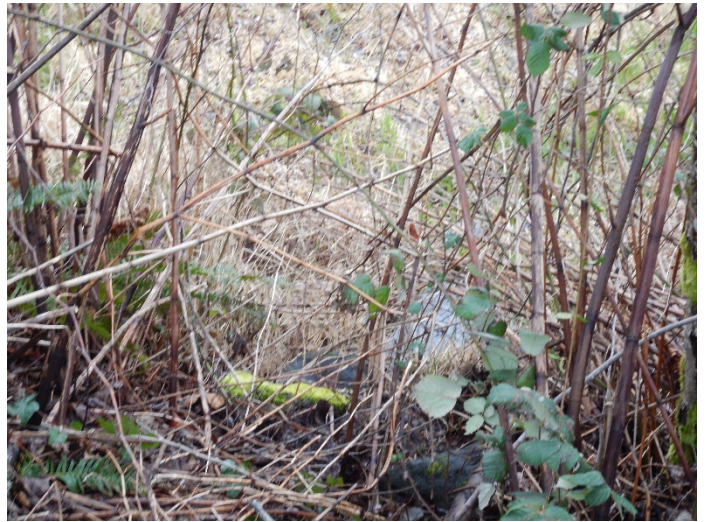
Photo #:28 (DSCN0731)

Description: Facing east, photo of Outfall 1 and the riparian area that stormwater would discharge to.

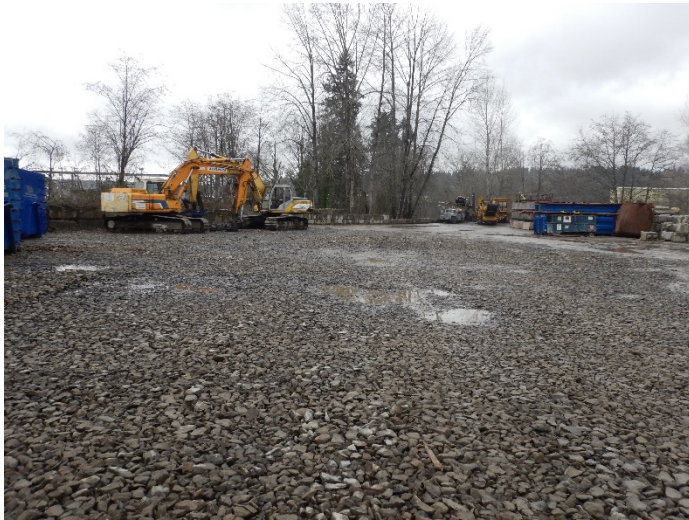
Photo #:29 (DSCN0732)

Description: Facing west, photo equipment and containers within the concrete processing area.

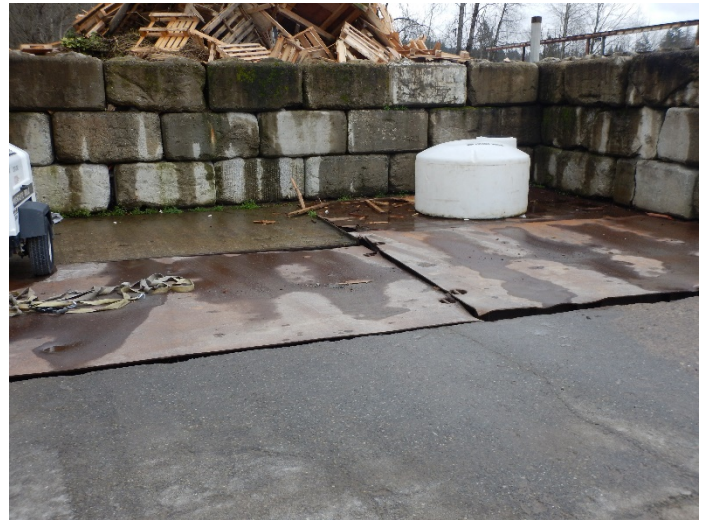
Photo #:30 (DSCN0733)

Description: Facing east, photo of the oil/water separator.

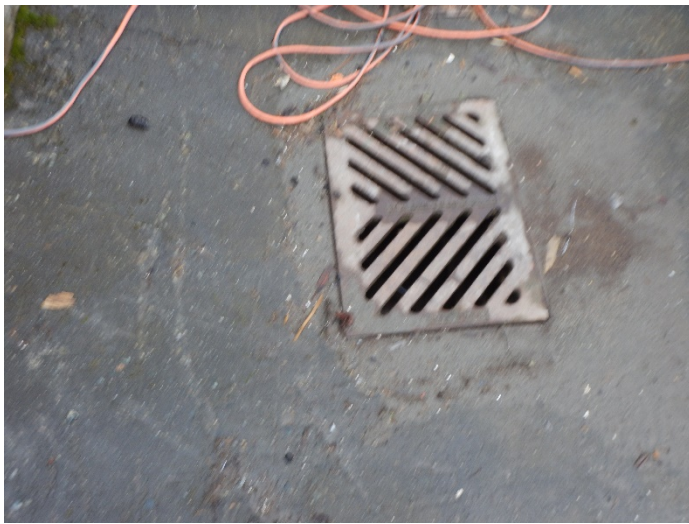
Photo #:31 (DSCN0734)

Description: Photo of one of the catch basins in the paved portion of the facility.

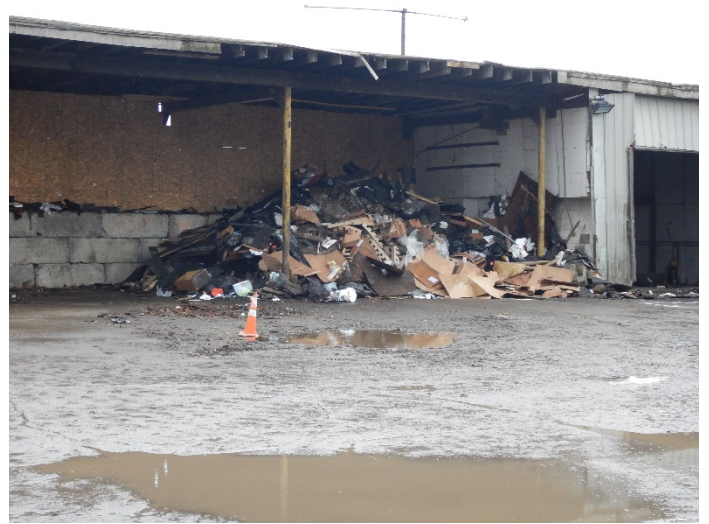
Photo #:32 (DSCN0735)

Description: Facing southwest, photo of the miscellaneous waste pile that gets transferred off-site for disposal at a waste management facility.

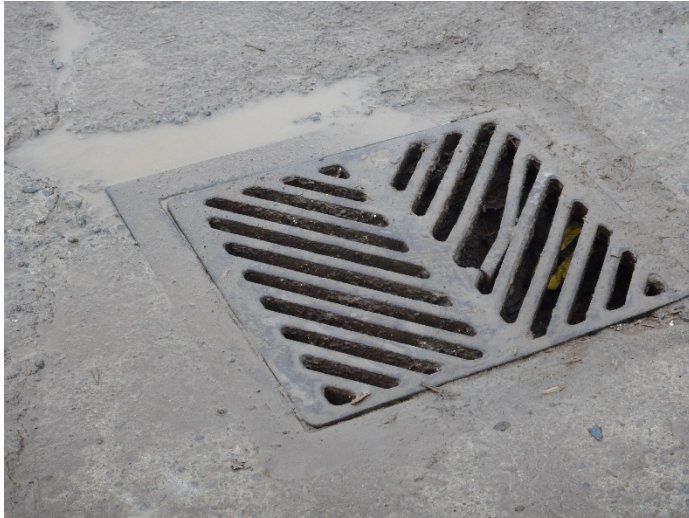
Photo #:33 (DSCN0736)

Description: Photo of one of the catch basins within the paved portion of the facility.

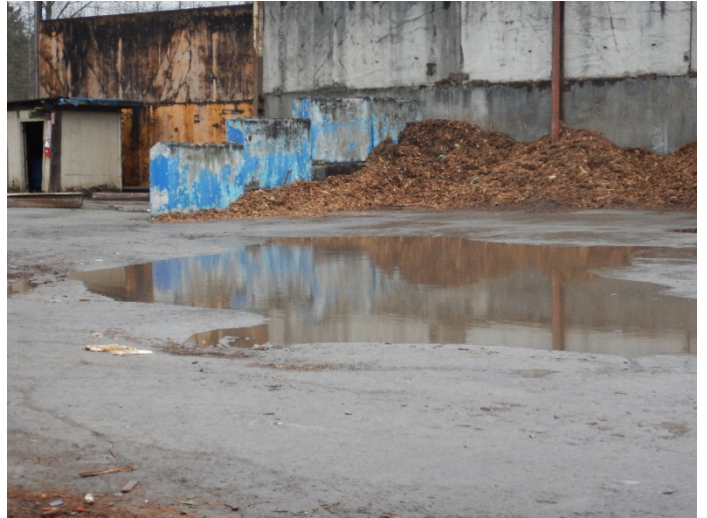
Photo #:34 (DSCN0737)

Description: Facing southeast, photo of stormwater pooling near discarded wood products.

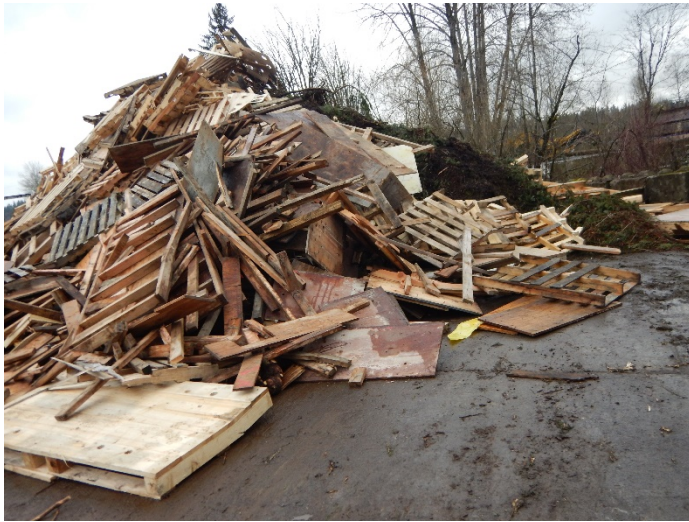
Photo #:35 (DSCN0738)

Description: Facing north, photo of the wood pile.

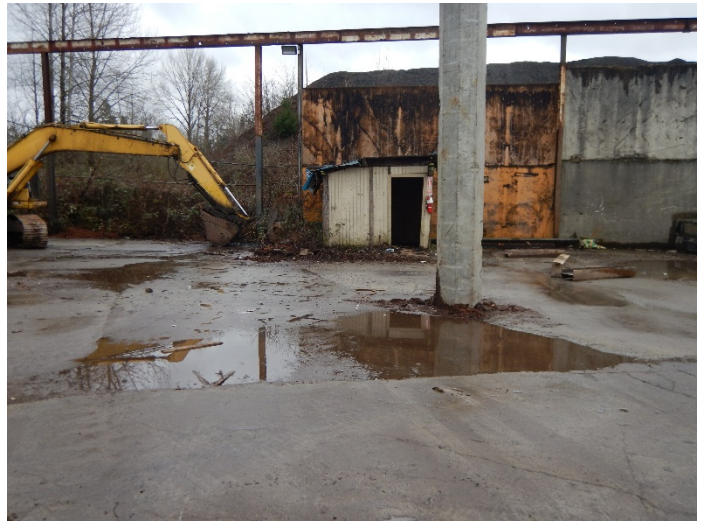
Photo #:36 (DSCN0739)

Description: Facing south, photo of the old wellhouse. This wellhouse will soon be decommissioned by the City of Redmond.

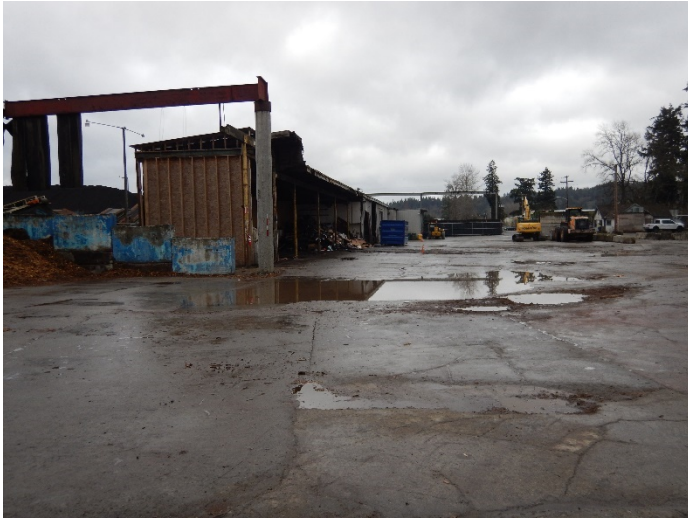
Photo #:37 (DSCN0740)

Description: Facing west, photo of water pooling the paved portion of the yard.

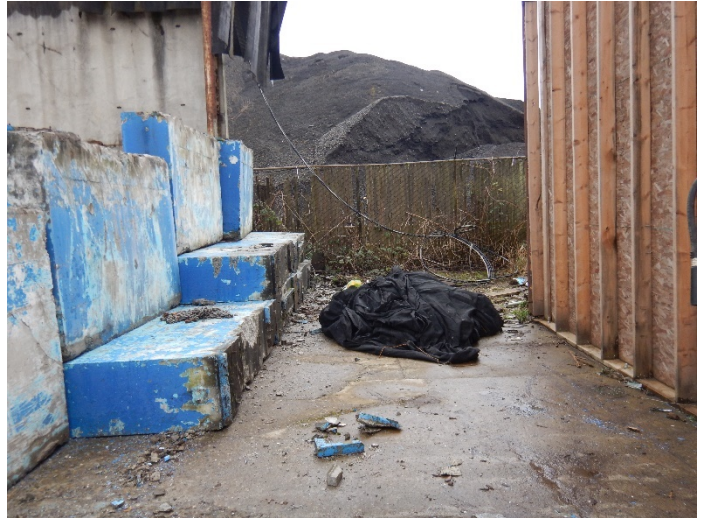
Photo #:38 (DSCN0741)

Description: Facing south, photo of discarded materials near the covered storage shed. Note the neighboring facility's large pile of product near the property fence line.

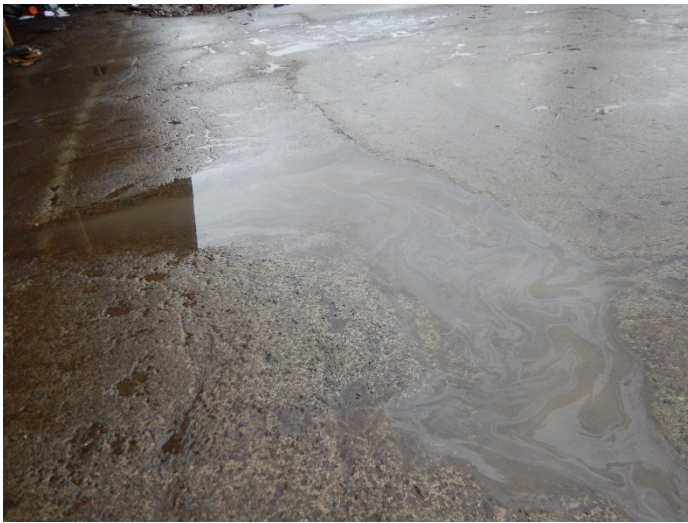
Photo #:39 (DSCN0742)

Description: Facing west, photo of visible sheen in the water pooling near the covered miscellaneous waste pile.

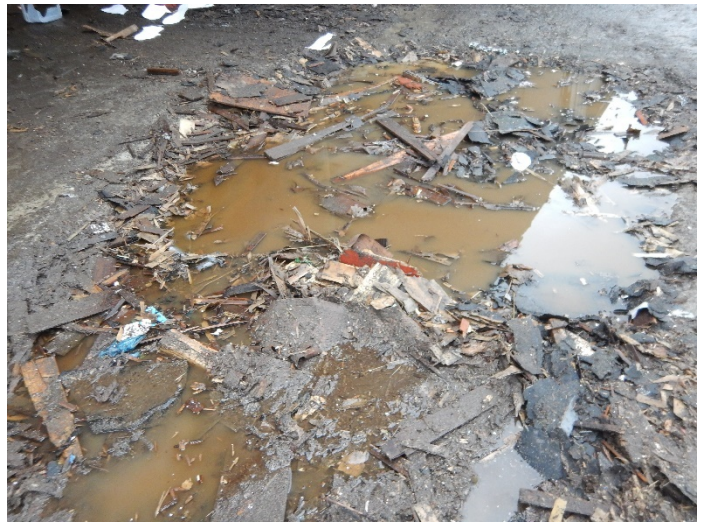
Photo #:40 (DSCN0743)

Description: Photo of trash and debris in water pooled near the miscellaneous waste pile.

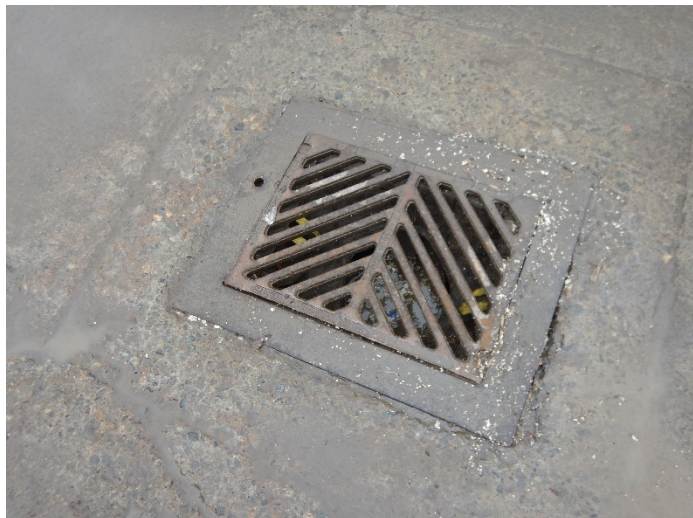
Photo #:41 (DSCN0744)  
Description: Photo of one of the catch basins.

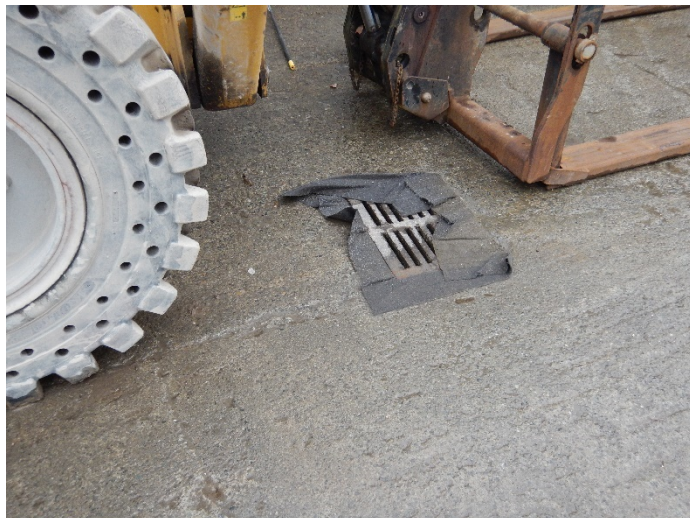
Photo #:42 (DSCN0745)  
Description: Facing south, photo of one of the catch basins.

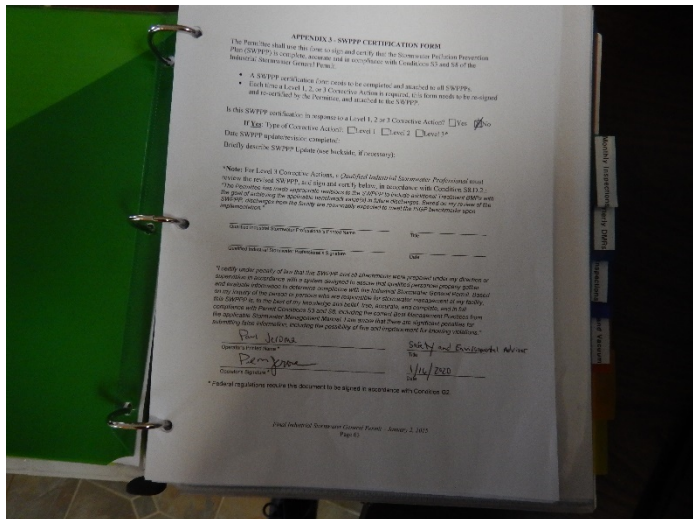
Photo #:43 (DSCN0746)  
Description: Photo of most recent SWPPP certification.

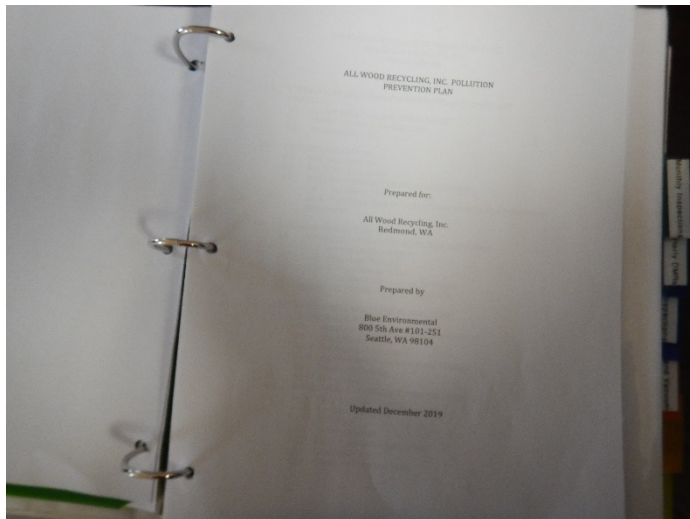
Photo #:44 (DSCN0747)  
Description: Photo of the cover page of the SWPPP.
