## Region 6 Compliance Assurance and Enforcement Division

### INSPECTION REPORT

| Company Name: | City of Mercedes | | |
| Identification/Permit Number: | TX0021547/TXR05V314 | | |

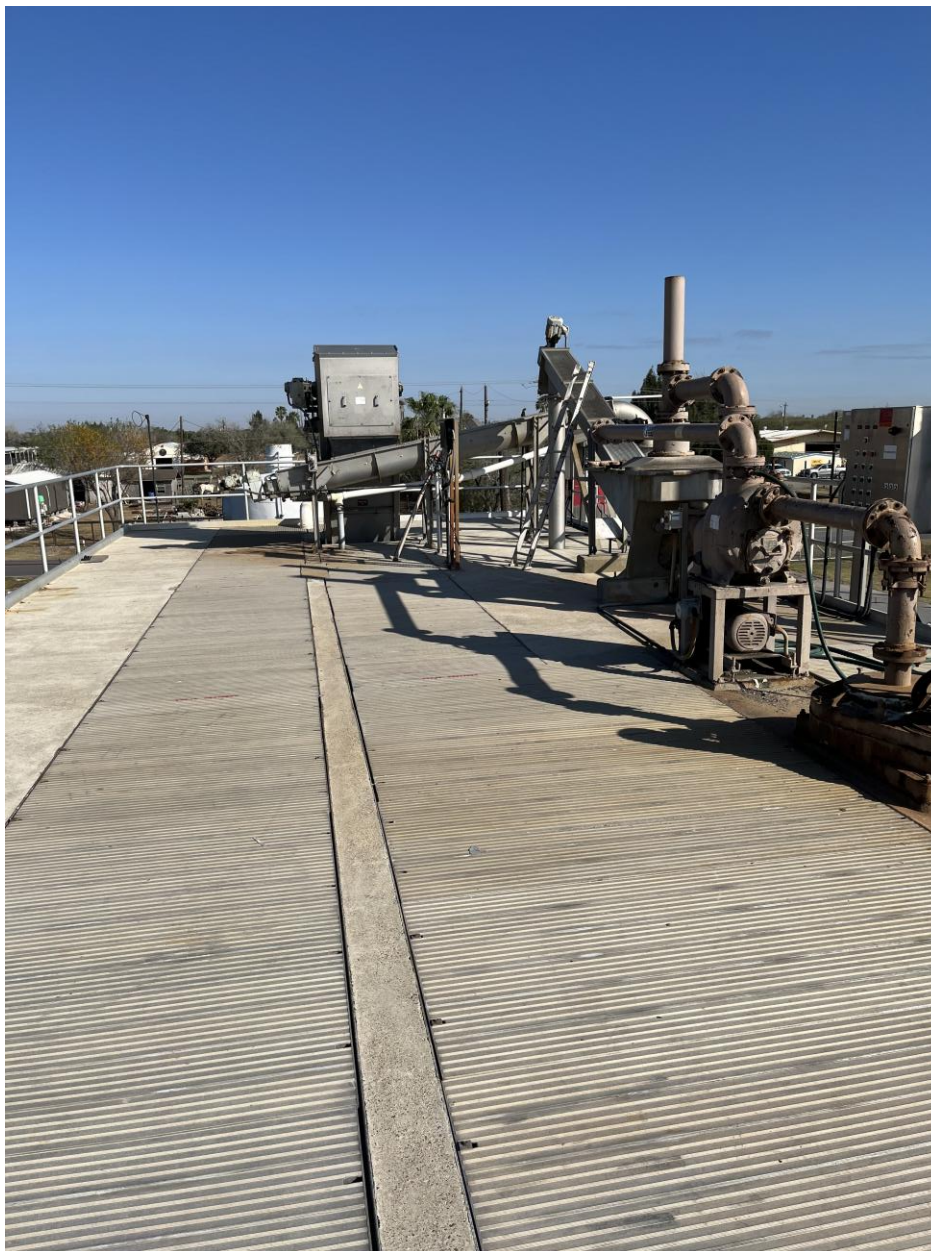
Photo No. 1

Bar Screen

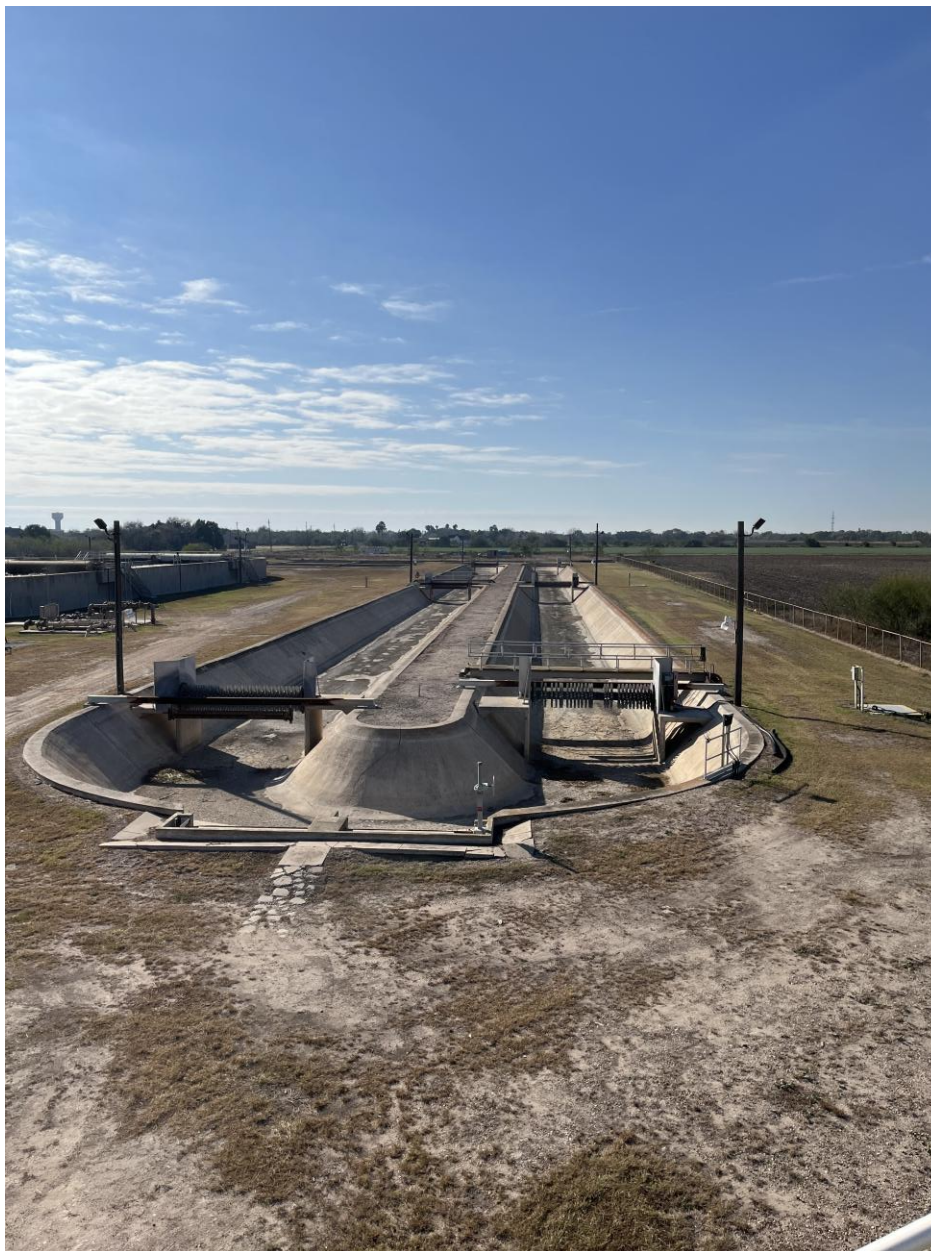
Photo No. 2

- Racetrack Aeration Basin No. 1 Out of Service  
At the time of the inspection, Racetrack Aeration Basin No. 1 was not in operation. Facility staff reported that the associated secondary clarifier receiving flow from this basin had been taken offline due to a structural crack in the center well. Because the clarifier could not reliably perform solids separation under these conditions, influent flow to Racetrack No. 1 was suspended until repairs to the clarifier structure could be completed and the unit returned to service.

Specifically, during the inspection it was observed that Racetrack Aeration Basin No. 1 was not in operation because the secondary clarifier receiving flow from this basin had been taken offline due to a crack in the center well structure. Additionally, Rotor No. 4 associated with Racetrack Aeration Basin No. 2 was not operational, reducing the available aeration and mixing capacity for that treatment unit.

It is also noted that the City has previously been cited by the Texas Commission on Environmental Quality (TCEQ) for issues associated with Racetrack No. 1 (also referred to as an oxidation ditch) during a prior inspection conducted in 2024. The recurrence of operational deficiencies associated with this treatment unit indicates a continuing concern regarding the proper maintenance and reliability of critical treatment infrastructure at the facility.

Racetrack #1 Out of Service

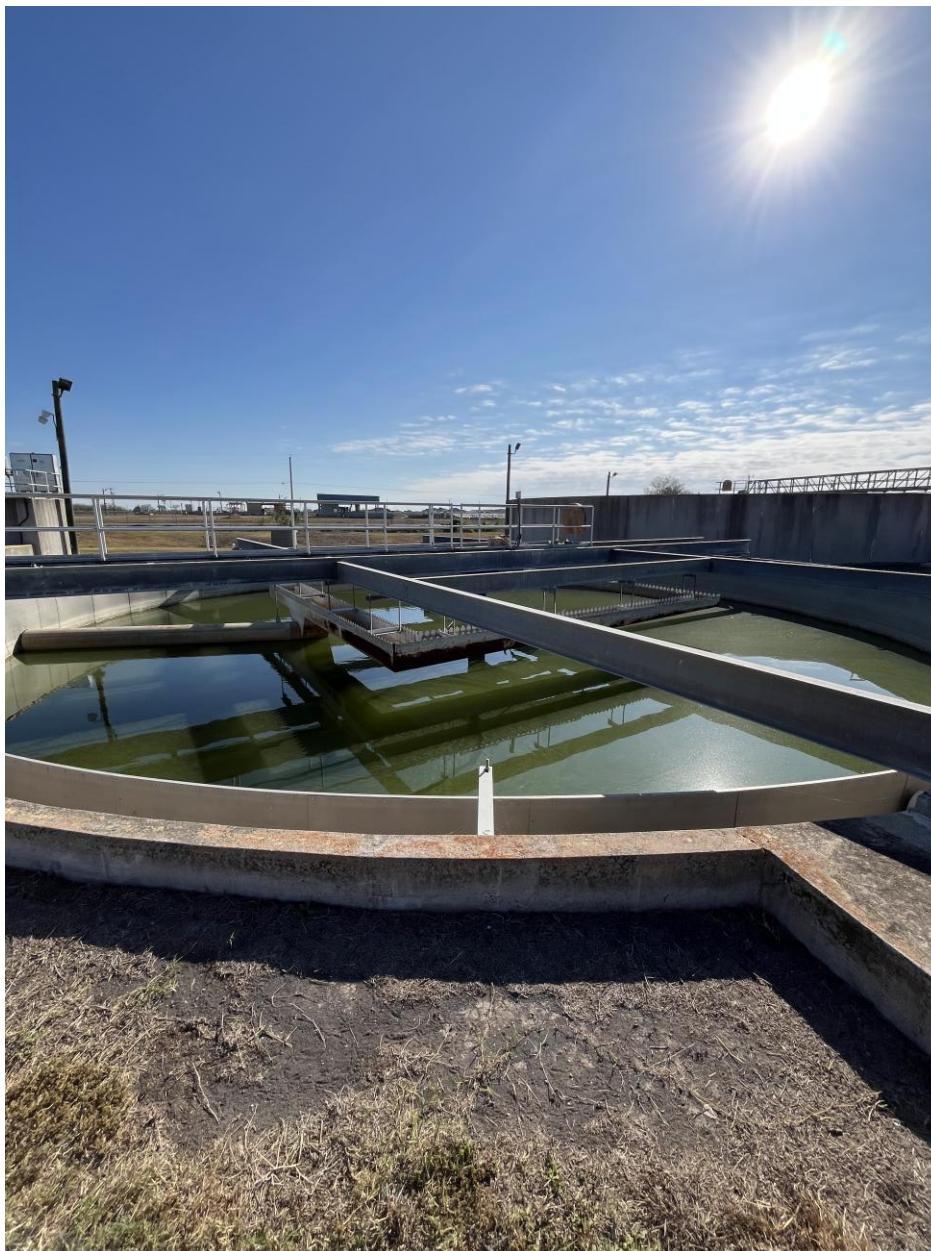
Photo No. 3

Clarifier #1 Out of Service with  
Cracked Well

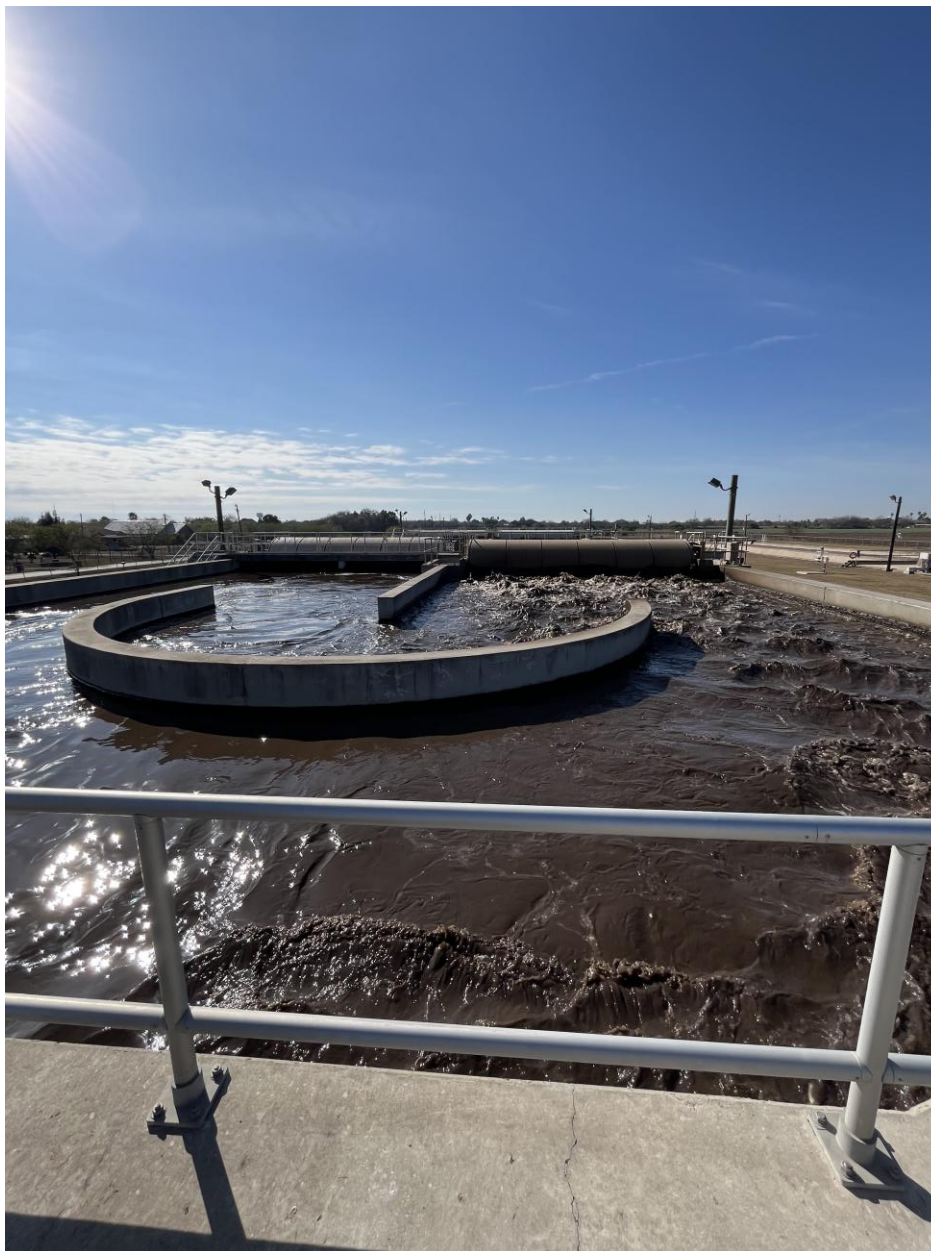
Photo No. 4

- Partial Mechanical Failure in Racetrack Aeration Basin No. 2  
Racetrack Aeration Basin No. 2 was in service; however, one of the two-disc rotors used for aeration and mixing was not operational at the time of inspection. With only one rotor functioning, the basin may experience reduced oxygen transfer and mixing efficiency, which could potentially affect biological treatment performance if sustained for an extended period.

Racetrack #2

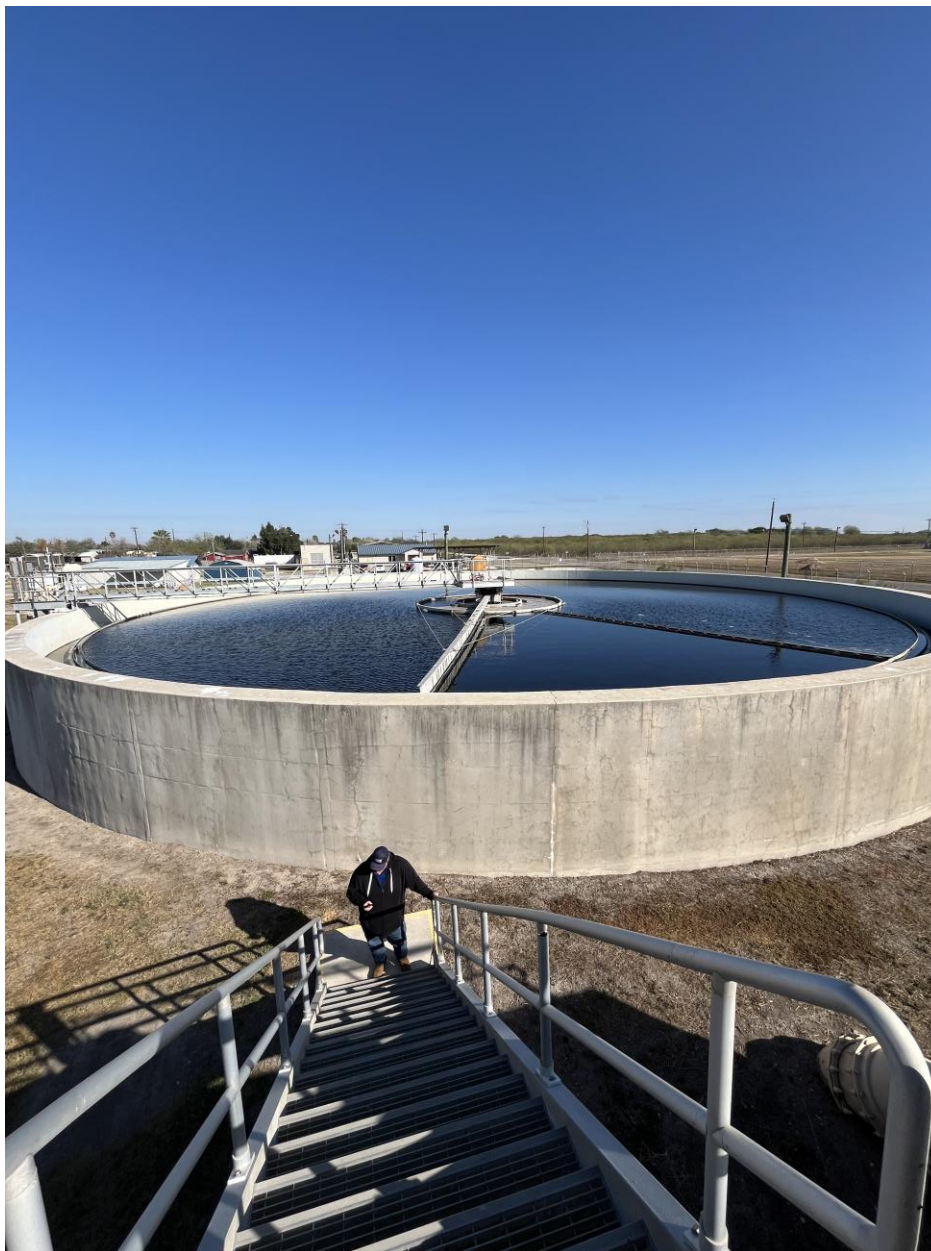
Photo No. 5

Clarifier #2

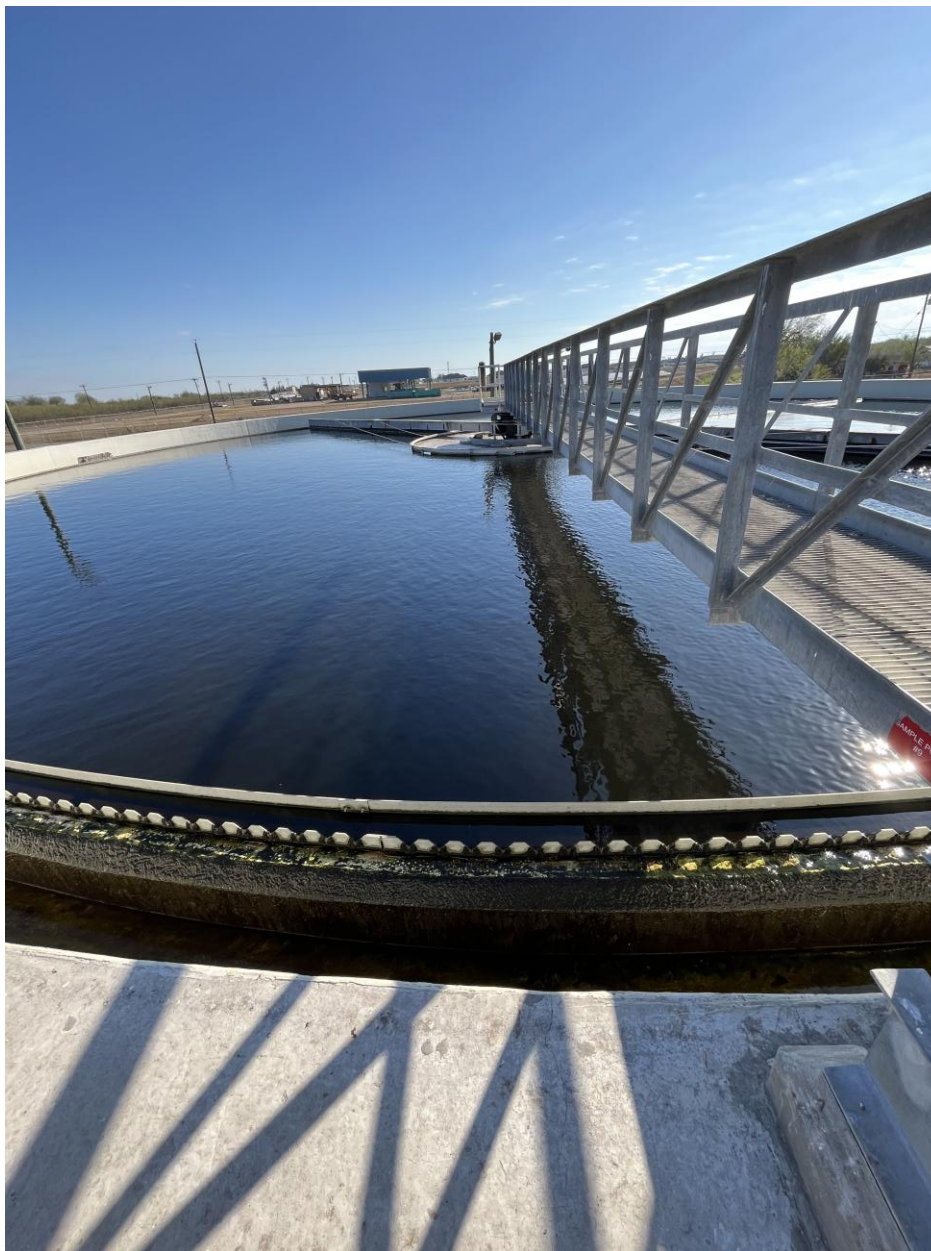
Photo No. 6

Clarifier #3

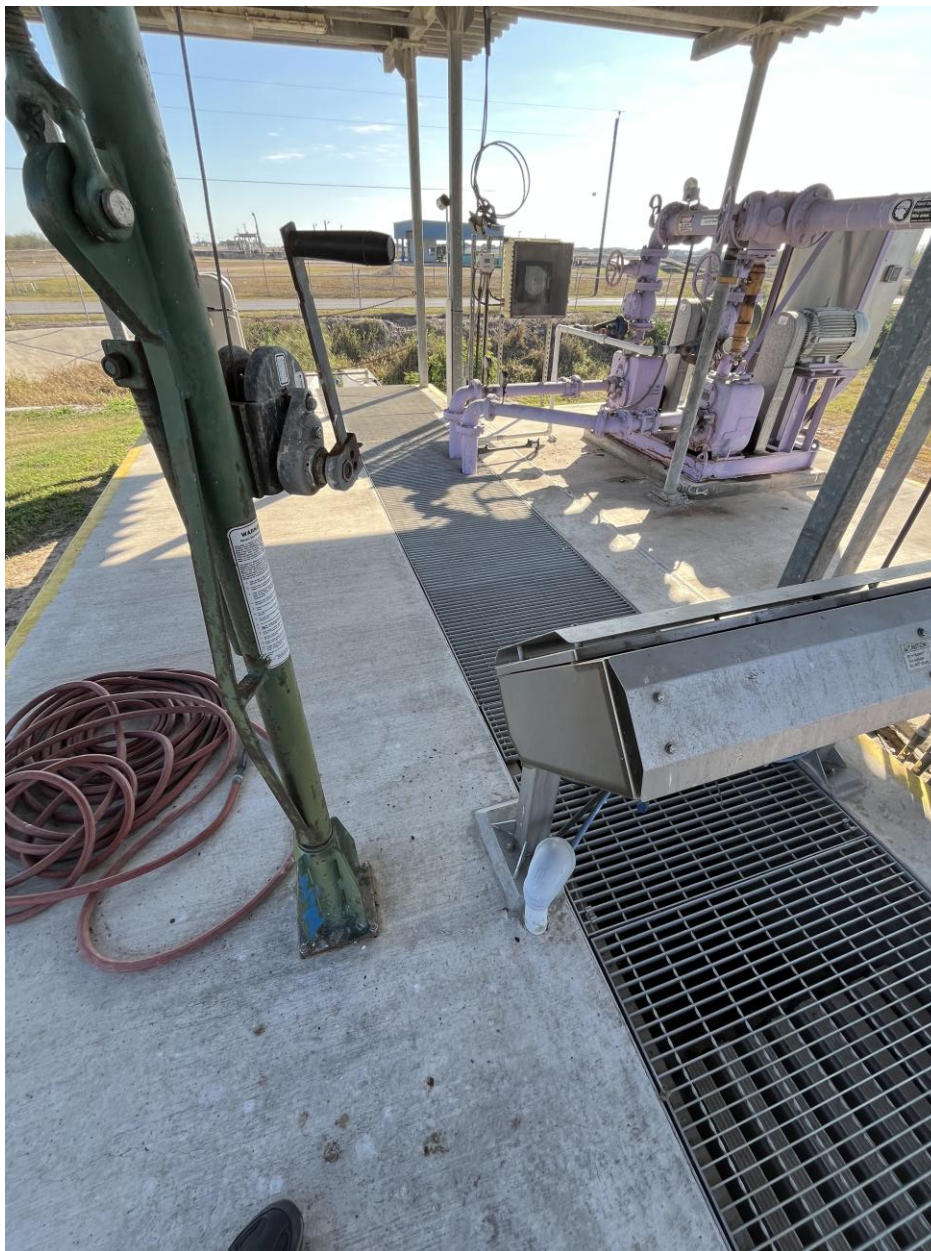
Photo No. 7

UV Disinfection

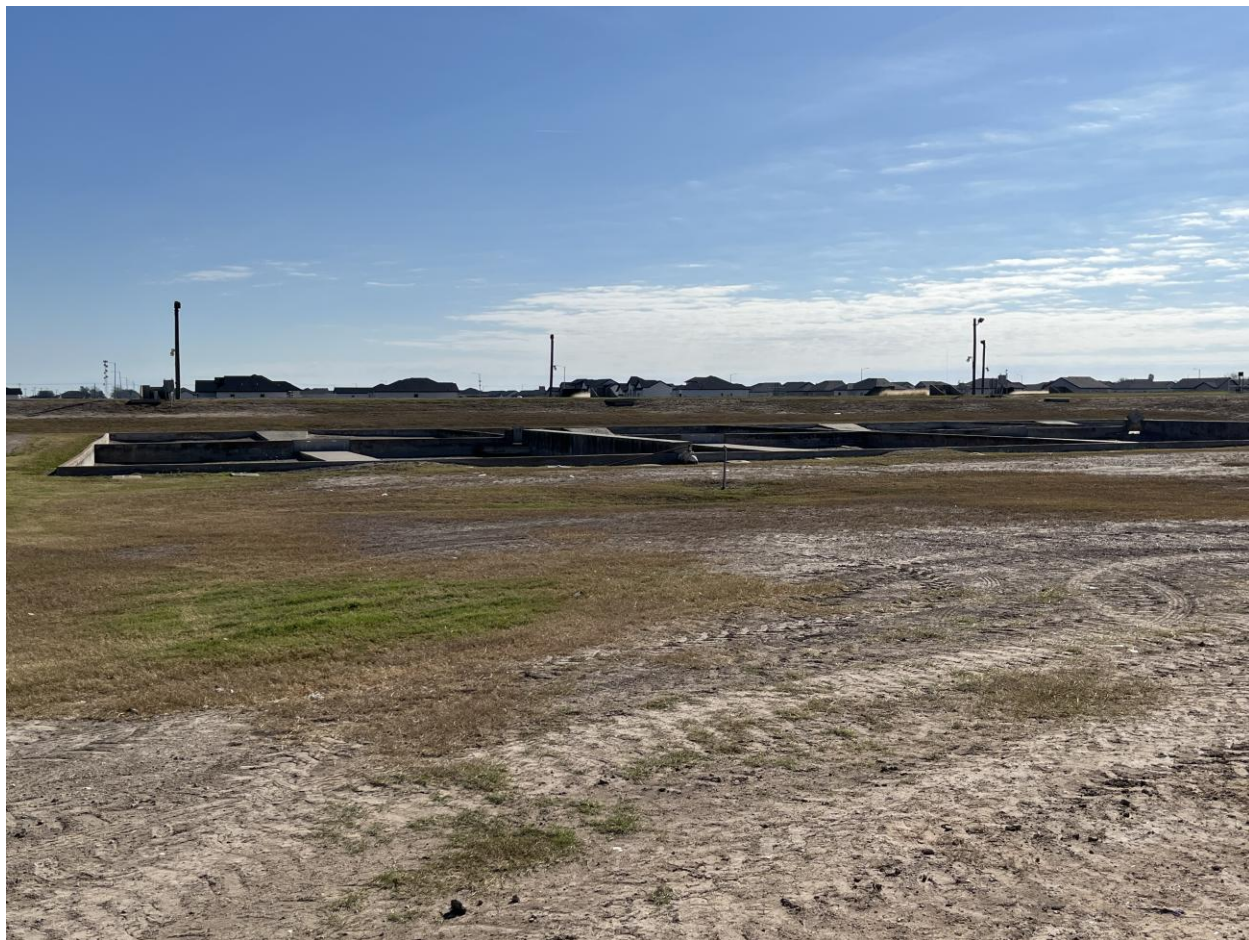
Photo No. 8

Drying Beds

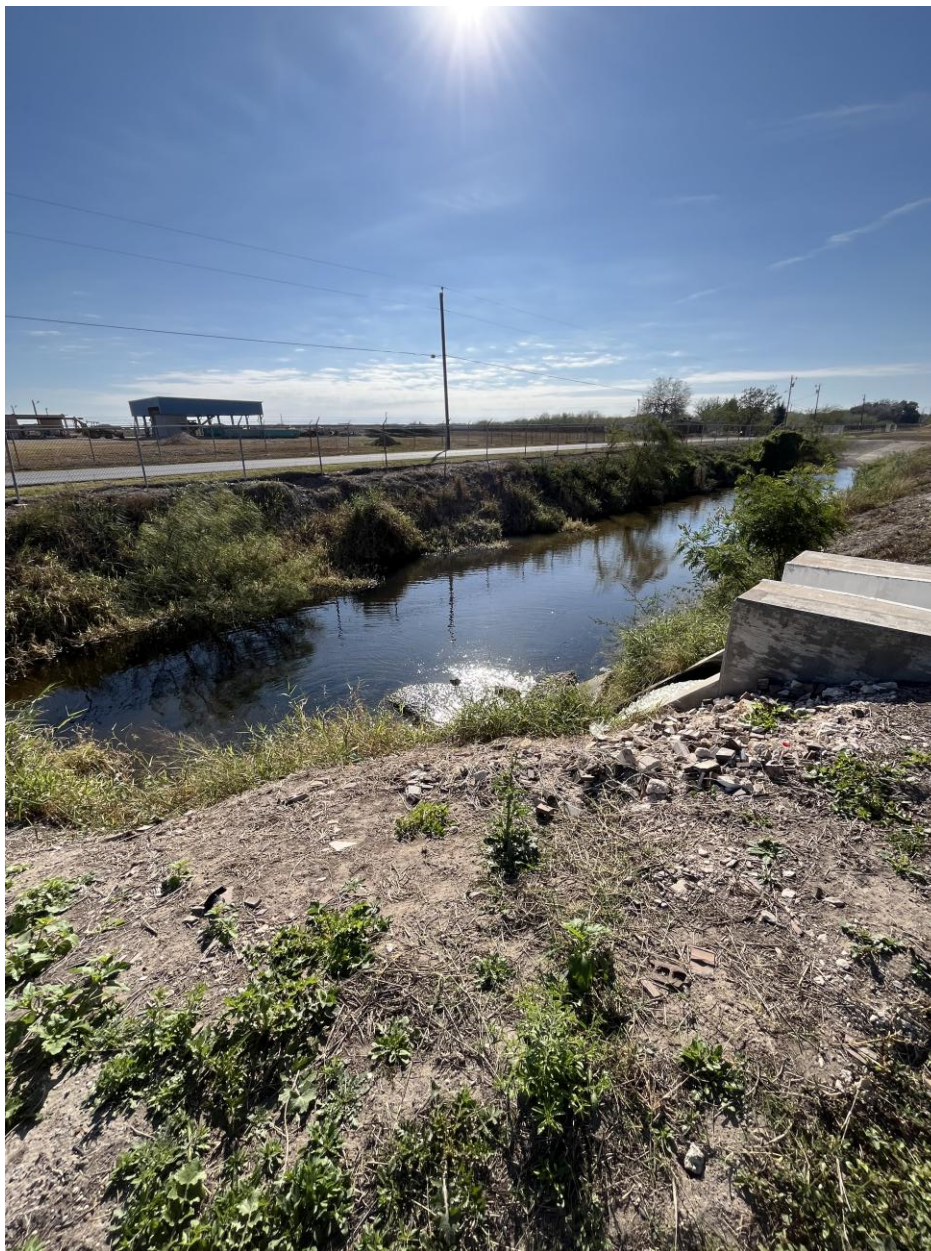
Photo No. 9

Outfall 001
