**UNITED STATES ENVIRONMENTAL PROTECTION AGENCY  
REGION 2, ECAD-WCB**

| <b>Program:</b> Sanitary Sewer System | <b>Inspection Type:</b> Compliance Evaluation Inspection | |
| <b>Permittee Name:</b> East Windsor MUA | <b>NPDES/ICIS No.:</b> NJ0023787, PID NO. 95449 | |

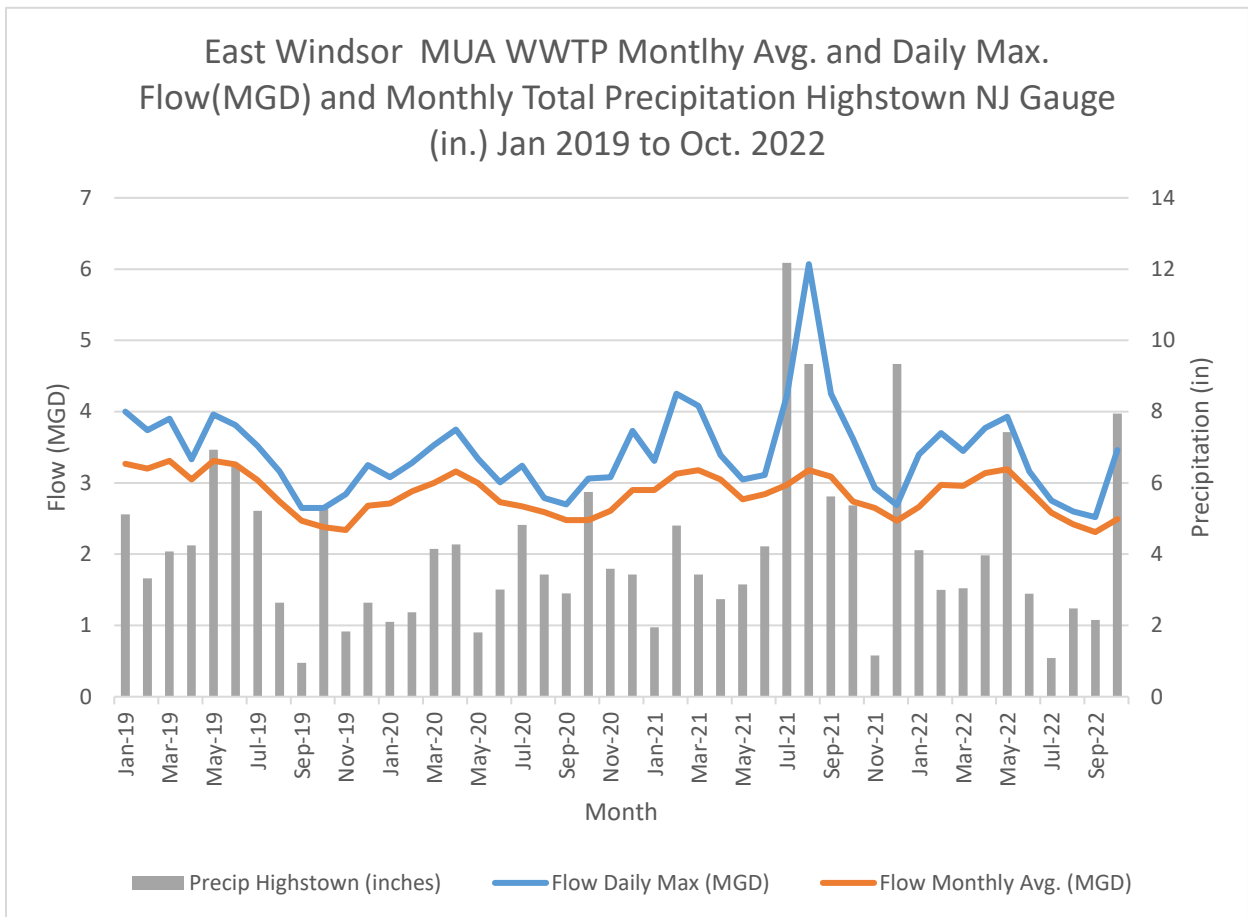
- On-site pump station inspections are conducted by EWMUA twice per week on Mondays and Fridays.
- Flow data at the EWMUA WWTP from EPA’s Enforcement and Compliance History Online (“ECHO”) database and precipitation data at the Highstown NJ gauge from the Northeast Regional Climate Center shown below, depict daily maximum and monthly average flows and the monthly total precipitation data. As shown in the graph below there are some monthly maximum flow spikes associated with high precipitation events that appear to be indicative of Inflow and Infiltration (“I&I”) issues in the collection system.

5. As identified in paragraph 17 there appears to be fairly large increases in flow associated with wet weather. EWMUA has worked to reduce I&I from the system and identified that there is a 10 year capital plan. Please provide plans/schedules to reduce I&I into the collection system.

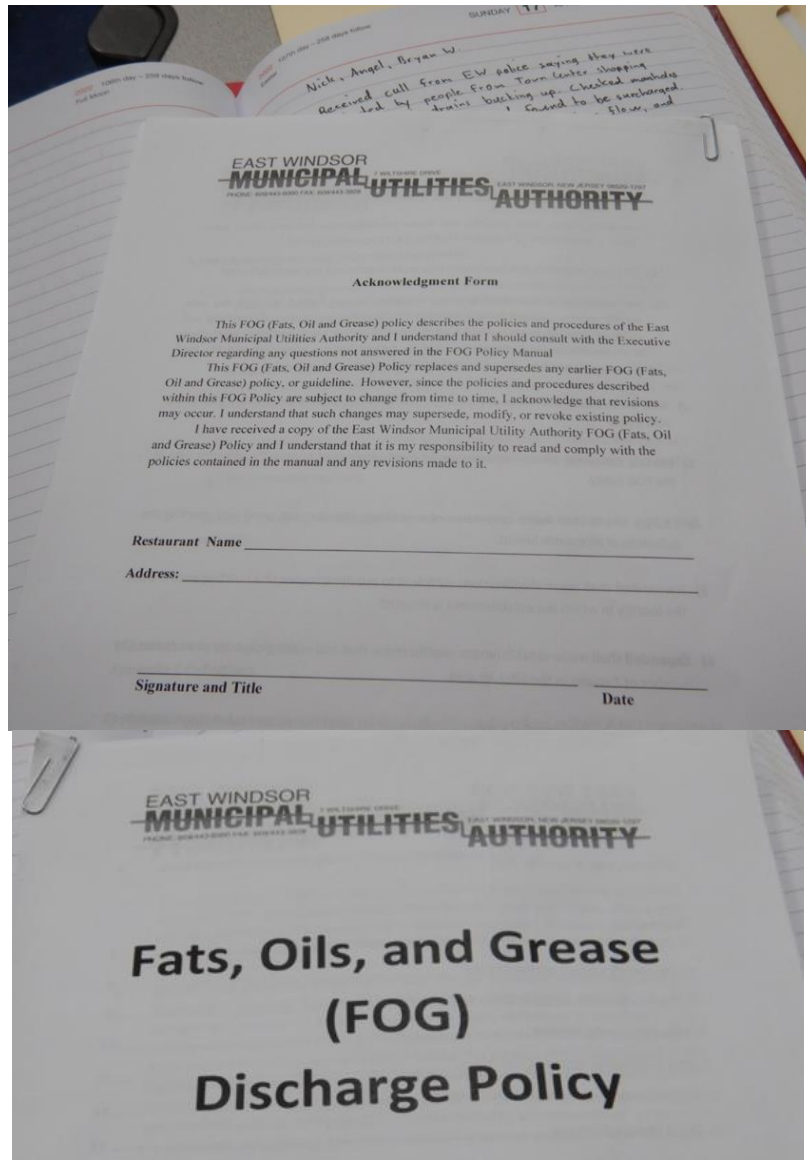
24. Fats, Oils and Grease (“FOG”)  
EWMUA said that it conducts annual inspections of grease traps. This program was started about 2 years ago, EWMUA inspector checks grease traps, installations of piping, markouts, had problems with restaurants during Covid. Currently they inspect about 75% of restaurants per year, and looking to hire another person to do inspections and markouts. Seeing more grease in pump stations. Started a \$200 per year grease trap inspections and records fee for commercial establishments. Pump stations are cleaned with a vacuum truck which brings pump station grease cleaning to the pit at the WWTP. The wastewater goes to the plant, grease is backhoed shoveled out to and taken to incineration. As shown below new restaurants are required to sign to the EWMUA FOG Policy. EWMUA will check new restaurants to make sure that they are tied into a grease interceptor. Existing restaurants not in the signed system yet. If grease trap inspection show that grease trap is more than 70% full for existing restaurants will require restaurants to sign on to grease policy. If they don't comply will get the local township health department involved.
