## RCRA FOCUSED COMPLIANCE INSPECTION REPORT

TAV Holdings, Inc.  
3311 Empire Boulevard, SW  
Atlanta, Georgia 30334  
EPA ID # GAD033537663

January 28, 2022

**TAV Holdings, Inc.**  
**Atlanta, Georgia**  
**EPA ID No.: GAD033537663**  
**EPA RCRA Focused Compliance Inspection Photographs**

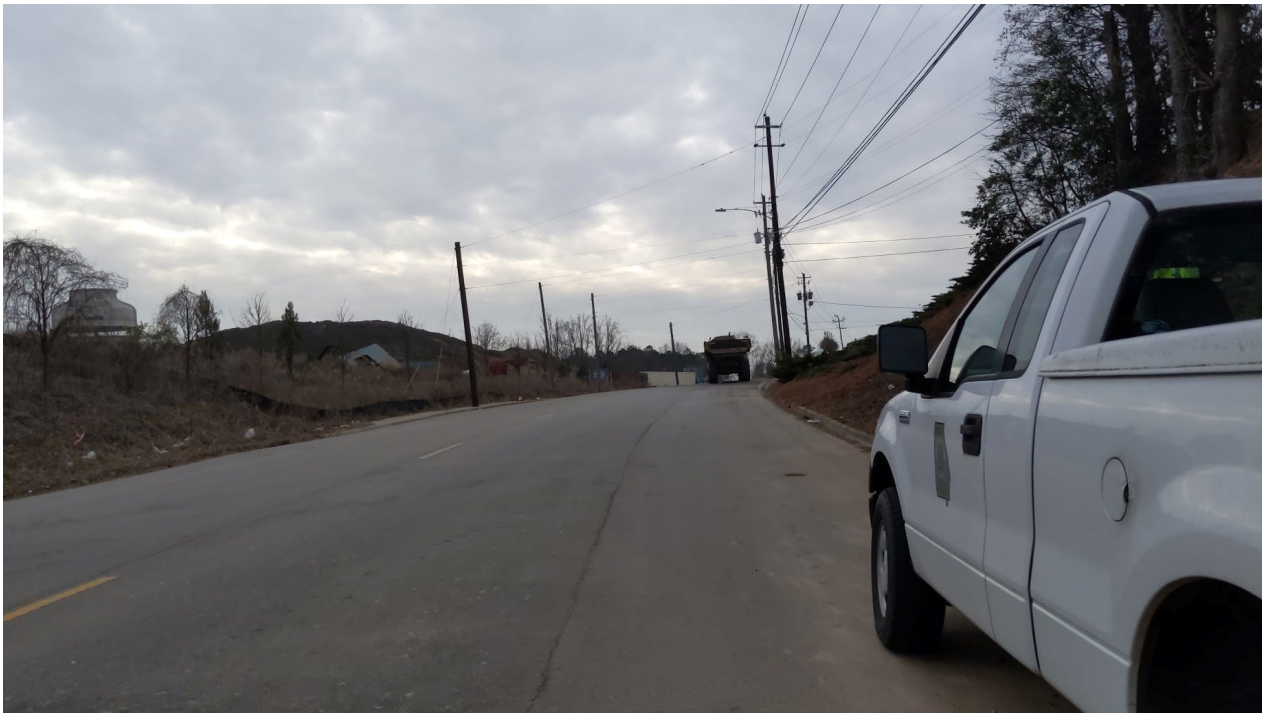
Upon arrival at the Facility, the EPA inspector observed a dump truck hauling material back-and-forth across Empire Boulevard from the Keebler Complex at 111 Hollow Tree Lane to the laydown yard and stockpile at 3320 Empire Boulevard. The dump truck was observed operating and carrying a full load of ASR waste material without a tarp or cover. The EPA inspector observed ASR waste material spilling out of the back of the dump truck and onto Empire Boulevard (*Photographs 1 and 2*).

Photograph 1 of 30: Dump Truck Hauling Material Back and Forth Across Properties

**Pursuant to Paragraph 82 of the RCRA 7003 Order, Respondents must perform immediate stabilization measures to eliminate the ongoing release of solid and hazardous waste to the environment and to ensure that ongoing operations do not cause or contribute to further releases and must “immediately cease all activities (including operations, business practices, and material management, including commingling, mixing, and receipt and transfer of ASR waste) that may result in the release of solid and/or hazardous waste into the environment, including, but not limited to, ceasing the placement of ASR waste, intermediates from the processing of ASR waste, materials resulting from the processing of ASR waste, wastewaters and/or process waters, sludge, and/or any other wastes, directly onto the ground, including onto asphalt, concrete, or other surfaces.”**

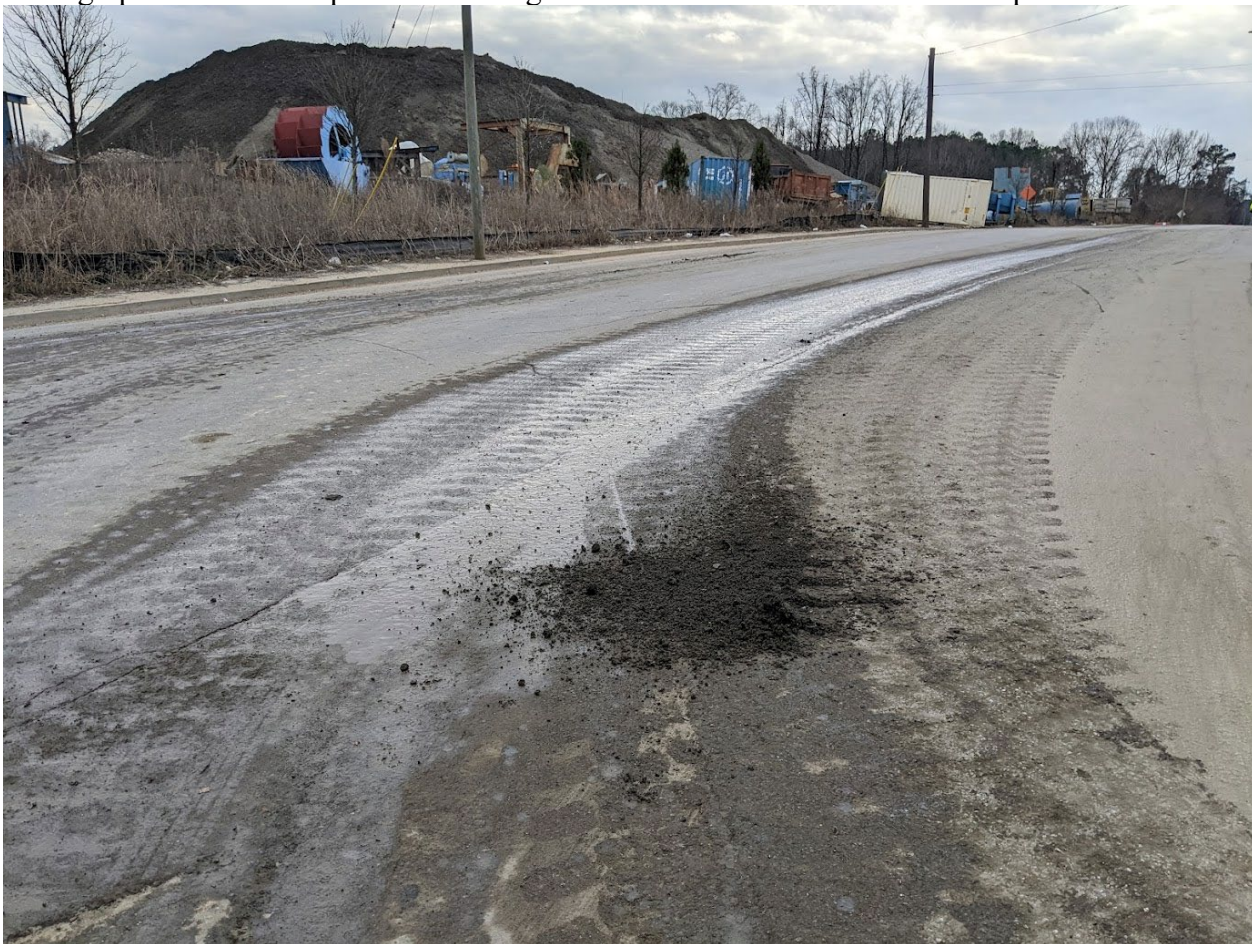
Photograph 2 of 30: Material Spillage onto Empire Blvd. off the Back of the Dump Truck

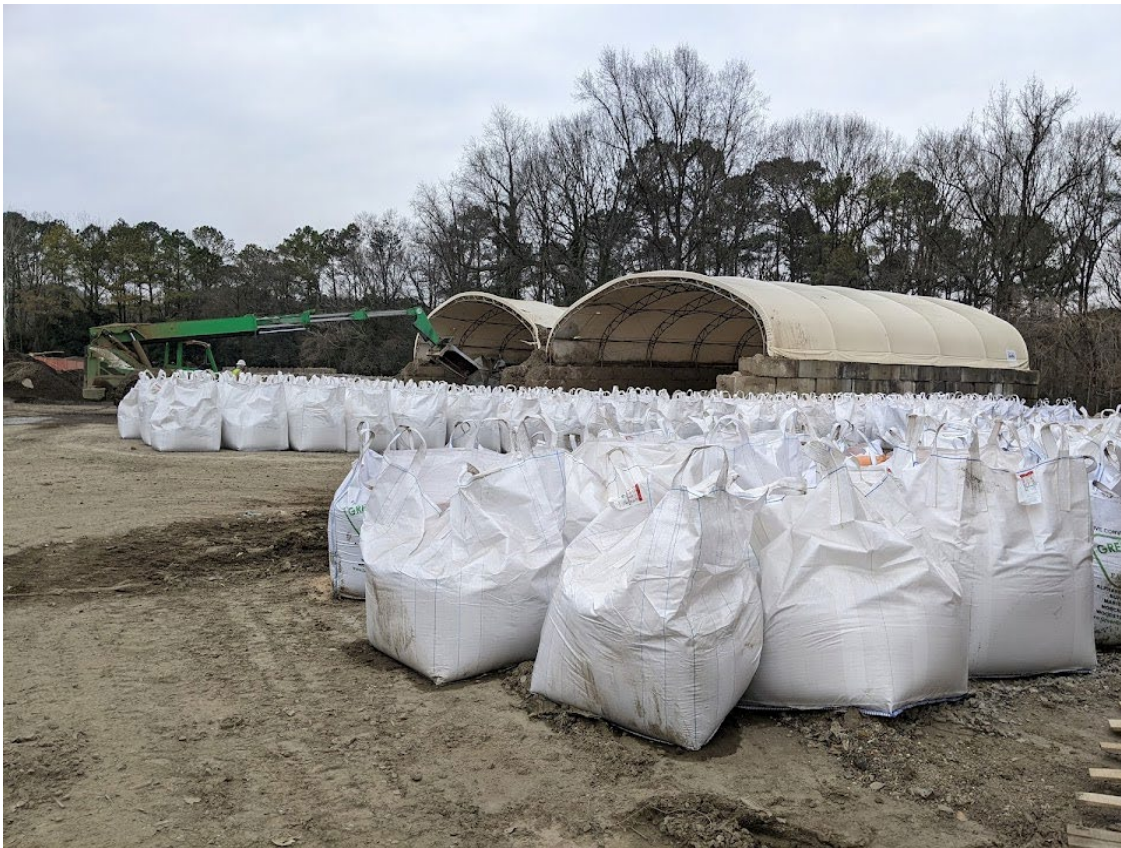
At the time of the FCI, the EPA inspector observed super-sack containers full of sand, staged near Receiving and in the Jig Pad Area (*Photographs 3, 4, and 5*). Facility representatives informed the EPA that these containers are to be used to aid in the prevention of off-site releases and stormwater run on and runoff. The EPA inspector also observed the addition made to a preexisting containment wall viewed during the October 6, 2021 CEI in the Jig Pad Area (*Photographs 6, 7, and 8*). Facility representatives explained to the EPA inspector that the addition consists of a horizontal and vertical expansion of the wall which includes the use of concrete and an expansion foam between two layers of stone blocks. TAV indicated in Section V. *Zero-Discharge Facility* of its January 21, 2022, Response Letter to EPA’s RCRA 7003 Order that it had “completed the work necessary to capture, retain, and use on-site all stormwater that was previously directed to the NPDES outfalls” and believed to have “satisfied the requirement of paragraph 82 of the Order”. At the time of the FCI, Facility representatives explained that the wall could not be finished because the contractor hired to construct the wall ran out of concrete. The inspector observed the unfinished wall (*Photograph 9*). It appears ASR waste that mixes with stormwater, wastewater and process water and gathers in the Jig Pad Area, is leaving the site by going through, over, and under the wall (*Photographs 10-18*).

Photograph 3 of 30: Super-Sacks Filled with Sand

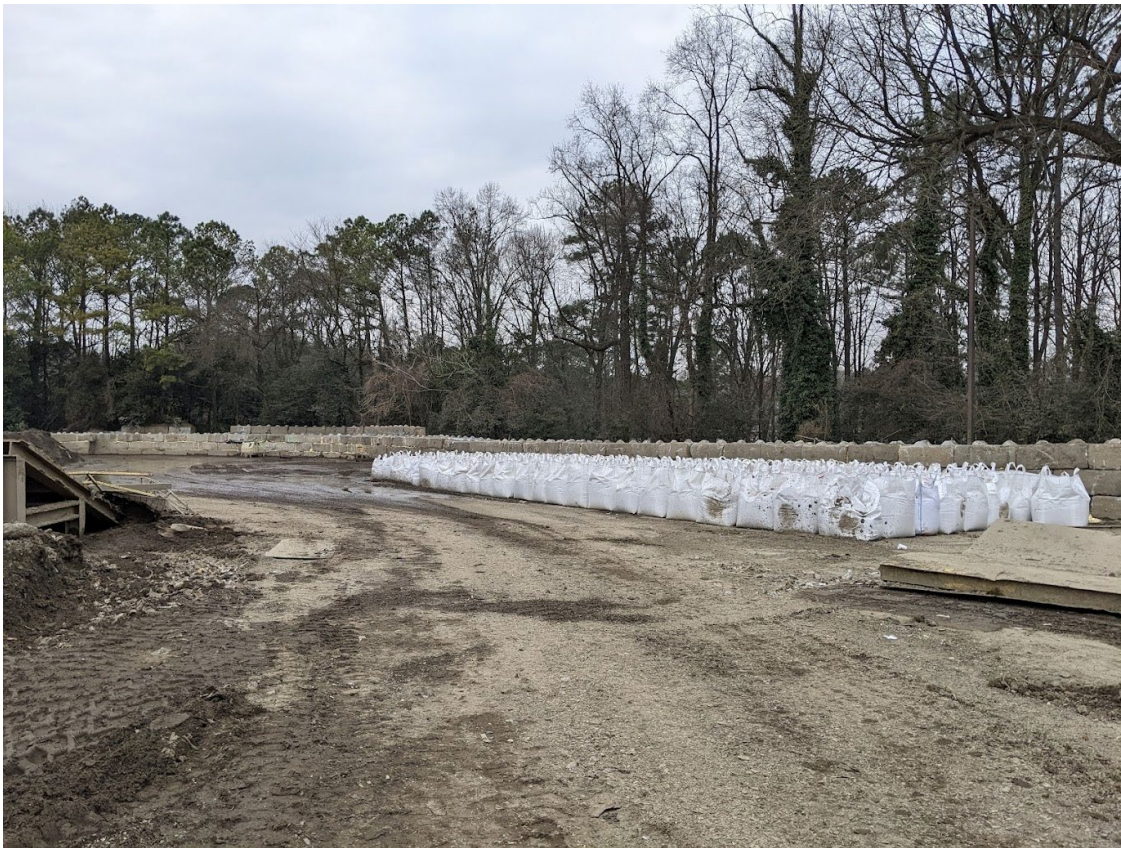
Photograph 4 of 30: Jig Pad Area with New Wall Addition and Super-Sacks

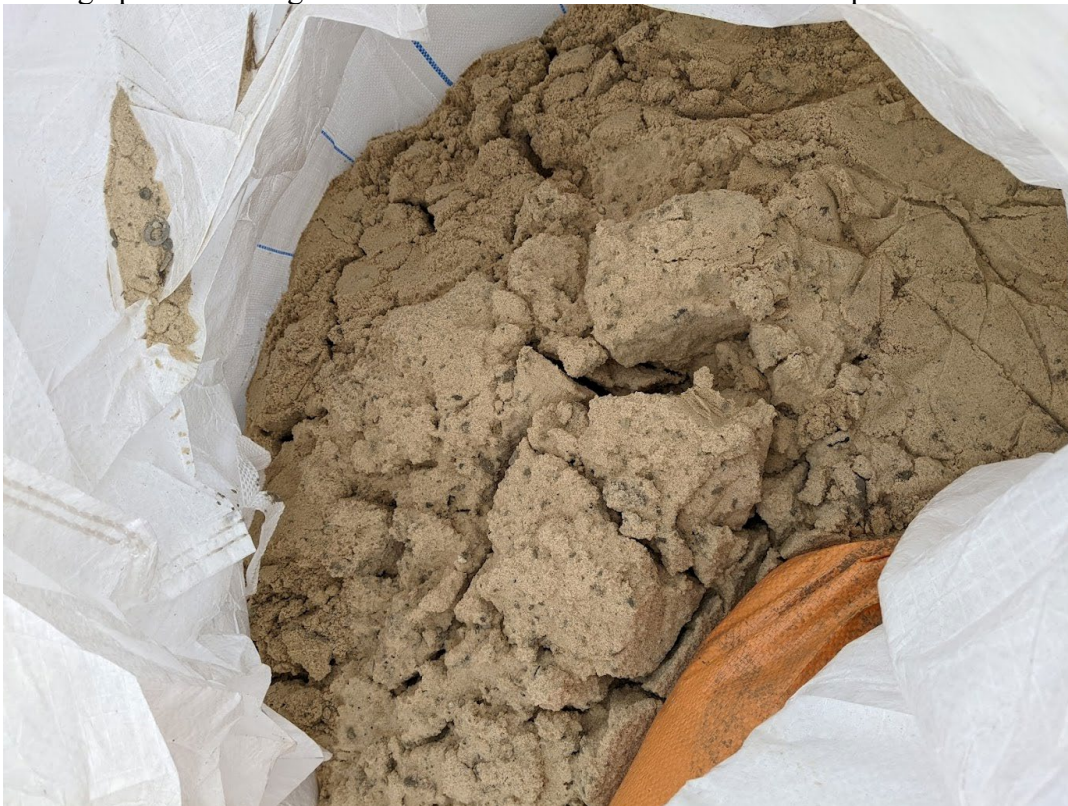
Photograph 5 of 30: Sand Inside Super-Sacks

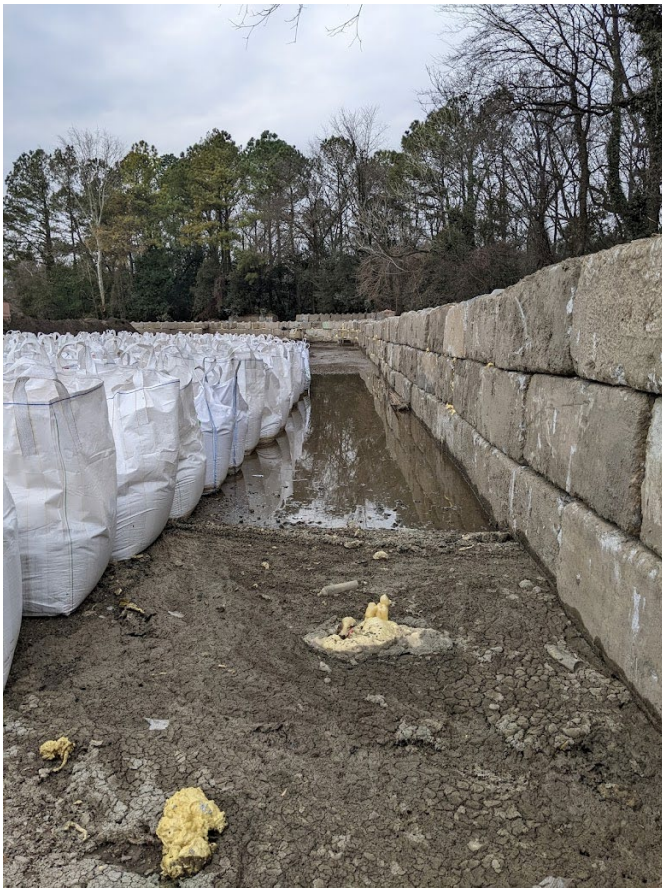
Photograph 6 of 30: Jig Pad Area Wall Addition

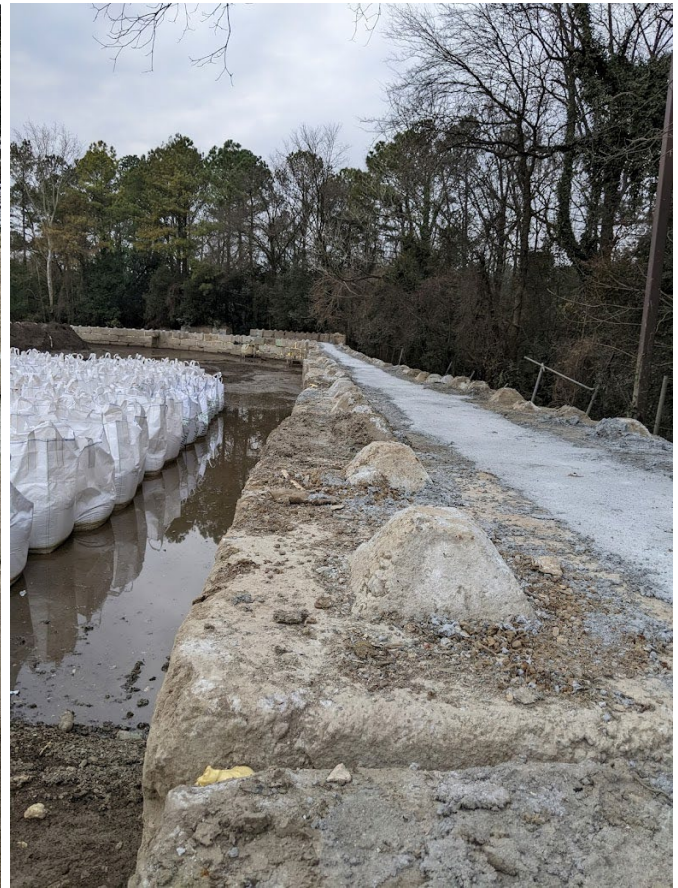
Photograph 7 of 30: Jig Pad Area Wall Addition

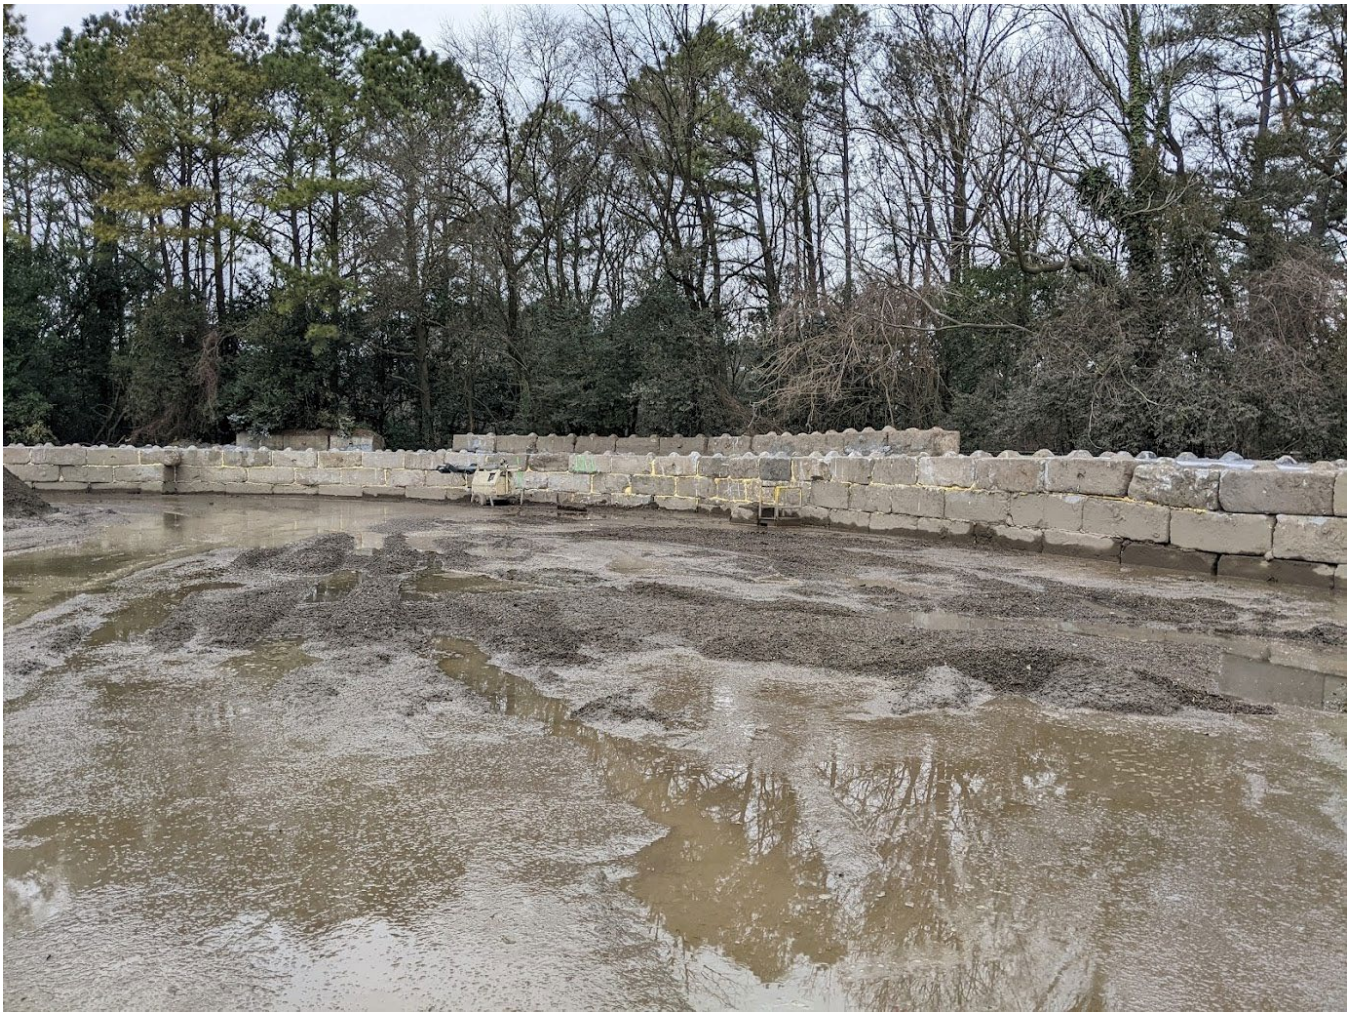
Photograph 8 of 30: Jig Pad Area Wall Addition

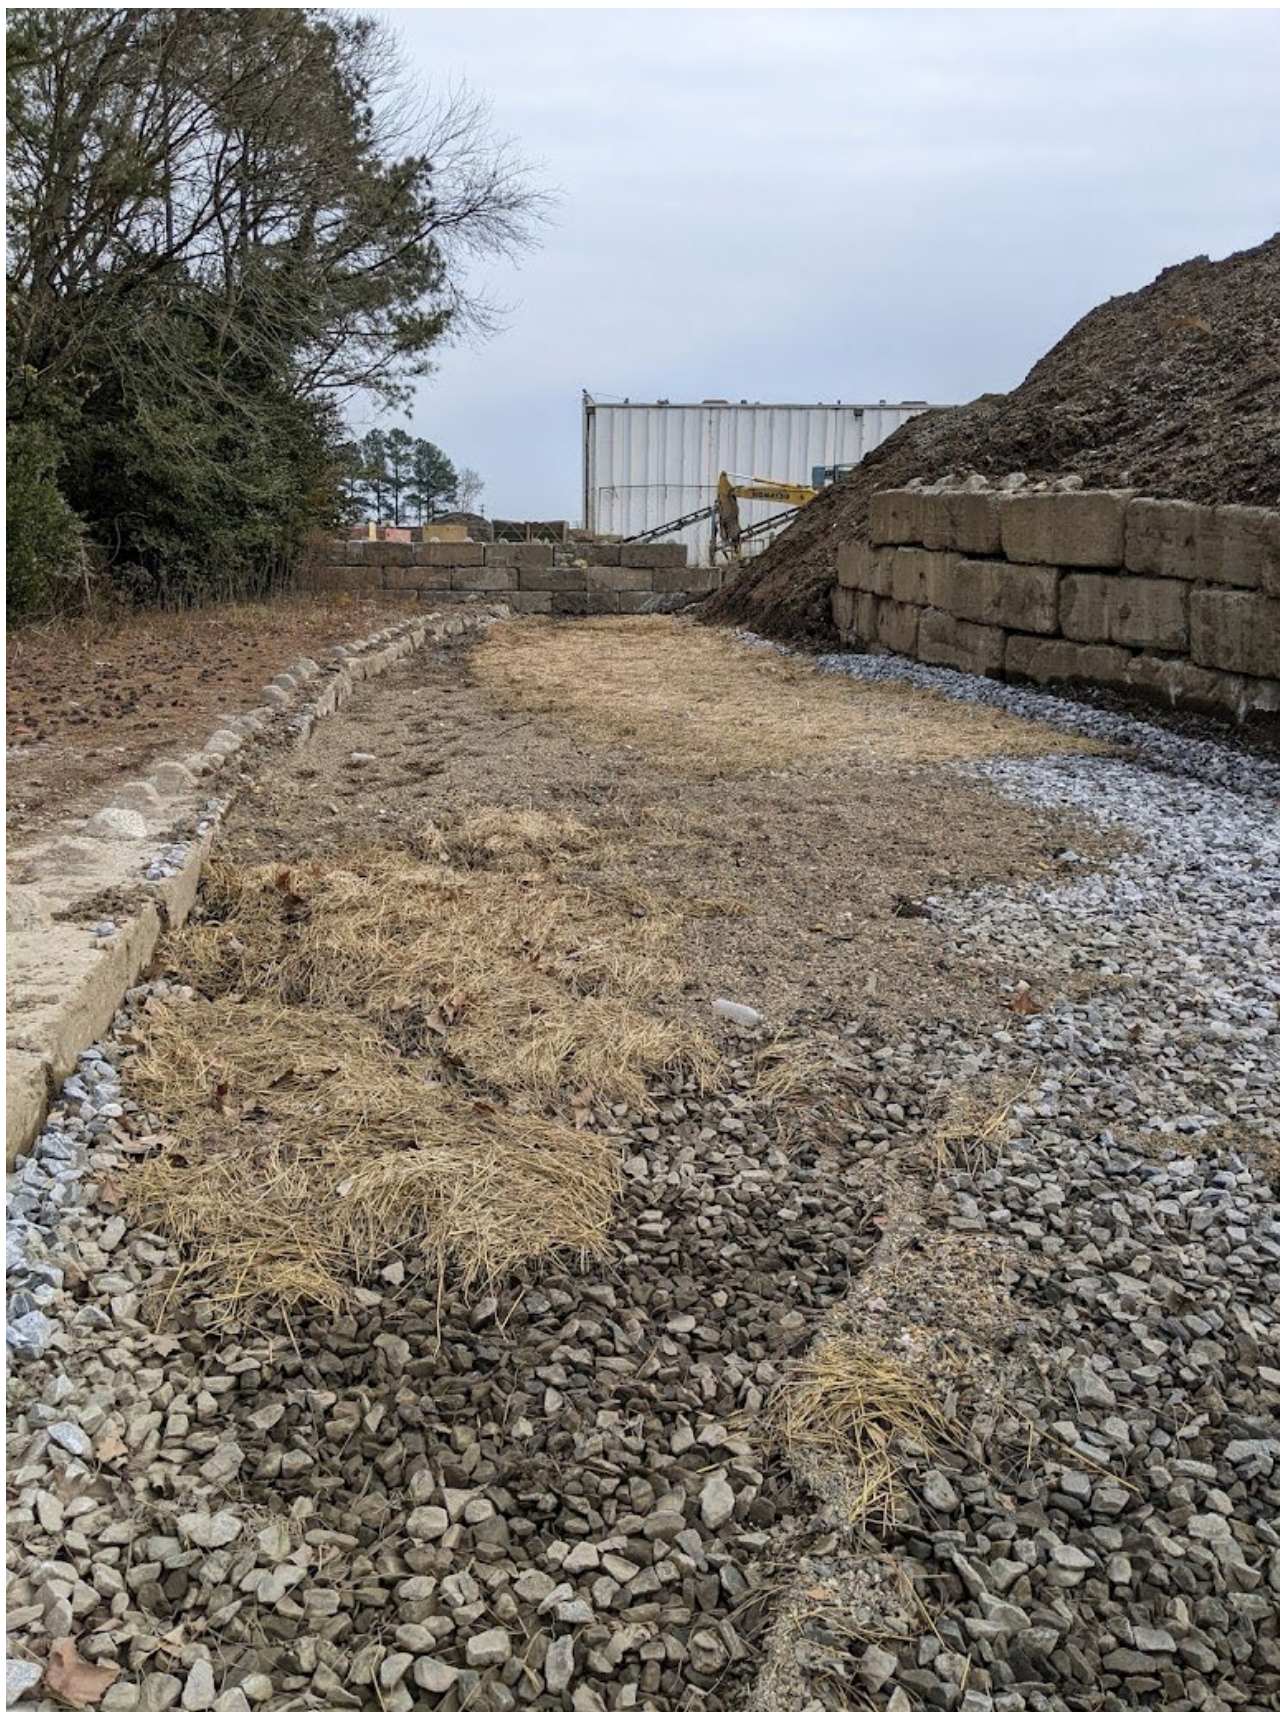
Photograph 9 of 30: Backside of Unfinished Wall in Jig Pad Area that Leads to Outfall 003

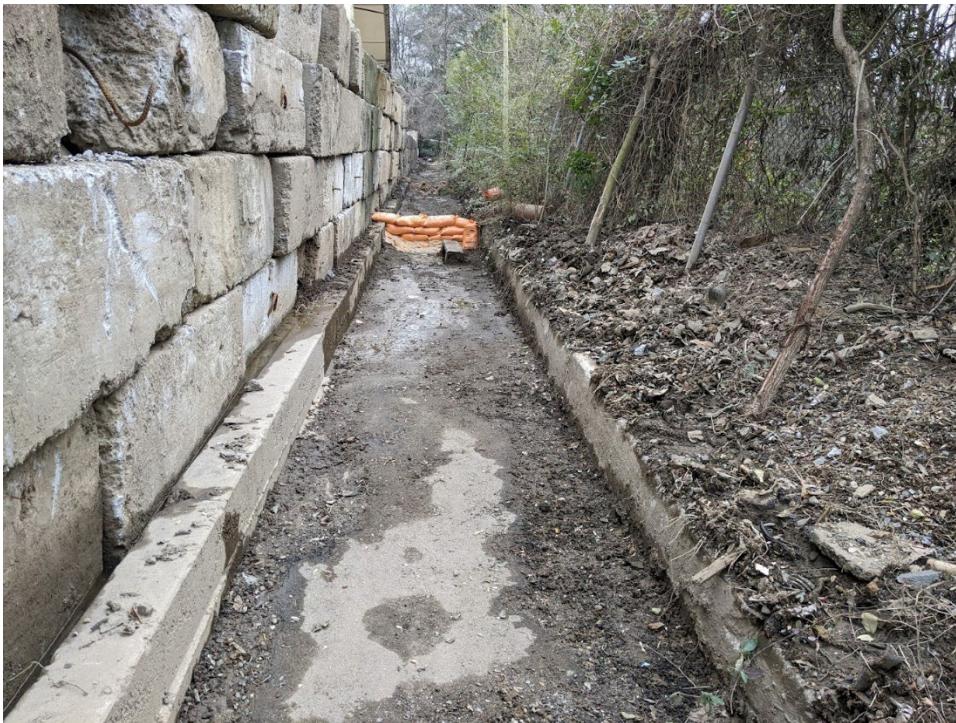
Photograph 10 of 30: Storm Drain Behind Jig Pad Area Wall

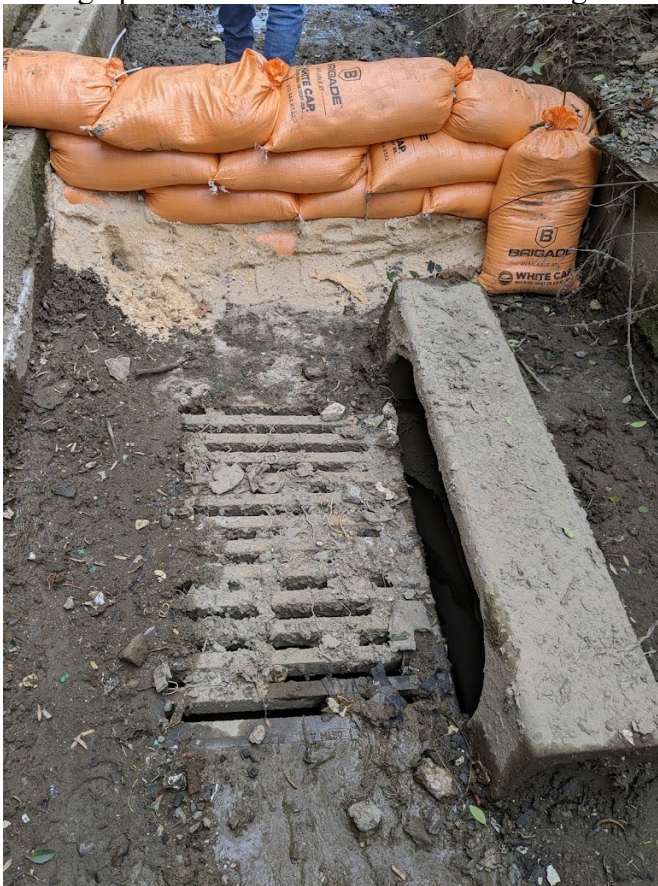
Photograph 11 of 30: Close up of Storm Drain with Debris Behind Jig Pad Wall

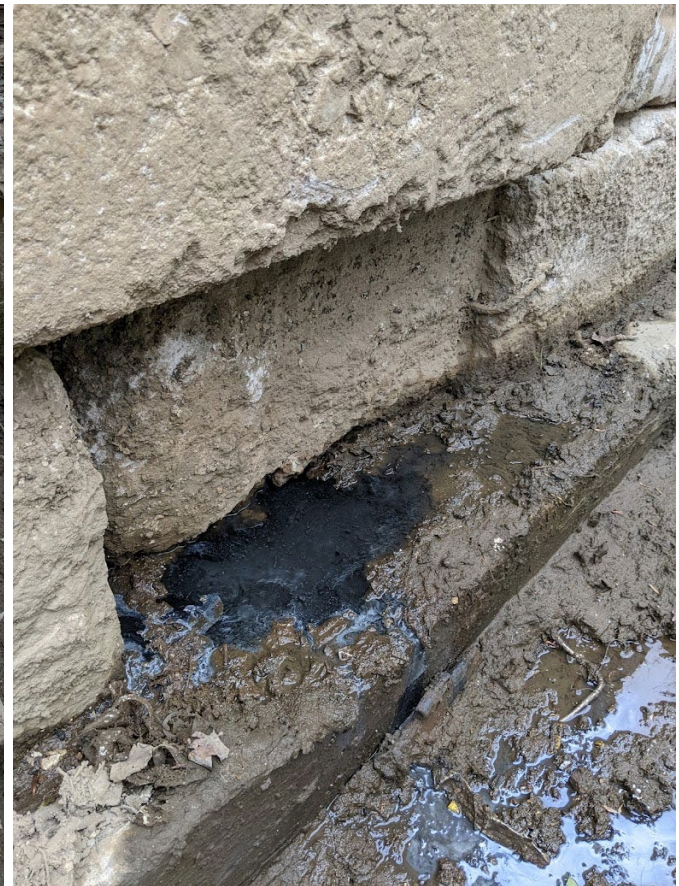
Photograph 12 of 30: Unknown Substance Behind Jig Pad Wall

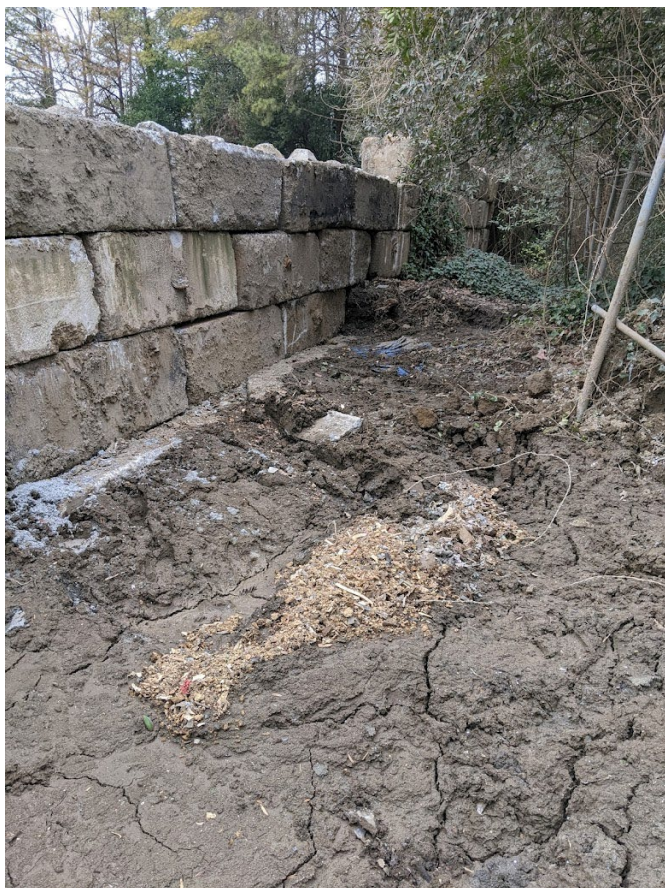
Photograph 13 of 30: Debris Settling in Jig Pad Area Behind Wall

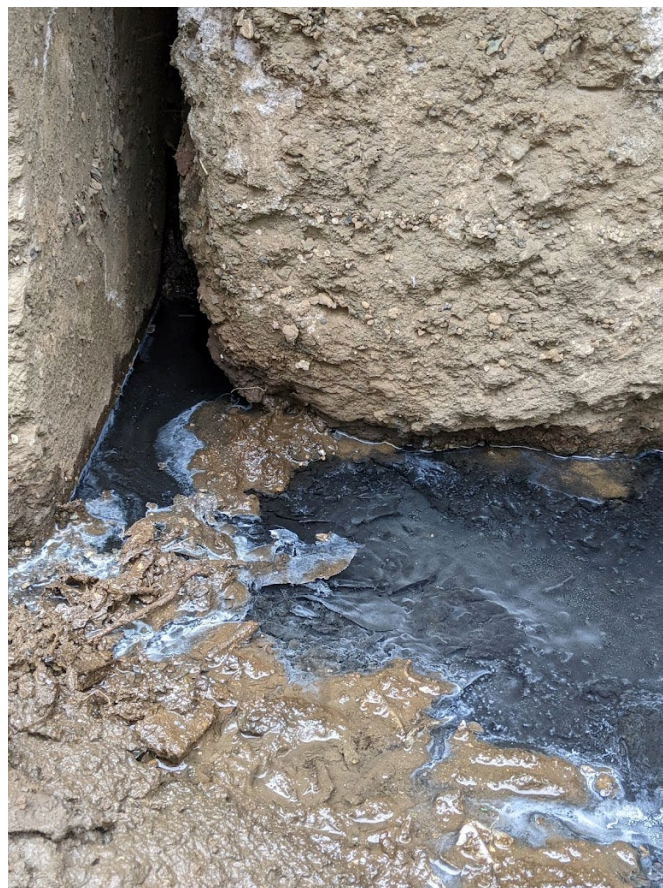
Photograph 14 of 30: Unknown Substance Behind Jig Pad Wall

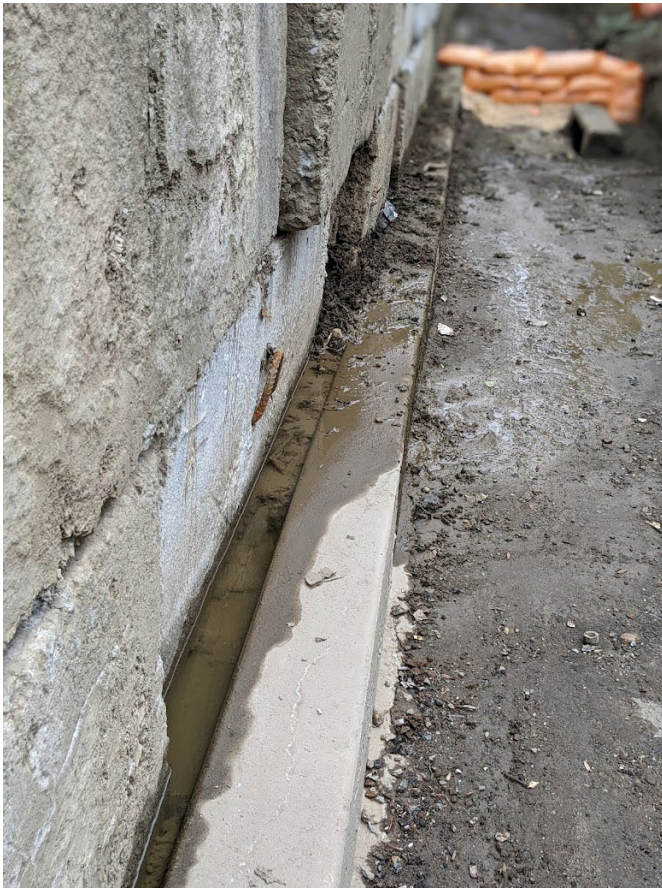
Photograph 15 of 30: Liquid that Appears to be Seeping Through the Wall

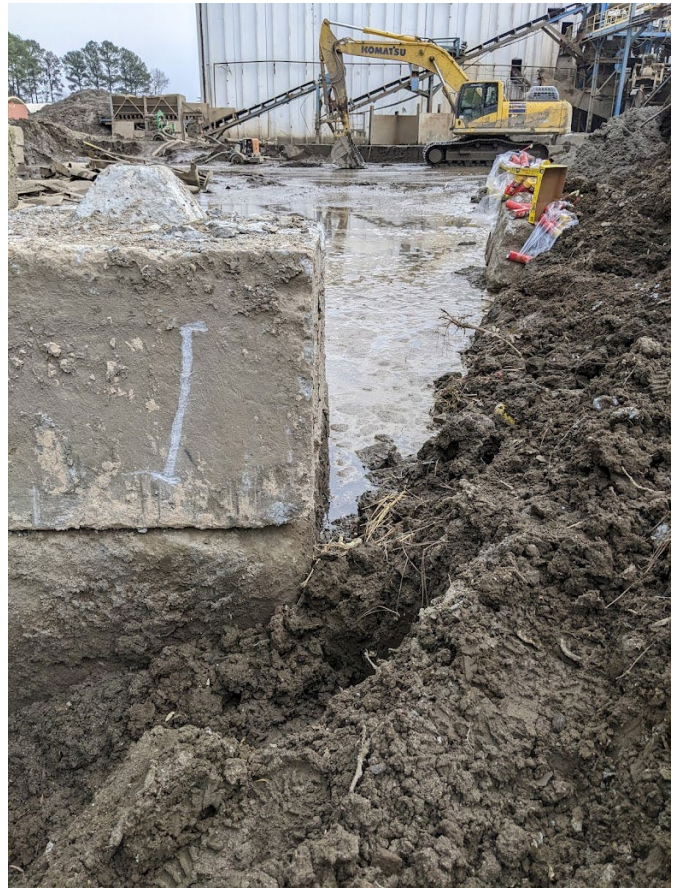
Photograph 16 of 30: Unfinished Wall in Jig Pad Area

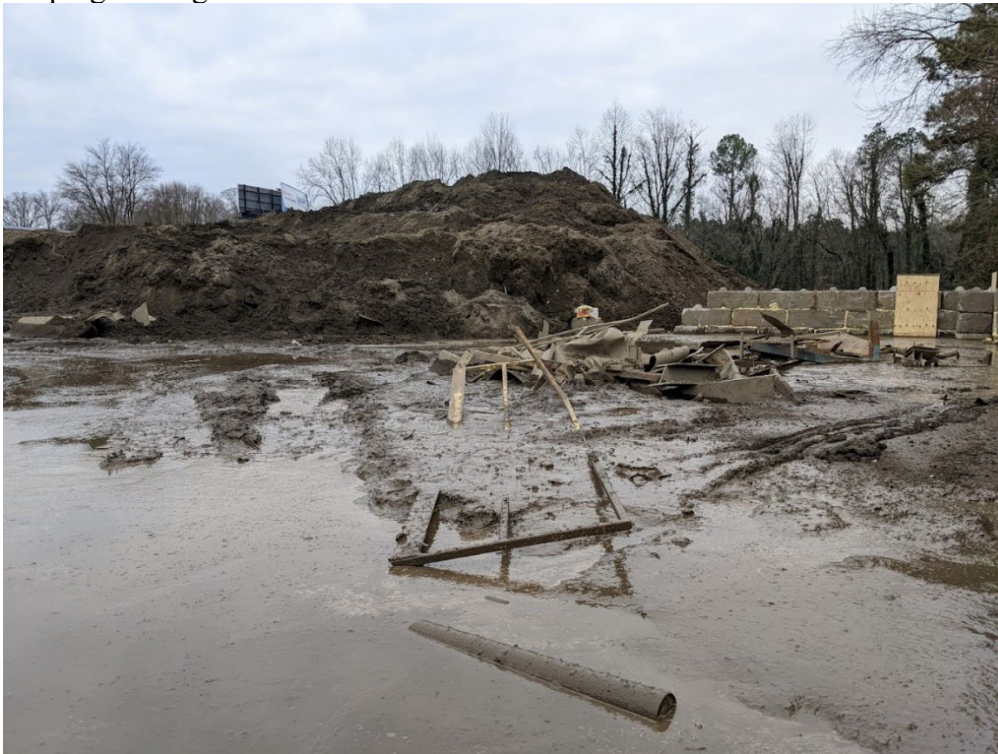
Photograph 17 of 30: Unfinished Wall in Jig Pad Area

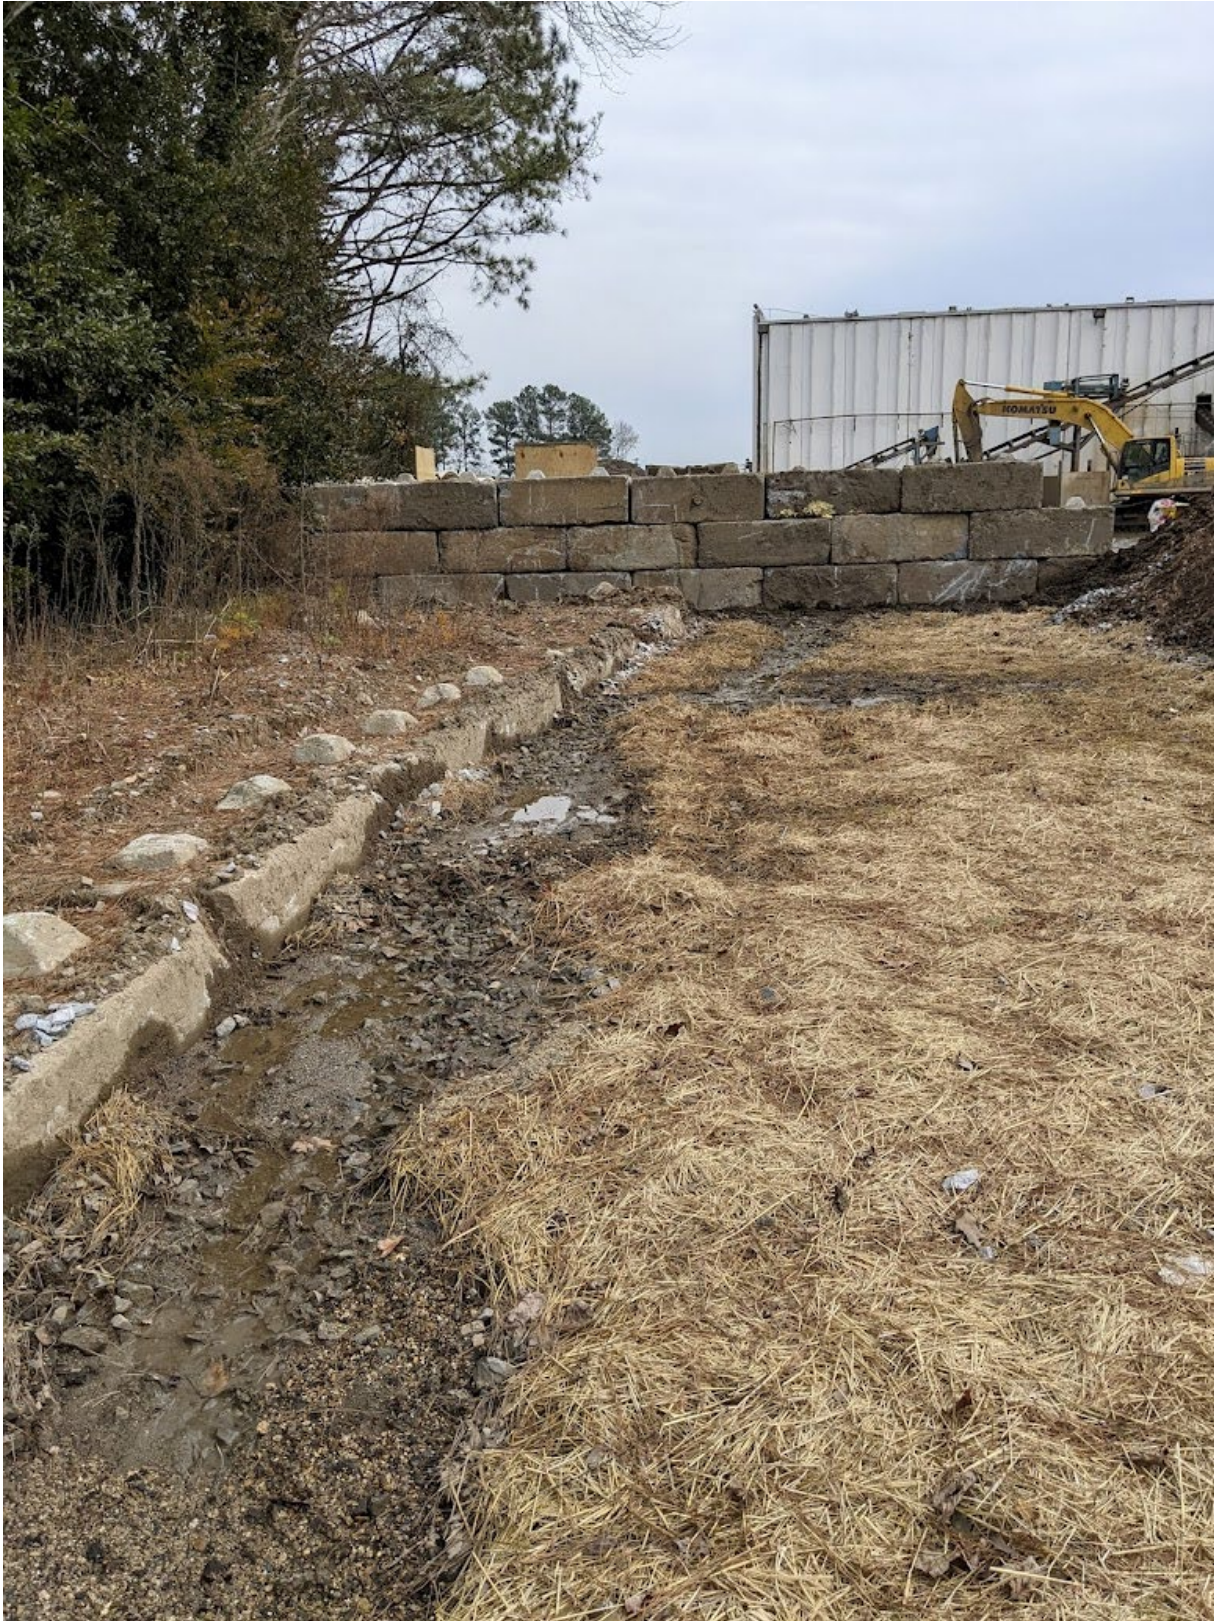
Photograph 18 of 30: Back Side of Unfinished Wall in Jig Pad Area that Leads to Outfall 003

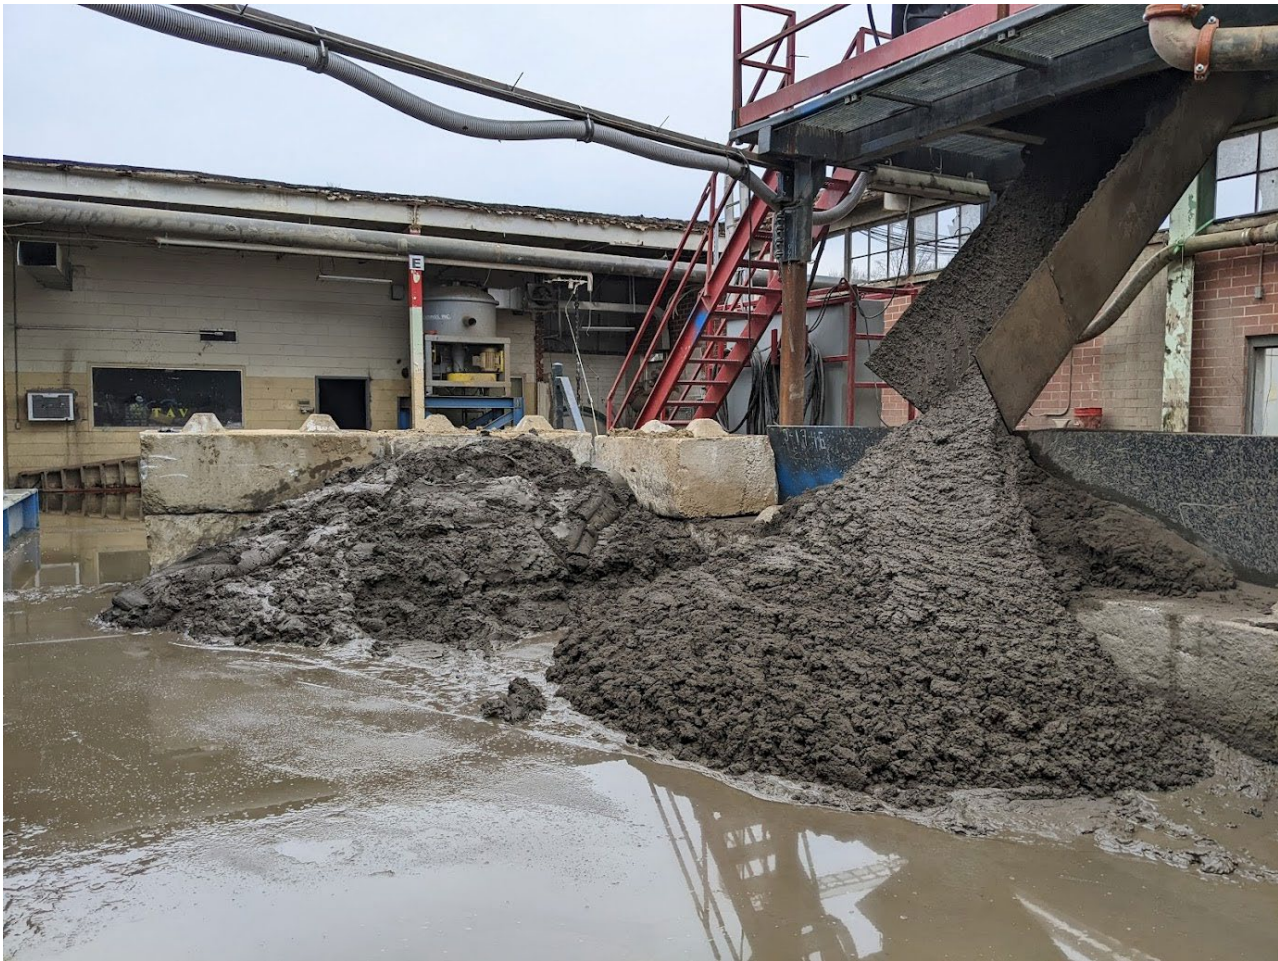
At the time of the FCI, the EPA inspector observed TAV to be fully operating and utilizing its separation technology. Wastewater, ASR materials waiting to be processed, and processed ASR materials/sludge were observed on the floor in the Keebler Building (*Photographs 19-22*). TAV employees were utilizing squeegees to push wastewater and processed ASR materials/sludge out the Keebler Building and onto the ground in the Wastewater Treatment (WWT) Area. A tank in the WWT Area that appeared to be utilized for managing process wastewater, was overflowing water into the WWT Area. This water then mixed with the wastewater and processed ASR materials/sludge ultimately making its way to the Jig Pad.

Photograph 19 of 30: Sludge from Centrifuge

**Pursuant to Paragraph 82 of the RCRA 7003 Order, Respondents must “immediately cease all activities (including operations, business practices, and material management, including commingling, mixing, and receipt and transfer of ASR waste) that may result in the release of solid and/or hazardous waste into the environment, including, but not limited to, ceasing the placement of ASR waste, intermediates from the processing of ASR waste, materials resulting from the processing of ASR waste, wastewaters and/or process waters, sludge, and/or any other wastes, directly onto the ground, including onto asphalt, concrete, or other surfaces.”**

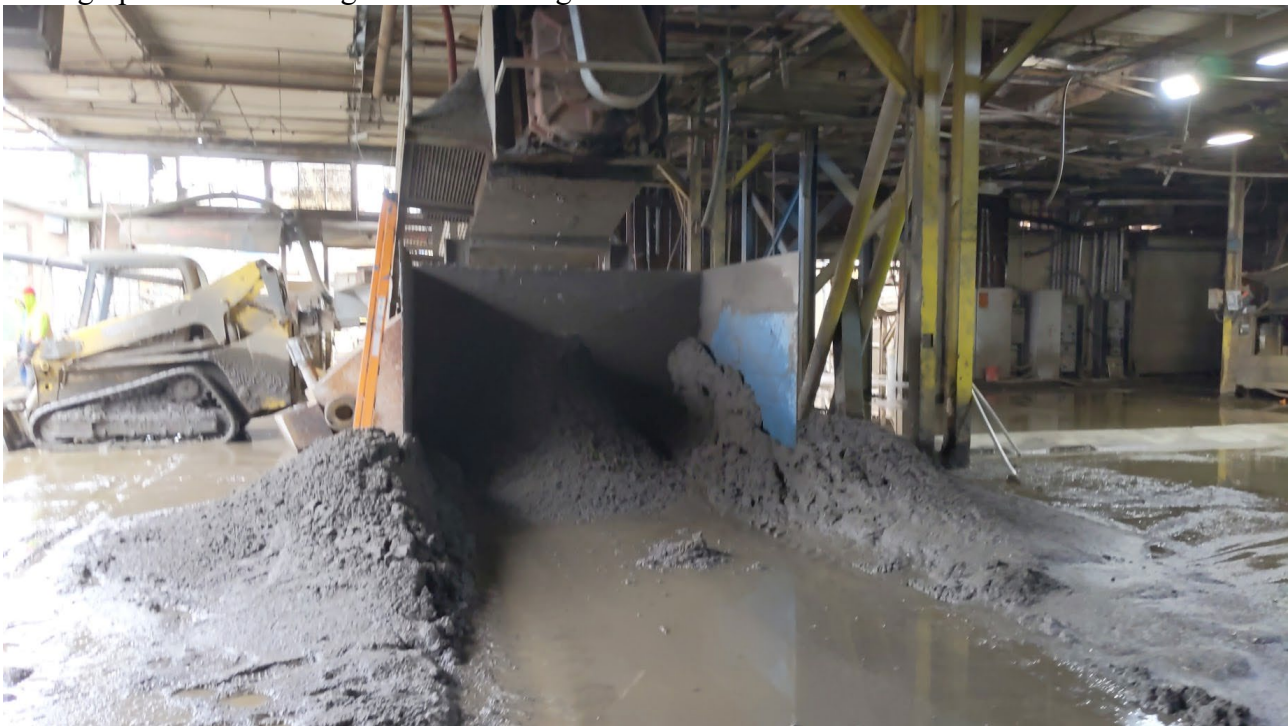
Photograph 20 of 30: Sludge from Screw Process Stored on the Ground in the Process Area

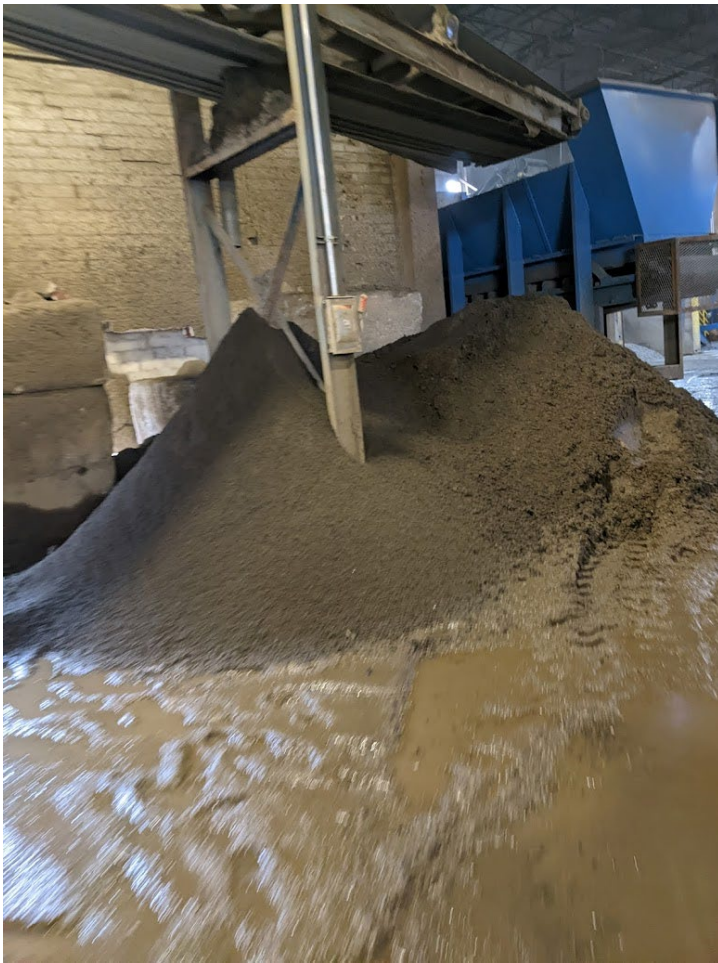
Photograph 21 of 30: Material Stored on the Ground in the Process Area

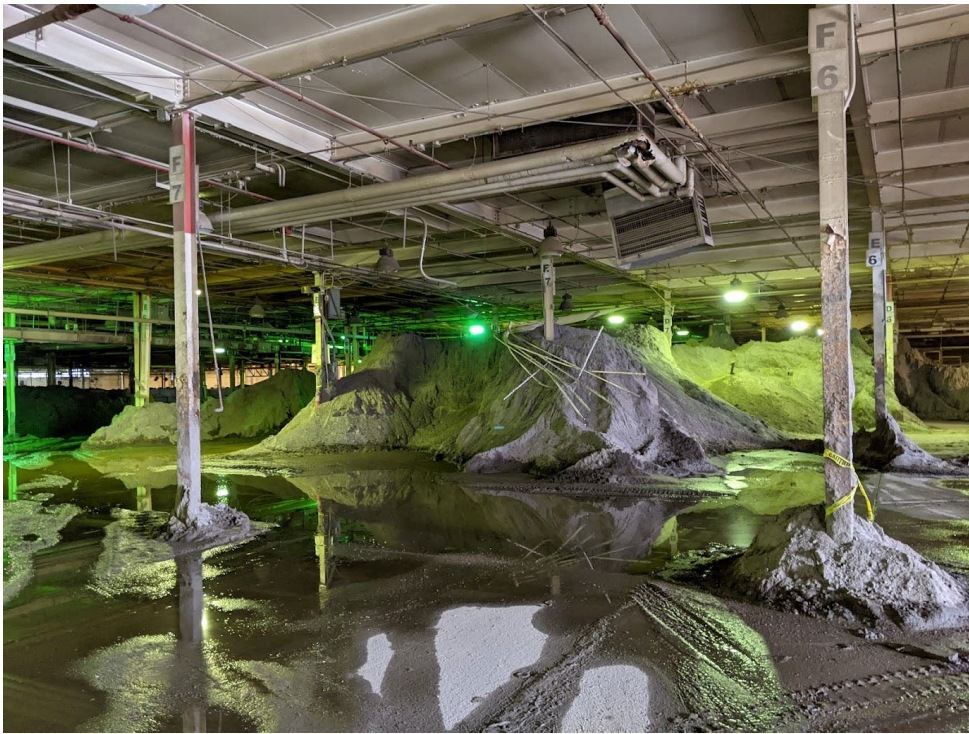
Photograph 22 of 30: Material Stored in Keebler Building

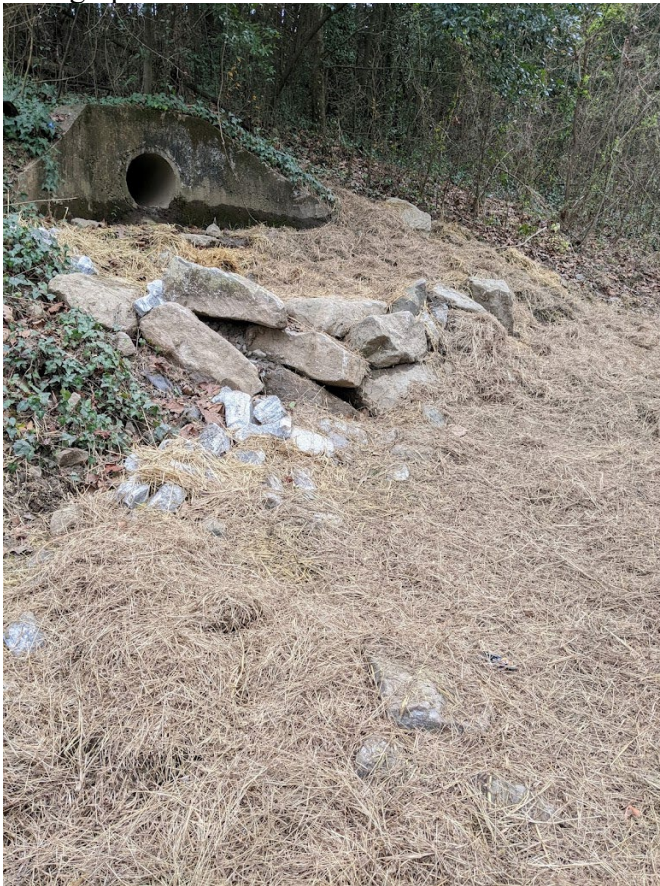
At the time of the FCI, the EPA inspector observed newly laid hay/riprap over portions of the ground where Outfall 002 (as identified in EPA’s CDIE Sampling Report) is located (*Photographs 23 and 24*). It is unclear if the implementation of this work supports efforts to cease operations that may result in releases to the environment as identified in Paragraph 82 of the Order, or if this falls under the Section VIII Additional Work provision found in Paragraph 93 of the Order. EPA was not made aware of this work or provided documentation for the contractor selection. In addition, it is unclear if the newly laid hay/riprap was laid over released ASR waste or whether the ASR waste was removed prior to laying the hay/riprap.

Photograph 23 of 30: Outfall 002 with Riprap

**Pursuant to Paragraph 93 of the RCRA 7003 Order, the EPA may determine, or Respondents may propose, that certain tasks, including stabilization, Site characterization, delineation,**
