## RCRA FOCUSED COMPLIANCE INSPECTION REPORT

TAV Holdings, Inc.  
3311 Empire Boulevard, SW  
Atlanta, Georgia 30334  
EPA ID # GAD033537663

January 28, 2022

**TAV Holdings, Inc.**  
**Atlanta, Georgia**  
**EPA ID No.: GAD033537663**  
**EPA RCRA Focused Compliance Inspection Photographs**

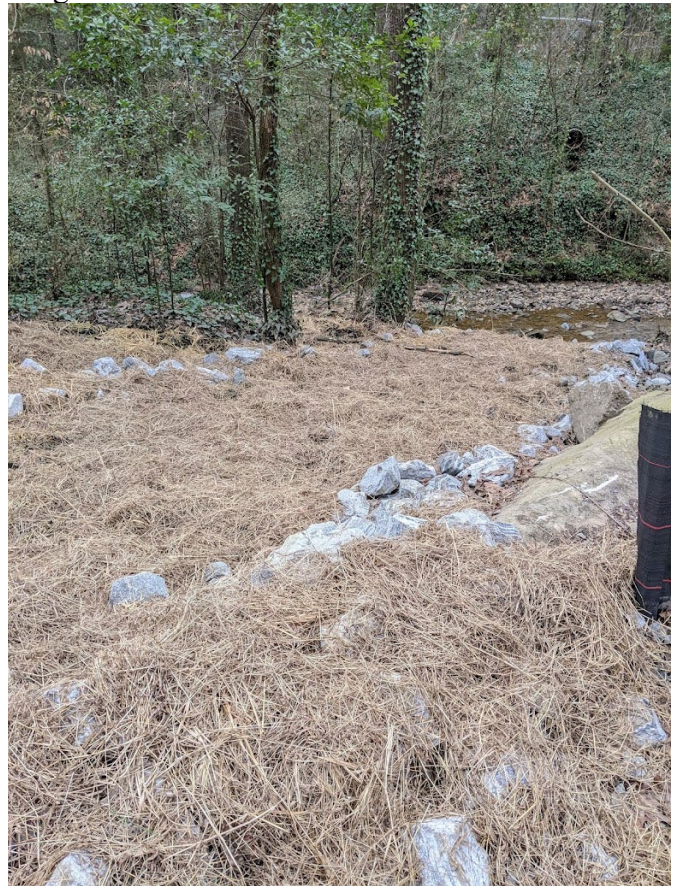
At the time of the FCI, the EPA inspector observed newly laid hay/riprap over portions of the ground where Outfall 002 (as identified in EPA’s CDIE Sampling Report) is located (*Photographs 23 and 24*). It is unclear if the implementation of this work supports efforts to cease operations that may result in releases to the environment as identified in Paragraph 82 of the Order, or if this falls under the Section VIII Additional Work provision found in Paragraph 93 of the Order. EPA was not made aware of this work or provided documentation for the contractor selection. In addition, it is unclear if the newly laid hay/riprap was laid over released ASR waste or whether the ASR waste was removed prior to laying the hay/riprap.

Photograph 24 of 30: Outfall 002 with Riprap

**Pursuant to Paragraph 93 of the RCRA 7003 Order, the EPA may determine, or Respondents may propose, that certain tasks, including stabilization, Site characterization, delineation,**

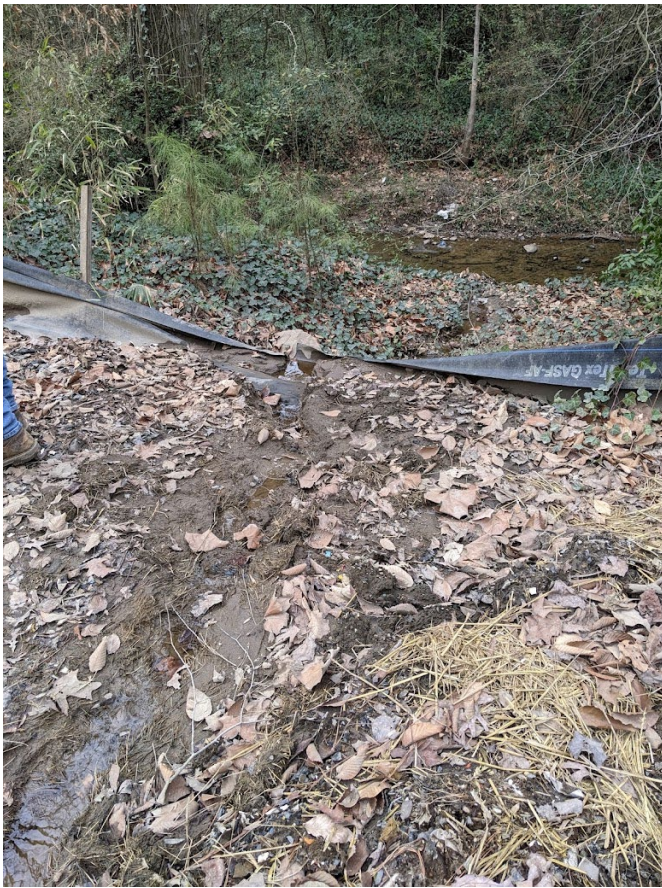
The EPA inspector observed three (3) outfalls in this area. ASR materials were present at each of the outfalls, throughout the woods leading back to the Facility, and in and around the unnamed tributary of the South River (*Photographs 25 and 26*).

Photograph 25 of 30: Outfall 003 Path to Creek

**Pursuant to Paragraph 82 of the RCRA 7003 Order, Respondents must “immediately cease all activities (including operations, business practices, and material management, including commingling, mixing, and receipt and transfer of ASR waste) that may result in the release of solid and/or hazardous waste into the environment, including, but not limited to, ceasing the placement of ASR waste, intermediates from the processing of ASR waste, materials resulting from the processing of ASR waste, wastewaters and/or process waters, sludge, and/or any other wastes, directly onto the ground, including onto asphalt, concrete, or other surfaces.”**

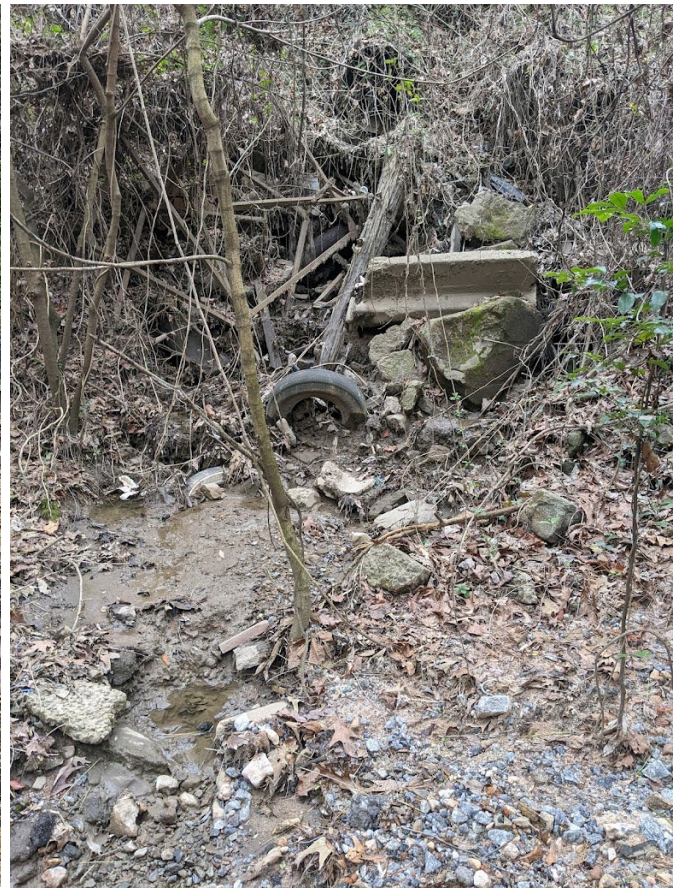
Photograph 26 of 30: Outfall from Storm Drain  
in Photograph 11

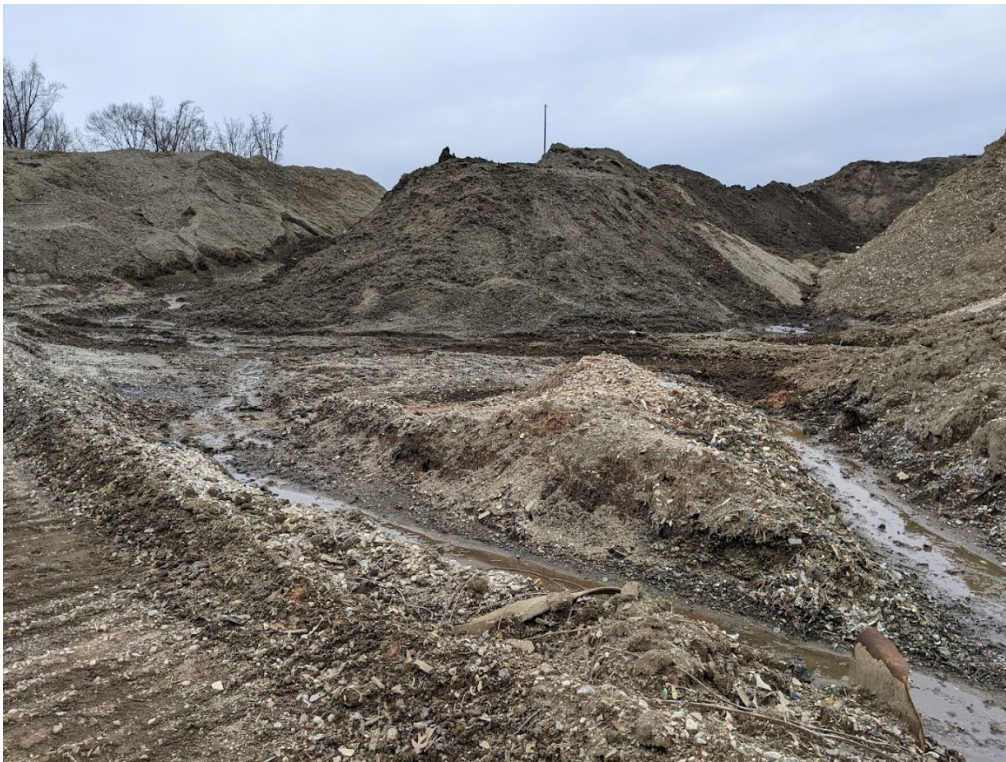
At the time of the FCI, the EPA inspector observed that the ASR waste material located in the lay-down yard is being allowed to discharge off-site with stormwater. Materials from the large ASR waste pile appear to be migrating off-site along the southern portion of the property towards the unnamed tributary, and on the northeastern portion of the property towards the stormwater retention pond (*Photographs 27-30*).

Photograph 27 of 30: Runoff from Material Storage at 3320 Empire Property

**Pursuant to Paragraph 82 of the RCRA 7003 Order, Respondents must “immediately cease all activities (including operations, business practices, and material management, including commingling, mixing, and receipt and transfer of ASR waste) that may result in the release of solid and/or hazardous waste into the environment, including, but not limited to, ceasing the placement of ASR waste, intermediates from the processing of ASR waste, materials resulting from the processing of ASR waste, wastewaters and/or process waters, sludge, and/or any other wastes, directly onto the ground, including onto asphalt, concrete, or other surfaces”**

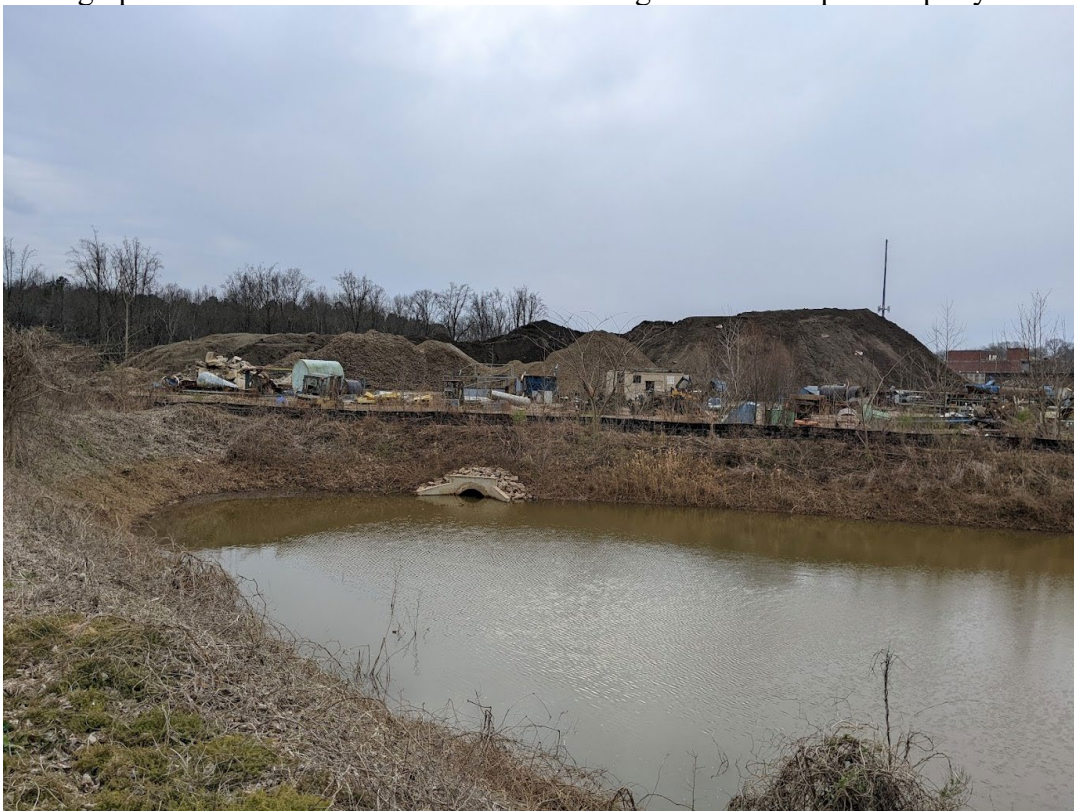
Photograph 28 of 30: Stormwater Retention Pond for Material Storage at 3320 Empire Property

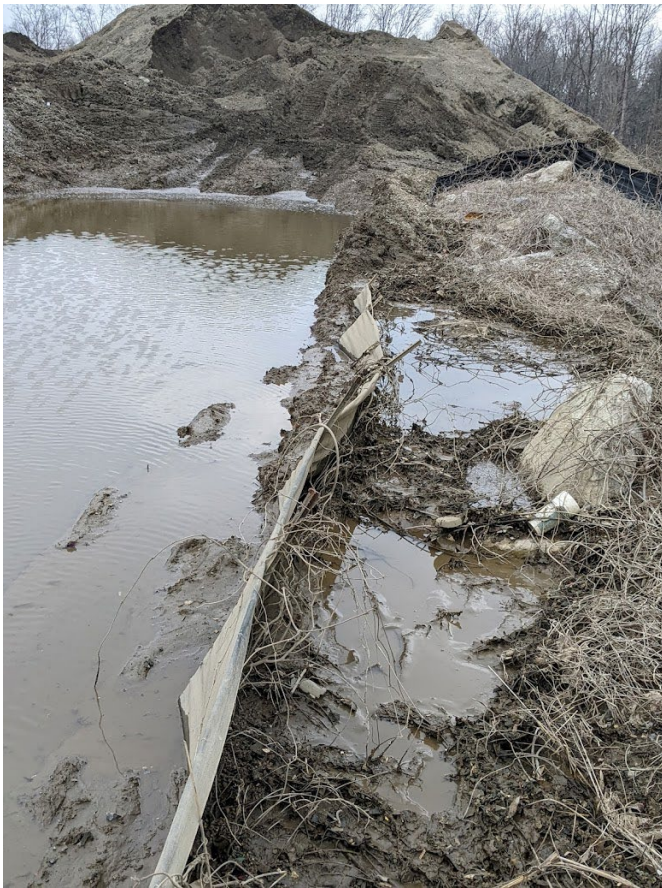
Photograph 29 of 30: 3320 Empire Property

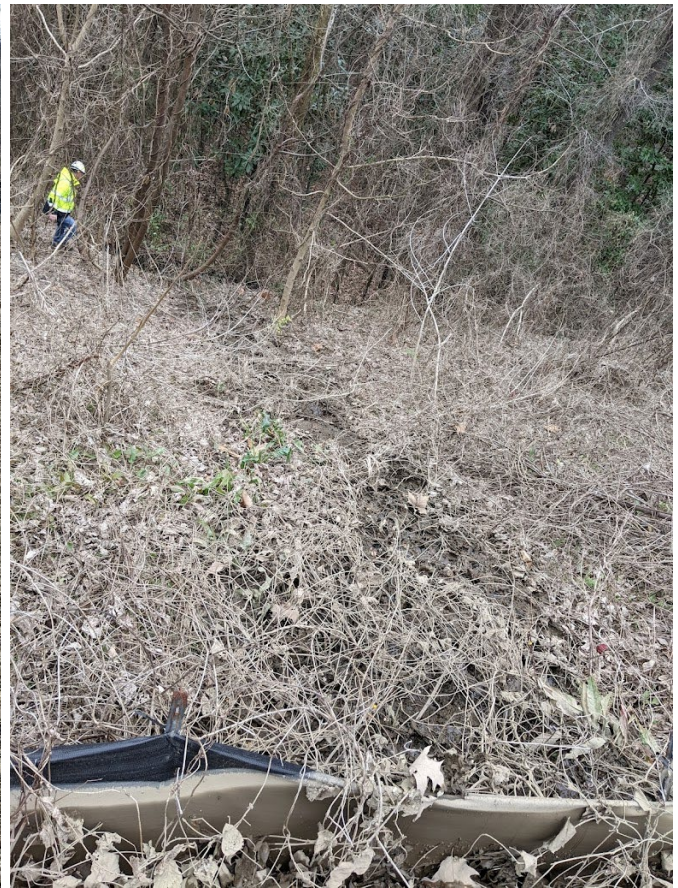
Photograph 30 of 30: Material Leaving 3320 Property Towards Creek
