## **RCRA Inspection Report**

Holcim (US) Inc./Geocycle LLC.  
8677 Hwy 45 Alternate South  
Artesia, Mississippi 39736  
EPA ID# MSD077655876  
Primary NAICS: 562211 – Hazardous Waste Treatment and Disposal

December 13, 2022, at 9:12 a.m.

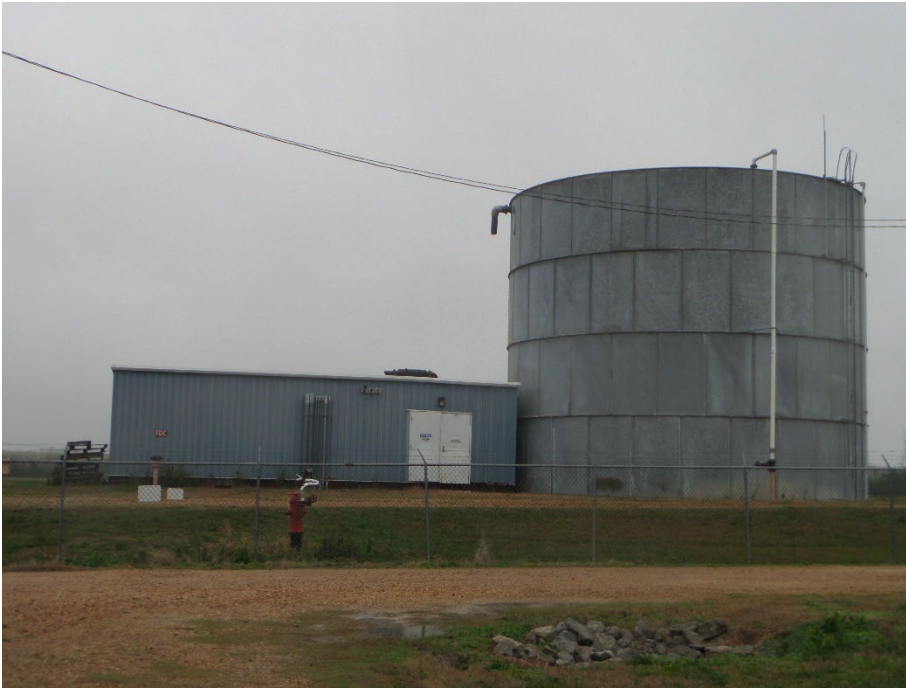
The inspection team first inspected the tank farm and the surrounding area. The facility has a nitrogen tank that is utilized for keeping a nitrogen blanket in the overall tank system. The facility also has a 250,000-gallon water tank with a water cannon (Photograph 1) that can be utilized in event of an emergency. Quarterly tests are conducted of the fire system.

Photograph 1: Water Cannon and 250,000-gallon Water Tank

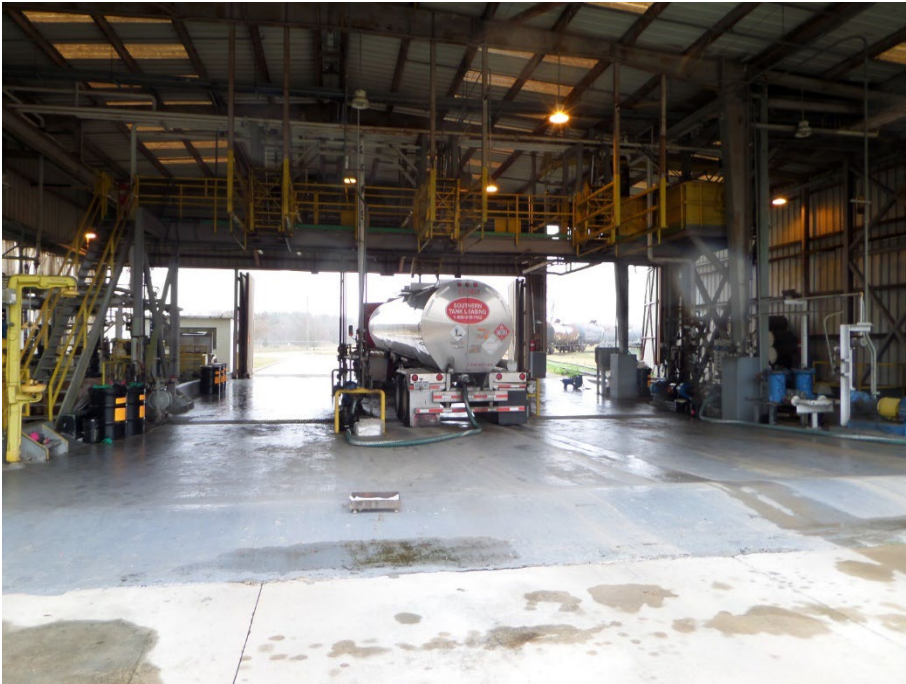
The facility operates a process that allows trucks to drive in and empty hazardous waste in one of two available truck bays (Photographs 2 and 3). Samples are taken and retained for 90-days. At the time of the inspection, there were two satellite accumulation areas (SAAs) at each truck bay. One SAA is used to accumulate personal protective equipment (PPE) solids, and the other is used to accumulate hazardous waste liquids. The inspectors observed one 55-gallon drum in each of the four SAAs. Each container was closed, labeled as "Hazardous Waste," and with an indication of hazard.

Photograph 2: Permitted Truck Bay

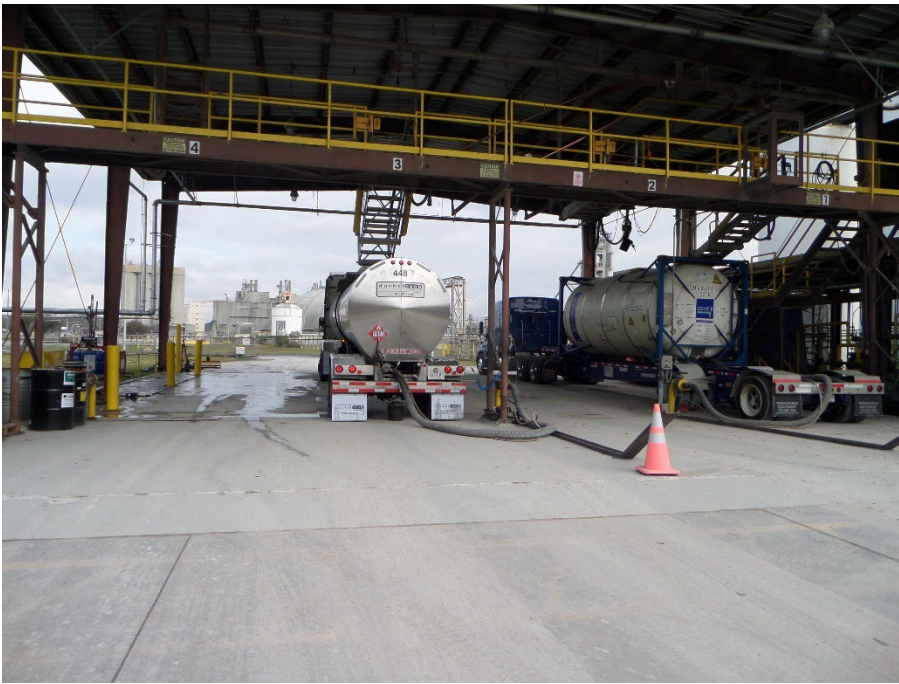
Photograph 3: Permitted Truck Bay

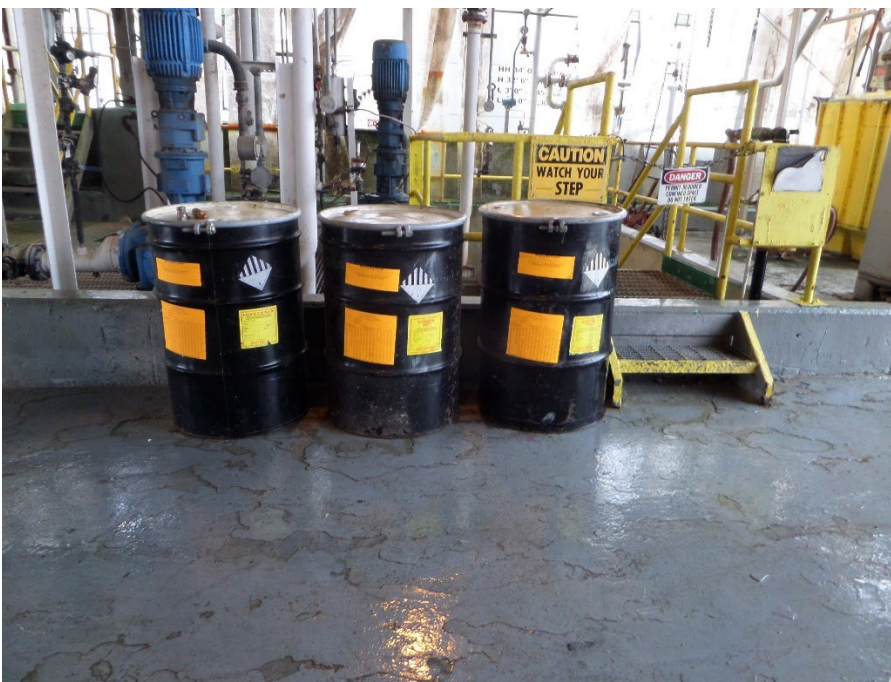
This area also contained a hazardous waste central accumulation area (CAA) for storage of 55-gallon containers. At the time of the inspection, the inspectors observed three 55-gallon containers in the CAA (Photograph 4). All the containers were observed to be closed, labeled as "Hazardous Waste," marked with a hazard indication and dated (two drums were dated July 11, 2022, and one was dated September 15, 2022). Based on the facility's response to the inspector's enquiry regarding the dating of these containers, it appeared that the facility was, at the time of the inspection, marking containers with an accumulation start date when each container first began accumulating hazardous waste in the SAA. Pursuant to 11 Miss. Admin. Code Pt. 3, R. 1.3 [40 C.F.R. § 262.15(a)(6)(iii)] small and large quantity generators who accumulate hazardous waste in excess of the amounts listed in the SAA Permit Exemption must mark or label the container(s) holding the excess accumulation of hazardous waste with the date the access amount

began accumulating. The facility documented that they had shipped facility generated wastes on August 5, 2022, which supports the facility's claim that containers in the CAA should have been dated on or after August 5, 2022. Therefore, it appears that the two drums that were marked with accumulation start dates which exceeded the 90-day accumulation time limit allowable under the LQG Permit Exemption were marked with erroneous accumulation start dates.

**Pursuant to 11 Miss. Admin. Code Pt. 3, R. 1.3 [40 C.F.R. § 262.17(a)(5)(i)(C)], which is a condition of the LQG Permit Exemption, a generator must mark or label its containers with the date upon which each period of accumulation begins clearly visible for inspection on each container.**

Photograph 4: Three 55-gallon Hazardous Waste Drums in Central Accumulation Area

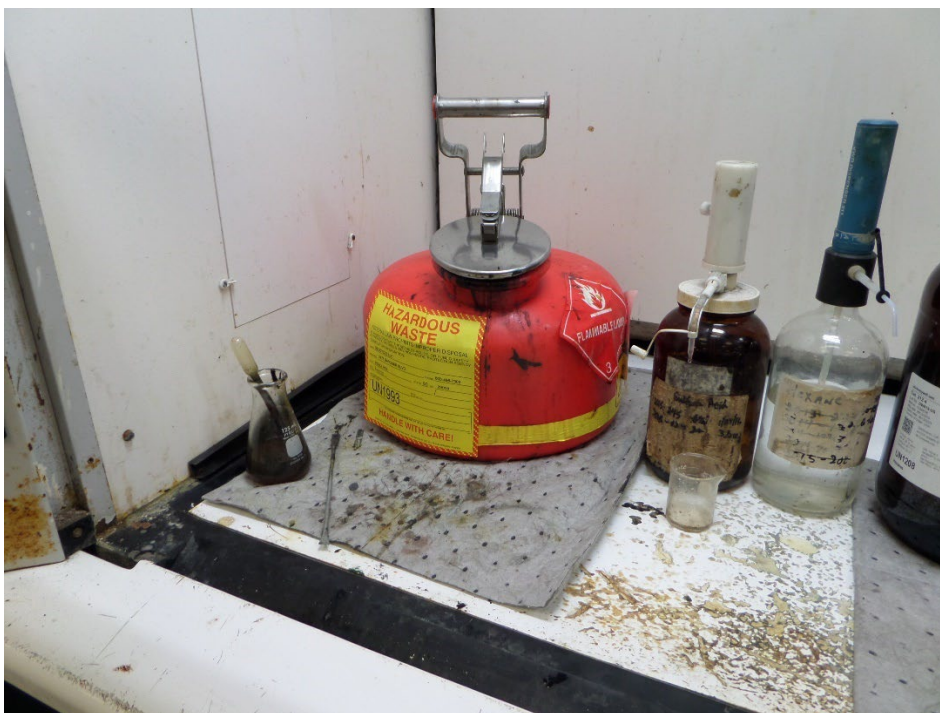
Photograph 5: Satellite Accumulation Container in Fume Hood

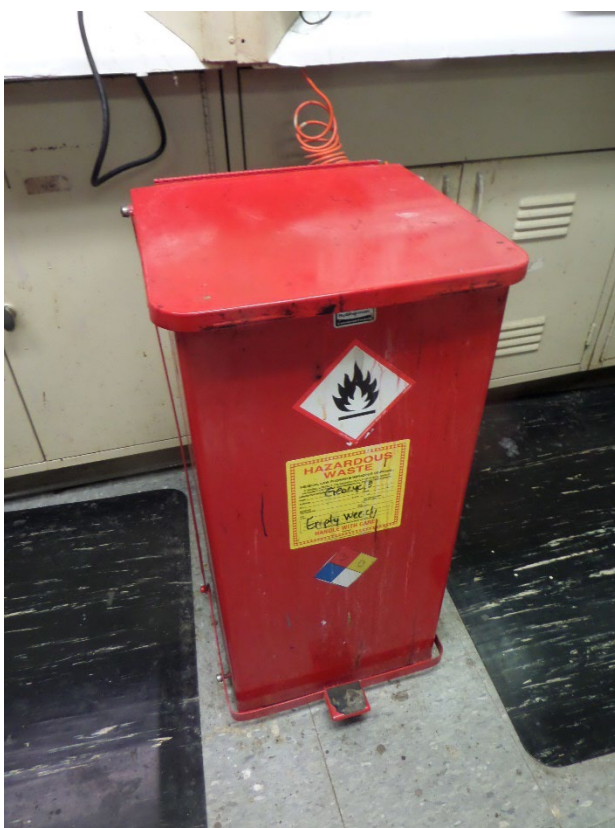
Photograph 6: SAA Container with HW Label and Hazard Marking

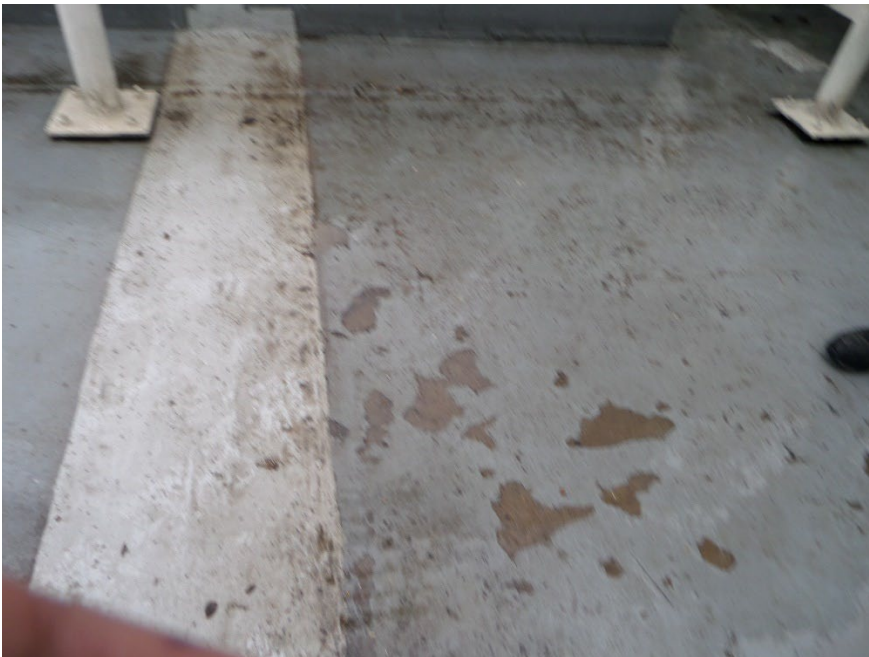
During the walk-through around the base of the tanks in the tank farm area, the inspectors observed that some of the cracks and gaps on the floor of the secondary containment appeared to have been repaired. Some areas of patching could be observed. The overall state of the containment system, concrete, and coating appeared to be generally good, but some limited areas needed repair before the issues became a major issue. At the time of the inspection, the secondary containment floor and wall appeared to have a small hairline crack in the concrete wall and some limited cracks or peeling in the coating for the tank farm (Photographs 10, 11, and 12). After the inspection the facility repaired some of the areas. Some repairs may have been delayed due to the weather conditions during winter (Figures 4, 5, and 6).

**Pursuant to the RCRA Permit, Part IX. Tanks [40 C.F.R. § 264 Subpart J], which incorporates Section I.X.D.1. Design and Construction [40 C.F.R. § 264.193(e)(1)(iii)], a facility using a tank system for storing or treating hazardous waste must provide secondary containment with an external liner system that is free of cracks or gaps. The secondary containment system must be constructed or lined with materials that are compatible with the wastes to be placed in the tank system and must have sufficient strength and thickness to prevent failure.**

Photograph 10: Missing Coating in Tank Farm

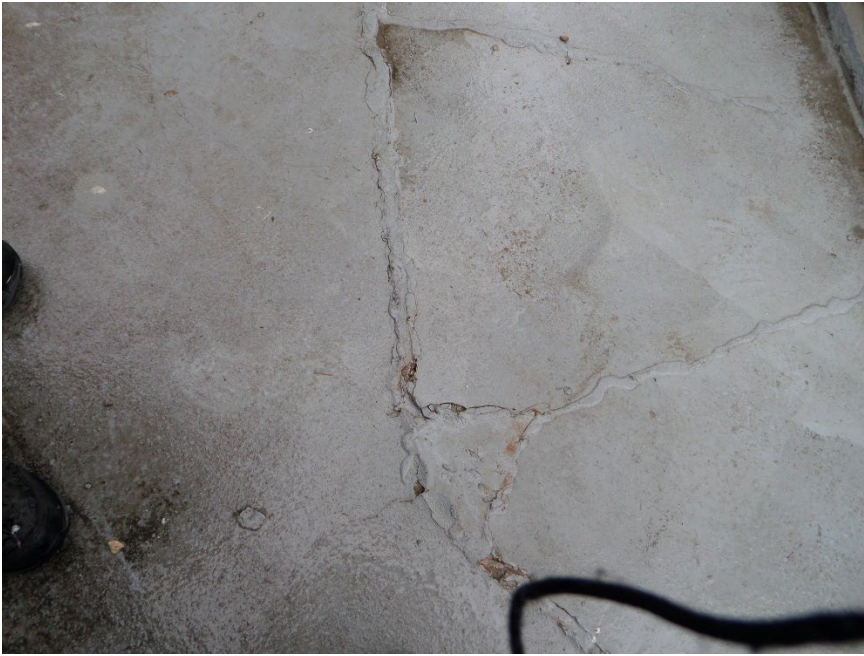
Photograph 11: Some Minor Cracking in Coating

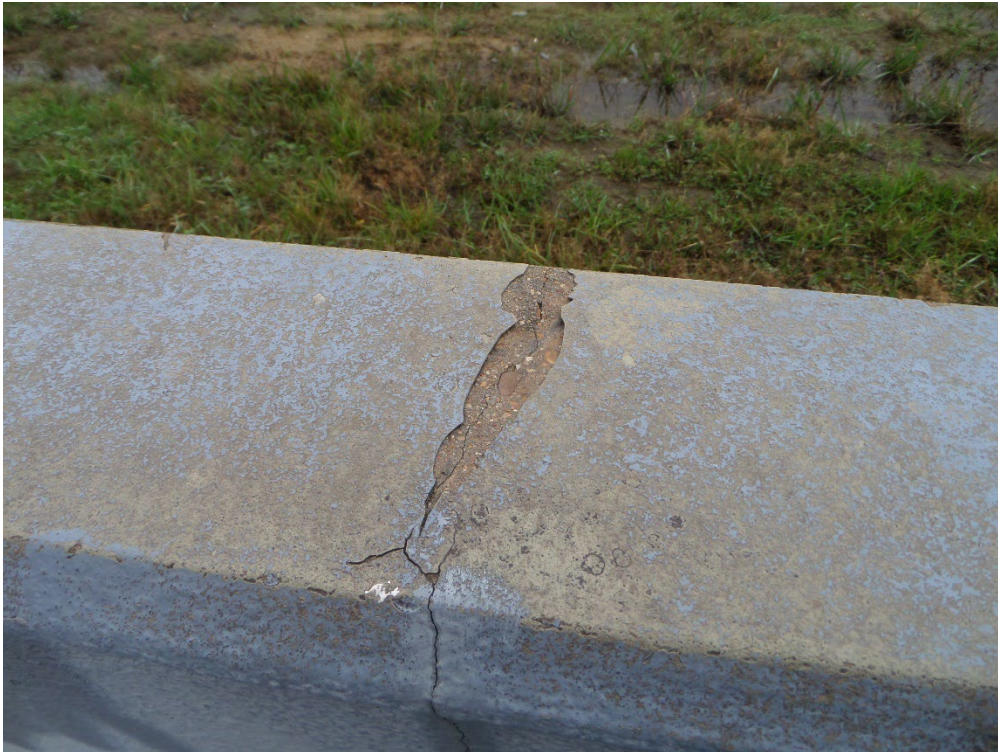
Photograph 12: Hairline Crack in Containment Wall and Missing Coating

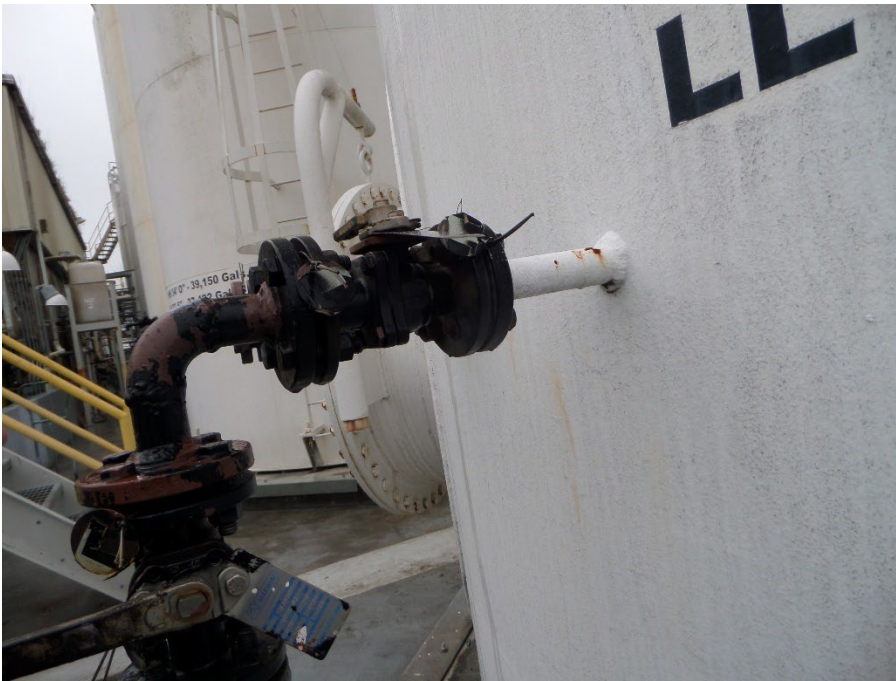
**Pursuant to the RCRA Permit, Part VI. Organic Air Emission Standards for Tanks, Containers, Miscellaneous Units, and Equipment [40 C.F.R. § 264.1050] and [40 C.F.R. § 264.1080], which incorporates Section VI.A.2. Equipment Standards [40 C.F.R. § 264.1052 through 264.1058, 264.1060 through 264.1062, & 264.1064(b)], each piece of equipment subject to 40 C.F.R. Part 264 Subpart BB shall be tagged with a unique identification number.**

Photograph 13: Missing Coating & Corrosion and Obscured LDAR (Subpart BB) Tags

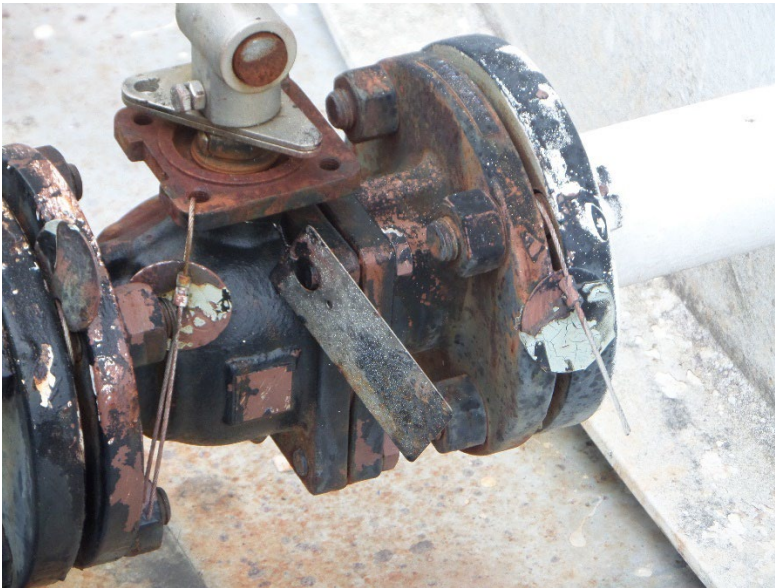
The tagging system for the pumps, valves, connectors, and other ancillary equipment were inspected. Some of the identification number tags were illegible (Photographs 13, 14, and 15). Following the inspection, the facility replaced numerous tags (Figures 1, 2, and 3).

Photograph 14: Illegible LDAR Tags on Ancillary Equipment Subject to Subpart BB

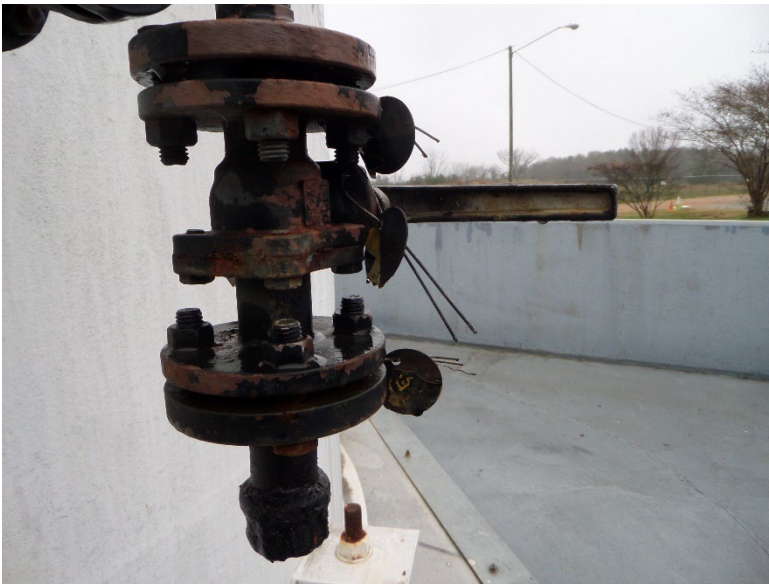
Photograph 15: Illegible LDAR Tags on Ancillary Equipment Subject to Subpart BB

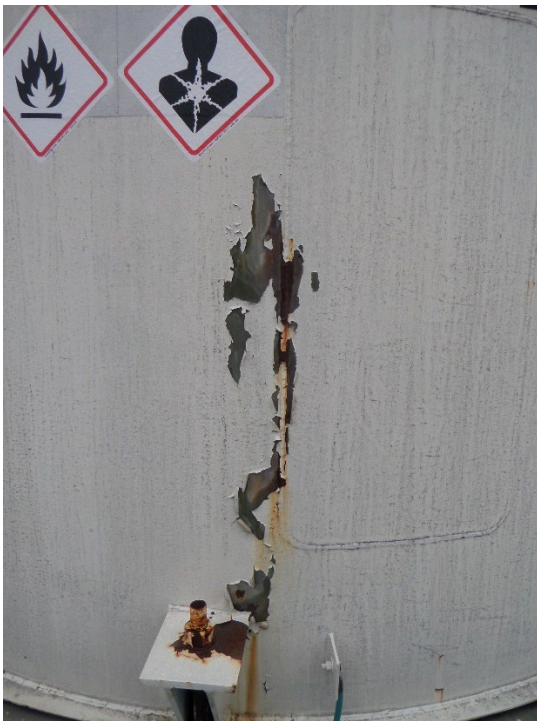
In addition, the inspectors observed some limited areas of paint peeling on a hazardous waste tank and signs of corrosion on several ancillary equipment pieces associated with the tank system. The inspectors observed that the exposed areas were not coated with paint or similar weather resistance coating and/or either were showing signs of corrosion or lacked corrosion protection. We inspected the top of Waste Tank 4105. Waste Tank 4105 was not in service. The inspection team was able to utilize the stairs to view the top of Tank 4105. The tank appeared to be in good condition excepting areas under maintenance work, and no issues of concern were identified with the top area of the tank, and other tanks, excepting some areas of limited corrosion on some of the valves and tank closure devices. (Photographs 16, 17, 18, and 19).

Photograph 16: Peeling Paint and Corrosion on HW Tank

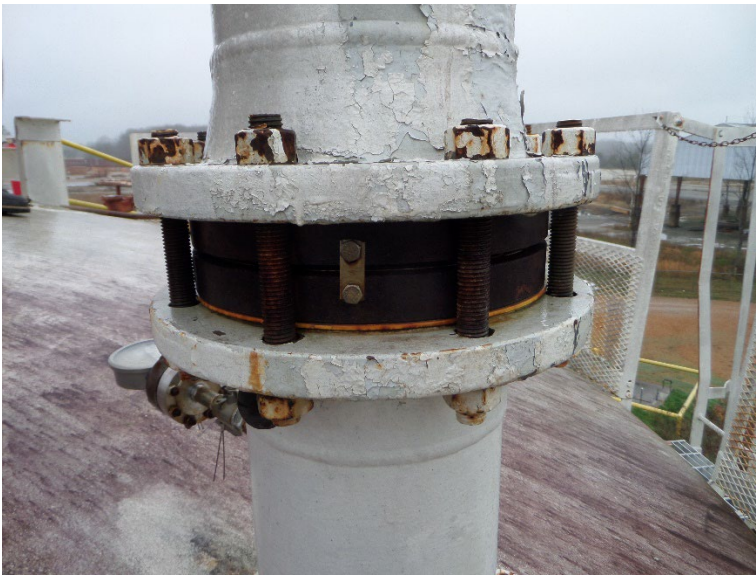
Photograph 17: Corrosion on Connector & Bolts

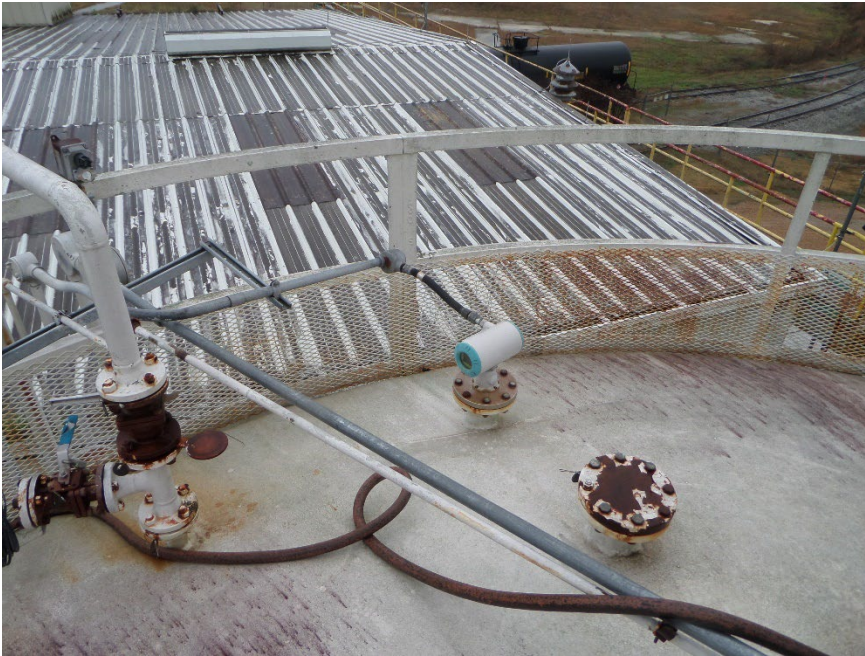
Photograph 18: Missing Coating and Corrosion on Top of Tank 4105

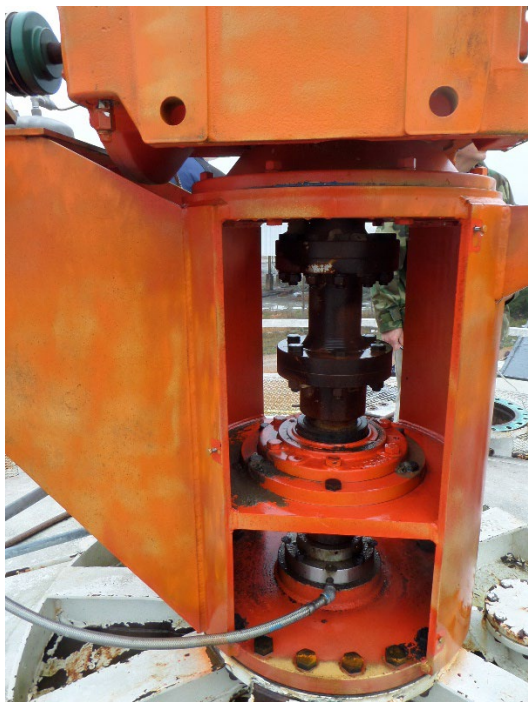
Photograph 19: Impeller Motor, Some Corrosion Visible on Tank Around Impeller Motor Base
