UNITED STATES ENVIRONMENTAL PROTECTION AGENCY
REGION 2, ECAD-WCB
 21st Floor, 290 Broadway, NY, NY 10007

COMPLIANCE EVALUATION INSPECTION REPORT

Program: Industrial Compliance Evaluation Inspection	Inspection Type: Compliance Evaluation Inspection	
Permittee Name: Burlington Beef	NPDES/ICIS No.: NJ0099198 (Ground Water) and NJG197670 (Terminated SW Permit)	
Inspection Entry Date: February 19, 2025 Inspection Entry Time: 11:00 AM	Inspection Exit Date: February 19, 2025 Inspection Exit Time: 1:30 PM	
Facility Inspected: Burlington Beef 30 Burlington Road Monroeville, NJ, 08343	Lat, Long: 39.620338, -75.199911 NAICS / SIC Code: 2011 (Meat Packing Plants)	
EPA Representative(s): Daniel Asselin, Environmental Engineer, EPA Region 2, ECAD-WCB, (212) 637-4262, Asselin.daniel@epa.gov		
State Representative(s): Tiffany Malcolm, NJDEP, tiffany.malcolm@dep.nj.gov Steve Mathis, NJDEP, steve.mathis@dep.nj.gov		
On-Site Facility Representative(s): Adam Kohn, General Manager, adam@burlingtonbeef.com Cynthia "Cindy" Kohn, Owner & Vice President, cindy@burlingtonbeef.com Thomas "Tommy" Patten, Office Manager, tom@burlingtonbeef.com

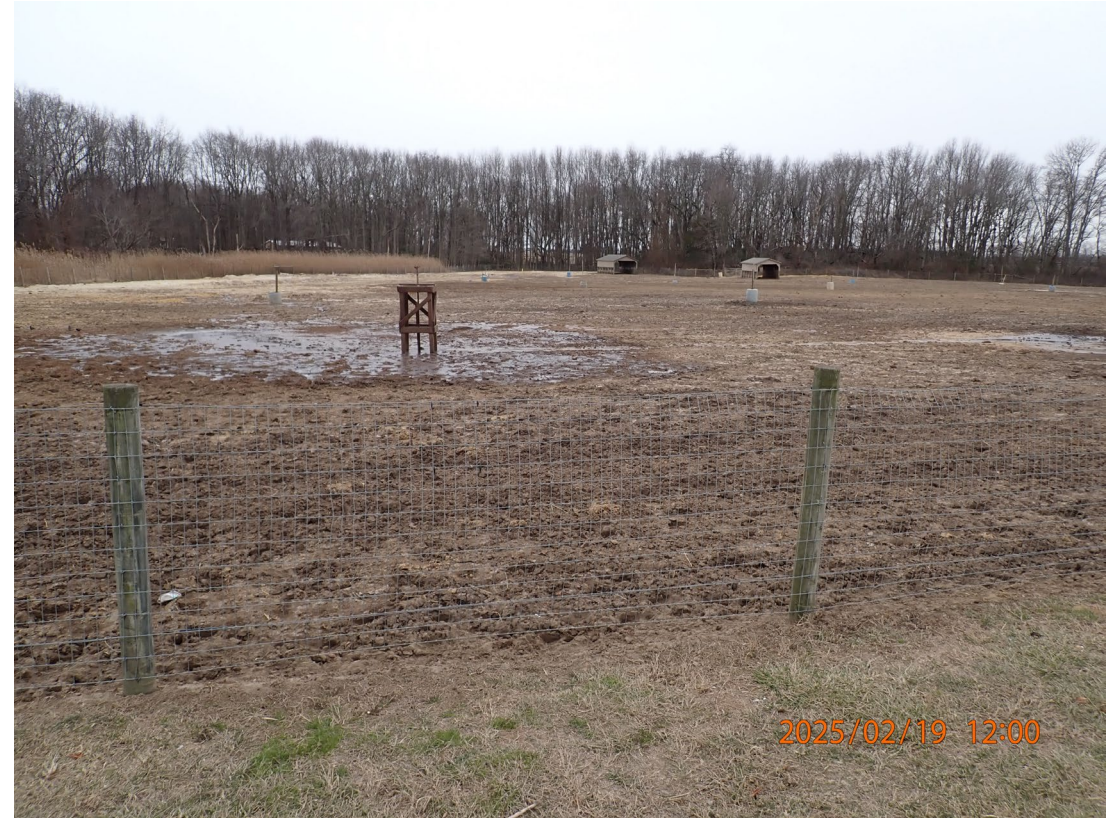
EPA began the inspection on the northern portion of the spray field. EPA observed mild puddling in the spray field (as shown in photograph P2190006). The Site representatives stated that there are four (4) lines of sprinklers in the spray field (with line 1 being the northernmost line and line 4 being the southernmost line), prior to discharging process wastewater to the spray field they said that they inspect the spray field for signs of puddling and if present, they discharge to a different line of sprinklers. EPA observed groundwater monitoring well 1 north of the spray field (as shown in photograph P2190009). EPA noted that PVC pipe was missing a cap and the well cover was not locked. Following the inspection, the Site representatives provided EPA with photographs of the PVC pipe capped and the cover locked. The Site representative stated that groundwater monitoring well 1 (“MW-1”) was located upgradient, north of the spray field, groundwater monitoring well 2 (“MW-2”) was located within the spray field, and groundwater monitoring well 3 (“MW-3”) was located downgradient, south of the spray field, with each being a separate well not connected in any way.

permittee should look for areas of buildup of solids, ponding or channeling, and excessive or lack of vegetative growth. Part II of the Site's O&M Manual contains the stated requirements, however, at the time of the inspection, it was apparent to EPA that weekly visual inspections were not being taken place as multiple areas of ponding and erosion within the spray area were observed (as shown in photographs P2190013, P2190027, P2190028, P2190029, P2190030, and P2190031) and the entire spray field to be barren (as shown in photograph P2190006).

- f. Part IV.E.2.a.ii of the Permit states that the Facility's O&M Manual should contain a "schedule of tilling, growth and harvesting of vegetation to ensure appropriate cover of the spray field." At the time of the inspection, EPA observed the spray field completely barren (as shown in photograph P2190006).

P2190006 – Northern portion of the spray field.

At the time of the inspection, the Site representatives discussed the possibility of regrading the spray field to increase the elevation of the edges (specifically the southeastern portion), installing a berm around the perimeter of the spray field, creating a path surrounding the spray field to allow for easy access to MW-3 and to observe all portions of the spray field, and dividing the spray field in sections to allow vegetation growth in one section at a time.

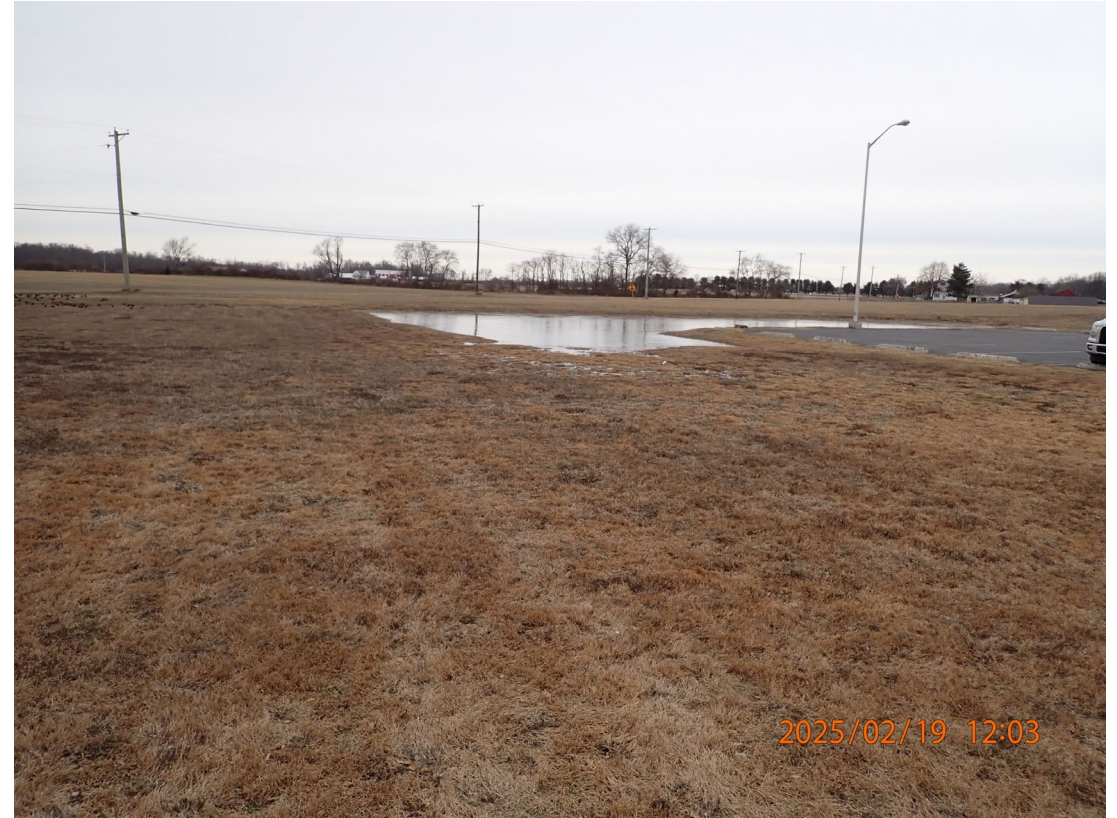
EPA also observed the western stormwater retention basin (as shown in photograph P2190008). The Site representative stated that there are two (2) retention basins onsite, one in the west and one in the east. All stormwater from the parking lots and roof gutters are channeled to one of the two retention ponds.

P2190008 – Retention pond on the western portion of the Site.

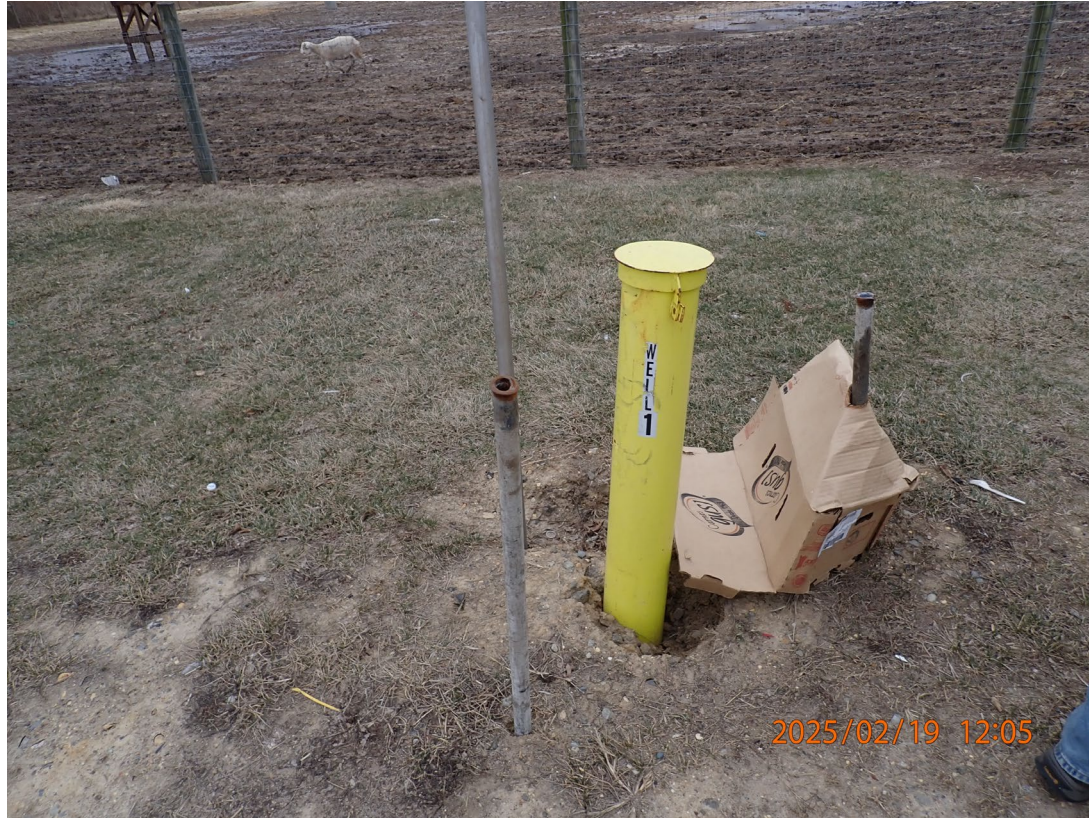
P2190009 – Monitoring Well 1, located north of the spray field.

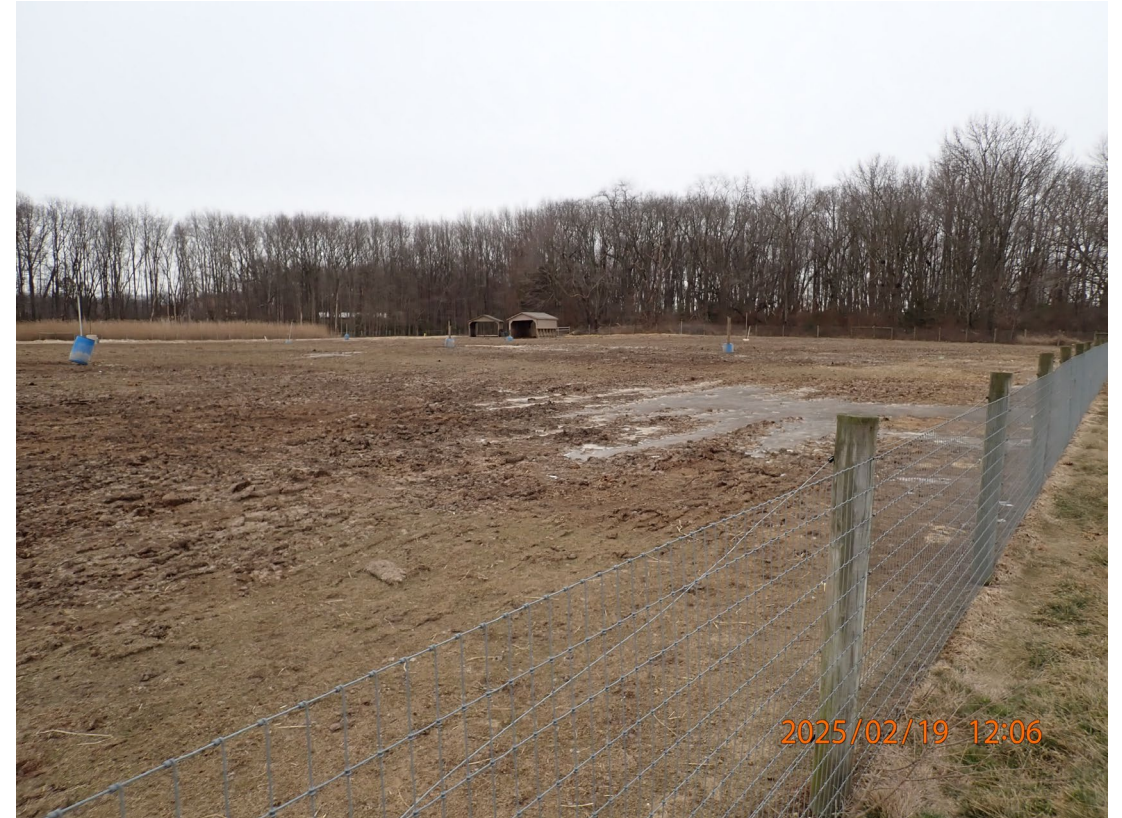
The inspection continued to the western edge of the spray field, along Burlington Road. EPA observed mild puddling and erosion along the western portion of the spray field (as shown in photographs P2190010 and P2190011, respectively). EPA observed an unauthorized discharge leaving the southwestern corner of the spray field. Photograph P2190034 shows the unauthorized discharge along Burlington Road, south of the Site. EPA observed MW-3, south of the spray field (as shown in photograph P2190012). The PVC pipe within MW-3 was uncapped and the well cover was unlocked, similar to MW-1.

P2190010 – Western edge of the spray field, along Burlington Road.

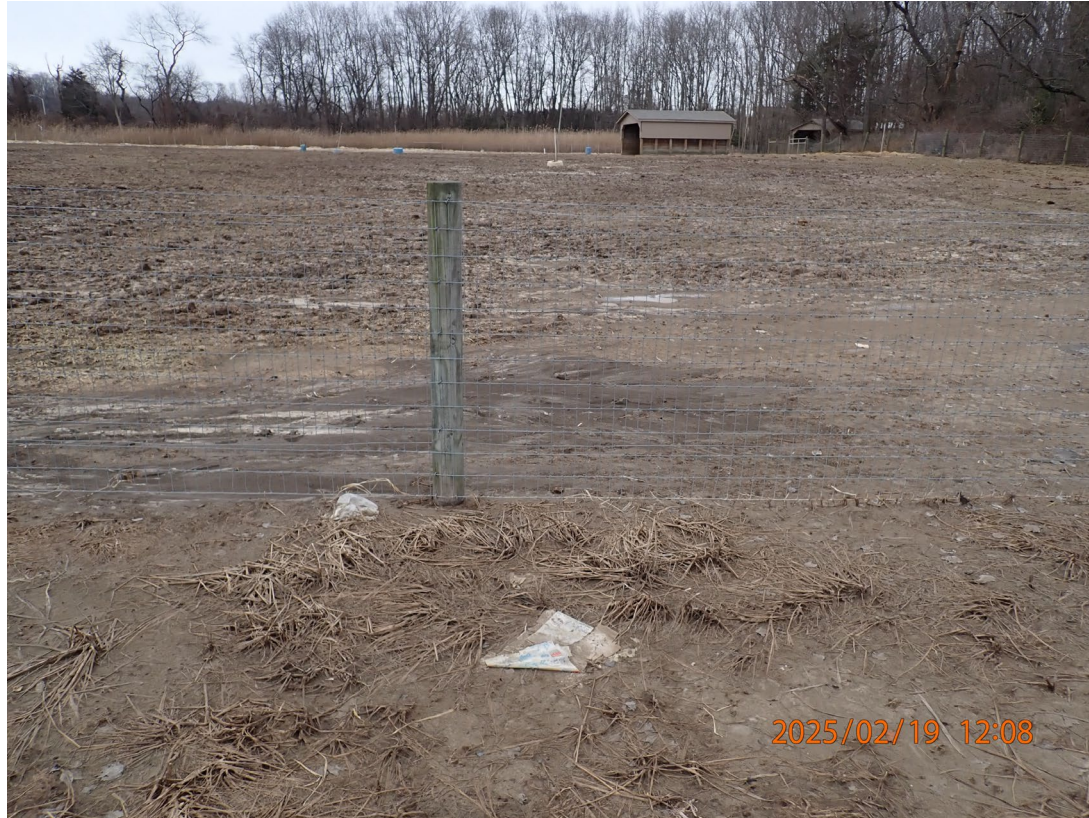
P2190011 – Mild erosion along the southwestern corner of the spray field.

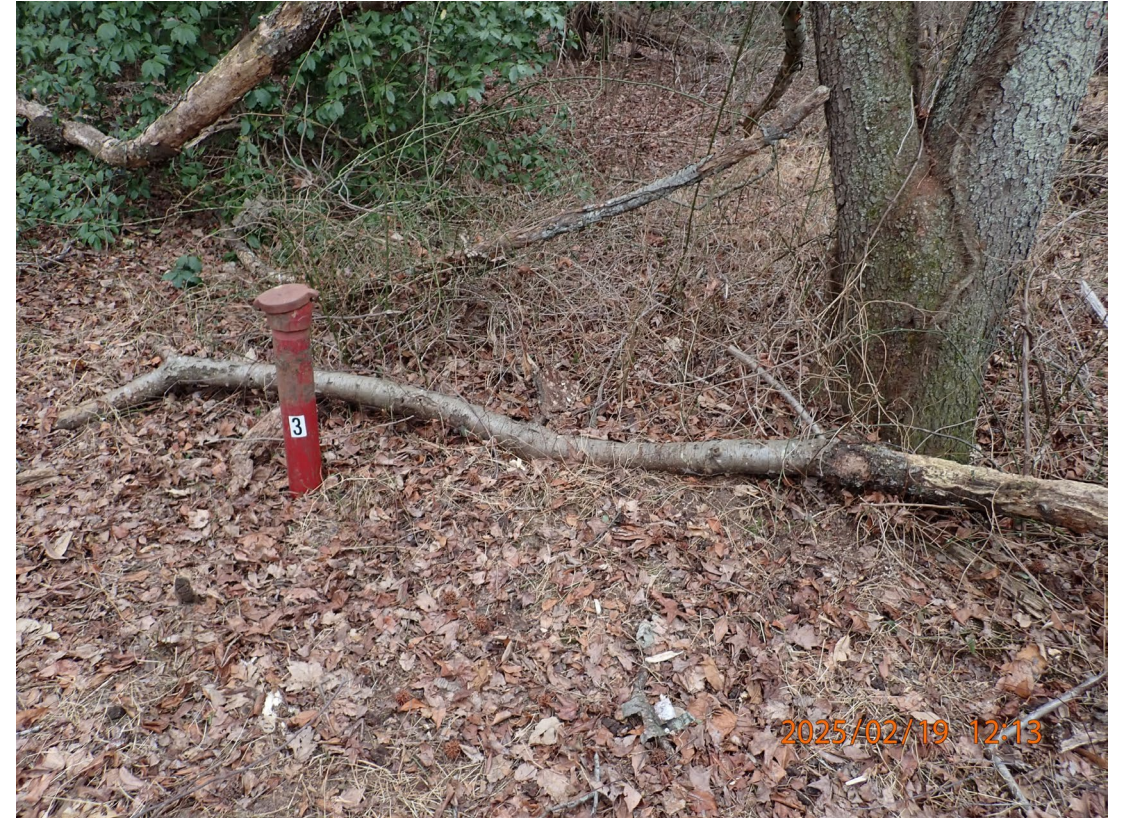
P2190012 – Monitoring Well 3, located south of the spray field.

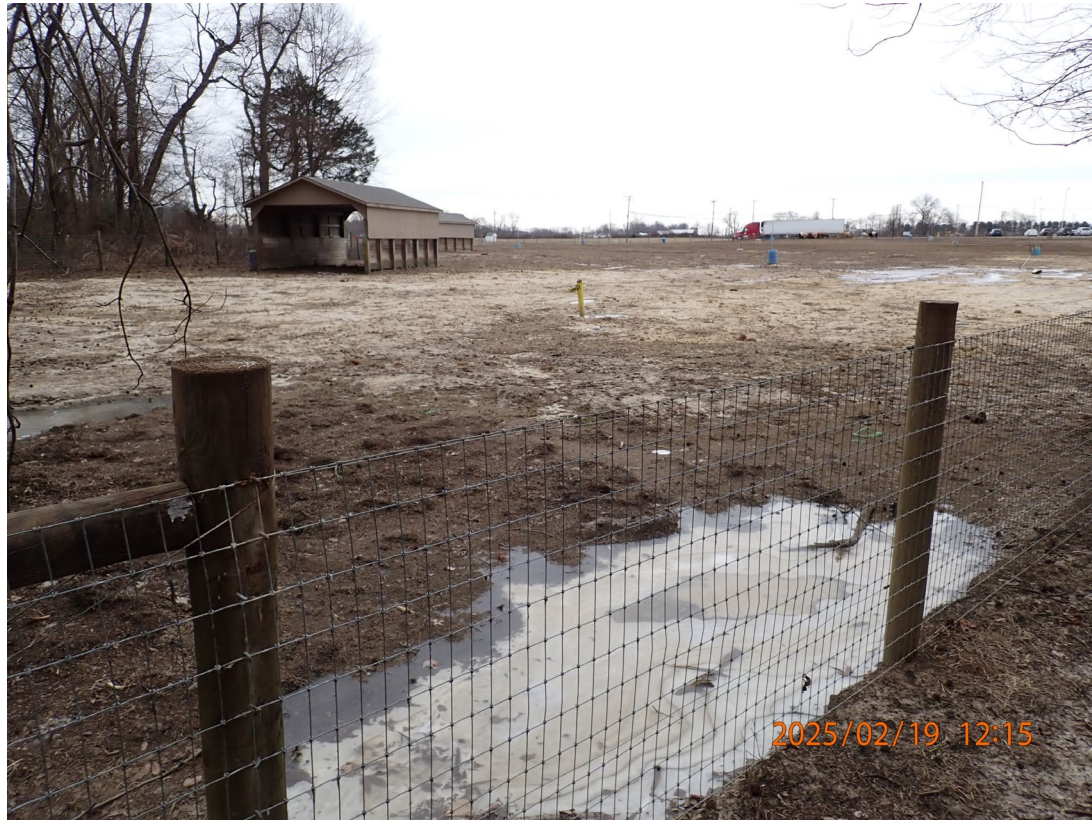
P2190013 – Frozen puddles in the southeastern corner of the spray field.

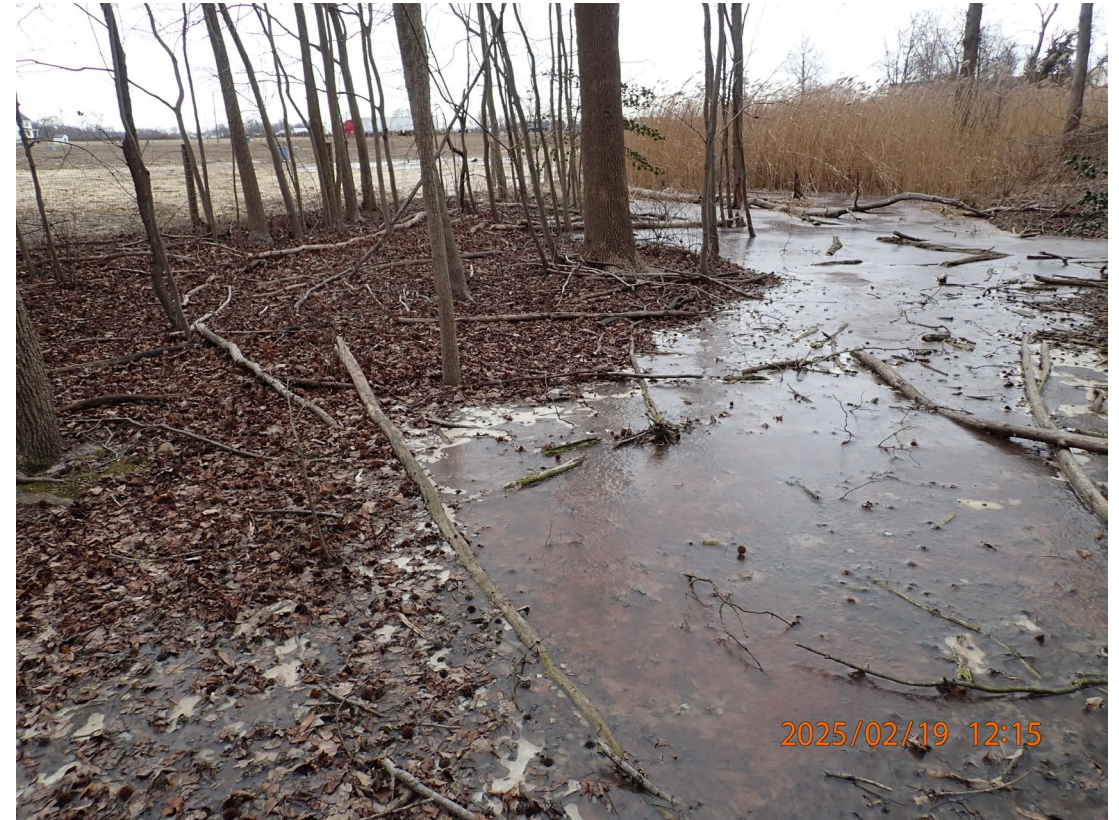
The inspection continued to the southeastern portion of the Site. Prior to reaching the southern edge of the spray field, EPA observed a flow from the direction of the Site (as shown in photographs P2190014, P2190015, P2190020, and P2190021). The flow appeared to be red in nature, as shown in photographs P2190016, P2190017, P2190018, P2190022, P2190023, and P2190024. Additionally, EPA observed multiple signs of erosion on the southern portion of the Site (as shown in photographs P2190019 and P2190025). EPA was able to track the unauthorized discharge back to the southeastern corner of the Site's spray field. EPA observed multiple signs of frozen puddling within the spray field in the southeastern corner (as shown in photographs P2190013, P2190026, P2190027, P2190029, and P2190030). Additionally, EPA observed signs of erosion within the spray field (as shown in photographs P2190028 and P2190031) and just outside the southeastern portion of the spray field (as shown in photographs P2190032 and P2190033). EPA noted a distinct foul odor while in this portion of the Site. Additionally, EPA noted that the perimeter of the spray field was not bermed and only contained a metal fence. EPA was able to track the unauthorized discharge to an unnamed tributary of Muddy Run, which is a tributary of Maurice River, which flows to the Delaware Bay, a water of the US.

P2190014 – Frozen, unauthorized discharge leaving the southeastern portion of the spray field.

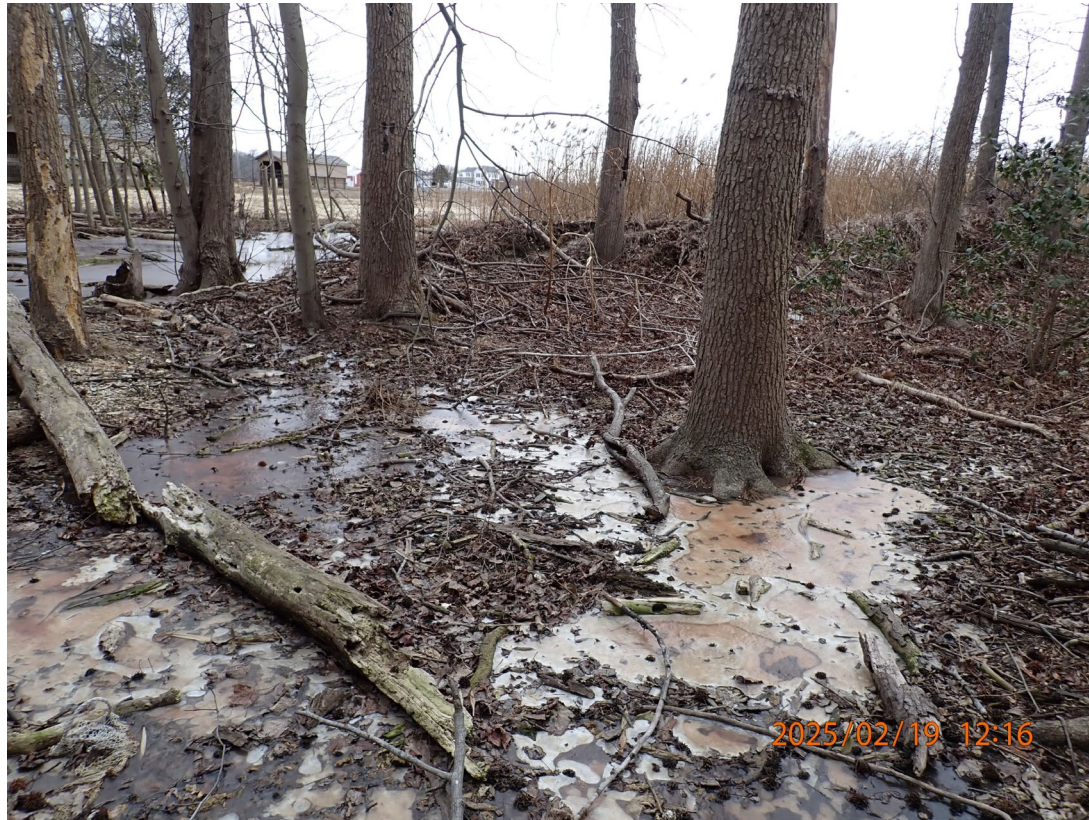
P2190015 – Unauthorized discharge leaving the southeastern portion of the spray field.

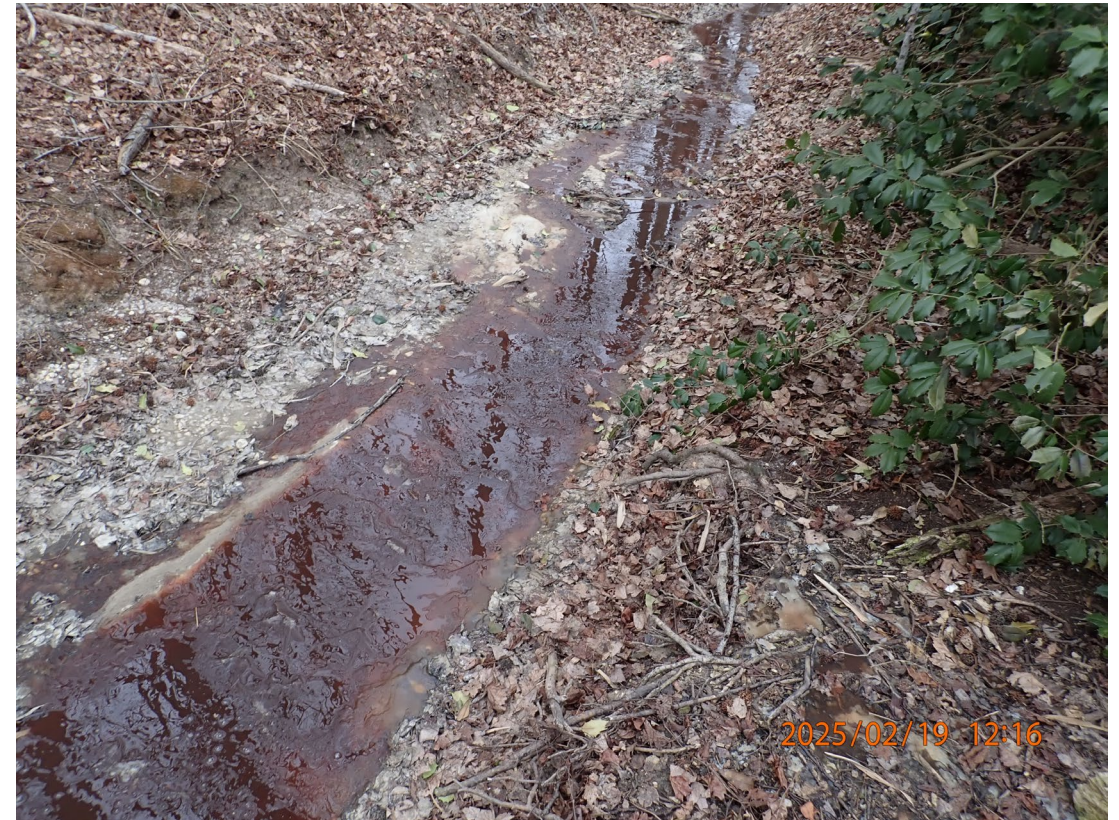
P2190016 – Red, unauthorized discharge leaving the southeastern portion of the spray field.

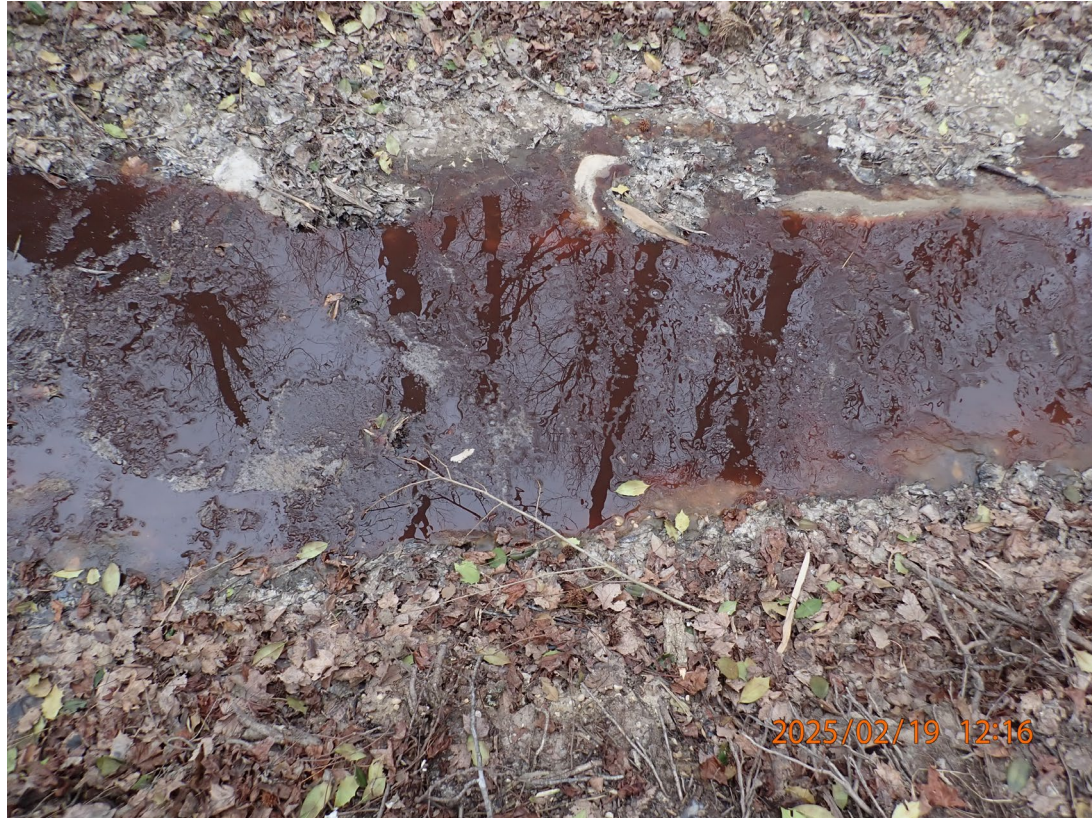
P2190017 – Red, unauthorized discharge leaving the southeastern portion of the spray field.

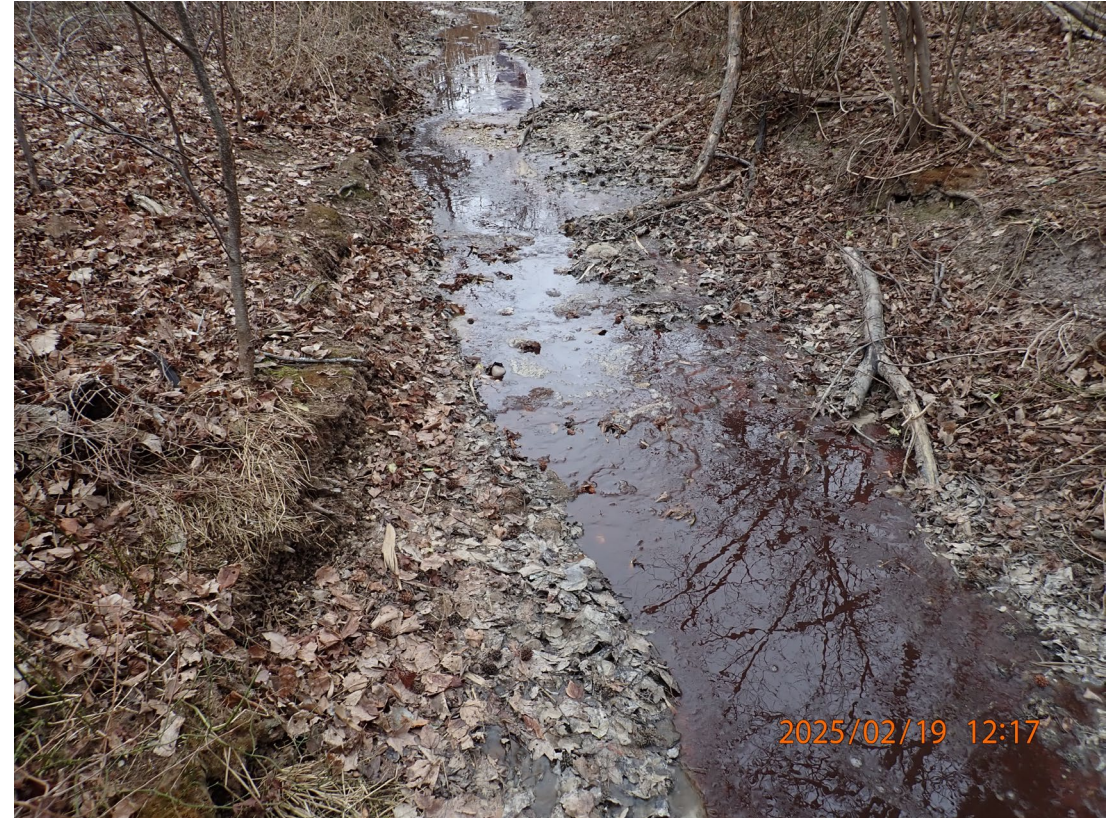
P2190018 – Red, unauthorized discharge leaving the southeastern portion of the spray field.

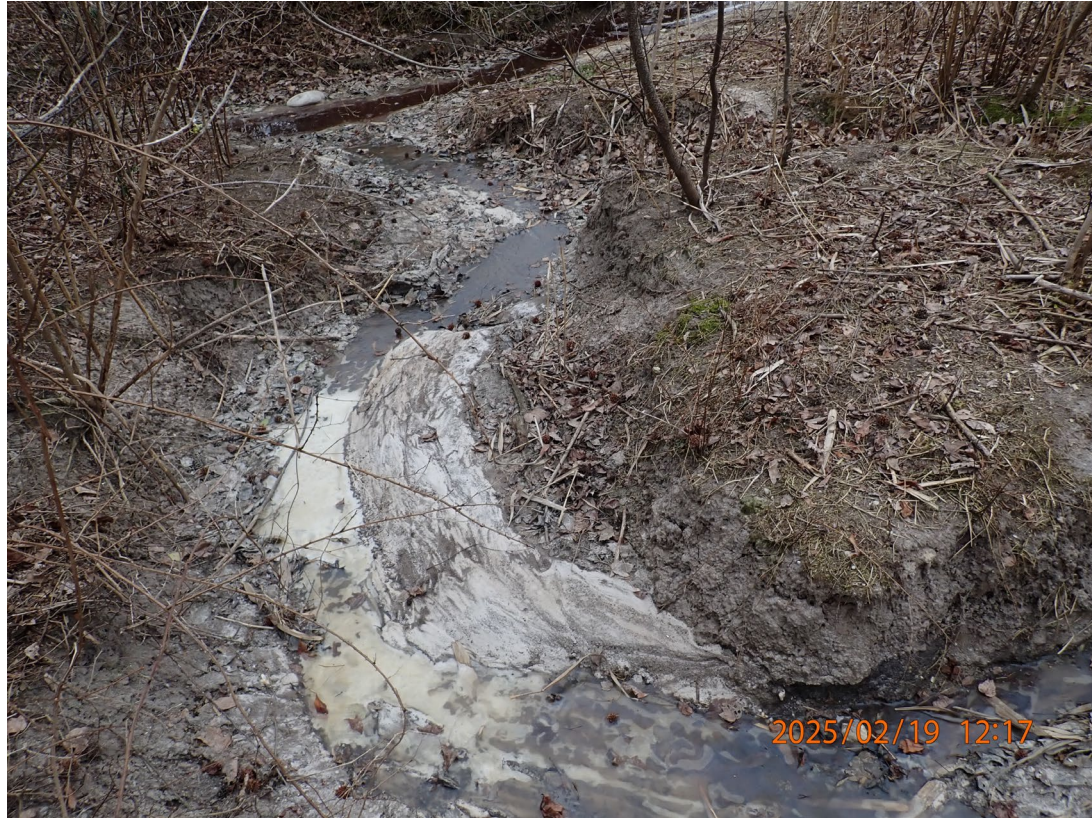
P2190019 – Erosion in the southeastern portion of the Site.

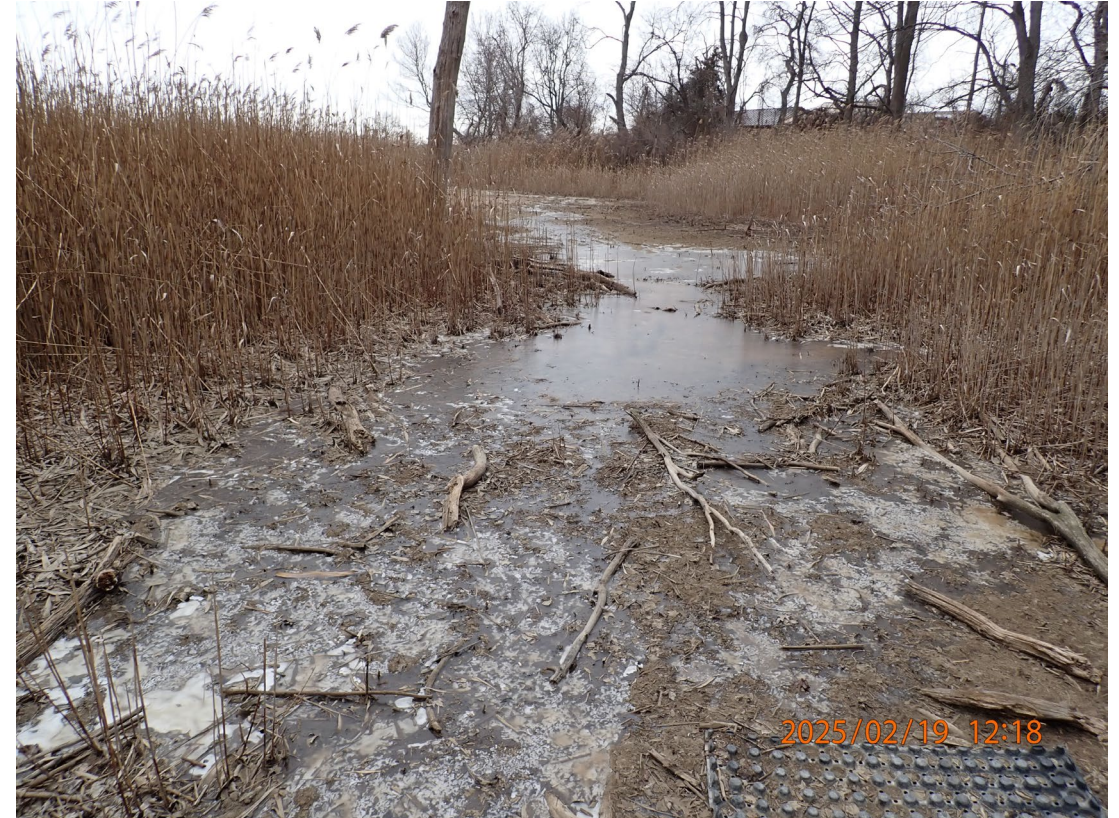
P2190020 – Frozen, unauthorized discharge leaving the southeastern portion of the spray field.

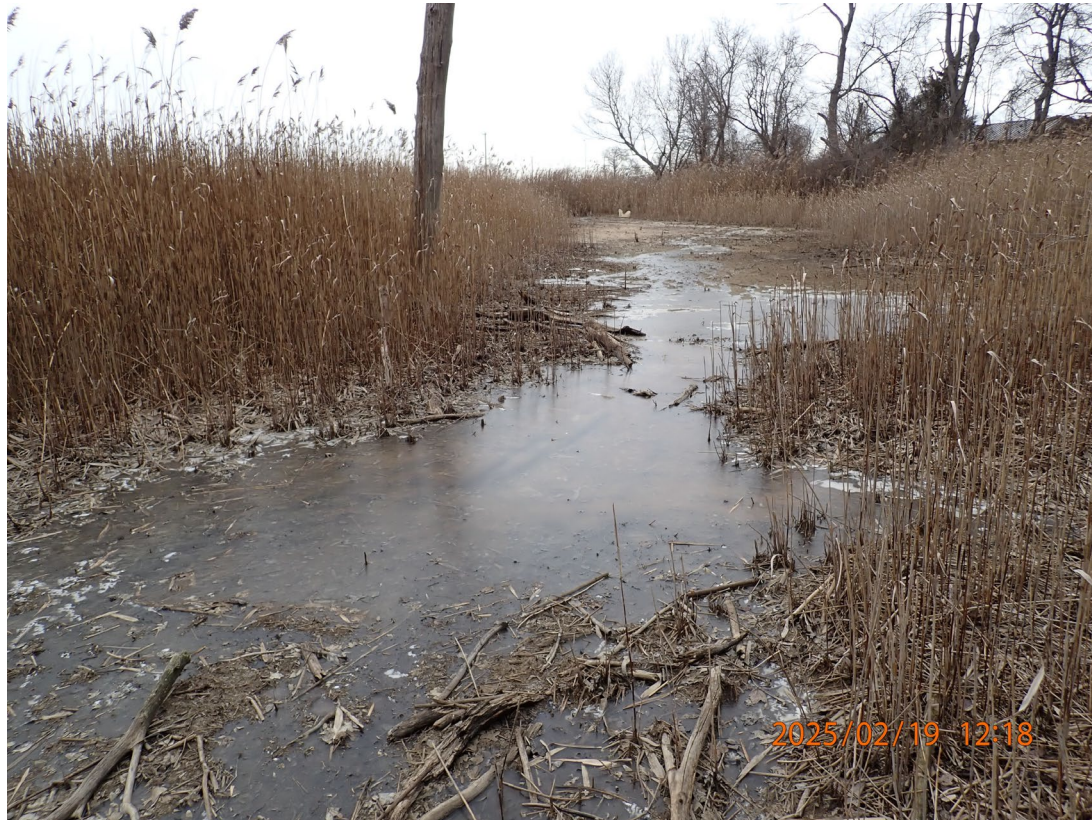
P2190021 – Frozen, unauthorized discharge leaving the southeastern portion of the spray field.

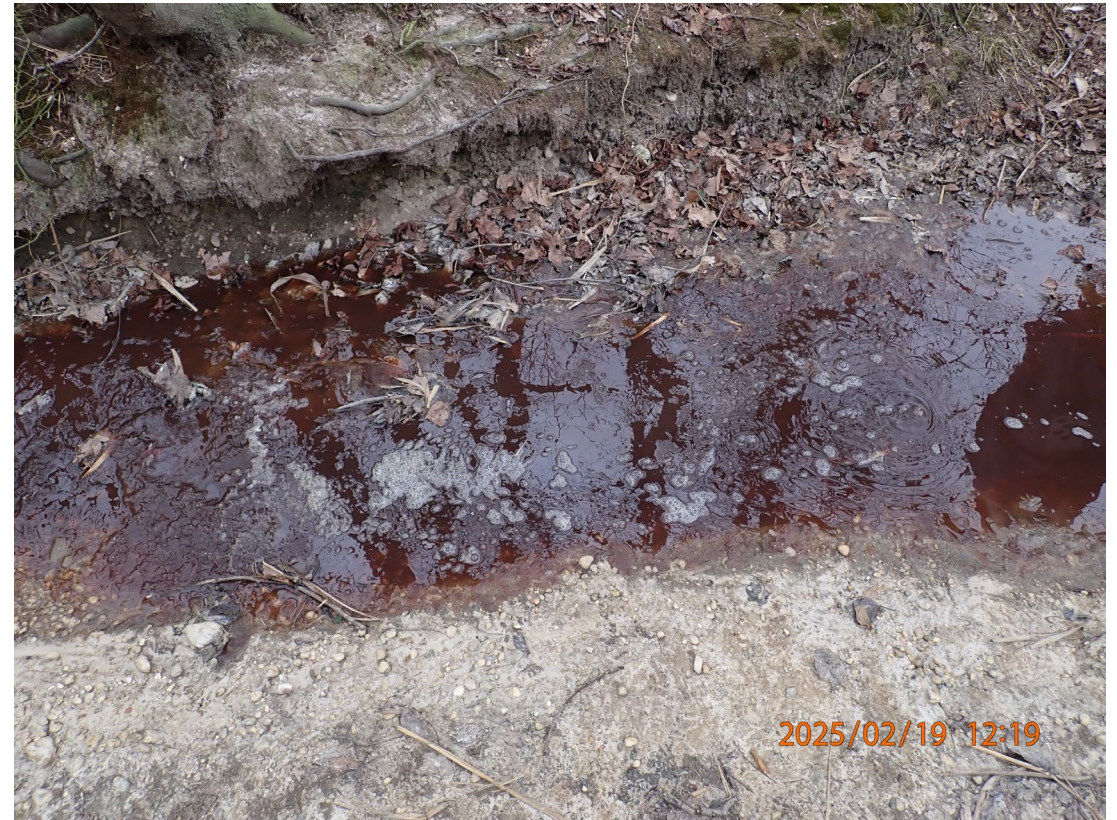
P2190022 – Red, unauthorized discharge leaving the southeastern portion of the spray field.

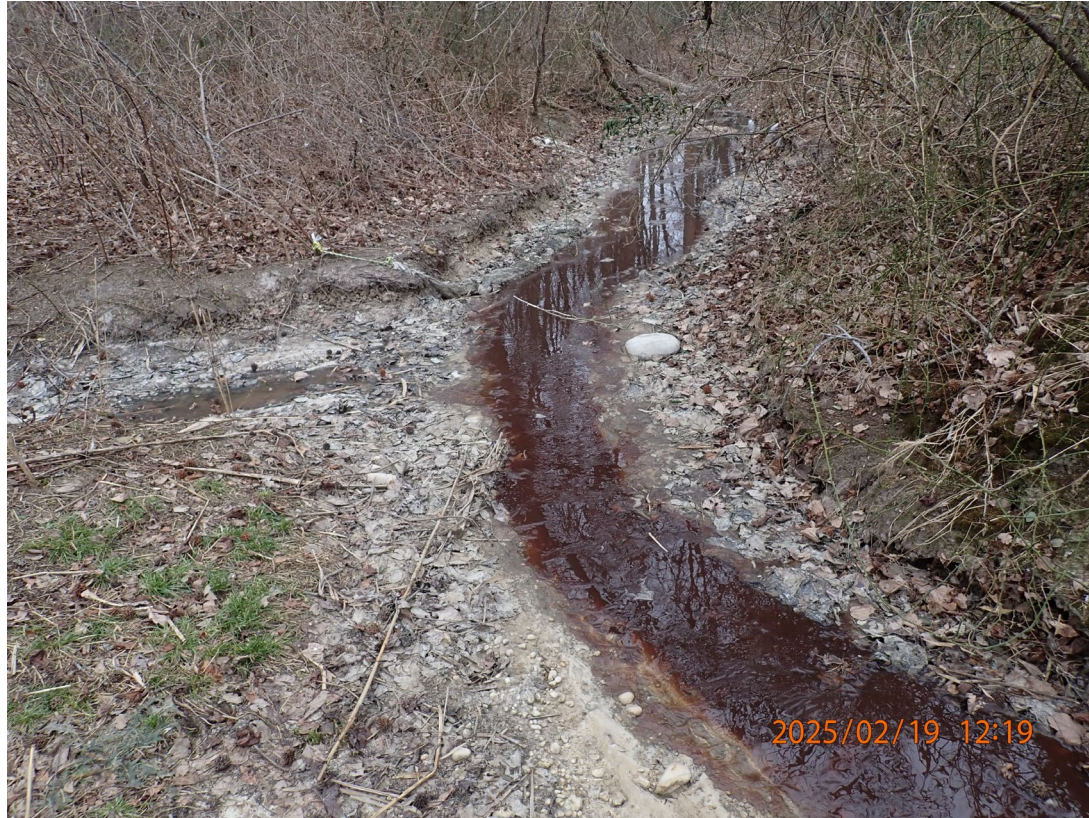
P2190023 – Red, unauthorized discharge leaving the southeastern portion of the spray field.

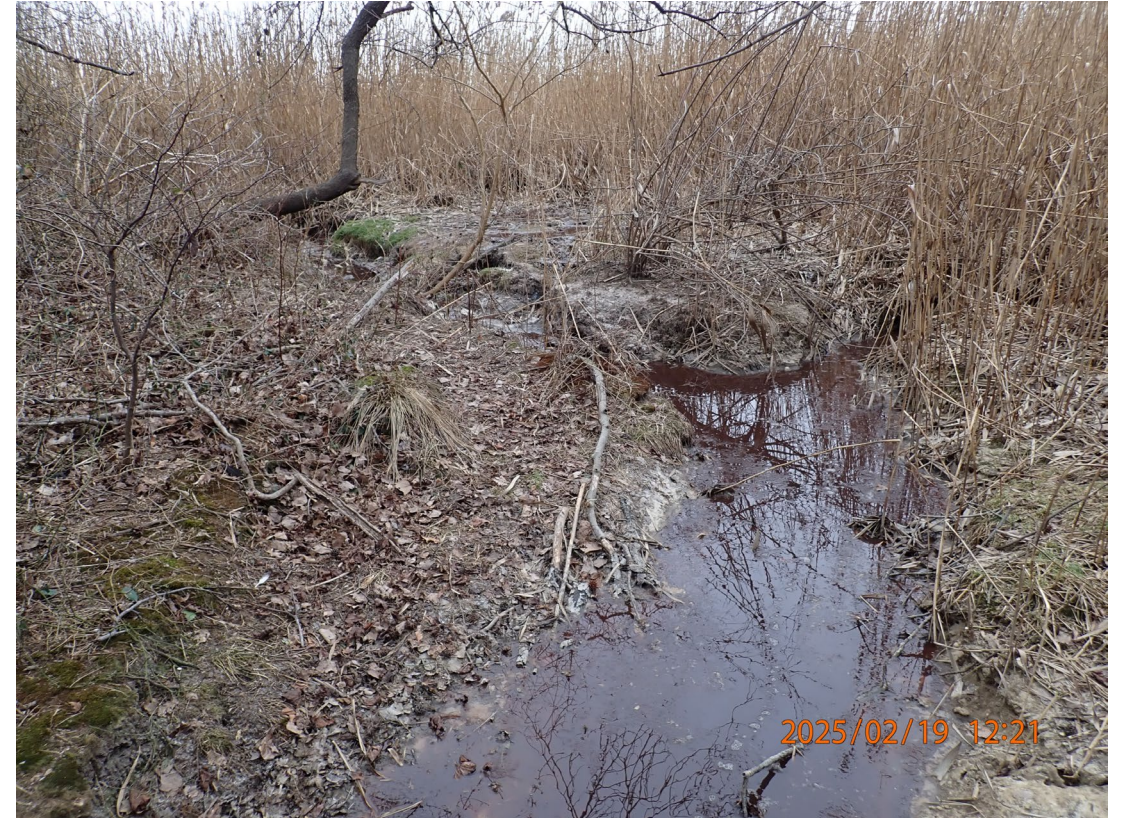
P2190024 – Red, unauthorized discharge leaving the southeastern portion of the spray field.

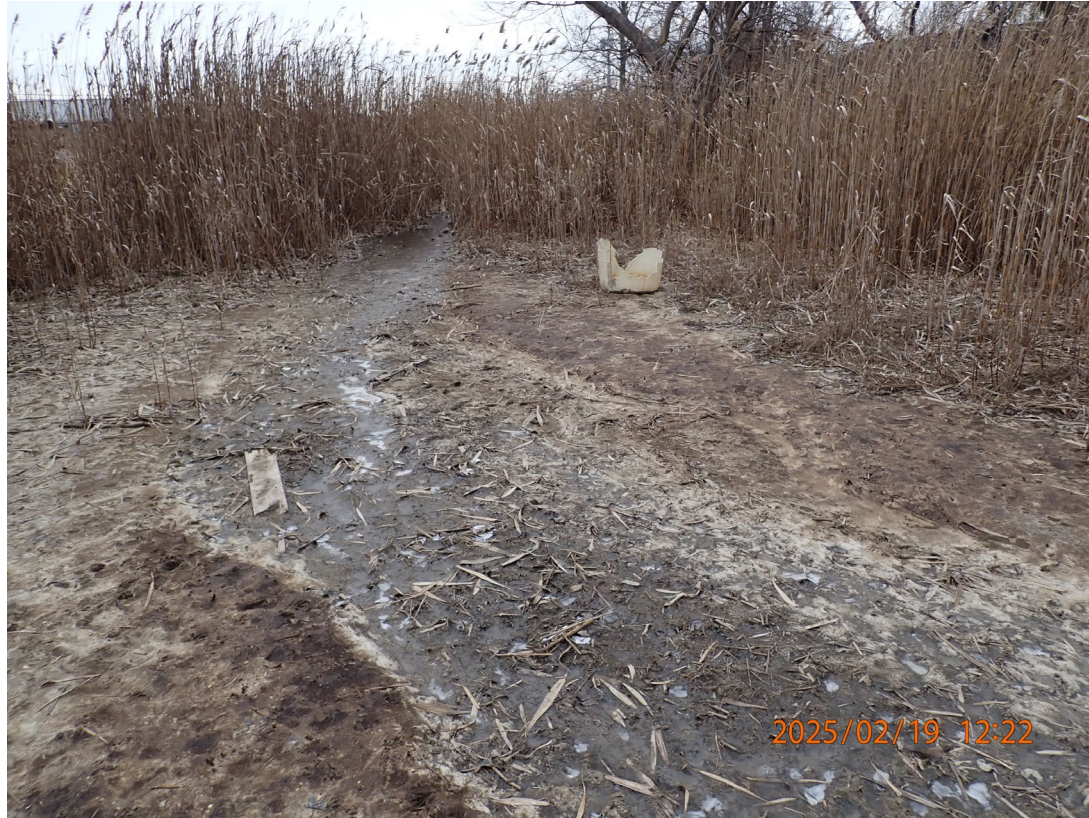
P2190025 – Erosion in the southeastern portion of the Site.

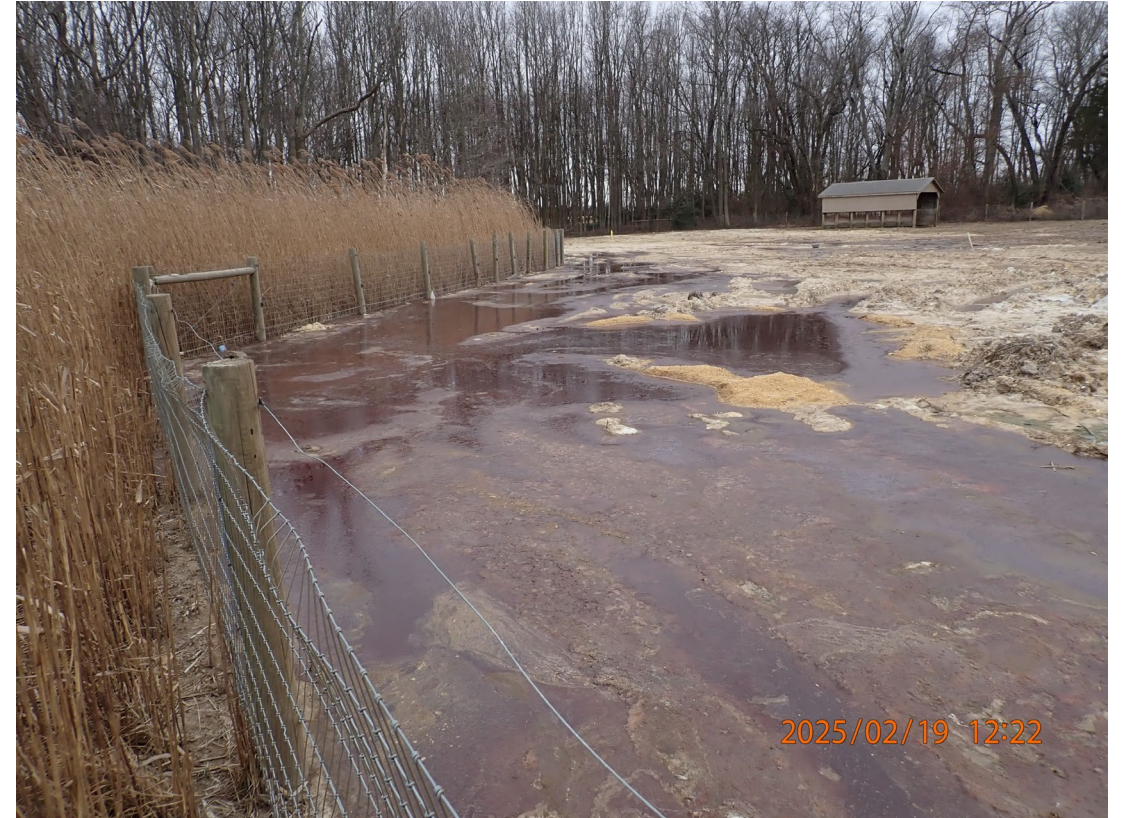
P2190026 – Frozen, red, puddles in the southeastern portion of the spray field.

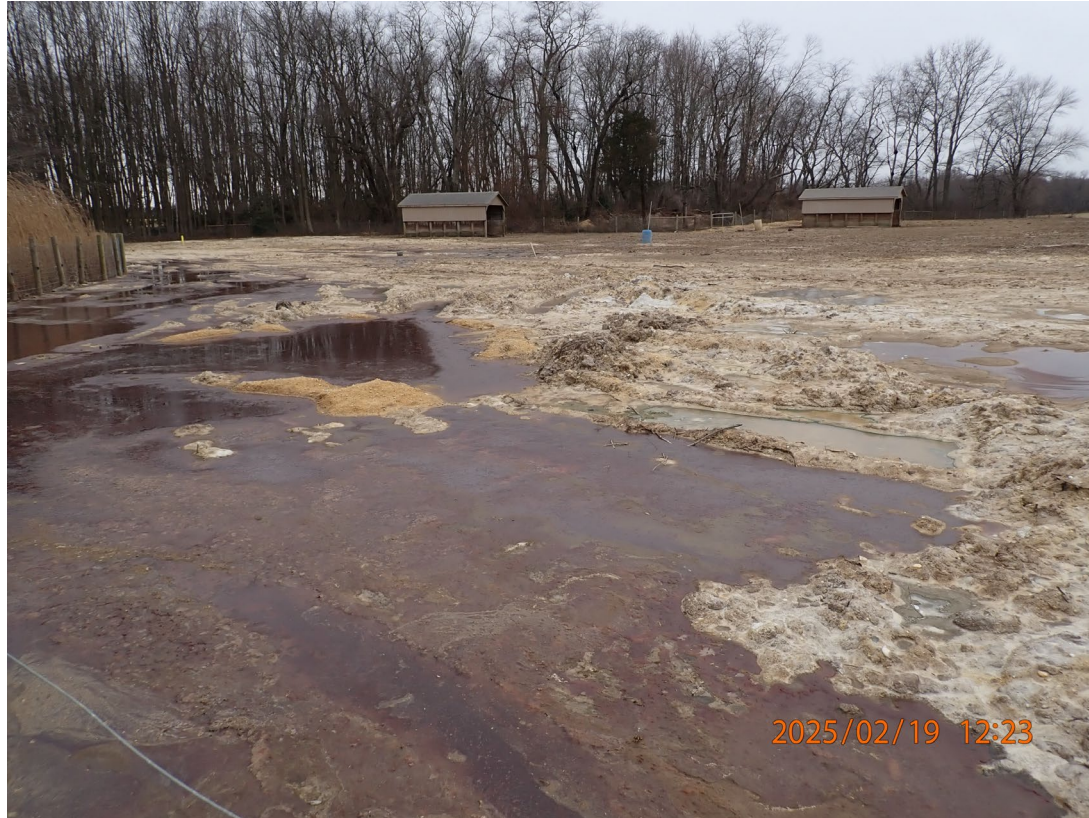
P2190027 – Frozen, red, puddles in the southeastern portion of the spray field.

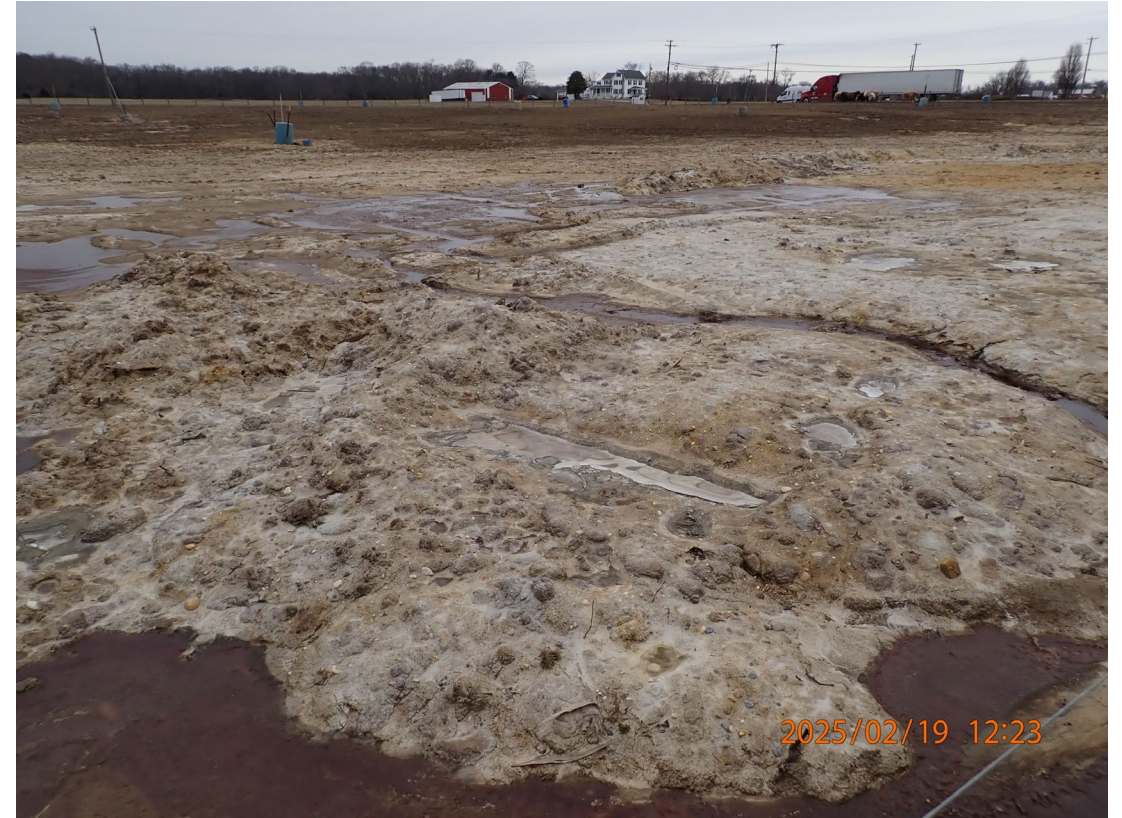
- d. During EPA’s inspection on February 19, 2025, EPA observed multiple instances of unauthorized discharge leaving the southern portion of the spray field. As described previously in this report, the Facility discharges its process wastewater to the spray field. EPA observed an unauthorized discharge on the southwestern portion of the spray field, along Burlington Road (as shown in photograph P2190034). Additionally, EPA observed an unauthorized discharge leaving the southeastern portion of the spray field as well (as shown in photographs P2190014-P2190033), entering an unnamed tributary of Muddy Run (which is a tributary of Delaware Bay and the Atlantic Ocean, both considered Waters of the U.S.). EPA noted the discharge appeared to be red in nature. EPA observed erosion within the spray field, as shown in photographs P2190028 and P2190031.

P2190028 – Frozen, red, puddles in the southeastern portion of the spray field.
