UNITED STATES ENVIRONMENTAL PROTECTION AGENCY
REGION 2, ECAD-WCB
 21st Floor, 290 Broadway, NY, NY 10007

COMPLIANCE EVALUATION INSPECTION REPORT

Program: Industrial Compliance Evaluation Inspection	Inspection Type: Compliance Evaluation Inspection	
Permittee Name: Burlington Beef	NPDES/ICIS No.: NJ0099198 (Ground Water) and NJG197670 (Terminated SW Permit)	
Inspection Entry Date: February 19, 2025 Inspection Entry Time: 11:00 AM	Inspection Exit Date: February 19, 2025 Inspection Exit Time: 1:30 PM	
Facility Inspected: Burlington Beef 30 Burlington Road Monroeville, NJ, 08343	Lat, Long: 39.620338, -75.199911 NAICS / SIC Code: 2011 (Meat Packing Plants)	
EPA Representative(s): Daniel Asselin, Environmental Engineer, EPA Region 2, ECAD-WCB, (212) 637-4262, Asselin.daniel@epa.gov		
State Representative(s): Tiffany Malcolm, NJDEP, tiffany.malcolm@dep.nj.gov Steve Mathis, NJDEP, steve.mathis@dep.nj.gov		
On-Site Facility Representative(s): Adam Kohn, General Manager, adam@burlingtonbeef.com Cynthia "Cindy" Kohn, Owner & Vice President, cindy@burlingtonbeef.com Thomas "Tommy" Patten, Office Manager, tom@burlingtonbeef.com

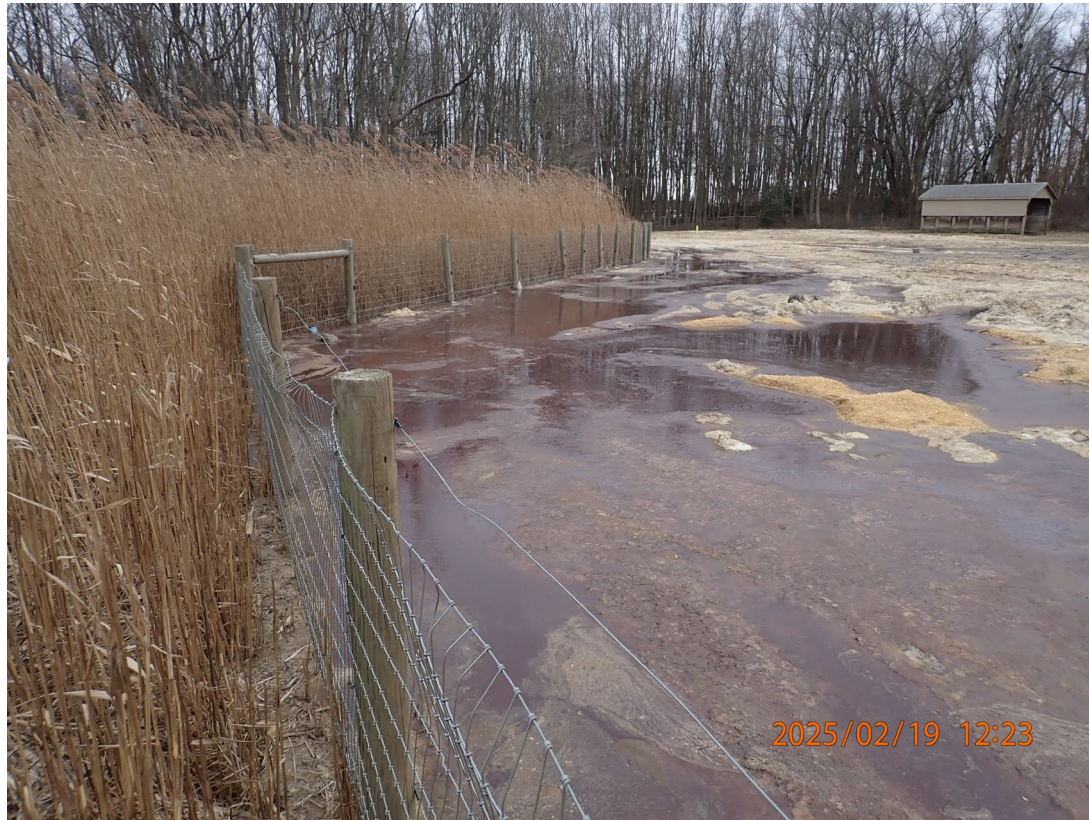
P2190029 – Frozen, red, puddles in the southeastern portion of the spray field.

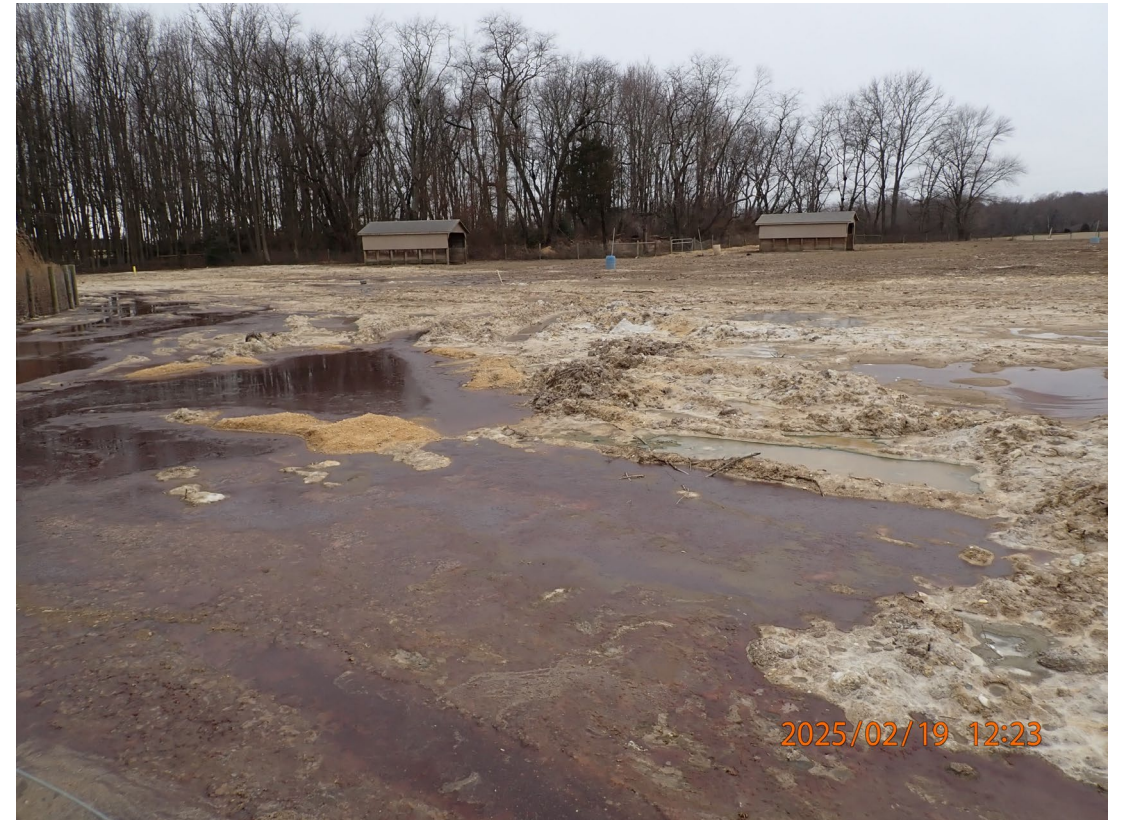
P2190030 – Frozen, red, puddles in the southeastern portion of the spray field.

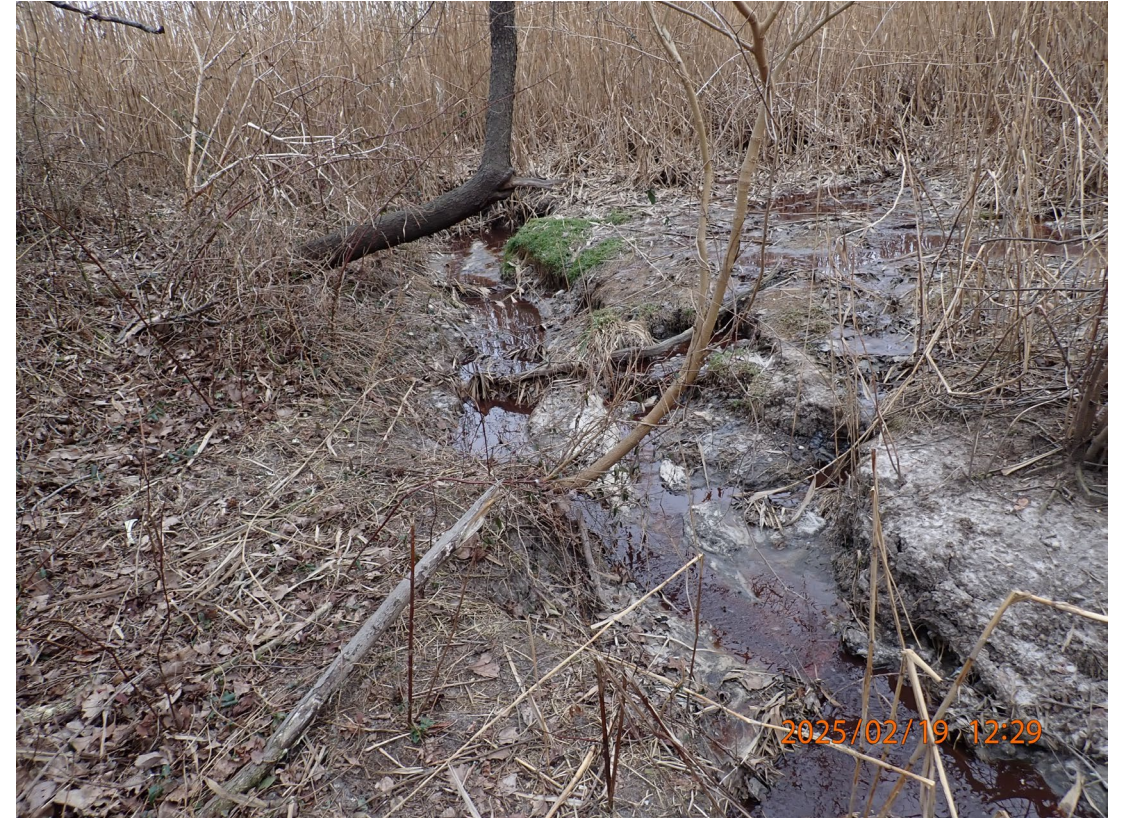
P2190032 – Red, unauthorized discharge leaving the southeastern portion of the spray field.

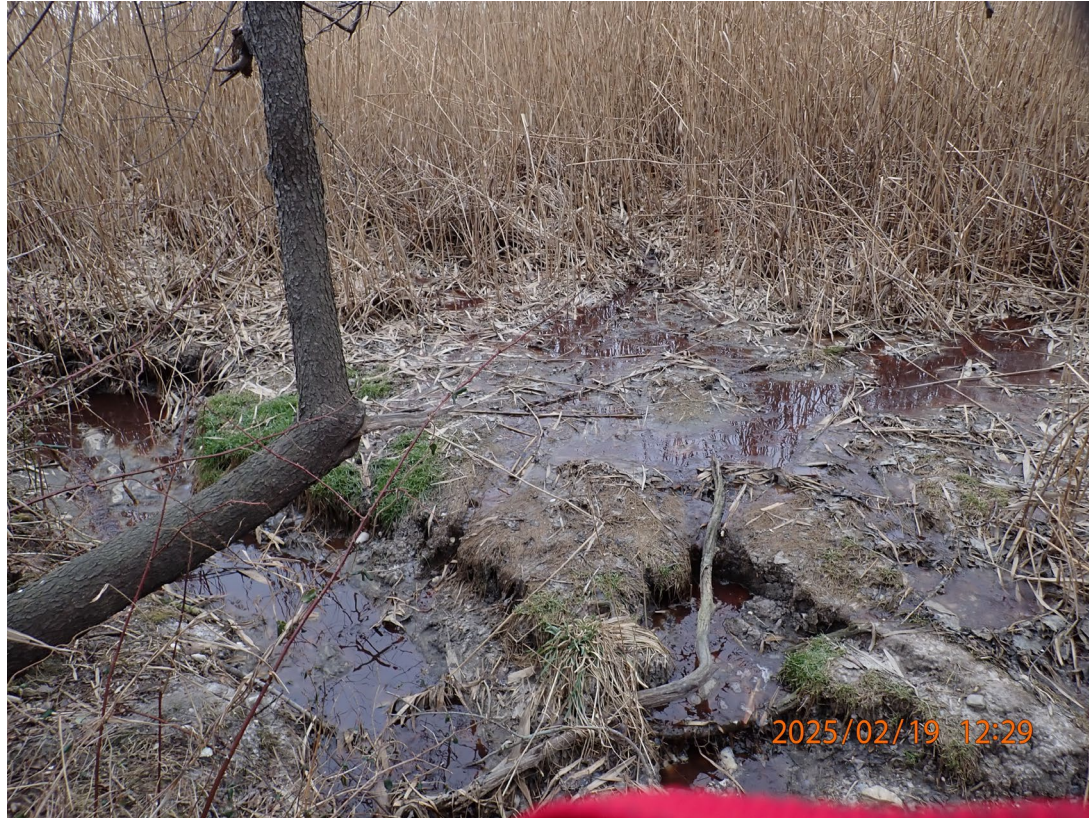
P2190033 – Red, unauthorized discharge leaving the southeastern portion of the spray field.

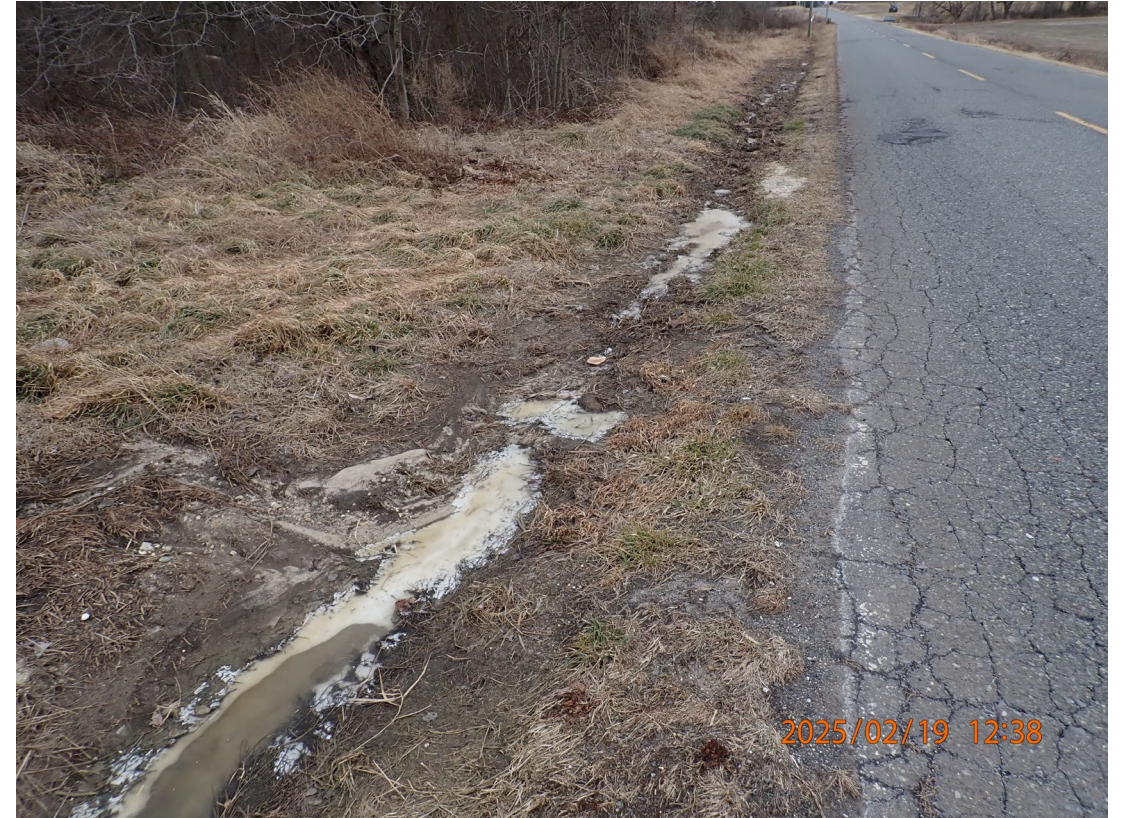
P2190034 – Unauthorized discharge leaving the southwestern portion of the spray field, along Burlington Road.

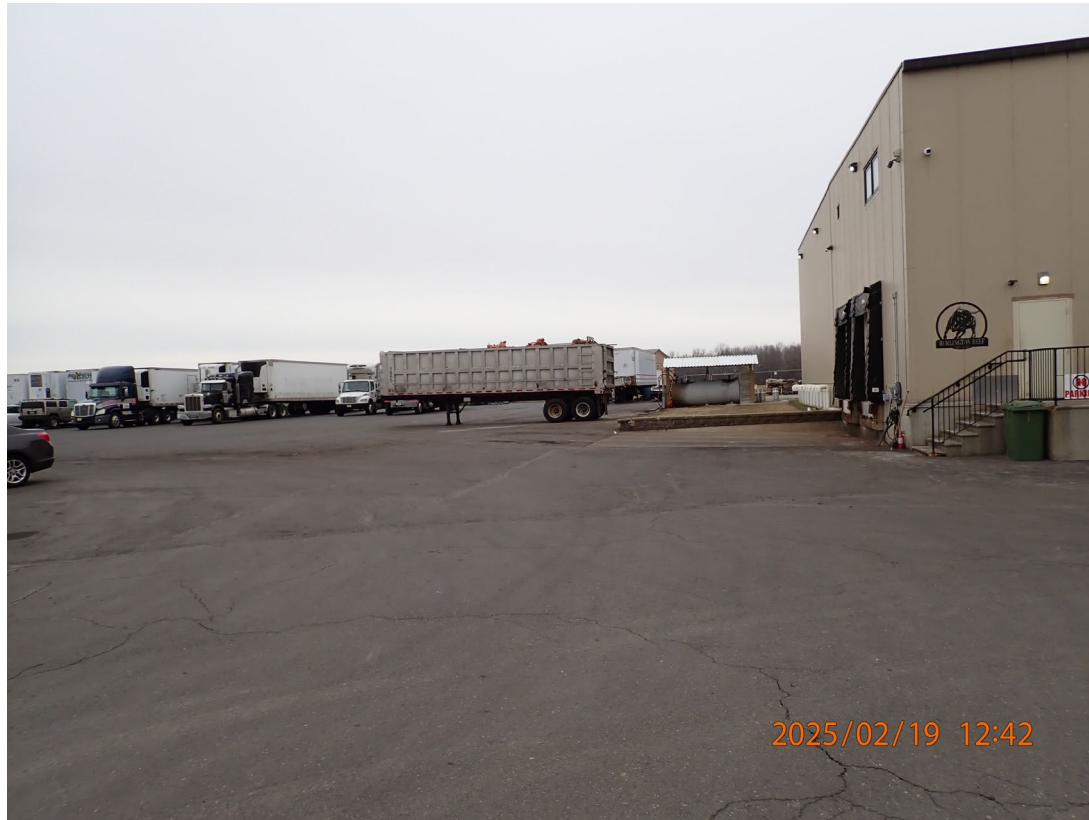
P2190035 – Container full of bones on the western portion of the Site.

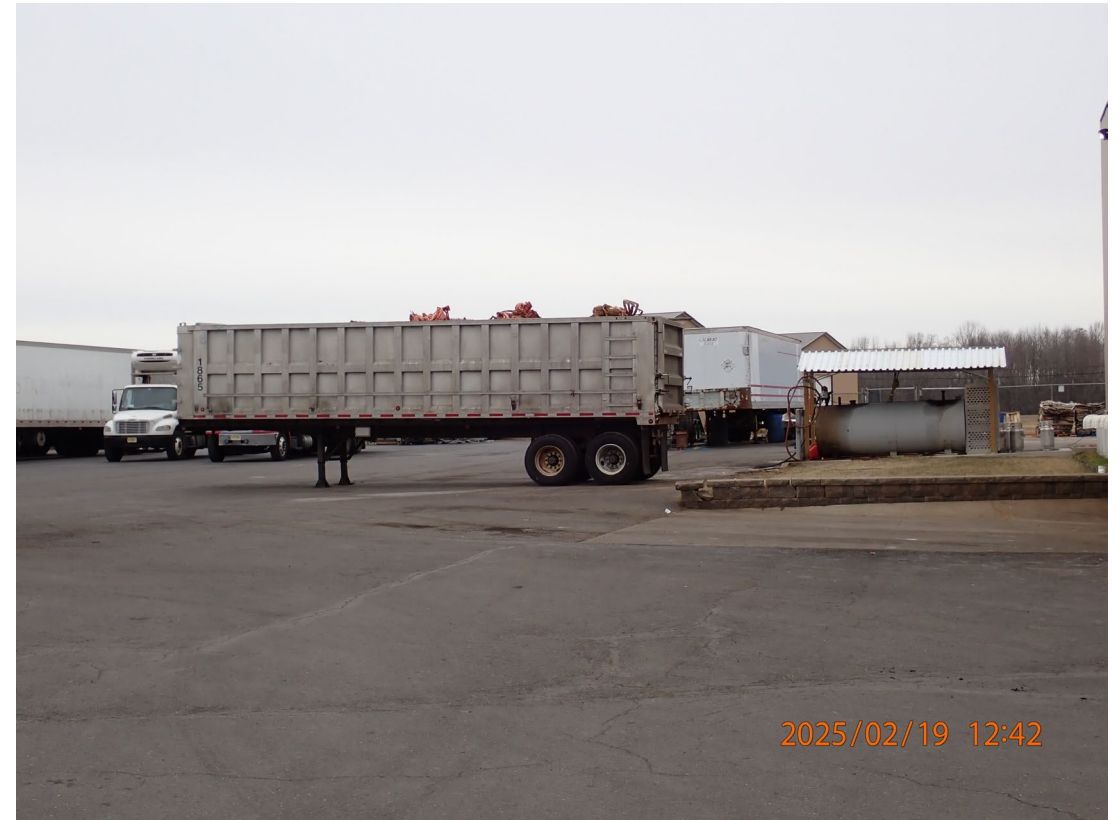
EPA continued the inspection to the eastern portion of the Site. While walking over, EPA observed a container full of animal bones and parts to the west of the main building (as shown in photograph P2190036). EPA observed evidence of forklift maintenance and dry absorbent placed on the ground in the eastern portion of the Site (as shown in photographs P2190037 and P2190044). The Site representative stated this was from a hydraulic leak in the forklift and that the floor drain is connected to an underground storage tank. EPA observed the eastern stormwater retention basin (as shown in photographs P2190041 and P2190042). EPA observed mild litter and debris within the eastern stormwater basin.

P2190036 – Container full of bones on the western portion of the Site.

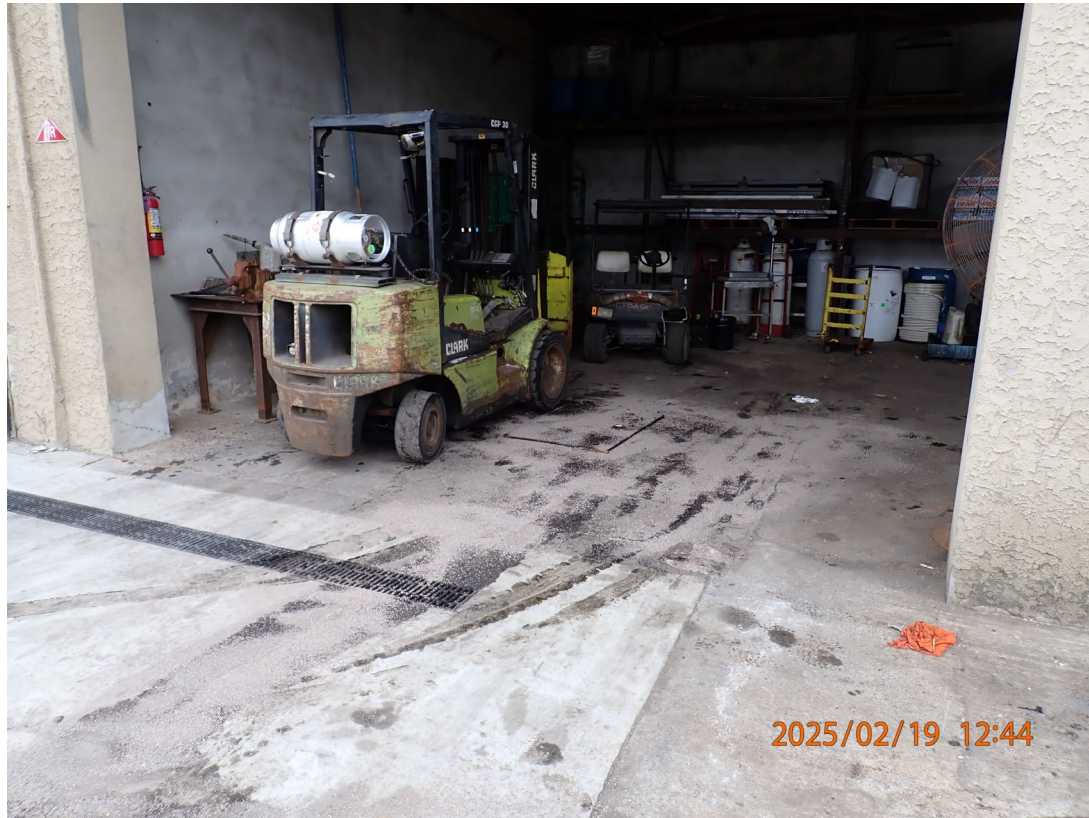
2. At the time of the inspection, EPA observed absorbent spread across the eastern portion of the Site and under a forklift (as shown in photographs P2190044 and P2190037). The Site representative stated that the forklift had a hydraulic leak which was fixed. The hydraulic fluid and absorbent outside the garage have potential to enter the eastern retention pond. Please ensure that all vehicle maintenance is conducted inside and contained, and that the absorbent is cleaned up and properly disposed.

P2190037 – Forklift maintenance and quick dry on the ground in the eastern portion of the Site.

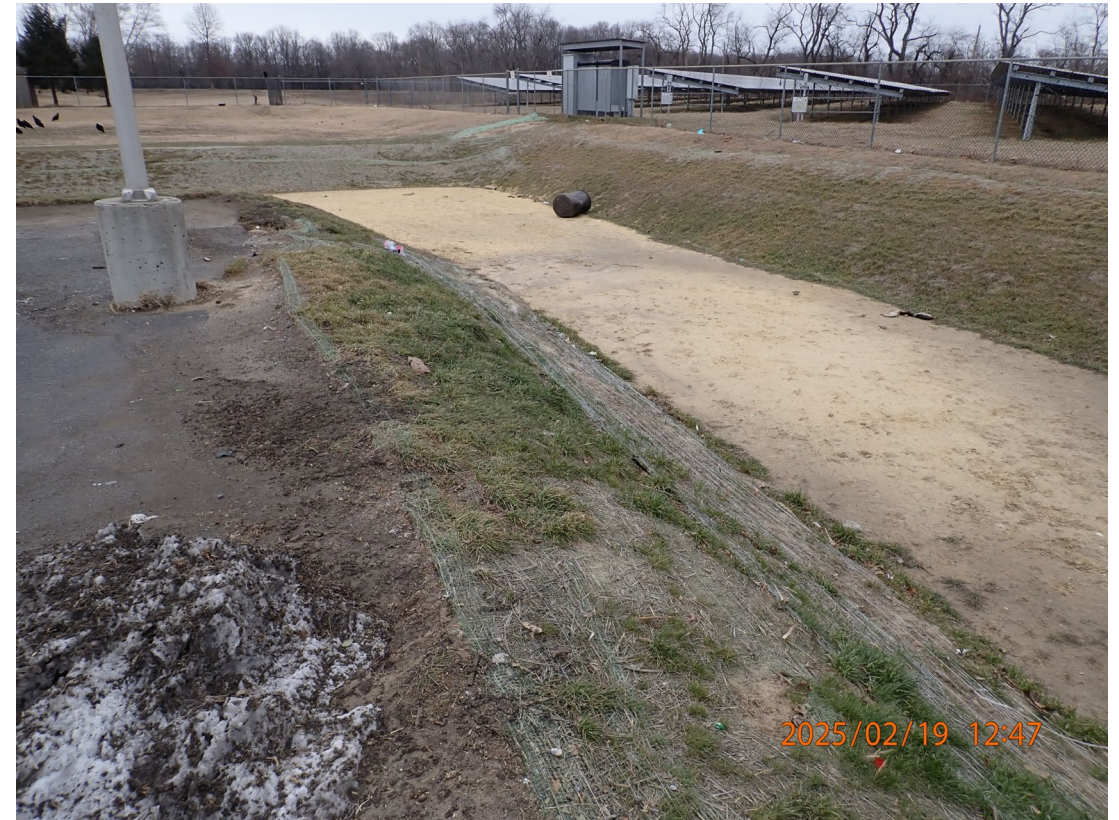
P2190042 – Retention pond on the eastern portion of the Site.

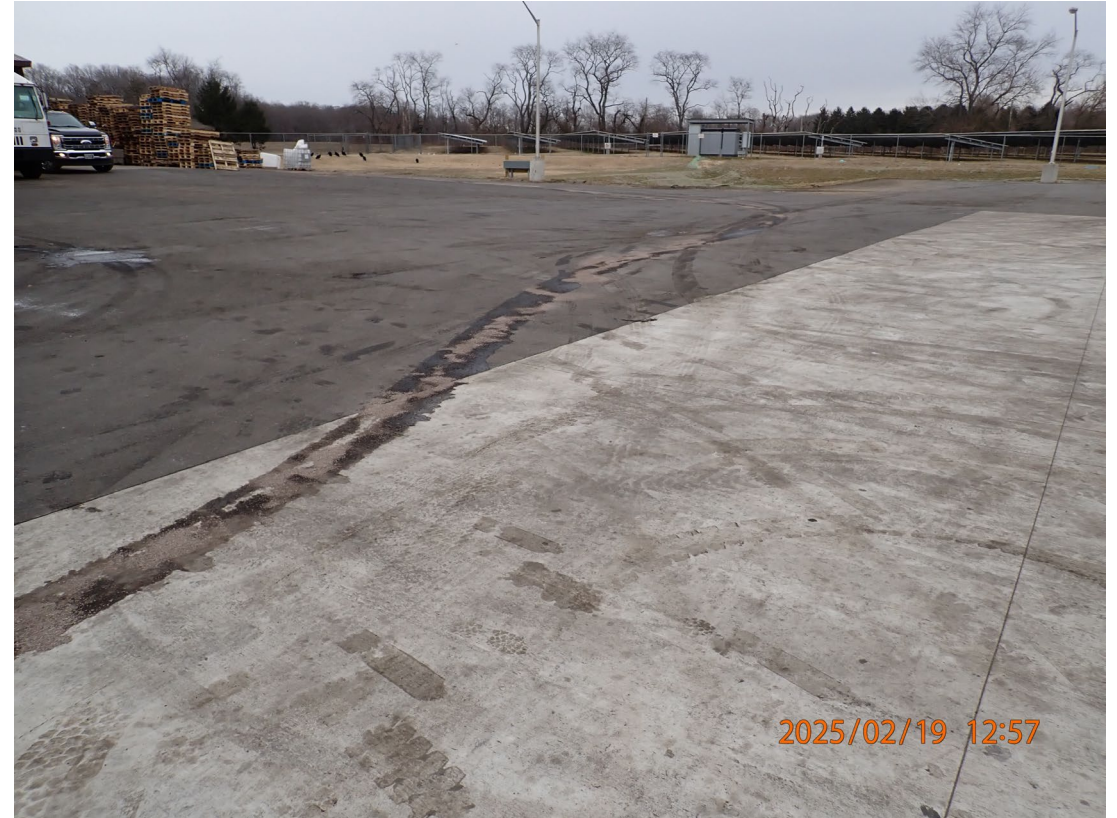
P2190044 – Quick dry over hydraulic fluid leak.

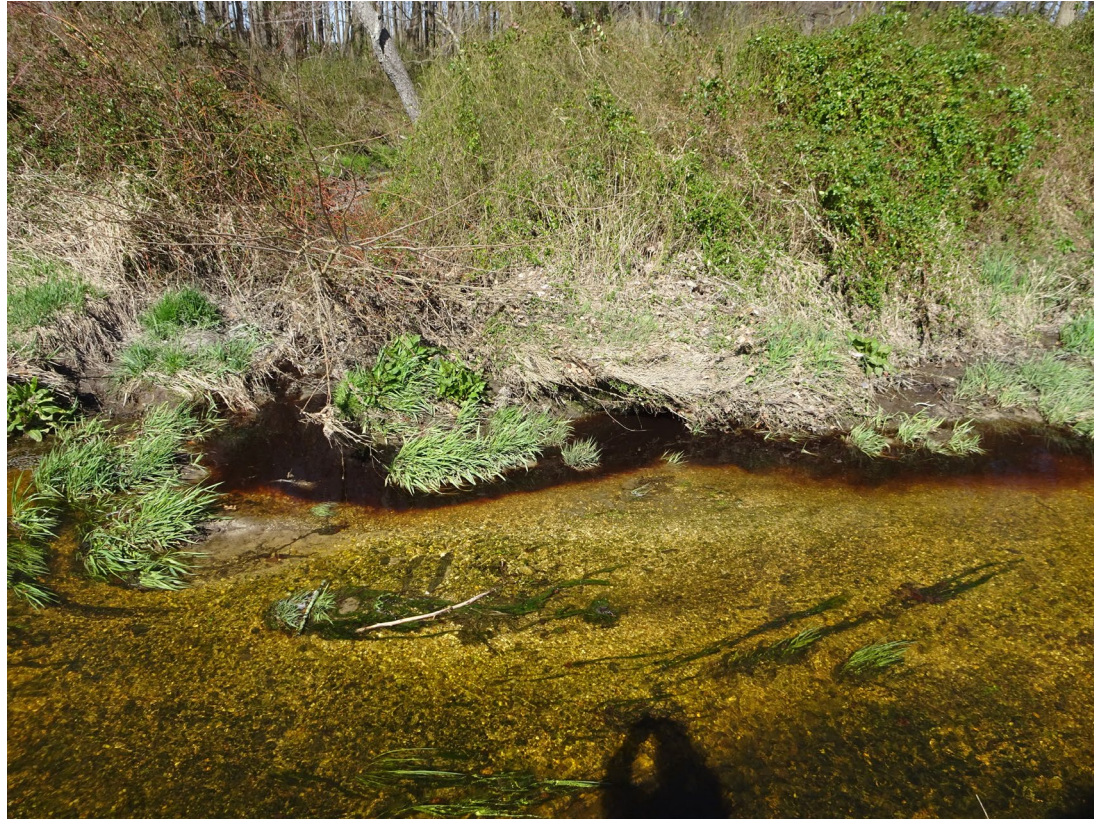
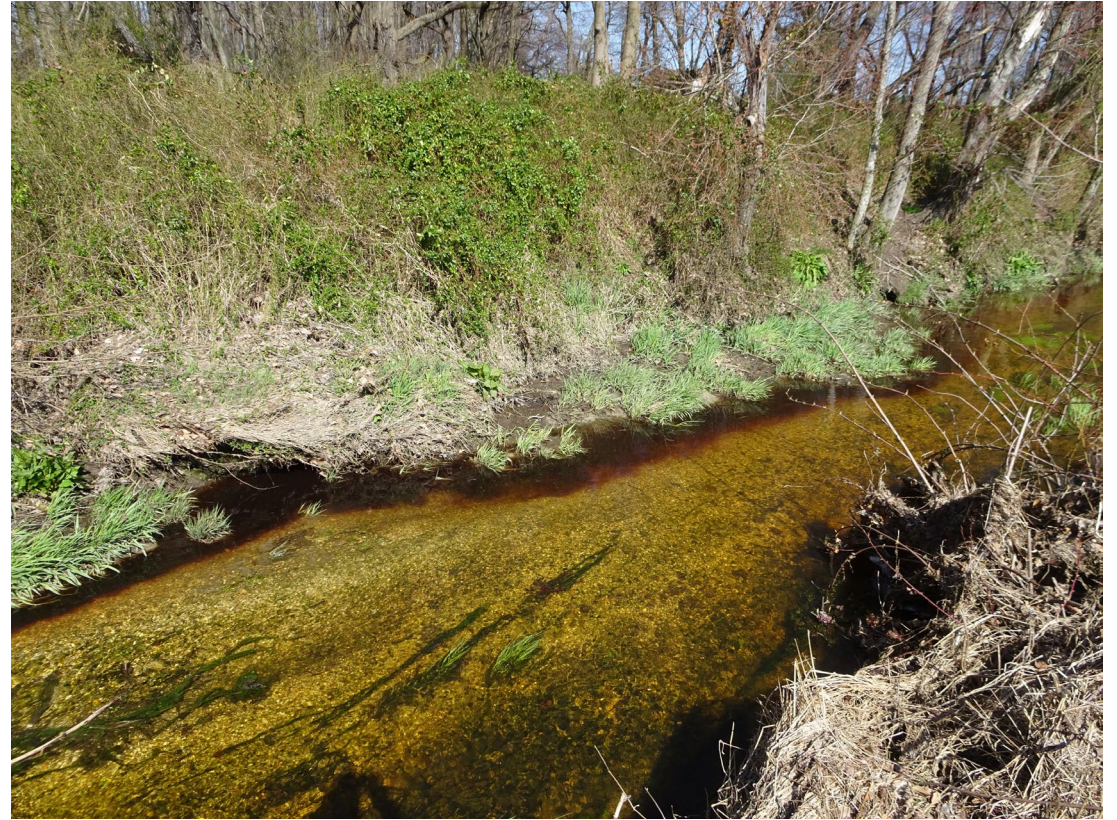
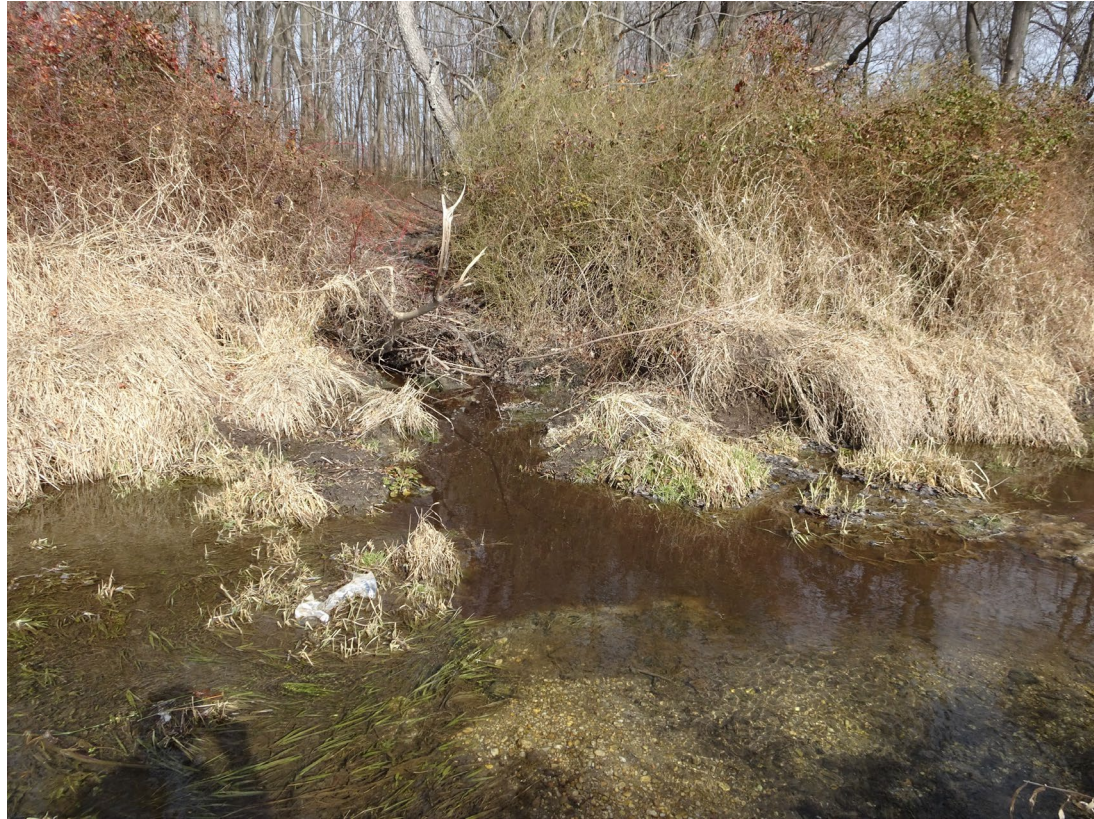
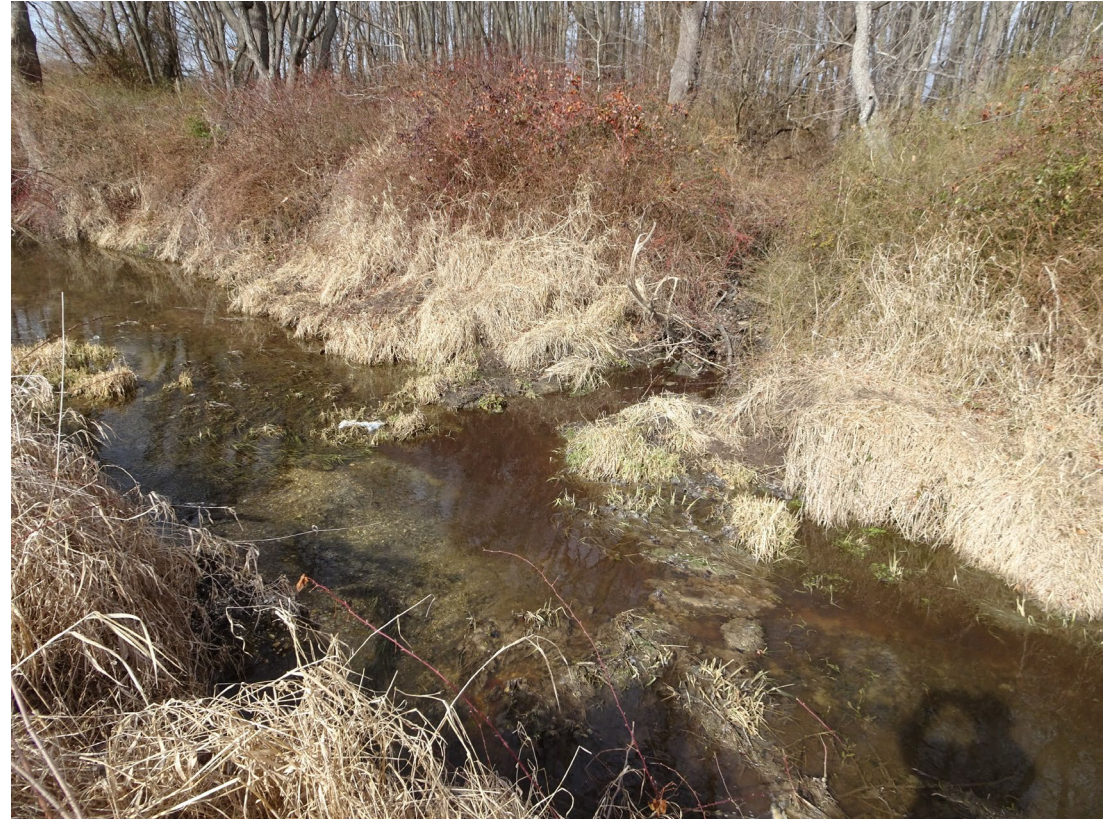
- c. As shown in the photographs provided to EPA by the Cumberland Salem Soil Conservation District (“SCD”), (Attachment 3), the red discharge can be seen downstream, in an unnamed tributary of Muddy Run, adjacent to the Burlington Beef property. This attachment includes photographs displaying a red discharge entering a stream south of the Site. These photographs were taken on March 12, 2024 and February 3, 2025.

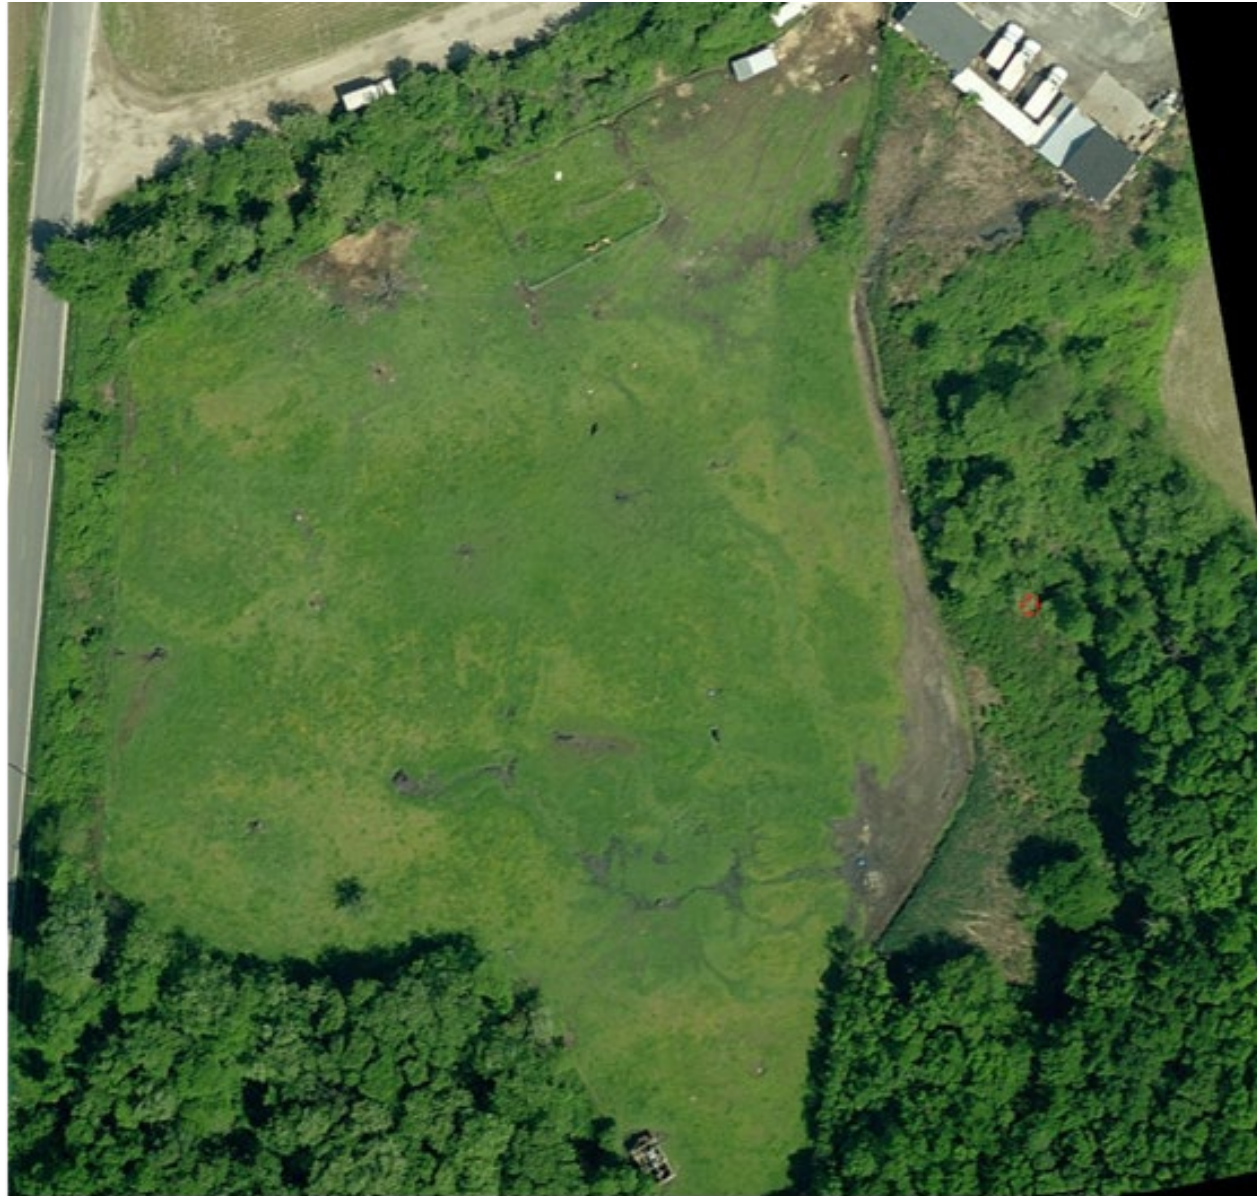
May 13, 2007

- e. Following the inspection, EPA reviewed past aerial images of the Site online at CONNECTExplorer EagleView, (Attachment 4). The aerial images show a potential discharge leaving the southeastern portion of the Site’s spray field as far back as May 13, 2007.
