**Region 6 - Enforcement & Compliance Assurance Division**  
**INSPECTION REPORT**

| Inspection Date(s): | 06/28/2023 | |
| Regulatory Program(s) | AWIA/SDWA | |
| Facility Name: | <b>Hot Springs Utilities</b> | |

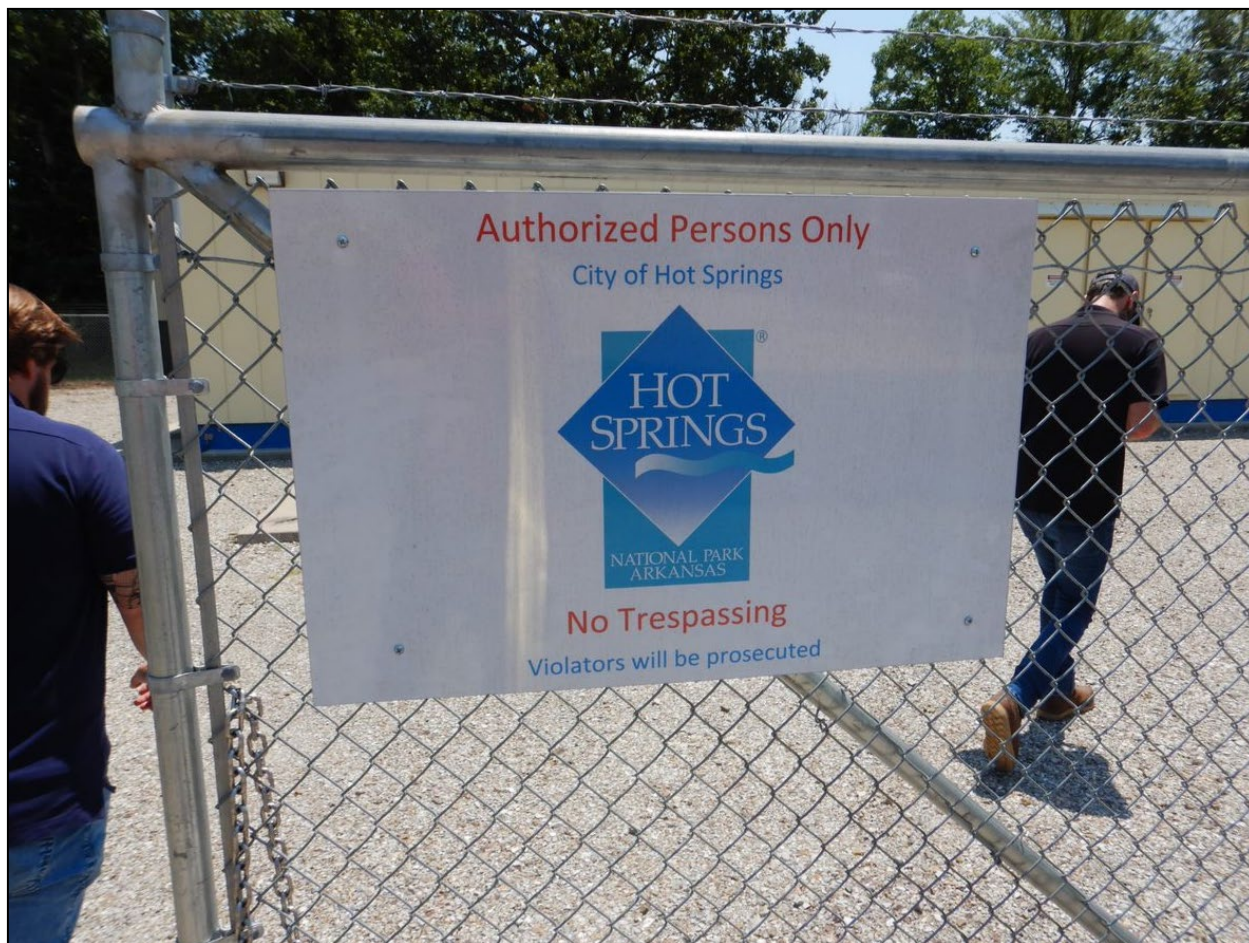
**Photograph 1. Perimeter Fence, Ouachita WTP** View of a security sign posted on the perimeter fence of the Ouachita WTP displaying the name of the System as well as "No Trespassing."

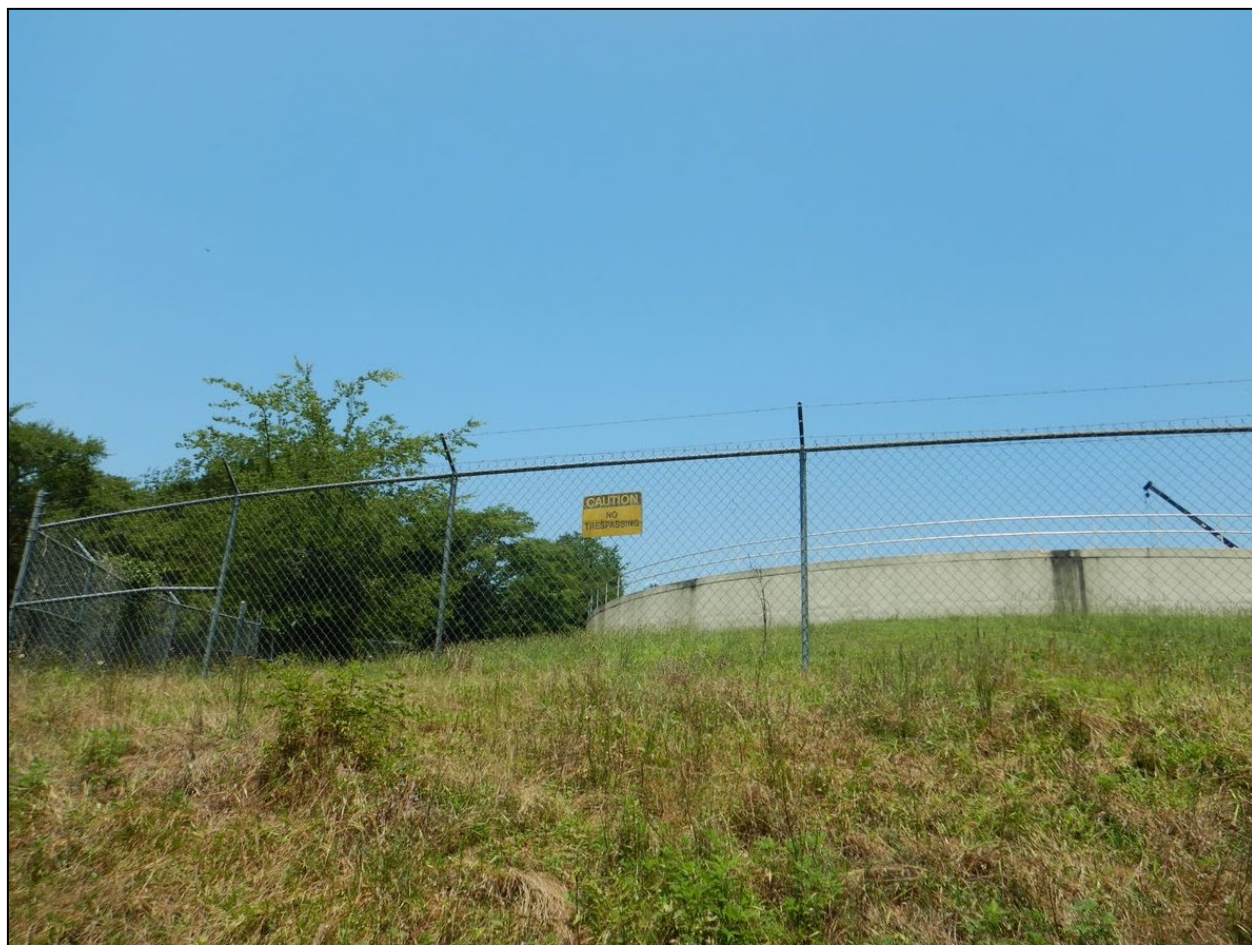
**Photograph 2. Perimeter Fence, Ouachita WTP** View of the locked barbed wire fence surrounding the Ouachita WTP displaying an additional security sign reading “No Trespassing.”

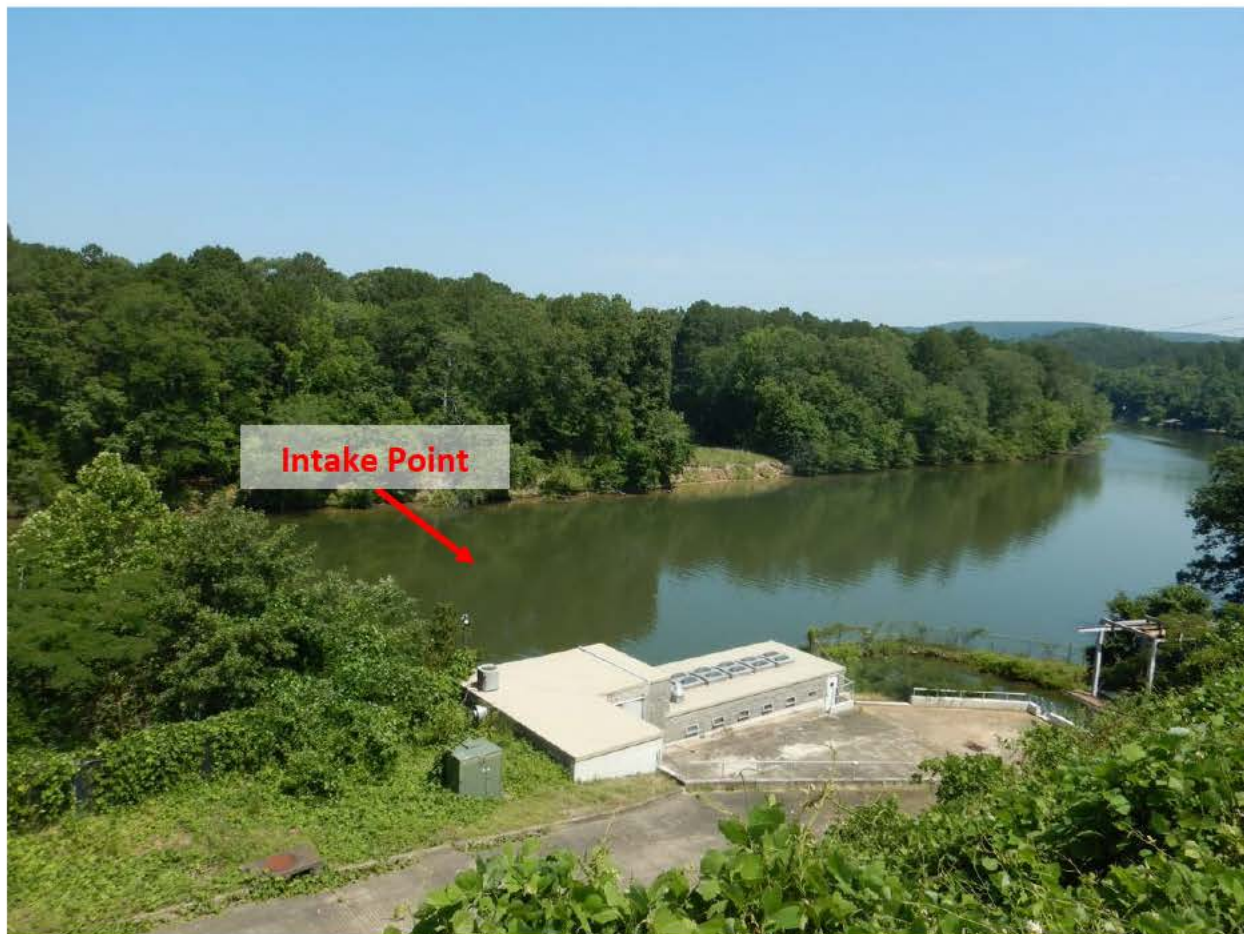
**Photograph 3. Raw Water Intake** View of the raw water pump station containing five pumps, as well as the raw water intake point in the Ouachita River. There was no buoy representing the intake point, and System representatives stated that the buoy had been washed away during a recent storm.

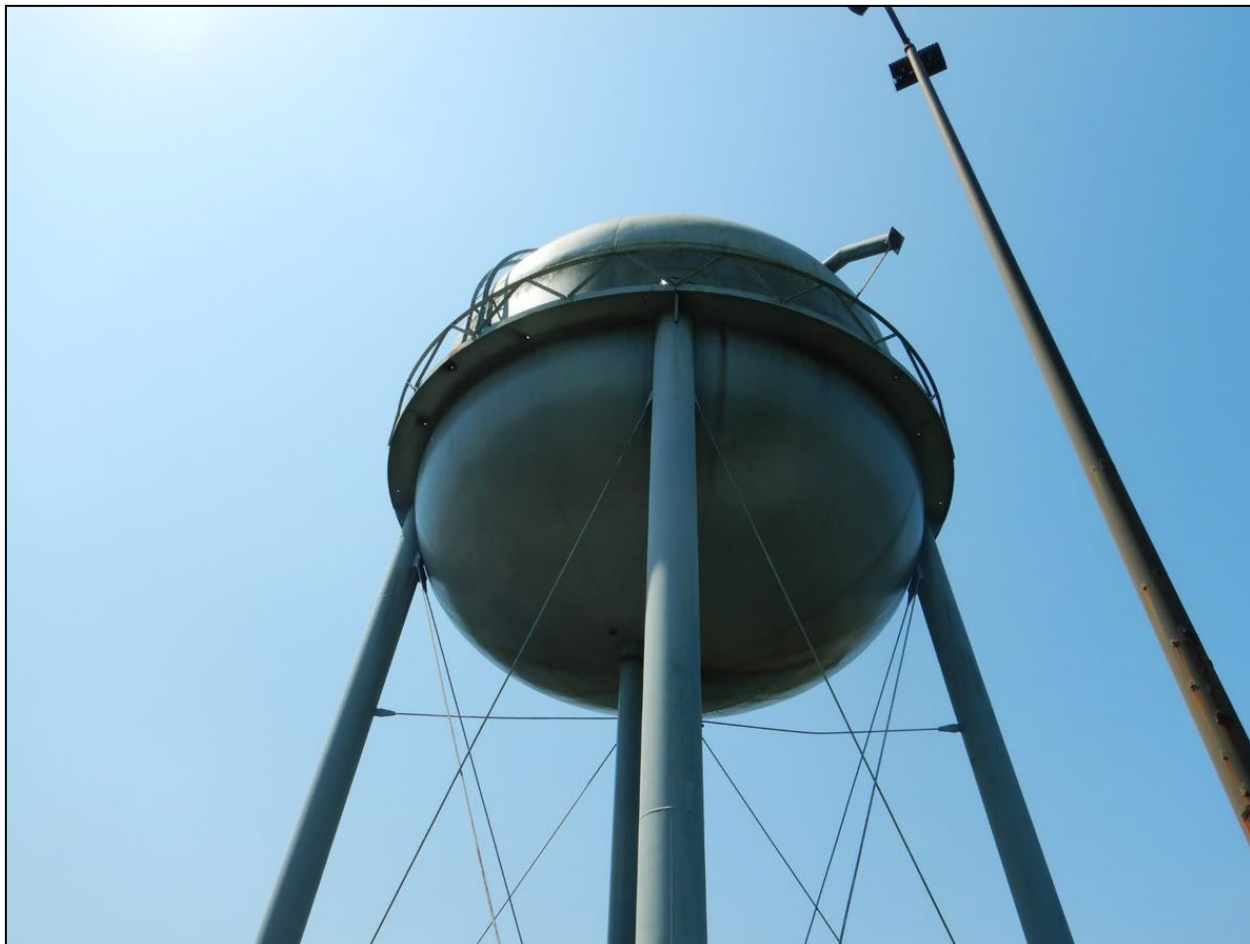
Following the intake, the 100,000-gallon elevated backwash water storage tank was observed (refer to [Appendix 2, Photograph 4](#)). System representatives stated that the tank contained finished water from the WTP, and it was used to backwash the filters at the treatment plant. The Water Production Manager stated that the high service pumps which send treated water into the distribution system were used to fill the tank, and that there were check valves on the lines from the pumps to the tank to prevent backflow. There was a concrete splash pad beneath the terminus of the overflow pipe, and it appeared to be worn in the area closest to the tank (refer to [Appendix 2, Photograph 6](#)). The Water Production Manager stated that they were waiting to hear back on bids that were sent out to rehabilitate this tank.

**Photograph 4. Backwash Water Storage Tank** View of the 100,000-gallon backwash storage tank that holds finished water until it is needed for a backwash cycle.

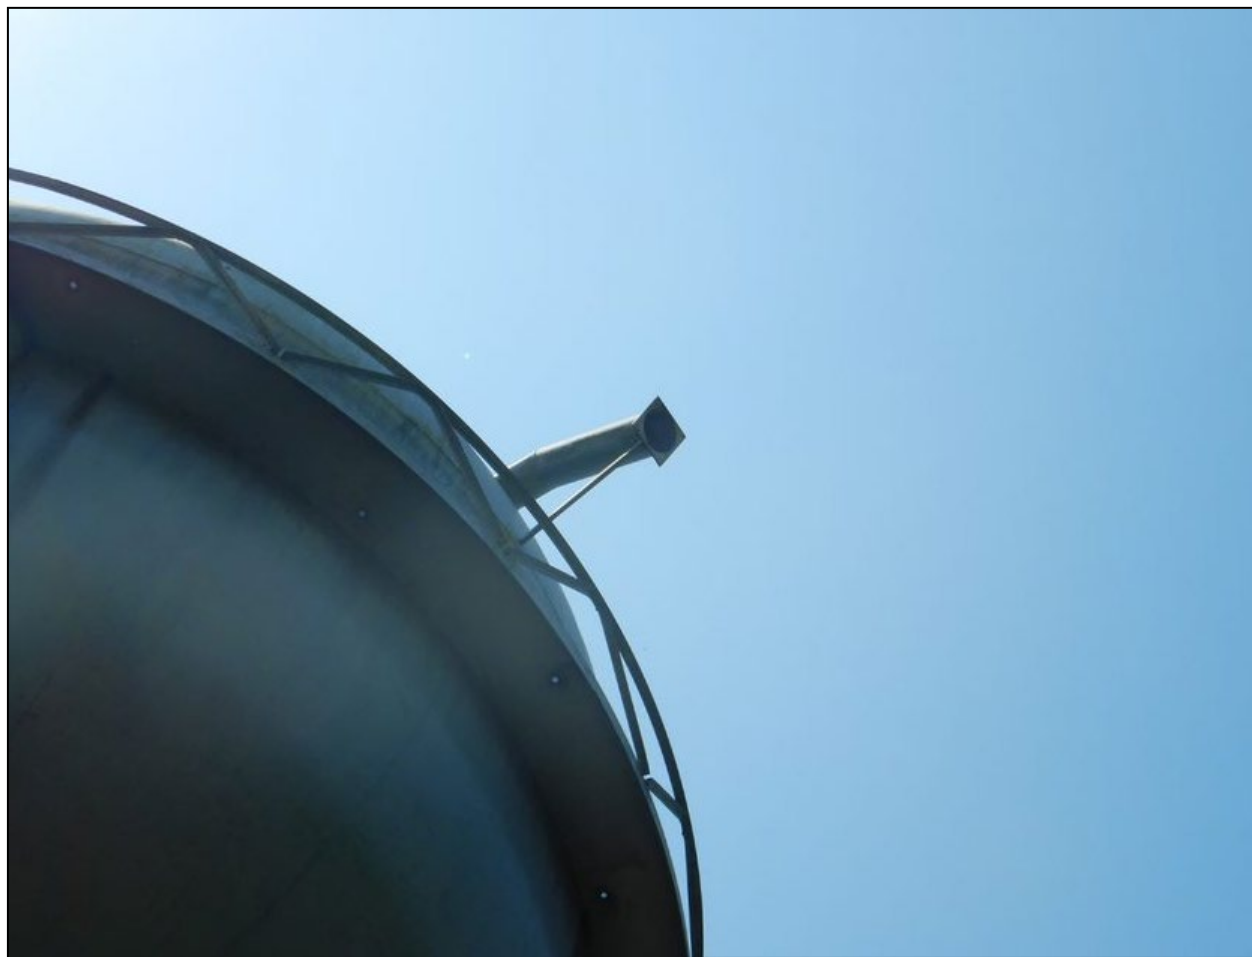
**Photograph 5. Backwash Water Storage Tank** Close-up view of the overflow pipe extending out of the top of the backwash storage tank. It was unclear if the opening was screened or not.

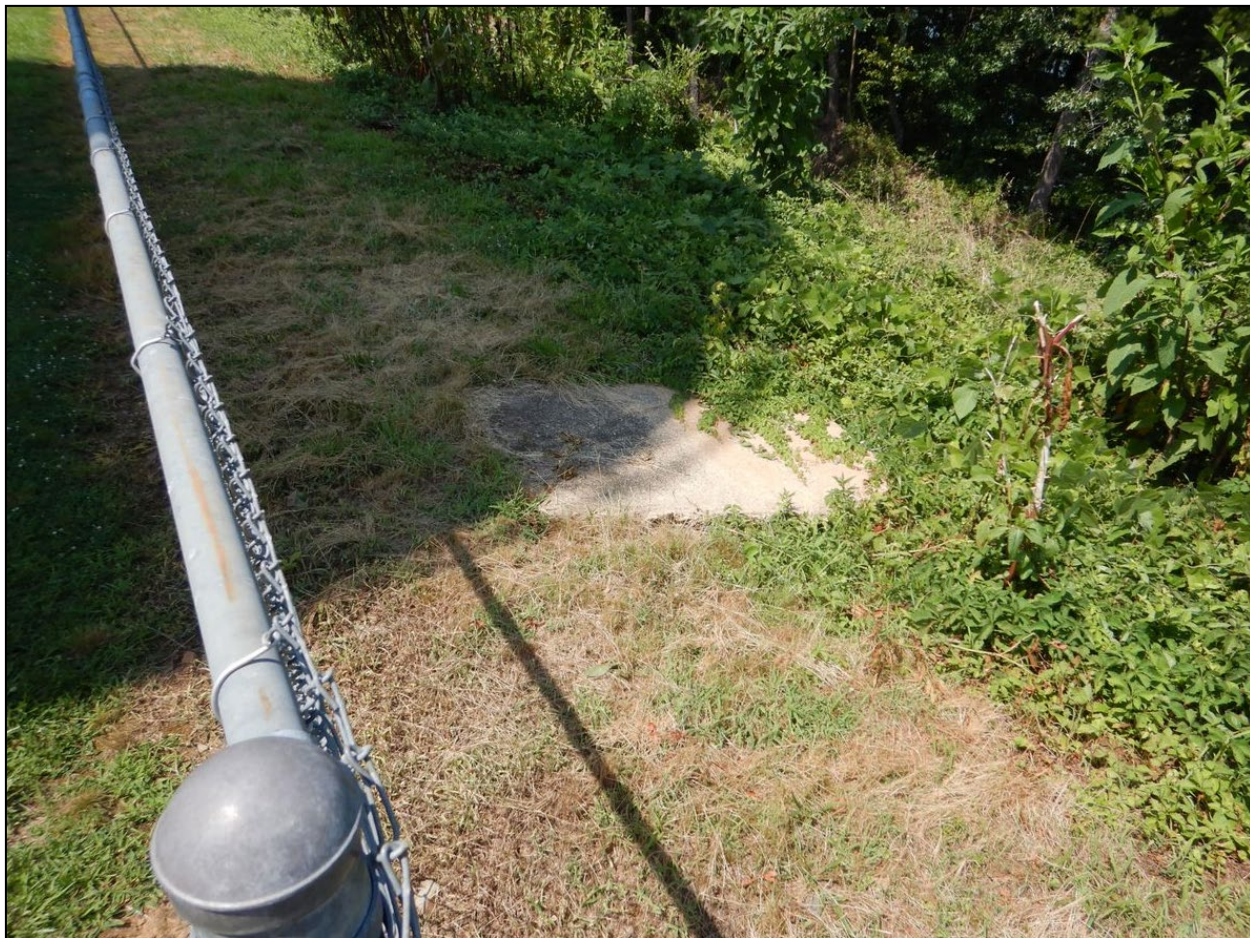
**Photograph 6. Concrete Splash Pad, Backwash Storage Tank** View of the concrete pad that was positioned below the terminus of the overflow pipe that extended off of the backwash storage tank. The pad appeared to be worn in the area closest to the tank

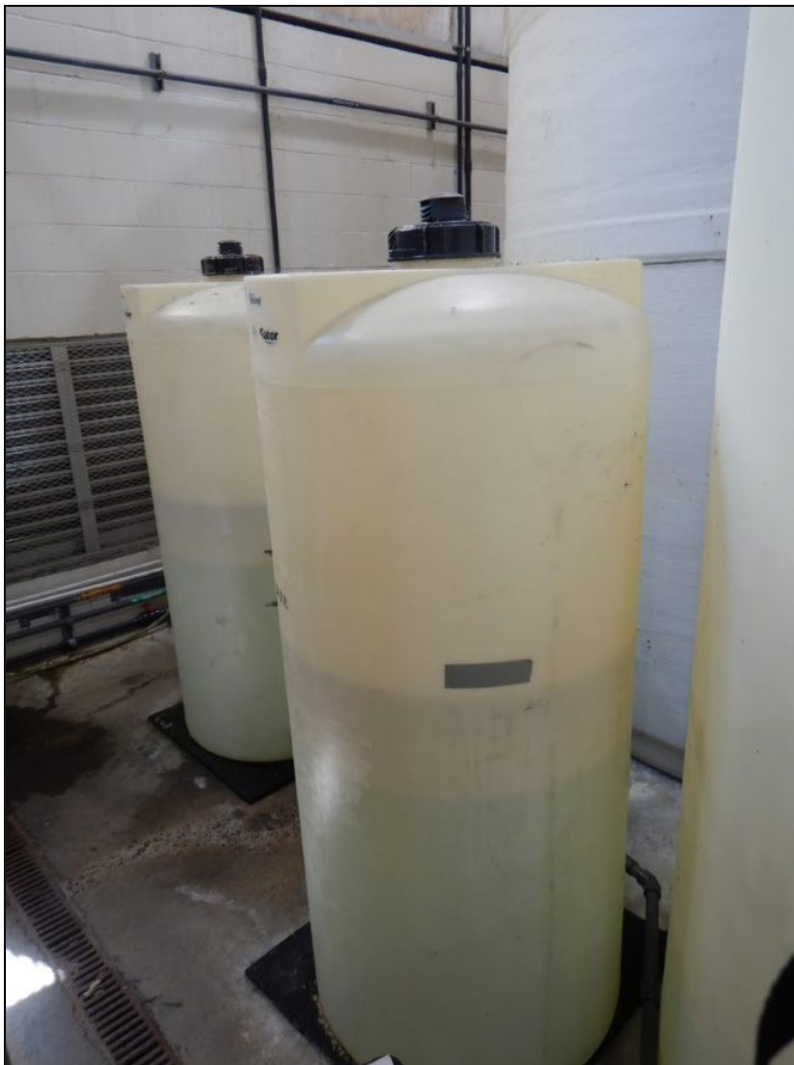
**Photograph 7. Chemical Storage Room, Ouachita WTP** View the two poly-orthophosphate day tanks that were present inside of the caustic soda, poly-orthophosphate, and coagulant chemical storage room.

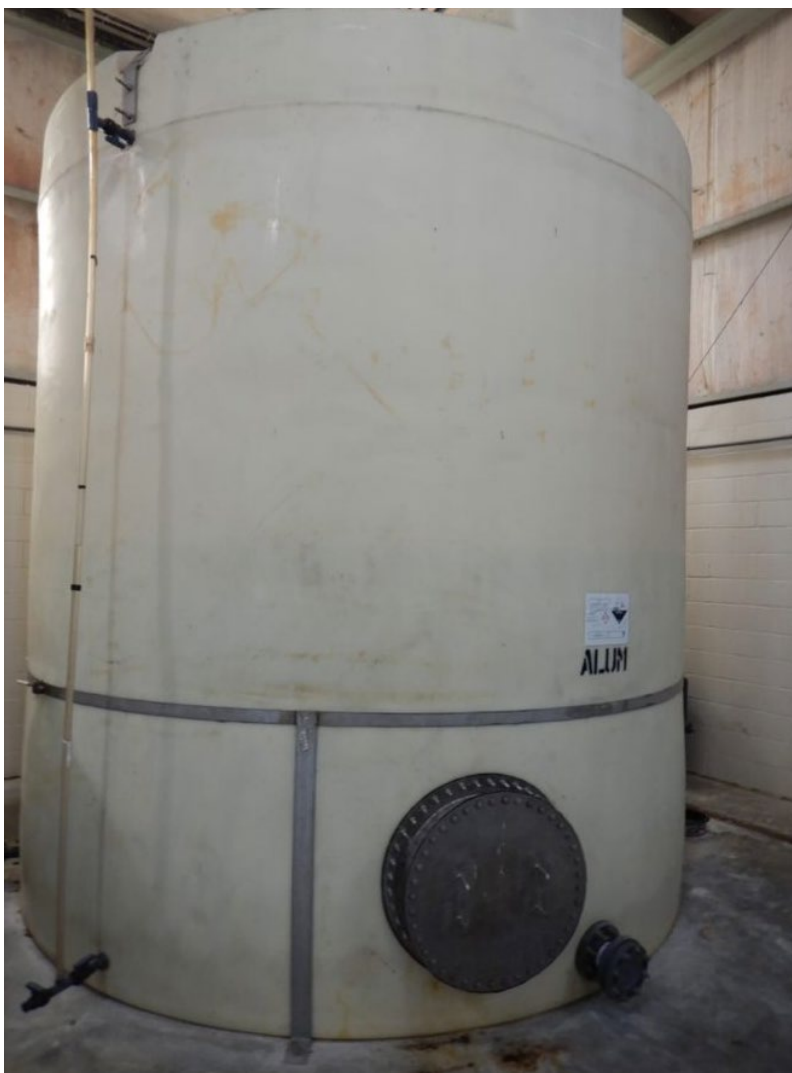
**Photograph 8. Chemical Storage Room, Ouachita WTP** View the coagulant storage tank that was present inside of the caustic soda, poly-orthophosphate, and coagulant chemical storage room.

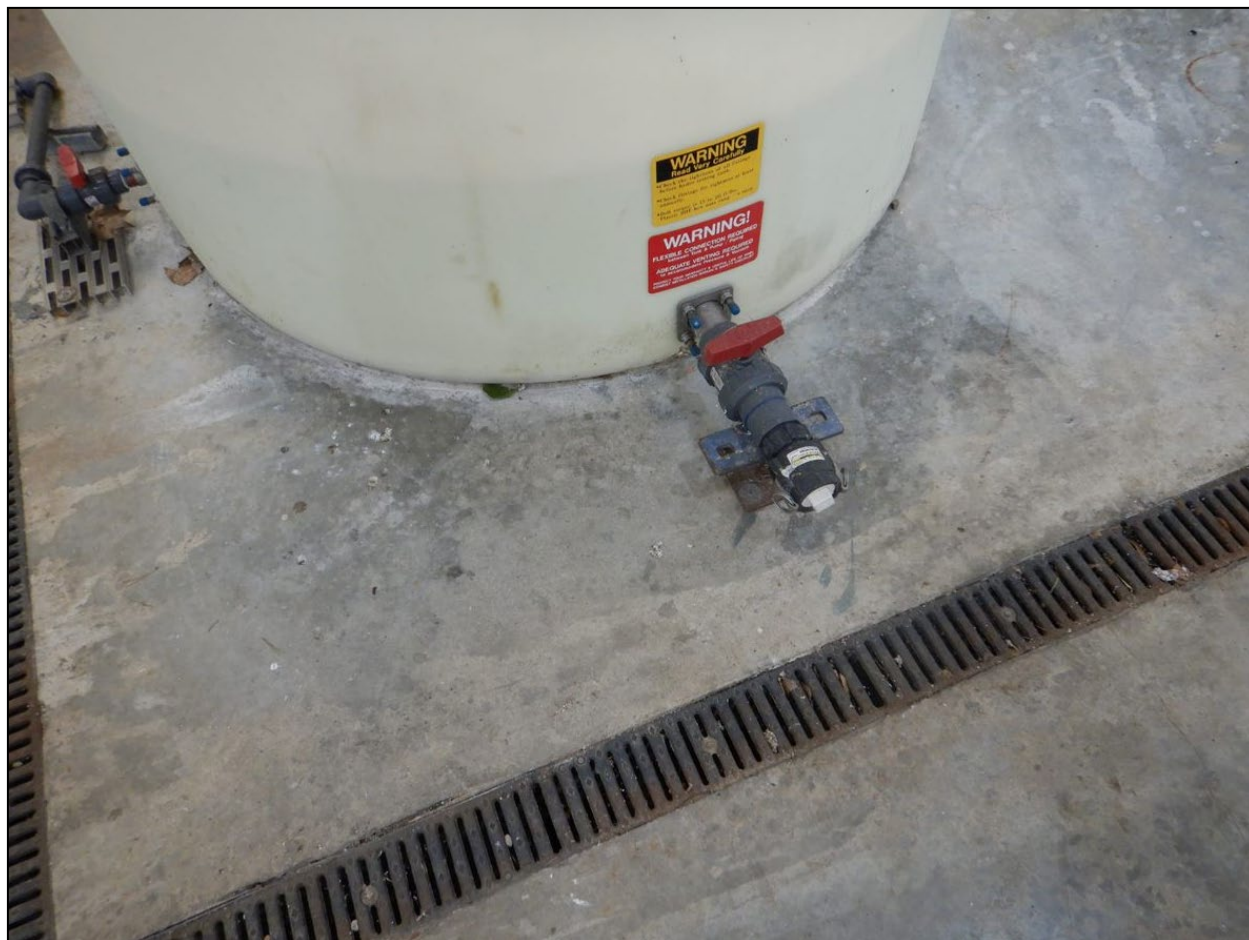
**Photograph 9. Chemical Storage Room, Ouachita WTP** View of the drainage on the floor surrounding the chemical tanks inside of the caustic soda, poly-orthophosphate, and coagulant chemical storage room. System representatives stated that the drain led to an onsite backwash product pond. It is unknown if this presents a concern with the plant's NPDES discharge.

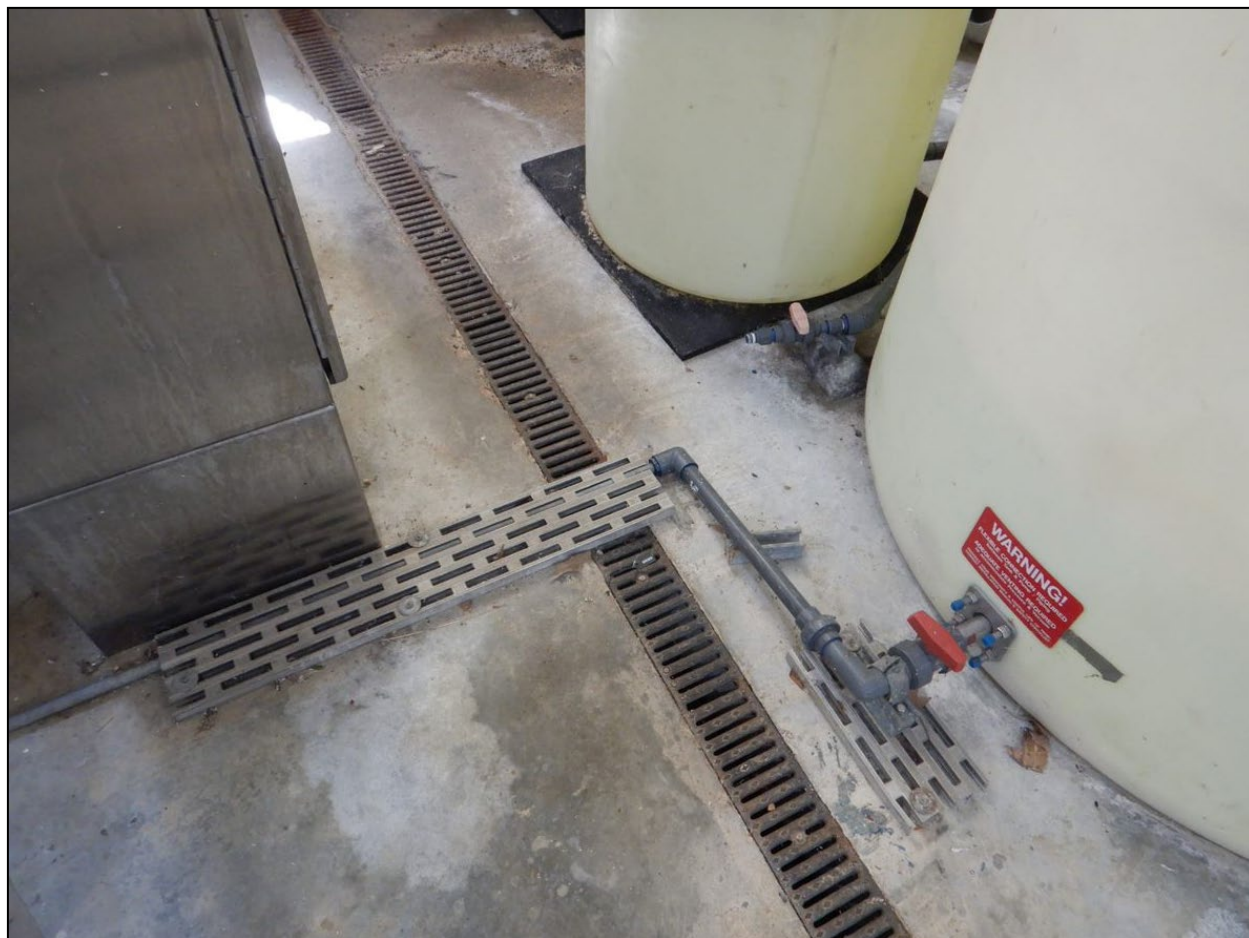
**Photograph 10. Chemical Storage Room, Ouachita WTP** Additional view of the drainage on the floor surrounding the chemical tanks inside of the caustic soda, poly-orthophosphate, and coagulant chemical storage room. System representatives stated that the drain led to an onsite backwash product pond. It is unknown if this presents a concern with the plant's NPDES discharge.

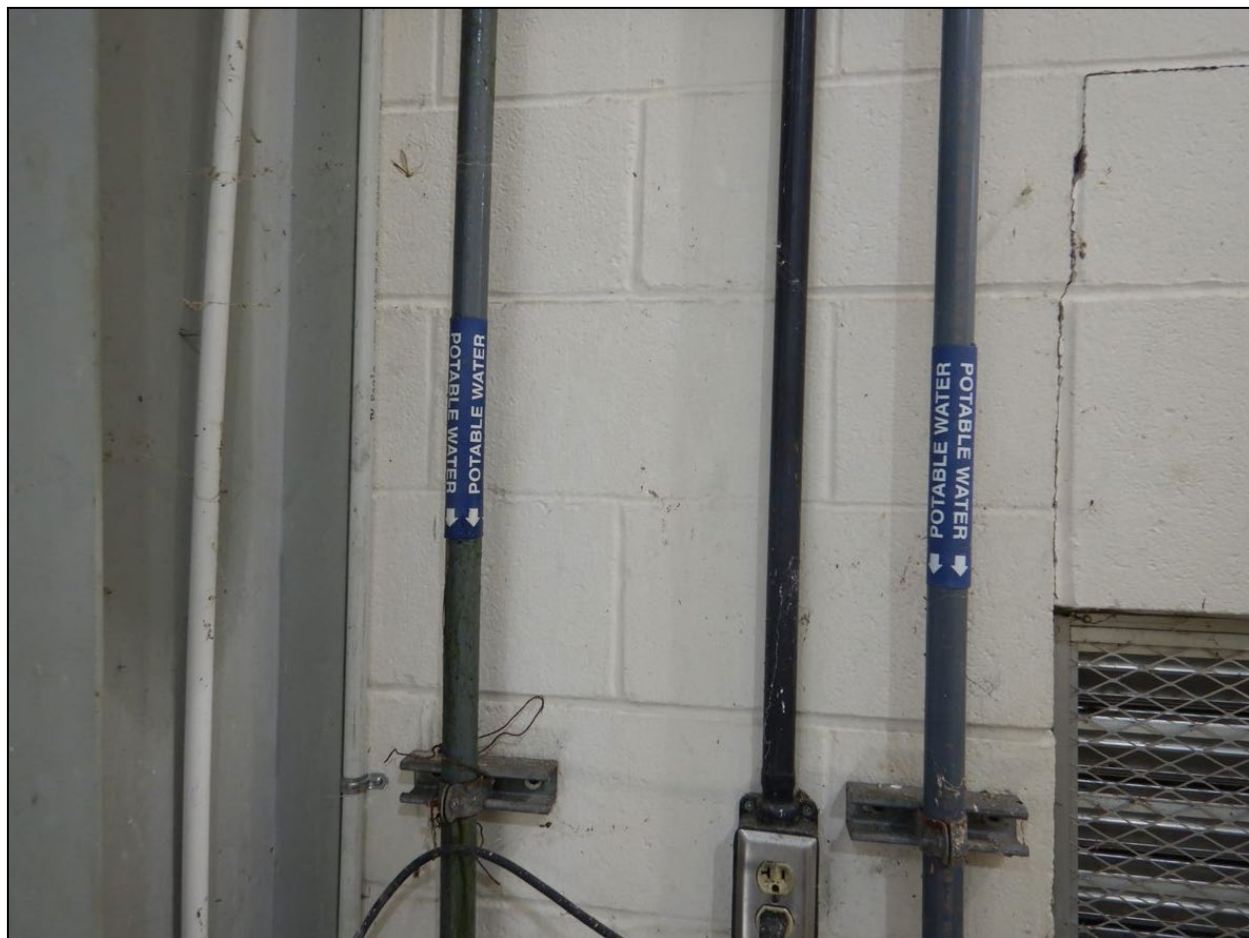
**Photograph 11. Potable Water Lines, Chemical Storage Room, Ouachita WTP** View of the potable water lines used to inject carry water for chemical addition in the caustic soda, poly-orthophosphate, and coagulant chemical storage room. These individual lines did not contain backflow prevention, but System representatives stated that an RPZ outside the building created backflow prevention for this entire building.

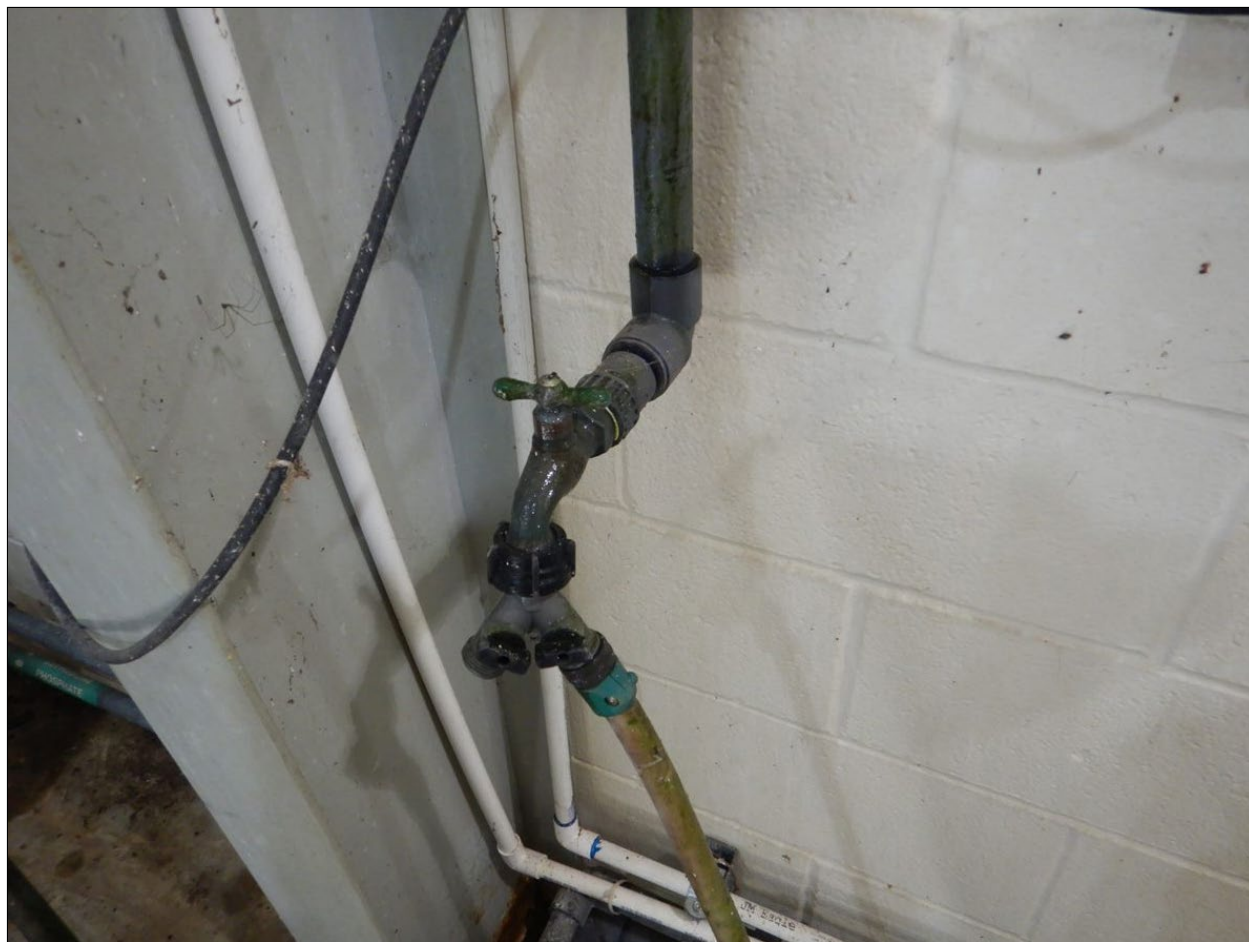
**Photograph 12. Potable Water Line, Chemical Storage Room, Ouachita WTP** View of a potable water line with a threaded hose tap in the caustic soda, poly-orthophosphate, and coagulant chemical storage room. This line did not contain backflow prevention, but System representatives stated that an RPZ outside the building created backflow prevention for this entire building.

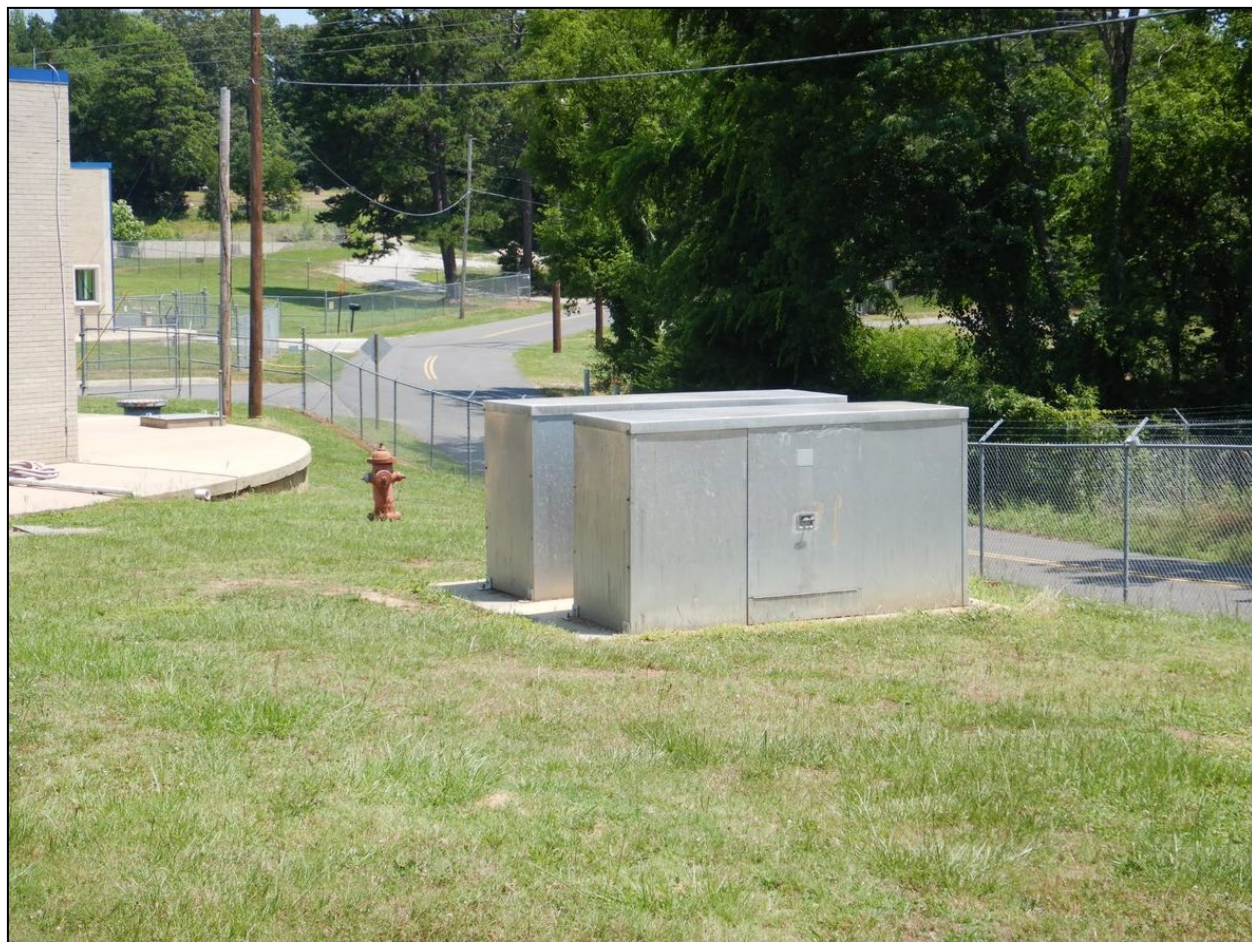
**Photograph 13. RPZ Vaults, Ouachita WTP** View of the two RPZ vaults containing RPZs outside of the chemical storage rooms. The RPZs are used to create backflow prevention.

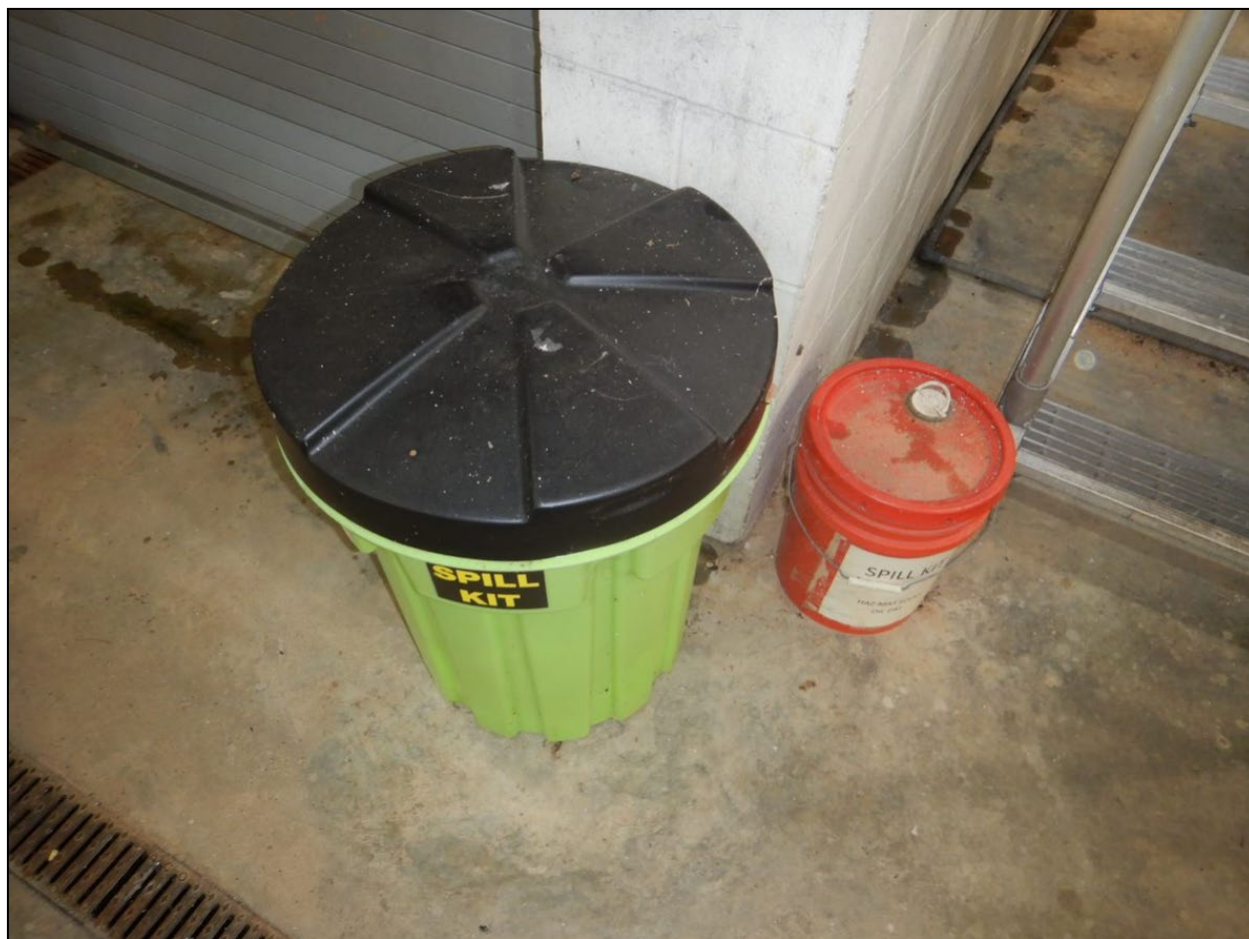
**Photograph 14. Chemical Storage Room, Ouachita WTP** View of a chemical spill kit that was present in the caustic soda, poly-orthophosphate, and coagulant chemical storage room.

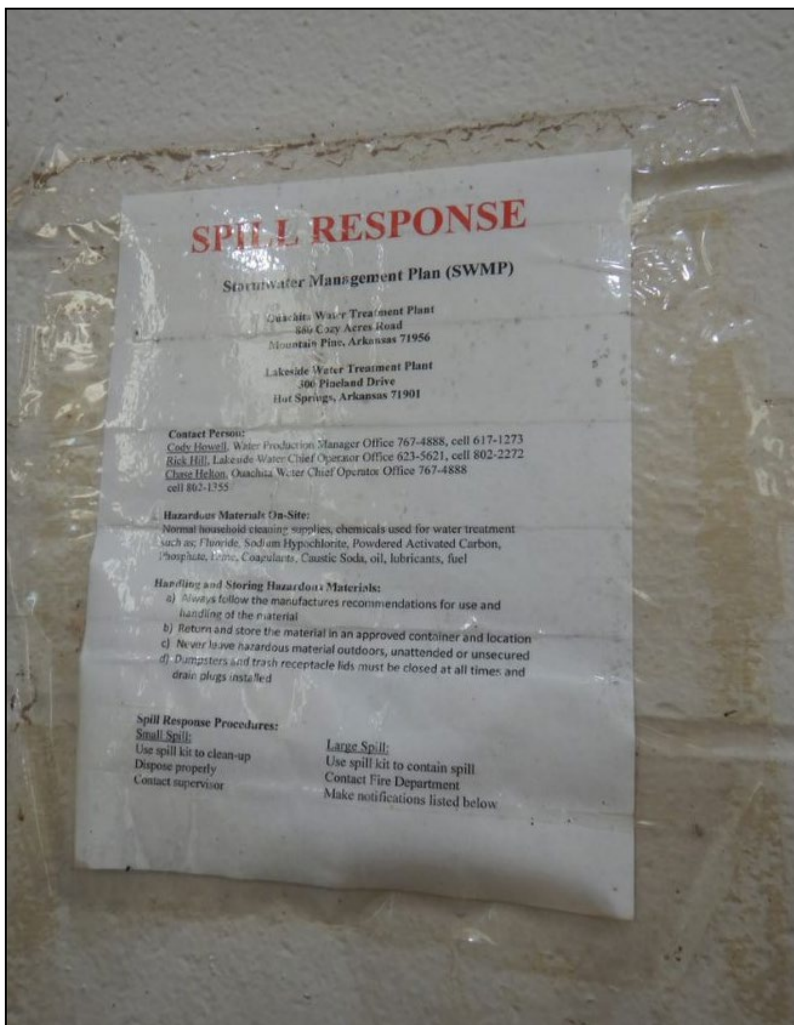
**Photograph 15. Chemical Storage Room, Ouachita WTP** View of a chemical spill response SOP that was posted above the spill kit in the caustic soda, poly-orthophosphate, and coagulant chemical storage room.

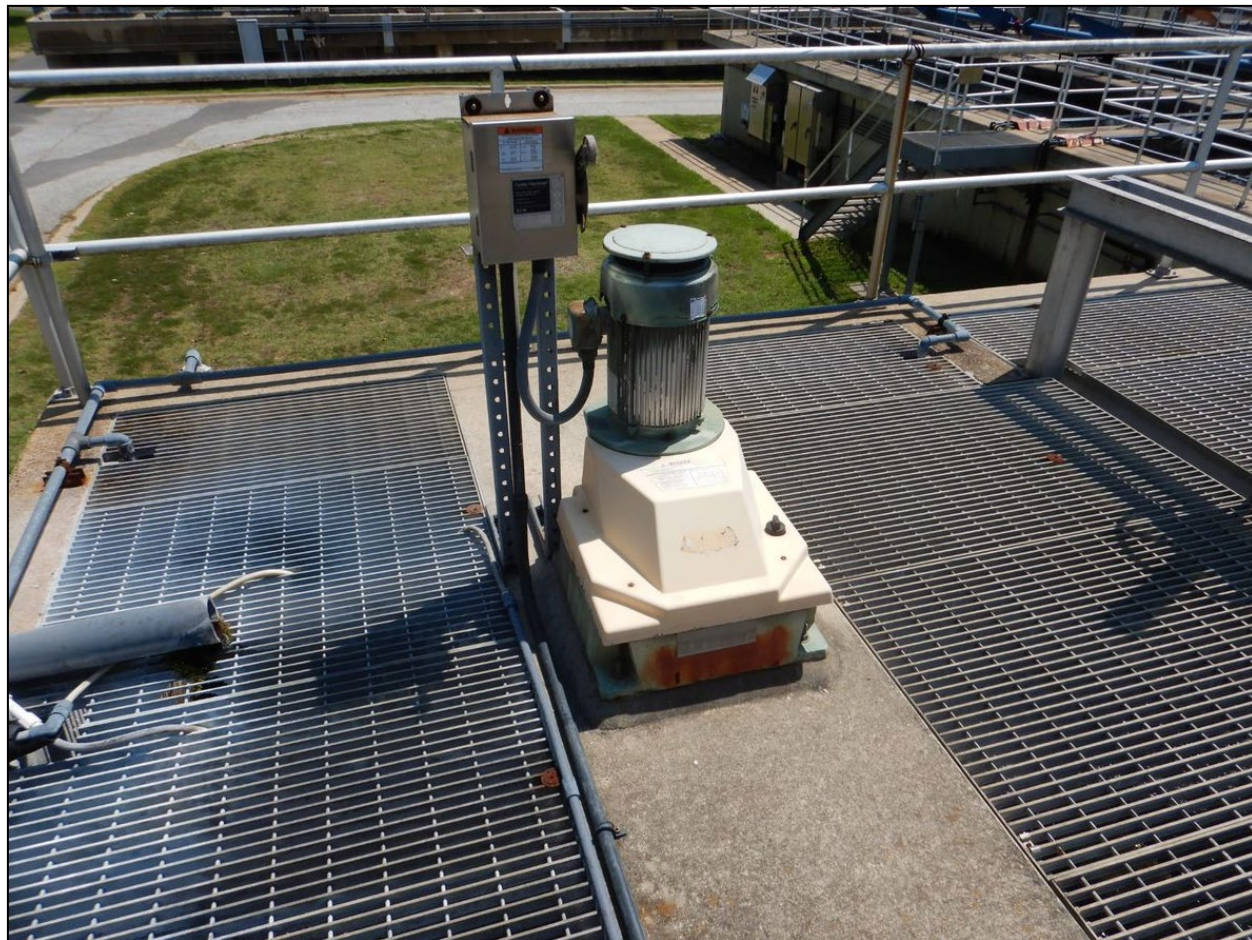
**Photograph 16. Rapid Mixer, Ouachita WTP** View of one of the two rapid mixers at the Ouachita WTP. Only one mixer was in use during the inspection, and System representatives stated that only one was needed for adequate mixing.

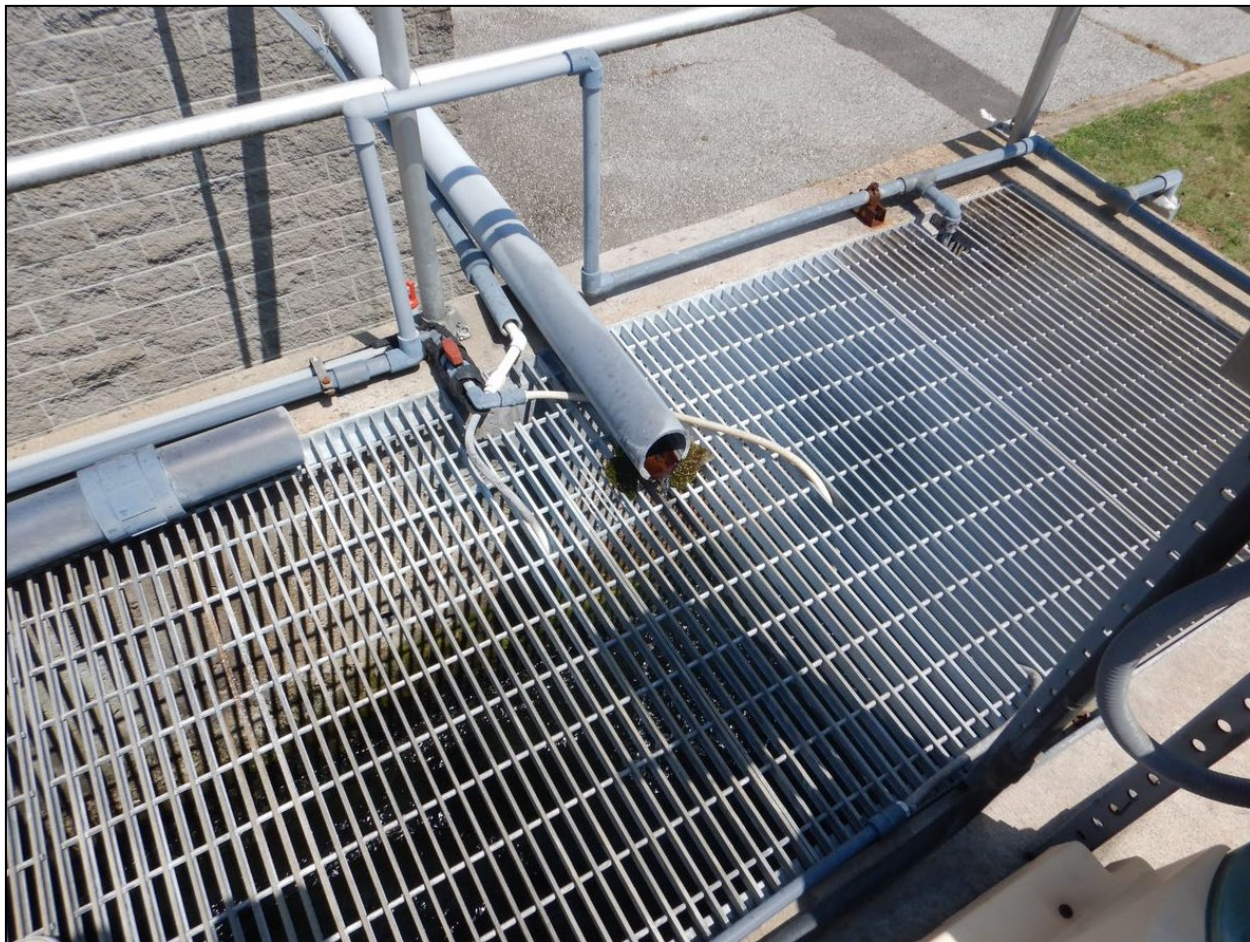
**Photograph 17. Chemical Feed Lines, Ouachita WTP** View of the chemical injection lines used at the rapid mix chamber at the Ouachita WTP. System representatives stated that this was where coagulant was injected.

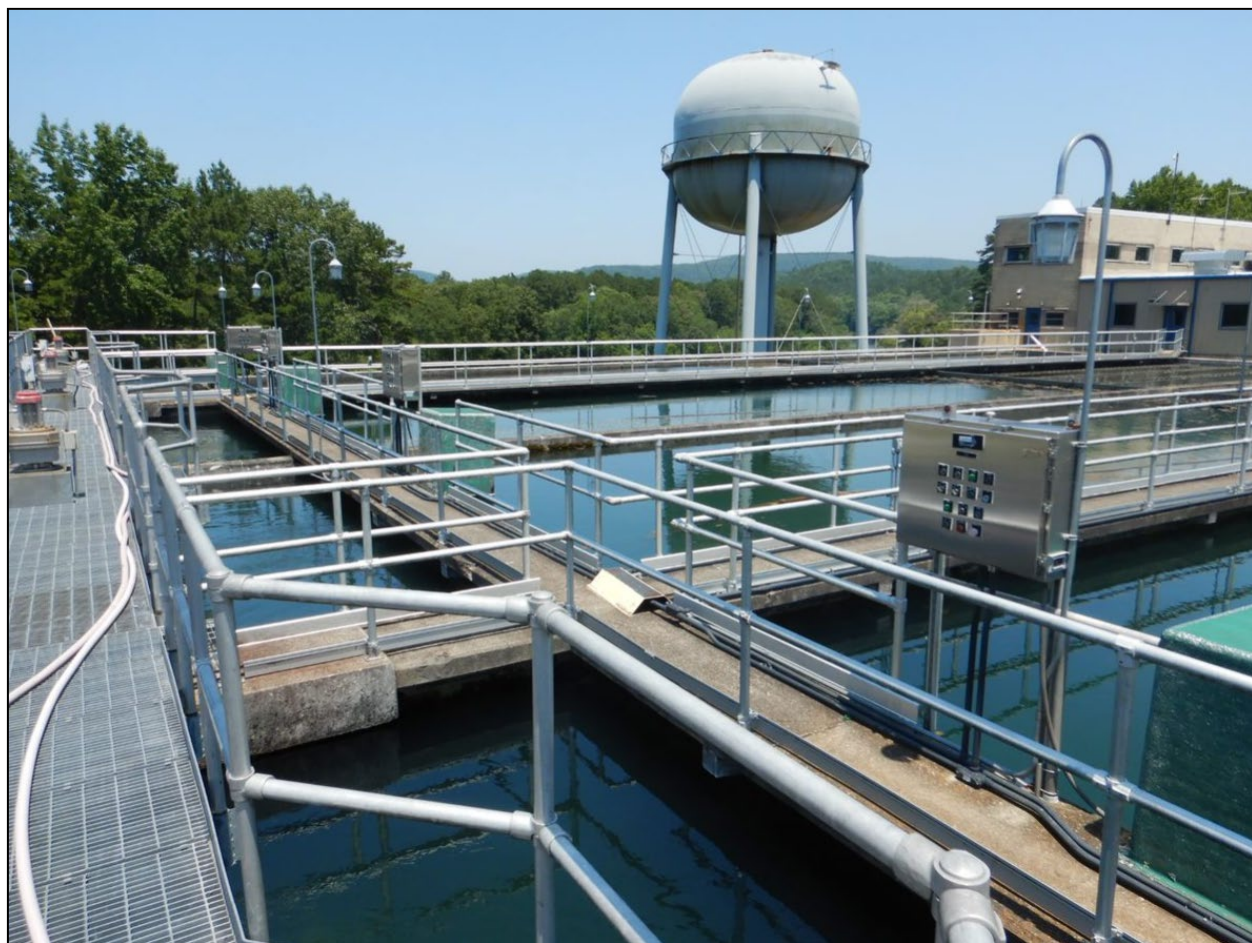
**Photograph 18. Sedimentation Basin Nos. 1-3, Ouachita WTP** View of Sedimentation Basin Nos. 1-3. Not pictured are Basin Nos. 4 and 5, which are also clustered in this area.

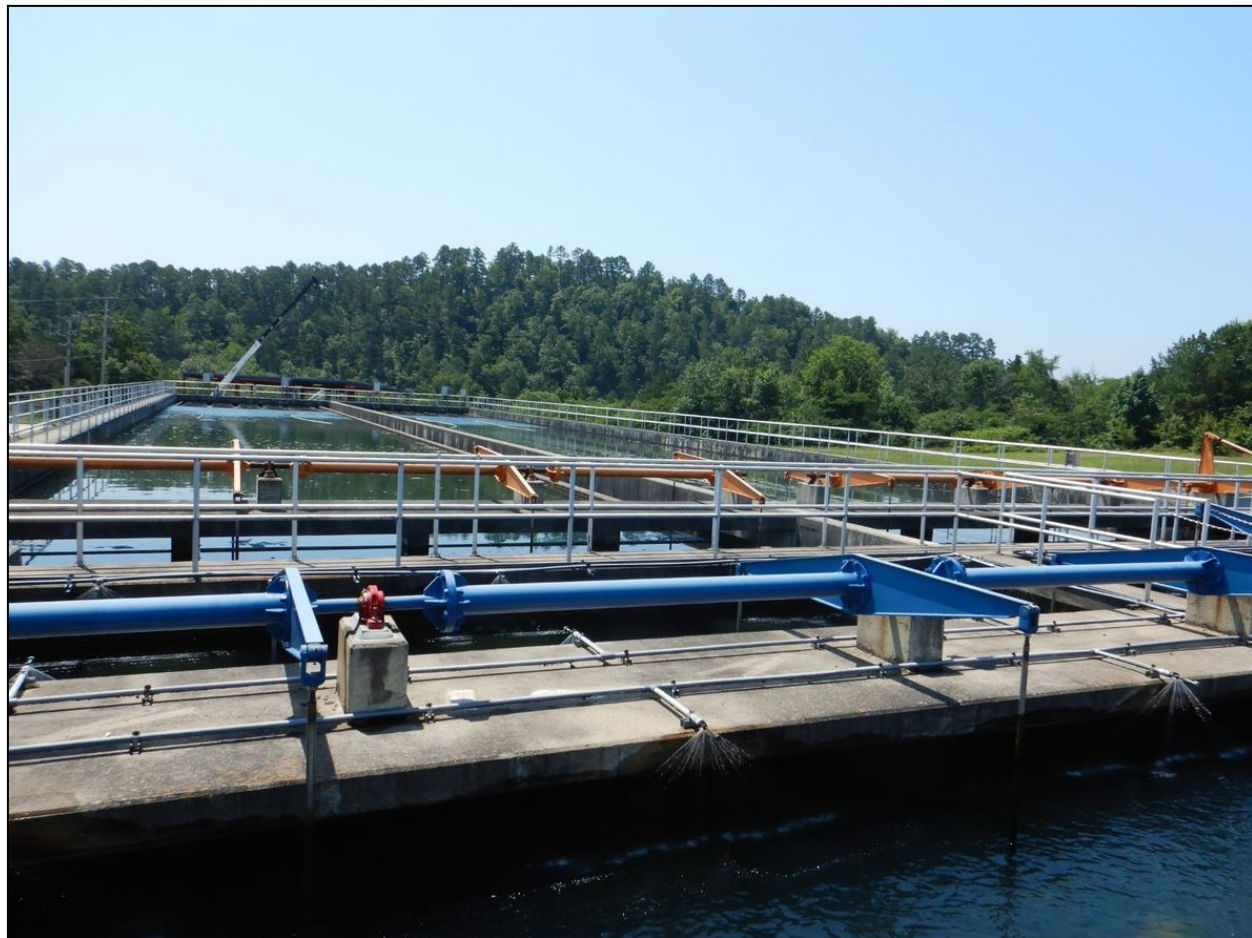
**Photograph 19. Sedimentation Basin Nos. 6 and 7, Ouachita WTP** View of Sedimentation Basin Nos. 6 and 7, which are clustered in a separate area from Basin Nos. 1-5.
