**Region 6 - Enforcement & Compliance Assurance Division**  
**INSPECTION REPORT**

| Inspection Date(s): | 06/28/2023 | |
| Regulatory Program(s) | AWIA/SDWA | |
| Facility Name: | <b>Hot Springs Utilities</b> | |

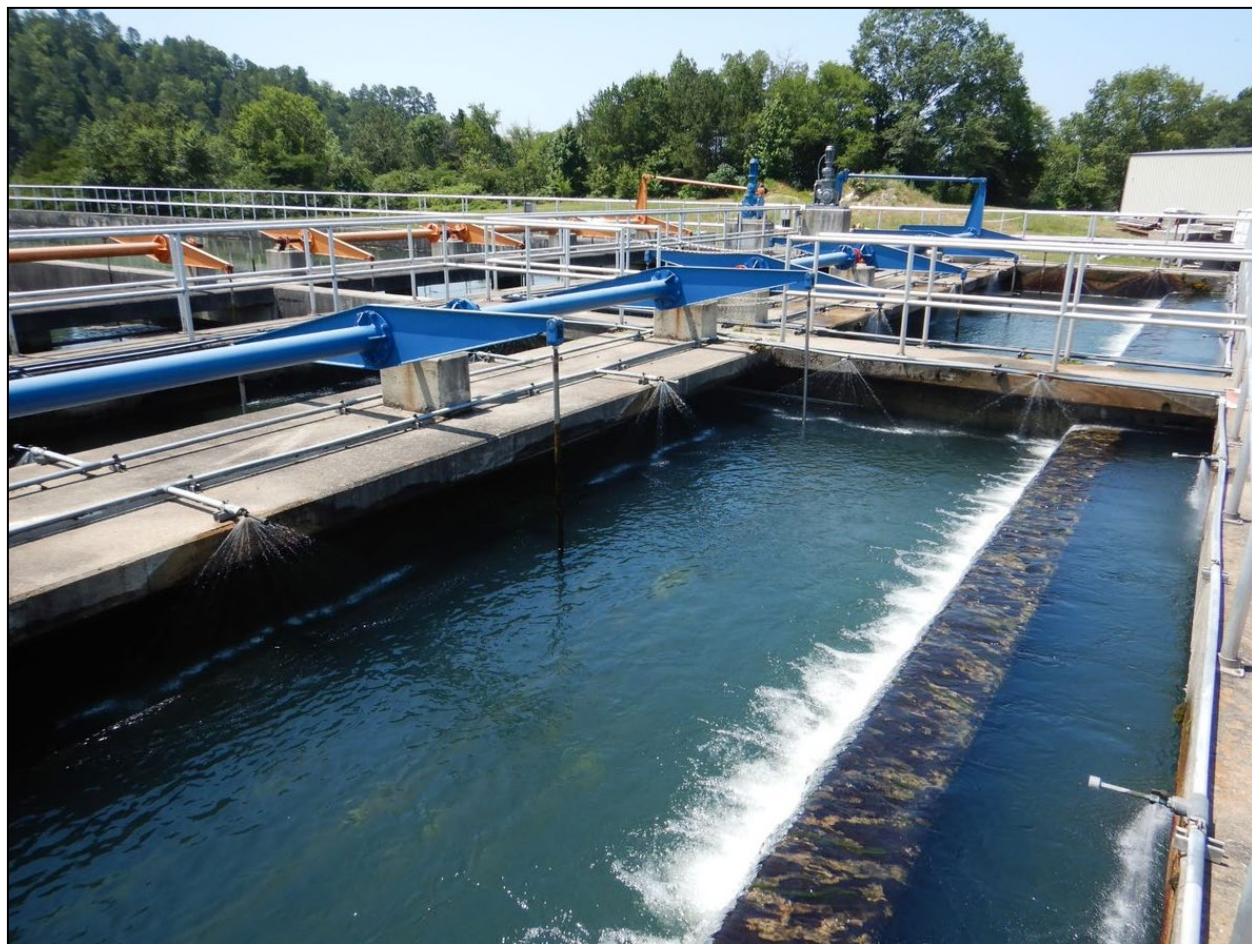
**Photograph 20. Flocculation Chamber, Sedimentation Basin No. 6** View of the flocculation chamber associated with Sedimentation Basin No. 6. A slow mix was occurring in the chamber to try to generate floc.

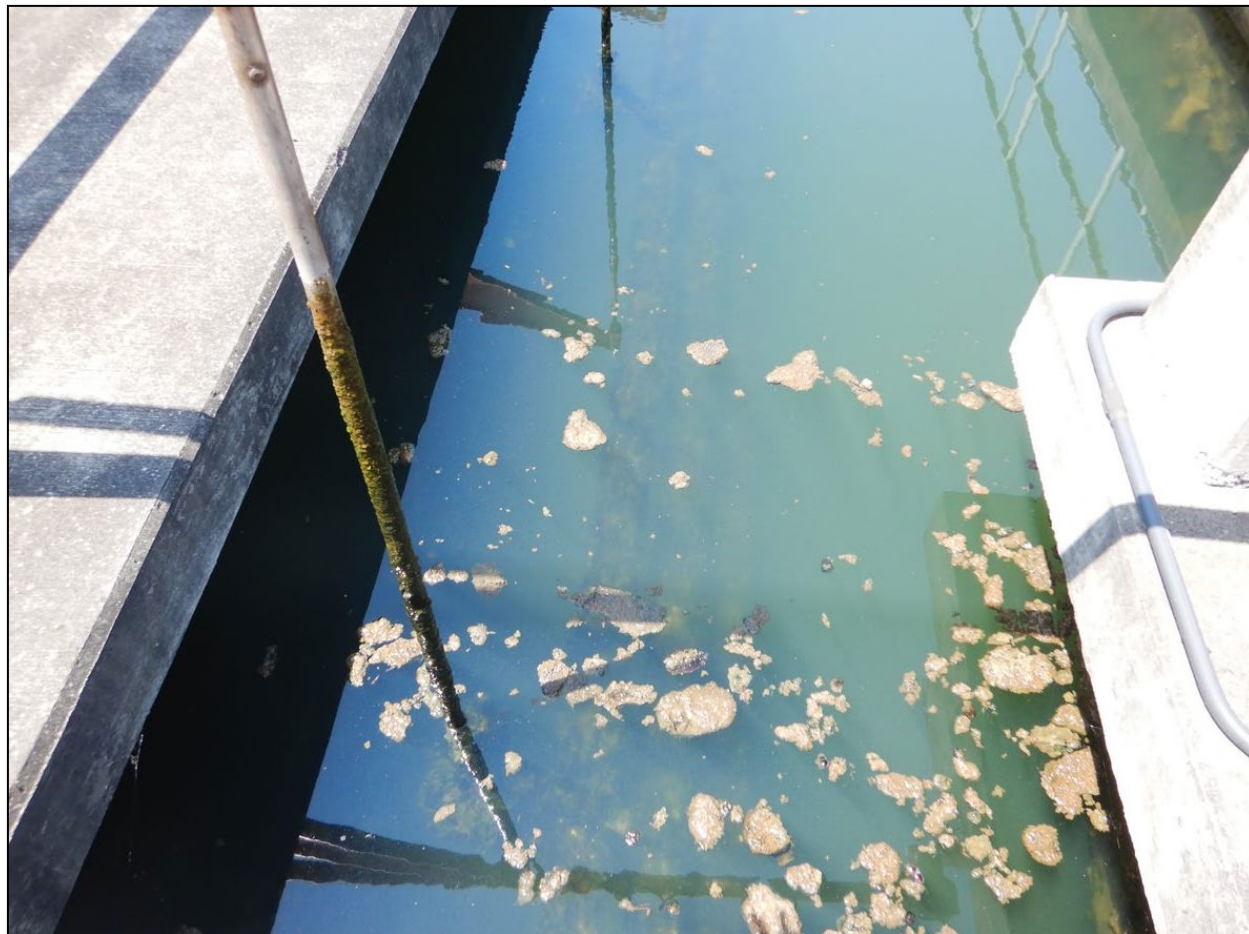
**Photograph 21. Floating Solids, Flocculation Chamber** View of floating, bulking solids that were floating on surface of the flocculation chamber for Sedimentation Basin No. 6. System representatives stated that this was a common challenge in the summer.

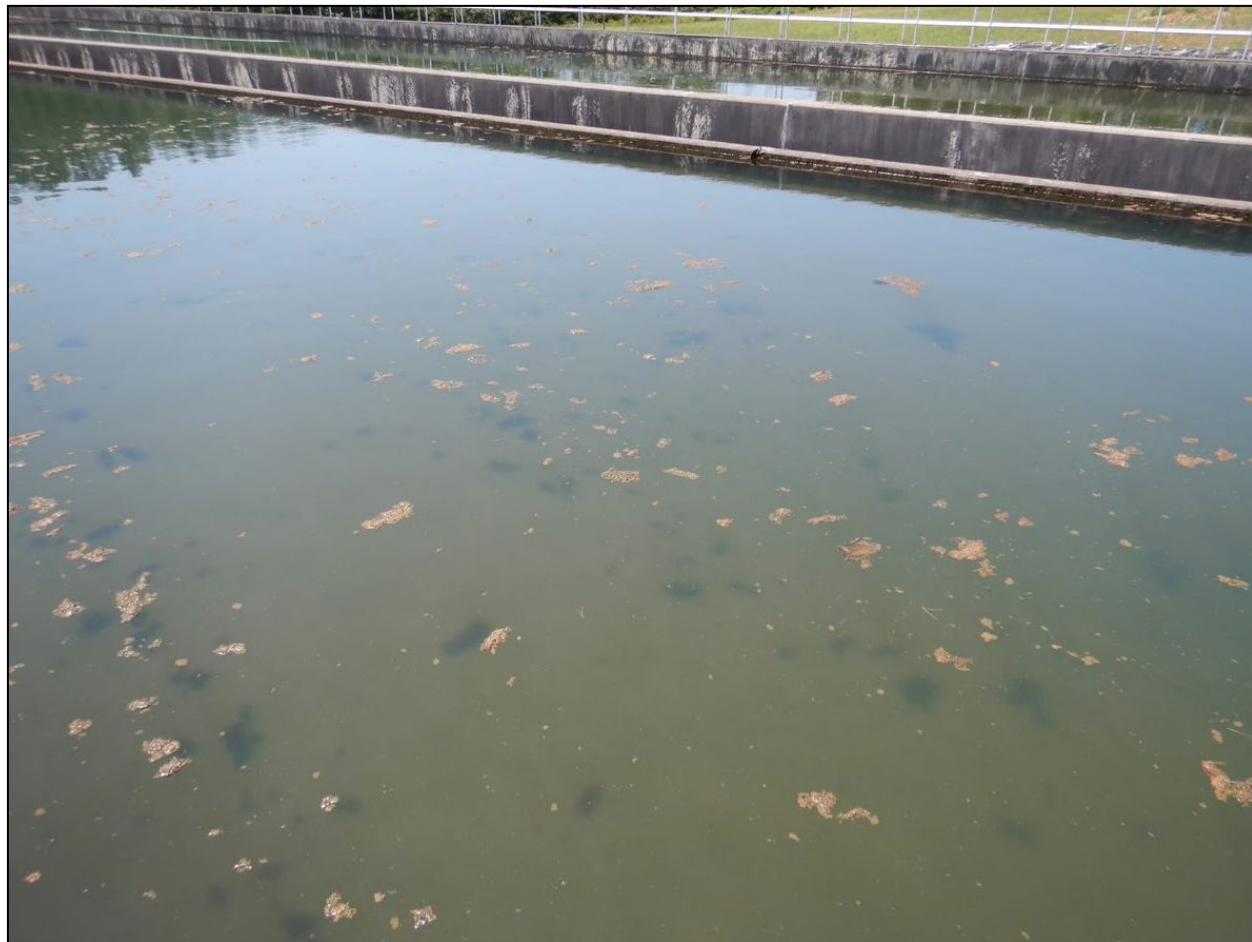
**Photograph 22. Sedimentation Basin No. 6** View of floating, bulking solids at the surface of Sedimentation Basin No. 6. System representatives stated that this was a common challenge in the summer.

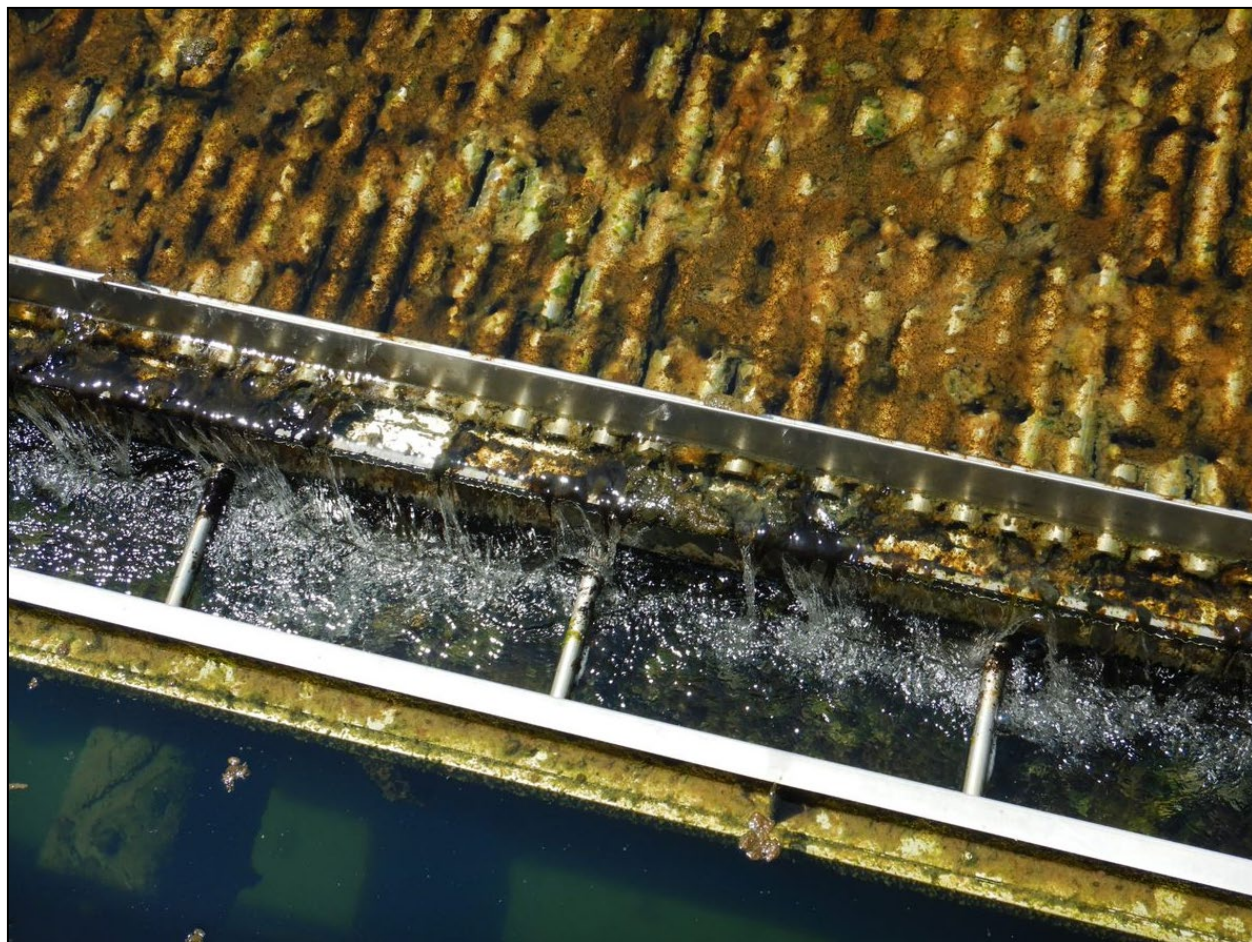
**Photograph 23. Weirs, Sedimentation Basin No. 6** Close up view of the weirs at the end of Sedimentation Basin No. 6. There was algae growing in the weirs that was causing some short circuiting.

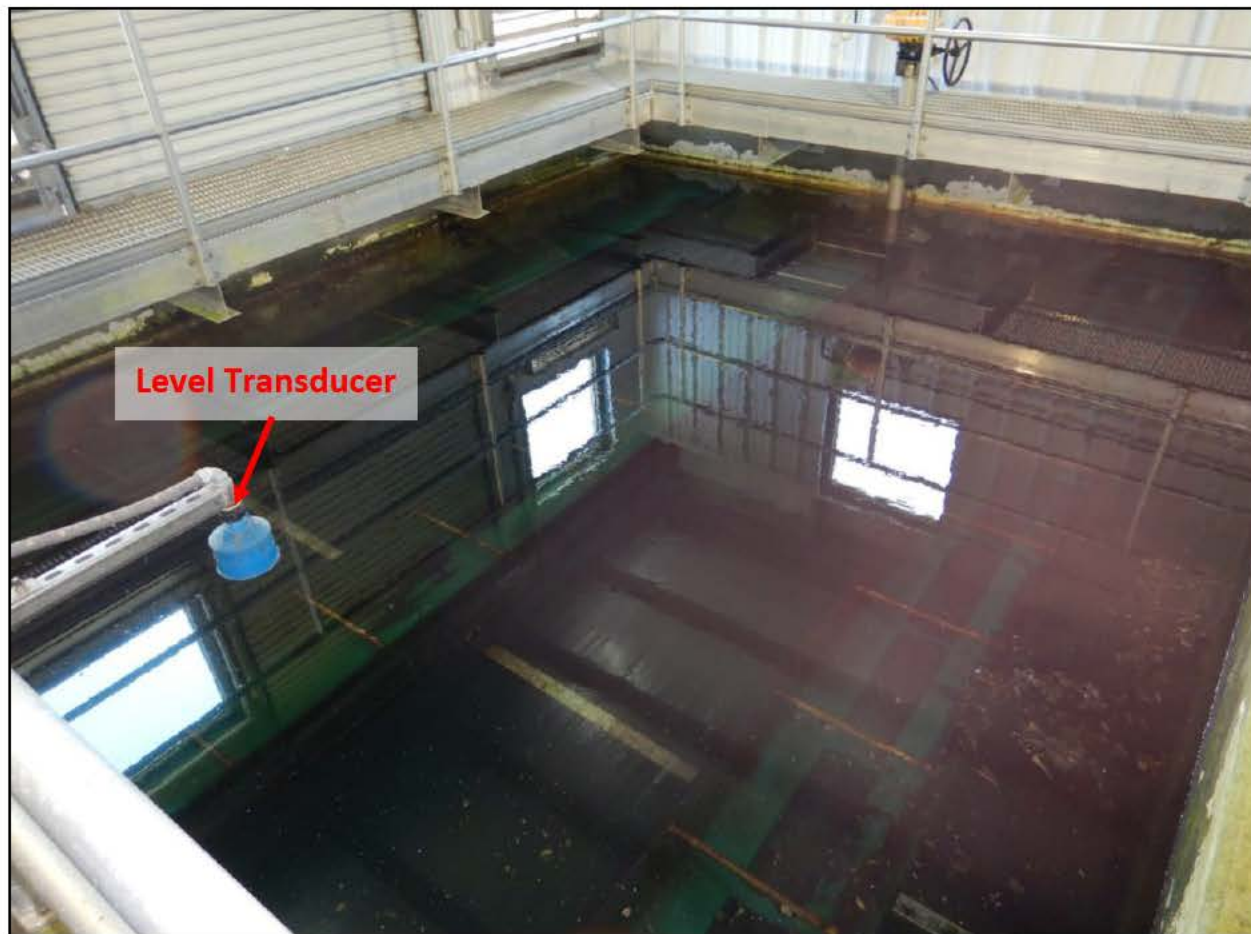
**Photograph 24. Filter No. 2, Ouachita WTP** View of Filter No. 2 at the Ouachita WTP. There are nine total filters at the WTP, and each contains a level transducer which determines when a backwash cycle should occur.

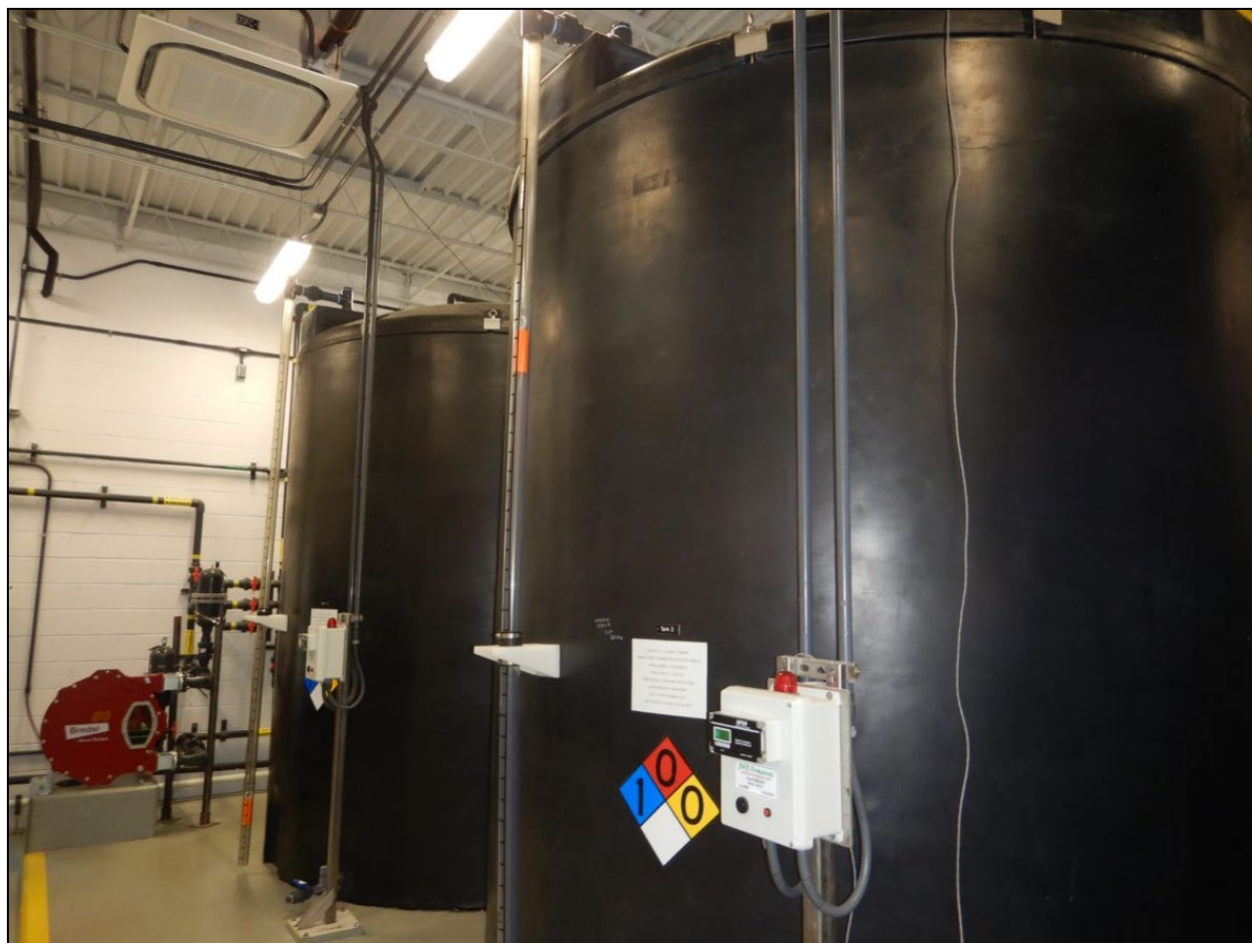
**Photograph 25. Sodium Hydroxide Storage Room, Ouachita WTP** View of the two, sodium hydroxide storage tanks at the Ouachita WTP. There were electronic level indicators present next to each of the tanks.

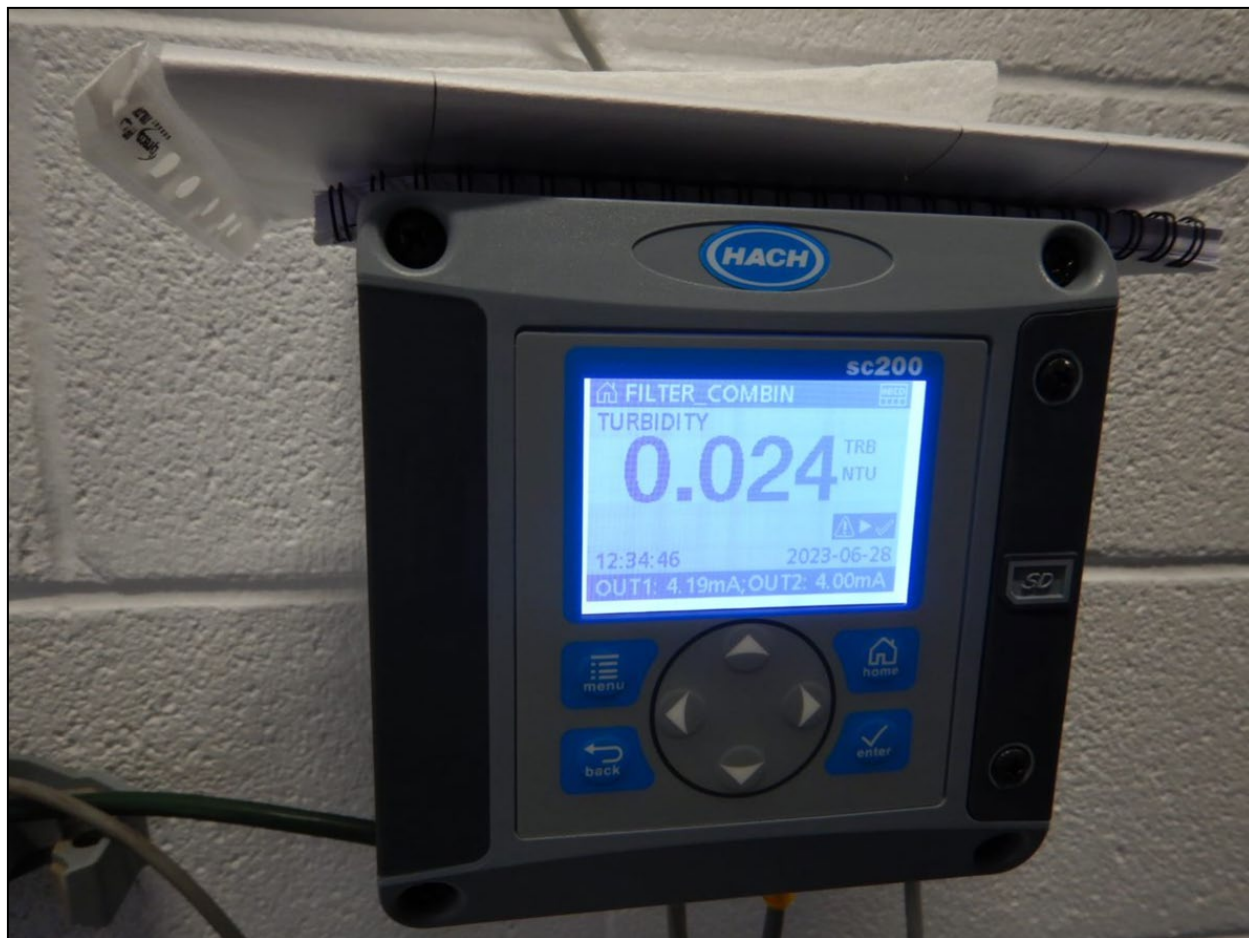
**Photograph 26. Combined Filter Effluent Turbidimeter** View of the combined filter effluent turbidimeter that was present inside of the sodium hydroxide storage room. The turbidimeter was reading 0.024 NTU at 12:34 p.m., and System representatives stated that this reading came from a common effluent line extending from the filters.

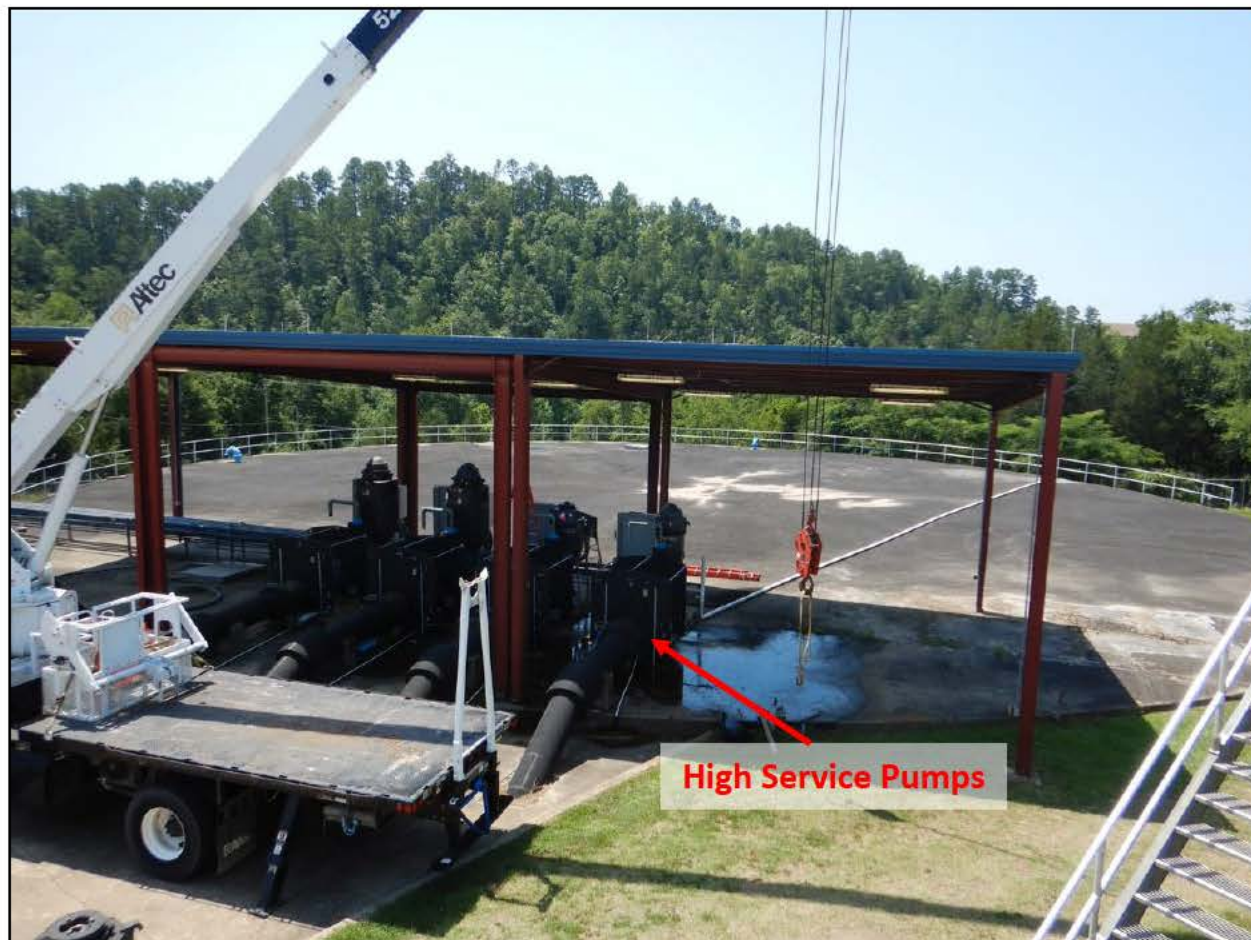
**Photograph 27. Clear Well #3, Ouachita WTP** View of the 2,000,000gallon Clear Well #3 that was present onsite at the Ouachita WTP. Also visible in this image are the four, high service pumps that send treated water into the distribution system.

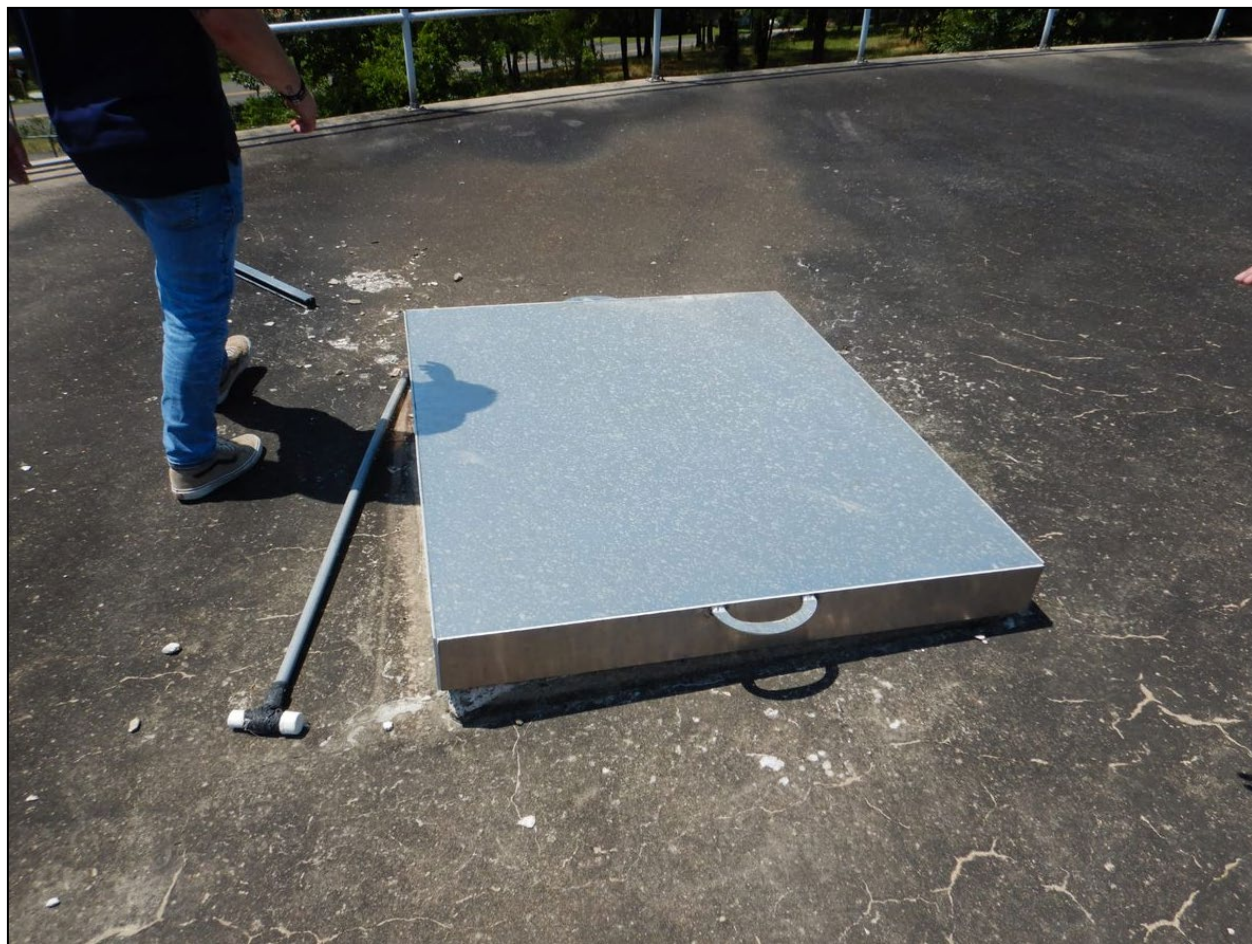
**Photograph 28. Hatchway, Clear Well #3** View of the elevated hatchway leading to Clear Well #3 that was covered by a loose-fitting, shoebox style lid.

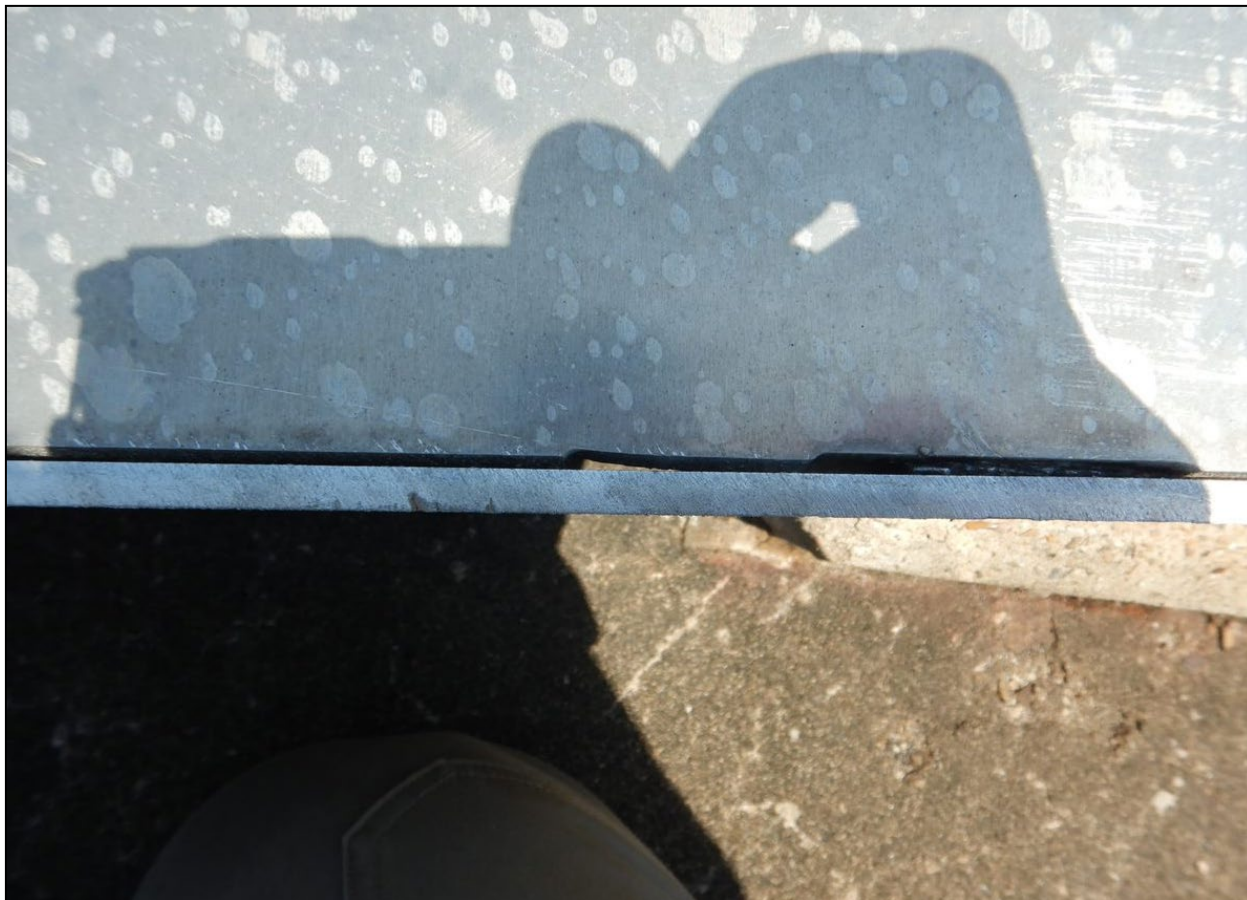
**Photograph 29. Shoebox Lid, Clear Well #3 Hatchway** Close up view of the seam of the shoebox lid covering the elevated hatchway leading to Clear Well #3. There was a crack in the seam that would allow rainwater to get through.

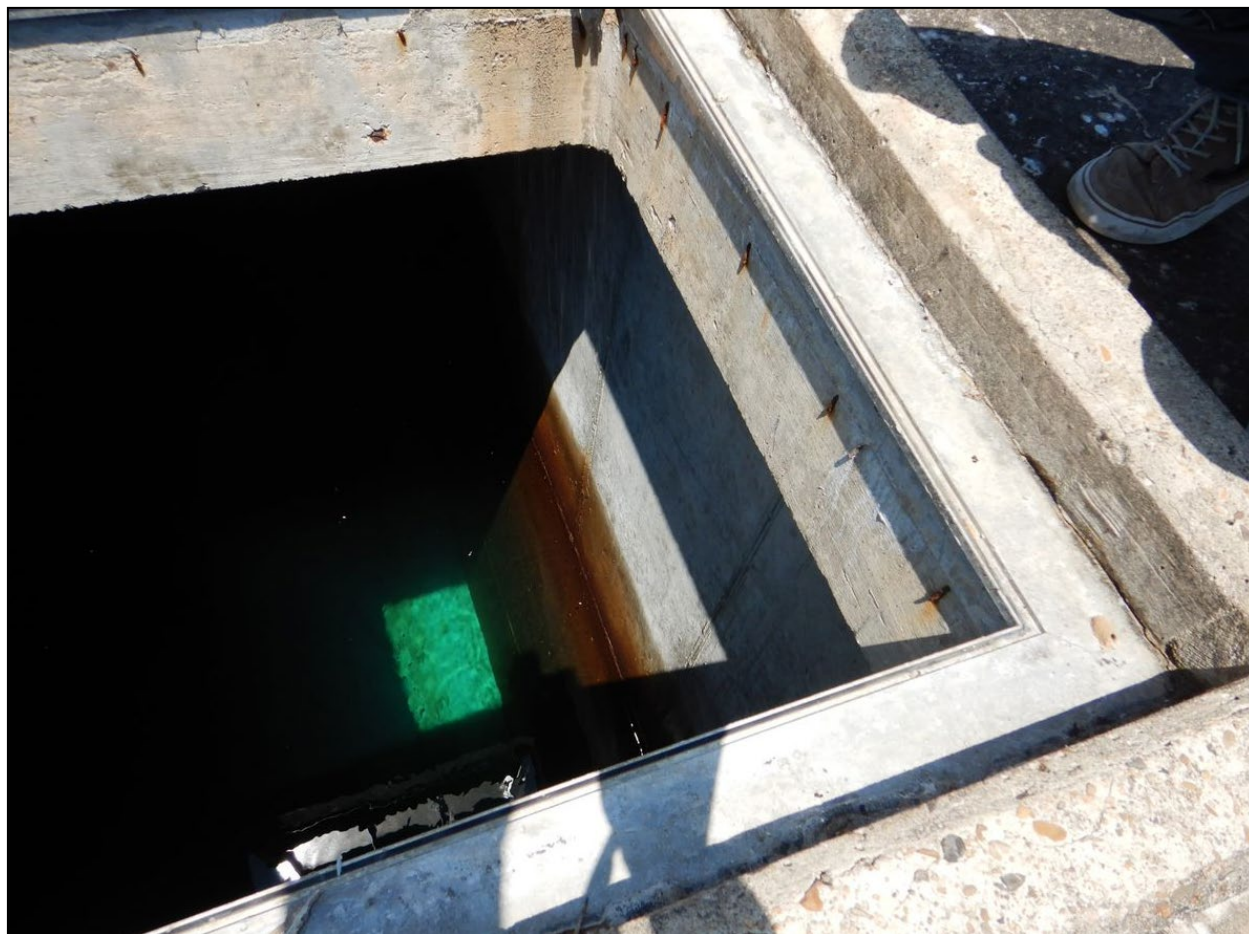
**Photograph 30. Hatchway, Clear Well #3** View the inside of the elevated hatchway leading to Clear Well #3. The inside of the hatchway did not contain drainage, and the lid was flush with the top of the tank. If water were to get inside of the lid, it appeared that it would pool over the hatch and possibly get into the clear well.

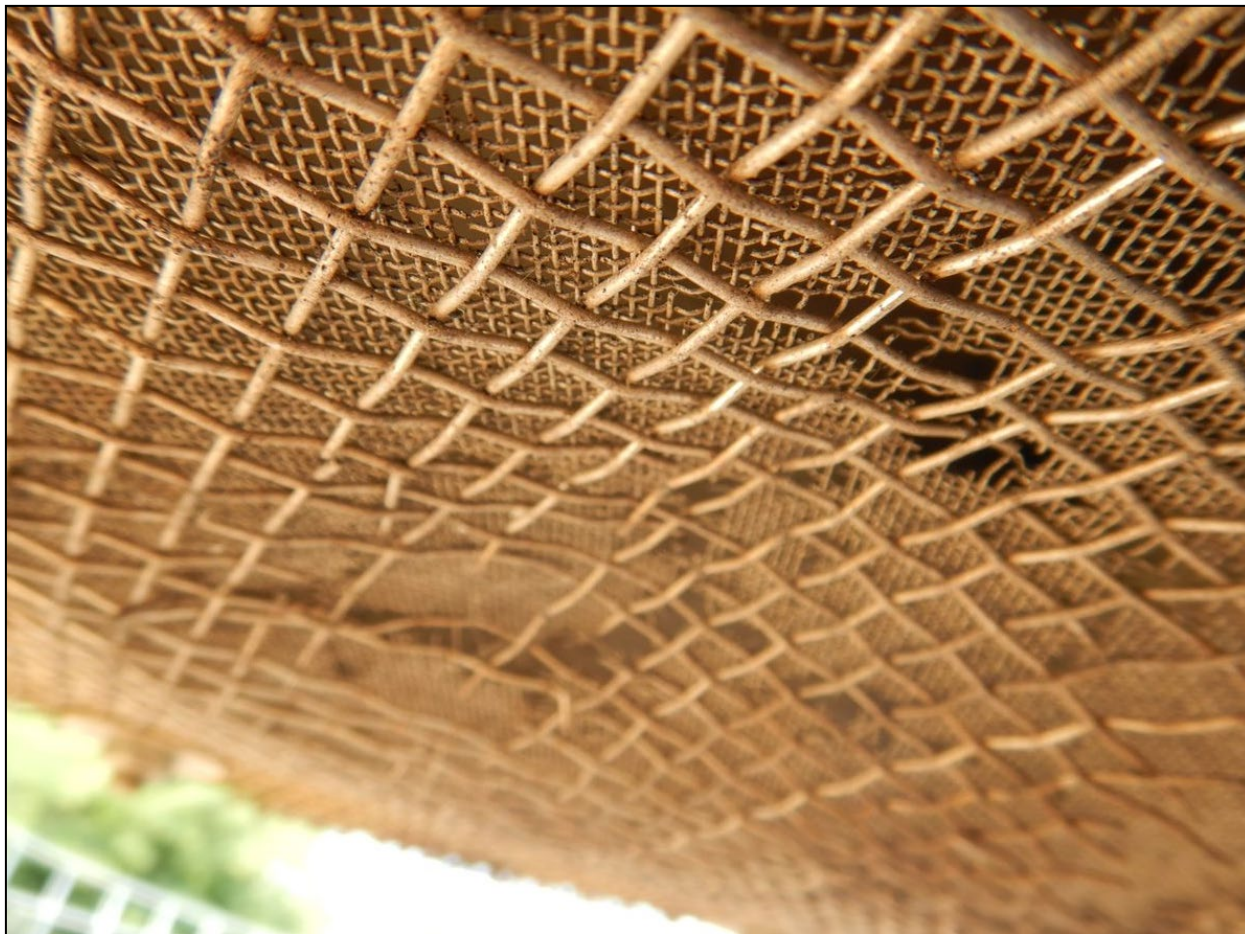
**Photograph 31. Air Vent, Clear Well #3** View of the mesh screen covering the opening top one of the air vents on top of Clear Well #3. The screen was ripped and had holes.

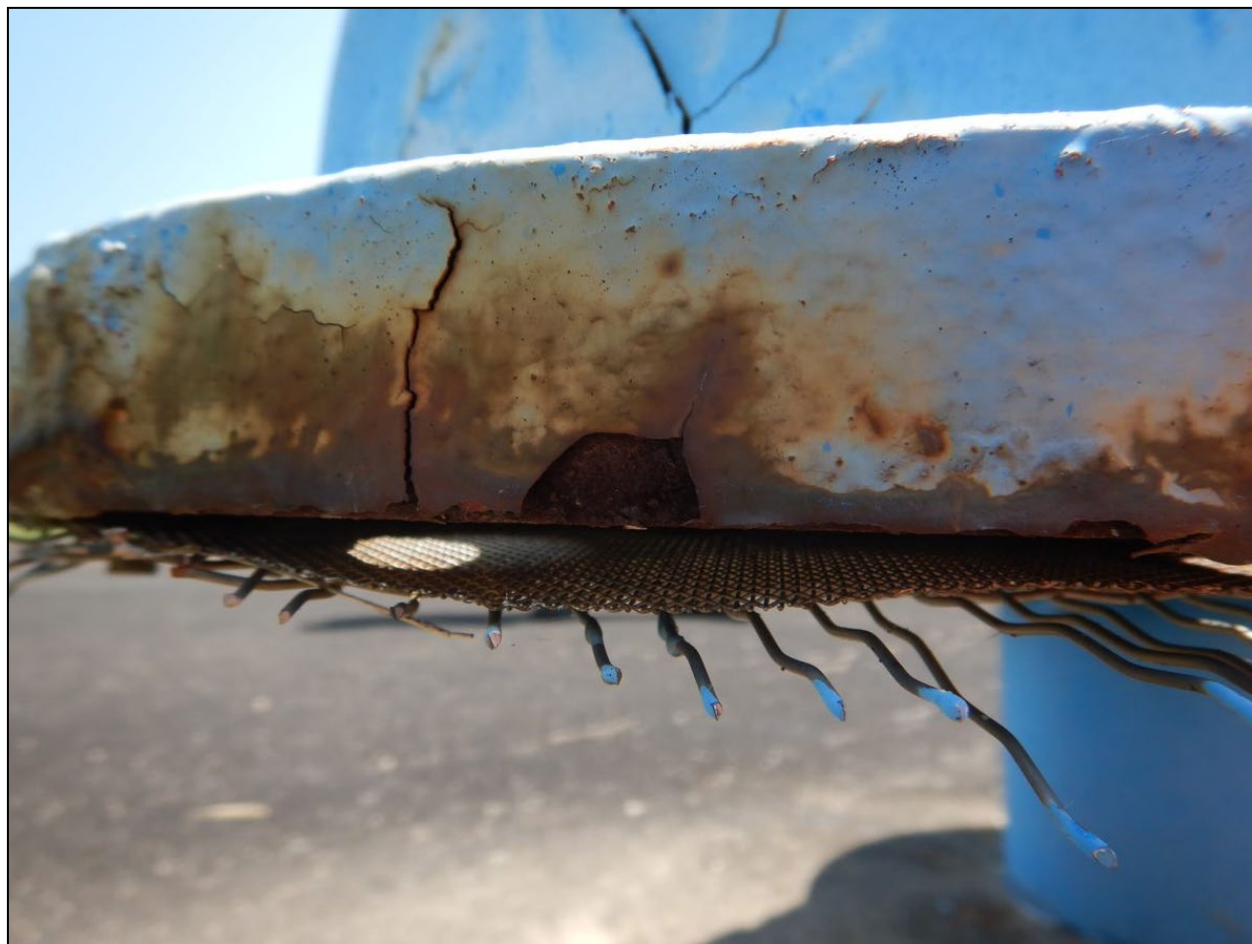
**Photograph 32. Air Vent, Clear Well #3** Side view of a mesh screen covering the opening top one of the air vents on top of Clear Well #3. The screen was not securely fastened to the opening, creating a large hole.

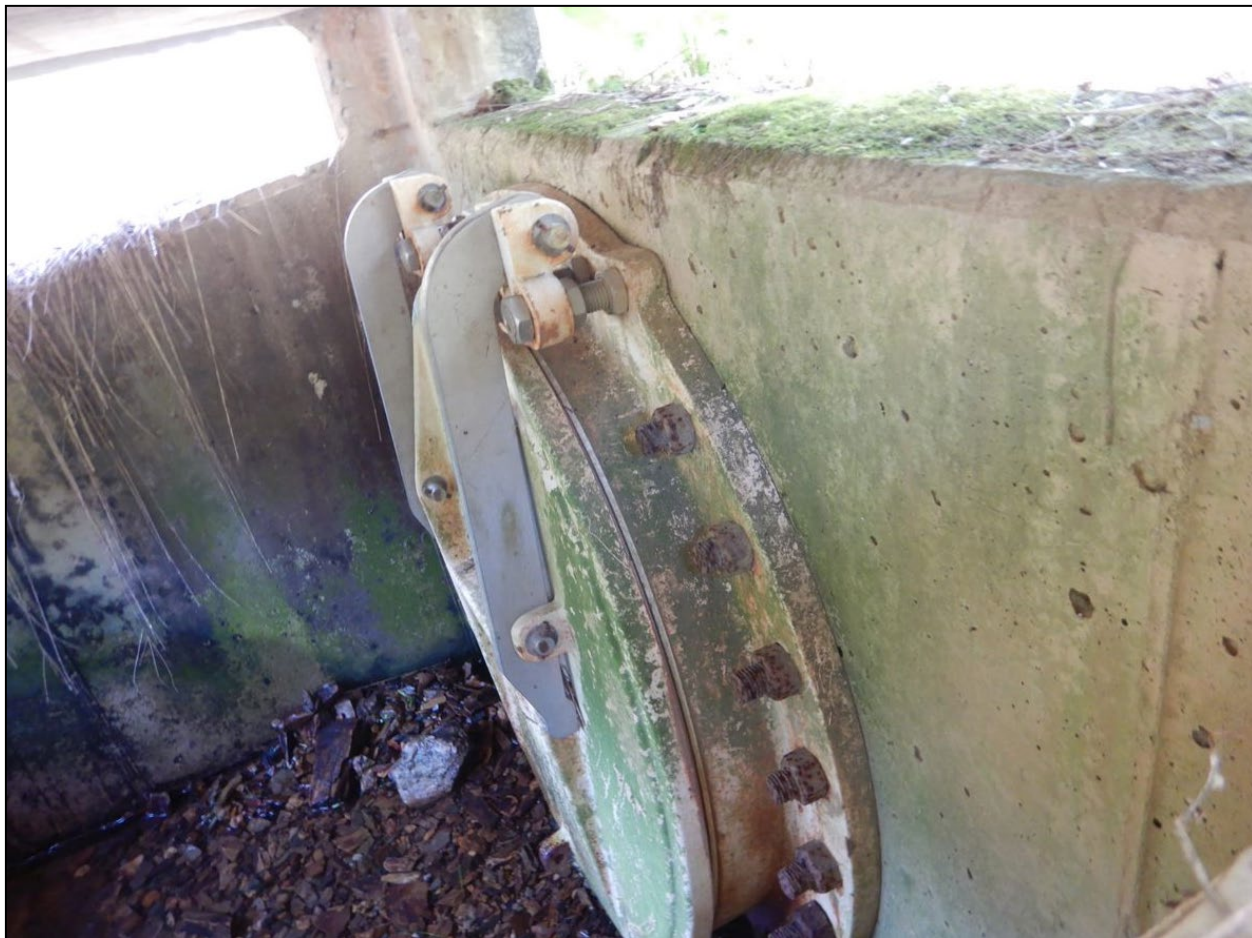
**Photograph 33. Overflow Pipe, Clear Well #3** View the end of the overflow pipe that extended from Clear Well #3 and terminated below grade under a manhole. A flapper was covering the end of the pipe and it had a tight seal.

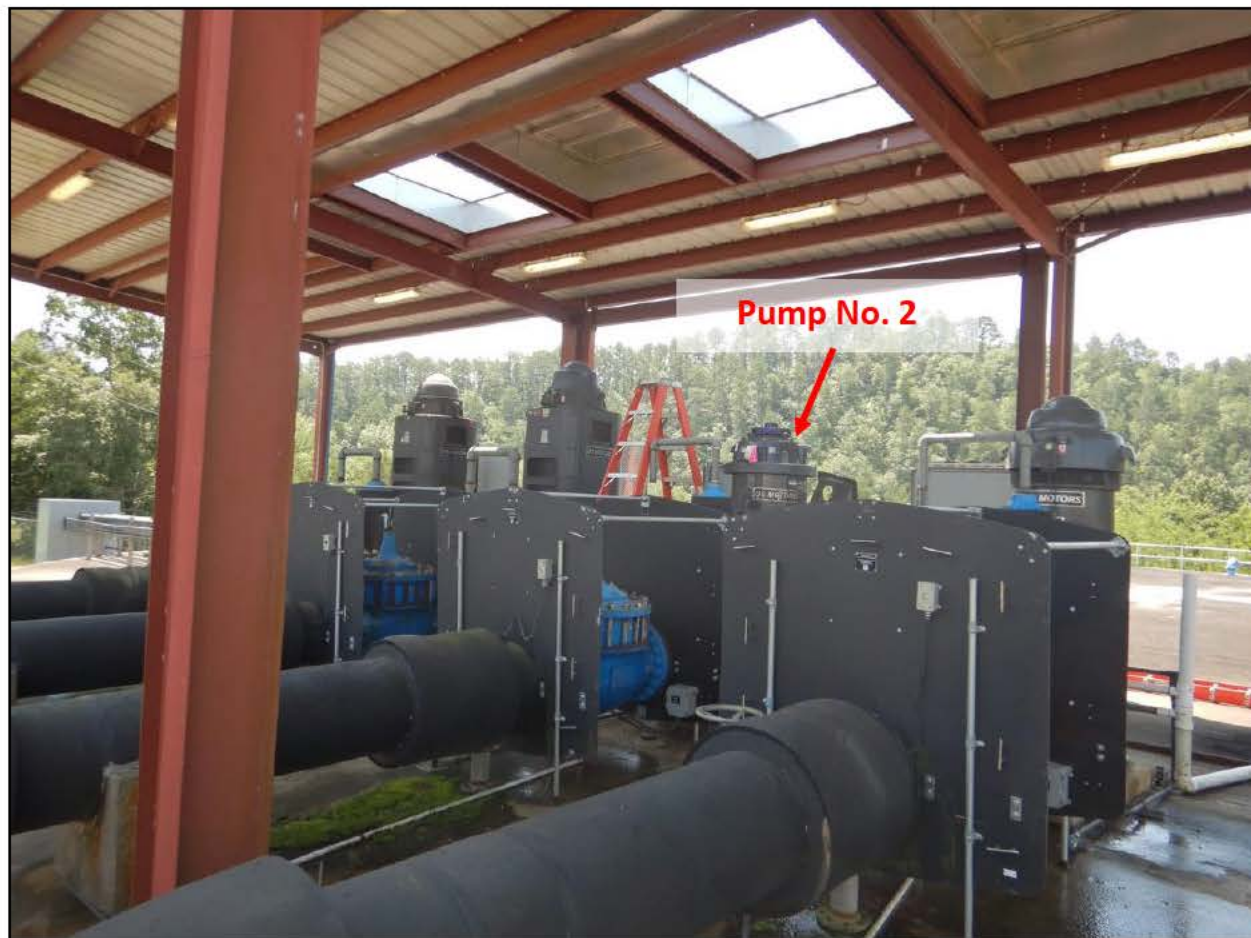
**Photograph 34. High Service Pumps, Ouachita WTP** View of the four high service pumps that are used to pump finished water from Clear Well #3 into the distribution system. Pump No. 2 was offline during the inspection because the motor was being repaired.

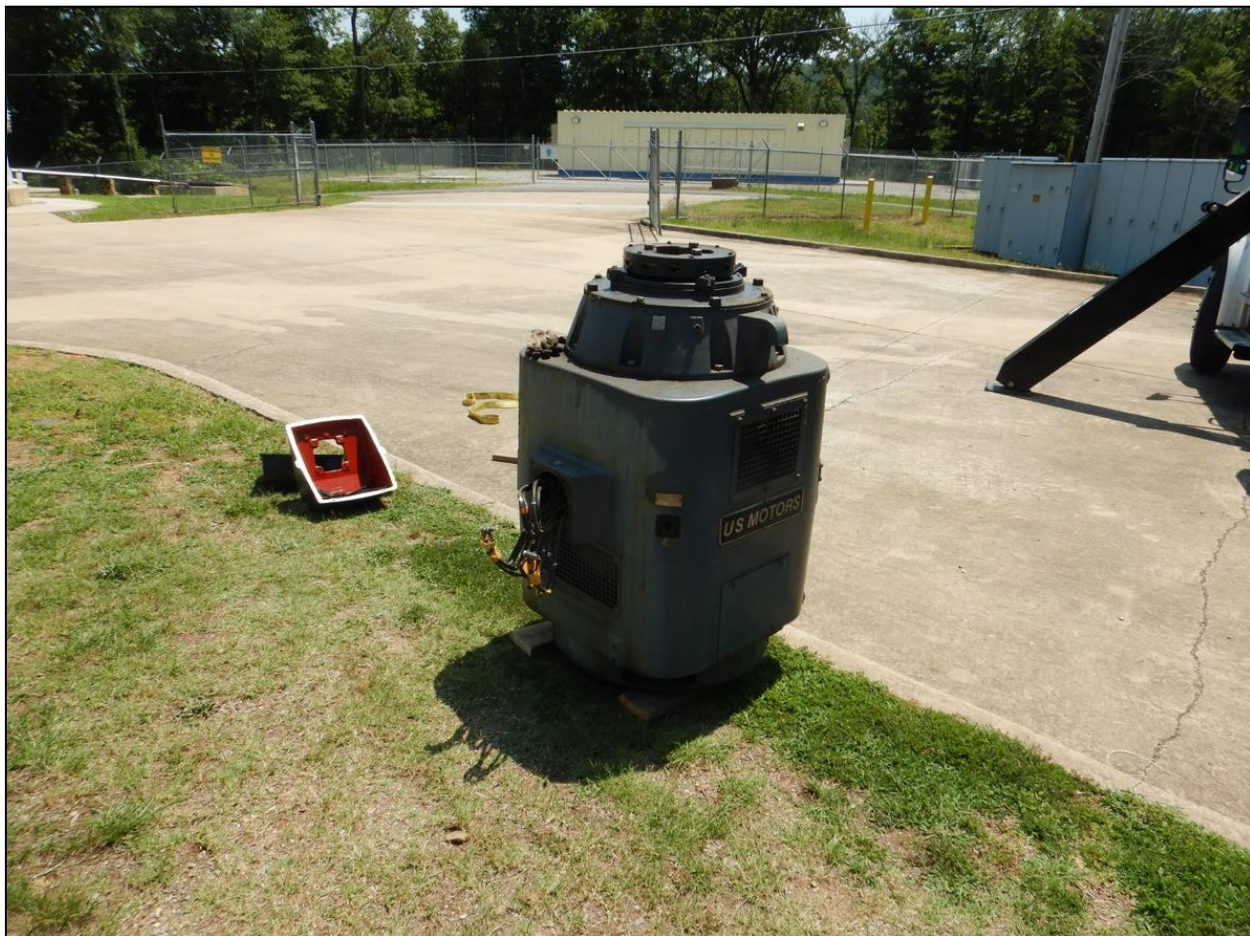
**Photograph 35. Pump No. 2 Motor** View of the high service Pump No. 2 motor was sitting on the ground next to the other pumps because it was under repair.

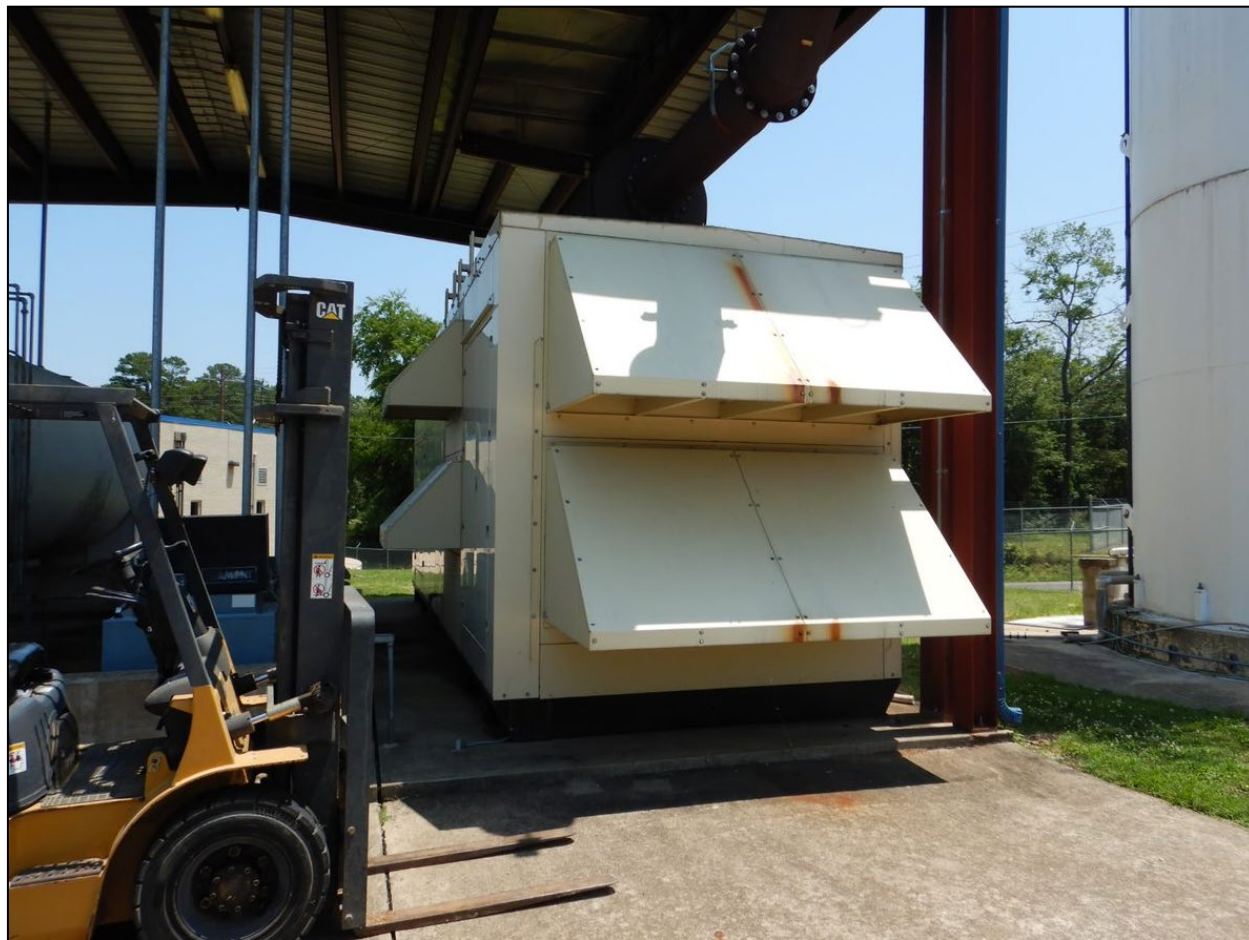
Lastly, the mounted 2.0 MW backup generator was observed (refer to [Appendix 2, Photograph 36](#)). The Water Production Manager stated that the generator could handle the full load of the WTP in the event of a power outage, and that the generator would turn on automatically. He stated that the generator was load tested every Wednesday.

**Photograph 36. Mounted Generator, Ouachita WTP** View of the mounted 2.0 MW backup generator at the Ouachita WTP. The Water Production Manager stated that the generator could handle the full load of the WTP in the event of a power outage, and that the generator would turn on automatically.

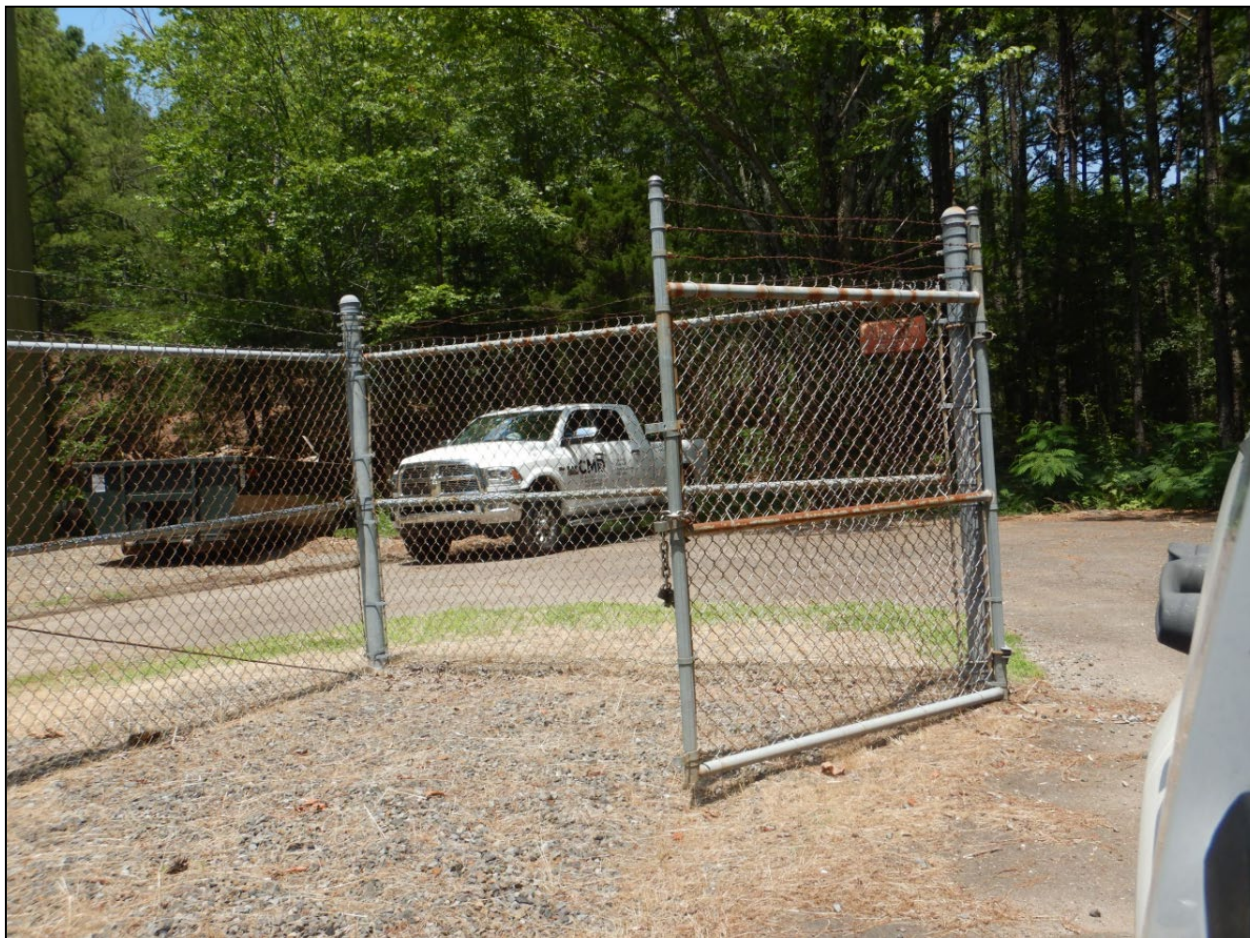
**Photograph 37. Perimeter Fence, Music Mountain Property** View of the perimeter fence that contained barbed wire surrounding the Music Mountain property. The fence was locked when the EPA Inspector arrived.
